HURRICANE ANDREW STORM SUMMARY AND IMPACTS ON THE BEACHES OF FLORIDA SPECIAL REPORT

**US Army Corps
of Engineers**
Jacksonville District

**Florida Department of
Natural Resources**
Division of Beaches and Shores

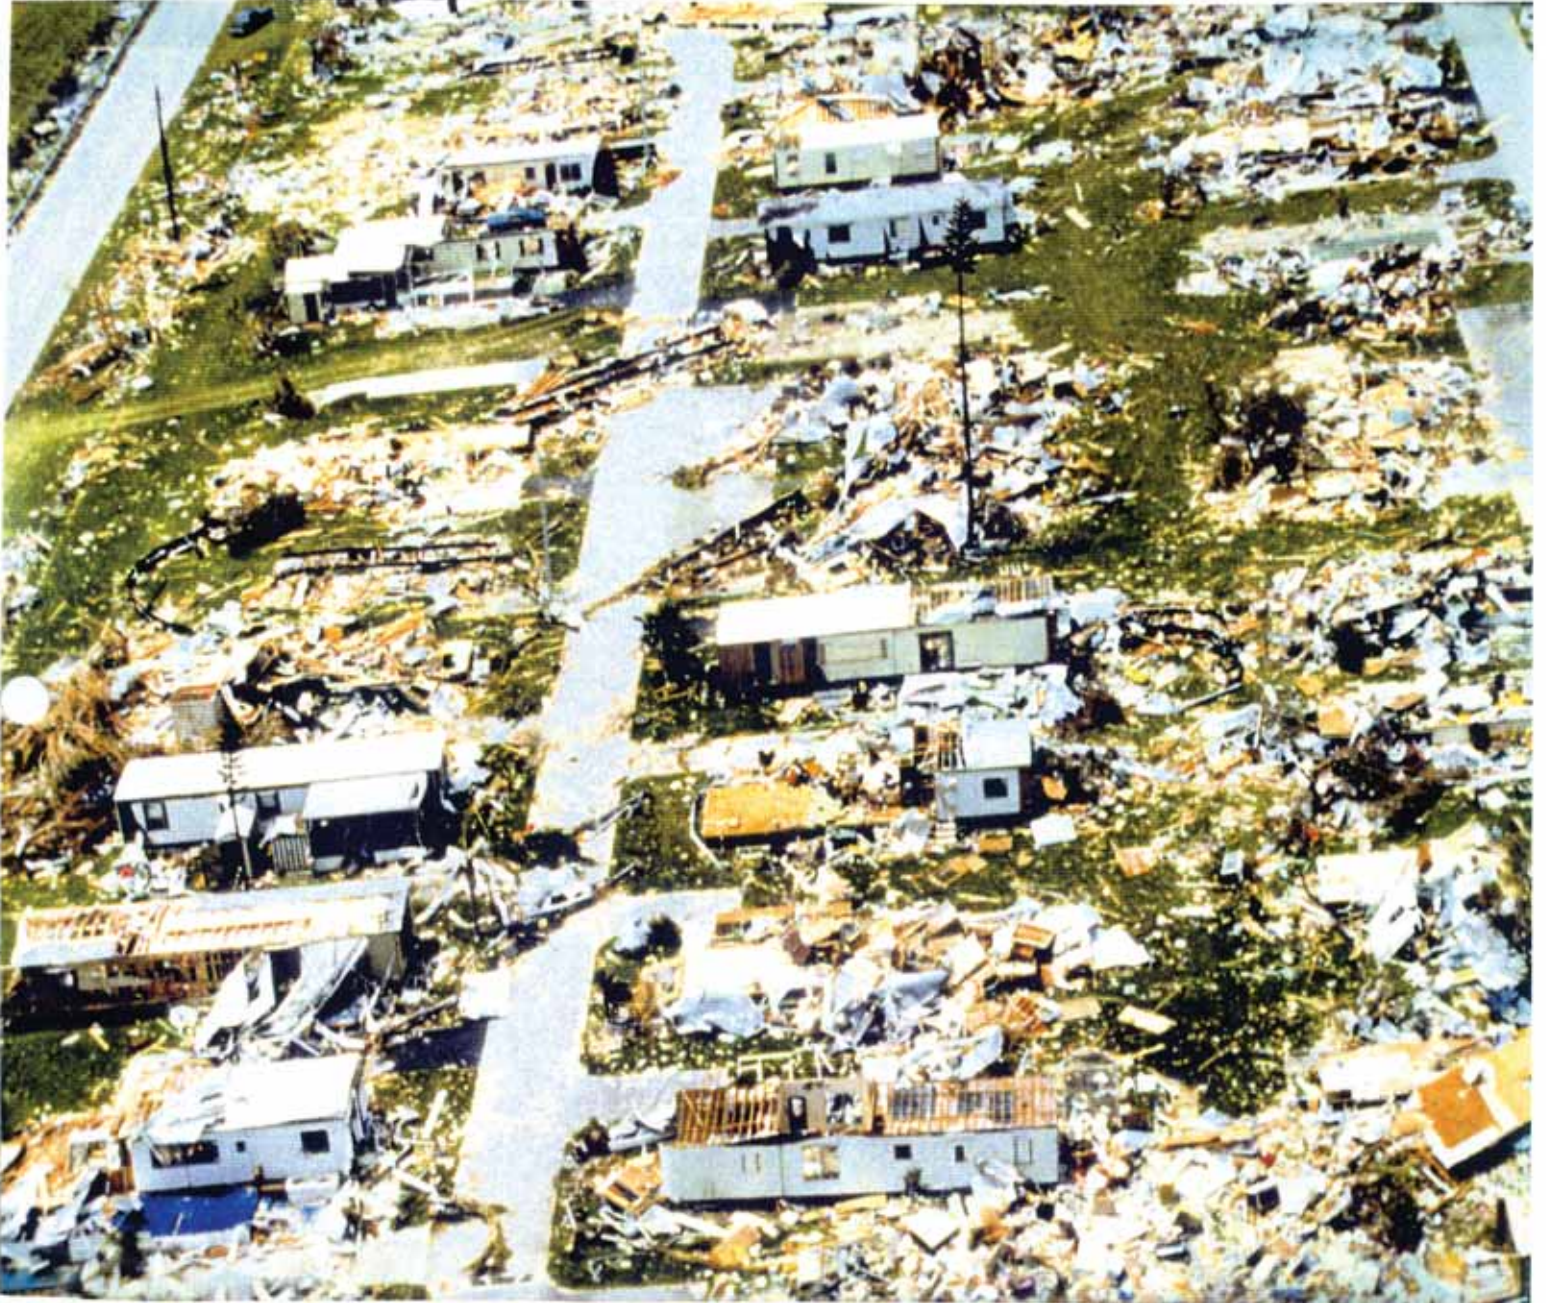
FIGURE 16
DAMAGE TO MOBILE HOMES

10. The county has documented impacts to over 50 percent of the artificial reefs. These impacts are listed in Table 4. Slight to moderate impacts were noted to the near shore reef system. Moderate impacts were found to offshore reef areas at the 65-75 foot depth. Slight to moderate impacts were found in reef areas at the 45-55 foot depth. Slight impacts were found to reef areas in less than 40 feet, with exceptions. Figures 16 through 19 depict damages to mobile homes, town homes, duplexes, and single family homes, respectively.

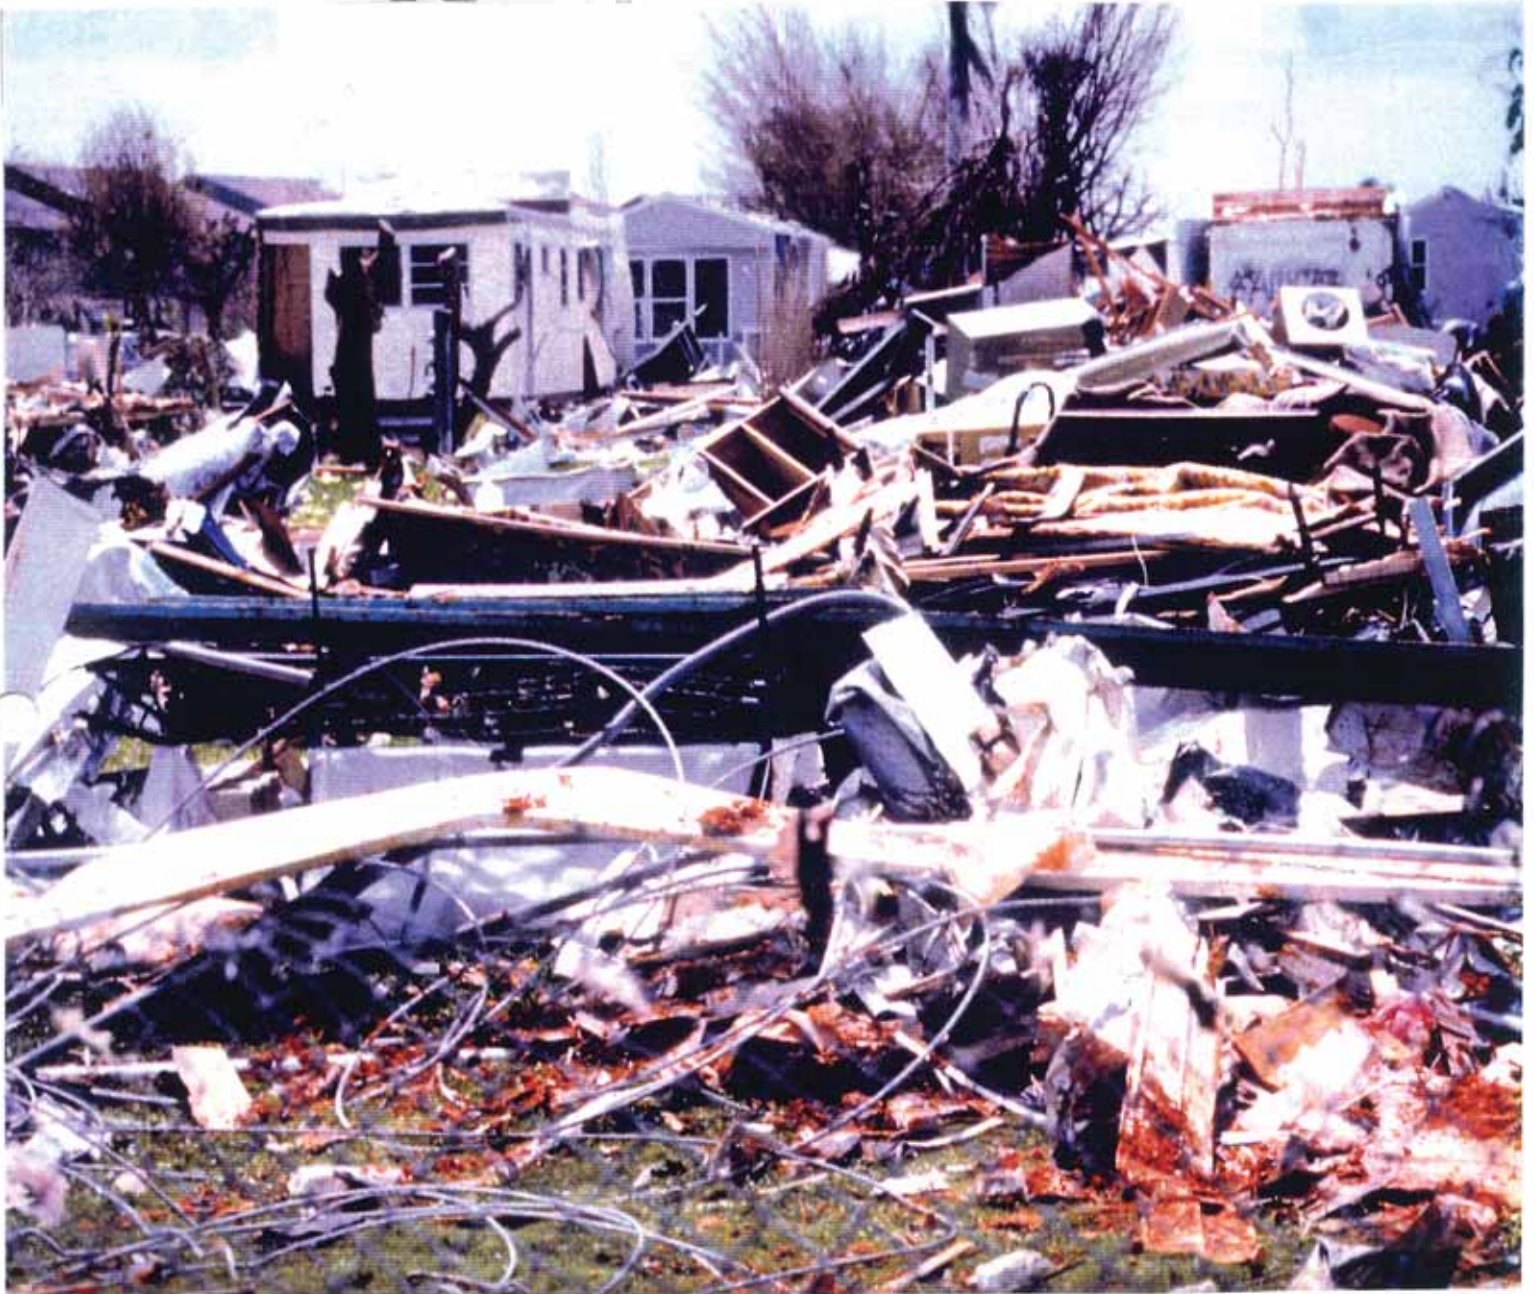
FIGURE 23
DEBRIS

19. Construction and demolition material is estimated at 1.3 million cubic yards of debris, equivalent to 13 Nimitz class aircraft carriers. A total of 39 burn sites have been approved by Dade County. Figure 25 shows a typical burn site. HARO had responsibility for removal of sunken vessels in and around four marinas. The debris removal work is continuing, with an estimated completion date of November 1993.

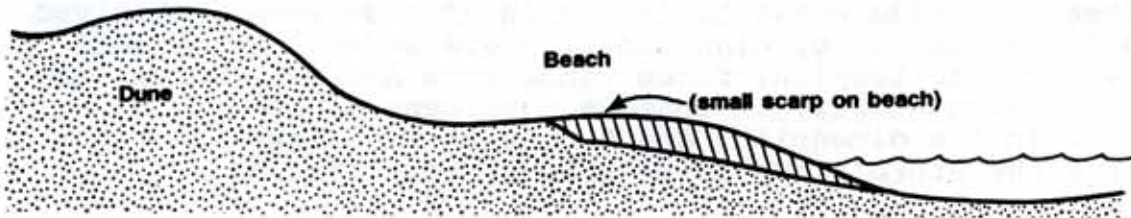
CONDITION I: MINOR BEACH EROSION

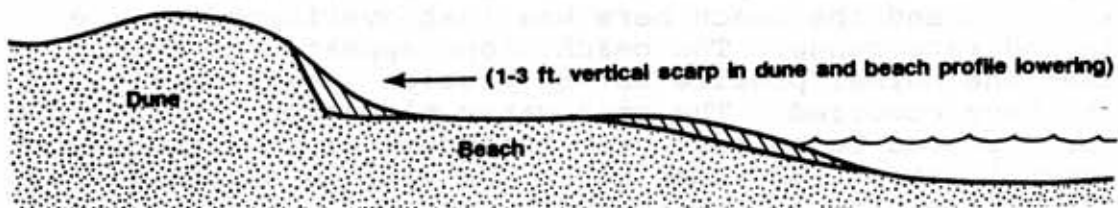
CONDITION II: MINOR DUNE AND BEACH EROSION

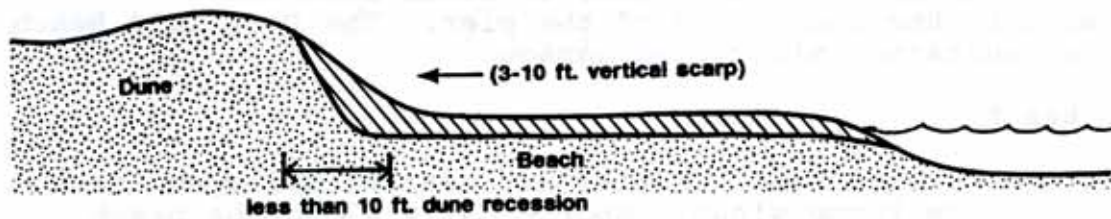
CONDITION III: MODERATE DUNE EROSION AND BEACH PROFILE LOWERING

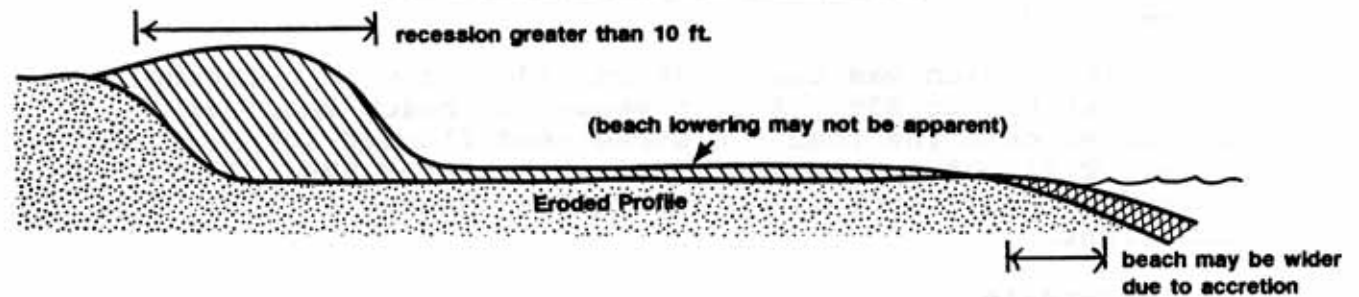
CONDITION IV: MAJOR DUNE EROSION
