MEMORANDUM

SUBJECT: April 2019 Supplemental Site Assessment Results and Recommendations
Rolling Hills Construction and Demolition (C&D) Debris Disposal Facility
6990 Rolling Hills Road
Pensacola, Escambia County, Florida

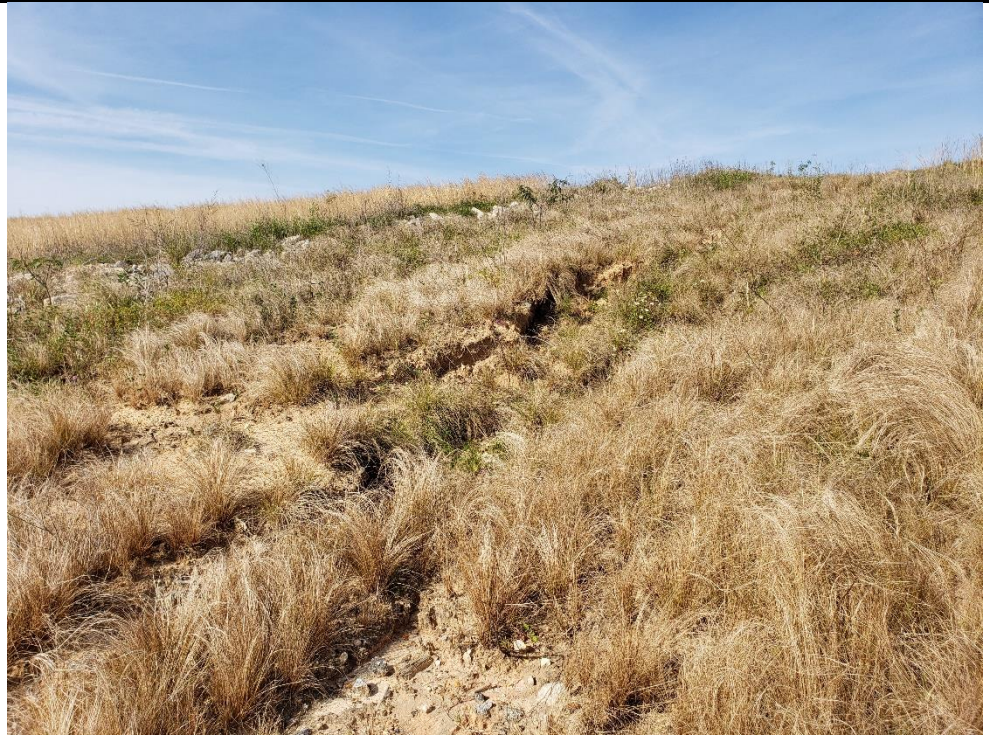
View of rill erosion at West Slope that is partially obscured by vegetation.

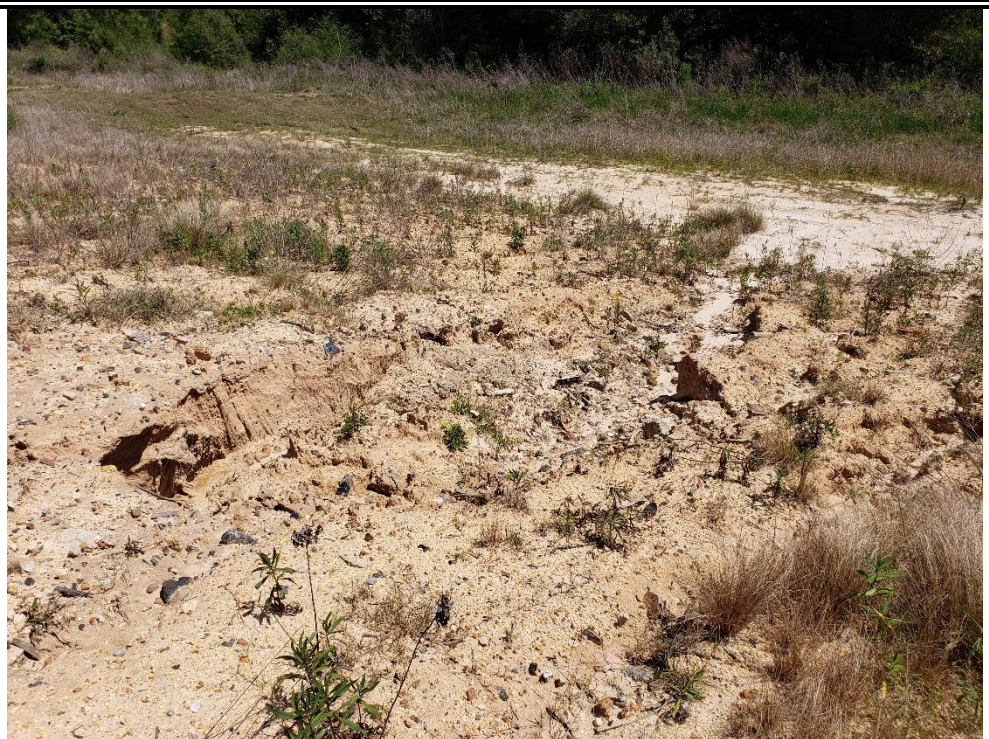
Photograph 2

Foreground – View of rill erosion along East Slope. Background – View of accumulation of eroded cover soil material along toe of East Slope.

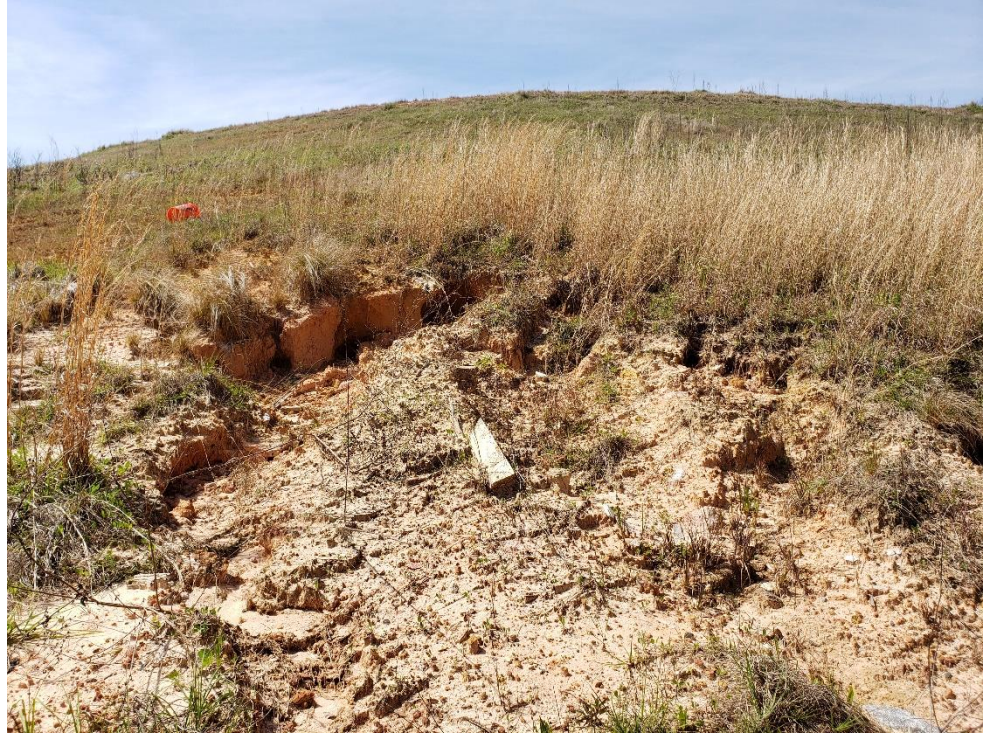
View of erosion and exposed C&D debris along the East Slope.

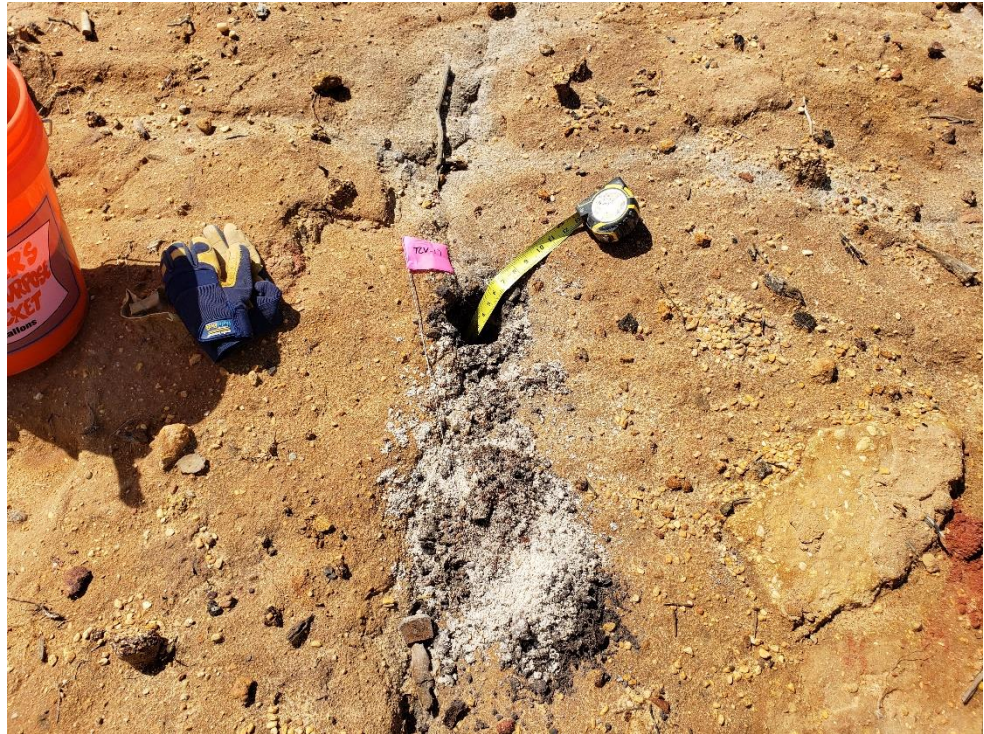
Photograph 4

View of cover soil thickness verification borehole (TCV-17) at East Slope. Cover soil thickness was verified using a tape measure which indicates a 6-inch thick cover soil at this location.

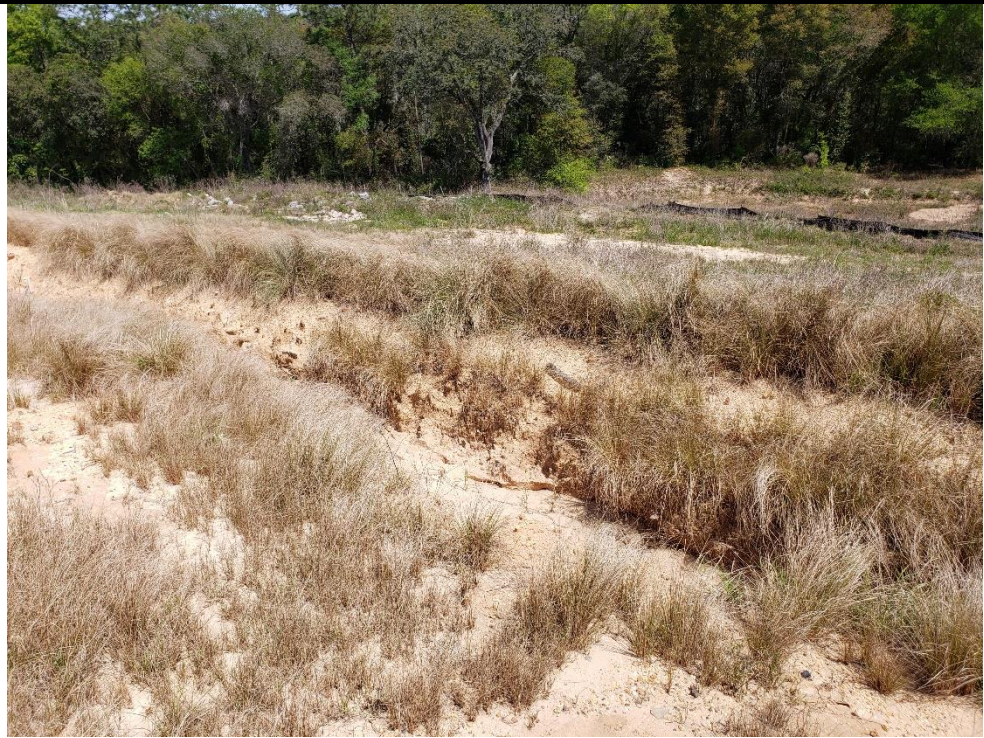
- The condition of the side slope bench (i.e., nearly the entire length) continues to deteriorate as channelized flow continues to erode material and fill the bench invert (see Photograph 5).
- The condition of the haul road has deteriorated, and sediments eroded from this area have accumulated in the perimeter stormwater channel, completely obscuring one of two culvert pipes under the road crossing (see Photograph 6).

View of poor vegetative cover at sideslope bench on East Slope, allowing continued erosion to the cover system.

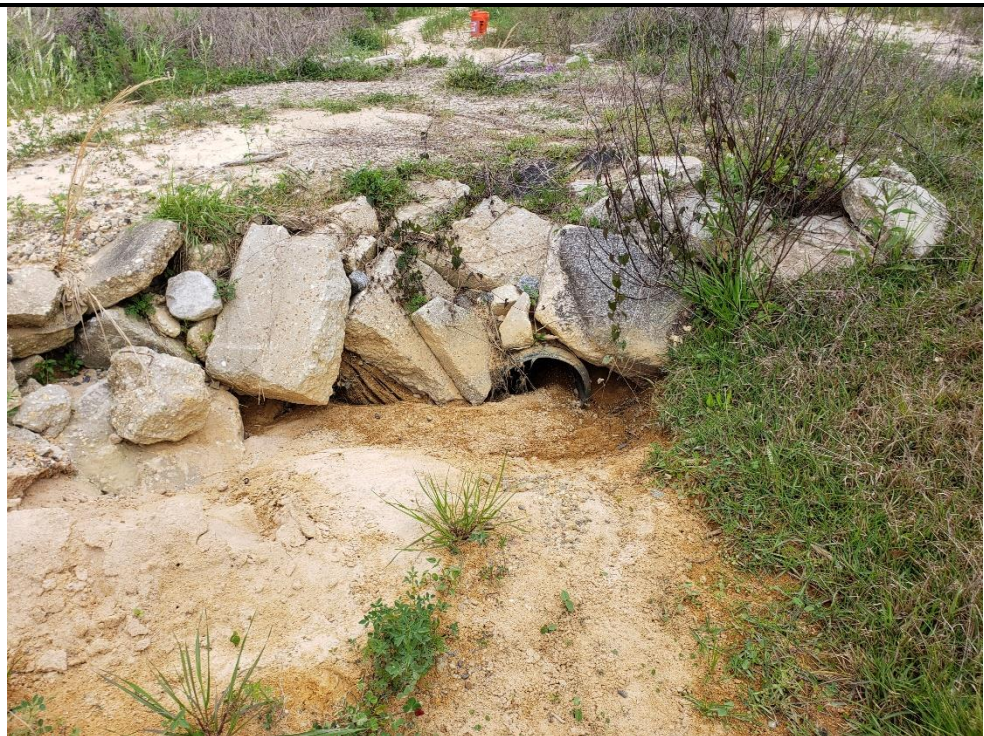
Photograph 6

View of obstructed culvert pipes at perimeter stormwater channel at haul road crossing. Note, the left pipe has been completely obstructed by sediments and displaced geotextile fabric.

7. The culvert pipes under the road crossing should be flushed to allow unimpeded stormwater conveyance.
8. It is understood that FDEP is requesting an aggressive construction schedule to complete Site closure as soon as possible. It is recommended that FDEP consider postponing the start of construction to seasonally drier months (e.g., November, December, etc.) to avoid unanticipated weather delays and possible rework of completed construction activities.

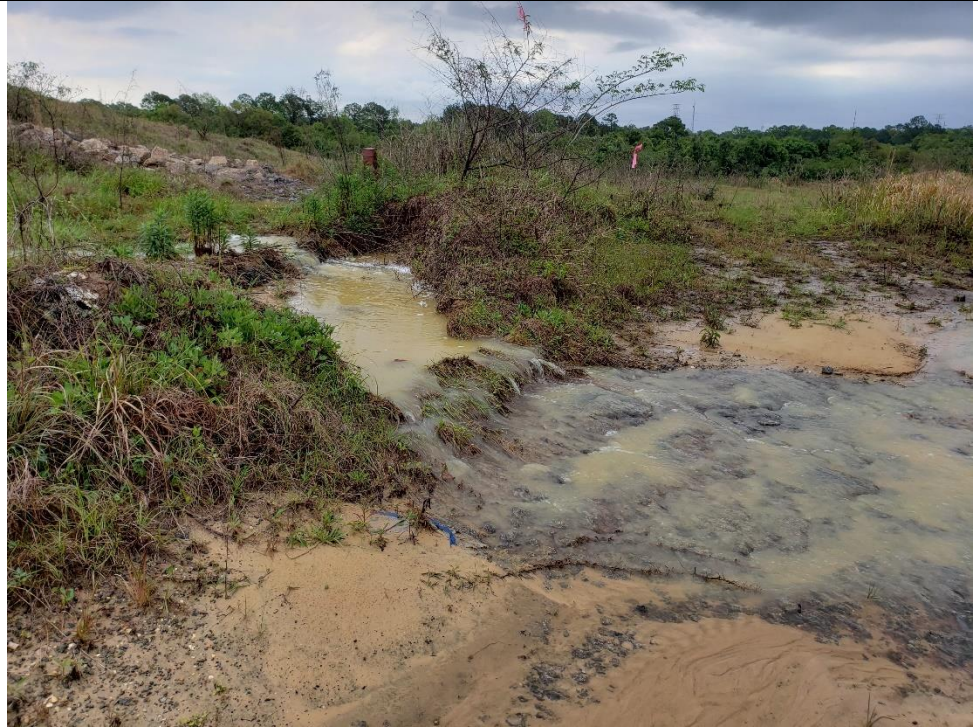
- Two (2) blowouts of the perimeter berm where stormwater was observed discharging from the perimeter channel (see Photographs 7 and 9).
- Portions of the perimeter access road exhibited significant erosion of road material due to breaches of the perimeter berm (see Photographs 8 and 10).
- Isolated areas of significant erosion (i.e., rills greater than 12 inches deep) of the cover system have developed on the East and West Slopes (see Photographs 1 to 3).
- Erosion was observed at the south extent of the stormwater retention pond embankment.
- The condition of the perimeter stormwater channel appears to have degraded, with a majority of the channel (i.e., nearly the entire length) now exhibiting some sediment deposits, displaced turf reinforcement mat (TRM) and underlying soils, and/or soft or yielding soils along the channel bottom. (see Photograph 12).

View of breach of perimeter berm (to left of photo) in southwest corner of West Slope and stormwater flow exiting to perimeter access road.

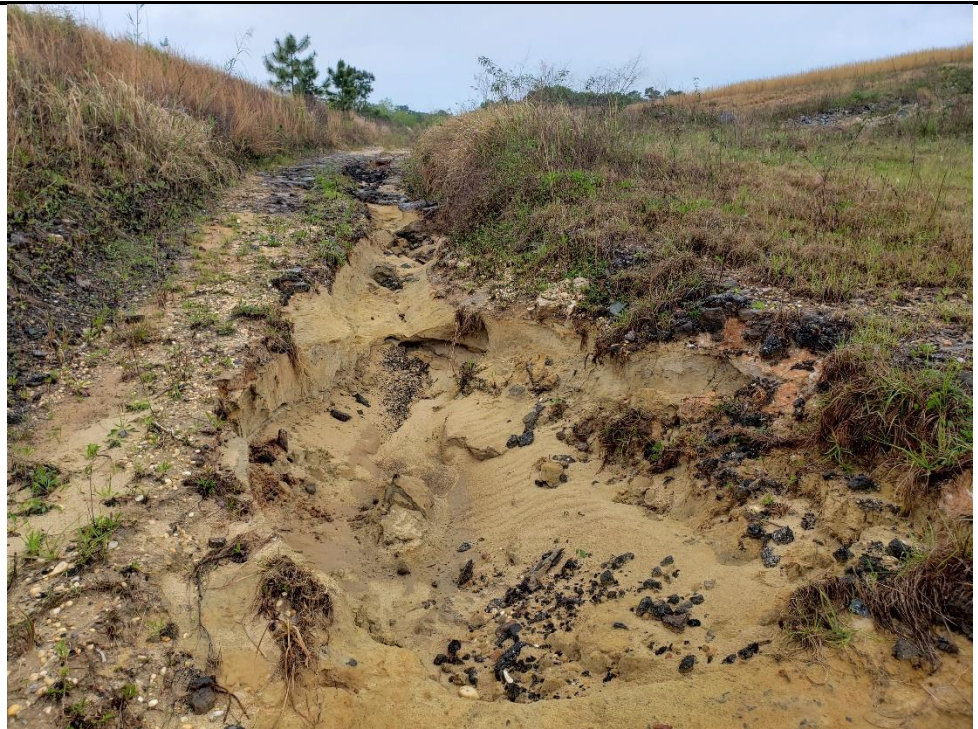
Photograph 8

View of significant erosion of perimeter access road material (located downstream from breach noted in Photograph 7) caused by stormwater exiting perimeter stormwater channel.

6. Following repairs to the perimeter stormwater channel, the perimeter access road should be repaired with comparable road materials to allow vehicular access.

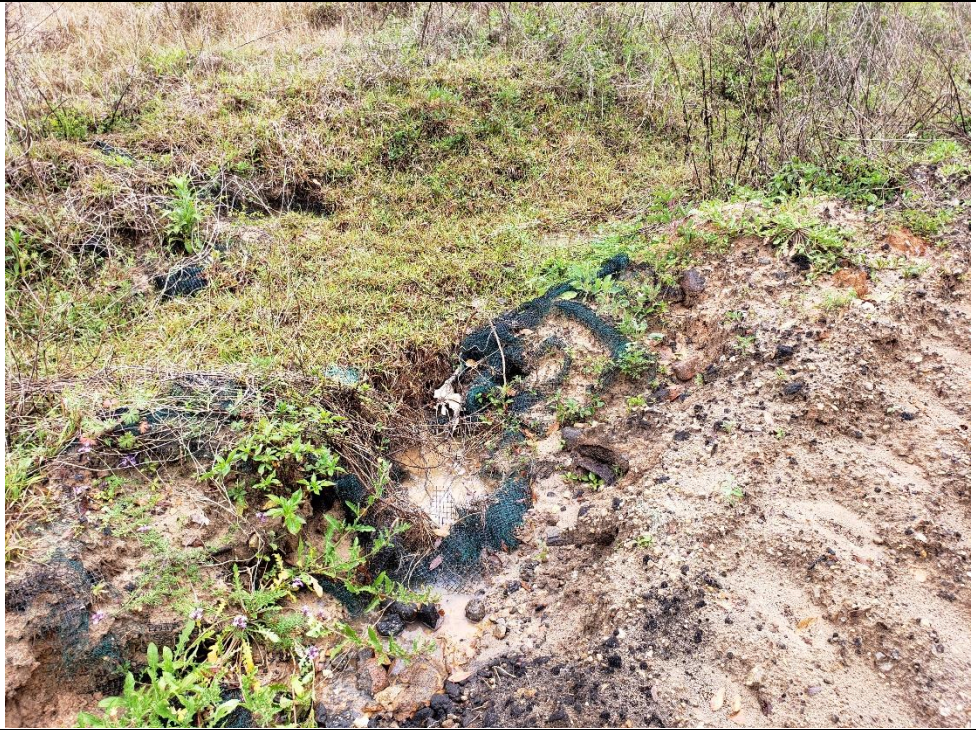
View of breach of perimeter berm and exposed TRM near boundary of North and East Slopes.

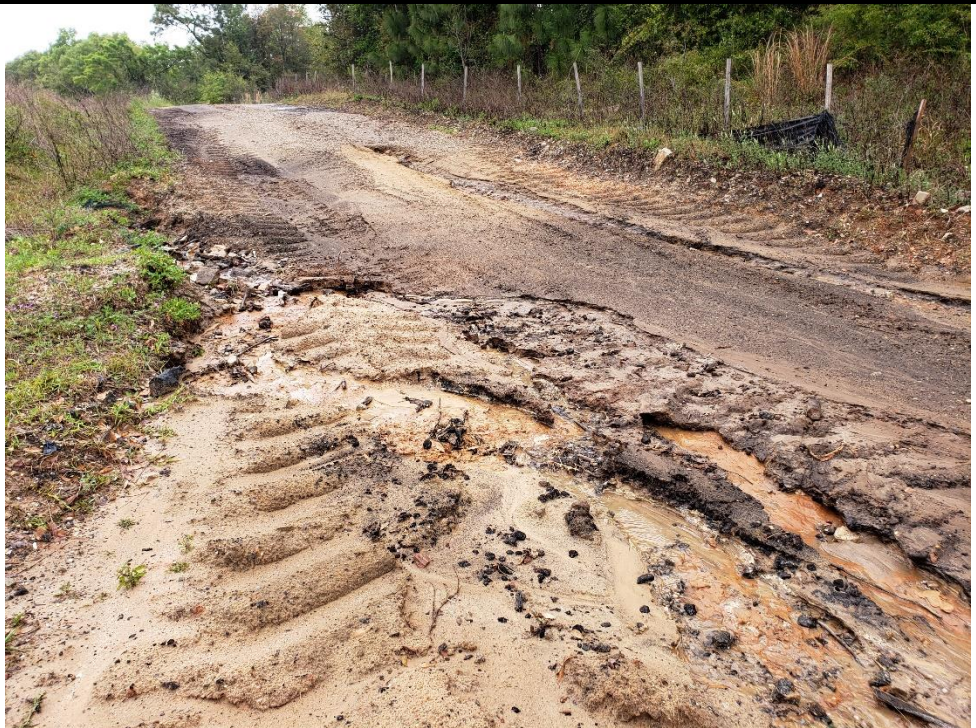
Photograph 10

View of erosion of perimeter access road (located downstream from breach noted in Photograph 9) caused by stormwater exiting perimeter stormwater channel.

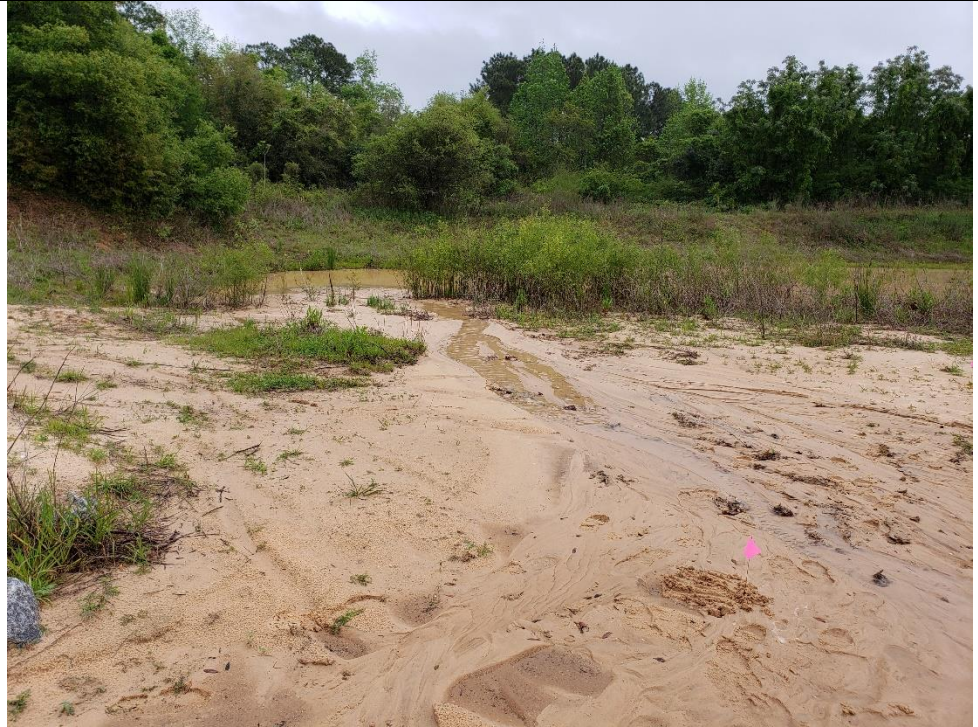
View of sediment accumulation in area of east stormwater channel (SWC-6) outlet. Foreground – pin flag marking the location of a verification boring to estimate the thickness of sediments in the stormwater retention pond.

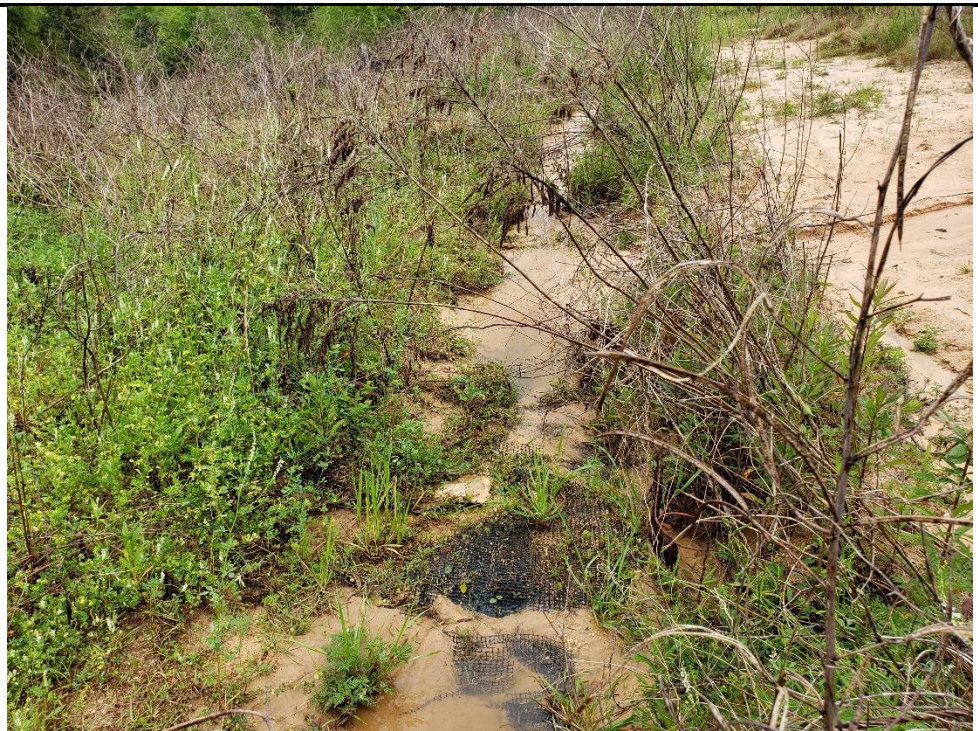
Photograph 12

View of perimeter stormwater channel located in the northeast corner of the East Slope. Background – displaced cover system soils impeding stormwater conveyance. Foreground – exposed TRM material.

4. A majority of the Site perimeter channel exhibited varying degrees of deficiency, including but not limited to: (i) impedance of stormwater conveyance due to sediment deposits; (ii) displacement of underlying soils and TRM; (iii) soft or yielding soils along the channel bottom; (iv) irregularity of channel grade (evidenced by pooling of stormwater); and (v) degradation of the perimeter berm. Due to the variability of deficiencies observed throughout the length of the channel, it is recommended that FDEP consider requesting a comprehensive linear foot unit rate to address the entire span of the channel (e.g., from SW-5 to SW-6) to restore positive stormwater conveyance and channel geometry in accordance with the May 2018 Closure Corrective Action Plan.
