Hurricane Dennis & *Hurricane Katrina*

Final Report on 2005 Hurricane Season Impacts to Northwest Florida

**Florida Department of Environmental Protection
Division of Water Resource Management
Bureau of Beaches and Coastal Systems
April 2006**

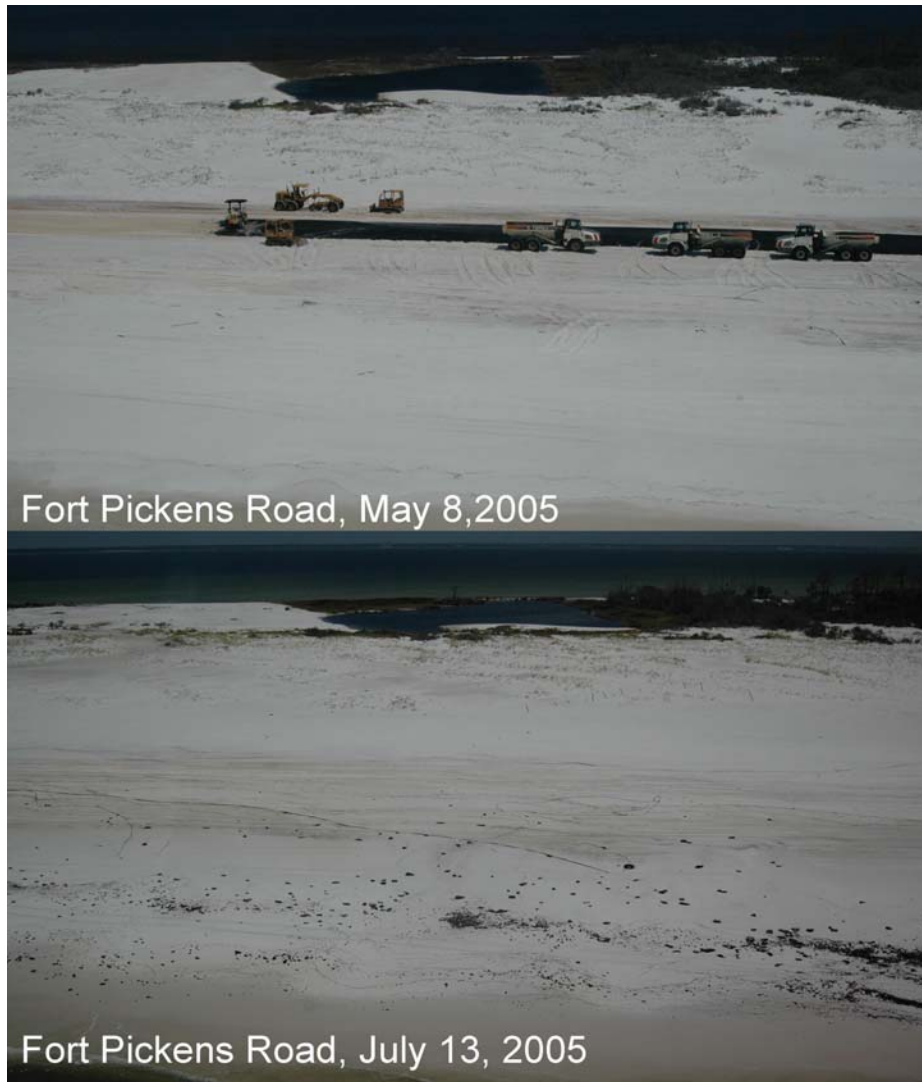
Hurricane Ivan (2004) destroyed five miles of park road and dunes on western Santa Rosa Island between Pensacola Beach and Fort Pickens. Post-storm reconstruction of the park road had just been completed when Tropical Storm Arlene damaged a quarter-mile segment of park road on June 11, 2005. One month later, Hurricane Dennis destroyed much of the new park road and buried most of it under sand overwash deposits for most of its seven-mile length (Photo 1).

Photo 1. Fort Pickens Road before and after Hurricane Dennis.

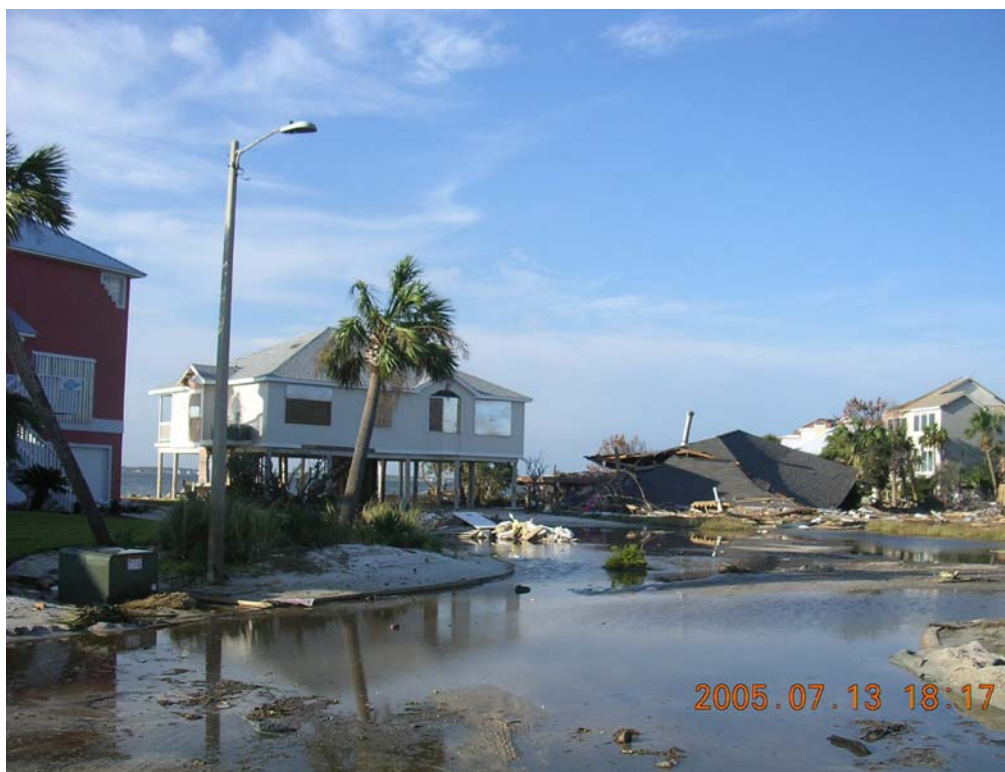
Throughout Pensacola Beach within the Coastal Building Zone, 123 major structures sustained major damage, including 23 structures that were destroyed. Of these, 15 major structures located seaward of the established Escambia County Coastal Construction Control Line sustained major damage. In addition, 15 major structures sustained damage to nonhabitable understructure areas.

Photo 2. Destroyed dwelling, Pensacola Beach.

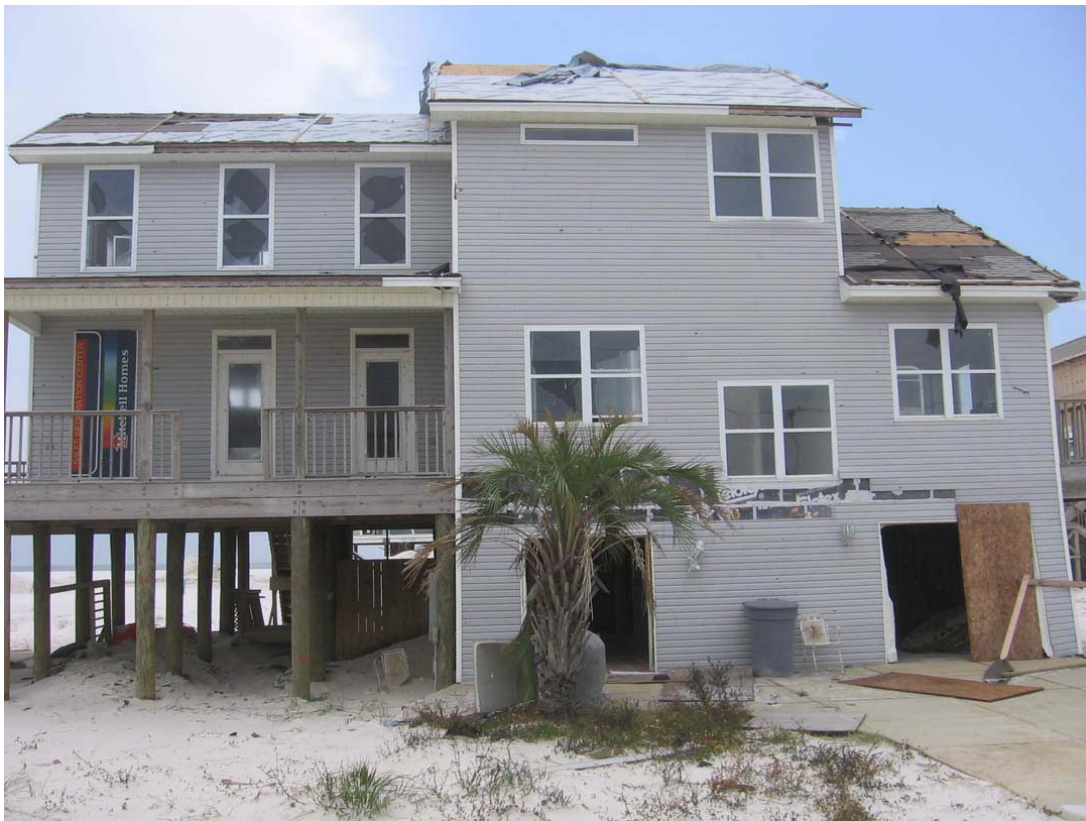
Likewise, Pensacola Beach had few remaining major structures that had not already been damaged or destroyed by both Hurricanes Ivan and Dennis. In contrast to Dennis's minimal gulf-front damage, Katrina did affect many dwellings with its storm tides and waves. Along Pensacola Beach, two single-family dwellings sustained major structural damage. One of these dwellings was seaward of the Coastal Construction Control Line and the other was in the second tier of construction immediately landward of the line. Perhaps more significantly, 34 single-family dwellings and one multifamily dwelling sustained understructure damage (Photo 4). Numerous dwellings were flooded and many were inundated with layers of sand.

Photo 4. Dwelling with understructure damage, Pensacola Beach (R126.3).

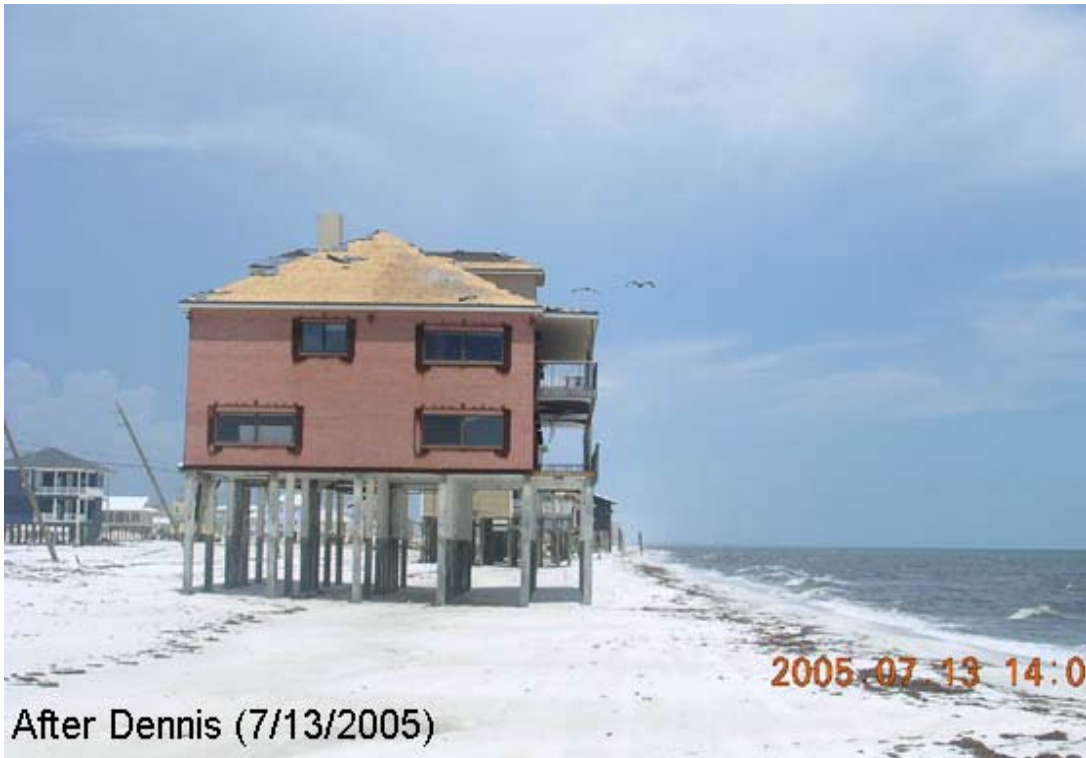
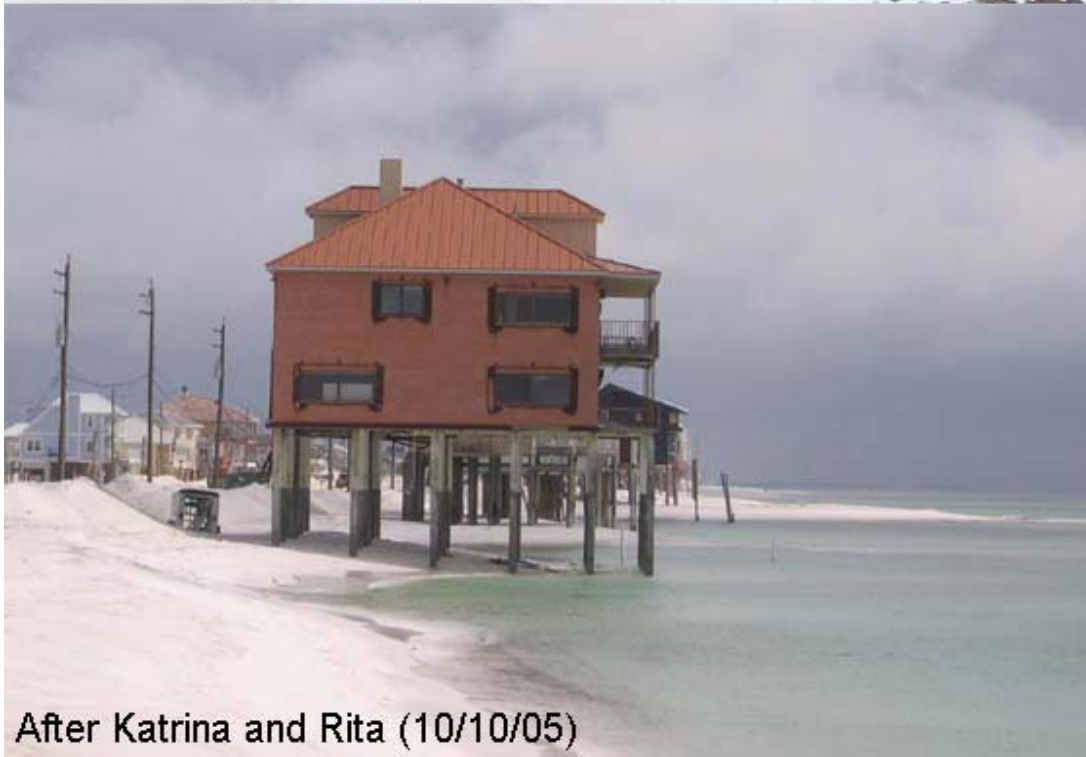
Photo 5. Dwelling with roofing and understructure damage, Navarre Beach (R192.6).

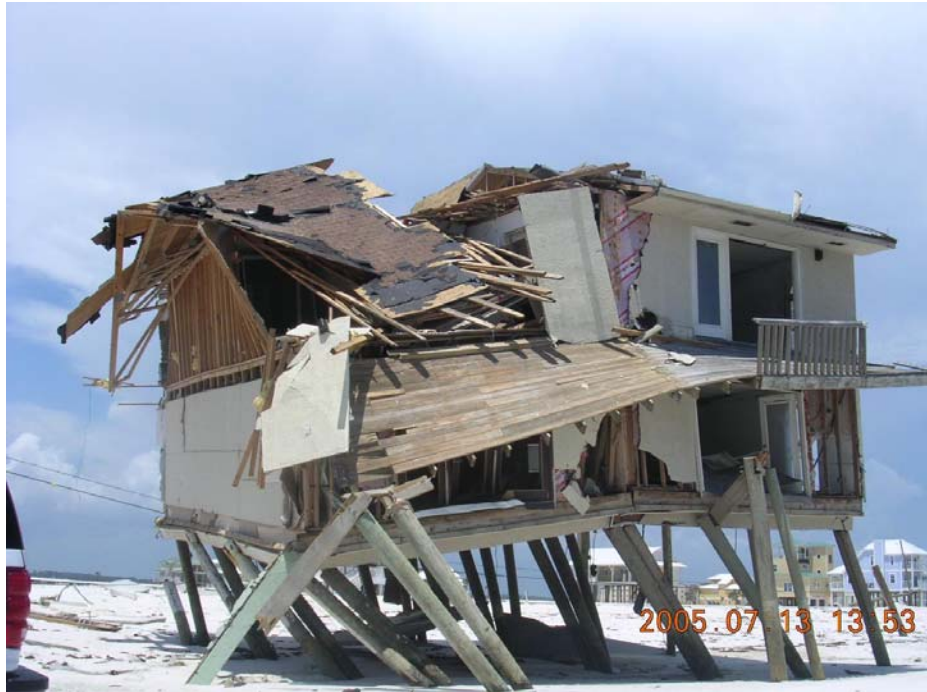
Photo 6. Non-conforming pile supported dwelling destroyed, Navarre Beach (R193).

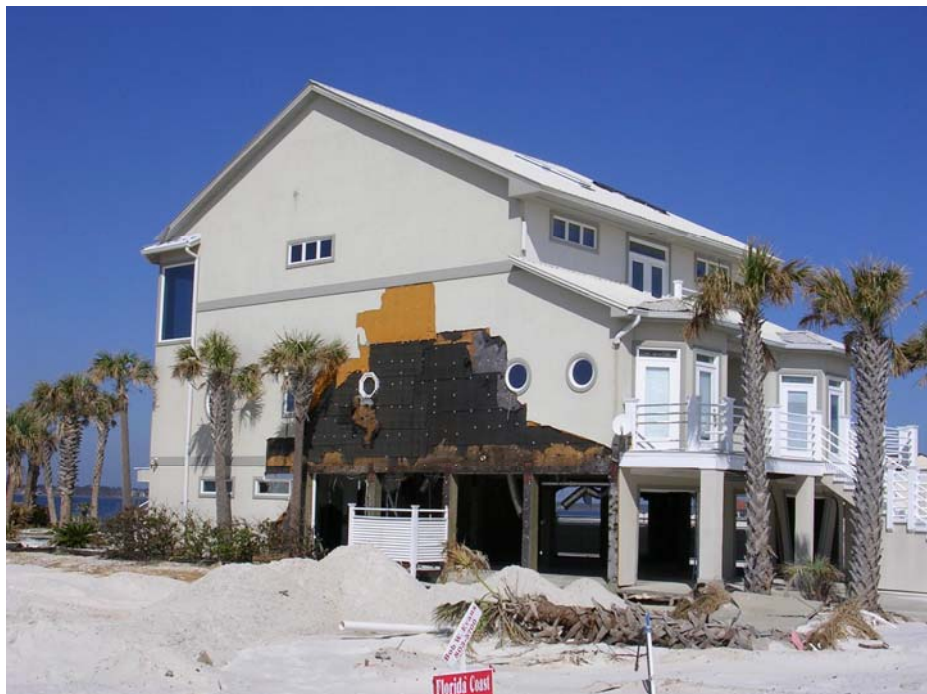
1995, in Navarre Beach would have now experienced three storm events equal to or greater than a 100-year event (Opal, Ivan, and Dennis), plus one 35-year event (Georges), and two 25-year events (Erin and Isidore) in a 10-year period. Many pile supported structures also sustained damage to their nonhabitable understructure areas (Photo 7).

Photo 7. Understructure and siding damage, Navarre Beach (R194).

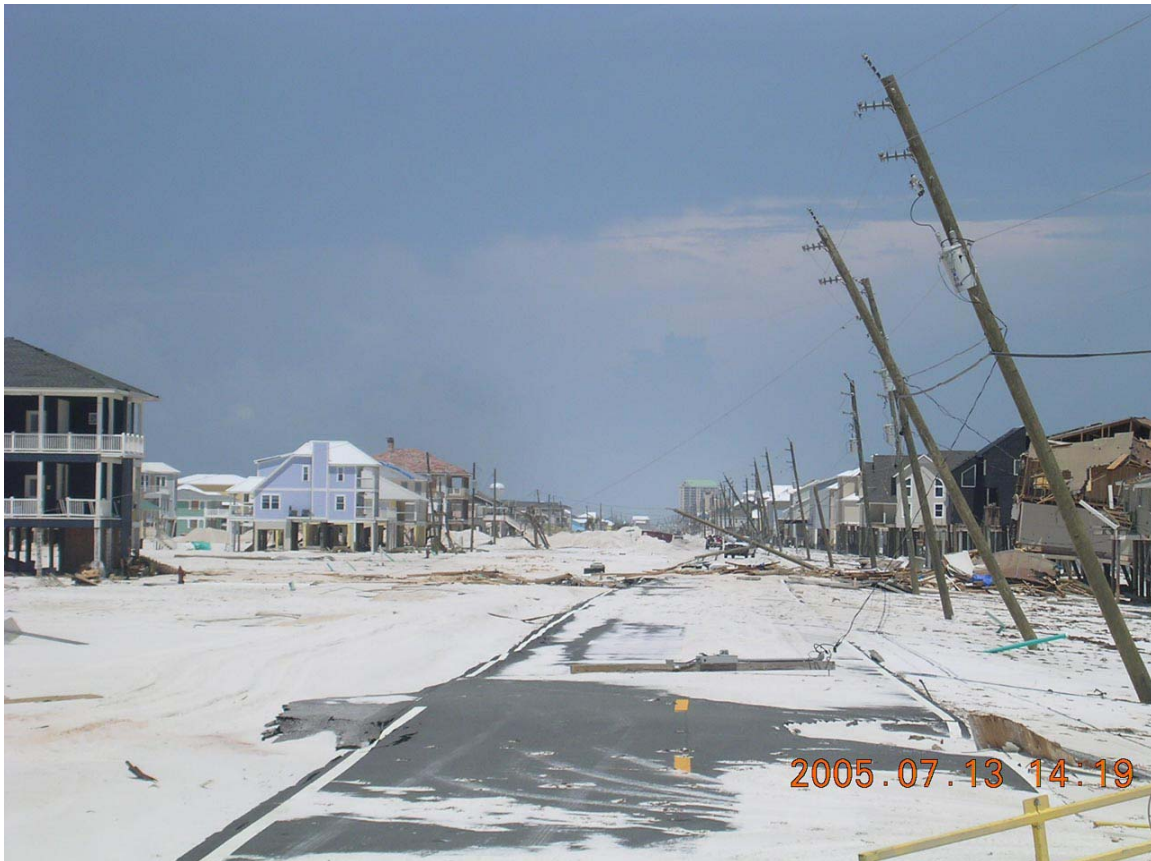
Photo 8. Infrastructure damage along Gulf Boulevard, Navarre Beach (R192.5).

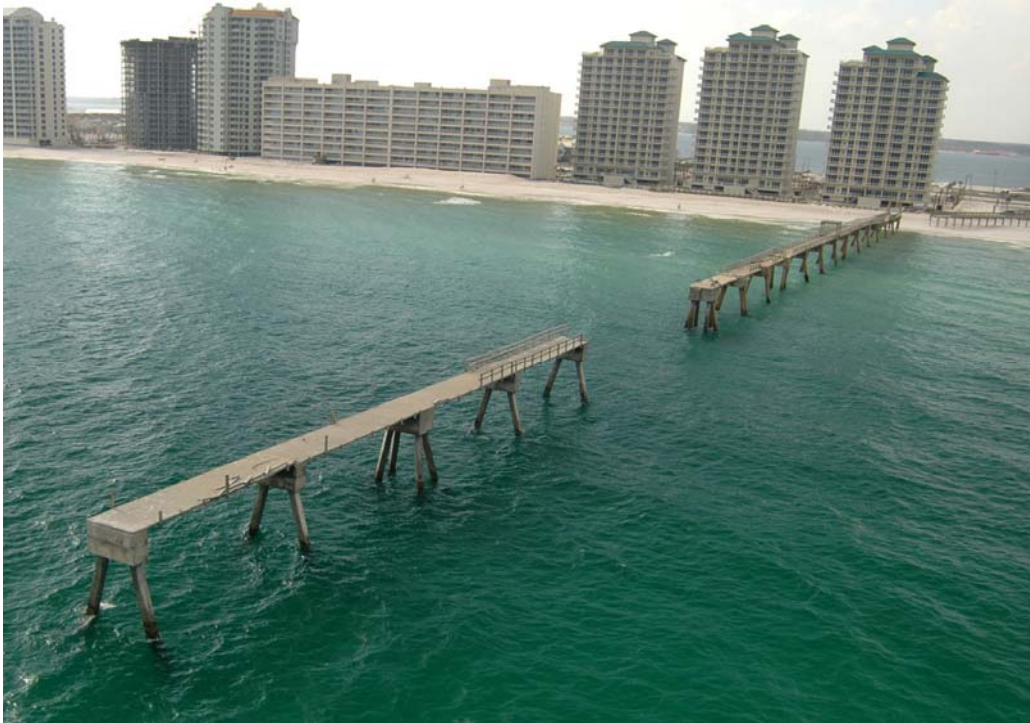
Photo 9. Damage to Navarre Fishing Pier (R209).

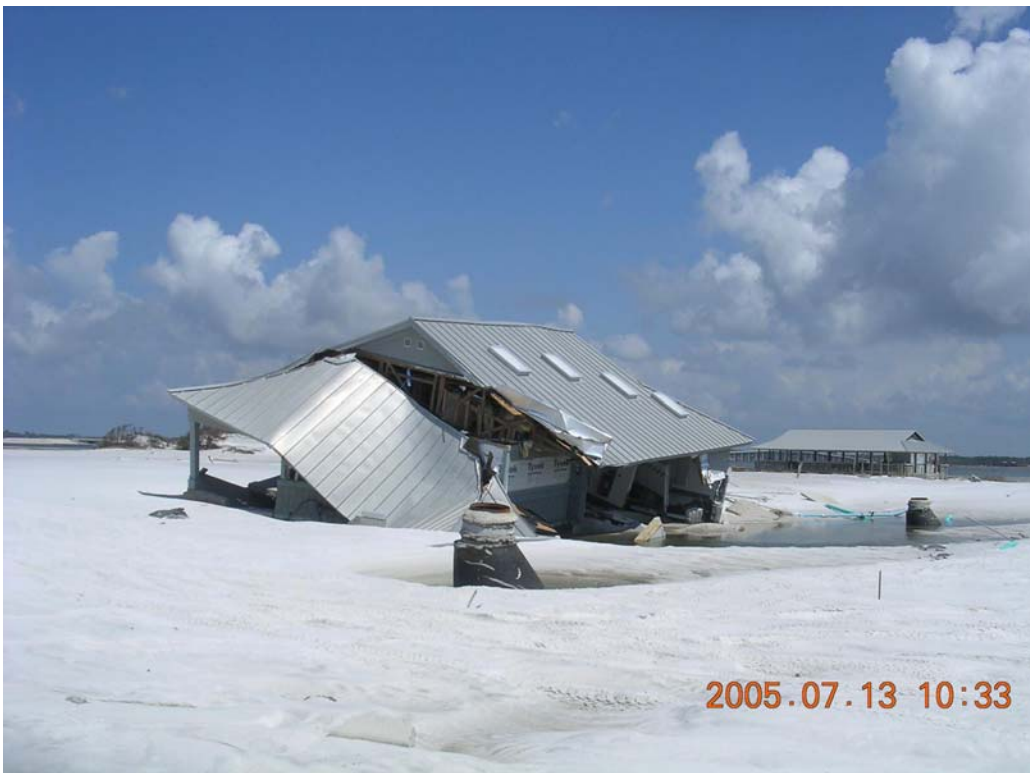
Photo 10. Bathhouse destroyed at Navarre Beach State Park (R213).

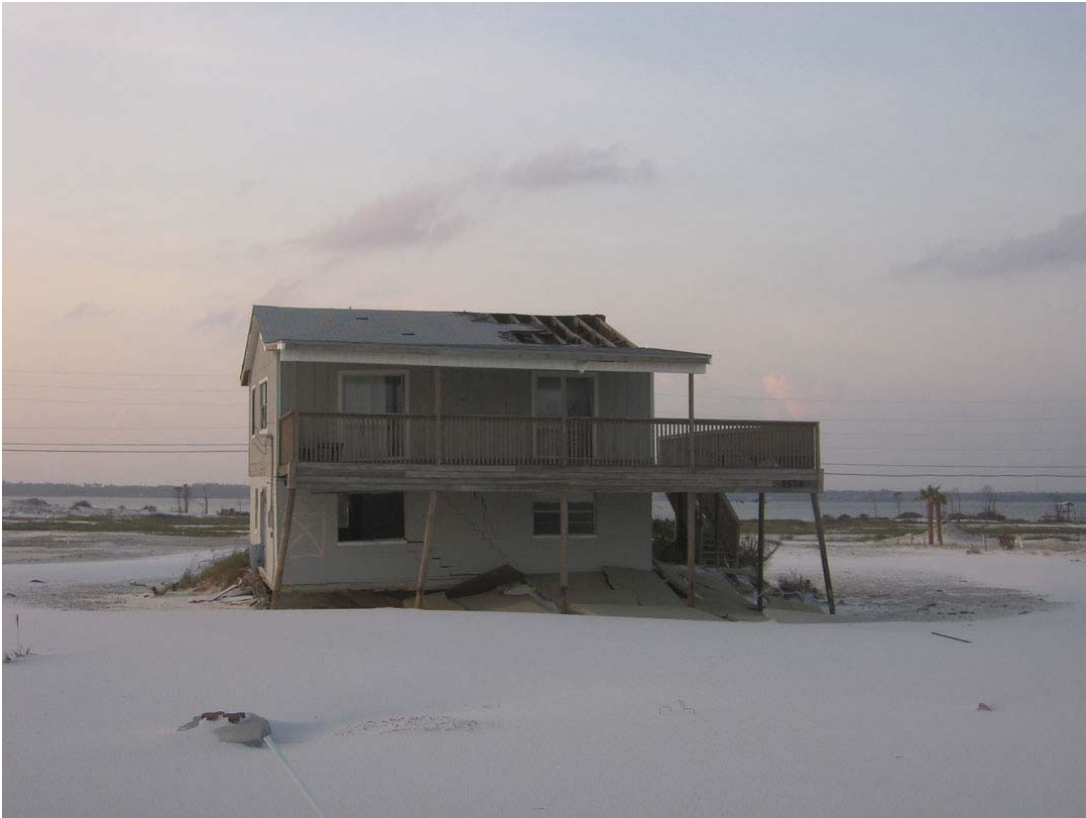
Photo 11. Dwelling destroyed, Navarre Beach (R196.2).

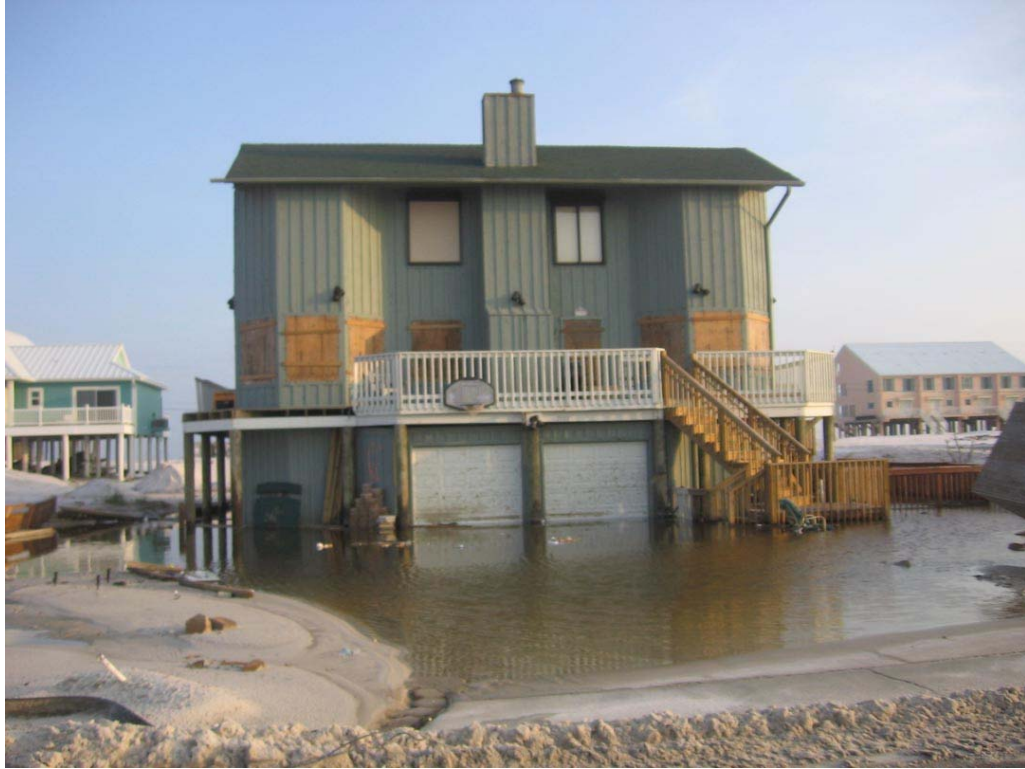
Gulf Boulevard, the seaward road, was destroyed by Dennis between R192.5 and R205. After the additional erosion associated with the passage of Hurricane Katrina, Gulf Boulevard was sited within the backshore of the beach. White Sands Boulevard, the second road inland from the gulf, has been buried by sand during both storms and sustained north pavement edge damage along much of its length between R194 and R205. Post-Dennis sand removal along White Sands Boulevard created levies that forced the retention of some of Katrina's flood waters. Dwellings seaward of White Sands Boulevard had experienced significant removal of understructure sand after Dennis that created pockets of flooding at each dwelling after Katrina (Photos 12 and 13).

Photo 12. Dwelling with understructure flooding, Navarre Beach (R198.9).

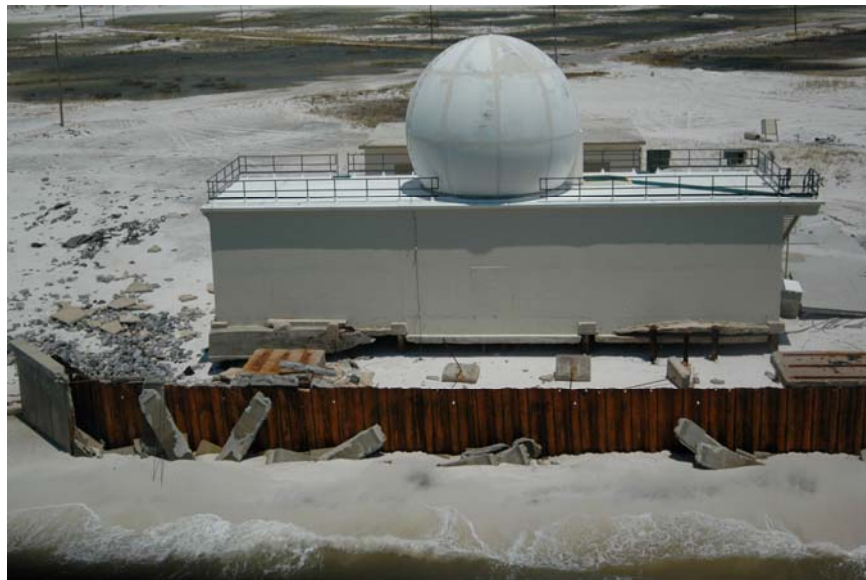
Photo 14. Destroyed seawall and damaged building foundation.

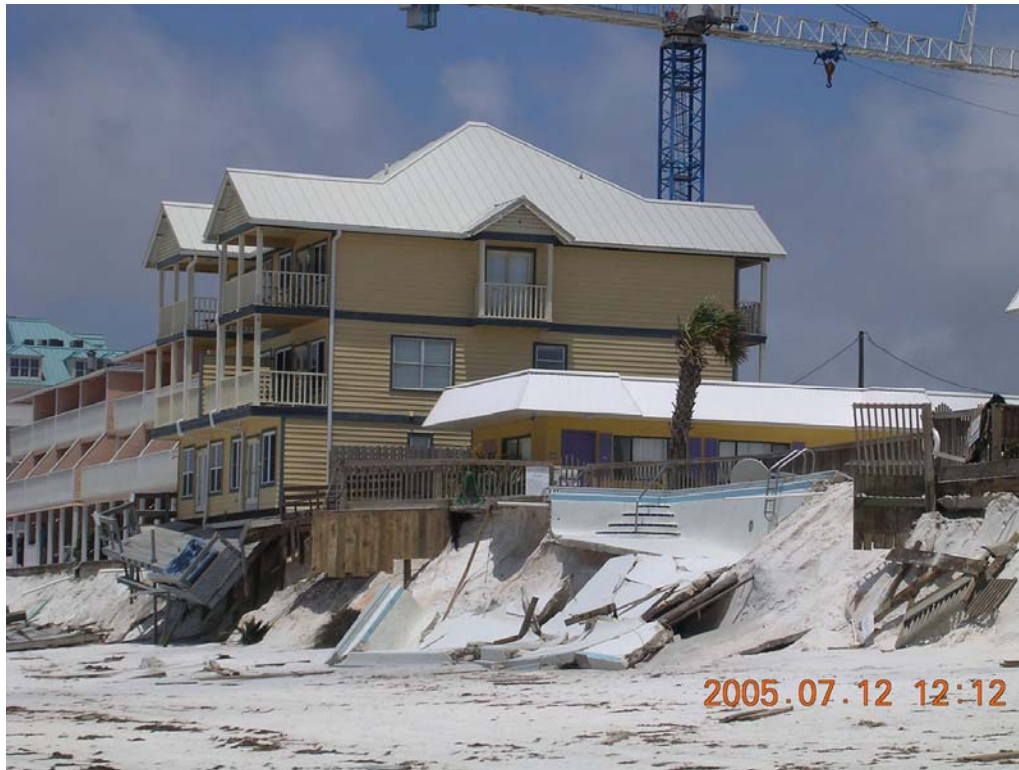
Photo 15. Destin erosion damage (R43.5).

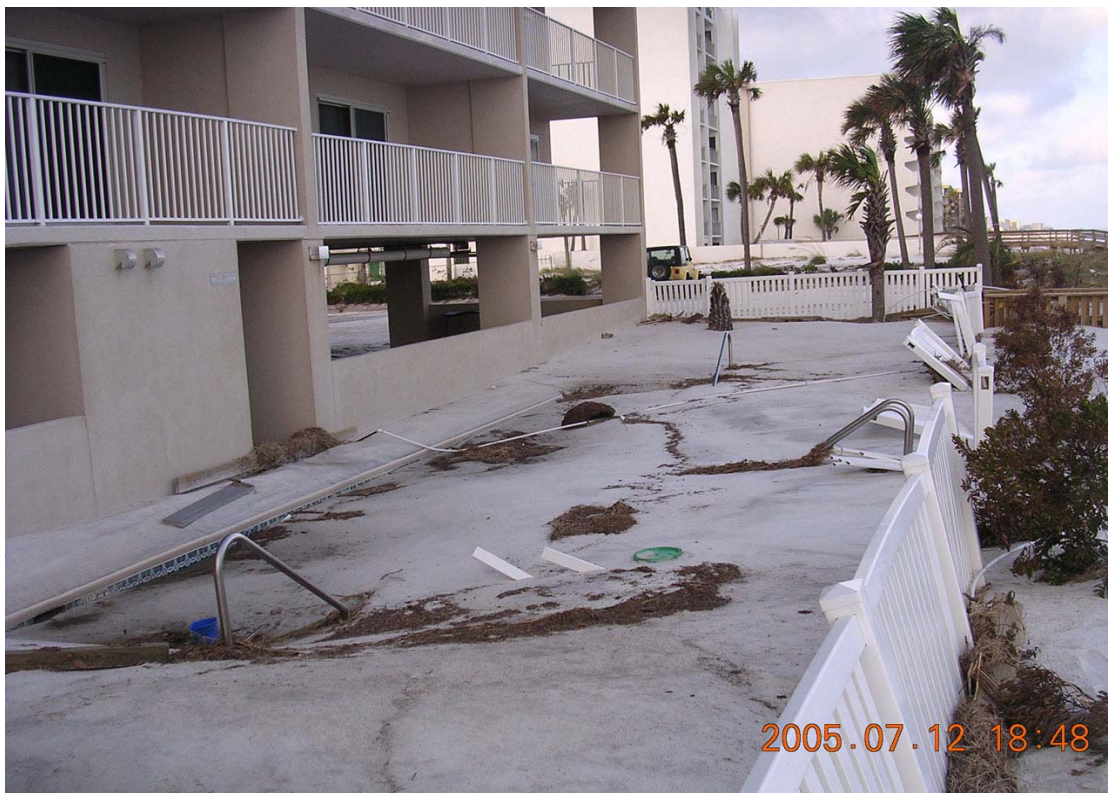
Photo 16. Pool filled with sand (R5.5).

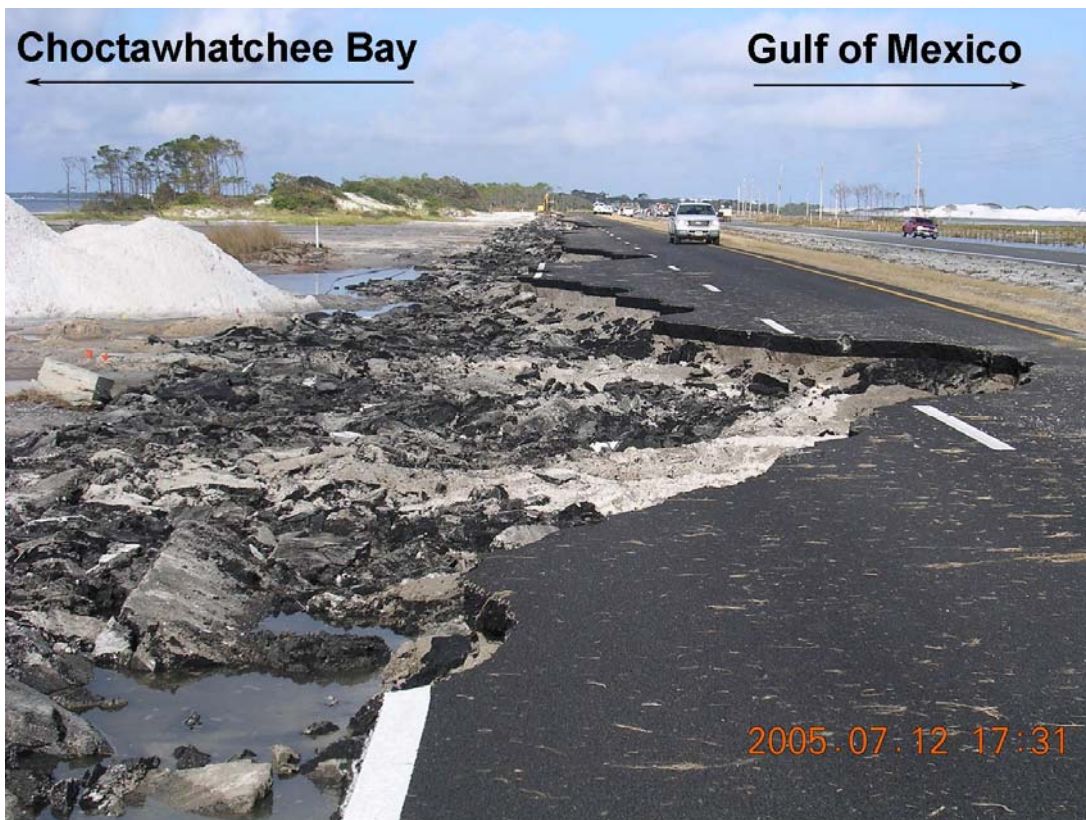
At a military installation at V608, a 100-foot segment at the east end of a 700-foot concrete seawall was destroyed. Significant scour occurred behind the destroyed wall, exposing a former radio tower foundation and undermining the southeast corner of a building. Other major damage from Dennis in this area was to U.S. Highway 98 near V606 (Photo 17). The damage from Dennis was substantially less than that which occurred during Hurricane Opal (1995) and Ivan (2004). The +14-foot storm tide measured after Hurricane Opal in this area had destroyed about 2.5 miles of the highway, plus seven major military structures along with 1330 feet of concrete seawall at an officers club and a beach club. Ivan's storm tide of +8 to +9 feet through this area destroyed a smaller segment of the highway as well as the beach club facilities (V618).

Photo 17. Damage to U.S. Highway 98 between Ft. Walton Beach and Destin (V606).

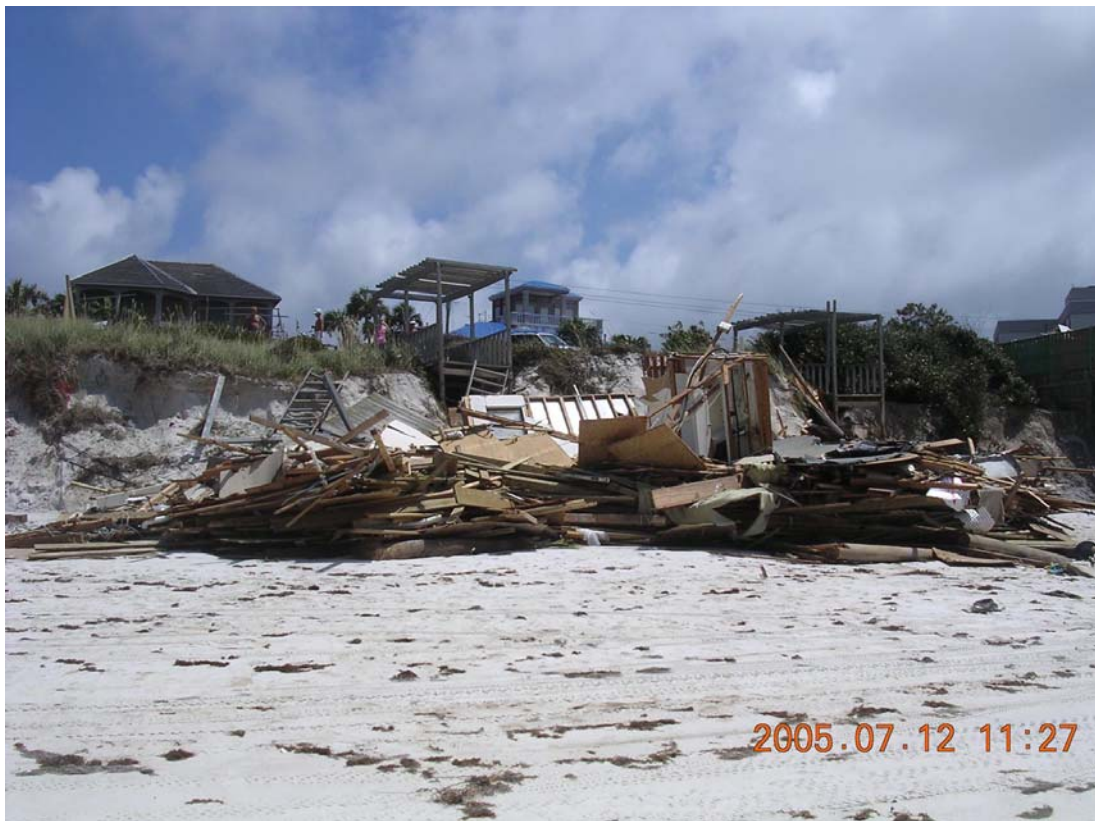
Photo 18. Destin dwelling destroyed (R49).

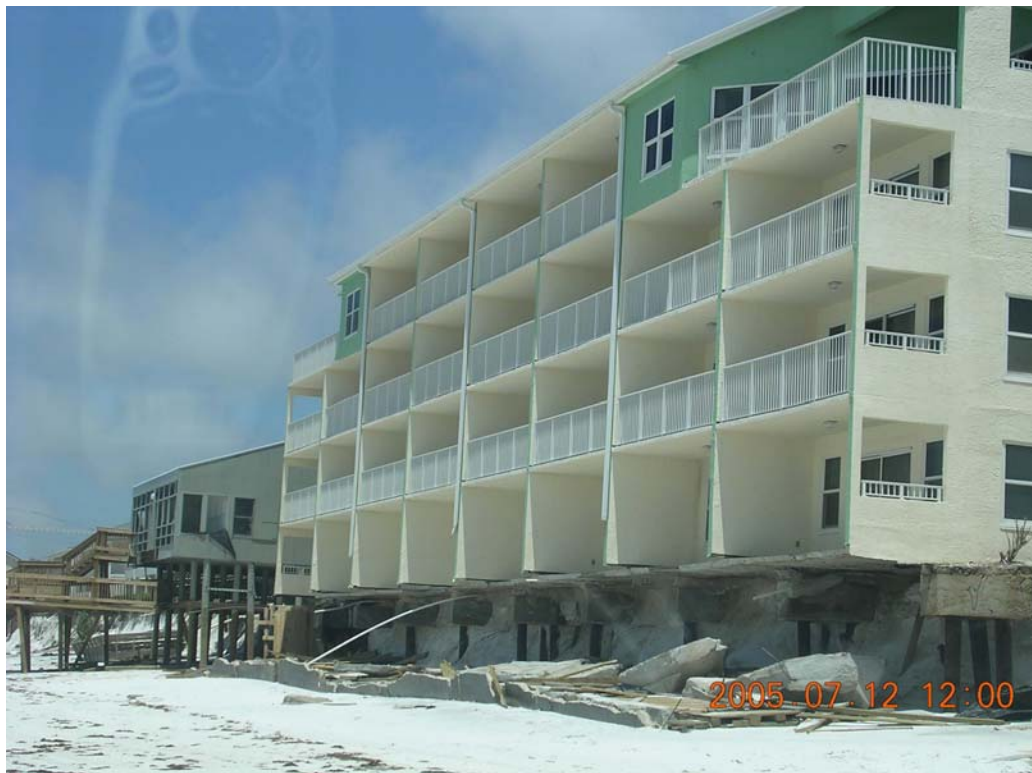
Photo 20. Concrete wall failure and building undermined, Destin (R45).

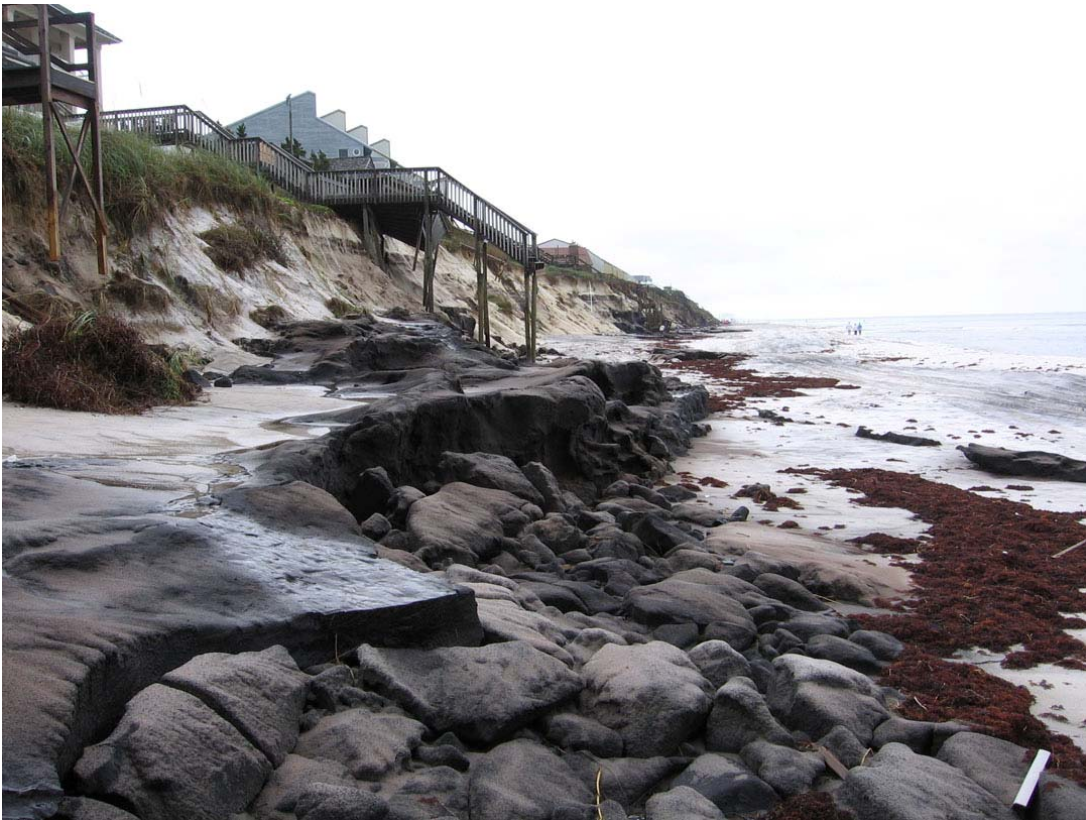
Photo 21. Peat strata exposed by erosion, Seacrest Beach (R108.8).

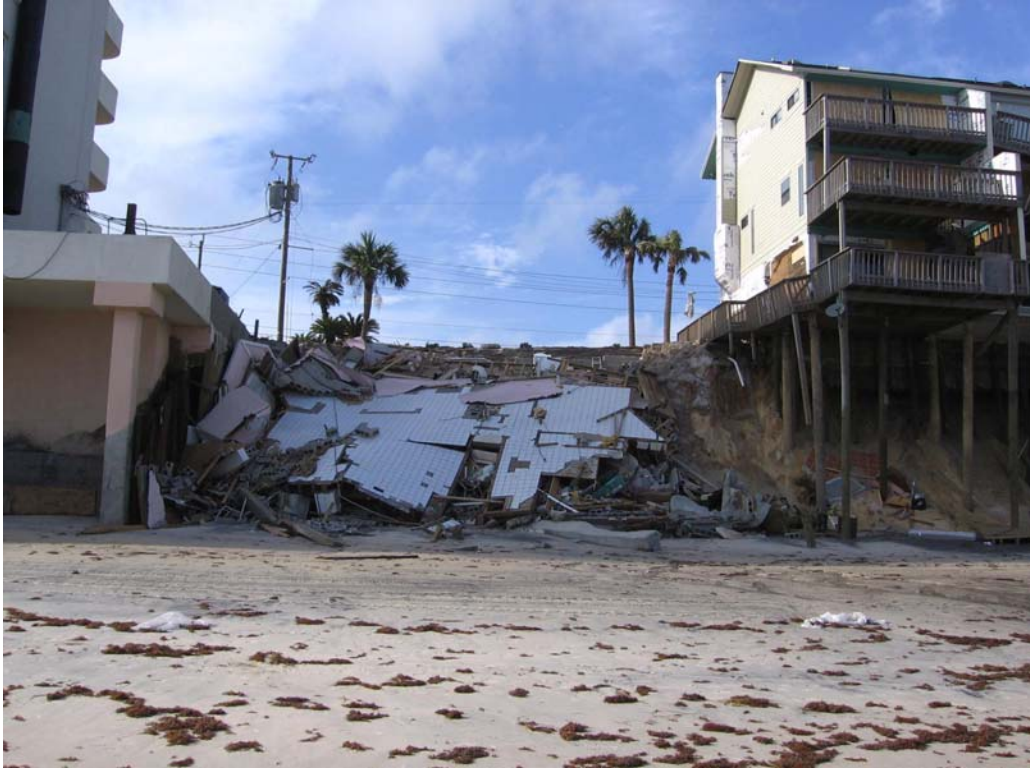
Photo 22. Single-family dwelling destroyed, Miramar Beach (R9).

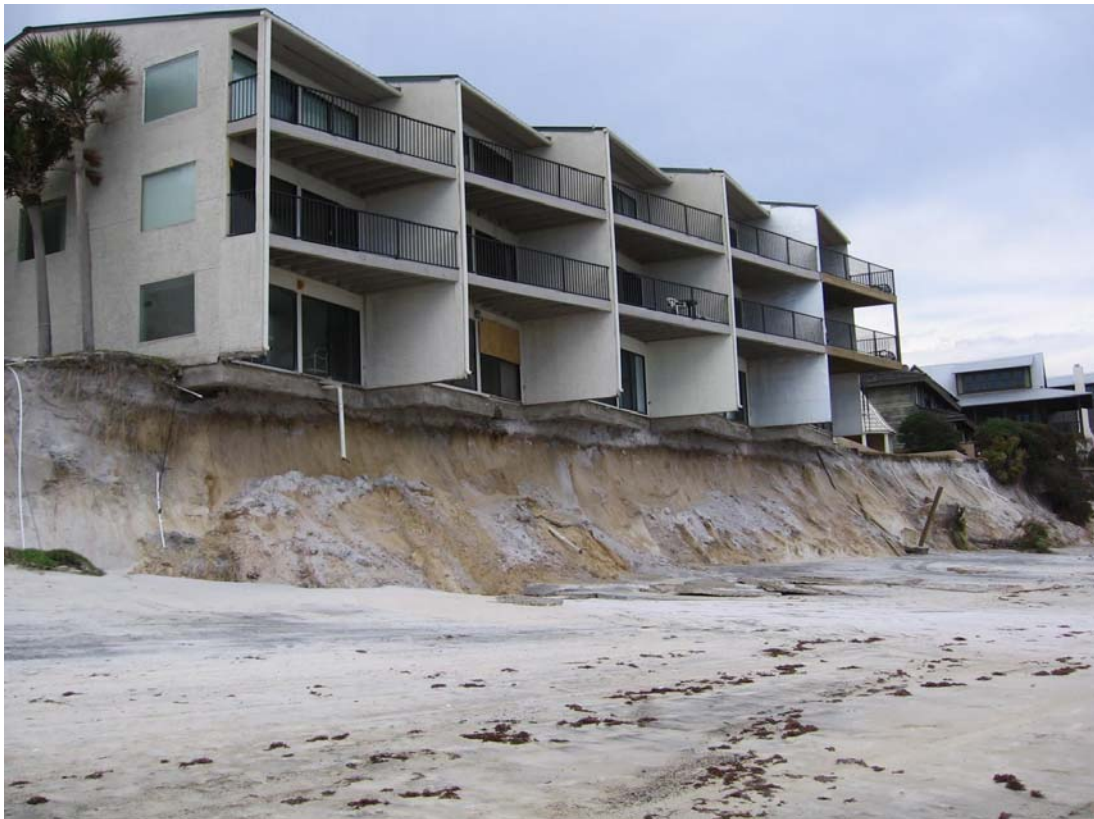
Photo 24. Imminently threatened building, Blue Mountain Beach (R60).

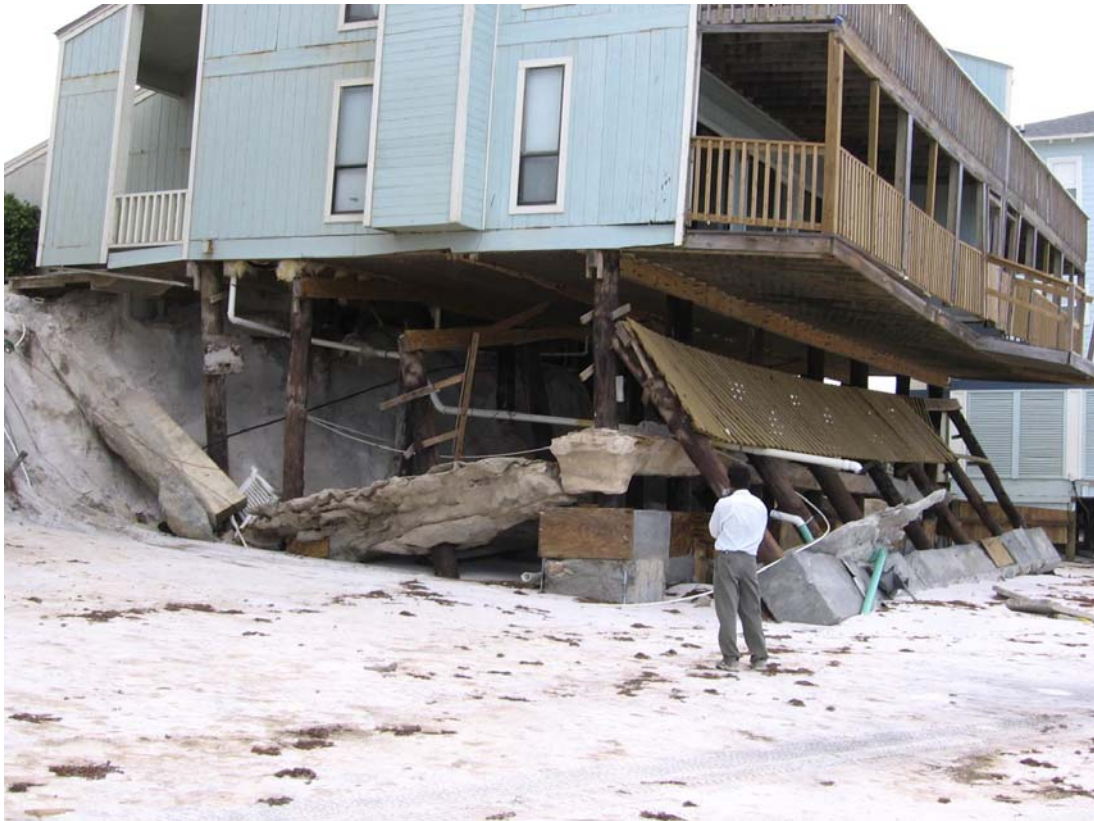
Photo 25. Damaged structure, Gulf Trace (R68).

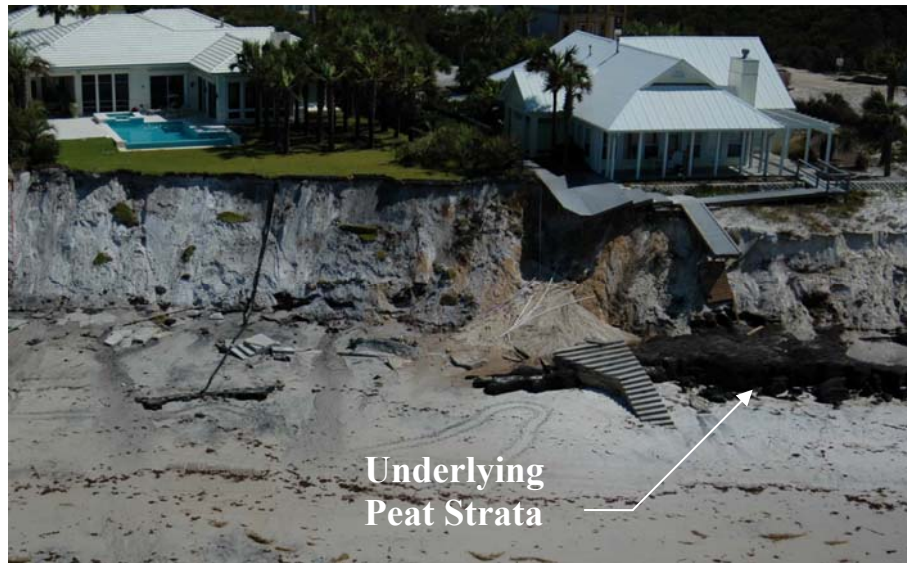
Photo 26. Imminently threatened structure, Seacrest Beach (R112.4).

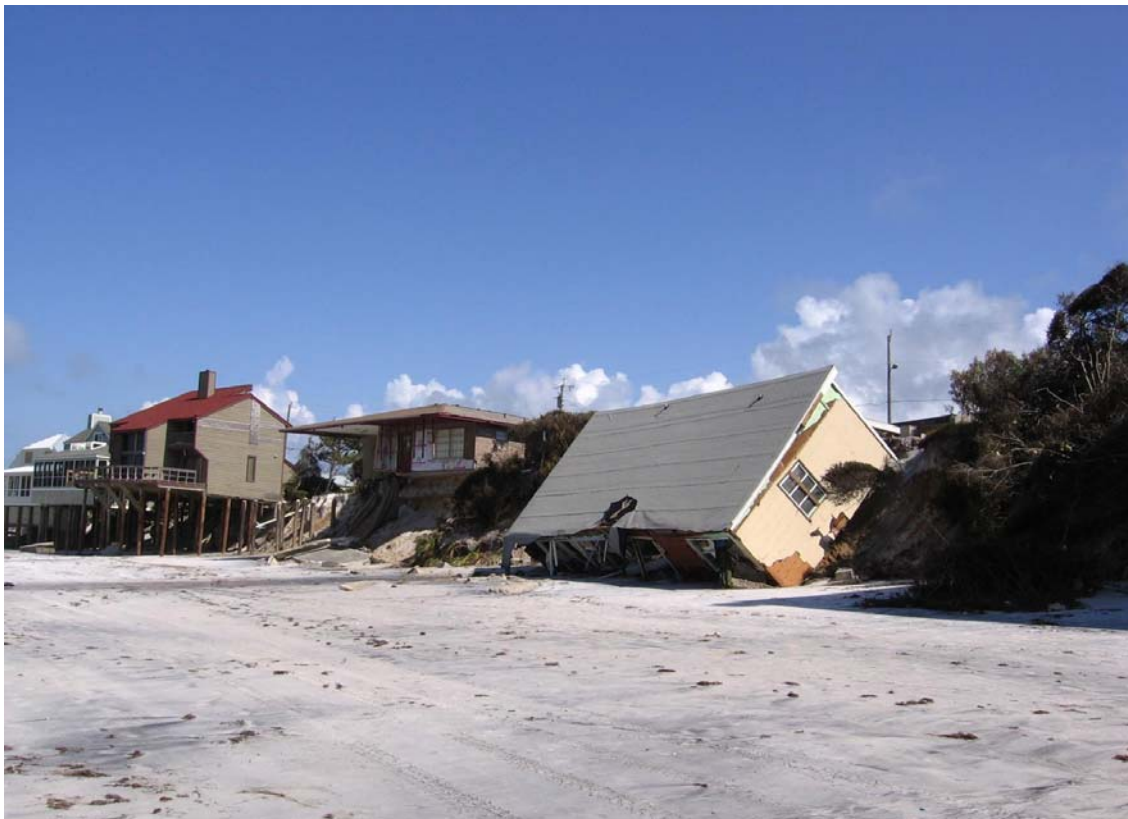
Photo 27. Dwelling destroyed, Inlet Beach (R123).

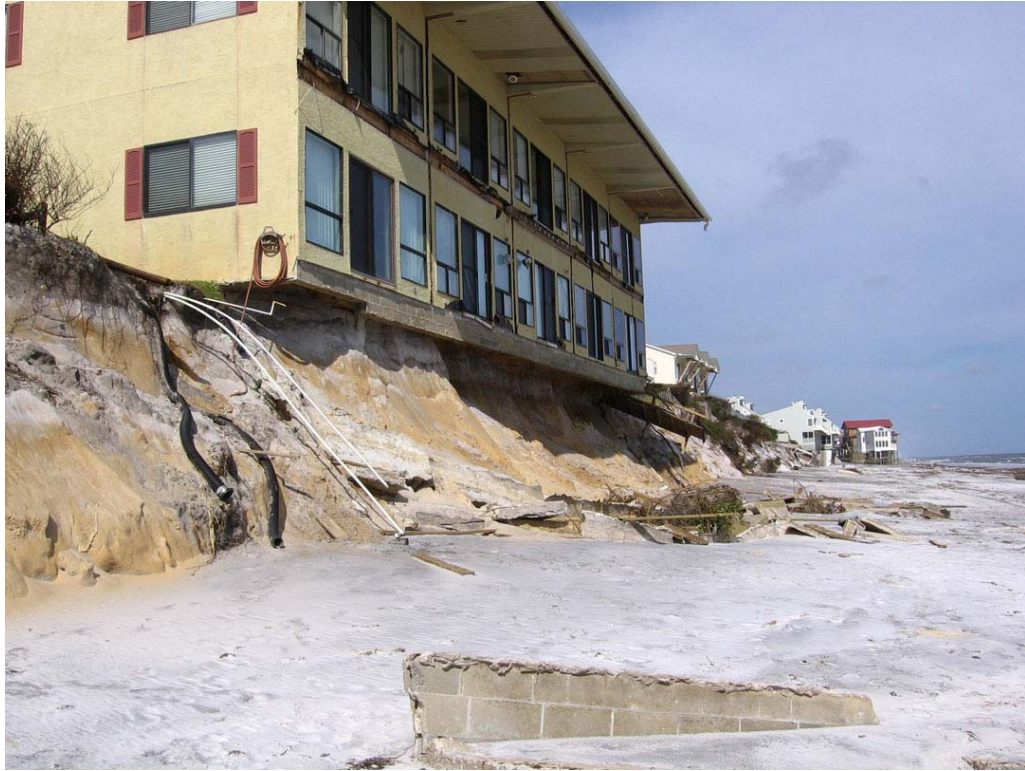
Photo 28. Condominium undermined by Dennis, Beach Highlands (R43.2).

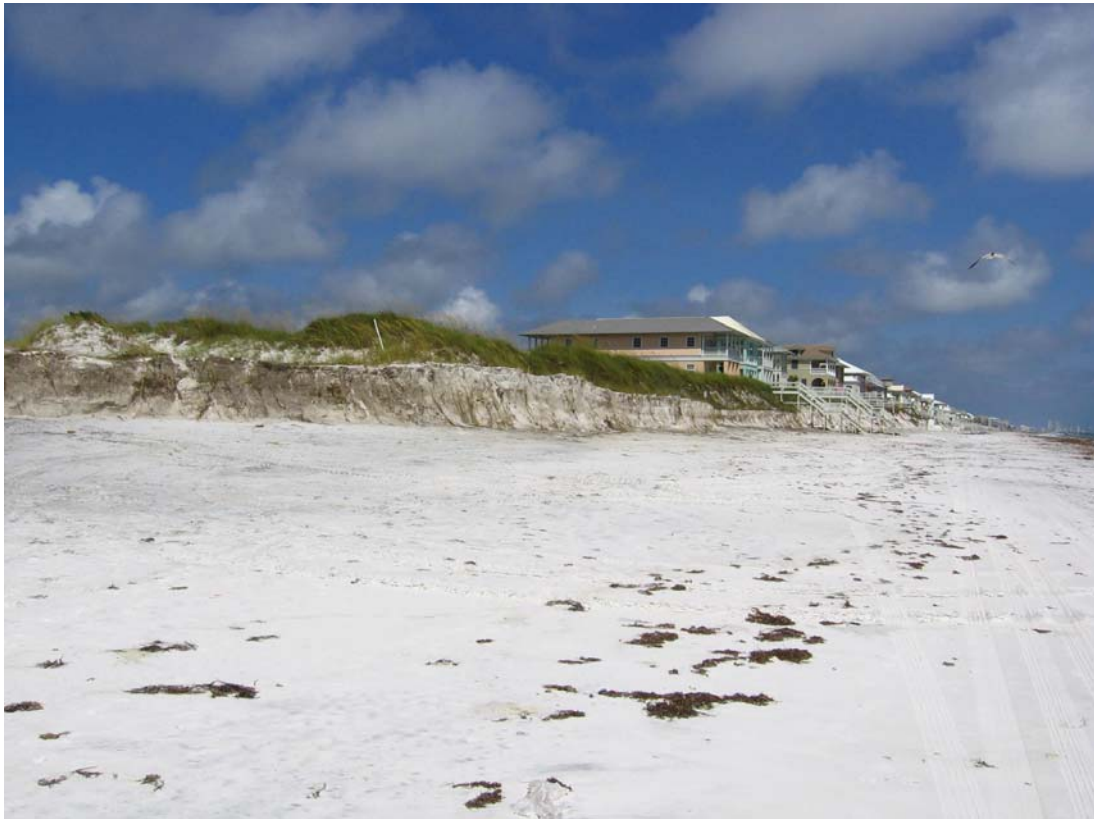
Photo 31. Major beach and dune erosion, Carillon Beach (R2.5).
