Hurricane Dennis & *Hurricane Katrina*

Final Report on 2005 Hurricane Season Impacts to Northwest Florida

**Florida Department of Environmental Protection
Division of Water Resource Management
Bureau of Beaches and Coastal Systems
April 2006**

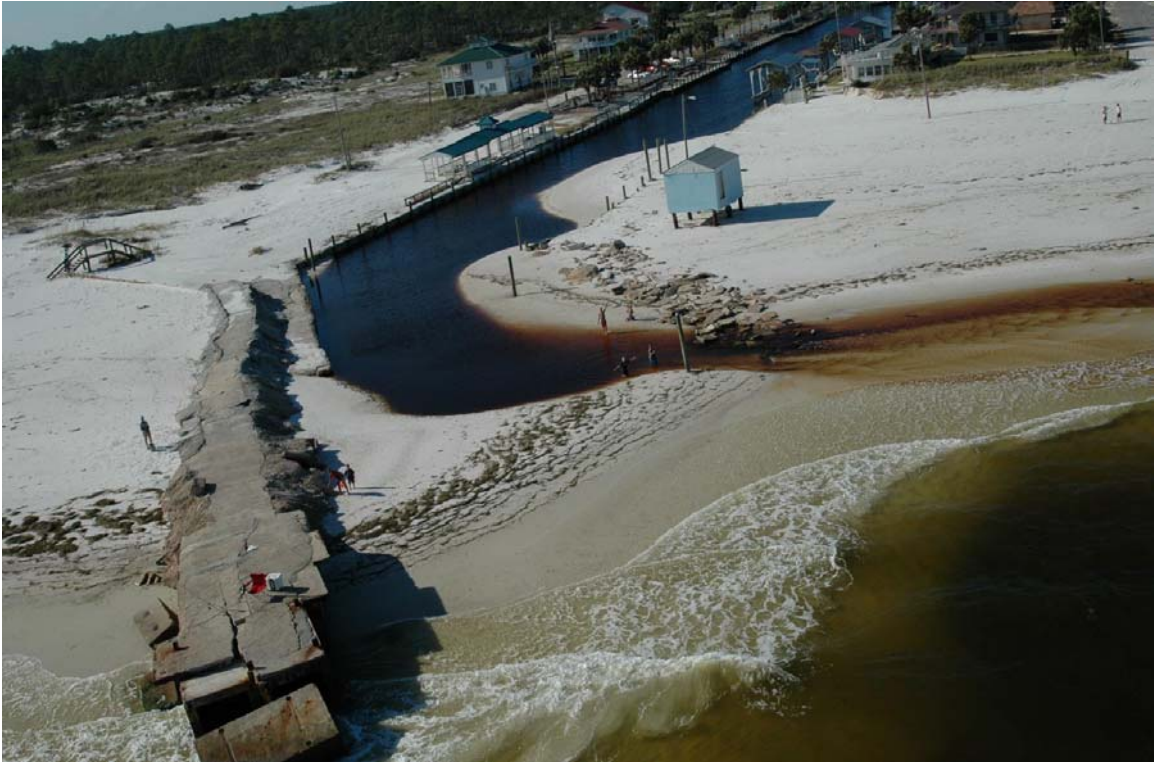
Photo 36. Entrance shoaling in Mexico Beach Inlet (R127.7).

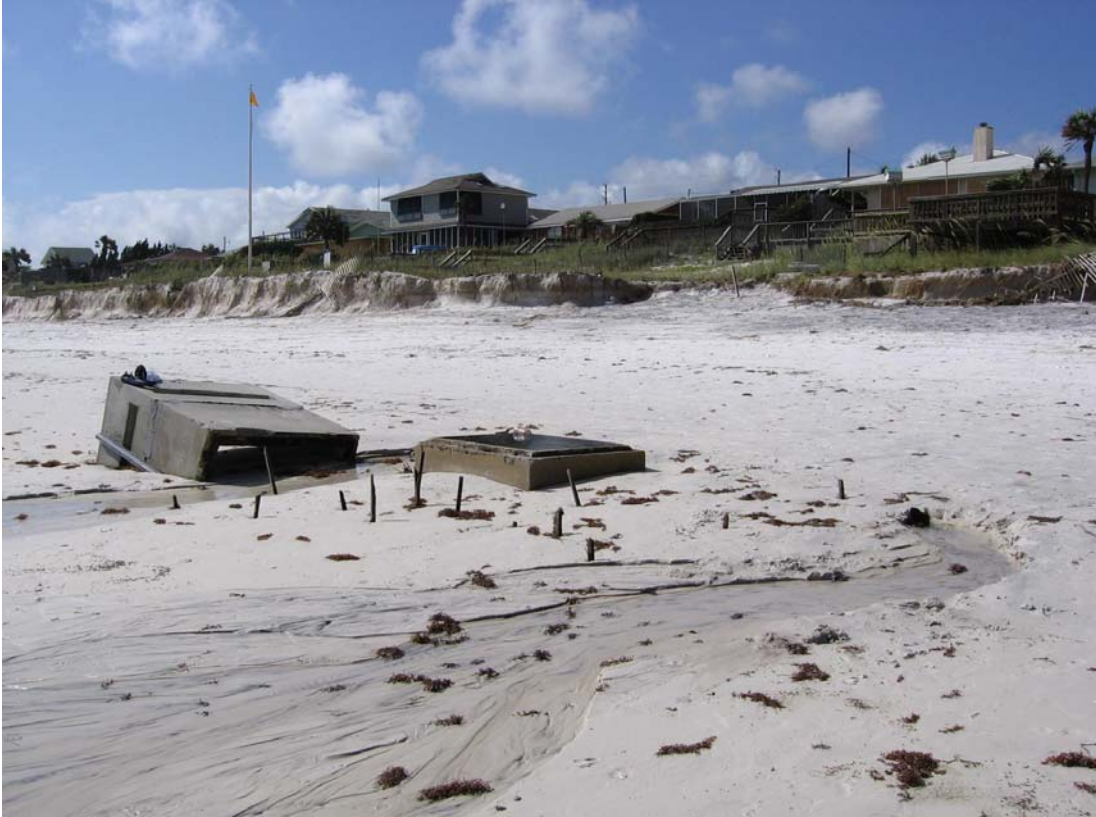
Photo 37. Outfall system damaged (R11).

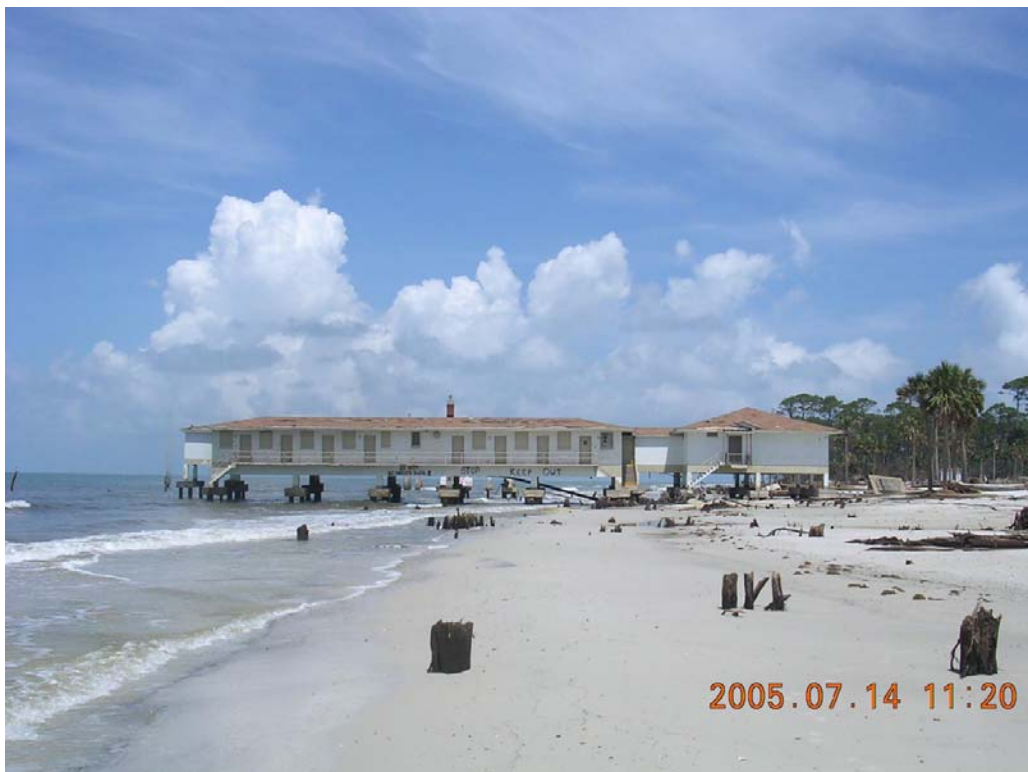
Photo 41. Severe beach erosion at the Cape San Blas Lighthouse (R111.5).
(Structure depicted in photo has been removed.)

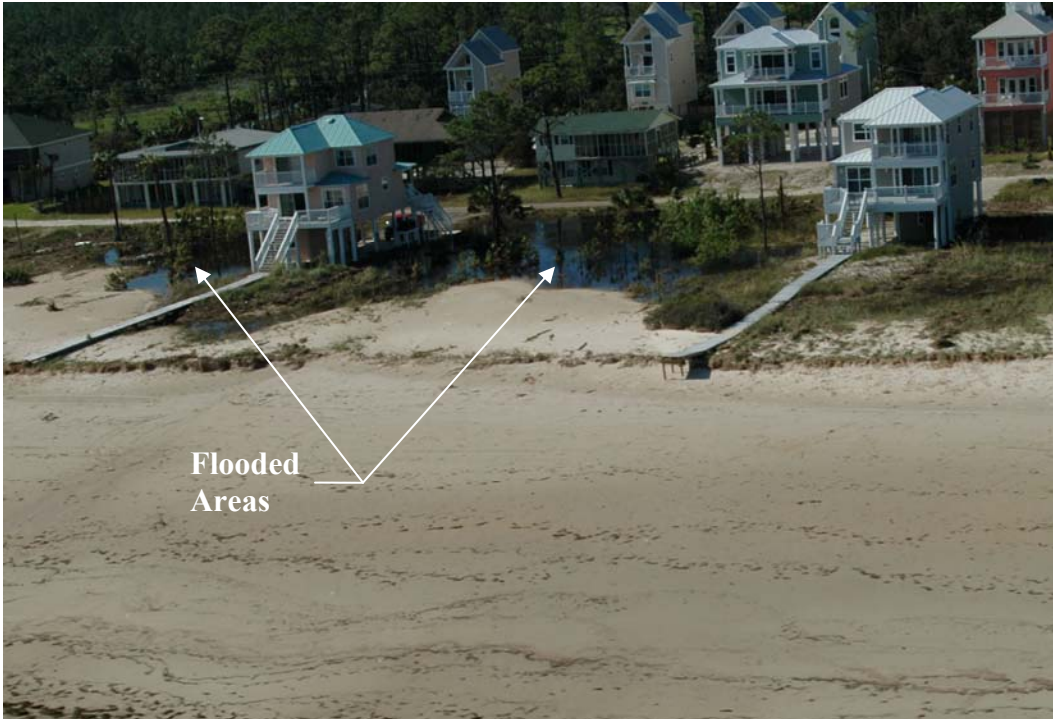
Photo 42. Significant flooding near Money Bayou (R141.5).

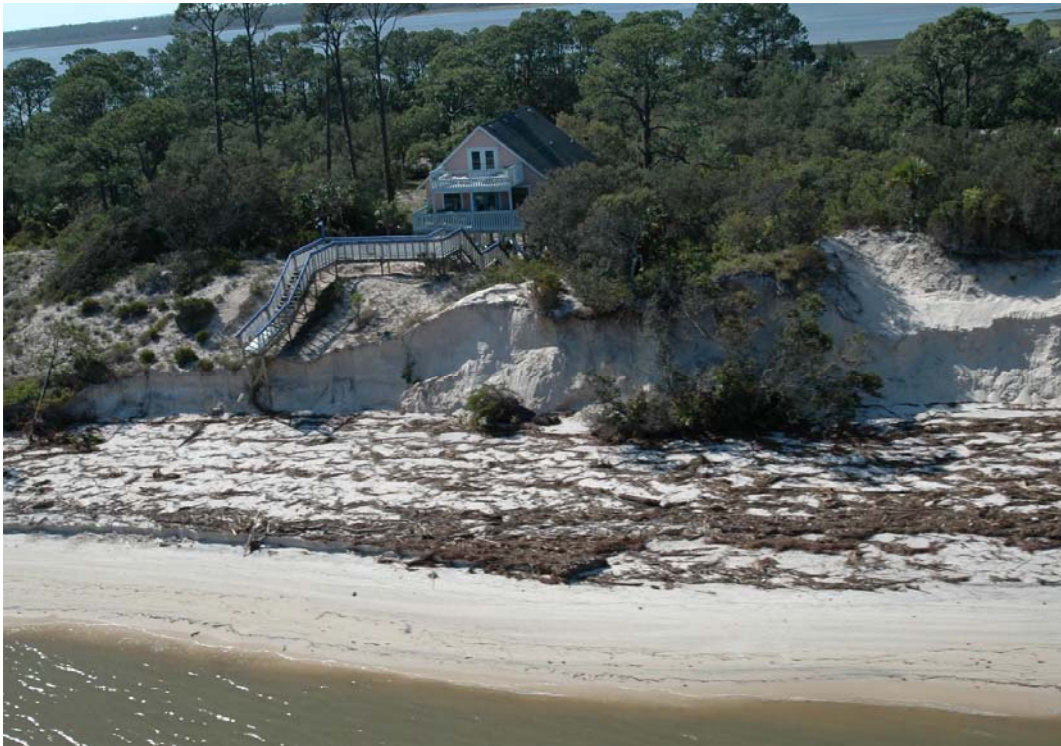
Photo 43. Dune erosion at Indian Pass (R160.4).

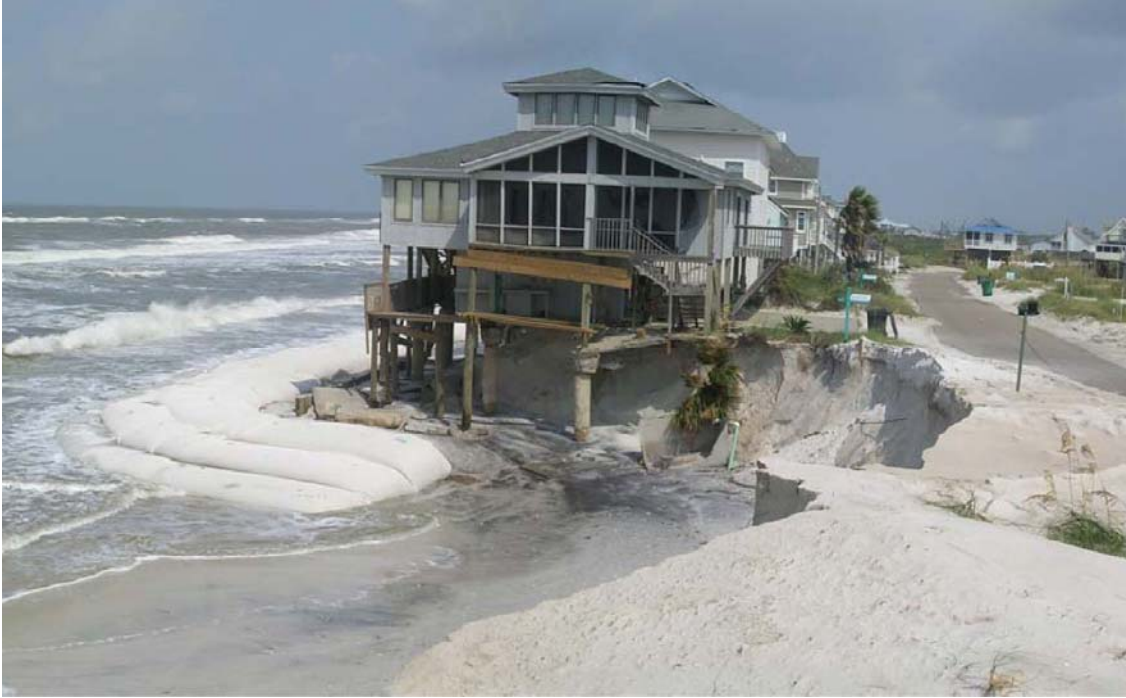
Photo 44. Dune erosion threatening Dunes Drive, St. Joseph Peninsula (R83.6).

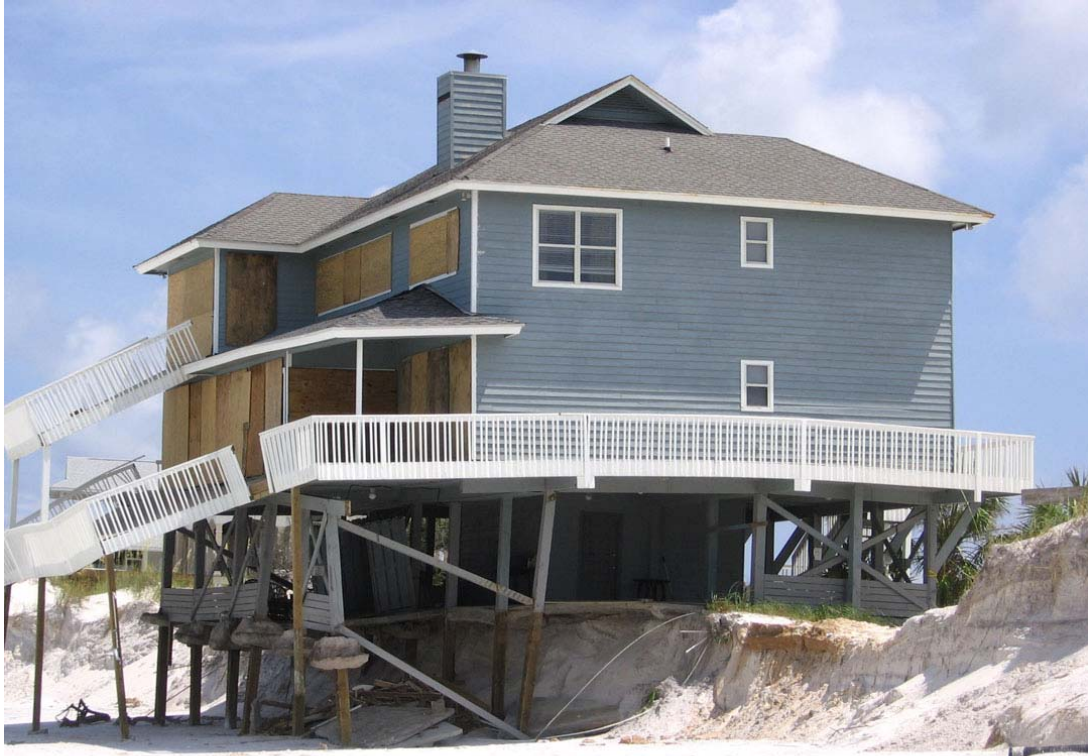
Photo 45. Foundation damage to dwelling, St. Joseph Peninsula (R75.2).

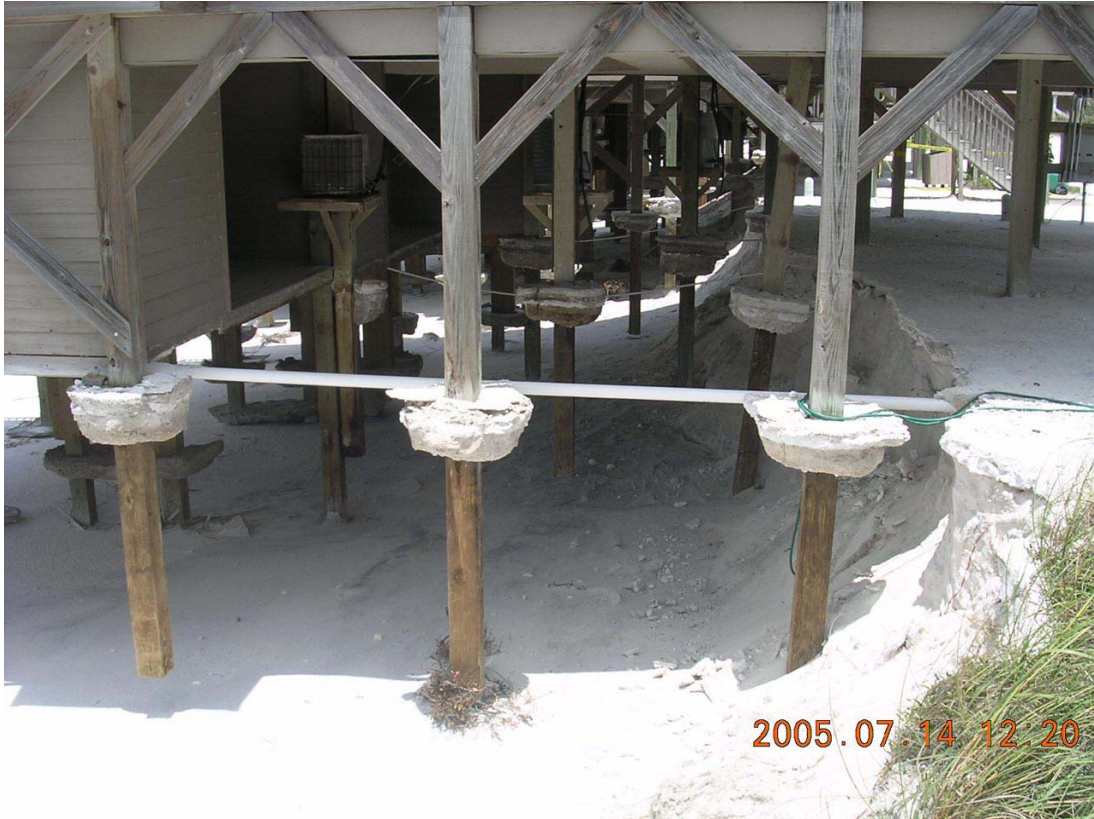
Photo 46. Undermined building with piles suspended, St. Joseph Peninsula (R90.8).

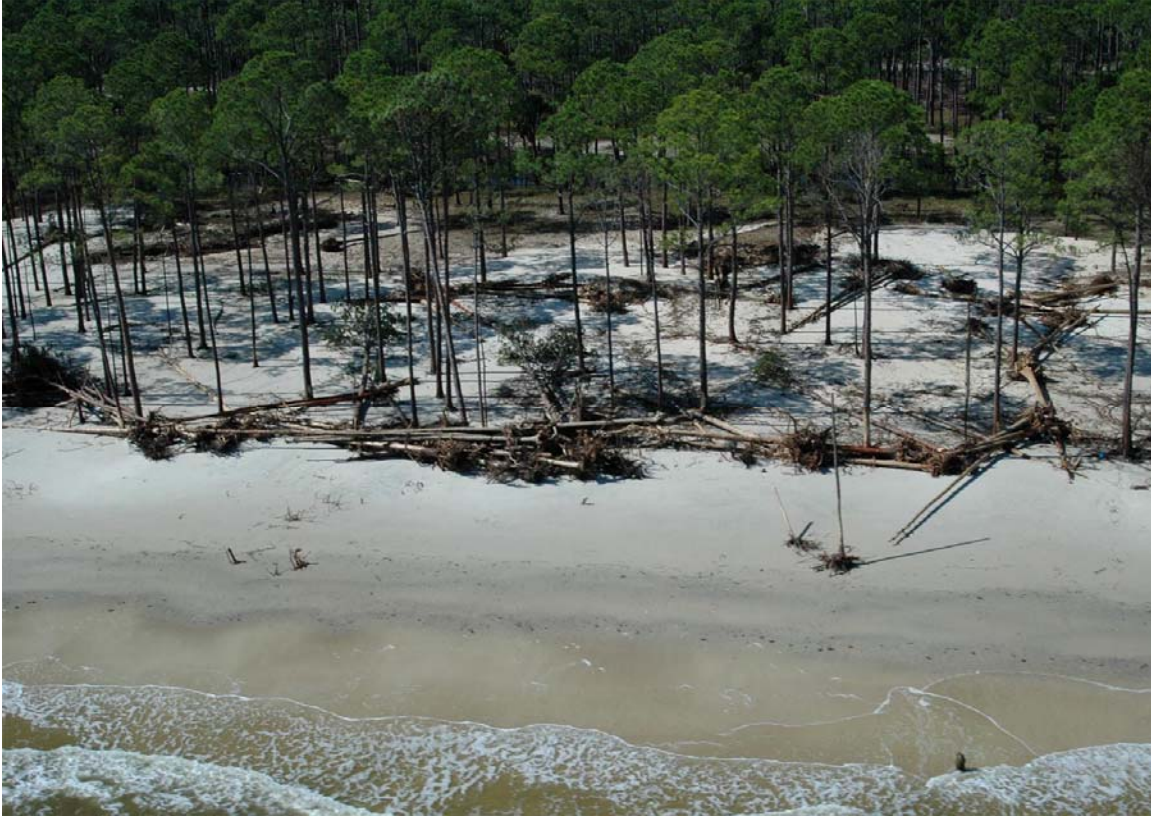
Photo 47. Severe erosion, St. Vincent Island (V37).

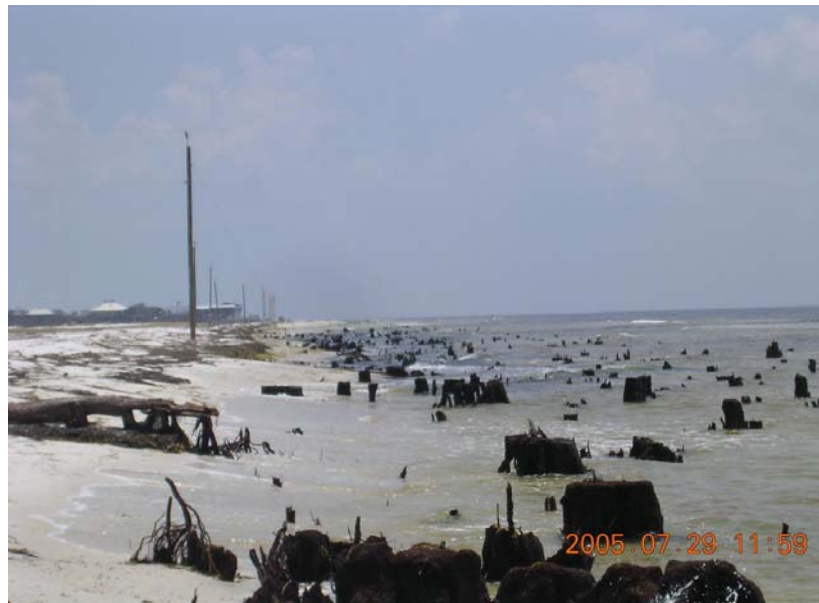
Photo 52. Exposed tree stumps, Dog Island (R165).

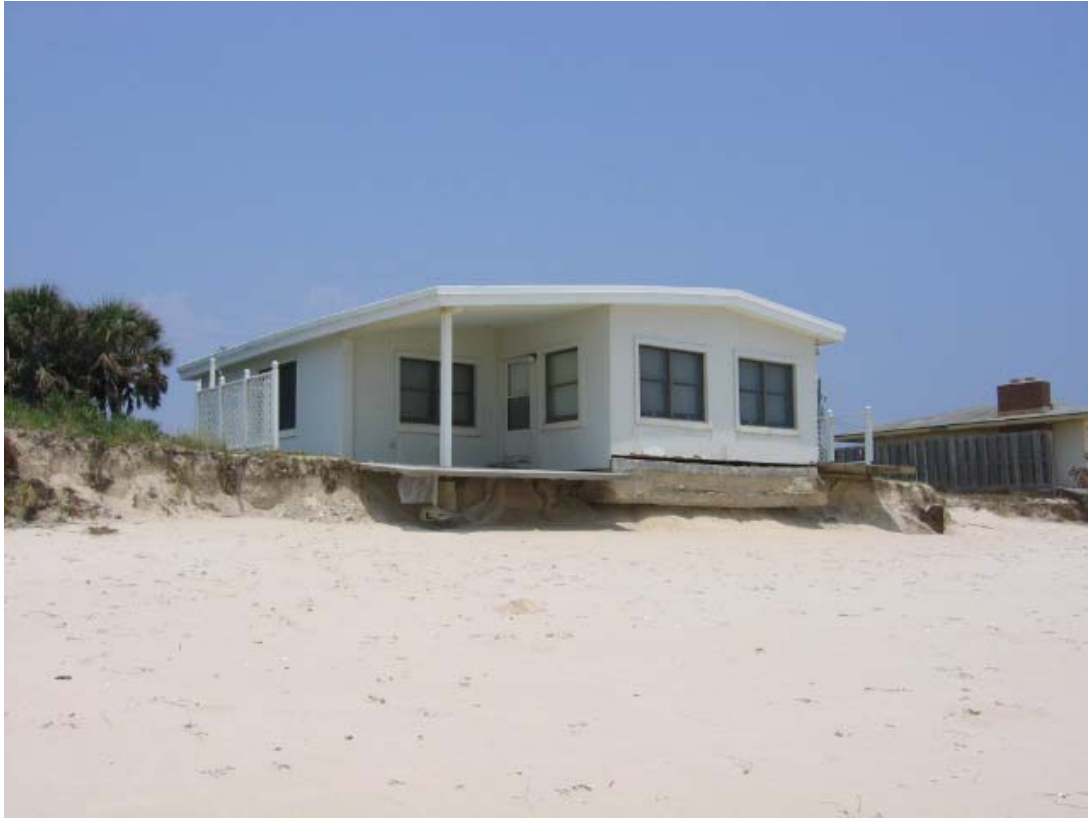
Photo 53. Foundation damage to dwelling, St. George Island (R80.3).

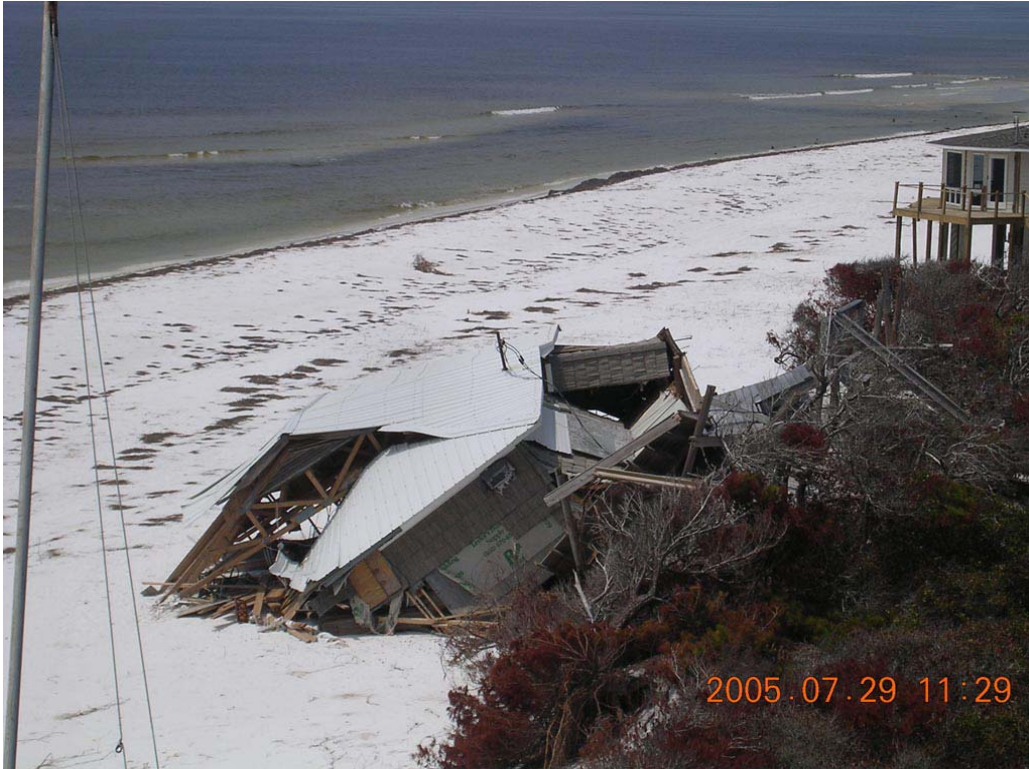
Photo 54. Dwelling destroyed, Dog Island (R169.7).

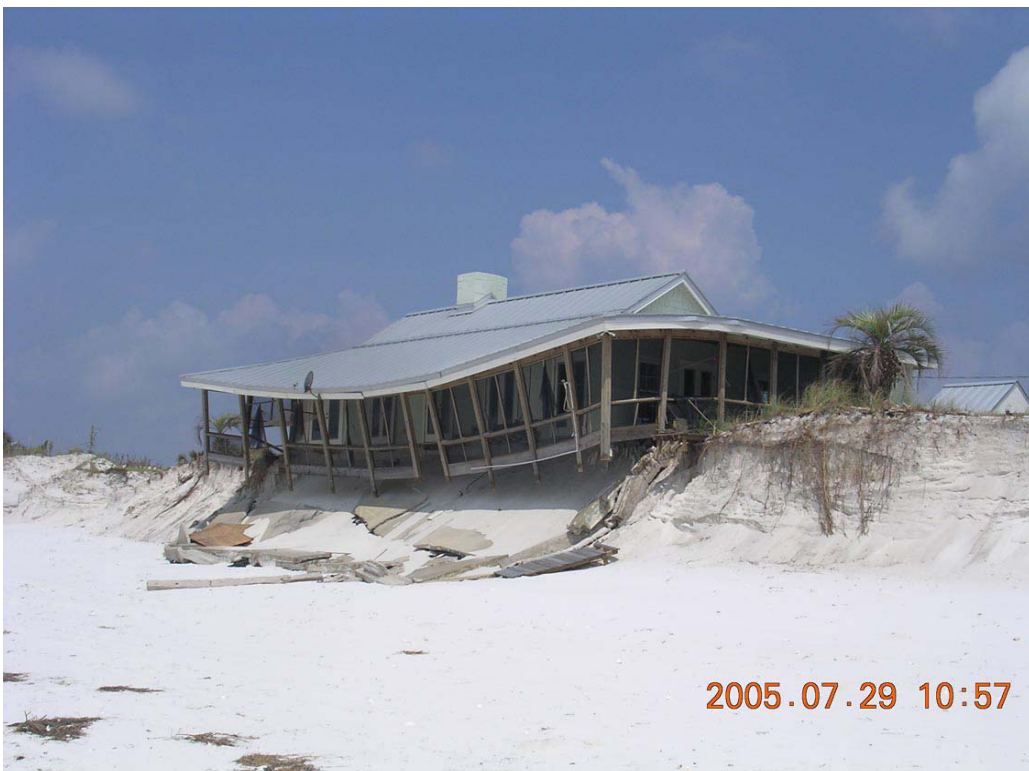
Photo 55. Dwelling undermined and damaged, Dog Island (R176.2).

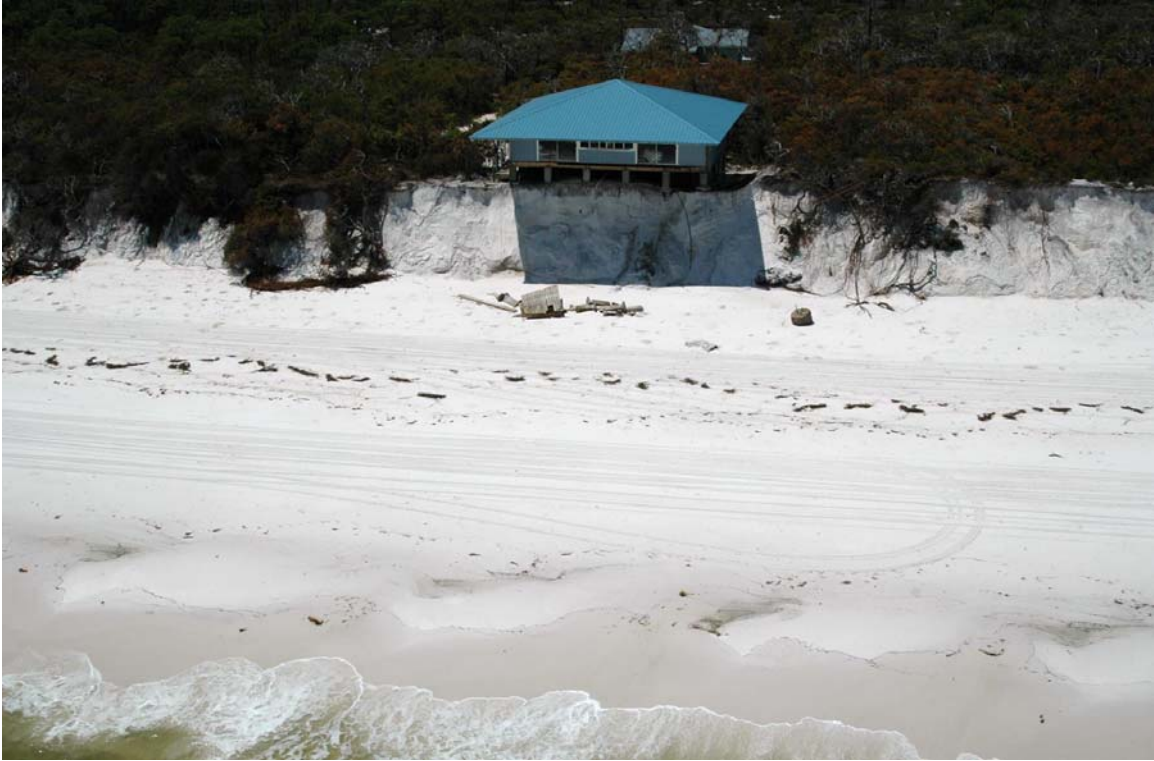
Photo 56. Imminently endangered dwelling, Dog Island (R172.5).

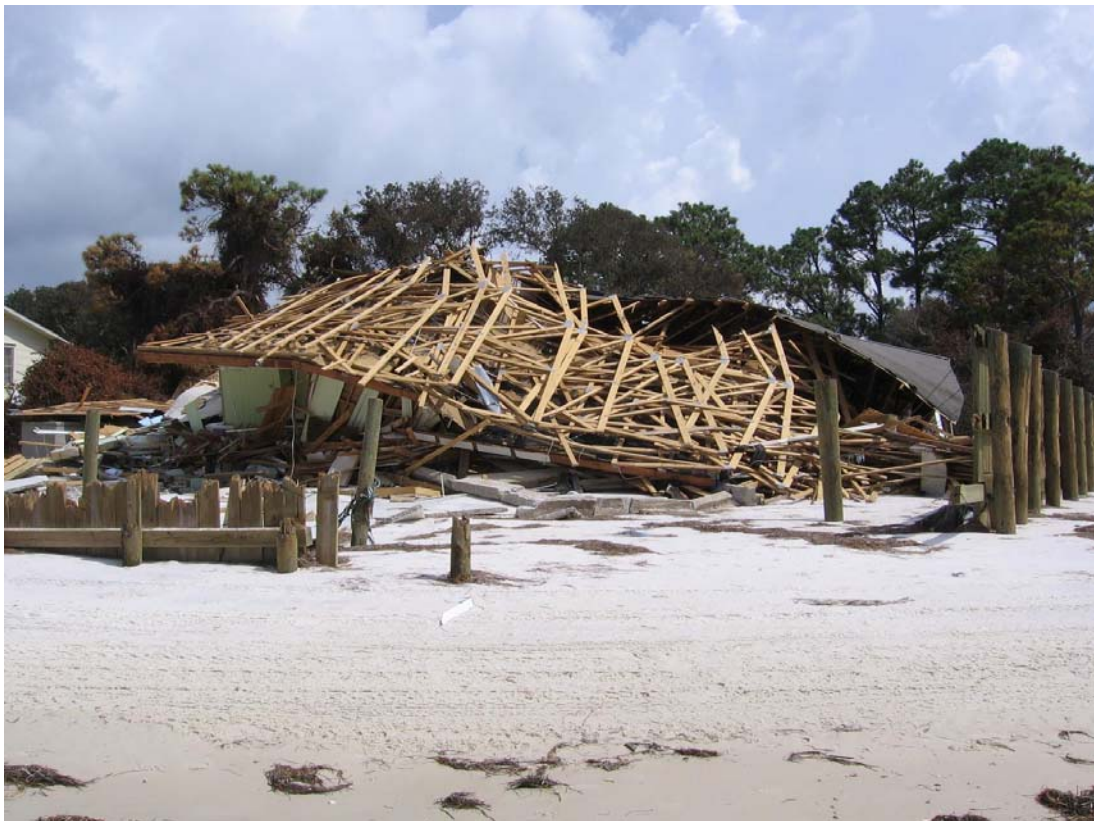
Photo 58. Dwelling destroyed, Southwest Cape (R210.2).

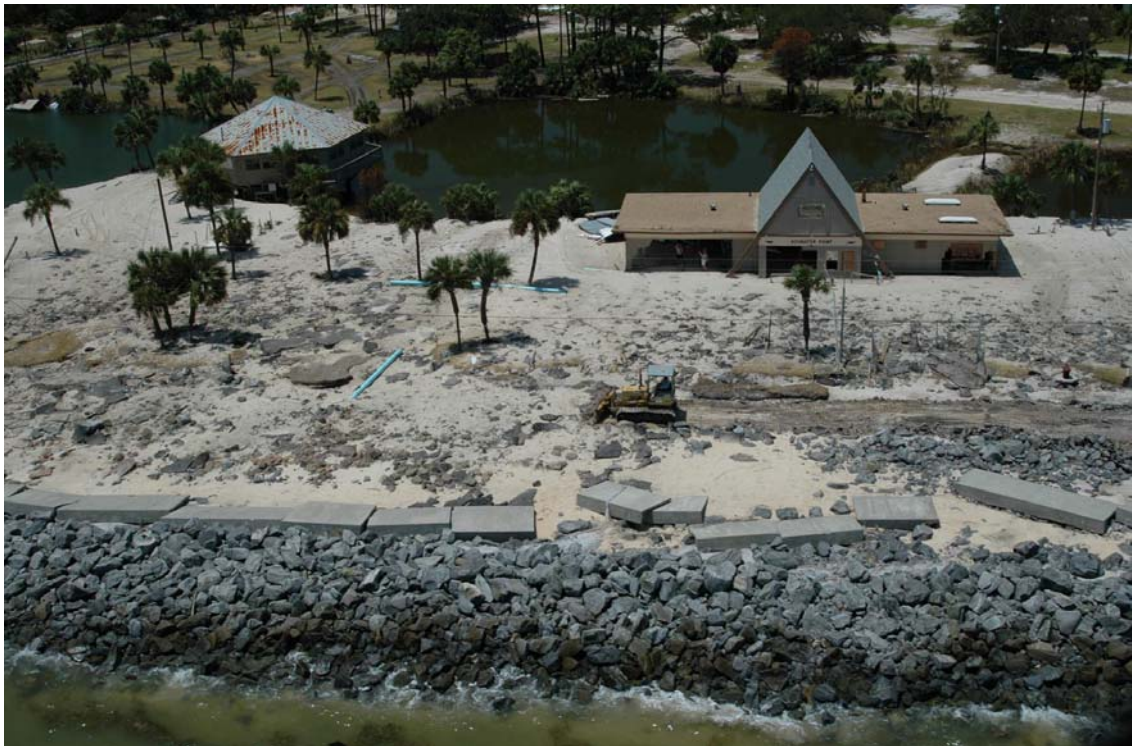
Photo 60. Revetment damaged; road and commercial building destroyed, Southwest Cape (R212.4).

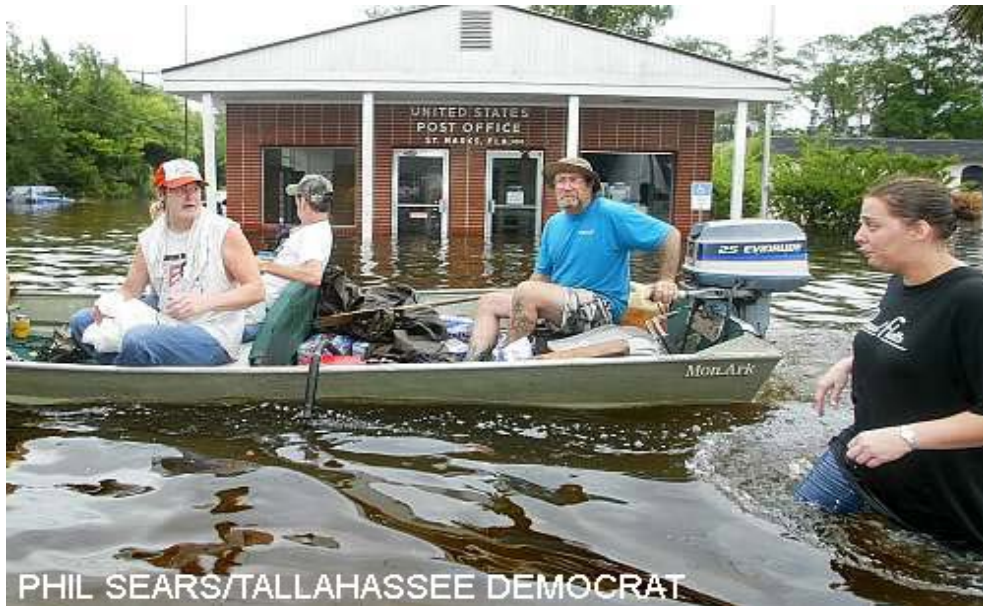
Photo 62. U.S. Post Office flooded in St. Marks, Florida (Tallahassee Democrat).

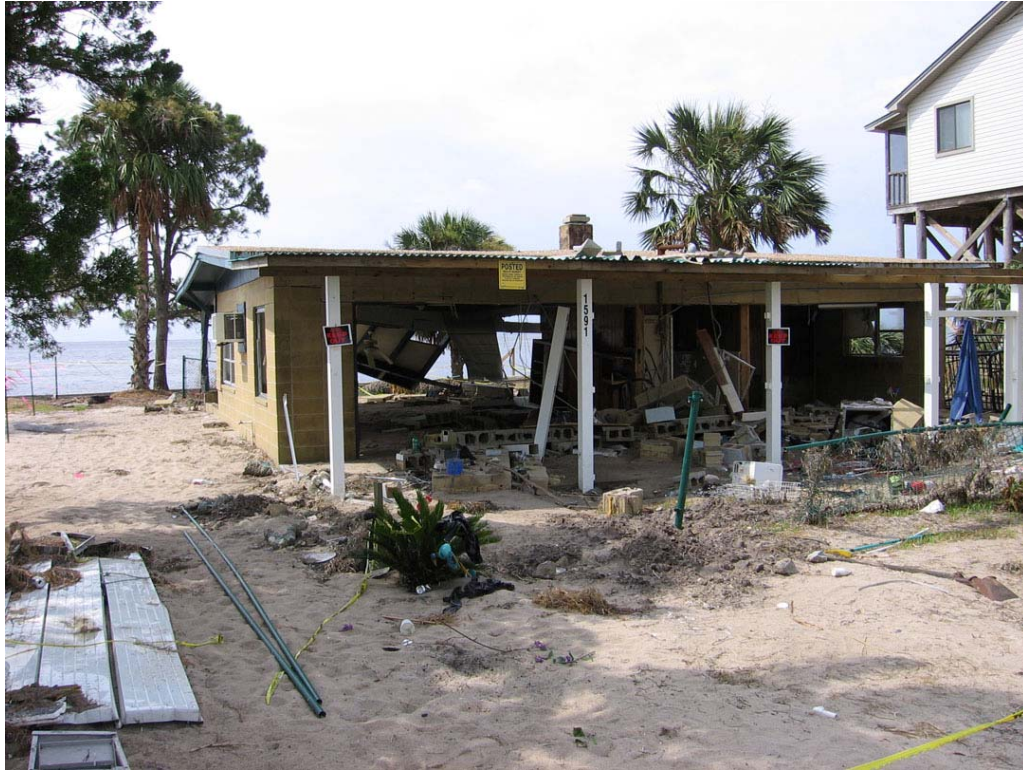
Photo 63. Dwelling destroyed, Shell Point (URS, 2005).
