Hurricane Irma Post-Storm Beach Conditions and Coastal Impact in Florida

**Division of Water Resource Management
Florida Department of Environmental Protection**

April 2018

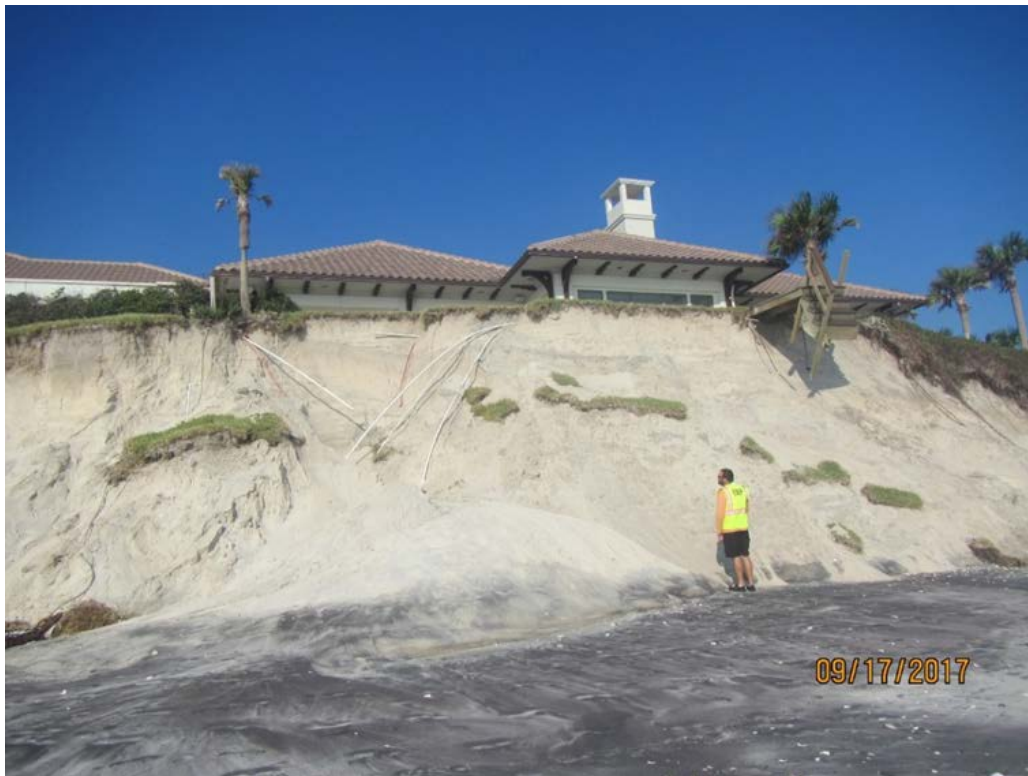
Irma's impact along the northern coast of St. John's County (R1-R118) north of St. Augustine Inlet was particularly severe, resulting in 115 buildings being left in imminent danger of incurring damage from another major storm (see Figure 9 and Figure 10). Example profiles of the major beach and dune erosion are shown in Figure 11 at R28 in Ponte Vedra and in Figure 12 at R94 in South Ponte Vedra adjacent to three destroyed single-family dwellings. South of St. Augustine Inlet, major beach and dune erosion (condition IV) was sustained along Anastasia Island State Park (R123-R140). Along the developed segment of Anastasia Island (R140-R193), including St. Augustine Beach, Crescent Beach and Matanzas Shores, the island sustained moderate to major beach and dune erosion (condition III to IV). Major beach and dune erosion is shown in Figure 13 at R142 in St. Augustine Beach adjacent the St. Augustine Beach

Figure 9. Major dune erosion threatening structure at R30, Ponte Vedra.

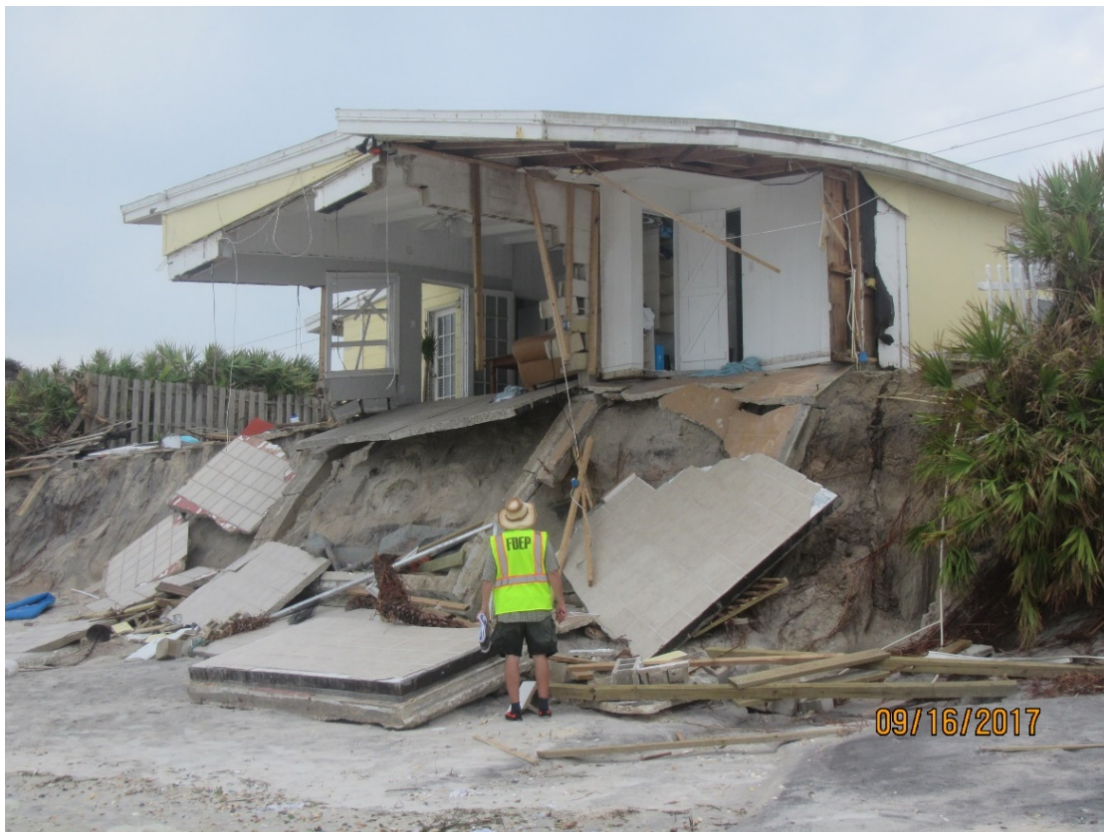
Figure 16. Single-family dwelling destroyed near R94, South Ponte Vedra.

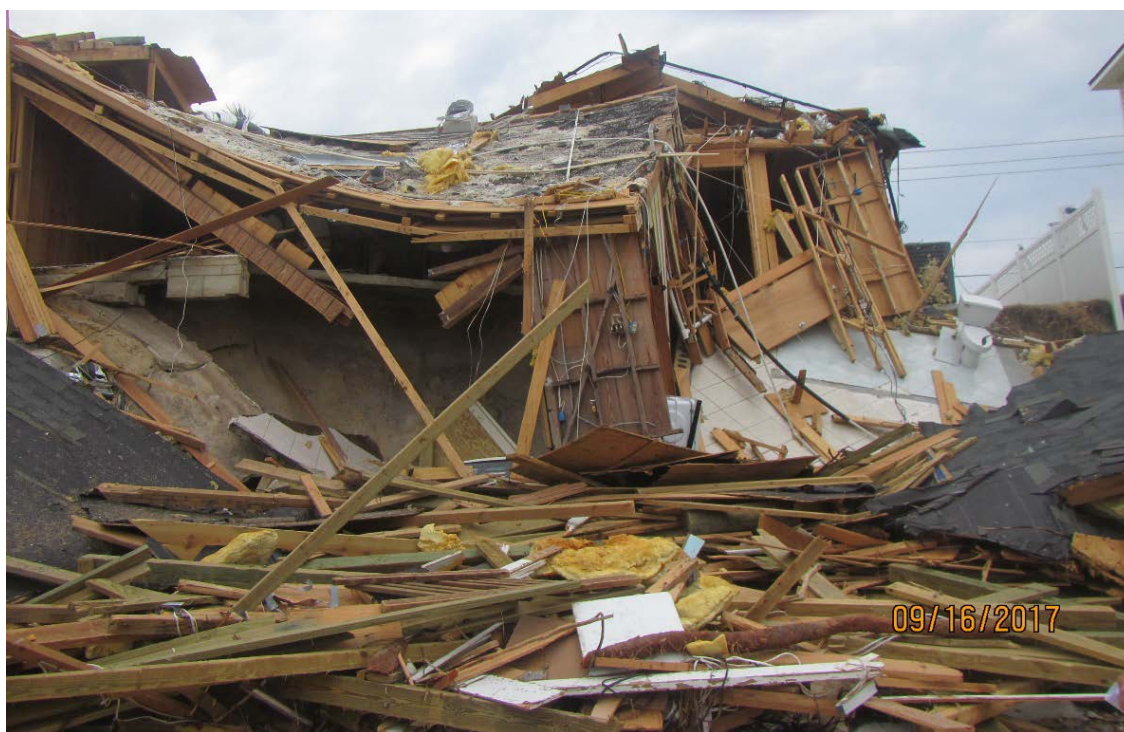
Figure 17. Seawall failure and single-family dwelling destroyed at R89.4, South Ponte Veda.

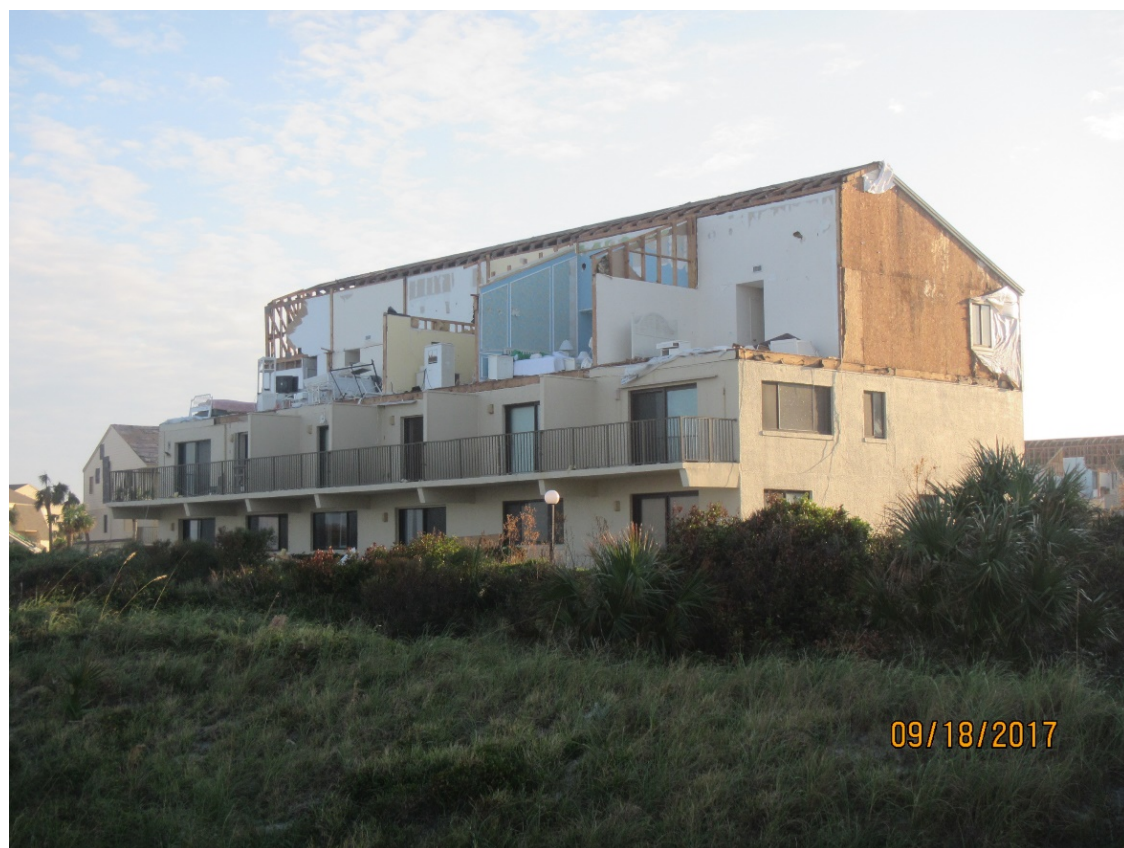
four condominium buildings being destroyed and five condominium buildings, eight single-family dwellings and a storage building sustaining major damage (Figure 18).

Figure 18. One of four condominiums destroyed by rain band tornado, Matanzas Shores, R192.4.

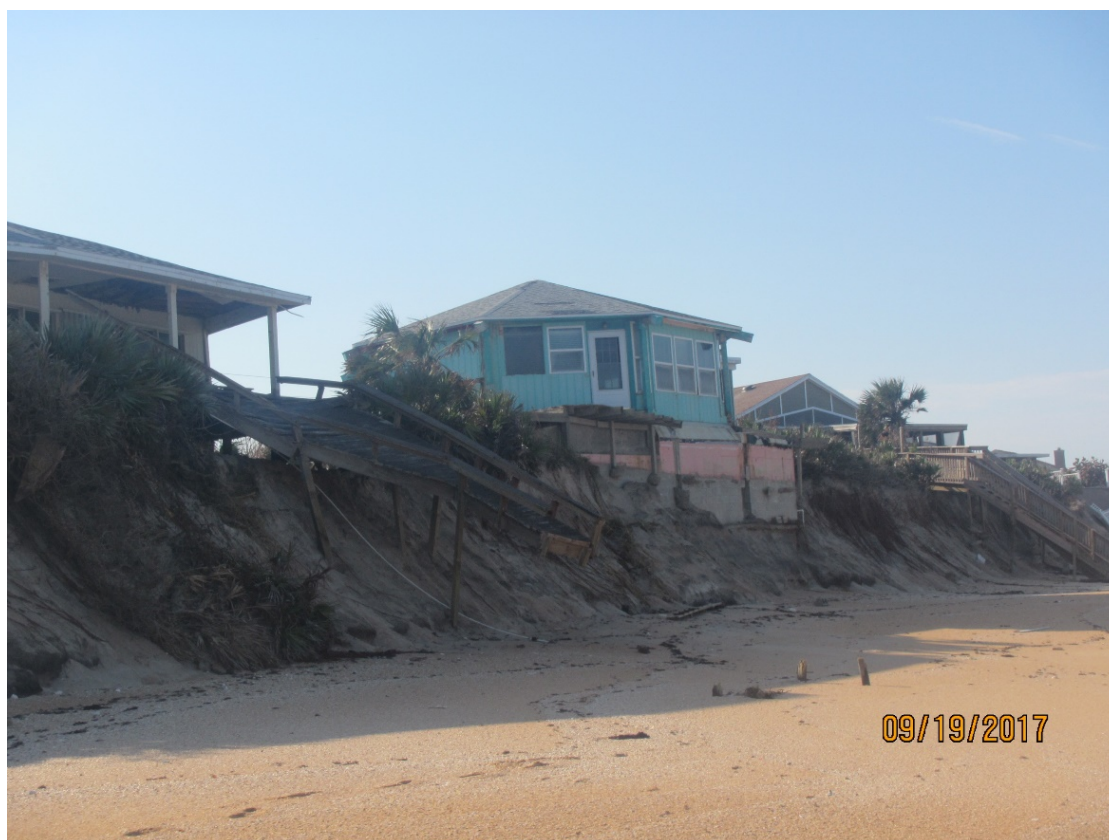
Figure 20. Single-family dwellings threatened along Painters Hill near R55.

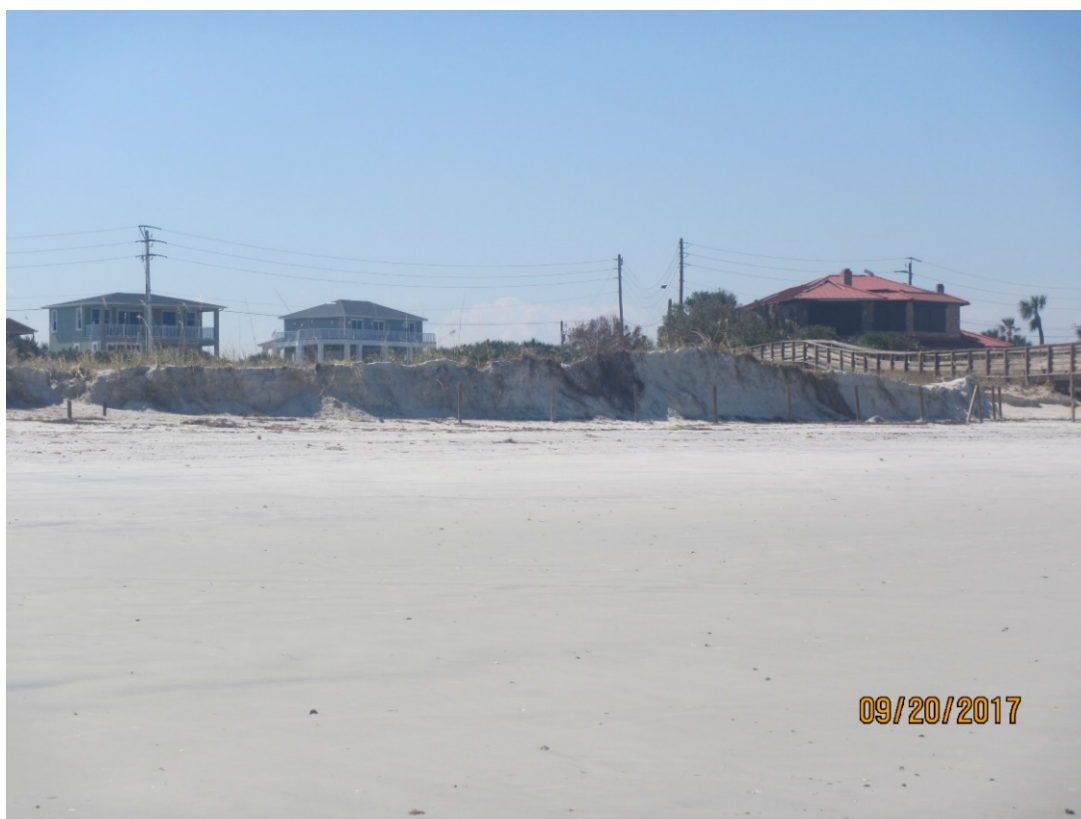
Figure 25. Major beach and dune erosion near R143, Town of Ponce Inlet.

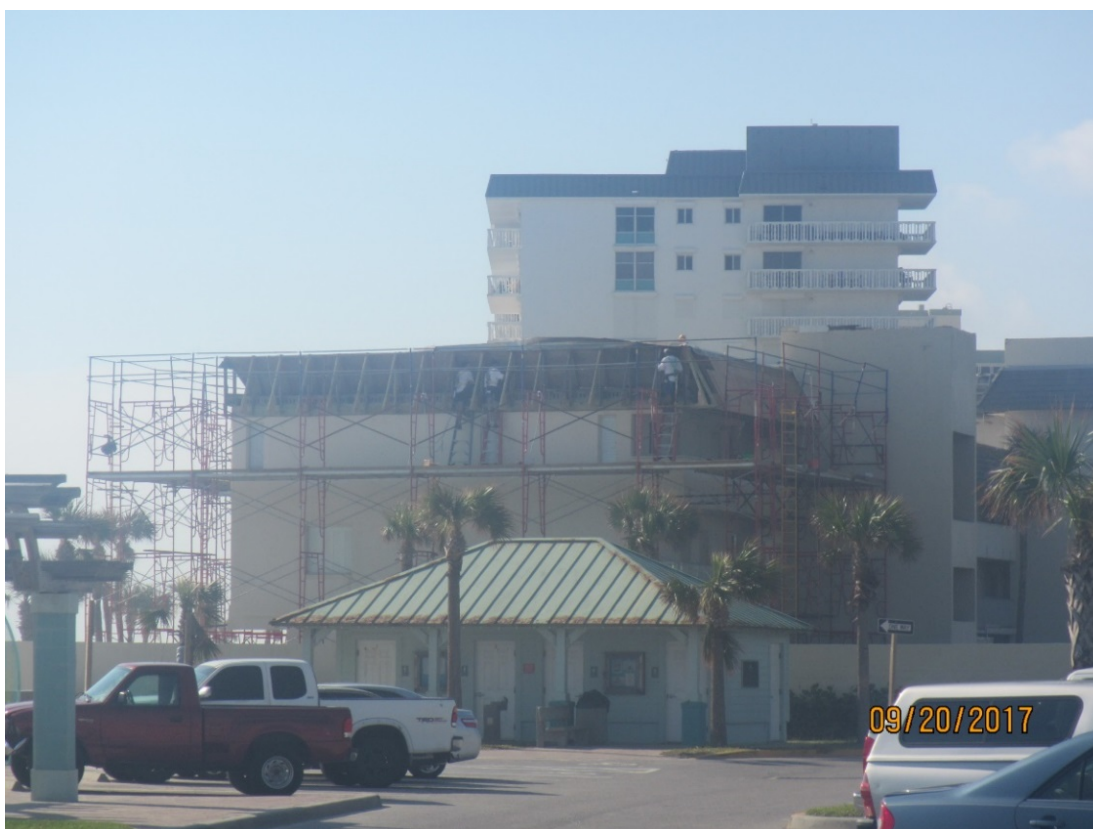
Figure 27. Wind damage to condominium at R40, Ormond Beach.

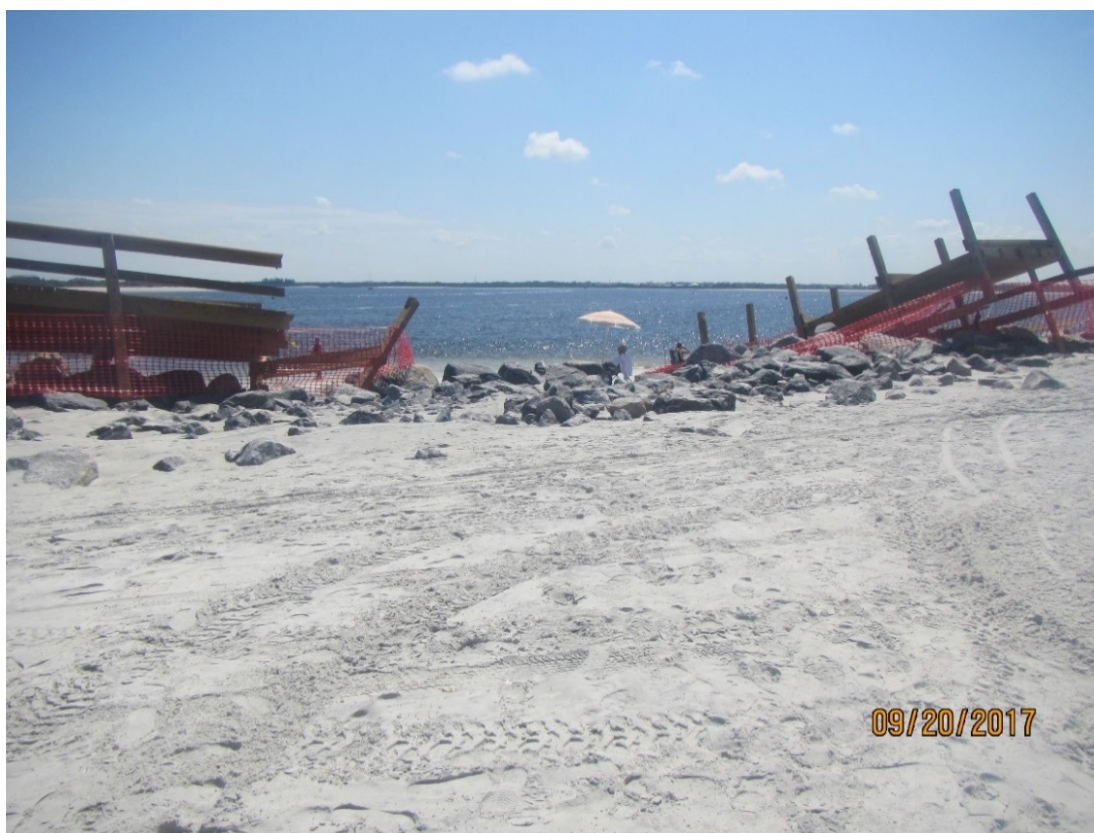
Figure 28. Major damage to north jetty and boardwalk at Ponce de Leon Inlet, R148.

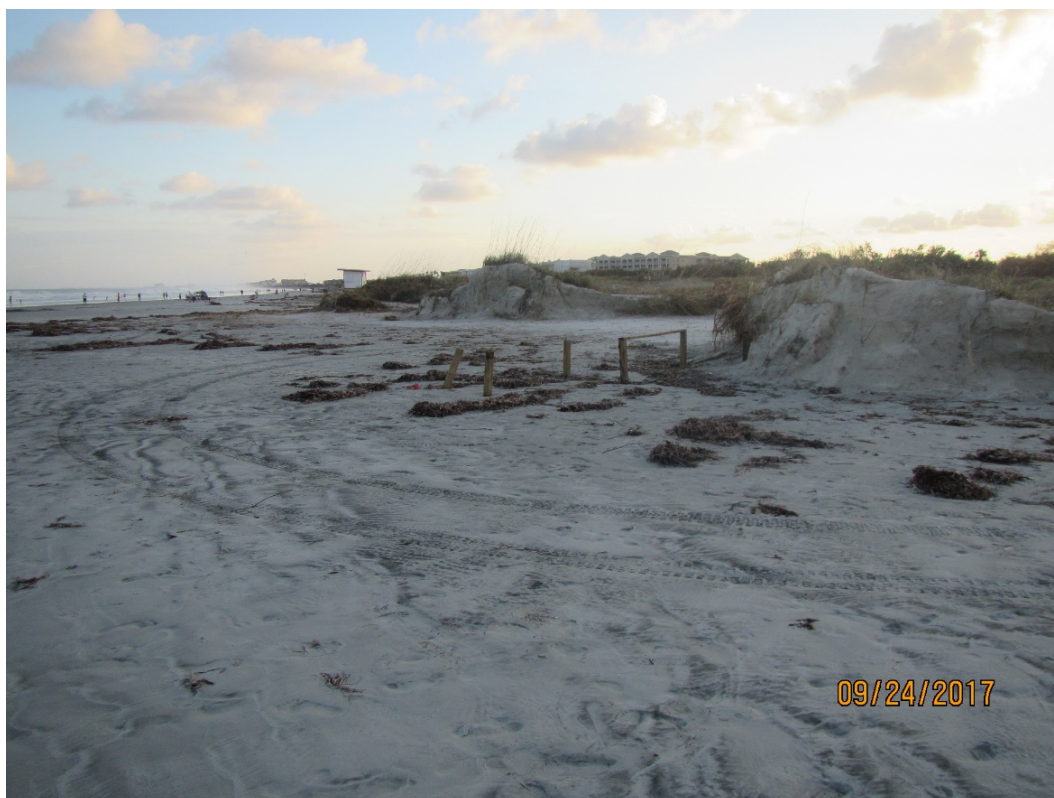
Figure 30. Major dune erosion at Jetty Park near R1, Port Canaveral.

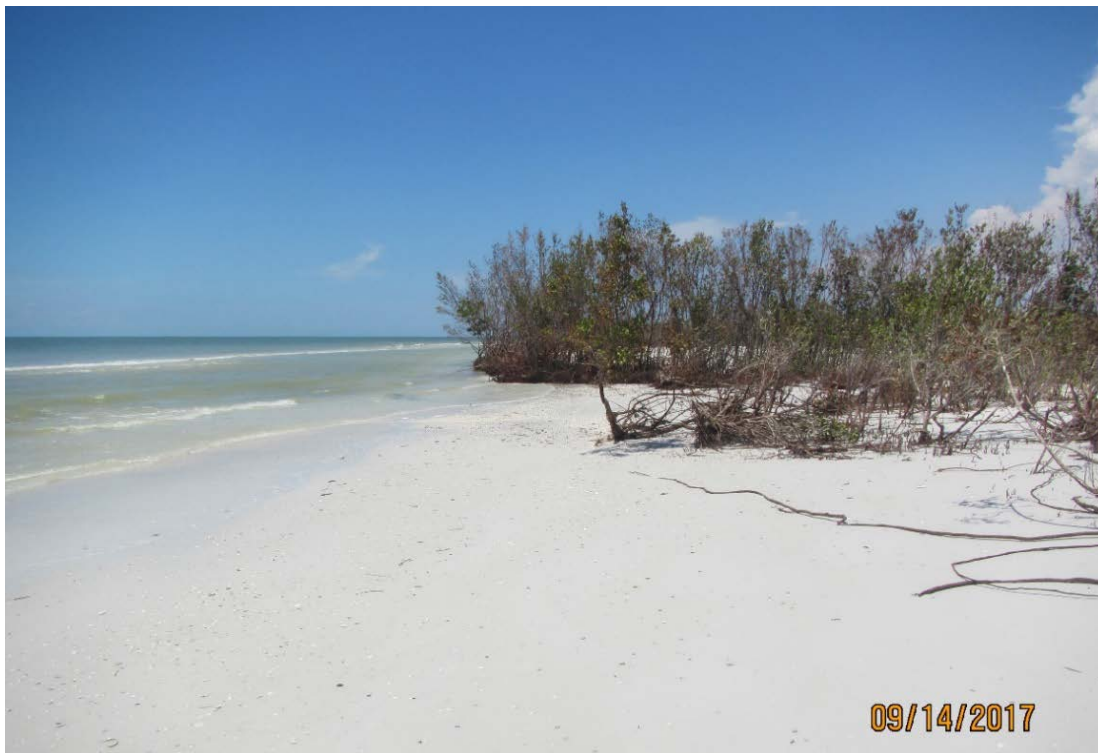
Figure 37. North Marco Island erosion near R132.

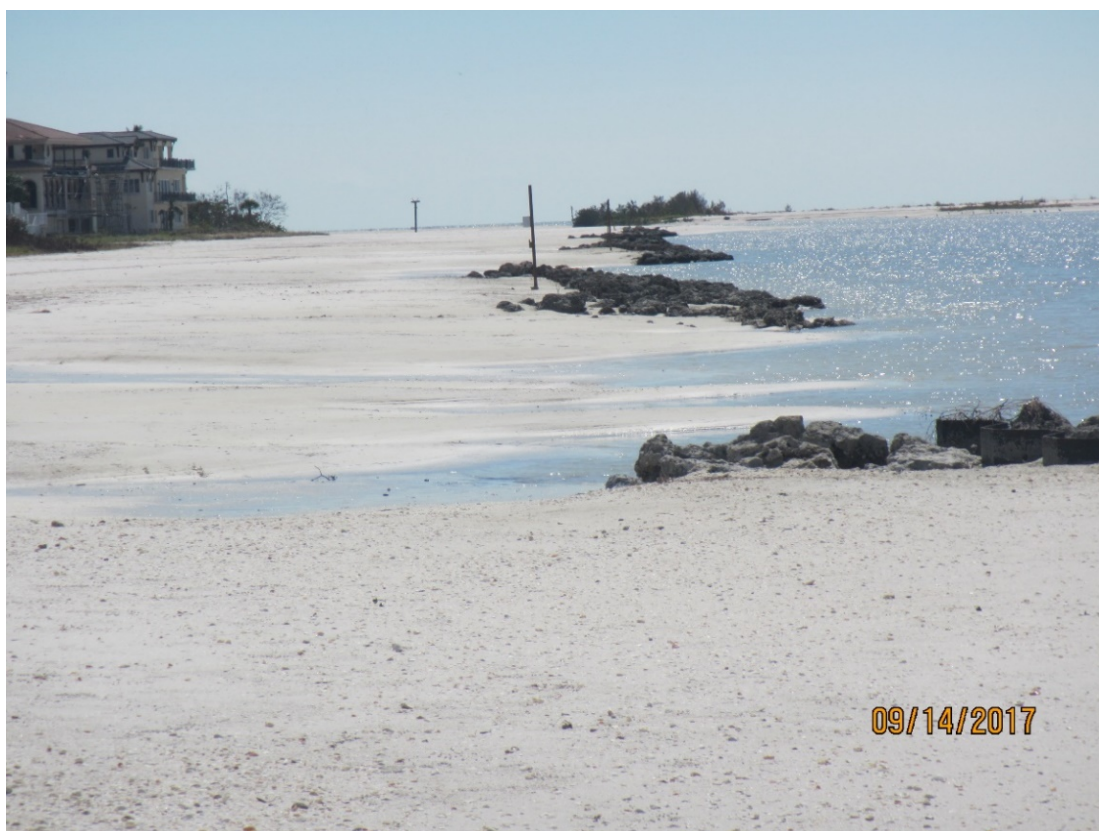
Figure 38. T-groin field along Hideaway Beach near V313.

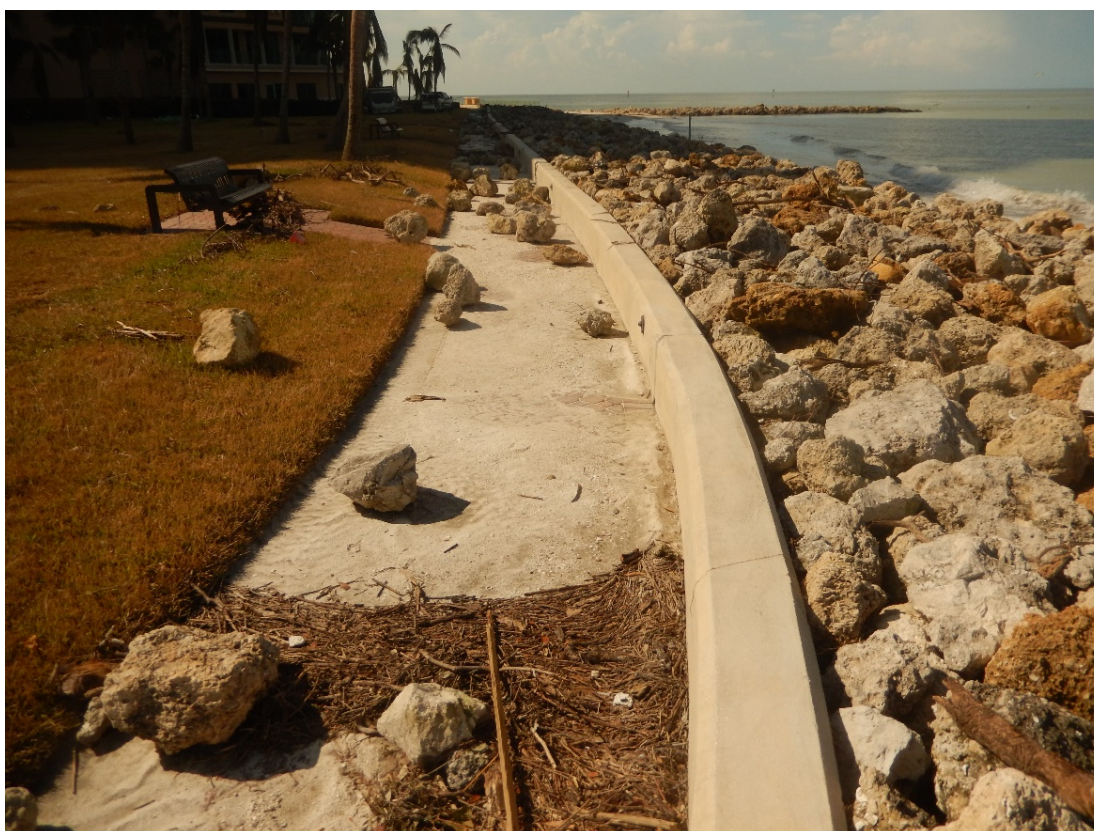
Figure 41. South Marco Island revetment damage near R148.

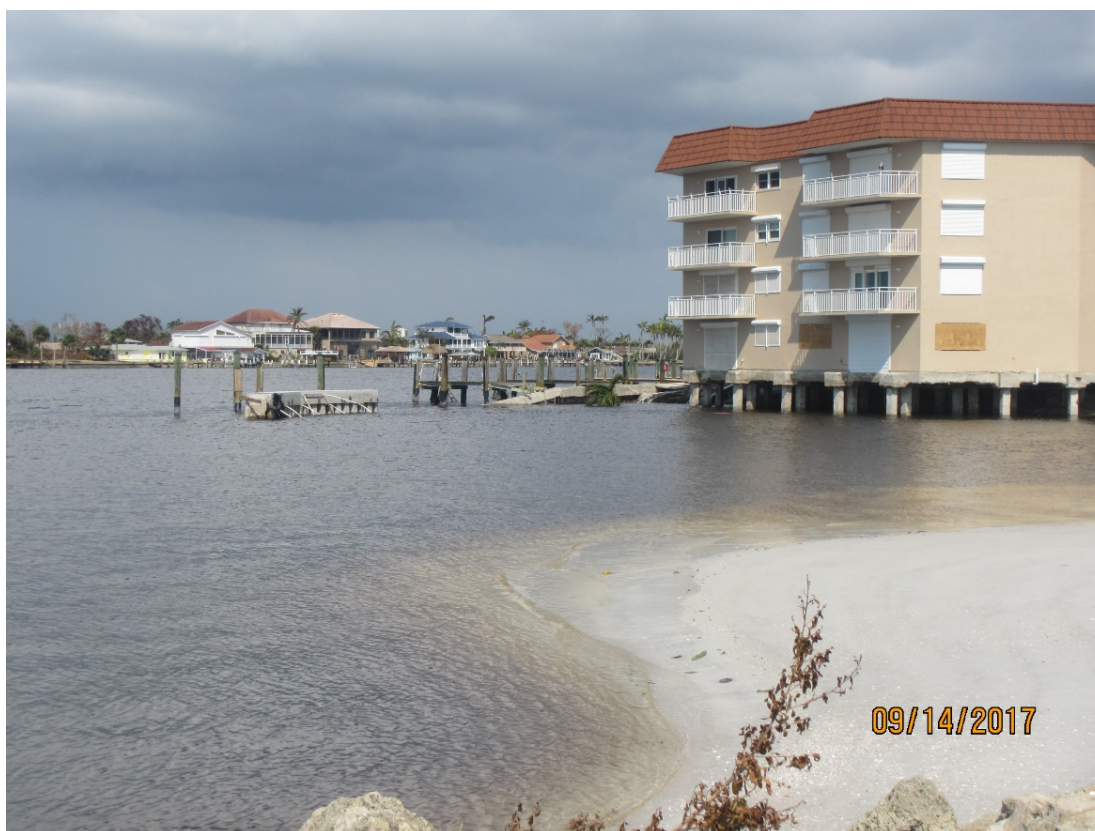
Figure 42. *Seawall destroyed and condominium undermined in Big Marco Pass near V310.*

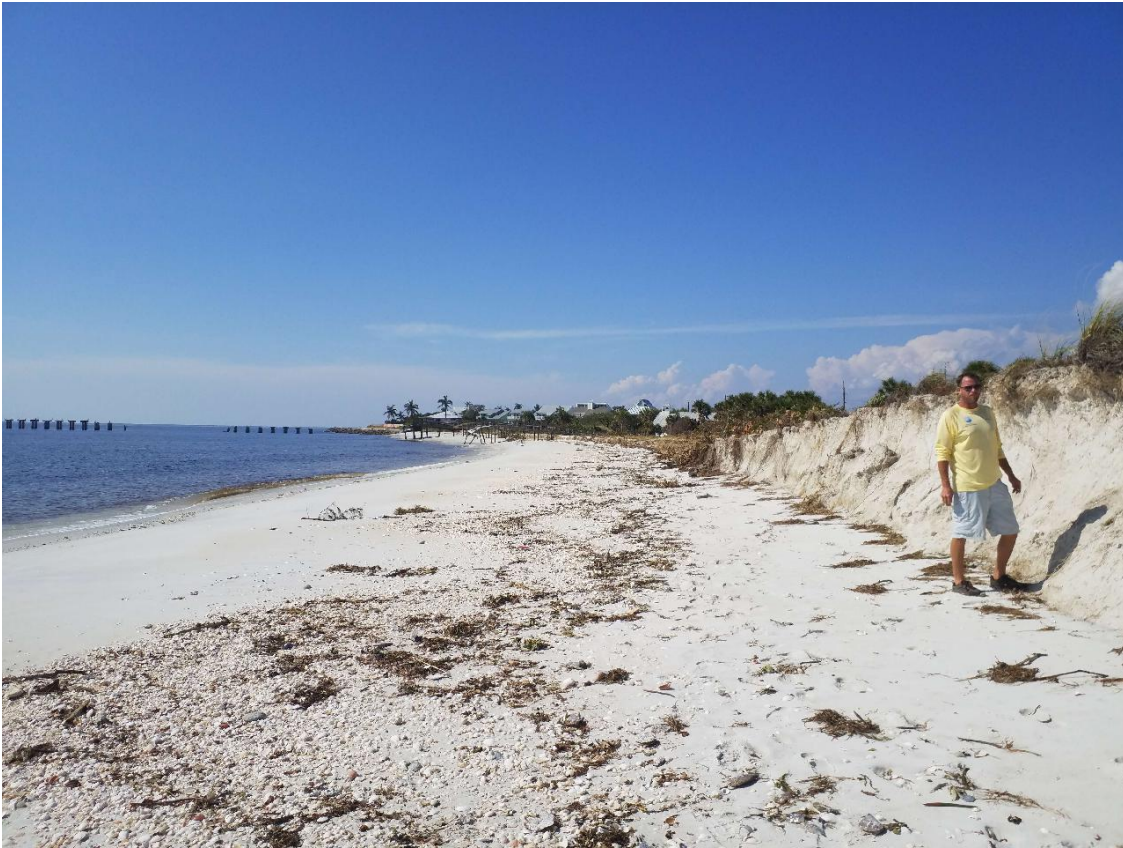
Figure 44. *Erosion and damage to dune walkovers at the southern end of Gasparilla Island State Park, R26.*

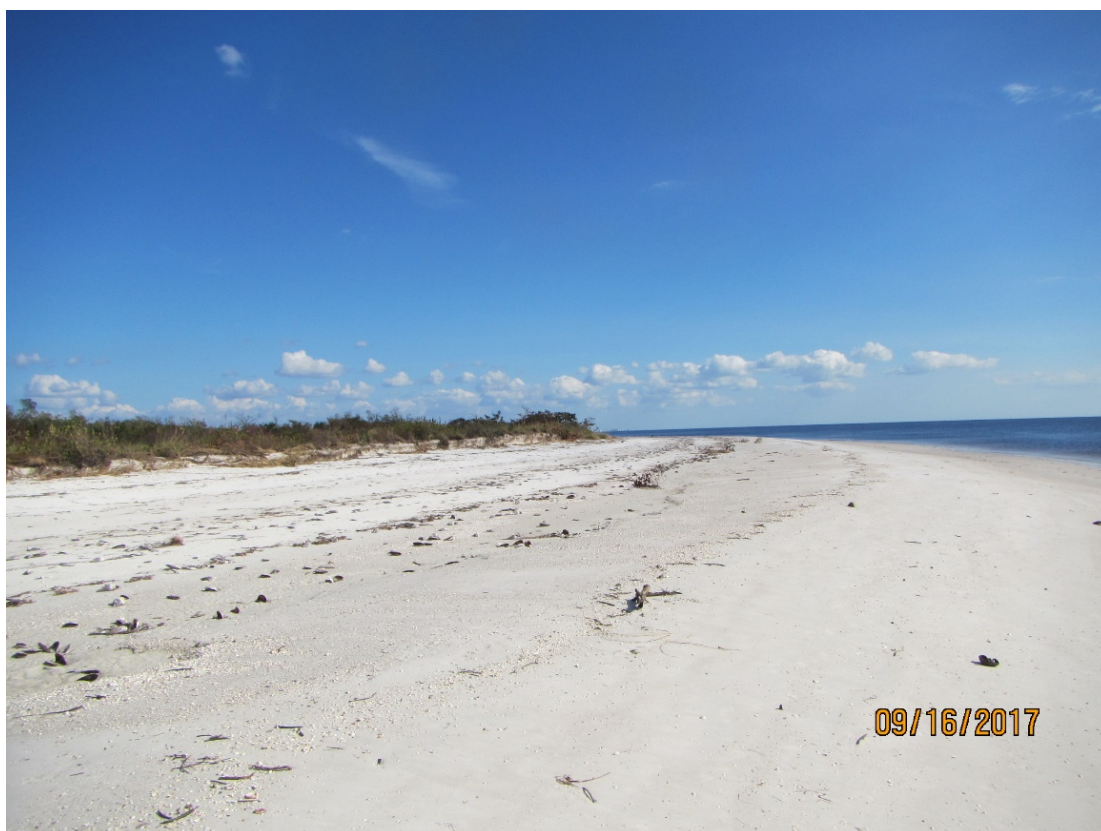
Figure 49. Minor erosion at the northern end of Lovers Key near R213.

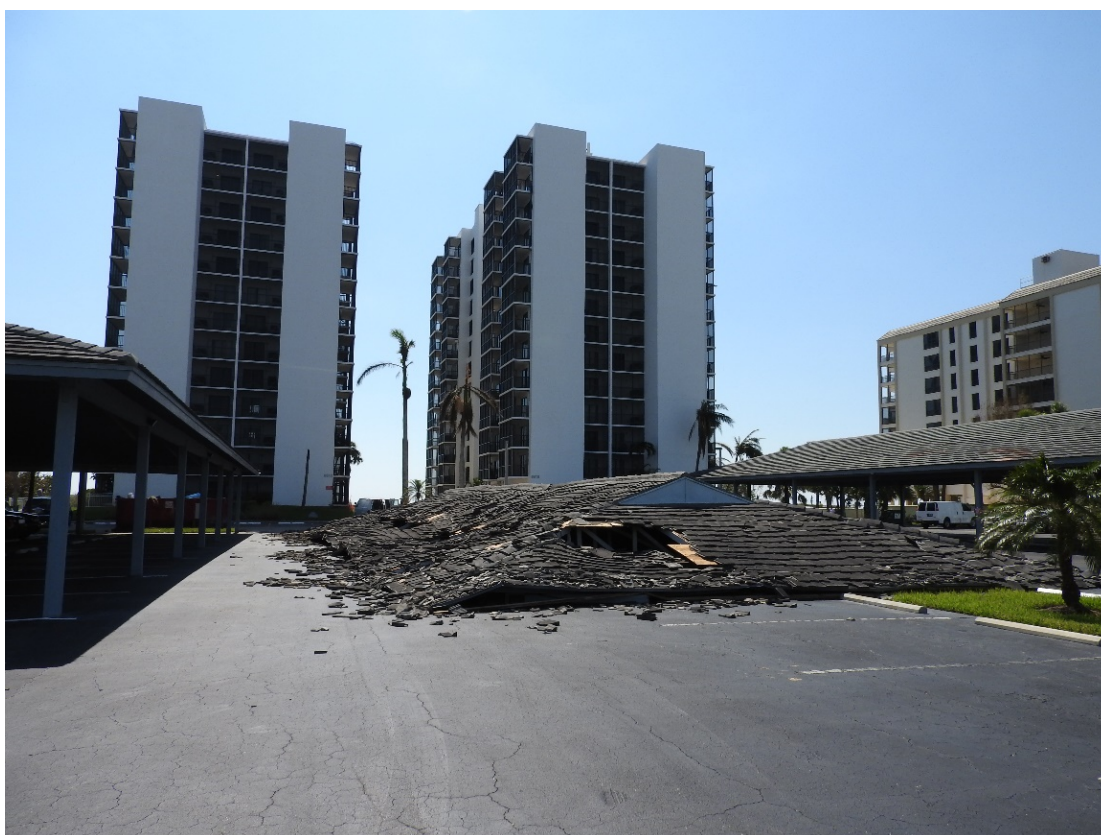
Figure 50. Collapsed parking garage structure at Fort Myers Beach near R201.

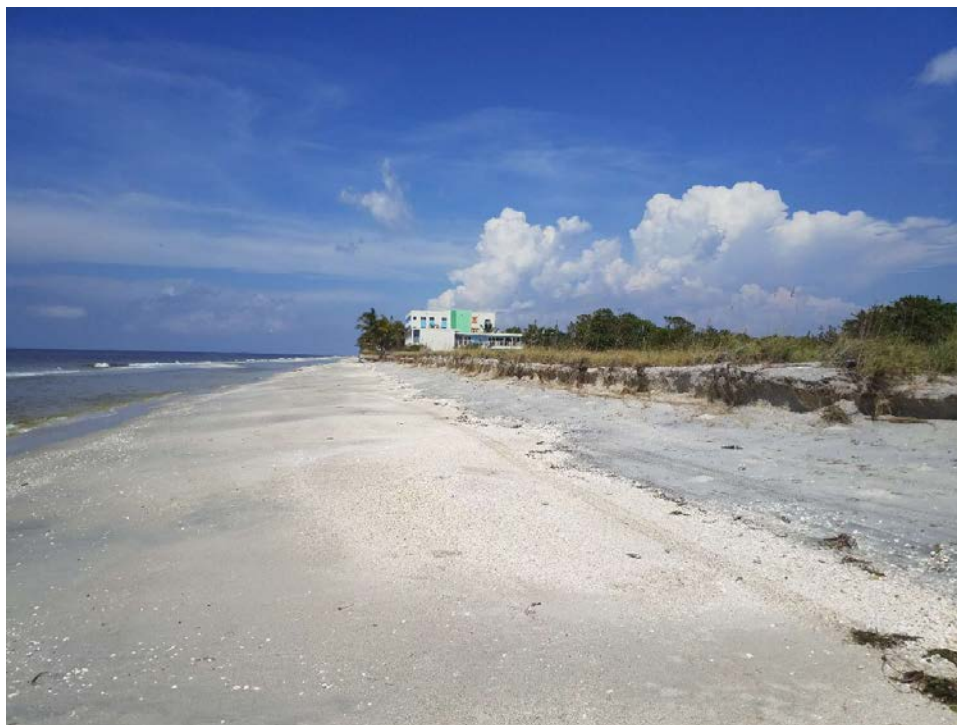
Figure 52. Beach and dune erosion at Stump Pass State Park near R16.

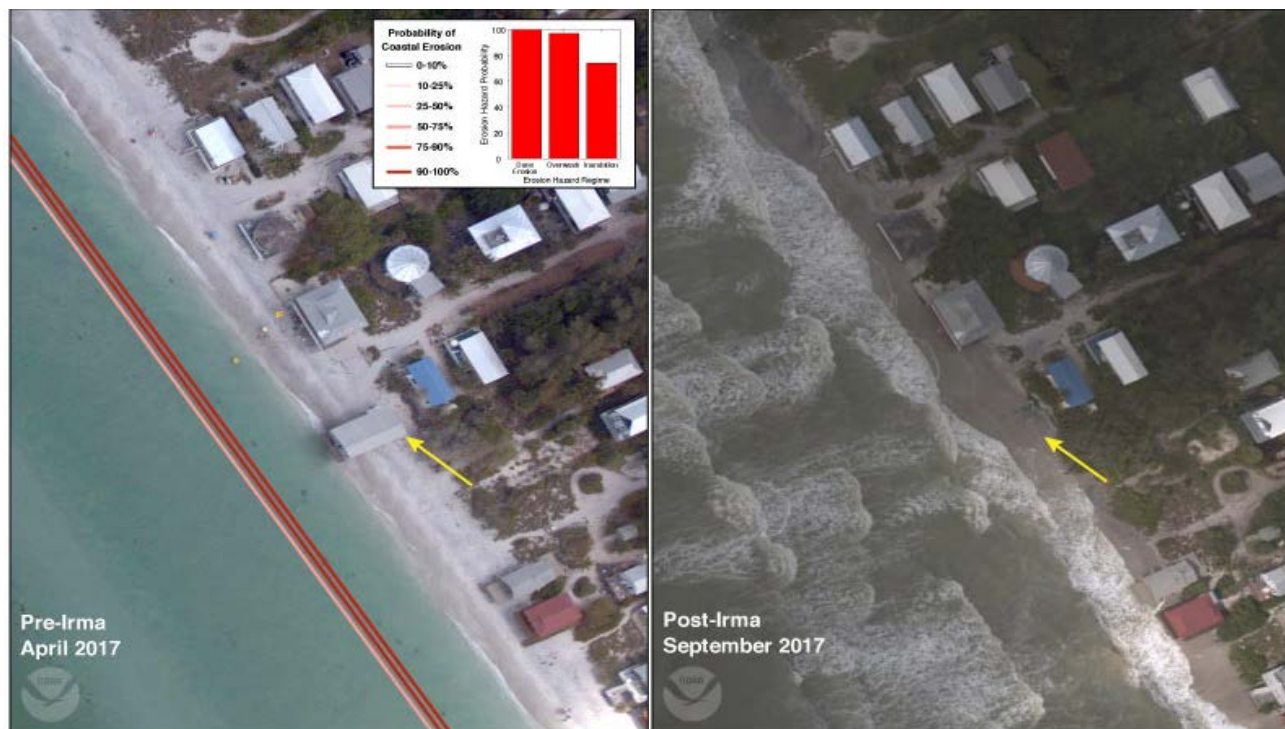
On Little Gasparilla Island, an older pile-supported single-family dwelling near R49 that was located on the active beach and into the foreshore seaward of mean high water was destroyed (Figure 53).

Figure 53. Comparative NOAA aerial photos showing the dwelling on Little Gasparilla Island destroyed near R49 (Source: National Assessment of Coastal Change Hazards, St. Petersburg Coastal and Marine Science Center, USGS).

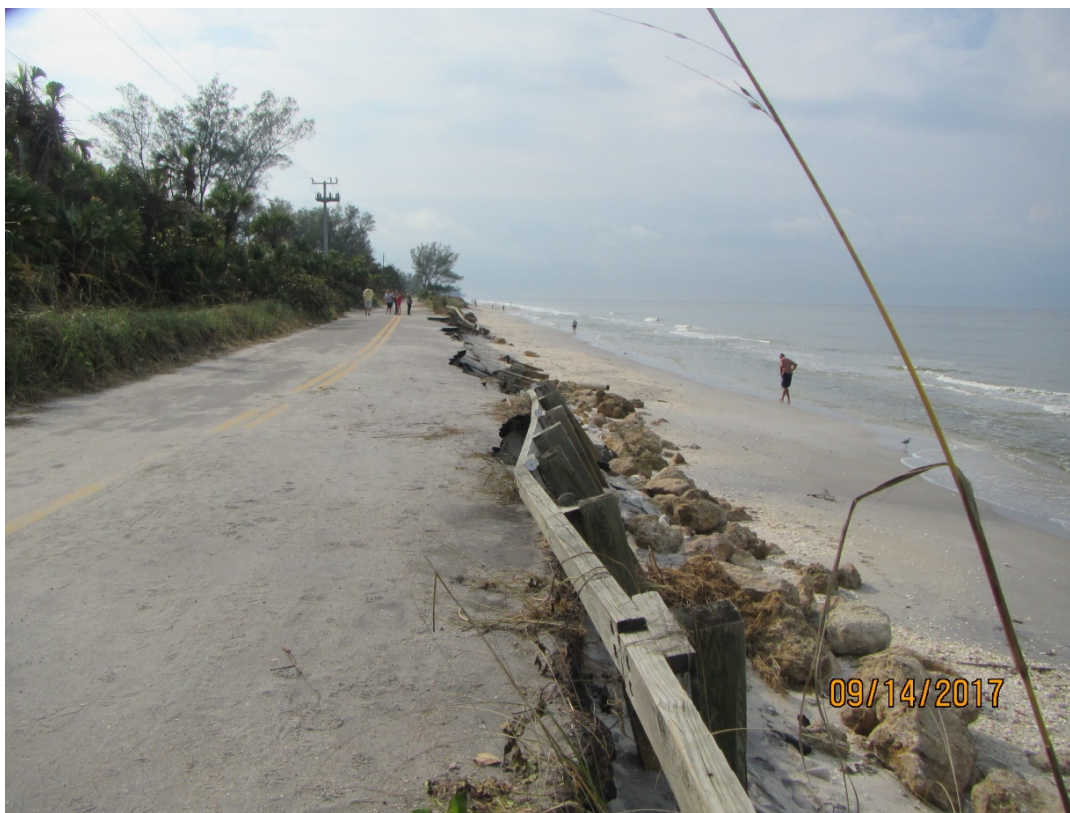
A small segment of beach erosion was observed near the south end of Manasota Key (R175-R176) where more than 100 feet of the Manasota Key Road sustained major damage (Figure 55). Another small segment of erosion was observed further south at R182, where a single-family dwelling is threatened (Figure 56).

Figure 55. *Dune erosion that damaged Manasota Key Road near R175.*

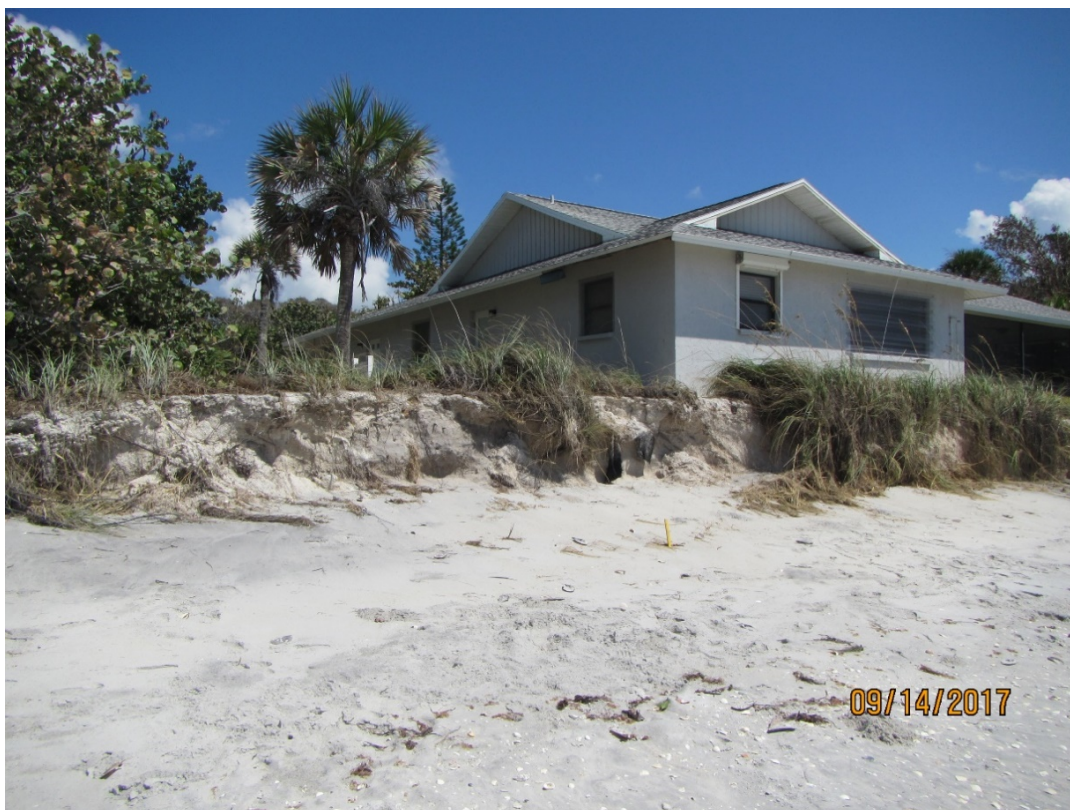
Figure 56. *Dune erosion that threatened a residence near R182.*

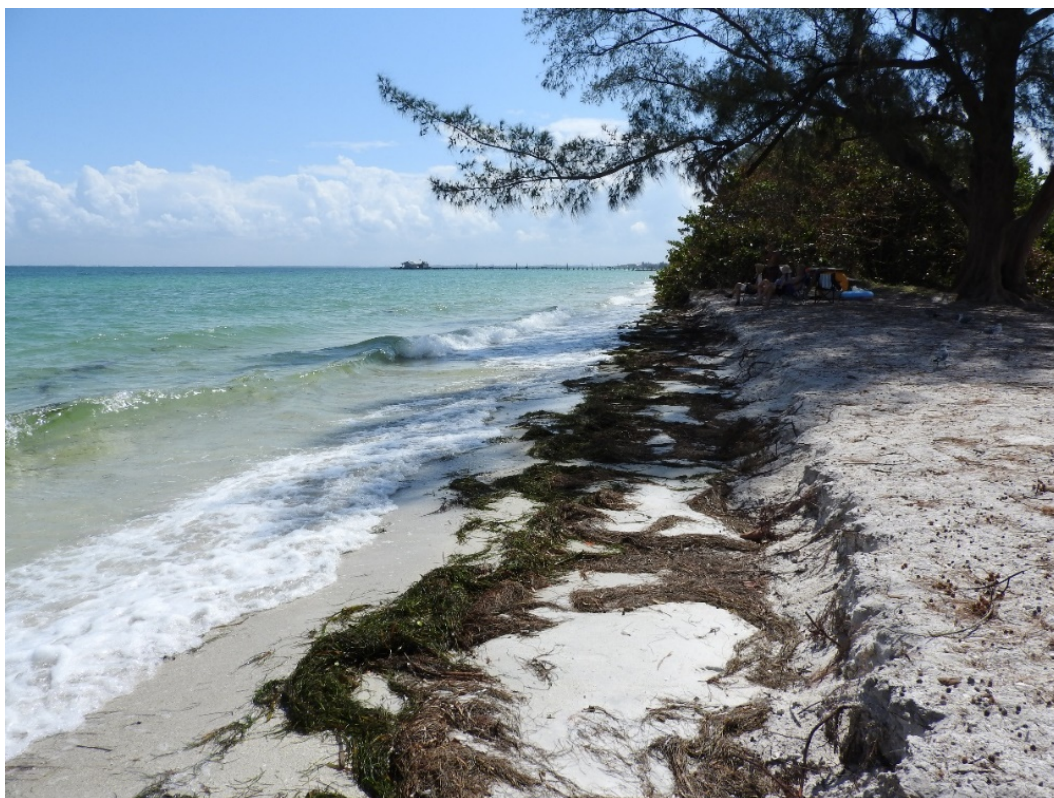
Figure 58. Beach erosion at the northern end of Anna Maria Island between R2 and City Pier.

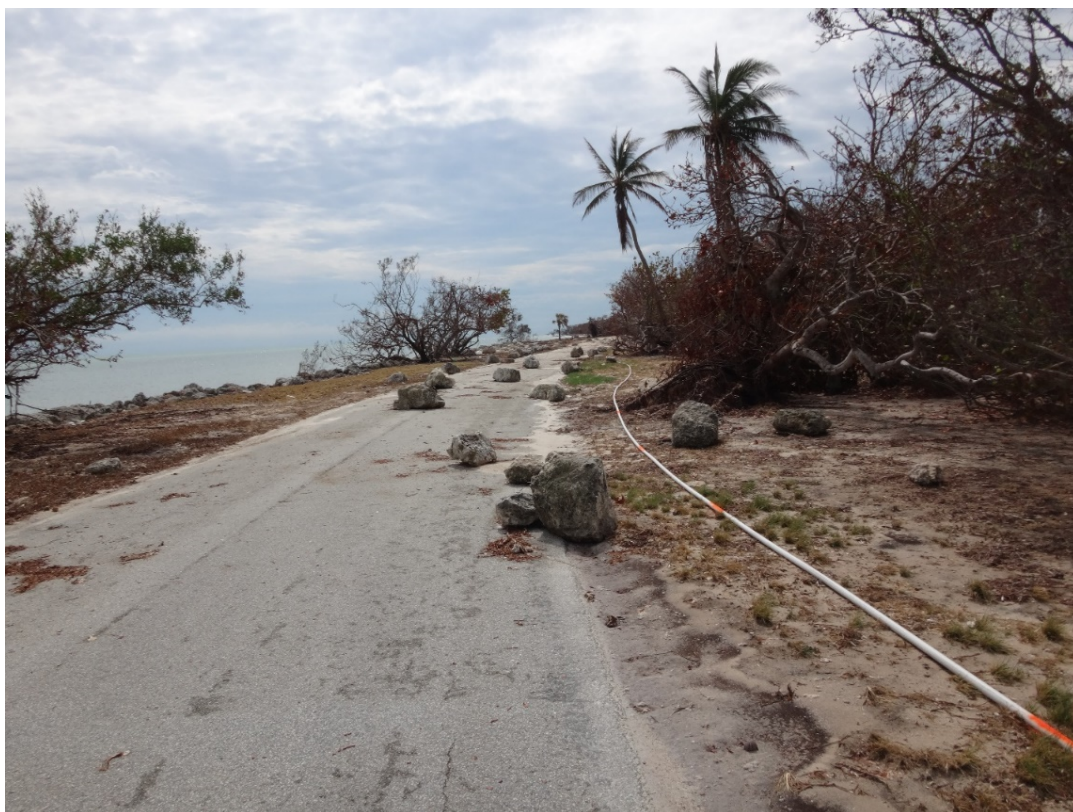
The 4.2-mile long island of Long Key has predominantly coarse-grained sand beaches. The eastern approximately 14,000 feet has mostly pocket beaches along a predominantly mangrove shoreline. Along the western 8,500 feet of the island is continuous beach averaging 25 feet in width. Of this beach segment, 5,700 feet are within the Long Key State Park and the western 2,800 feet front private development consisting of 14 single-family residences and five multi-family buildings. One mile of the state park beach is designated critically eroded. Hurricane Irma inflicted severe erosion and overwash along the entire beach front, as well as minor damage (level II damage) to 700 feet of boulder mound limerock revetment (Figure 63).

Figure 63. *The park road in Long Key State Park with overwash of revetment boulders.*

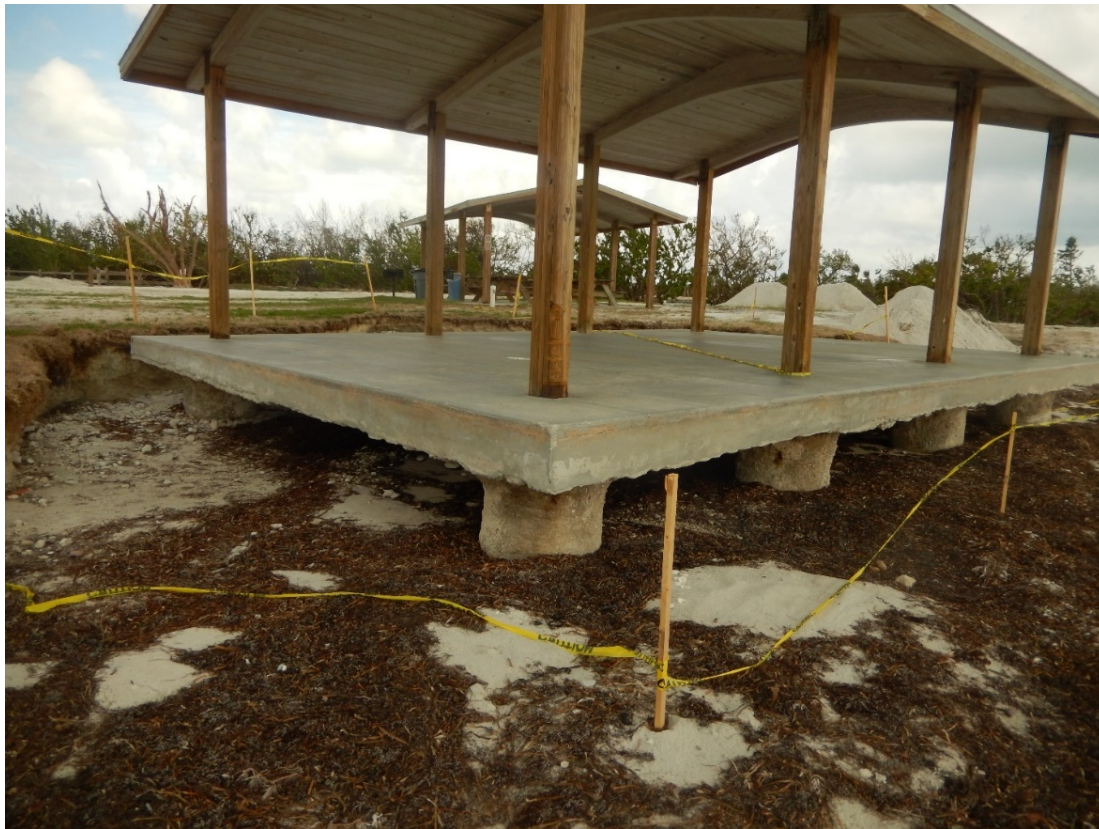
Little Crawl Key has a 1,500-foot beach that varies from 25 to 50 feet wide, which is within Curry Hammock State Park. This is the site of a truck-hauled beach restoration project constructed in 2008, with additional dune nourishment in 2011. The beach project was constructed with silicate sand, which has blended with the native calcium carbonate sediments on-site. Hurricane Irma inflicted major beach and dune erosion (condition IV) along the eastern approximately 400 feet of the beach, and moderate beach and dune erosion (condition III) along the western 1,100 feet of the beach. The erosion along the eastern stretch of beach has undermined two of the four pavilion structures (Figure 66).

Figure 66. Undermined pavilion at Curry Hammock State Park.

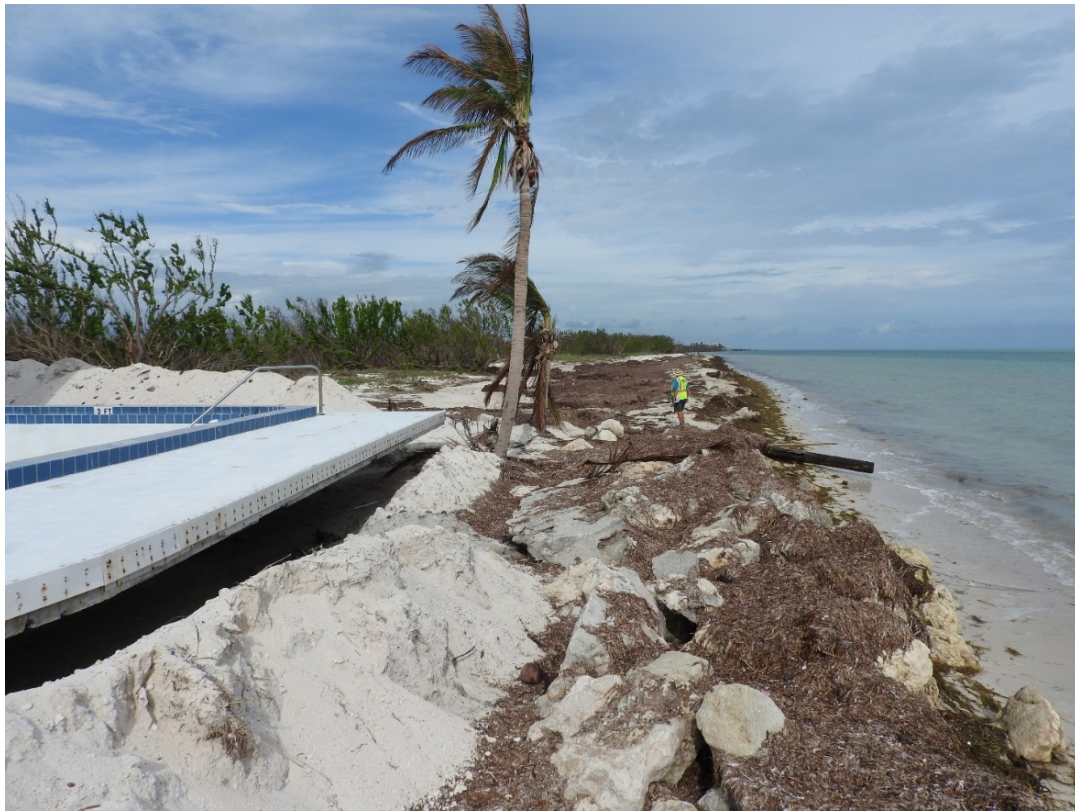
Figure 68. *Damaged revetment and undermined pool at Coco Plum Beach.*
