Hurricane Irma Post-Storm Beach Conditions and Coastal Impact in Florida

**Division of Water Resource Management
Florida Department of Environmental Protection**

April 2018

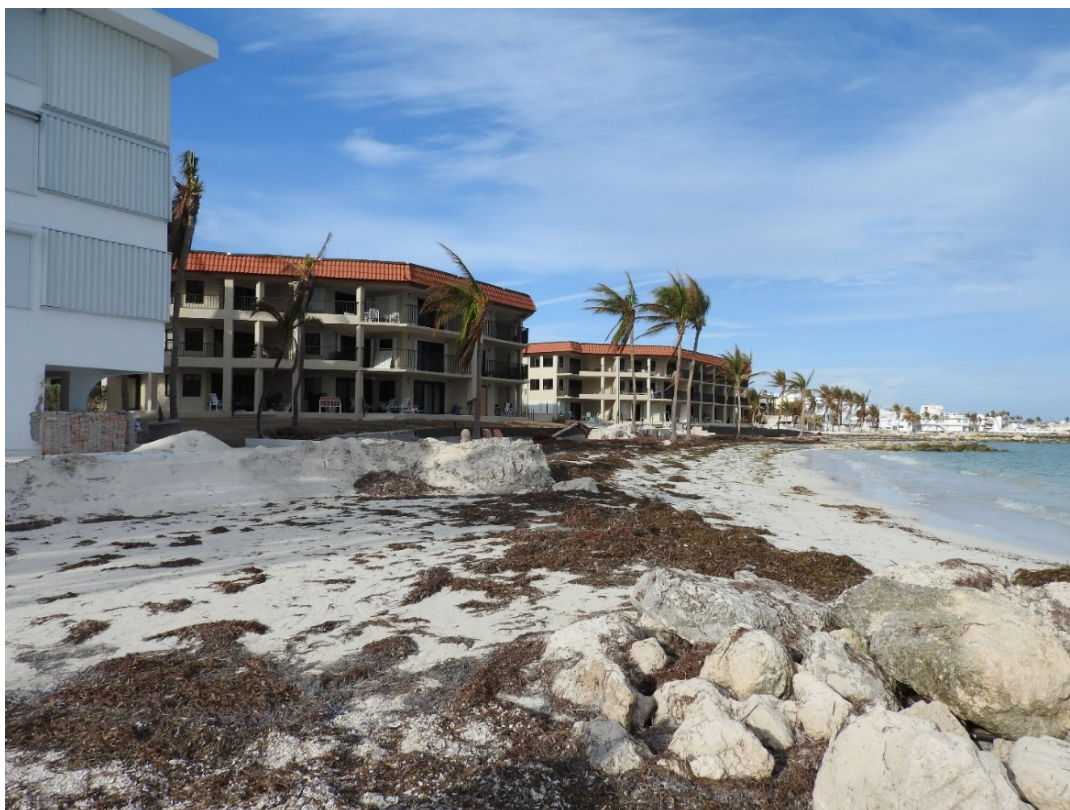
Figure 69. Major beach erosion, Key Colony Beach.

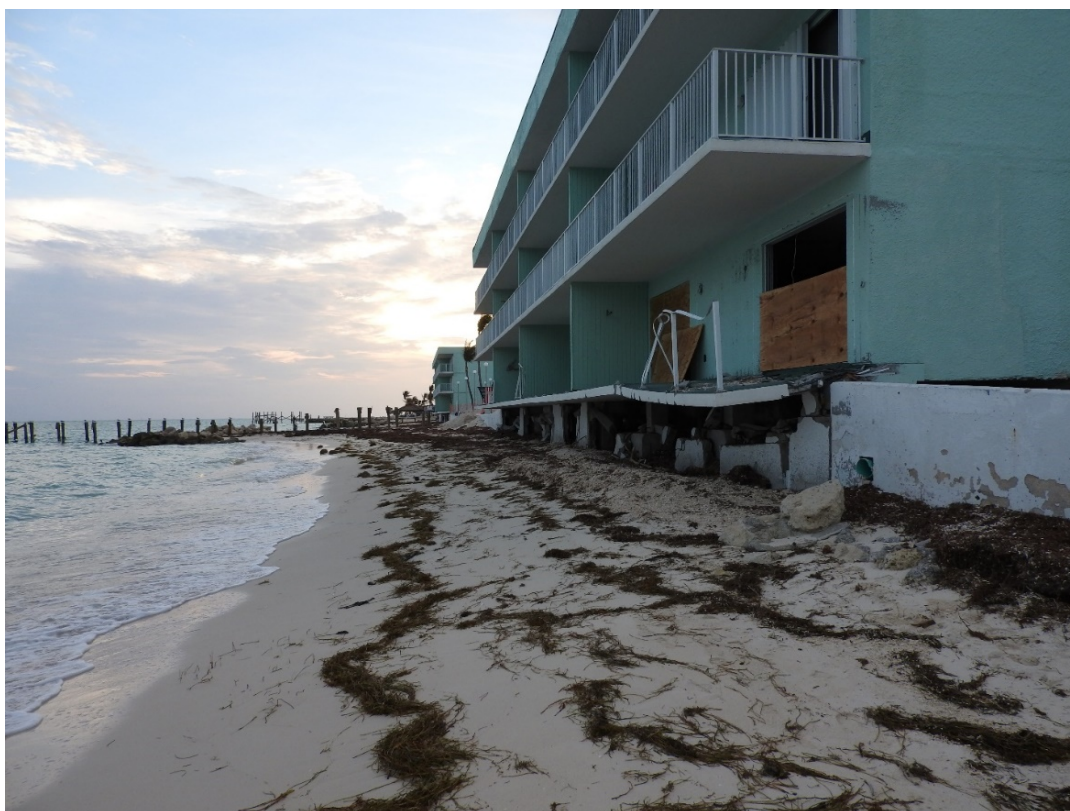
Figure 70. Building damage, Key Colony Beach.

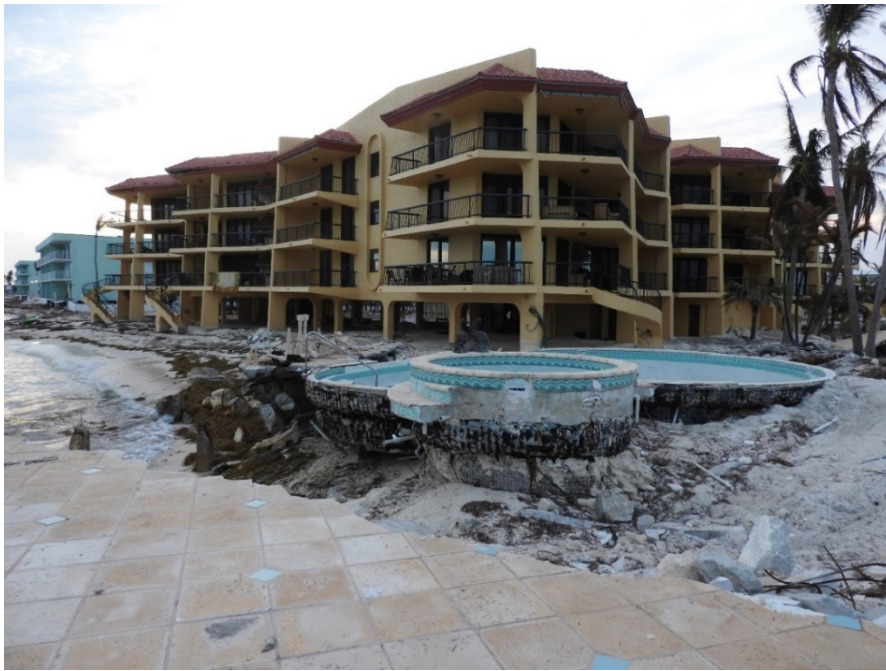
Figure 71. Major damage to shoreline development, Key Colony Beach.

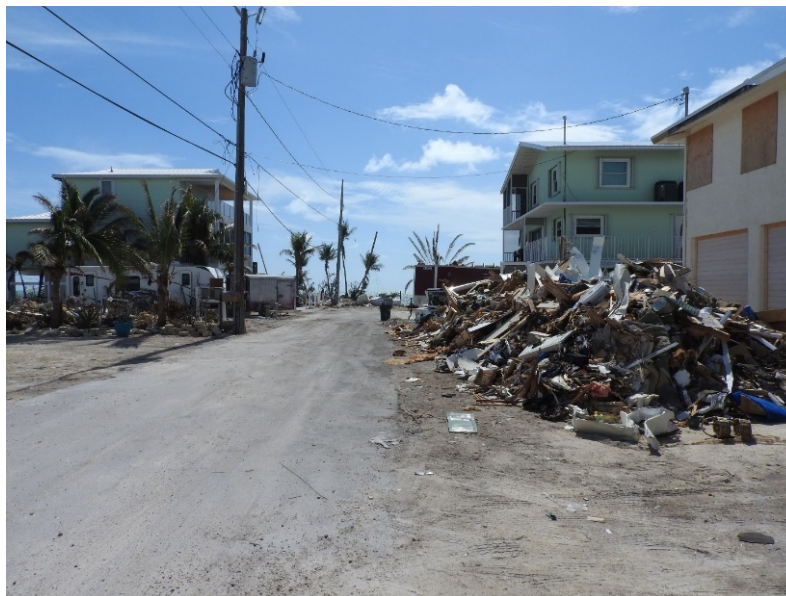
Figure 72. Debris piles throughout City of Marathon.

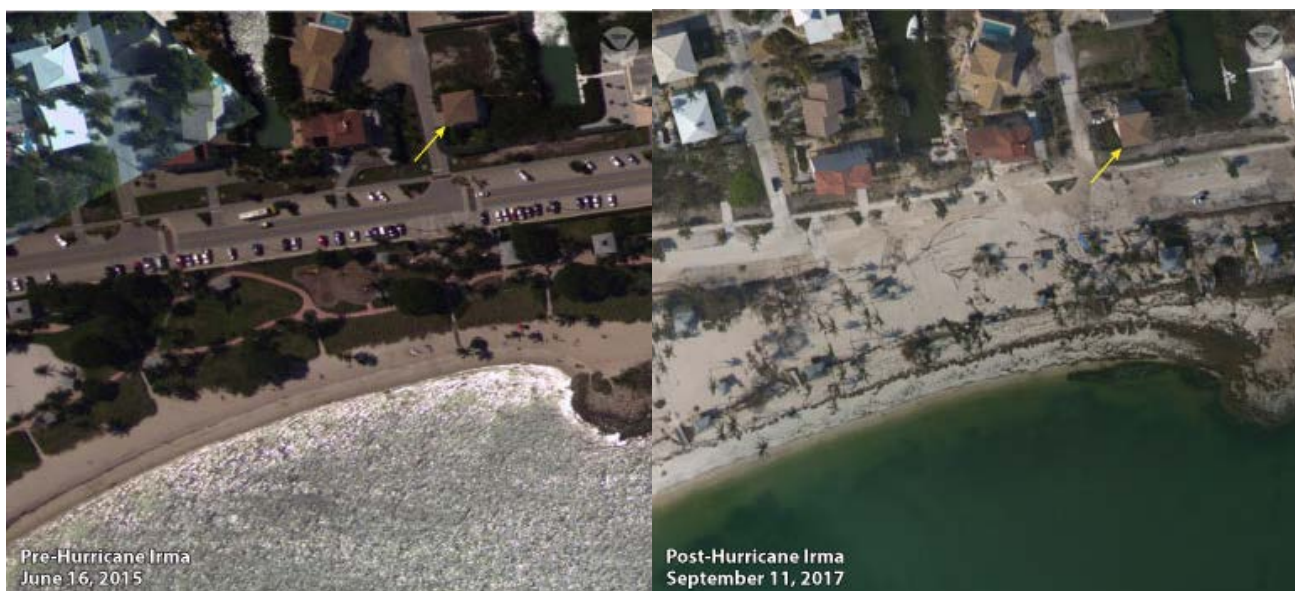
Figure 73. Sombrero Beach, Monroe County Park, impacted by the storm surge causing substantial overwash and park damage (Source: National Assessment of Coastal Change Hazards, St. Petersburg Coastal and Marine Science Center, USGS).

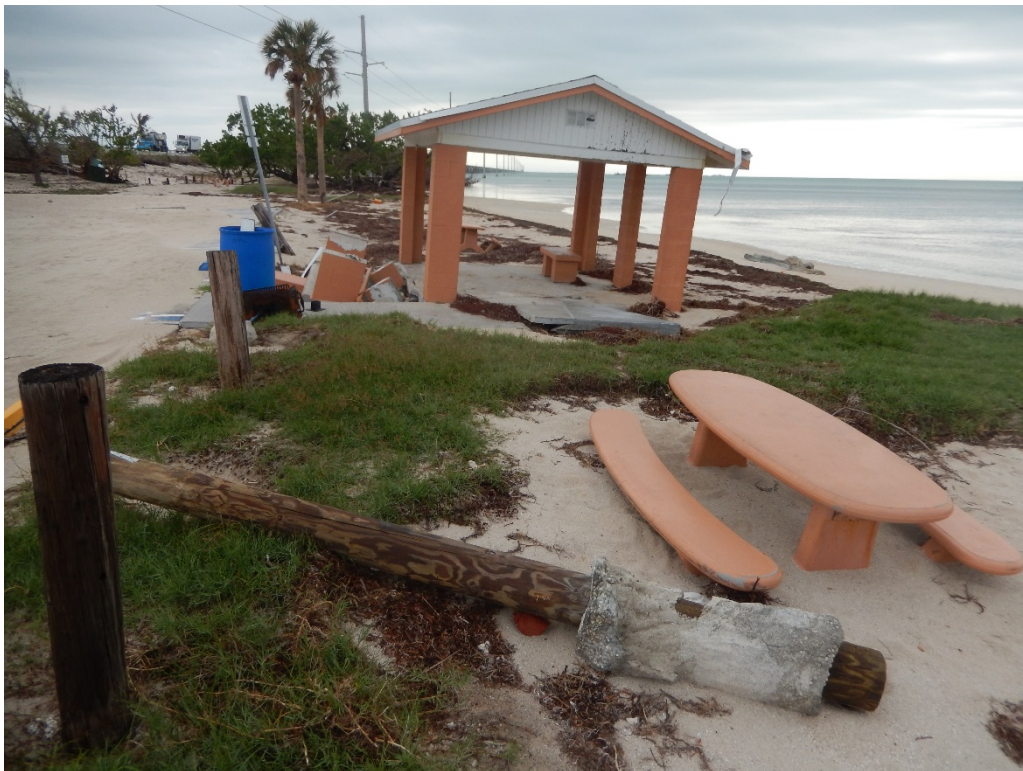
Figure 77. Monroe County park damages on Little Duck Key.

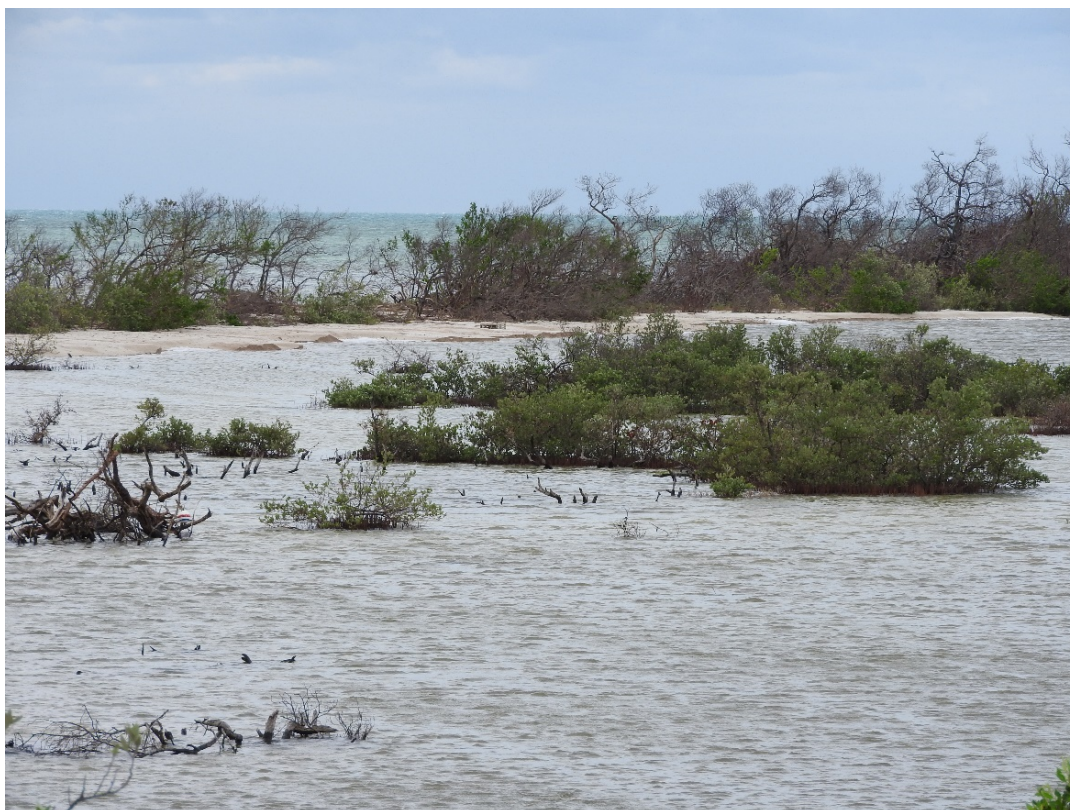
Figure 78. *Ohio Key beach rolled over into lagoon by overwash.*

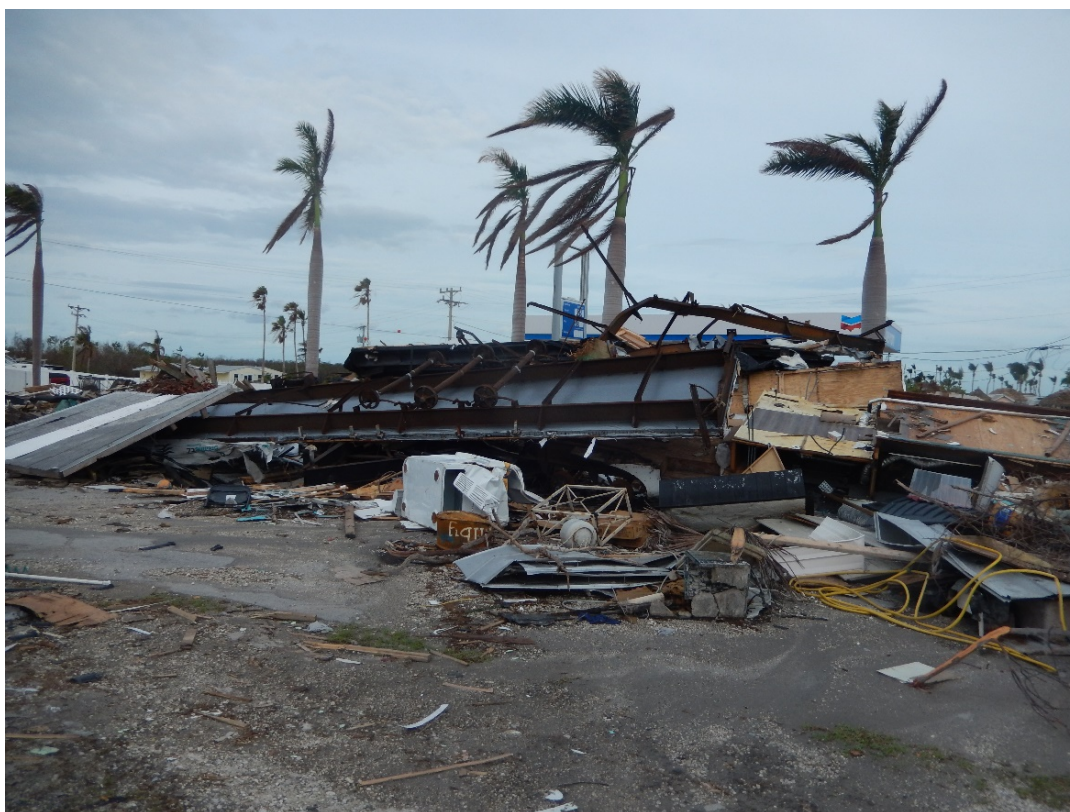
Figure 79. *Trailer damage, Ohio Key Campgrounds.*

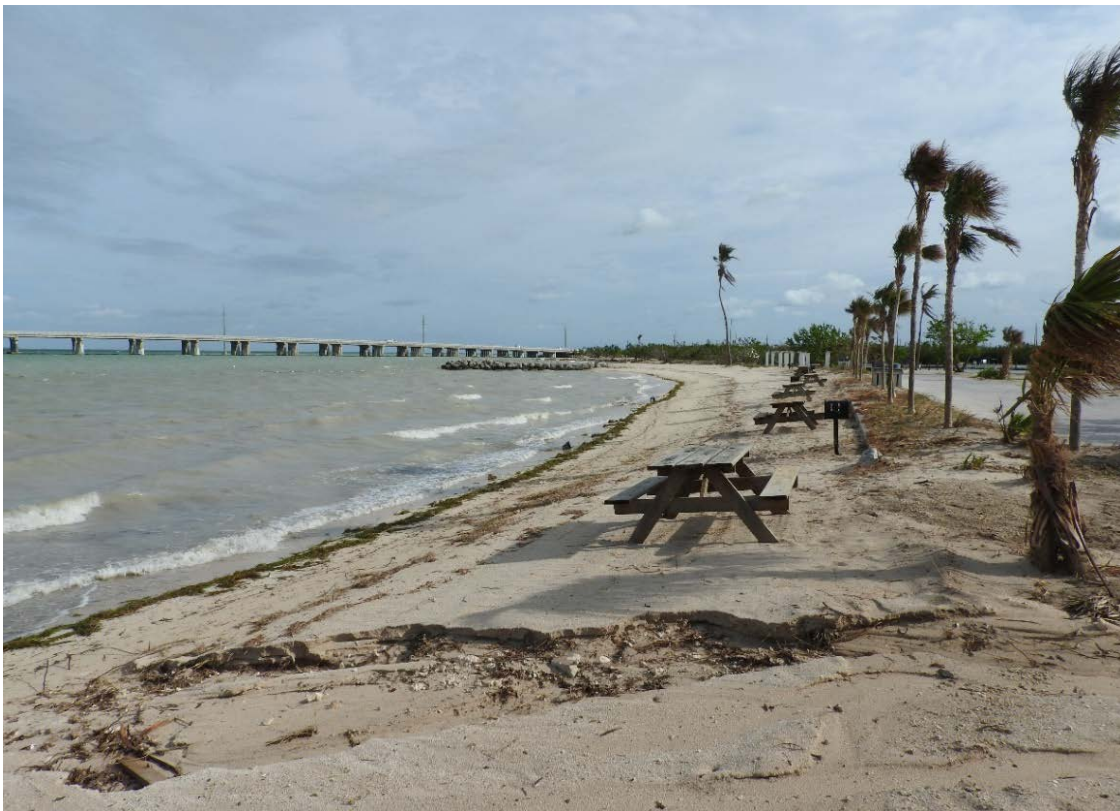
Figure 80. *Calusa Beach erosion, Bahia Honda State Park (Picnic tables replace lost pavilions after the storm).*

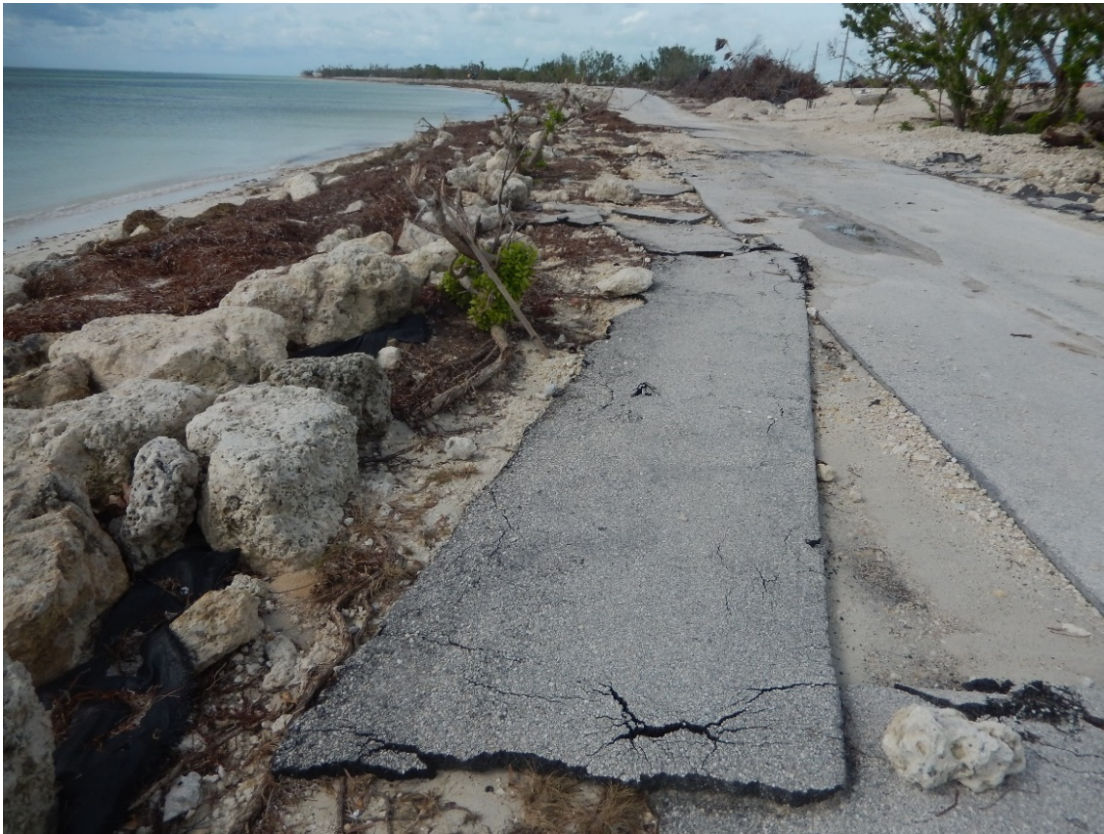
Figure 83. *Bahia Honda State Park road and revetment damage.*

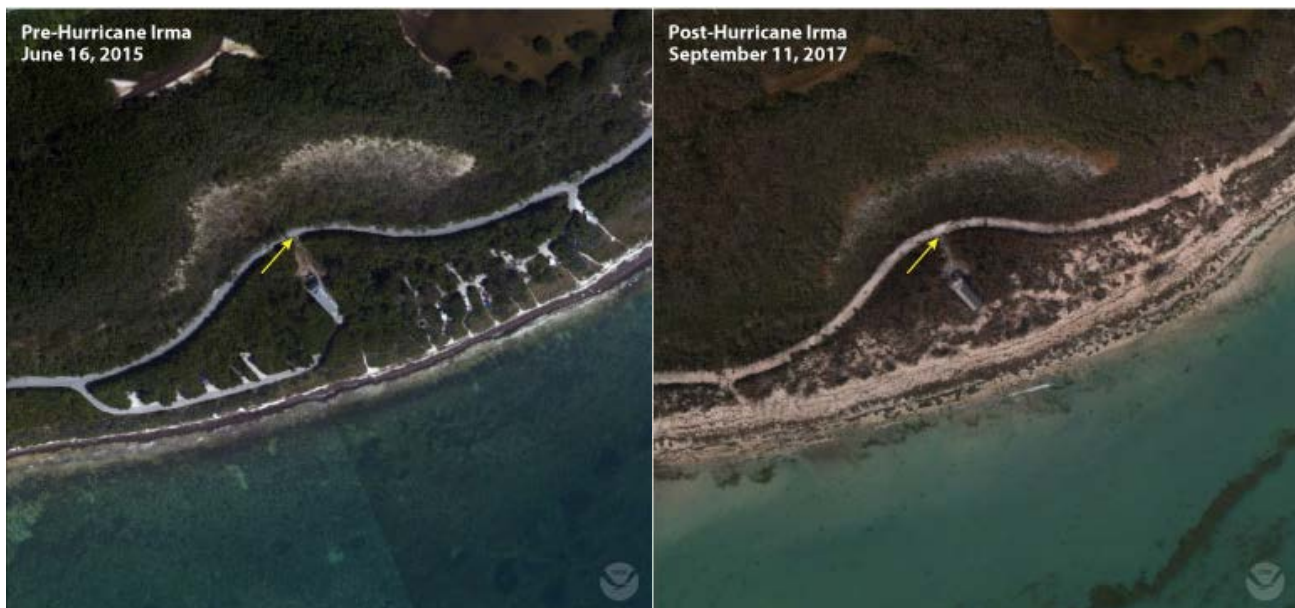
Figure 84. Comparative NOAA aerial photos of the Bahia Honda State Park campgrounds adjacent to Sandspur Beach (Source: National Assessment of Coastal Change Hazards, St. Petersburg Coastal and Marine Science Center, USGS).

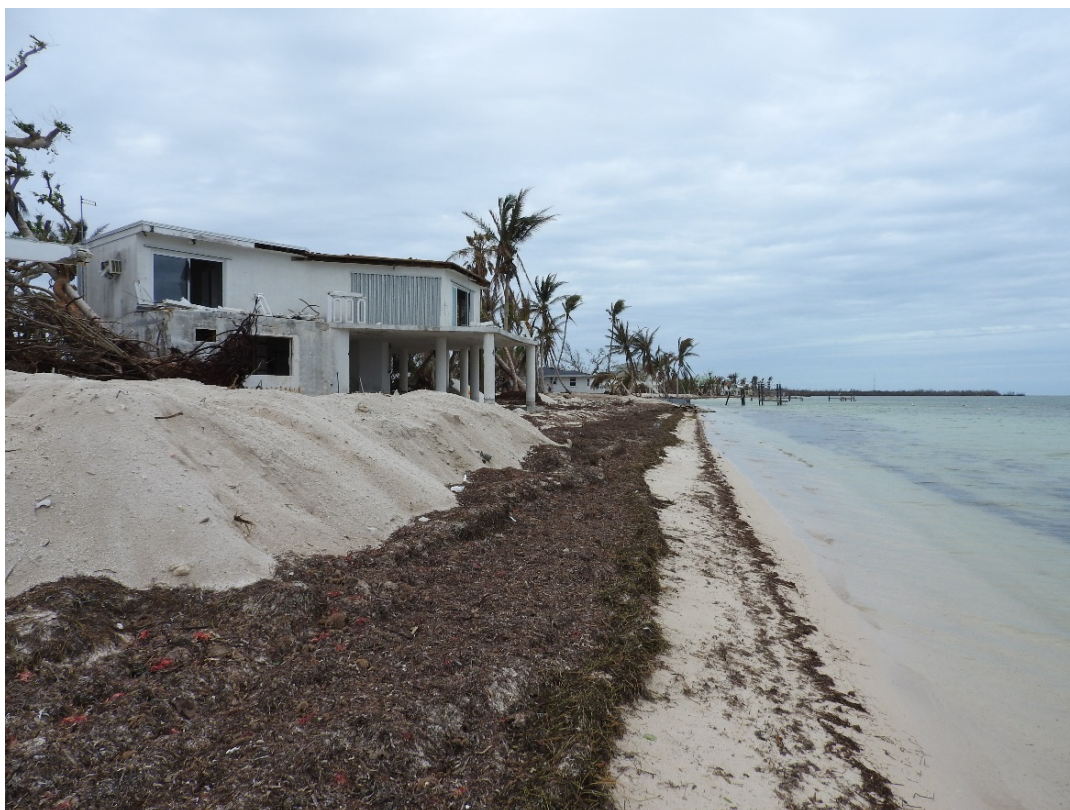
Figure 90. Major erosion and structural damage along Long Beach, Big Pine Key.

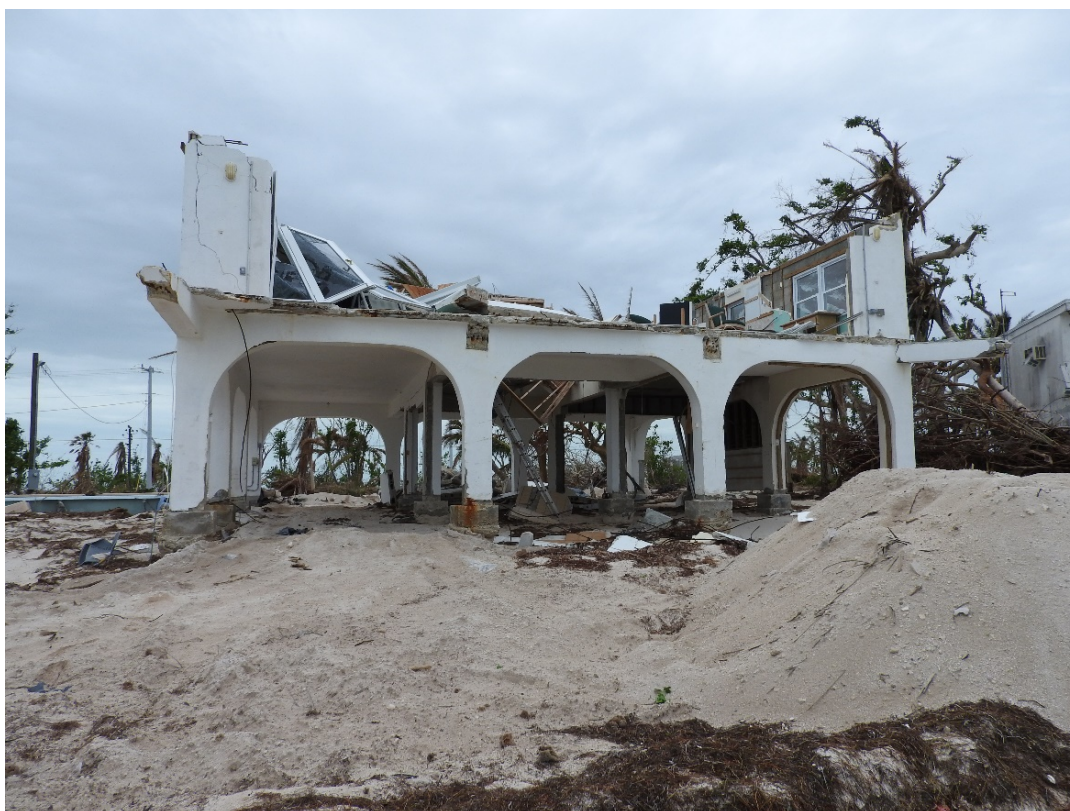
Figure 91. Single-family dwelling destroyed, Long Beach, Big Pine Key.

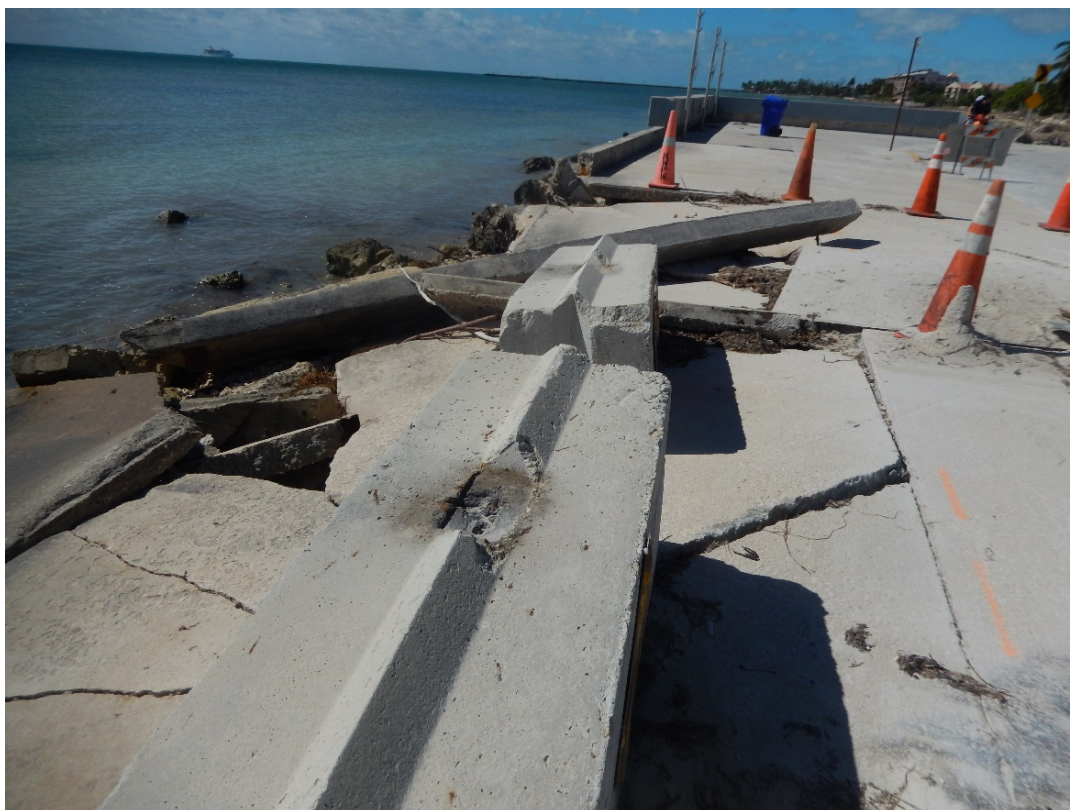
Figure 97. *Bertha Street end seawall damage, Key West.*
