*Preliminary Hurricane Michael Post-Storm
Beach Conditions and Coastal Impact Report*

**Division of Water Resource Management
Florida Department of Environmental Protection
November 2018**

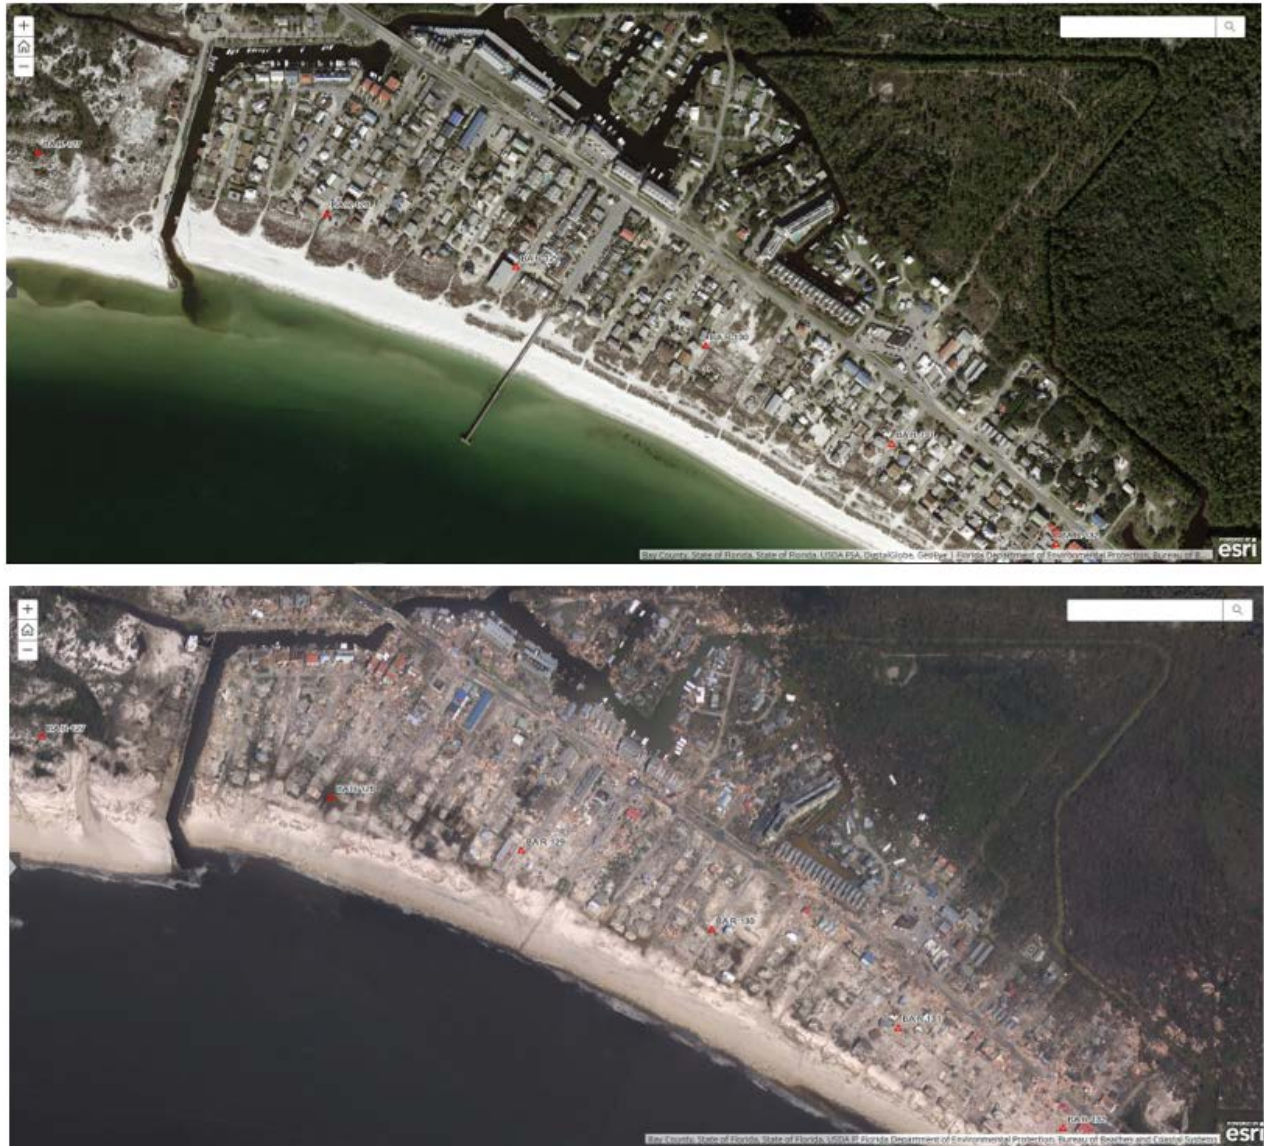
Figure 8. Aerial photo comparison of the severe damage in Mexico Beach (R127-R132).

To the east of Crooked Island, the most severe damage from Michael was sustained along the mainland coast of eastern Bay County at Mexico Beach (*Figure 8*). On top of the storm surge, breaking waves caused the most severe damages. Many exterior water marks to 30 feet above sea level suggest the wave setup and wave uprush caused the severe damage that resulted in most of the development being

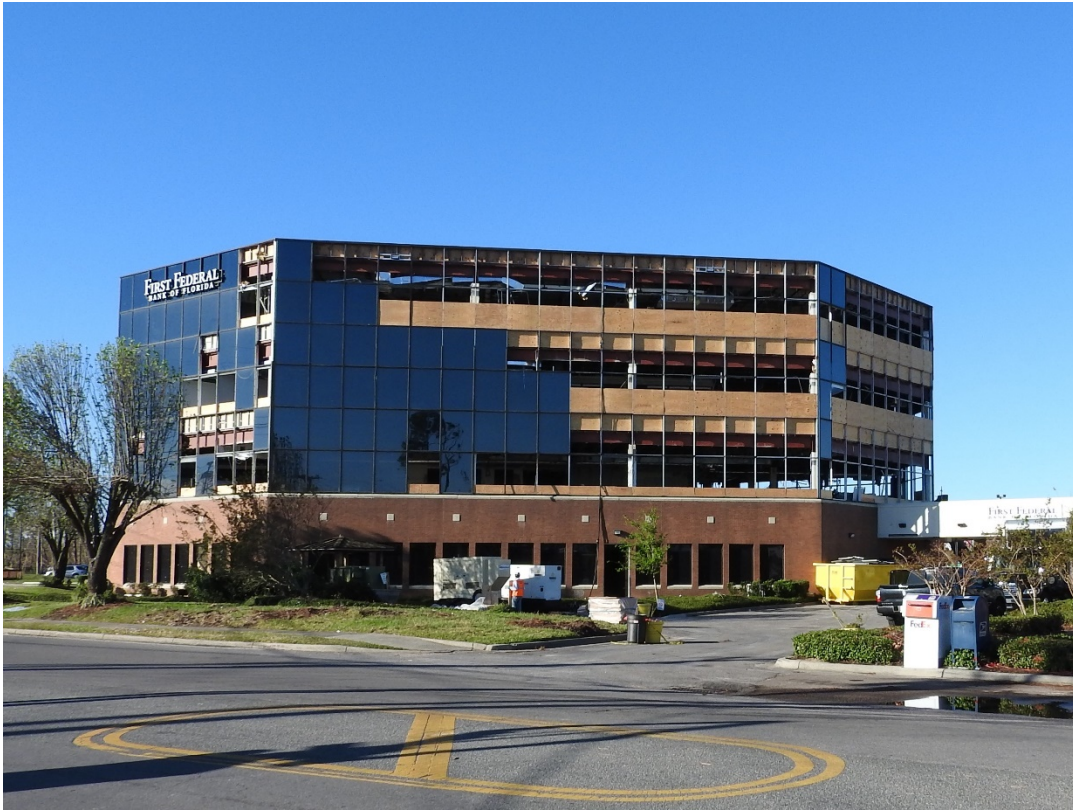
Figure 10. Bank with severe wind damage on 23rd Street, Panama City.

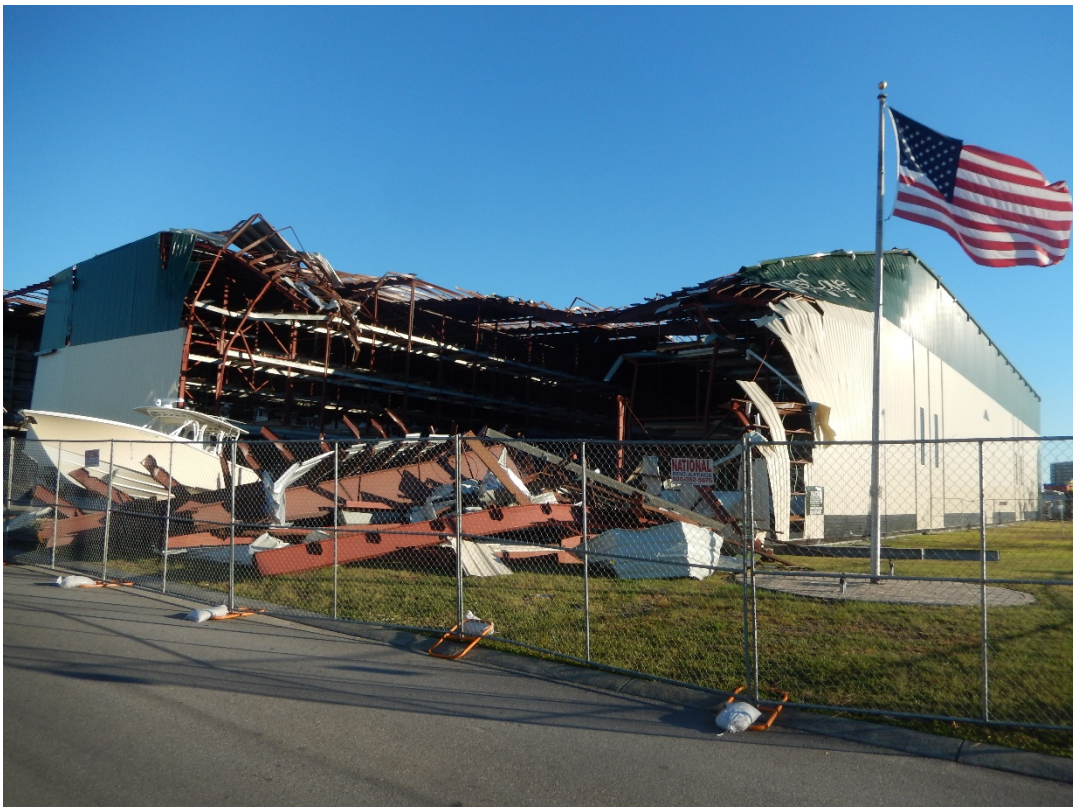
Figure 11. Dry storage marina with wind damage on Thomas Drive, Panama City Beach.

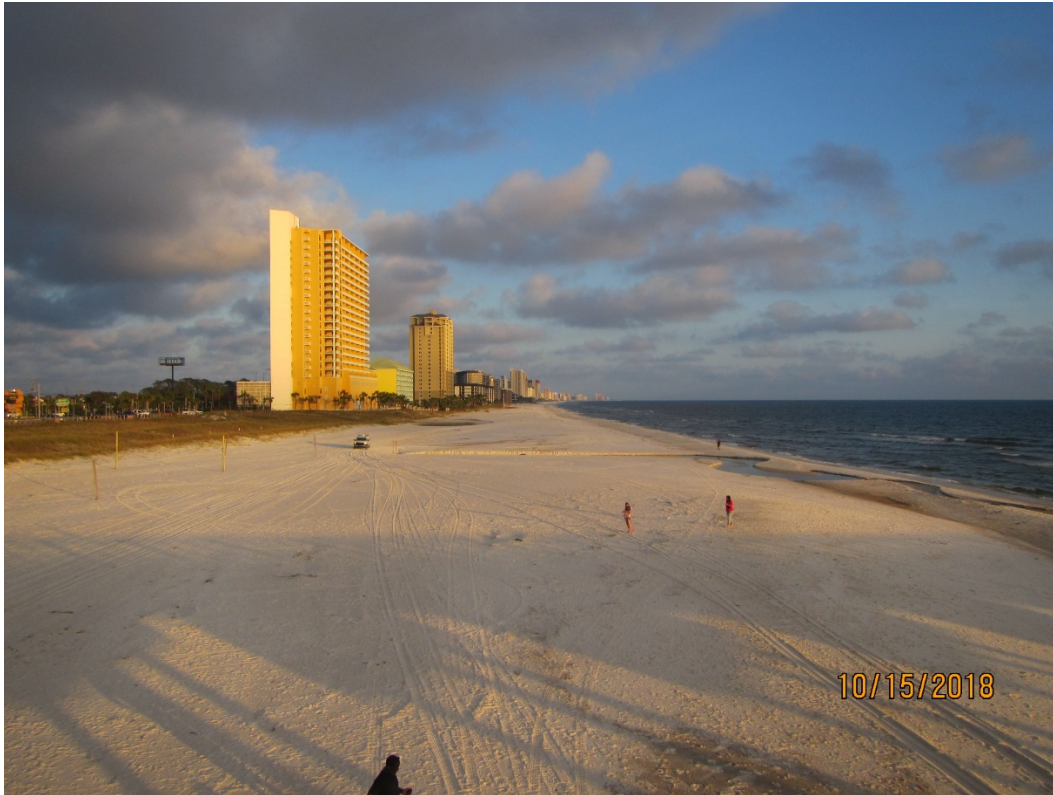
Figure 12. Beach erosion near R57, east of M.B. Miller Pier, Panama City Beach.

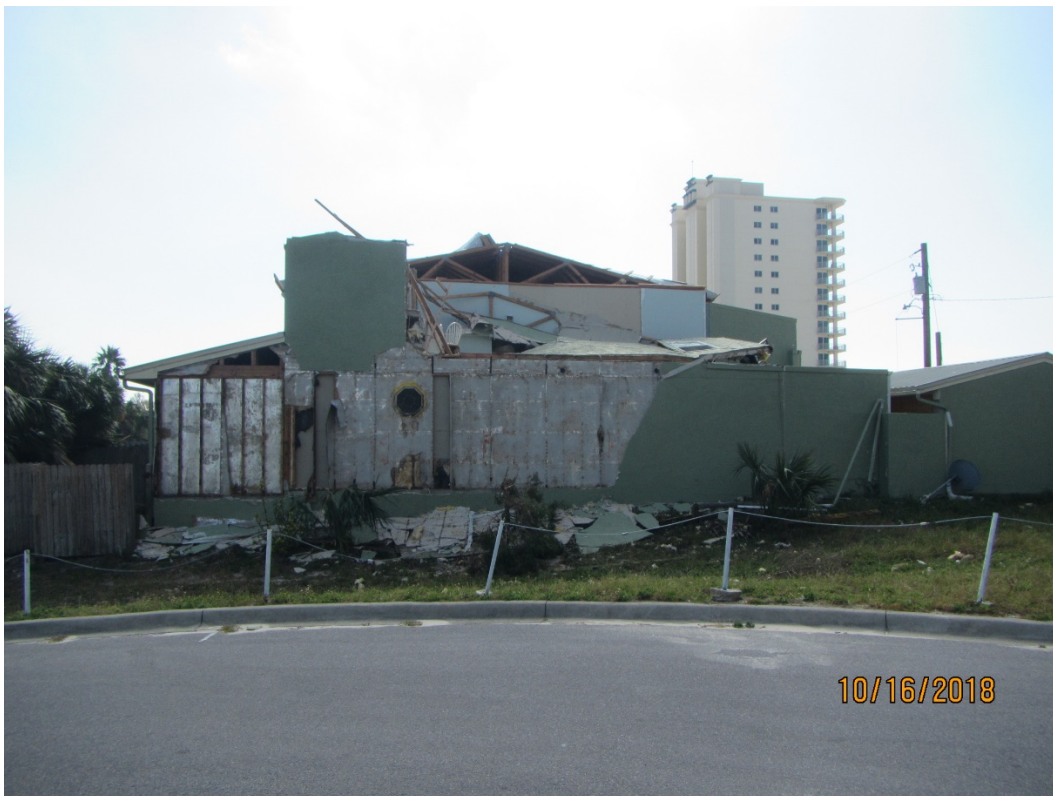
Figure 13. Wind damages on a multifamily dwelling near R73, Panama City Beach.

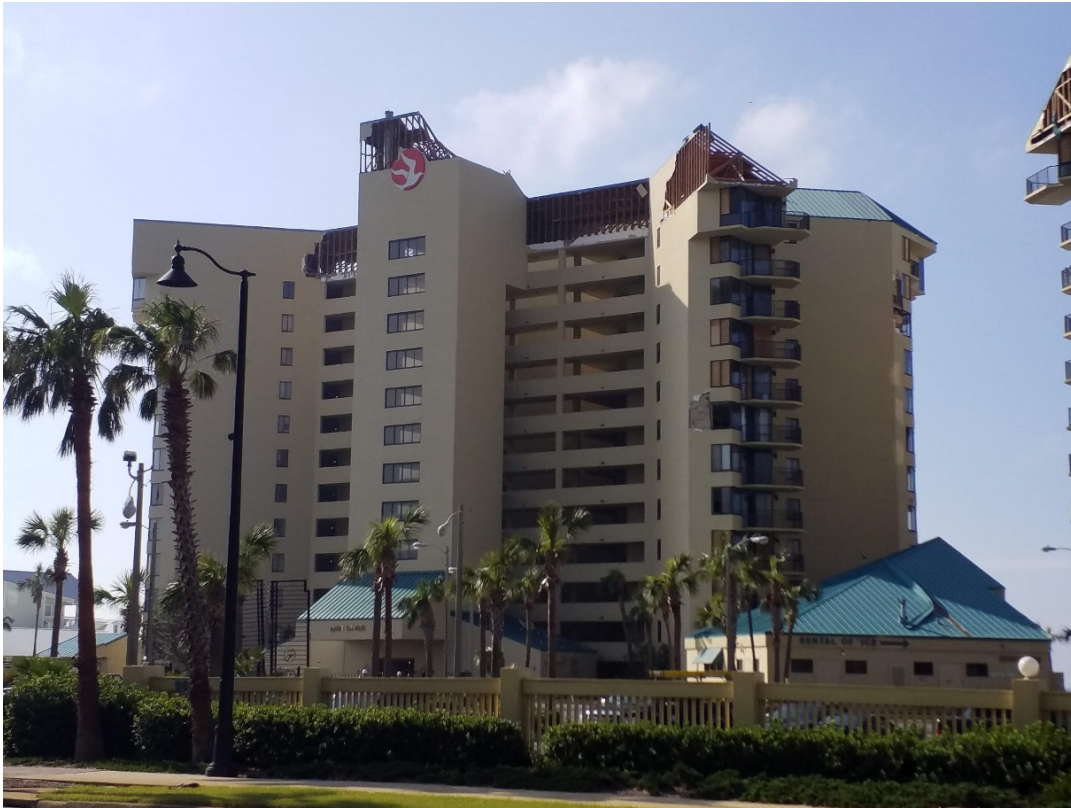
Figure 14. Wind damages on the Sunbird Condominiums near R67, Panama City Beach.

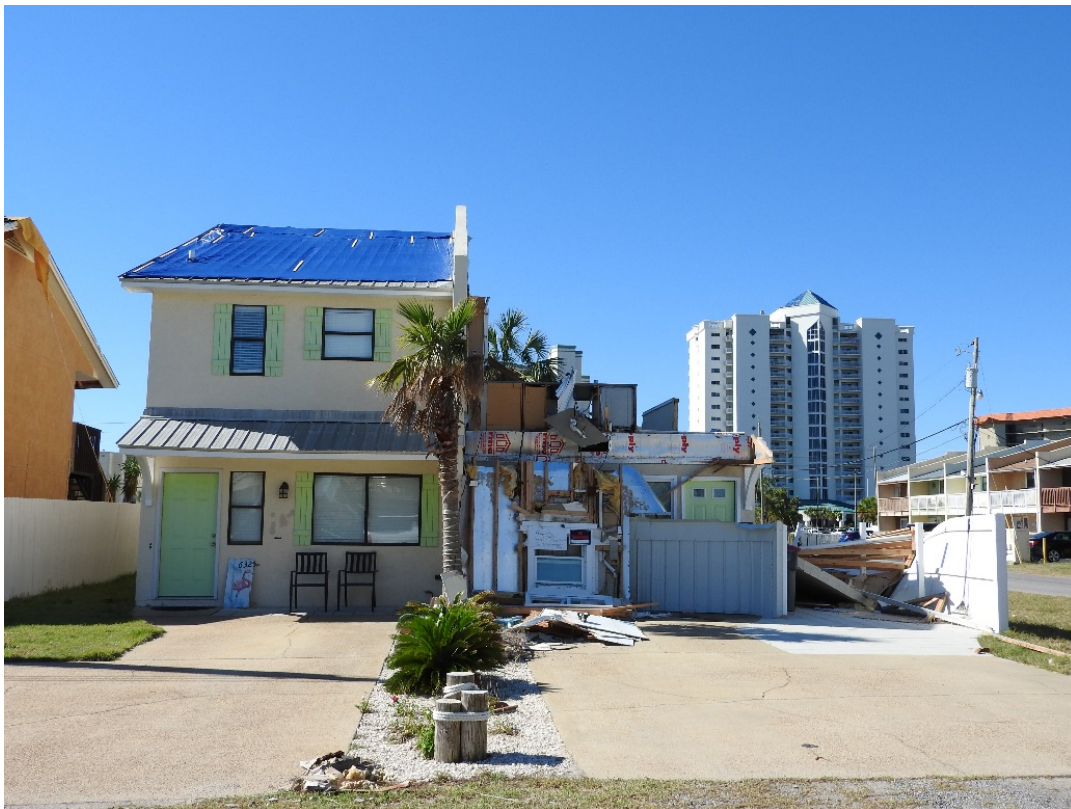
Figure 15. Roof damage and destroyed dwelling near R82, Panama City Beach.

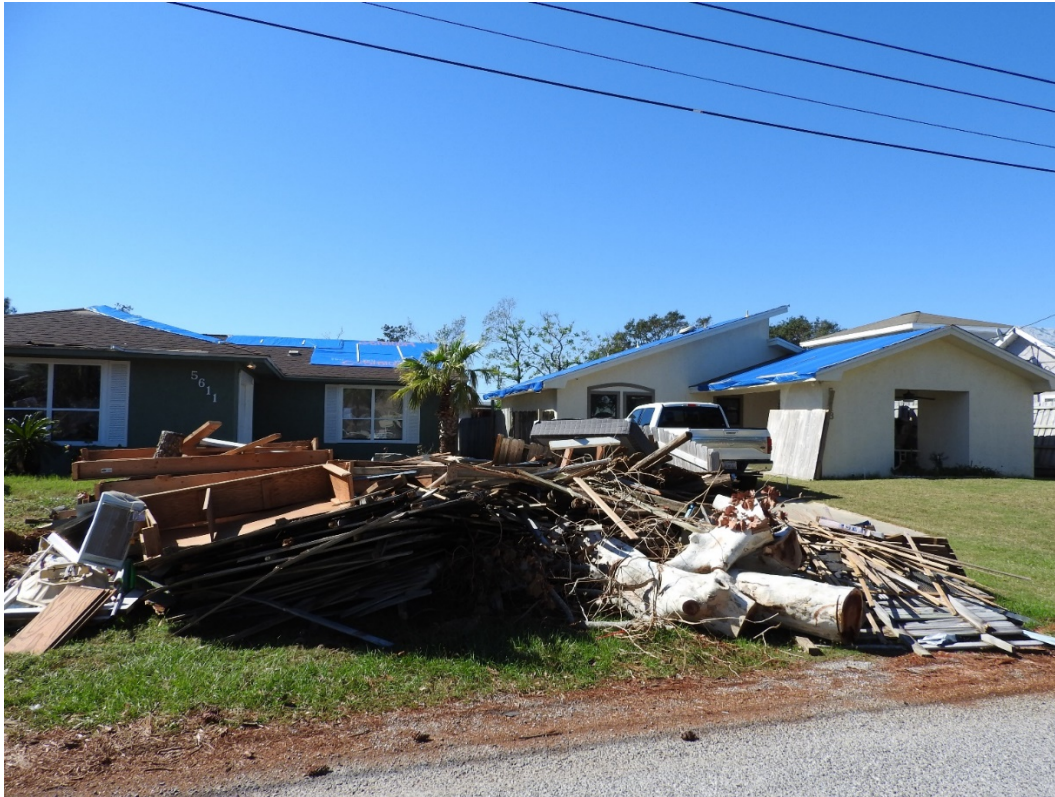
Figure 16. Roof damage on a single-family dwelling near R86, Panama City Beach.

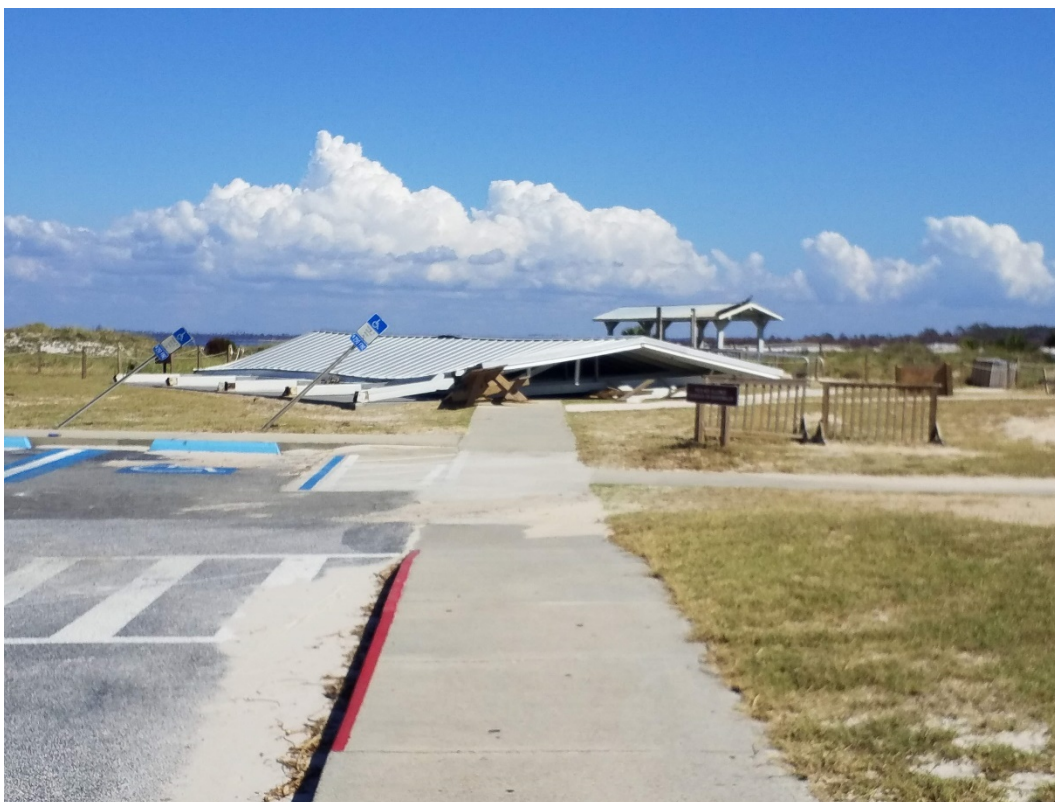
Figure 17. Collapsed pavilion near R97, St. Andrews State Park.

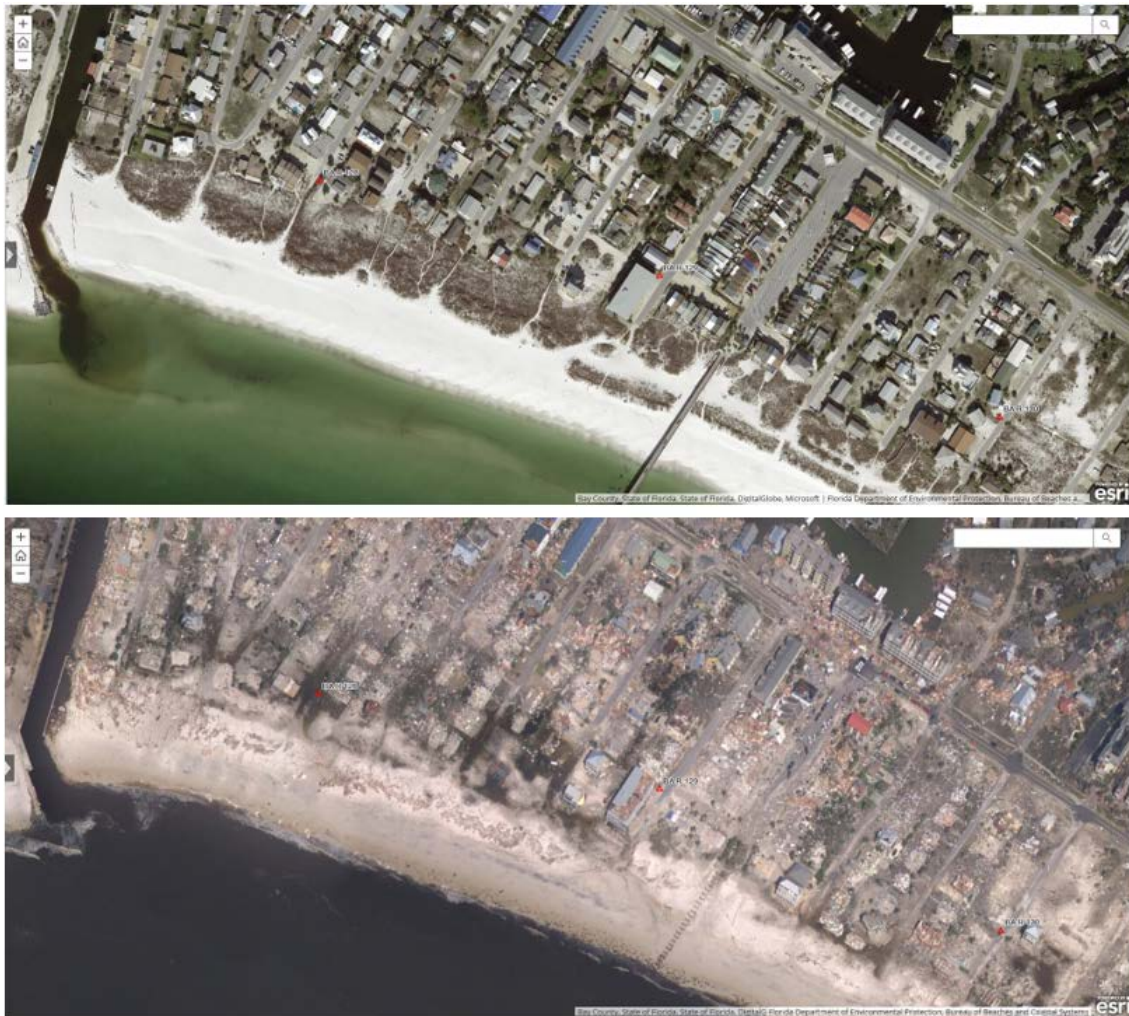
Figure 20. Aerial photo comparison of severe damage in Mexico Beach (R127.5-R130).

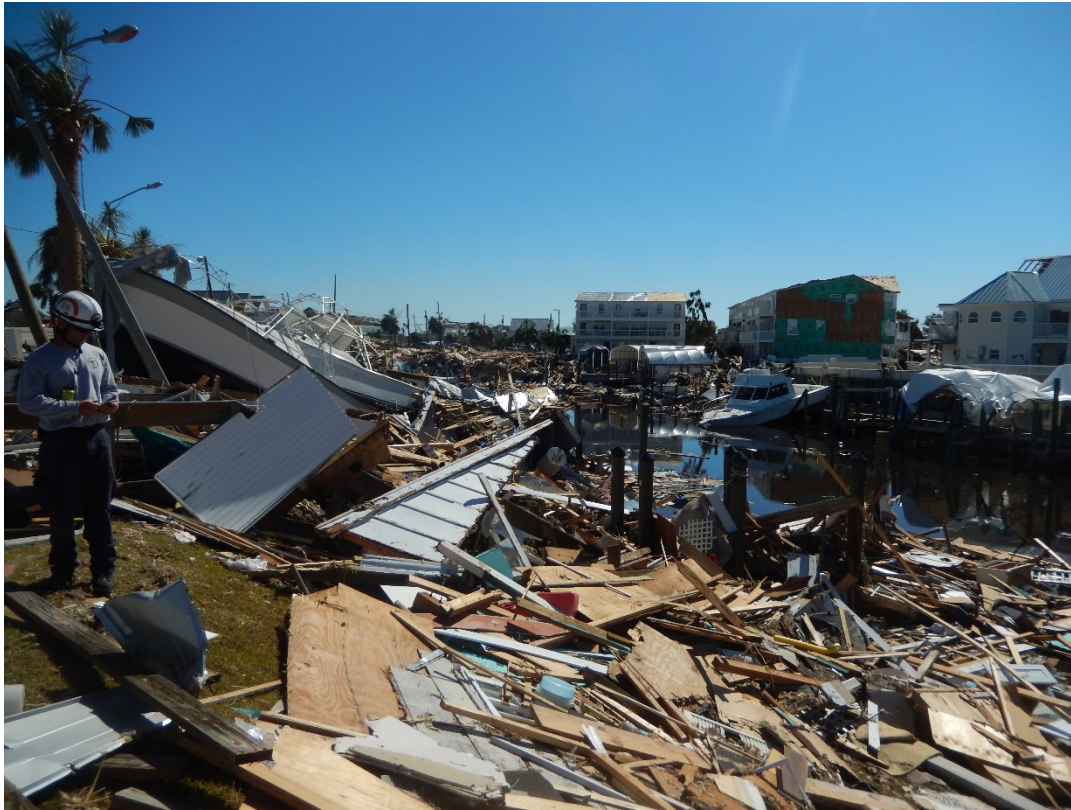
Figure 21. Debris and damages at Mexico Beach Canal, R127.5.

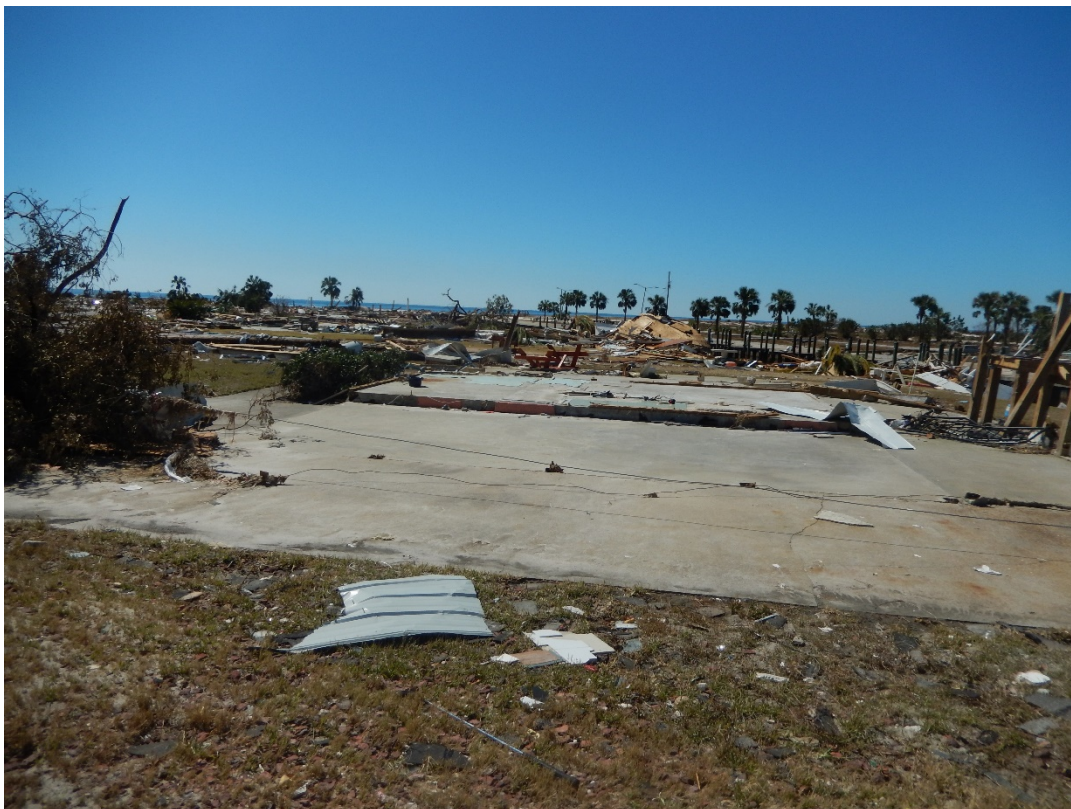
Figure 22. Rows of beach houses destroyed and removed by the storm surge, R127.5.

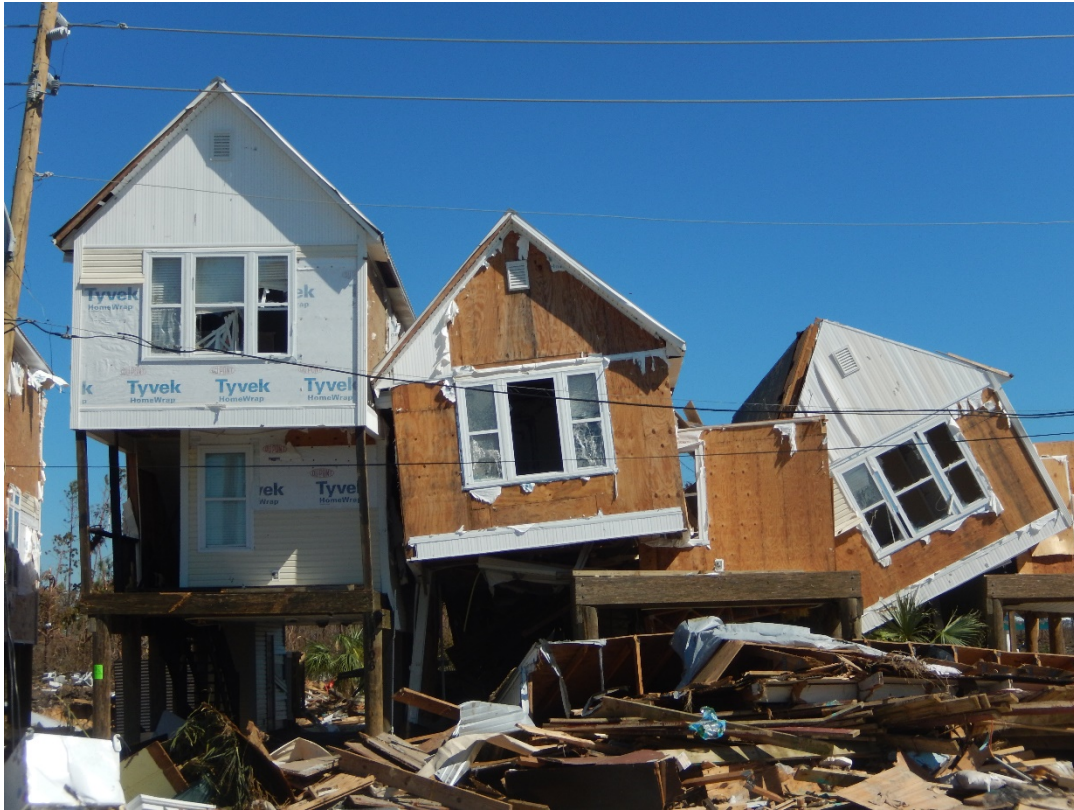
Figure 23. Beach dwellings north of U.S. 98 lifted off their foundations, R128.

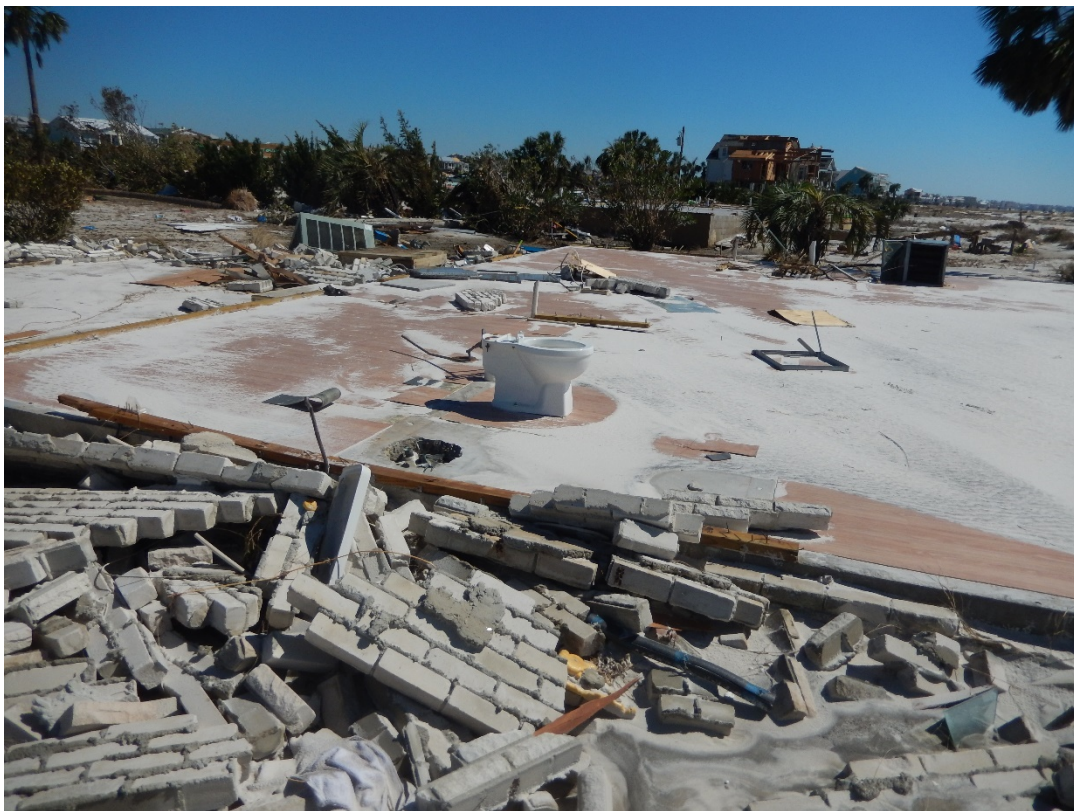
Figure 24. Remains of typical beach house destroyed near R128, Mexico Beach.

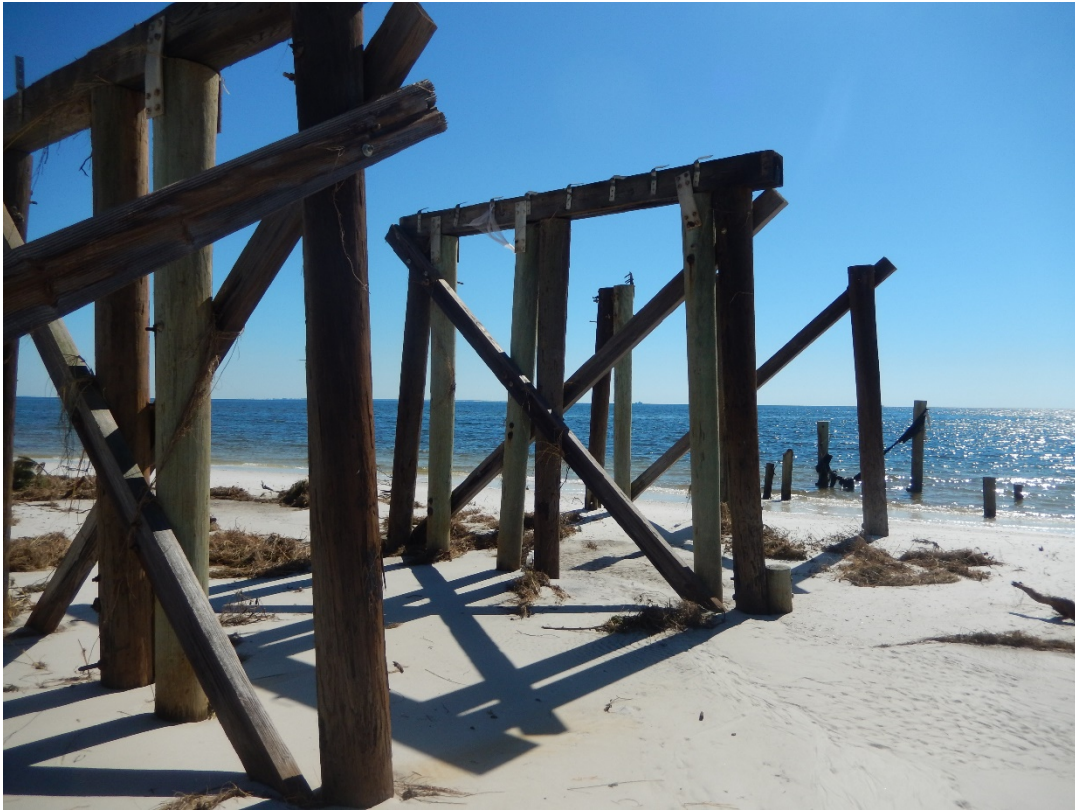
Figure 25. Mexico Beach pier destroyed near R129.

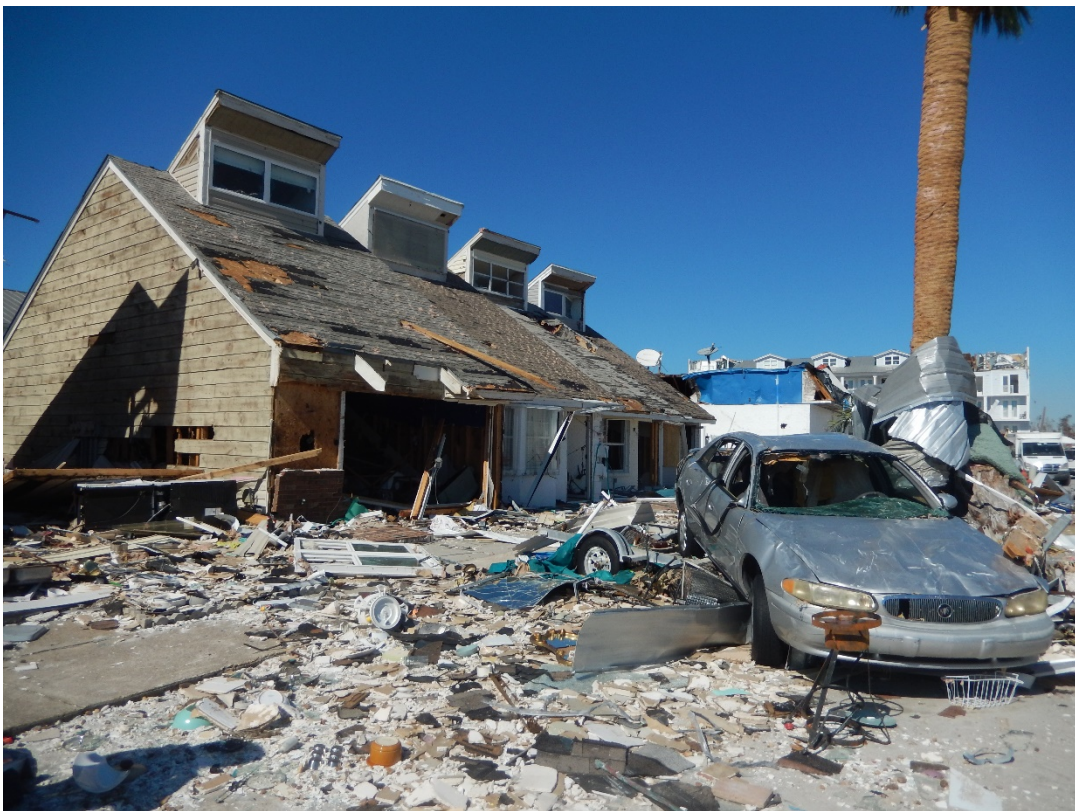
Figure 26. Multifamily dwelling destroyed near R129, Mexico Beach.

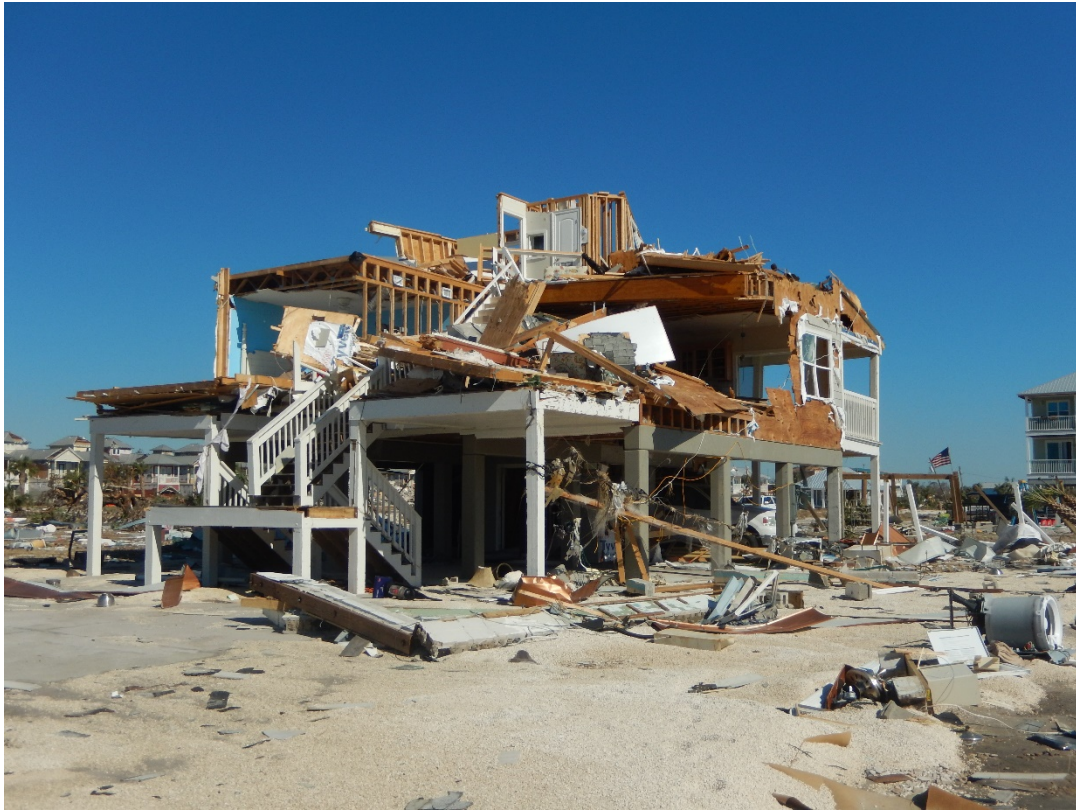
Figure 27. Pile-supported dwelling destroyed near R129, Mexico Beach.

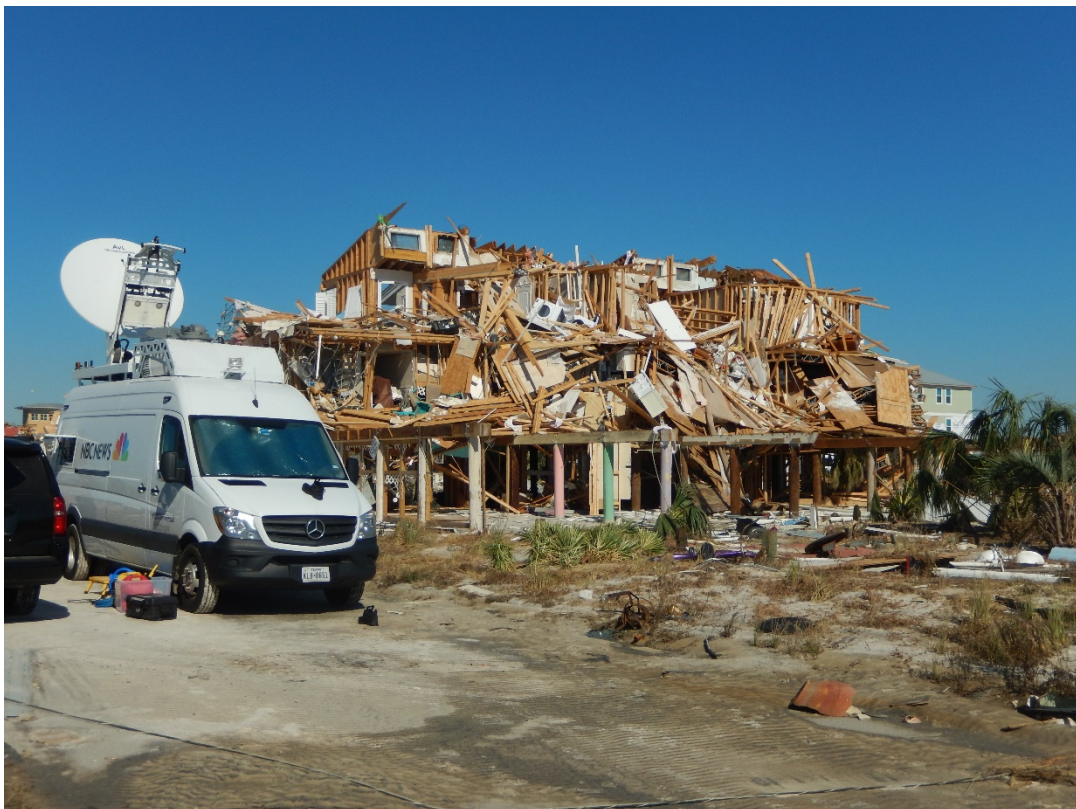
Figure 28. Pile-supported multifamily dwelling destroyed near R129, Mexico Beach.

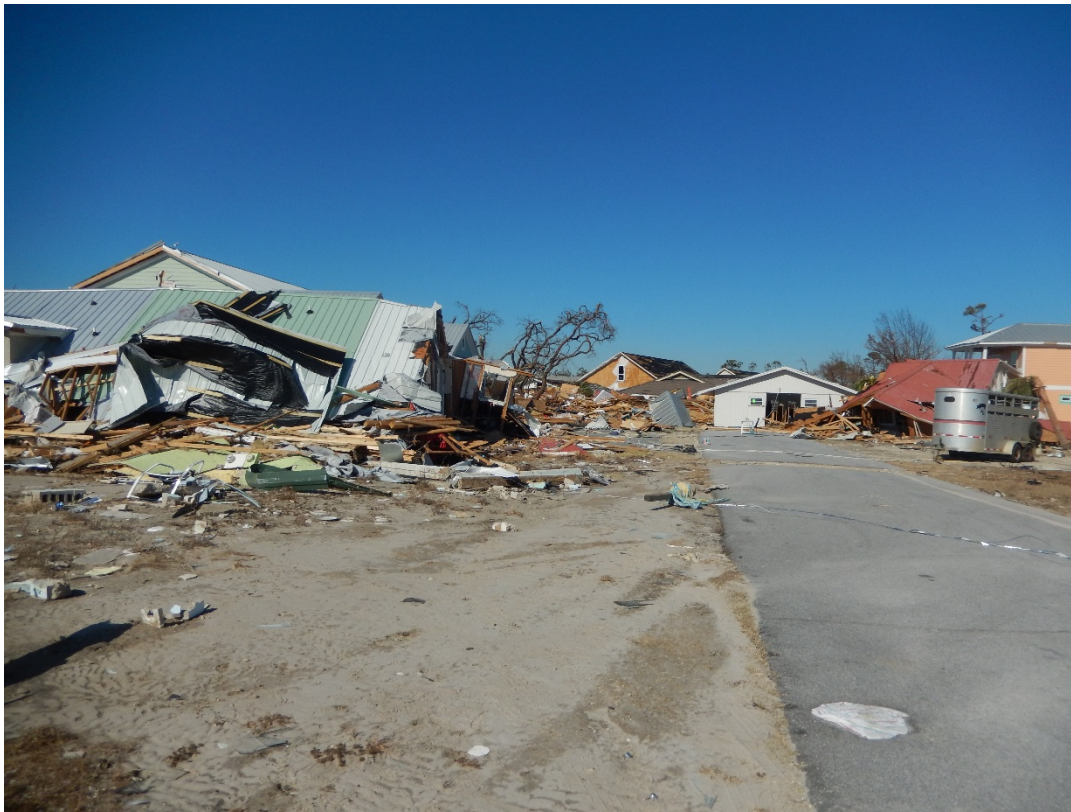
Figure 29. Buildings transported several hundred feet landward by the flood across U.S. 98 and deposited on 15th Street, R130, Mexico Beach.

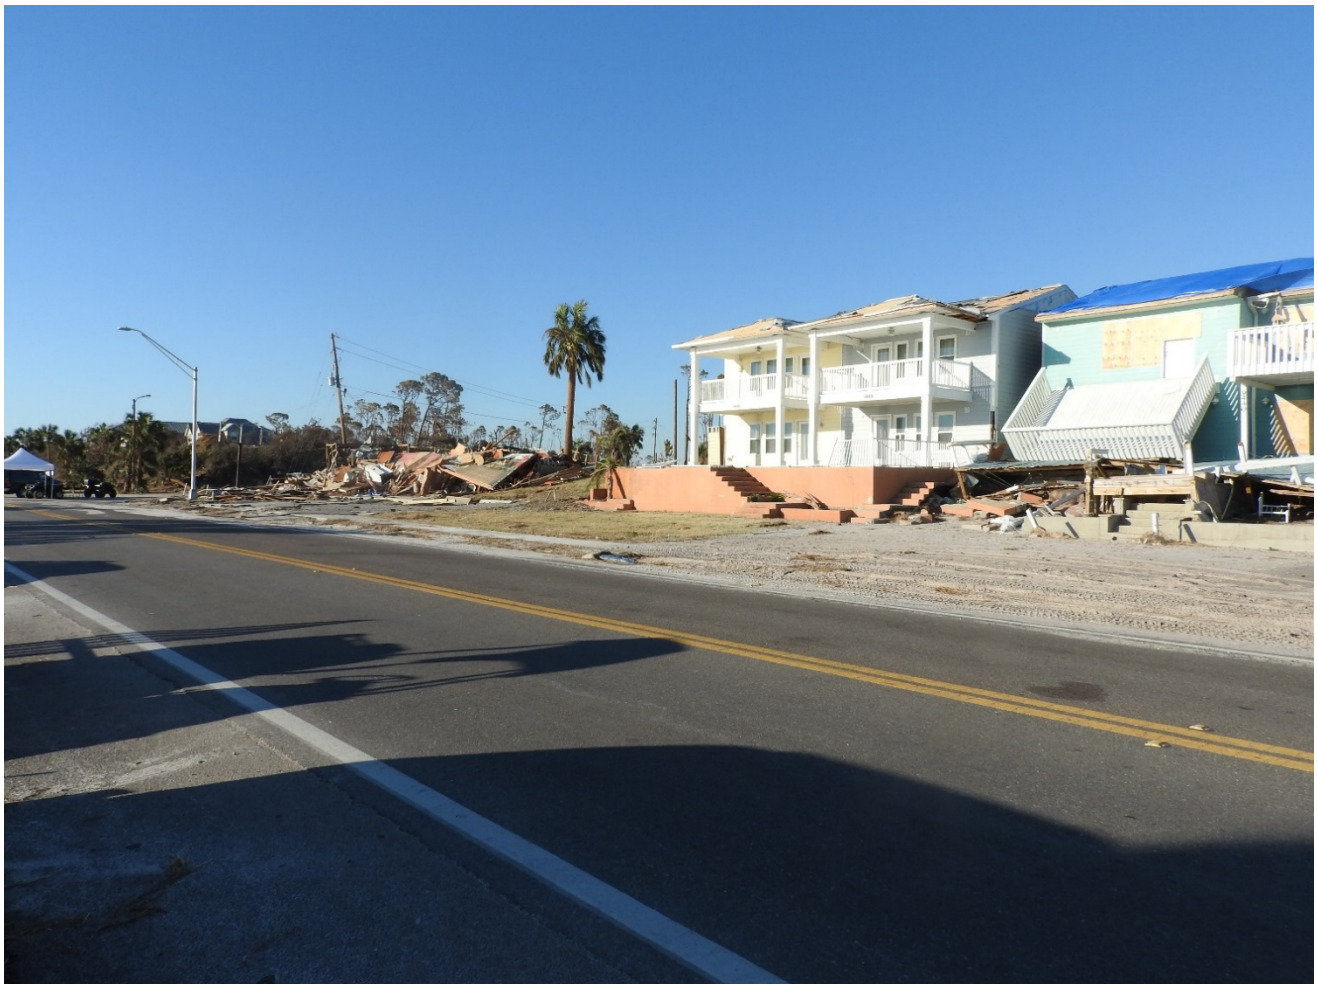
Figure 40. High water mark of +21.2 feet NAVD along U.S. 98 and S.R. 386 near R1, Beacon Hill.

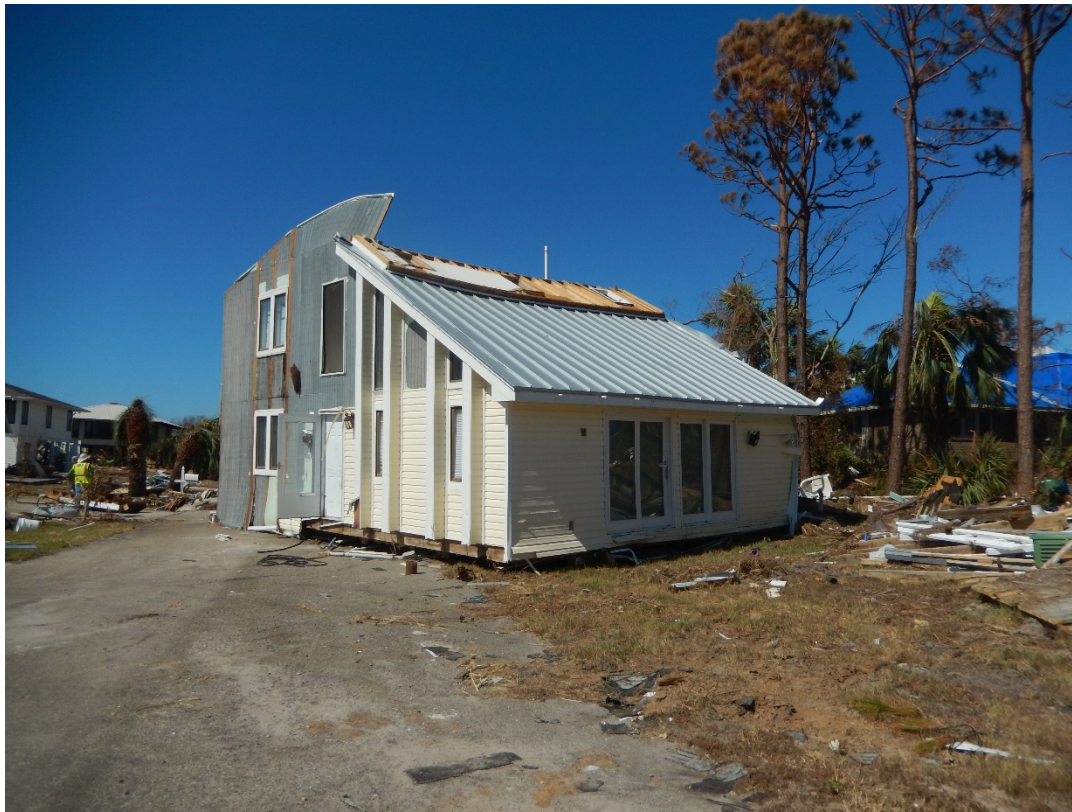
Figure 44. Dwelling transported by storm surge onto Trade Winds Dr. near R6, Beacon Hill.

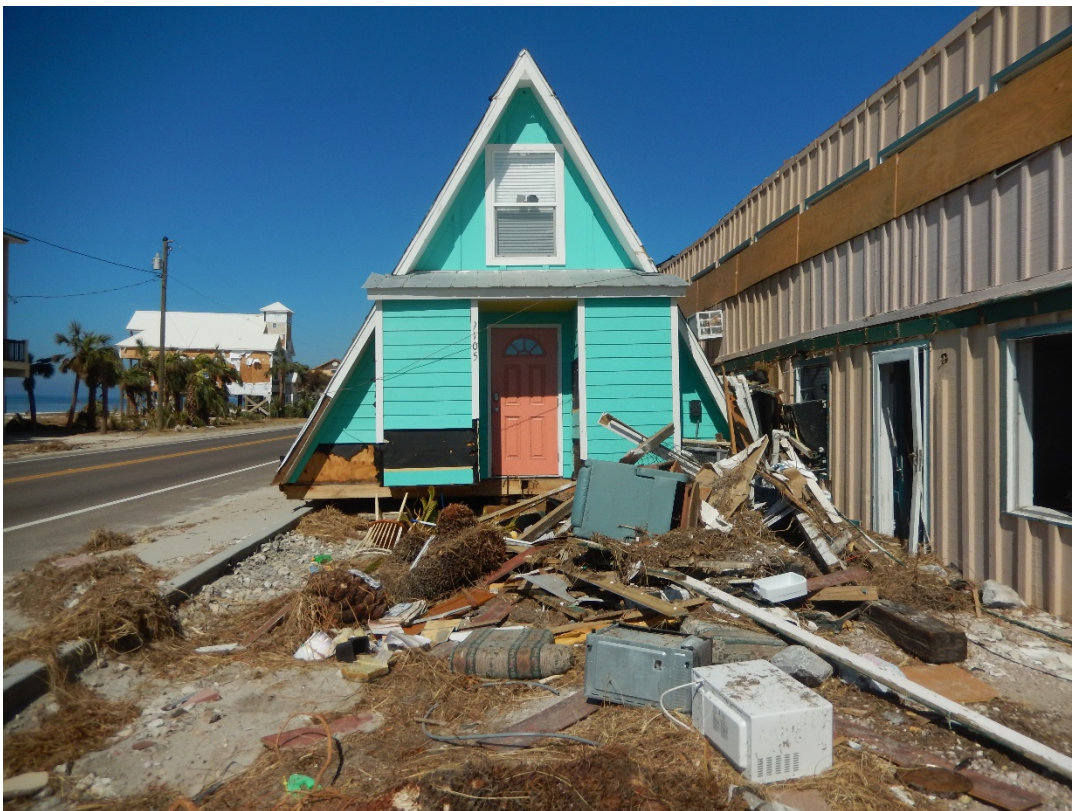
Figure 45. Dwelling transported across U.S. 98 by the storm surge, Beacon Hill.

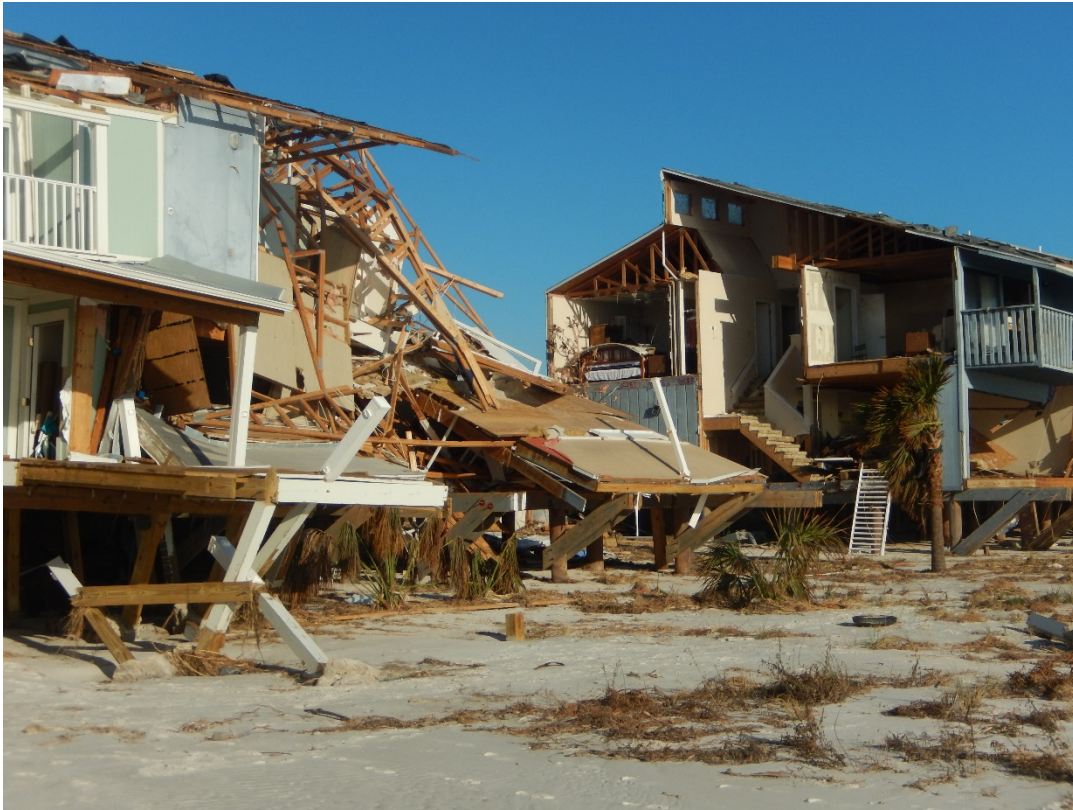
Figure 47. Townhouses destroyed near R7, Beacon Hill.

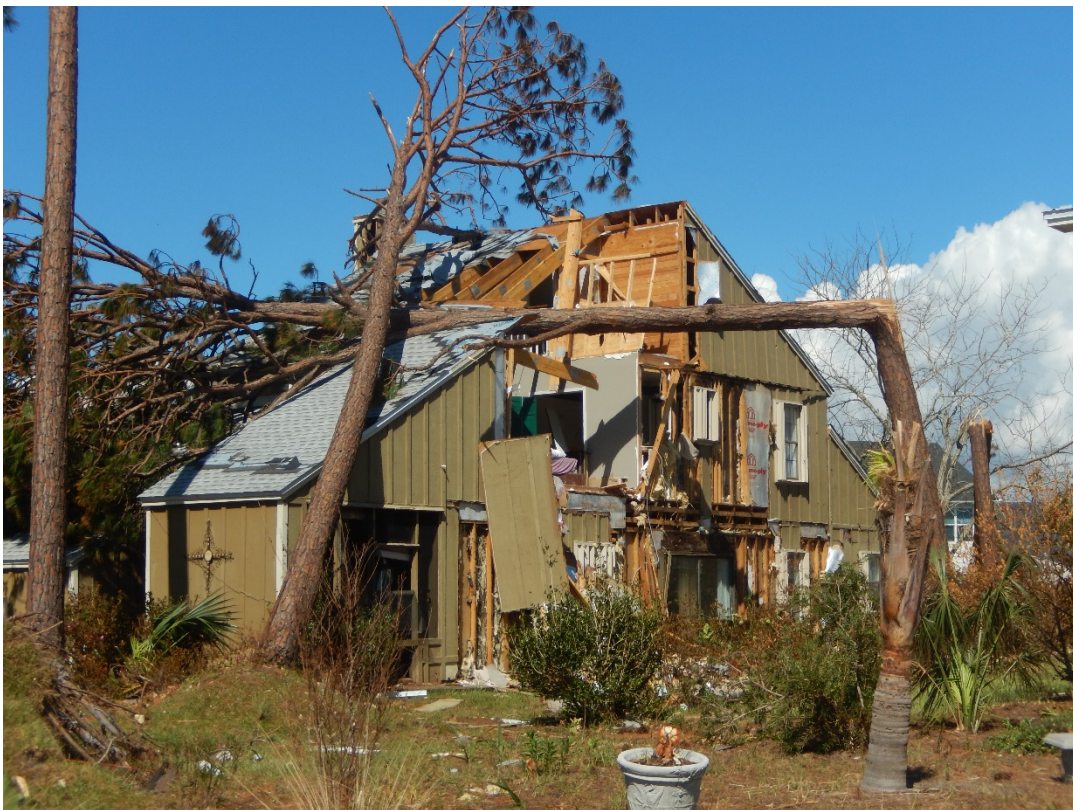
Figure 48. Major damage to dwelling due to high winds and fallen trees, Beacon Hill.
