*Preliminary Hurricane Michael Post-Storm
Beach Conditions and Coastal Impact Report*

**Division of Water Resource Management
Florida Department of Environmental Protection
November 2018**

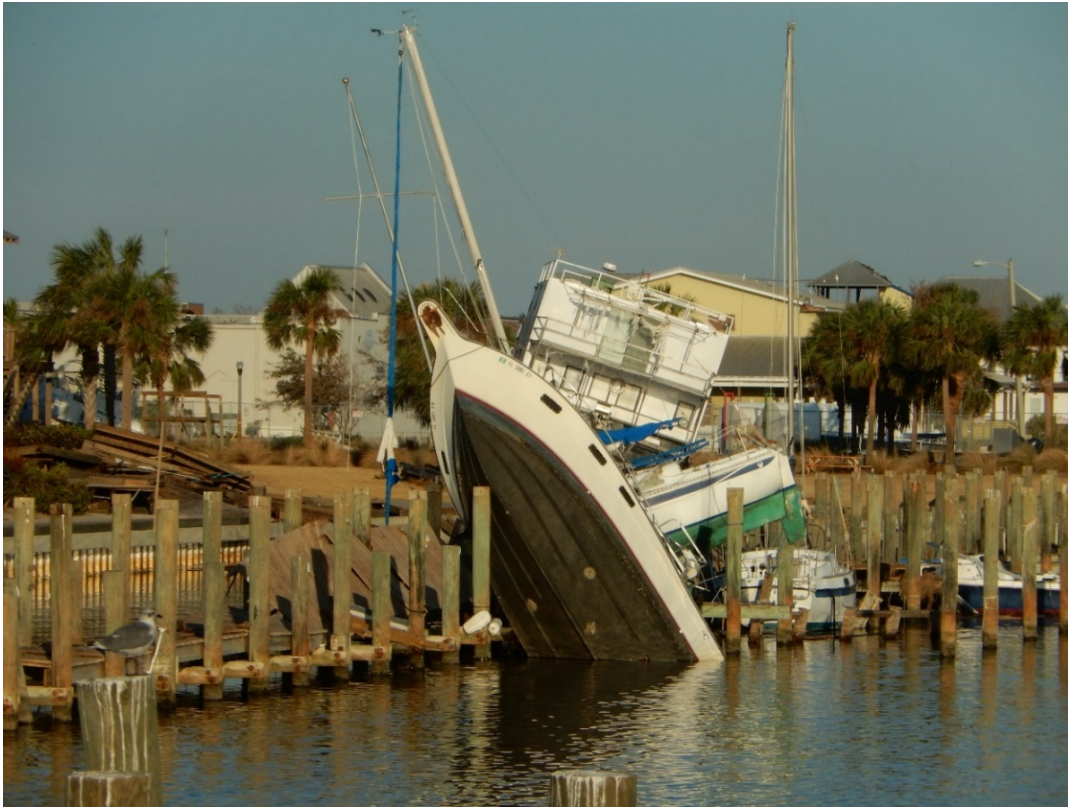
Figure 49. Marina damage due to the storm surge, Port St. Joe.

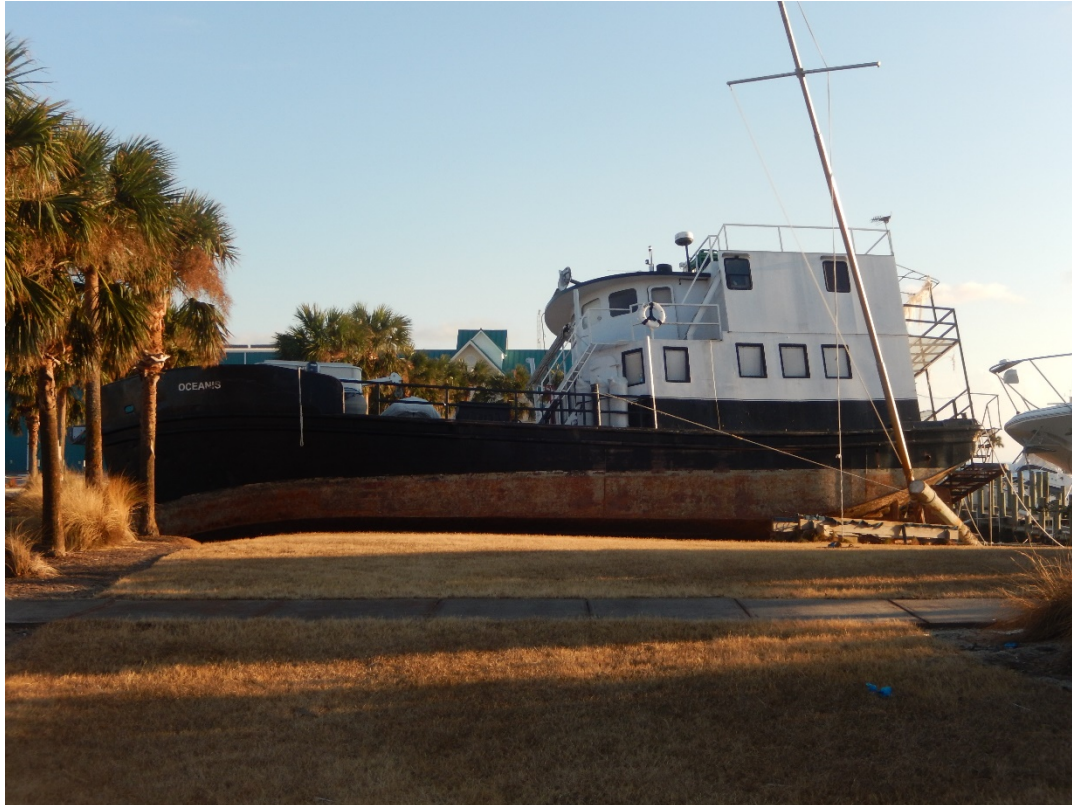
Figure 50. Ship carried onto upland by the storm surge, Port St. Joe.

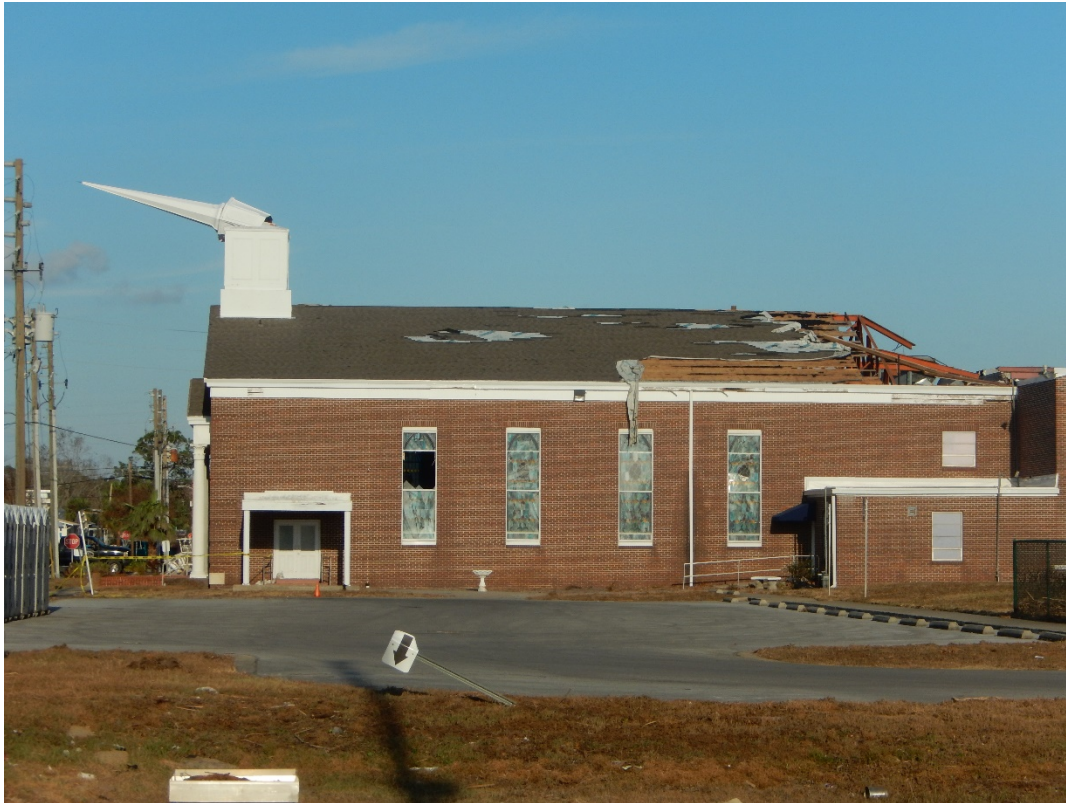
Figure 51. First Baptist Church with major wind damage, Port St. Joe.

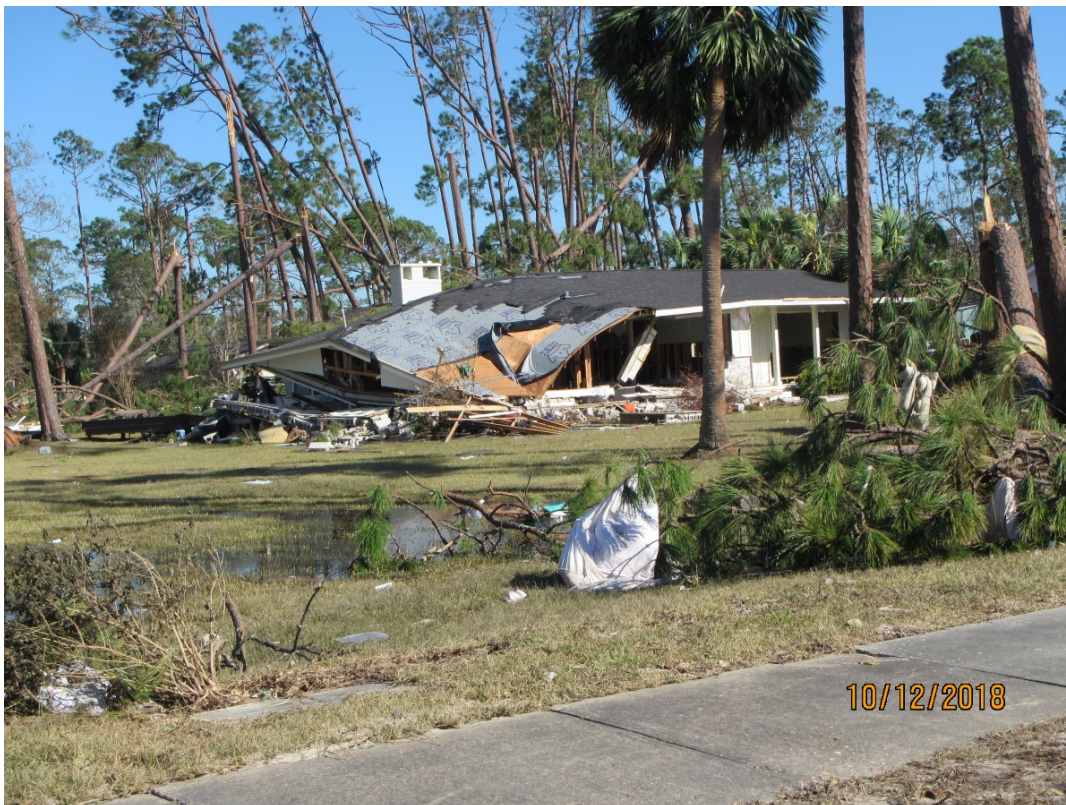
Figure 52. Dwelling destroyed by the storm surge from St. Joseph Bay, Port St. Joe.

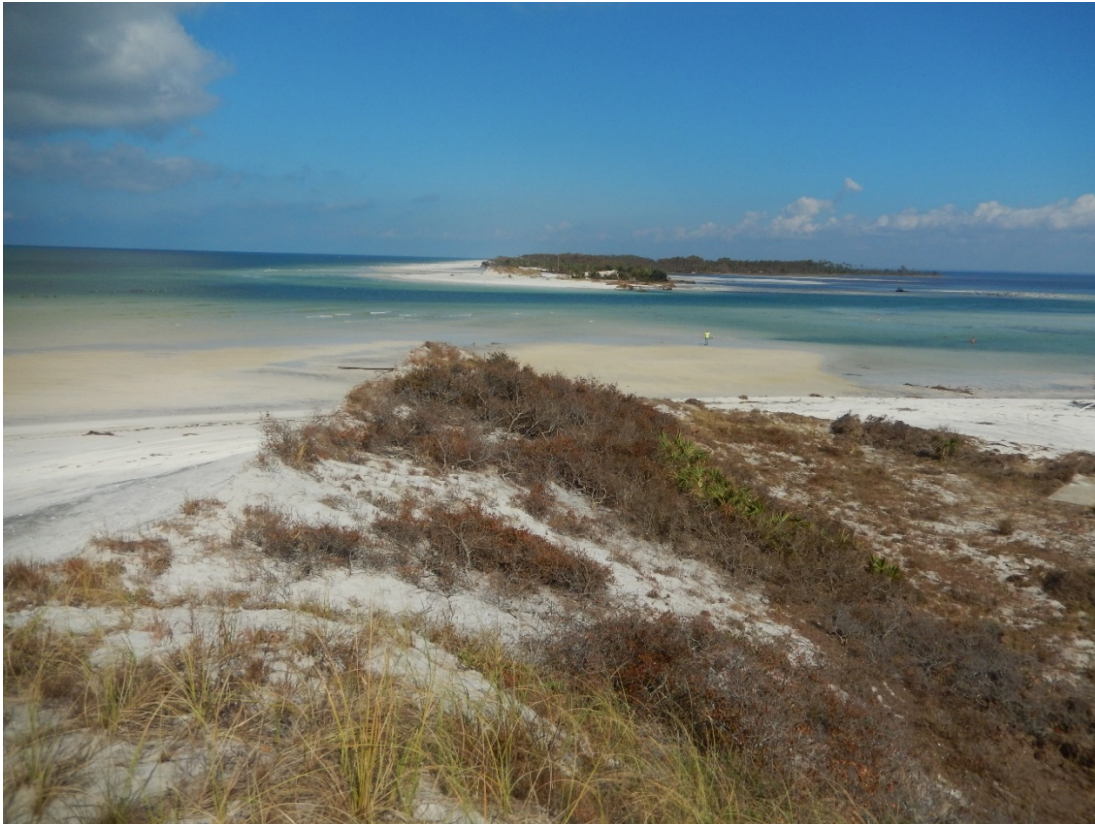
The greatest geomorphological change to the Gulf County coast caused by Hurricane Michael was a barrier breach near the midpoint of St. Joseph Peninsula. The barrier breakthrough occurred generally between DEP reference monuments R71 and R72, at a place called Eagle Harbor just north of the marina within T.H. Stone Memorial St. Joseph Peninsula State Park (**Figures 53-54**). A primary breach of approximately 900 feet in width resulted in the scouring of a tidal channel approximately 200 feet wide by an average of six to eight feet deep. A maximum depth of around 10 feet was reported by Florida Fish and Wildlife Conservation Commission (FWC) officers at the site. A smaller and less hydraulically stable breach was also created immediately to the north of the larger breach near DEP reference monument R71. The significant effect of these breaches is to truncate the peninsula as well as the state park, isolating all the campgrounds, cabins, park administration facilities and much of the park's infrastructure from vehicular access. Should the breach remain open, a significant long-term impact to the adjacent park beaches may be expected. Longshore sediment transport may be expected to remove a large volume of sand from the adjoining beaches and carry the material into the aquatic preserve within St. Joseph's Bay.

Figure 53. Breach of St. Joseph Peninsula between R71 and R72.

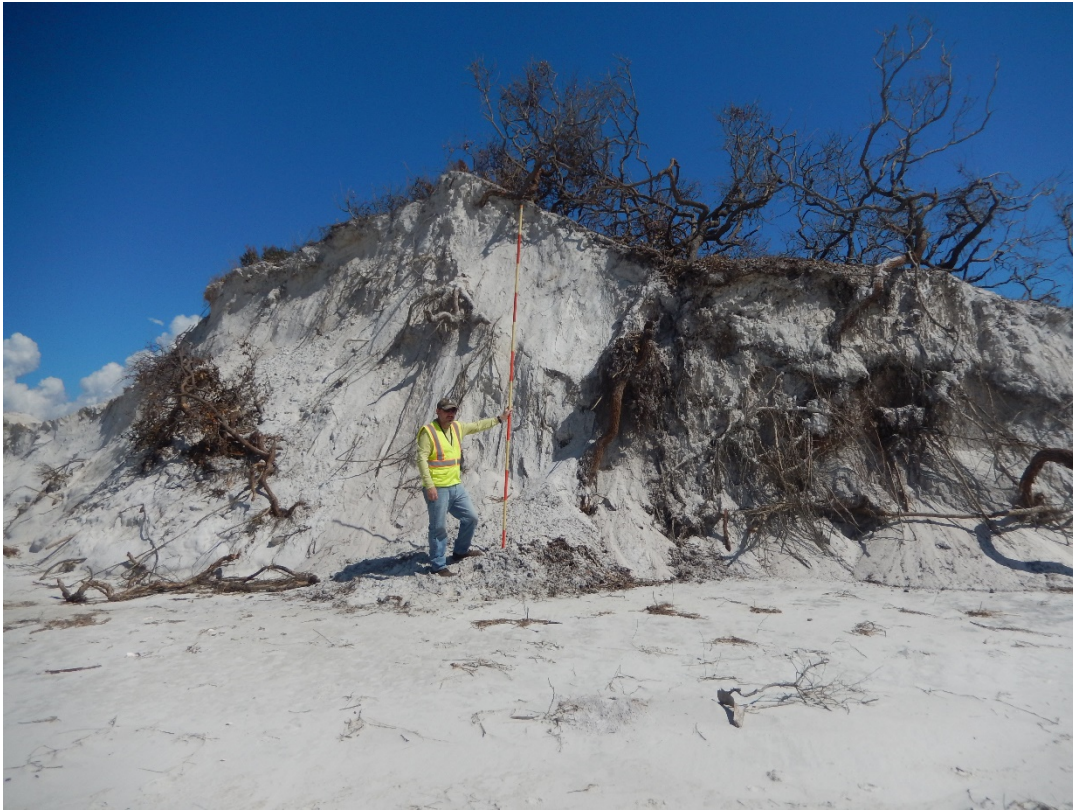
Figure 55. Major dune erosion (12-foot escarpment) near R74, St. Joseph Peninsula.

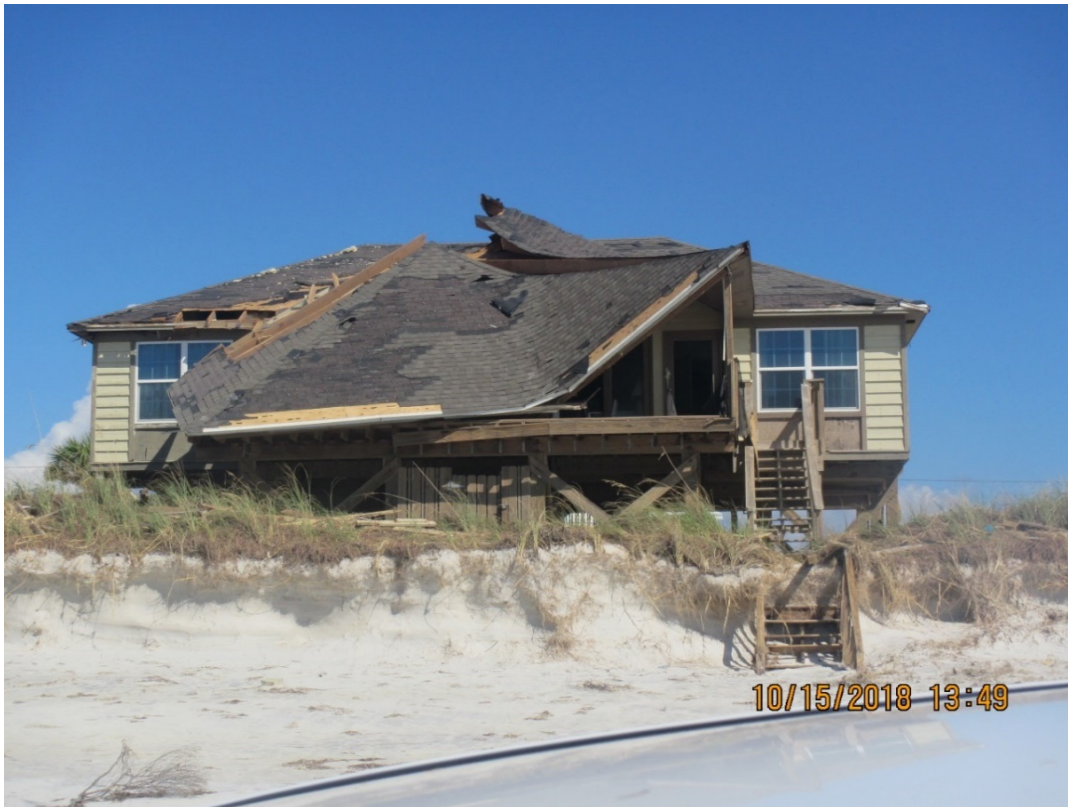
Figure 57. Major roof damage due to high winds near R85, St. Joseph Peninsula.

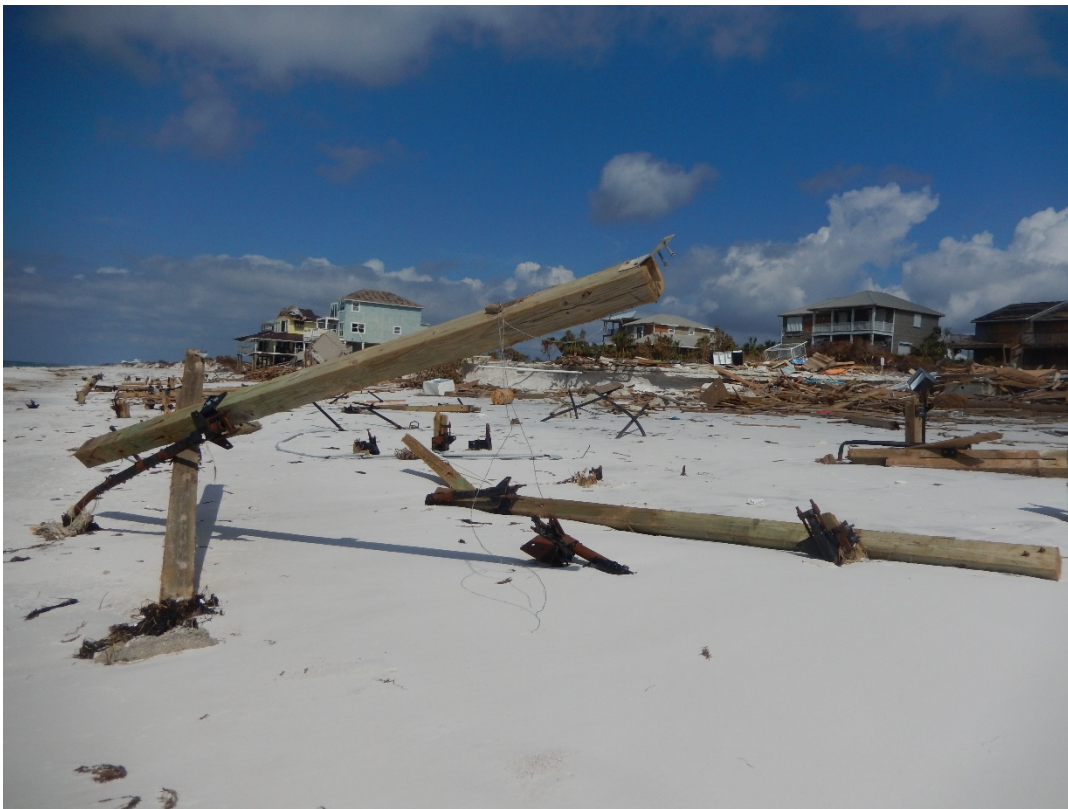
Figure 58. Remains of four destroyed townhouse buildings on Nassau Lane near R90.5, St. Joseph Peninsula.

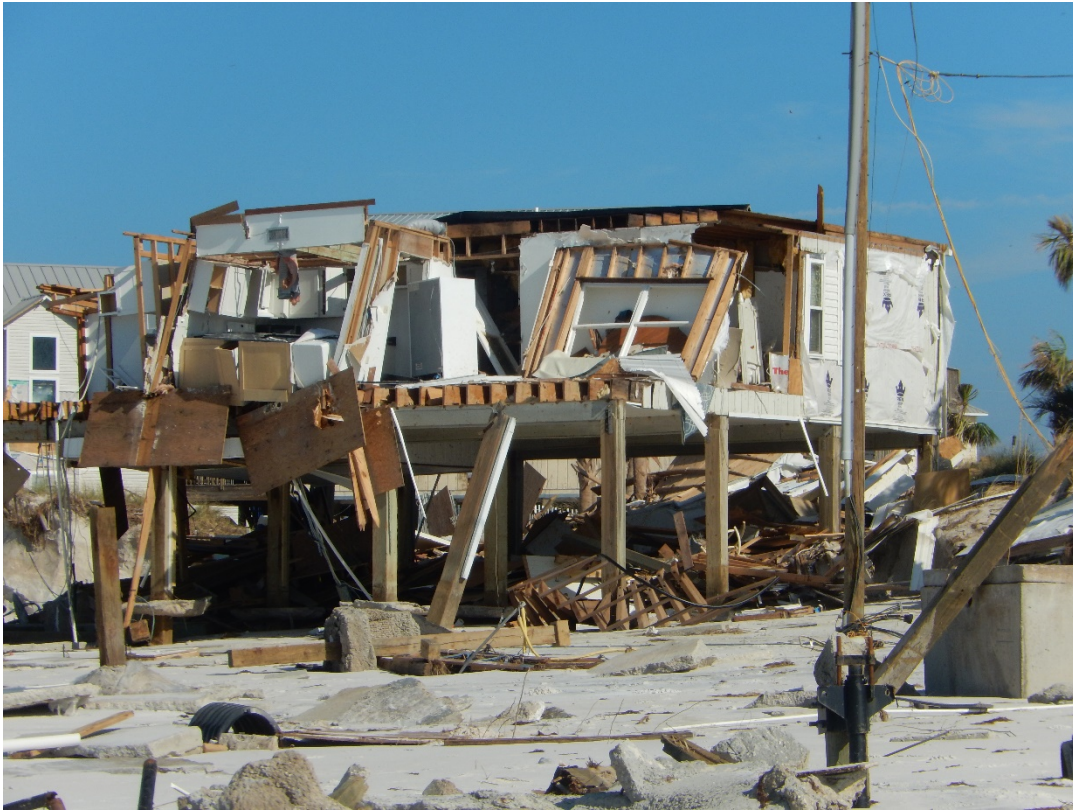
Figure 59. *Pile-supported dwelling destroyed near R97.5, St. Joseph Peninsula.*

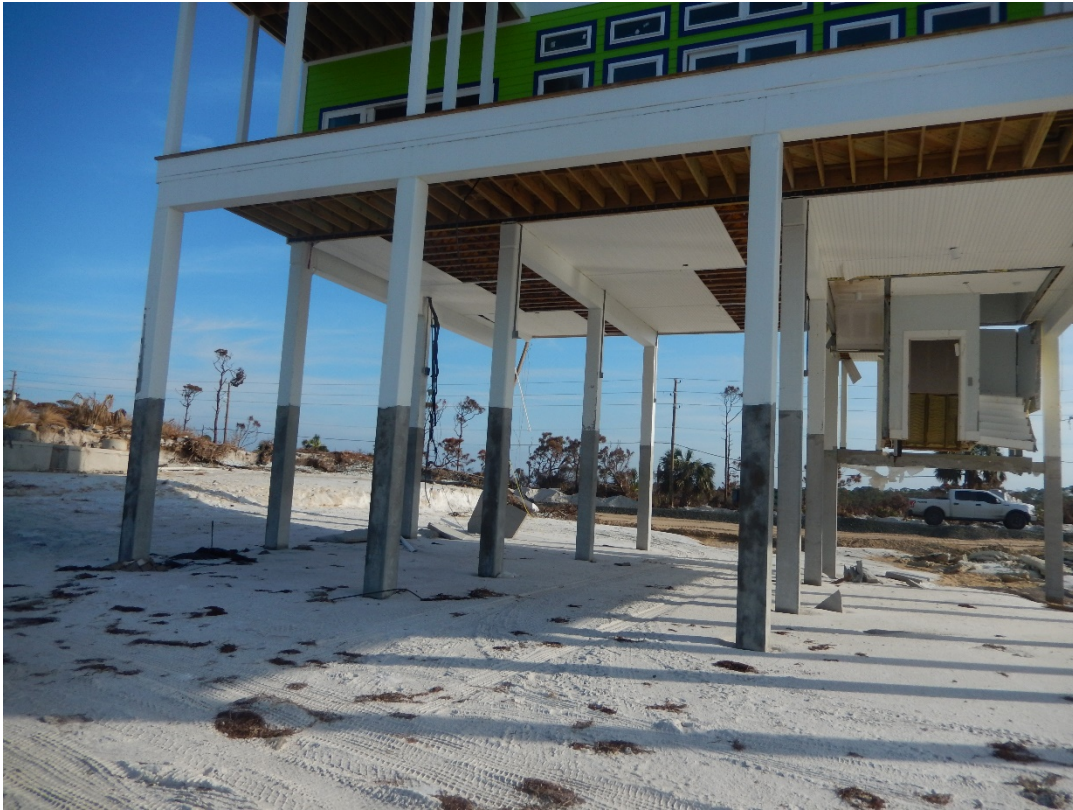
Figure 61. Over six feet of vertical loss of grade beneath structure near R104.

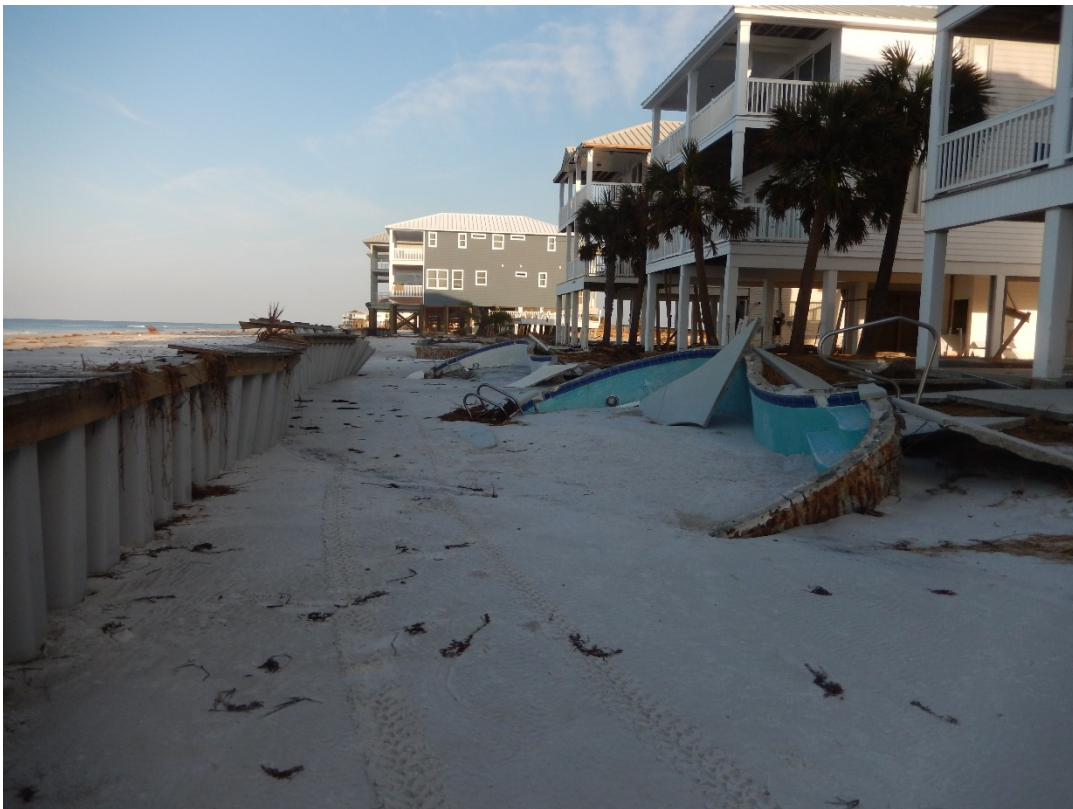
Figure 62. Major damage to bulkheads and swimming pools near R104.

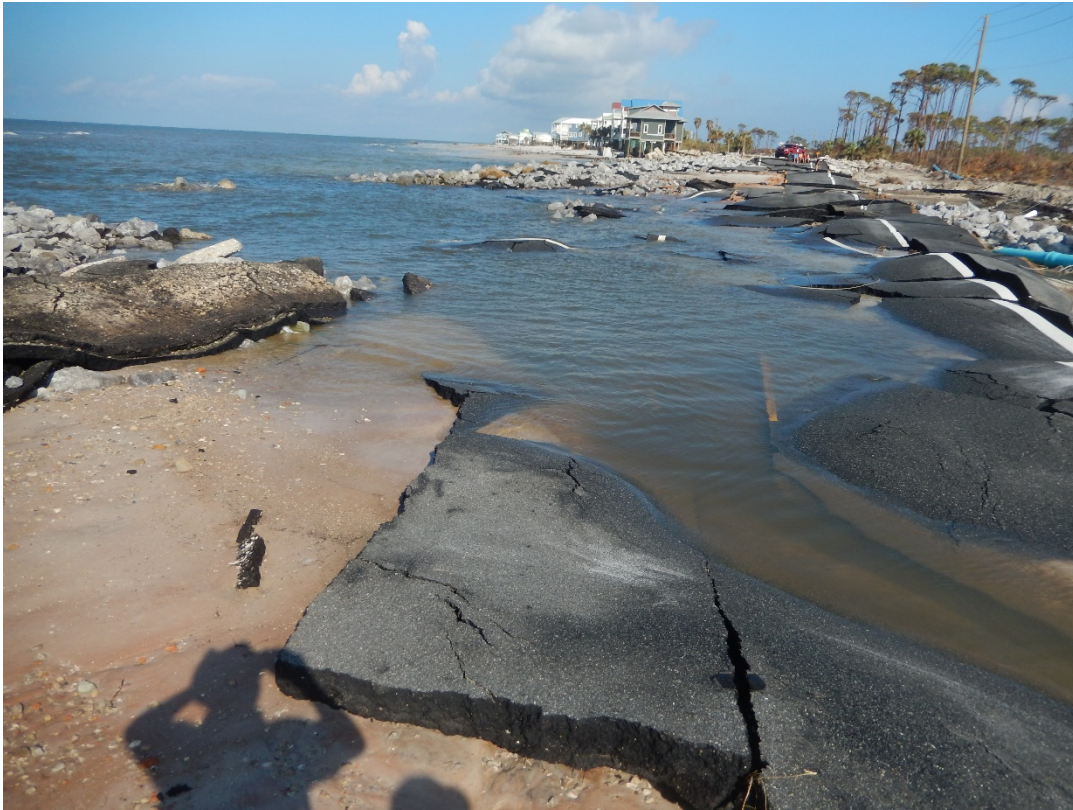
Figure 63. County Road 30E destroyed north of the Stump Hole revetment, R105.

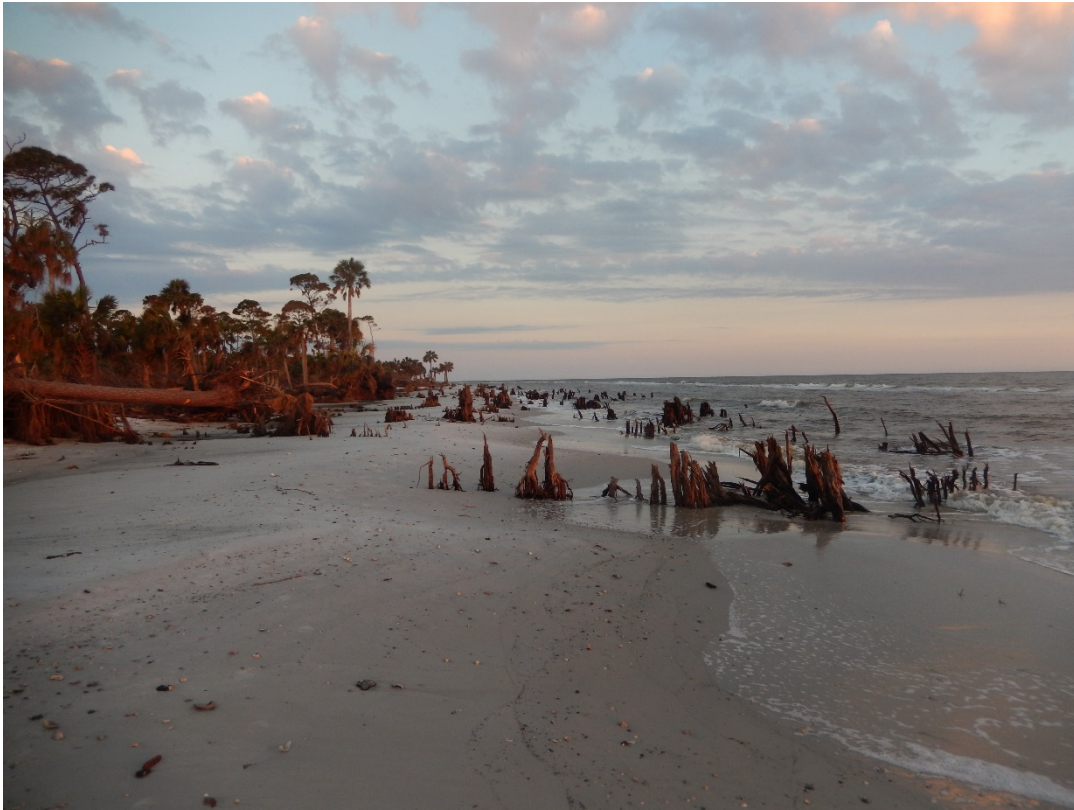
Figure 65. Severe beach and dune erosion at Cape San Blas, R110.

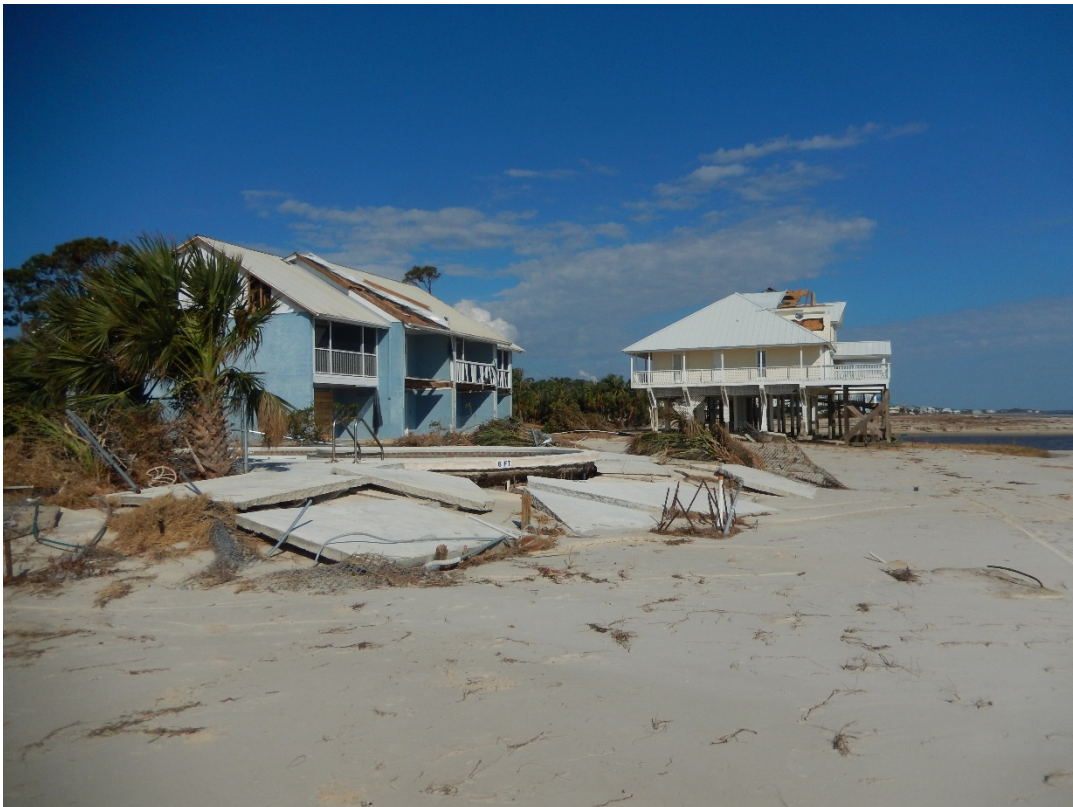
Figure 66. Storm surge damages at Money Bayou, R140.

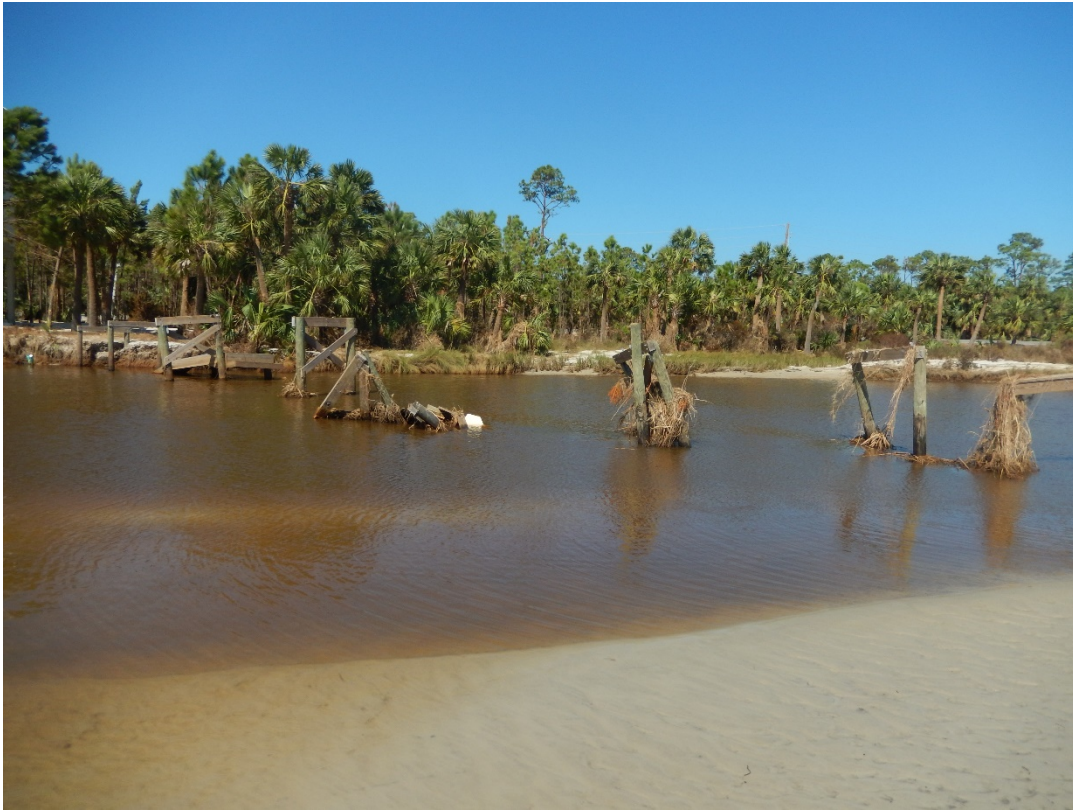
Figure 67. Bridge destroyed across Money Bayou, R140.5.

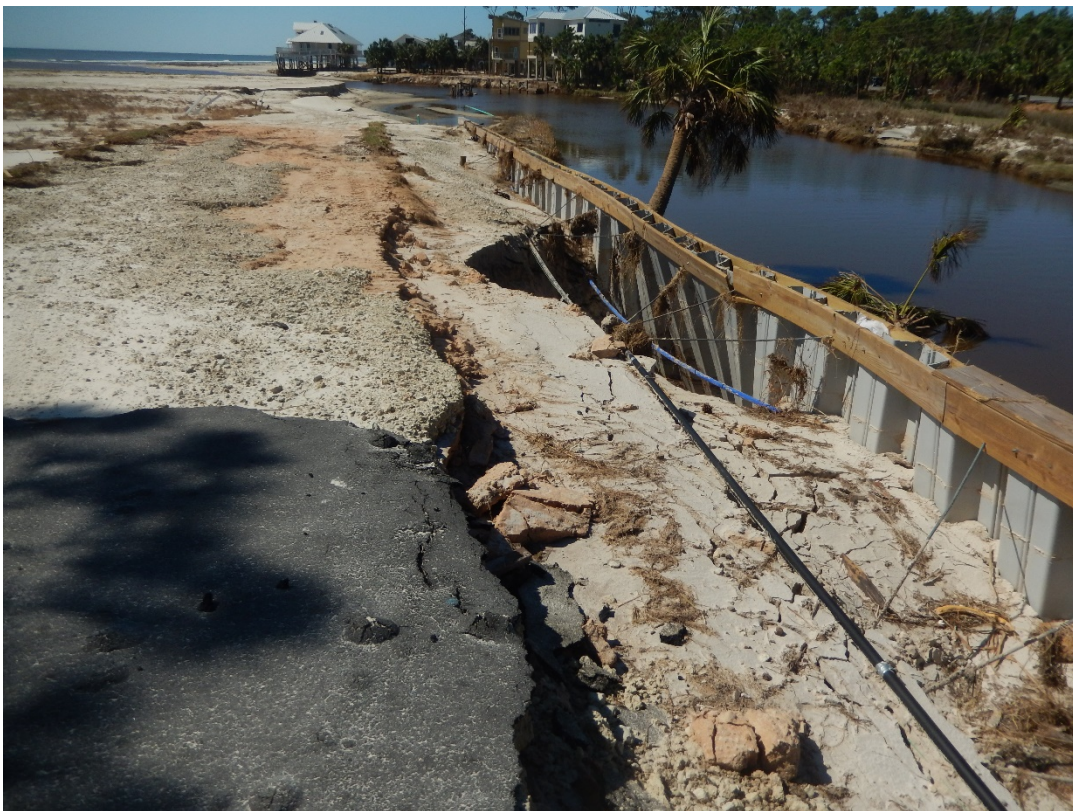
Figure 68. Bulkhead on Money Bayou damaged, R141.

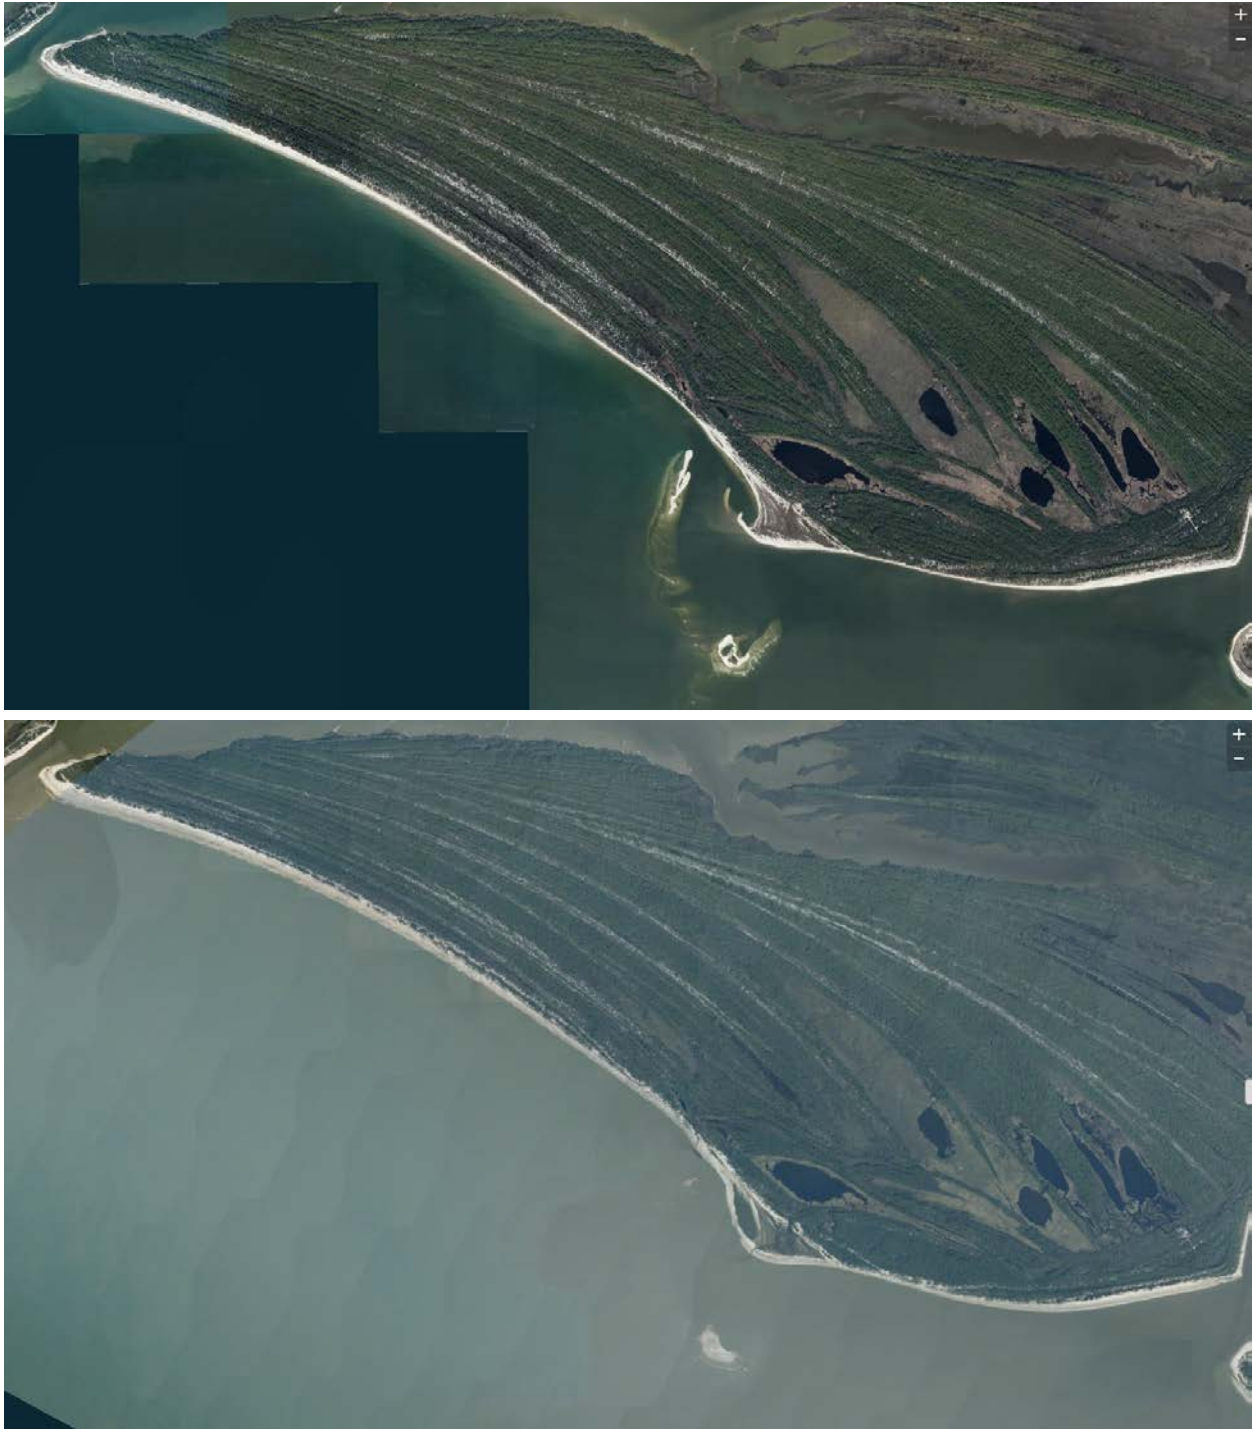
Figure 70. Before and after of major coastal changes to St. Vincent Island.

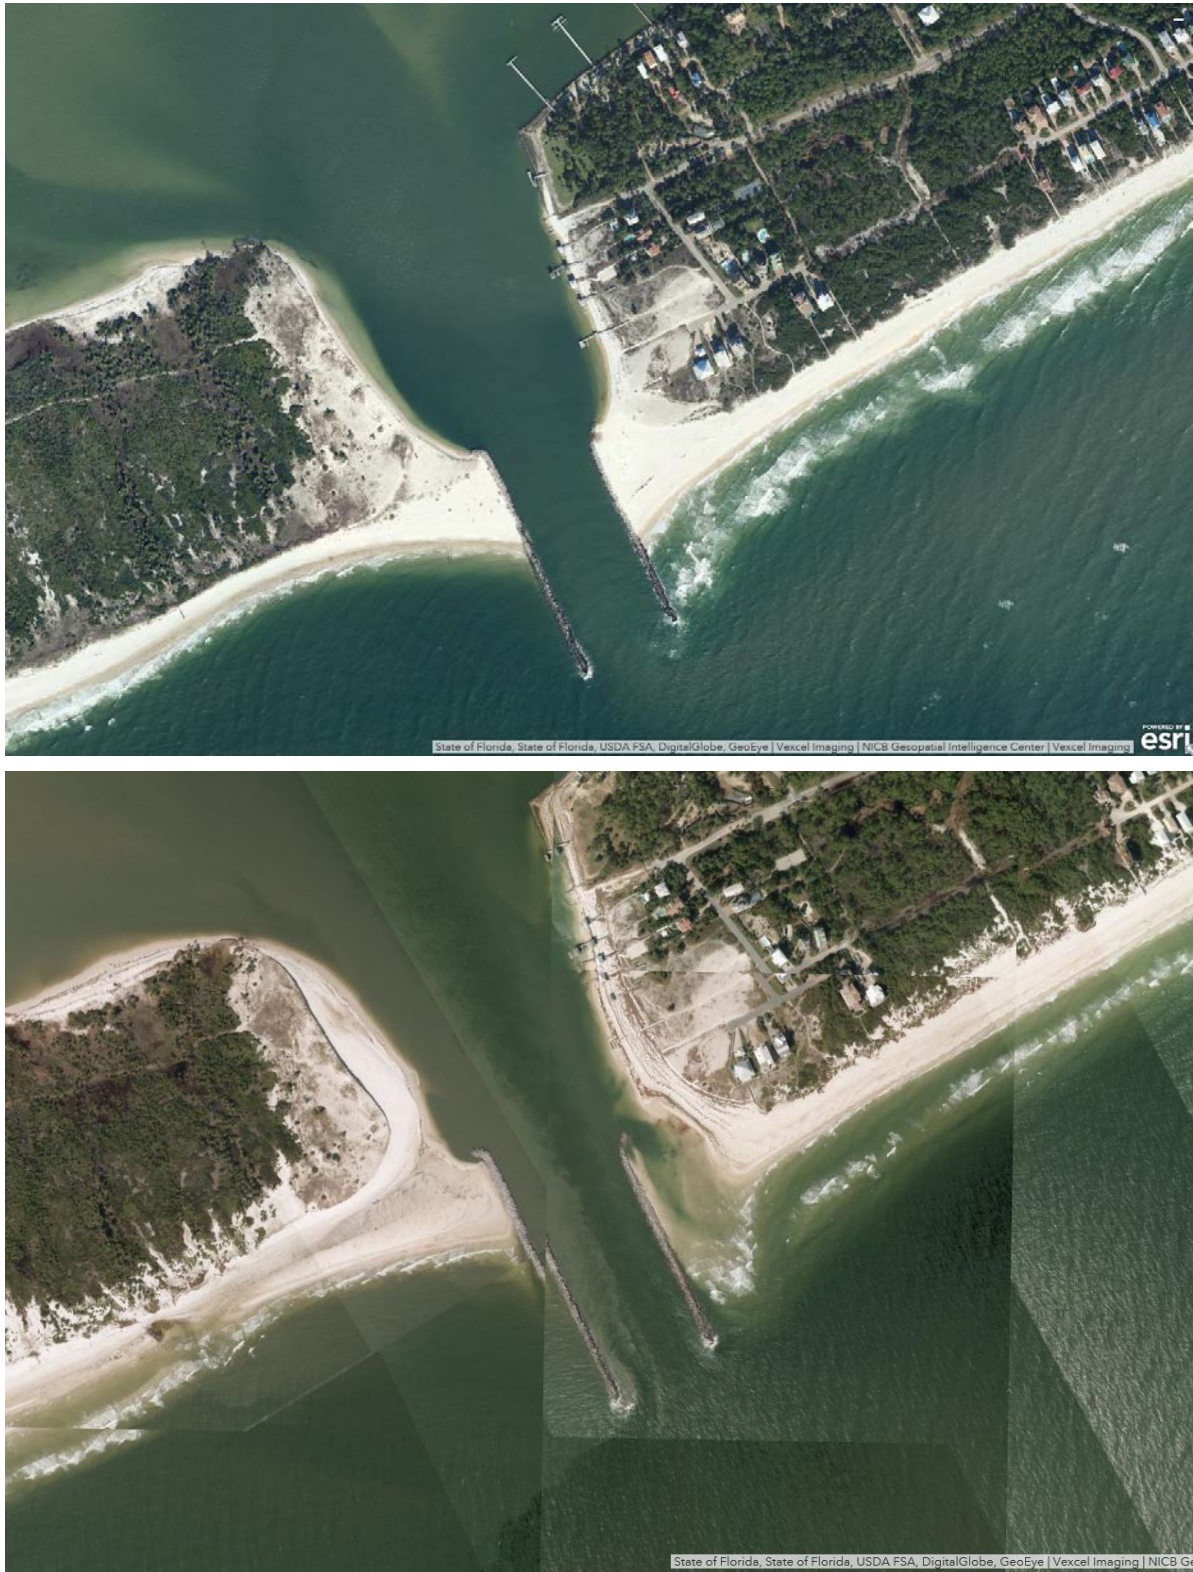
Figure 71. Before and after of breaching of the Sike's Cut jetties from St. George Island, R51-R52.

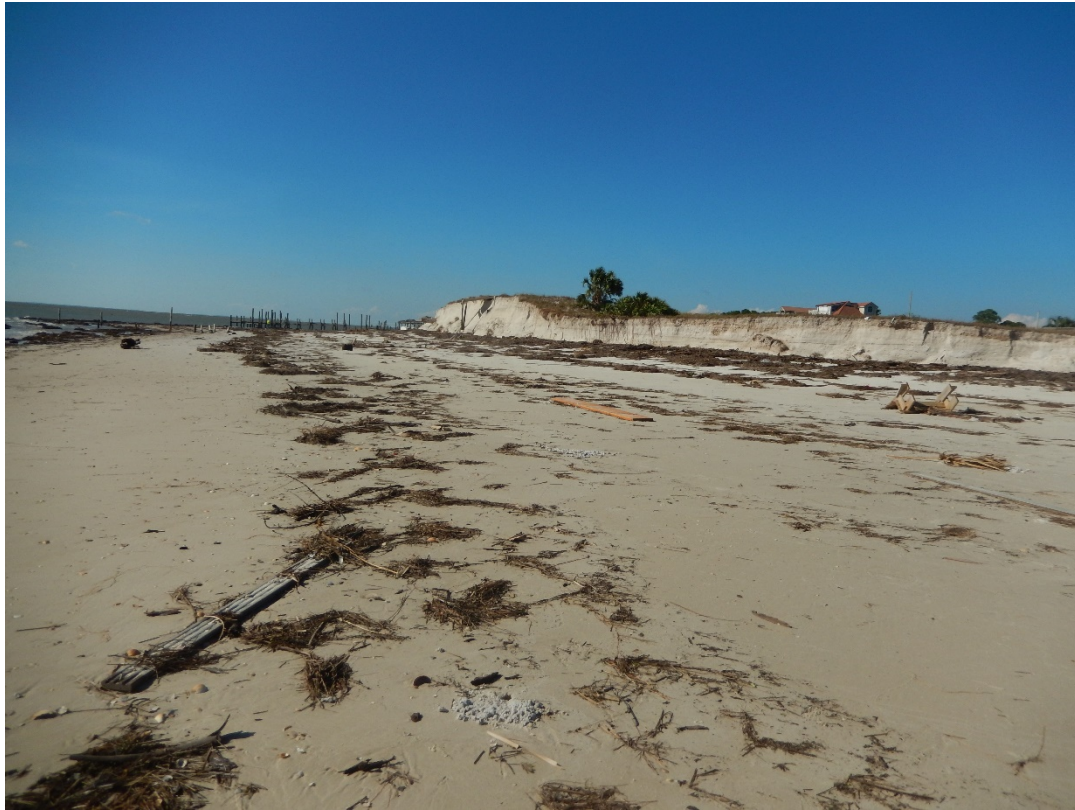
Along St. Vincent Island, Little St. George Island, and the St. George Island Plantation between DEP reference monuments R52 and R73, major beach and dune erosion (Condition IV) was sustained (**Figure 72**). Along the St. George Island Plantation, the vegetation and dunes retreated as much as 50 feet, leaving much of the development of single-family dwellings now fronting a low unvegetated beach.

Figure 72. Major beach and dune erosion at Sikes Cut at R52, St. George Island.

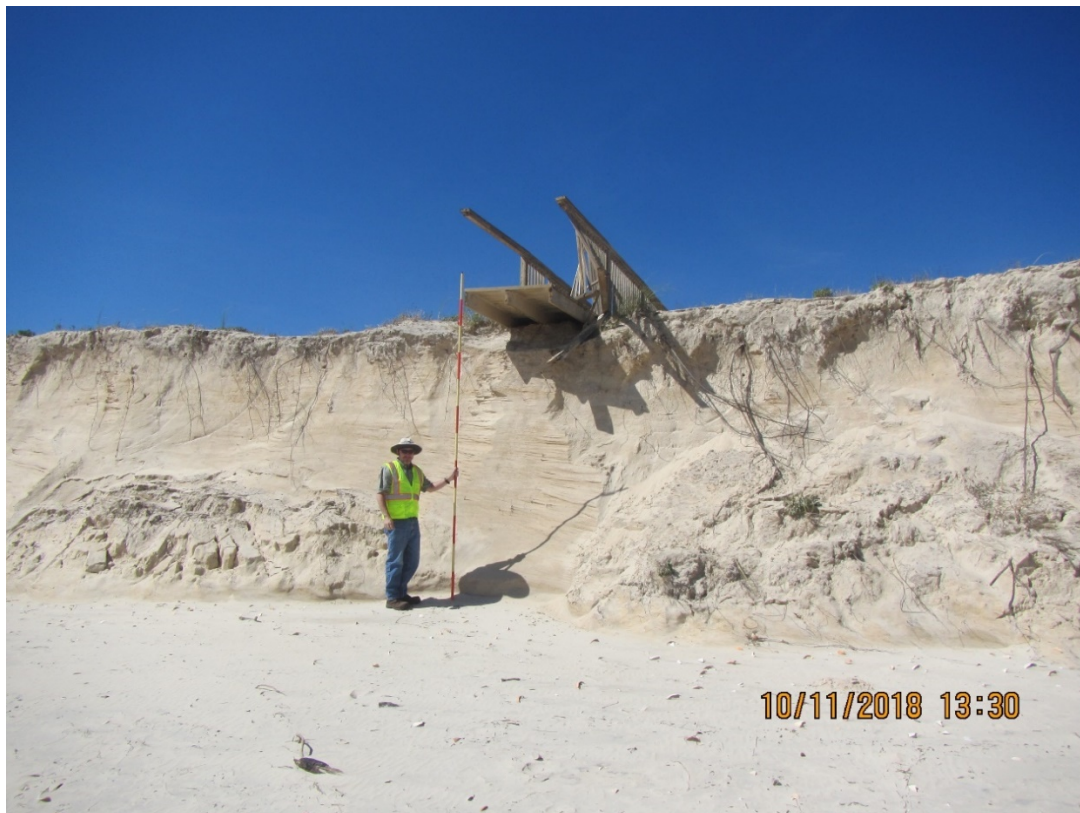
Figure 73. Major dune erosion at R72, St. George Island.

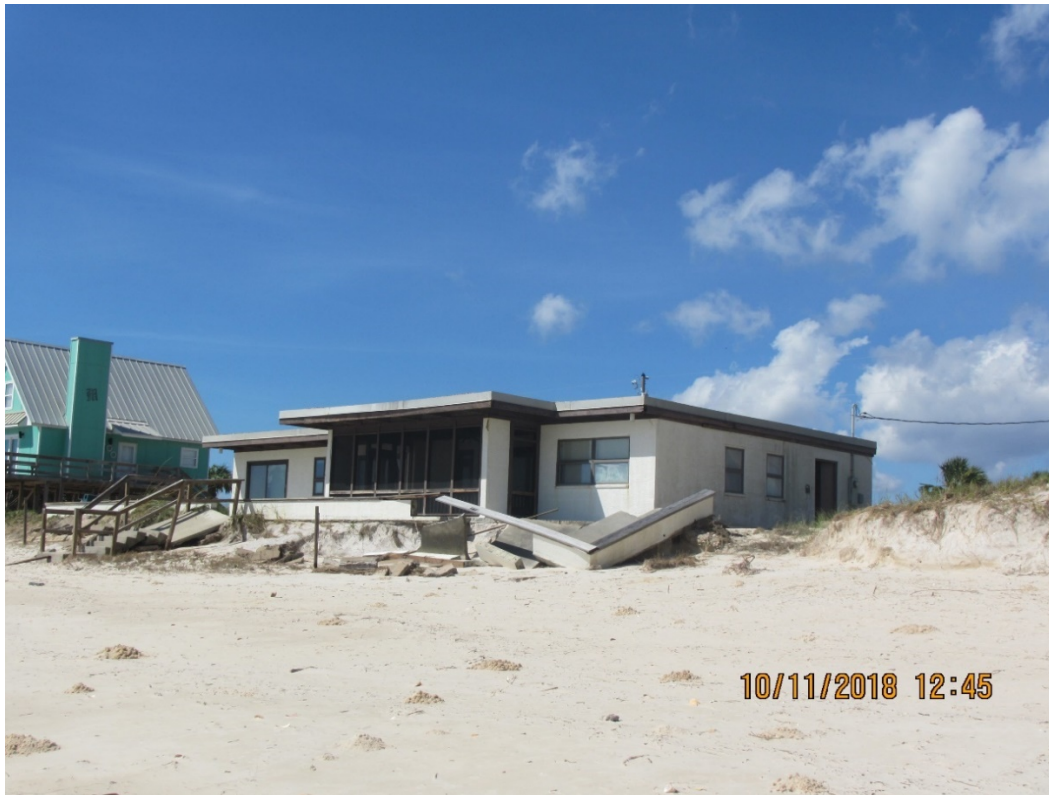
Figure 74. Dwelling damaged near R78, St. George Island.

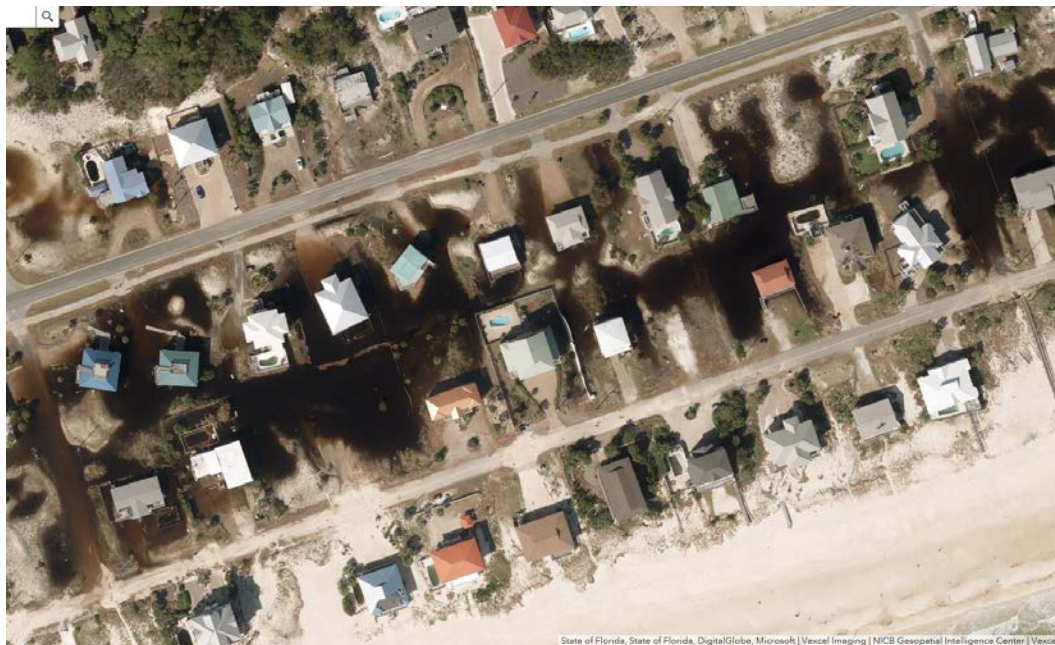
Figure 75. Flooded interdunal depression on St. George Island between R87-R99.

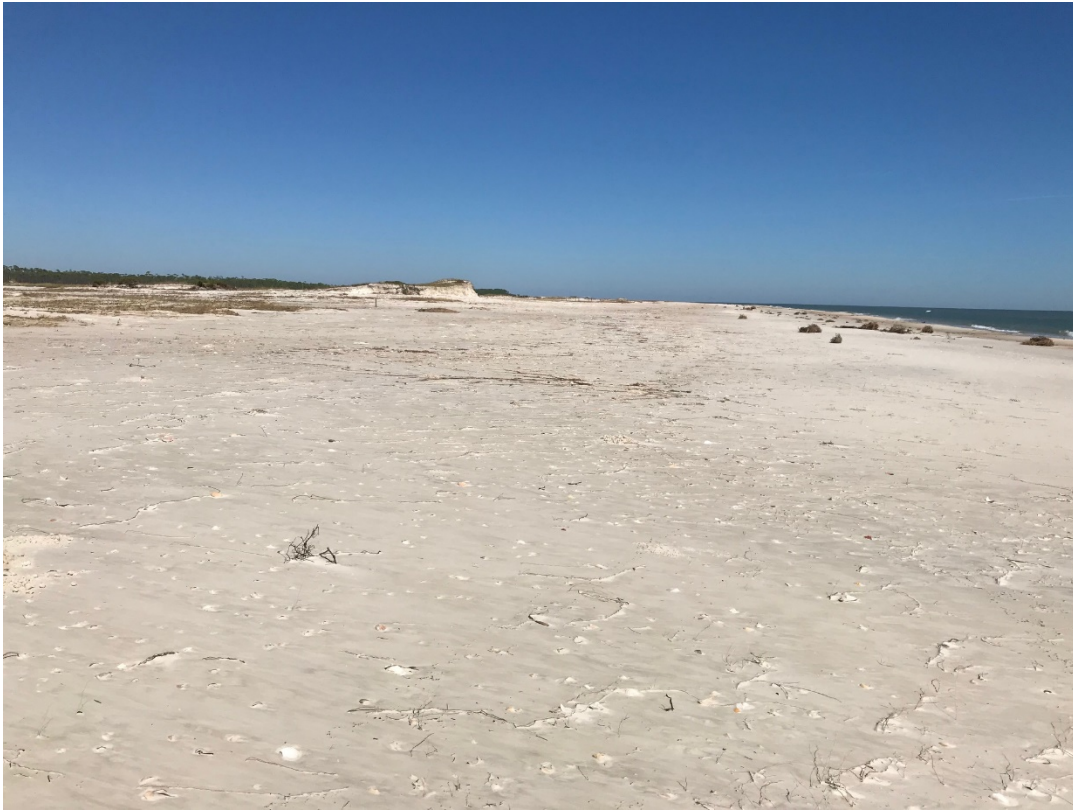
In the Dr. Julian G. Bruce St. George Island State Park, which extends along the eastern 8.4 miles of St. George Island between DEP reference monuments R105 and R149, major beach and dune erosion (Condition IV) was sustained (**Figure 76**). Near the state park entrance at R105.4 and R106, large storm tide runout channels cross the beach and dune region gulfward of the park road. This area was a region of large washover fans where the storm surge flowed across the island into St. George Sound. This same area experienced similar flooding impacts during Hurricanes Agnes (1972), Elena and Kate (1985), and Dennis (2005). Between R110 and R117 at East Slough, extensive washover fans exist where the storm surge flowed across this narrow segment of the island. Similar to along East Gulf Beach Drive, the park segment between the two high public use areas at East Slough (R117.5) and Sugar Hill (R128), has a generally continuous elongated meandering lake both gulfward and landward of the park road left from the entrapment of the storm surge between the primary dune field and a more landward ancient dune field. Several more storm tide runout channels cross the beach and dune region gulfward of the park road along this stretch between East Slough and Sugar Hill. East of Sugar Hill between DEP reference monuments R128 and R149 at the eastern end of St. George Island, there was nearly total inundation of the island during the storm surge, which leveled the dunes and left large washover deposits.

Figure 76. *Dunes leveled across St. George Island State Park.*
