*Preliminary Hurricane Michael Post-Storm
Beach Conditions and Coastal Impact Report*

**Division of Water Resource Management
Florida Department of Environmental Protection
November 2018**

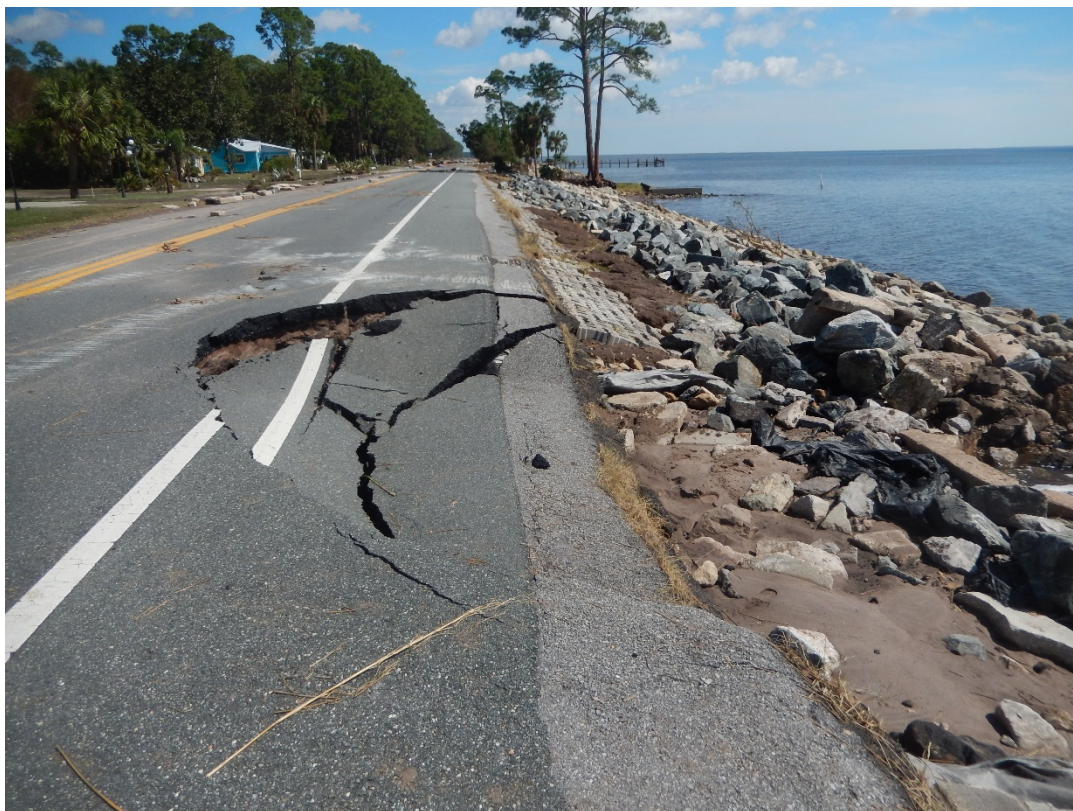
Figure 79. U.S. Highway 98 damaged near Eastpoint.

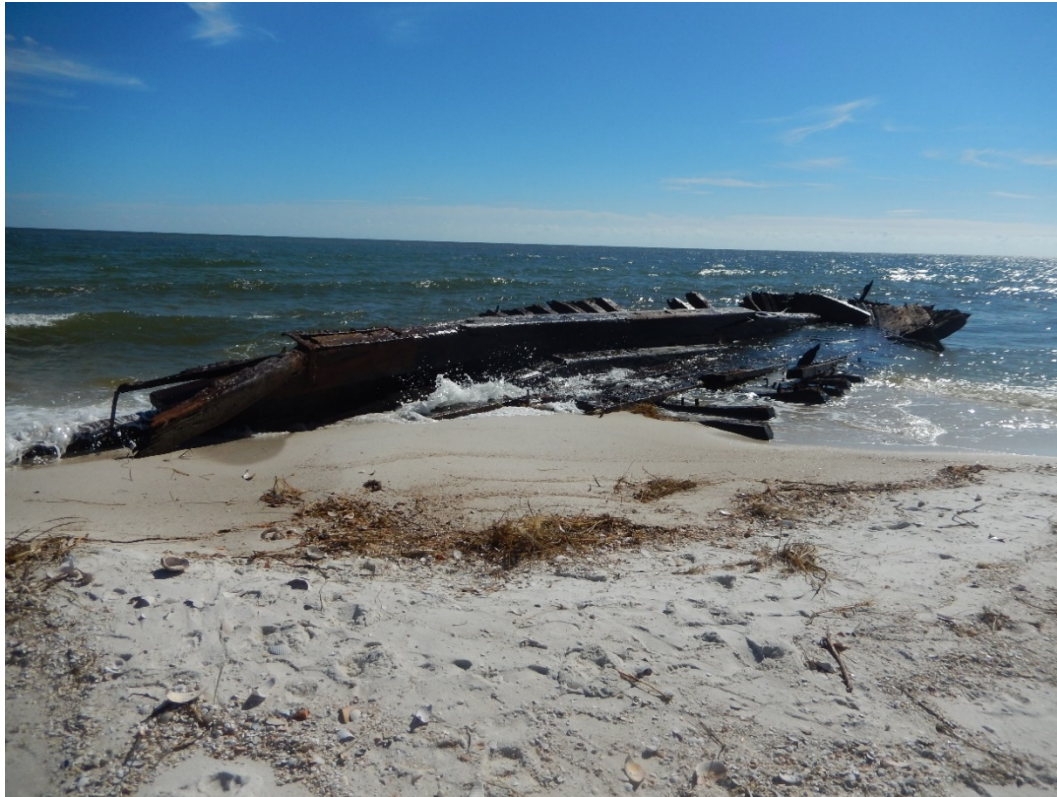
Figure 80. 19th century shipwreck uncovered by erosion near R158, Dog Island.

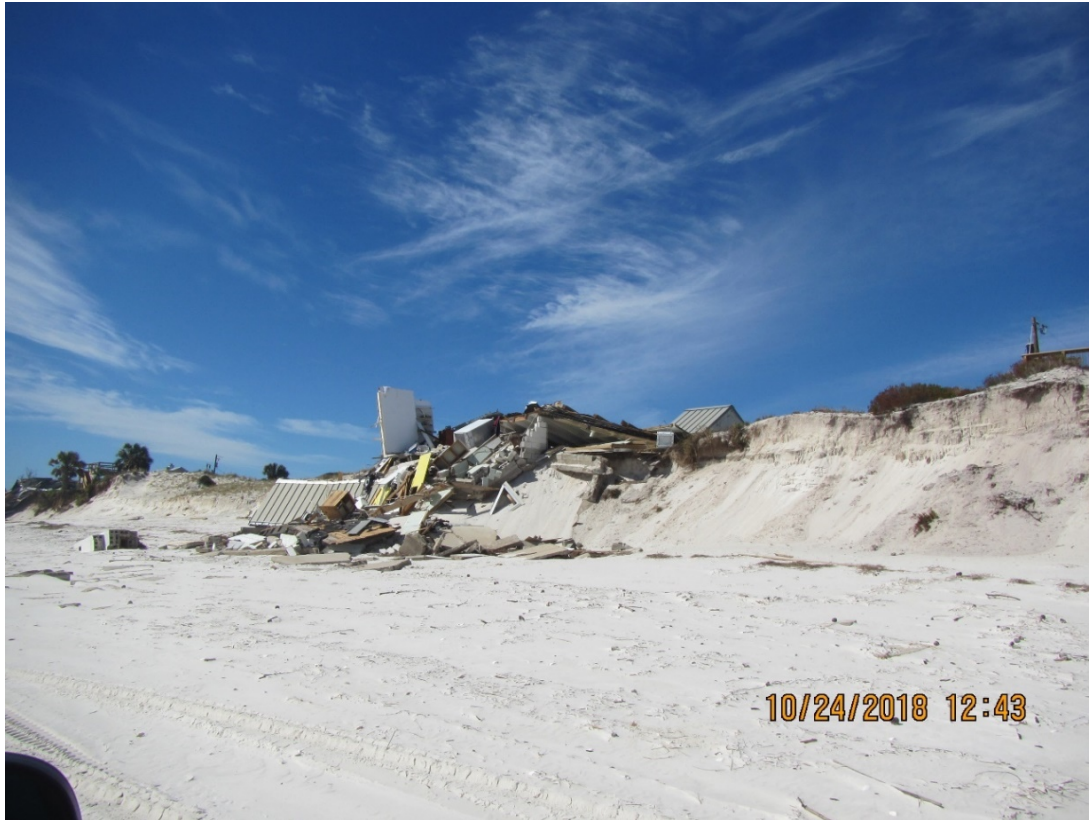
Figure 84. Dwelling destroyed near R176, Dog Island.

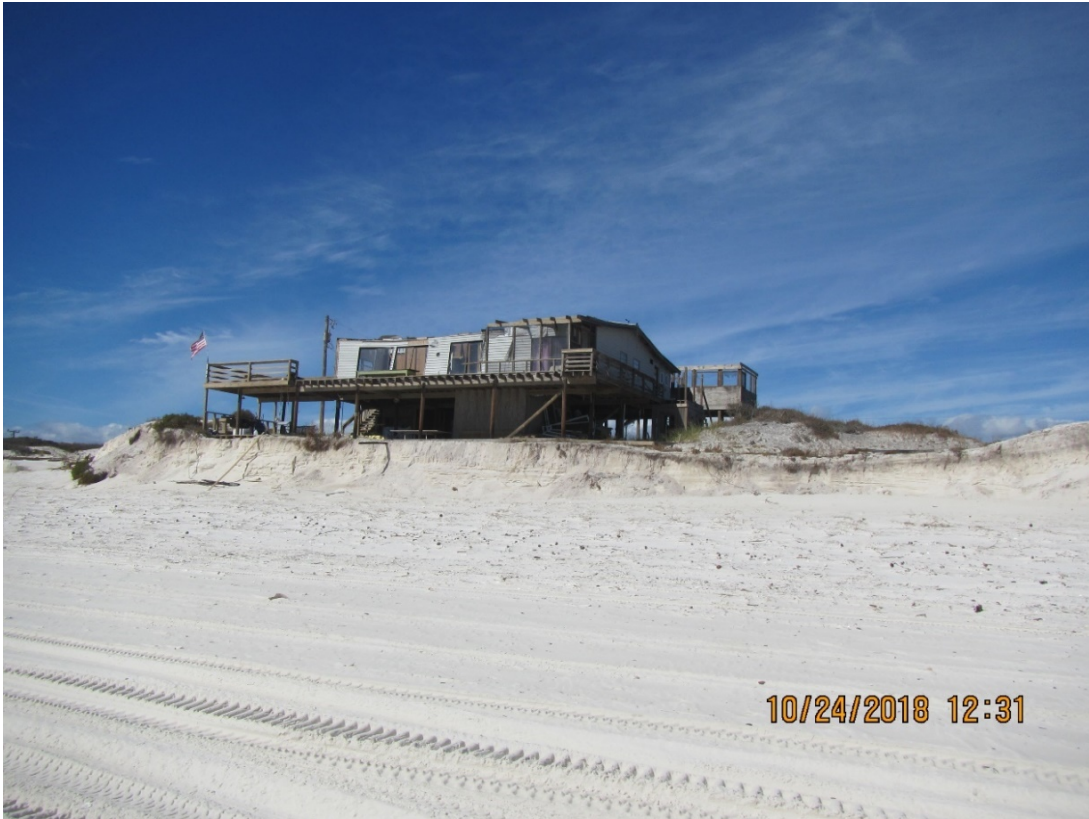
Figure 85. Dwelling destroyed near R178, Dog Island.

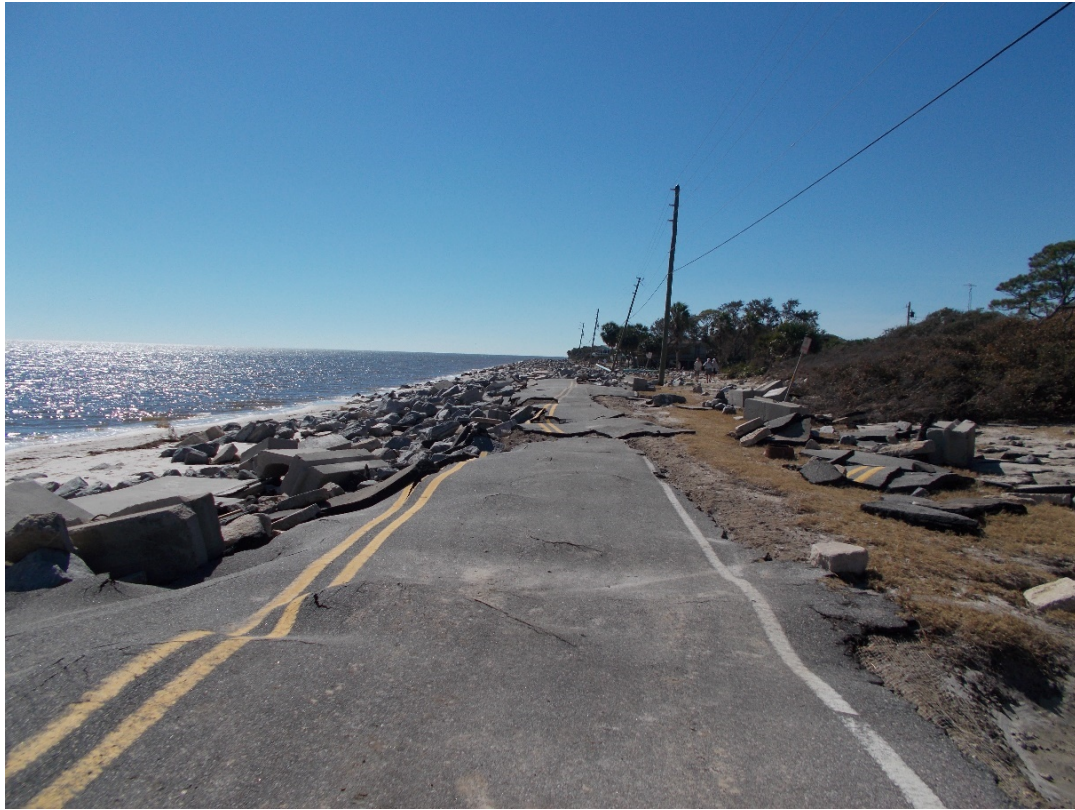
Figure 88. 3,000 feet of road and revetment destroyed between R211-R214, Southwest Cape.

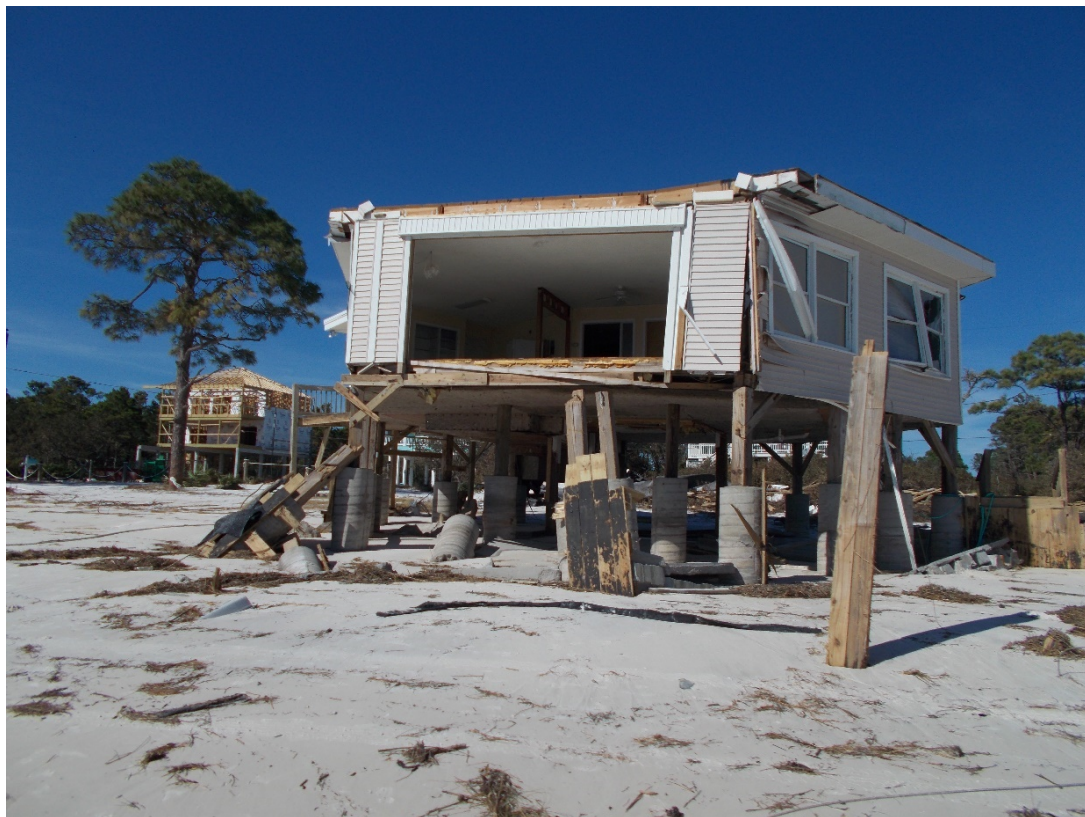
Figure 89. Dwelling destroyed near R210, Southwest Cape.

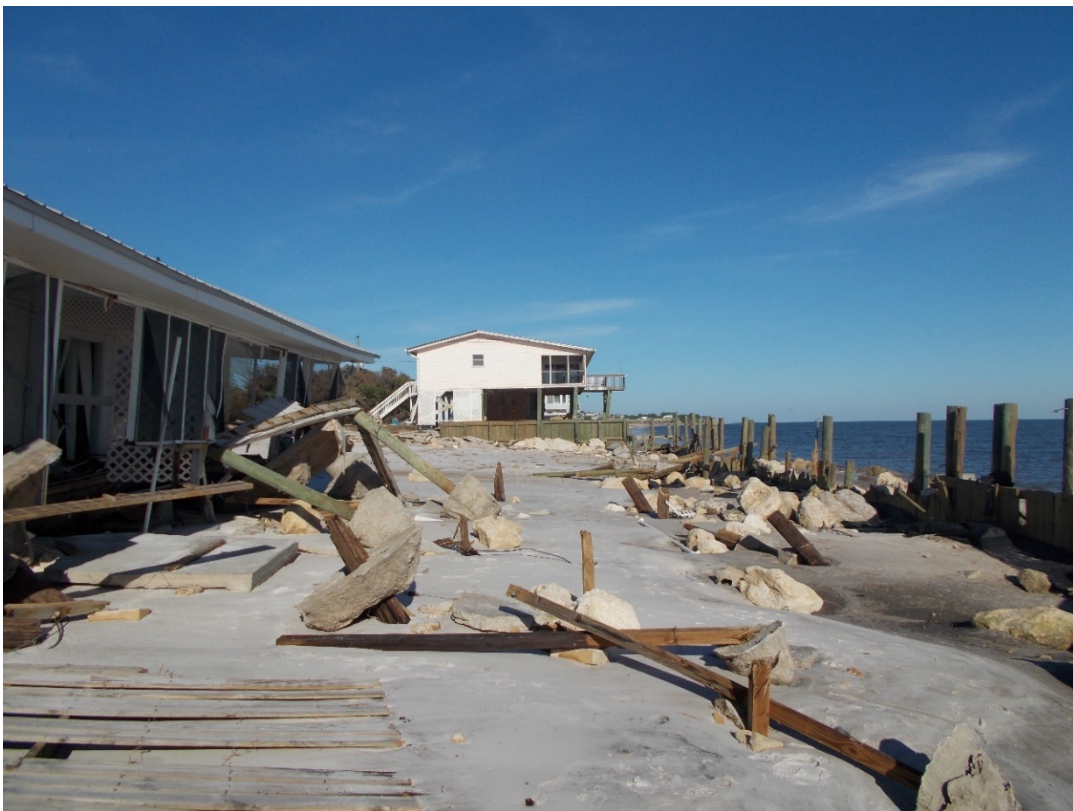
Figure 91. Dwelling and bulkhead damaged near R214.5, Southwest Cape.

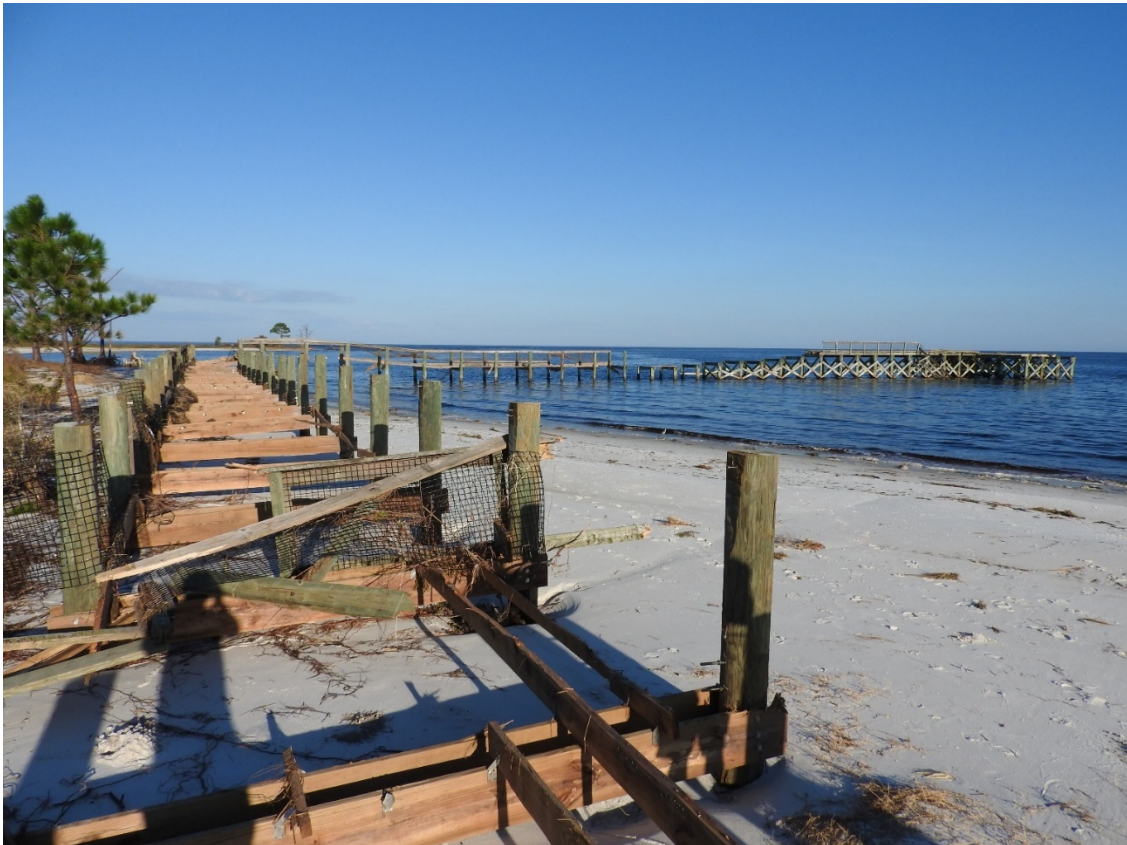
On Mashas Sands, two nonhabitable major structures were substantially destroyed. On the southern shoreline, the Mashas Sands timber fishing pier was substantially destroyed by the storm surge and wave forces. Along the same shoreline, 300 feet of elevated timber walkway that provided access to the pier was destroyed. The terminal boulder mound groin at the canal entrance near the pier was undamaged. At the Mashas Sands eastern shoreline, the public bath house was destroyed.

Figure 93. Fishing pier and access walkway damaged at Mashas Sands, V303.

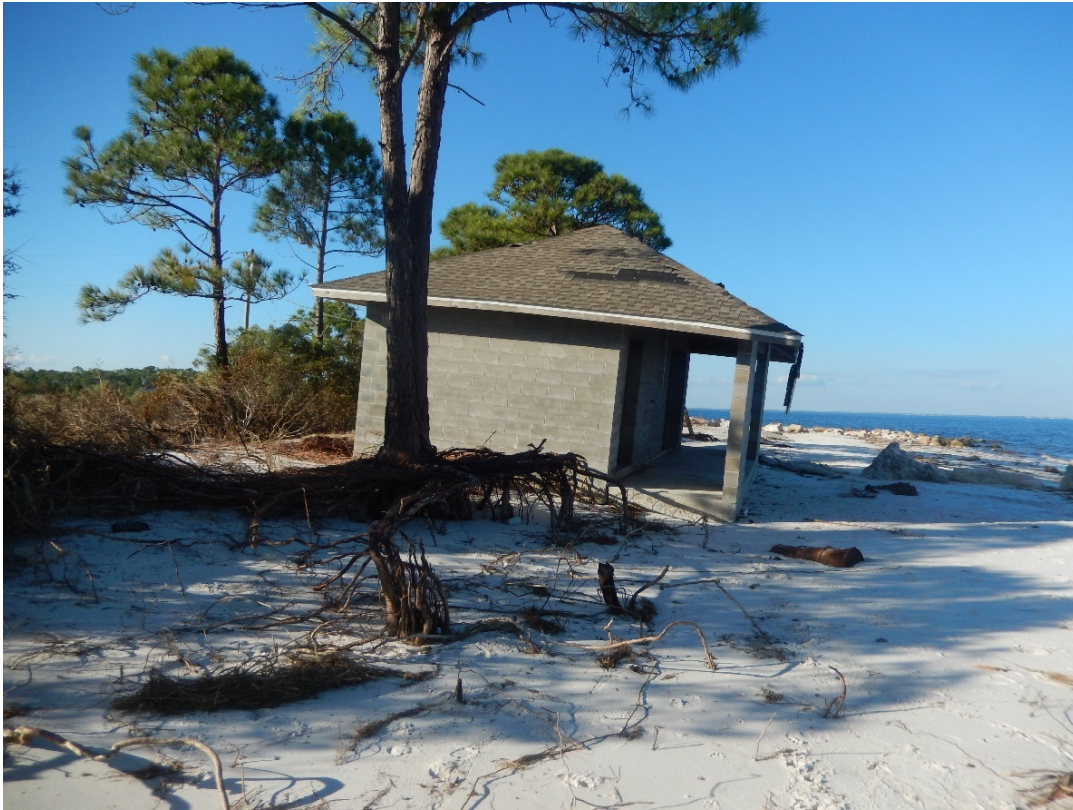
Figure 94. Bathhouse destroyed at Mashers Sands, V314.

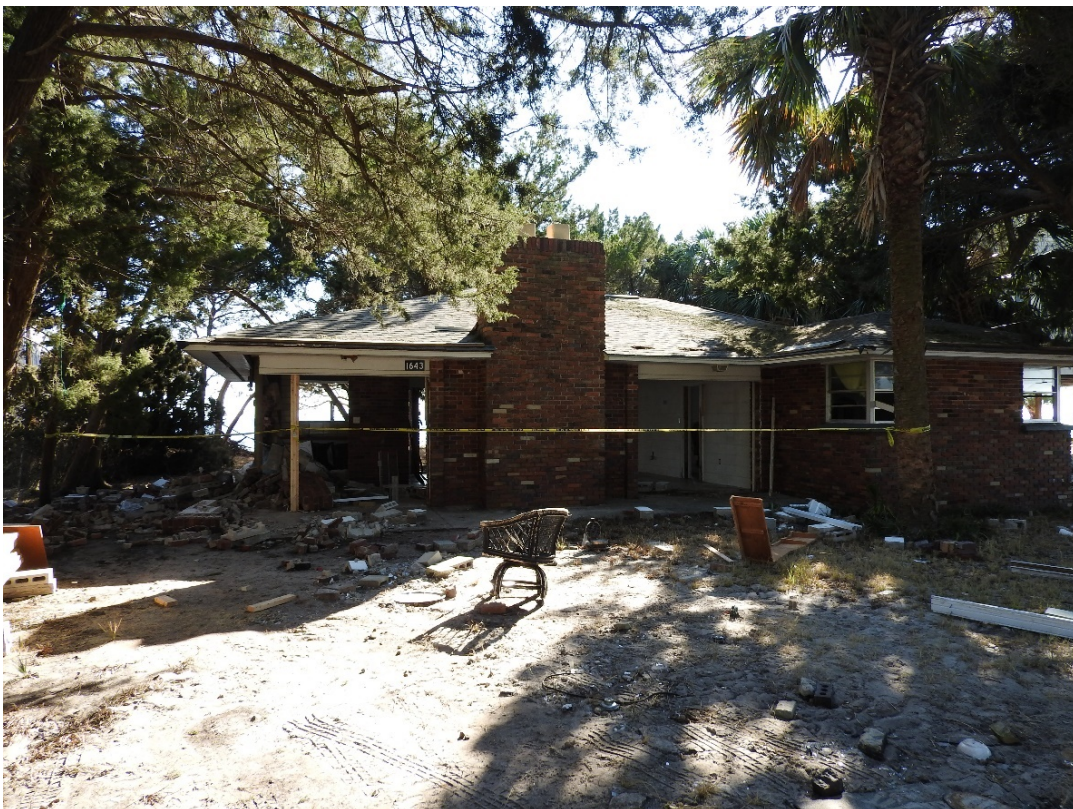
Figure 95. Dwelling with major damage from the storm surge at Shell Point, V342.

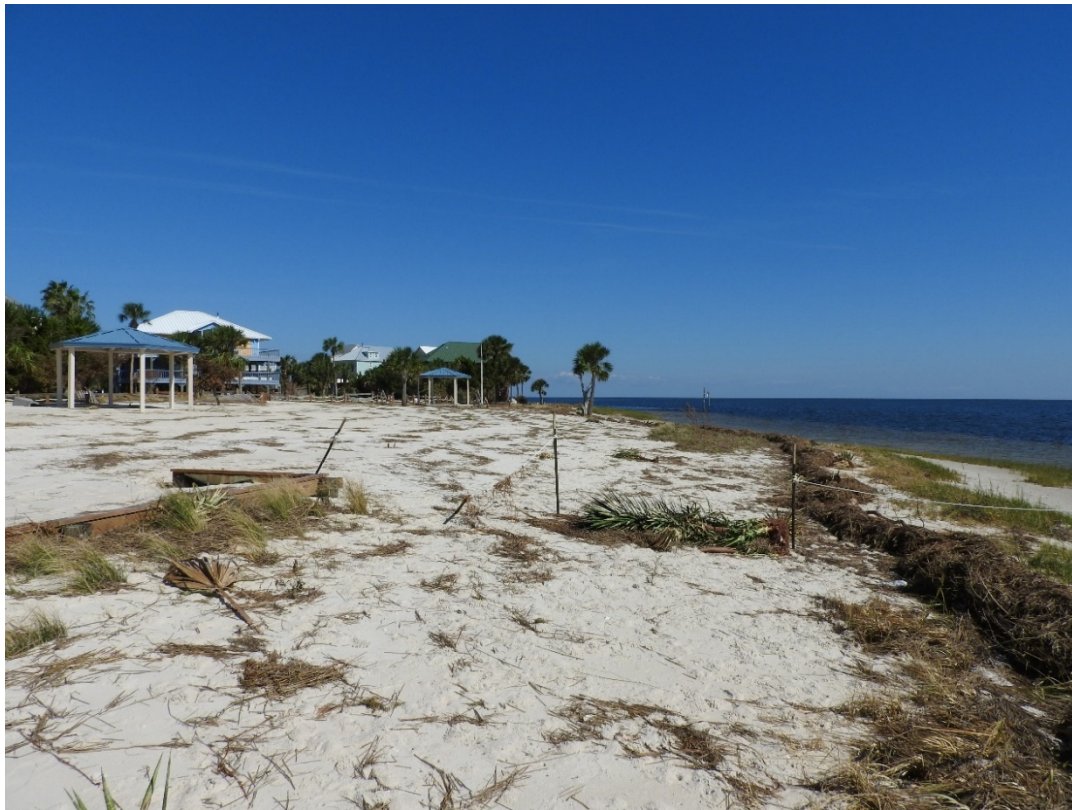
Figure 96. *Minor erosion to public beach at Shell Point, V355.*

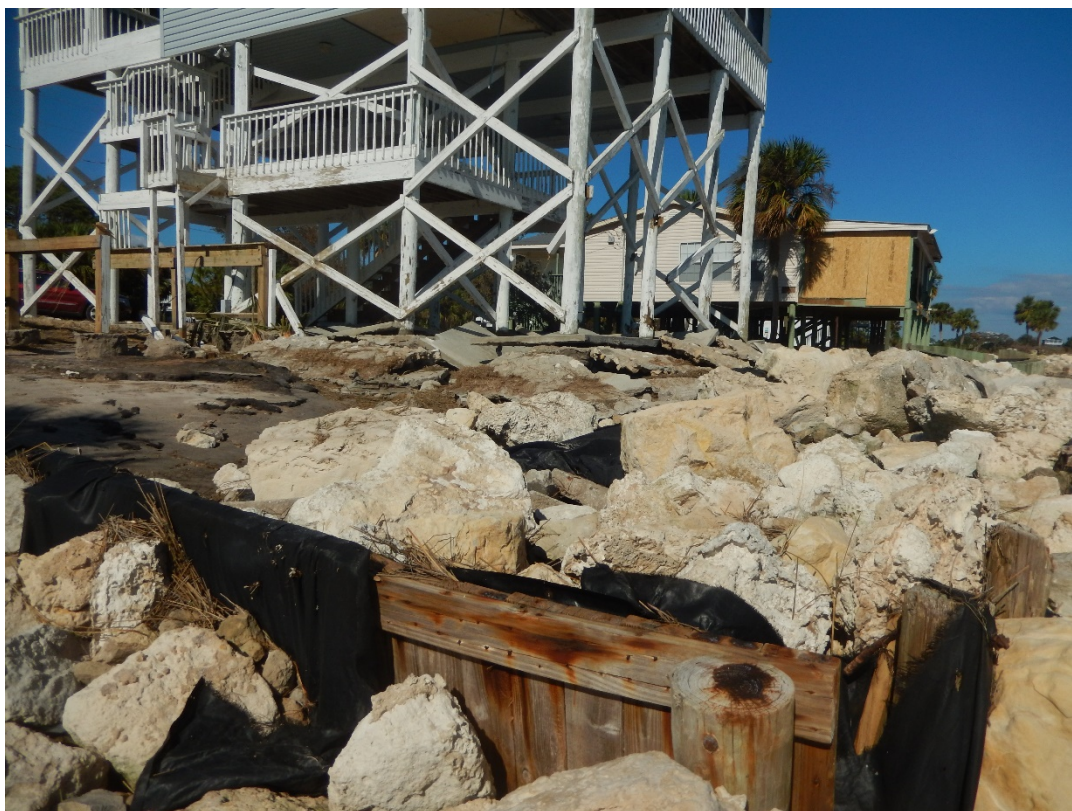
Figure 97. *Rock revetment damaged and dwelling with parking slab and bracing damage at Shell Point, V361.*
