*Hurricane Michael Post-Storm
Beach Conditions and Coastal Impact Report*

**Division of Water Resource Management
Florida Department of Environmental Protection**

January 2019

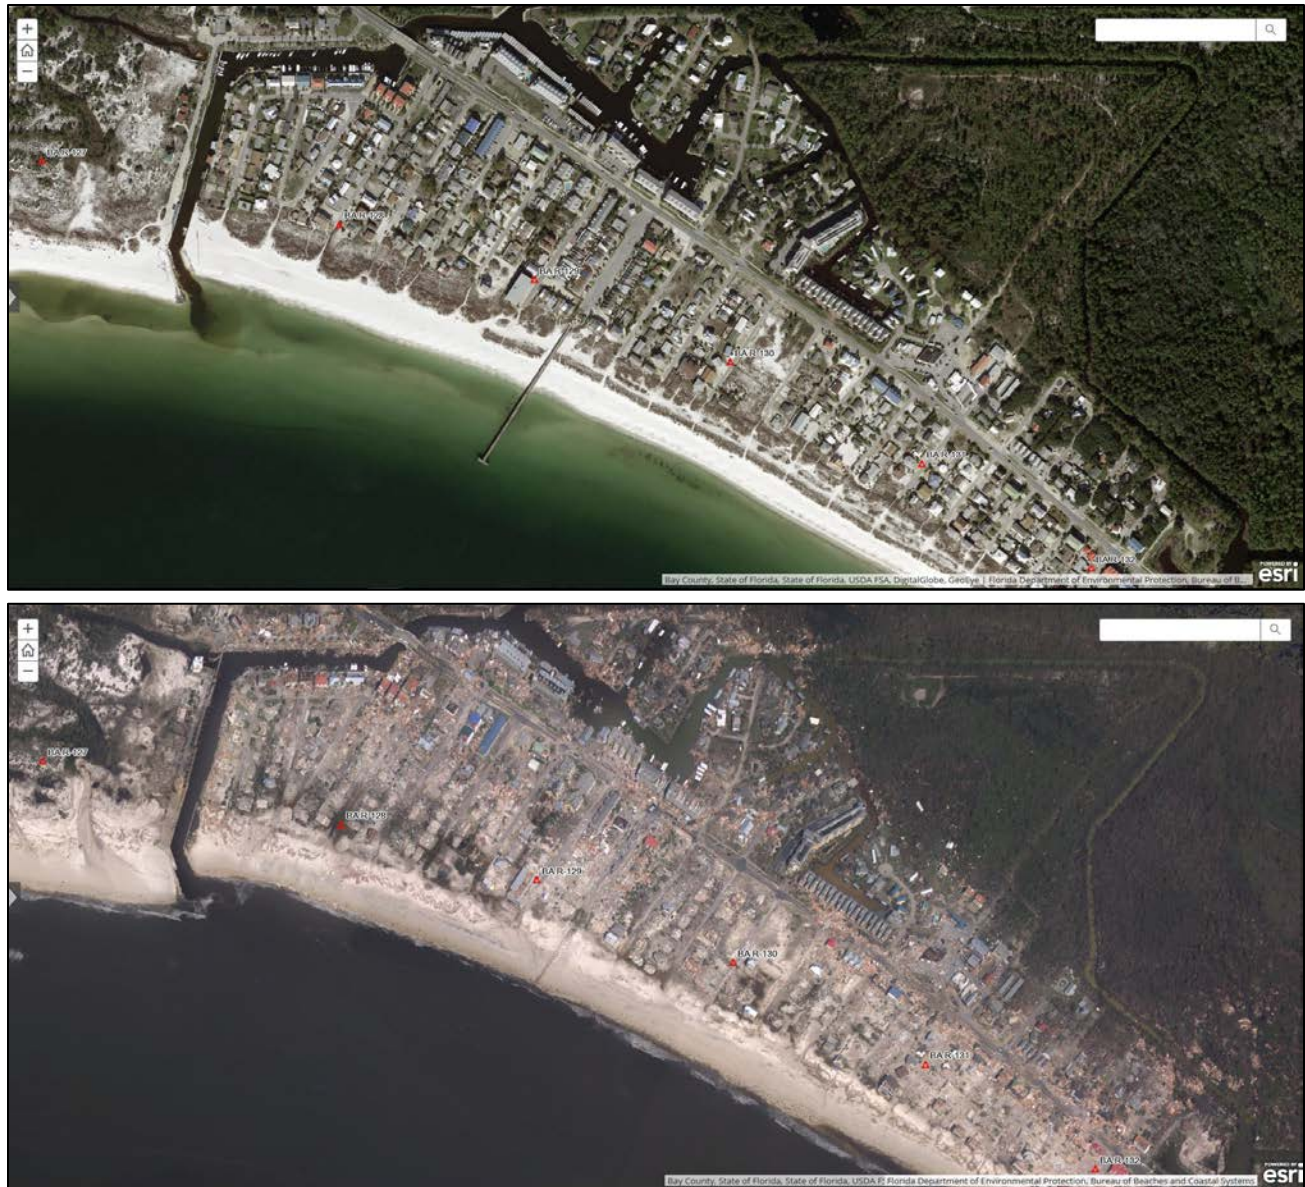
Figure 8. Aerial photo comparison of the severe damage in Mexico Beach (R127-R132). Source: Vexcel Imaging/NICB Geospatial Intelligence Center.

To the east of Crooked Island, the most severe damage from Hurricane Michael was sustained along the mainland coast of eastern Bay County at Mexico Beach (**Figure 8**). On top of the storm surge, breaking waves caused the most severe damages. Many exterior water marks to 30 feet above sea level suggest the wave setup and wave uprush resulted in the destruction of most of the development seaward of U.S. Highway 98. Hurricane Michael's extreme storm tides and the high winds greatly exceeded the hurricane-resistant coastal construction standards of the Florida Building Code. Of the 210 buildings in Mexico Beach with major damage seaward of the Coastal Construction Control Line (CCCL), 180 buildings were destroyed, or roughly 85%. In addition, landward of the CCCL to the landward limit of the Coastal Building Zone, roughly 45% of the damaged buildings were destroyed. Within the Coastal

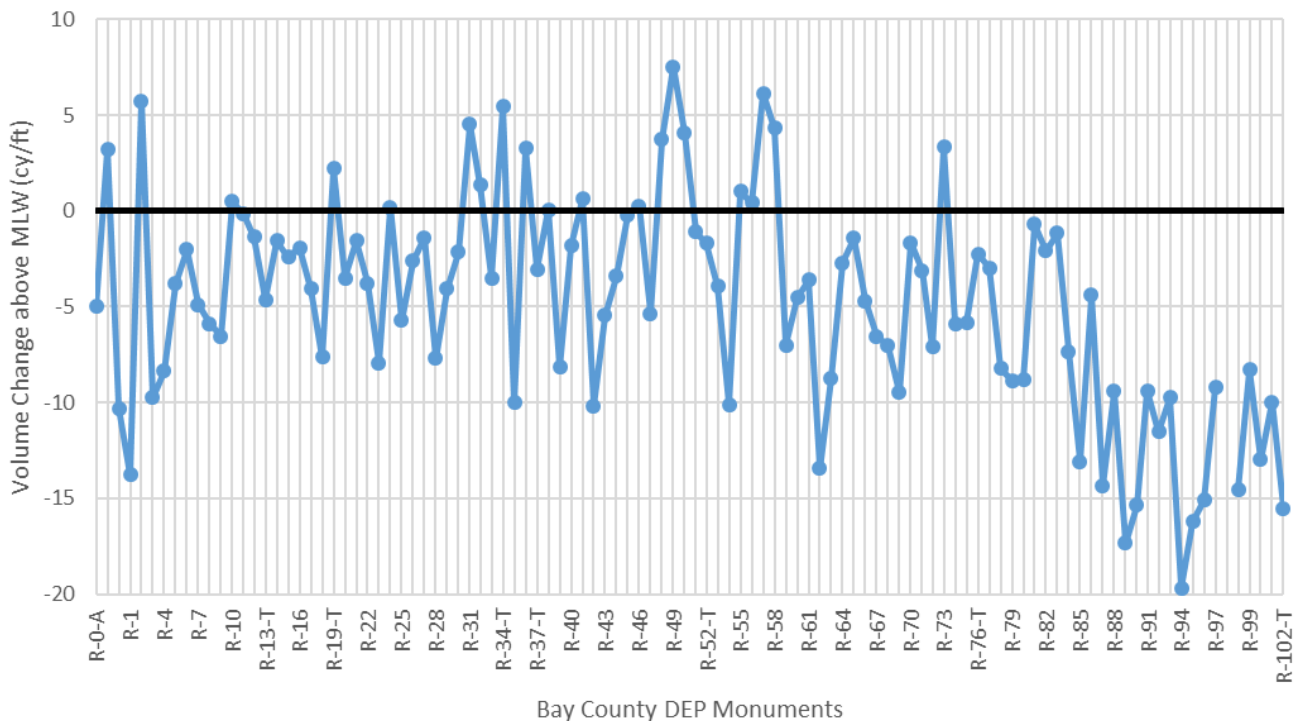
Along western Bay County, minor to major beach and dune erosion was sustained (Condition I-IV). **Figure 10** shows the net erosion plotted across western Bay County west of Tyndall Air Force Base, including St. Andrews State Park (R92-R102) where major beach and dune erosion was sustained. Along the federal shore protection project (R0-R92), which was subject to storm tides of five to six feet, a total erosion volume of approximately -787,000 cubic yards above mean low water (MLW) was calculated. Much of the eroded volume remained above MLW in the form of overwash across the beach berm, and therefore a net erosion volume of approximately -369,000 cubic yards was calculated.

Figure 10. Net erosion along western Bay County (R0-R102) above Mean Low Water (MLW).

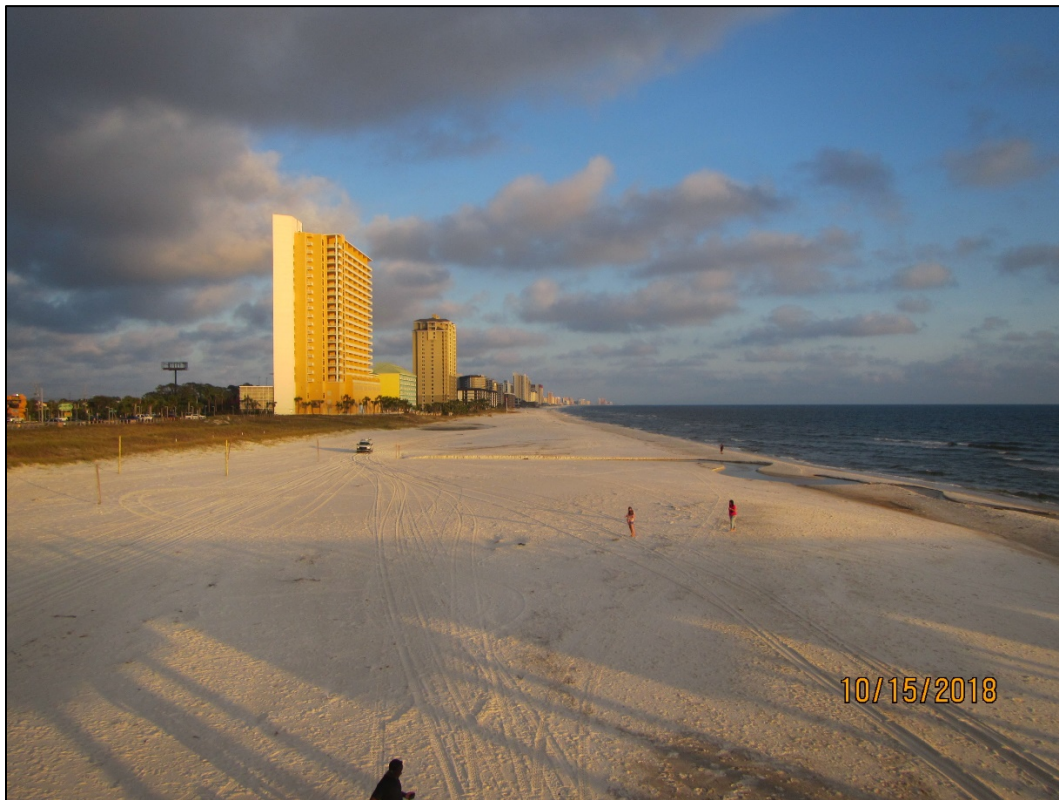
Figure 11. Beach erosion near R57, east of the M.B. Miller Pier, Panama City Beach.

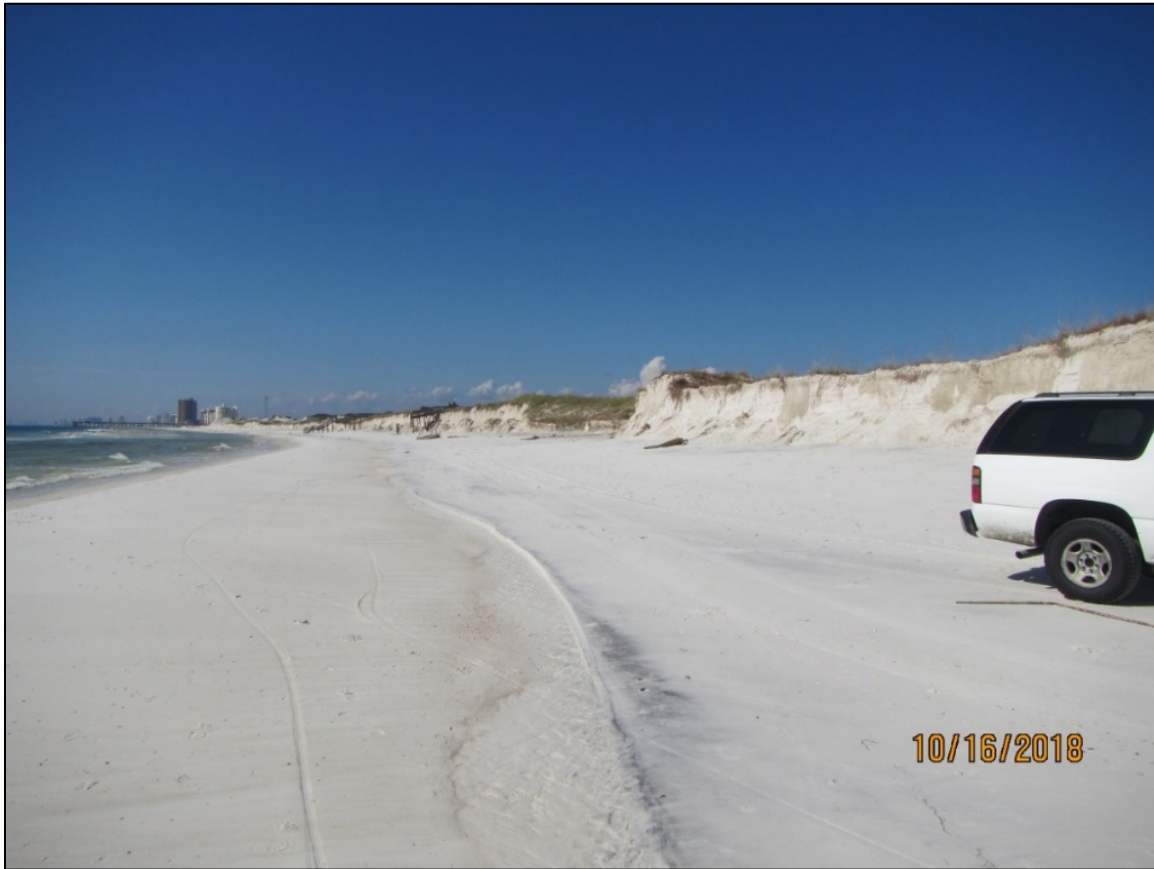
Figure 12. Major beach and dune erosion near R97, St. Andrews State Park.

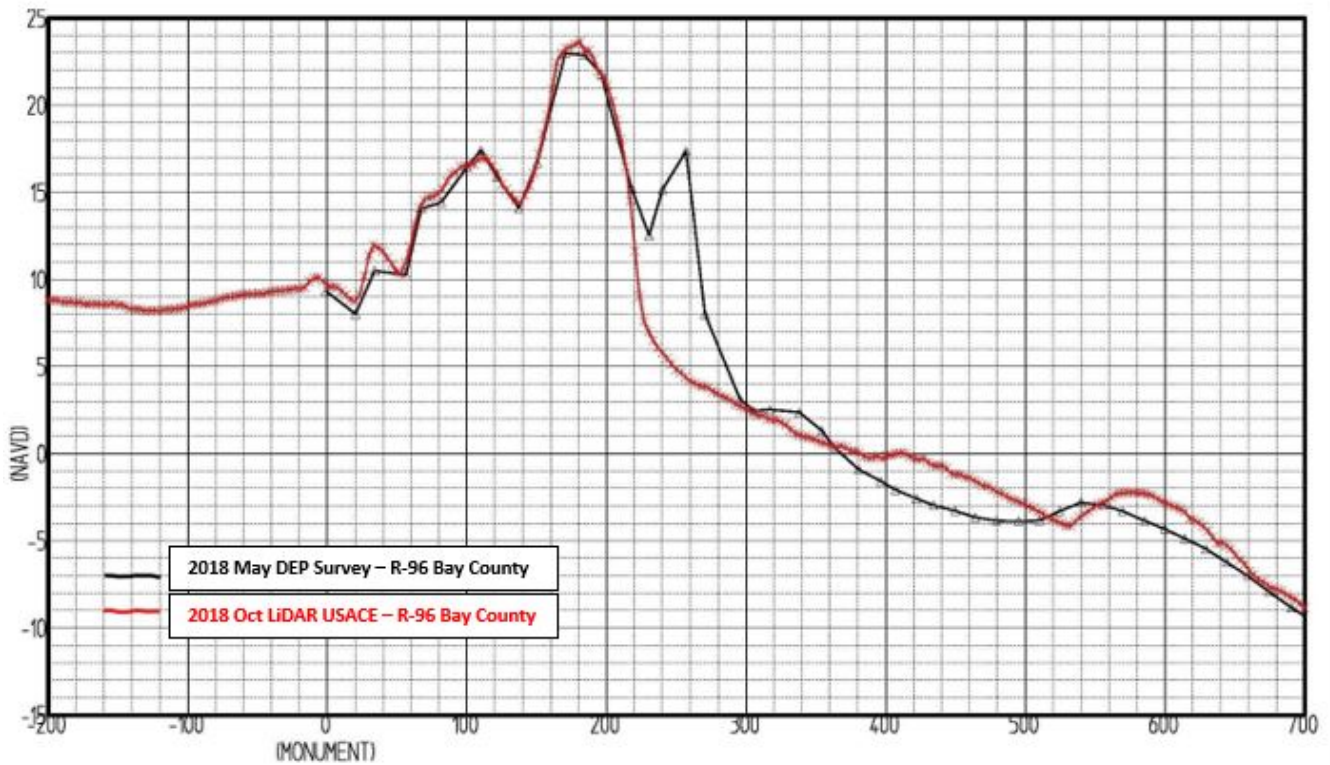
Figure 13. Pre-storm and post-storm profile comparison of major dune erosion in St. Andrews State Park, R96.

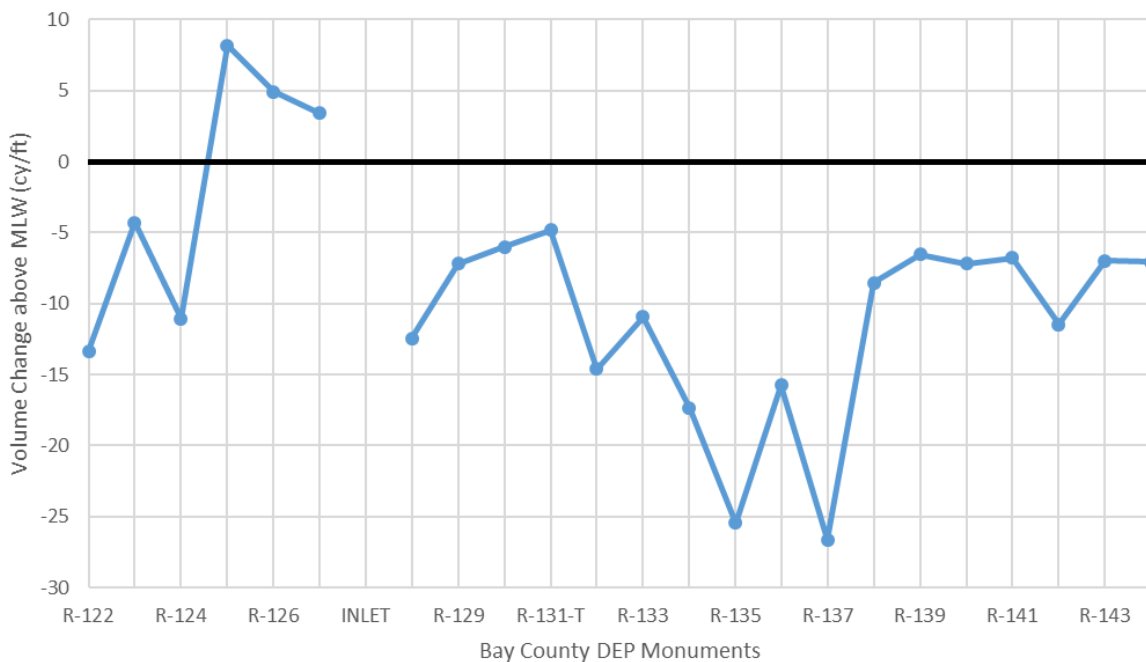
Figure 14. Net erosion along Mexico Beach, eastern Bay County (R122-R144) above MLW.

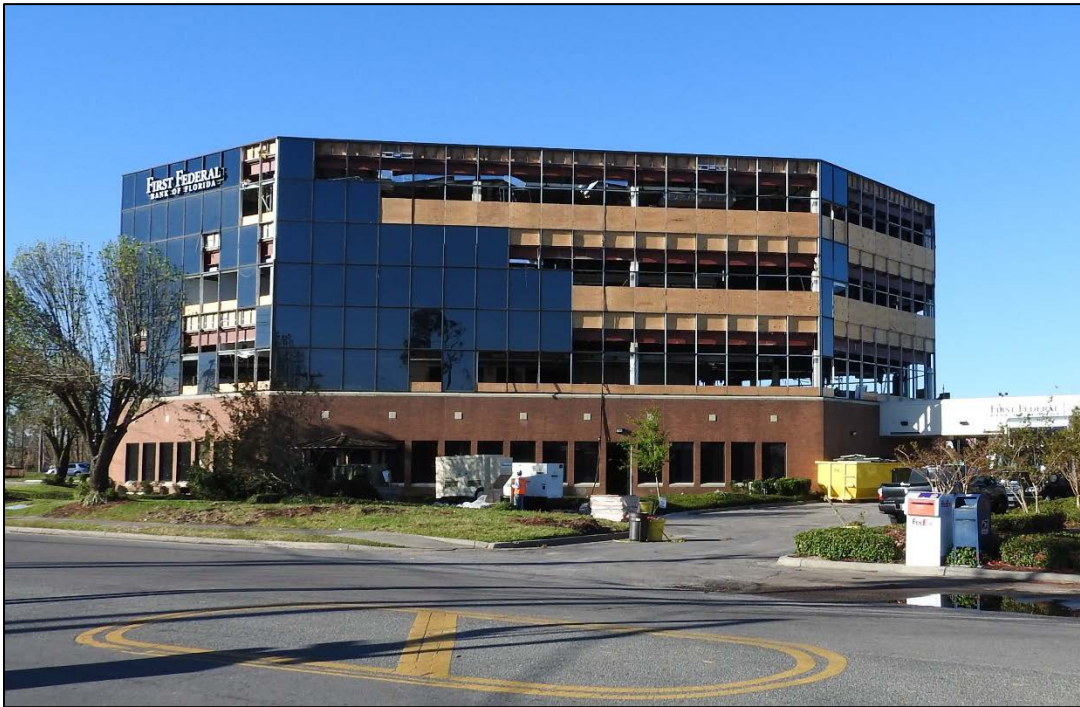
Figure 15. Bank with severe wind damage on 23rd Street, Panama City.

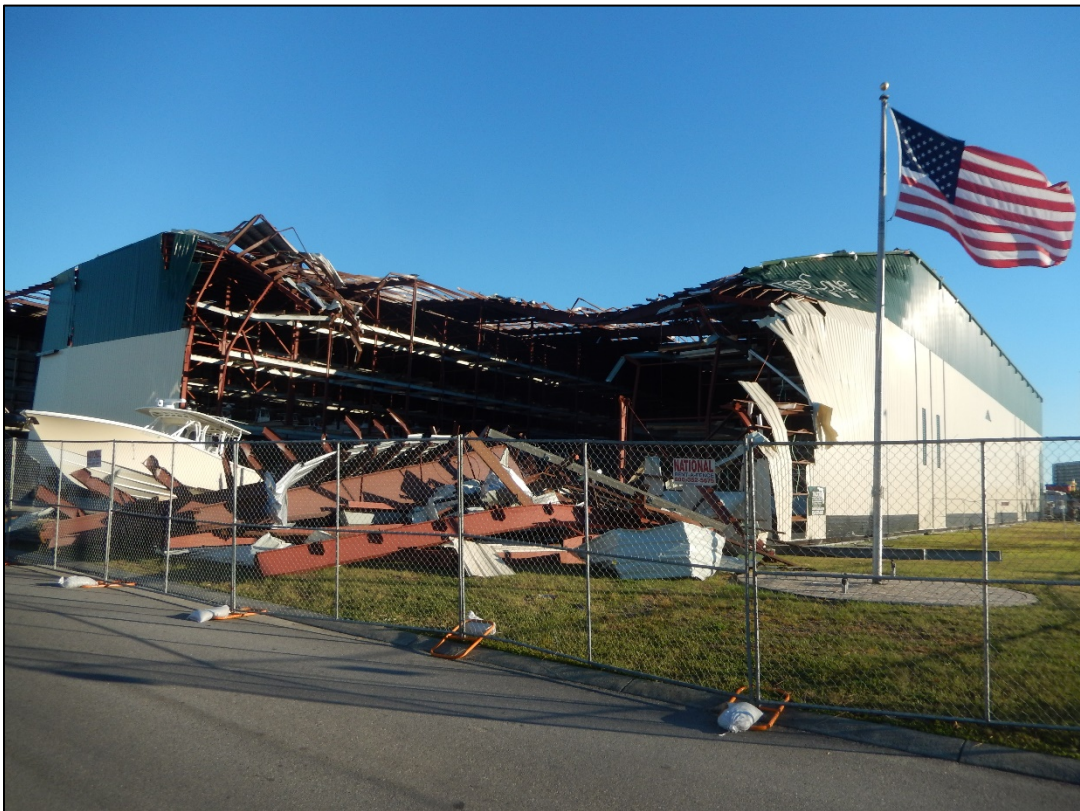
Figure 16. Dry storage marina with wind damage on Thomas Drive, Panama City Beach.

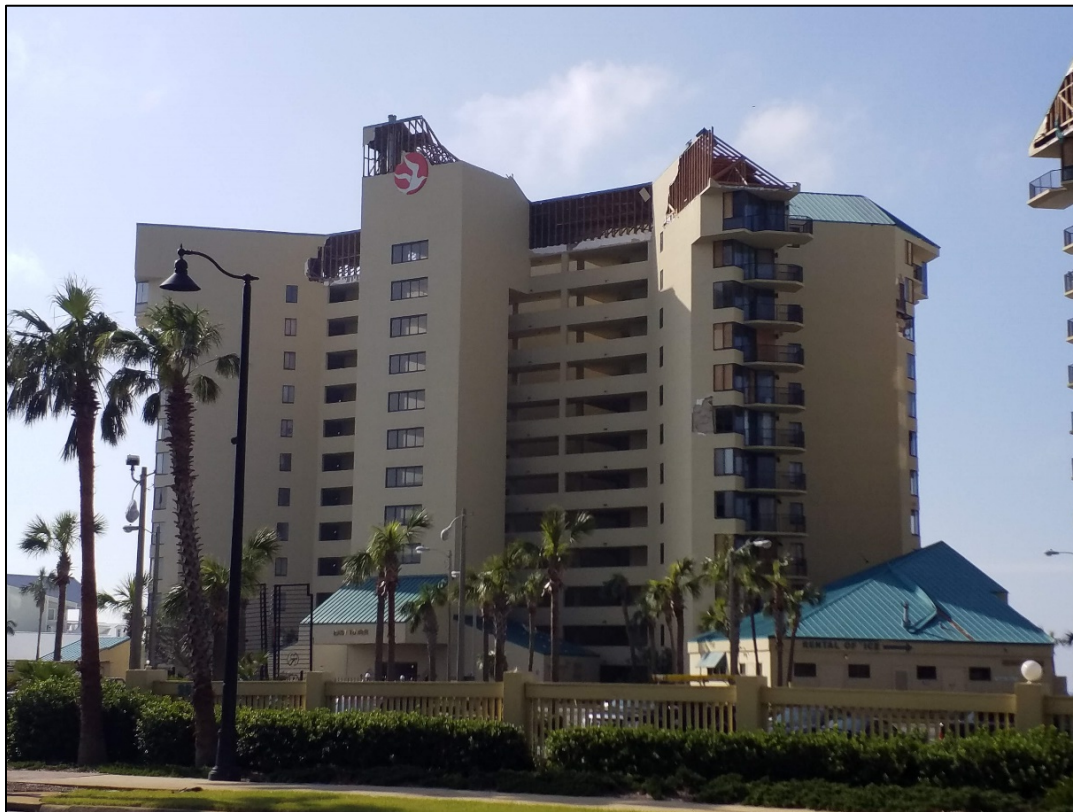
Figure 17. Wind damages on the Sunbird Condominiums near R67, Panama City Beach.

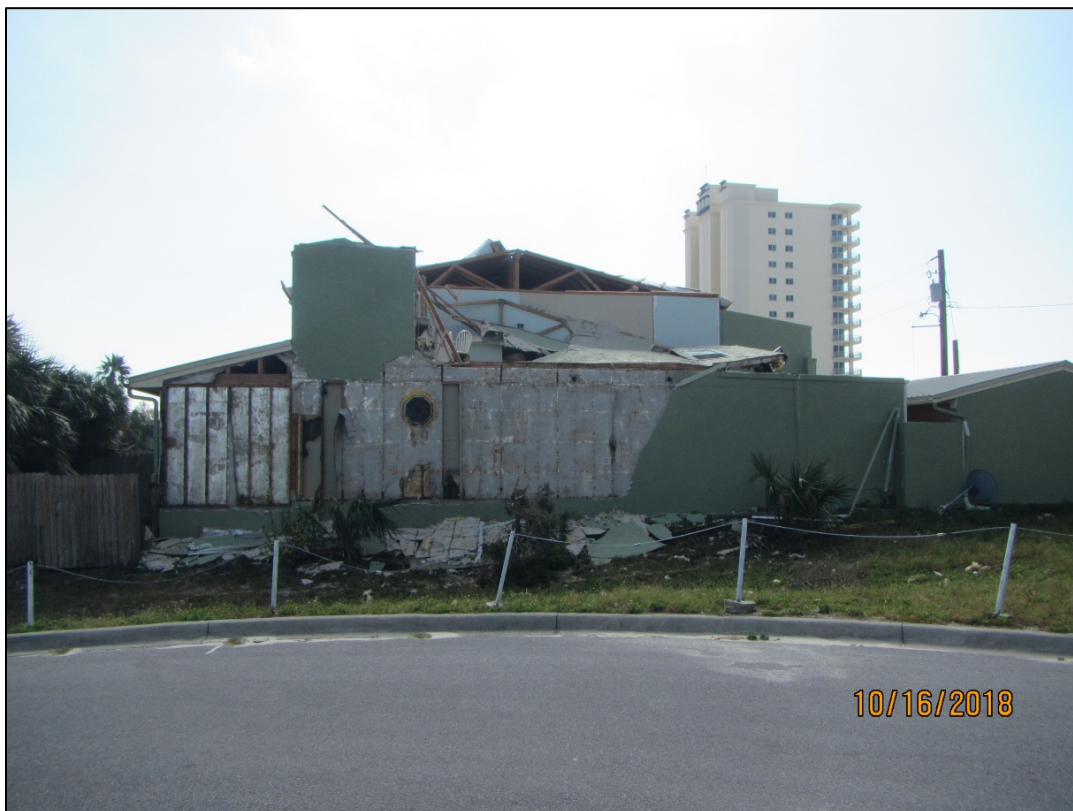
Figure 18. Wind damages on a multifamily dwelling near R73, Panama City Beach.

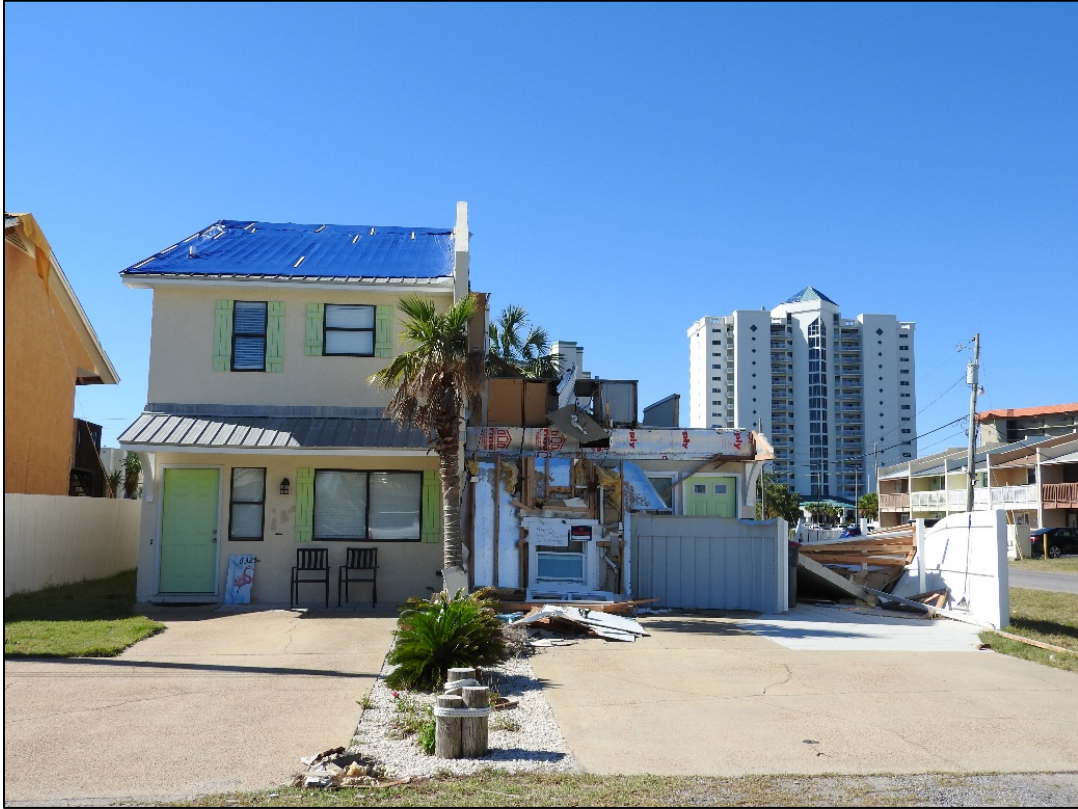
Figure 19. Roof damage and destroyed dwelling near R82, Panama City Beach.

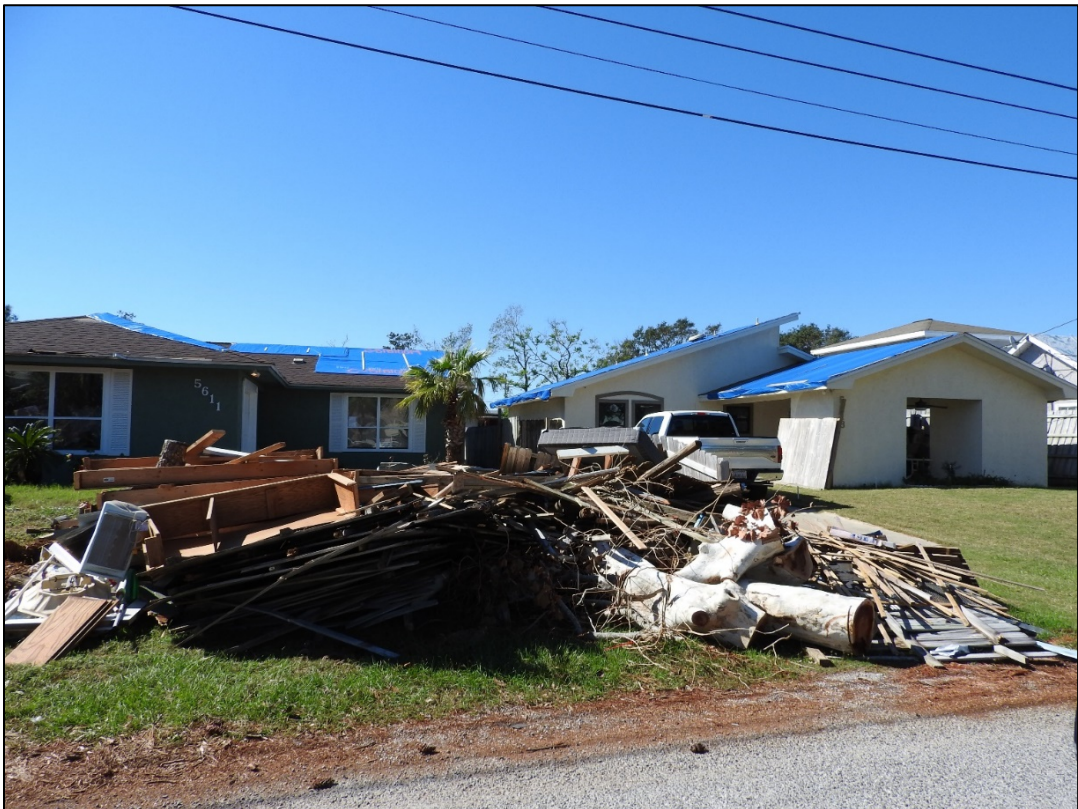
Figure 20. Roof damage on a single-family dwelling near R86, Panama City Beach.

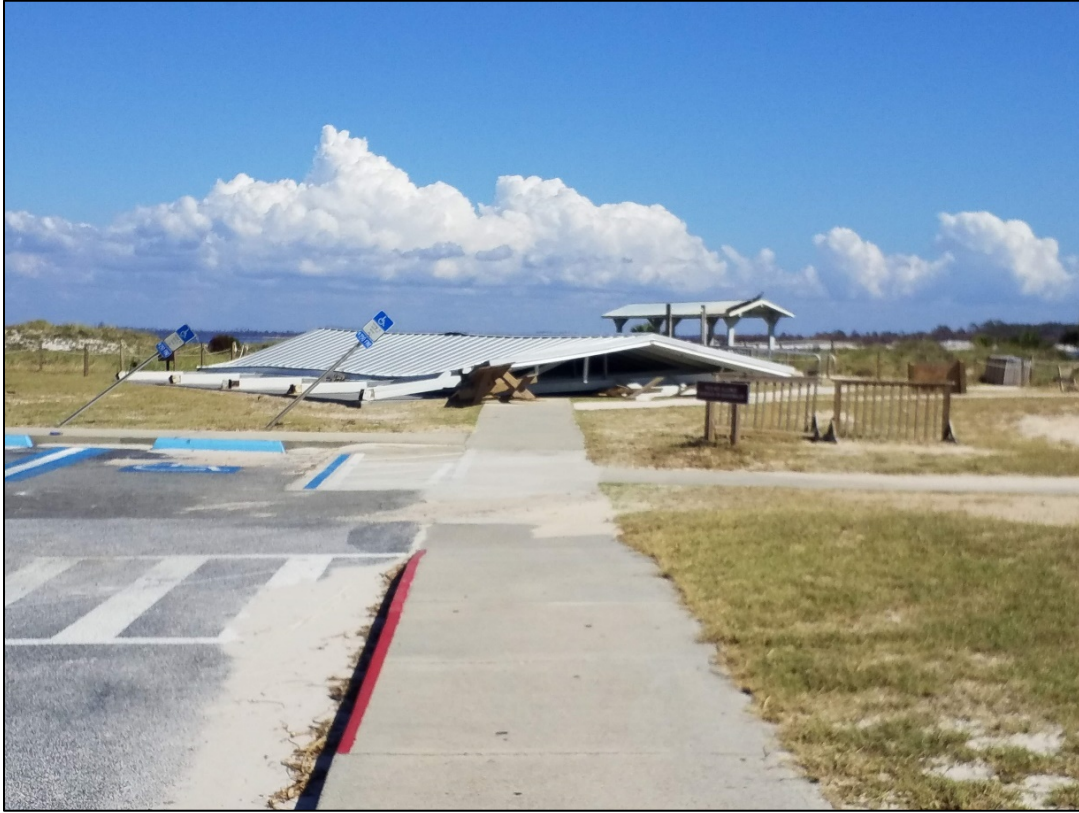
Figure 21. Collapsed pavilion near R97, St. Andrews State Park.

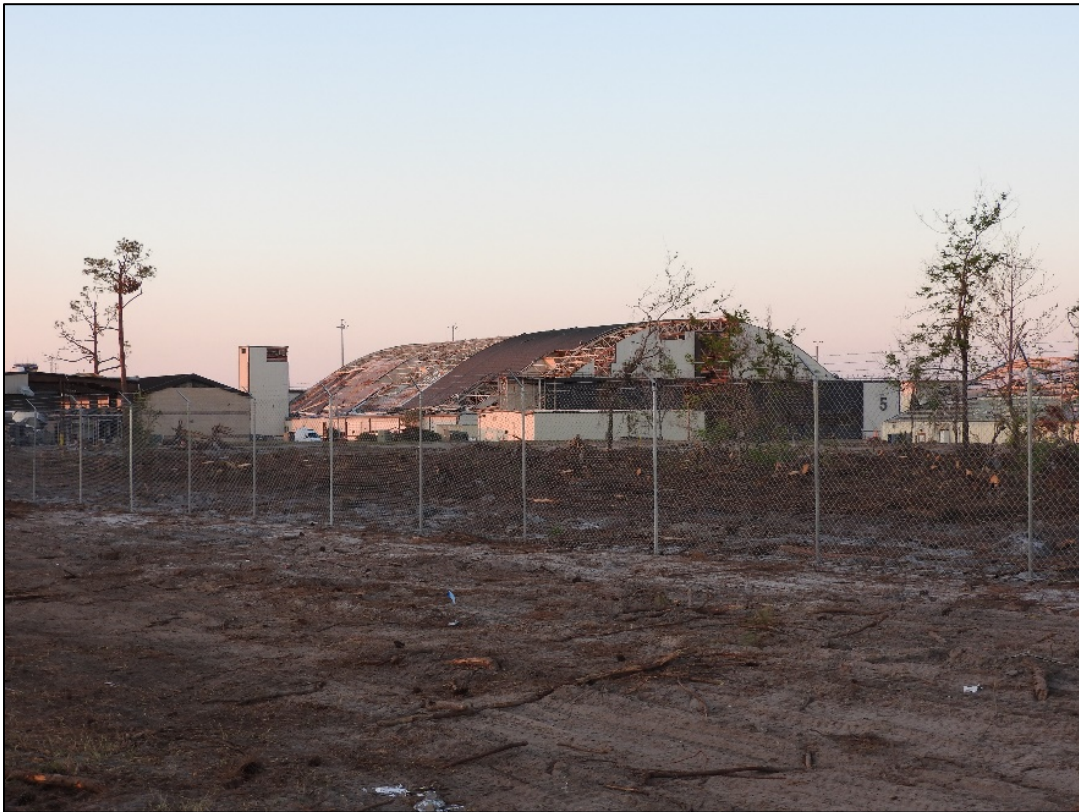
Figure 22. Tyndall Air Force Base, aircraft hangar damage.

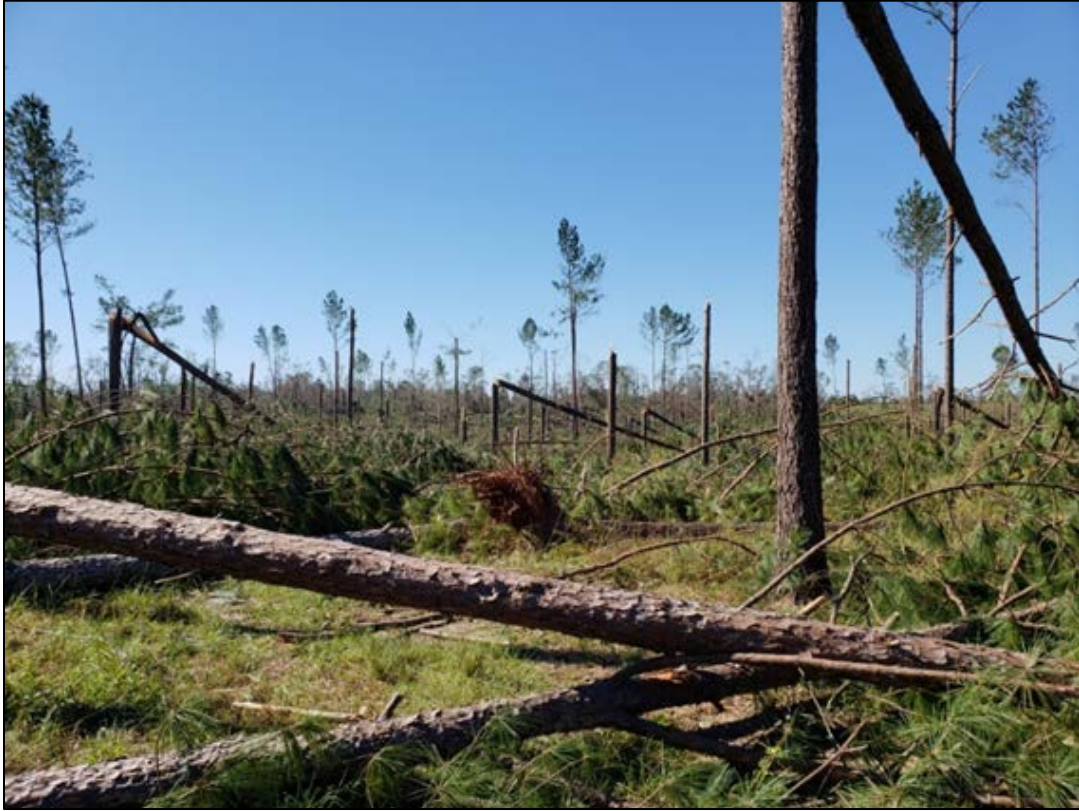
Figure 23. Bay County, pine forest leveled.

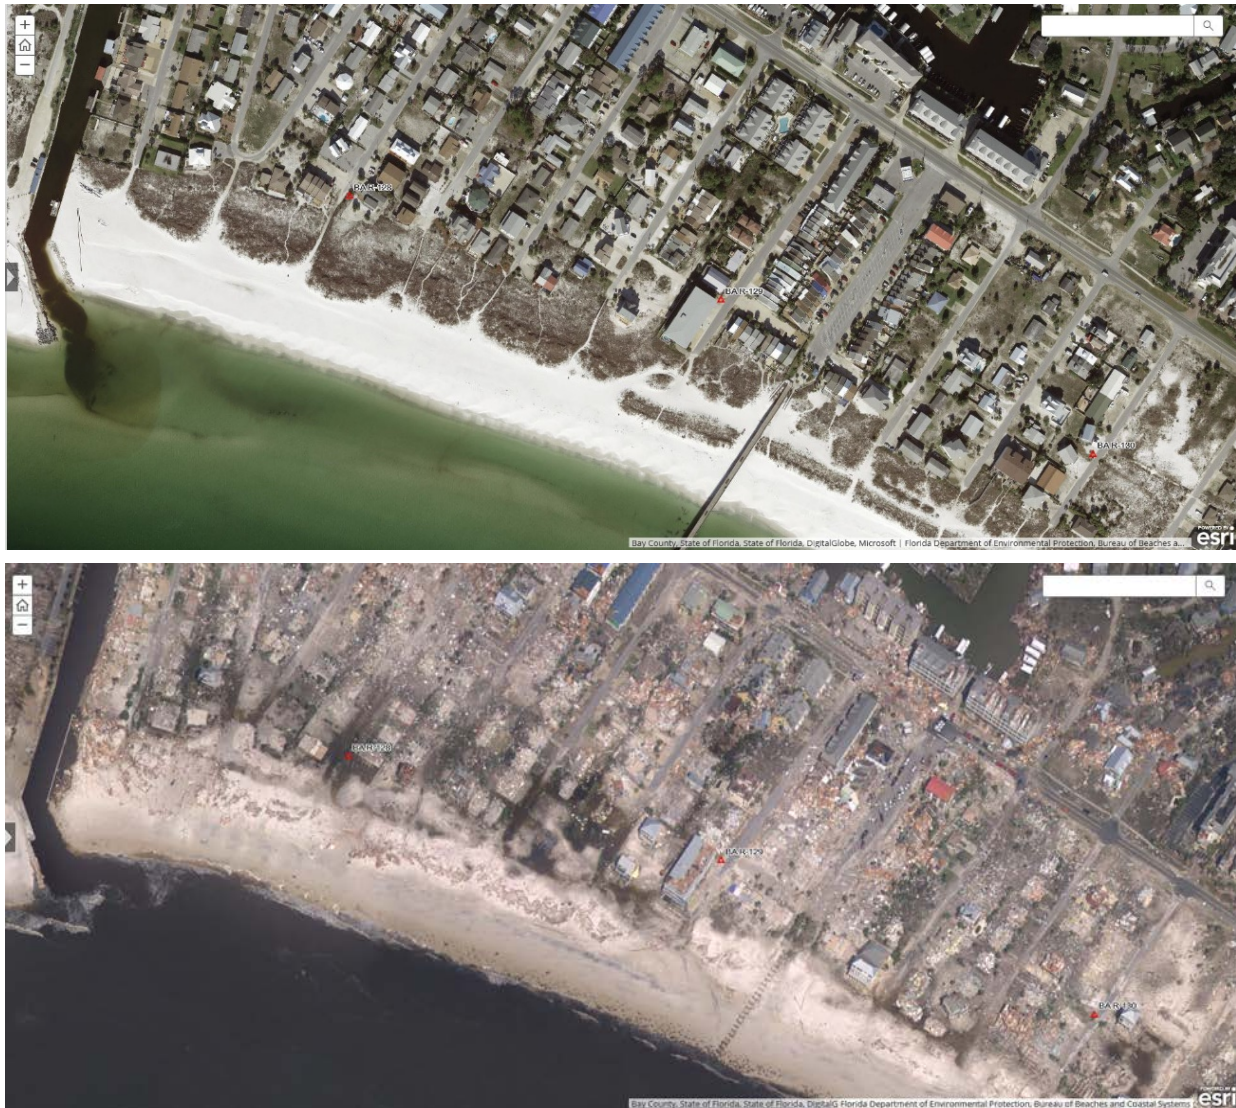
Figure 25. Aerial photo comparison of severe damage in Mexico Beach (R127.5-R130). Source: Vexcel Imaging/ NICB Geospatial Intelligence Center.

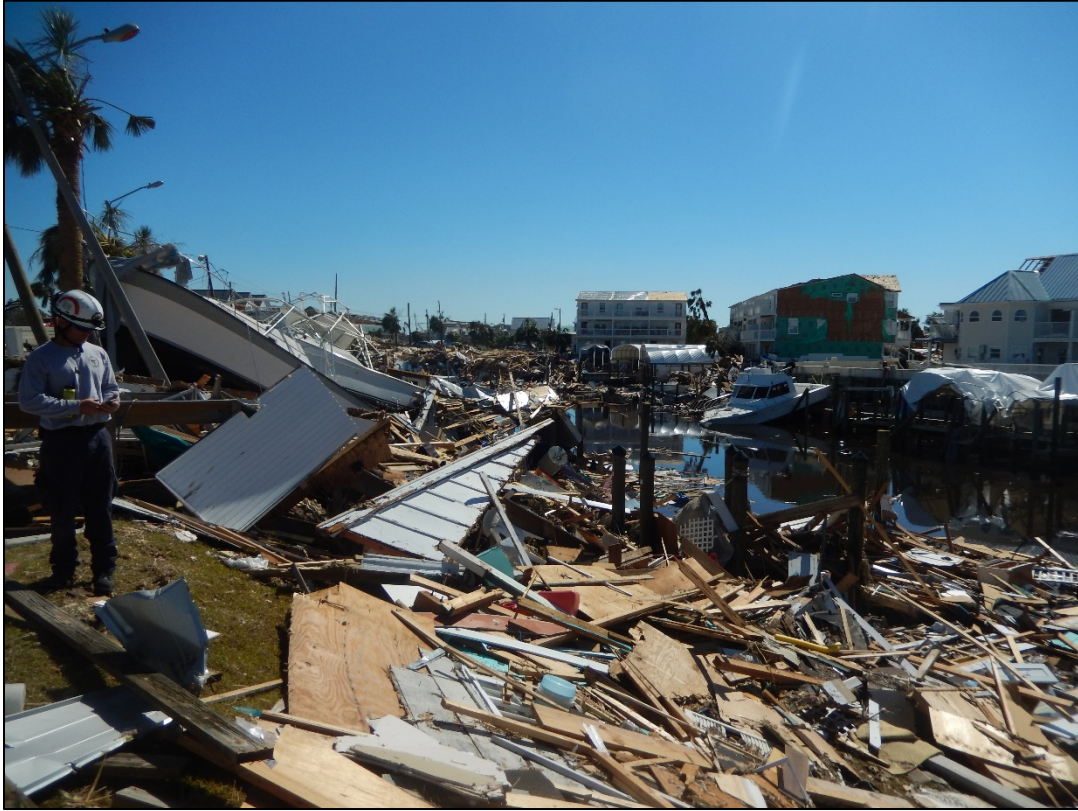
Figure 26. Debris and damages at Mexico Beach Canal, R127.5.

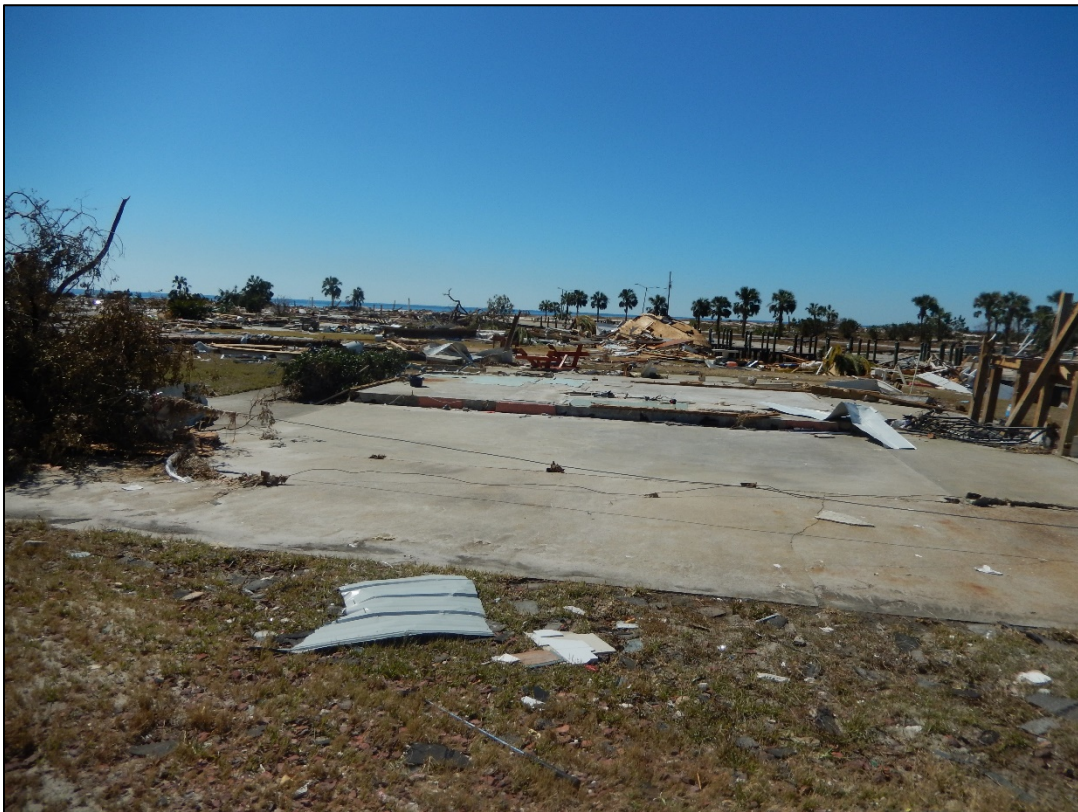
Figure 27. Rows of beach houses destroyed and removed by the storm surge, R127.5, Mexico Beach.

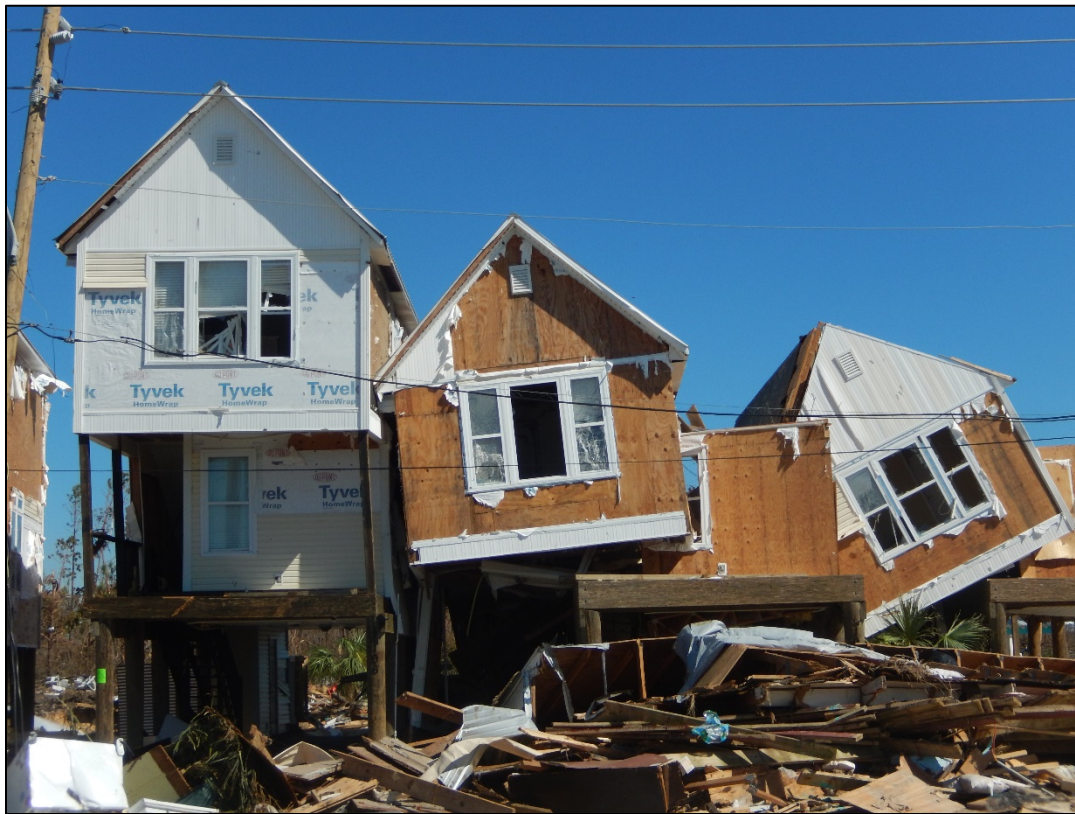
Figure 28. Beach dwellings north of U.S. 98 lifted off their foundations, R128, Mexico Beach.

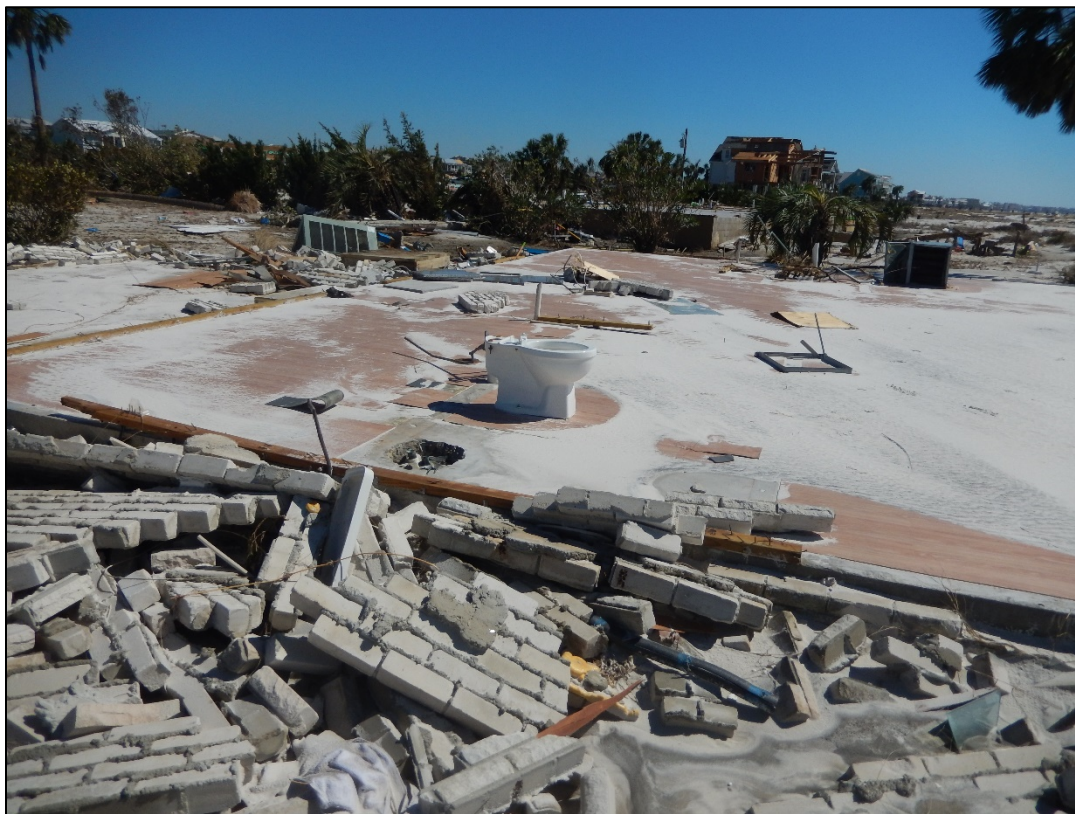
Figure 29. Remains of typical beach house destroyed near R128, Mexico Beach.

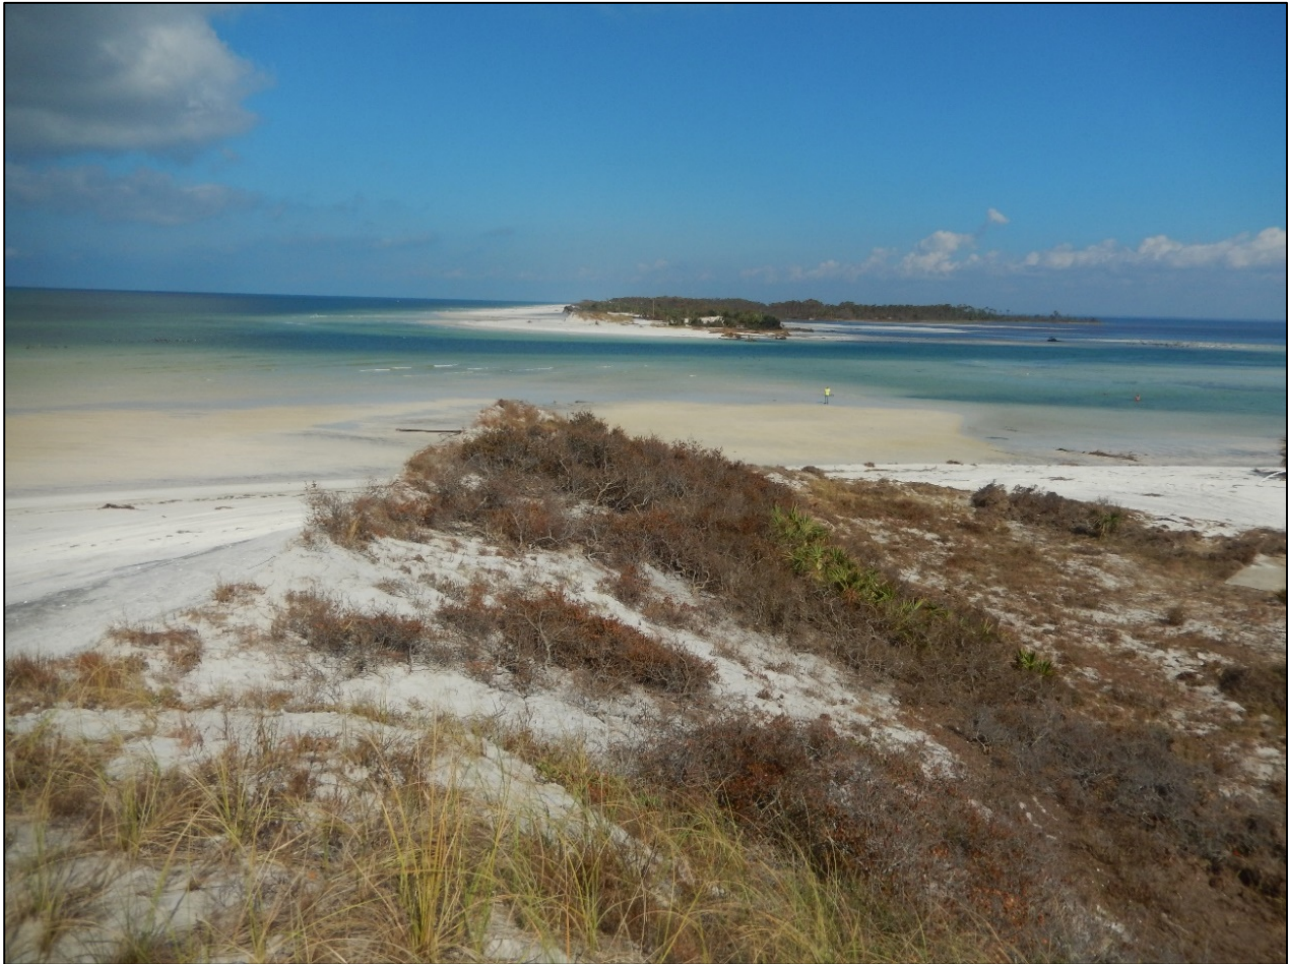
Hurricane Michael's greatest geomorphological impact to the Gulf County coast was a barrier breach near the midpoint of St. Joseph Peninsula. This breakthrough of the barrier peninsula occurred generally between R71 and R72, at a place called Eagle Harbor just north of the marina within T.H. Stone Memorial St. Joseph Peninsula State Park (**Figures 45-46**). To the north of the breach, northern St. Joseph Peninsula, now an island extending between R32 and R71, sustained a net loss of approximately one million cubic yards of beach and dune sand above MLW.

Figure 45. Breach across St. Joseph Peninsula between R71 and R72.

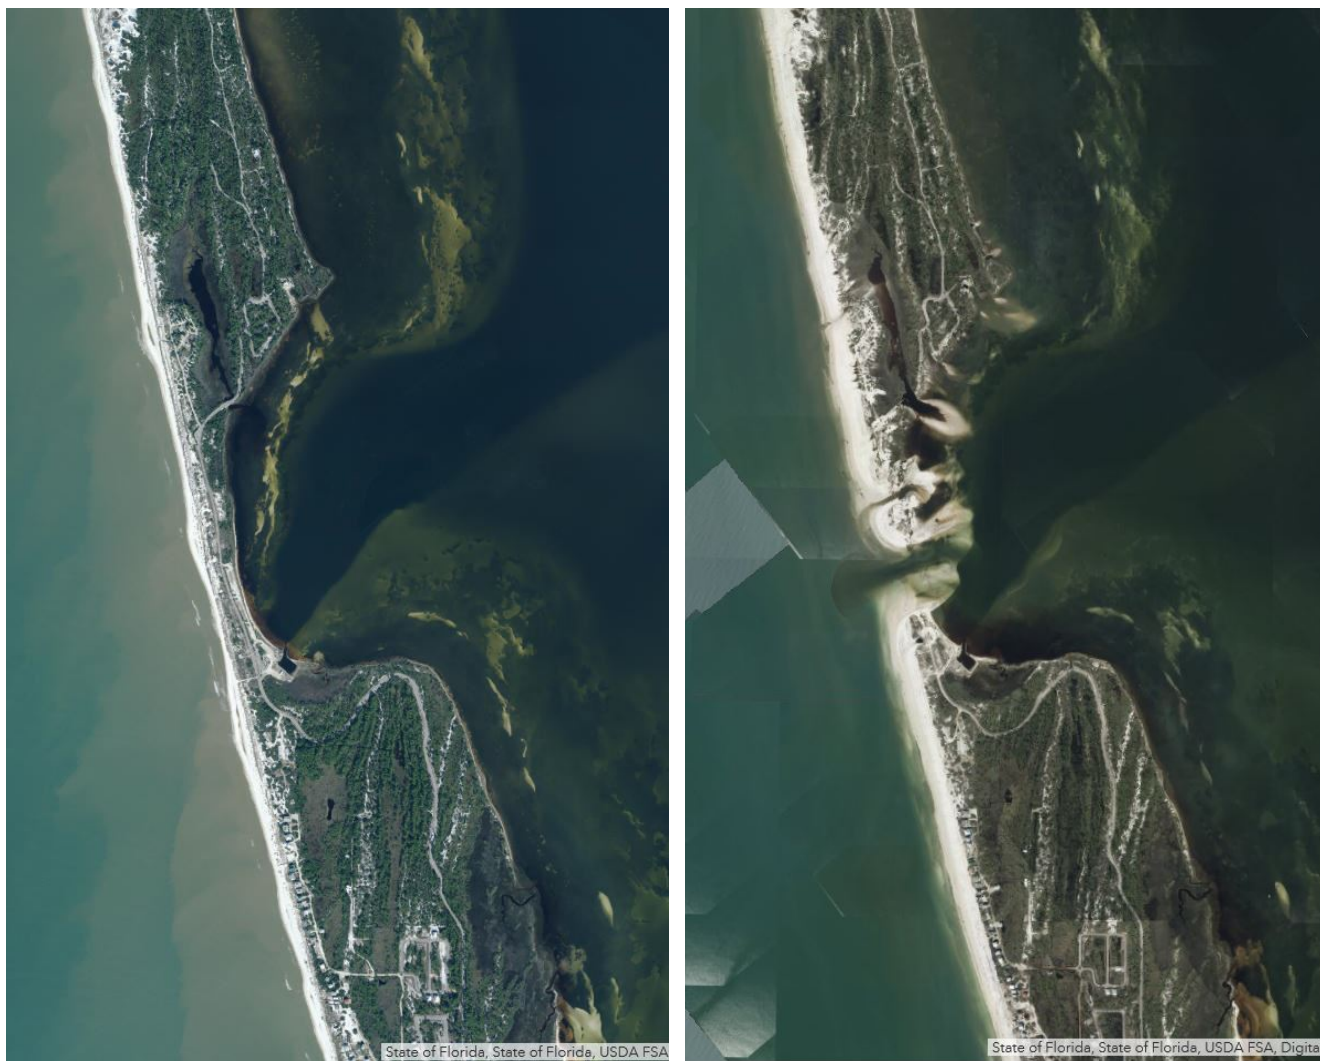
Figure 46. Before and after aerial photos of breach across St. Joseph Peninsula between R71 and R72 (Source: Vexcel Imaging/ NICB Geospatial Intelligence Center).
