*Hurricane Michael Post-Storm
Beach Conditions and Coastal Impact Report*

**Division of Water Resource Management
Florida Department of Environmental Protection**

January 2019

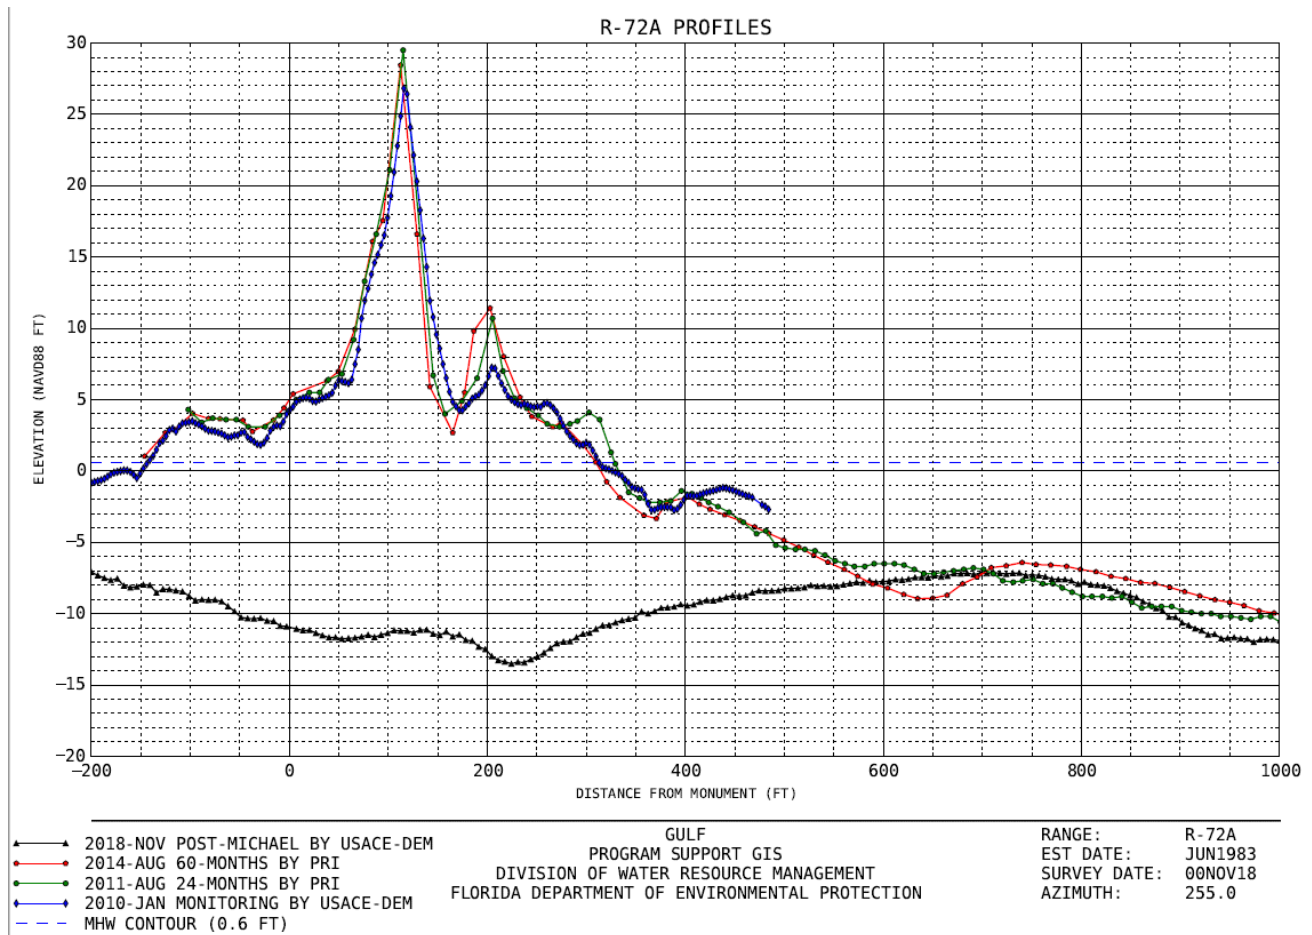
Figure 47. Pre-storm and post-storm profile comparison at the site of the breach across St. Joseph Peninsula.

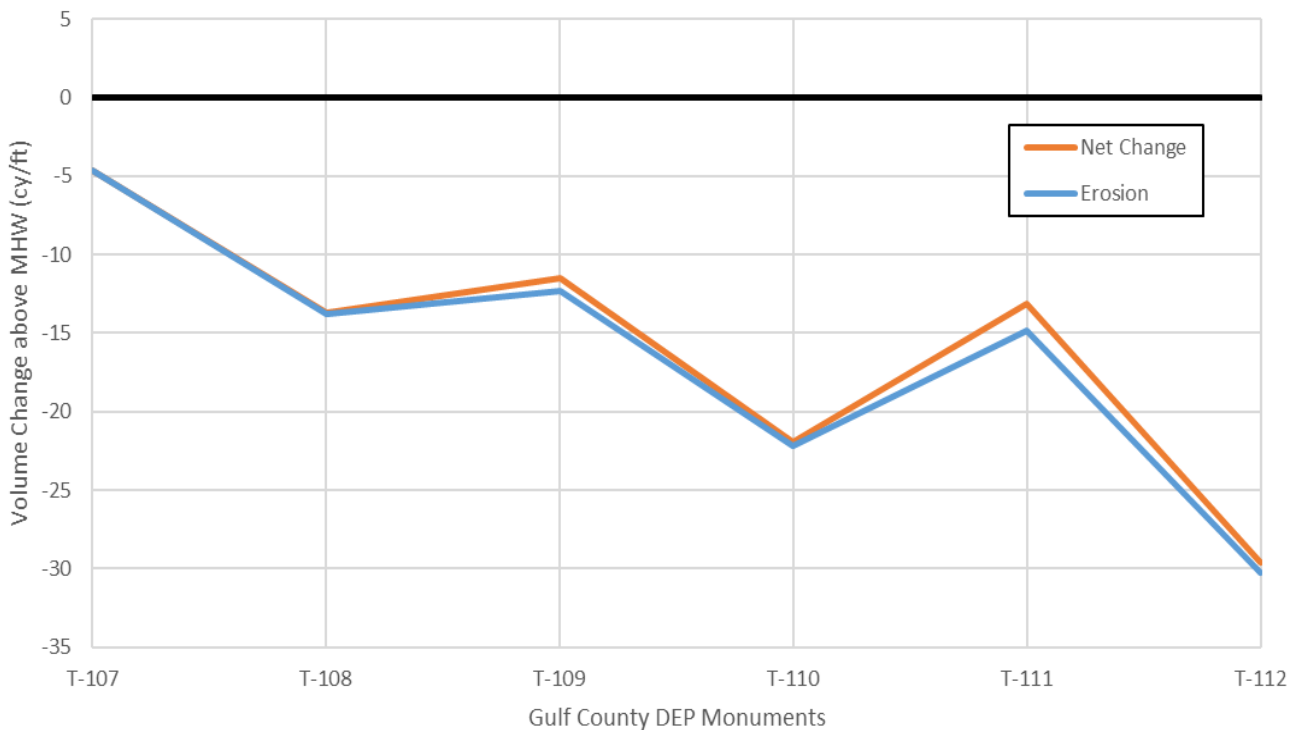
Figure 49. Total and net volume change along the western shoreline of Cape San Blas above MLW.

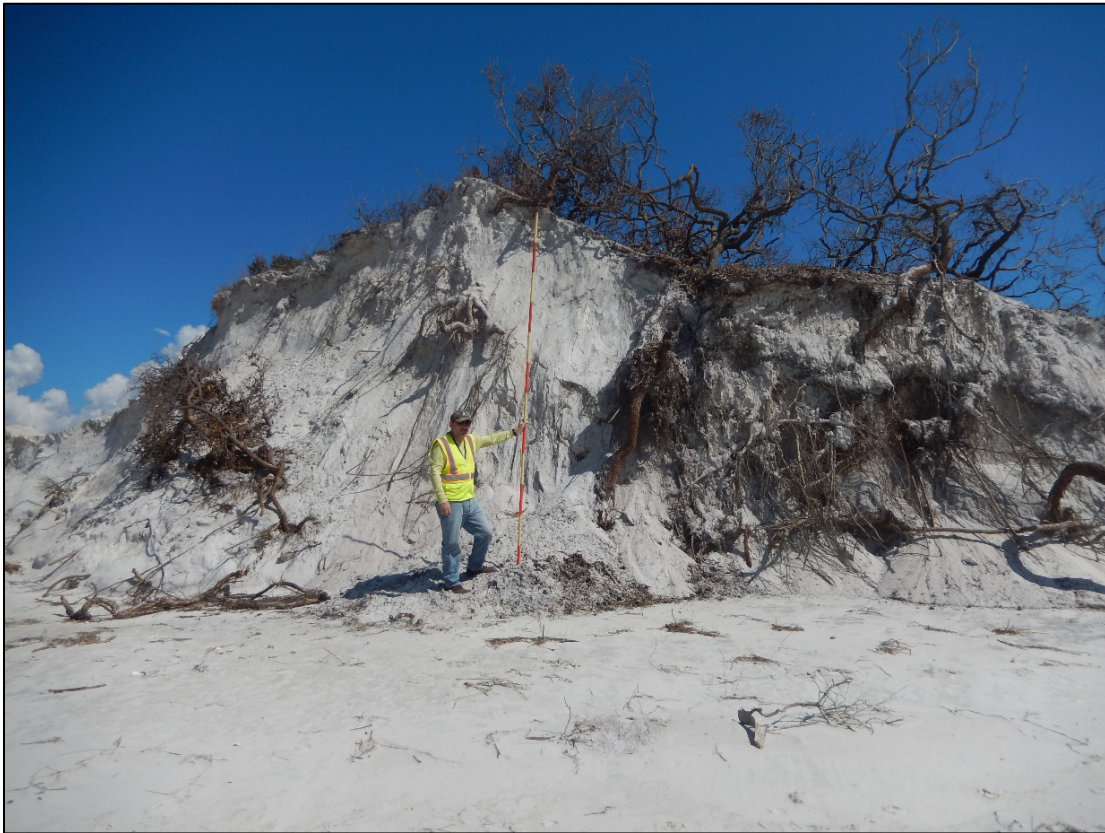
Major dune erosion at R74 within the state park is shown in **Figure 50**. Also, major dune erosion is seen looking south from R77 along the developed segment of St. Joseph Peninsula in **Figure 51**.

Figure 50. Major dune erosion (12-foot escarpment) near R74, St. Joseph Peninsula.

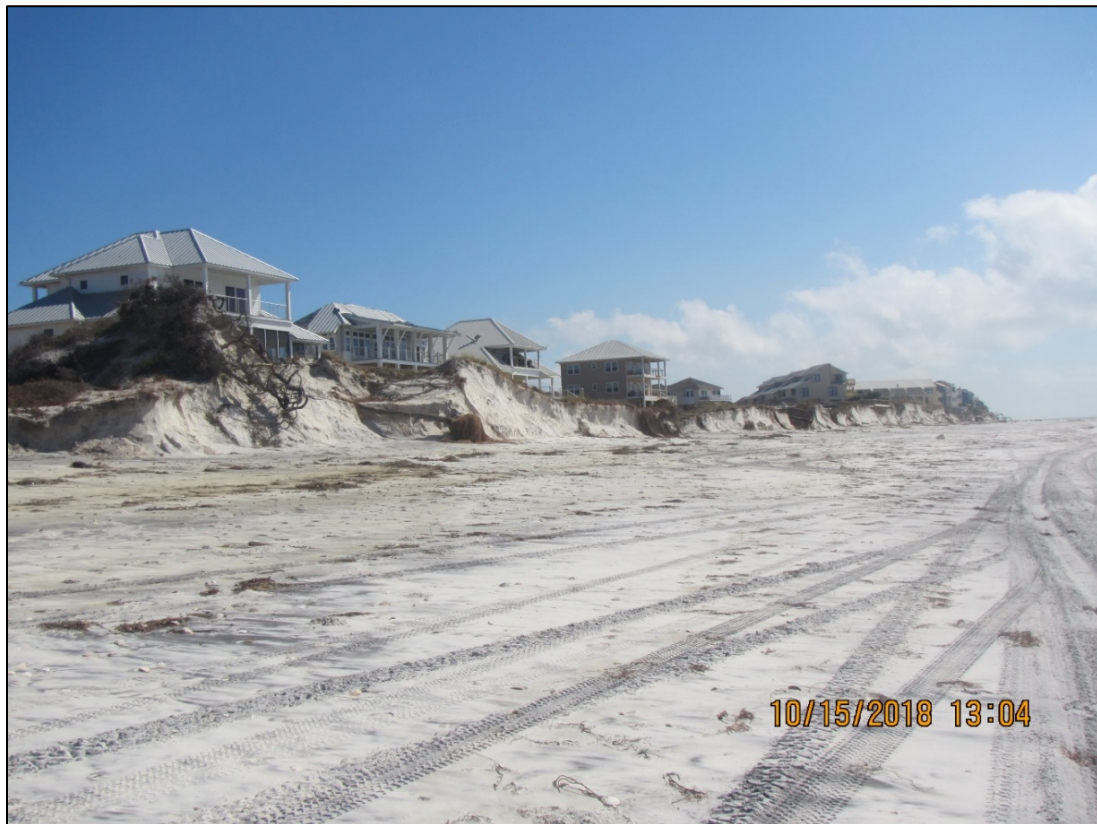
Figure 51. Major dune erosion, R77, St. Joseph Peninsula.

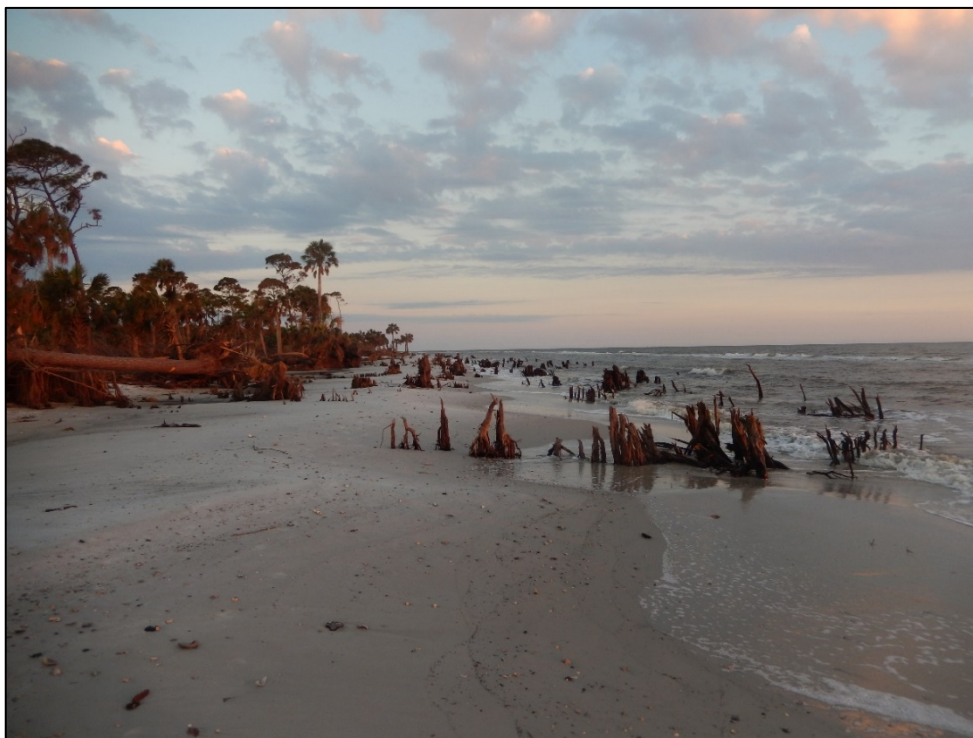
South of St. Joseph Peninsula, the west shore of Cape San Blas has a historic background erosion rate of -40 feet per year of shoreline recession. **Figure 52** shows the severe erosion conditions following Hurricane Michael near R110 at the site of the historic Cape San Blas Lighthouse, which was relocated to Port St. Joe in 2014. Another major geomorphological change to the Gulf County coast caused by Hurricane Michael was observed through the loss of approximately 660 feet off the southern tip of Cape San Blas (**Figure 53**).

Figure 52. Severe beach and dune erosion at Cape San Blas, R110.

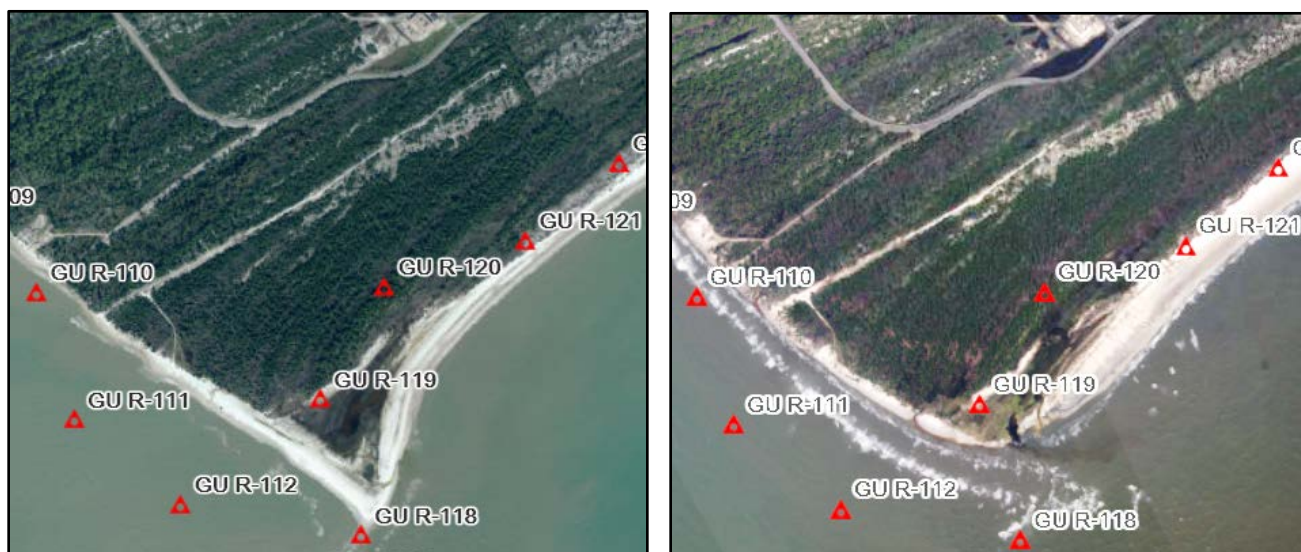
Figure 53. Before and after aerial photos of Cape San Blas showing the loss of 660 feet off the cape at R118. (Source: Vexcel Imaging/NICB Geospatial Intelligence Center)

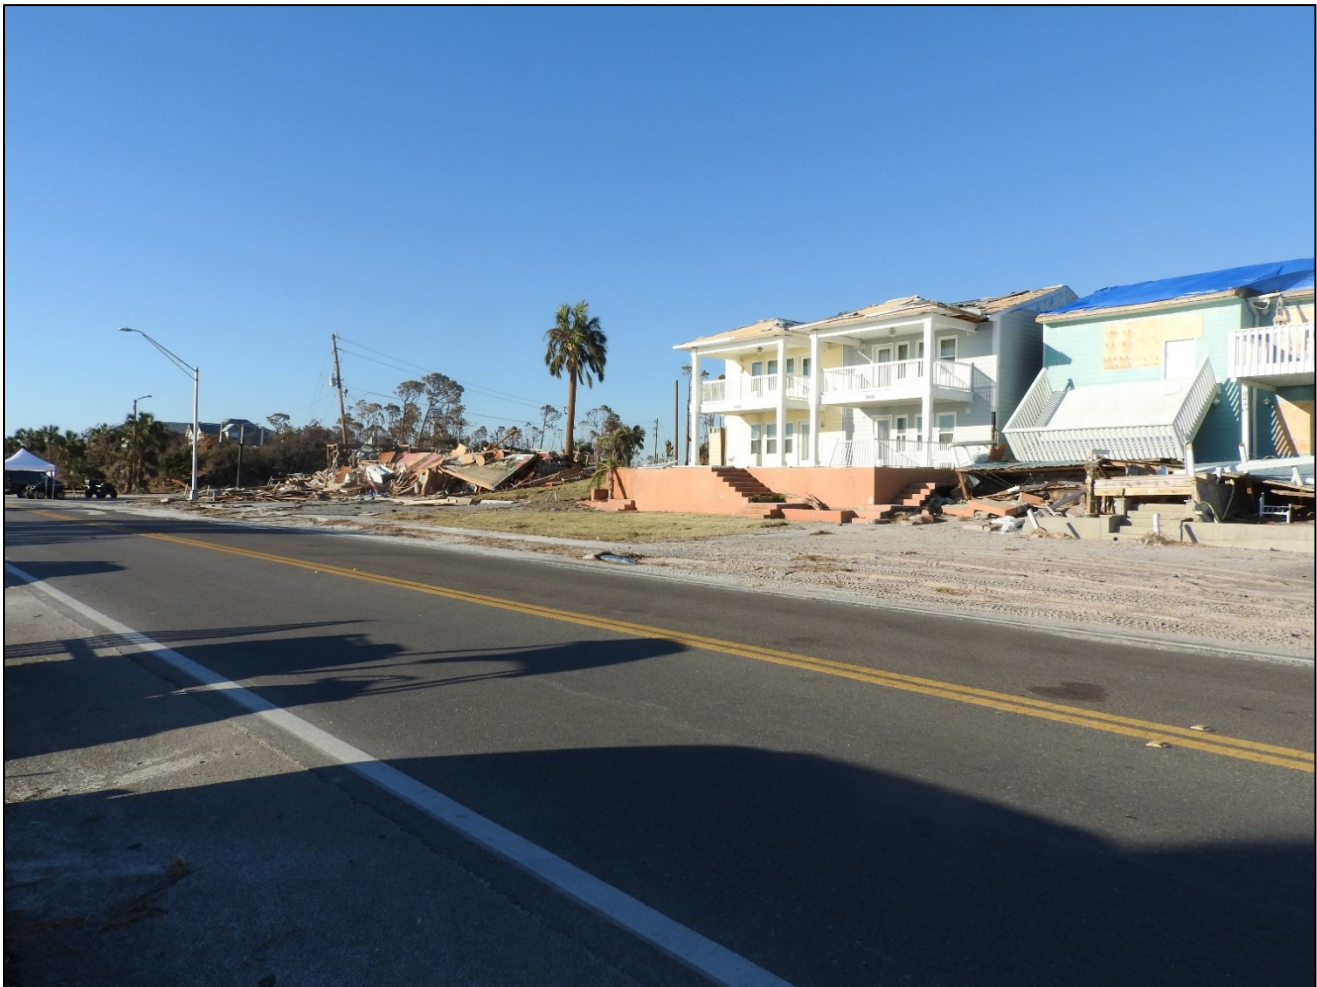
Figure 54. Site of high water mark of +21.2 feet NAVD along U.S. 98 and S.R. 386 near R1, Beacon Hill.

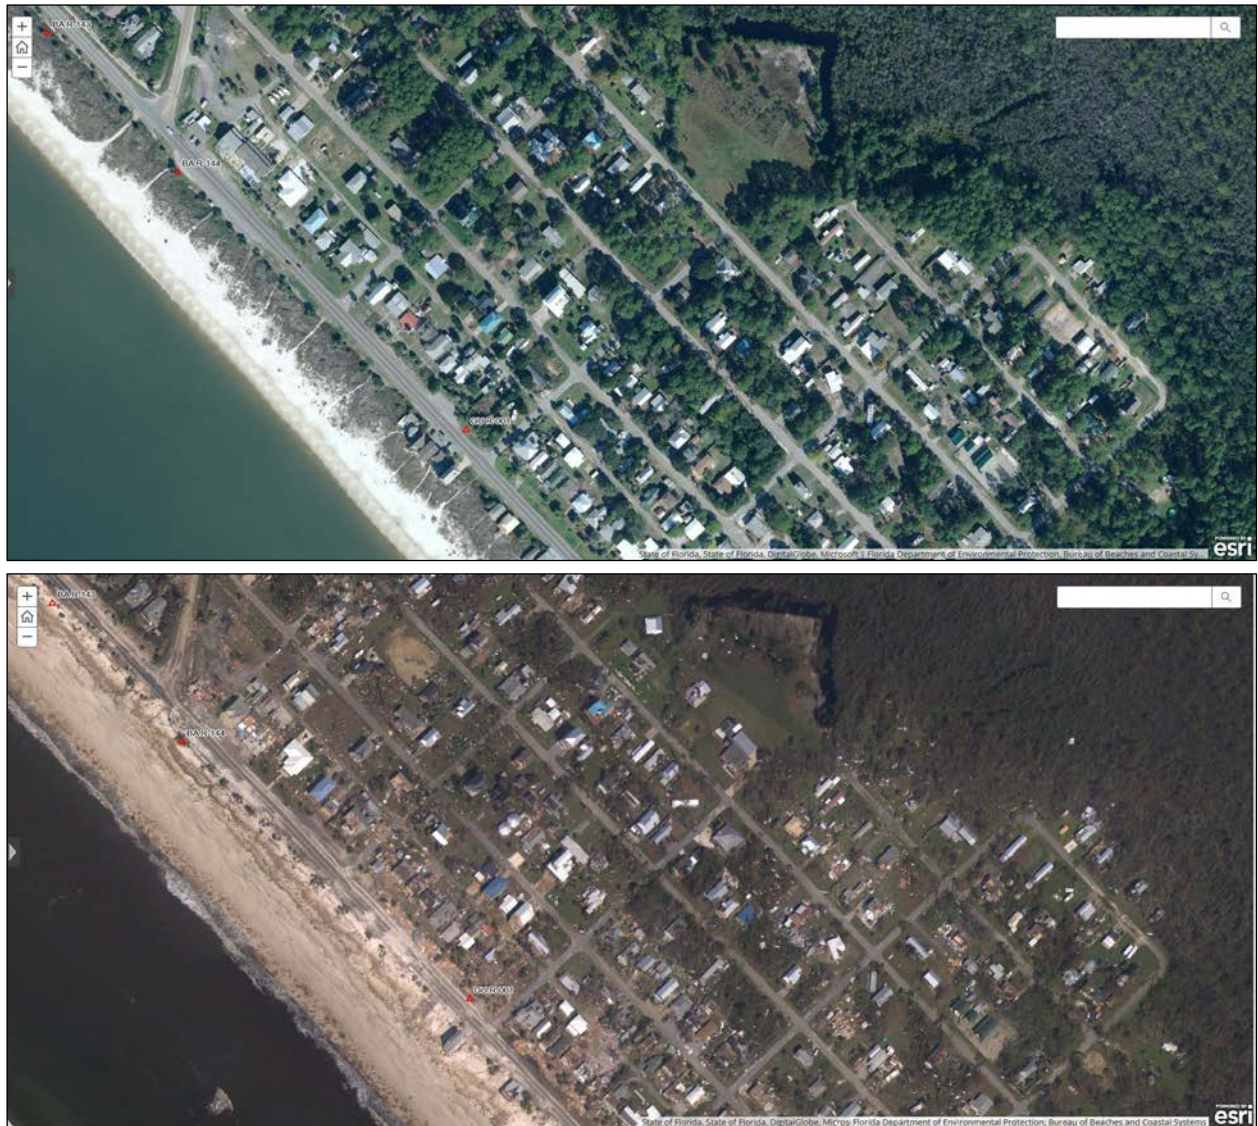
Figure 55. Before and after aerial photo comparison in Beacon Hill (R1). Source: Vexcel Imaging/ NICB Geospatial Intelligence Center.

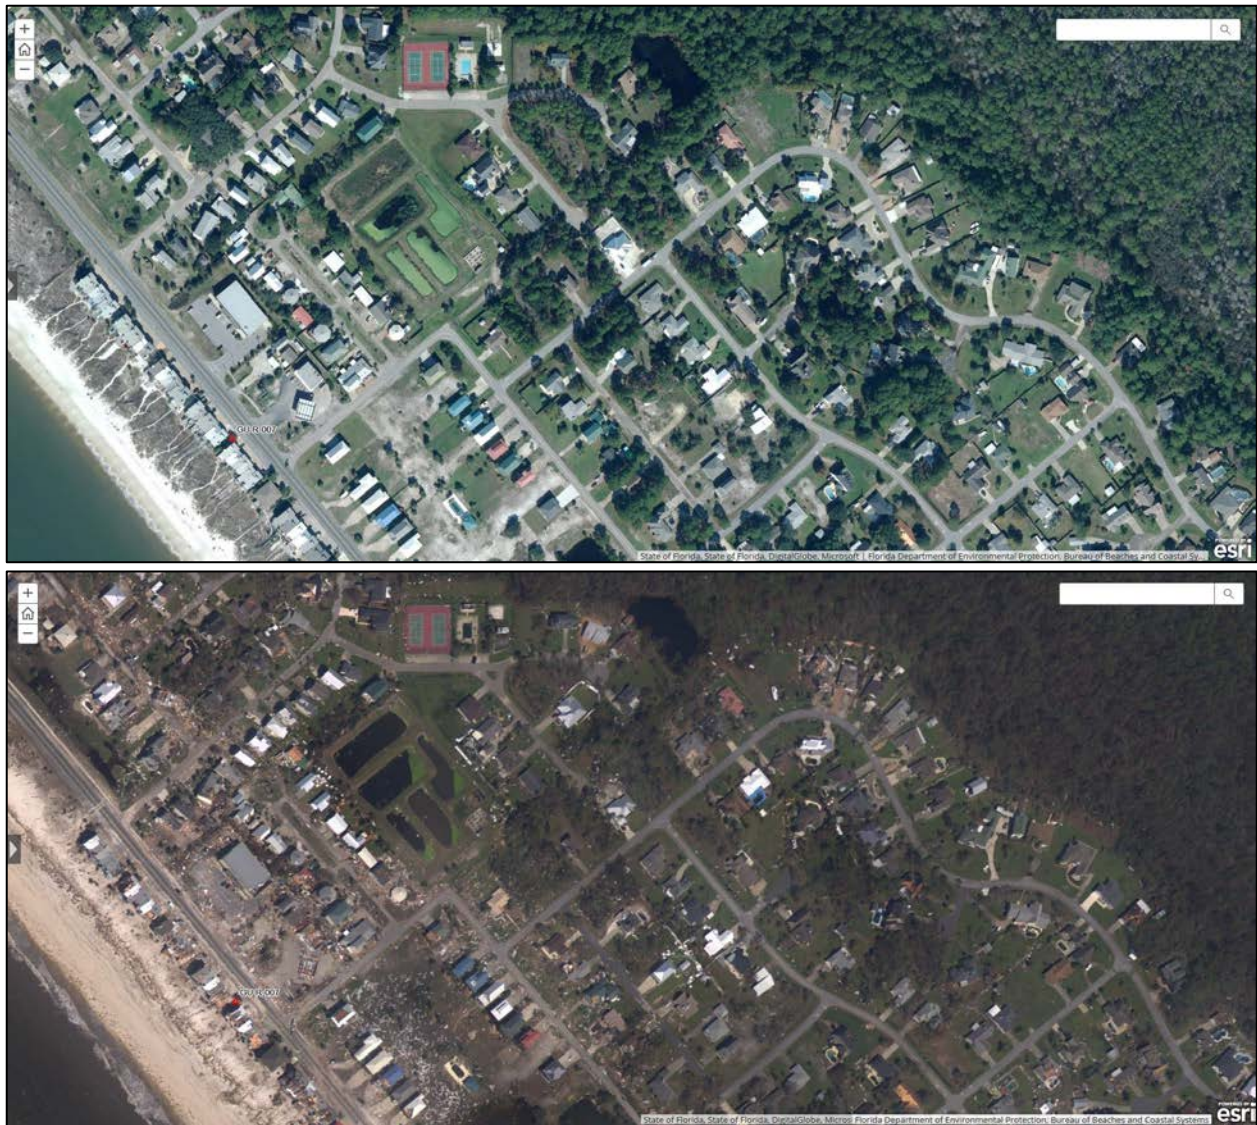
Figure 60. Aerial photo comparison in Beacon Hill (R7). Source: Vexcel Imaging/ NICB Geospatial Intelligence Center.

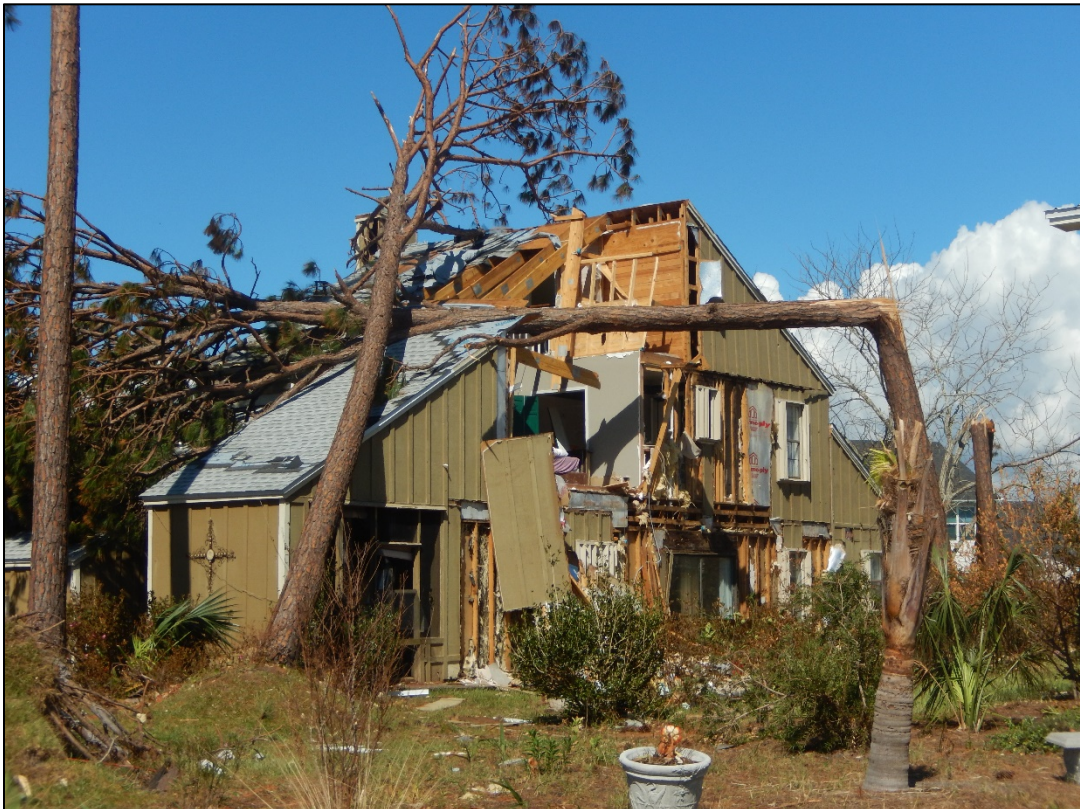
Figure 62. Major damage to dwelling due to high winds and fallen trees, Beacon Hill.

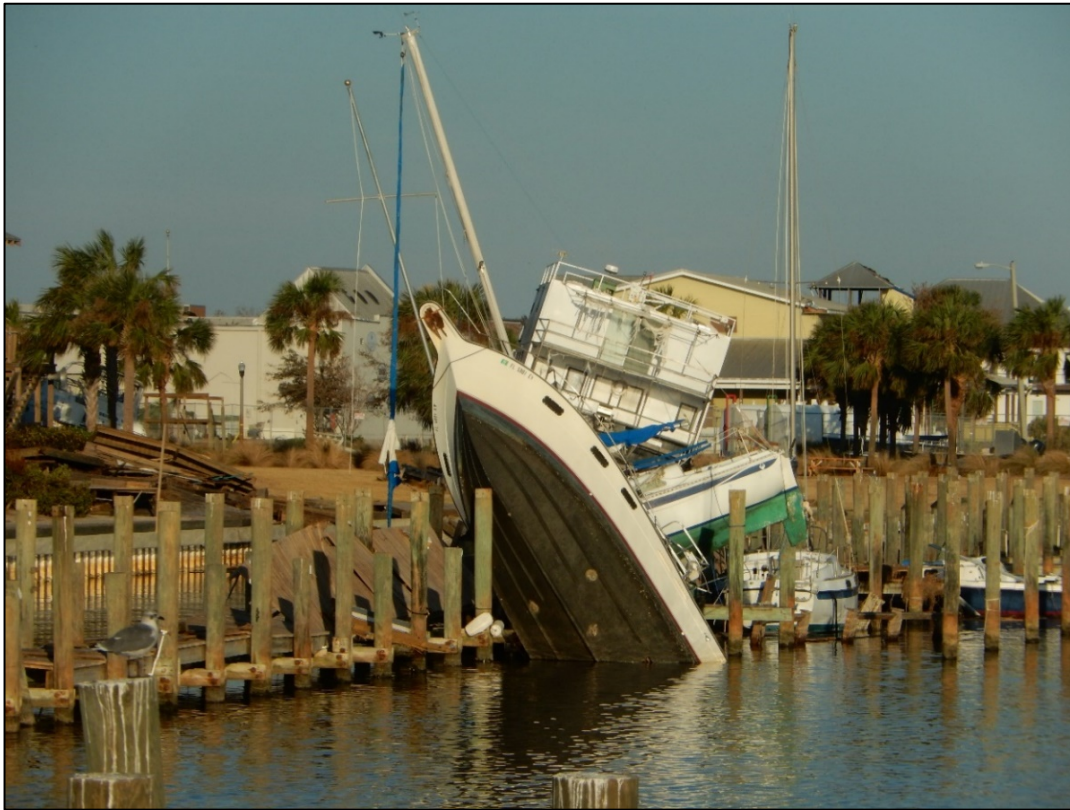
Figure 63. Marina damage due to the storm surge, Port St. Joe.

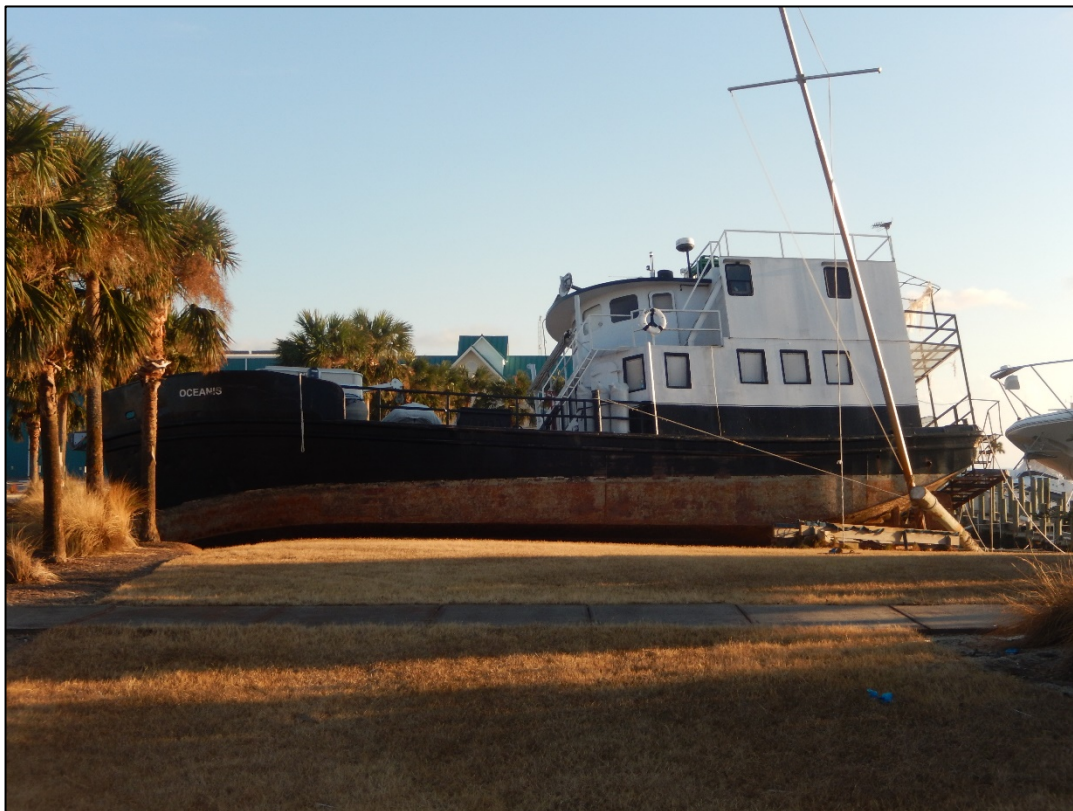
Figure 64. Ship carried onto upland by the storm surge, Port St. Joe.

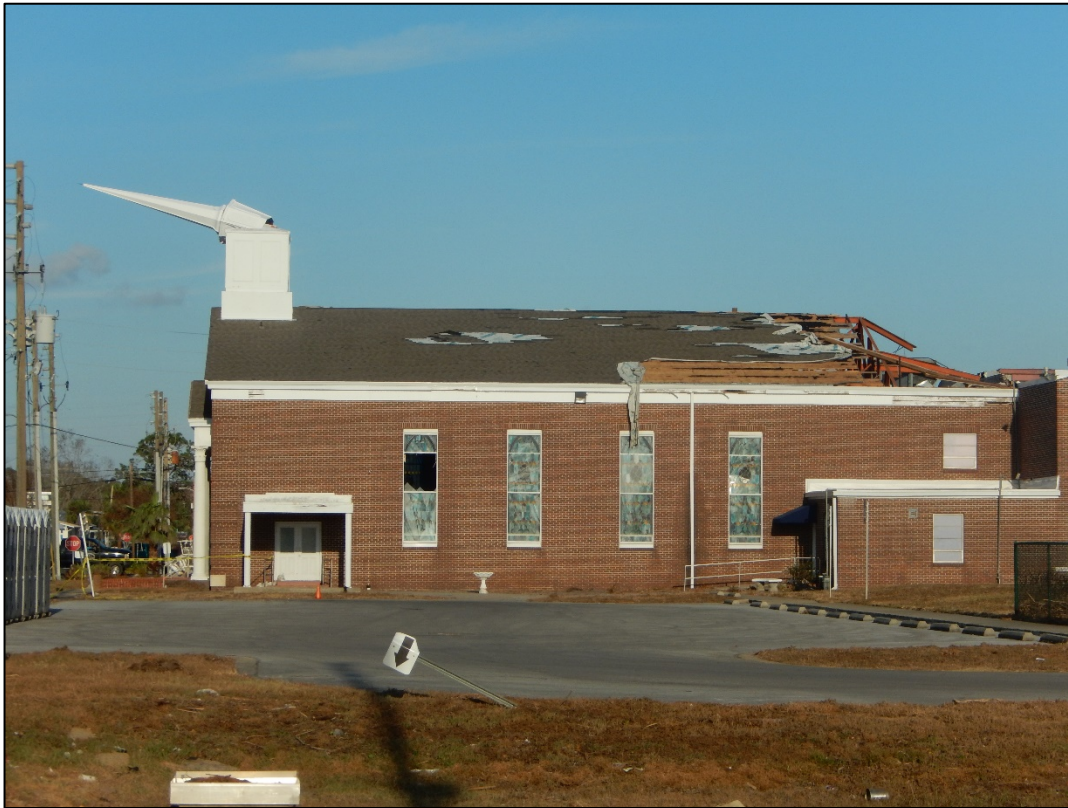
Figure 65. First Baptist Church with major wind damage, Port St. Joe.

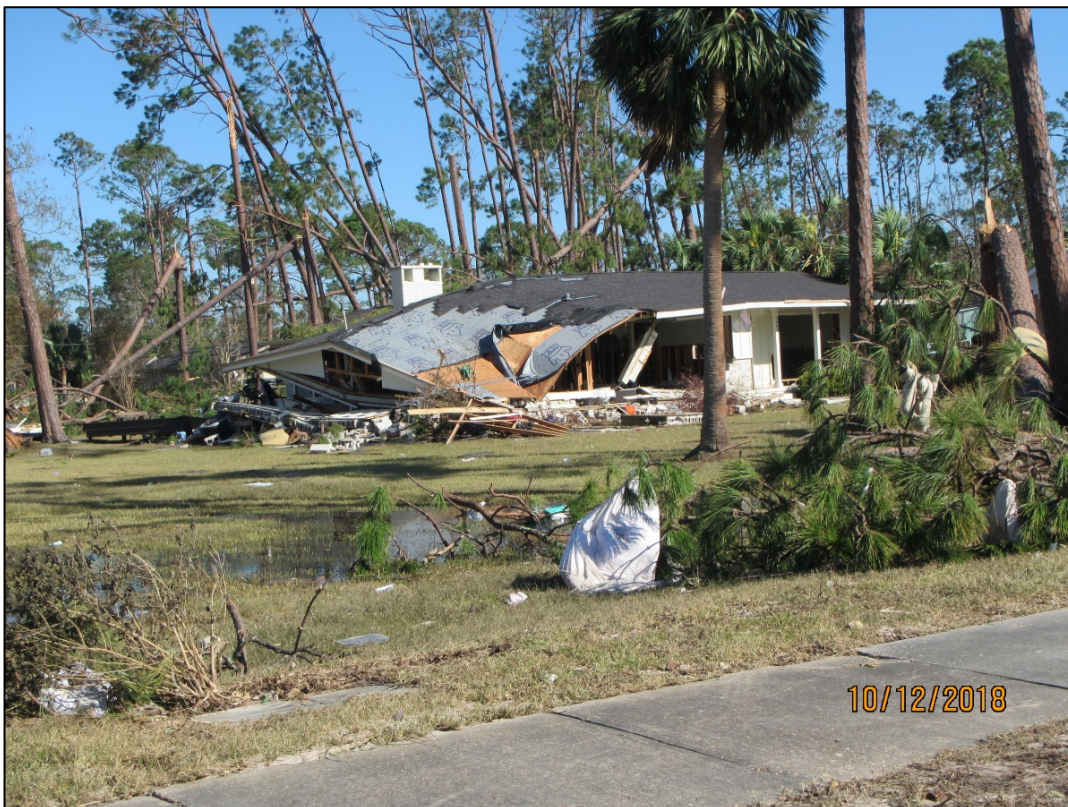
Figure 66. Dwelling destroyed by the storm surge from St. Joseph Bay, Port St. Joe.

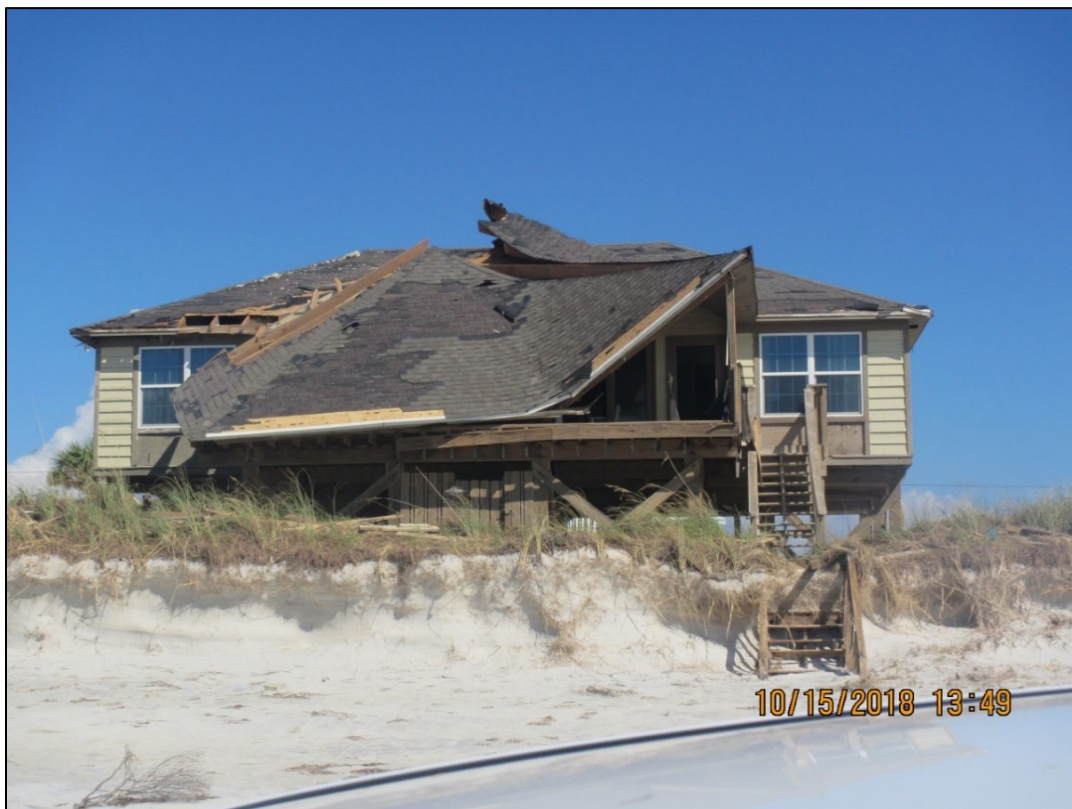
Figure 68. Major roof damage due to high winds near R85, St. Joseph Peninsula.

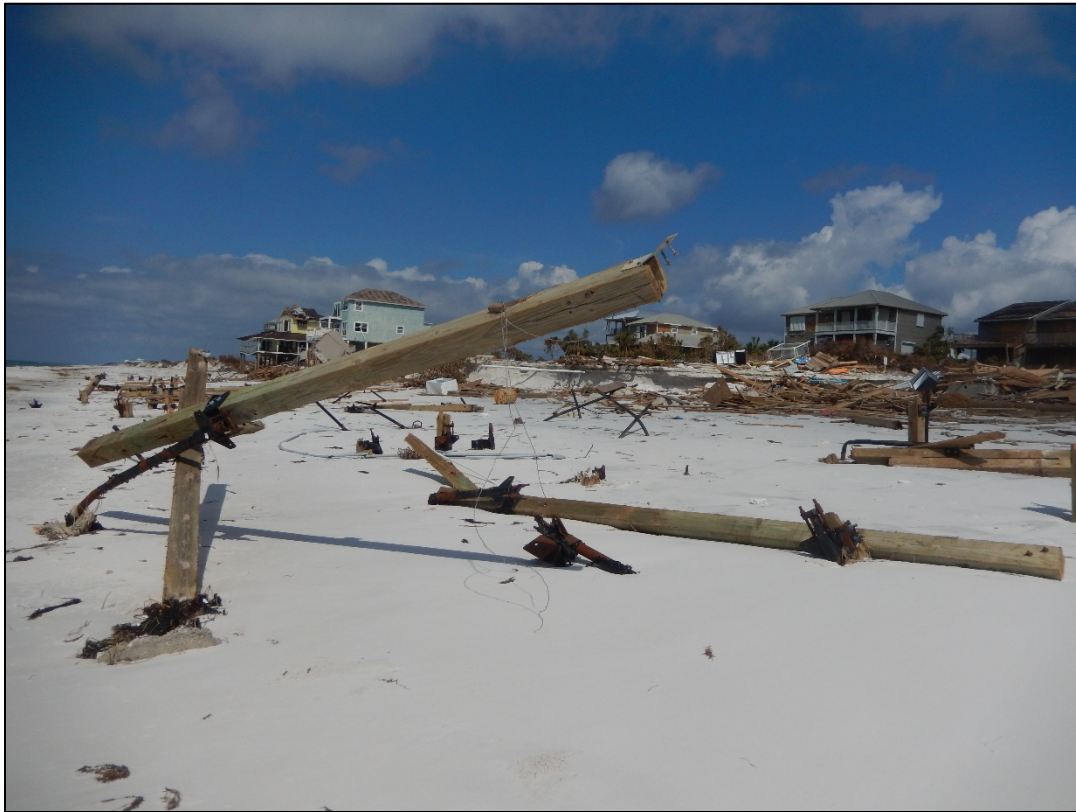
Figure 69. Remains of four destroyed townhouse buildings on Nassau Lane near R90.5, St. Joseph Peninsula.

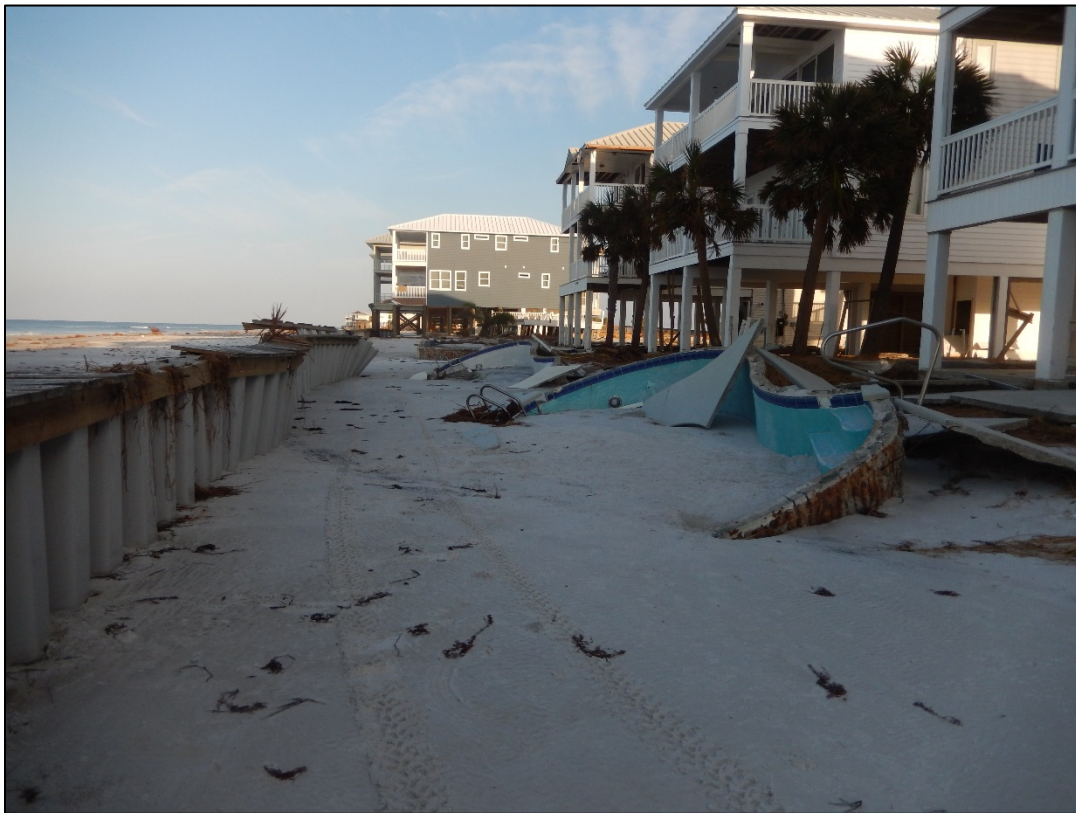
Figure 73. Major damage to bulkheads and swimming pools near R104.

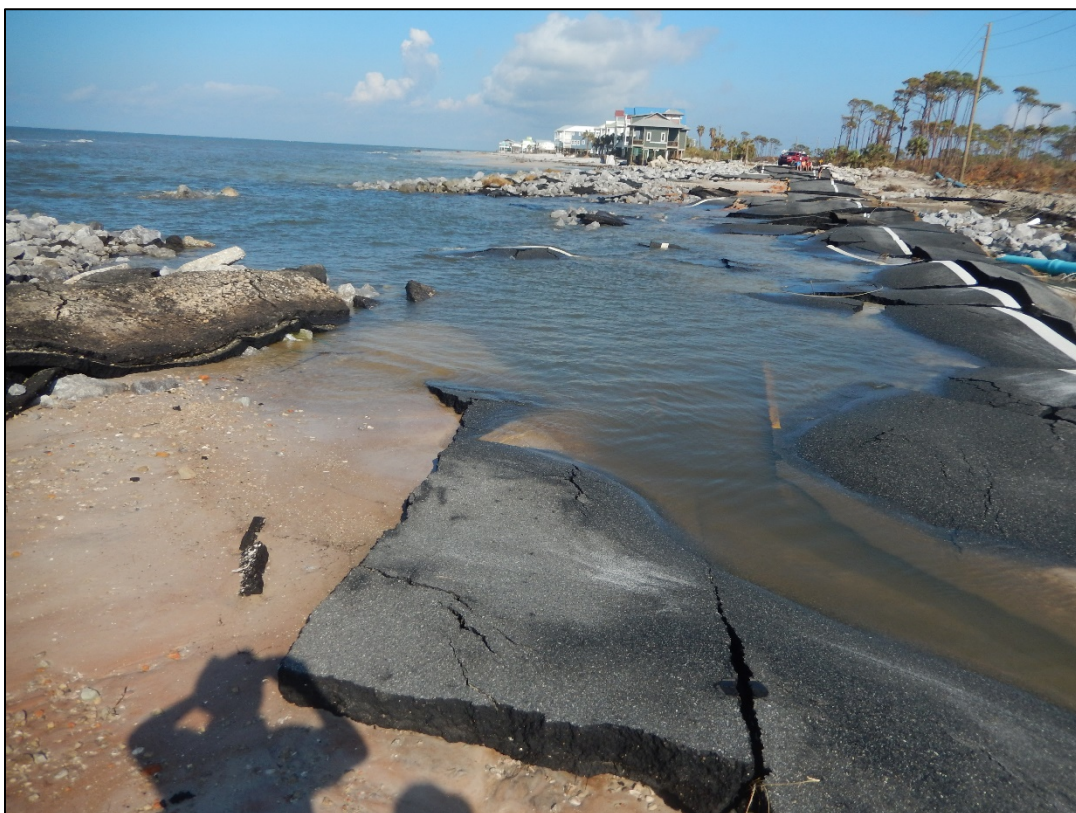
Figure 74. County Road 30E destroyed north of the Stump Hole boulder mound, R105.

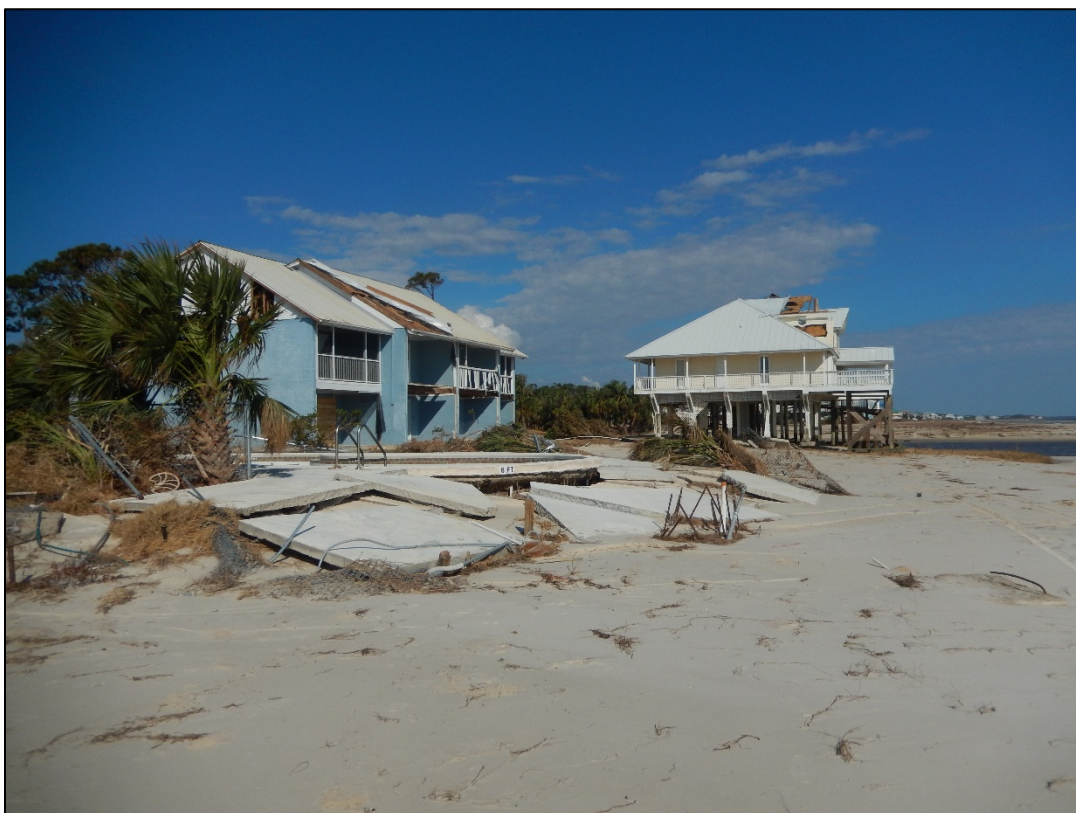
Figure 76. Storm surge damages at Money Bayou, R140.

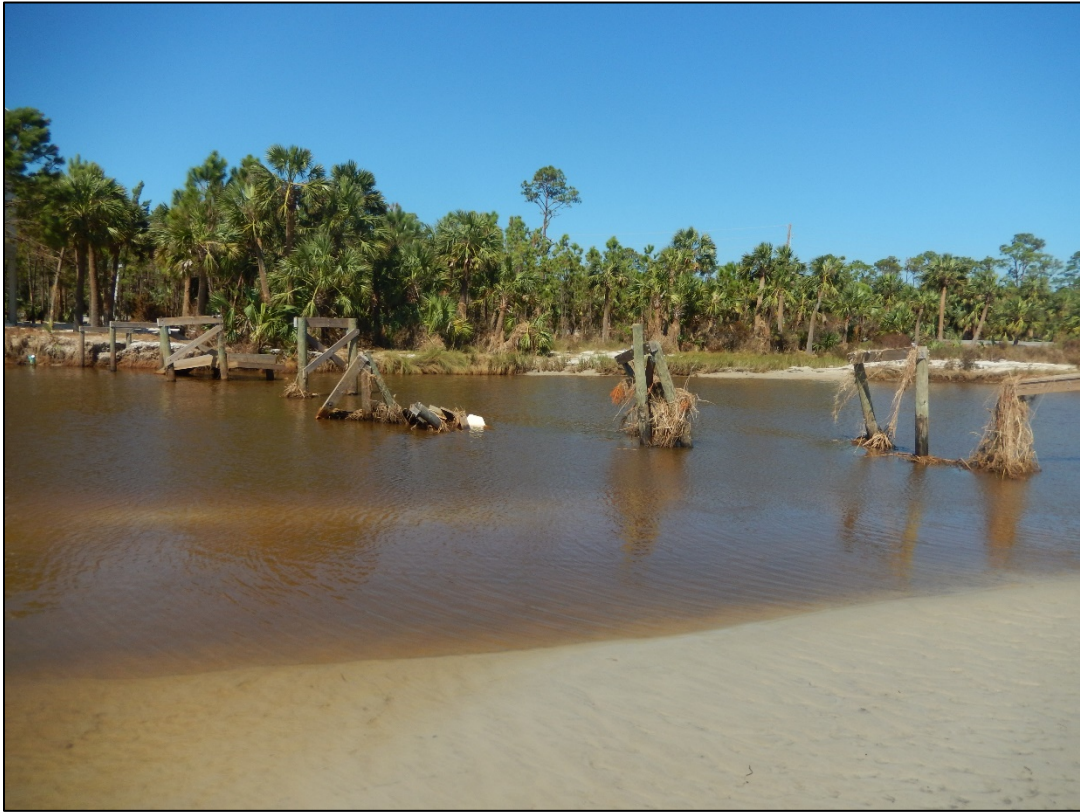
Figure 77. Bridge destroyed across Money Bayou, R140.5.

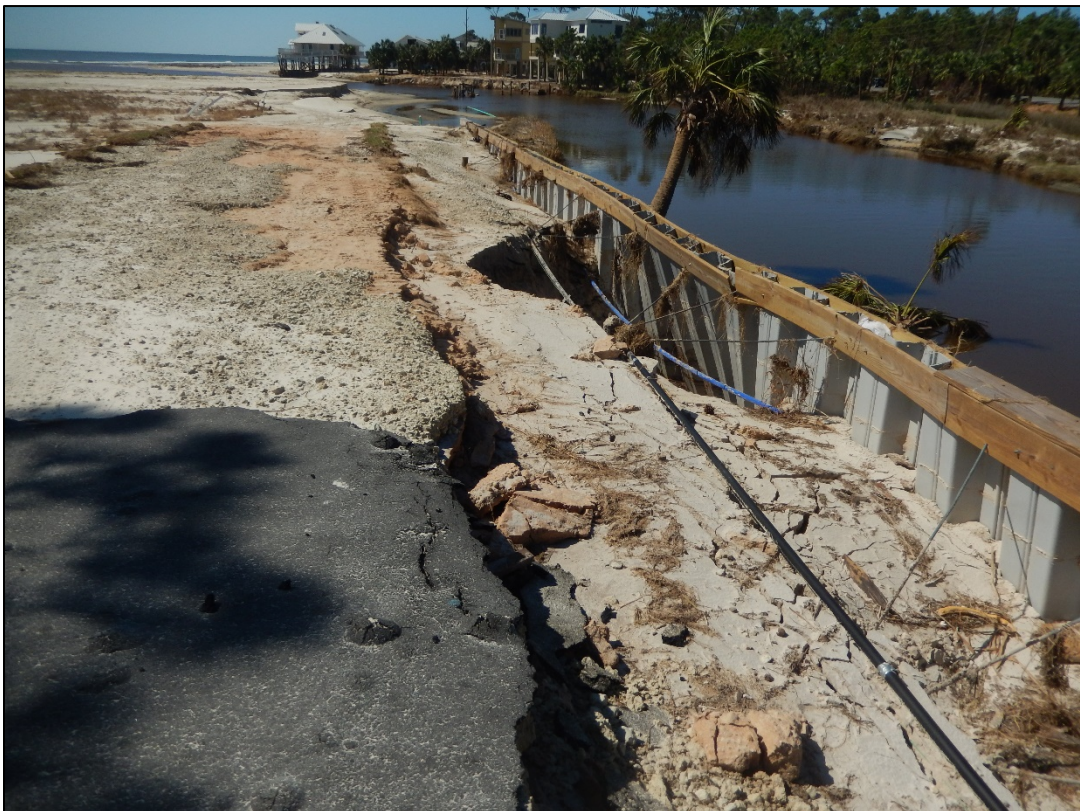
Figure 78. Bulkhead on Money Bayou damaged, R141.

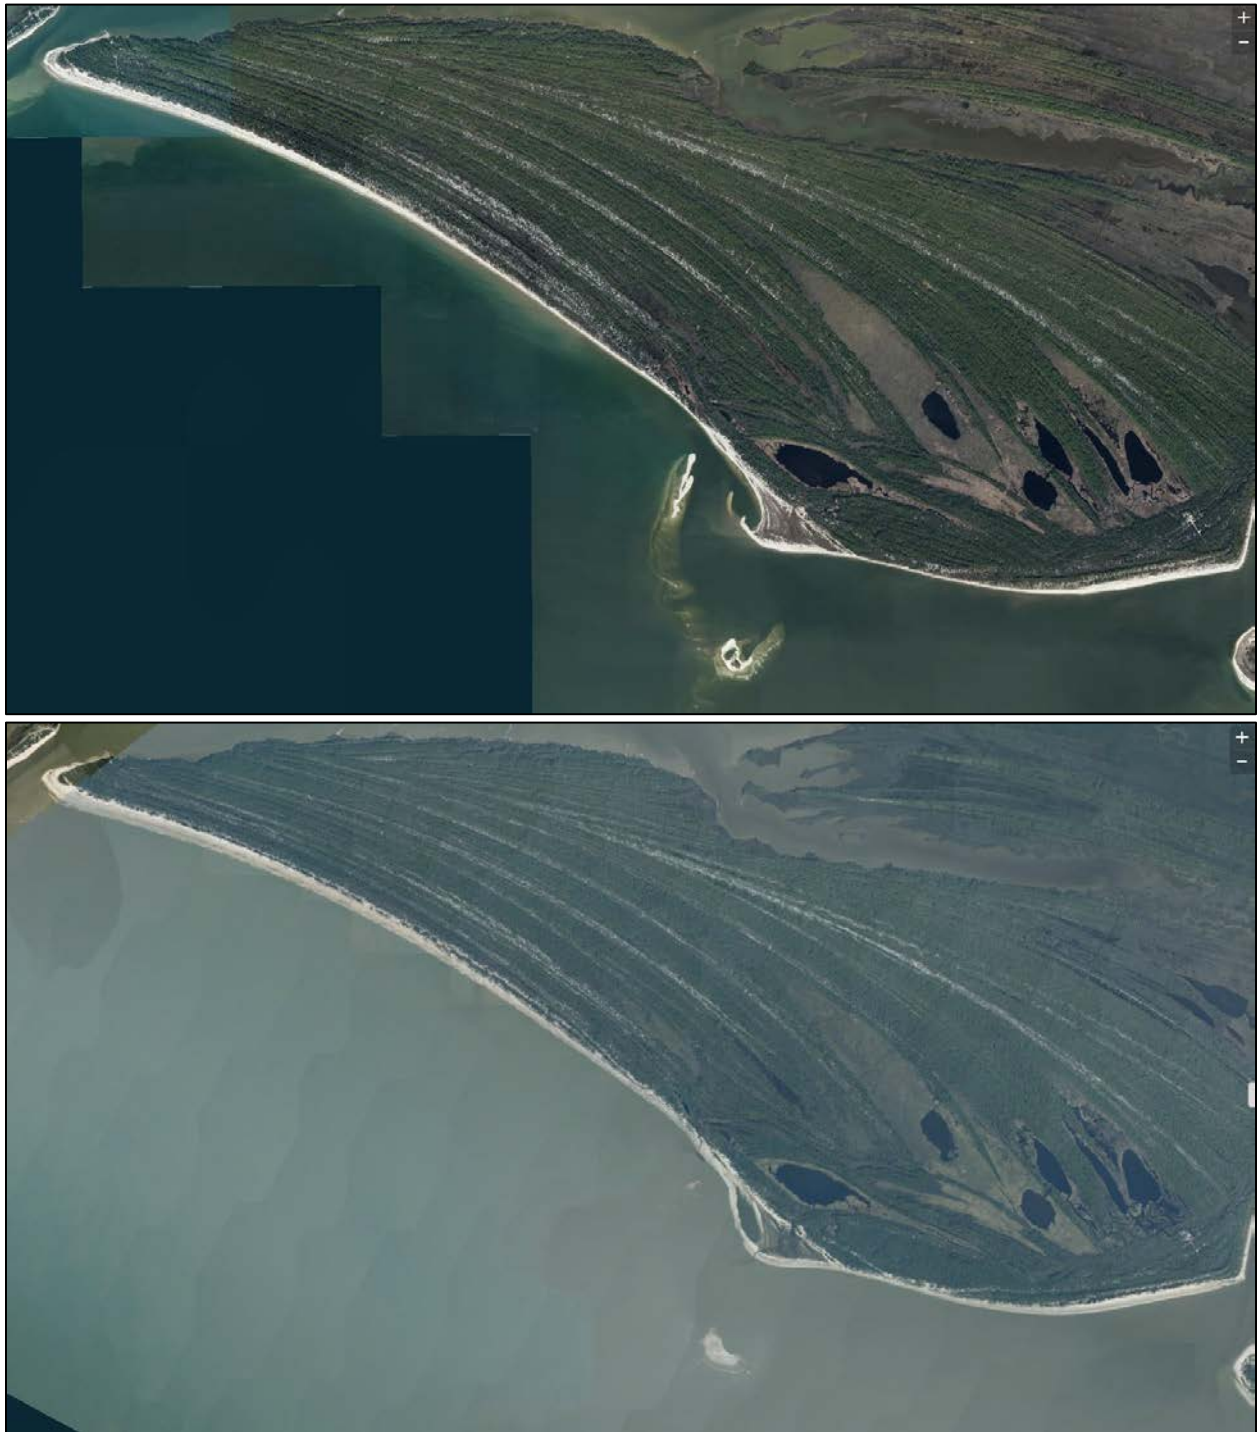
Figure 80. Before (above) and after (below) aerial photos showing major coastal changes to St. Vincent Island. Source: Vexcel Imaging/ NICB Geospatial Intelligence Center.
