*Hurricane Michael Post-Storm
Beach Conditions and Coastal Impact Report*

**Division of Water Resource Management
Florida Department of Environmental Protection**

January 2019

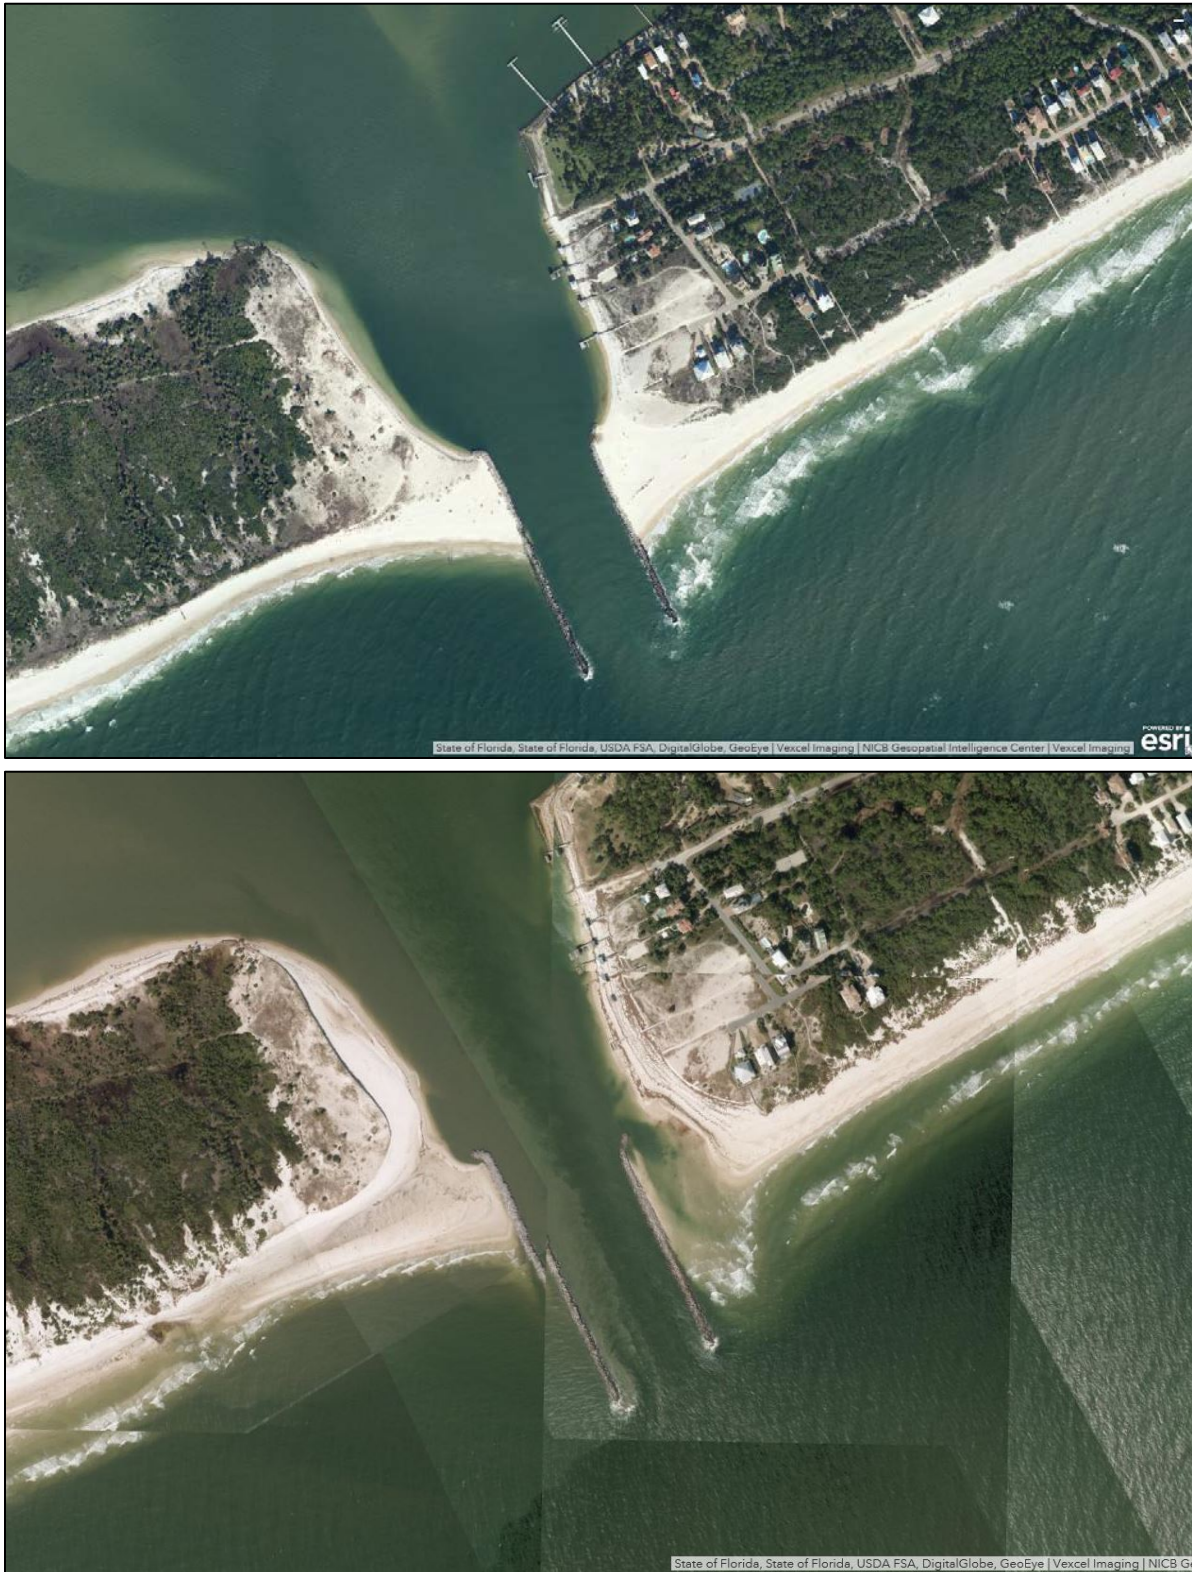
Figure 81. Before (above) and after (below) aerial photos showing breaching of the Bob Sikes Cut jetties from St. George Island, R51-R52. Source: Vexcel Imaging/ NICB Geospatial Intelligence Center.

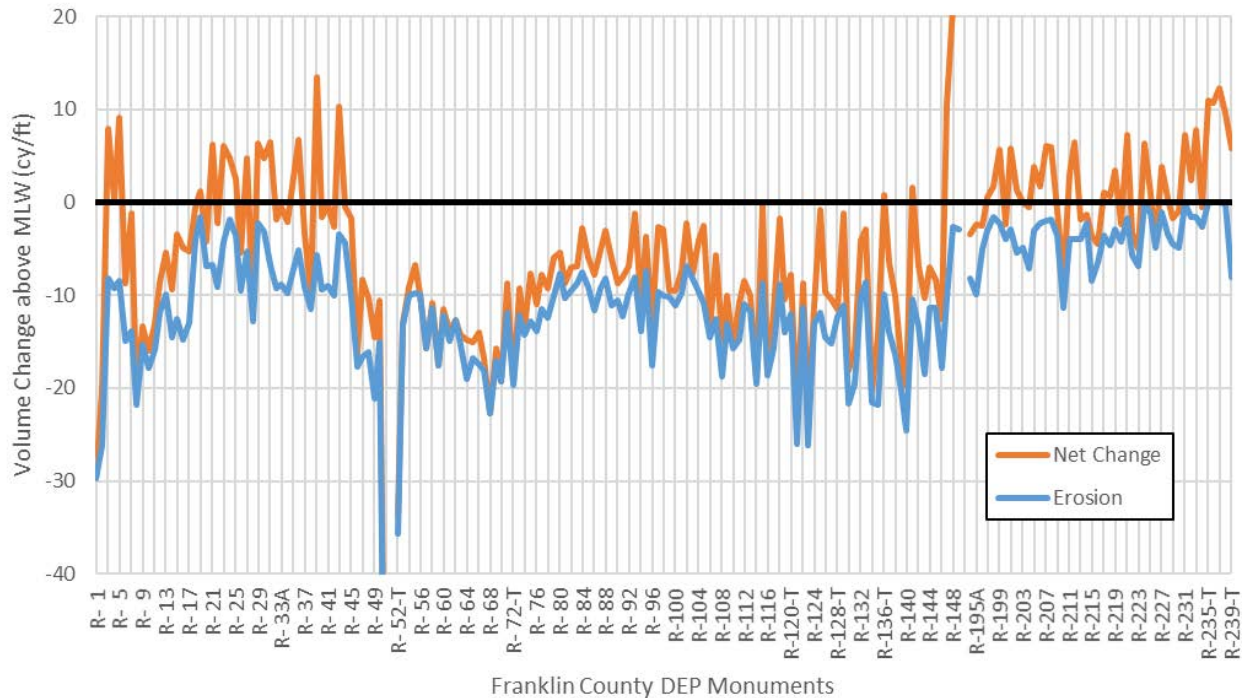
Figure 82. Total and net volume change along Franklin County above MLW.

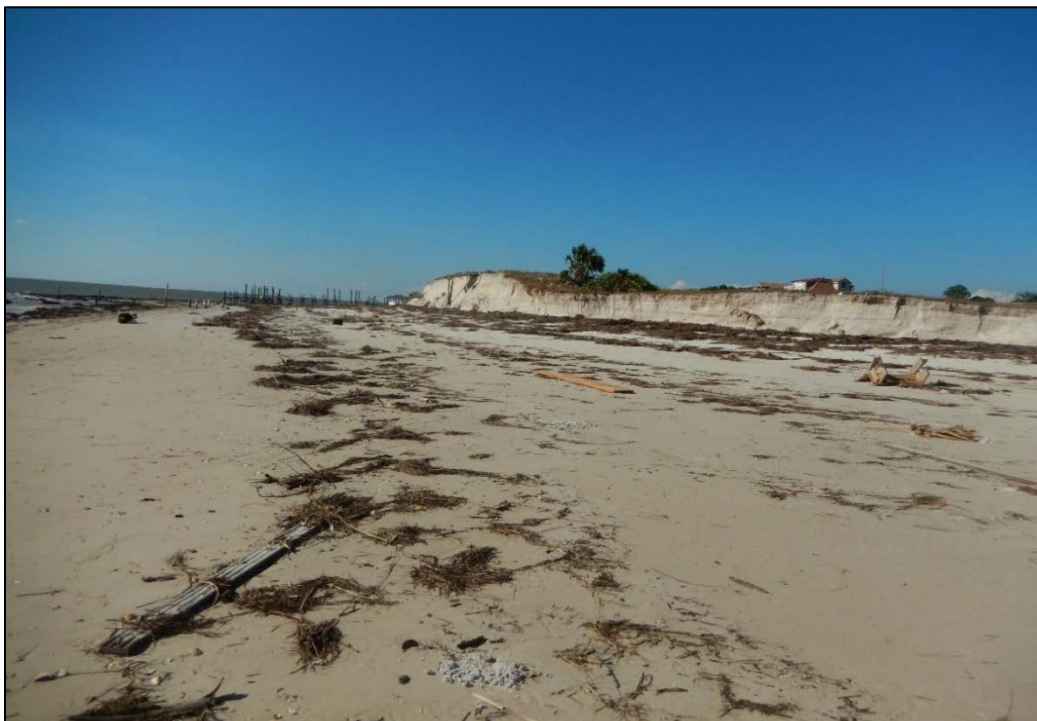
Figure 83. Major beach and dune erosion at Bob Sikes Cut at R52, St. George Island.

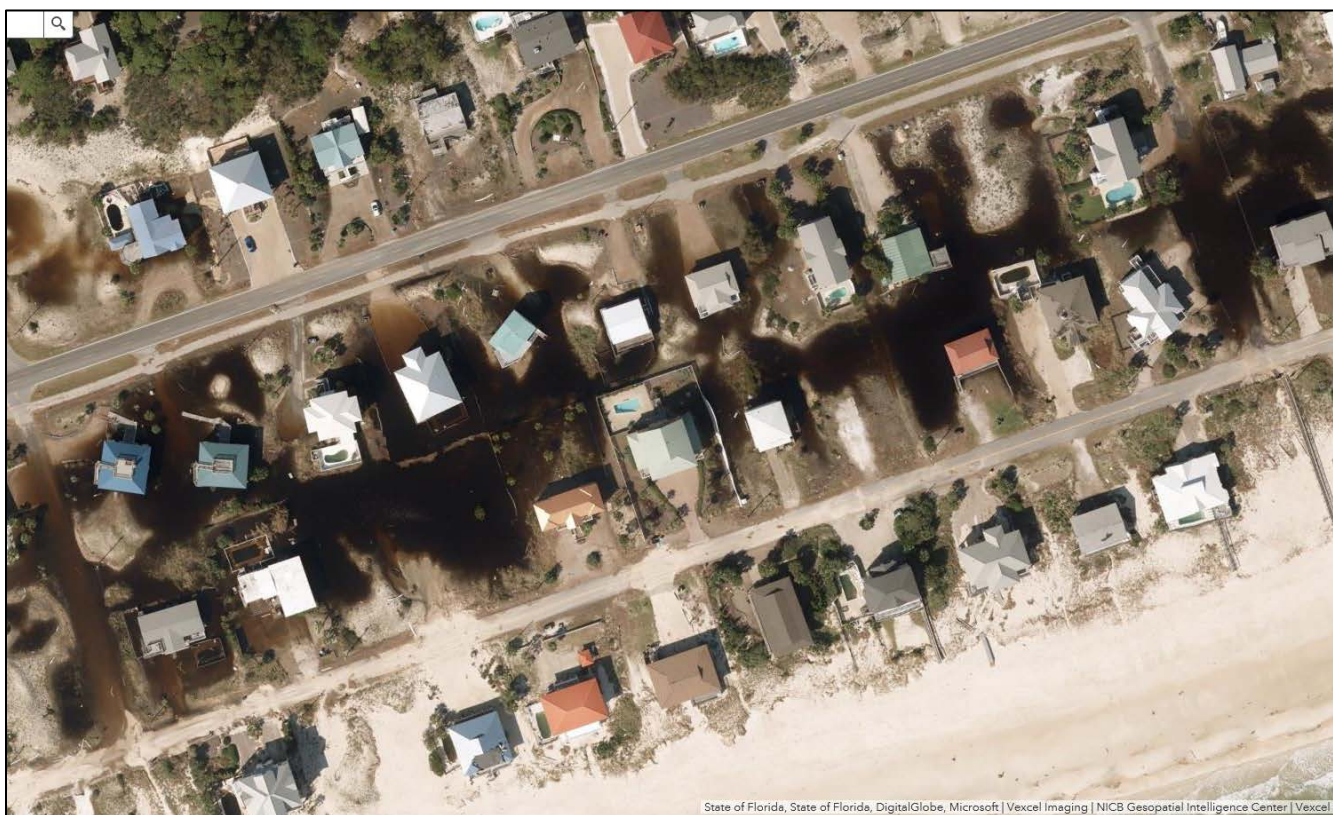
Figure 85. Flooded interdunal depression on St. George Island between R87-R99. Source: Vexcel Imaging/ NICB Geospatial Intelligence Center.

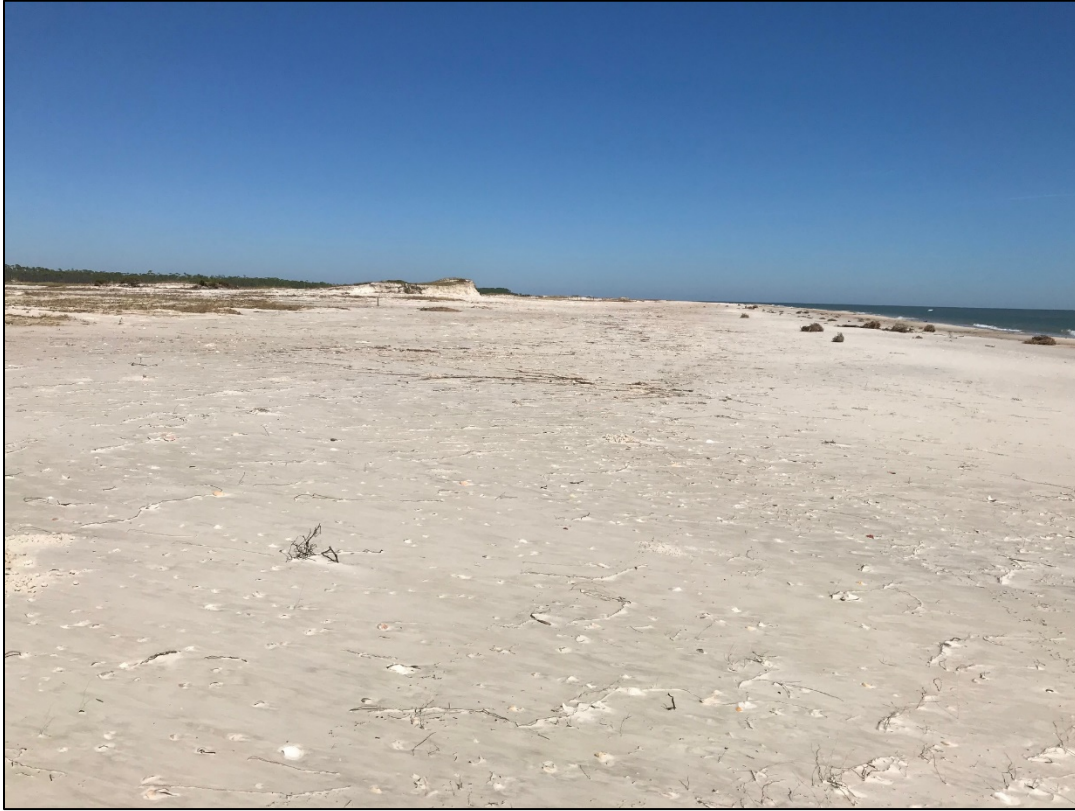
In the Dr. Julian G. Bruce St. George Island State Park, which extends along the eastern 8.4 miles of St. George Island between R105 and R149, major beach and dune erosion (Condition IV) was sustained (**Figure 86**).

Figure 86. Dunes leveled across St. George Island State Park.

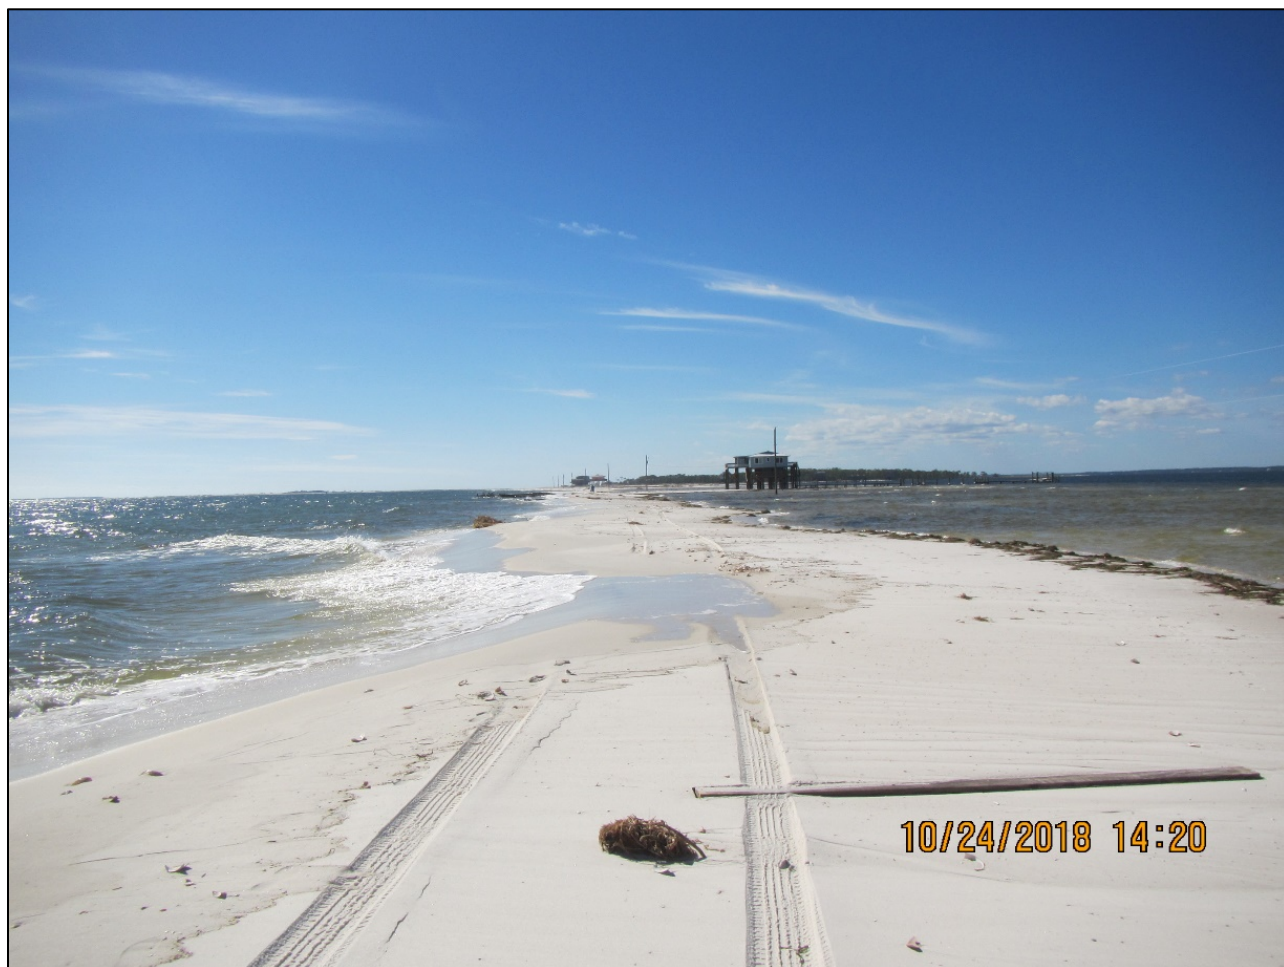
between R165-R169 were inundated by the storm surge, causing further deflation of these narrow island segments with substantial sediment transport into the St. George Sound side of Dog Island (**Figure 87**).

Figure 87. Narrows near R159, Dog Island.

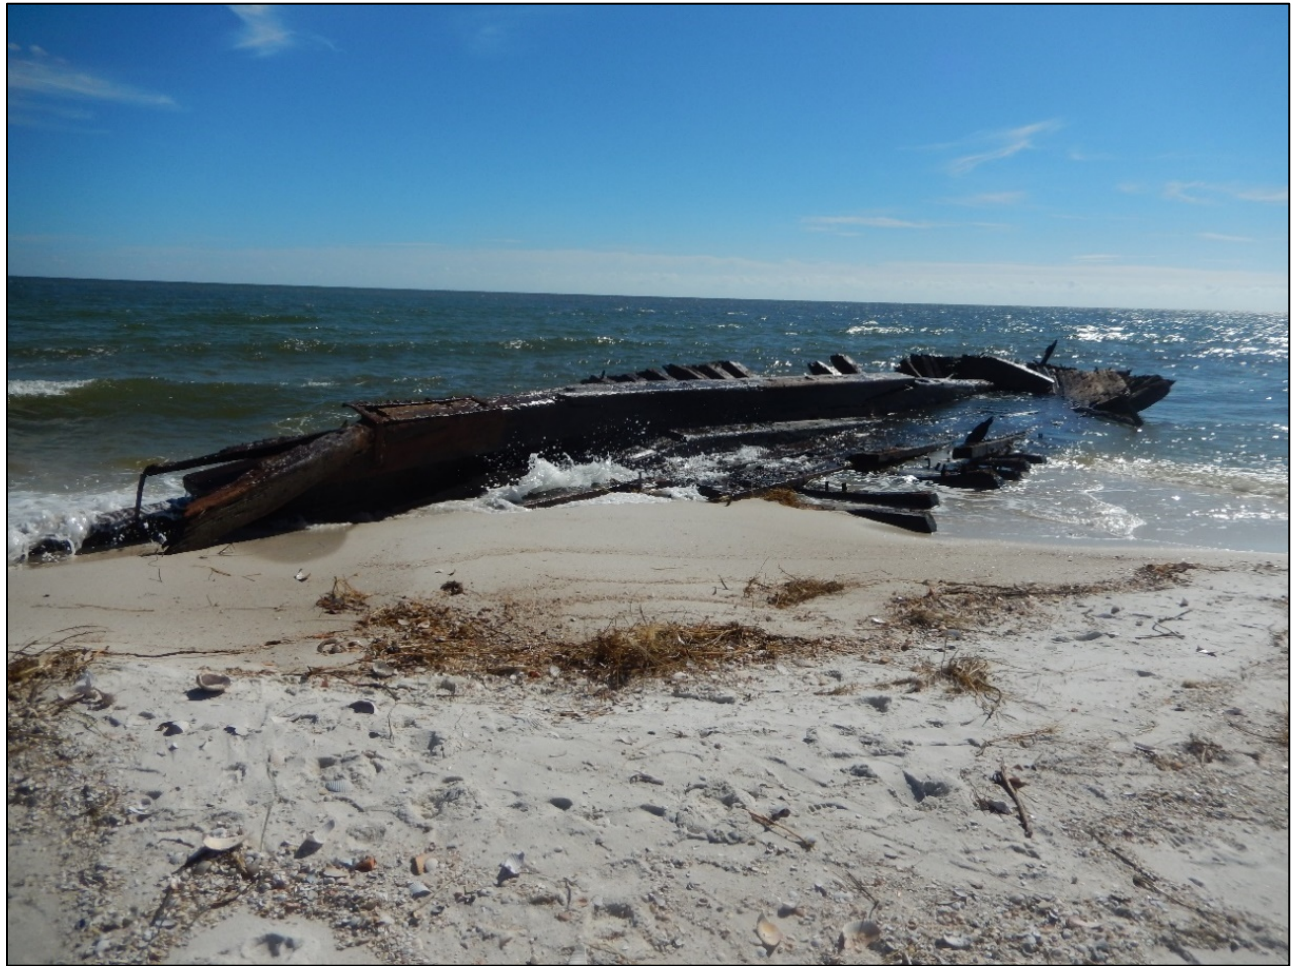
This overwash and landward beach migration has uncovered historical 19th century shipwrecks and remnants of a commercial dock near R158, which was destroyed in the “Carrabelle Hurricane” of 1899 (**Figure 88**). Along much of the remainder of the island, the vegetation line retreated as much as 50 feet and greater.

Figure 88. 19th century shipwreck uncovered by erosion near R158, Dog Island.

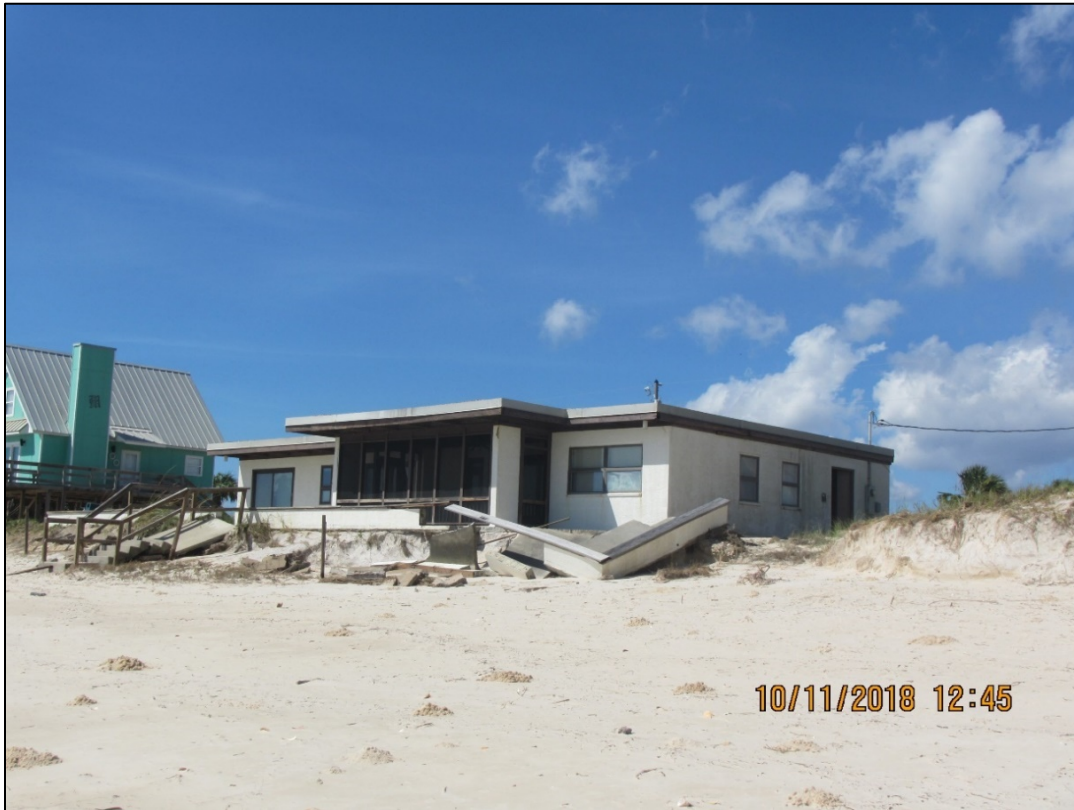
Figure 89. Dwelling damaged near R78, St. George Island.

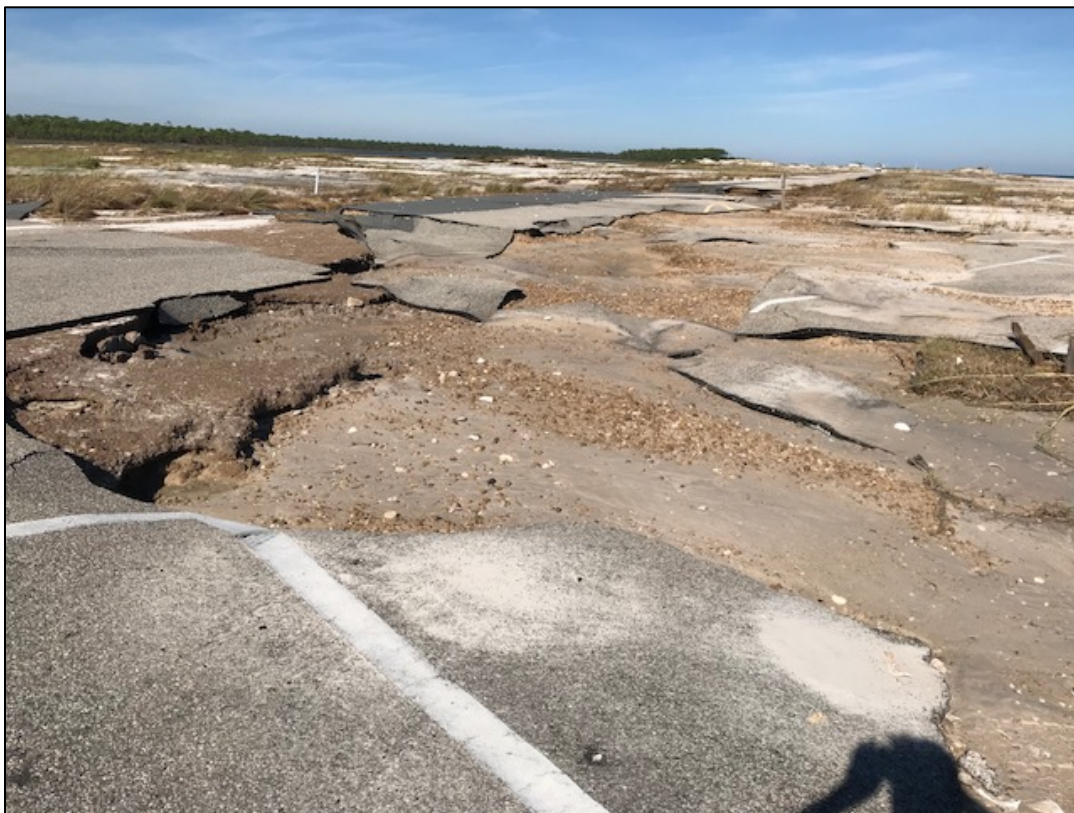
Figure 90. State park road destroyed near R108, St. George Island.

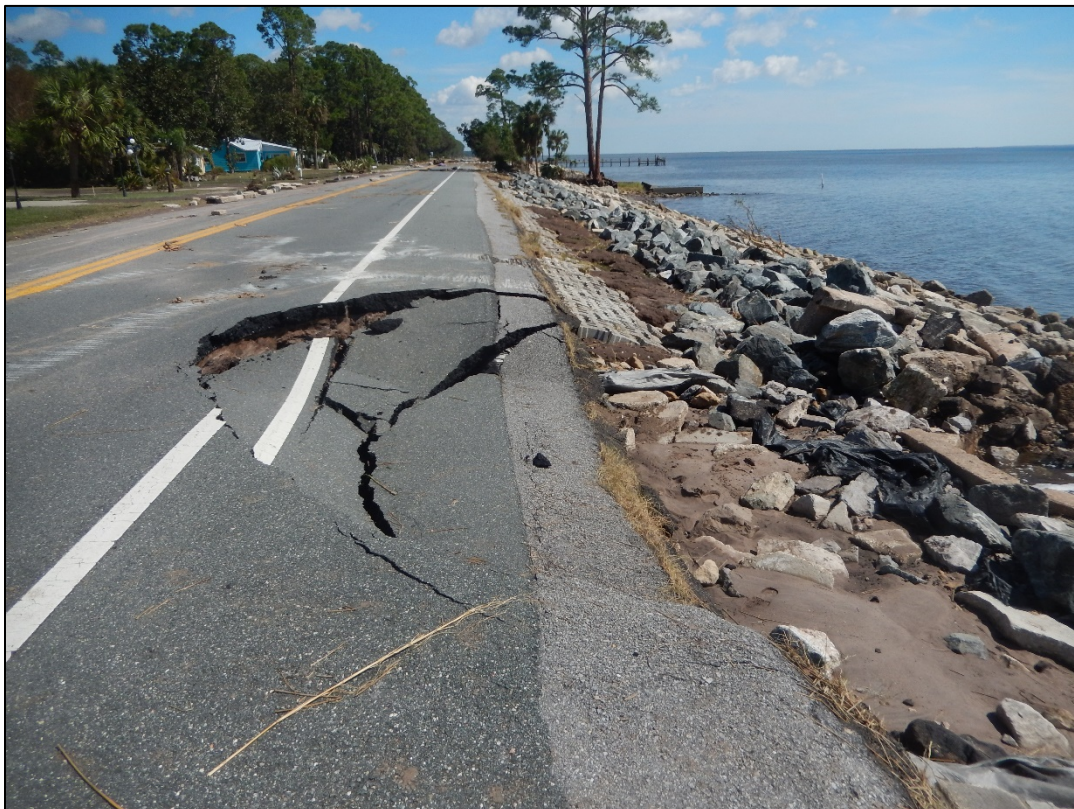
Figure 92. U.S. Highway 98 damaged near Eastpoint.

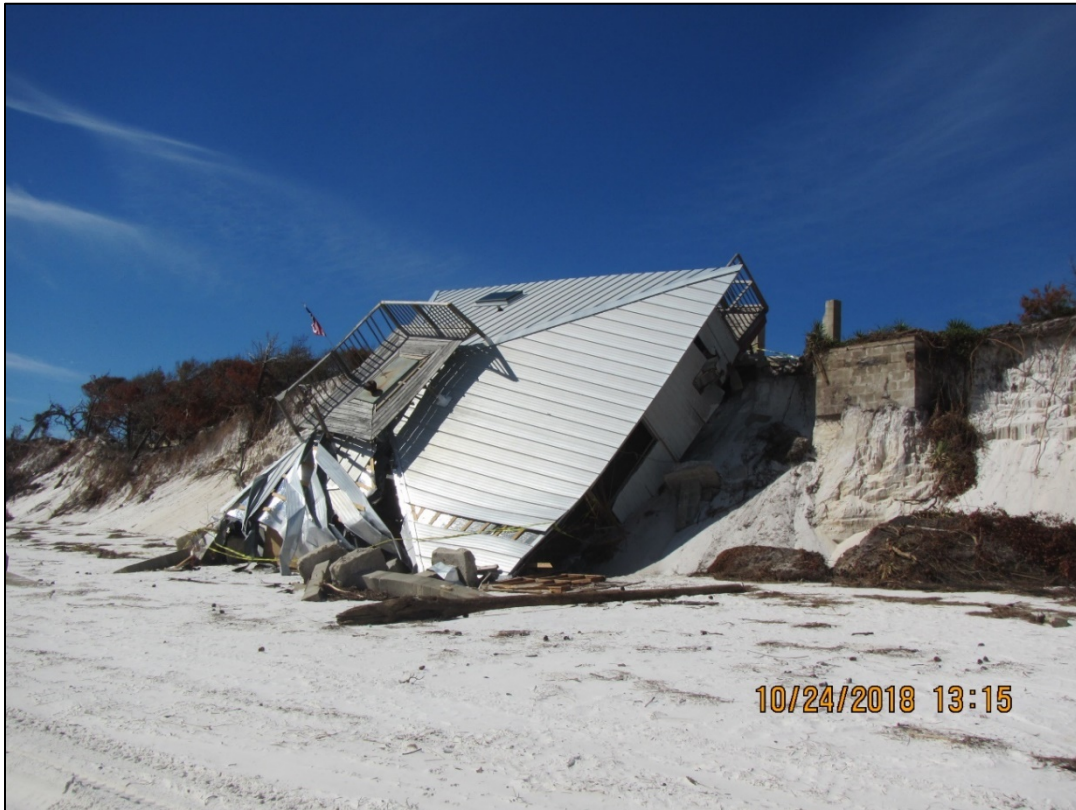
Figure 93. Dwelling destroyed near R173, Dog Island.

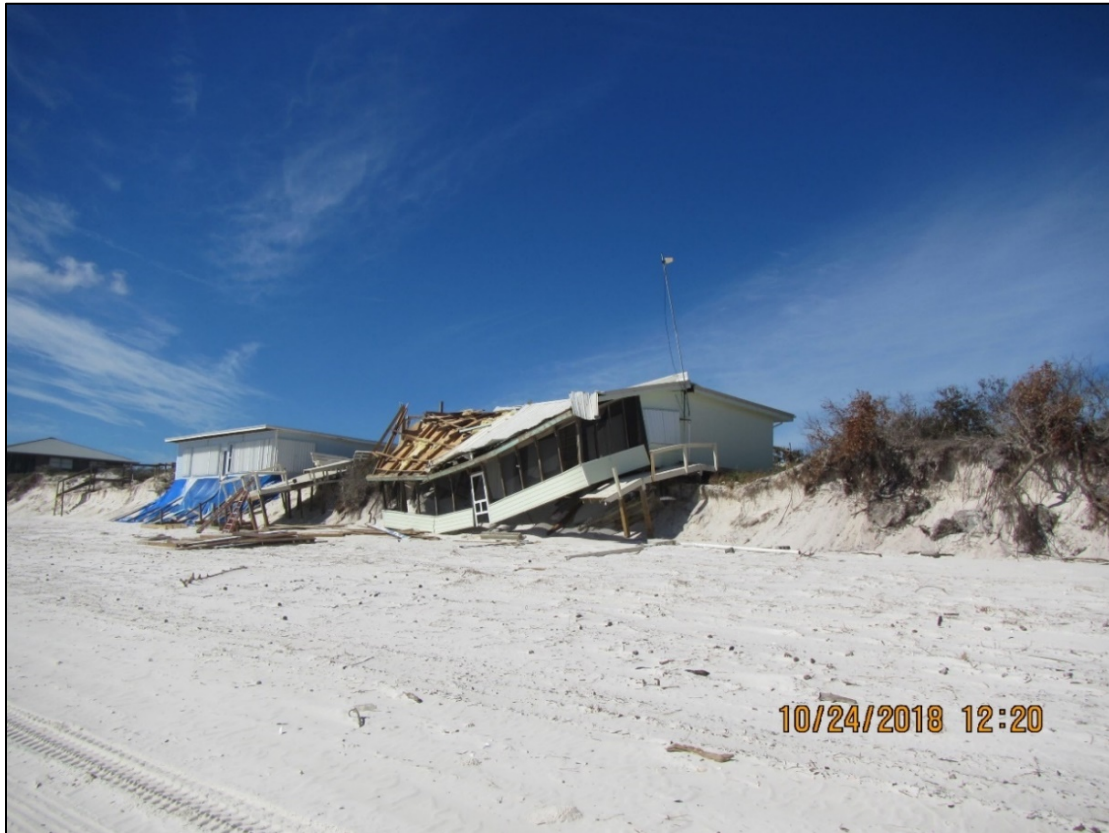
Figure 97. Dwelling destroyed near R179, Dog Island.

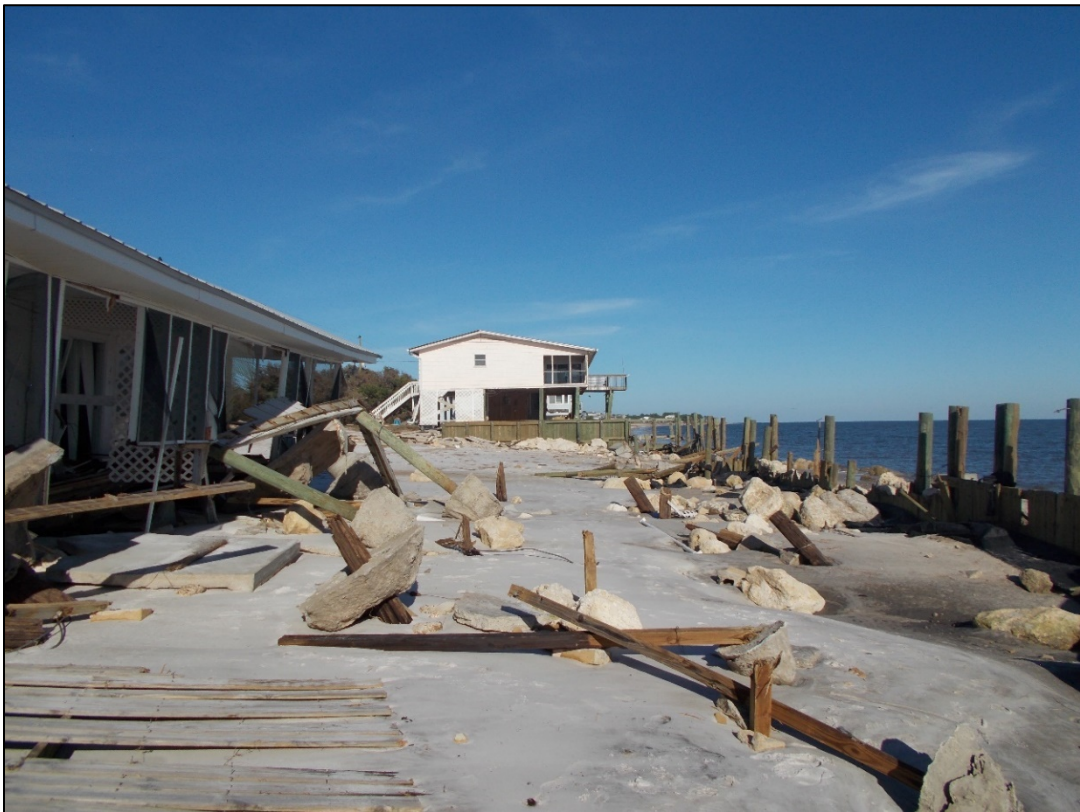
Figure 102. Dwelling and bulkhead damaged near R214.5, Southwest Cape.

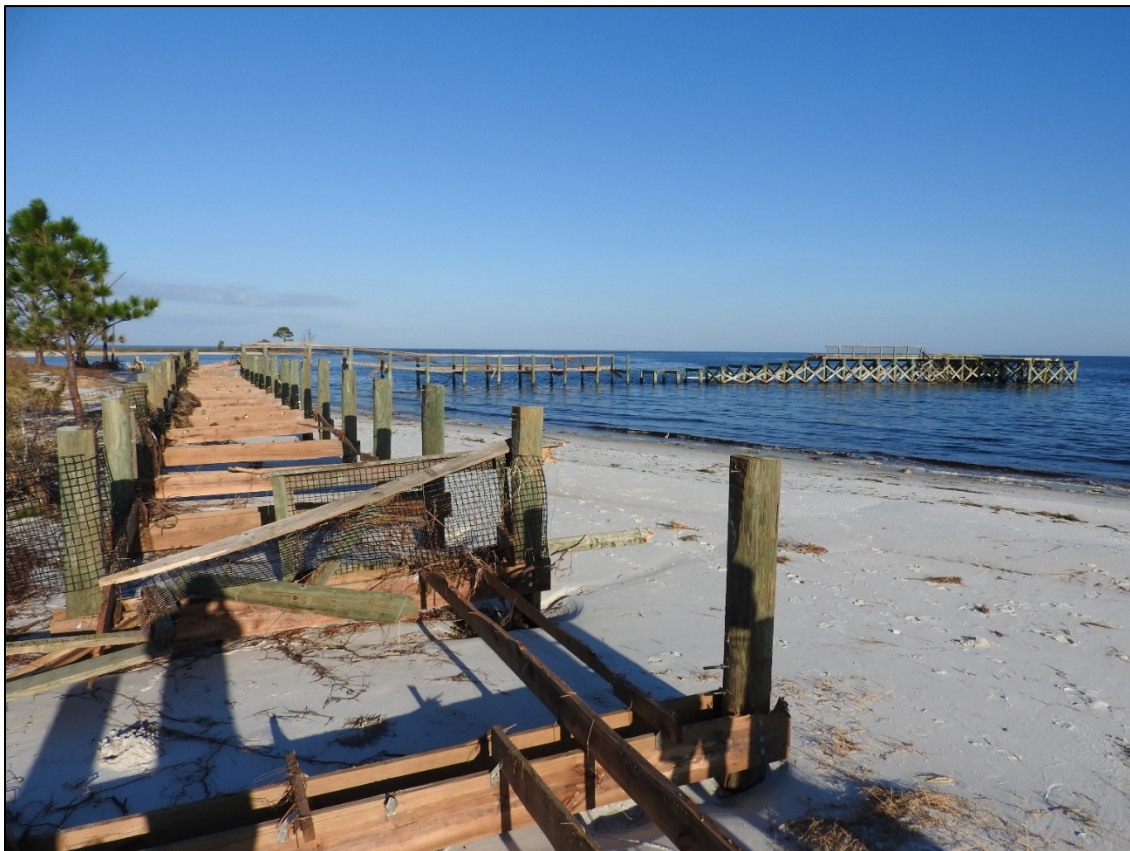
Figure 104. Fishing pier and access walkway damaged at Mashes Sands, V303.

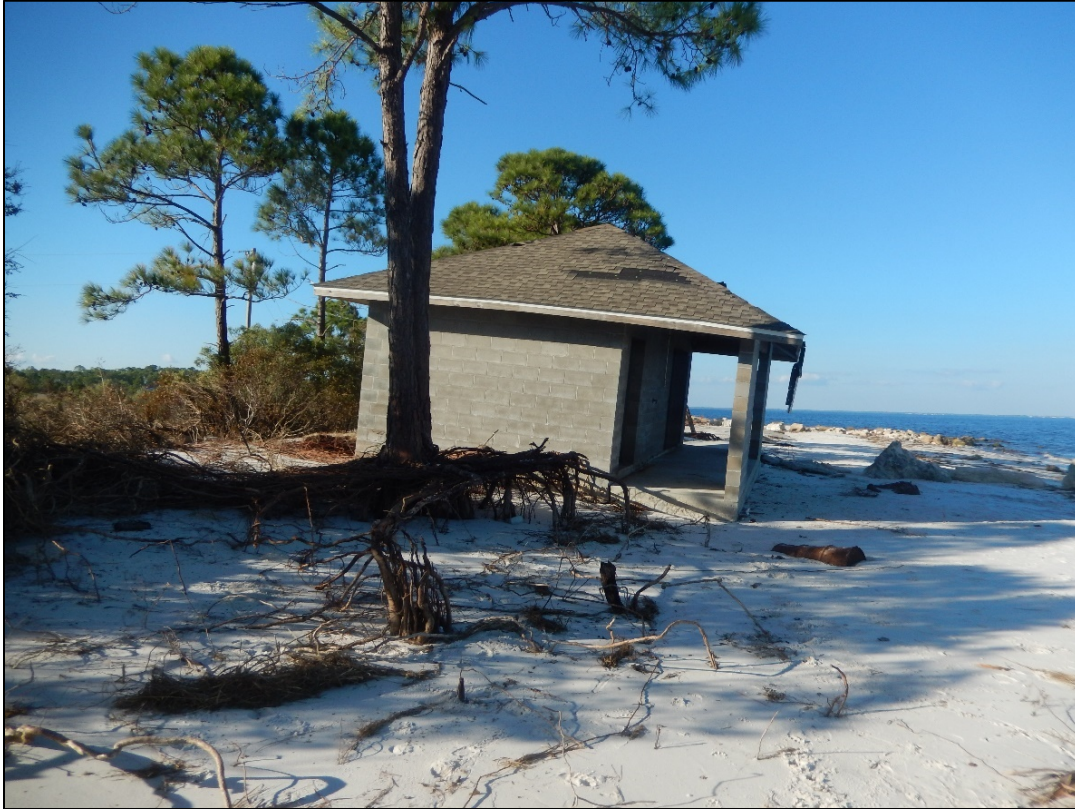
Figure 105. Bathhouse destroyed at Mashas Sands, V314.

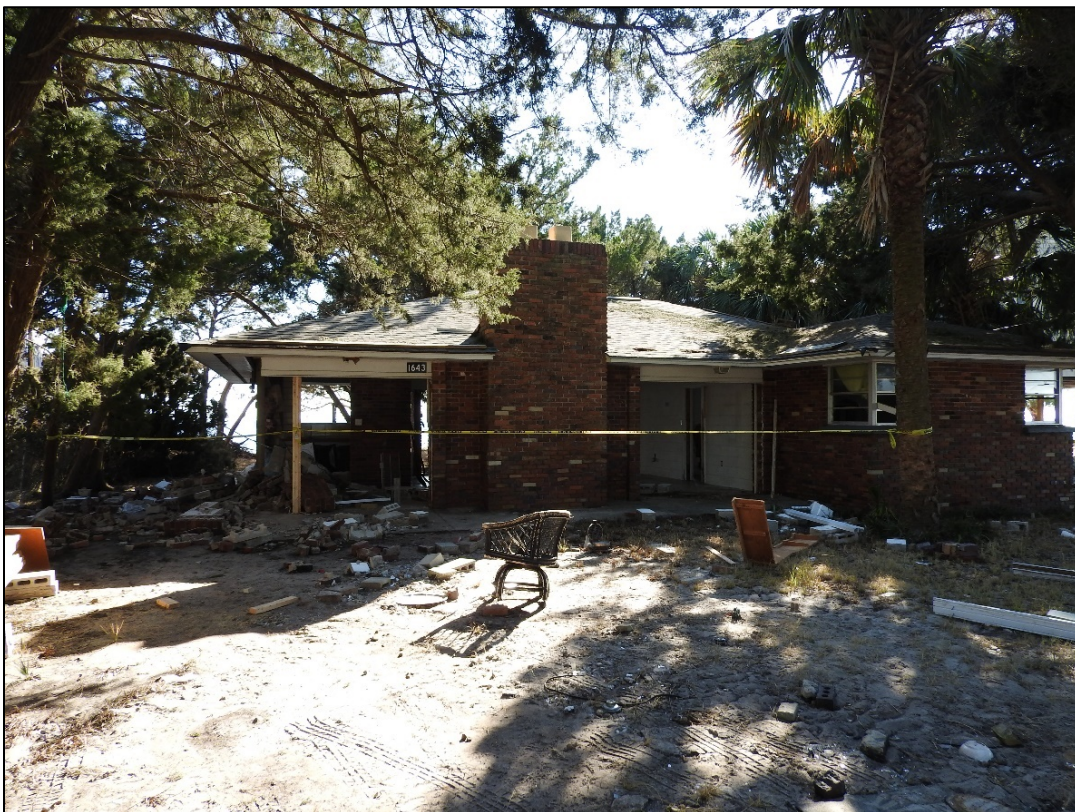
Figure 106. Dwelling with major damage from the storm surge at Shell Point, V342.

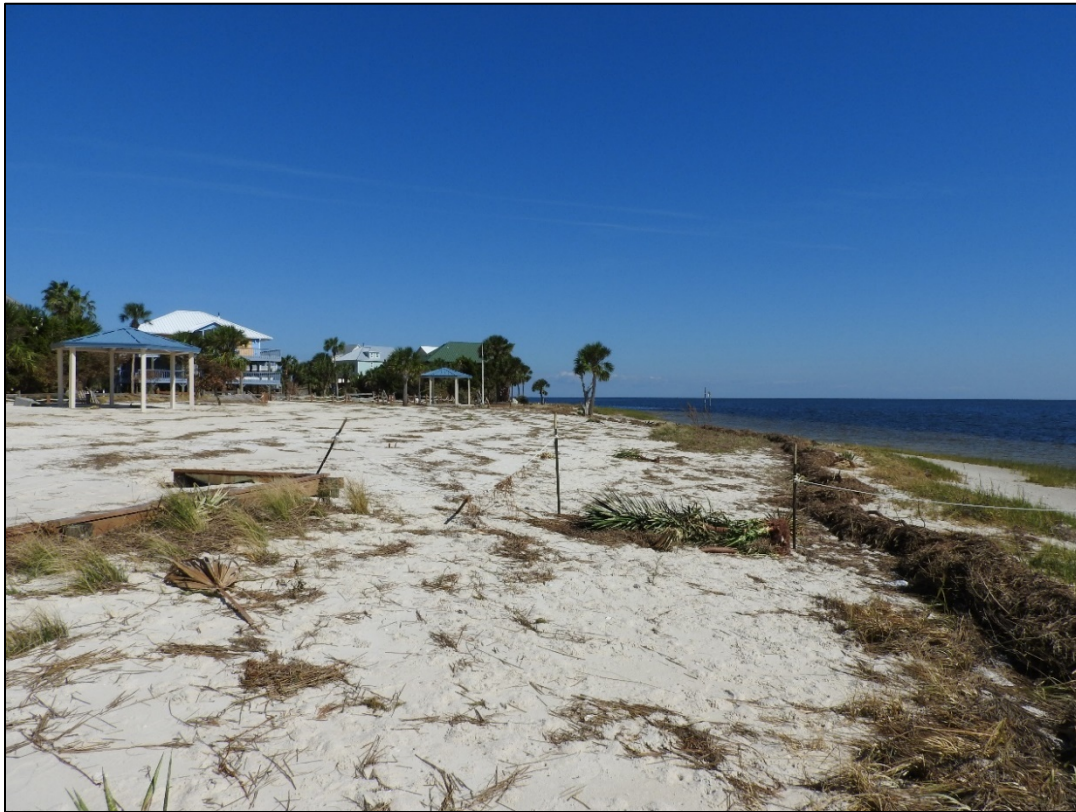
Figure 107. *Minor erosion to public beach at Shell Point, V355.*

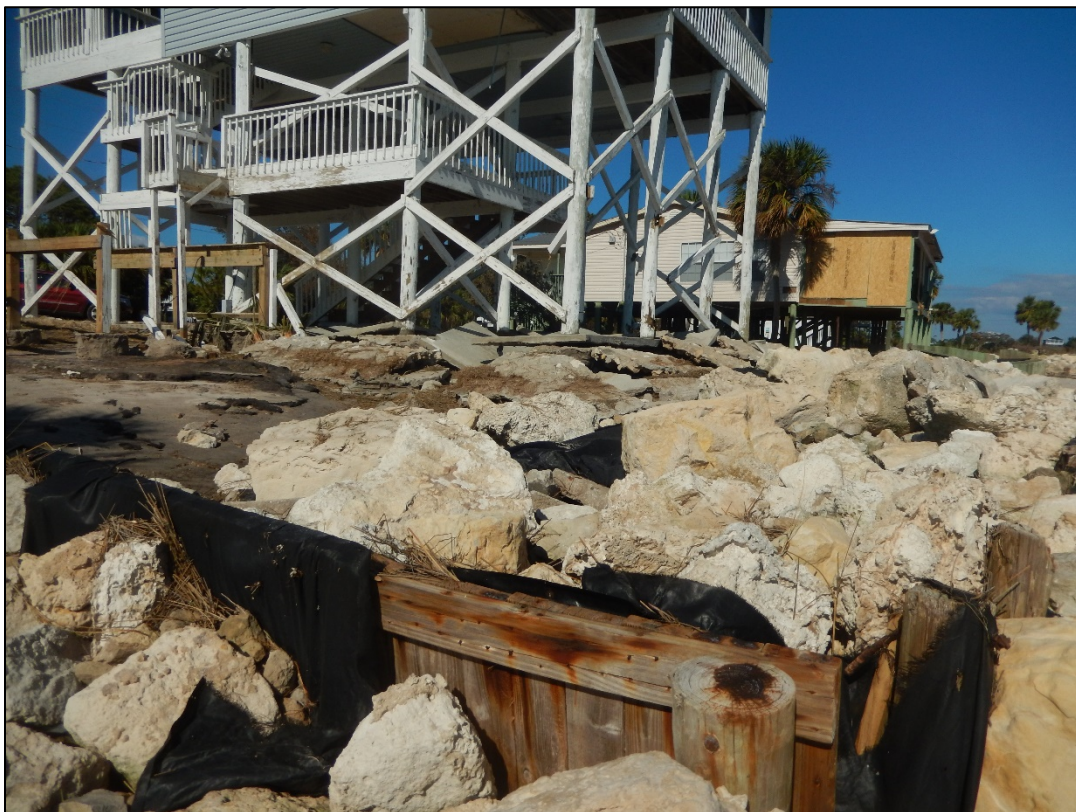
Figure 108. *Rock revetment damaged and dwelling with parking slab and bracing damage at Shell Point, V361.*
