***Hurricane Michael Post-Storm
Beach Conditions and Coastal Impact Report***

**Division of Water Resource Management
Florida Department of Environmental Protection**

**January 2019
(Revised April 2019)**

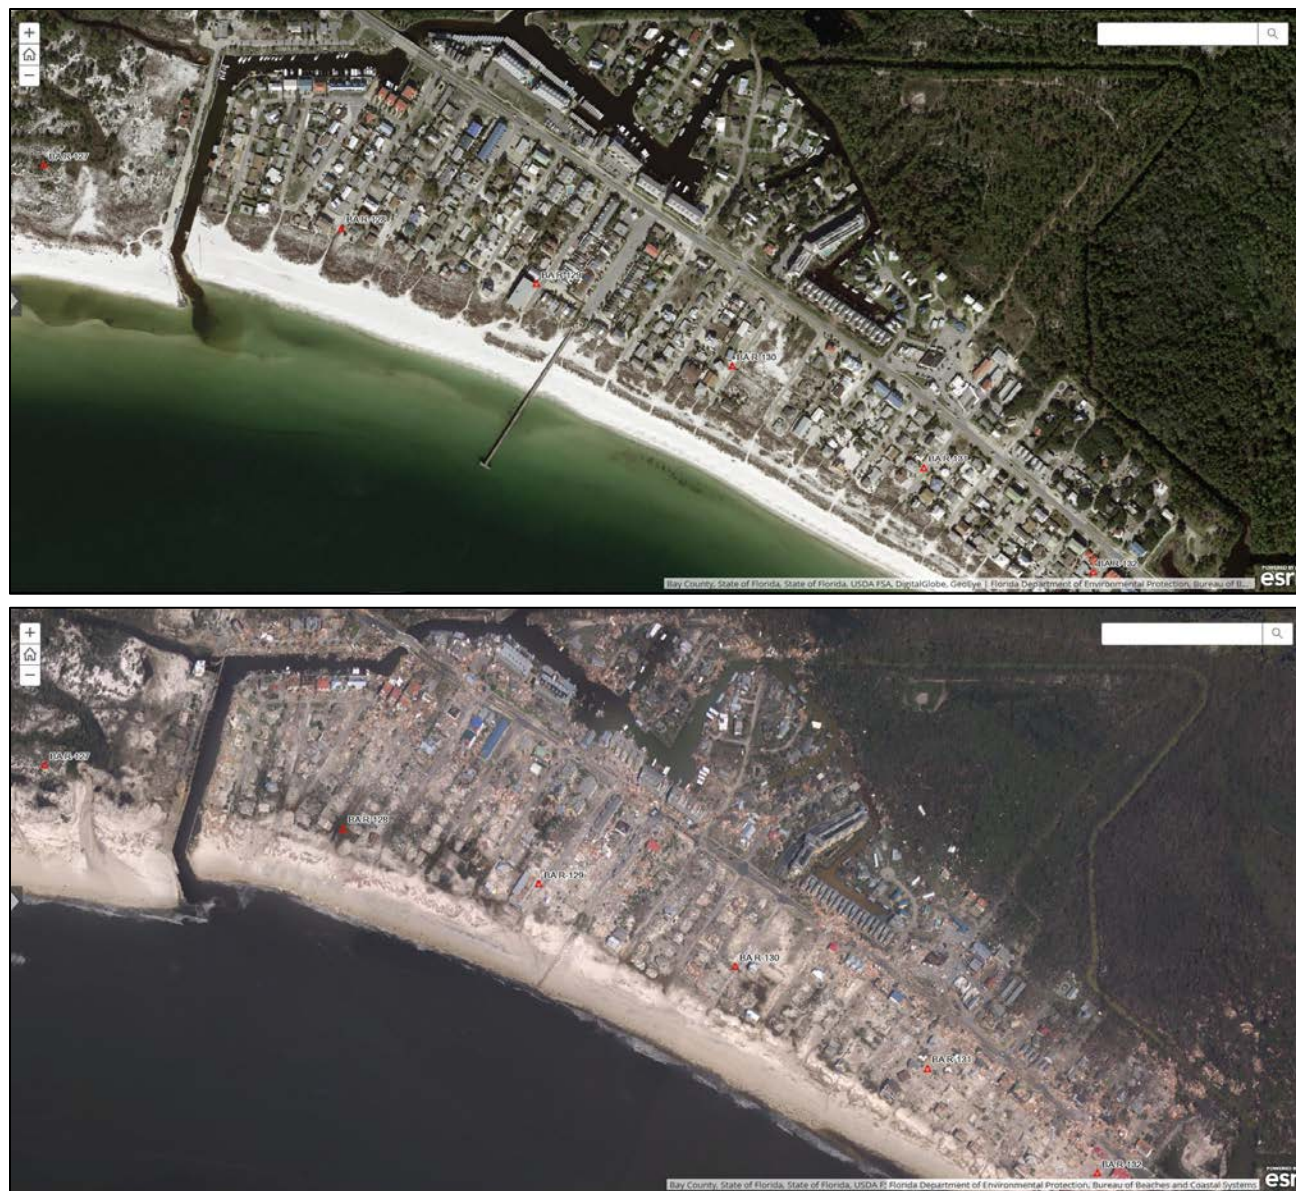
Figure 8. Aerial photo comparison of the severe damage in Mexico Beach (R127-R132). Source: Vexcel Imaging/ NICB Geospatial Intelligence Center.

To the east of Crooked Island, the most severe damage from Hurricane Michael was sustained along the mainland coast of eastern Bay County at Mexico Beach (**Figure 8**). On top of the storm surge, breaking waves caused the most severe damages. Many exterior water marks to 30 feet above sea level suggest the wave setup and wave uprush resulted in the destruction of most of the development seaward of U.S. Highway 98. Hurricane Michael's extreme storm tides and the high winds greatly exceeded the hurricane-resistant coastal construction standards of the Florida Building Code. Of the 210 buildings in Mexico Beach with major damage seaward of the Coastal Construction Control Line (CCCL), 180 buildings were destroyed, or roughly 85%. In addition, landward of the CCCL to the landward limit of the Coastal Building Zone, roughly 45% of the damaged buildings were destroyed. Within the Coastal

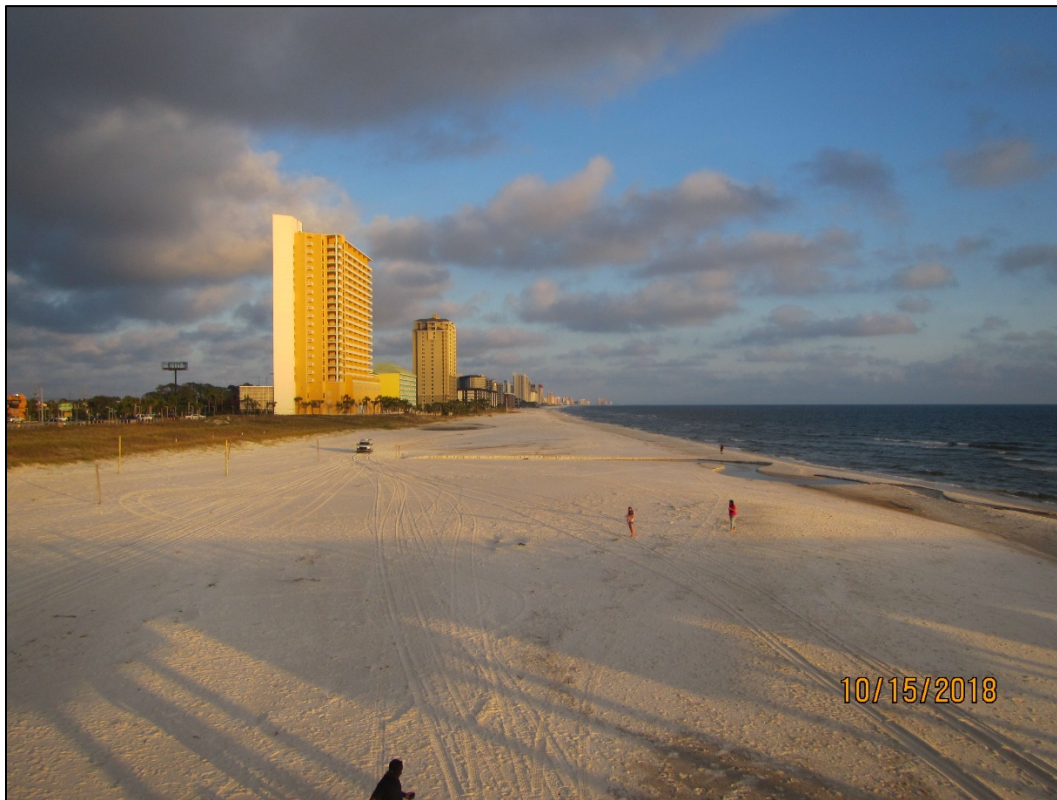
post-storm survey calculated a total loss of material for the project to be approximately -546,000 cubic yards. **Figure 11** shows post-storm beach conditions along the shore protection project near R57.

Figure 11. Beach erosion near R57, east of the M.B. Miller Pier, Panama City Beach.

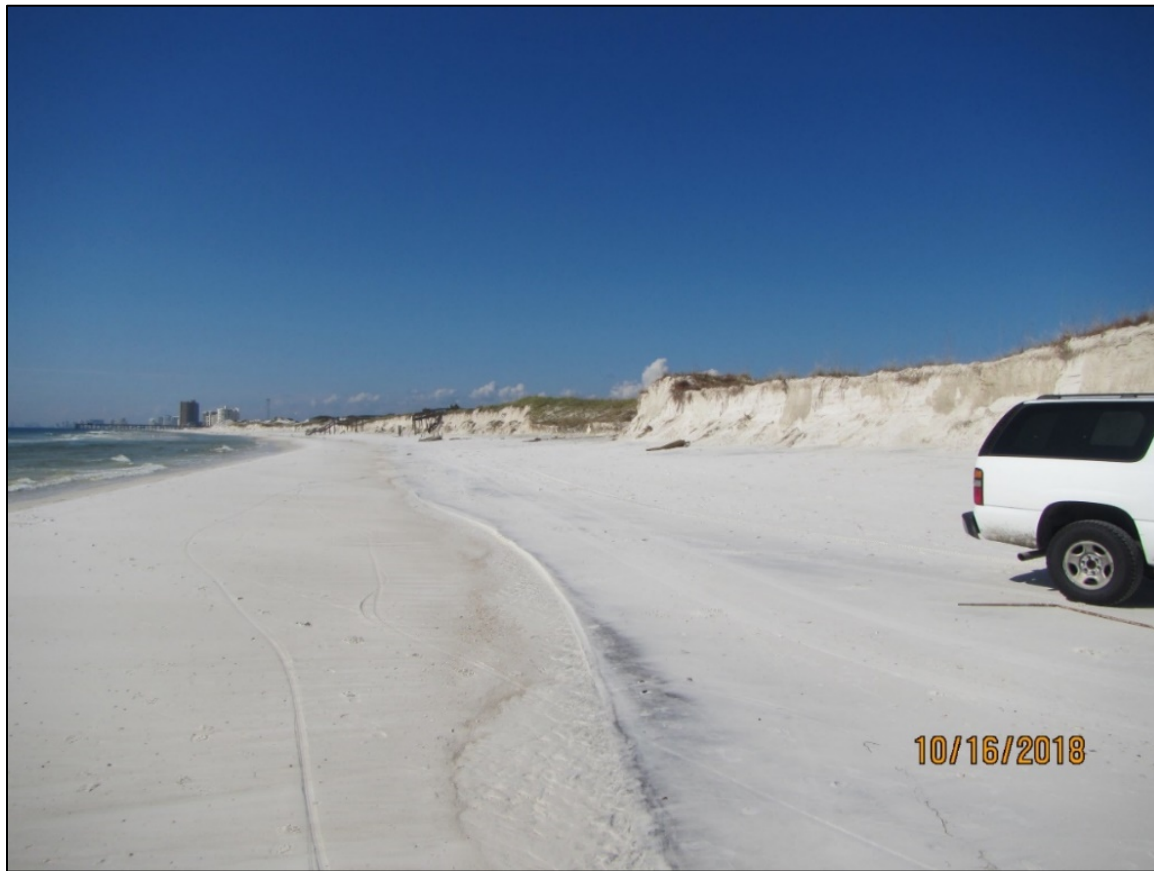
Figure 12. Major beach and dune erosion near R97, St. Andrews State Park.

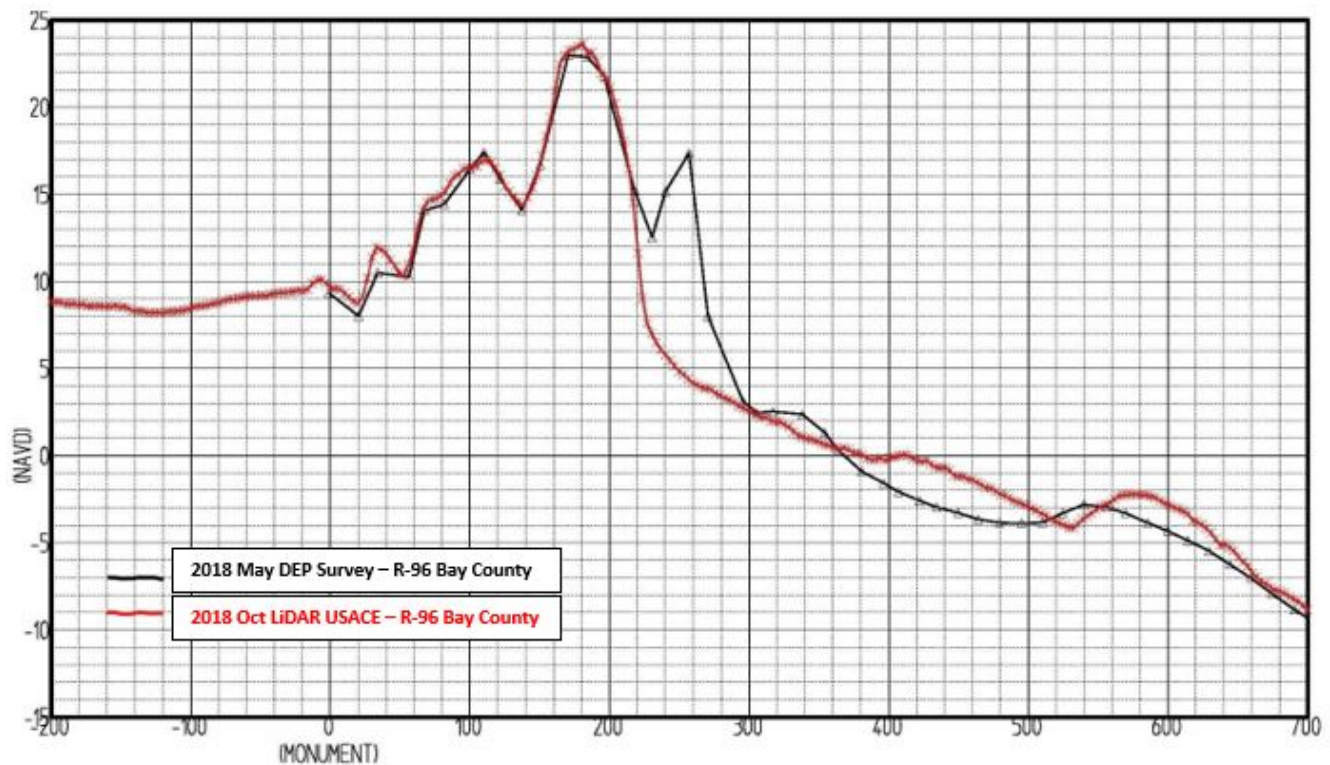
Figure 13. Pre-storm and post-storm profile comparison of major dune erosion in St. Andrews State Park, R96.

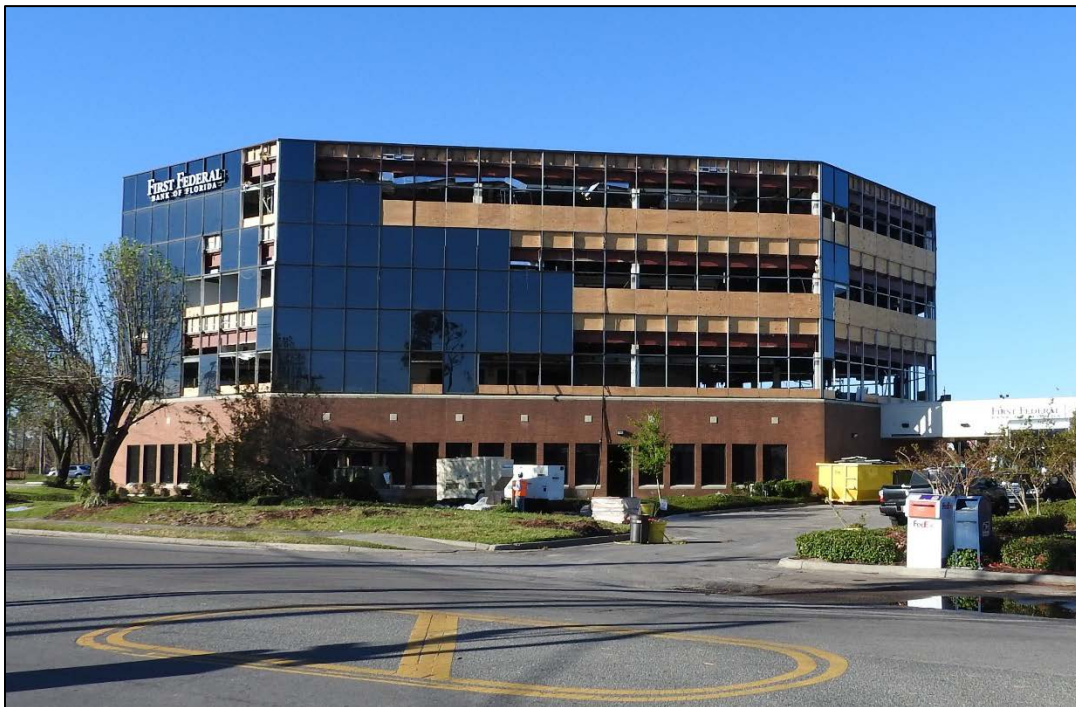
Figure 15. Bank with severe wind damage on 23rd Street, Panama City.

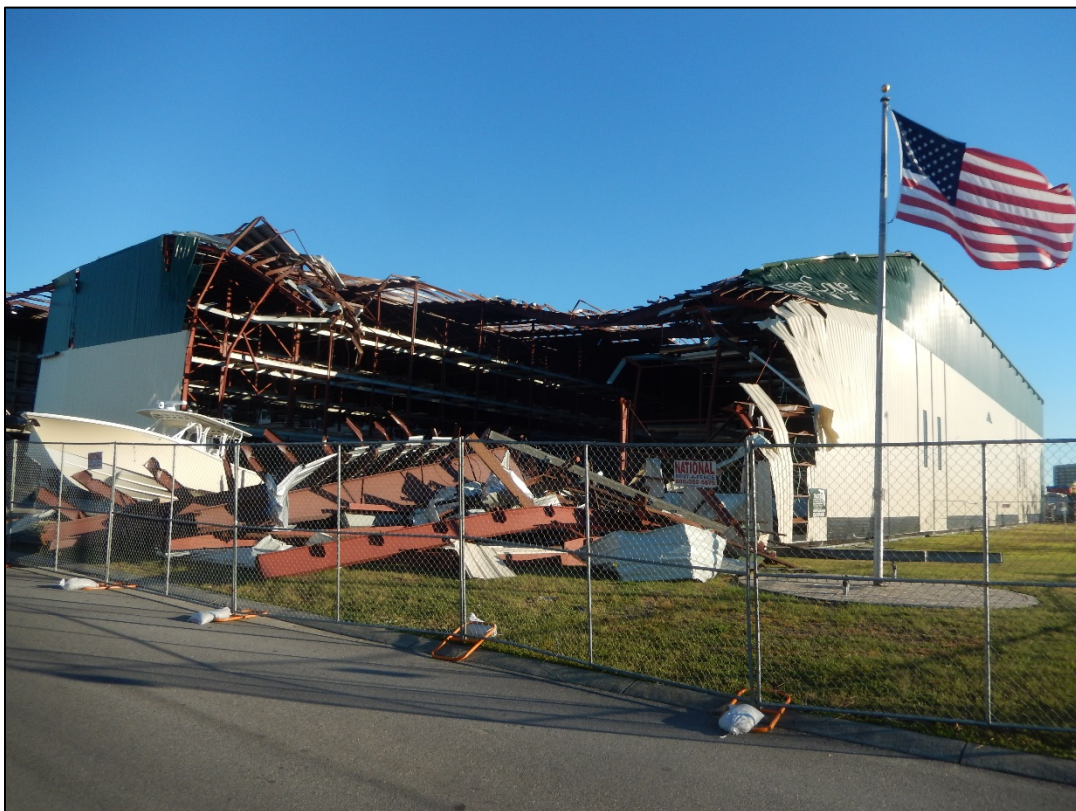
Figure 16. Dry storage marina with wind damage on Thomas Drive, Panama City Beach.

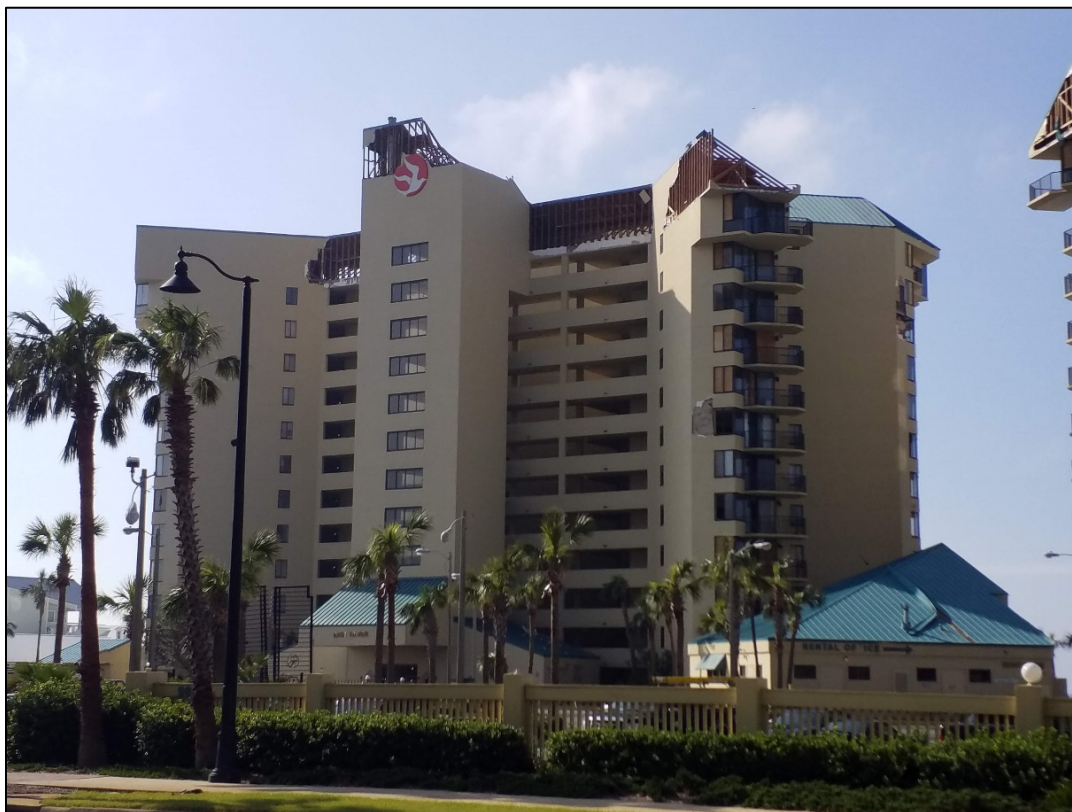
Figure 17. Wind damages on the Sunbird Condominiums near R67, Panama City Beach.

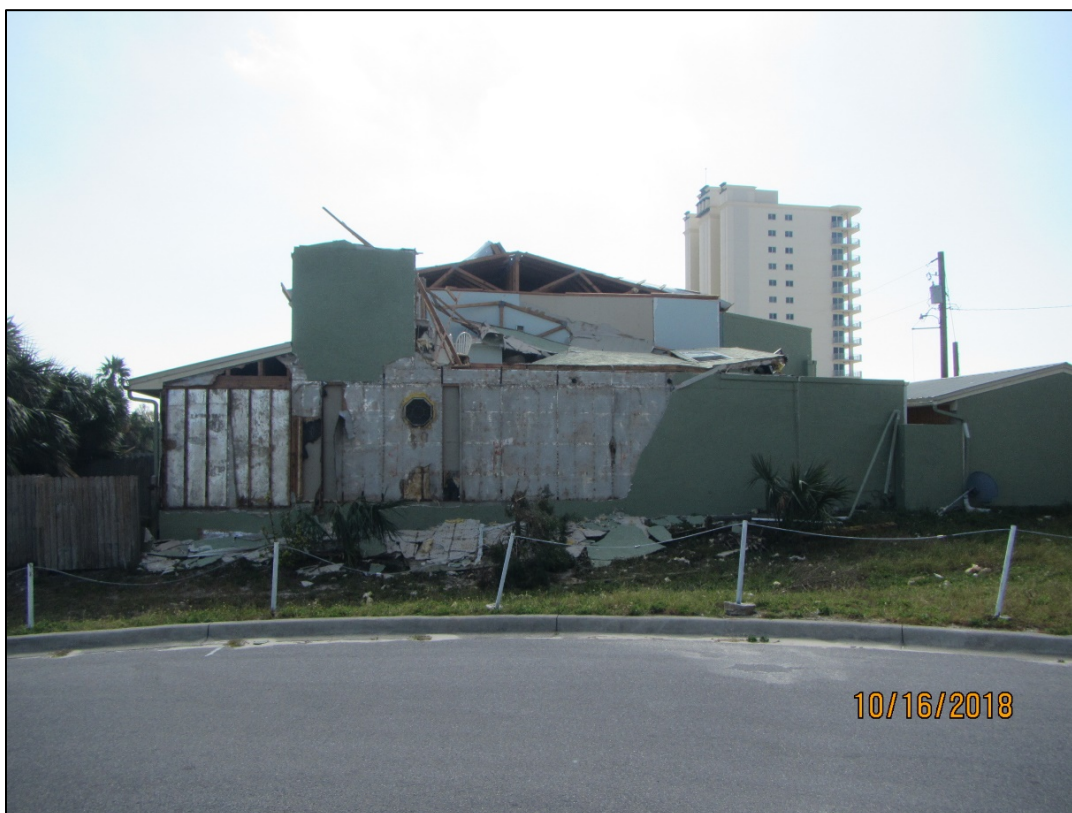
Figure 18. Wind damages on a multifamily dwelling near R73, Panama City Beach.

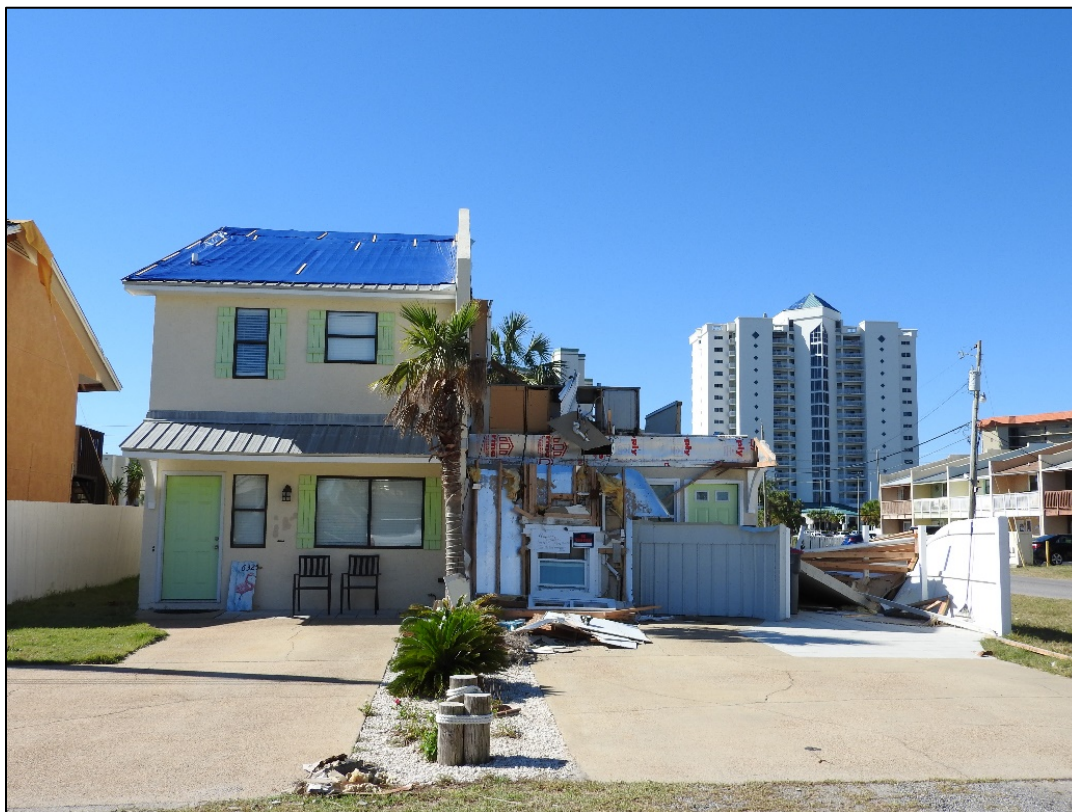
Figure 19. Roof damage and destroyed dwelling near R82, Panama City Beach.

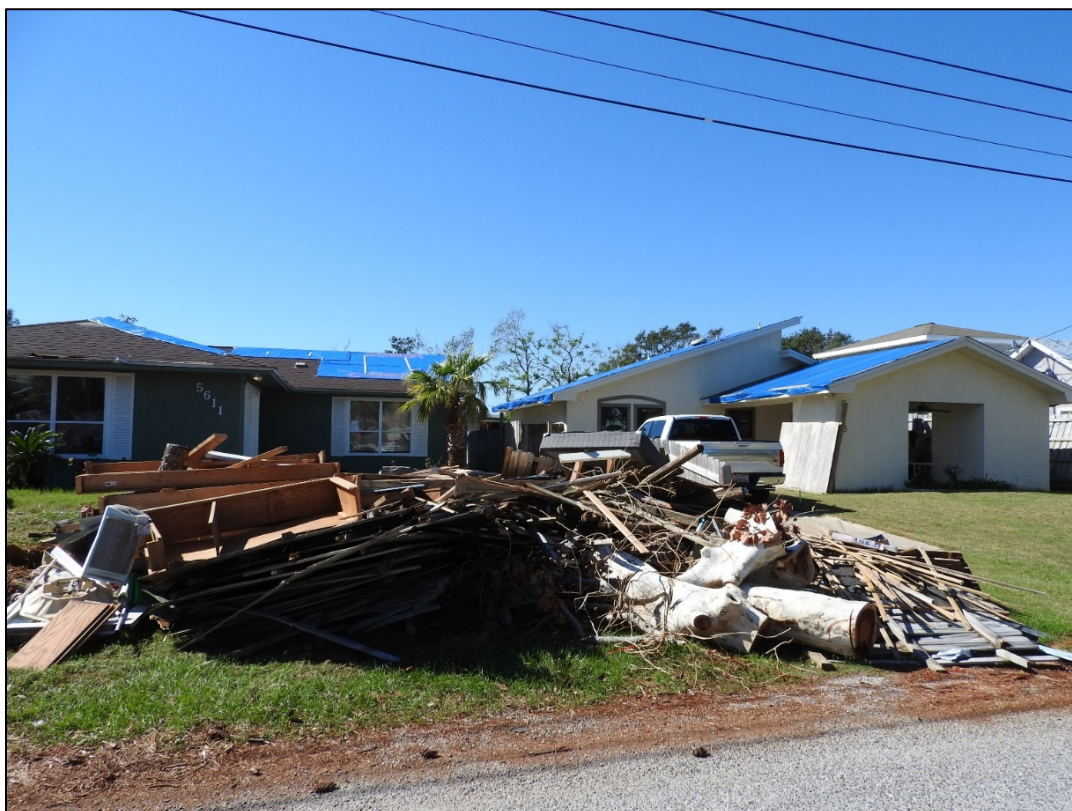
Figure 20. Roof damage on a single-family dwelling near R86, Panama City Beach.

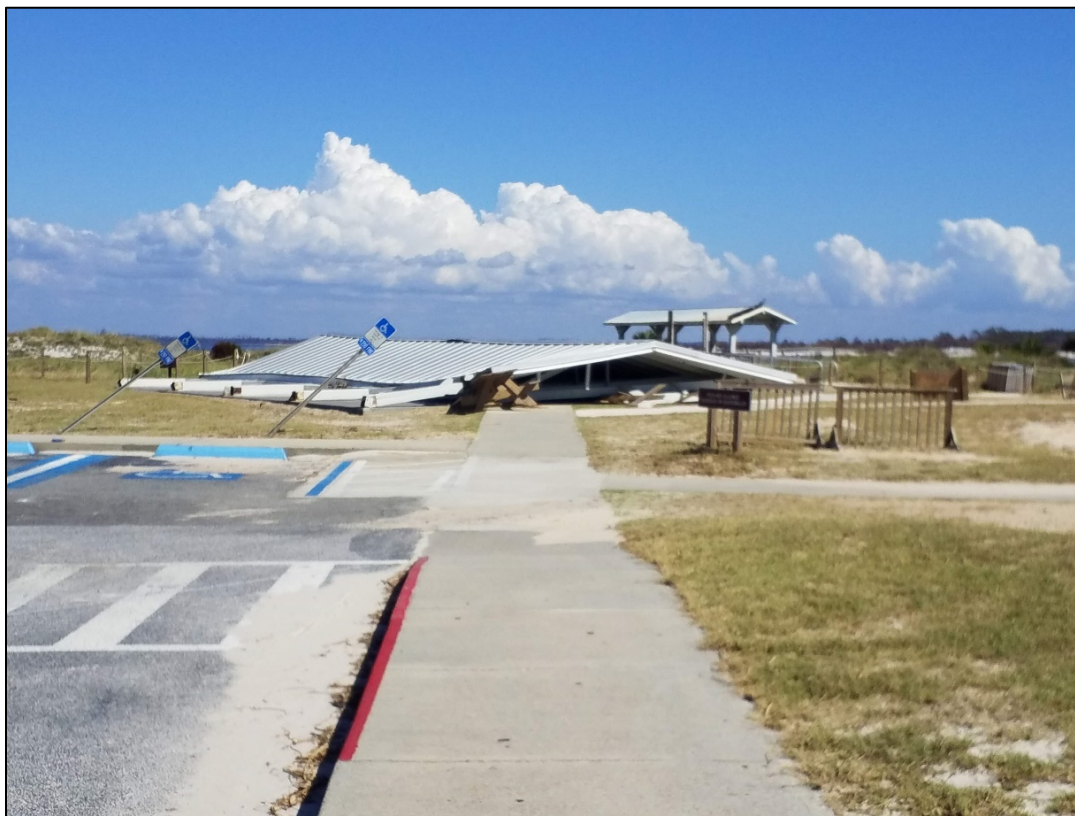
Figure 21. Collapsed pavilion near R97, St. Andrews State Park.

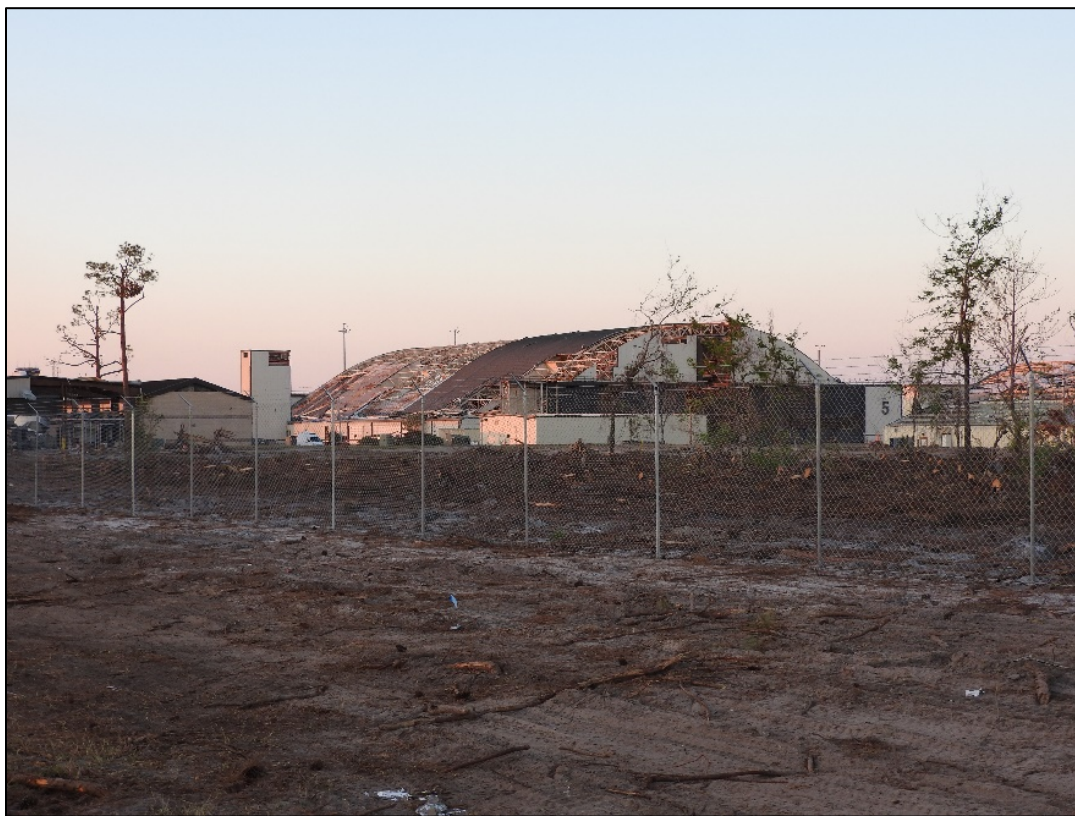
Figure 22. Tyndall Air Force Base, aircraft hangar damage.

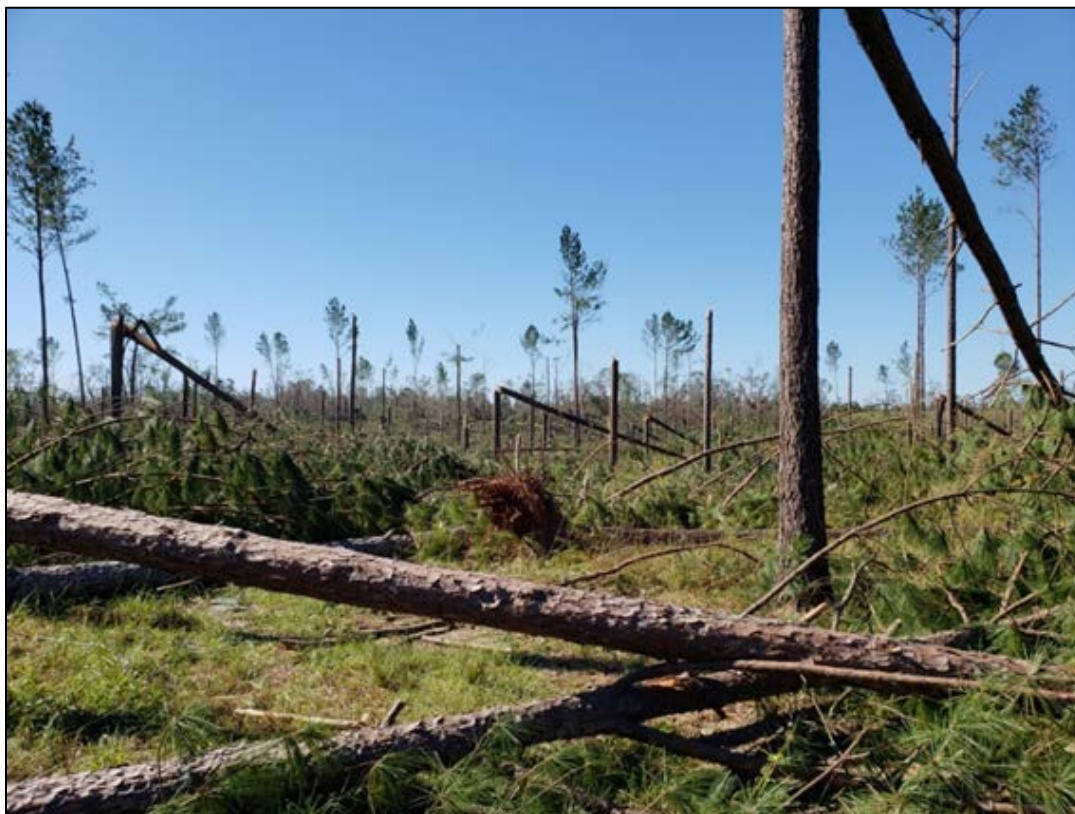
Figure 23. Bay County, pine forest leveled.

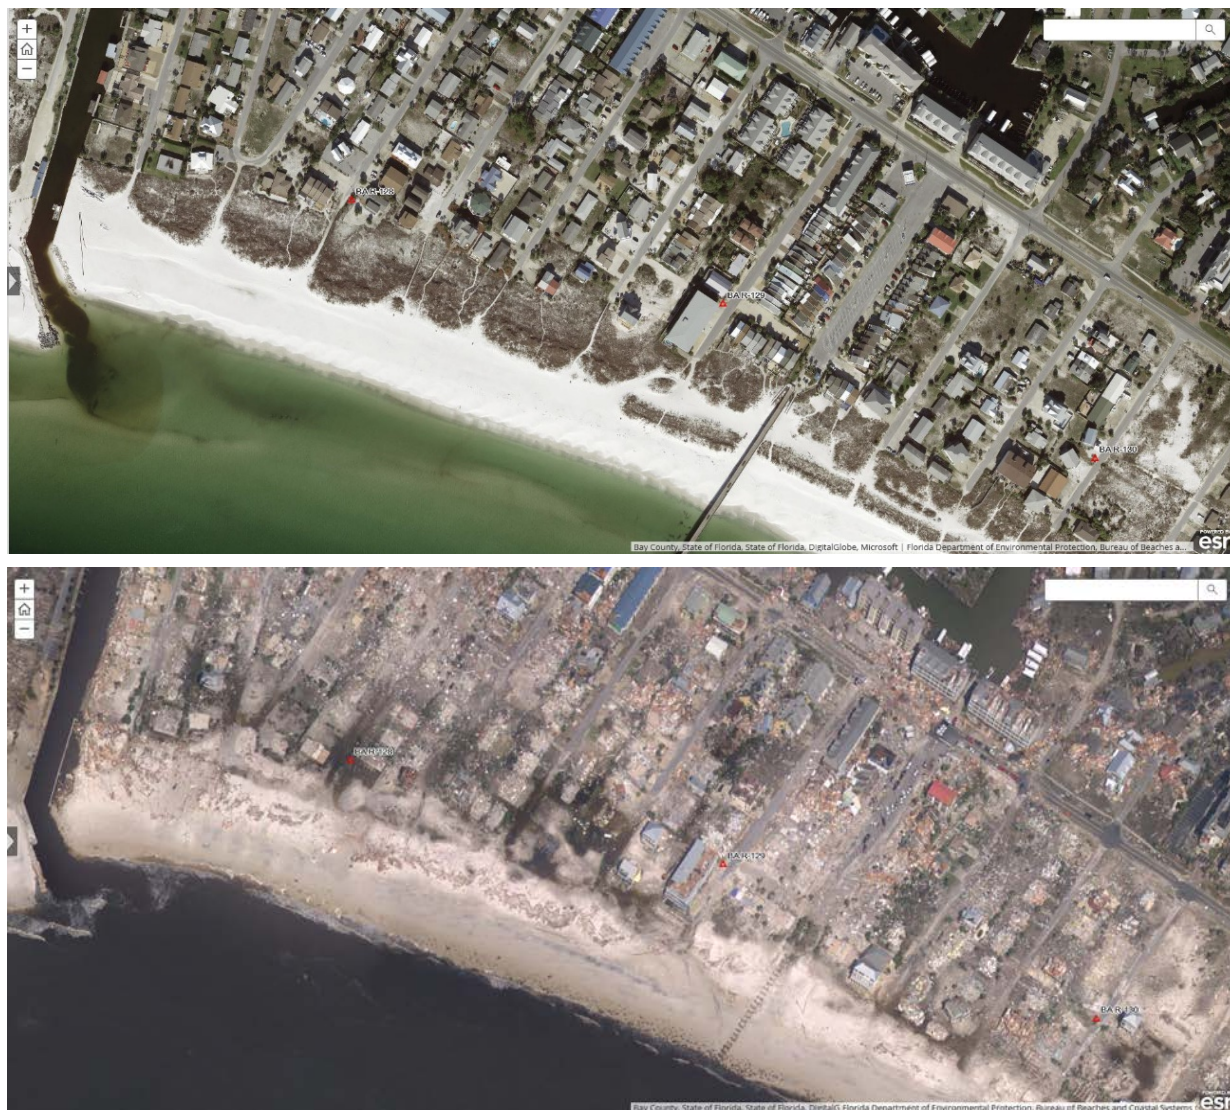
Figure 25. Aerial photo comparison of severe damage in Mexico Beach (R127.5-R130). Source: Vexcel Imaging/ NICB Geospatial Intelligence Center.

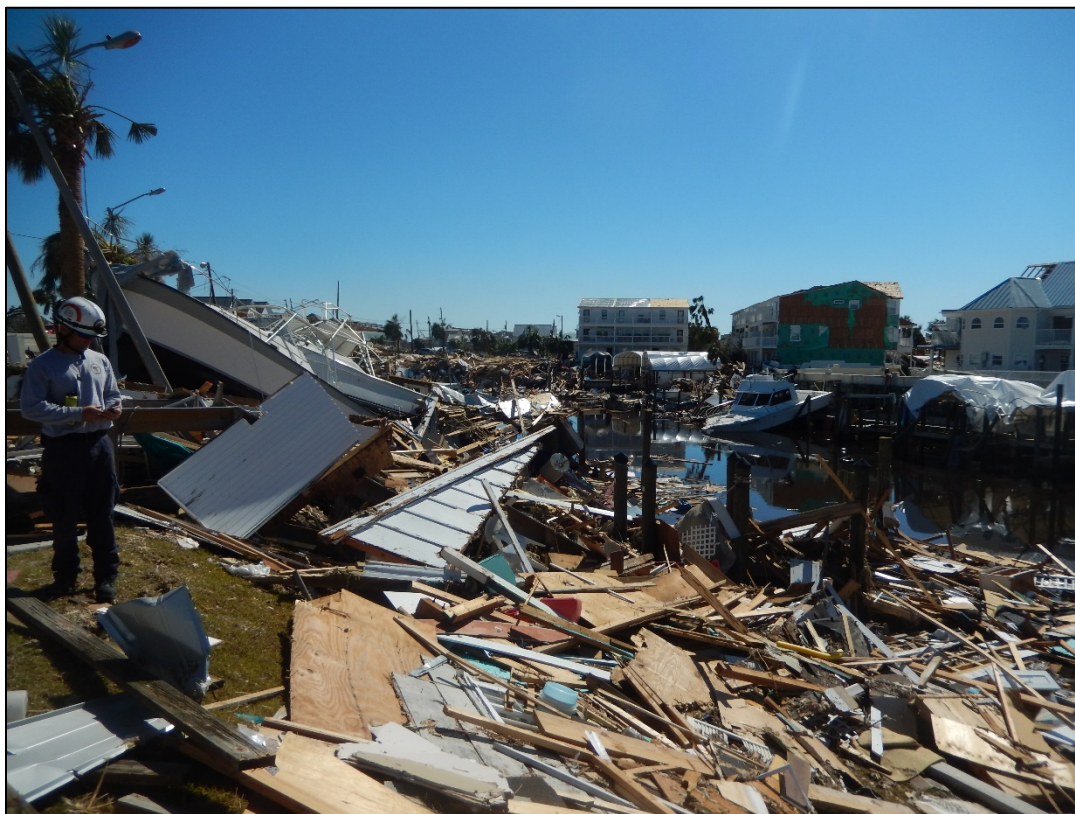
Figure 26. Debris and damages at Mexico Beach Canal, R127.5.

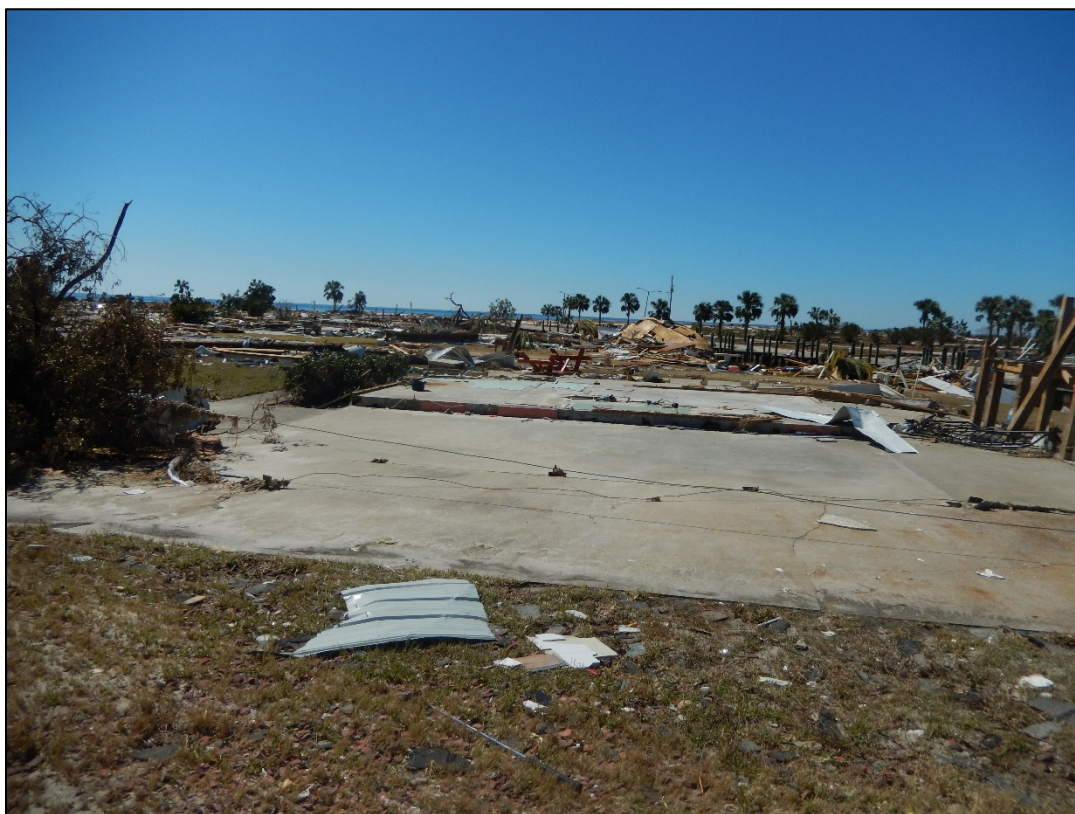
Figure 27. Rows of beach houses destroyed and removed by the storm surge, R127.5, Mexico Beach.

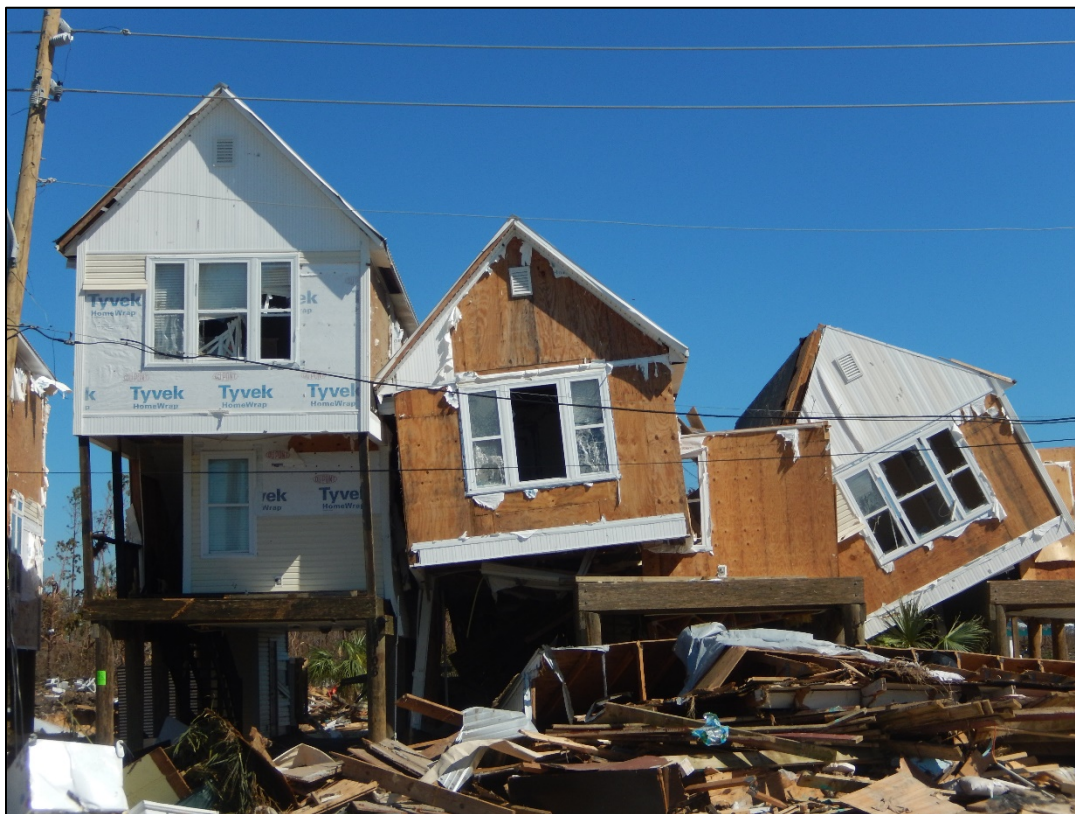
Figure 28. Beach dwellings north of U.S. 98 lifted off their foundations, R128, Mexico Beach.

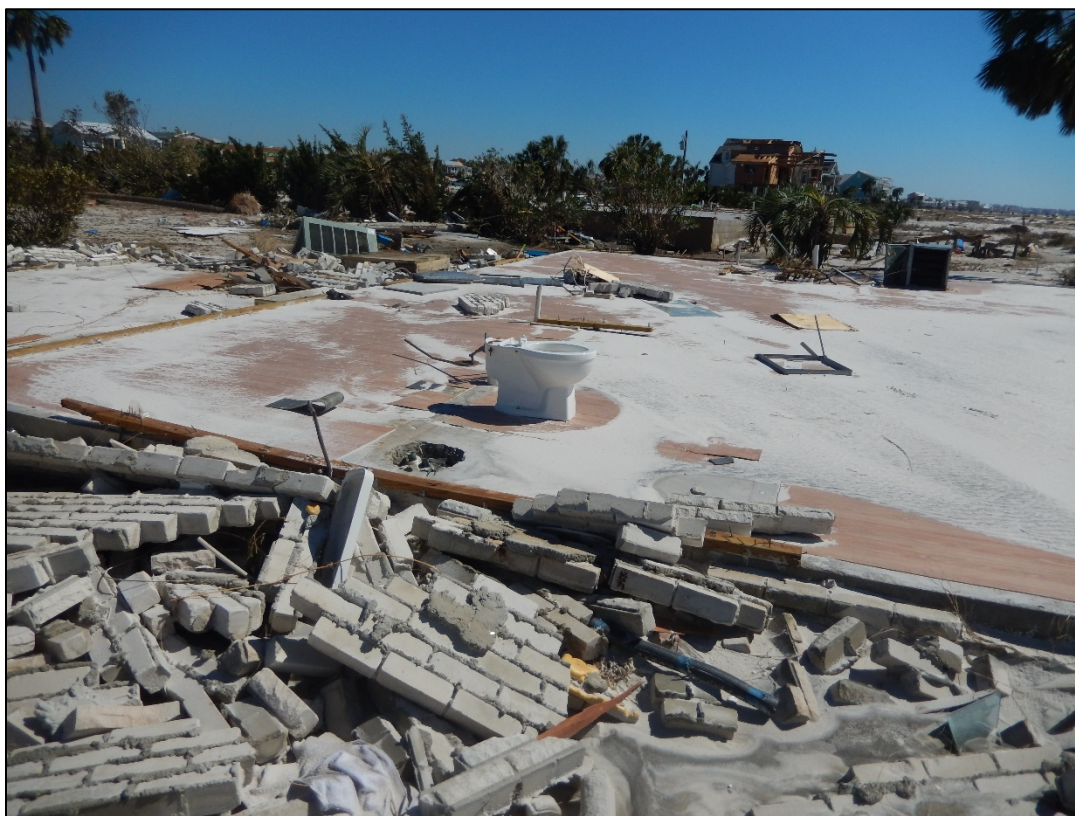
Figure 29. Remains of typical beach house destroyed near R128, Mexico Beach.

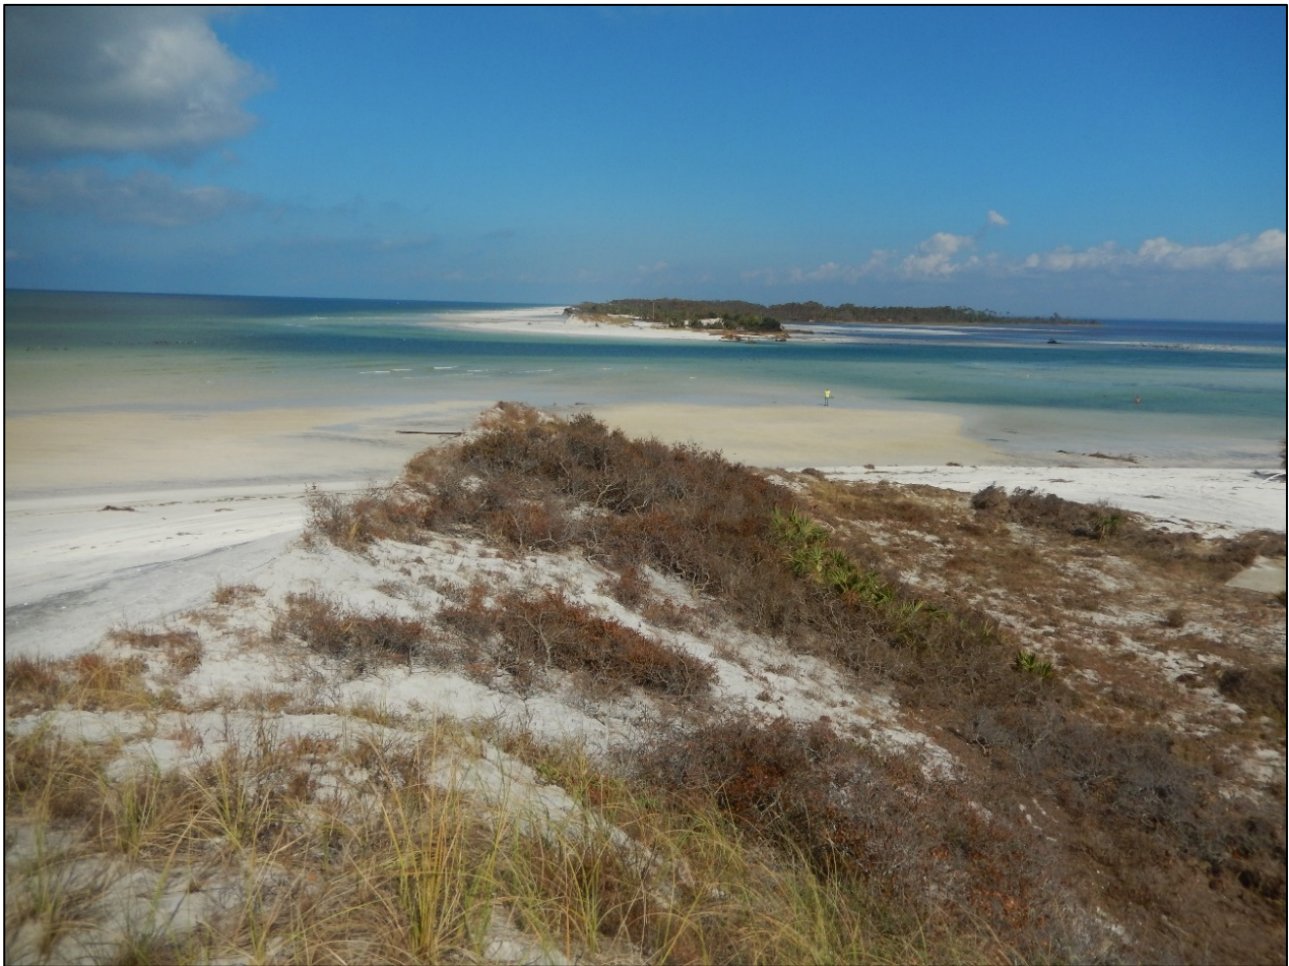
Hurricane Michael's greatest geomorphological impact to the Gulf County coast was a barrier breach near the midpoint of St. Joseph Peninsula. This breakthrough of the barrier peninsula occurred generally between R71 and R72, at a place called Eagle Harbor just north of the marina within T.H. Stone Memorial St. Joseph Peninsula State Park (**Figures 45-46**). To the north of the breach, northern St. Joseph Peninsula, now an island extending between R32 and R71, sustained a net loss of approximately one million cubic yards of beach and dune sand above MLW.

Figure 45. Breach across St. Joseph Peninsula between R71 and R72.

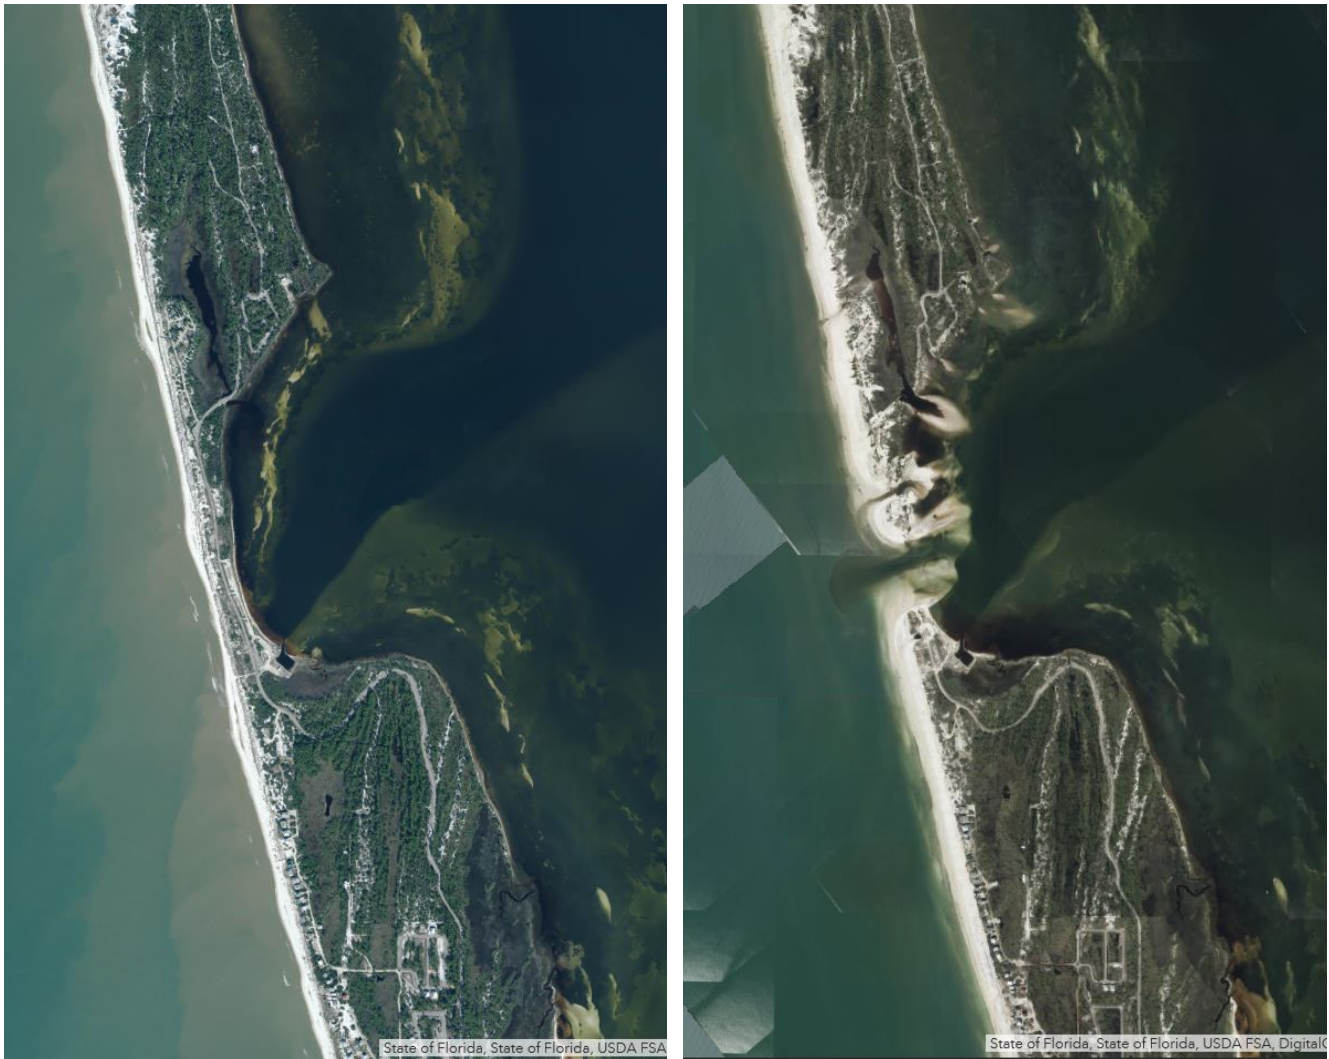
Figure 46. Before and after aerial photos of breach across St. Joseph Peninsula between R71 and R72 (Source: Vexcel Imaging/ NICB Geospatial Intelligence Center).

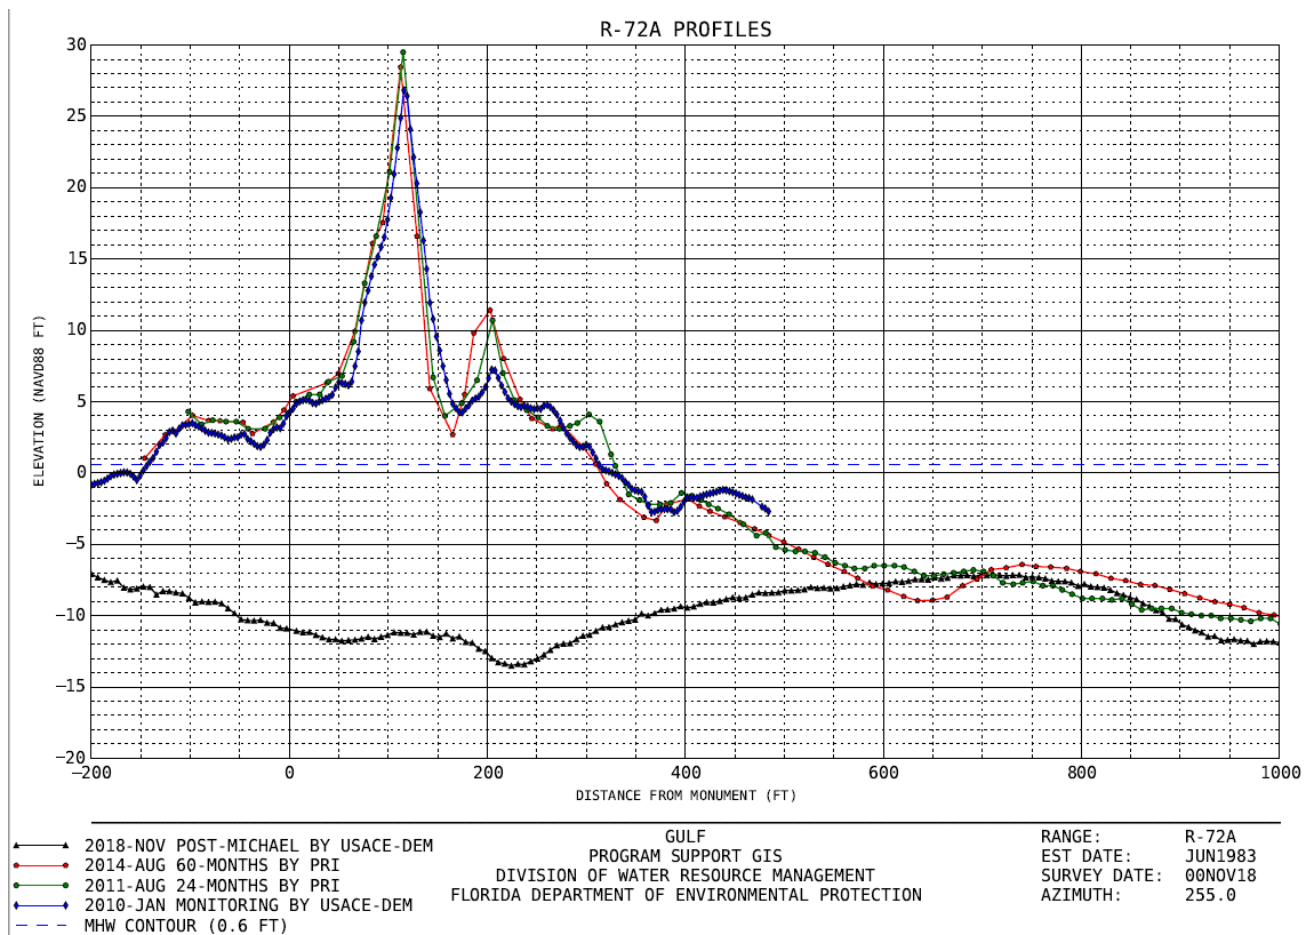
Figure 47. Pre-storm and post-storm profile comparison at the site of the breach across St. Joseph Peninsula.

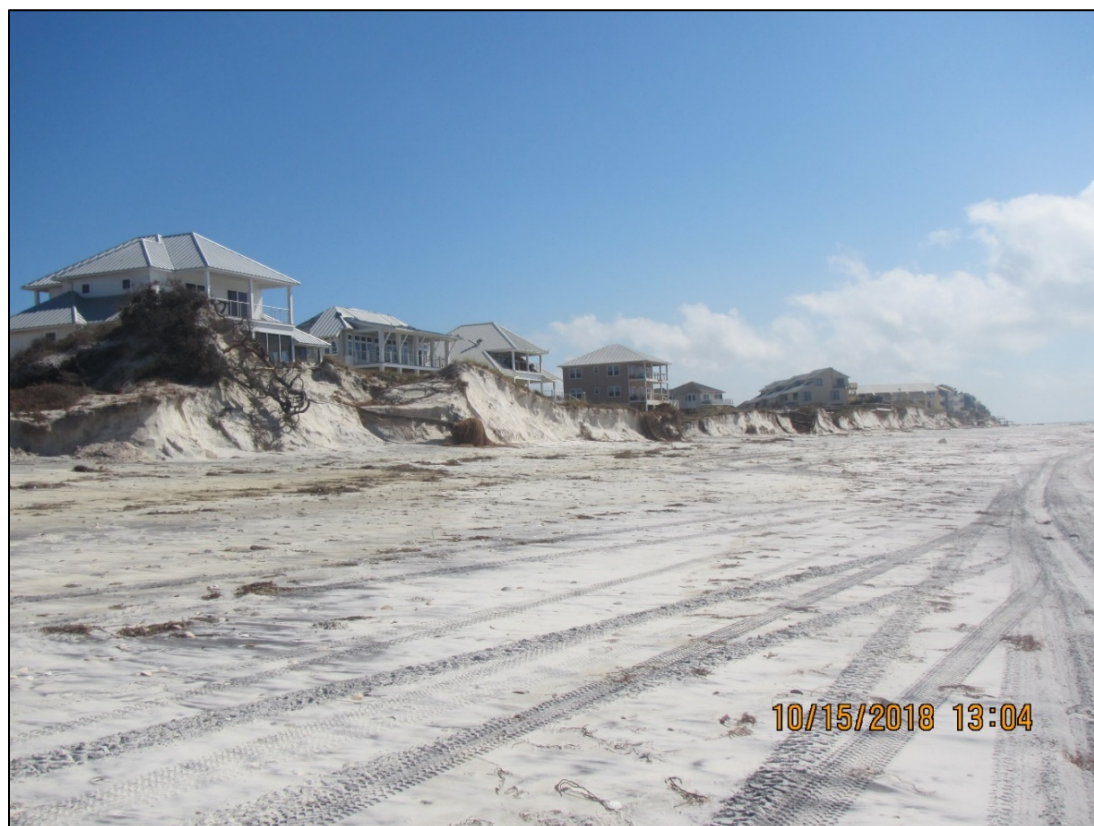
Figure 51. Major dune erosion, R77, St. Joseph Peninsula.
