***Hurricane Michael Post-Storm
Beach Conditions and Coastal Impact Report***

**Division of Water Resource Management
Florida Department of Environmental Protection**

**January 2019
(Revised April 2019)**

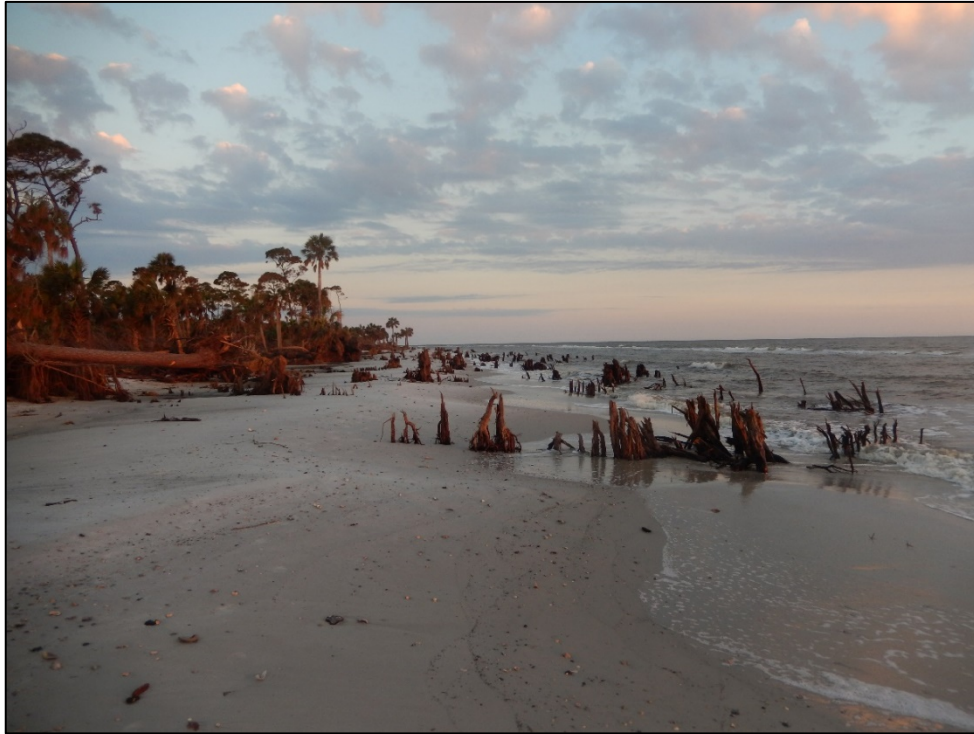
South of St. Joseph Peninsula, the west shore of Cape San Blas has a historic background erosion rate of -40 feet per year of shoreline recession. **Figure 52** shows the severe erosion conditions following Hurricane Michael near R110 at the site of the historic Cape San Blas Lighthouse, which was relocated to Port St. Joe in 2014. Another major geomorphological change to the Gulf County coast caused by Hurricane Michael was observed through the loss of approximately 660 feet off the southern tip of Cape San Blas (**Figure 53**).

Figure 52. Severe beach and dune erosion at Cape San Blas, R110.

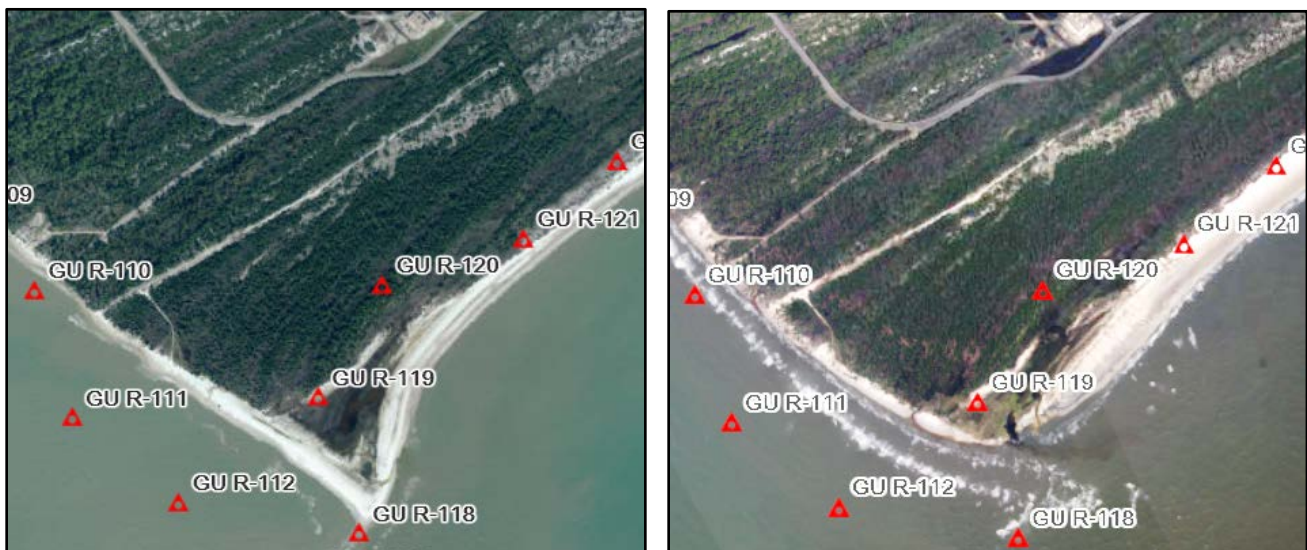
Figure 53. Before and after aerial photos of Cape San Blas showing the loss of 660 feet off the cape at R118. (Source: Vexcel Imaging/ NICB Geospatial Intelligence Center)

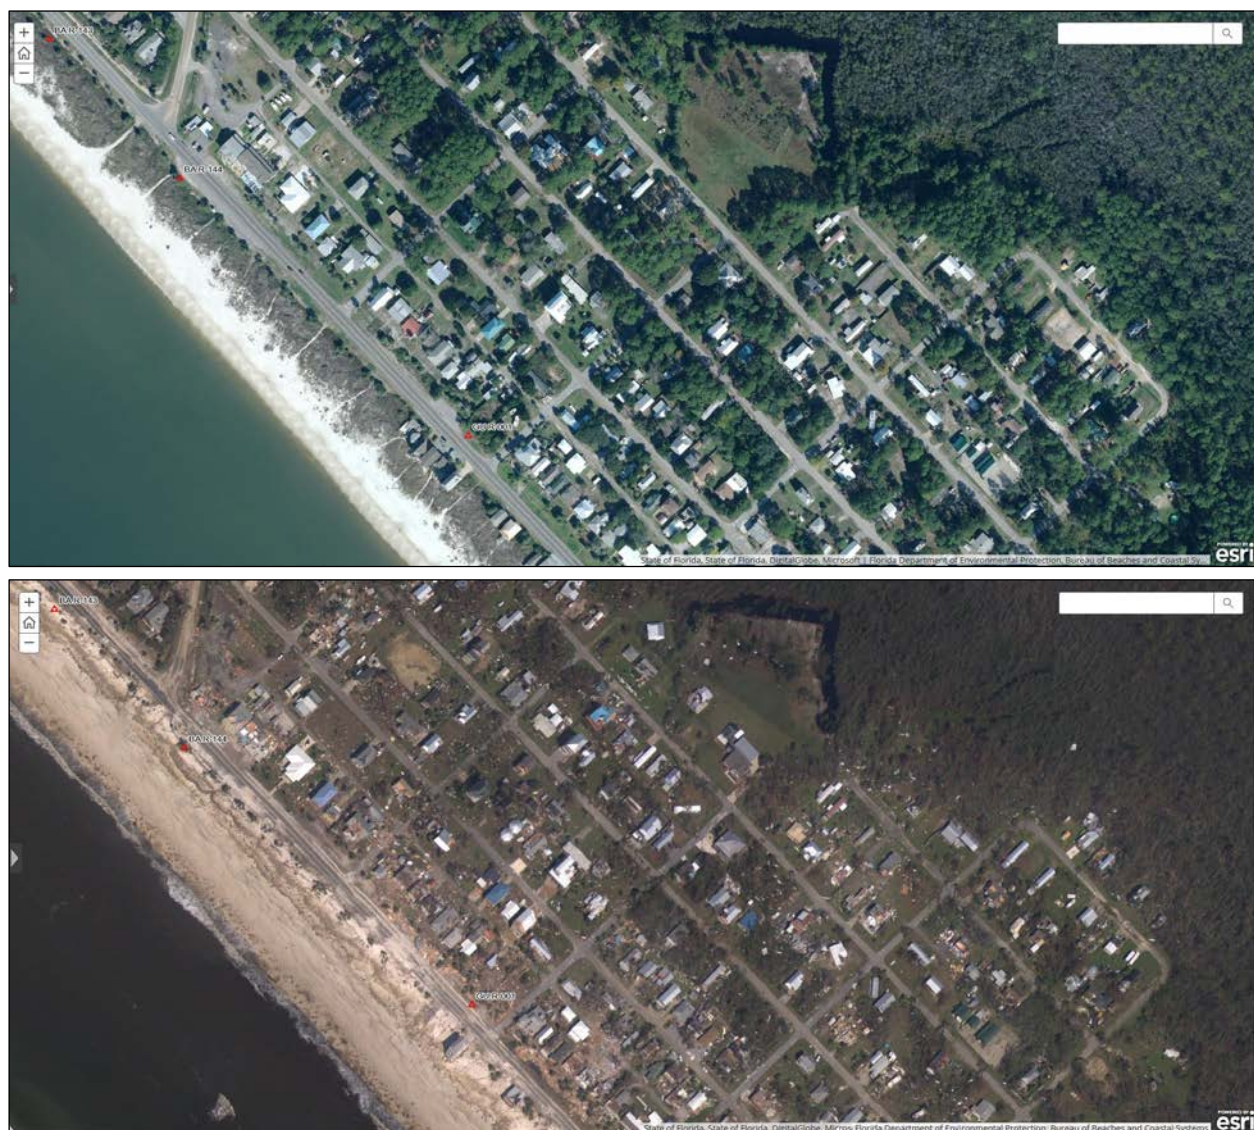
Figure 55. Before and after aerial photo comparison in Beacon Hill (R1). Source: Vexcel Imaging/ NICB Geospatial Intelligence Center.

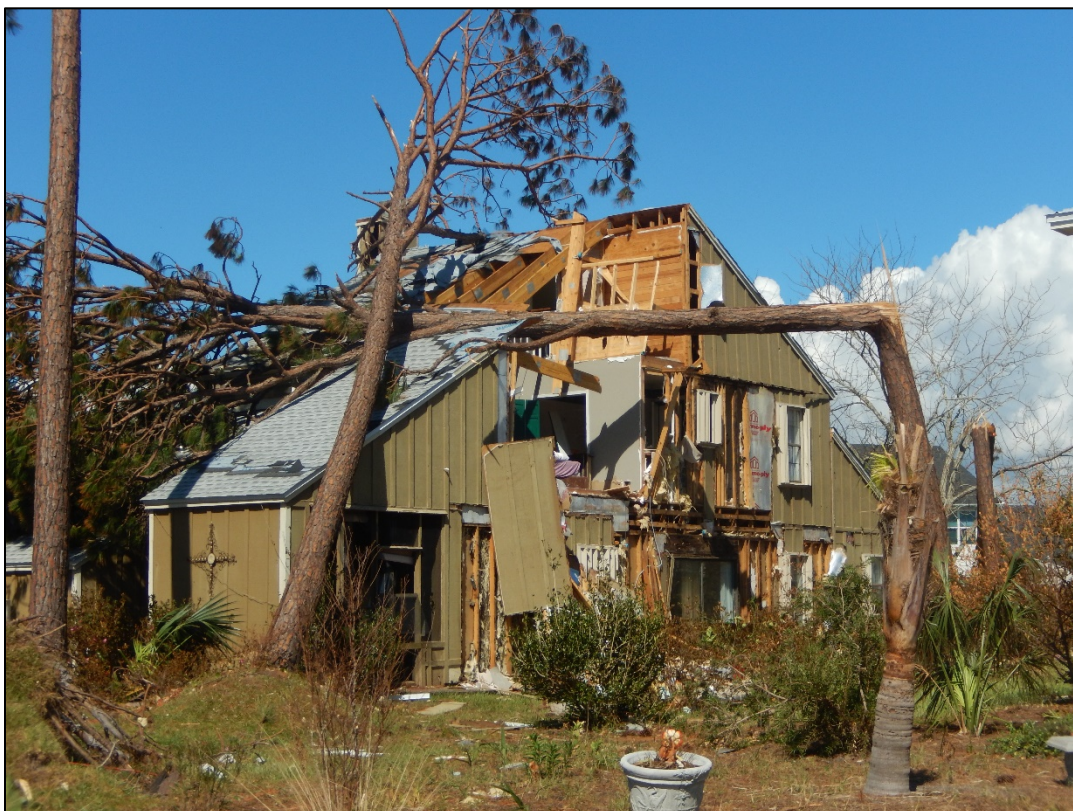
Figure 62. Major damage to dwelling due to high winds and fallen trees, Beacon Hill.

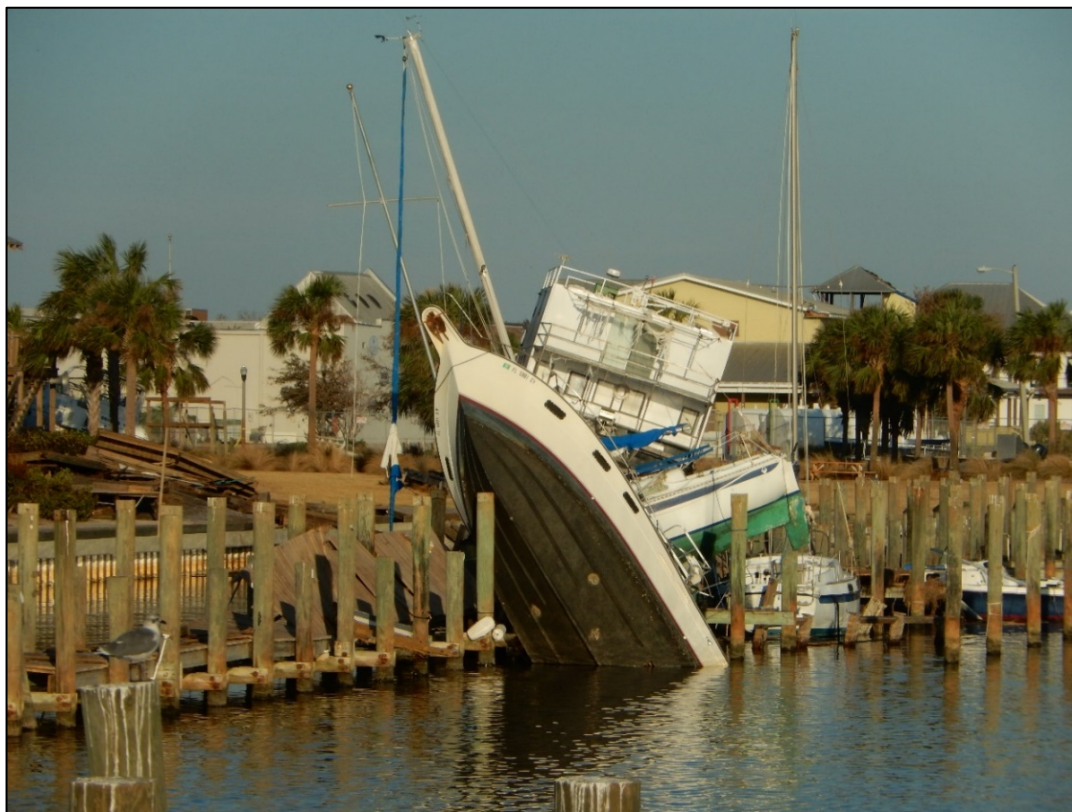
Figure 63. Marina damage due to the storm surge, Port St. Joe.

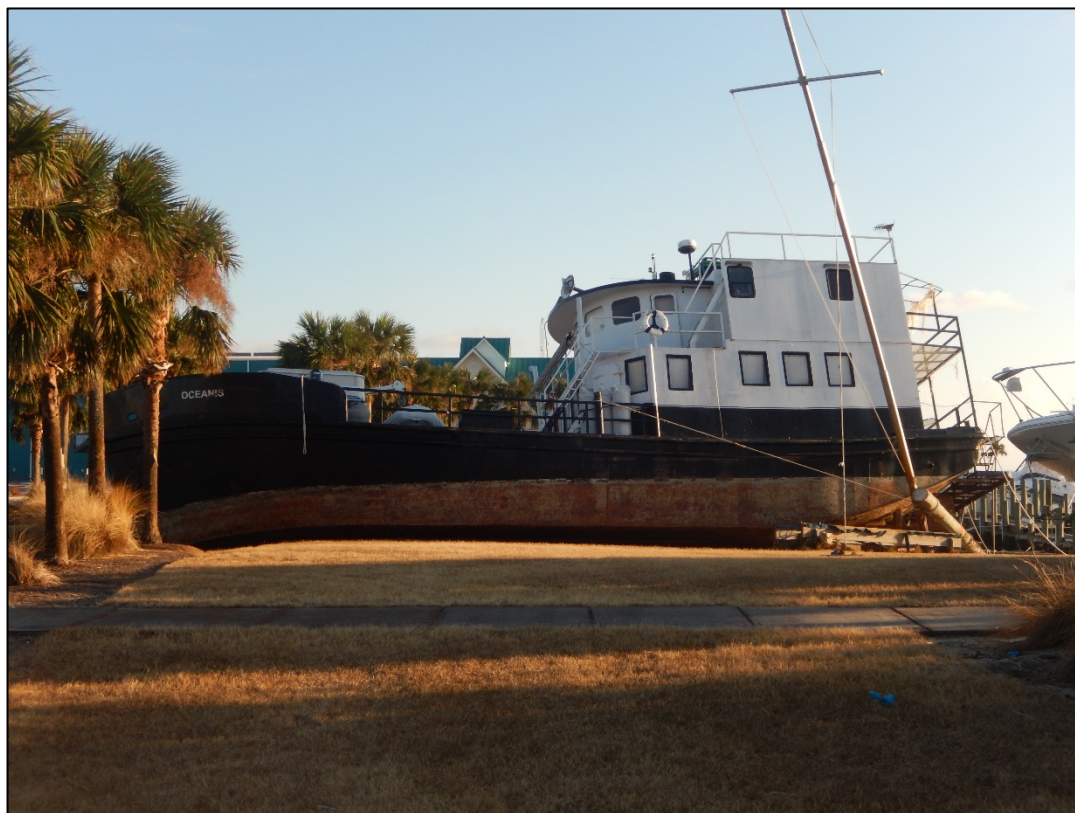
Figure 64. Ship carried onto upland by the storm surge, Port St. Joe.

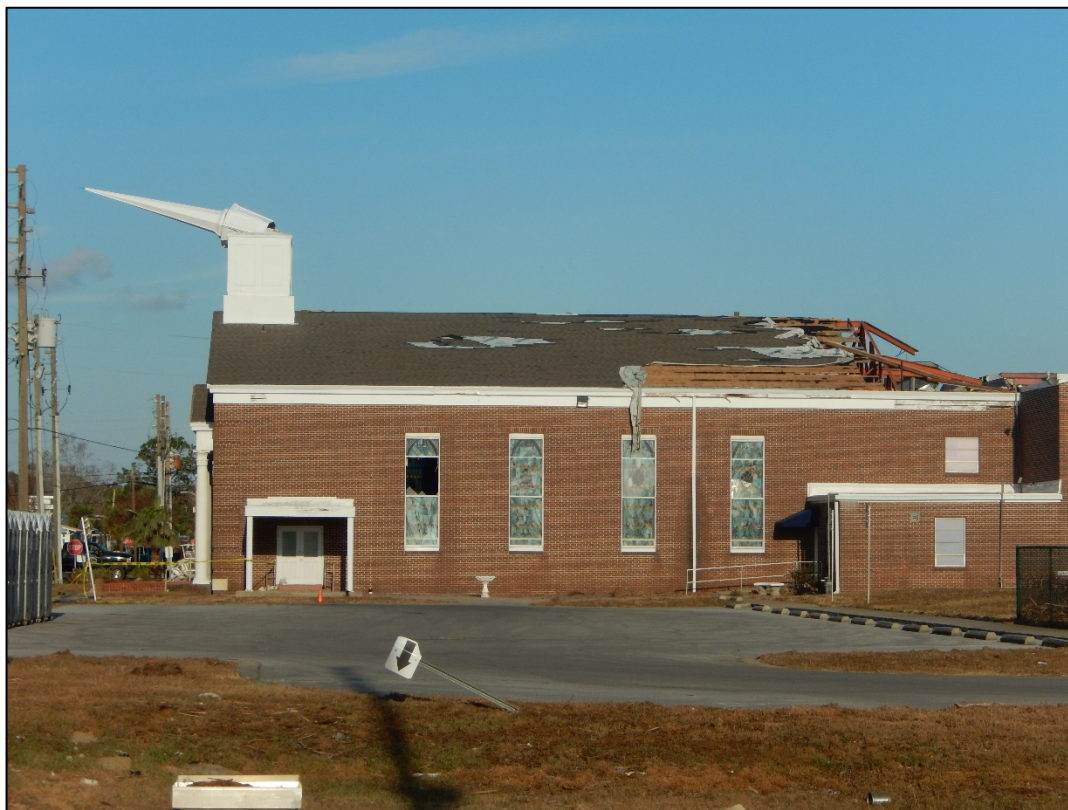
Figure 65. First Baptist Church with major wind damage, Port St. Joe.

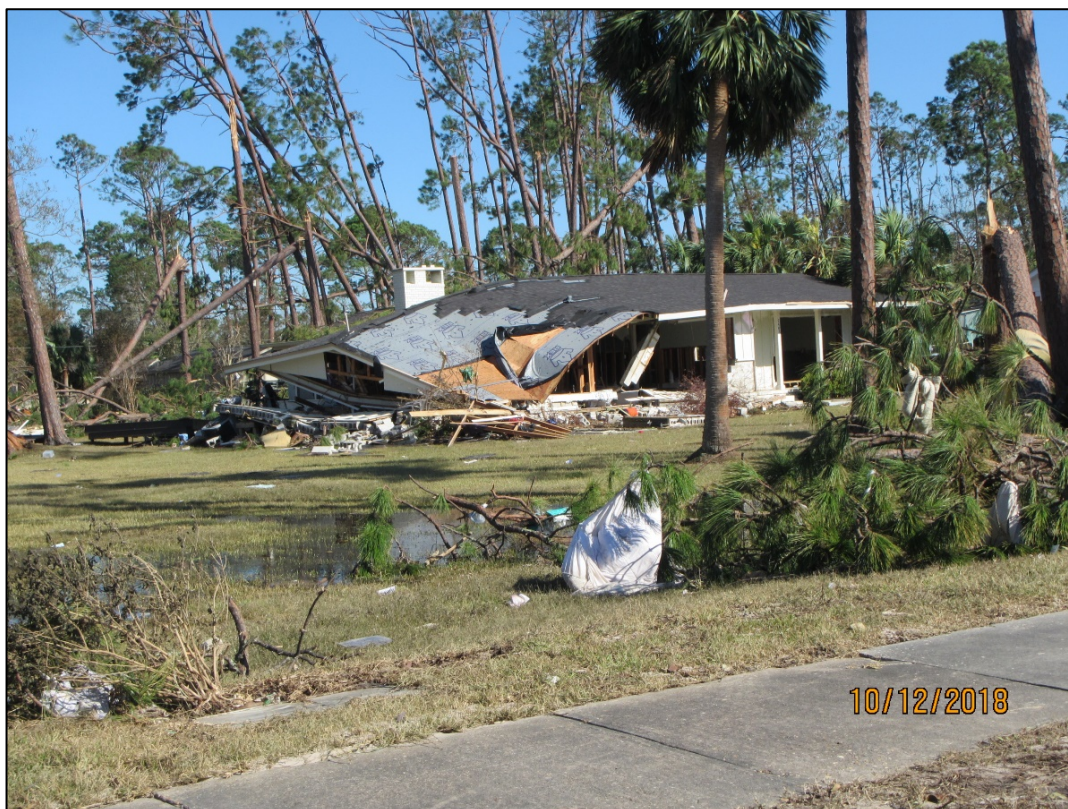
Figure 66. Dwelling destroyed by the storm surge from St. Joseph Bay, Port St. Joe.

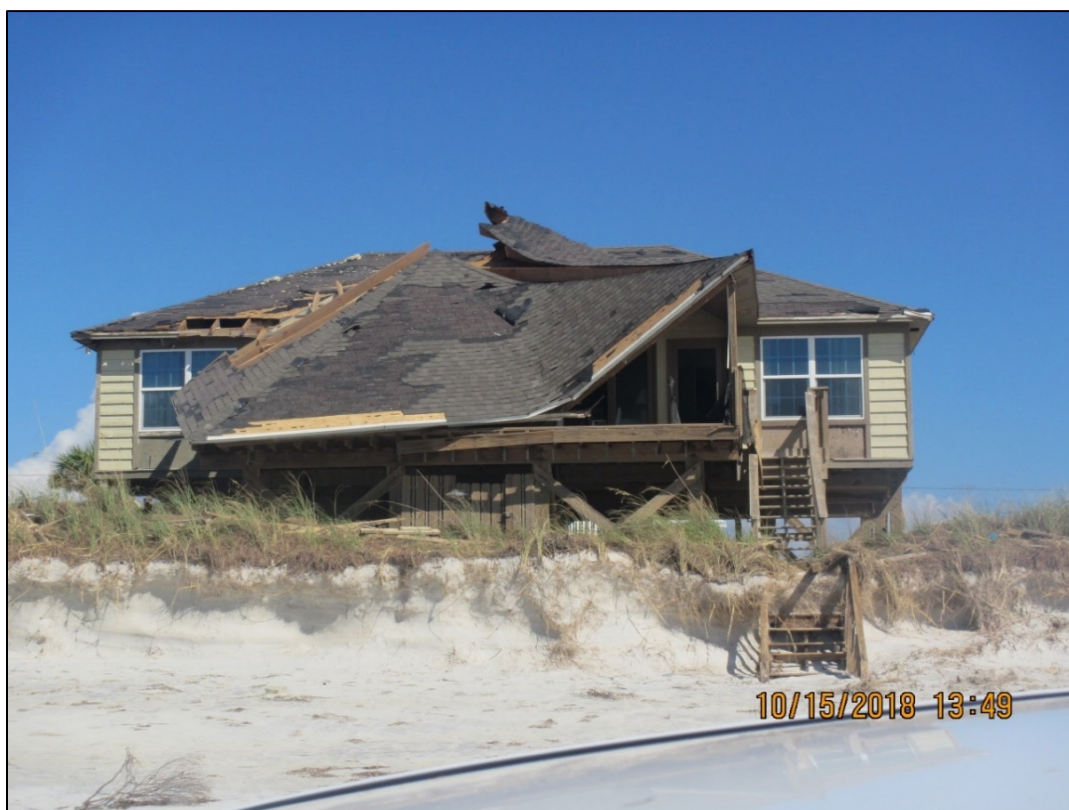
Figure 68. Major roof damage due to high winds near R85, St. Joseph Peninsula.

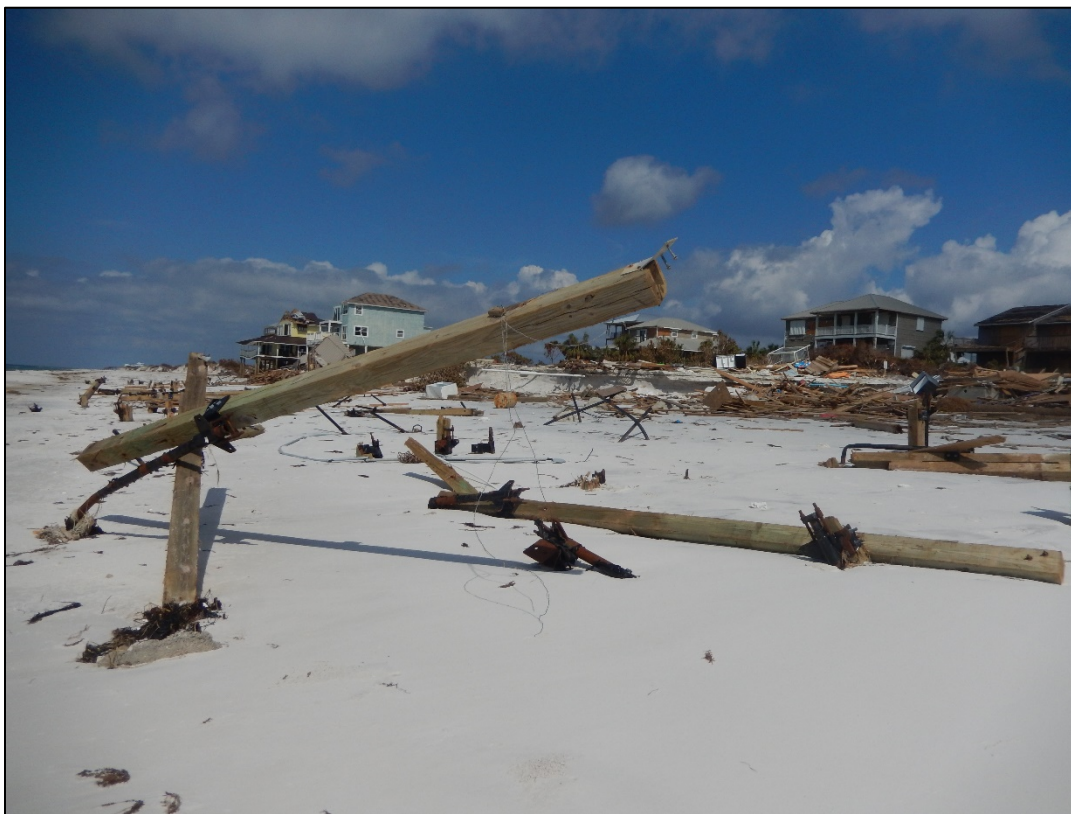
Figure 69. Remains of four destroyed townhouse buildings on Nassau Lane near R90.5, St. Joseph Peninsula.

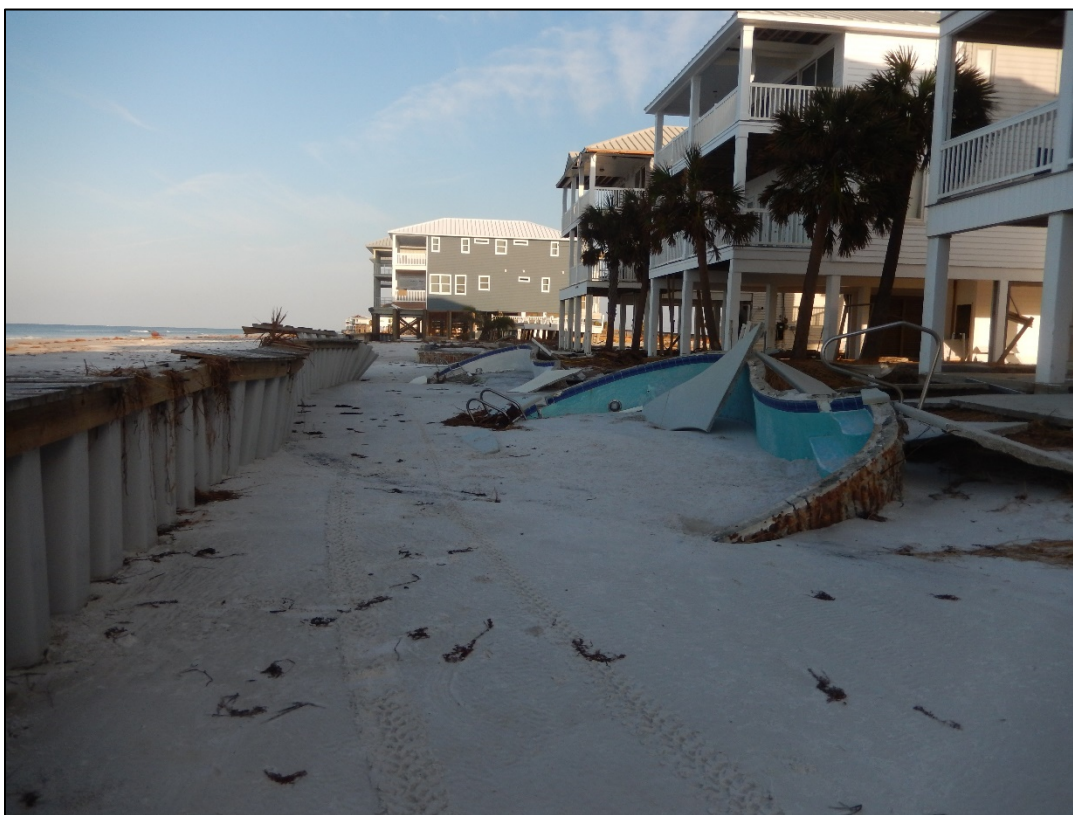
Figure 73. Major damage to bulkheads and swimming pools near R104.

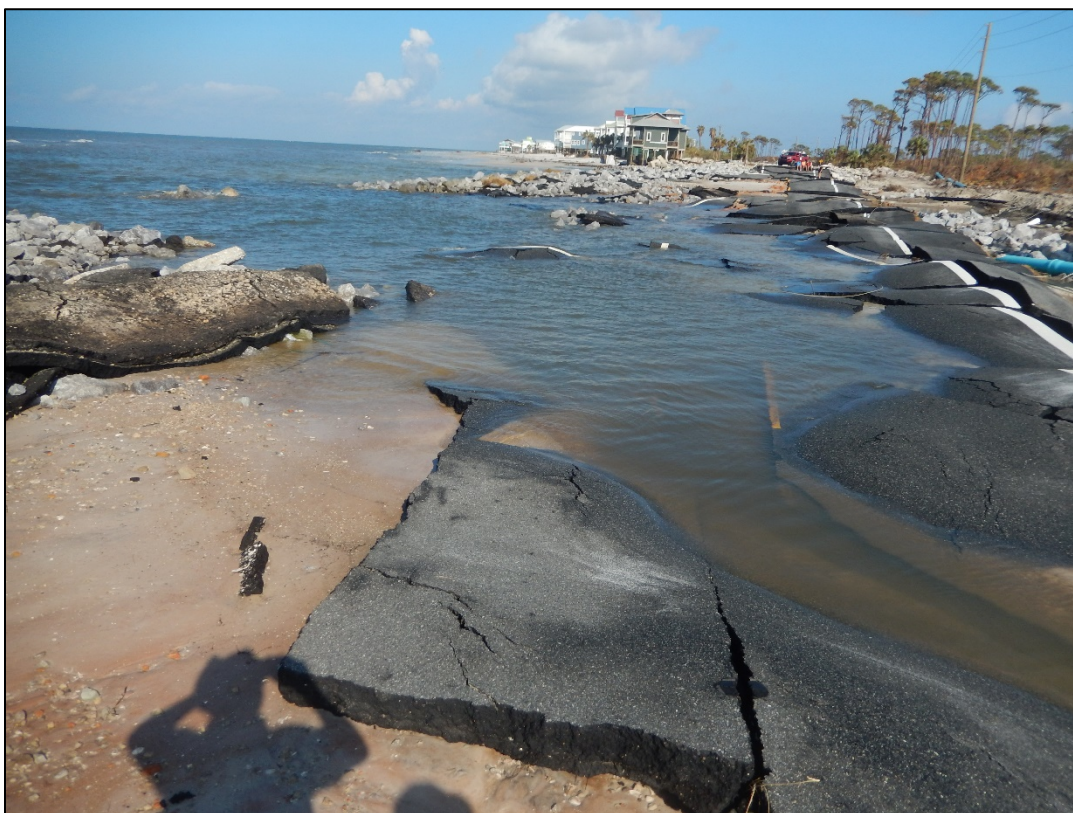
Figure 74. County Road 30E destroyed north of the Stump Hole boulder mound, R105.

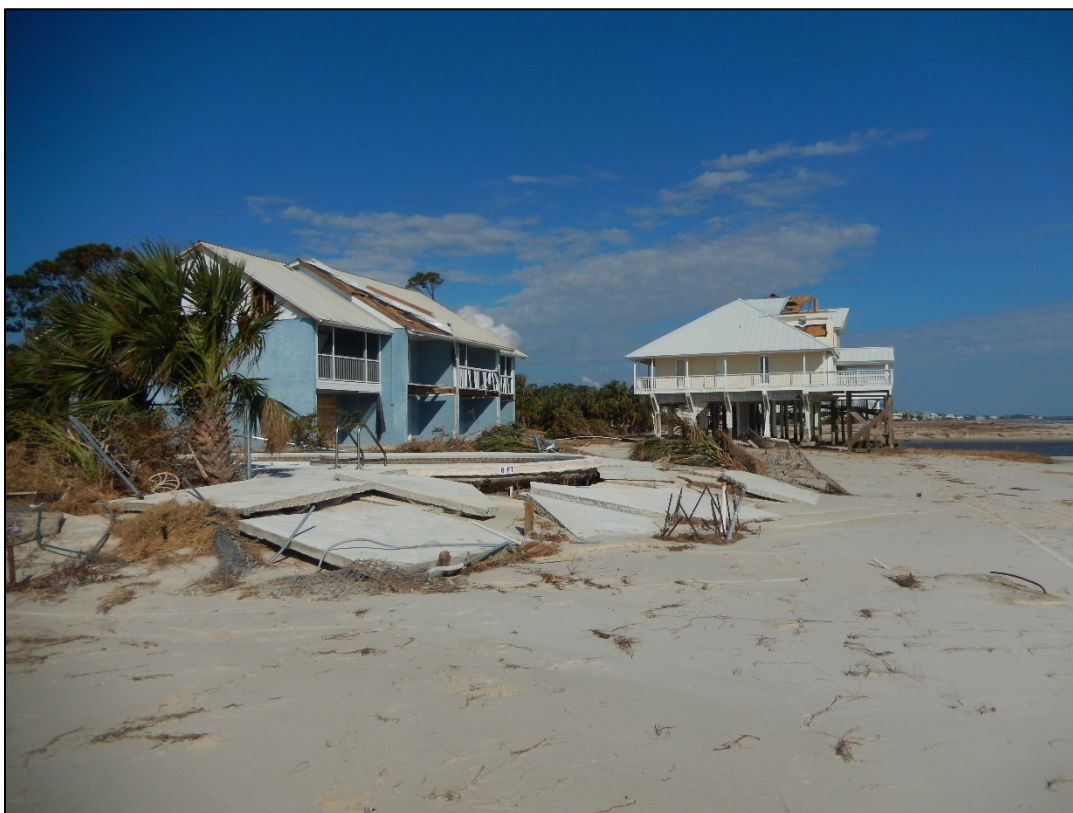
Figure 76. Storm surge damages at Money Bayou, R140.

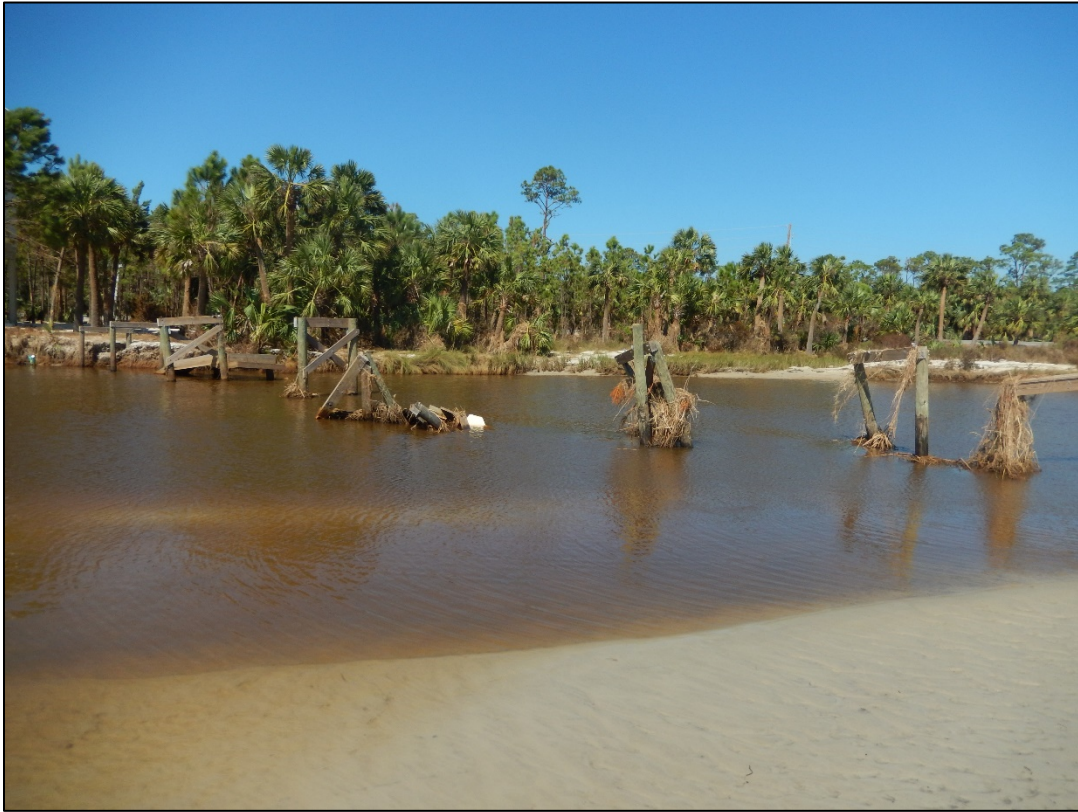
Figure 77. Bridge destroyed across Money Bayou, R140.5.

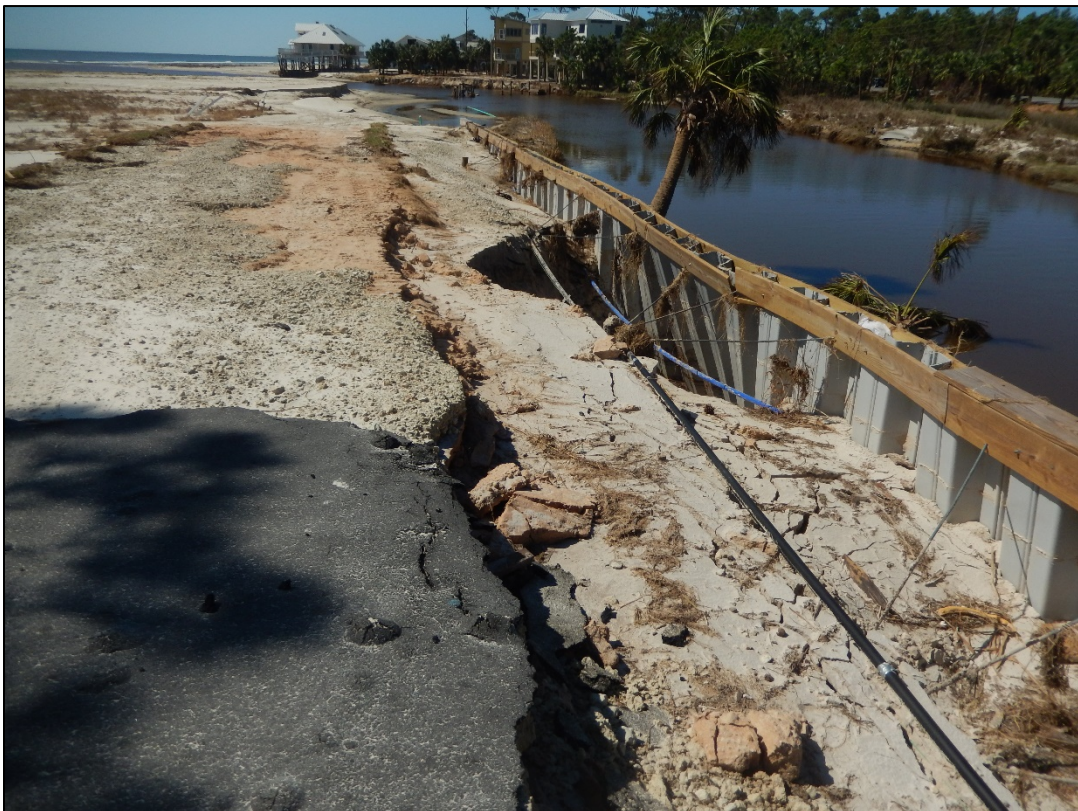
Figure 78. Bulkhead on Money Bayou damaged, R141.

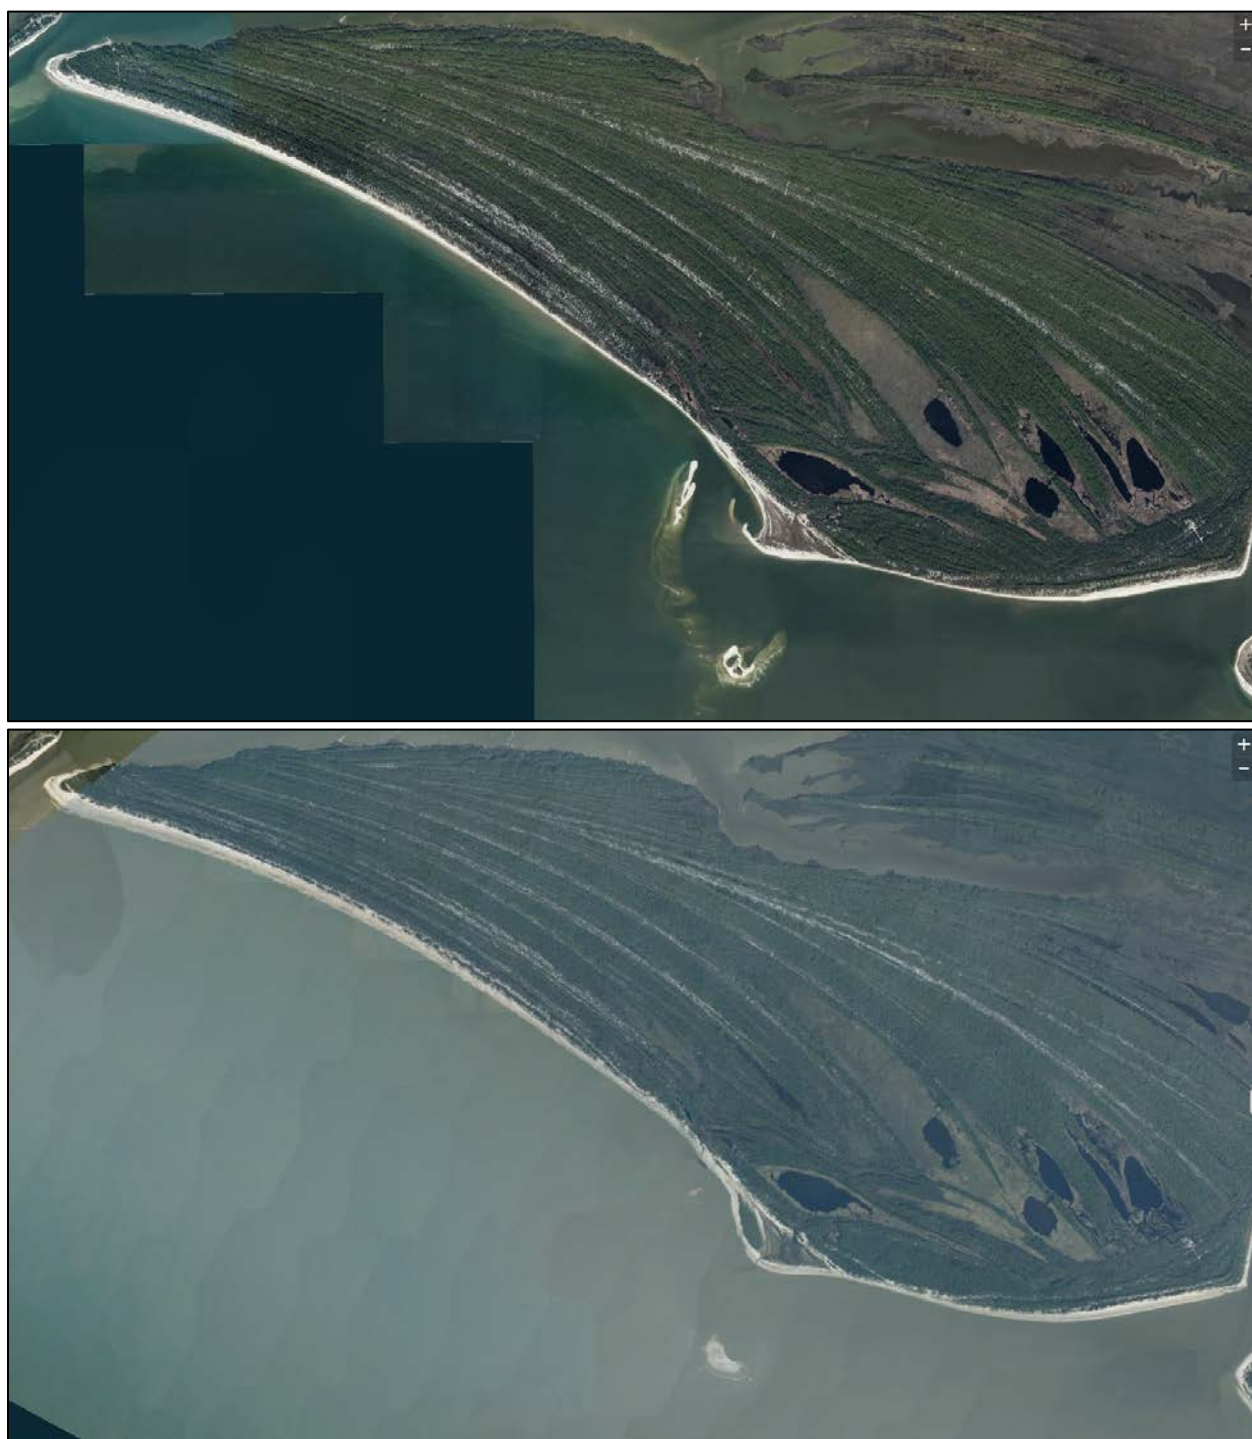
Figure 80. Before (above) and after (below) aerial photos showing major coastal changes to St. Vincent Island. Source: Vexcel Imaging/ NICB Geospatial Intelligence Center.

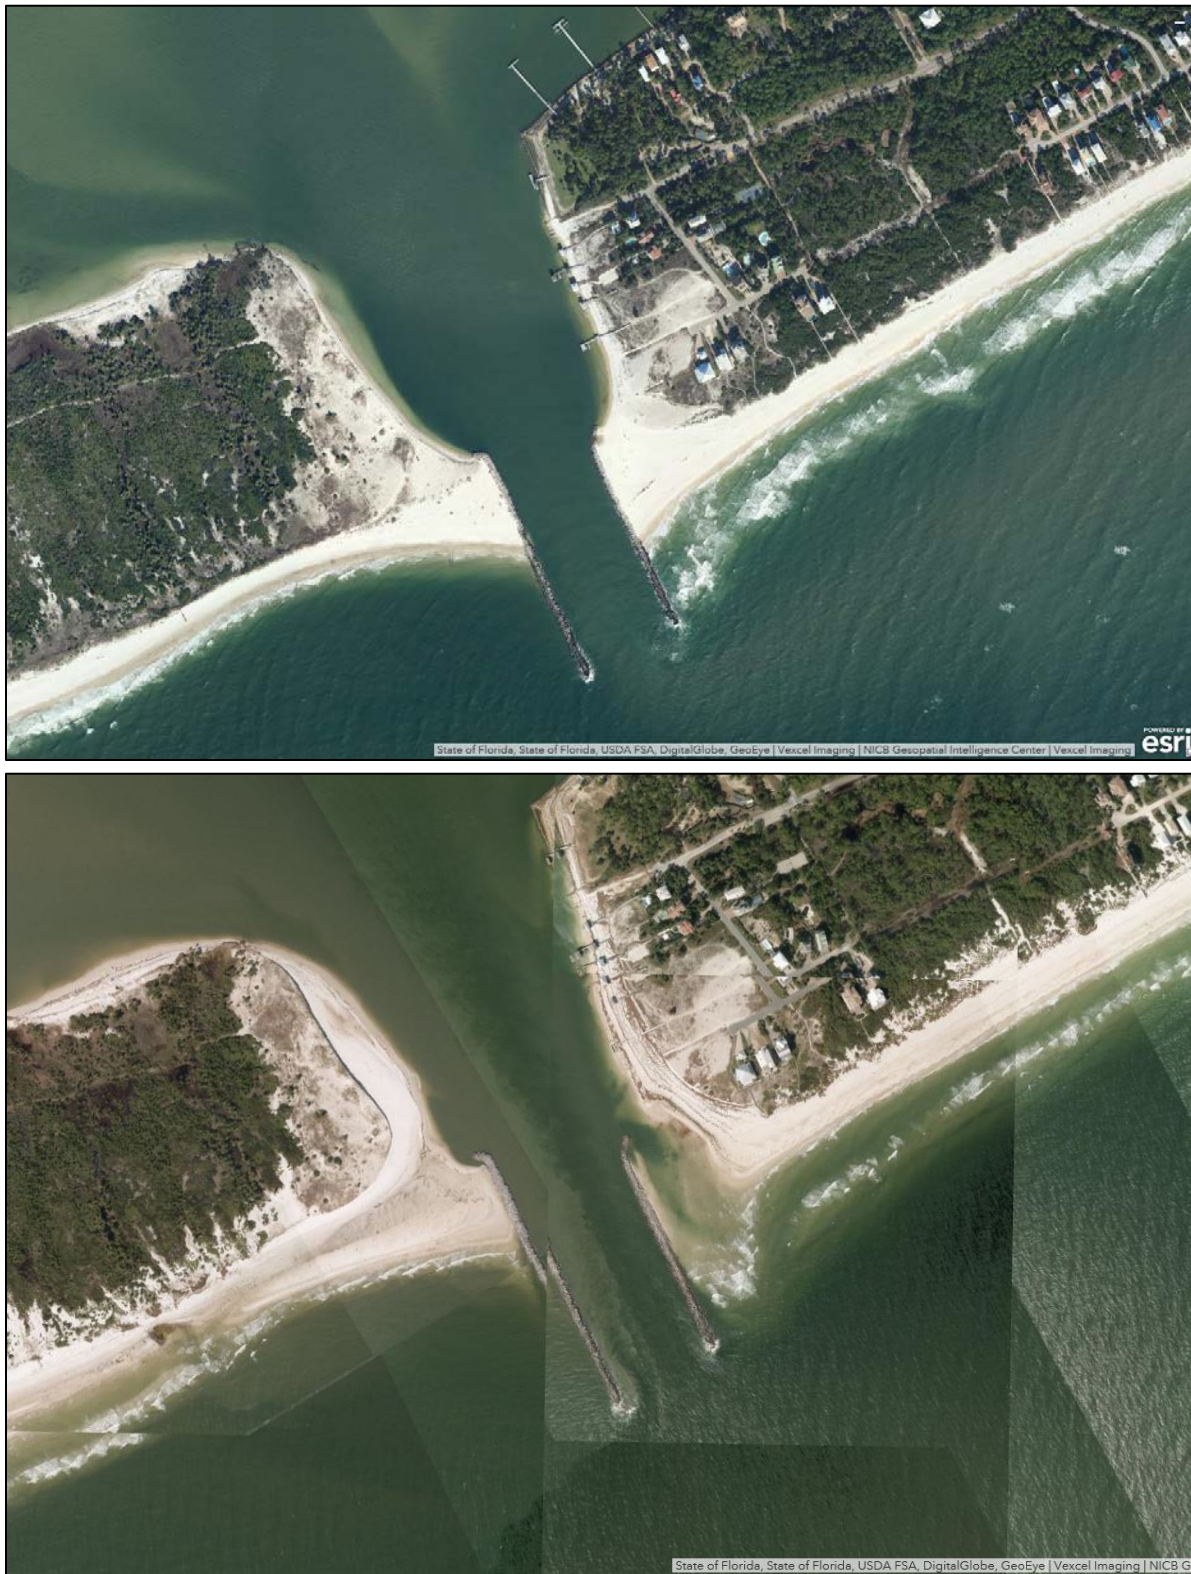
Figure 81. Before (above) and after (below) aerial photos showing breaching of the Bob Sikes Cut jetties from St. George Island, R51-R52. Source: Vexcel Imaging/ NICB Geospatial Intelligence Center.

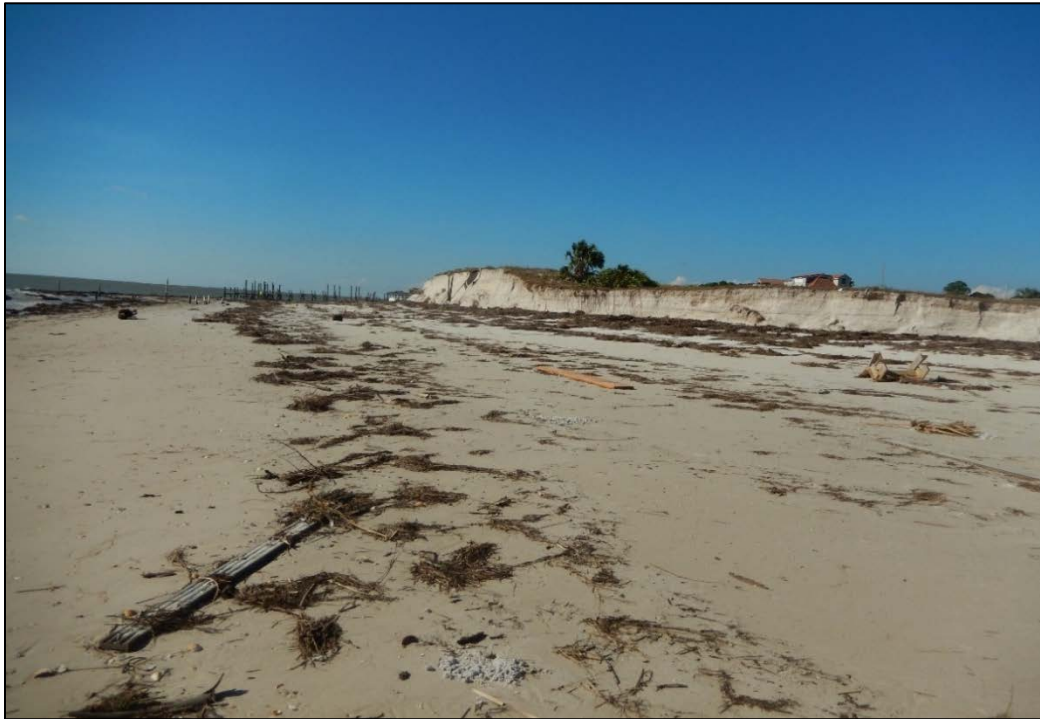
Figure 83. Major beach and dune erosion at Bob Sikes Cut at R52, St. George Island.

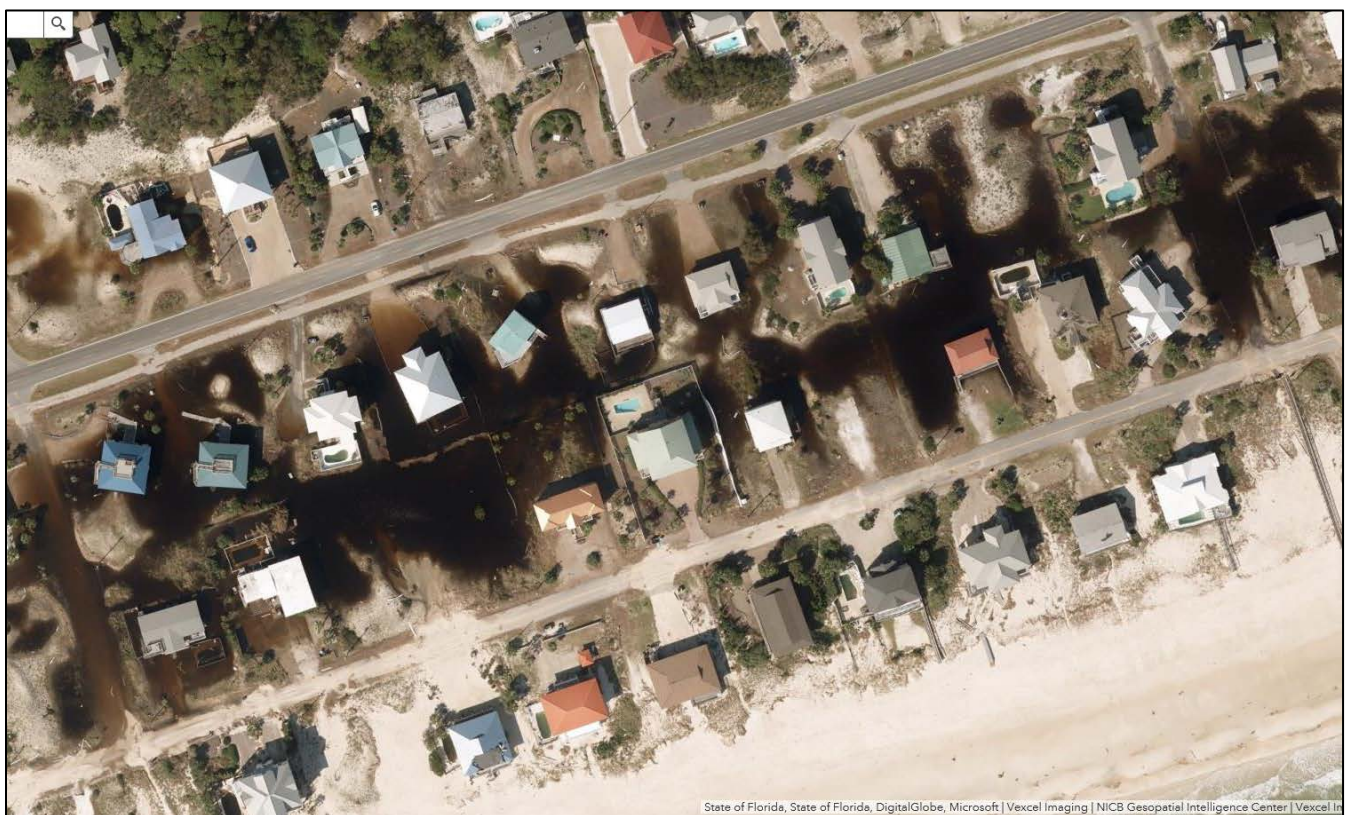
Figure 85. Flooded interdunal depression on St. George Island between R87-R99. Source: Vexcel Imaging/ NICB Geospatial Intelligence Center.

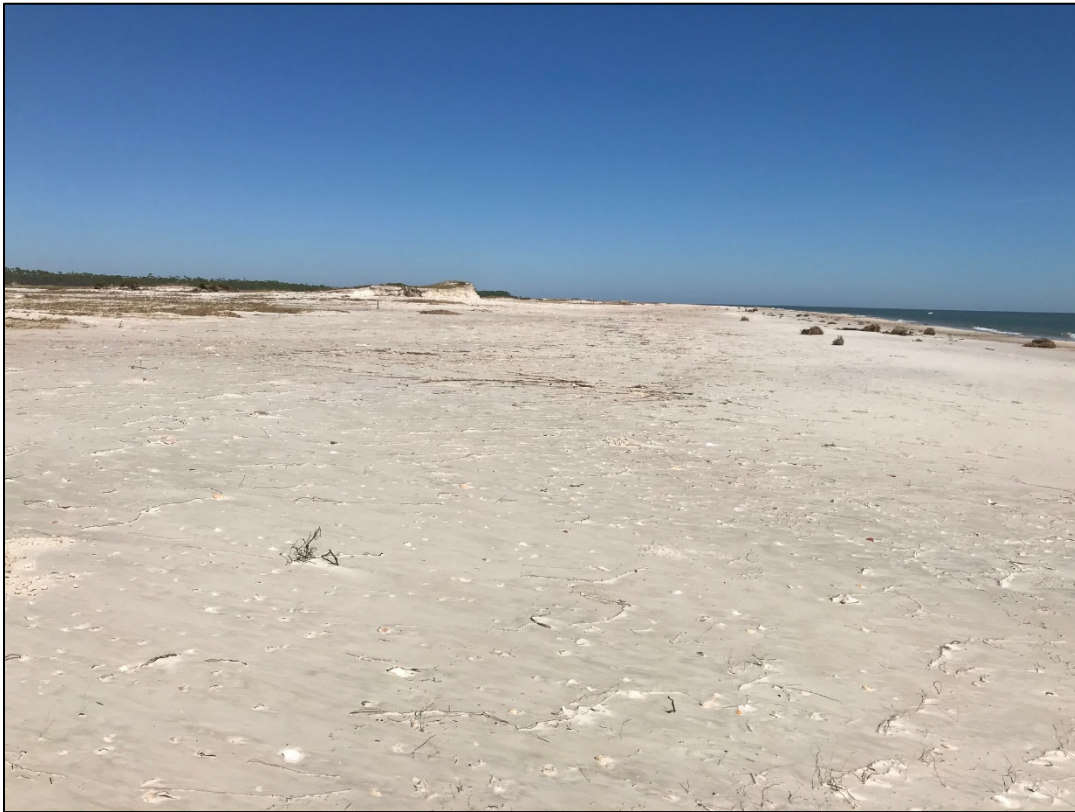
In the Dr. Julian G. Bruce St. George Island State Park, which extends along the eastern 8.4 miles of St. George Island between R105 and R149, major beach and dune erosion (Condition IV) was sustained (**Figure 86**).

Figure 86. *Dunes leveled across St. George Island State Park.*

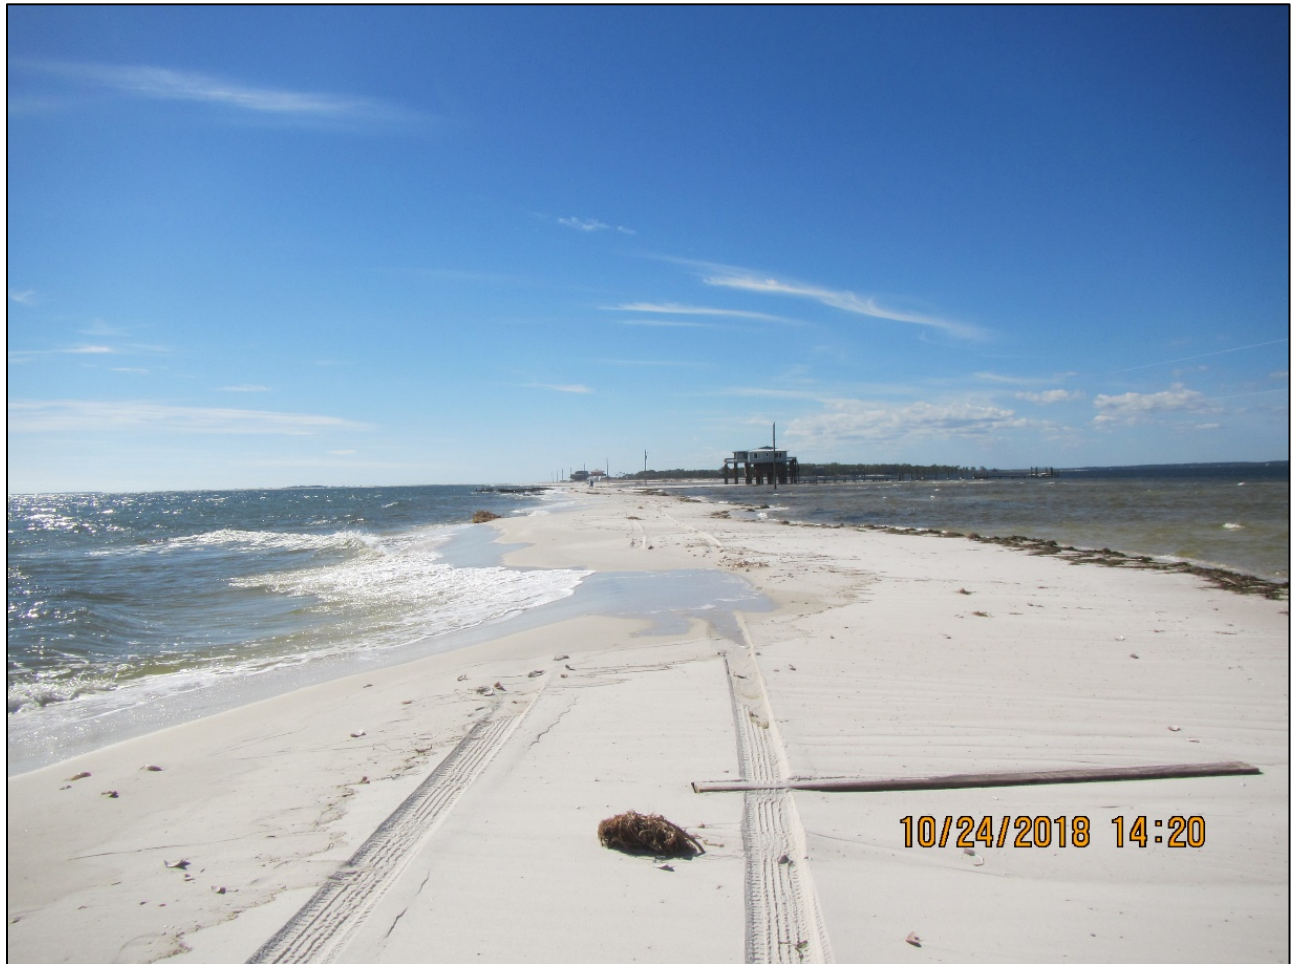
between R165-R169 were inundated by the storm surge, causing further deflation of these narrow island segments with substantial sediment transport into the St. George Sound side of Dog Island (**Figure 87**).

Figure 87. Narrows near R159, Dog Island.

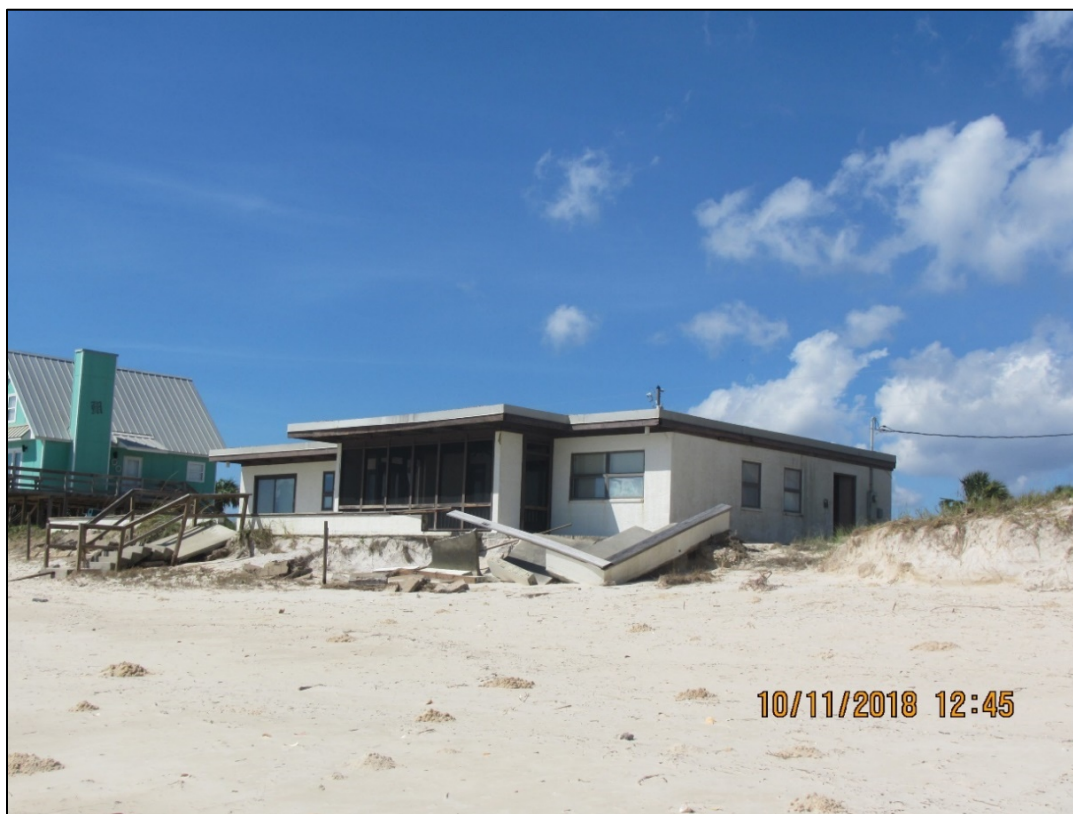
Figure 89. Dwelling damaged near R78, St. George Island.
