***Hurricane Michael Post-Storm
Beach Conditions and Coastal Impact Report***

**Division of Water Resource Management
Florida Department of Environmental Protection**

**January 2019
(Revised April 2019)**

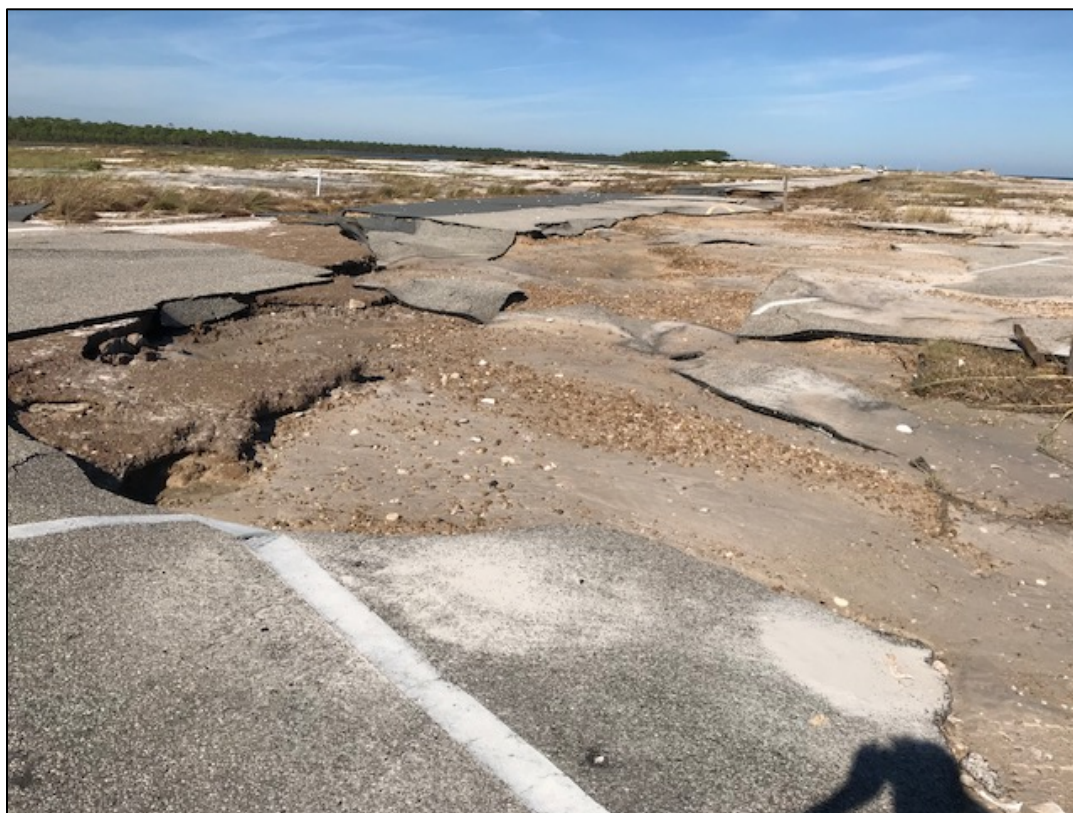
Figure 90. State park road destroyed near R108, St. George Island.

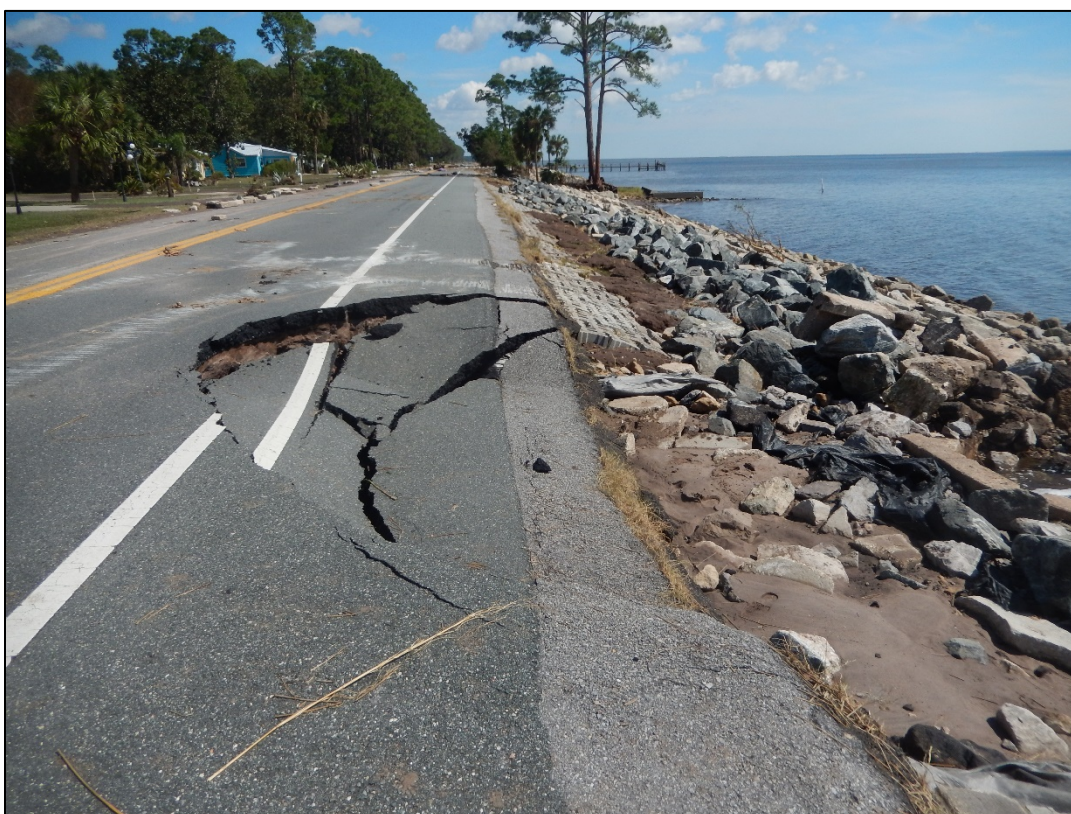
Figure 92. U.S. Highway 98 damaged near Eastpoint.

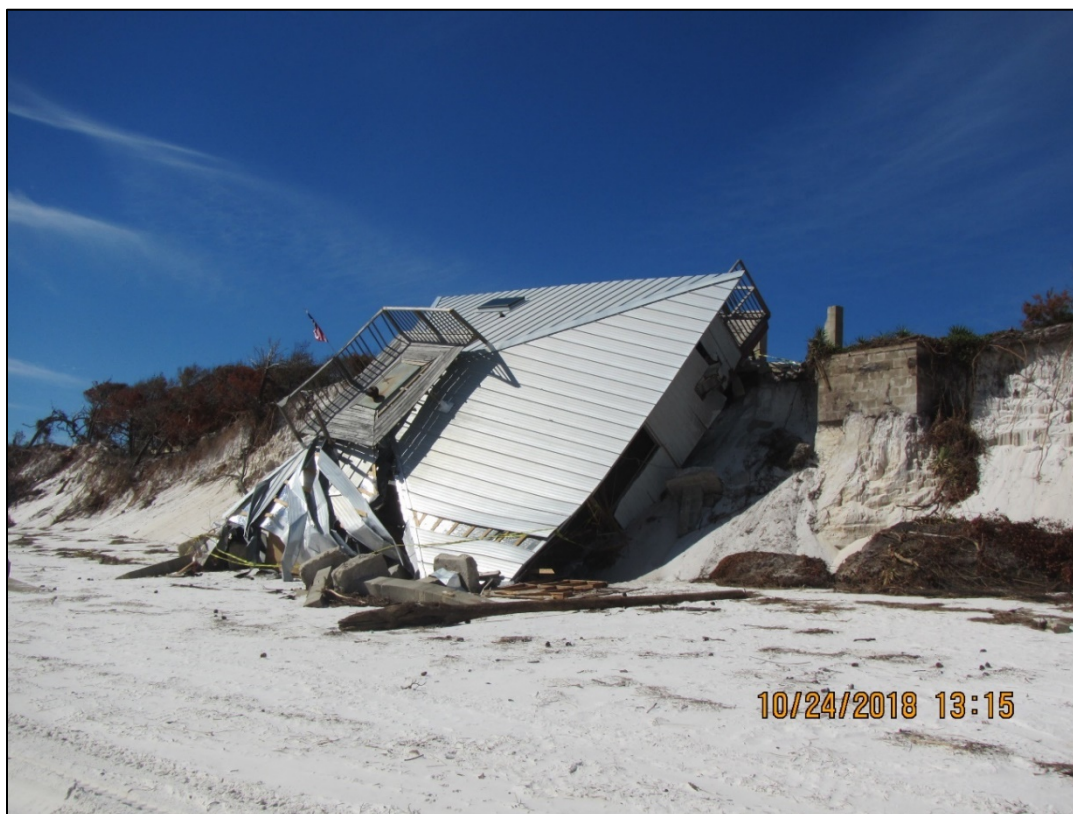
Figure 93. Dwelling destroyed near R173, Dog Island.

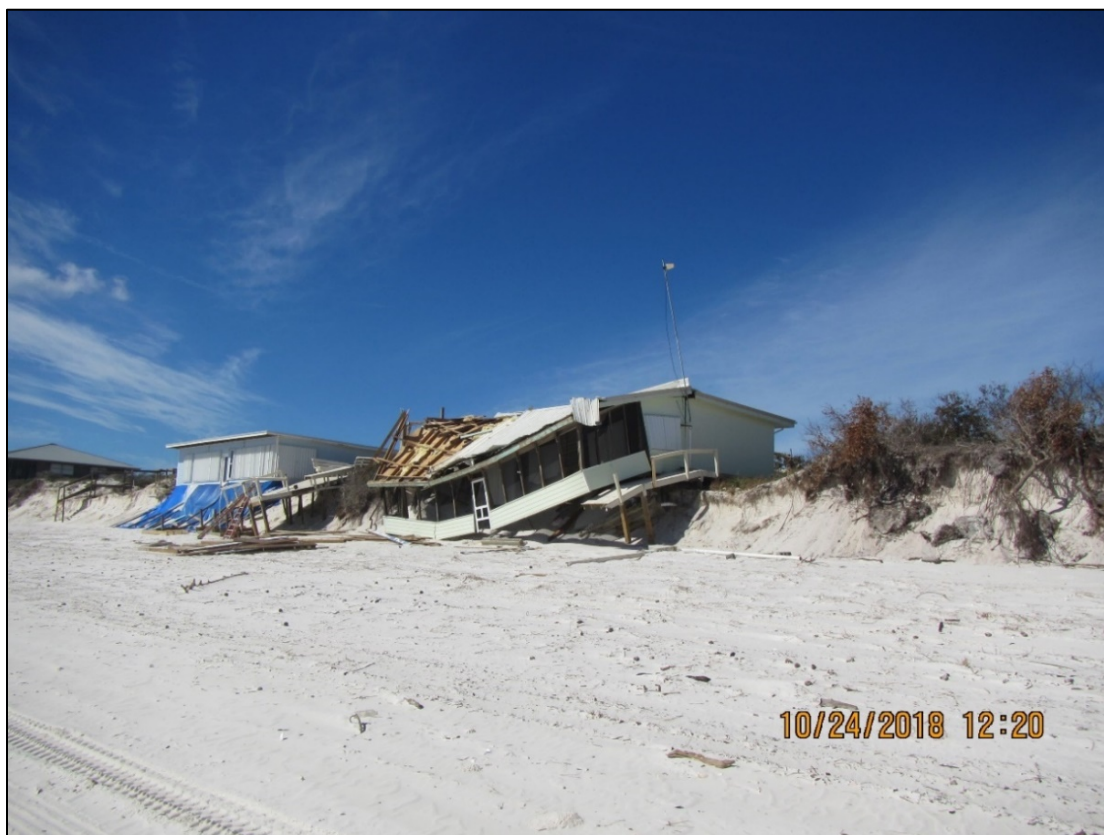
Figure 97. Dwelling destroyed near R179, Dog Island.

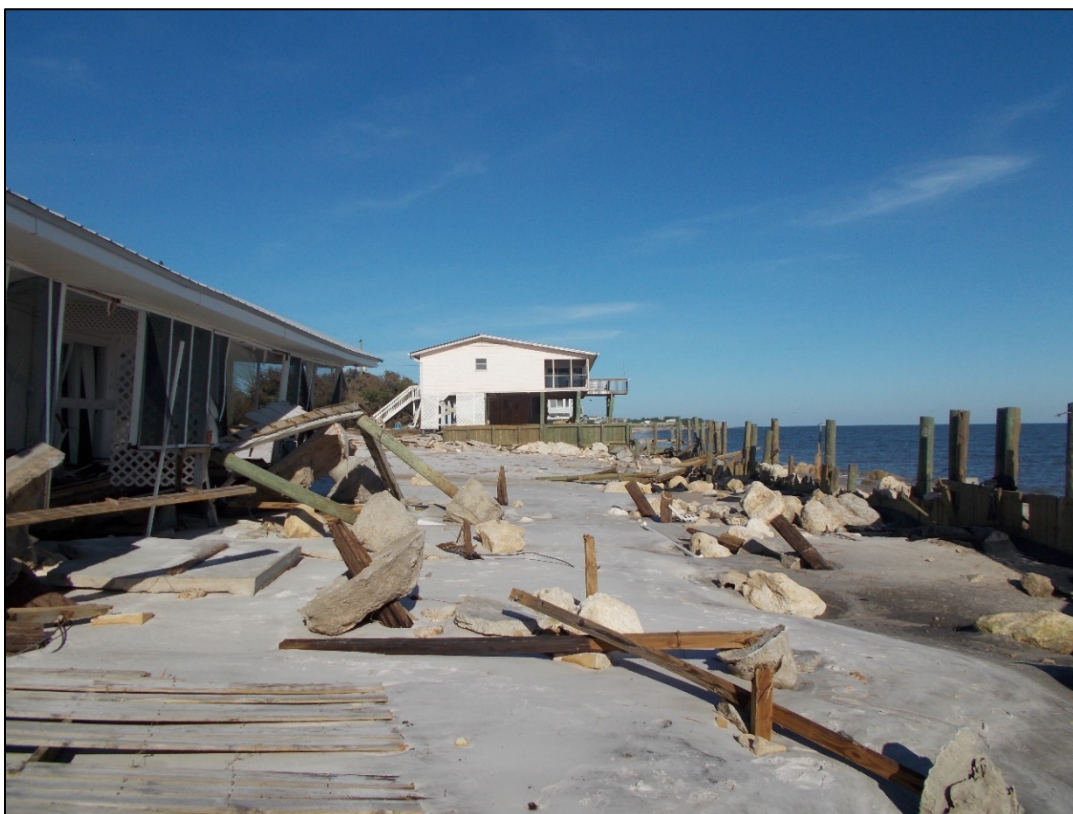
Figure 102. Dwelling and bulkhead damaged near R214.5, Southwest Cape.

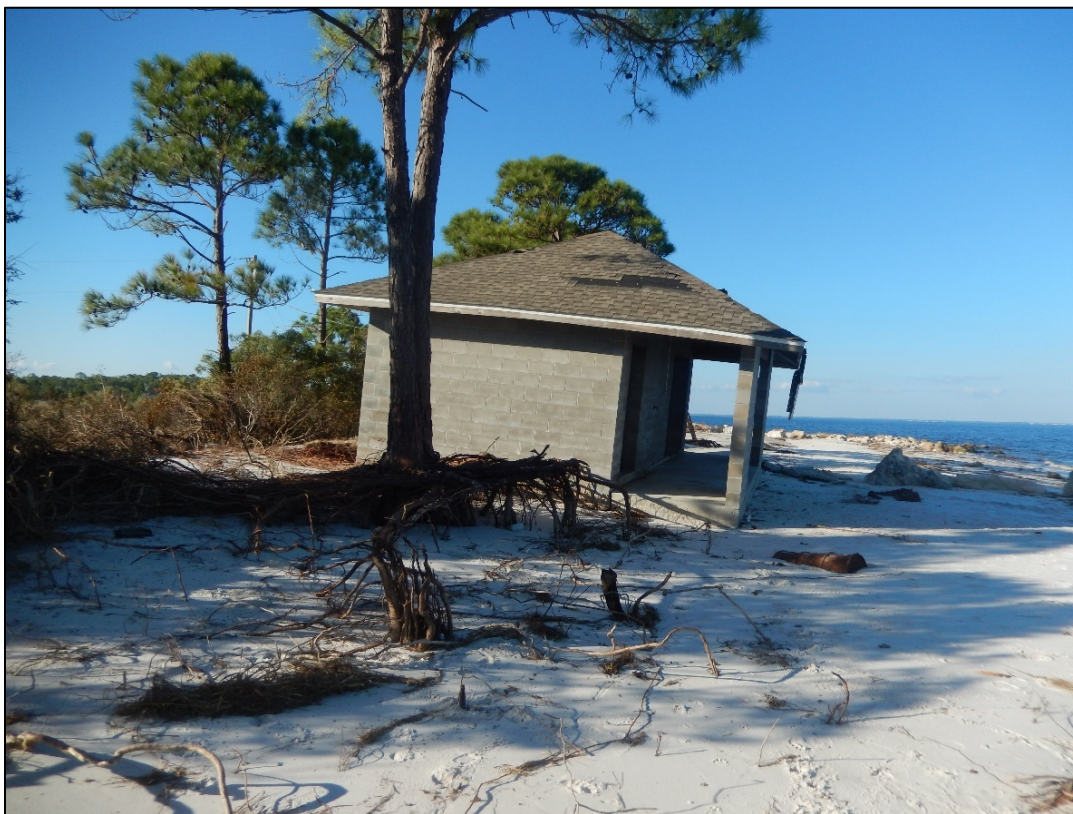
Figure 105. Bathhouse destroyed at Mashas Sands, V314.

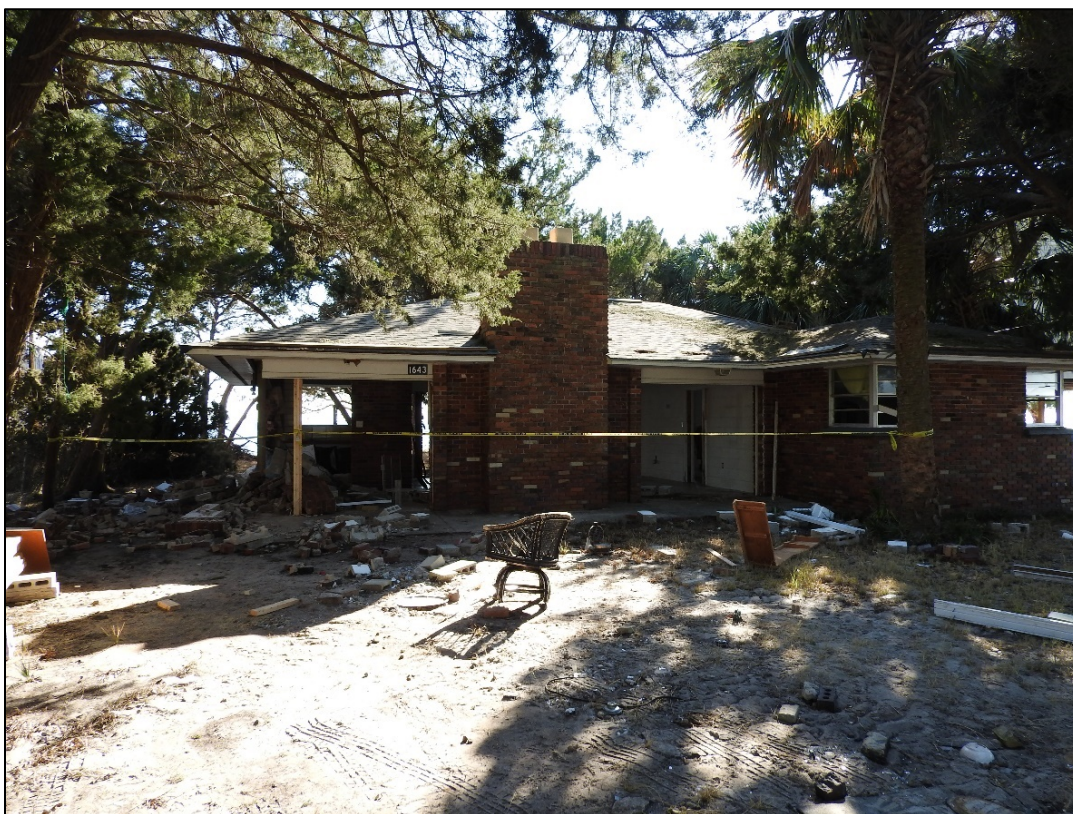
Figure 106. Dwelling with major damage from the storm surge at Shell Point, V342.

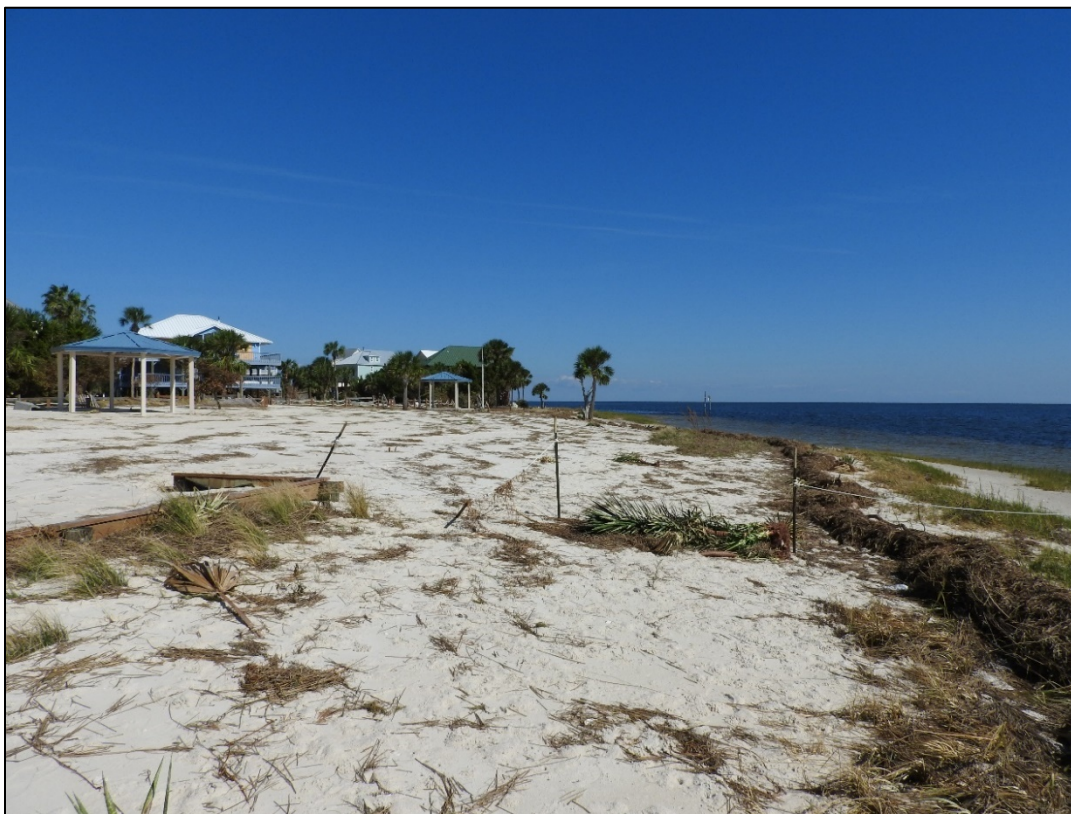
Figure 107. Minor erosion to public beach at Shell Point, V355.

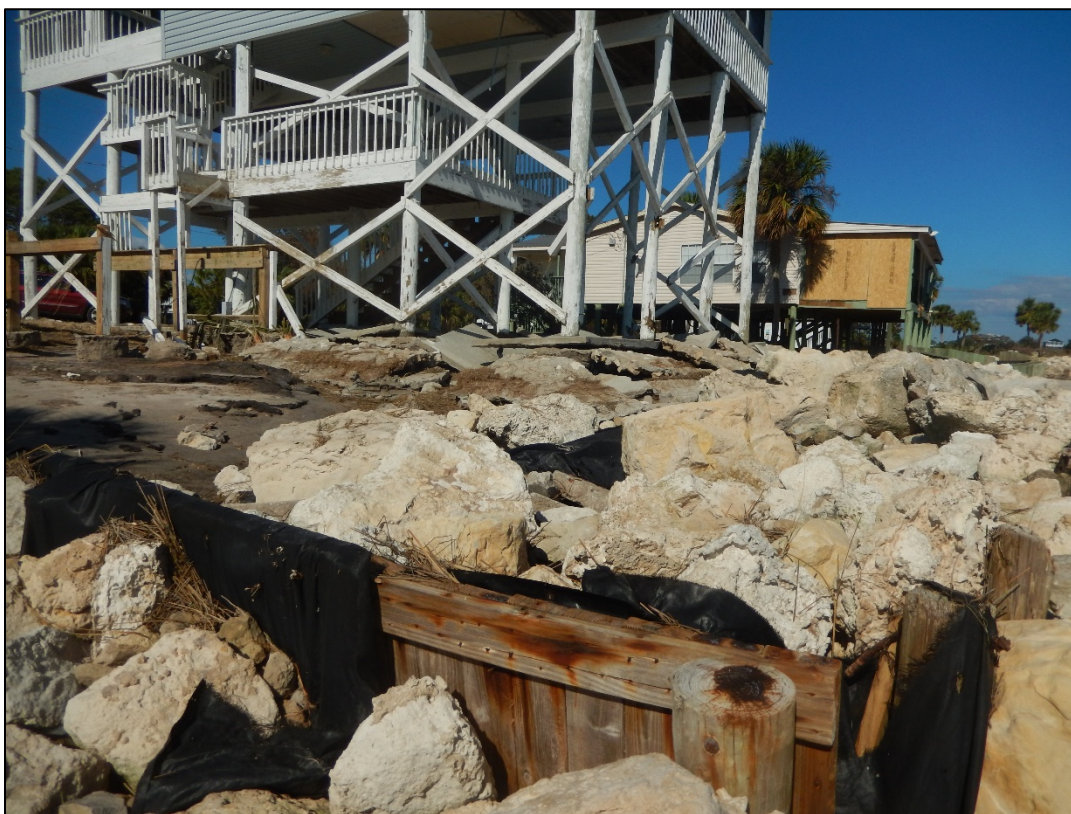
Figure 108. Rock revetment damaged and dwelling with parking slab and bracing damage at Shell Point, V361.
