Sarasota County
2017 NPDES MS4 Annual Report

Alligator Creek WBID 2030 TMDL
Implementation Plan

Supplemental Stormwater Management Program

April 23, 2018

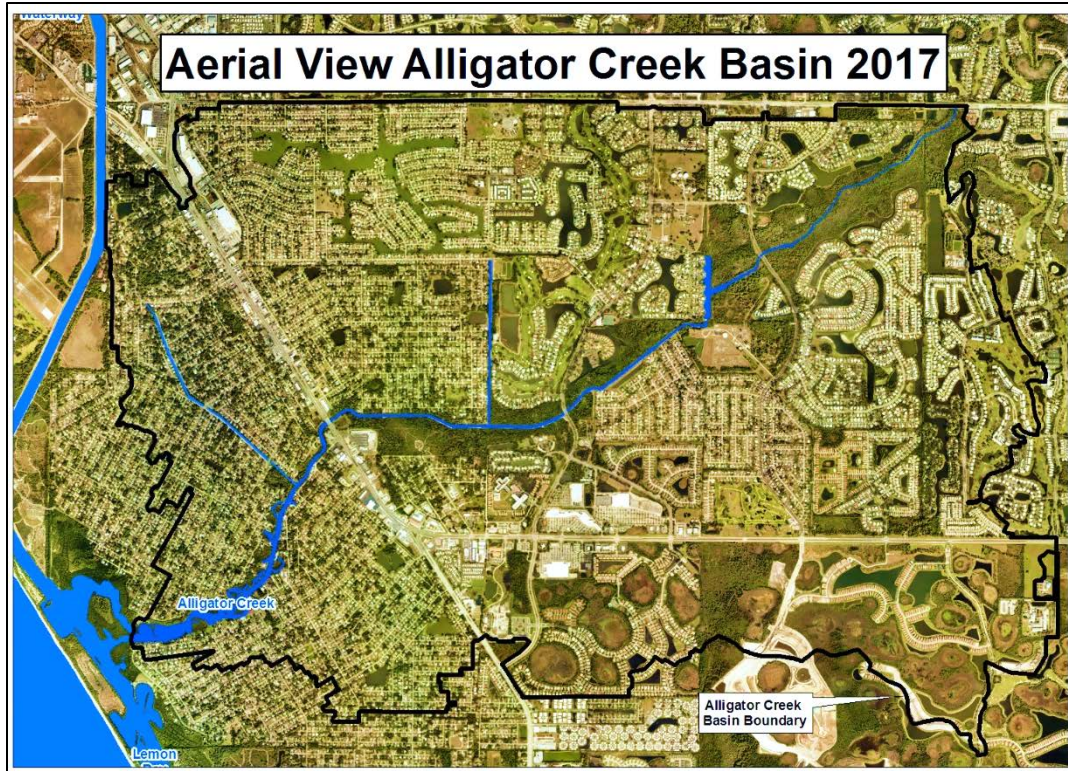
Figure 1. Aerial View of the Alligator Creek Basin.

Located in Venice Florida, the Alligator Creek Basin is a small, rectangular drainage basin of 6,800 acres with a 5-mile long creek that runs diagonally from the northeast to the southwest. The headwaters are wetlands, the middle reach is a canalized creek and the bottom third is a mangrove-lined tidal creek. Flow from the Alligator Creek Basin goes to Lemon Bay then to the Gulf of Mexico. Flushing rates that would move pollutants to the Gulf are strongly influenced by freshwater inflows from Alligator and other adjacent creeks according to the Lemon Bay Watershed Management Plan which is available at:

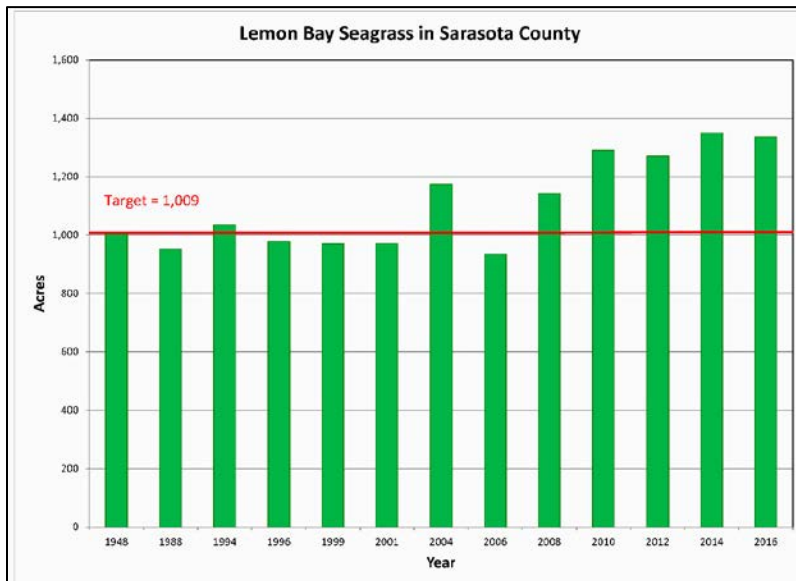
Figure 7. Chart of Seagrass Acreage for the Sarasota County portion of Lemon Bay.

Seagrass is used as an indicator of healthy water quality by the Tampa Bay, Sarasota Bay and Charlotte Harbor National Estuary Programs. Using aerial maps produced by the SW Florida Water Management District, seagrass acreage goals were set for bays. Near Alligator Creek, Lemon Bay is meeting its seagrass target and Dona/Roberts Bay is not. Seagrass targets were the foundation of the FDEP Numeric Nutrient Criteria for bays in SW Florida. These criteria are the formal regulatory standards for nitrogen and phosphorus in bays (62-302 FAC). More can be learned about seagrass targets on the Sarasota Water Atlas Bay Conditions pages at <http://www.sarasota.wateratlas.usf.edu/bay-conditions/>. The premise of seagrass targets is that increased nitrogen will cause an increase in chlorophyll, that shades out the seagrass resulting in a decrease in seagrass acreage.

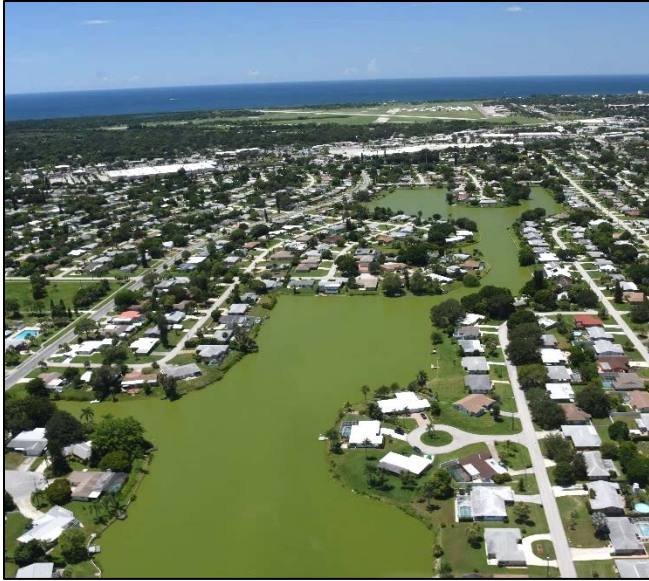
Figure 10. Aerial View of green water in Venice Gardens Lakes.

The Venice Gardens Lake System is composed of three lakes that are interconnected by culverts. When water levels are high, flow from the lake travels over a broad weir into Briarwood Waterway then to Alligator Creek. In the lakes, elevated levels of nitrogen, phosphorus and chlorophyll exceed water quality standards. The lakes are very green with low transparency.

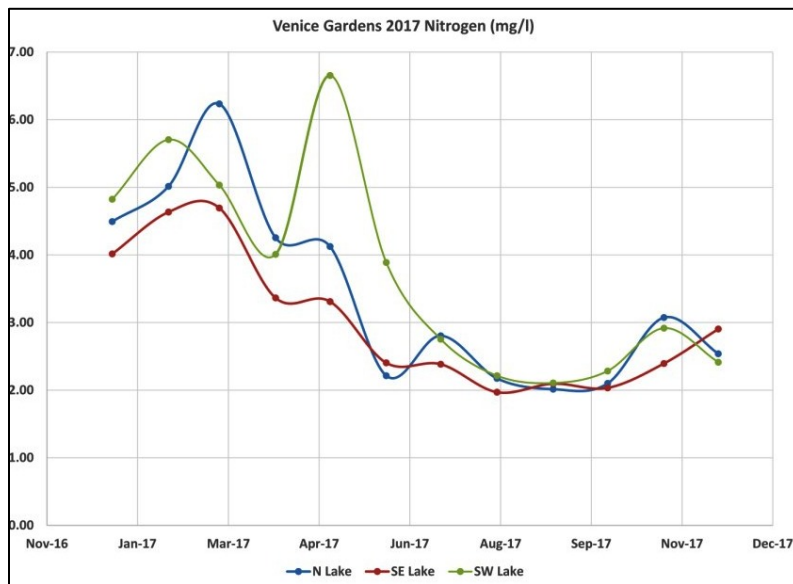
Figure 11. Graph of Nitrogen Concentrations in Venice Gardens Lakes.

It is unclear why the lakes are so eutrophic because the contributing land use is served by sanitary sewer and is not a heavy user of fertilizer. Historic wet weather leaks of wastewater may have enriched the lakes with nutrients. Another hypothesis is that little or no discharge from the lakes in dry season may result in accumulated nutrients, or accumulated nutrients in sediments are a source of nutrients in the water.

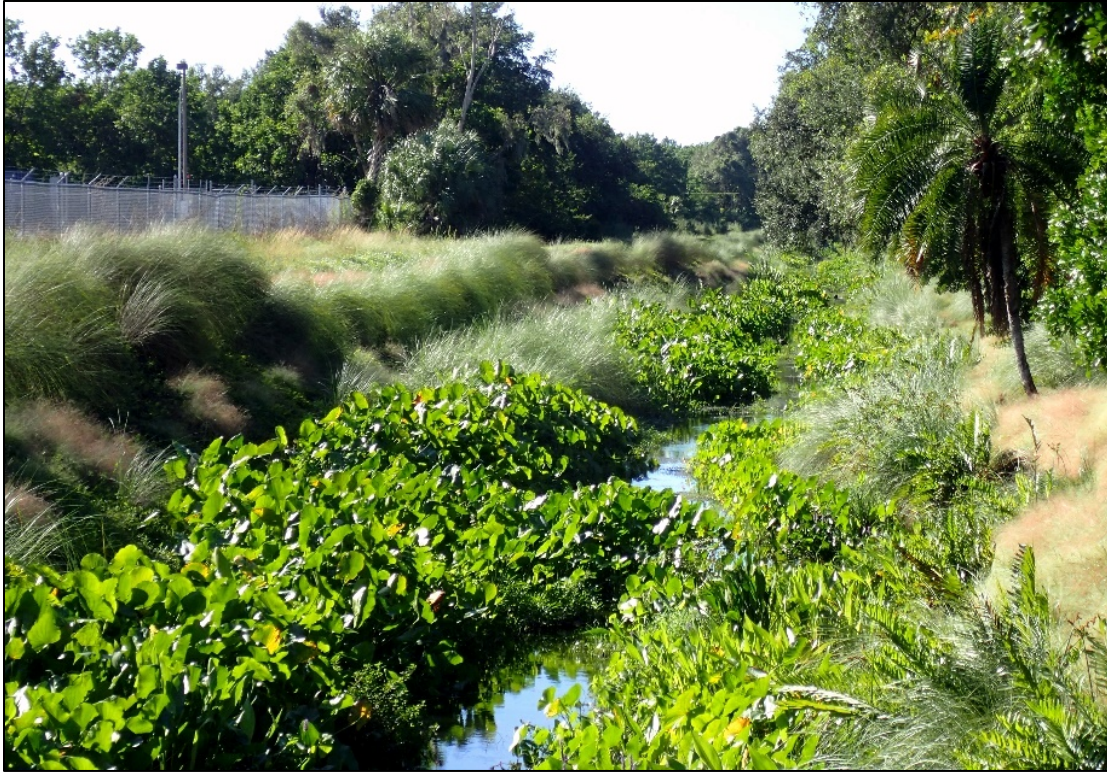
Figure 12. Naturalized Briarwood Waterway 2017.

In 2017, a project to naturalize the Briarwood and Siesta Waterways was completed. The project was not built to remove pollutants but similar installations such as filter marshes are known to remove nutrients.

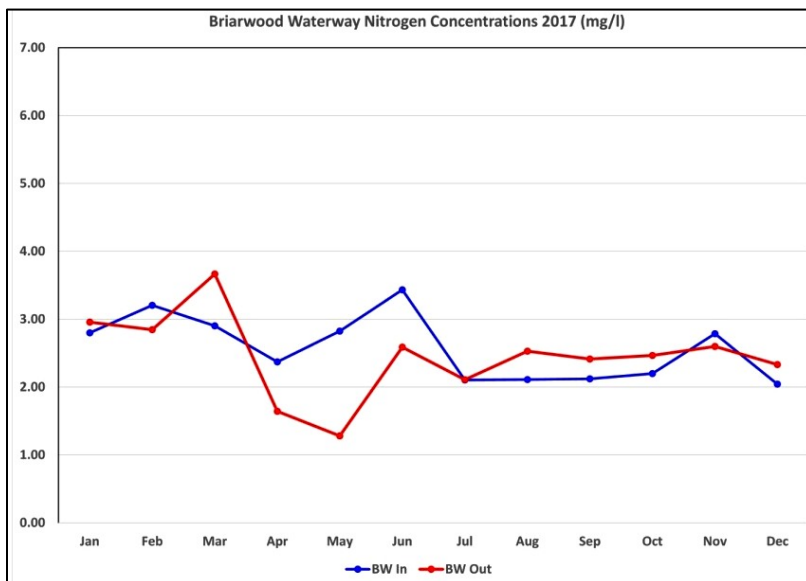
Figure 13. Graph of Nitrogen Concentrations in Briarwood Waterway.

On average, there is a slight reduction (5%) in the average nitrogen concentration of the water as it flows through the Briarwood Waterway but is inconsistent. Additional monitoring and analysis may provide valuable information about this process and how to maximize nutrient removal.

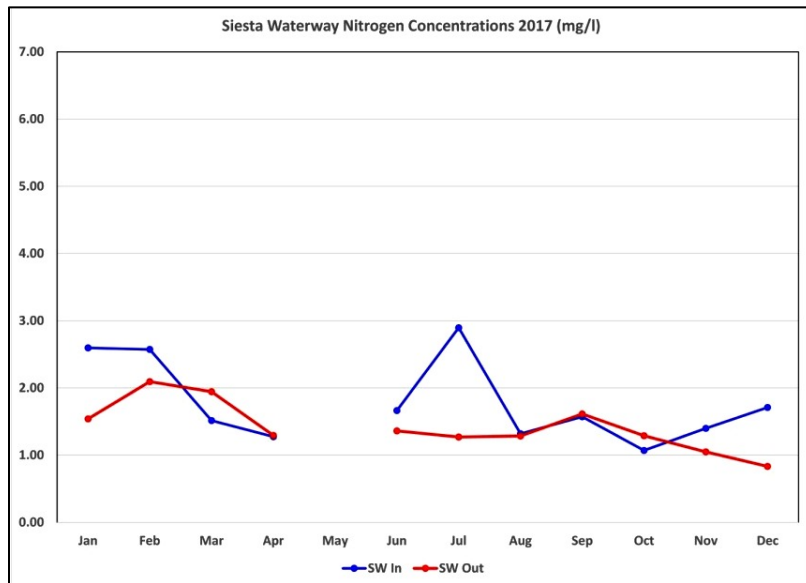
Figure 14. Graph of Nitrogen Concentrations in Siesta Waterway.

On average there was a 37% reduction of nitrogen concentration in the water flowing through the Siesta Waterway, but the process is inconsistent over the course of the year. Continued monitoring will inform about whether this is a reliable process for nutrient removal.

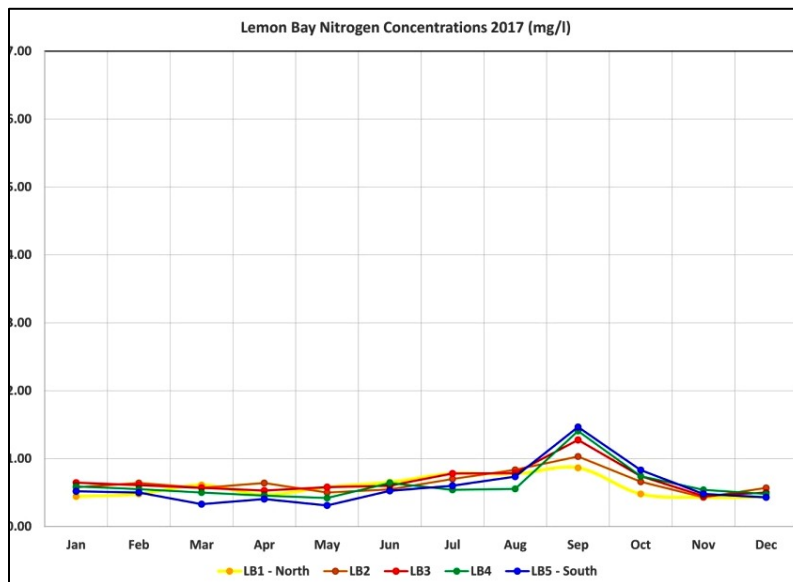
Figure 16. Graph of Nitrogen Concentrations in Lemon Bay 2017.

Lemon Bay experienced elevated levels of nitrogen in summer, especially September, in 2017. The least elevated segment of Lemon Bay was at the north, near Alligator Creek, suggesting that Alligator Creek was not the source of this condition.

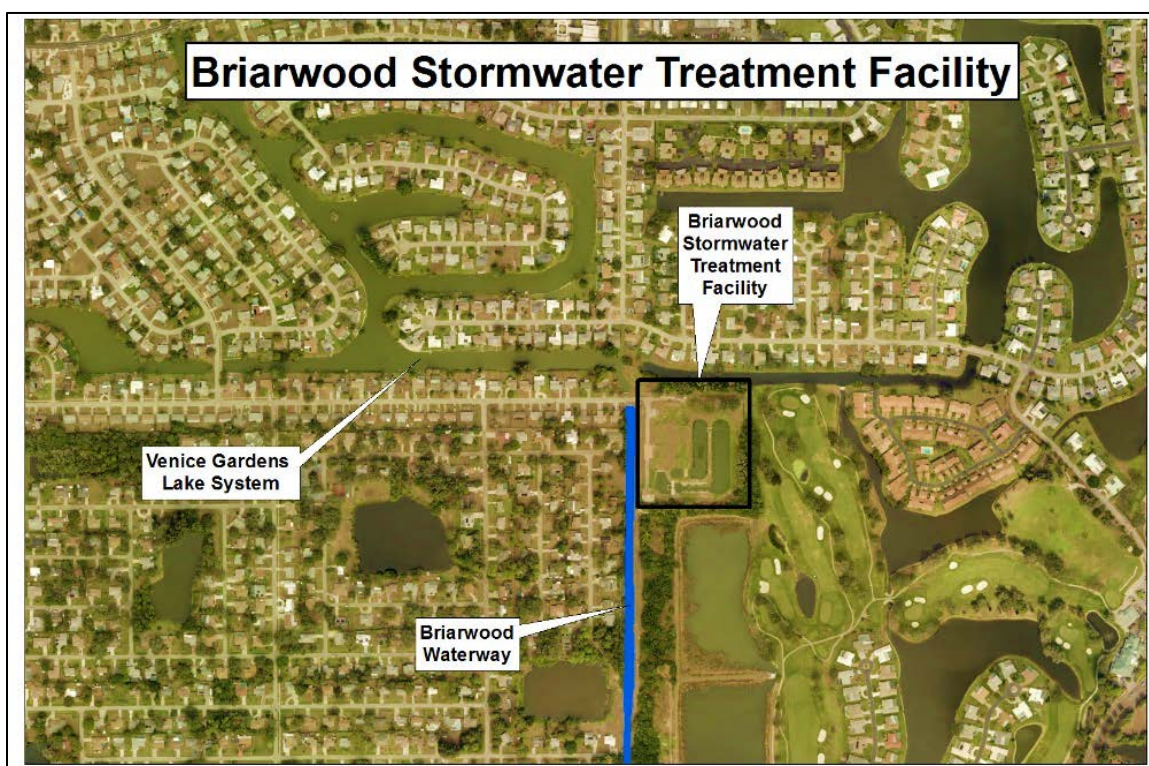
Figure 17. Location of the Briarwood Stormwater Treatment Facility.

In 2012, the construction of the Briarwood Stormwater Treatment Facility (BSTF) was completed. It is located at the juncture of the Venice Gardens Lakes and the Briarwood Waterway. The treatment goal is to reduce nutrient and suspended solids pollution to Alligator Creek and Lemon Bay through a treatment train consisting of stormwater harvesting, engineered wetlands and biologically active upflow media filters. Lake water is pumped through the facility then discharged back to the lake or the the Briarwood Waterway, depending on lake levels. More can be learned about the BSTF at:

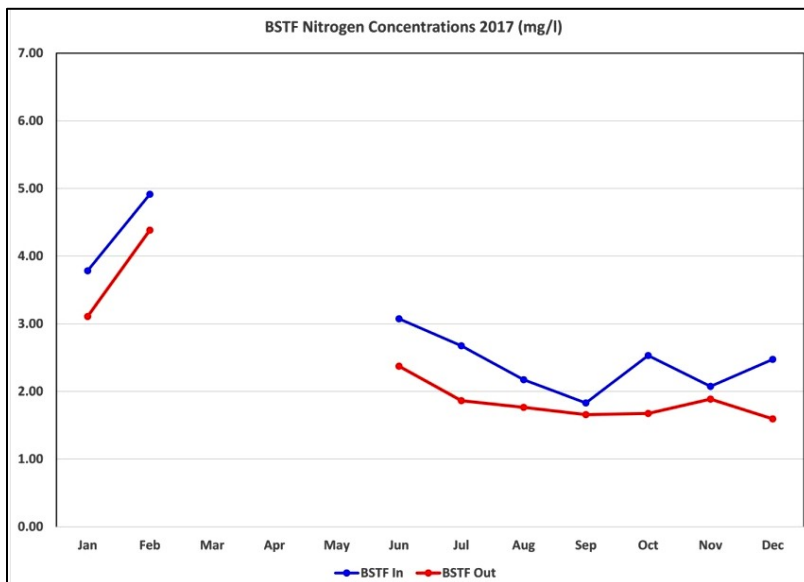
Figure 19. Nitrogen Concentrations in and out of the BSTF.

In 2017, the nitrogen concentration of the water leaving the BSTF was lower than the water entering the facility for every month with data. During very dry weather the BSTF

is turned off to prevent dewatering of the Venice Gardens Lakes. It is also turned off for annual maintenance. Samples are not taken when there is no flow.

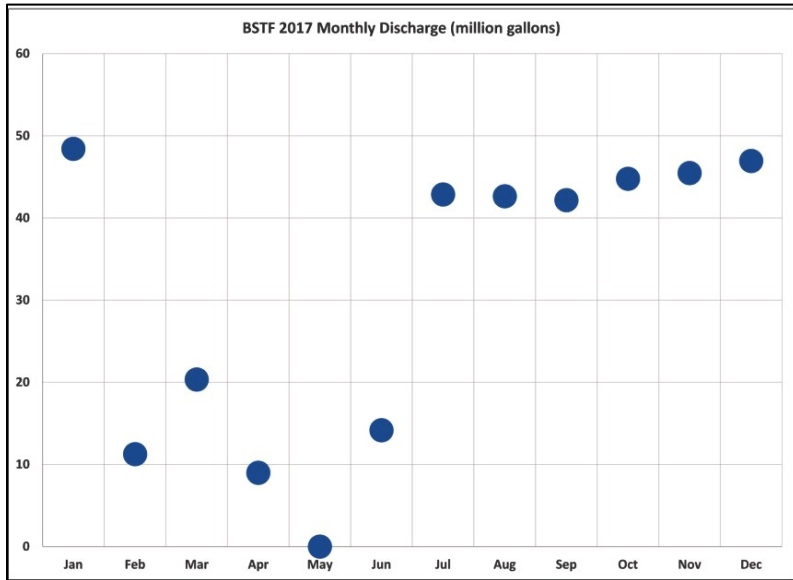
Figure 20. Graph of Monthly Discharge from the BSTF.

In 2017, the BSTF removed 2,391 pounds of nitrogen. The TMDL calls for the removal of 3,336 pounds per year of nitrogen so the BSTF achieved 72% of the TMDL goal. Much of the time the discharge was to the lake though, so it is not a direct reduction to Alligator Creek.
