## **Appendix C – 2024 Reconnaissance Survey Methods & Results**

Coastal Eco Group (CEG) was contracted by the Florida Department of Environmental Protection (DEP) to conduct an in-water reconnaissance survey (2024 Recon Survey) to better understand the interaction between tires and coral reef habitat. Divers quantified the number and condition of tires on reef habitat, the severity of tire-related impacts to reef substratum and fauna and the degree to which tires had been recruited to by sessile reef organisms (e.g., macroalgae, sponges, octocorals and stony corals). Recon sites were targeted using the side scan sonar results and detected tire locations from the 2024 Tire Survey, which are displayed in **Figure C-1**. The 2024 Tire Survey report is provided in **Appendix B**. Dive sites were selected from within the extent of densest tires adjacent to coral reef habitat in the data provided. Recon sites were assigned numerical identifiers and priority was given to sites with the greatest potential for reef impacts based on their proximity to dense tire aggregations. CEG divers conducted dives at T30 discrete sites from April 1 to April 15, 2024. Locations and dives completed duri

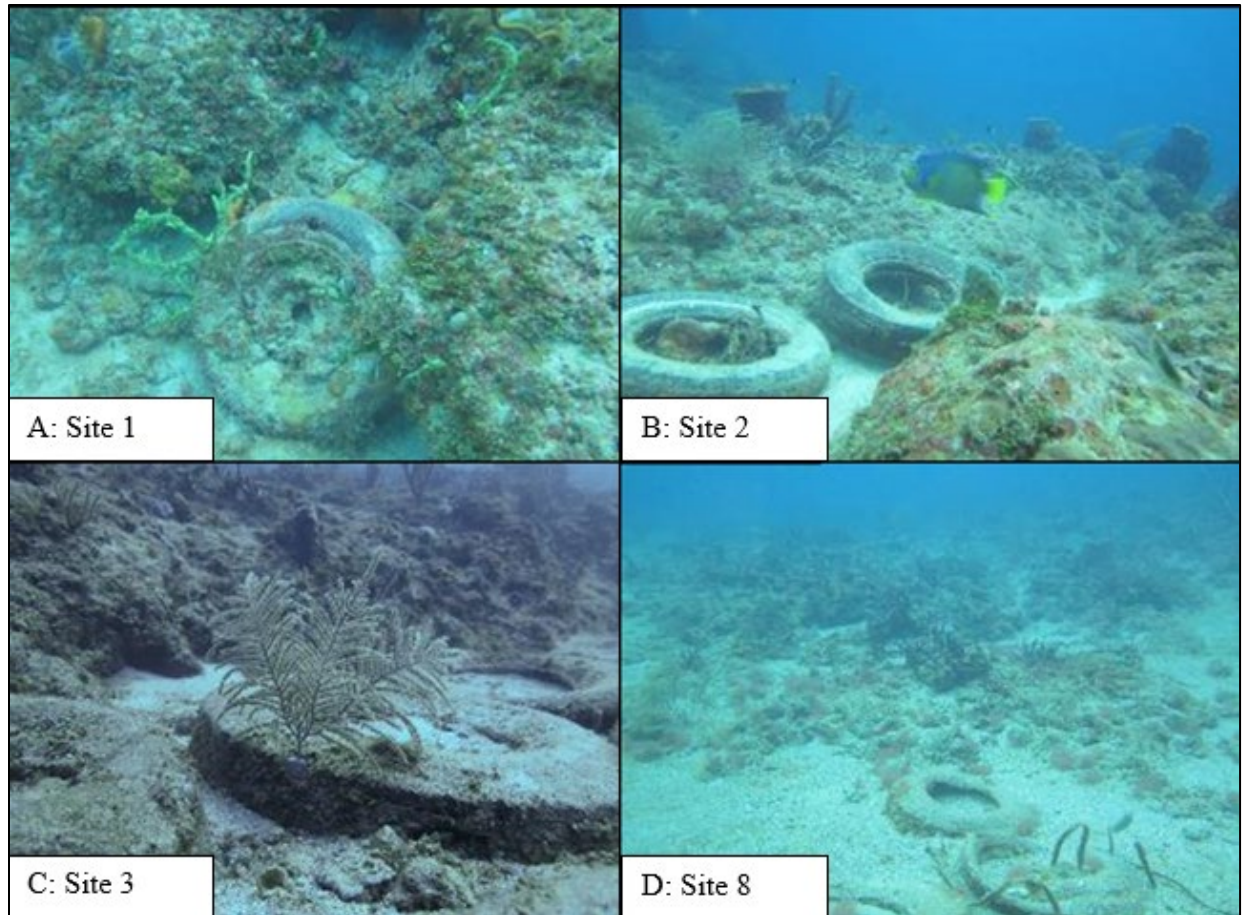
Attached anthozoan fauna (Fauna on Tire category as Rank #5, **Table C-1**) consisted of octocorals and stony corals (**Image C-1a**) at >30% cover (Rank #5). Four sites had tires with this ranking (**Table C-2**). The reef fauna impact category represented areas where tires have damaged reef fauna. In general, most sites had low scores of 1-2. The greatest recorded impact on reef fauna was represented by Rank #3 indicating 40-60% of damage to fauna (Sites 3, 8, 11 and 27). This damage was typified by areas of reef devoid of fauna in a band along the bottom portion of coral reef habitat from the sand/reef interface to approximately 0.5 m above the seafloor. These areas were only occupied by turf and crustose coralline red algae representing potential damage caused by shifting of tires eliminating attached reef fauna, and/or preventing any new growth. This was similar in the data recorded in the substrate impact category, all of which ranked in the little to no impact categories (Rank #1-2). Only Site 3 had substrate damage recorded between 40-60% (Rank #3), which was coral reef habitat scrubbed bare of flora and fauna.

**Image C-1.** Representative photos of tires on/near coral reef habitat. (A) Sites 1, (B), Site 2, (C) Site 3 and (D) Site 8, from the April 2024 reconnaissance dives, photographed by CEG.

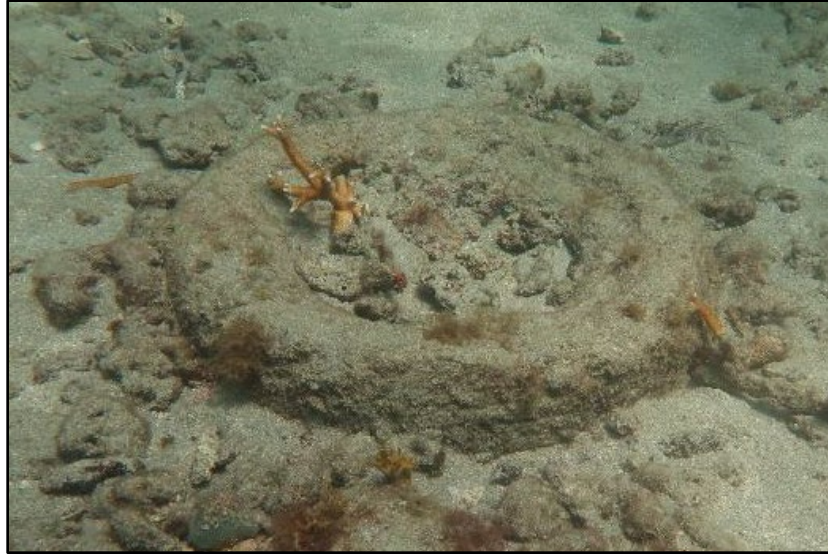
**Image C-2.** North of Site 29, one colony and fragments of *A. cervicornis* were found within and nearby a tire. DGPS position of the area was recorded for future reference. Image taken by CEG divers on April 19, 2024.

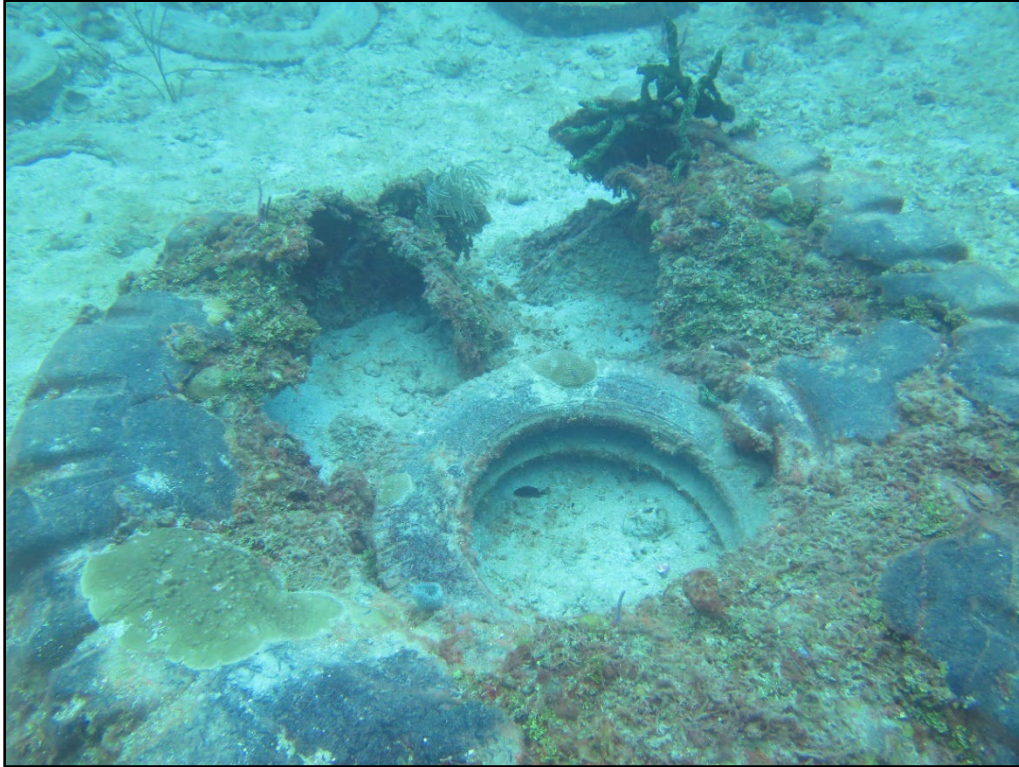
**Photo Gallery Image 1.** A loose, mostly exposed tire (tire condition rank=2) with >10% attached stonies/octocorals (fauna on tire rank=4) at Site 1. Image taken by CEG April 4, 2024.

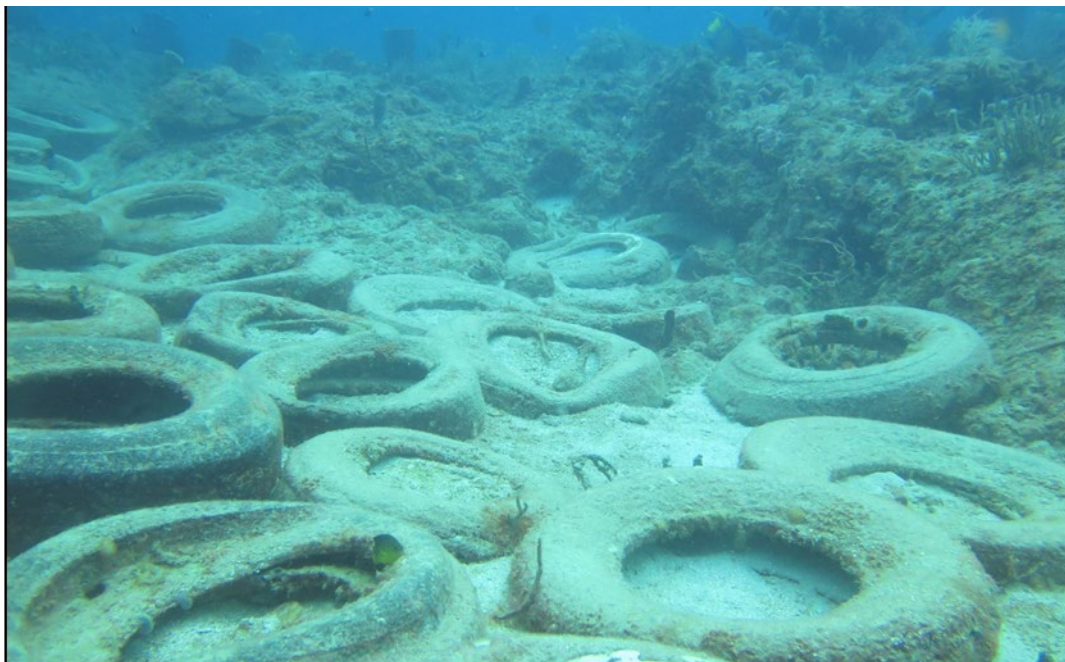
**Photo Gallery Image 2.** An abundance of tires partially buried (tire condition rank=3) with over 10 tires observed on hardbottom at Site 2. Image taken by CEG April 4, 2024.

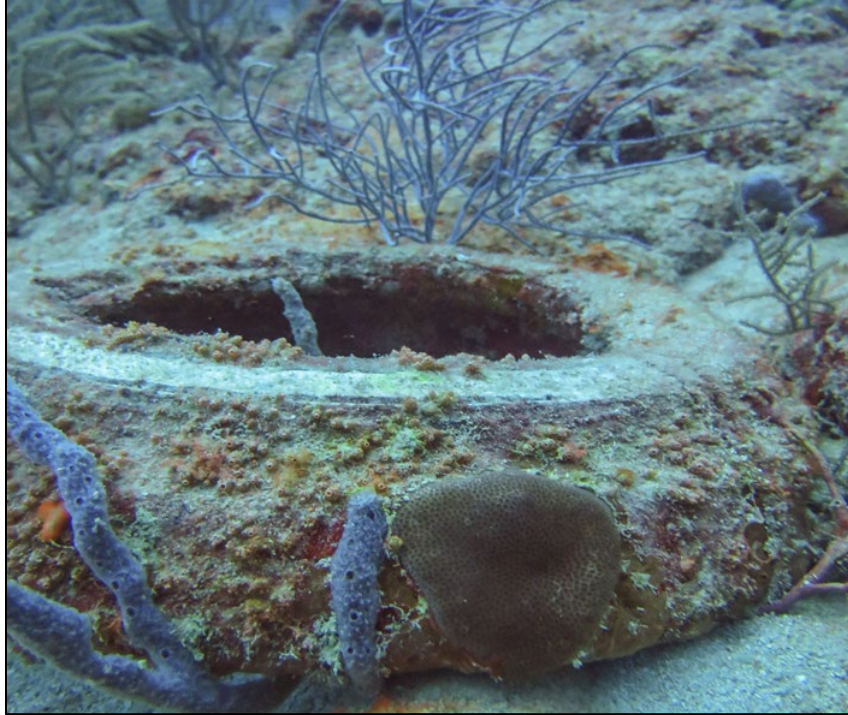
**Photo Gallery Image 3.** A tire trapped in hardbottom (tire condition rank=3) with >30% observed stonies/octocorals and other fauna present (fauna on tire rank=5) and 20-40% fauna damage (reef fauna impact rank=2) observed at Site 4. Image taken by CEG April 4, 2024.

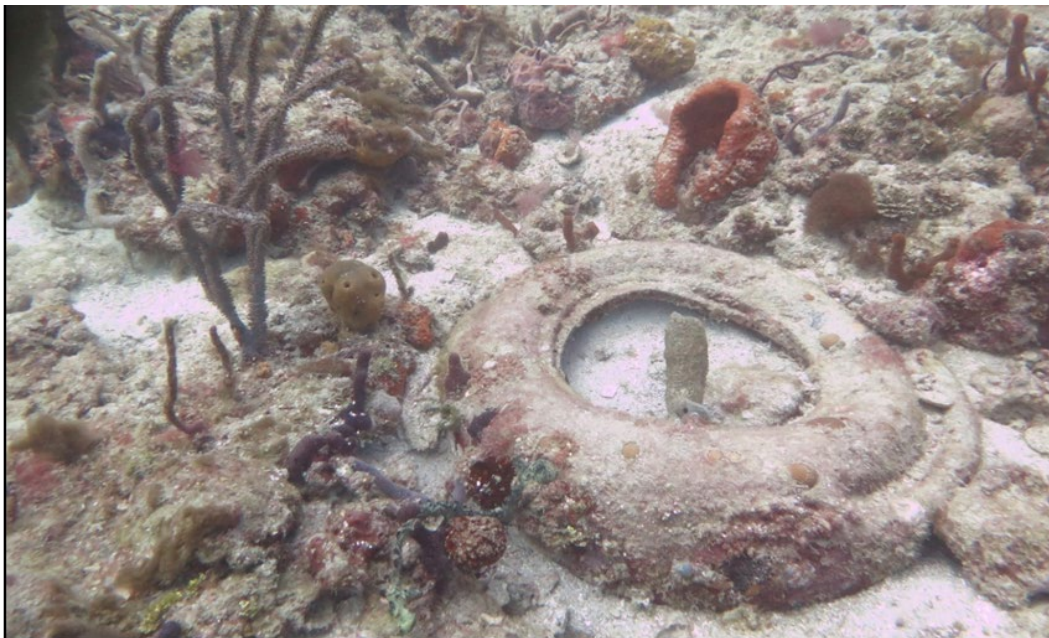
**Photo Gallery Image 4.** A tire trapped in hardbottom and partially buried (tire condition rank=3) with >10% stonies/octocorals present (fauna on tire rank=3) observed at Site 6. Image taken by CEG April 1, 2024.

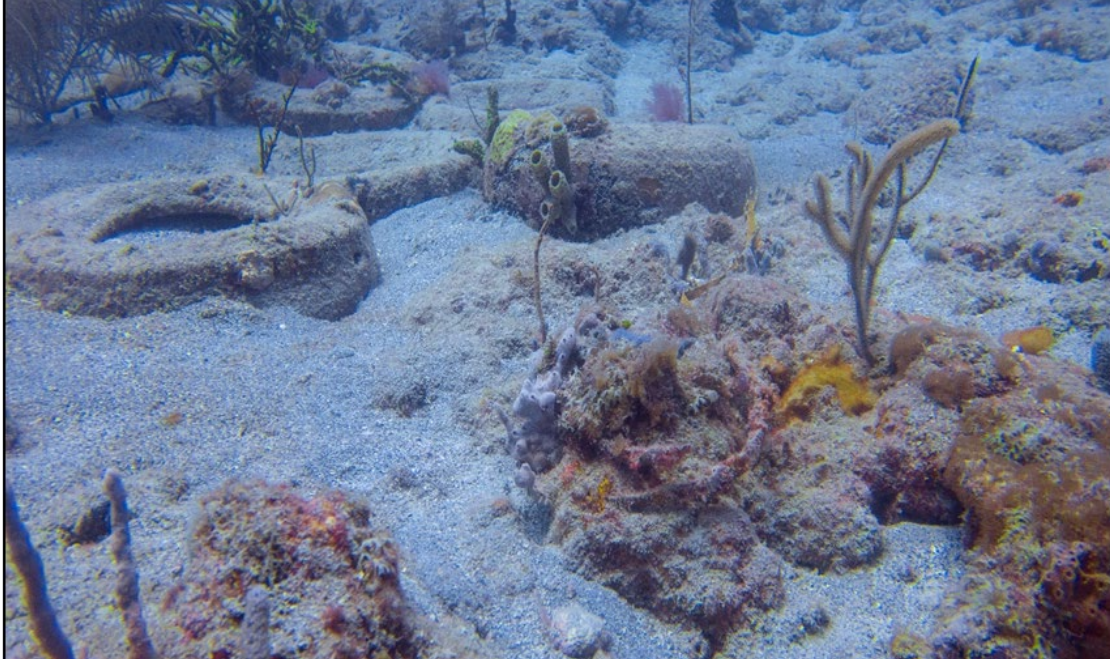
**Photo Gallery Image 5.** Multiple tires with >10% fauna (fauna on tire rank=3) observed at Site 10. Image taken by CEG April 15, 2024.

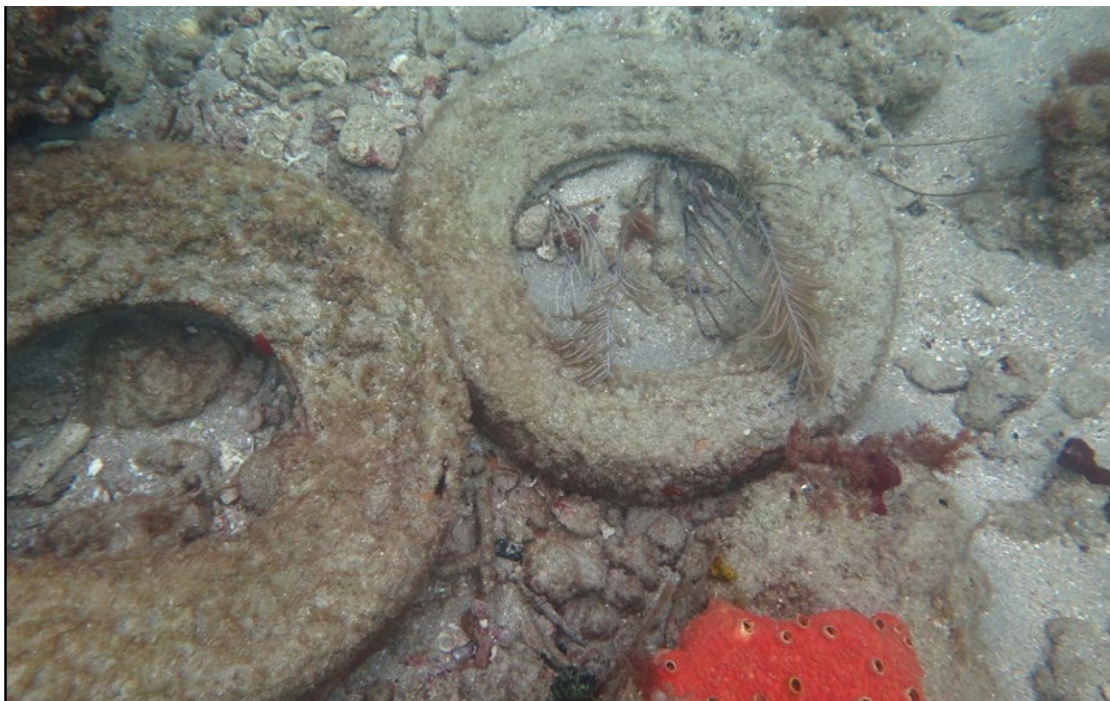
**Photo Gallery Image 6.** Loose, mostly exposed tires (tire condition rank=2) with turf and macroalgal growth (fauna on tire rank=2) and 20-40% fauna damage (reef fauna impact rank=2) evident from bent octocorals at Site 13. Image taken by CEG April 4, 2024.

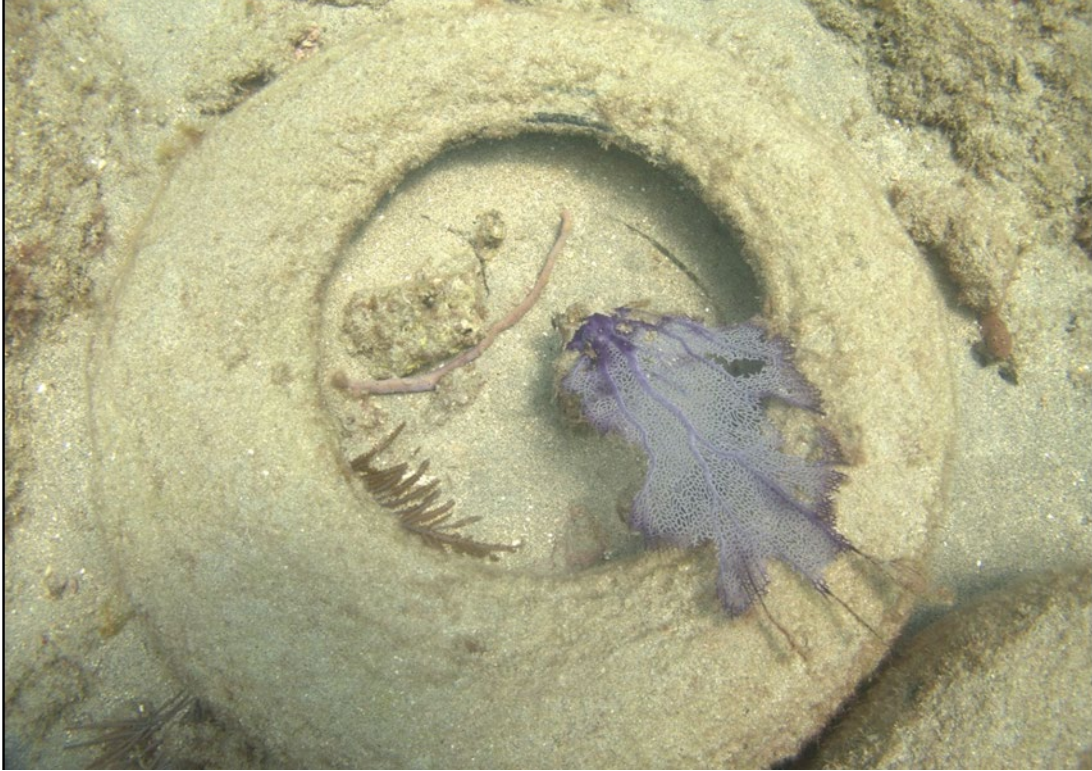
**Photo Gallery Image 7.** A tire with turf, no fauna growth, (fauna on tire rank=2) and 20-40% fauna damage (reef fauna impact rank=2) observed at Site 27. Image taken by CEG April 15, 2024.

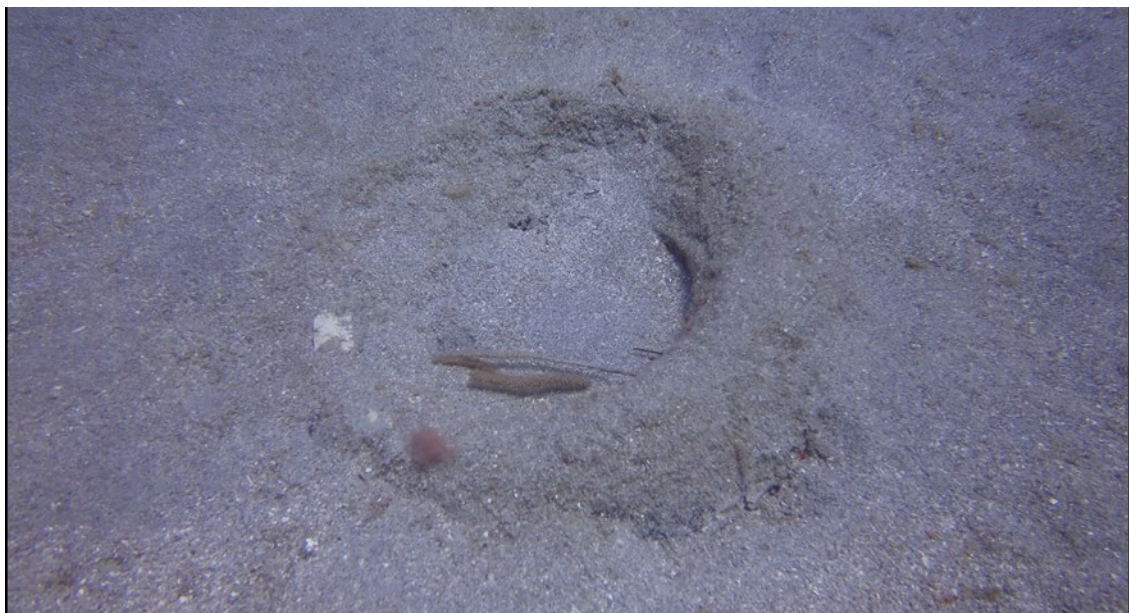
**Photo Gallery Image 8.** A tire >80% buried (tire condition rank=5) observed at Site 28. Image taken by CEG April 19, 2024.

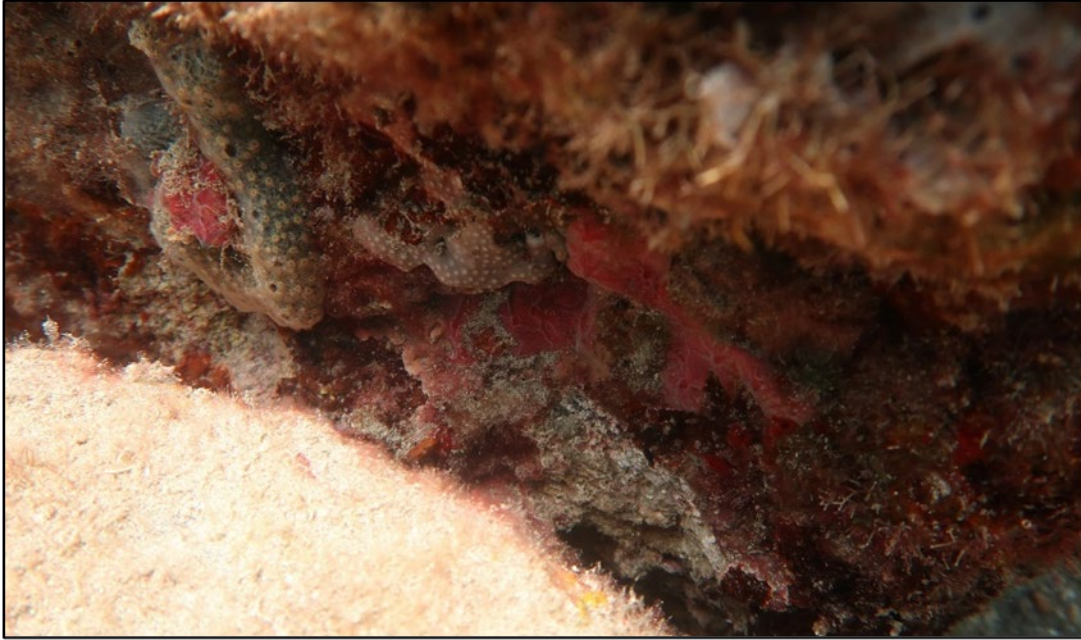
**Photo Gallery Image 9.** The edge of a mobile tire and hardbottom ledge with 20-40% substrate damage (substrate impact rank=2), possibly from shifting or rubbing of tire against the reef, observed at Site 29. Image taken by CEG April 19, 2024.

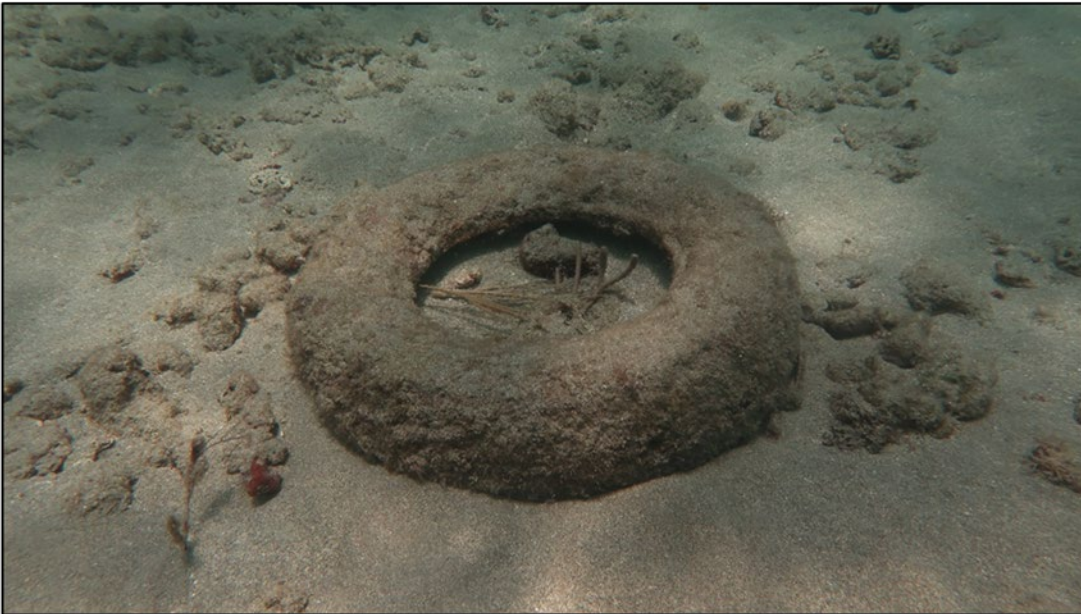
**Photo Gallery Image 10.** A loose, mostly exposed tire (tire condition rank=2) with turf but no fauna growth (fauna on tire rank=2) and less than 20% substrate damage (substrate impact rank=1) observed at Site 30. Image taken by CEG April 19, 2024.

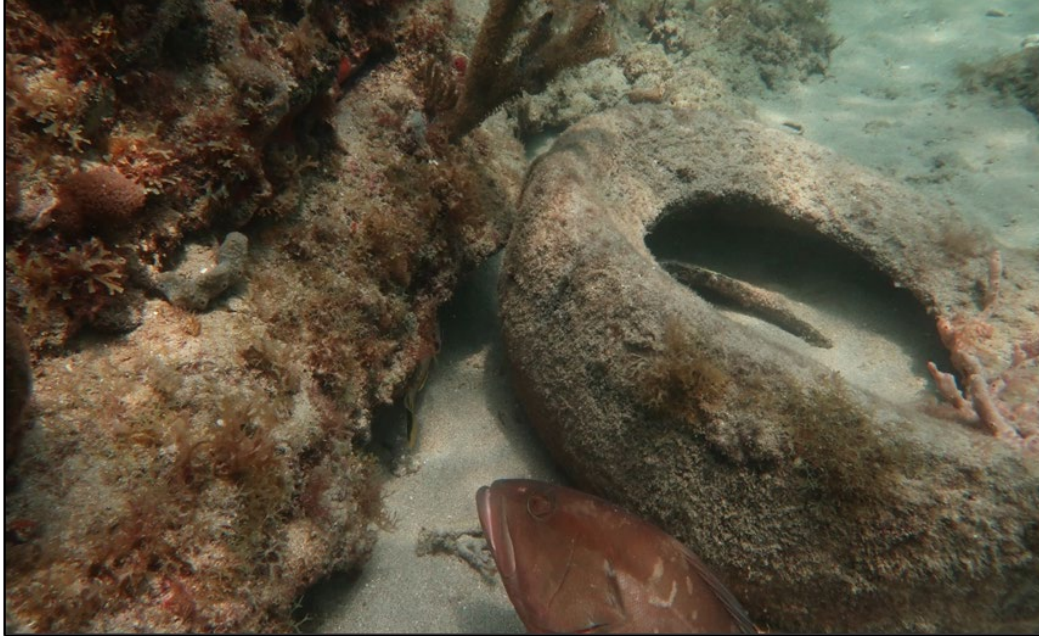
**Photo Gallery Image 11.** A tire near the hardbottom edge with >10% fauna growth (fauna on tire rank=3) and with less than 20% fauna and substrate damage (reef fauna impact and substrate impact ranks=1) observed at Site 31. Image taken by CEG April 19, 2024.

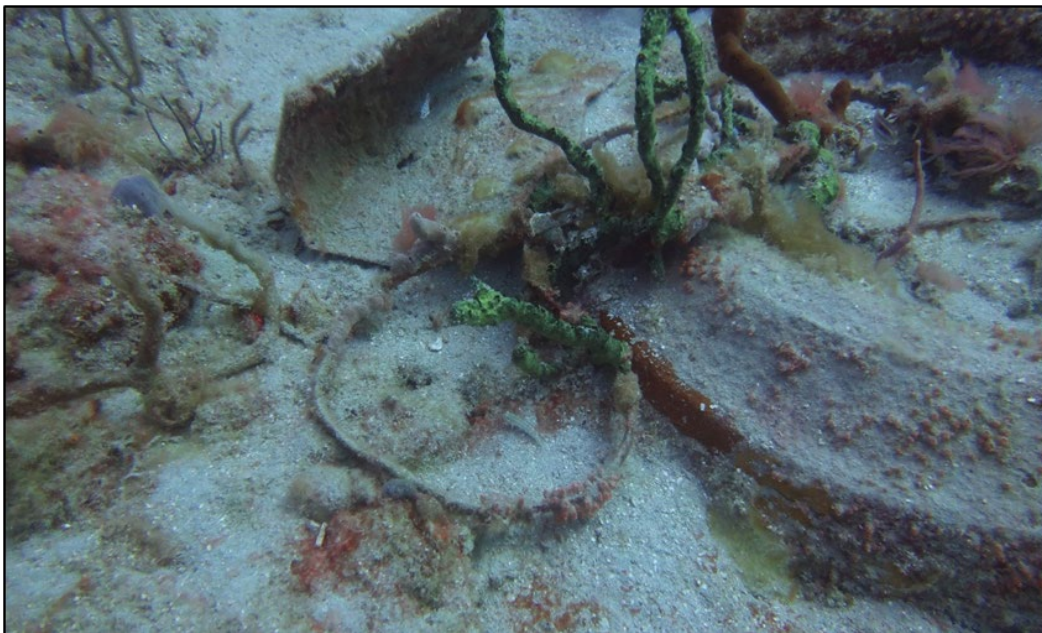
**Photo Gallery Image 12.** A tire >50% buried, entrapped, and immobile (tire condition rank=4) with >30% attached stonies/octocorals (fauna on tire rank=5) and 20-40% fauna and substrate damage (reef fauna and substrate impact ranks=2) observed at Site 32. Image taken by CEG April 19, 2024.

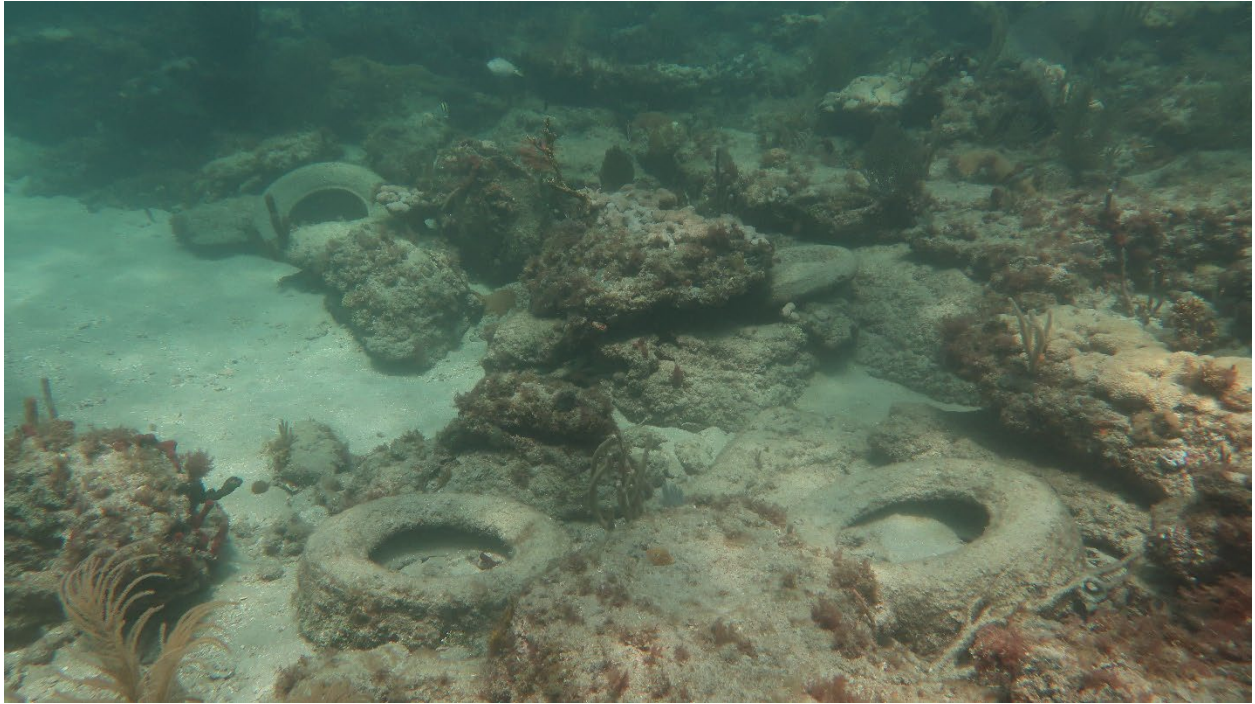
**Photo Gallery Image 13.** Overall image of Site 29 showing density of tires on the reef with potential negative fauna and substrate impact. Image taken by CEG April 19, 2024.

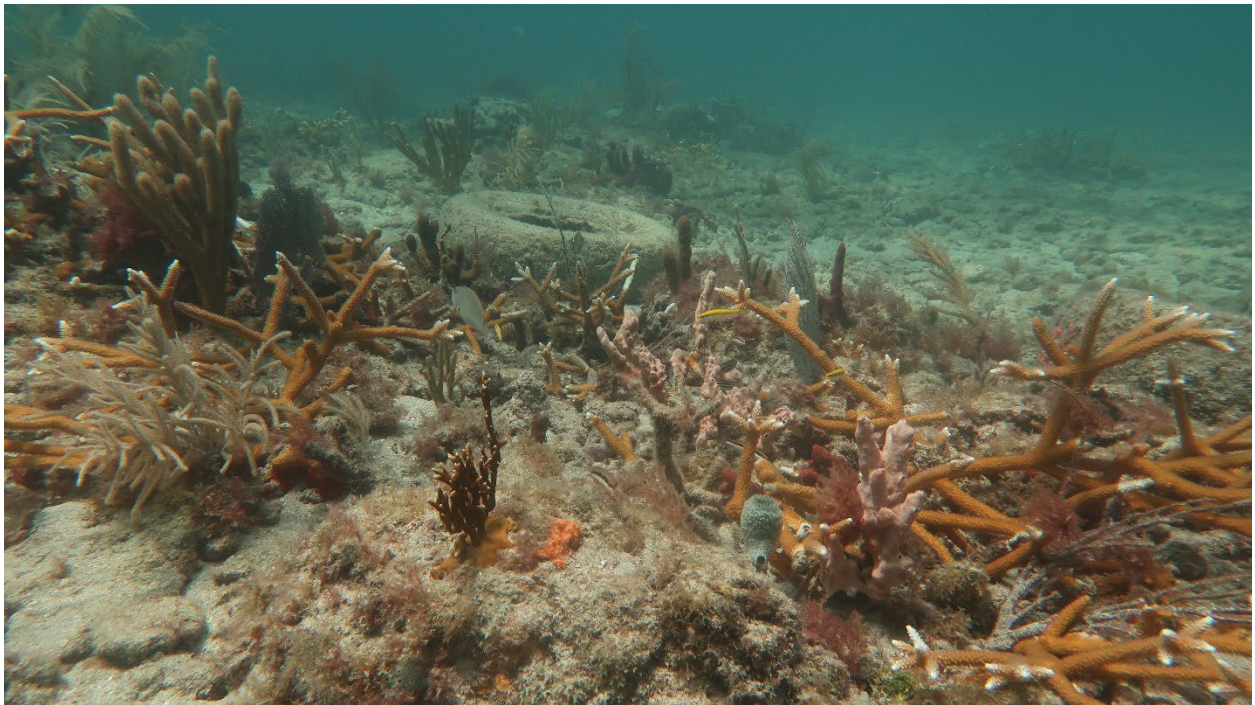
**Photo Gallery Image 14.** ESA-listed *Acropora cervicornis* colonies in close proximity to a loose and moveable tire at Site 29. Image taken by CEG April 19, 2024.

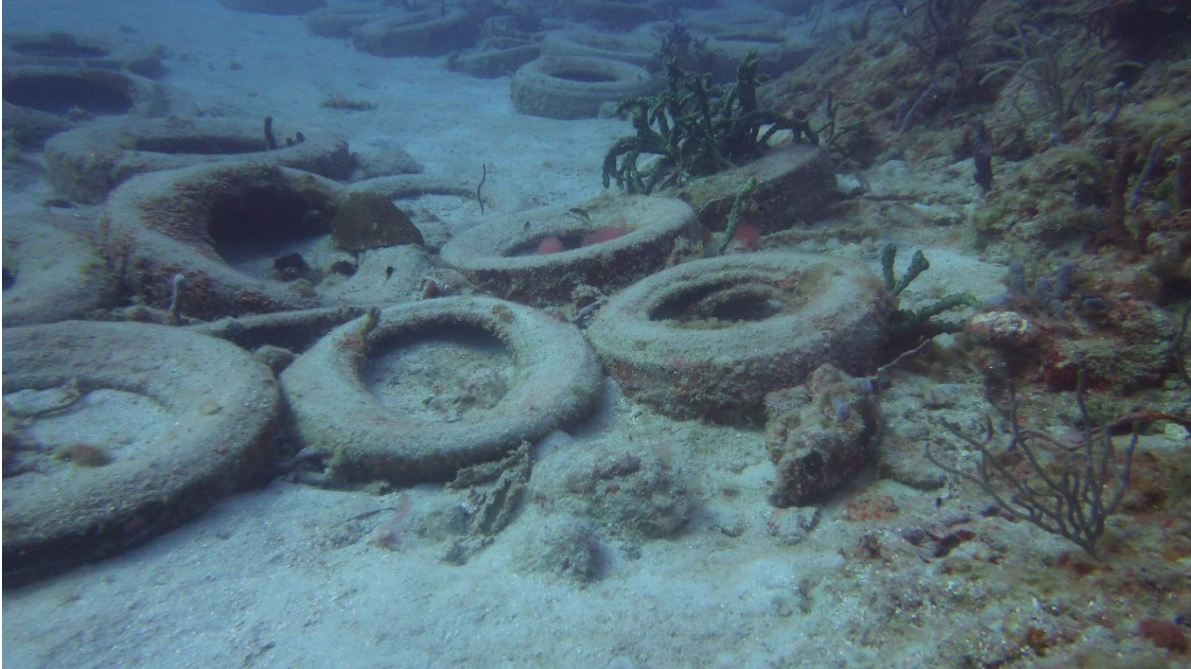
**Photo Gallery Image 15.** Overall image of Site 32 showing density of tires on hardbottom in close proximity to the reef edge with potential negative fauna and substrate impact. Image taken by CEG April 19, 2024.

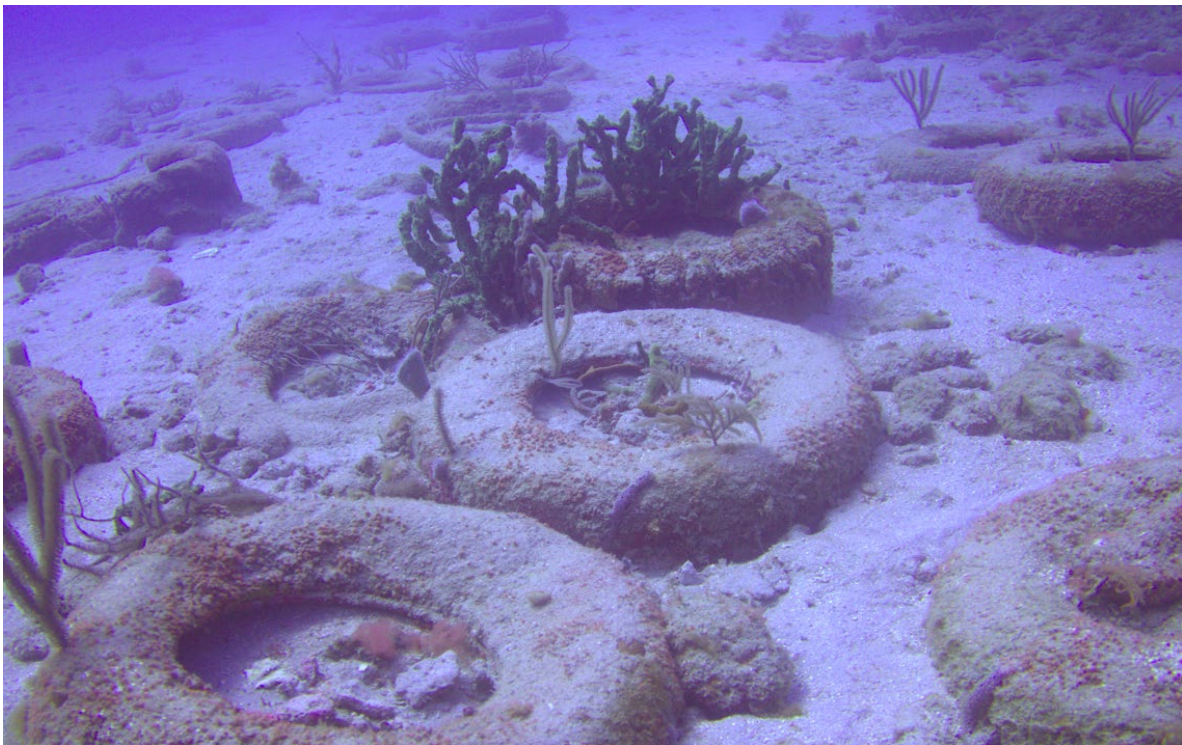
**Photo Gallery Image 16.** Overall image of Site 24 showing density of tires in close proximity to reef edge with potential negative fauna and substrate impact. Image taken by CEG April 15, 2024.

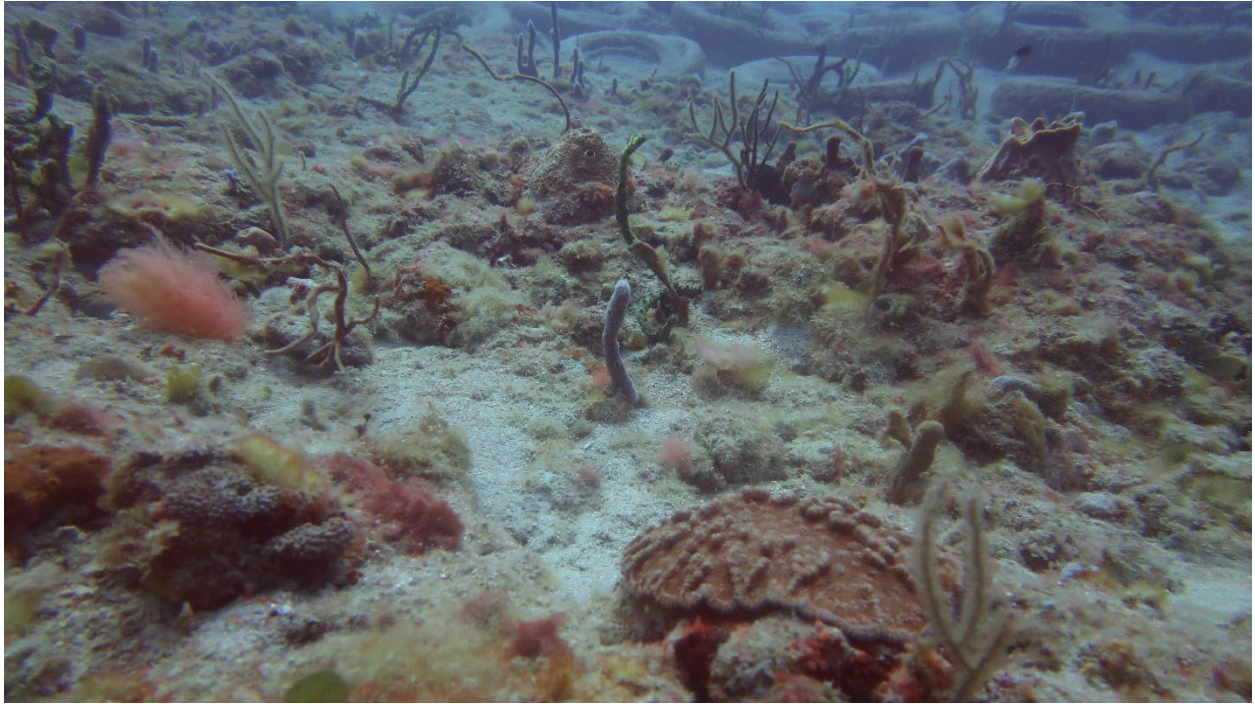
**Photo Gallery Image 17.** Overall image of Site 32 showing an ESA coral, *Mycetophyllia* sp. (bottom of image), in close proximity to high density of tires against the reef edge with potential negative fauna and substrate impact. Image taken by CEG April 19, 2024.
