2014 Survey Timeline

Nearshore Hardbottom Edge VS. Aerial Interpretation

Midtown Transects- regulatory assurance for impact prediction

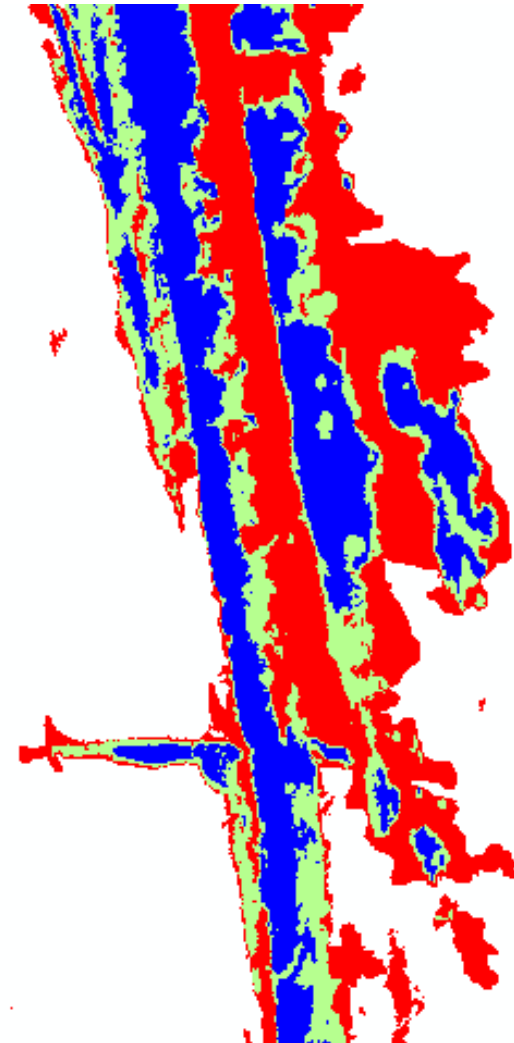
116 in situ characterization sites to quantitatively characterize and map hardbottom based on exposure and water depth

Depth (m) x Frequency of Occurrence	Sample Sites Visited
Nearshore x Low	27
Nearshore x Medium	24
Nearshore x High	18
Intermediate x Low	10
Intermediate x Medium	7
Intermediate x High	8
Offshore x Low	4
Offshore x Medium	7
Offshore x High	6
Undefined	5

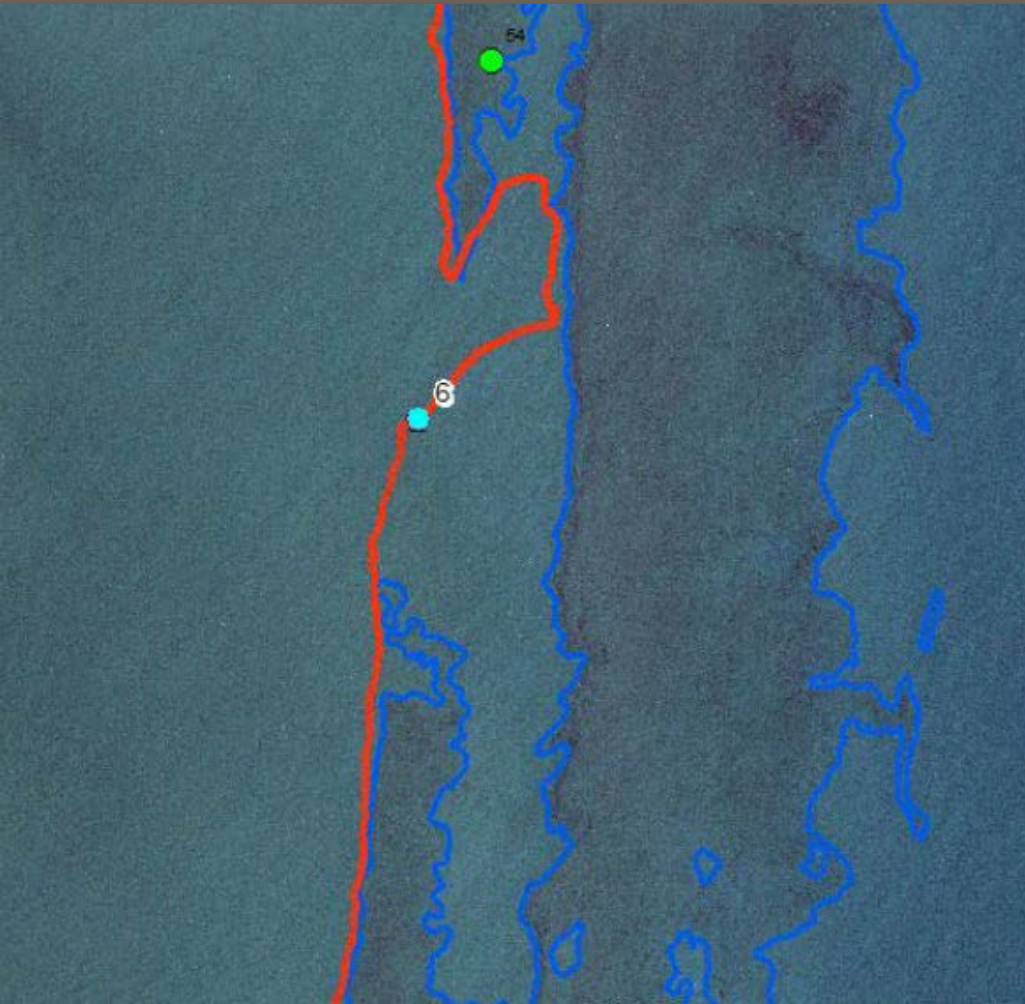
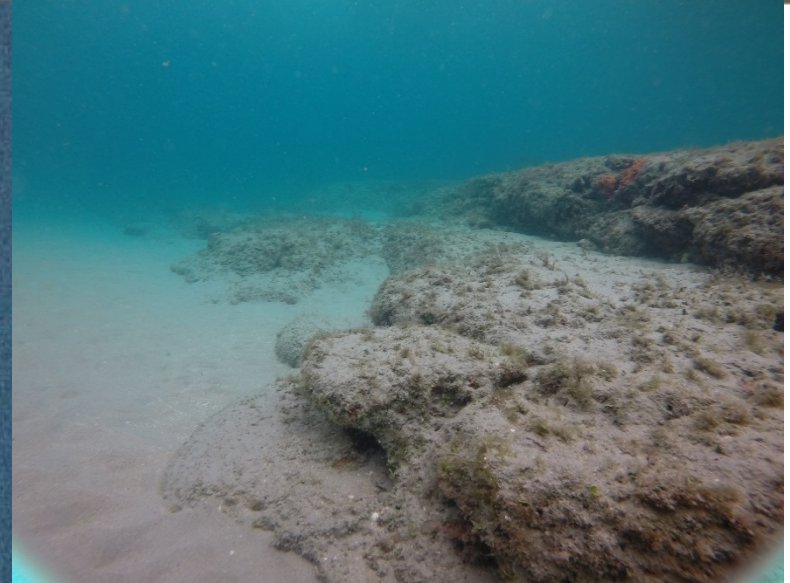
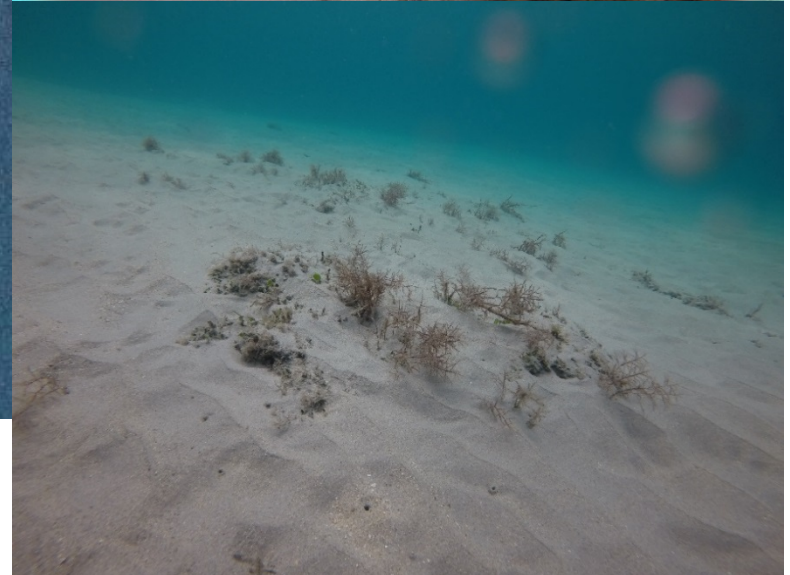
**Diver mapping of nearshore hardbottom edge
vs. aerial interpretation**

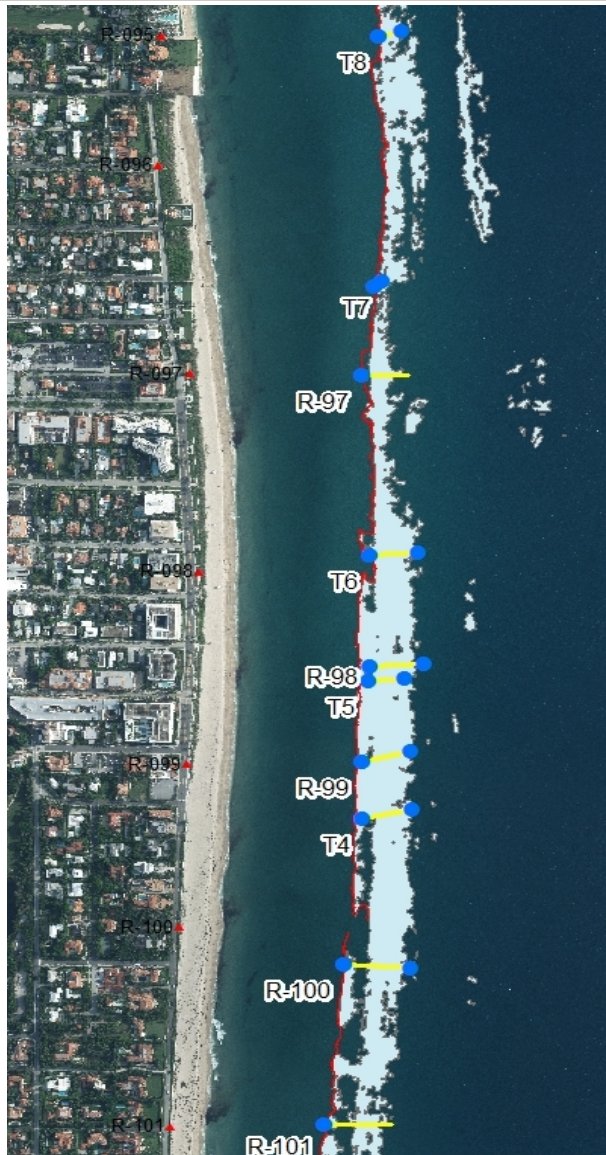
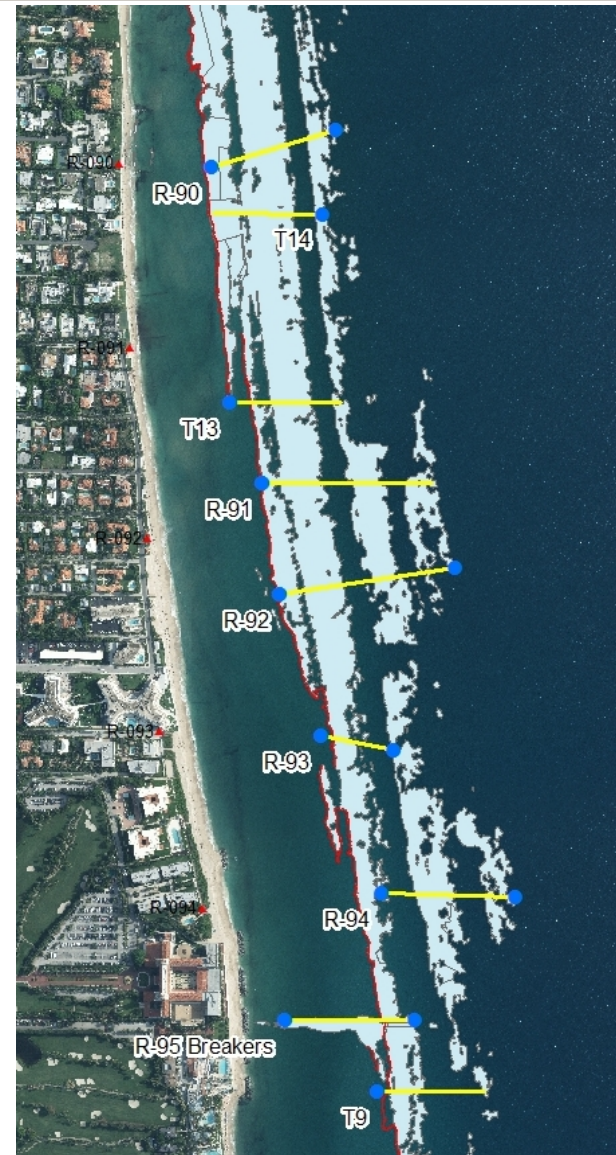
Midtown Benthic and Sediment Transects

Midtown Regulatory Sediment Transect	Date of Installation	Installed Length of Transect (m) based on Exposed Hardbottom, Not to Exceed 200 m
T14	10/3/2014	200
T13	10/2/2014	200
T9	10/2/2014	194
T8	10/1/2014	56
T7	10/1/2014	62
T6	10/1/2014	83
T5	9/30/2014	78
T4	9/30/2014	90

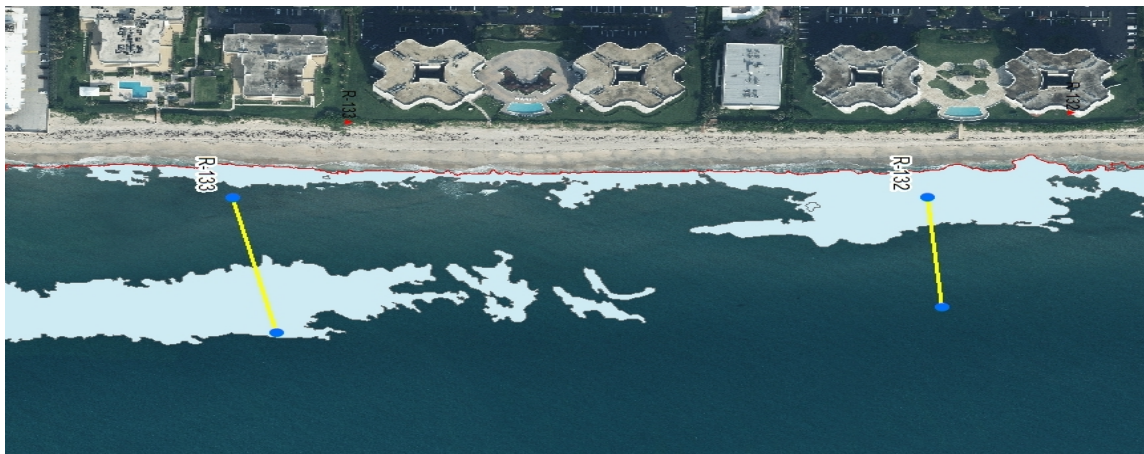
BMA Biological Monitoring Transect Proposed (Summer 2015)

R-79
R-79 Offshore Station
R-82
R-97 Offshore Station
R-135+500
R-139
R142
R-145

14 transects and 2 offshore stations- evaluate variability of sand cover over ephemeral and persistent hardbottom
