Big Hickory Pass Inlet Management Plan

Office of Resilience and Coastal Protection

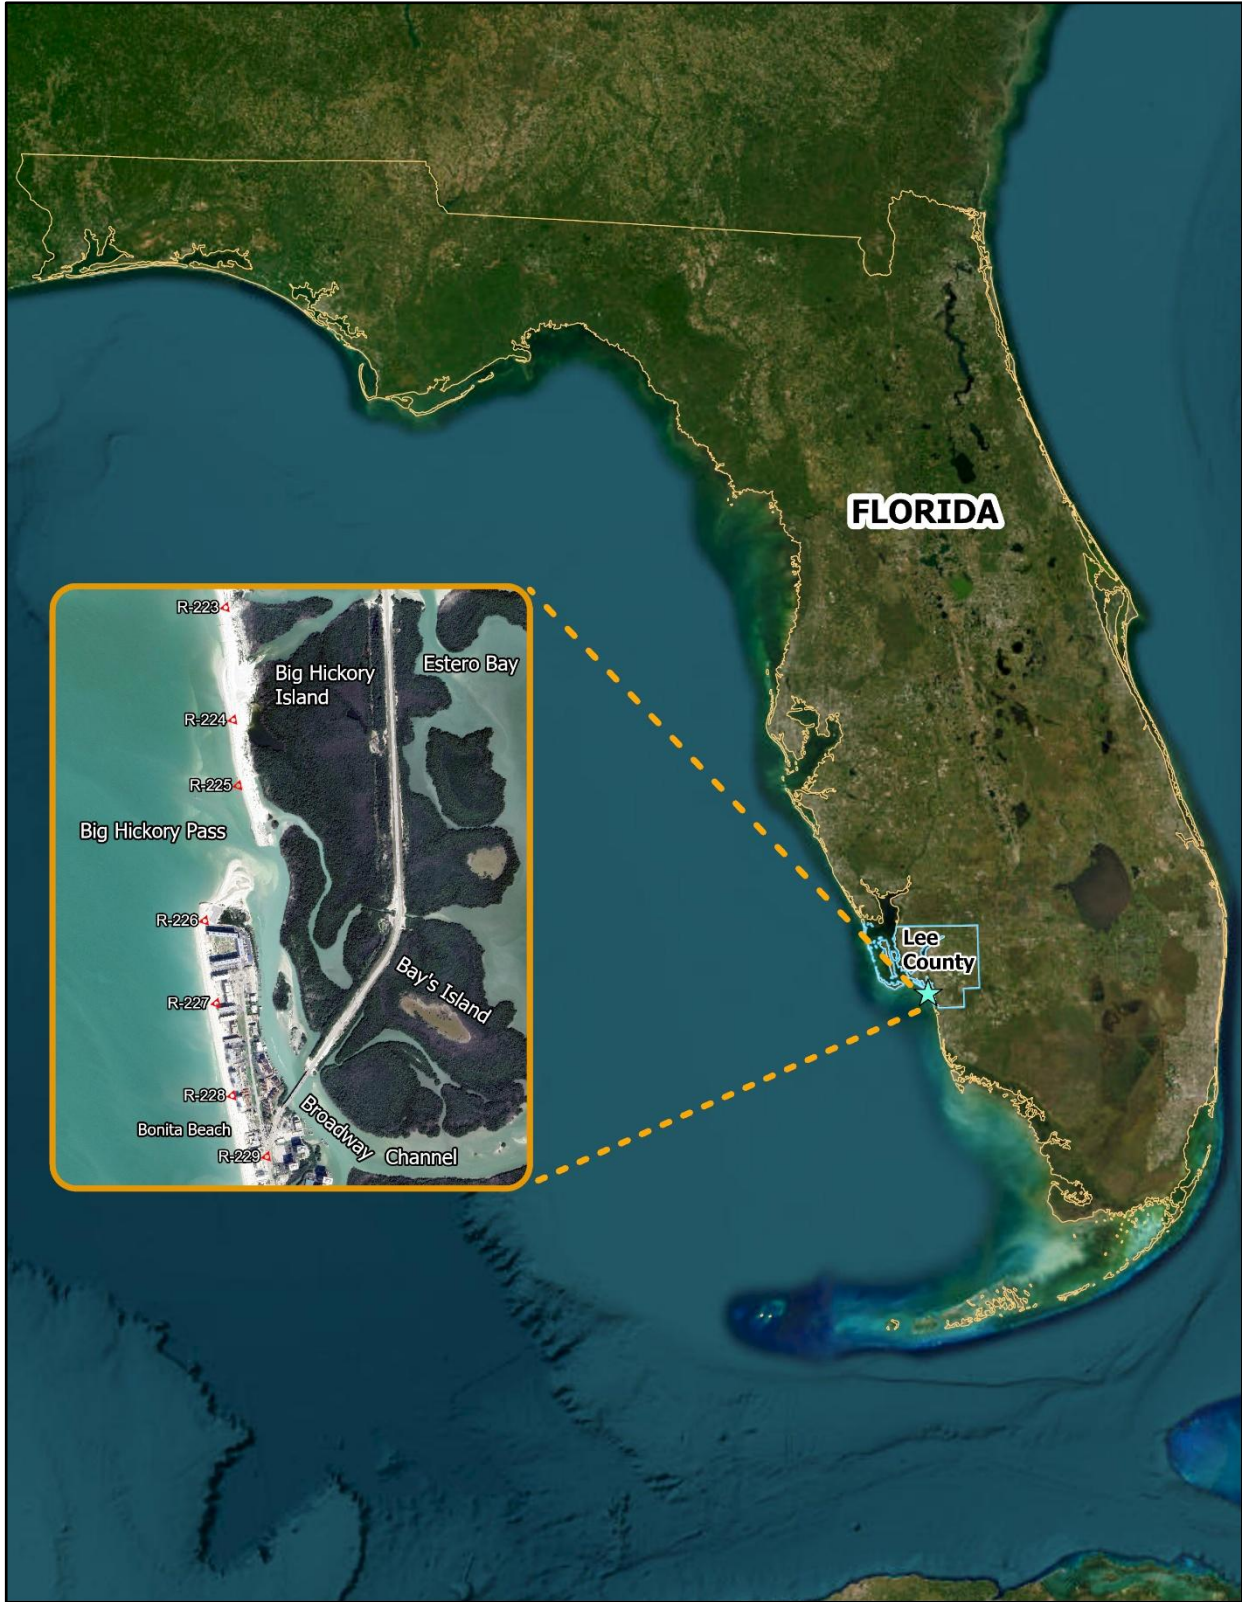
Figure 1. 2023 aerial photograph showing the location of Big Hickory Pass in Lee County (Esri Basemap).

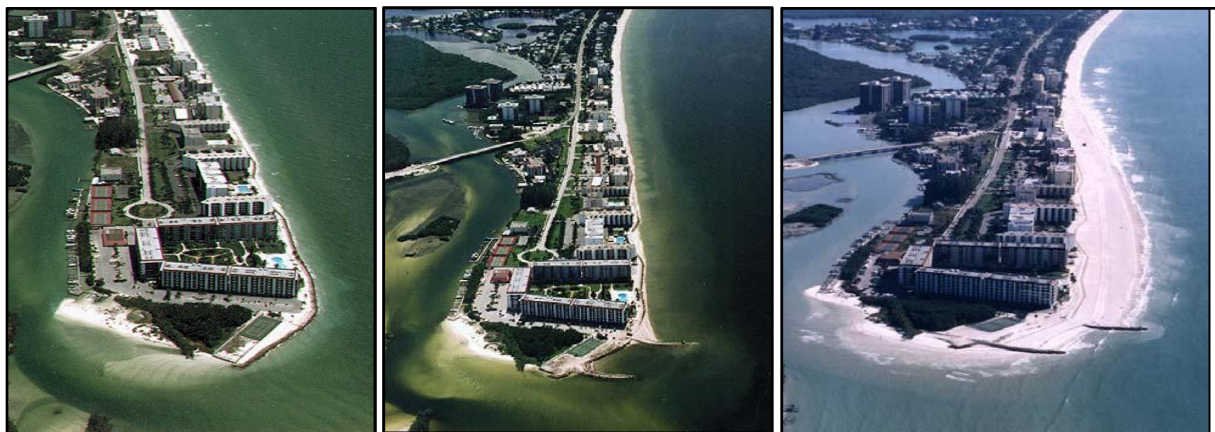
Figure 4. North end of Bonita Beach before construction of the terminal groins (left), after construction of the terminal groins (middle), and after placement of 217,000 cy of sand (right) (Olsen, 2023).

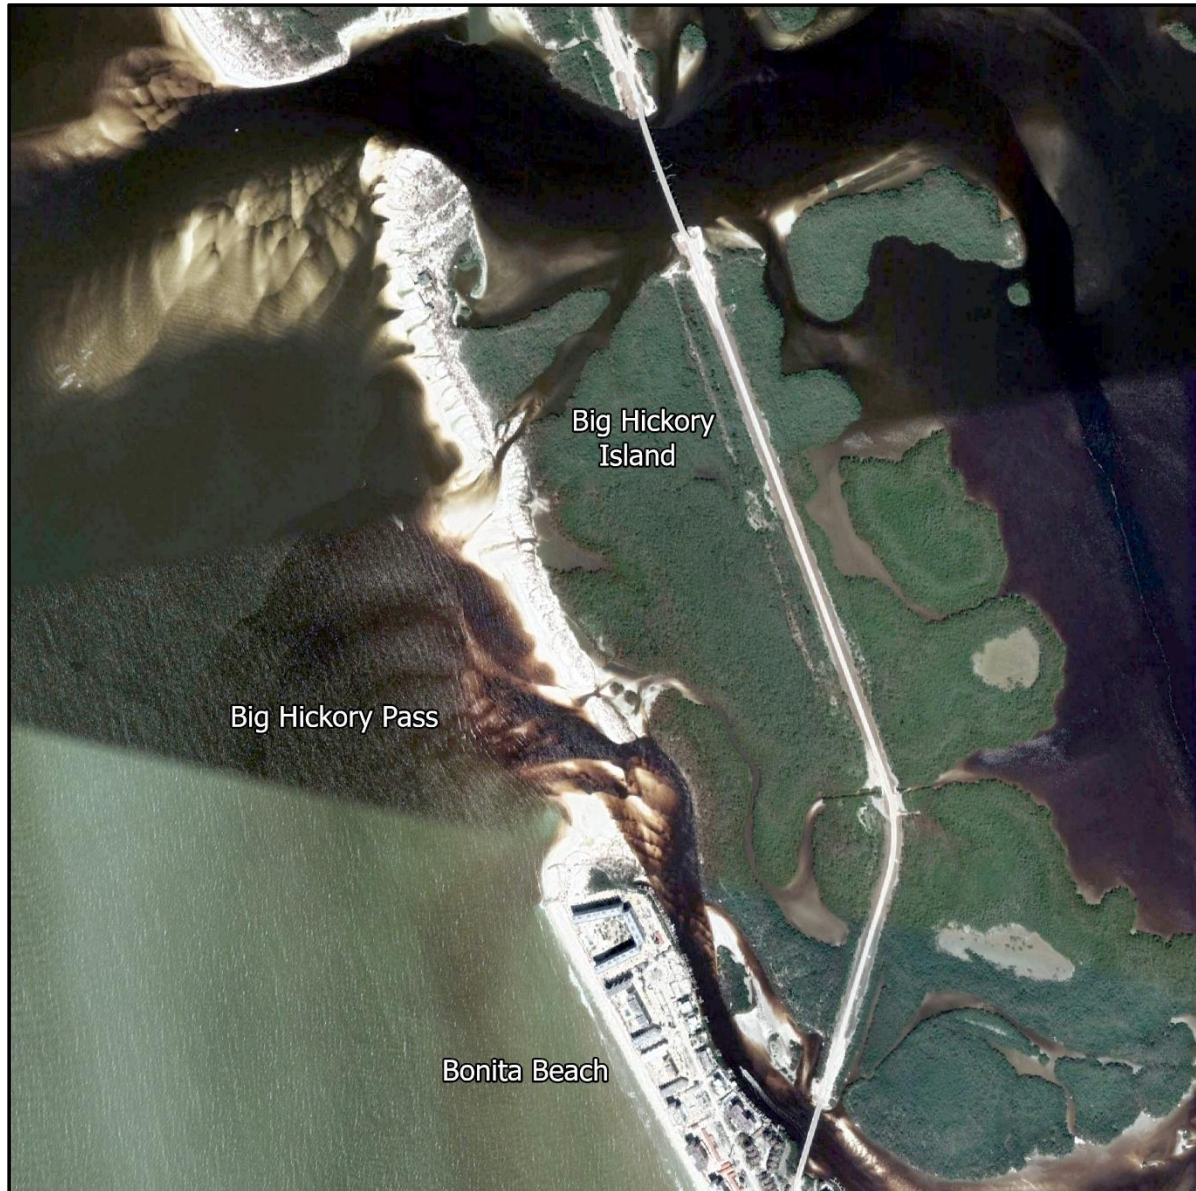
Figure 5. Big Hickory Pass and adjacent beaches in October 2022 following Hurricane Ian’s impact.
