Guana Project Report

Project Title: <u>Combining high-resolution surveys and numerical modeling to optimize water</u> <u>level management and contain nutrient levels in the Guana River Lake</u>

DEP Agreement Number: G3300

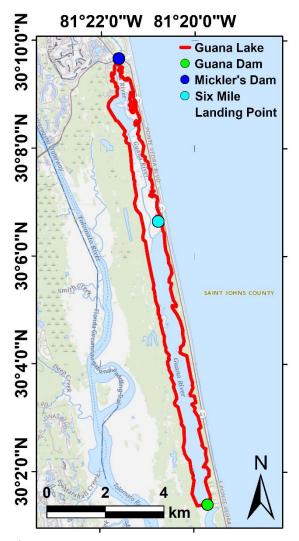
Figure 1. The Guana Lake, which boundaries are defined by the continuous red line. The Lake is connected to the Guana River in the south, through the Guana Dam (green dot) and in the north, through the Mickler's Dam (blue dot). The Six Mile public landing point is also indicated in the map (light blue dot). On the background, the USGS National Map.

Eutrophication is harming estuaries worldwide. In the majority of the Guana-Tolomato-Matanzas (GTM) estuary, high tidal flushing favors the dilution and transport of nutrients to the sea, and water quality standards for nutrients are met. An exception is Guana River "Lake" (Figure 1), an impounded estuary that receives water from a highly urbanized watershed (i.e., the Ponte Vedra area). A water control structure (i.e., the Guana Dam) separates the natural portion of Guana River from the impounded Guana "Lake" where tidal flushing is reduced, causing accumulation of excess nutrients and algal blooms.

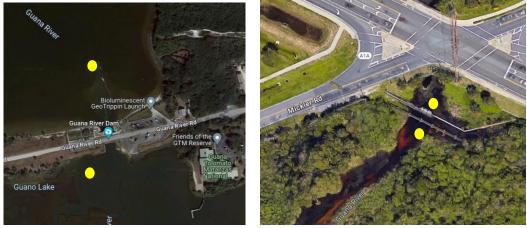
Figure 2. position of the pressure and salinity sensors at the two dams

During the month of September, we deployed salinity and pressure sensors both at the Guana Dam and Mickler's Dam. This will allow to calibrate the discharge coefficient for both weirs.

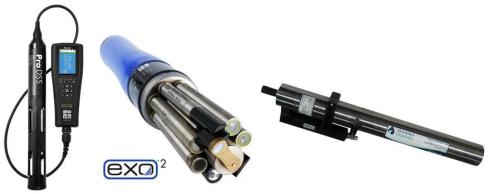
Figure 2. ProDSS, YSI EXO2 and Seabird SUNA nitrogen sensor

The calibration was performed at the GTMNERR lab in Ponte Vedra before each survey. Water quality parameters have been calibrated by using standard samples available in the lab. Calibration logs are available for review.

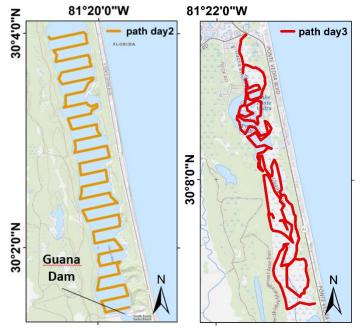
Figure 3. Path followed for days 2 and 3

- <u>Day 2</u>: Data collection (Water quality and bathymetry) in the southern part of Guana lake with HYCAT;
- <u>Day 3</u>: Data collection (Water quality and bathymetry) in the Northern side of the lake up to the Mickler's Dam with HYCAT;
