Documentation in Support of Category 4e

Waterbody/Watershed Identification

<i>Organization</i>	City of St. Petersburg
<i>Point of Contact</i>	Brejesh Prayman, P.O. Box 2842, St. Petersburg, FL, 33731-2842
<i>Waterbody(s)</i>	1700A, Crescent Lake
<i>No. Waterbody / Pollutant Combinations</i>	1 waterbody segment(s); Verified and/or Impaired for Nutrients on the Tampa Bay, Cycle 3, Verified List

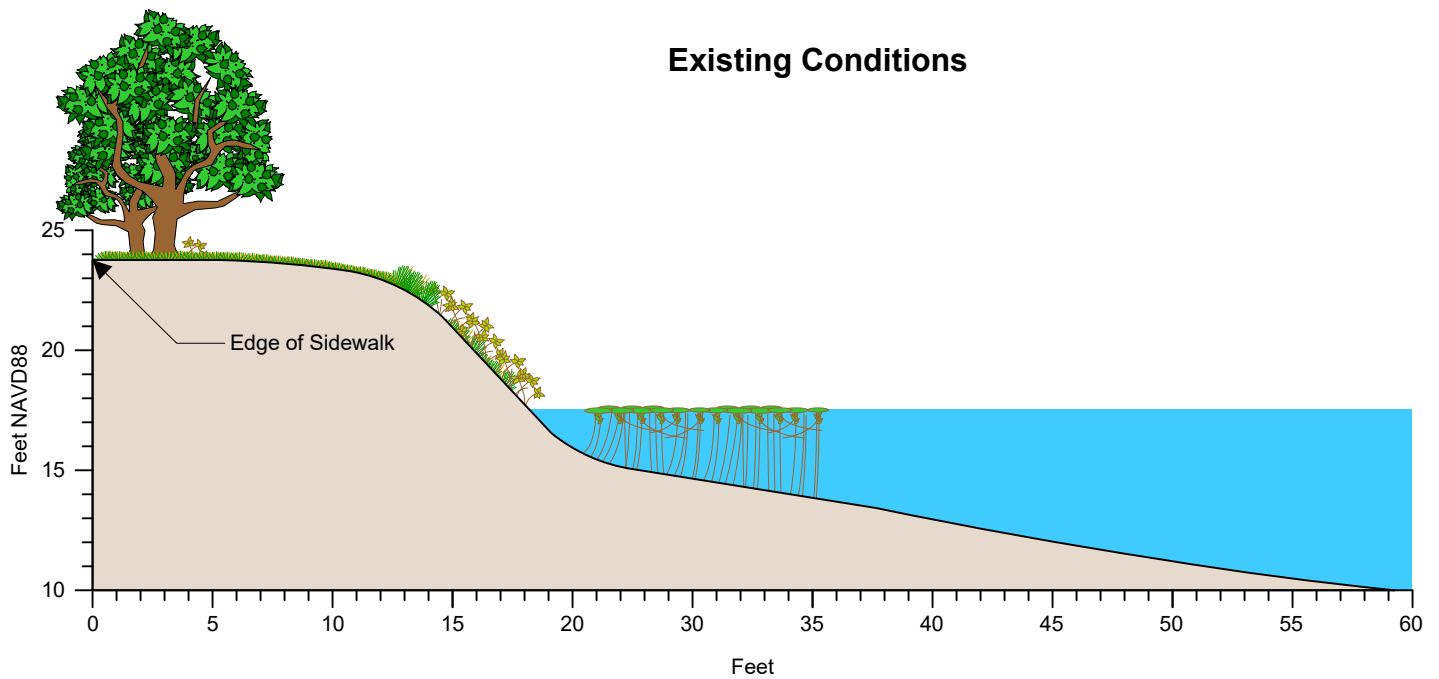
Figure 14
Littoral Zone A – Proposed Improvements
Crescent Lake Management Plan
St. Petersburg, Florida

Since Crescent Lake is a highly modified lake, a significant portion (approximately 50 percent) of its shoreline is steep and not conducive for rooted aquatic plant growth. The steep shorelines of Crescent Lake (greater than 20 degrees slope) could be reconstructed to provide gentler sloped littoral zones favorable for the growth and establishment of aquatic vegetation. As shown in Figure 14, the proposed conditions suggest a portion of the shoreline should be excavated past the current shoreline extent and fill should be placed to provide a littoral zone slope of less than 20 degrees. Once the slope of the shoreline has been modified, native wetland plants such as those provided previously in Table 3 should be planted to promote the establishment of wetland vegetation in the modified littoral zone. To extend the littoral zone further, FTW are suggested to be installed in the deeper portions (6 to 8 feet) of the littoral zone of Crescent Lake (Figure 14). Refer to the following Section 3.1.2 for further details on FTW installation.

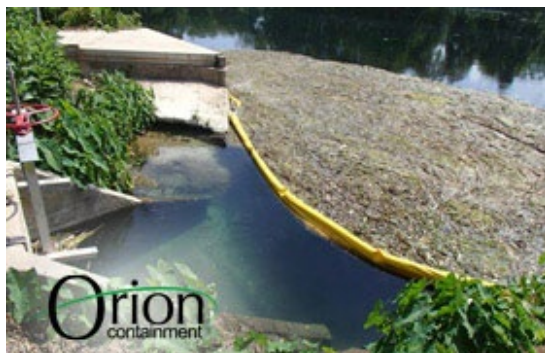
Most debris and nutrients enter Crescent Lake through stormwater inlets. To reduce the trash and nutrient input, it is recommended that the City apply a two-step inlet pollutant removal system approach. The first step applies a floating litter collection system. This system uses flotation devices, or pipe traps, coupled together to contain any floating trash from floating into Crescent Lake. To prevent smaller or submerged litter from entering the lake, the collection systems include an aluminum mesh skirt that attaches to the bottom side of the floating devices and is draped down using weights to ensure the skirt cleans the desired water column. The litter collection system is then manually cleaned as needed. The recommended orientation of the floating litter collection system (Figure 17) allows for proper interception of trash from the inlets while providing an ability to reach the flotation devices to clean out the litter collection system. There are many different manufacturers of litter collection systems including Watergoat, Elastec Trash and Debris Booms, Bandalong Boom Systems, and Orion Floating Debris Booms (pictured below) each with unique adaptations of the litter collection system that can be adapted to the needs of Crescent Lake. Education programs can be started around the litter collection system to increase awareness of the community to the different types of trash and volume of trash that enters the waterways.

Example of Litter Collection System Containing Debris
Source: Orion Containment 2019

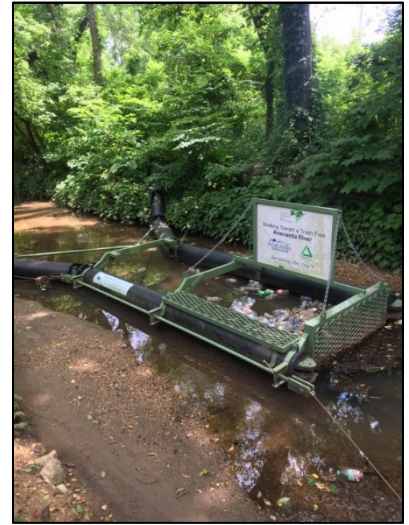
Example of a Stormwater Systems, Inc Trash Trap
Source: Stormwater Systems, Inc. 2019

- **Litter Trap** – litter trap uses the flow of the stormwater to push the floating debris (trash and organic material) into a collection basket. The basket is then periodically cleaned to remove the debris from the system. A litter trap uses a combination of floating booms and the trap itself to concentrate and capture the floating debris. The litter trap can be cleaned using a crane, boomtruck, backhoe or can be manually cleaned by volunteers or City employees. Costs range from \$32,000 to \$60,000 not including installation and delivery. An example of a litter trap follows.

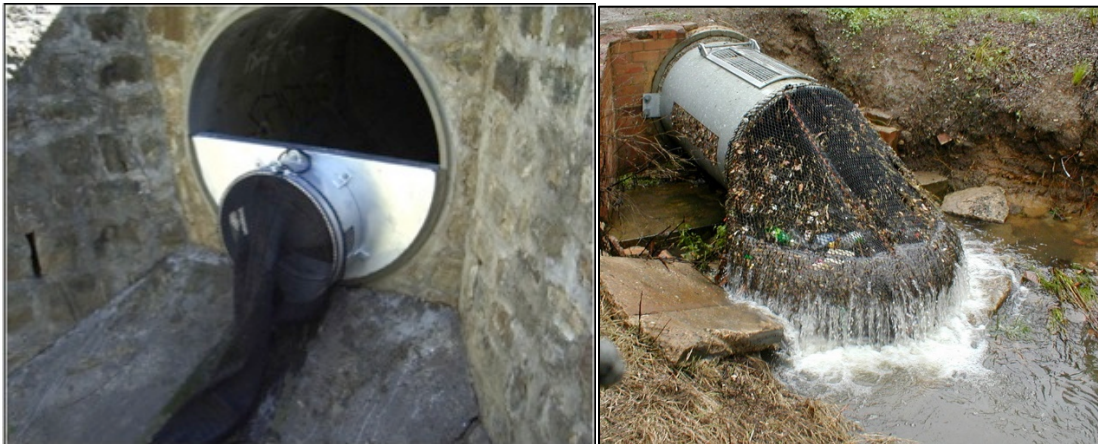
Example of Netting Trash Strap Installed in Stormwater Pipe
Source: Stormwater Systems, Inc. 2019

- **Netting Trash Trap** – Netting trash traps are installed into the outlet pipe (or downstream) and capture a wide range of pollutants ranging from large floating trash to organic materials as small as 5 millimeters wide while allowing the stormwater to flow into the lake unimpeded. Depending on the size of the netting installed, the net can be cleaned in a variety of ways. Smaller nets can be removed by City employees or volunteers and cleaned. Larger nets may require a crane, boomtruck, or backhoe based on the weight of trash collected by the netting. The final option is to use a vacuum truck and remove the trash by vacuuming the litter out of the net. Proper installation and sizing are necessary to ensure that no animals get captured by the netting trash trap. Netting trash traps are built to order and generally range from \$4,000-\$9,000 depending on the model and size, not including delivery and installation. Visual examples of the netting trash trap follow.

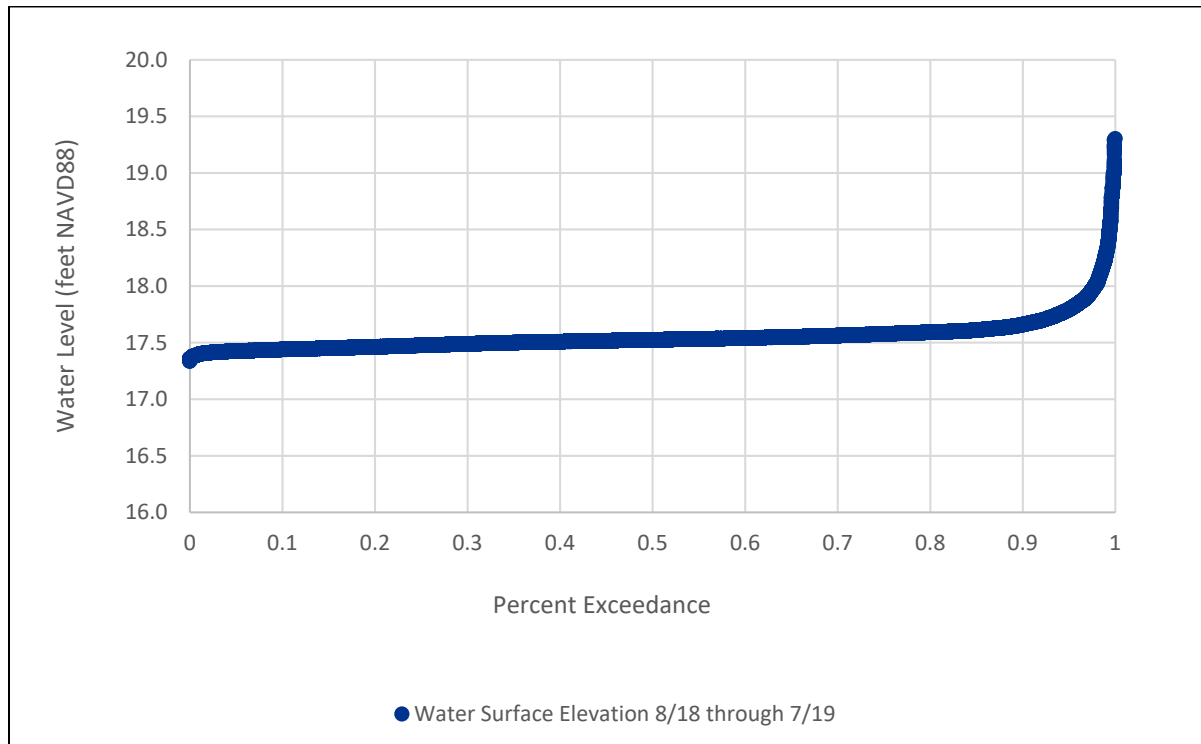
Figure 18. Percent Exceedance Curve of Crescent Lake Water Levels

A typical analytical approach to understanding water level variations or hydroperiods in a wetland community is to look at the water level percent exceedance curve to understand how often water levels exceed key elevations along the littoral zone. Figure 18 presents the percent exceedance curve of Crescent Lake for the period of record of August 2018 through July 2019.

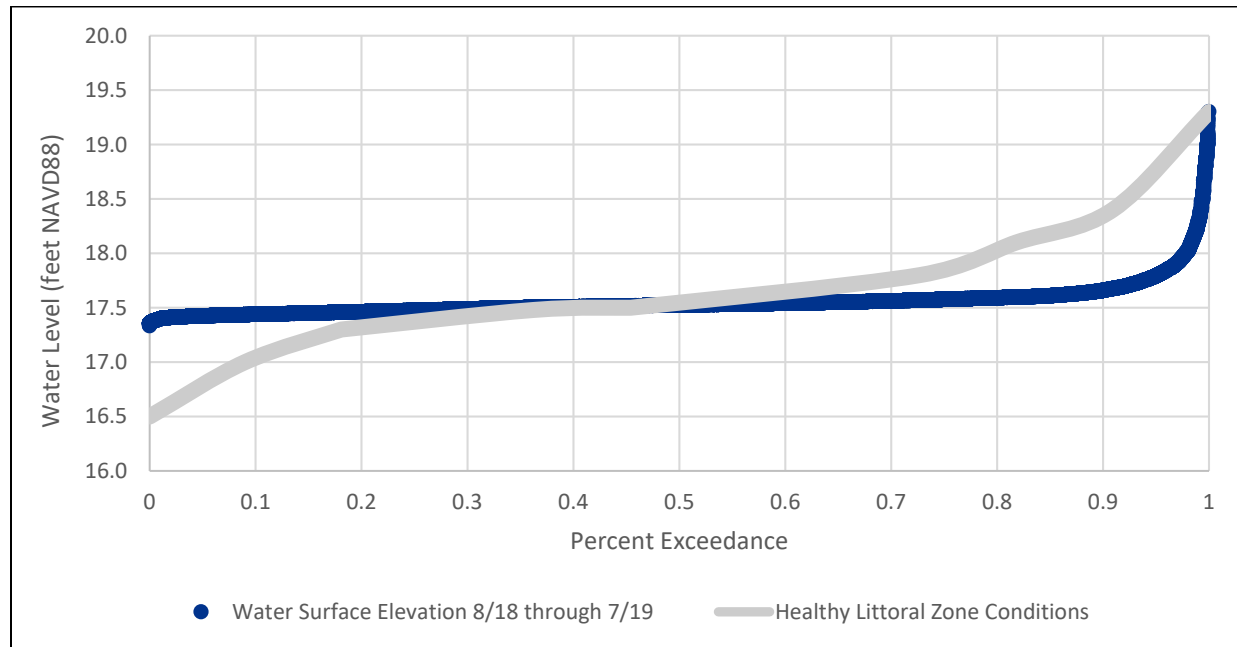
Figure 19. Percent Exceedance Curve for Reference Wetland
Crescent Lake Management Plan

One approach to improve the extent and the functionality of the littoral zone is to create a modification to the outlet weir that creates a lake hydroperiod that includes rainfall driven water level fluctuations that mimic natural wetlands in Florida. Figure 19 presents a percent exceedance curve of a reference natural wetland with a P50 level, or 50th percentile, equal to that of Crescent Lake.

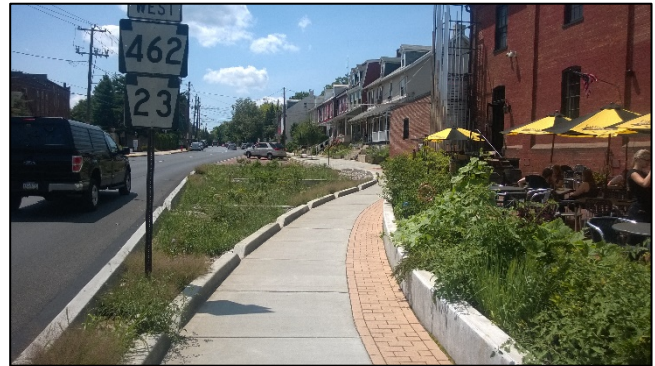
- Bioretention basin – Excavated surface depression with densely planted vegetation in an engineered soil layer on top of a subsurface storage bed. Runoff is collected from surrounding impervious surfaces or roof leader downspouts and is ponded above the engineering soil layer allowing the stormwater to be treated as it slowly infiltrates the

Example of Bioretention in an Urban Corridor

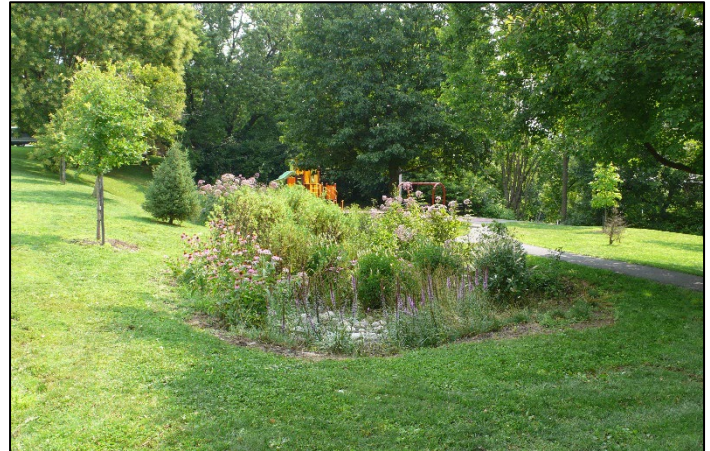
Example of Bioretention Basin in a City-owned Park

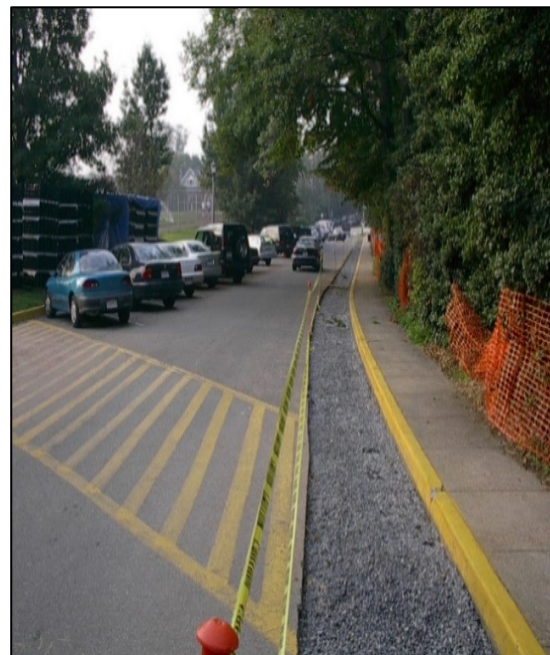
Infiltration trenches are channels or depressed areas with side slopes filled with vegetation or gravel that intercept runoff from upslope impervious areas. Infiltration trenches are similar in function to bioretention facilities but differ in their placement and appearance. Bioretention facilities are open to the surface while infiltration trenches are typically underneath an impervious surface with a surface inlet to allow the runoff to enter the trench. Infiltration trenches provide storage capacity during rainfall and allow the captured stormwater to infiltrate into the native subgrade soil below. Trenches are typically filled with an appropriate, clean, uniformly graded aggregate that provides adequate void spaces to store and filter stormwater prior to infiltration. Trenches can also include sand based structural soil to provide support under pavements while continuing to allow optimal storage capacity and rooting volume for trees. Alternatively, there are various manufactured storage media units that can be used in space-constrained areas to maximize runoff storage with high void percentages. Infiltration trenches are optimal for reducing runoff volume, attenuating flow, and facilitating direct groundwater recharge. Infiltration trenches applications include:

Example of Infiltration Trench Being Constructed along the Edge of a Street

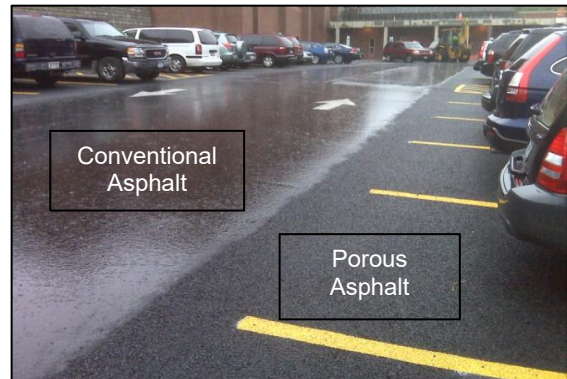
Permeable pavement systems are excavated areas filled with gravel and paved over with a porous concrete-asphalt mix, or various types of permeable pavers. Permeable pavements allow rainfall to immediately pass through the hardscape layer and into the gravel storage layer below. The rainfall is then stored in the gravel storage layer until it infiltrates into the native soil, similarly to an infiltration trench. Permeable pavements are typically utilized in areas where hard, yet permeable, surfaces are desired including parking lots, residential streets, alleys, sidewalks, playgrounds, and basketball courts. There are several different types of permeable pavements including:

Example Showing Porous Asphalt and Conventional Asphalt used in a Parking Lot

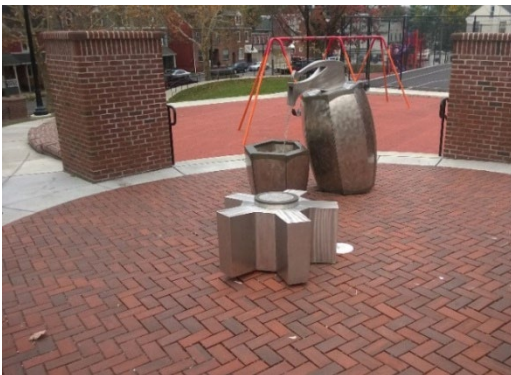
- Open grid pavers – Similar to permeable block pavers except they are designed with larger open areas filled with gravel, soil, or planted with turf grass that allows infiltration. Open grid pavers are often used for overflow parking areas, driveways or fire truck access lanes where infrequent traffic is expected.

Example of Permeable Block Pavers in Entrance to City-owned Park

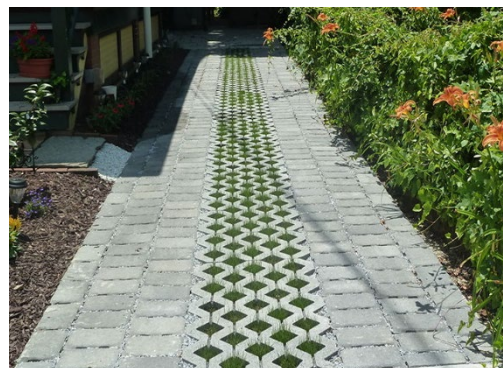
Example of Open Grid Pavers in Alleyway

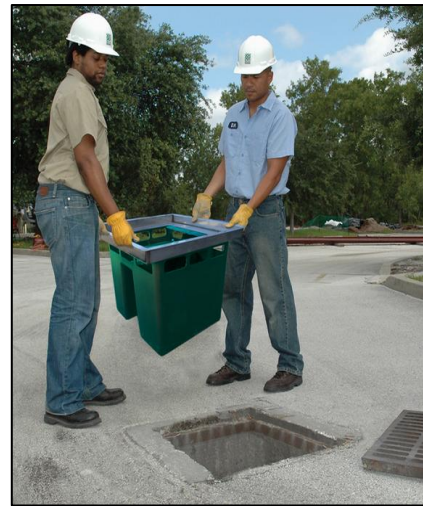
**Example of Catch Basin
Installation**
Source: Interstate Products,
Inc.
