*EVALUATION OF SANITARY
SEWER OVERFLOWS AND
UNPERMITTED DISCHARGES
ASSOCIATED WITH
HURRICANES HERMINE &
MATTHEW*

JANUARY 6, 2017

Prepared by RS&H, Inc. at the
direction of the Florida Department
of Environmental Protection

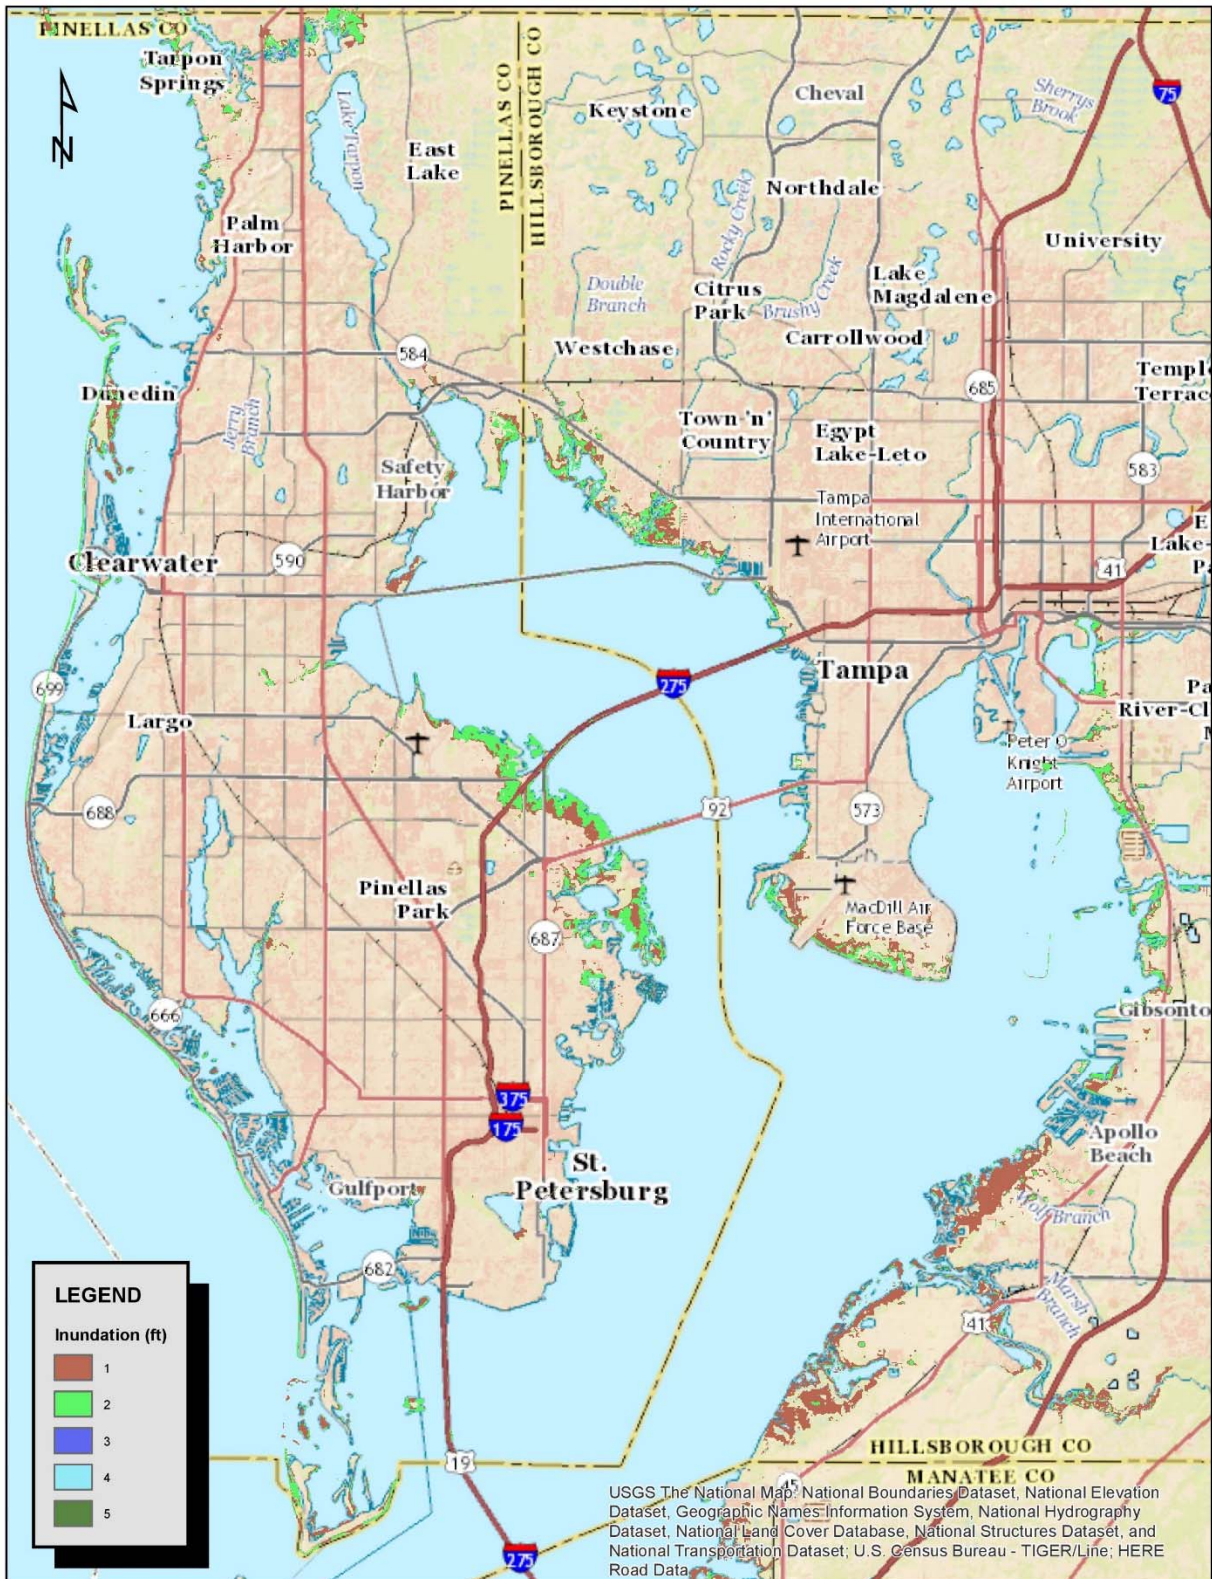
FIGURE 2-5 SOUTHWEST DISTRICT STORM SURGE FLOODING MAP

According to the information provided in Table 2-4, the Southwest District study area experienced an average peak tidal surge increase of 2.78 feet above the MHHW elevation during Hurricane Hermine. In addition, the tidal surge was above the MHHW elevation for approximately 33 hours. Elevated tailwater conditions are commonly associated with tidal surges. Elevated tailwater along with major rainfall from hurricanes typically overwhelm storm water drainage systems increasing the likelihood of inundation of low lying areas. According to the NOAA National Hurricane Center (NHC) GIS Archive information for Potential Storm Surge Flooding (Inundation), inundation of low lying areas within the Southwest District study area was predicted as the hurricane approached the area. As predicted inundation was experienced in low lying areas up to an approximate elevation of 4.0 feet (NAVD 88). Refer to Figure 2-5 for the NHC Potential Storm Surge Flooding Map showing the inundation in the Southwest District study area. The map is based on the National Weather Service (NWS) Sea Lake, and Overland Surges from Hurricanes (SLOSH) model.

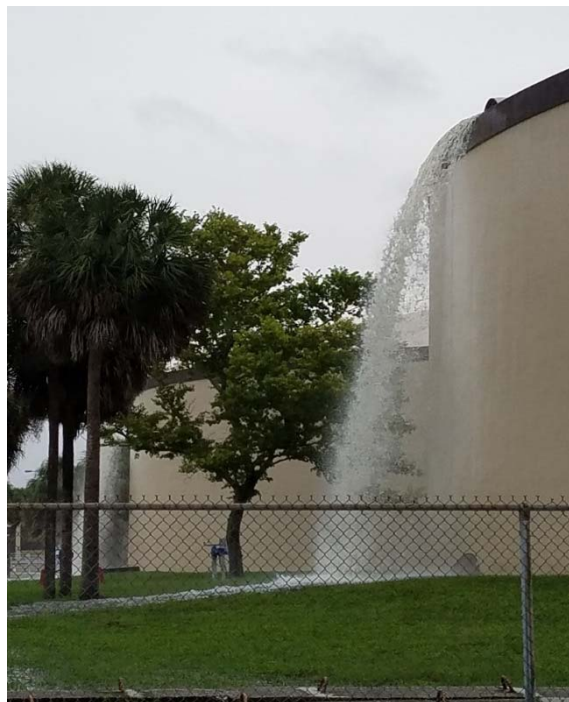
The unpermitted discharge occurred at the NWWRF. The volume of the discharge was 58 million gallons. The discharge originated from vents on the two holding tanks at the WRF. The holding tanks are used to retain treated reclaimed water prior to disposal in the injection wells or transmission to the community's reclaimed water distribution system. The overflow water eventually was conveyed by surface overflow and stormwater conveyance systems to the Walter Fuller Park stormwater pond north of the NWWRF. The overflow at the NWWRF was the product of I&I, and inundation in the sanitary sewer collection system which hydraulically overloaded the WRF beyond its capacity (in particular the effluent sand filters). The high volume of I&I was associated with saturated soils, elevated groundwater levels and above average rainfall.

FIGURE 3-1 NWWRF HOLDING TANK OVERFLOWING TO GRADE

In addition, inundation was caused by the sustained 33-hour tidal surge in conjunction with the high precipitation event. The aging collection system in the NWWRF service area, which also collects significant sanitary flow from St. Pete Beach, reportedly contains broken pipes, separated pipe joints, damaged manholes, leaky manhole covers, etc. These anomalies allowed excess water intrusion into the system from groundwater mounding, tidal inundation, and stormwater flooding.

In addition to I&I flows, high volumes of reclaimed and reject water contributed to the WRF being hydraulically overloaded. The high volume of reclaimed water influent is most likely a result of customers not using the reclaimed water during the rainy period. Between September 1 and September 4, 2016 more influent was coming into the WRF than could be disposed of in the deep injection wells and stored in the holding tanks

The primary failure mode at this location was hydraulic overloading caused by I&I and inundation in the service area sanitary sewer collection system. The effluent sand filters at the WRF were overflowing into the effluent trough; therefore, some of the flow was by-passed resulting in partially treated water (not meeting reclaimed water requirements) being discharged into the deep injection wells. In addition, during peak flows between September 1 and September 4, 2016 more influent was coming into the WRF than could be disposed of in the wells. The City's recommendation to prevent or alleviate this unpermitted discharge during a similar event is to increase the disposal capacity by adding another injection well and increase the hydraulic capacity of the effluent filters by constructing an additional filter.

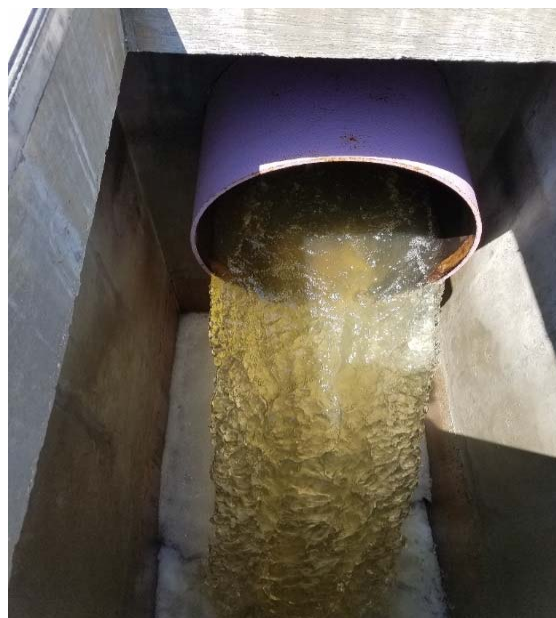
The aging collection system in the Albert Whitted and Southwest service areas, which also collects sanitary flow from the City of Gulfport, contains broken pipes, separated pipe joints, damaged manholes, leaky manhole covers, etc. These anomalies allowed excess water intrusion into the system from groundwater mounding, tidal inundation, and stormwater flooding. In addition to I&I flows, high volumes of unused reclaimed water from the city's distribution system and Eckerd College contributed to the SWWRF being hydraulically overloaded. The high volume of reclaimed water influent is most likely a result of customers not using the reclaimed water during the rainy period. Between August 30 and September 4, 2016 more influent was coming into the SWWRF than could be disposed of in the deep injection wells and/or stored

FIGURE 3-2 AWWRF OUTFALL PIPE DISCHARGE TO TAMPA BAY

The SWWRF flows were calculated / estimated based on flows to the deep injection wells and change in level of the storage tanks because the headworks were being bypassed. Other factors related to the SWWRF estimate was flow of reclaim water coming from Eckerd College and flow meter at Lift Station 85. Lift Station 85 (LS85) is the master lift station that was constructed to convey wastewater from the Albert Whitted service area to the SWWRF. The AWWRF flows were estimated based on the SWWRF flows and LS85 meter. Some meters were maxed out and not working (injection wells); and some were bypassed (SWWRF headworks). The valve at LS85 split the flows downstream of the flow meter to both the AWWRF and the SWWRF. Flow to the AWWRF was dependent on how open the valve was. The valve was adjusted to maximize the flows to the SWWRF without

causing overflows in the system. At times the valve was nearly closed and other times nearly fully open. Knowing how many pumps were running also helped City staff estimate the release. Average daily flow to the SWWRF for FY 2016 was approximately 20 MGD. The average daily flow over the 5 day period between August 30 and September 3, 2016 was 43.7 MGD (more than double the average daily flow). A peak flow of approximately 54 MGD was experienced on September 2, 2016.

The primary failure mode at this location was hydraulic overloading of the SWWRF caused by I&I and inundation in the Albert Whitted and Southwest service areas' sanitary sewer collection systems. According to the *Wet Overflow Mitigation Program – Phase I* study performed by CH2M Hill in April 2016, the most cost effective recommendations to prevent or alleviate this incident during a similar event includes the following upgrades at the SWWRF: expansion of the facility headworks, provide additional screening and grit removal capacity, provide another secondary clarifier, provide additional filtration capacity, provide additional disinfection capacity, and provide yard piping improvements. Also recommended is the installation of additional injection wells at the SWWRF site.

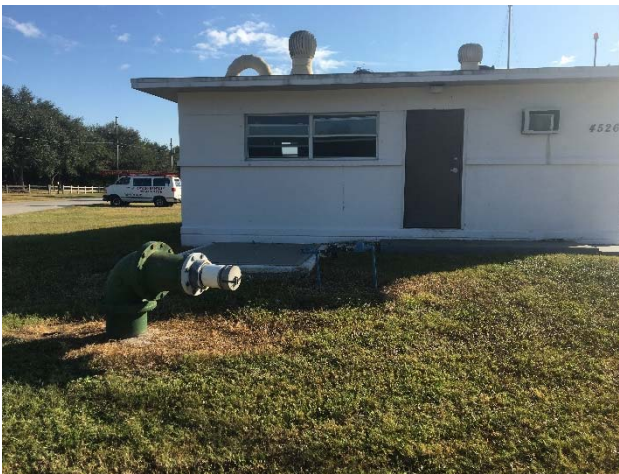
FIGURE 3-3 LIFT STATION NO. 1

82° 42'42.30" W). LS-2 then conveys the wastewater to Lift Station No. 1 (LS-1) located at the southwest corner of 29th Avenue South and Miriam Street South (Lat. 27° 44'27.24" N; Long. 82° 41'41.84" W). LS-1 is also the collection point for wastewater for the mid and eastern half of the City. LS-1 pumps wastewater to the City of St. Petersburg collection system where it is ultimately conveyed to the City of St. Petersburg Southwest Water Reclamation Facility for treatment. The portion of the collection system south of Gulfport Blvd. and west of 59th Street South is owned and operated by Pinellas County Utilities and pumped to the City of St. Petersburg's Northwest Water Reclamation Facility for treatment. As the city was incorporated in 1910 and a majority of the collection system was constructed circa 1960, similar to surrounding communities, a majority of the collection system is nearing the end of its design life.

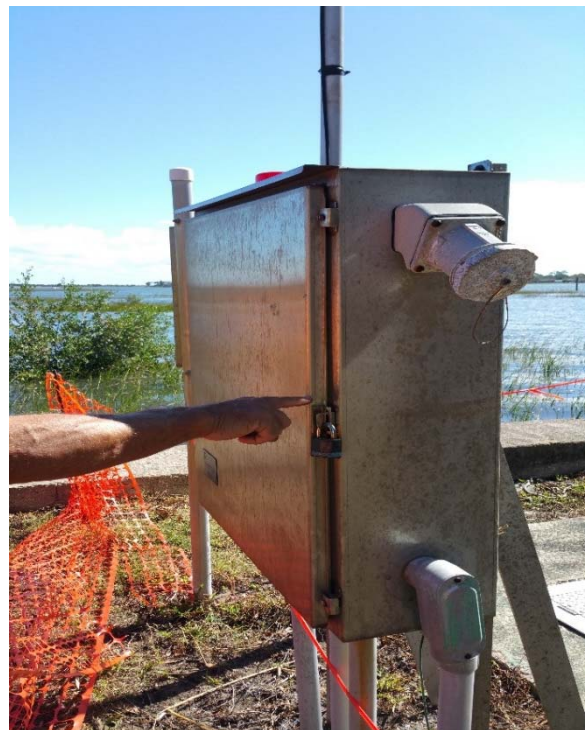
commenced system restoration activities at 6:30 AM on October 8 after the storm had passed and approval was given for access to the city's wastewater conveyance and transmission system. All spills were controlled

FIGURE 3-5 TIDAL SURGE FLOODING AT COSA PUMP STATION 22

via tank & haul operations and by bypass pumping by Sunday October 9, 2016 at 6 PM. The city's wastewater treatment plant remained operational throughout the storm with the assistance of its emergency generator. Staff took pre-storm precautions to sandbag vulnerable portions of the facility to ensure its reliability during the storm.

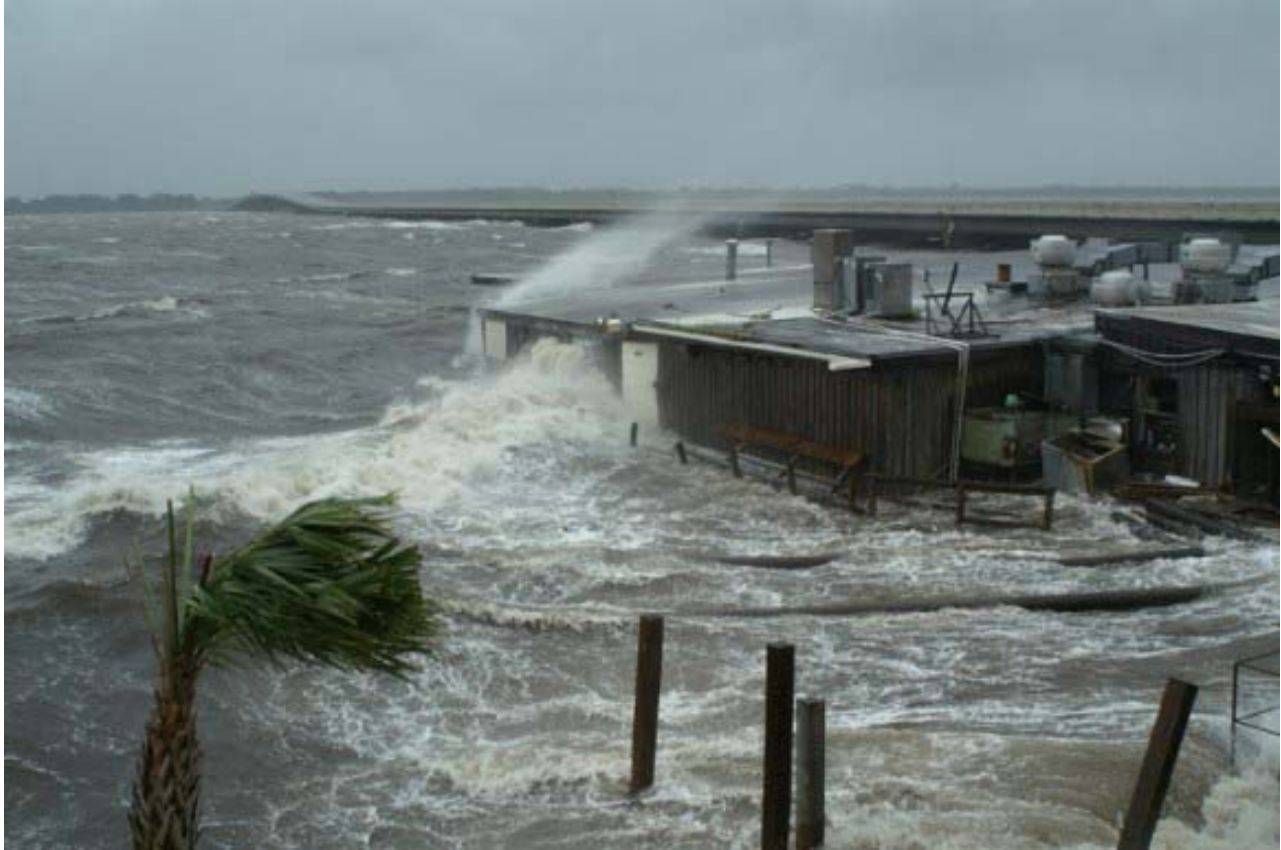
FIGURE 5-2 HURRICANE DENNIS (2005) PRODUCED SURGE FLOODING OF 7-9 FEET NEAR ST. MARKS, FL.
