**2024 Hurricane Season – Florida’s Southwest Gulf Coast  
Hurricane Helene and Hurricane Milton  
Post-Storm Beach Conditions and Coastal Impact  
Report  
Fiscal Year 2024-25**

**Office of Resilience and Coastal Protection  
Florida Department of Environmental Protection  
March 2025**

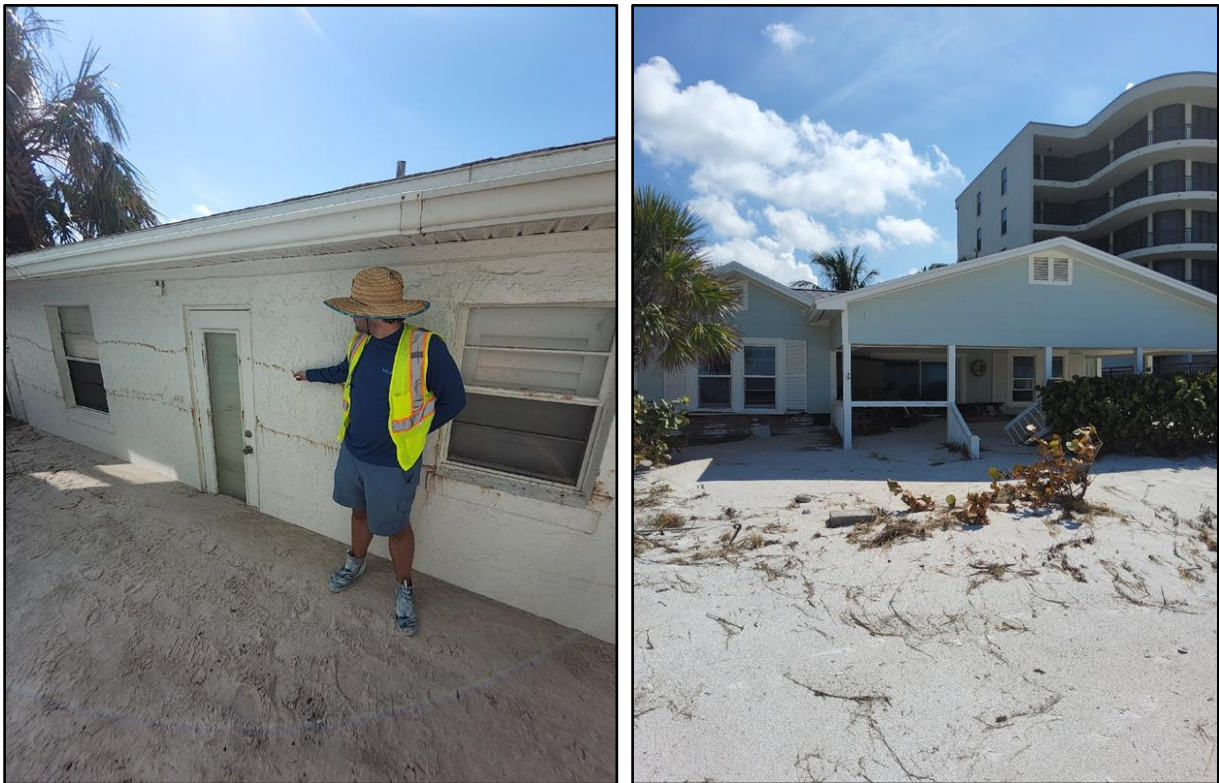
**Figure 16.** Indian Shores beach dwellings impacted by overwash sand from Helene’s storm surge at R-83 (left) and R-91 (right).

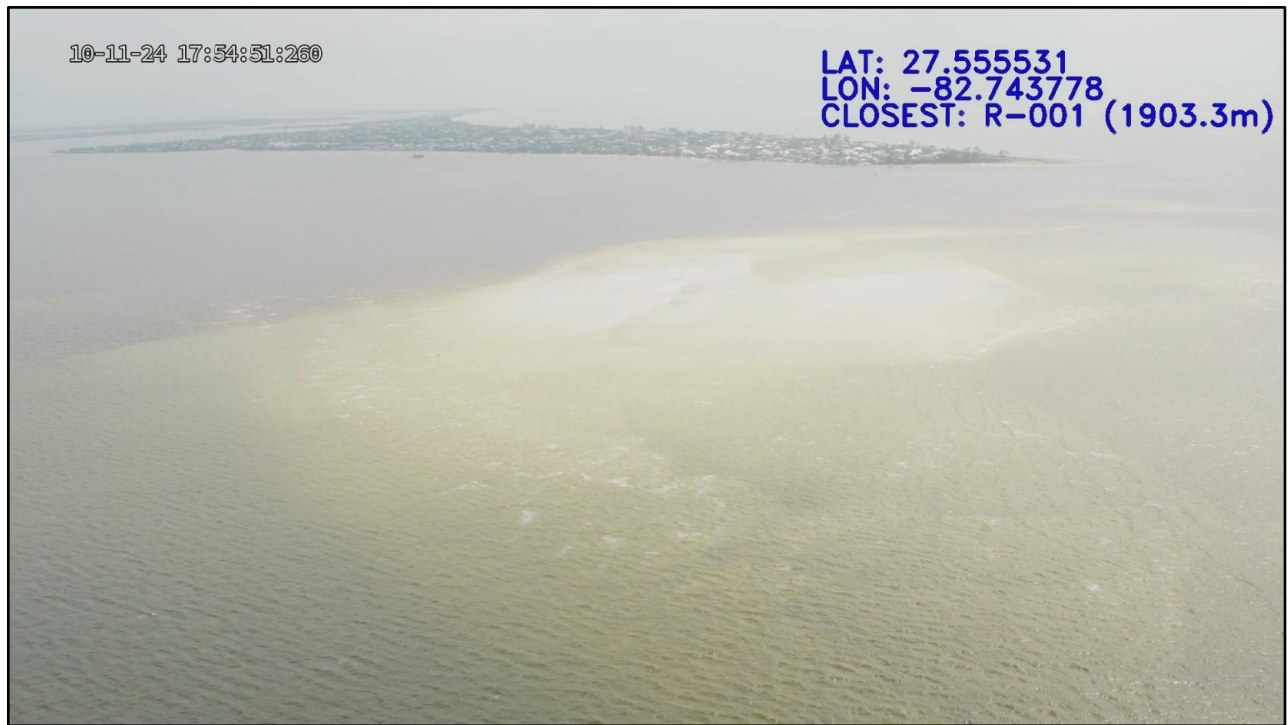
**Figure 26.** Passage Key north of Anna Maria Island reduced to only a sandbar with no vegetation due to the storm surge impacts of Hurricanes Helene and Milton.

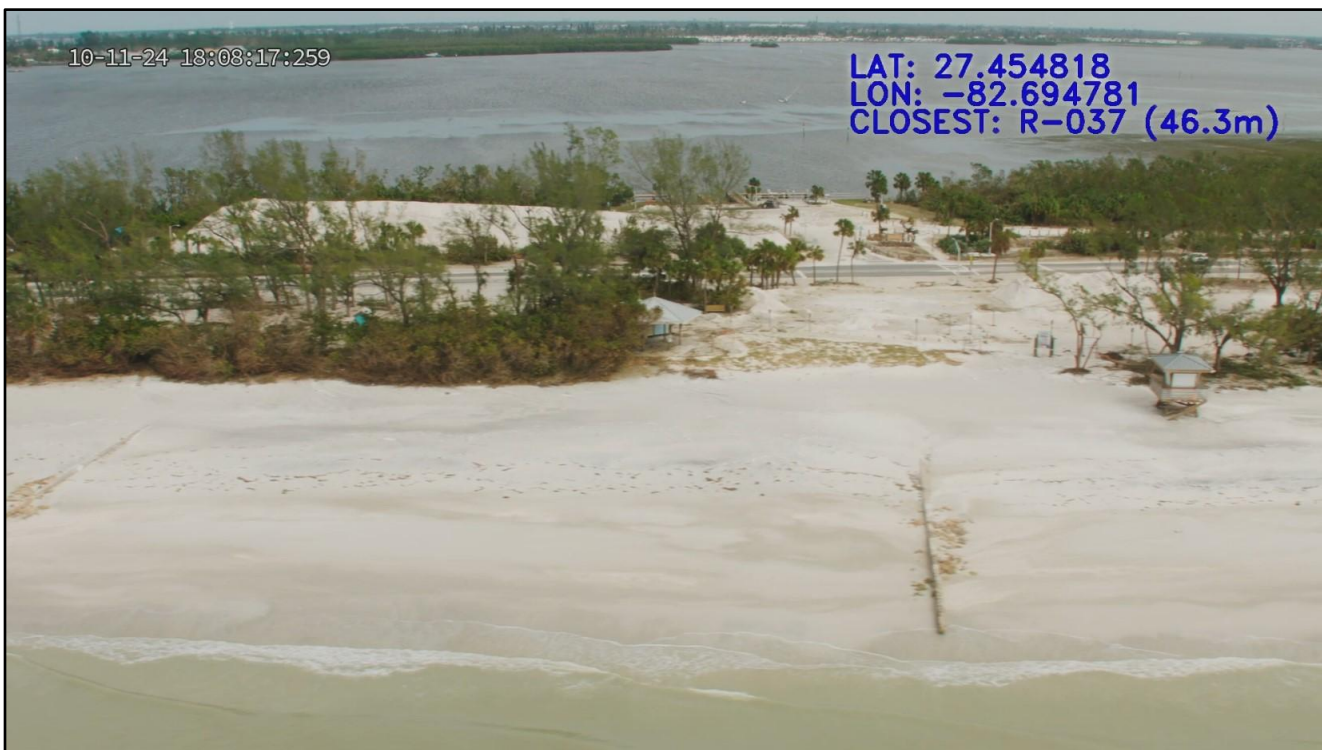
**Figure 31.** Major beach and dune erosion (condition IV) and stock-piled sand after Helene and Milton, at Coquina Beach, Anna Maria Island near R-37.

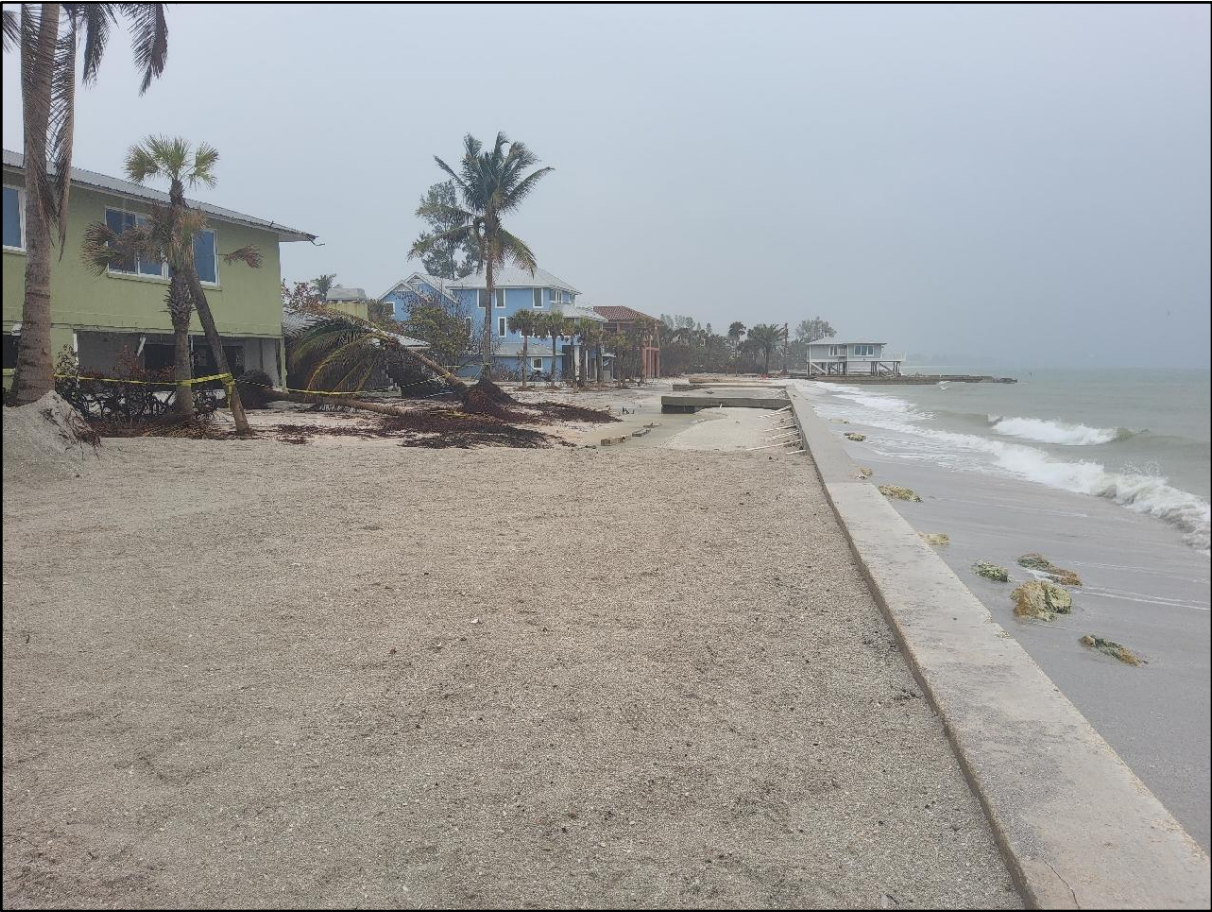
**Figure 32.** Major beach erosion (condition IV) due to Helene on northern Longboat Key near R-48.

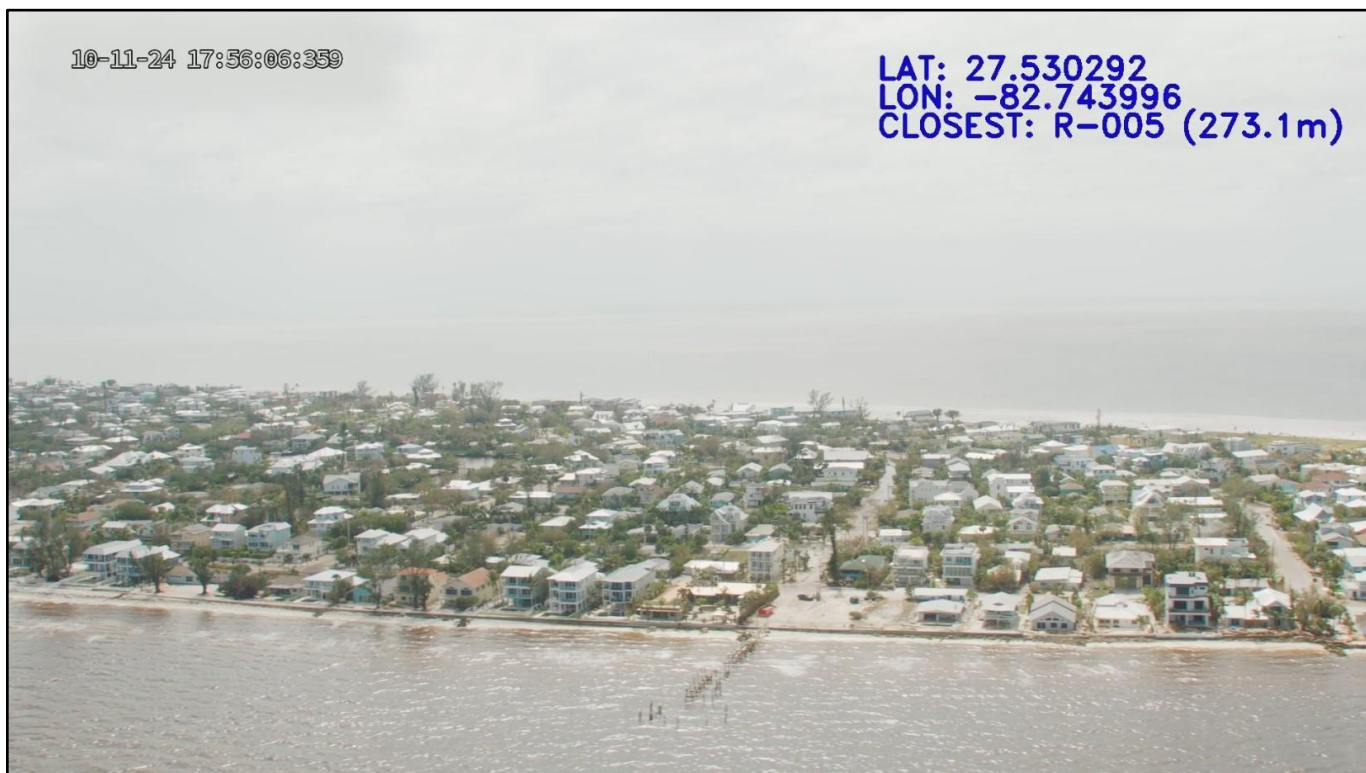
**Figure 36.** The northeast end of Anna Maria Island following both Hurricanes Helene and Milton showing the Rod & Reel Pier and two-story restaurant destroyed.

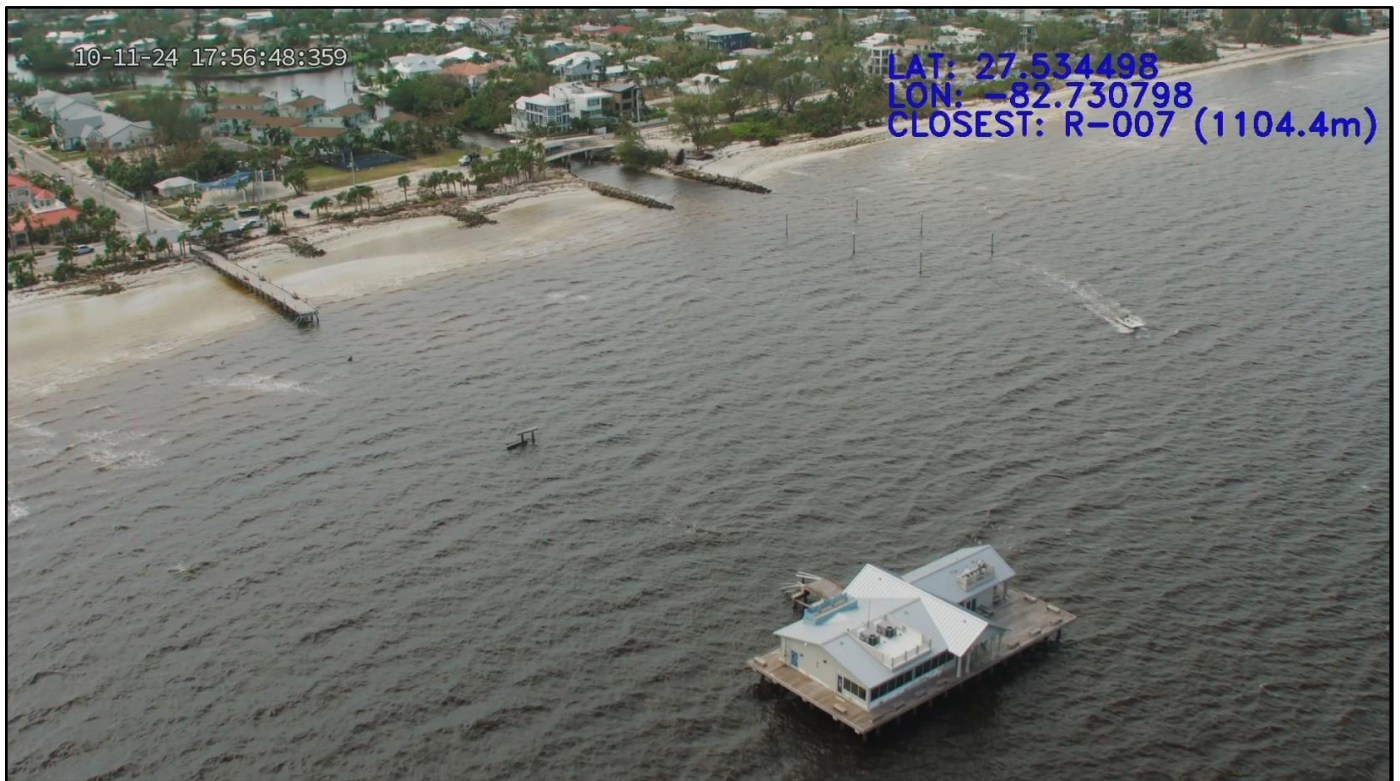
**Figure 39.** Milton destroyed the Anna Maria Island City Pier and damaged the restaurant and bait shop at Pine Avenue.

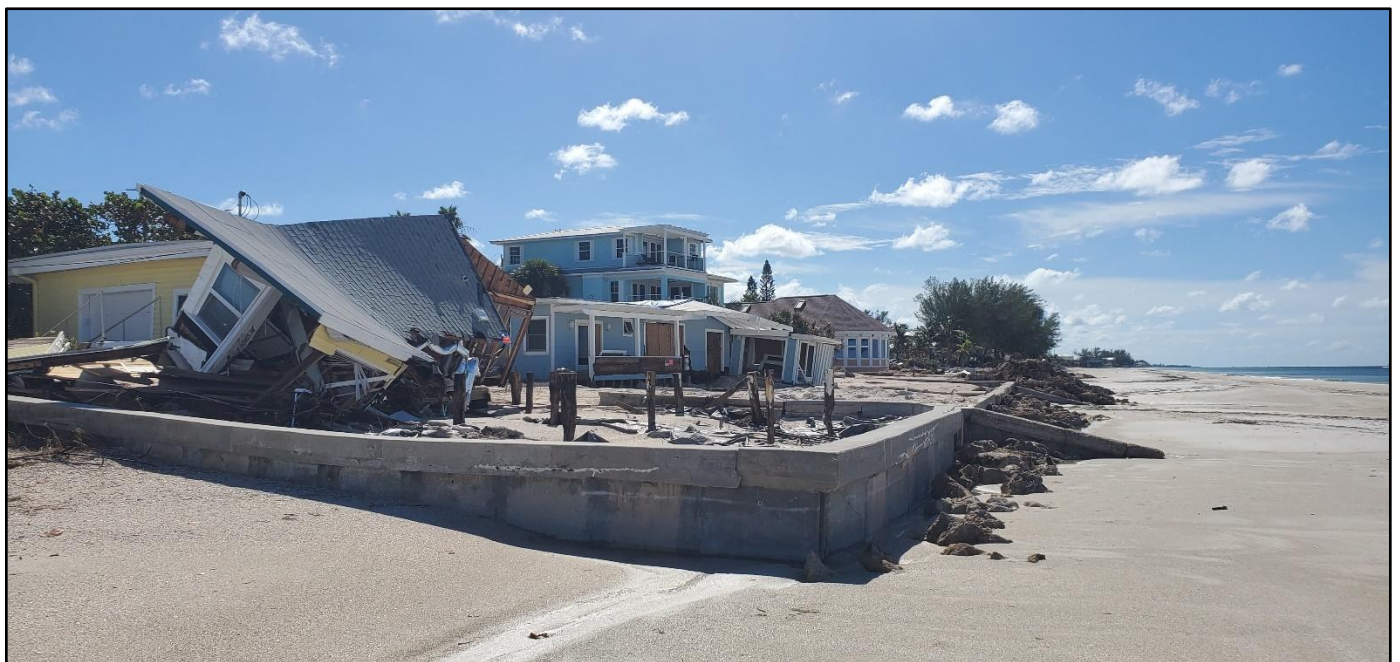
**Figure 40.** A single-family dwelling destroyed by Helene's storm surge on Anna Maria Island next to another home with major first floor damage near Avenue F near R-23.

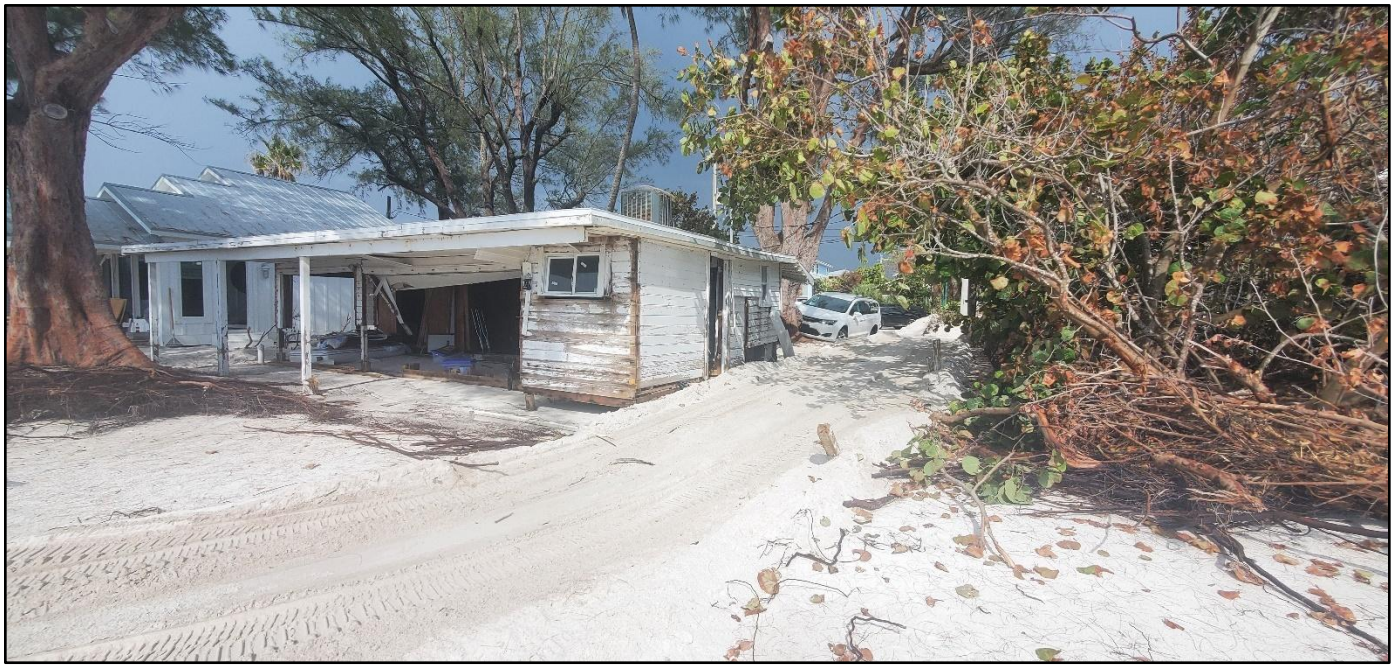
**Figure 41.** A gulf-fronting single-family dwelling on Anna Maria Island destroyed by Helene near 23<sup>rd</sup> Street North at R-28.

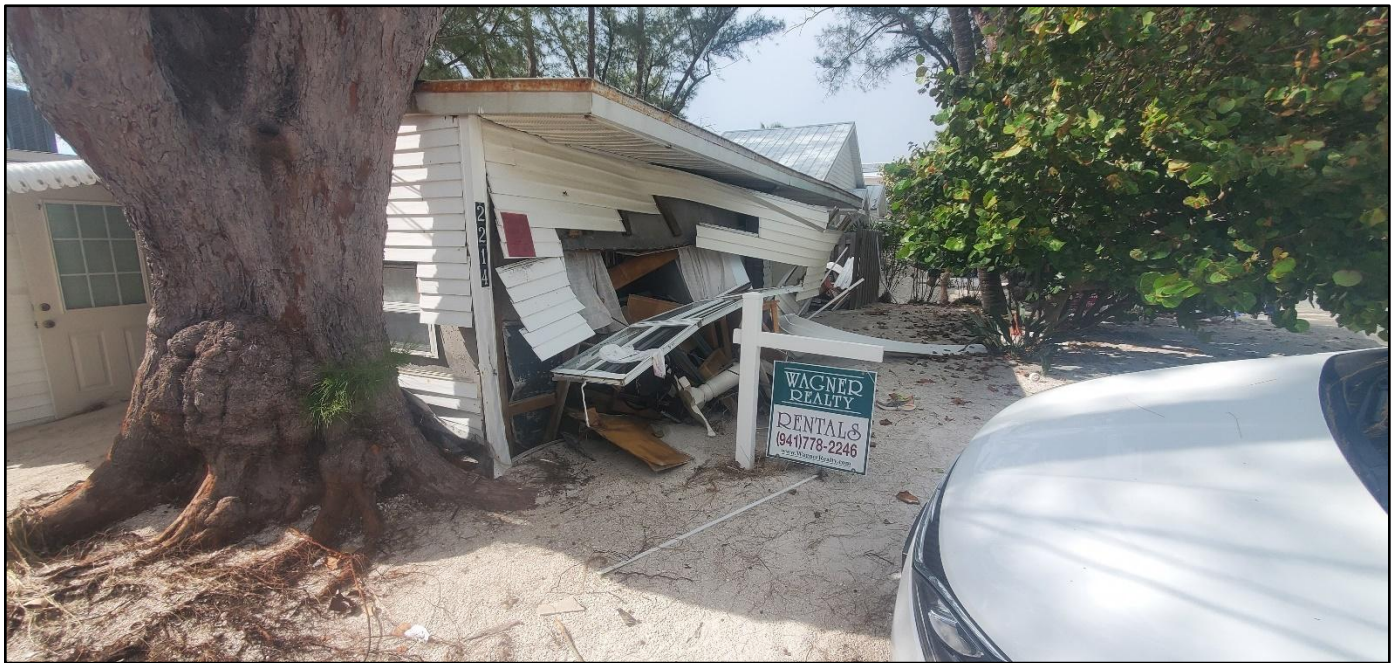
**Figure 42.** A single-family dwelling on Anna Maria Island with major first floor damage from Helene's storm surge near 23<sup>rd</sup> Street North at R-28.

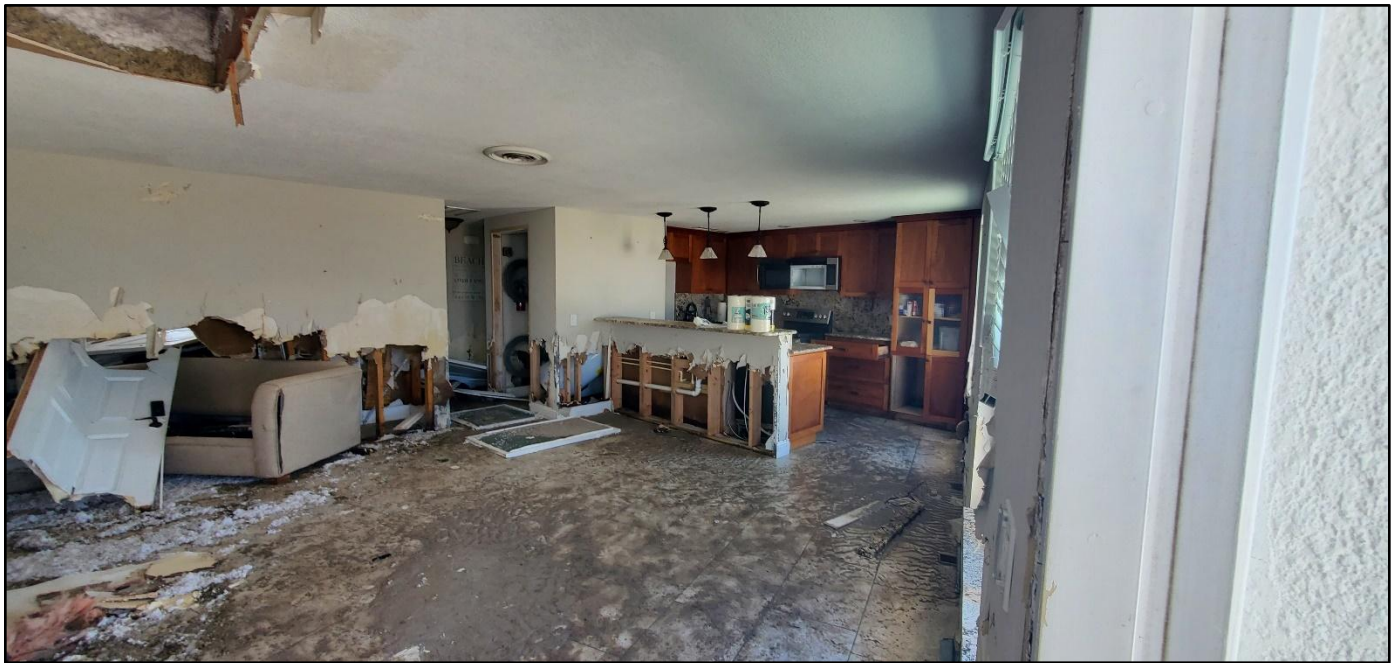
**Figure 43.** The interior of a single-family dwelling flooded by Helene’s storm surge on Anna Maria Island near R-34.

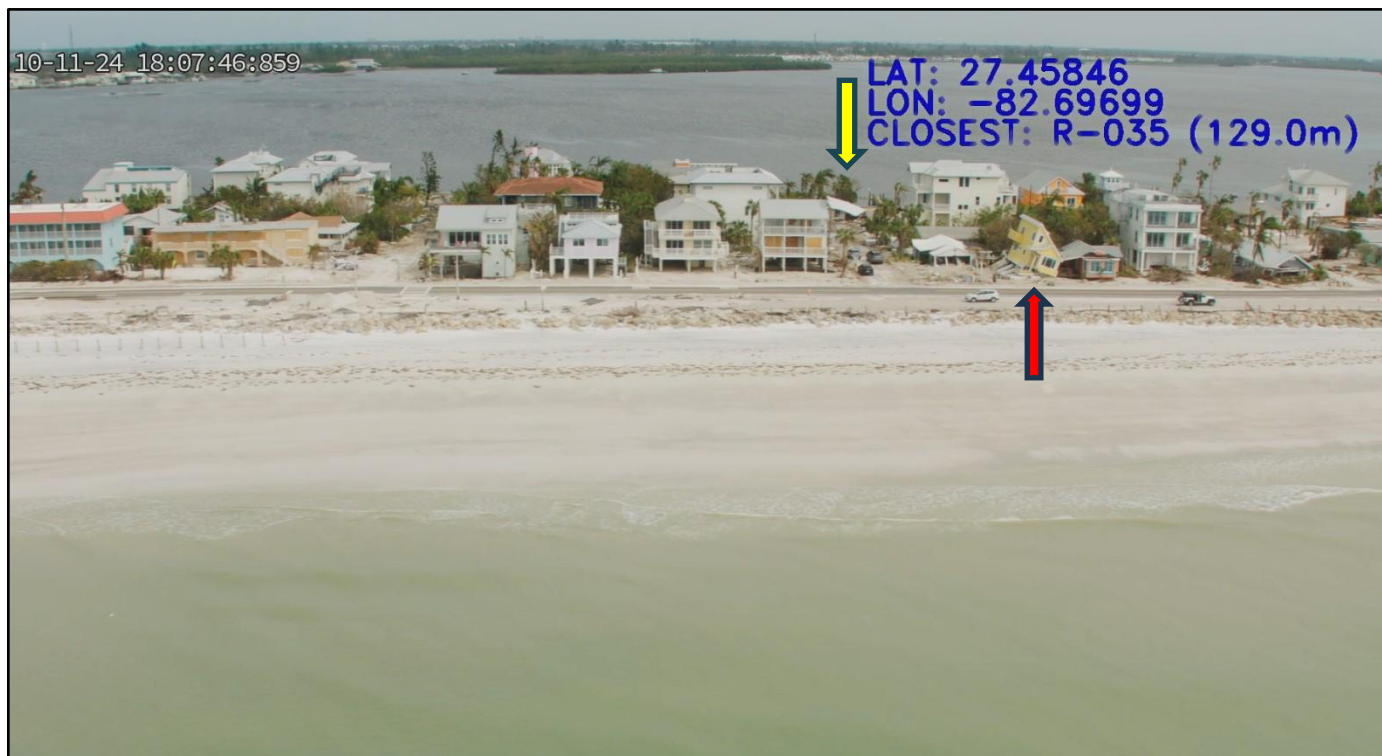
**Figure 45.** Major beach and dune erosion (condition IV) due to Helene and Milton on Anna Maria Island (R-35). Note the home toppled due to wind from Milton (red arrow) and the home impacted by Helene’s storm surge that was carried into the middle of 12th Street South (yellow arrow).

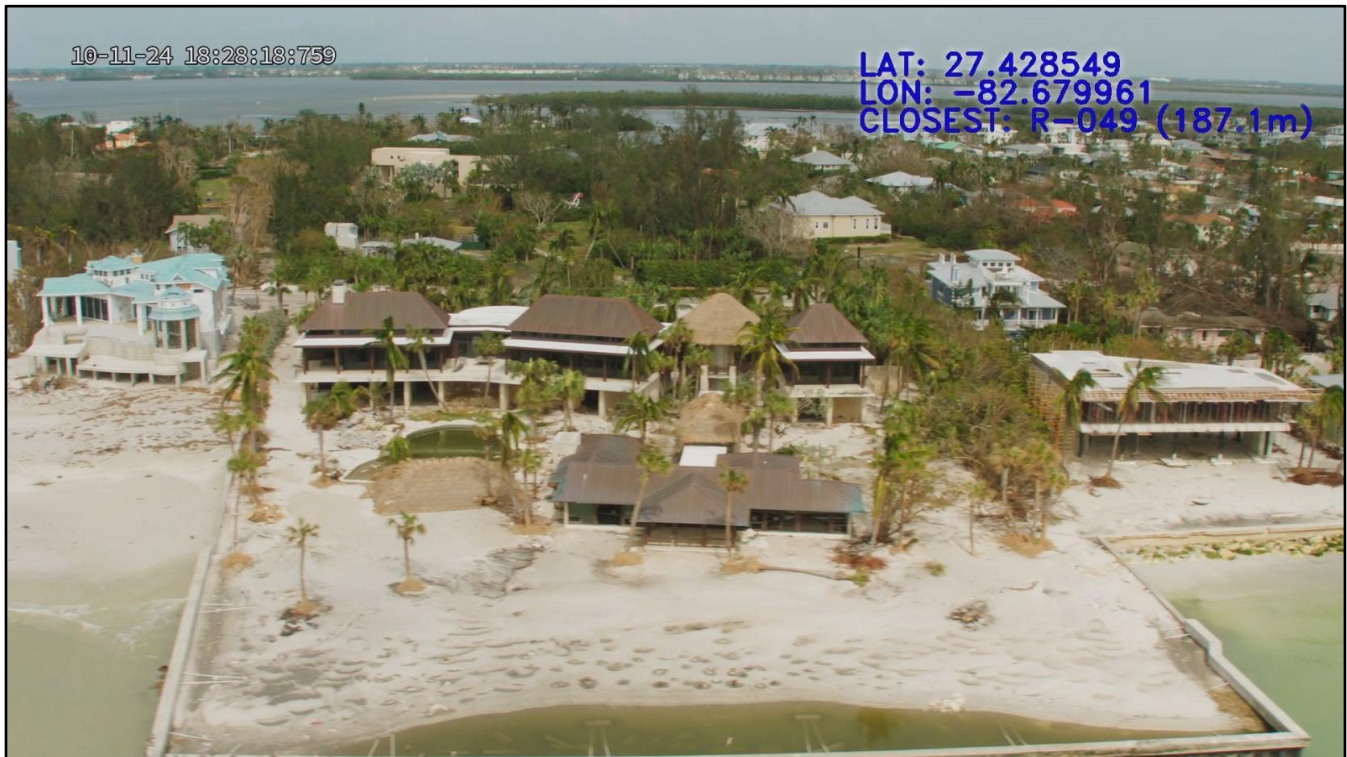
**Figure 48.** First floor flooding damage, seawall damage and major erosion (condition IV) following Helene and Milton on northern Longboat Key near R-49.

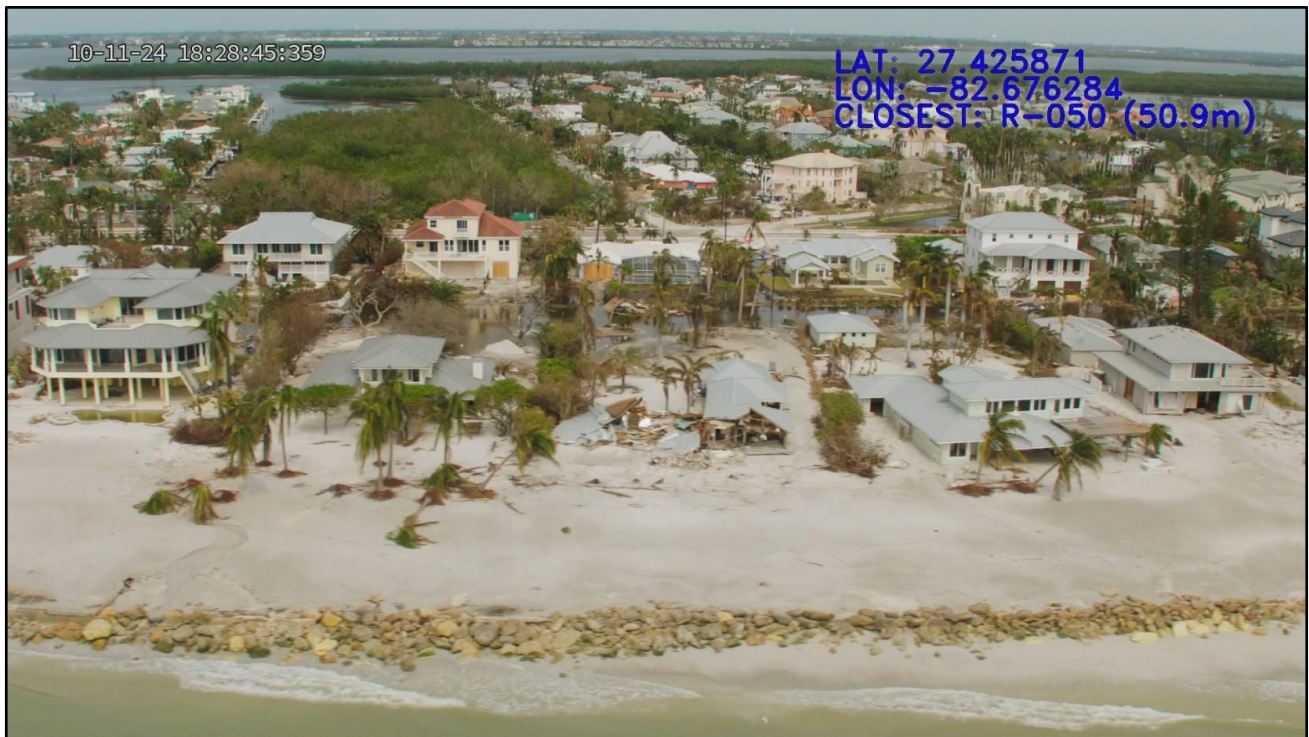
**Figure 49.** A single-family dwelling destroyed, armoring damage and major beach and dune erosion (condition IV) following Helene and Milton on Longboat Key near R-50.

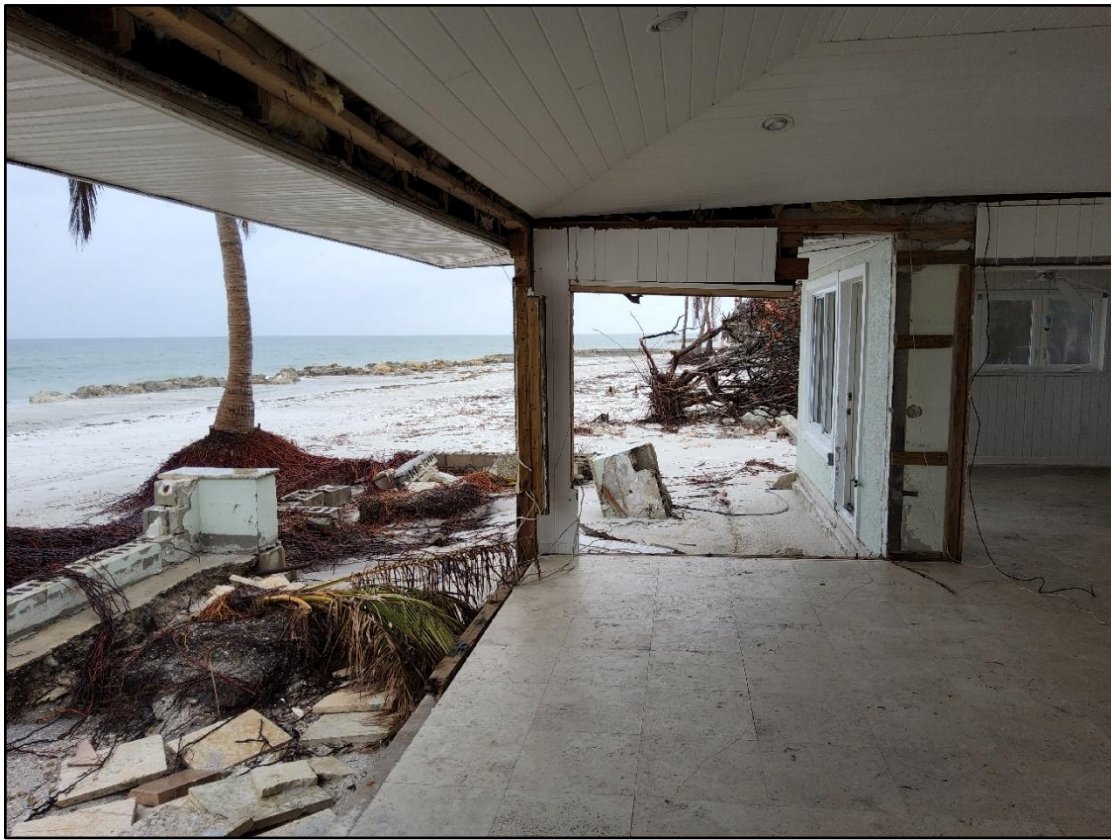
**Figure 51.** A single-family dwelling destroyed by Helene and major erosion (condition IV) on northern Longboat Key, near R-50.

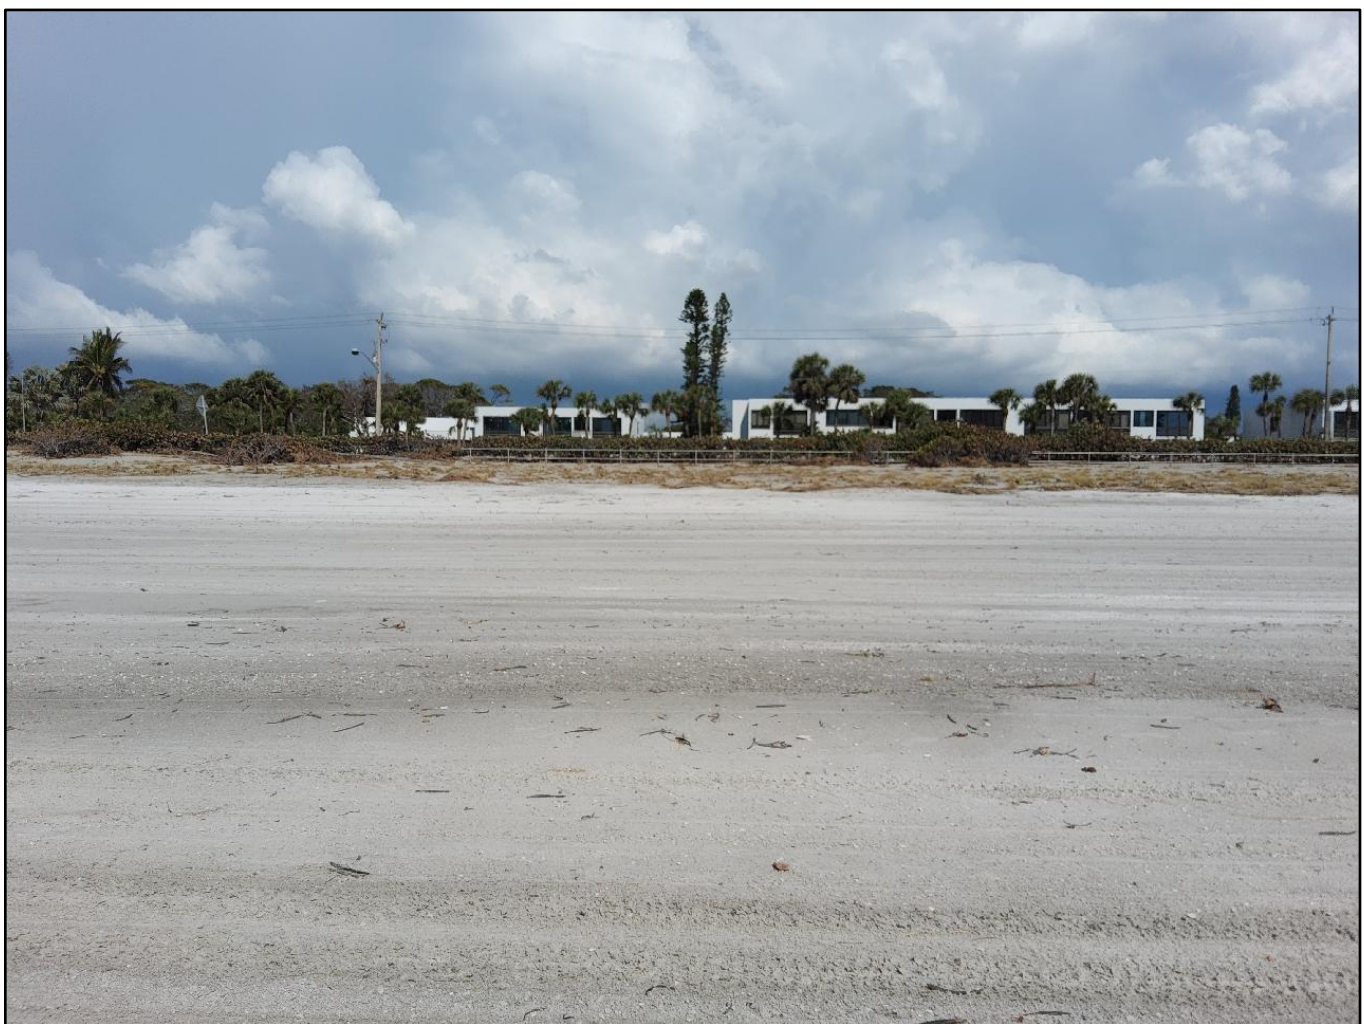
**Figure 53.** Major beach and dune erosion (condition IV) following Helene and Milton on Longboat Key (R-2 to R-3).

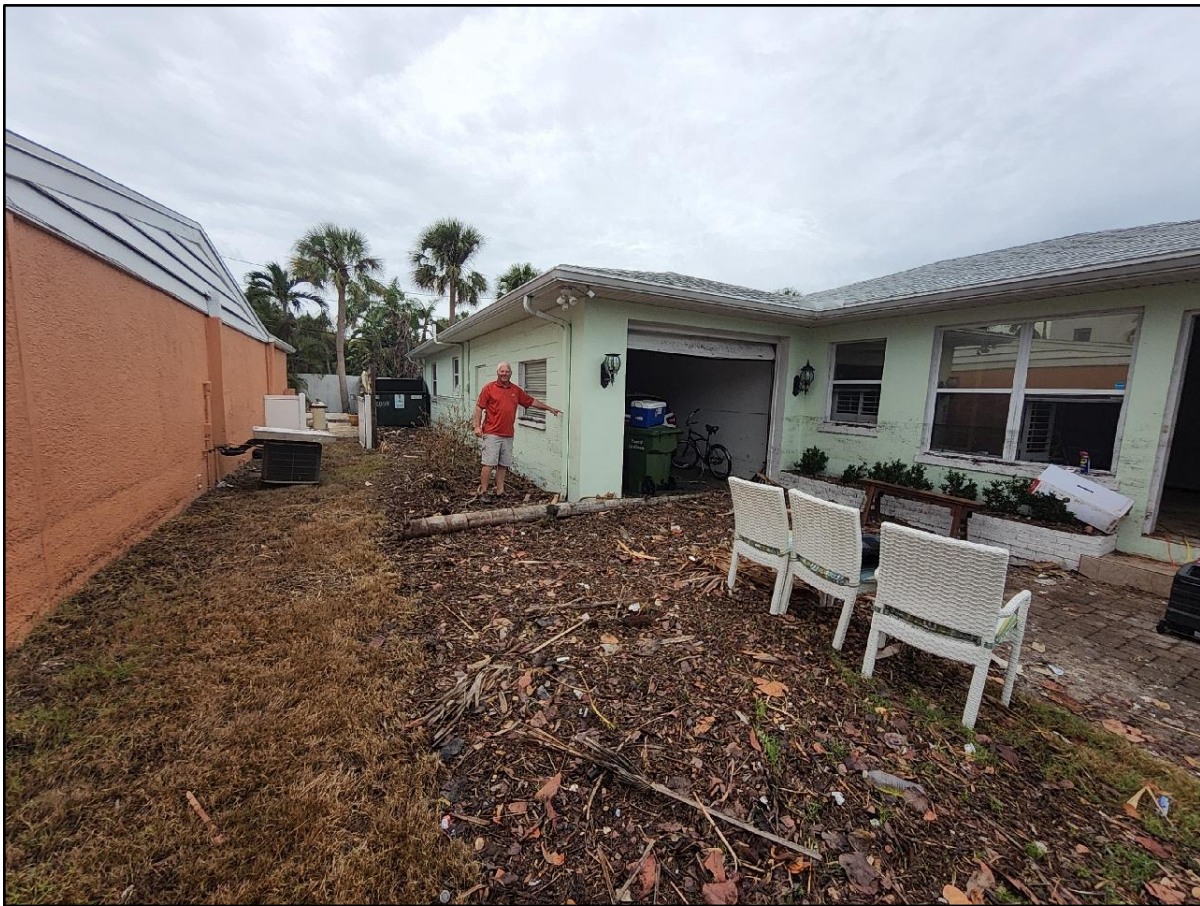
**Figure 56.** High water mark above a garage window base on home near St. Armands Circle off North Boulevard of the Presidents, Lido Key.

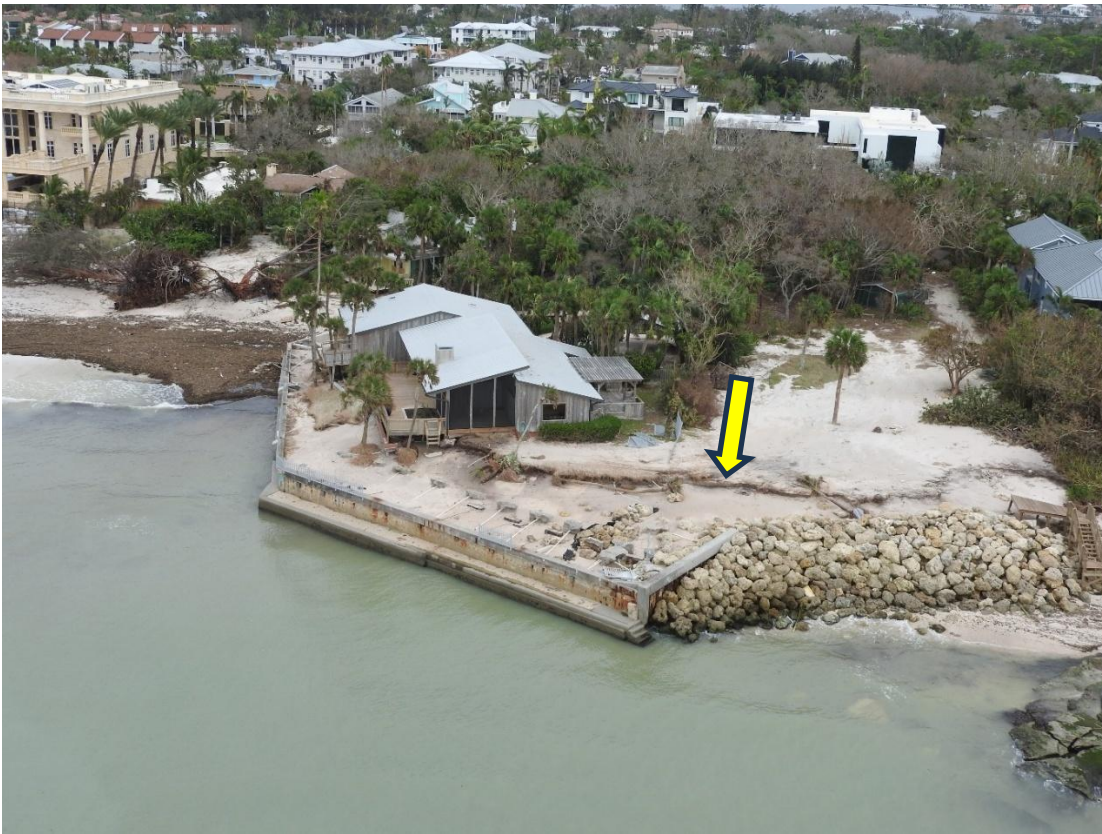
**Figure 62.** Major erosion (condition IV) with an escarpment at +8 to +9 feet on Siesta Key at Point of Rocks near R-62.

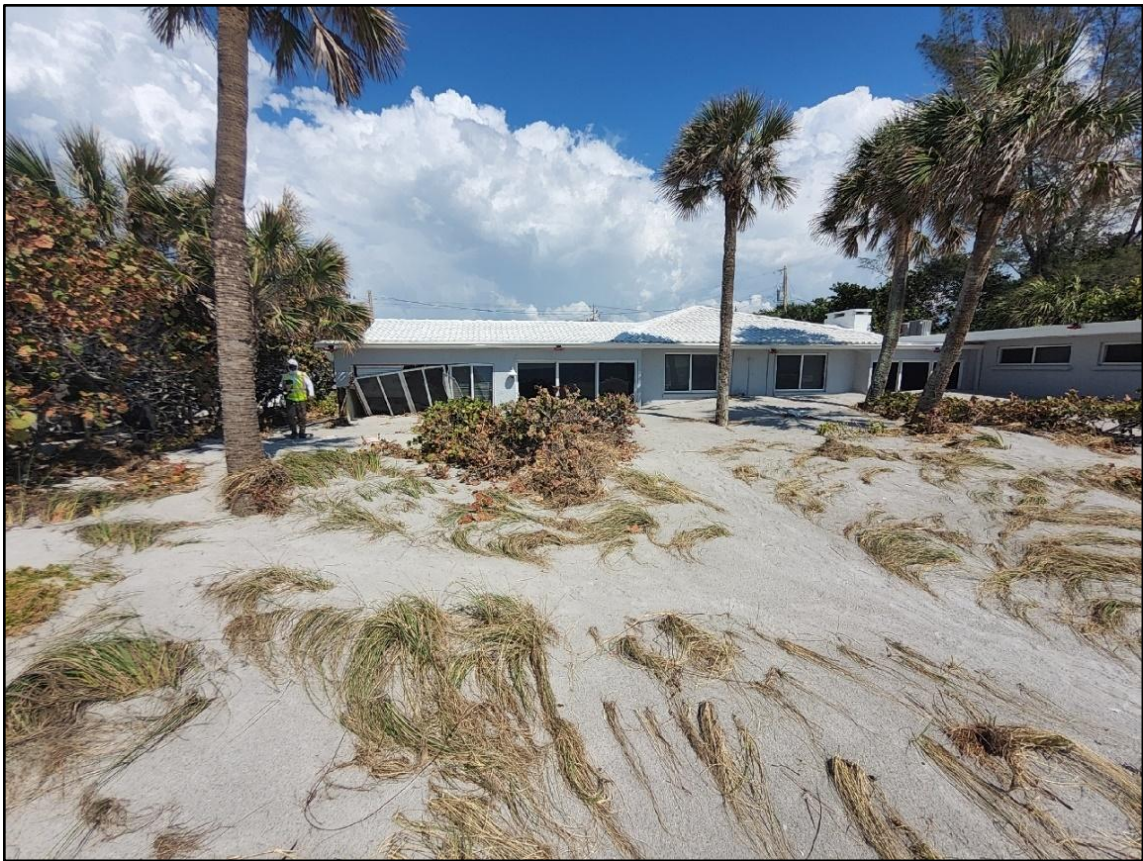
**Figure 83.** Single-family dwelling damaged by Helene’s storm surge on Longboat Key near R-10.

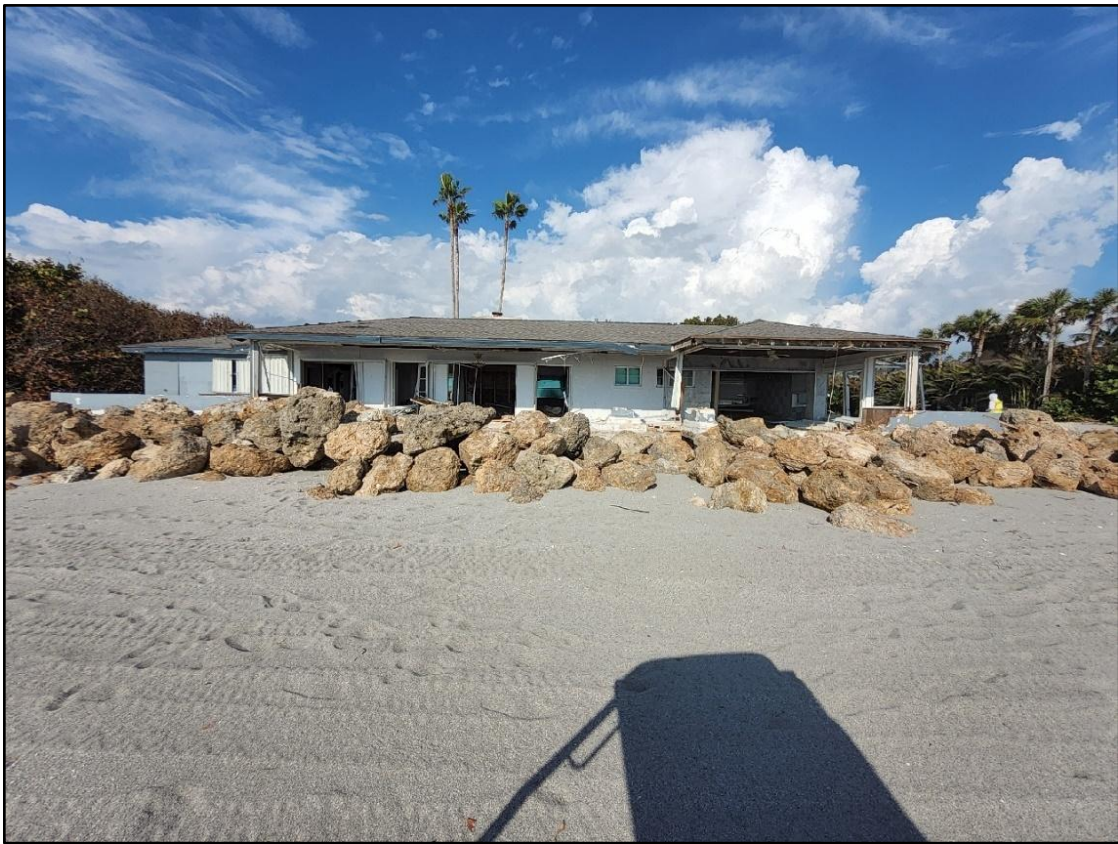
**Figure 85.** Major damage to rock revetment (level III) and to single-family dwelling on Siesta Key near R-67.

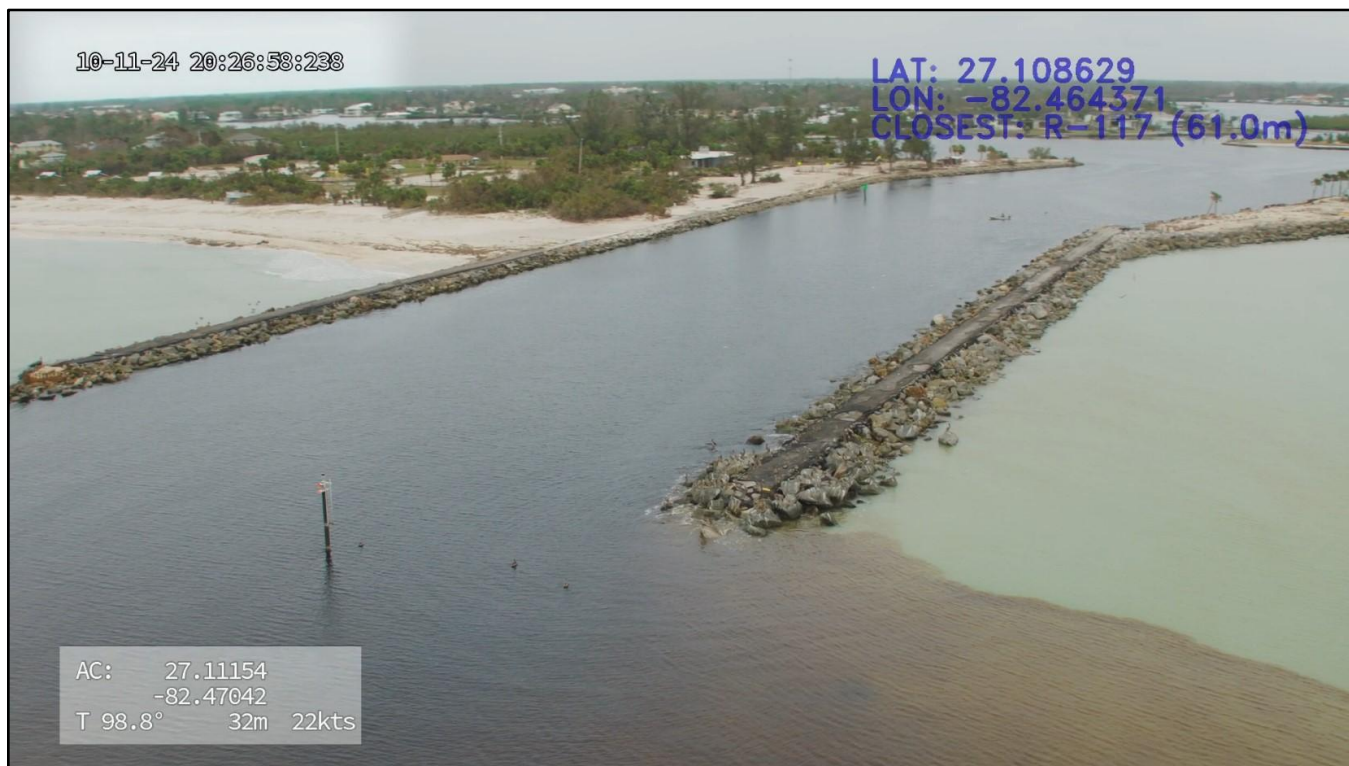
**Figure 96.** Major damage to the jetties of Venice Inlet by Helene and Milton.

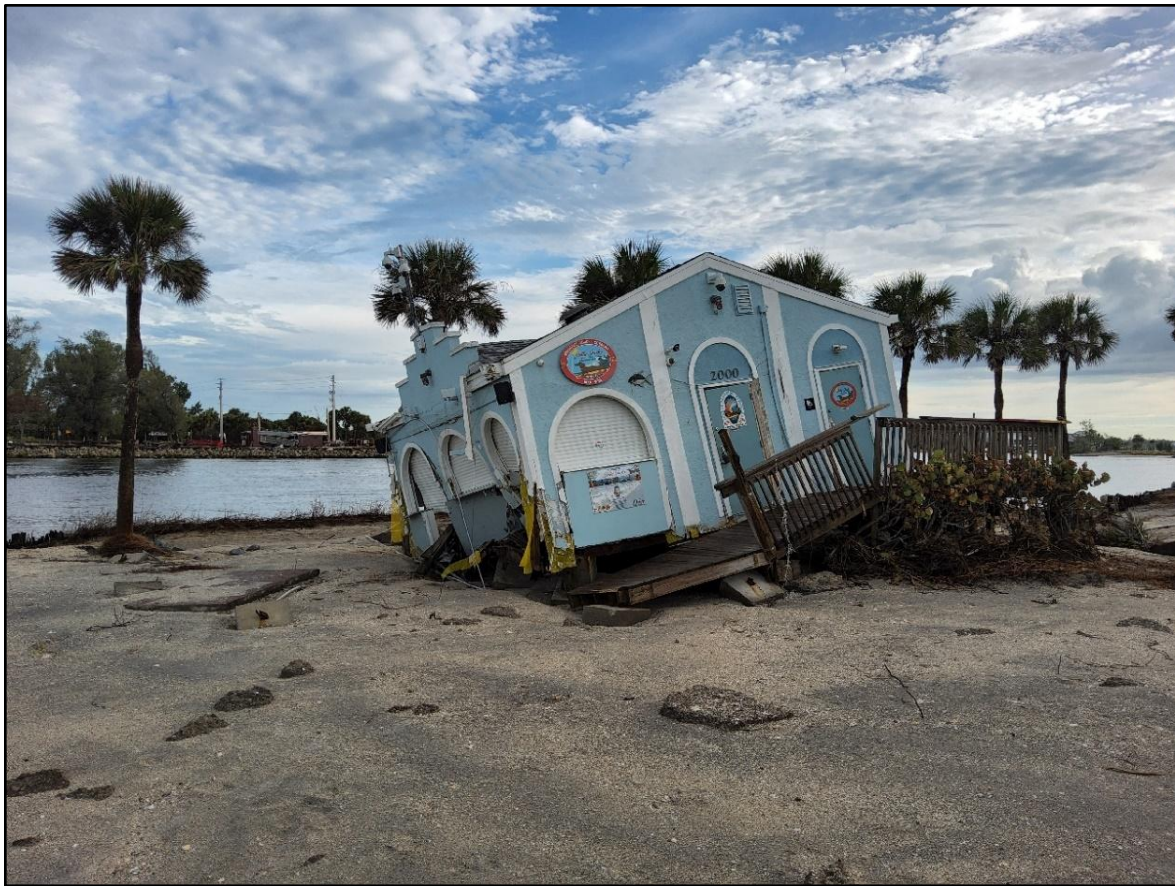
**Figure 97.** Jetty Jacks eatery destroyed by Helene at the Venice Inlet south jetty, R-115.

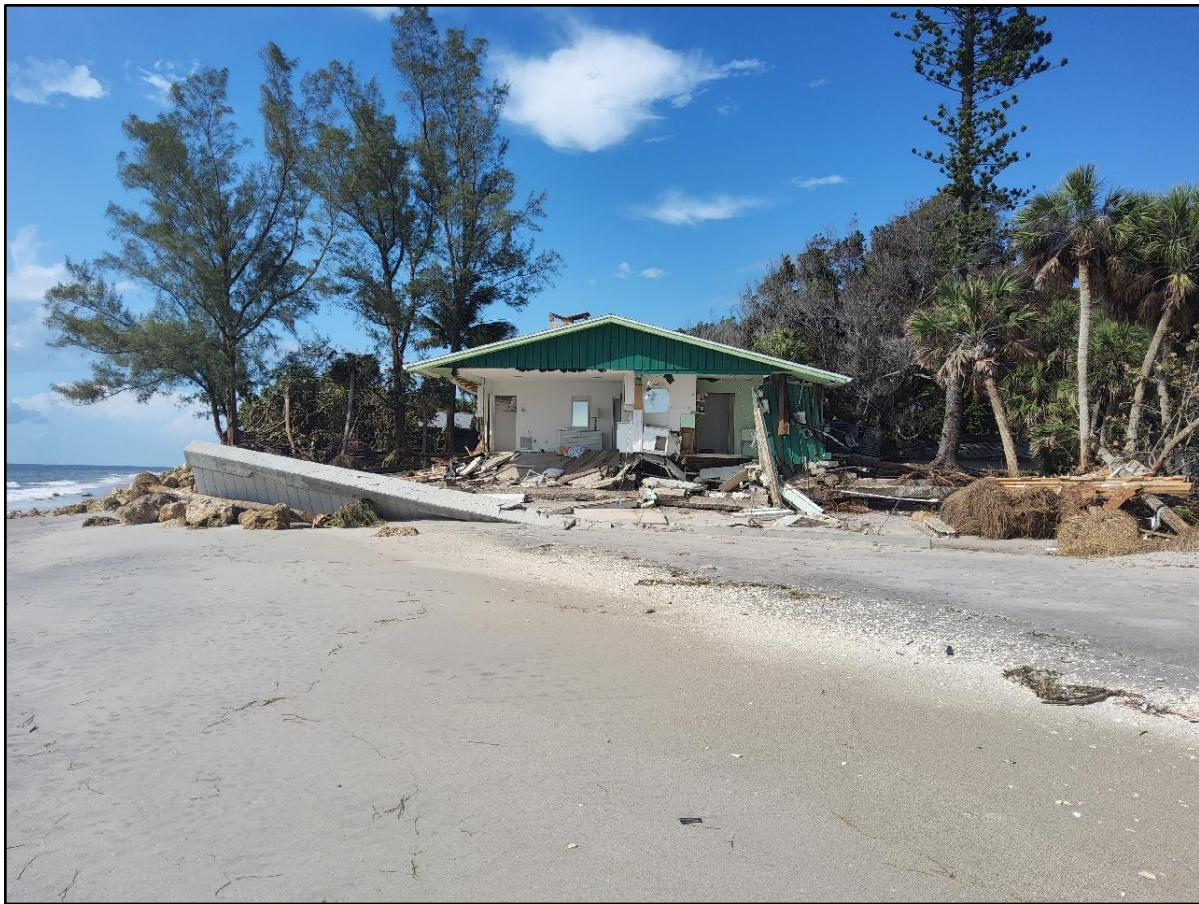
**Figure 101.** Single-family dwelling and seawall destroyed by Helene on Manasota Key near R-171.
