**2024 Hurricane Season – Florida’s Southwest Gulf Coast  
Hurricane Helene and Hurricane Milton  
Post-Storm Beach Conditions and Coastal Impact  
Report  
Fiscal Year 2024-25**

**Office of Resilience and Coastal Protection  
Florida Department of Environmental Protection  
March 2025**

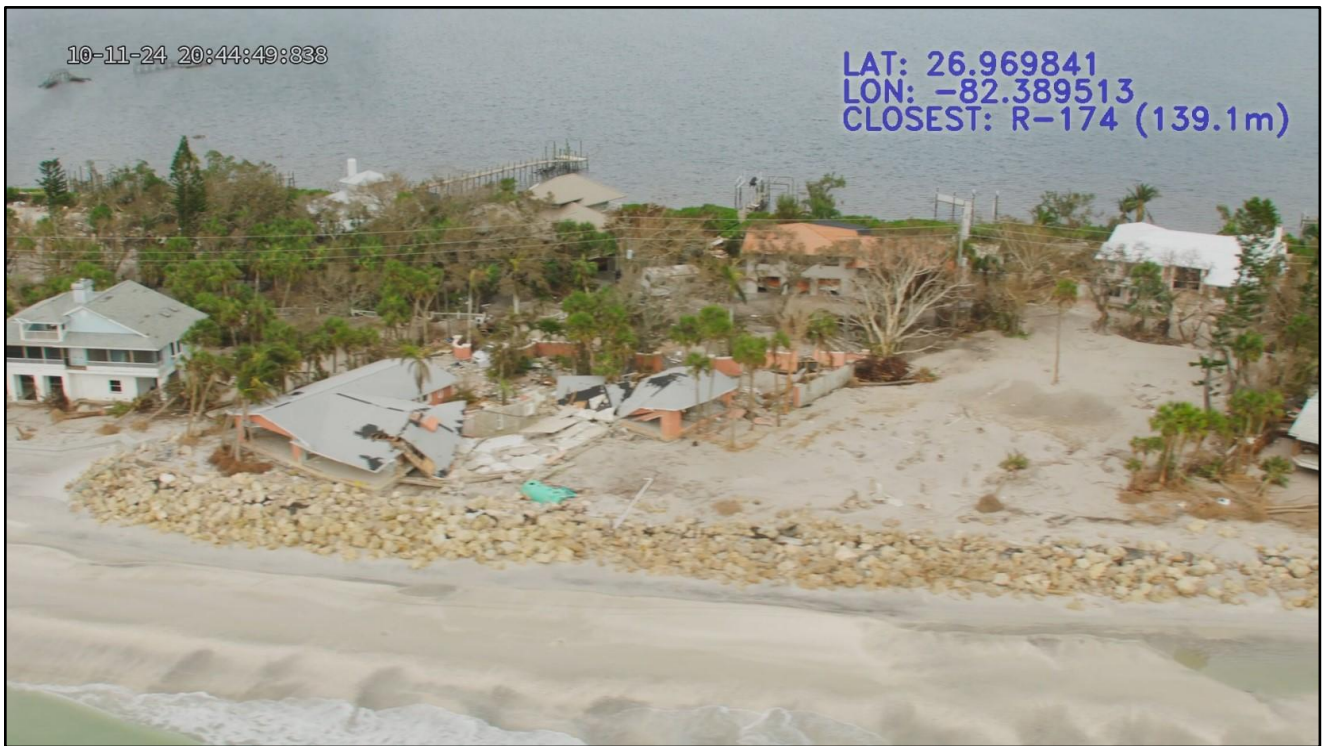
**Figure 105.** Single-family dwelling destroyed and major revetment damage by Milton on Manasota Key, R-173.

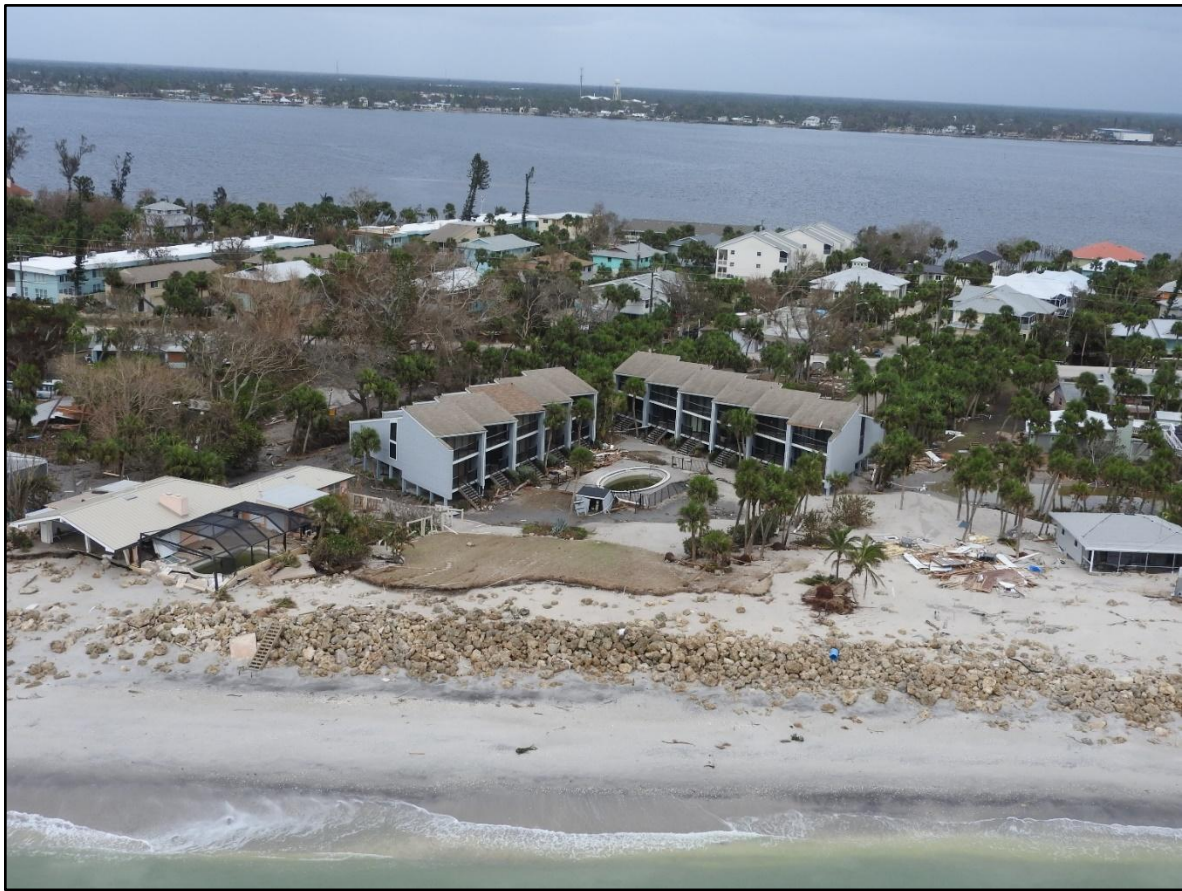
**Figure 107.** Major beach erosion and rock revetment damage following Milton at Englewood Beach near R-2.

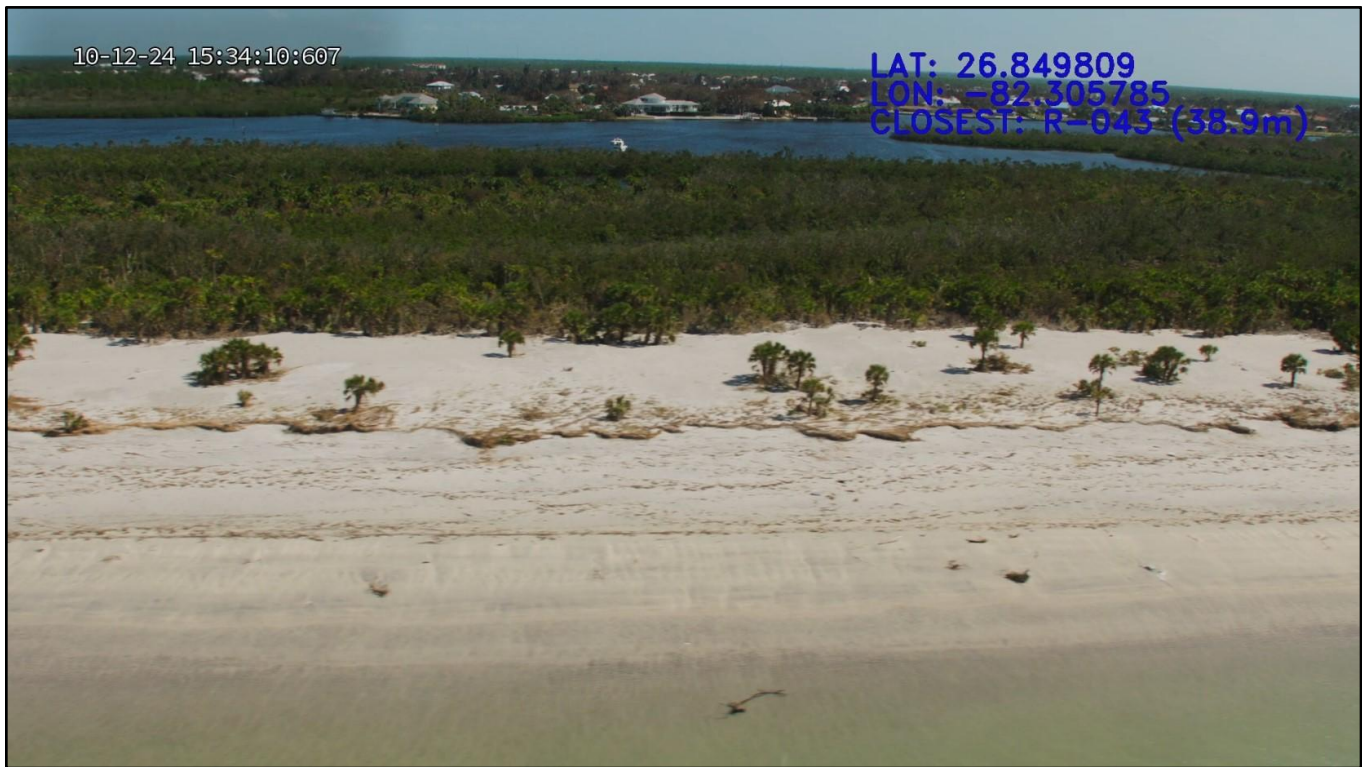
**Figure 113.** Major beach and dune erosion and storm surge overwash at Don Pedro Island State Park near R-43.

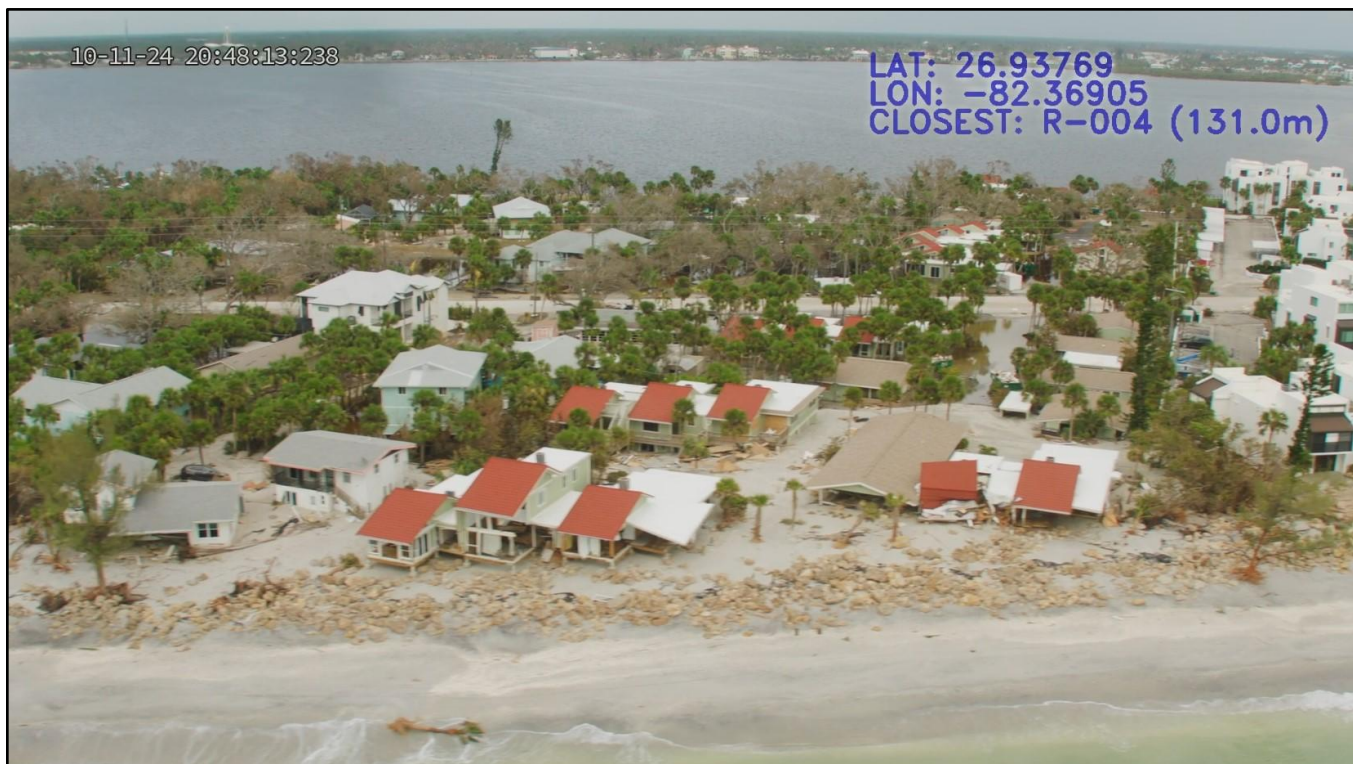
**Figure 115.** Multi-family dwellings damaged by Milton at Englewood Beach near R-4.

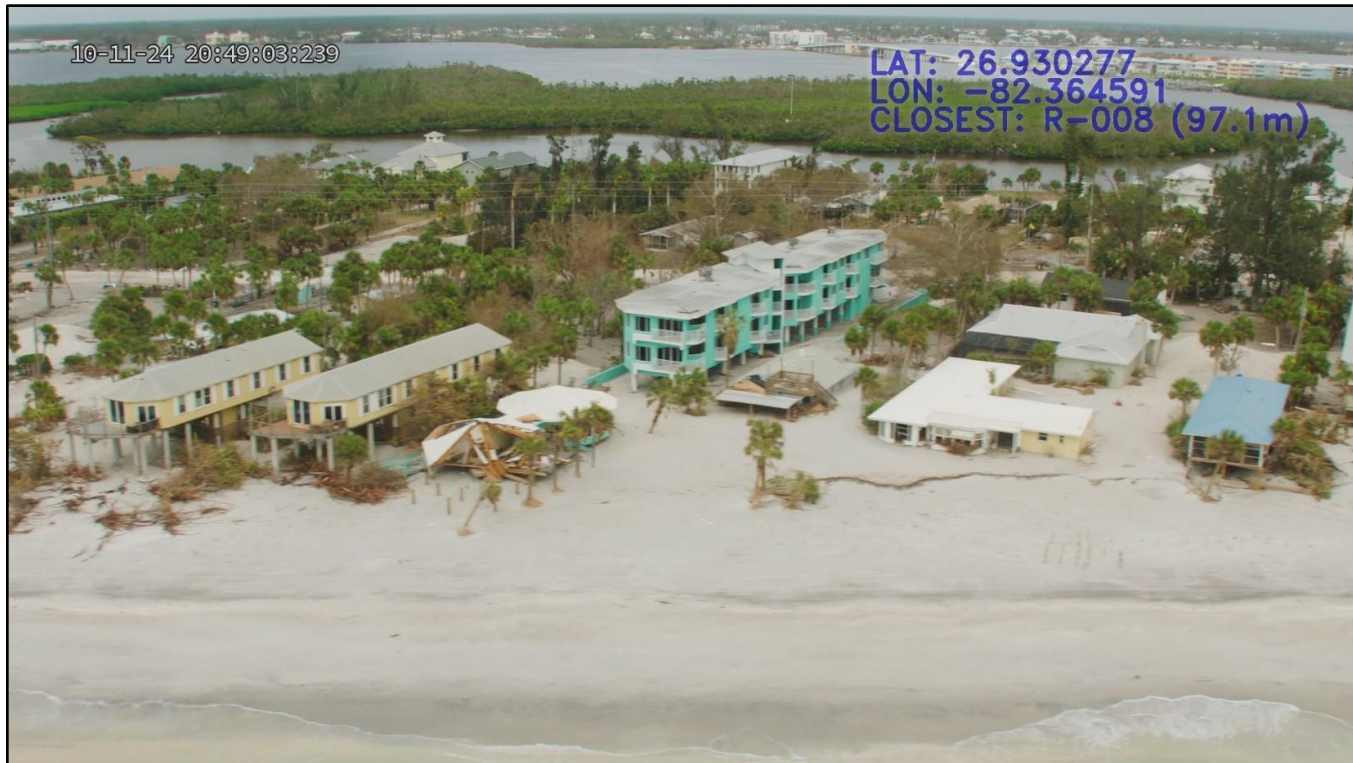
**Figure 116.** Multi-family dwellings damaged and destroyed by Milton at Englewood Beach near R-8.

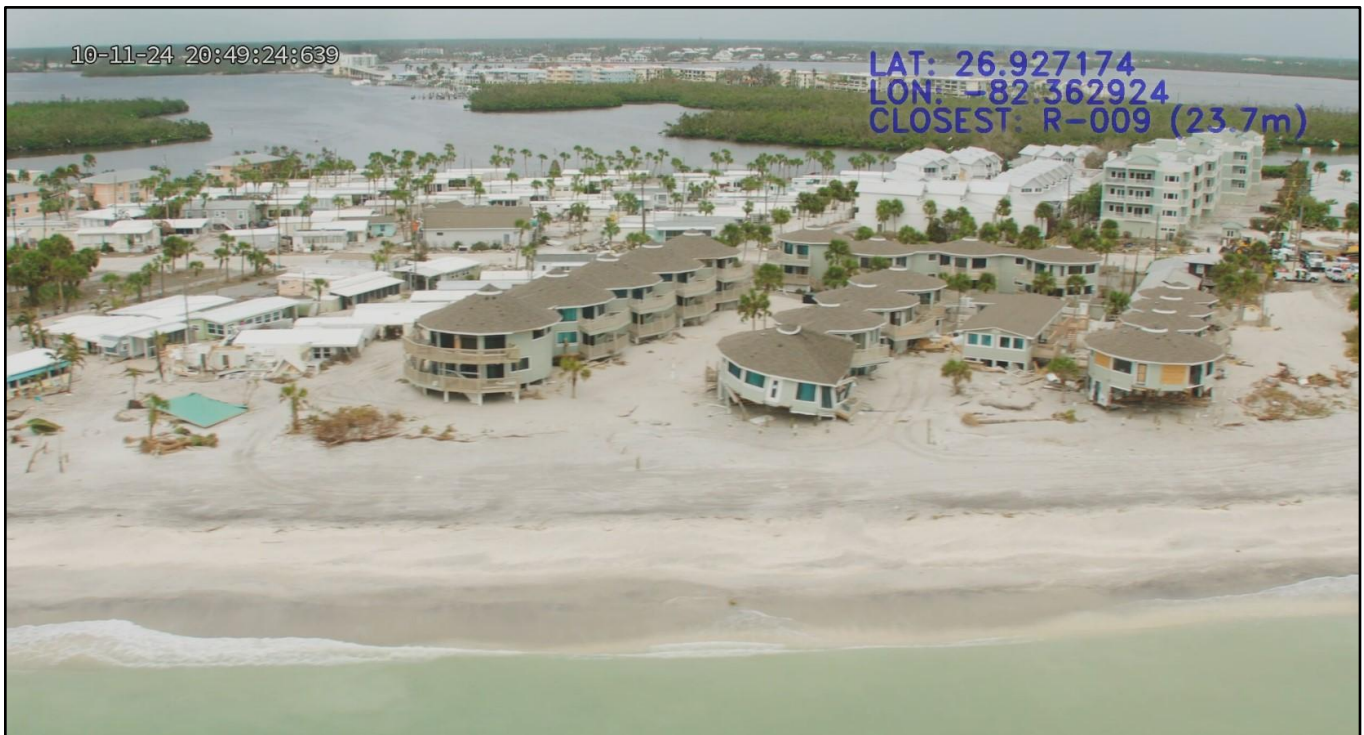
**Figure 117.** Multifamily dwellings with major damages due to Milton at Englewood Beach near R-9.

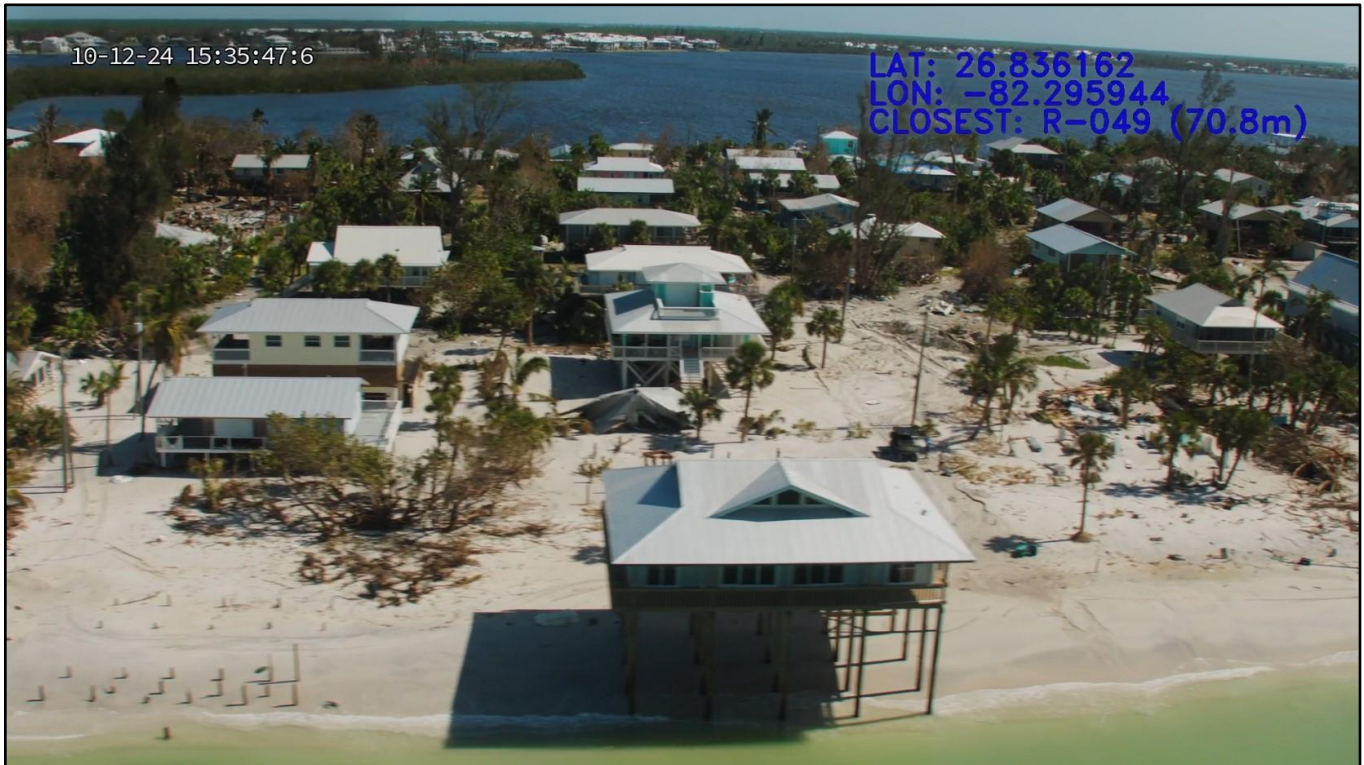
**Figure 118.** Single-family dwellings destroyed on Little Gasparilla Island by Milton near R-49.

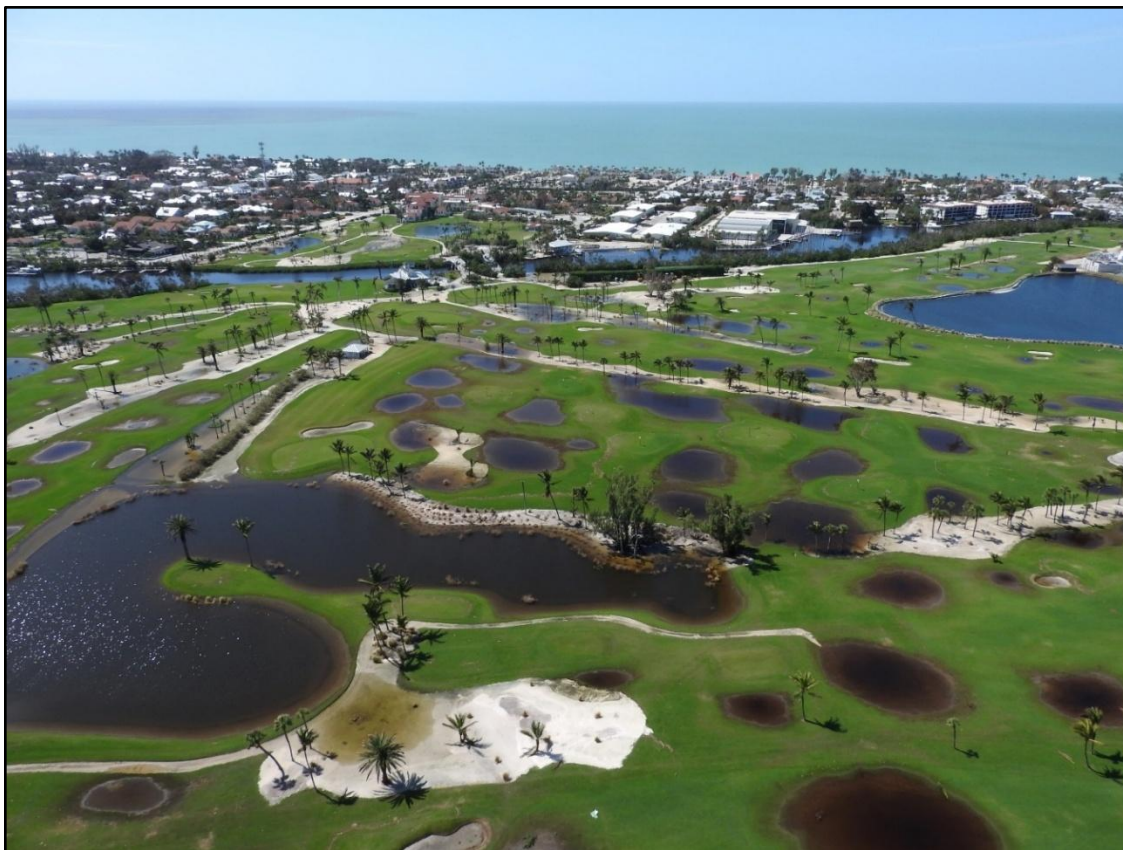
**Figure 123.** Water hazards on the Gasparilla Golf Club Course due to Milton near R-12.

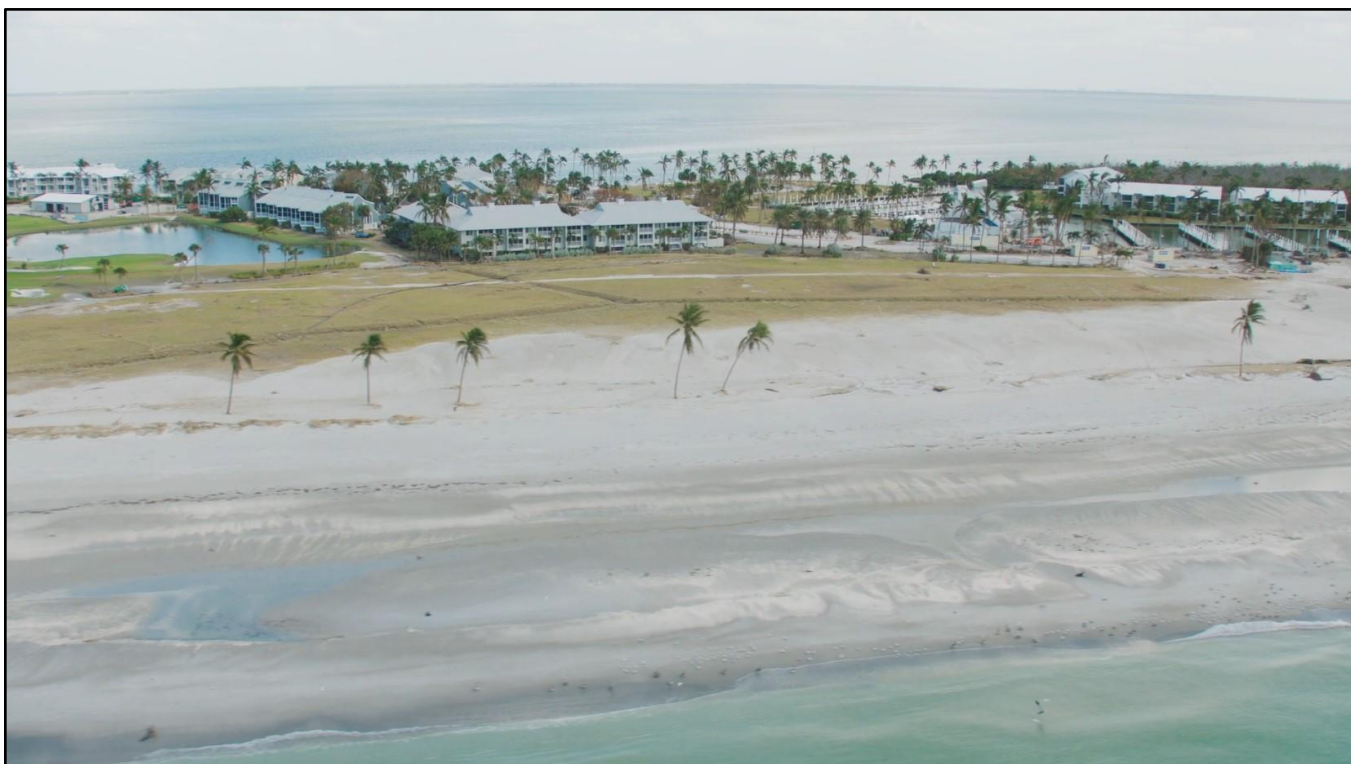
**Figure 132.** Major beach and dune erosion (condition IV) due to Helene and Milton at South Seas Plantation on Captiva Island near R-85.

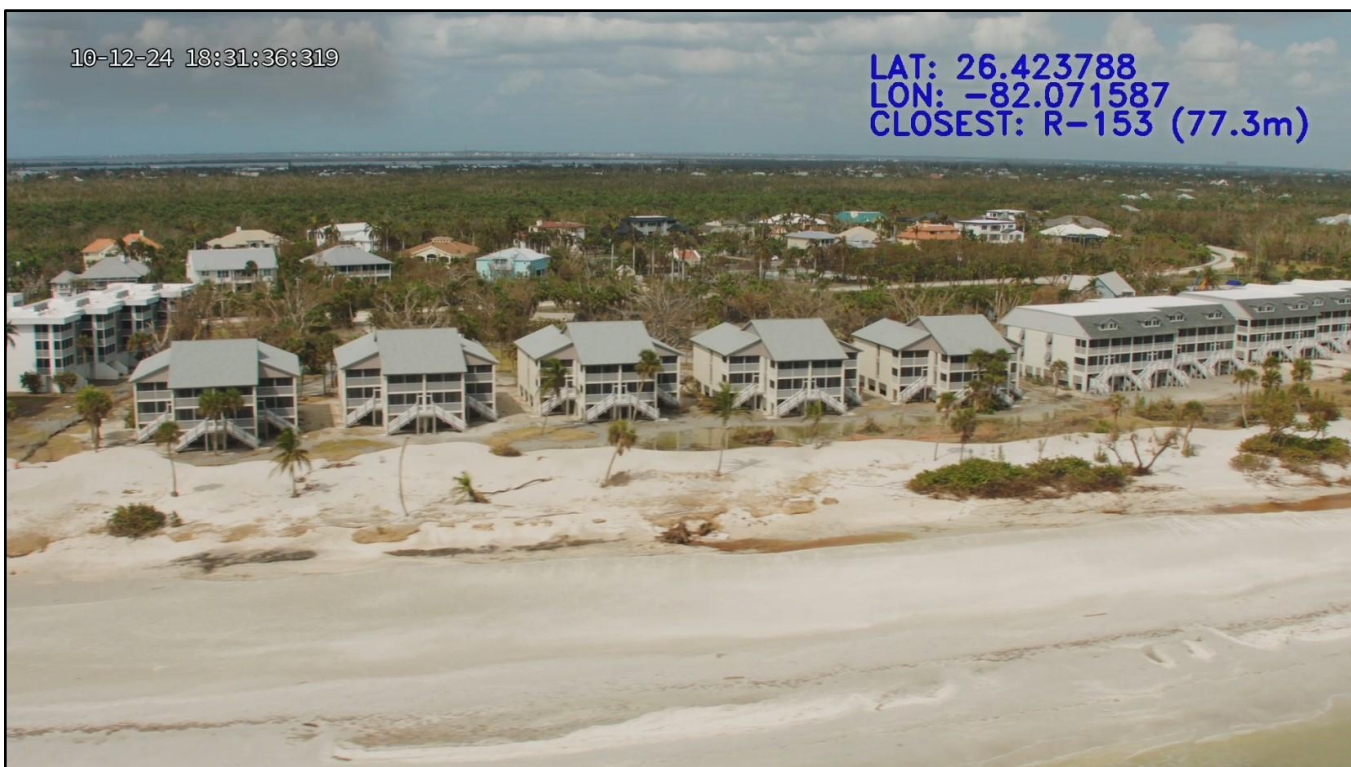
**Figure 133.** Major beach and dune erosion (condition IV) due to Helene and Milton on Sanibel Island near R-153.

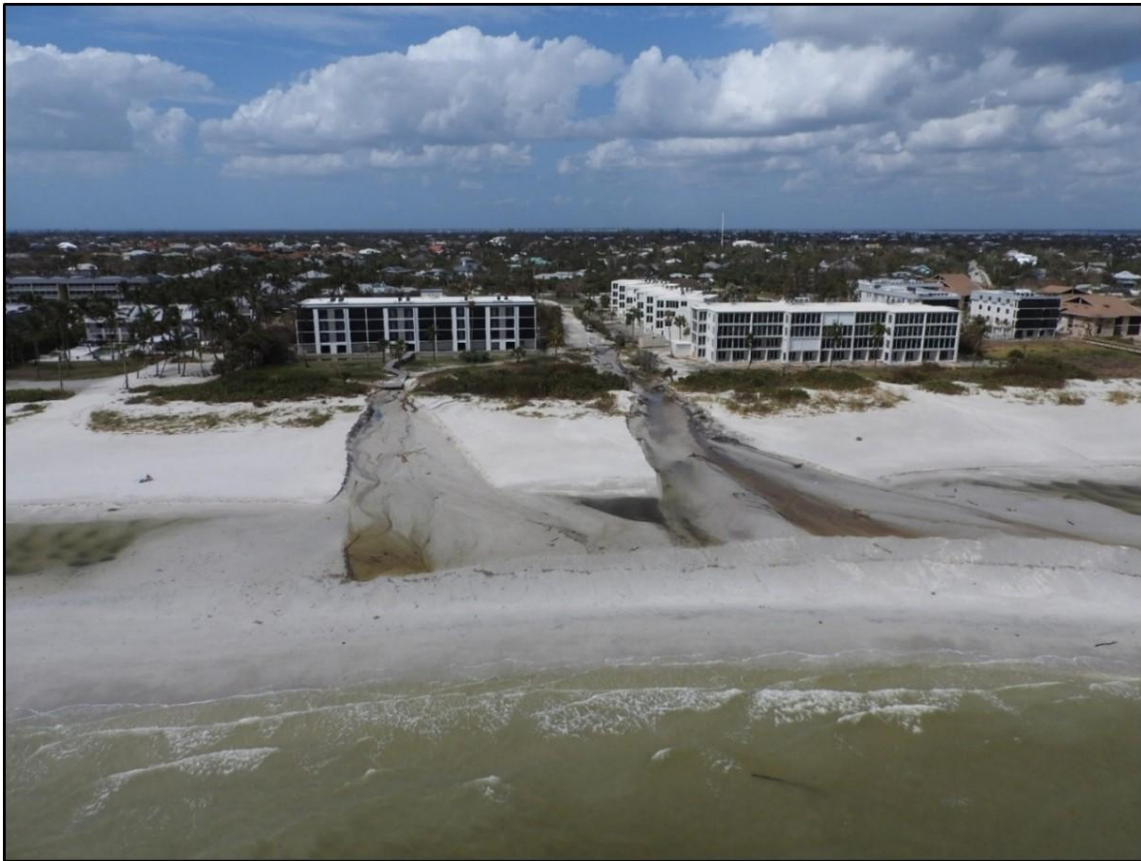
**Figure 134.** Storm surge discharge gullies following Milton on Sanibel Island near R-162.

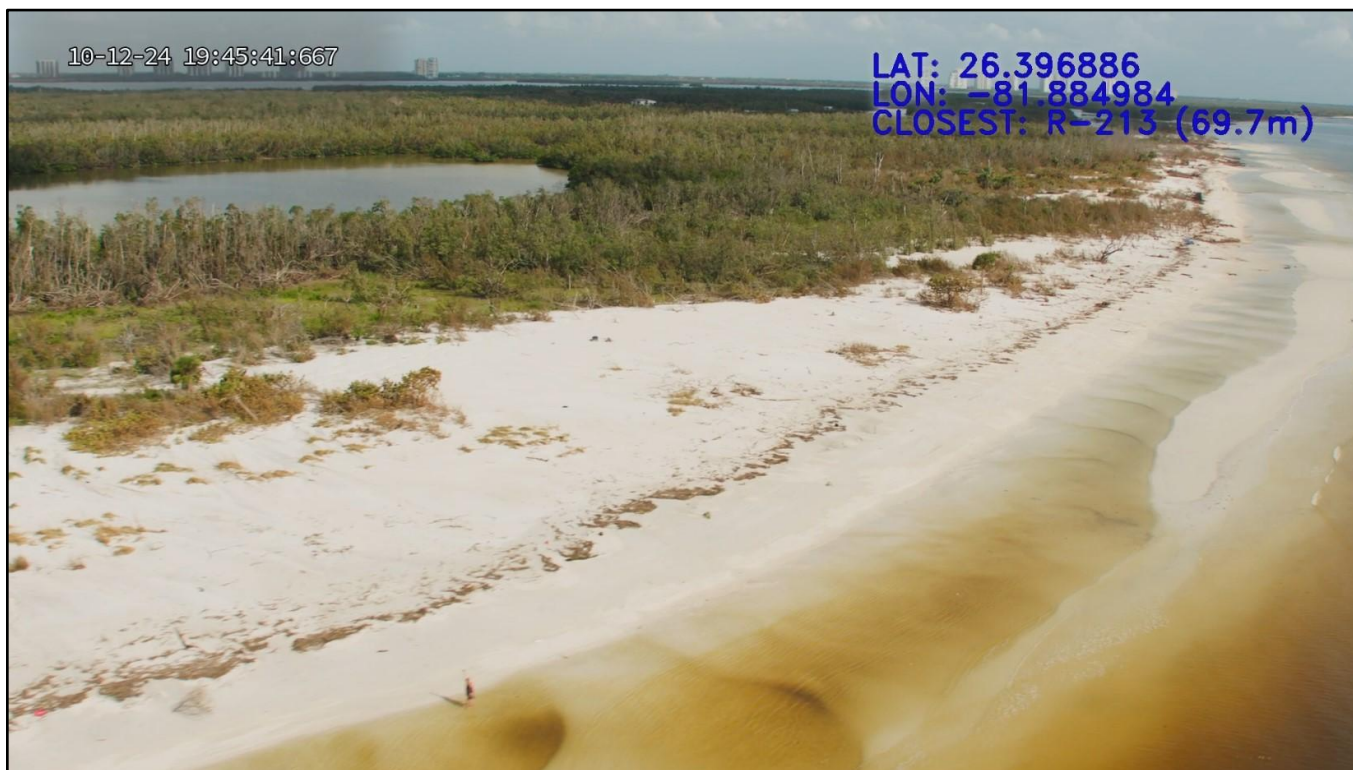
**Figure 137.** Nearshore storm-built sandbar with major beach and dune erosion (condition IV) due to Helene and Milton at Lover's Key State Park near R-213.

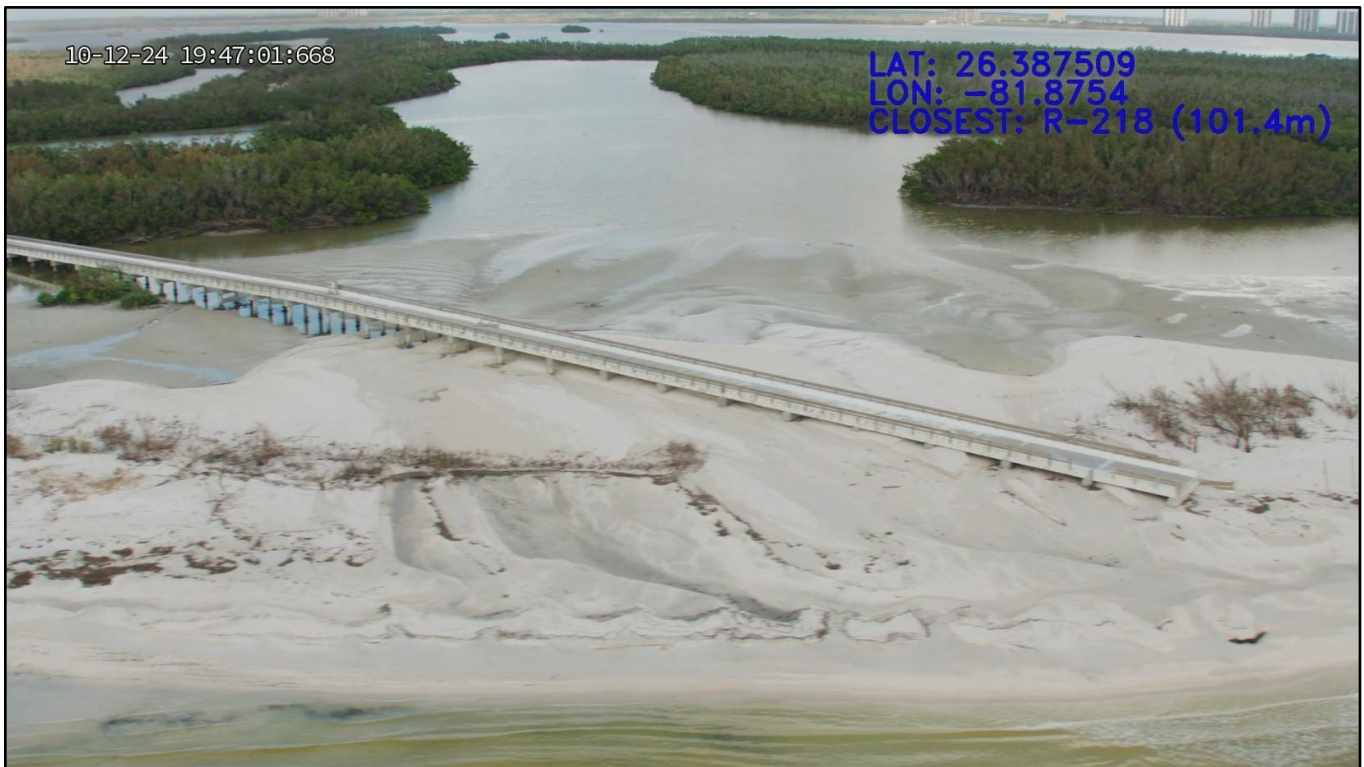
**Figure 138.** Major beach and dune erosion (condition IV) due to Helene and Milton at Lover’s Key State Park near R-218.

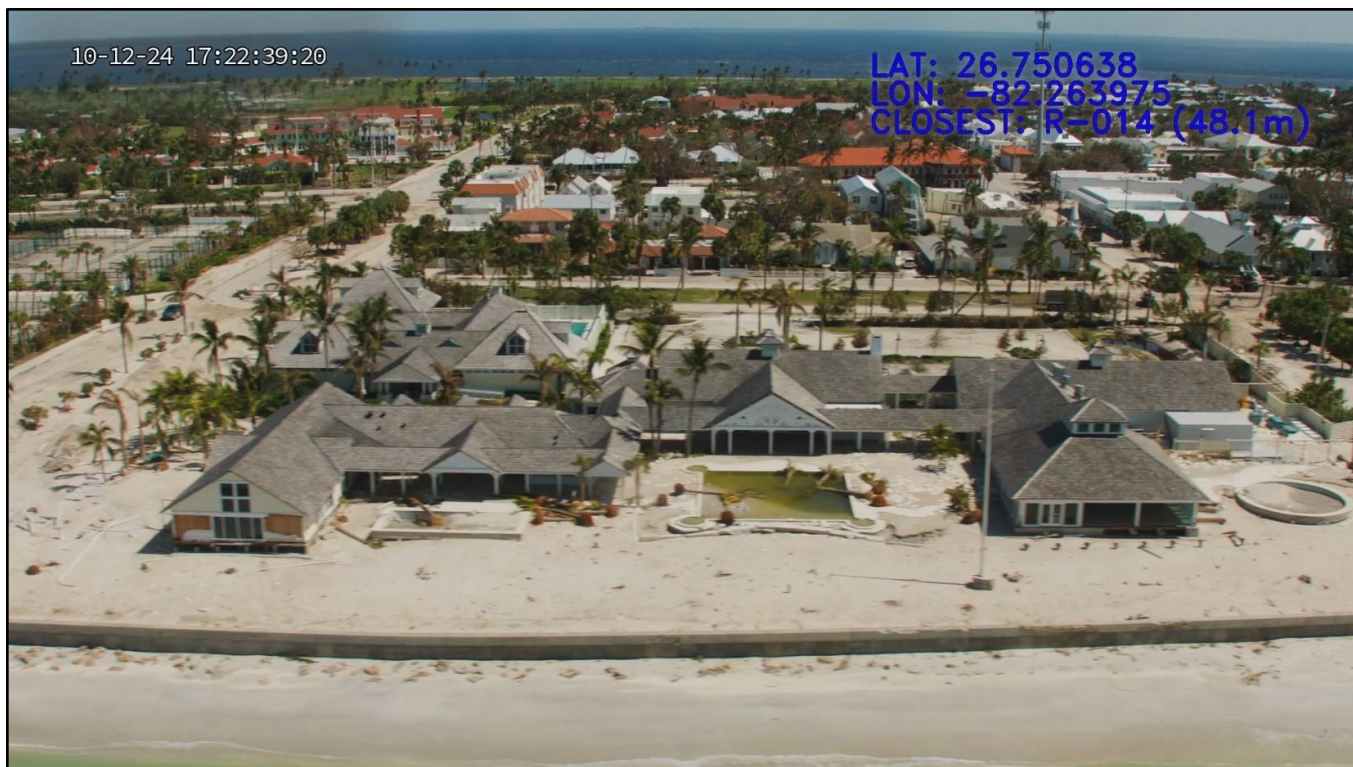
**Figure 139.** Major structural damage to the Gasparilla Inn Beach Club following Milton on Gasparilla Island near R-14.

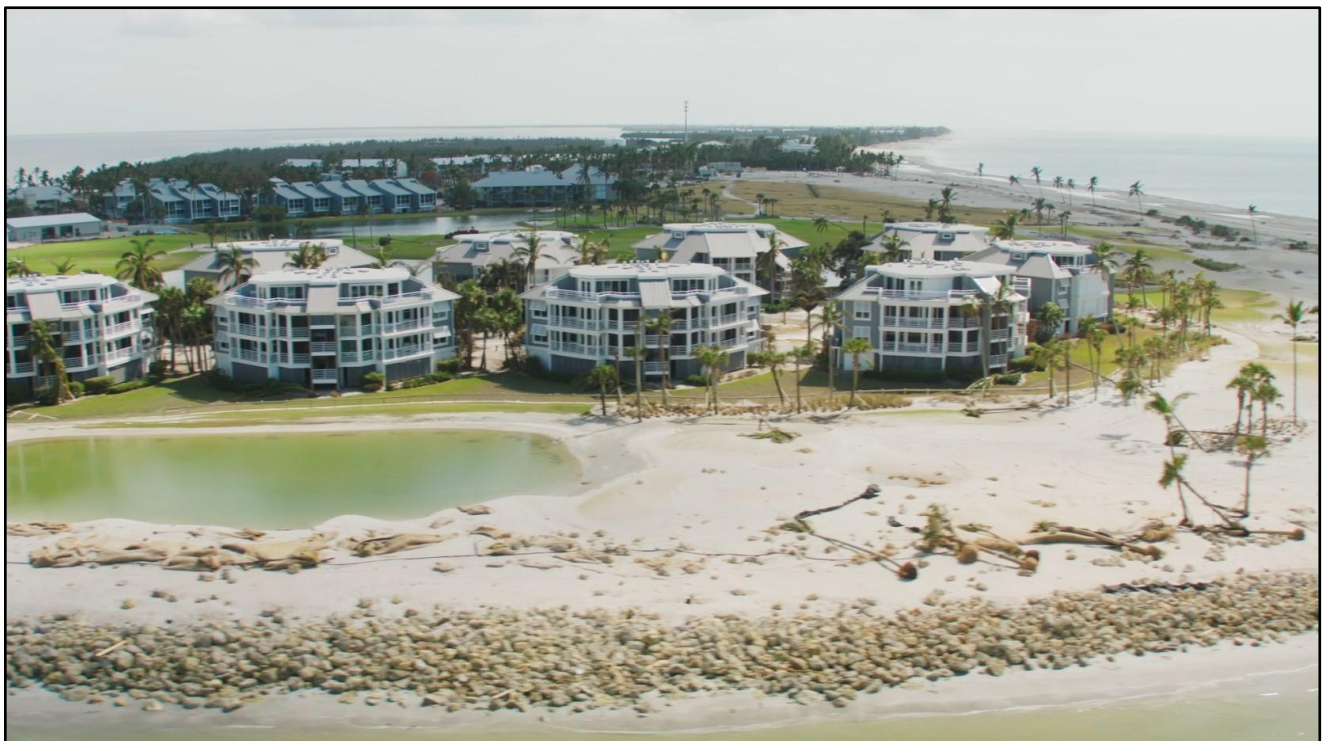
**Figure 141.** Rock revetment damage at South Seas Plantation at Redfish Pass on Captiva Island near R-84.

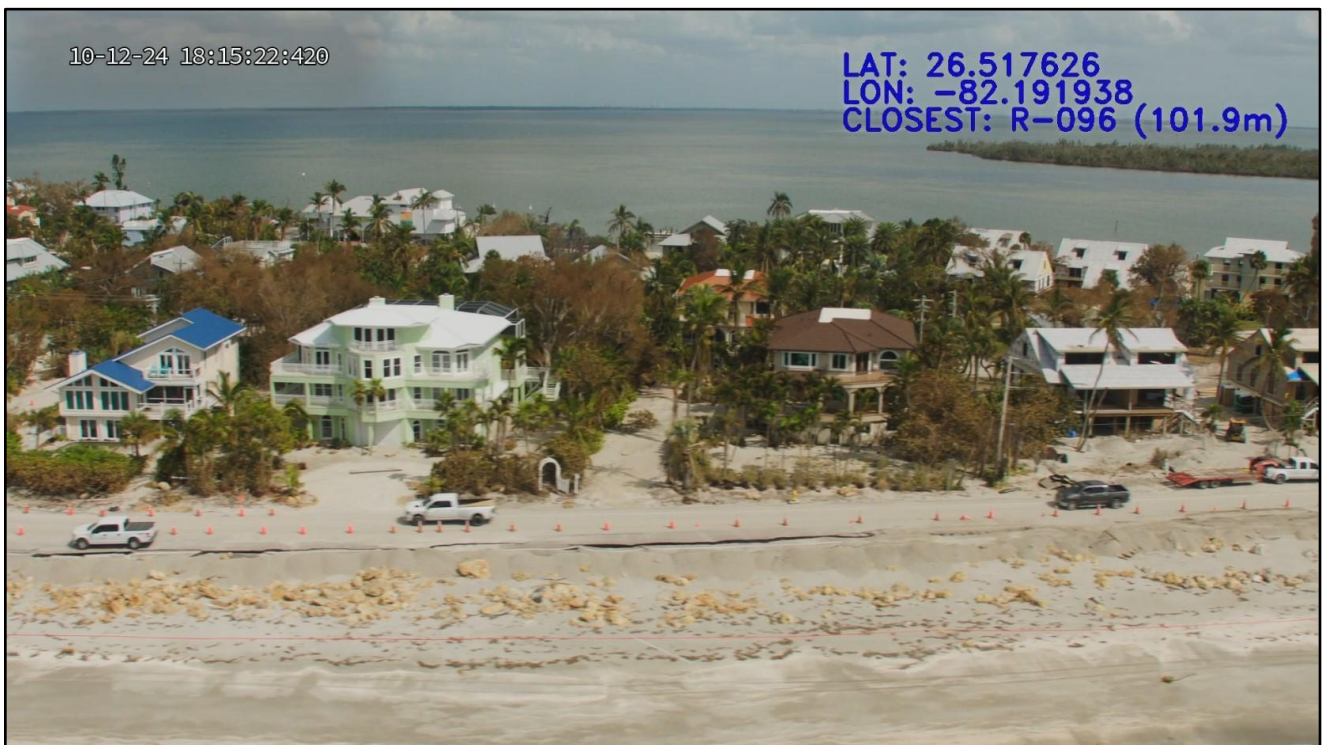
**Figure 143.** 500 feet of road damage along Captiva Drive on Captiva Island near R-96.

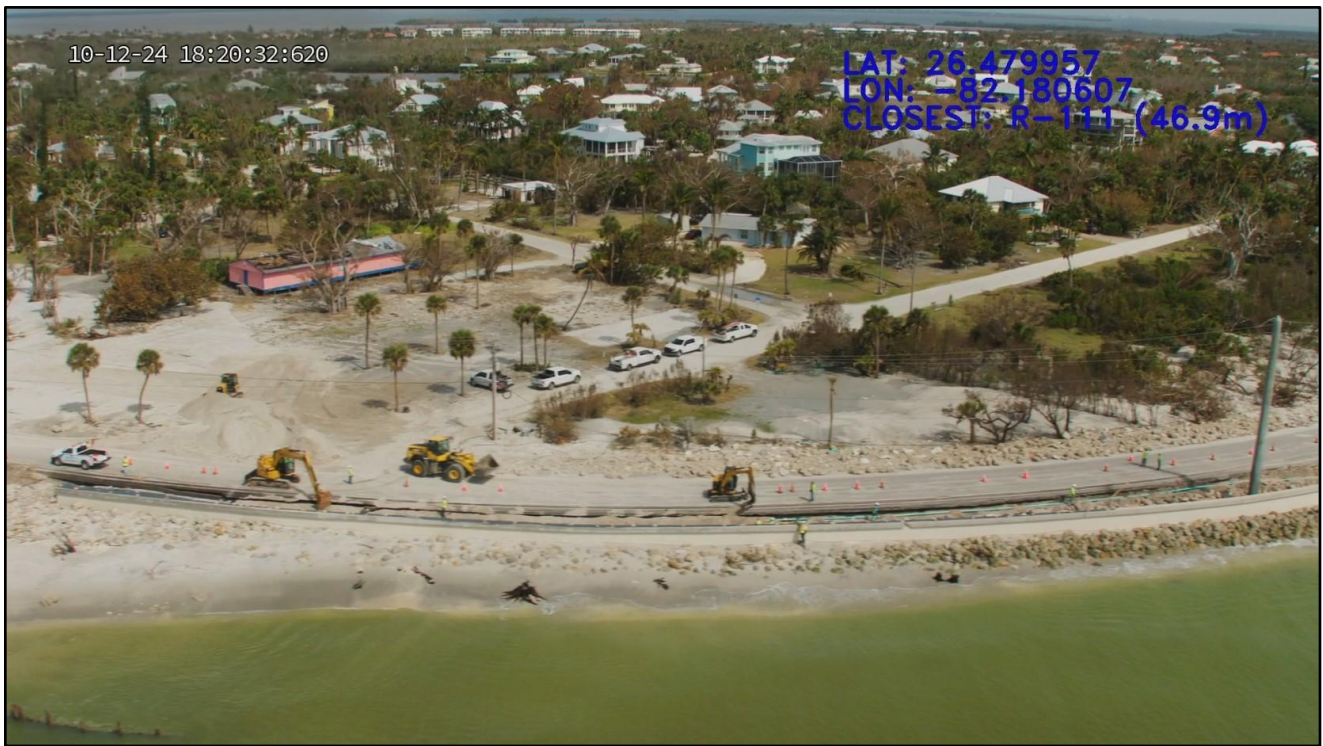
**Figure 144.** 120 feet of road damage on northern Sanibel Island near R-110.

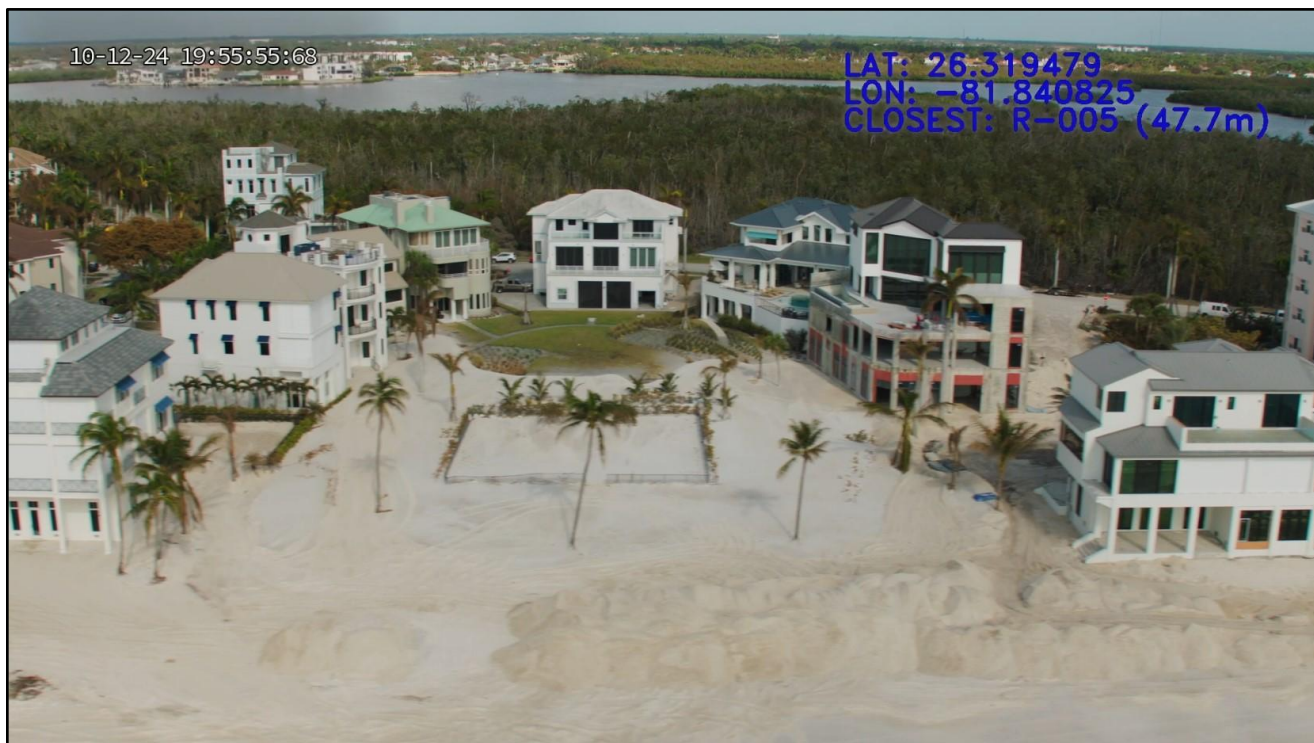
**Figure 146.** Major beach and dune erosion (condition IV) from Helene and Milton’s storm surge which filled the pool with overwash sand at Barefoot Beach near R-5.

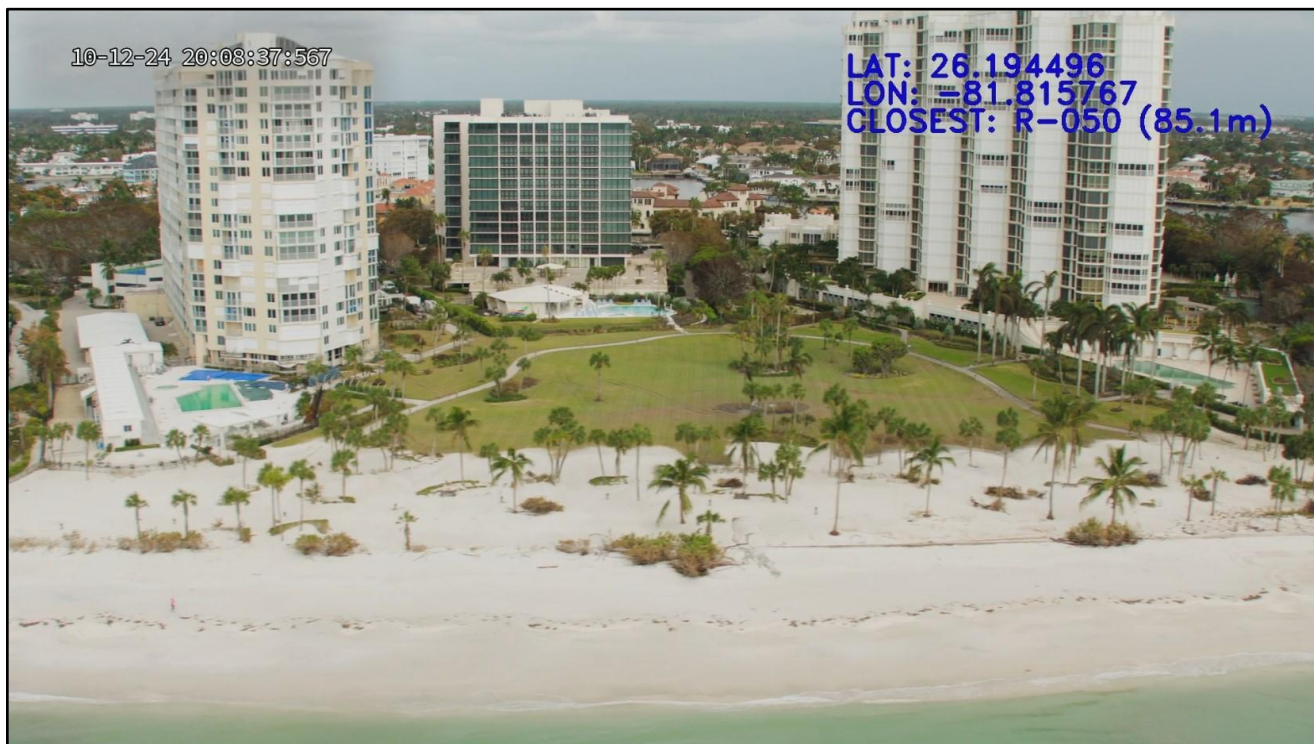
**Figure 147.** Major beach and dune erosion (condition IV) and storm surge overwash due to Helene and Milton at Park Shore/Naples near R-50.

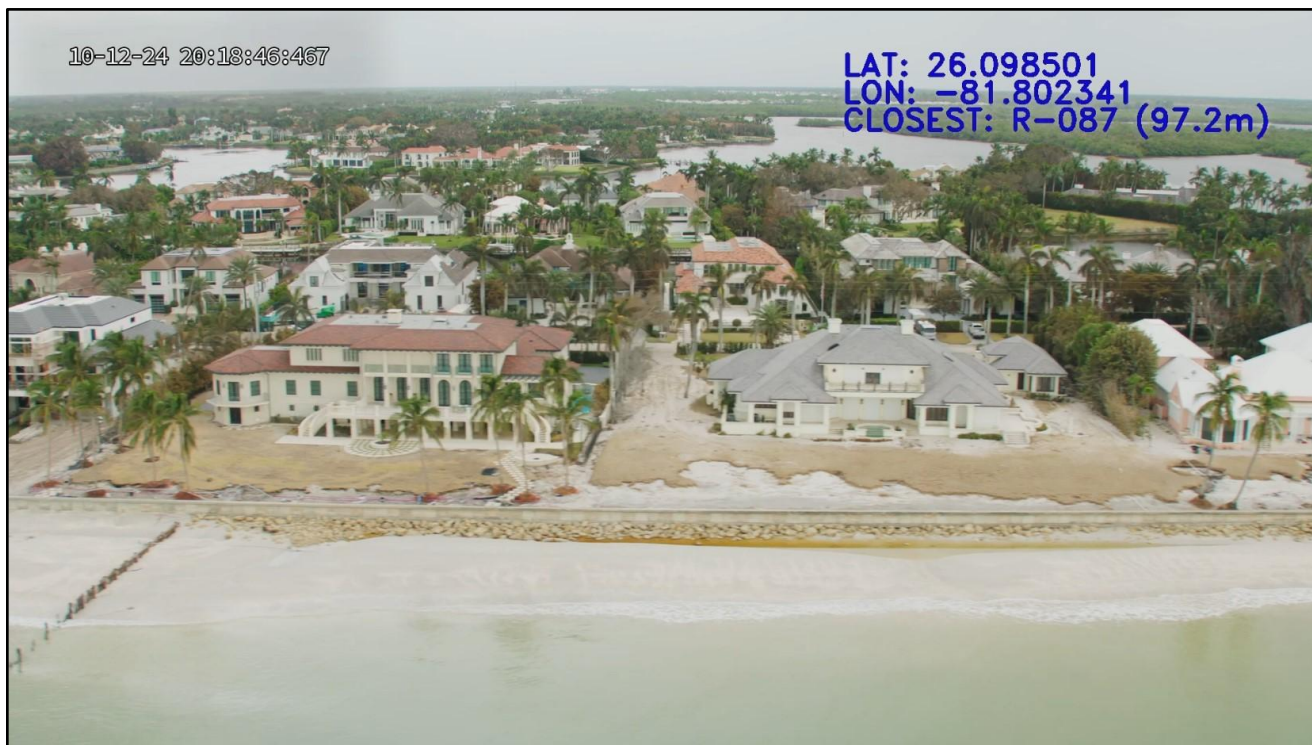
**Figure 148.** Major beach and dune erosion (condition IV) at Naples near R-87.

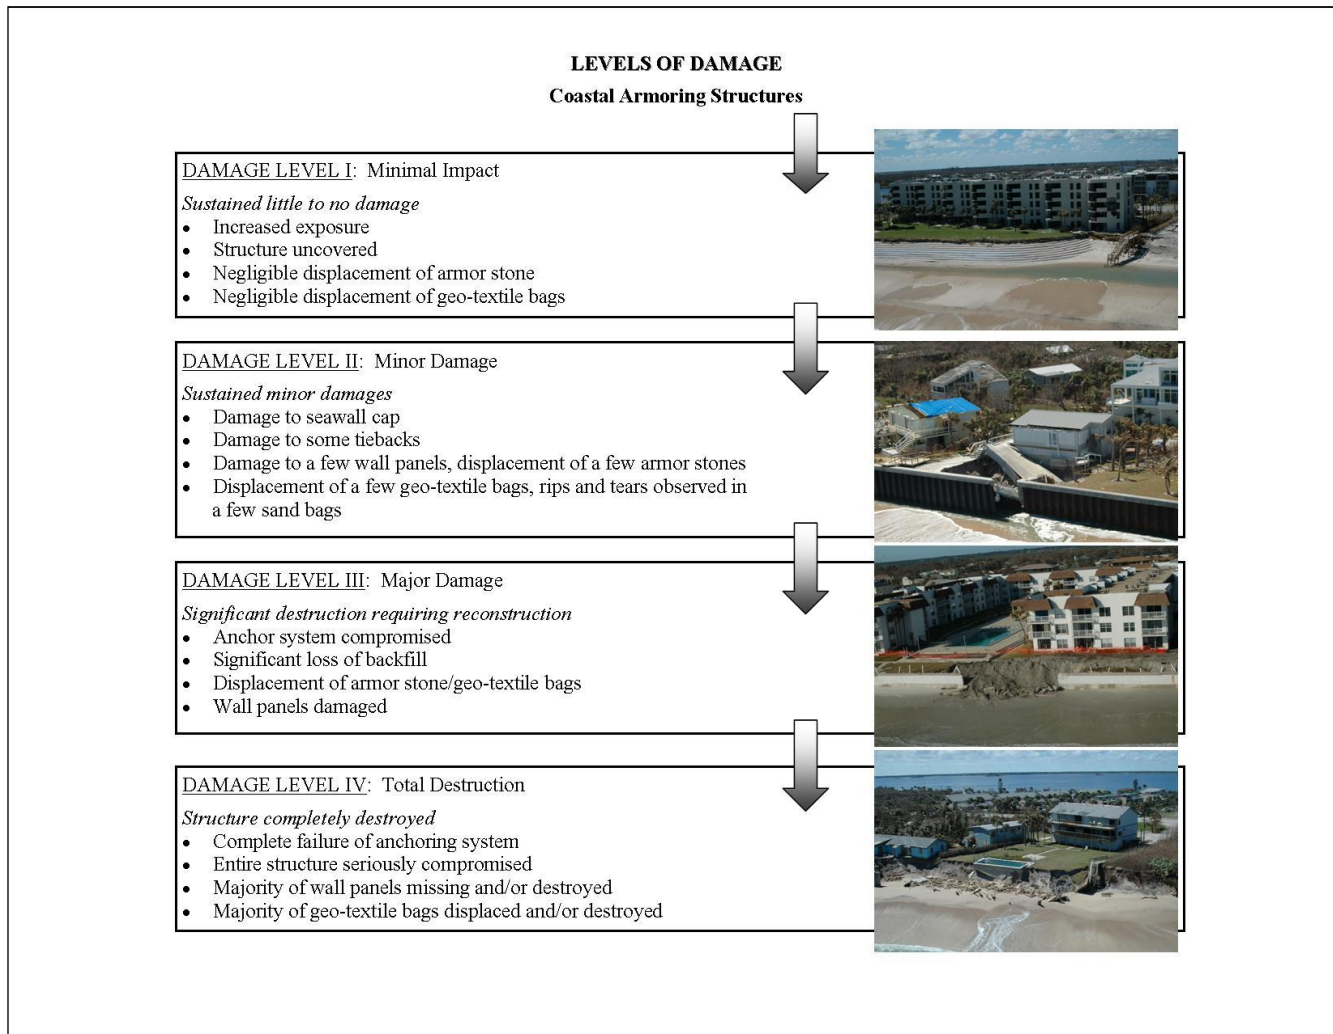
**Figure 150.** DEP’s Coastal Engineering graphic describing the levels of damage (I – IV) to coastal armoring structures, including seawalls and revetments.

A summary of damage to coastal armoring, including seawalls, bulkheads, revetments, or other rigid coastal protection structures fronting on the Gulf of America and Atlantic Ocean, is provided in **Table 2**. See Appendix A or **Figure 150** that describes the different damage levels to coastal armoring structures. Not included in this table is damage to retaining walls, concrete block walls, or concrete gravity walls that do not provide protection from erosion and storm tides and waves or armoring on interior tidal waters. Also not included are jetty structures constructed for navigation at ports and inlets. Hurricane Helene caused major damage to 233 major structures in Pinellas, Manatee and Sarasota Counties, including 70 that were destroyed. Hurricane Milton caused major damage to another 320 major structures. The majority of severe structural damages occurred in Sarasota and Charlotte Counties. In total, for the two hurricanes combined, 553 major structures were subjected to major structural damage in southwest Florida counties within the Coastal Building Zone. An overall summary of structural damage to major structures is given in **Table 3**. A more detailed description of these impacts by each county is provided in Section VI of this report.

**Note:** see Appendix A or Figure 150 that describes the different damage levels to coastal armoring structures.
