Lee County

Final Report

Water Quality and Treatment C-43 Mesocosm Using Combined Wetlands and Engineered Treatment Technologies DEP Grant Agreement Number INV10

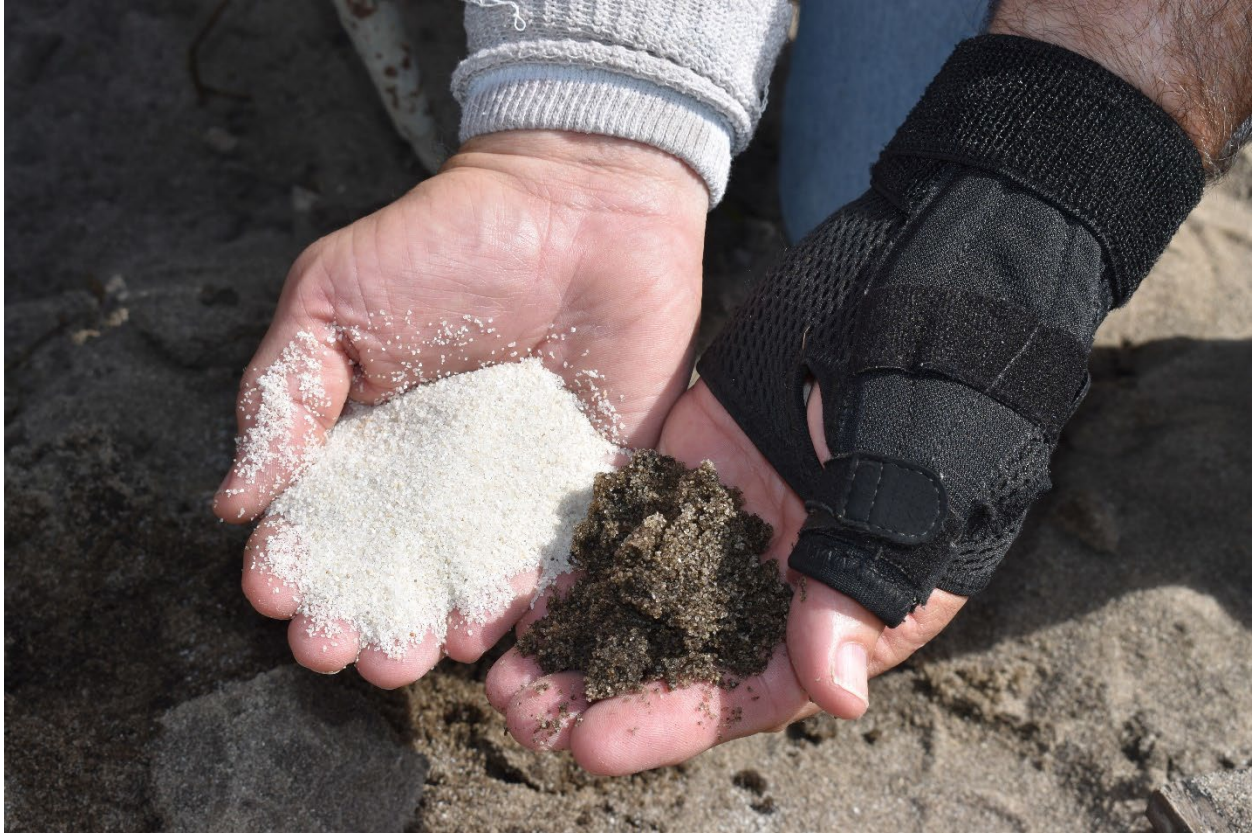
Routine maintenance of the project involved cleaned the sand filter on a regular basis. This involved removing schmutzdecke, and added new sand (Figure 6). Schmutzdecke is a visible biological skin that builds up in the top layer of the sand in the filter. It is a sticky layer or “muck” often referred to as the micro-flora skin or Schmutzdecke. Schmutzdecke is a German word meaning “dirty layer” (Huisman & Wood, 1974). The Schmutzdecke is often made of autotrophic bacteria, fungus, algae, protozoans, and a number of water living larvae plus the metals iron, manganese and silicon, but it makeup depends on the incoming water characteristics and the habitat in the certain filter (Huisman & Wood, 1974). The Schmutzdecke removes nitrogen and phosphate and releases oxygen. The fine sand grains leads to slow filtration which means that the water stays a long time above and in the filter, this gives the biological skin plenty of time to purify the water (Österdahl, 2015).

Figure 6. Comparison of clean sand and Schmutzdecke removed during maintenance of sand filter (3/23/22)

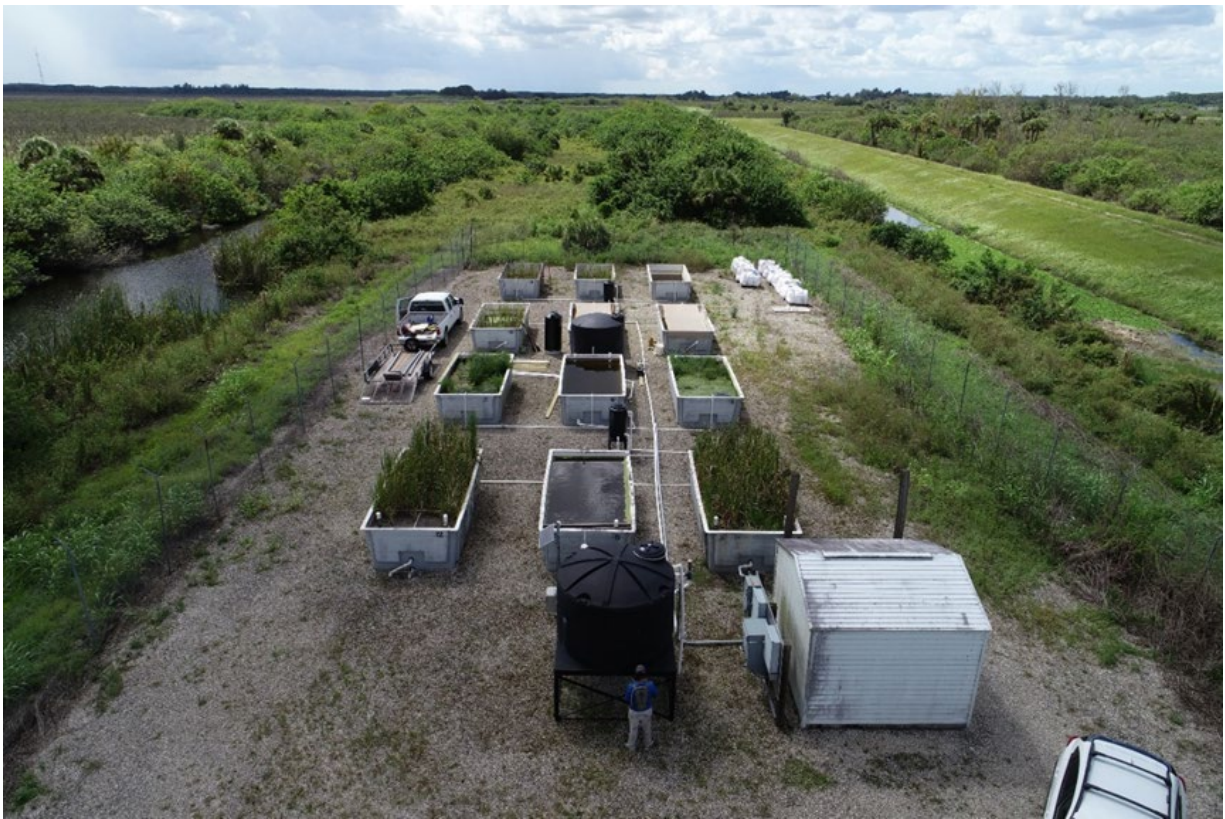
Figure 8. Photo of project site during construction (9-13-21)

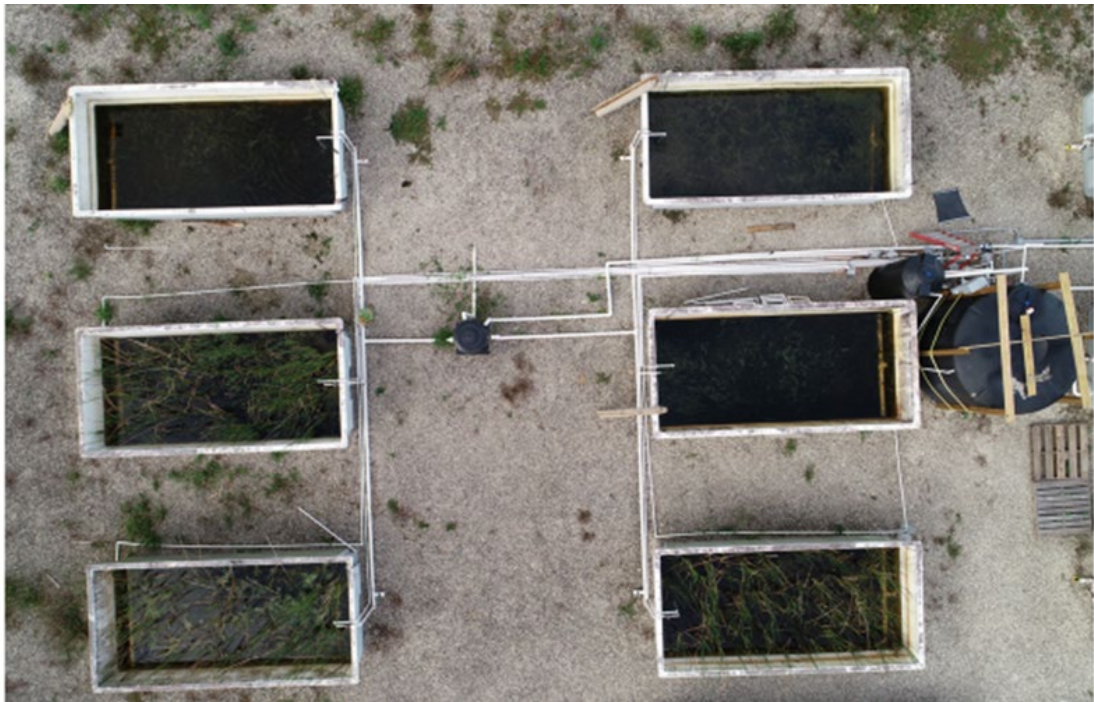
Figure 9. Photo of project site after construction (11-21-21)

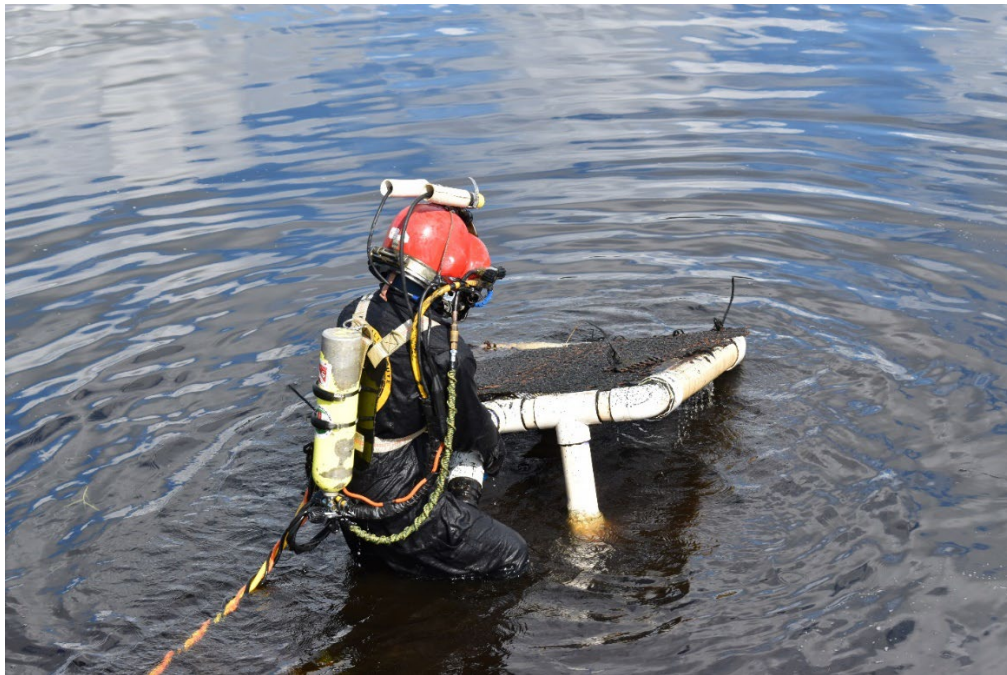
Figure 14. Caloosahatchee River (C-43) pump intake maintenance (10/15/21).

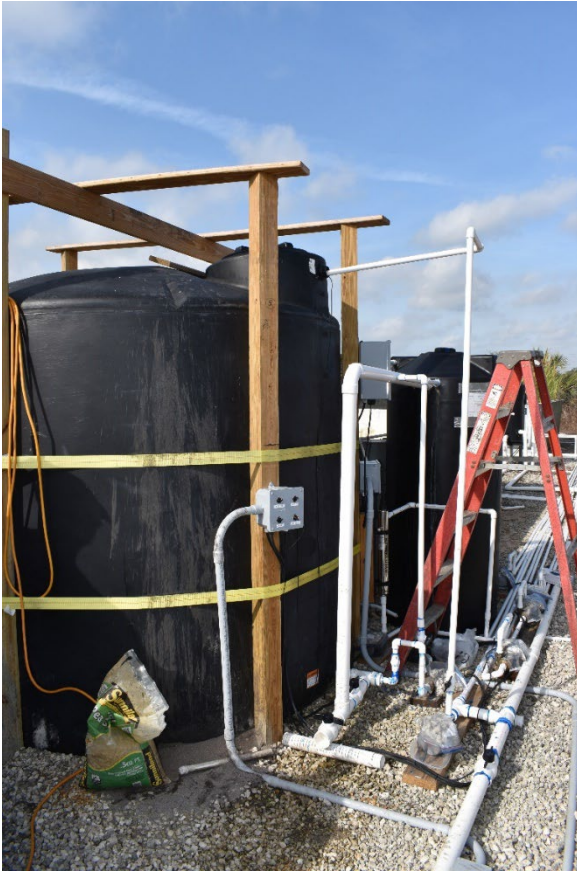
Figure 15. Sand filter (3/23/22)

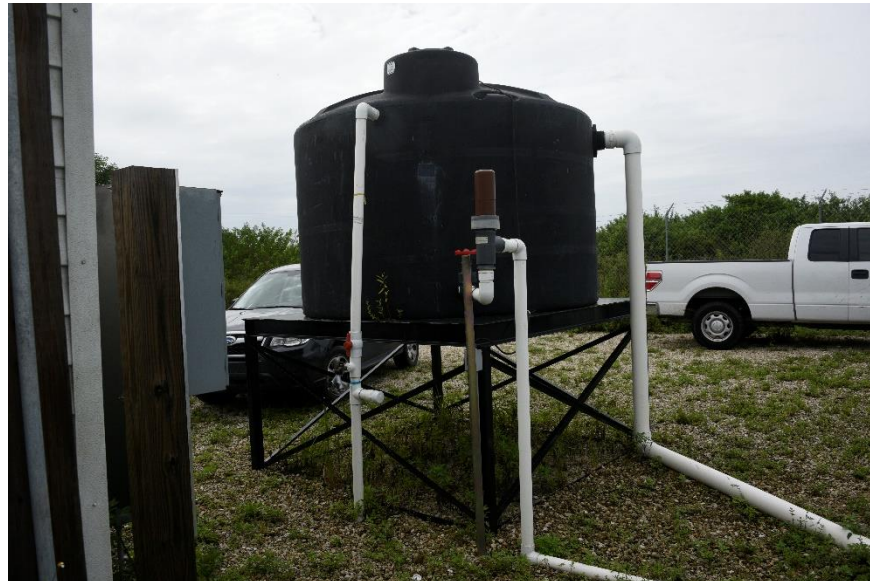
Figure 2. Primary water supply tank.

The water supply for the project comes indirectly from the Caloosahatchee River via a canal. A pump on the canal contains a screen to strain floating aquatic vegetation. The pump is located about 2,200 feet from the site and is maintained by the South Florida Water Management District. The water-supply pump feeds an onsite storage tank from which the water is pumped into various parts of the test apparatus.

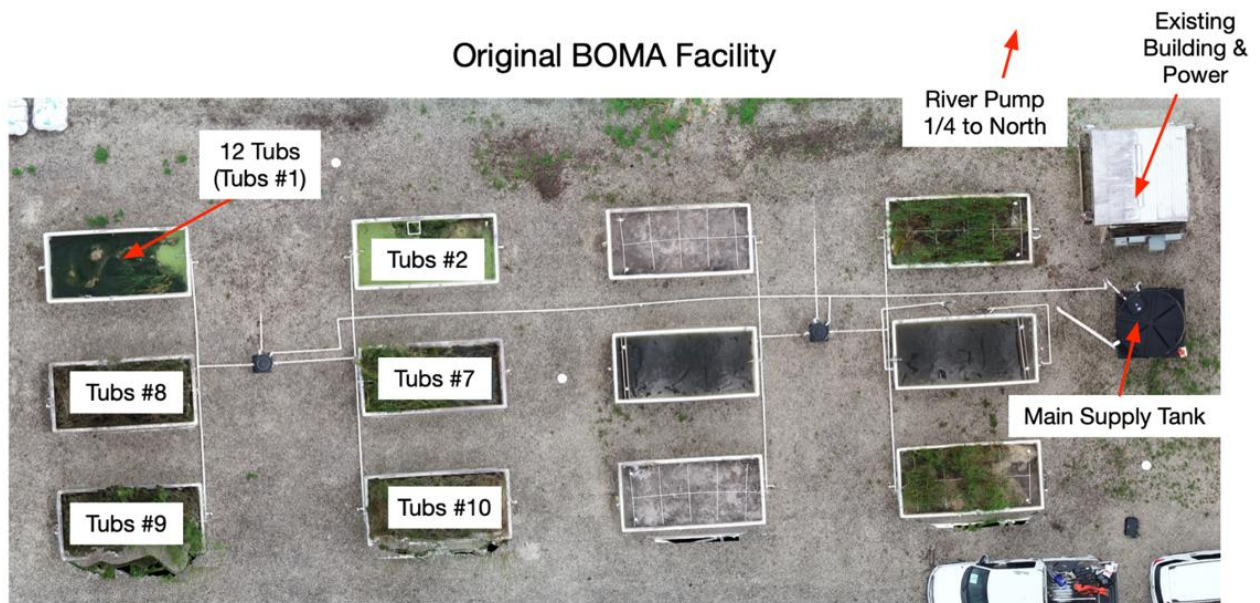
Figure 4. Layout of the site showing the main supply tank, the storage building with the power supply, and the tubs containing the vegetation.

Water from the Caloosahatchee River is pumped via a pipe to a main supply tank in the Boma test facility. The original Boma facility (see image below) consisted of the river water pump, the main supply tank, two holding tanks, and twelve test tubs. The experiment used the existing main supply tank, six tubs and added a new sand filter tank and a filtered water holding tank. Three parallel water paths were created, referenced, filtered, and UV-treated to compare water quality treatment. Two tubs were assigned to each path, the first with emergent plants and the second with submergent plants.

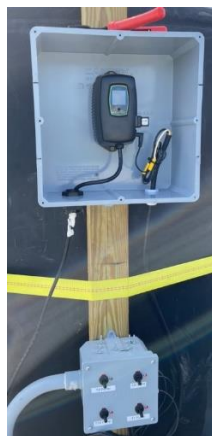
Figure 8. UV control and power control and indicator enclosure.

The power control system provided a method to check power availability, control pump, and UV light. All control systems were installed in water-resistant enclosures, with cable penetrations protected by gland fittings. The UV control module and one of the control boxes are shown in Figure 8.

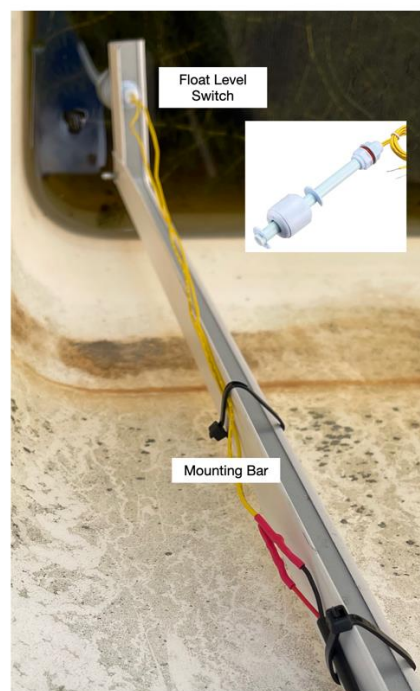
Figure 9. Water level float switch.

The monitoring system provided status on available power and water levels. Sensors included source AC power, 12 VDC power supply voltages, current flow to the pumps and UV light, and float switches to indicate the water level in the tanks and tubs. Since the water supply contained numerous particles and the water flow was small (≈ 1 gallon per minute from emergent to submergent tubs), standard flow meters would not work. Instead of expensive flow meters, low-cost float level sensors provided the water status. An example of the float switch and mounting system is shown in Figure 9. A summary of the monitoring system is given in Table 1.

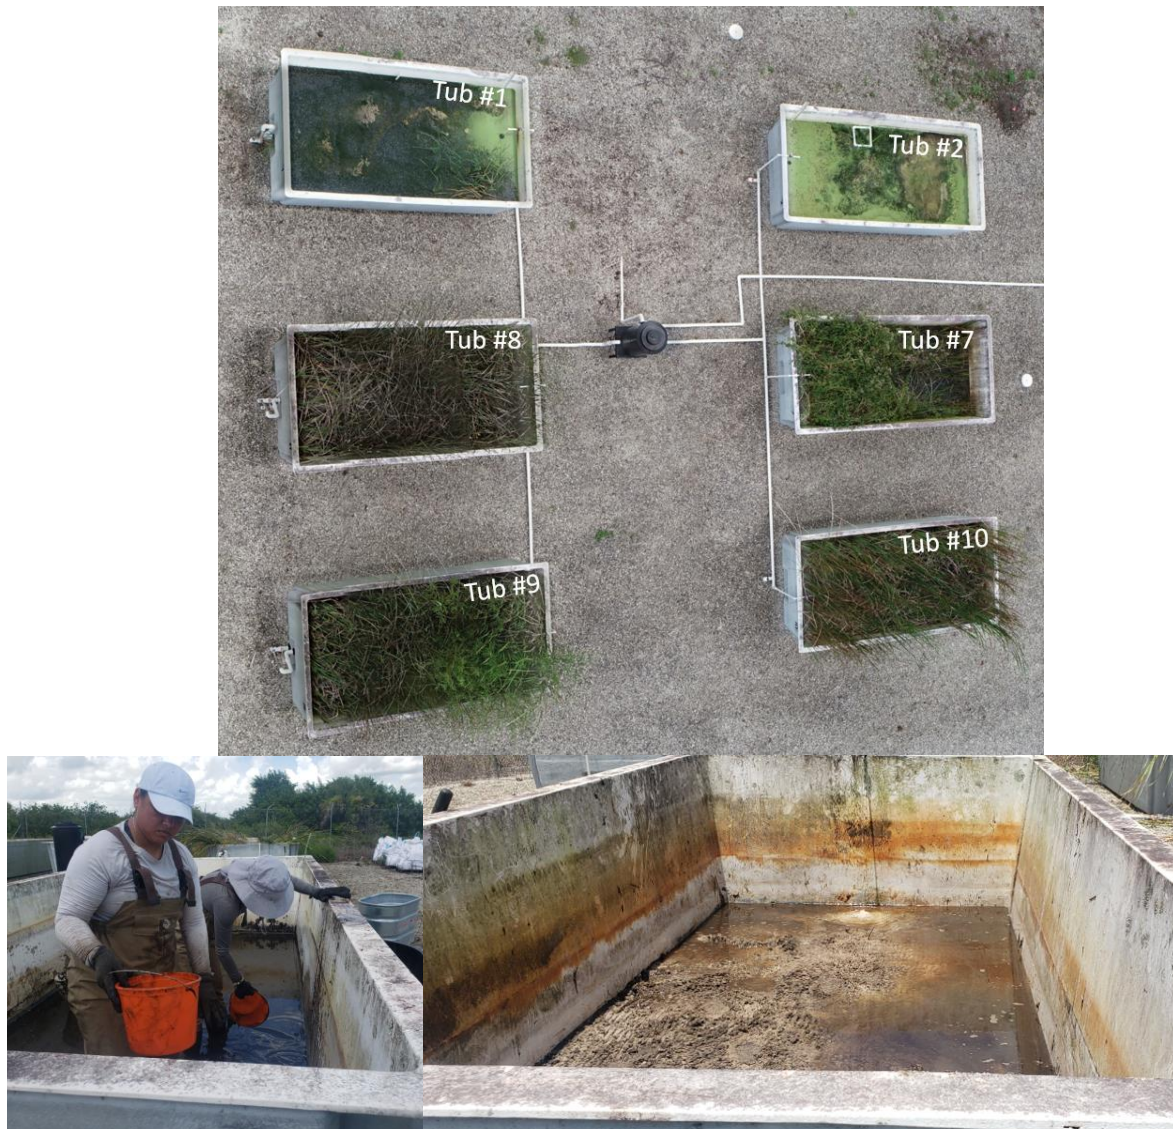
Figure 15. Top: Vegetative state of the tubs prior to being cleaned (07/02/2021). Photo taken with an aerial drone (DJI™ phantom 4 Pro). Bottom left: cleanup of the phytodetritus and sediment. Bottom right: tub after being cleaned.

When the project was started, the vegetation in the three tubs that utilized emergent vegetation (i.e., tubs 8, 9 and 10) already contained *Typha domingensis* (cattail) as well as some *Schoenoplectus californicus* (giant bullrush) and some other sedges and grasses such as the invasive plant *Panicum repens* (torpedo grass, Figure 15).

From 07/12/2021 to 07/15/2021, the tanks were cleaned of their vegetation as well as of their phytodetritus and sediment (Figure 15). This was accomplished by first unrooting the vegetation by hand and hand tools whilst taking care of preserving the roots of *T. domingensis* and *S. californicus*. The least severely damaged individuals of those two species were kept in a horse trough filled with water until they could be replanted (Figure 16). The heads of *T. domingensis* were chopped off with a machete as special attention was taken to limit the

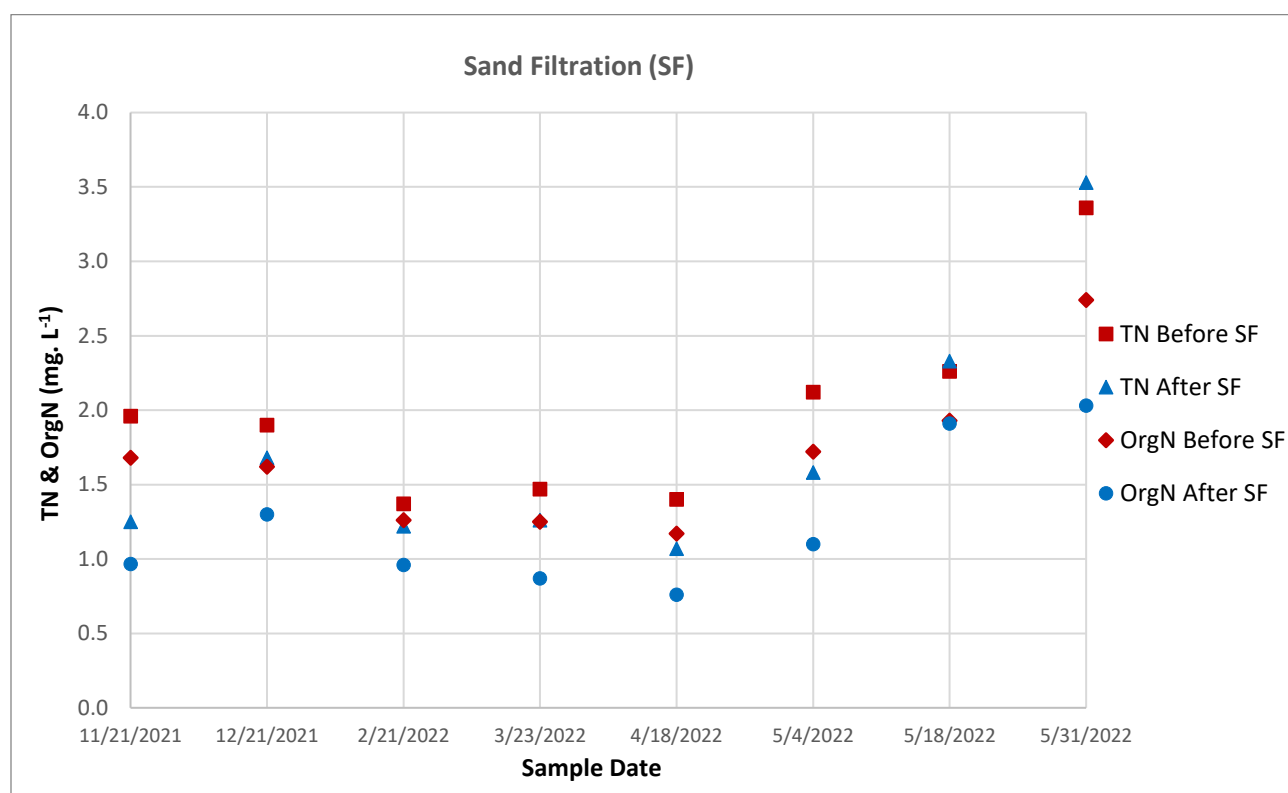
Figure 19. Plot of the total nitrogen and organic nitrogen before and after the sand filtration.

Figure 19 shows that in most cases the total nitrogen was lower after sand filtration, and there was also a reduction in the organic nitrogen. The box plots in Figure 20 show the same trend with a slight lowering of total nitrogen and organic nitrogen provided by sand filtration. It should be noted that some of the outlier measurements do impact the box plot full ranges in concentrations.

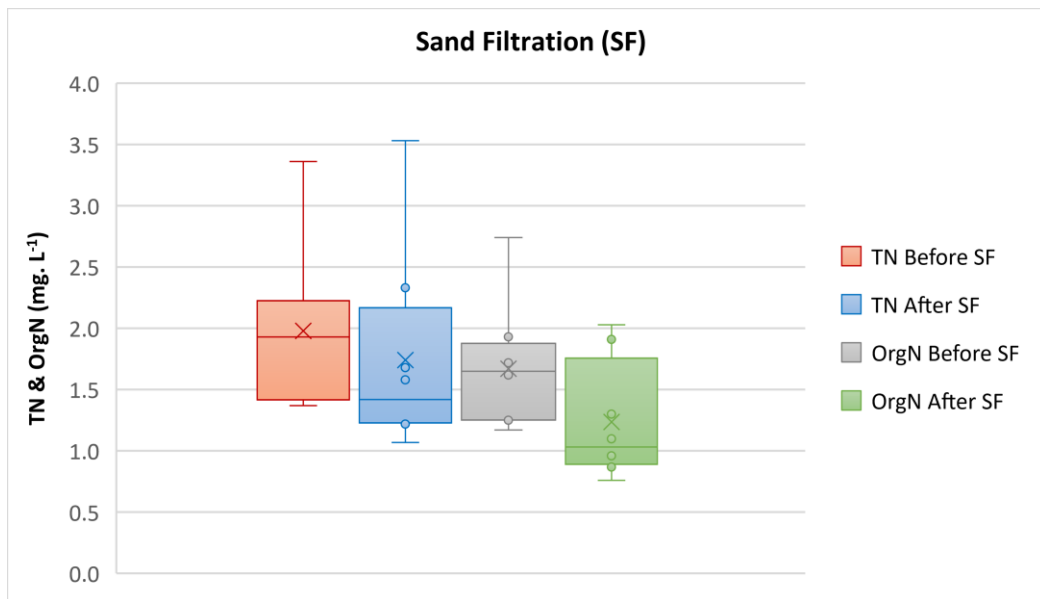
Figure 20. Box plots of total and organic nitrogen before and after sand filtration.
