# Long Branch Creek

## Bacterial Pollution Control Plan

Draft Report  
January 2017

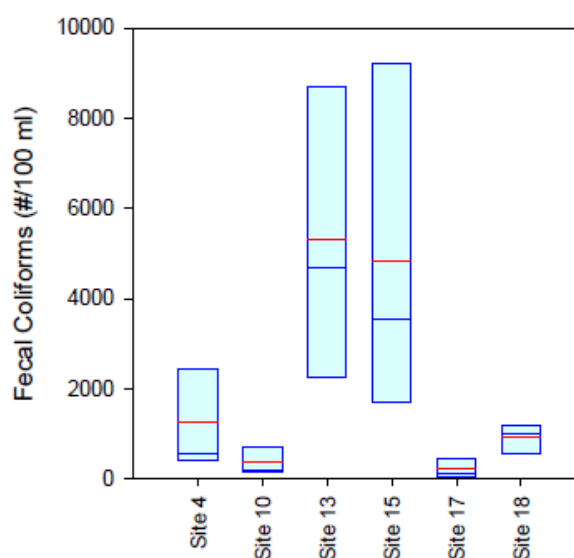
**Figure 8. Box and whisker plot of tributary ditch sites (ERD, 2012).**

Fecal coliform results were relatively low in the upstream portions of the creek in both the northern and southern branches; however, substantial increases were observed in the northern branch just upstream of the confluence (sites 7 and 8). This spike in fecal coliform does not appear to significantly impact downstream water quality given that site 11, just downstream of the confluence of the two branches, has the lowest mean fecal coliform results of all of the main channel sites. Fecal coliform remains relatively low in the main channel until site 16 which is the most downstream site. The source of the elevated results appear to be the two ditches that discharge to the creek between sites 14 and 16 as seen depicted as green triangles in Figure 9. Site 13 is Poinciana ditch and Site 15 is Whitney Rd. ditch; both are described in more detail later in the report.

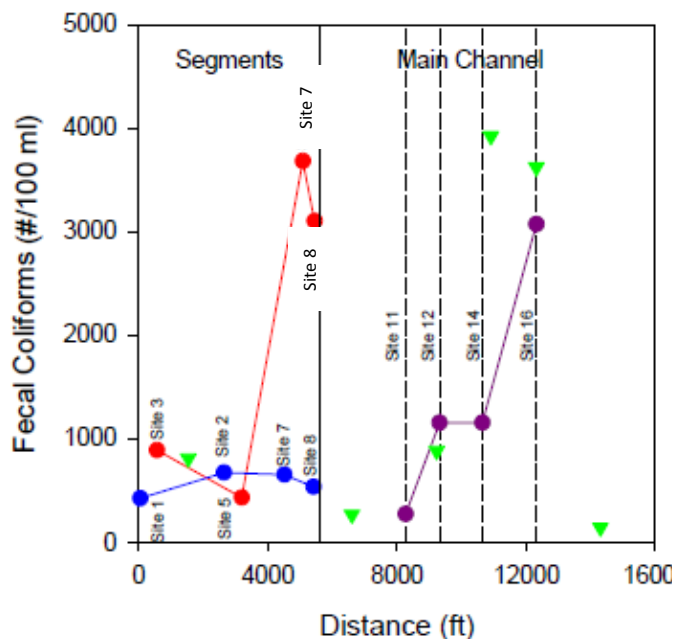
Figure 9. Mean fecal coliform for all sampling event plotted by distance from the headwaters (ERD, 2010).

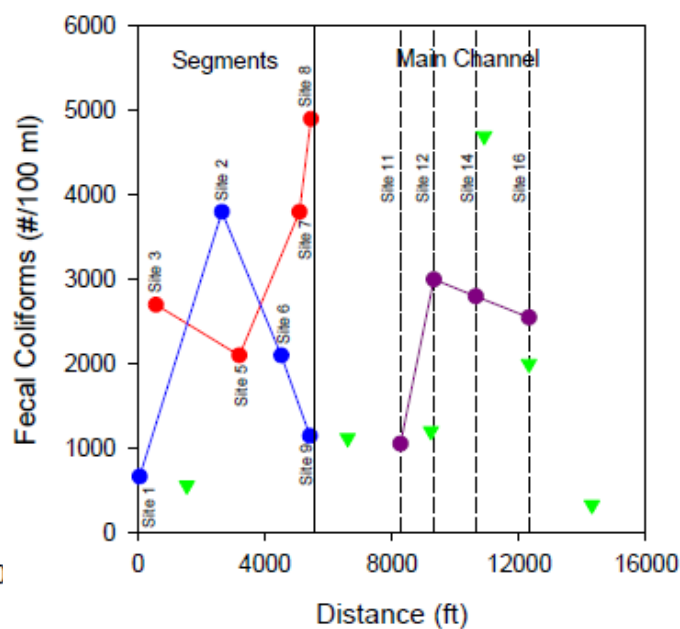
Figure 10. Mean fecal coliform during high flow event plotted by distance from the headwaters (ERD, 2010).

One sampling event on January 18, 2011 was conducted following a 2.88 inch rain event. In general, under these high flow conditions, results were elevated compared to other sampling events which occurred during more typical dry season flow conditions (Figure 10). The spike in the southern branch at site 2 did not occur during other sampling events and the spike at site 12 in the main channel occurred only during one other sampling event, but was not as extreme as during high flow conditions.

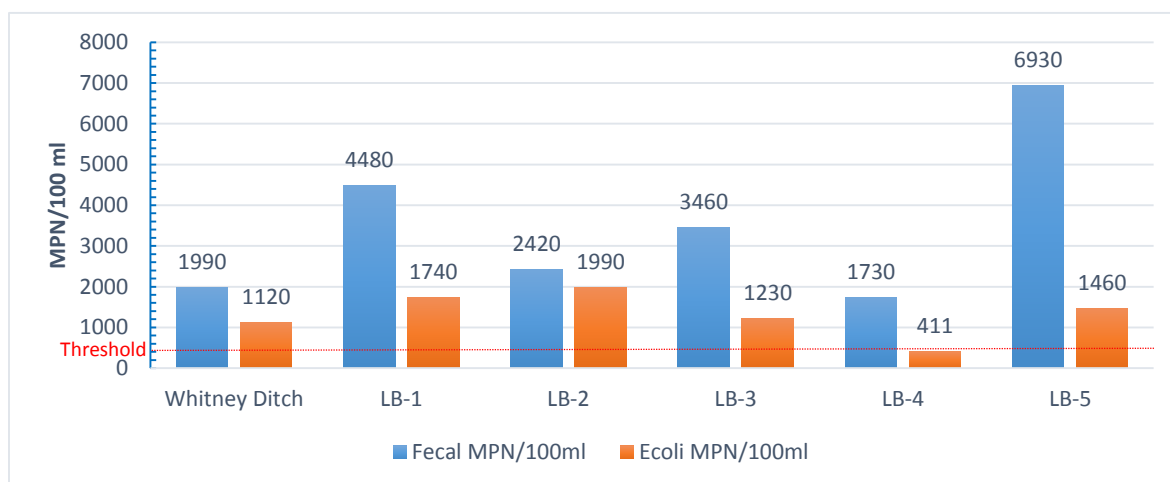
**Figure 10. Wet season bacteria results.**

Results from wet season sampling on September 1, 2015 are presented in Figure 12 and Table 7. Fecal coliform results for all six sites were elevated at levels above the 2015 water quality standard of 400 MPN/100 ml with most sites more than three times the standard. The highest levels occurred at site LB-5 in the north branch at 6,930 MPN/100 ml. *E. coli* results for all samples were still above the current criteria of 410 MPN/100 ml with LB-4 having the lowest concentration just above the limit.

The human genetic marker was only detected at sites LB-1, the most downstream site, and LB-2 at Poinciana ditch at moderate levels. Dog markers were found at all five sites in moderate to low concentrations. Horse DNA was not detected at the two sites sampled and bird markers were only found at trace levels, if at all.

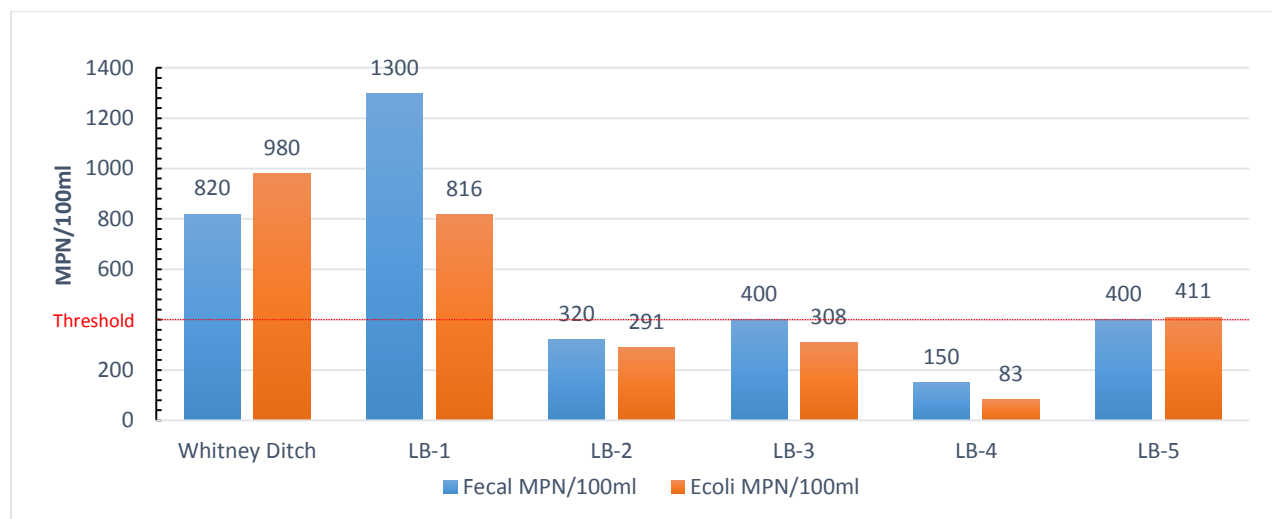
Figure 11. Dry season bacteria results.

Sampling was repeated near the end of the dry season on April 14, 2016. Results are presented in Figure 13 and Table 8. Both fecal coliform and *E. coli* results for two of the sites, LB-1 and Whitney, were elevated at levels above both the 2015 and current water quality standards. Four sites (LB-2, LB-3, LB-4, and LB-5) were at or below acceptable levels for both fecal coliform and *E. coli* during the dry season. Both fecal coliform and *E. coli* concentrations were lower at every site during the dry season than the wet season.

The human genetic marker was only detected at site LB-3 at trace levels. Dog markers were found in low concentrations at sites LB-1 and Whitney, trace concentrations at sites LB-2, LB-3 and LB-4 and were not present at site LB-5. Similarly to the wet season, horse DNA was not detected at the two sites sampled (LB-1 and LB-3) and bird markers were only found at trace levels if at all during the dry season.

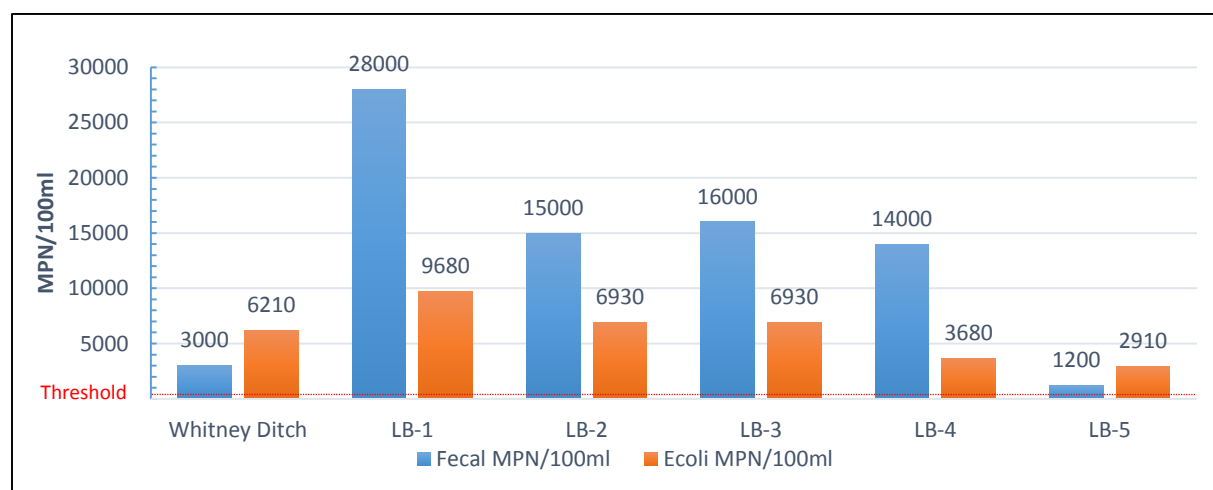
Figure 14. Storm event bacteria results.

The storm event results indicate high levels of bacteria at each sampling site (Figure 16) and that all sites were impacted by human source of bacteria (Table 9).

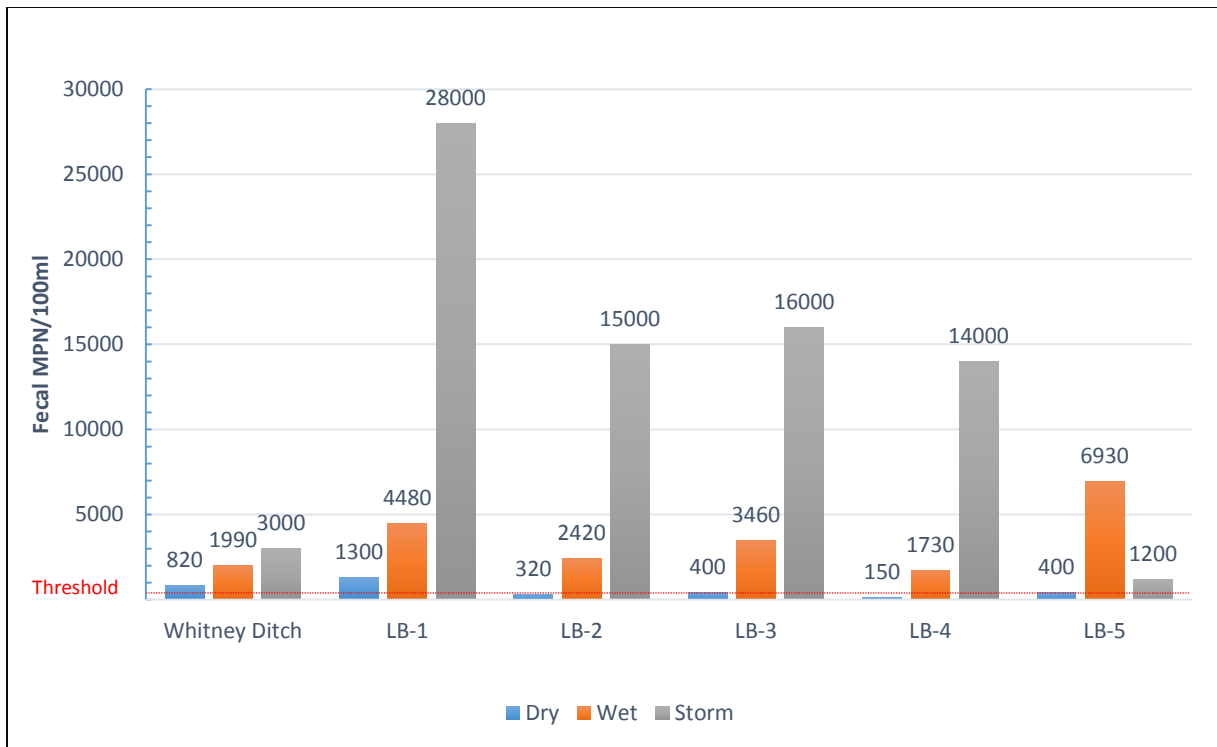
Figure 15. Fecal coliform results for all three sampling events.

Results indicate fecal coliform and *E. coli* concentrations are lower during the dry season, increase during the wet season, and are highest following a rain event with one exception at LB-5 (Figures 17 and 18). Fourteen of the eighteen samples exceeded the 2015 fecal coliform criteria with the four meeting the criteria all occurring during the dry season. Thirteen samples exceeded the *E. coli* criteria.

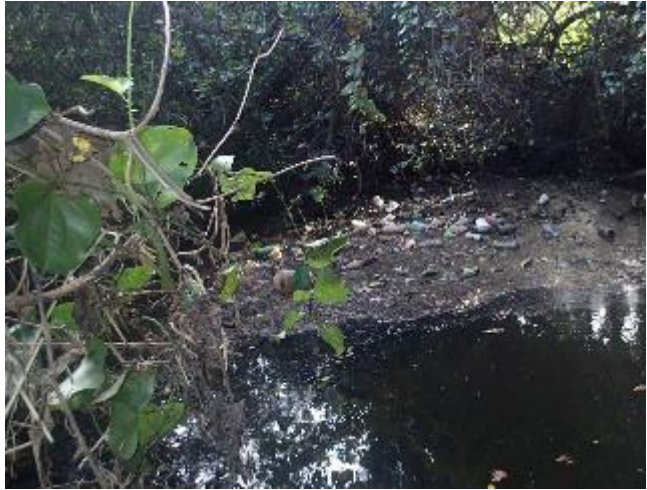
**Figure 18. Trash and debris found in Long Branch Creek**

Accumulated trash and debris were found in several ditches, in the creek, and in other areas throughout the watershed (Figure 18 and Figure 19). Each issue was either forwarded to the City of Largo or County crews for cleanup or County NPDES inspectors took enforcement actions if on private property (Appendix A).

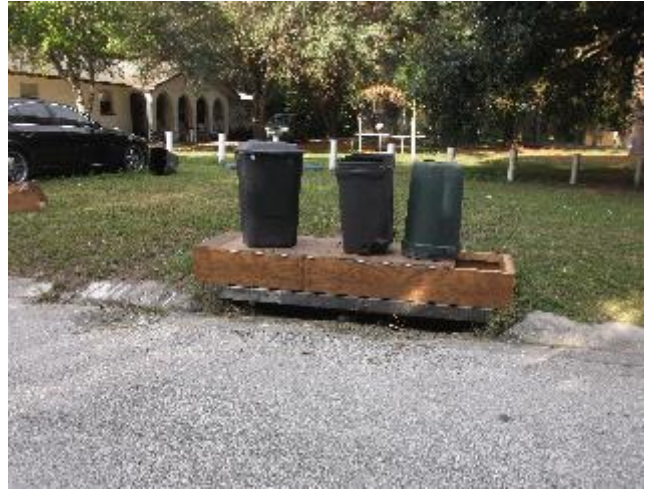
**Figure 19. Leaky trash cans stored on top of storm drain.**

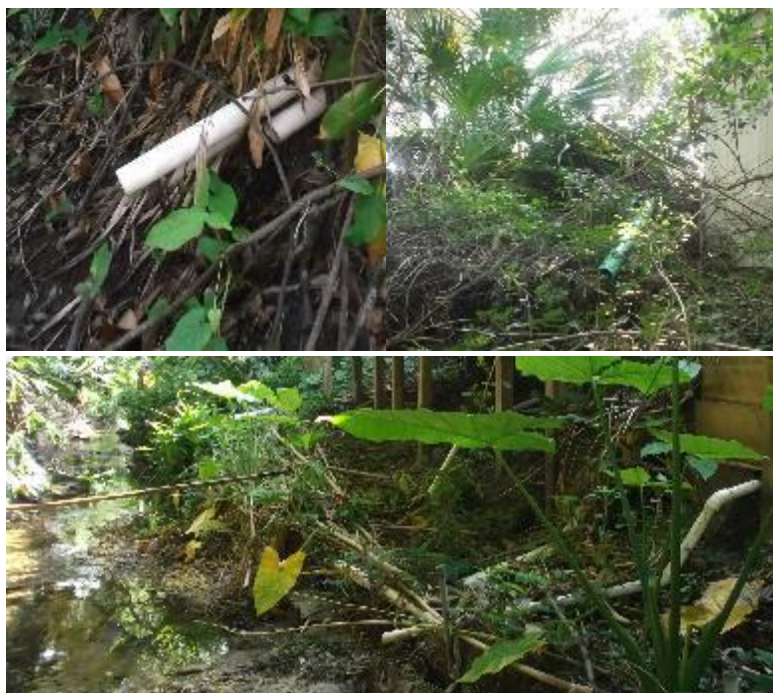
Figure 20. Illicit connections to Poinciana ditch

Several illicit connections of an unknown origin were found in Poinciana ditch. The connections were from residential backyards on either side of the ditch (Figure 20). It is suspected that they were mainly from washing machines, pools, and yard or roof drains. These were forwarded to County NPDES inspectors for enforcement (Appendix A).

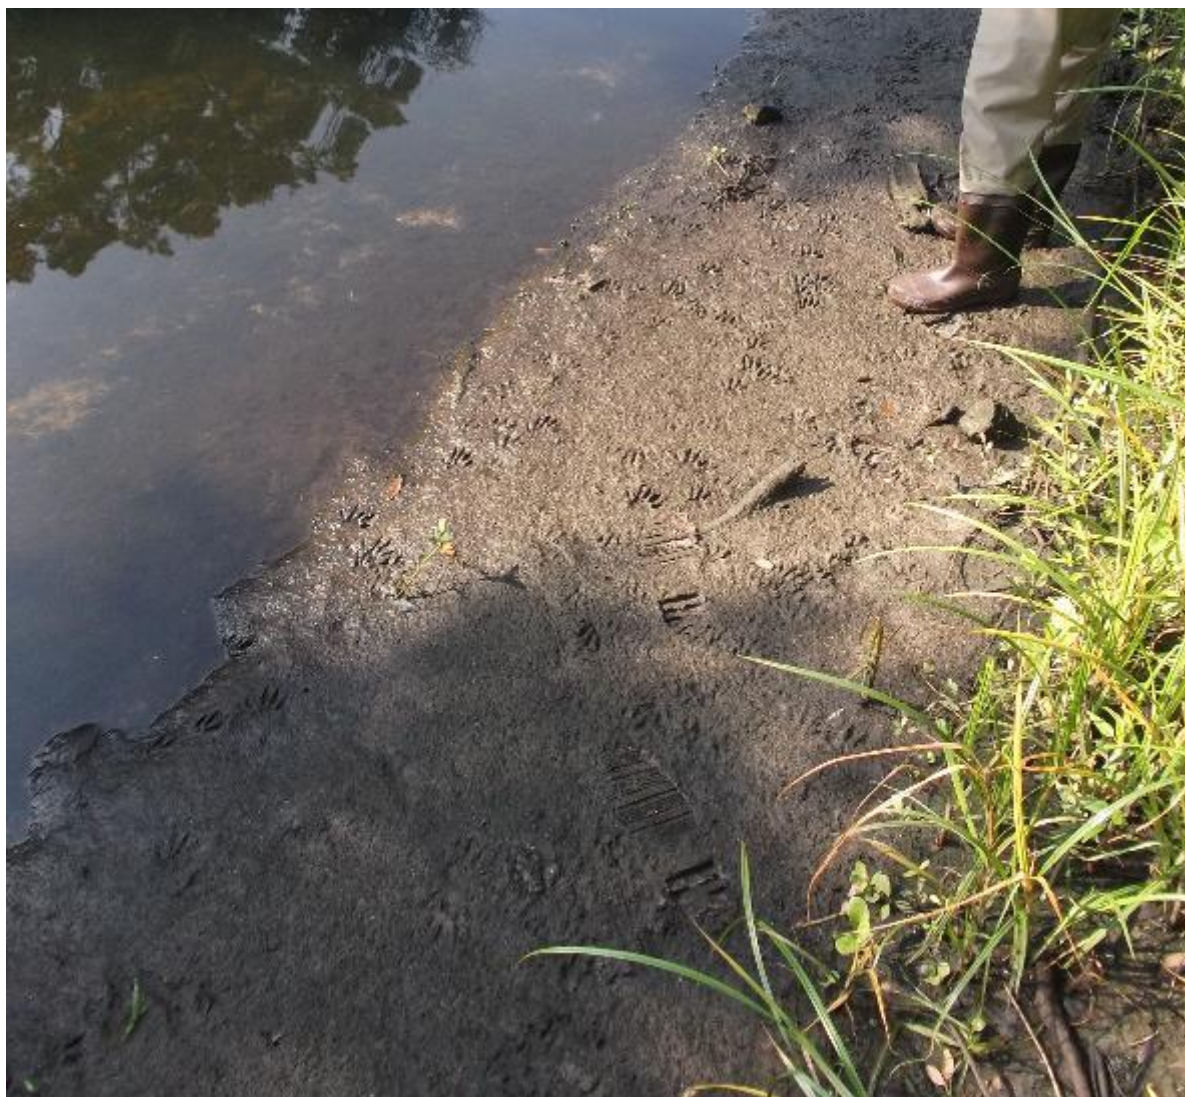
**Figure 21. Raccoon tracks near LB-1 on Long Branch Creek**

Although the MST sampling showed little to no bird sources impacting the creek, there was evidence of raccoon activity along the creek bank on several visits to the most downstream site at LB-1 and other wildlife in Poinciana ditch (Figure 21). Turtles have also been demonstrated to be a potential source of e coli in waterbodies (Bodden, Guffey, and Volk, *Turtle Populations as a Potential Source of E. Coli in Lake Elmendorf.*) 17 of 23 turtles tested produced a cloacal swab that was positive for E. coli. Coyotes have also been reported within the WBID, with 14 reported sightings since 2010. A map of sightings is presented in Figure 24. Wildlife is assumed to be a minor contributor to bacteria in the creek and is a natural source that cannot be addressed by management actions, therefore, it is not addressed in this Bacterial Pollution Control Plan.

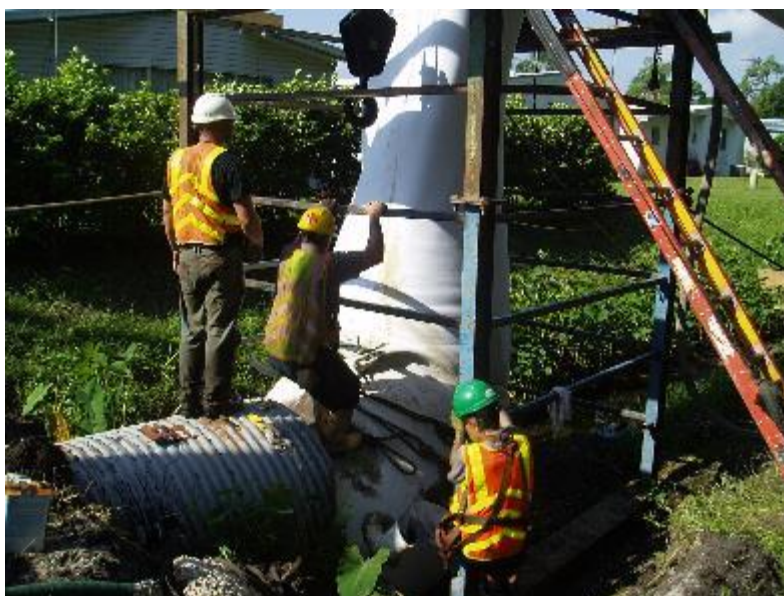
Figure 24: Long Branch Pipe Lining Project

A portion of Long Branch Creek, in the area south of East Bay Drive and west of U.S. 19, is conveyed via large diameter corrugated metal storm sewer pipes. These pipes had reached the end of their useful service life and needed to be rehabilitated. The Long Branch Storm Sewer Rehabilitation Project provided for the lining of approximately 50 linear feet of 60 inch diameter pipe running under 69th Street North, and approximately 450 linear feet of 72 inch diameter pipe running through the Blue Horizon Mobile Home Park, located at 5145 East Bay Drive.

The lining is anticipated to reduce sedimentation within the system. Research has demonstrated that bacteria can persist in sediments for weeks to months following introduction (Burton and Pitt 2002), so preventing sedimentation should be a key priority in a BPCP.

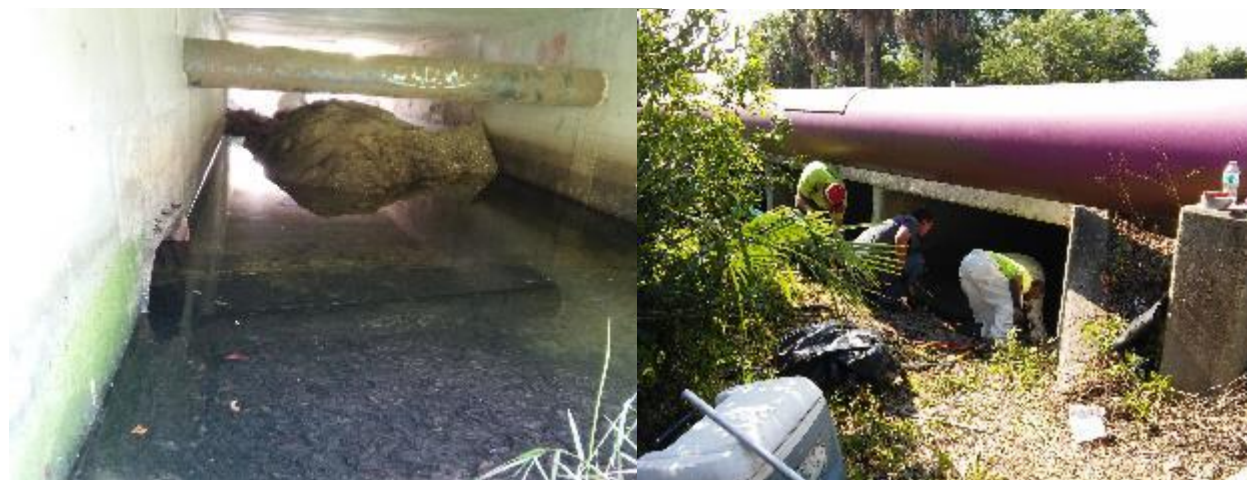
**Figure 27: Workers removing sediment from Long Branch Creek under Whitney Rd.**

In the Whitney Rd. area, sediment accrual under Whitney Rd. in the creek was observed. Approximately 200 feet of open drainage conveyance was cleared of exotic vegetation equating to 30 tons removed in March 2015. Sediment under the box culvert was excavated and disposed of in the spring 2016. A total of 300 tons of sediment was removed. See figures below.
