# **LOVERS KEY STATE PARK**

## Park Chapter

BIG CYPRESS REGION

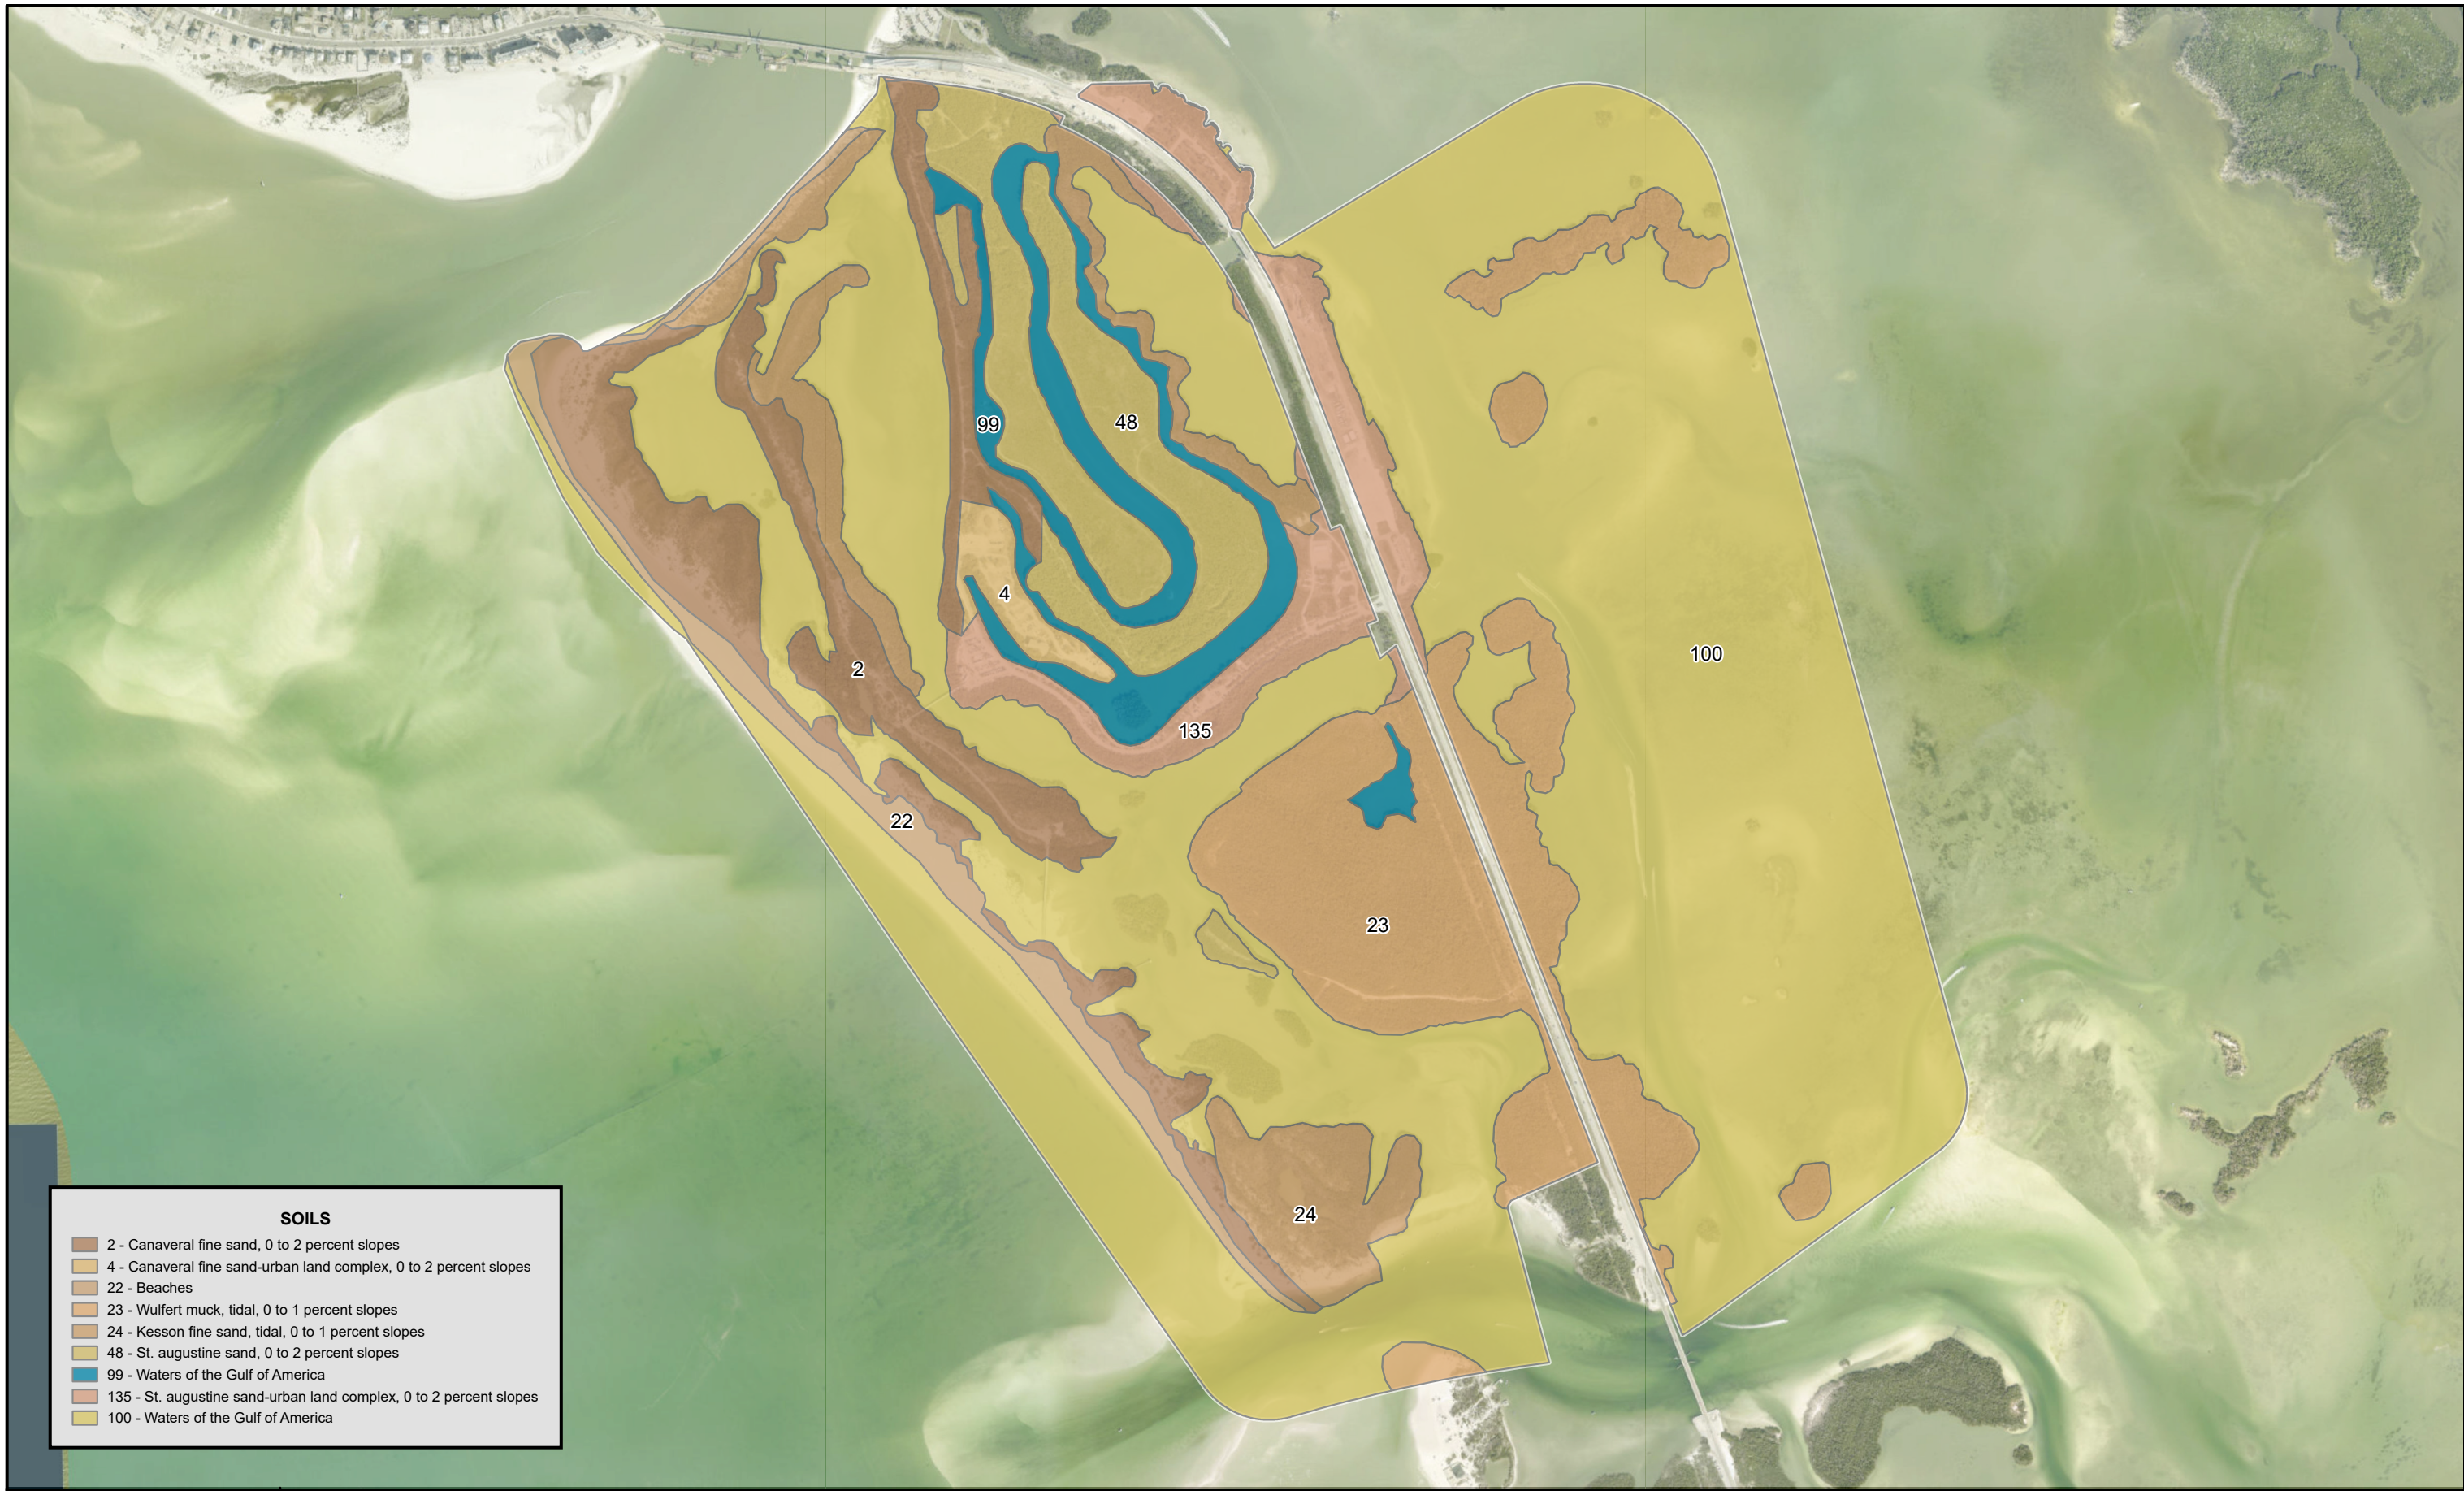
**SOILS**

- 2 - Canaveral fine sand, 0 to 2 percent slopes
- 4 - Canaveral fine sand-urban land complex, 0 to 2 percent slopes
- 22 - Beaches
- 23 - Wulfert muck, tidal, 0 to 1 percent slopes
- 24 - Kesson fine sand, tidal, 0 to 1 percent slopes
- 48 - St. augustine sand, 0 to 2 percent slopes
- 99 - Waters of the Gulf of America
- 135 - St. augustine sand-urban land complex, 0 to 2 percent slopes
- 100 - Waters of the Gulf of America

Five soil types have been identified at Lovers Key State Park from the Soil Survey of Lee County, Florida (Henderson 1984). A detailed description of these soil types is contained in the Appendix. The three main soil types found within the park include Canaveral fine sand, Wulfert muck and St. Augustine sand. Both the Canaveral fine sand and Wulfert muck are found naturally in this area. The Canaveral sand typically displays a dark grey color and contains sand and shell particles. Natural fertility of this soil is low, and the common vegetative cover includes cabbage palm (*Sabal palmetto*), wild coffee (*Psychotria nervosa*), sea grape (*Cocoloba uvifera*) and other plants found within coastal strand and maritime hammock natural communities. Wulfert muck typically is a dark reddish-brown muck that is flat and very poorly drained. This soil is most commonly associated with mangrove swamps and tidal marshes. All of the mangrove islands associated with the park have Wulfert muck as their soil type. The last main soil type, St. Augustine sand, only exists at this site due to earthmoving operations. With large scale dredge and fill taking place previously to prepare this island for waterfront lots and a beach resort, the winding canals within Black Island all display St. Augustine sand. This soil is variable in color and appearance but is mostly sandy in nature. It is described that St. Augustine soil has severe limitations for most urban recreational uses due to its high water table, and rapid permeability which can cause pollution of groundwater in areas with septic tanks.

The two other soils found within the park boundary, Beaches and Kesson fine sand, occur less commonly throughout Lovers Key State Park. As the name implies, Beaches is found on the beach facing the Gulf. This sediment is sandy white with mixed in shell fragments. Common vegetation is associated with beach dune and coastal grassland natural communities. The last soil type known as Kesson fine sand is found scattered around the park. These areas are tidally influenced and are similar to areas with Wulfert muck in that they support mangrove swamp and salt marsh natural communities. Kesson fine sand has a sandy surface displaying a pale brown color with rapid water permeability.
