Osborne Tire Reef Restoration Plan, Phases 1 and 2 Report

09 May 2024

DOCUMENT NO. CSA-Olsen-FL-24-82353-4007-103-REP-01-005

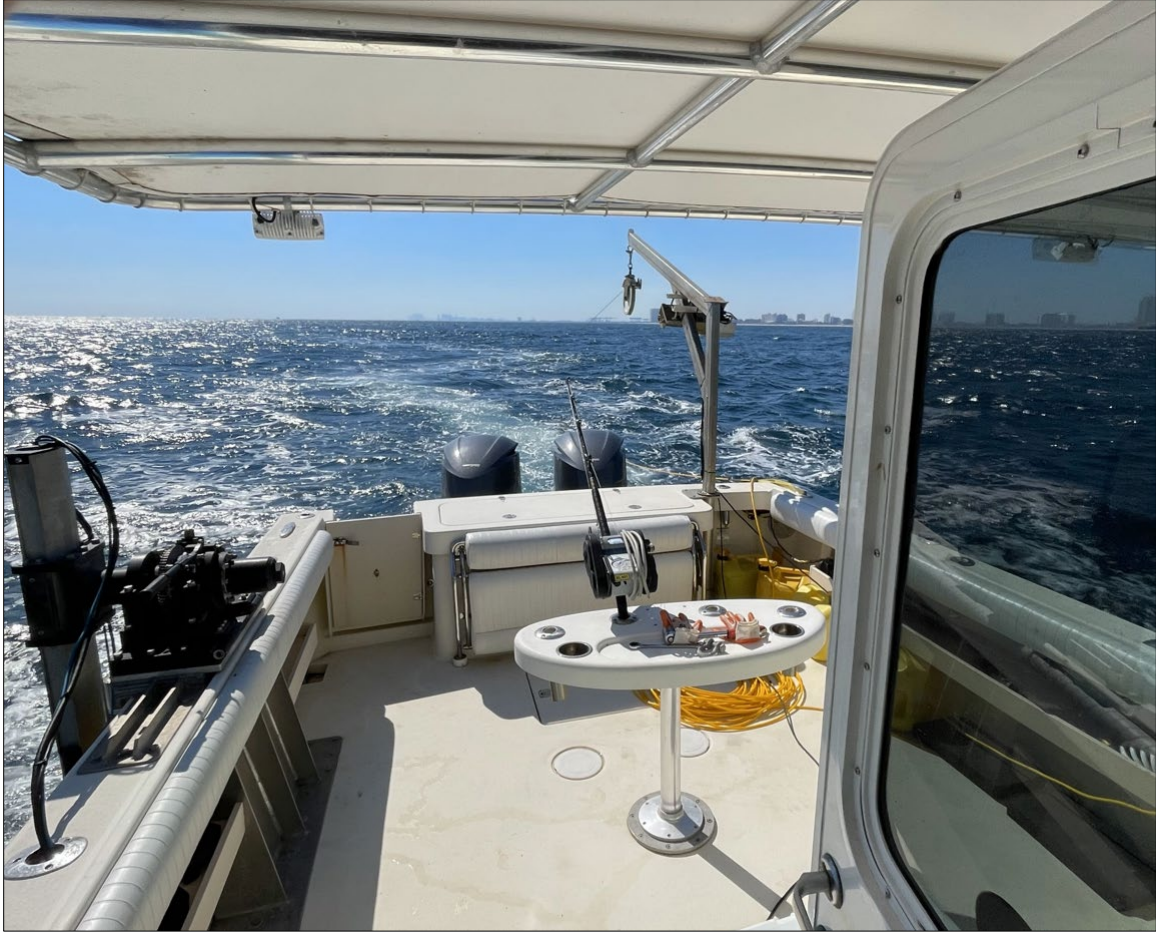
Image 1. Side-scan sonar deployed over the stern of the survey vessel with a davit and sheave block. Multibeam echosounder system on the side pole mounted on the starboard rail in the deployed position.

The SSS towfish was deployed on a winch-deployed line via a sheave block mounted on the vessel's stern davit. The MBES sonar head was mounted to the starboard rail using an OTS Mini Mount, a Marine Survey Fabrication product (**Image 1**).

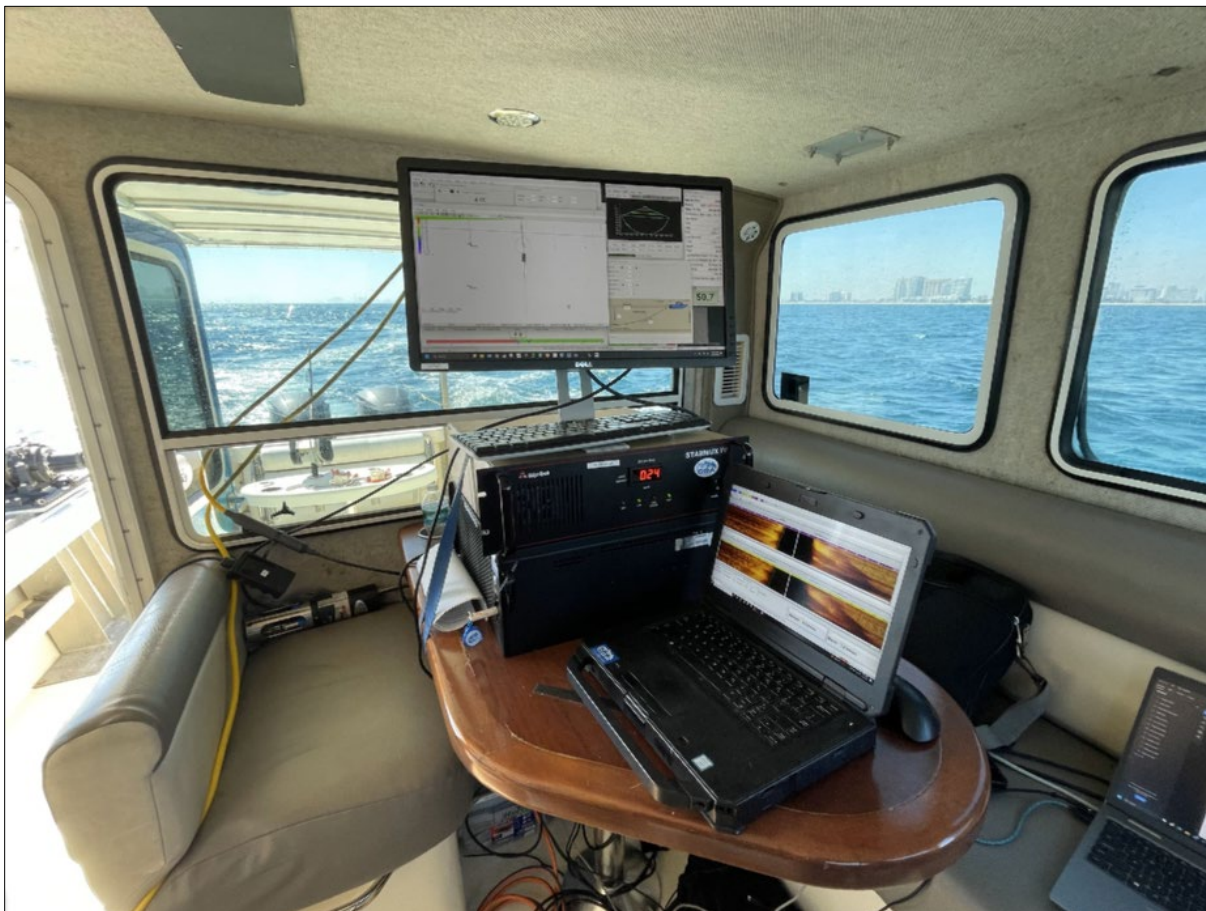
Image 2. Geophysical equipment set up in the cabin of the survey vessel offshore of Fort Lauderdale, Florida.

Permanent Reference Network (FPRN). The geophysical equipment was set up in an enclosed climate-controlled cabin on the survey vessel (**Image 2**). The SBG Apogee Marine inertial navigation system was set to log data for calculating improved horizontal and vertical positioning using SBG Qinertia software during post processing to produce smoothed best estimate of trajectory solutions. The project virtual reference station and Hypack geodesy were both referenced to the Florida State Plane Coordinate System, East Zone, North American Datum of 1983, 2011 adjustment and to the North American Vertical Datum of 1988 (feet). The Surveyors Control Report is provided in **Appendix C**.

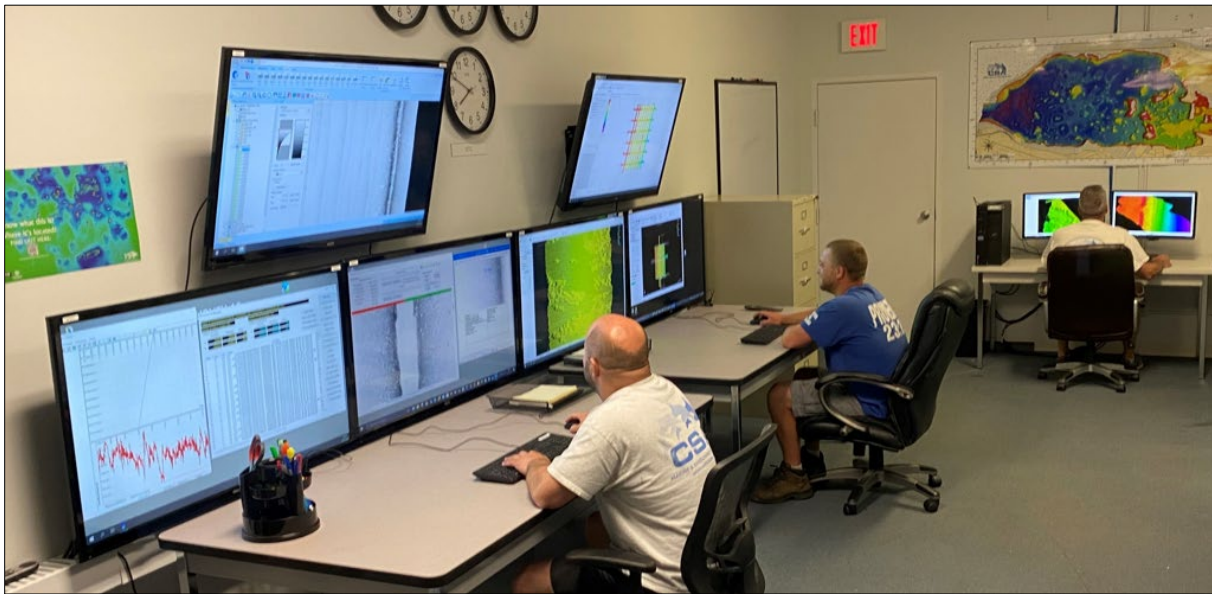
Image 3. Processing of the multibeam echosounder and side-scan sonar raw data for final deliverable.

SonarWiz 7 was used for post processing of the raw .JSF files. Processed and mosaicked SSS data were combined with bathymetry derived from the MBES to visualize depth changes, seafloor features, bottom types, and occurrence and spatial surface distribution of tires. Quality Assurance/Quality Control (QA/QC) of the SSS and MBES data was performed along the overlapping edges of the 2019 Survey footprint and the new limit of the 2024 Survey area. In these overlapping extents, both horizontal and vertical alignments were verified, as well as the presence of previously located features such as shipwrecks, individual tires and other natural hardbottom features during the post processing task (Image 3).

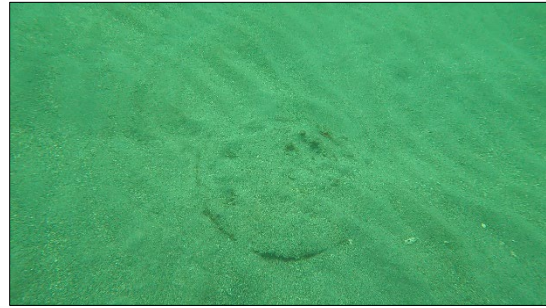
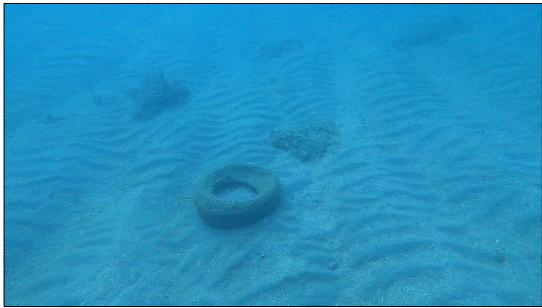
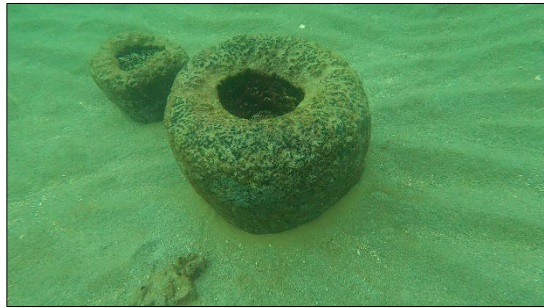
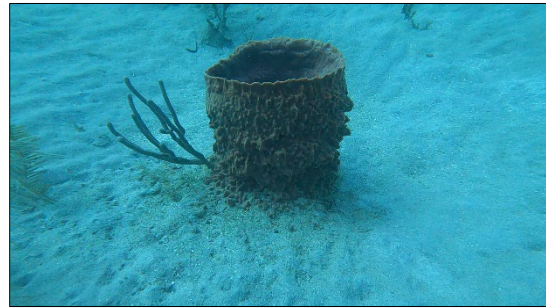
Multiple tires in shallow water

Single tire with heavy hydroid growth

Single tire barely exposed

Single tire amongst exposed hardbottom outcrops.

A pair of loggerhead sponges

Barrel sponge on low-relief hardbottom

Image 4. Identified features of tires in various states along with sponges that resembled tires.

Additionally, two species of large sponges (*Sphaciospongia vesparium* [loggerhead sponge] and *Xestospongia muta* [barrel sponge]) were identified as the potential selected targets at several sites which are identified in **Appendix D** and shown in **Image 4**. These large sponges, which ranged in size from approximately 30 to 60 cm in diameter and from 20 to >60 cm in height, have shapes approaching that of a tire and, in many cases, provide a SSS reflection like that of tires.

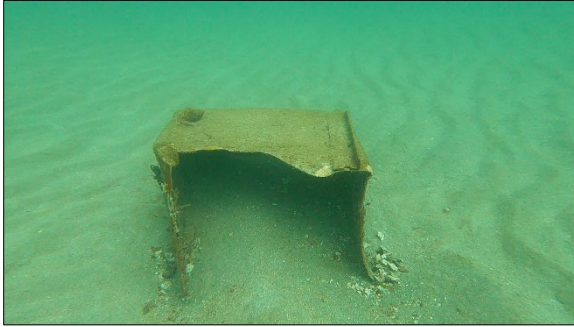
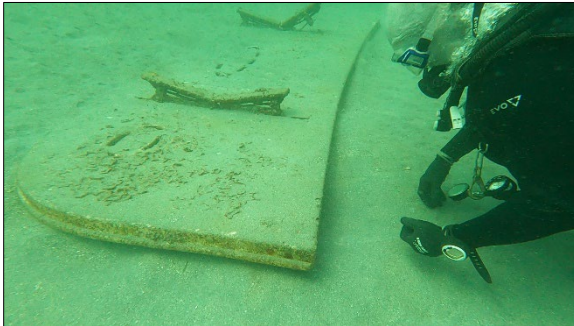
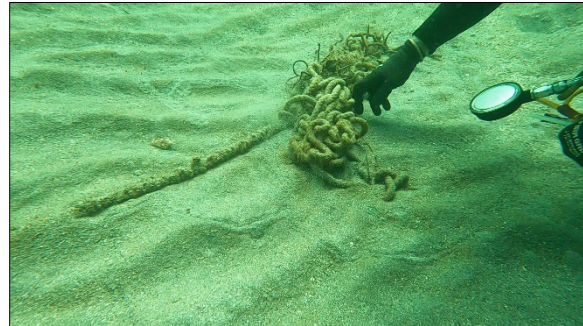
Large (3 ft) metal box

Lobster trap

Large dive platform

Clump of tangled line

Image 5. Objects that appeared in the geophysical data which warranted further investigation.

At the completion of each field day, all video and still photo data were downloaded and reviewed and then copied onto multiple storage devices for security and redundancy. Data files that accompany this report include an interactive georeferenced photo data file depicting what the divers discovered at each of the 61 ground truth sites. Notable features identified for further investigation during the diver ground truthing are found in **Image 5**.

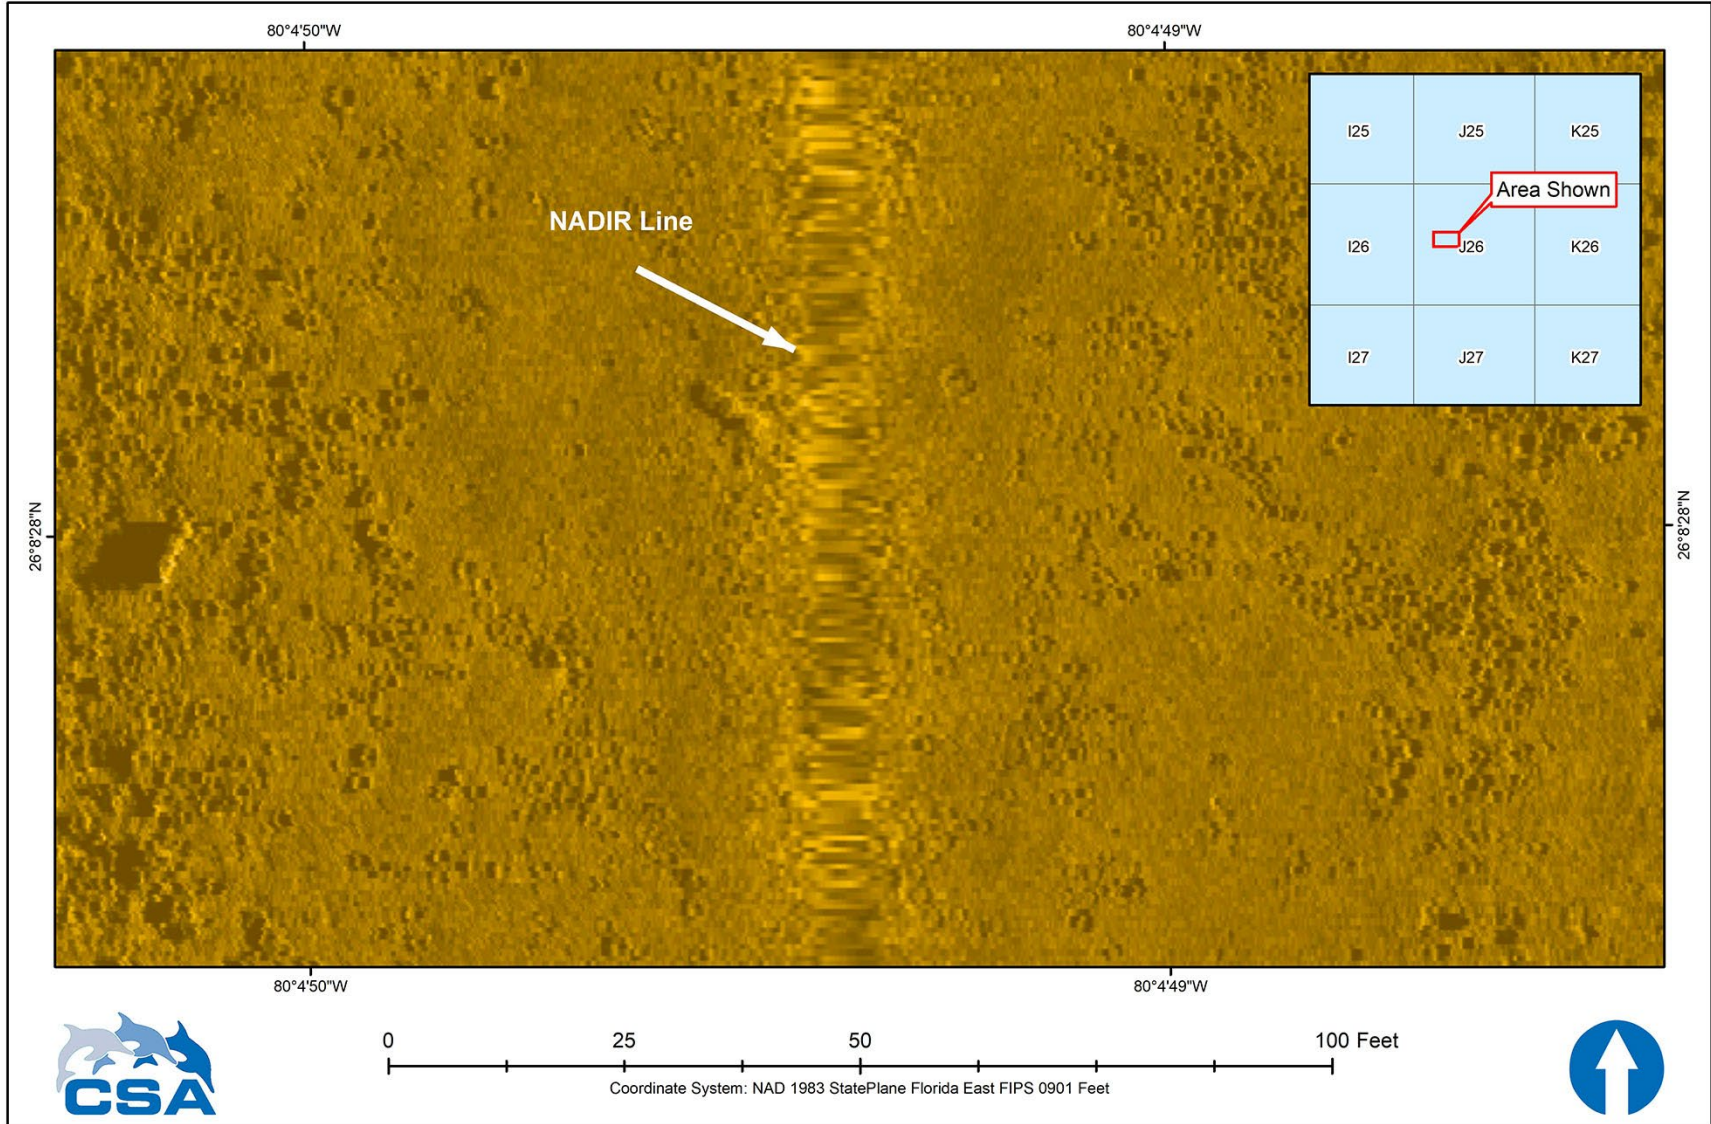
Figure 5. Example of image quality impacted by the presence of the nadir line.

Due to many of the factors mentioned, the model encountered challenges, specifically in the 2019 survey area. Impacted by sensor characteristics and the “Nadir” line (the line directly beneath the sonar sensor's path), the model struggled to capture potential tires in regions of poor image quality. **Figure 5** presents an example of complications experienced while analyzing the 2019 survey data. In the image (2019 Survey), we can see the SSS imagery with detected tires, and the Nadir line. Due to the low resolution or blurry imagery, the model detected tires of adequate clarity.

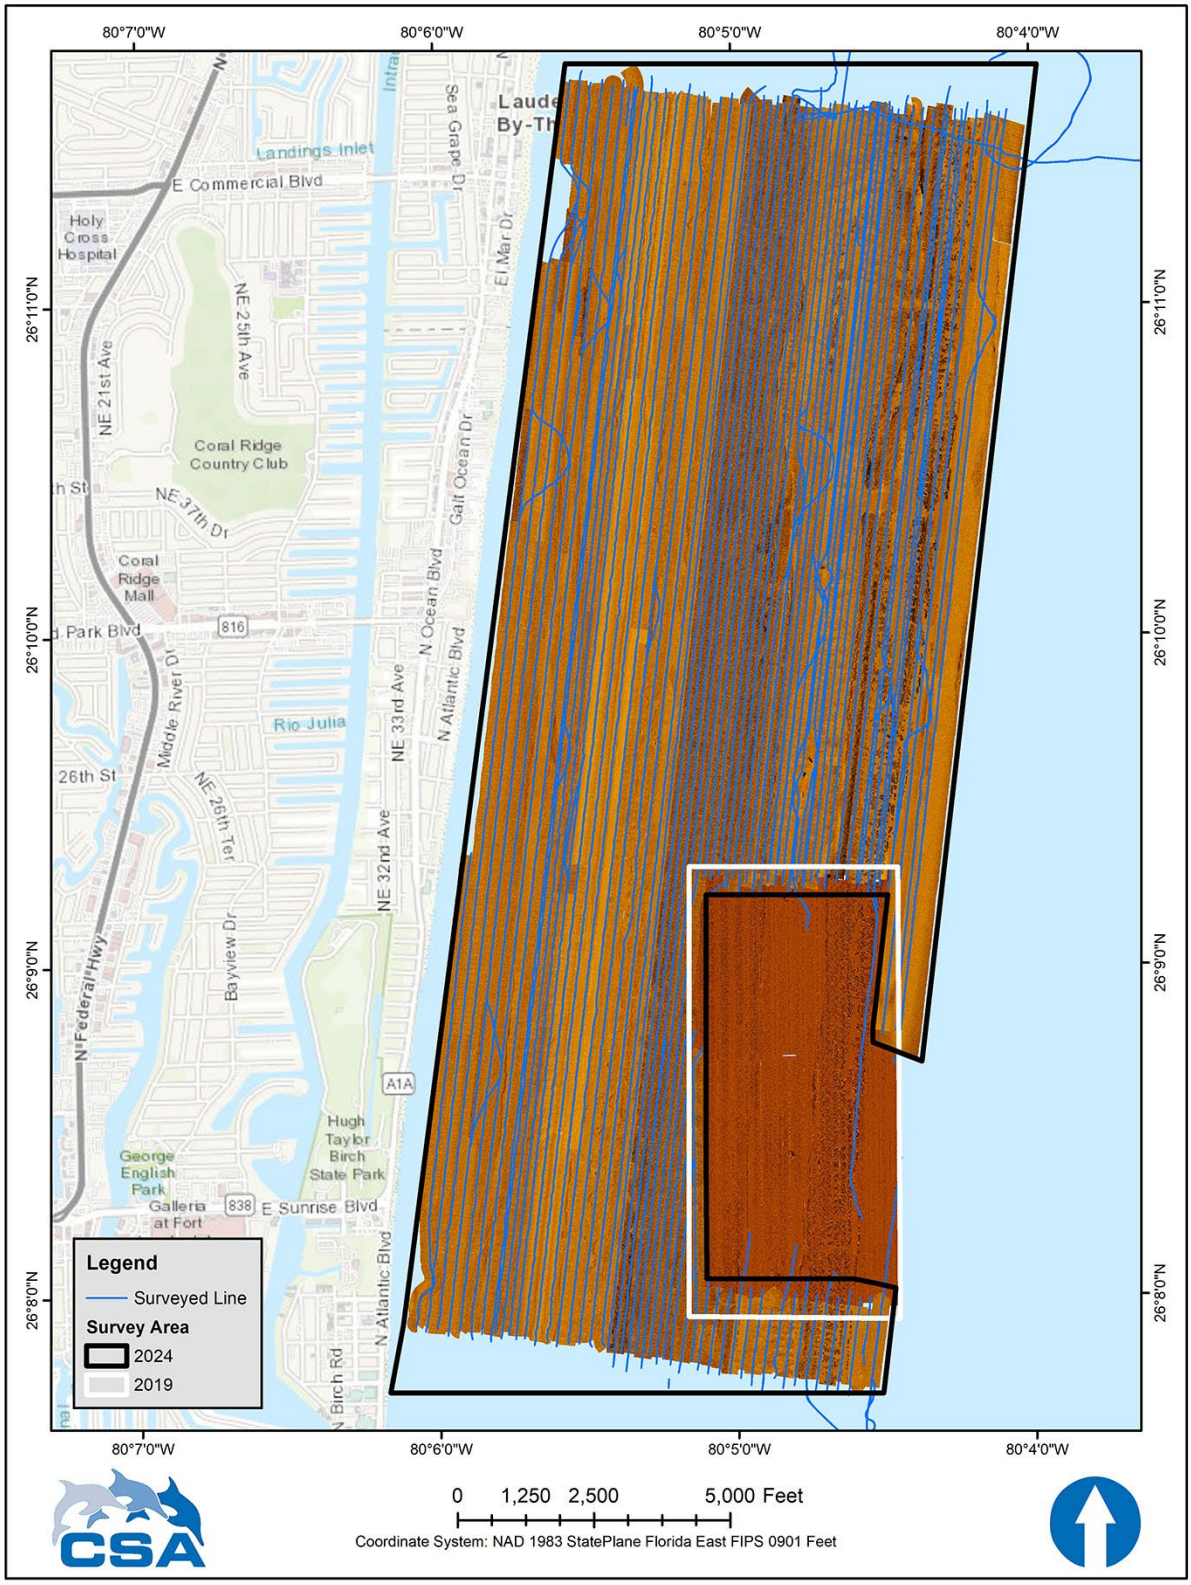
Figure 10. The Osborne Tire Reef 2024 Survey lines overlaid onto the side-scan sonar mosaic data.

Figure 10 presents survey lines acquired during the 2024 survey overlaid onto the SSS mosaic data. Survey lines were run on a north–south parallel transect. The darker shaded area immediately north of the 2019 Survey area resulted from the tighter line spacing of 700-kHz MBES. In the PDF version of this report, the reader may zoom into the image and observe some of the larger, more obvious seafloor features and anthropogenic materials.

Overall, tire distribution occurs throughout the entire OTR area. **Figure 10** shows the combined data sets for both the 2019 and 2024 Surveys and where the RCNN Model identified tires from the post-processed data. The Artificial Intelligence-based algorithm identified a combined total of nearly 80,000 tires using geophysical survey methods. As previously discussed, tires that were buried (i.e., not observed), largely submerged in sand or piled atop one another were not visibly discernible and could not be counted.
