Hurricane Ian & Hurricane Nicole
Preliminary Post-Storm Beach Conditions
and Coastal Impact Report

Office of Resilience and Coastal Protection
Florida Department of Environmental Protection
December 2022

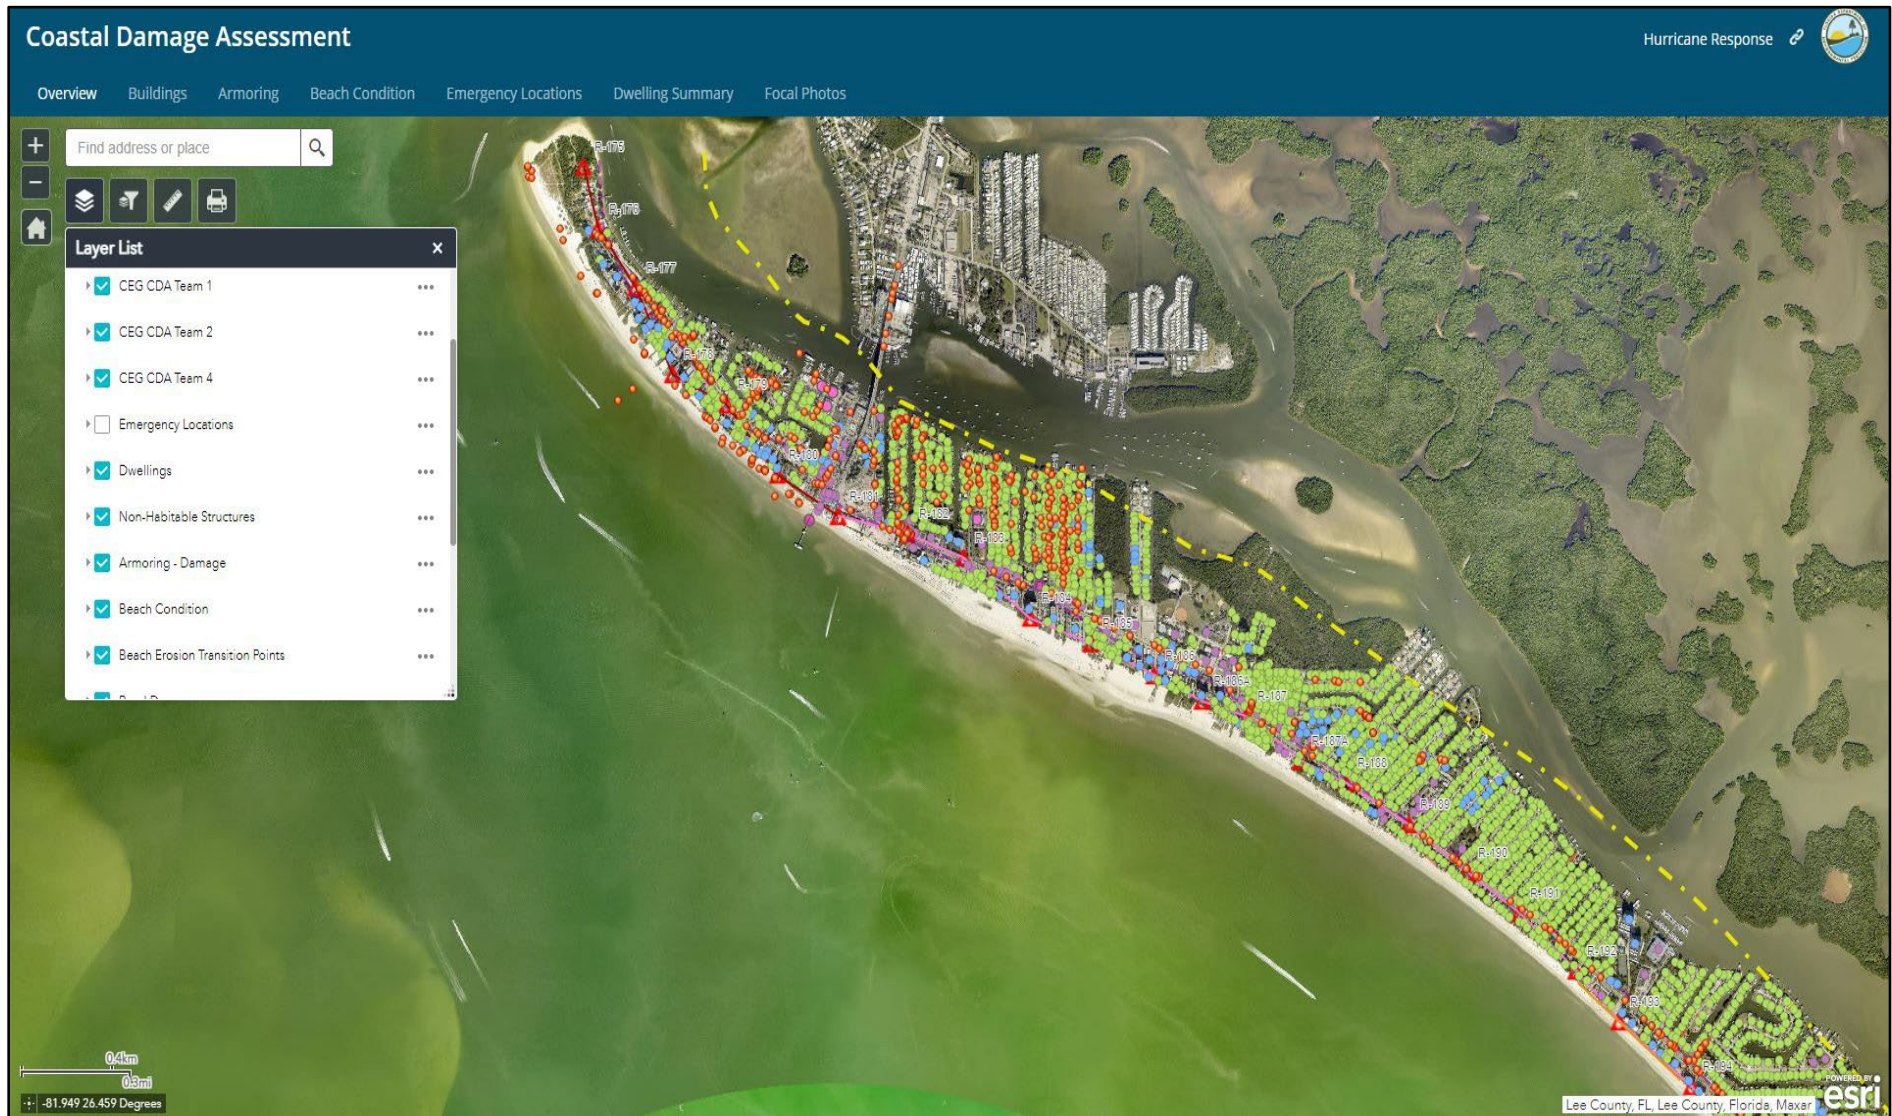
Figure 1. A snapshot of DEP data points collected within the coastal building zone that goes landward to the yellow dashed line.

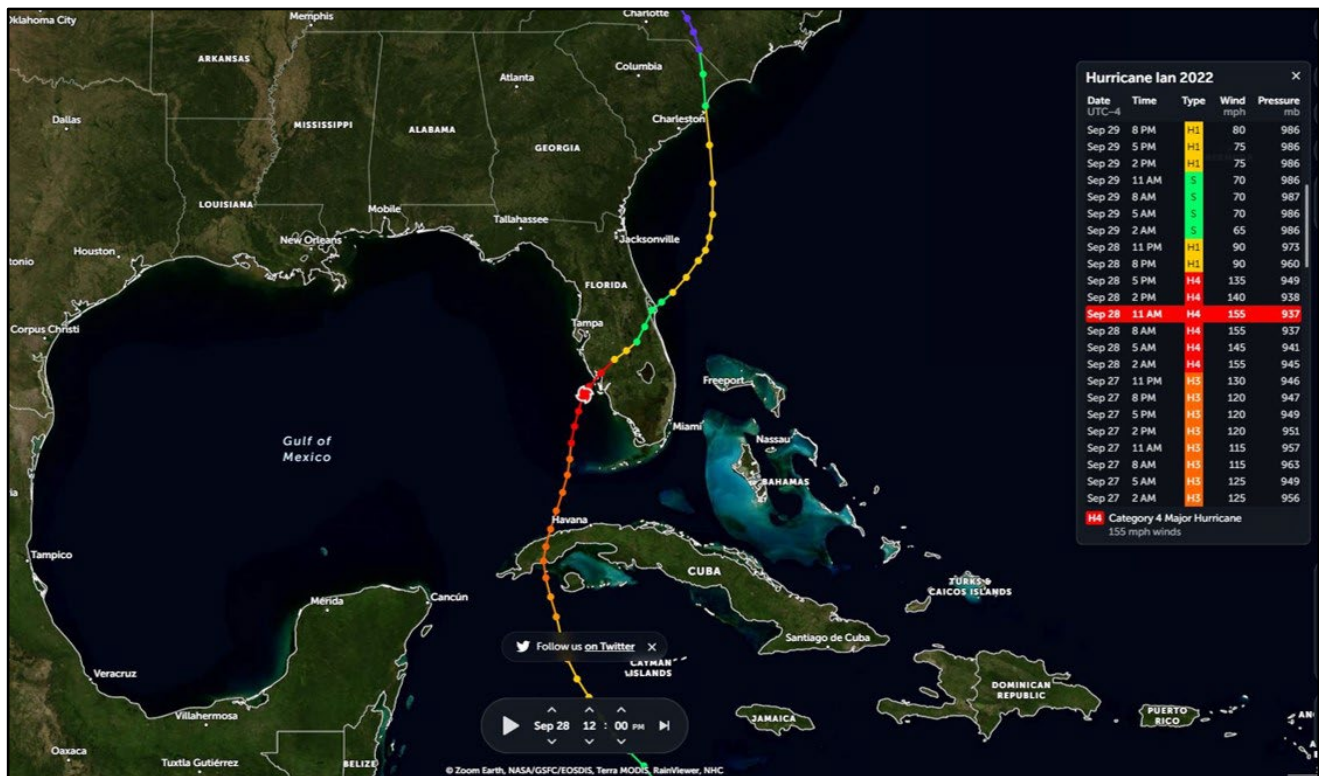
Figure 2. Hurricane Ian track (Source: Zoom Earth).

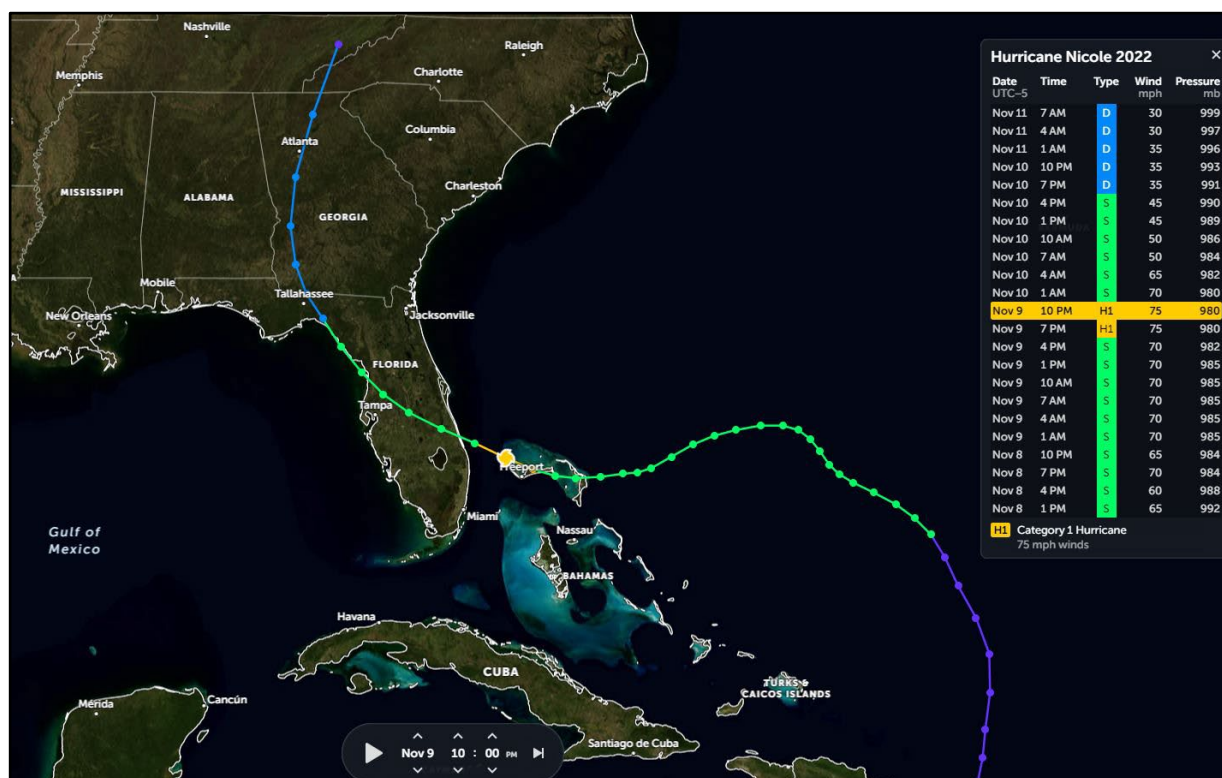
Figure 7. Hurricane Nicole track (Source: Zoom Earth).

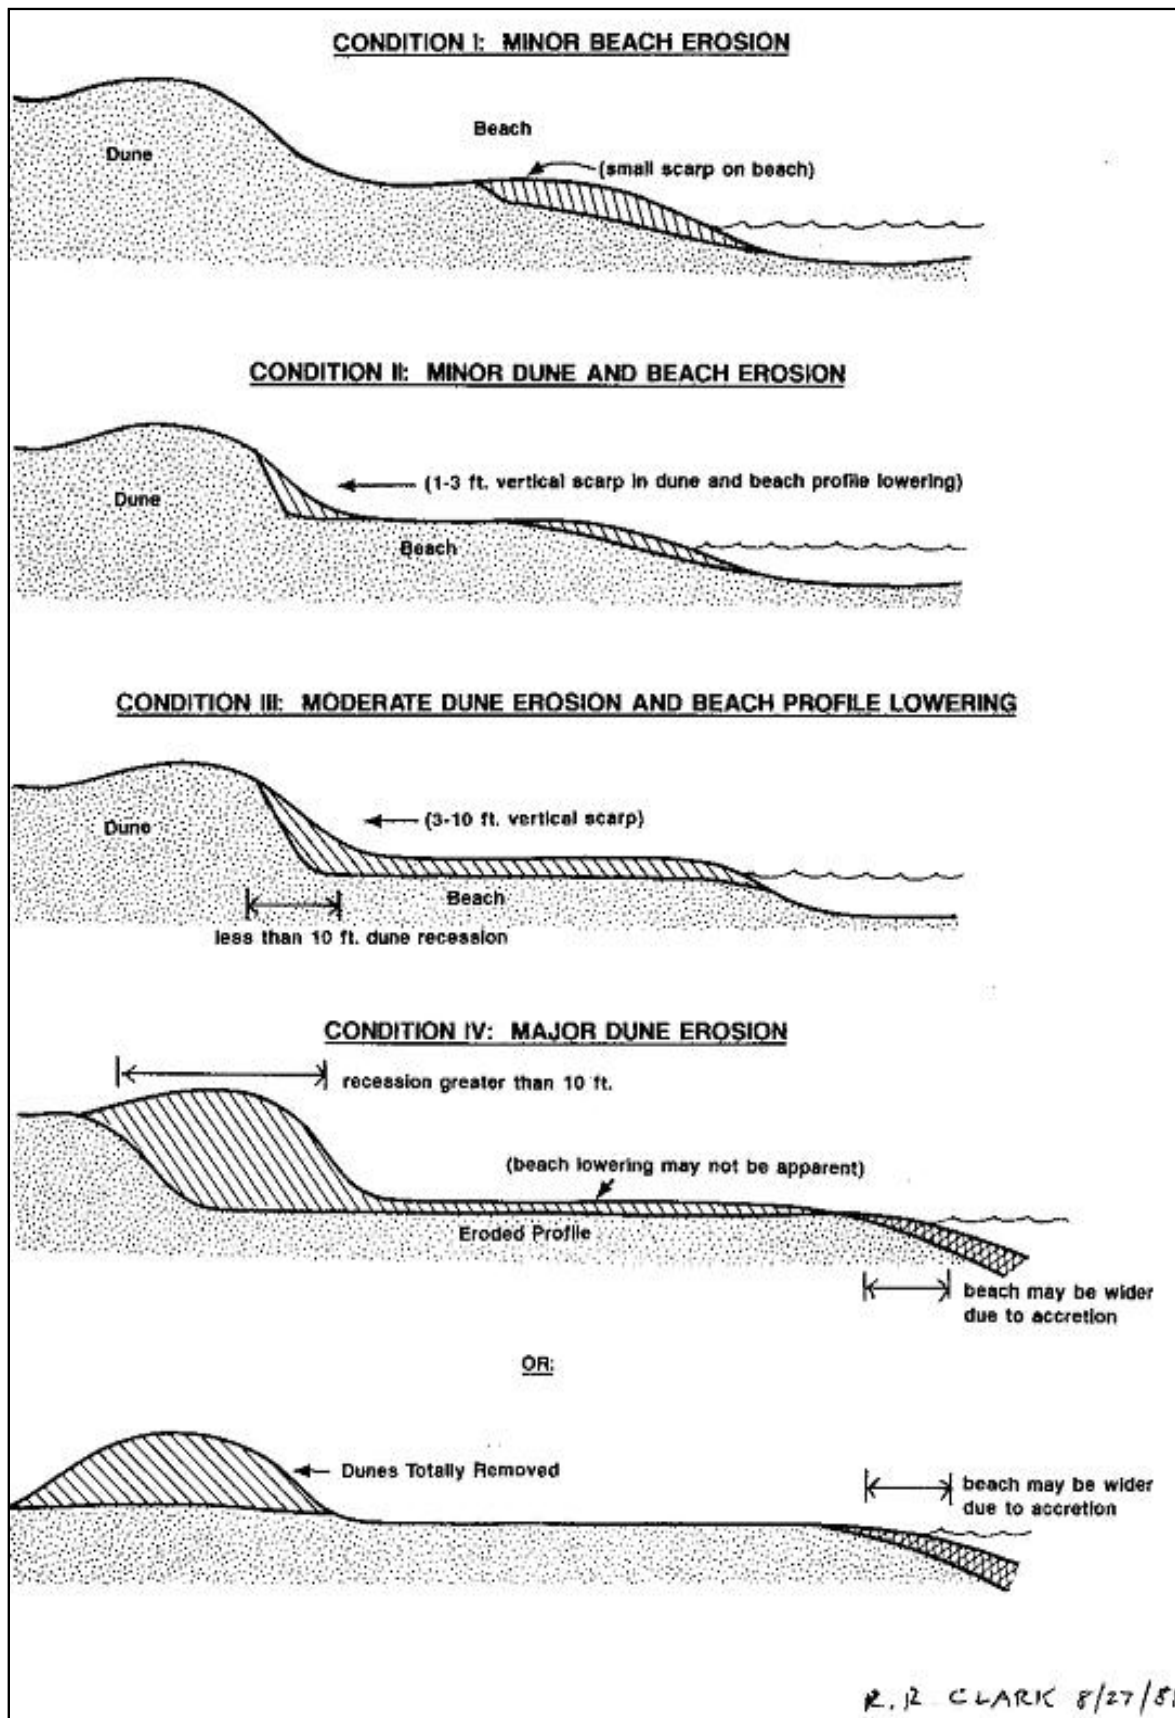
Figure 11. Beach Erosion Conditions I to IV.

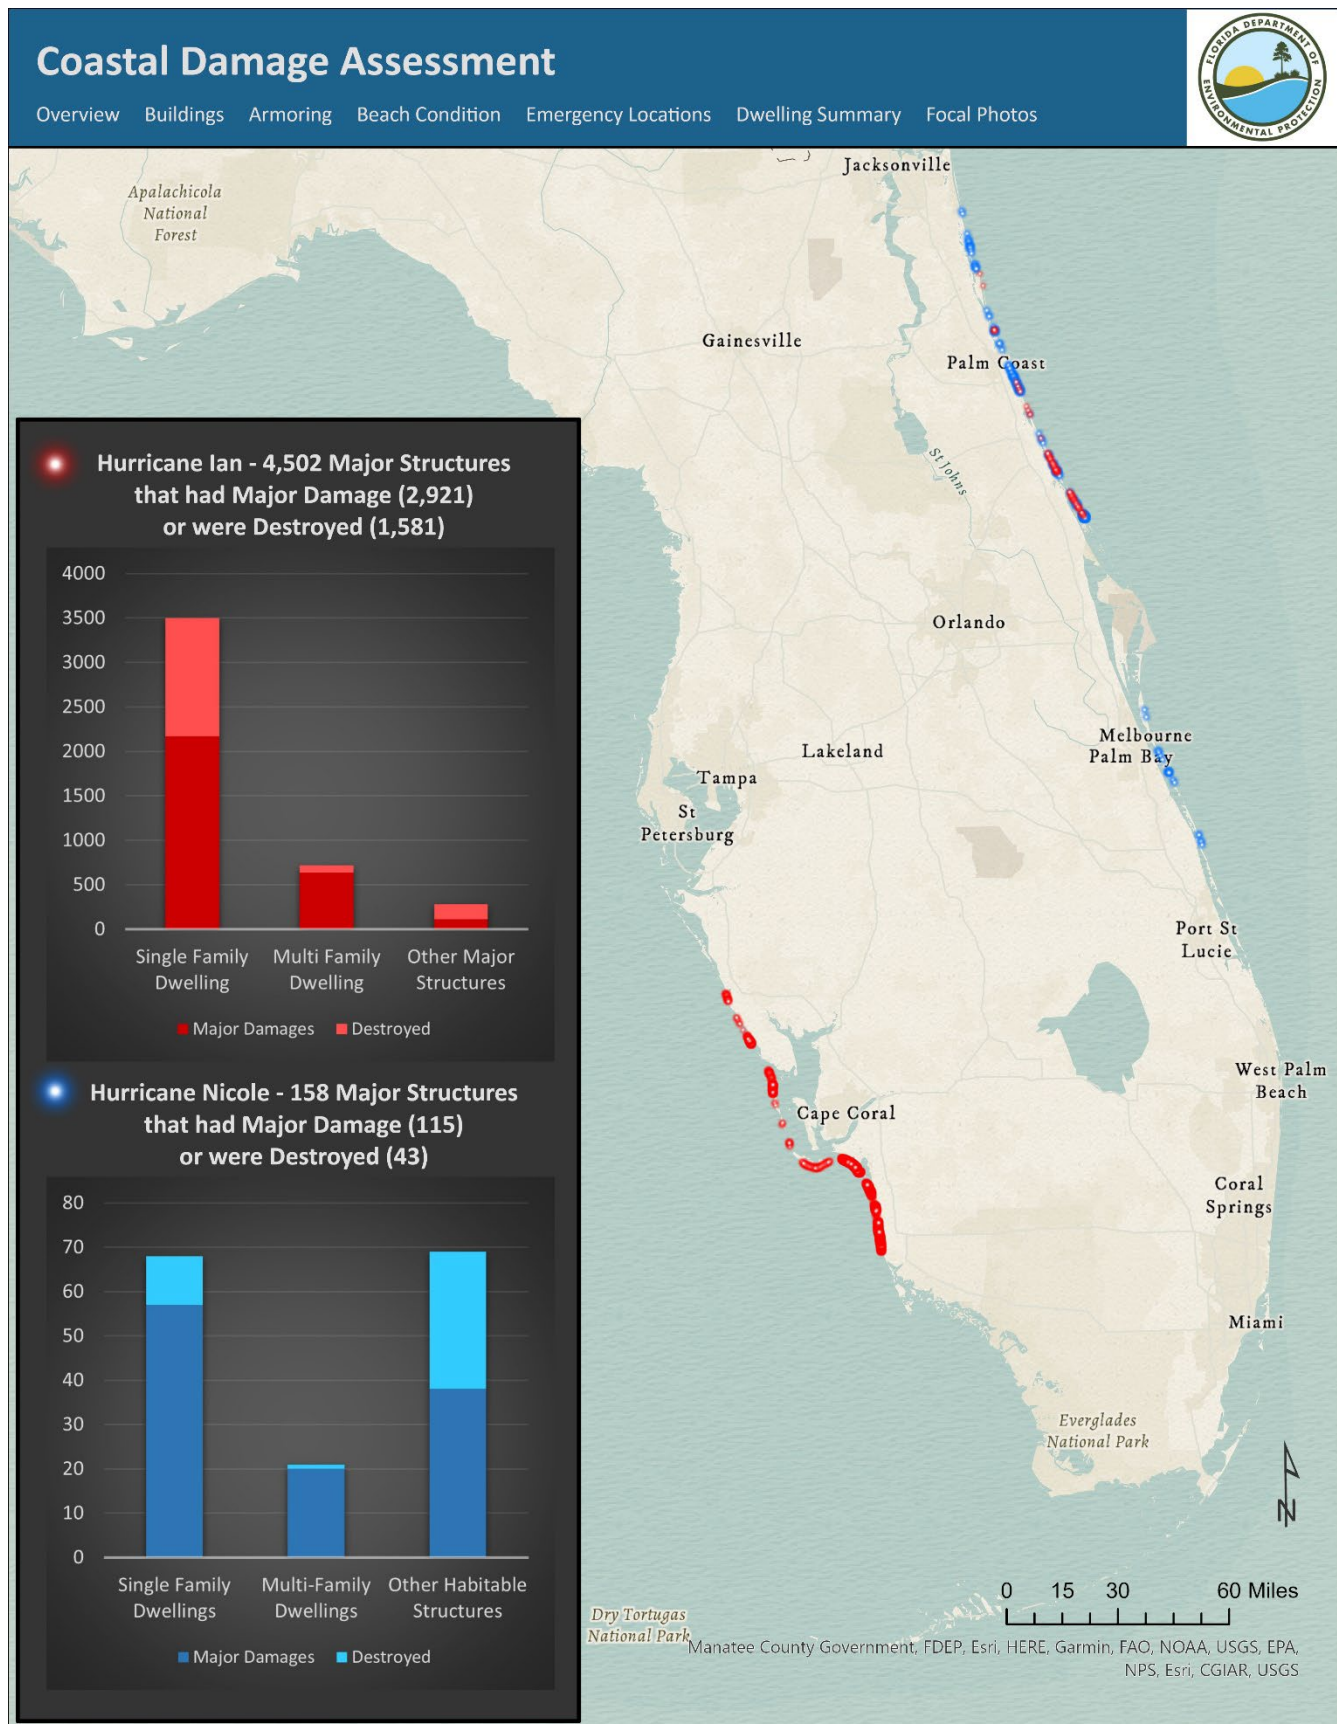
Figure 12. Summary of major damages to major structures from Hurricanes Ian and Nicole.

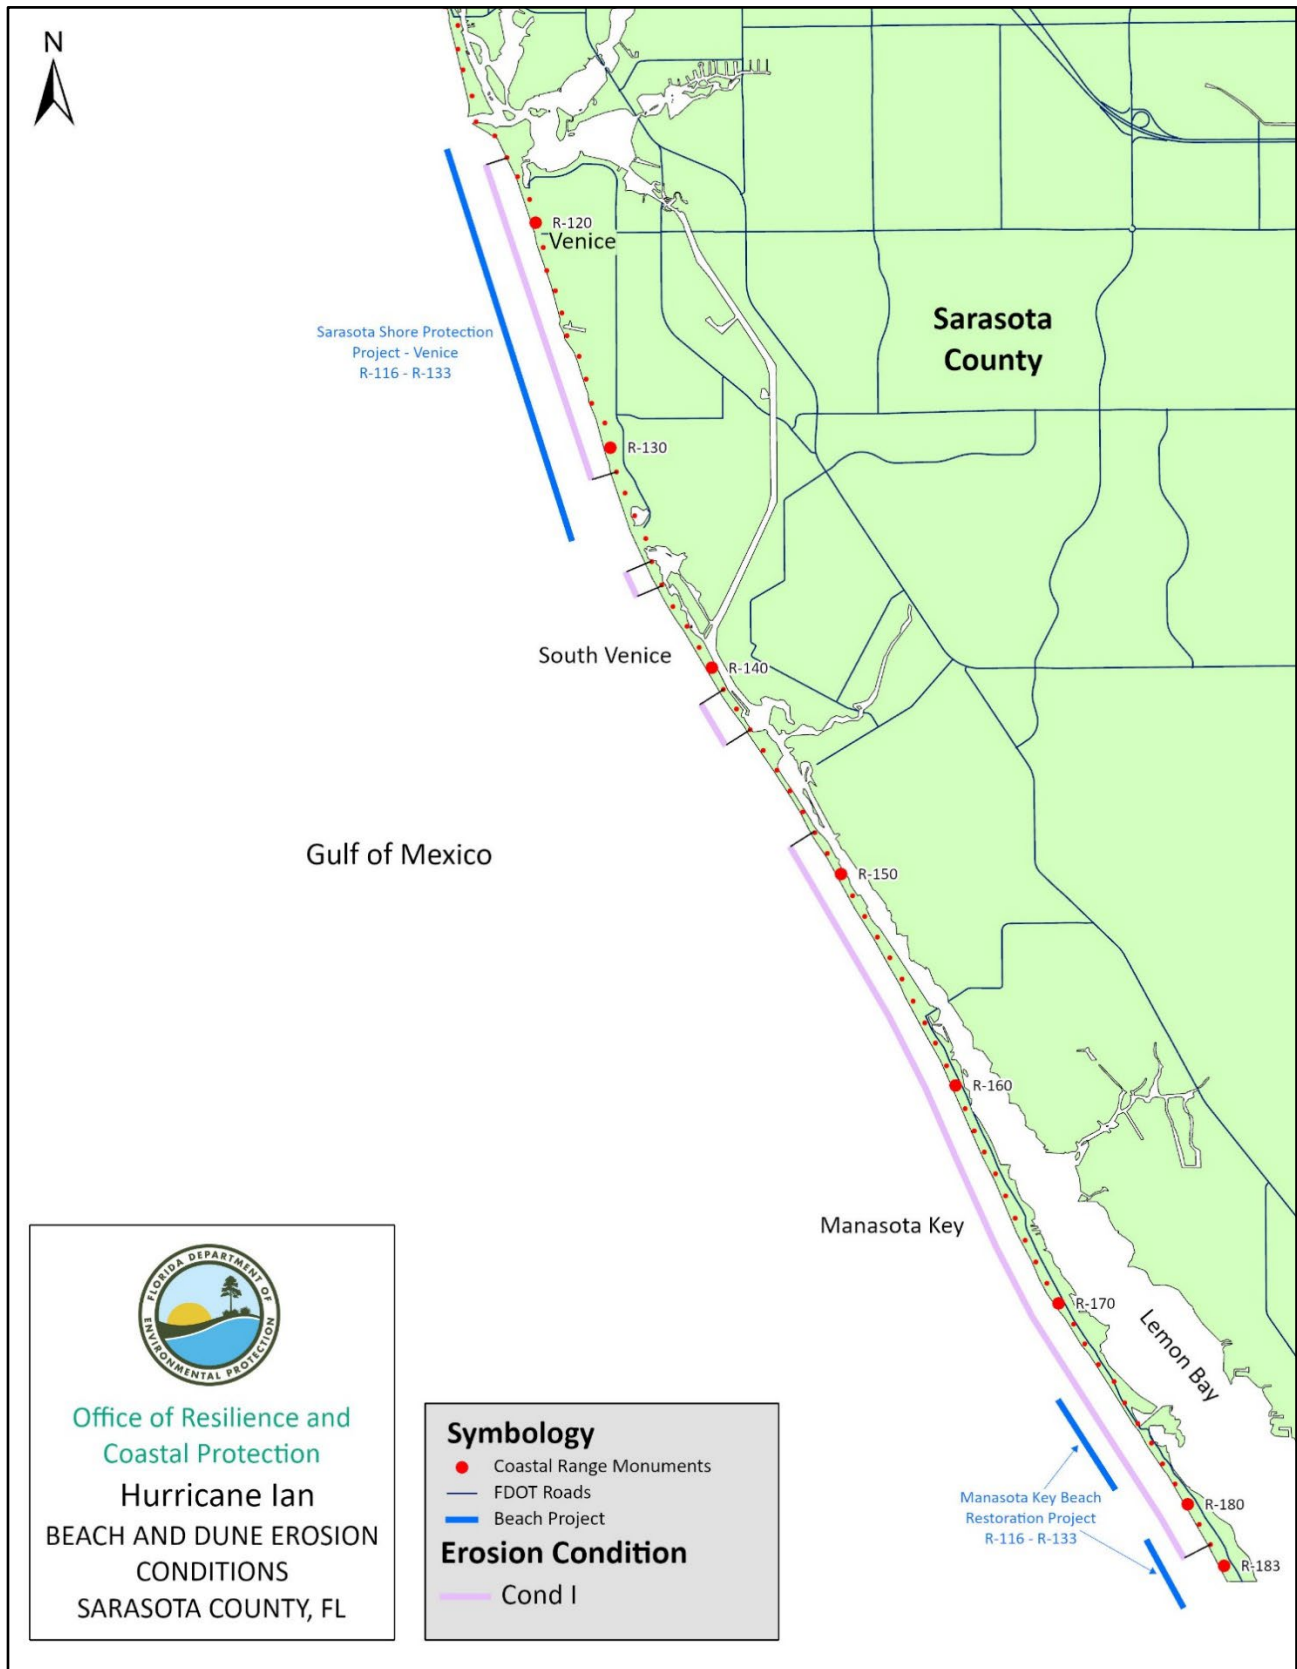
Figure 13. Sarasota County (Southern Section) Beach and Dune Erosion Conditions from Hurricane Ian.

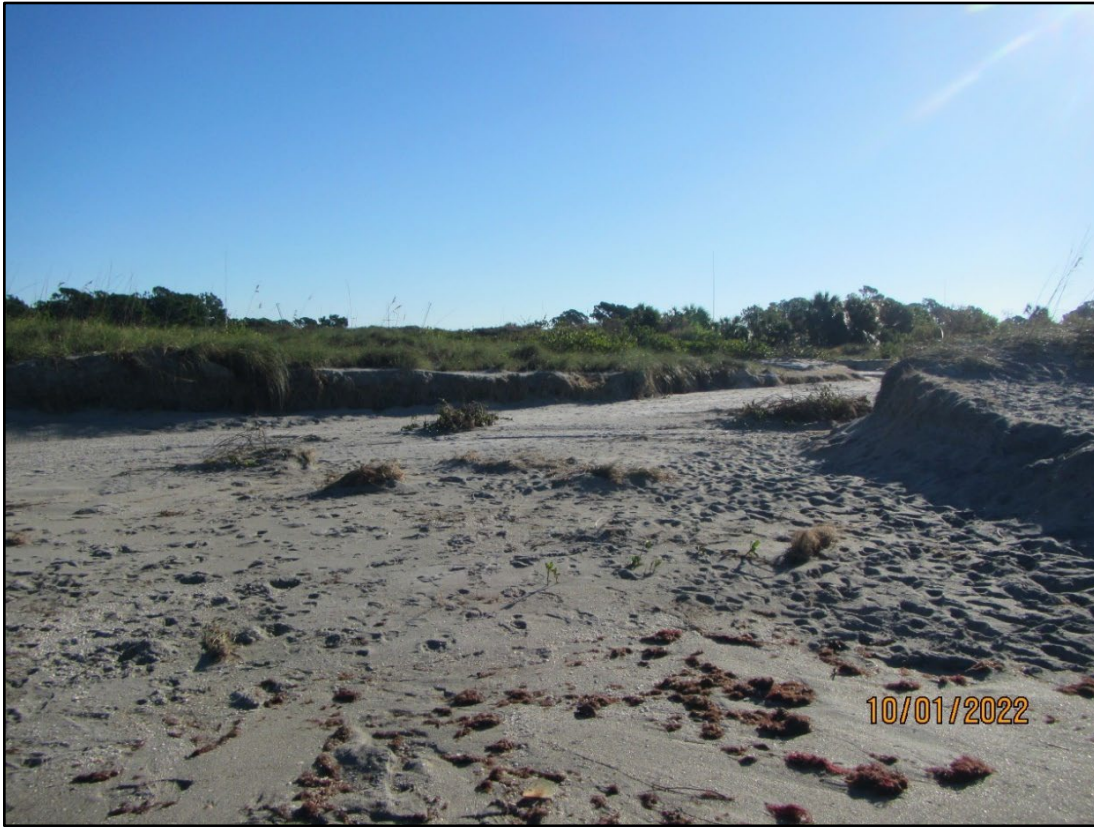
Figure 14. Storm water runoff gullies, Venice Beach (R-130).

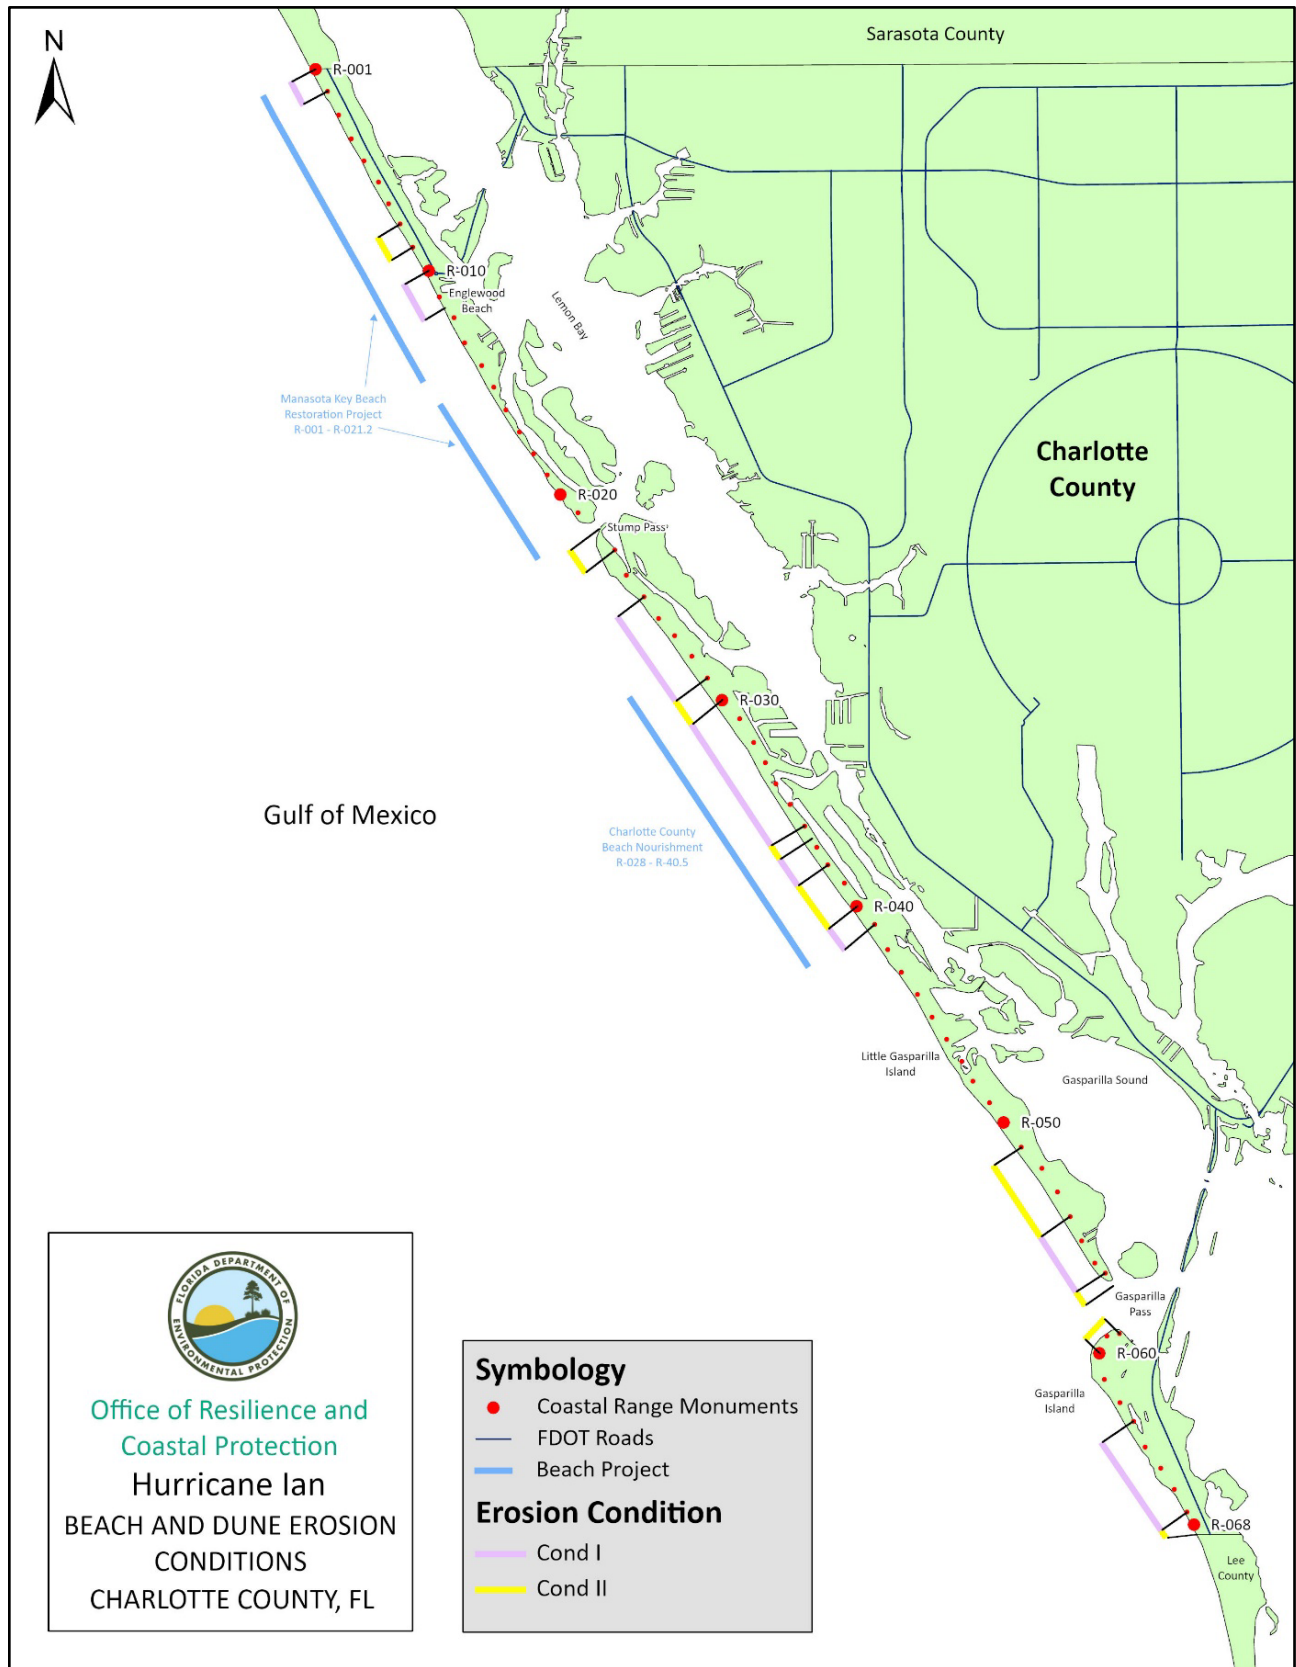
Figure 19. Charlotte County Beach and Dune Erosion Conditions from Hurricane Ian.

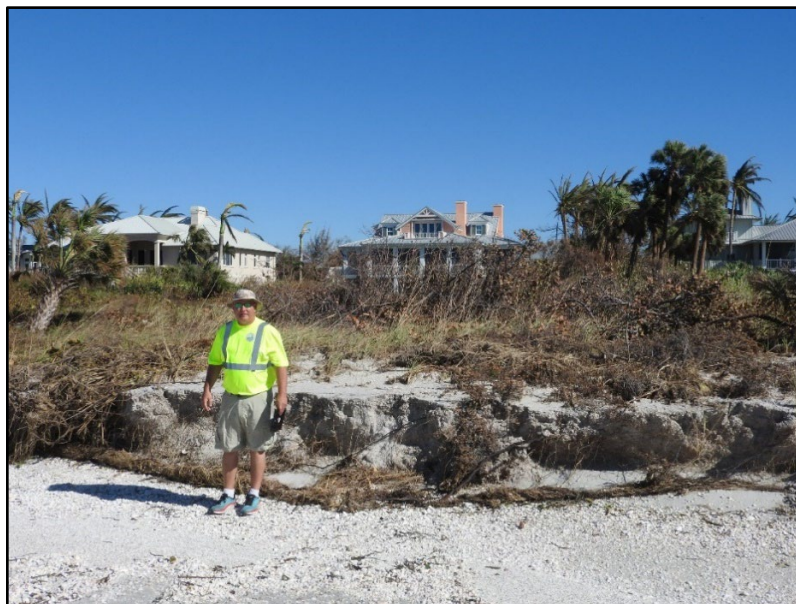
Figure 20. Minor beach and dune erosion, northern Gasparilla Island (R-59 CH).

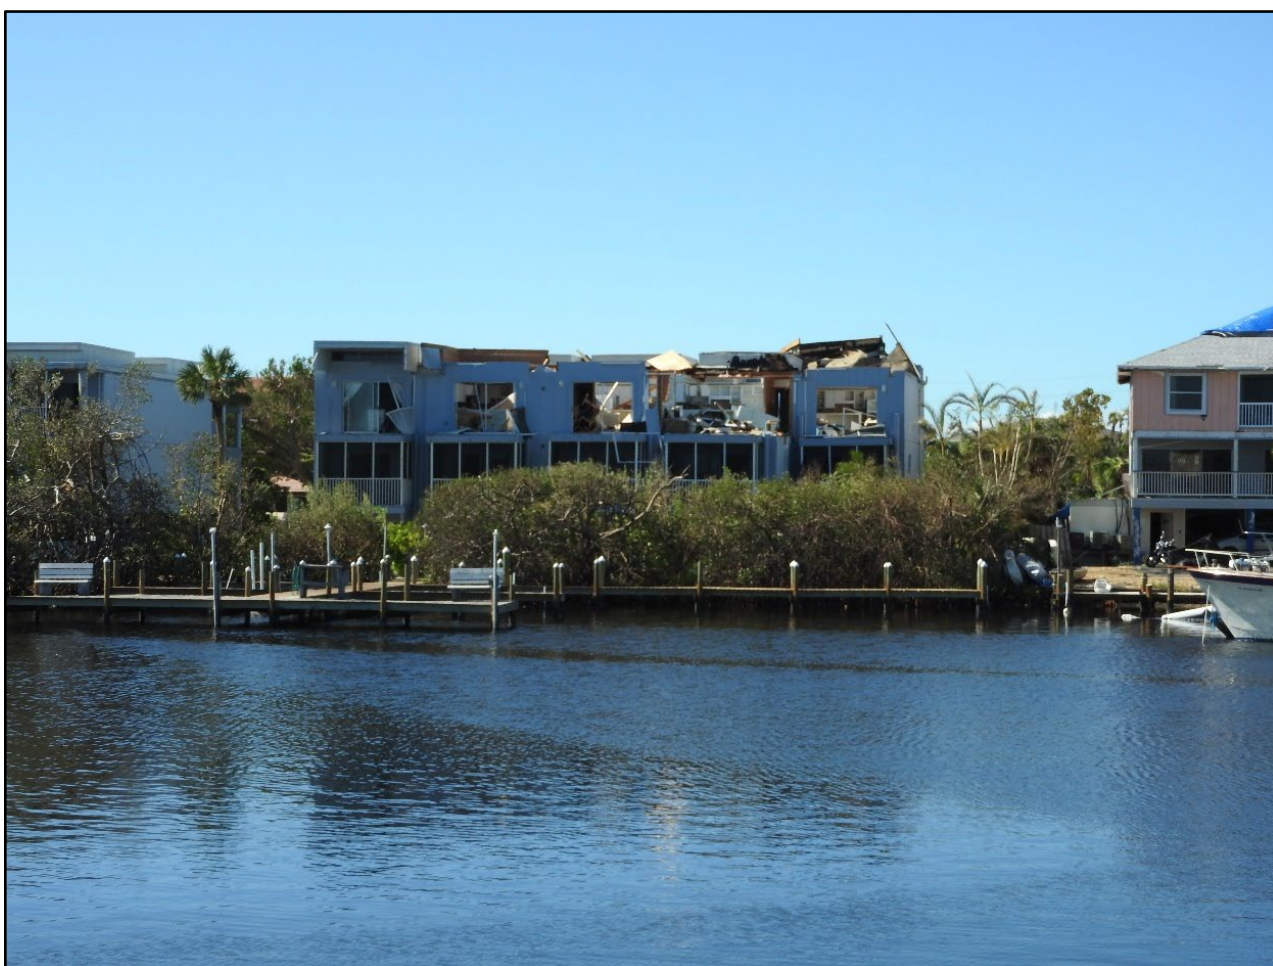
Figure 21. Condominiums destroyed in Englewood Beach (R-11).

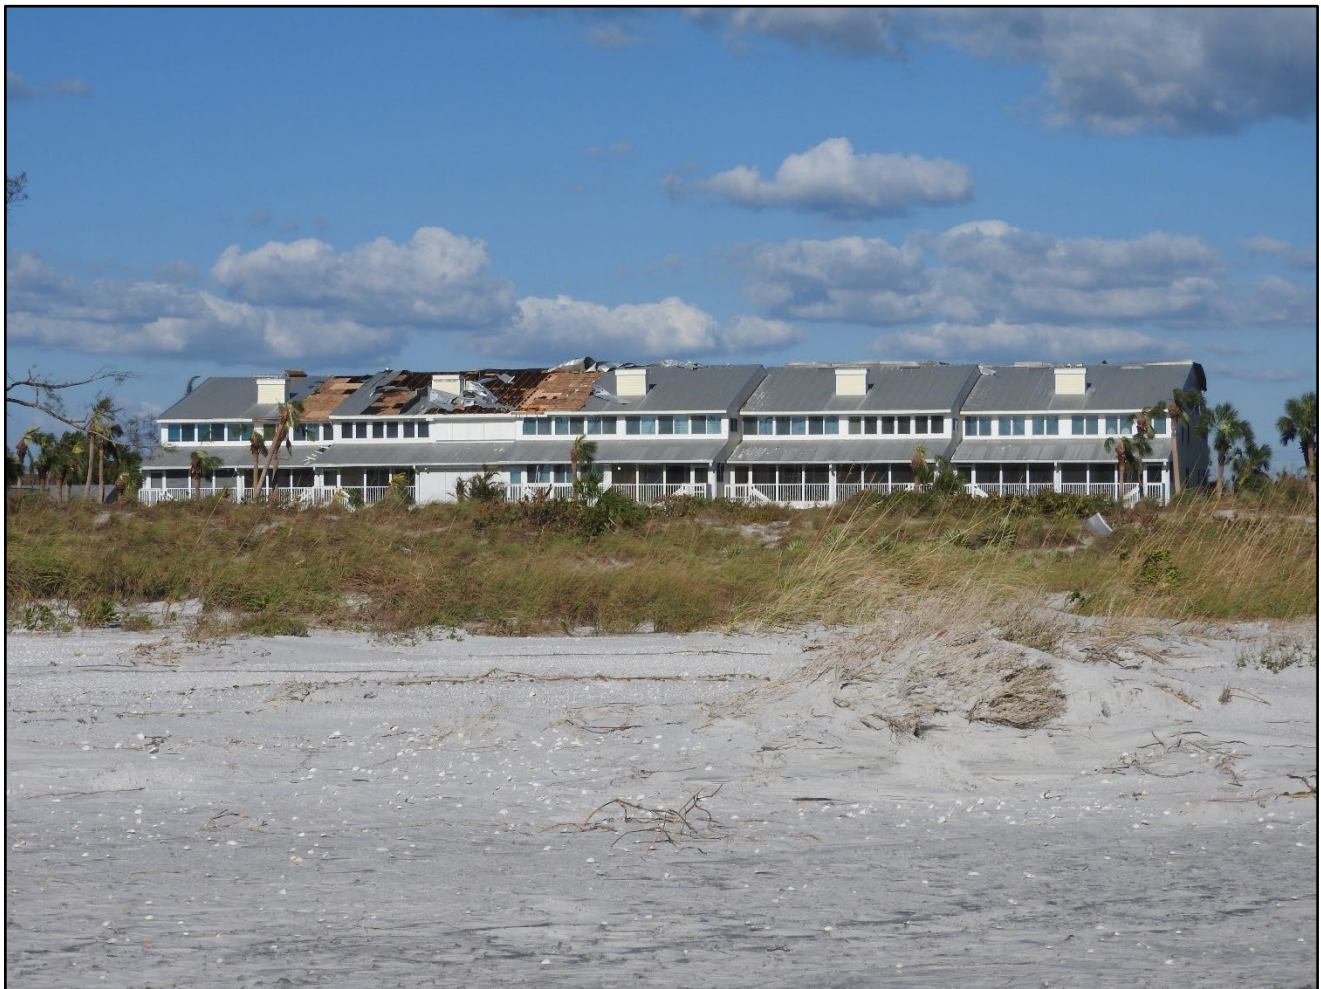
Figure 25. Major roofing damage on condominiums on northern Gasparilla Island (R-64 CH).

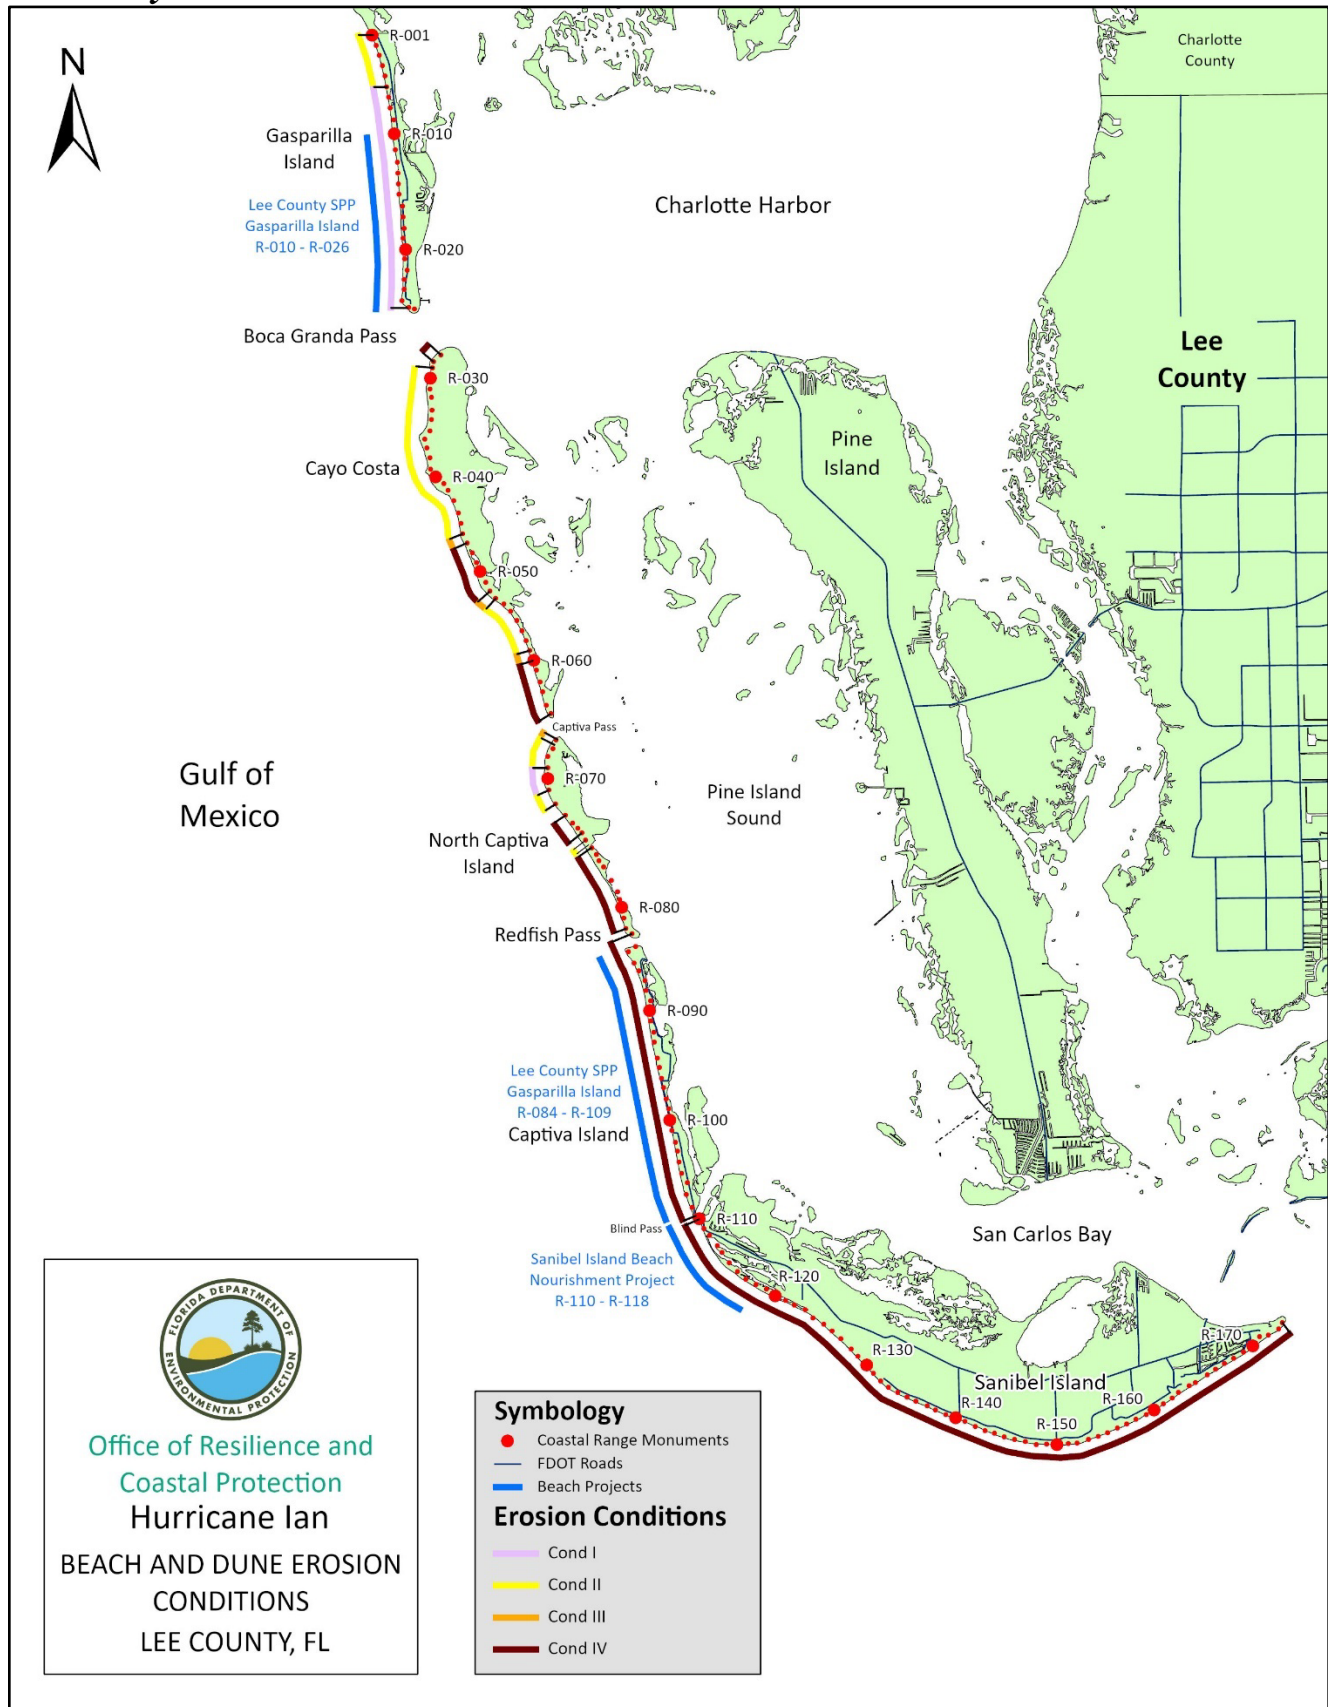
Figure 27. Lee County (North Section) Beach and Dune Erosion Conditions from Hurricane Ian.

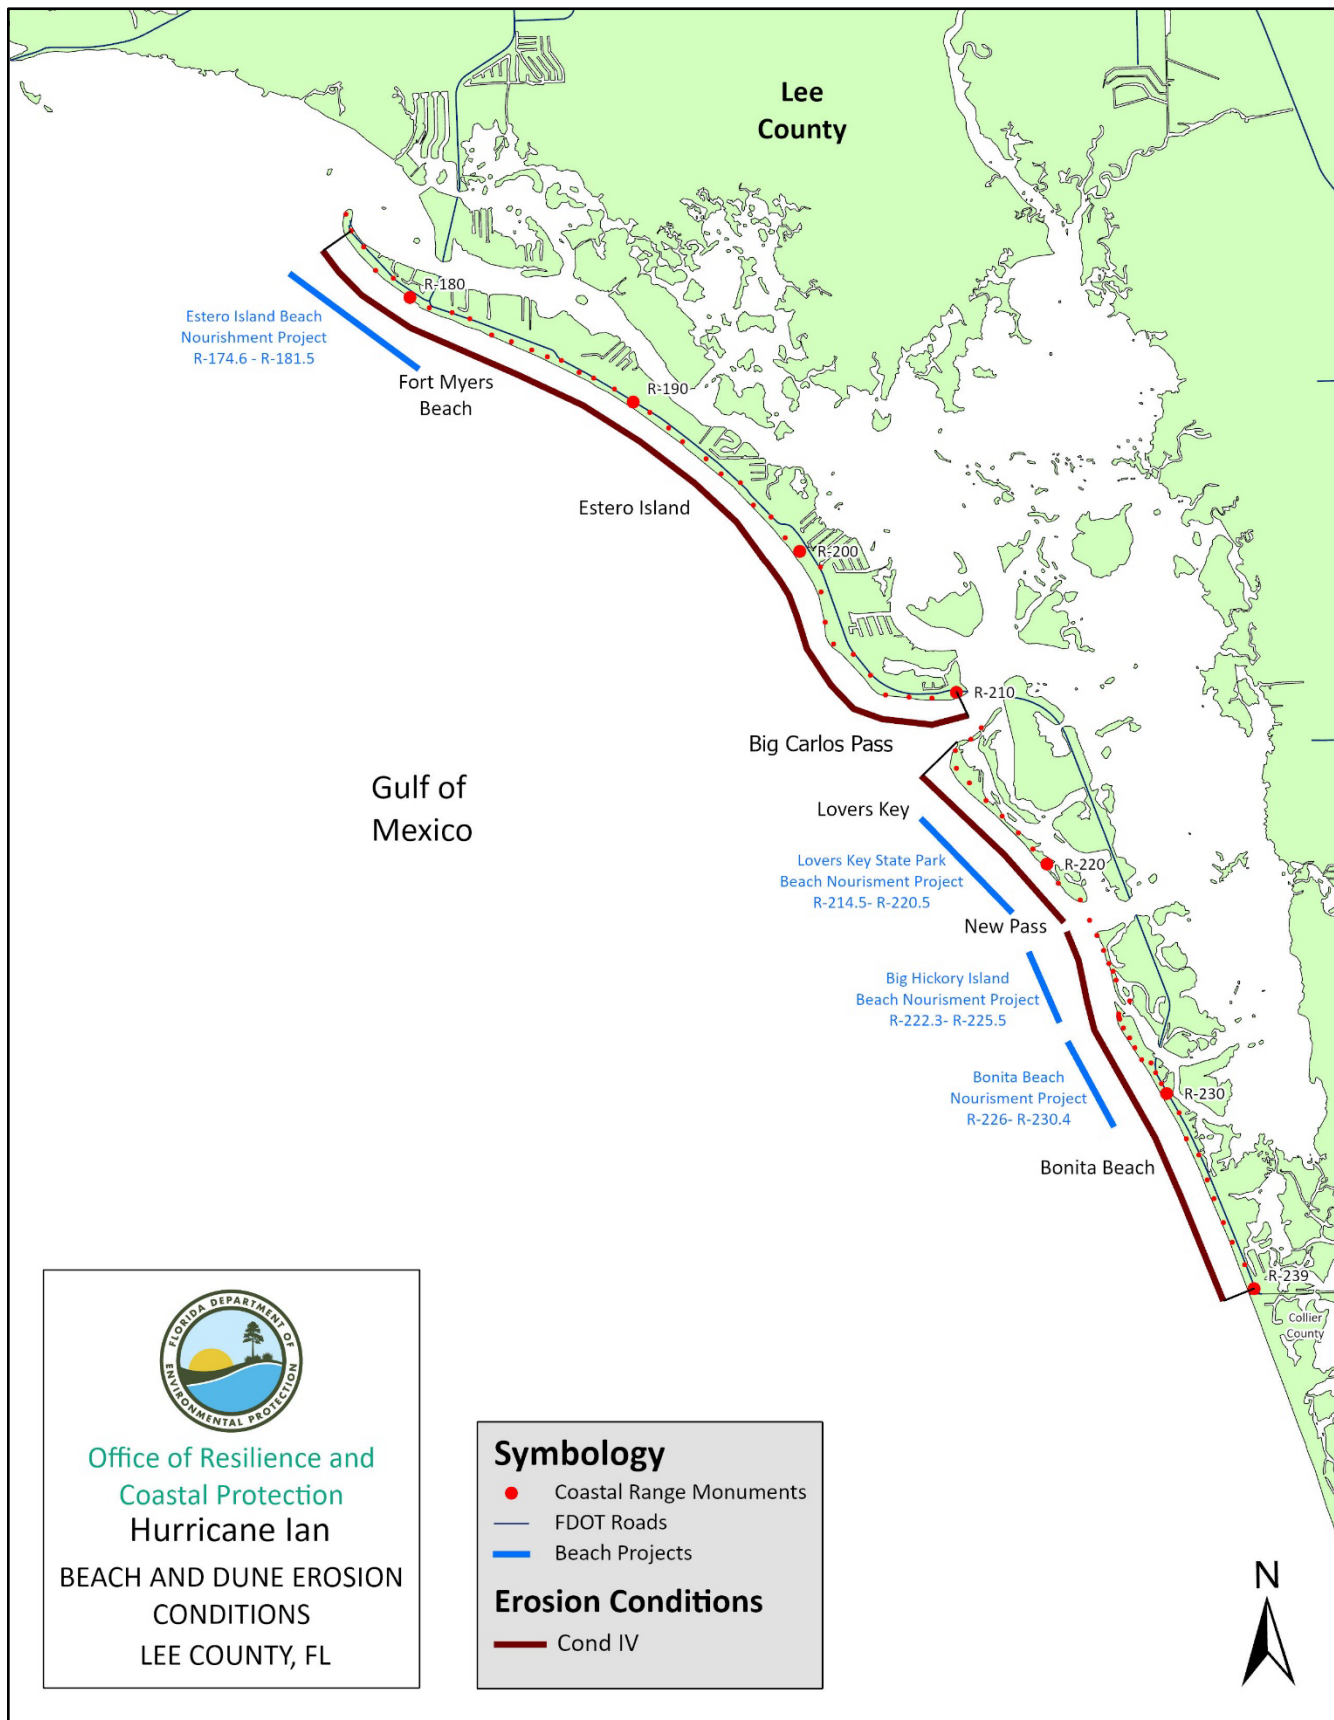
Figure 28. Lee County (South Section) Beach and Dune Erosion Conditions from Hurricane Ian.
