Hurricane Ian & Hurricane Nicole
Preliminary Post-Storm Beach Conditions
and Coastal Impact Report

Office of Resilience and Coastal Protection
Florida Department of Environmental Protection
December 2022

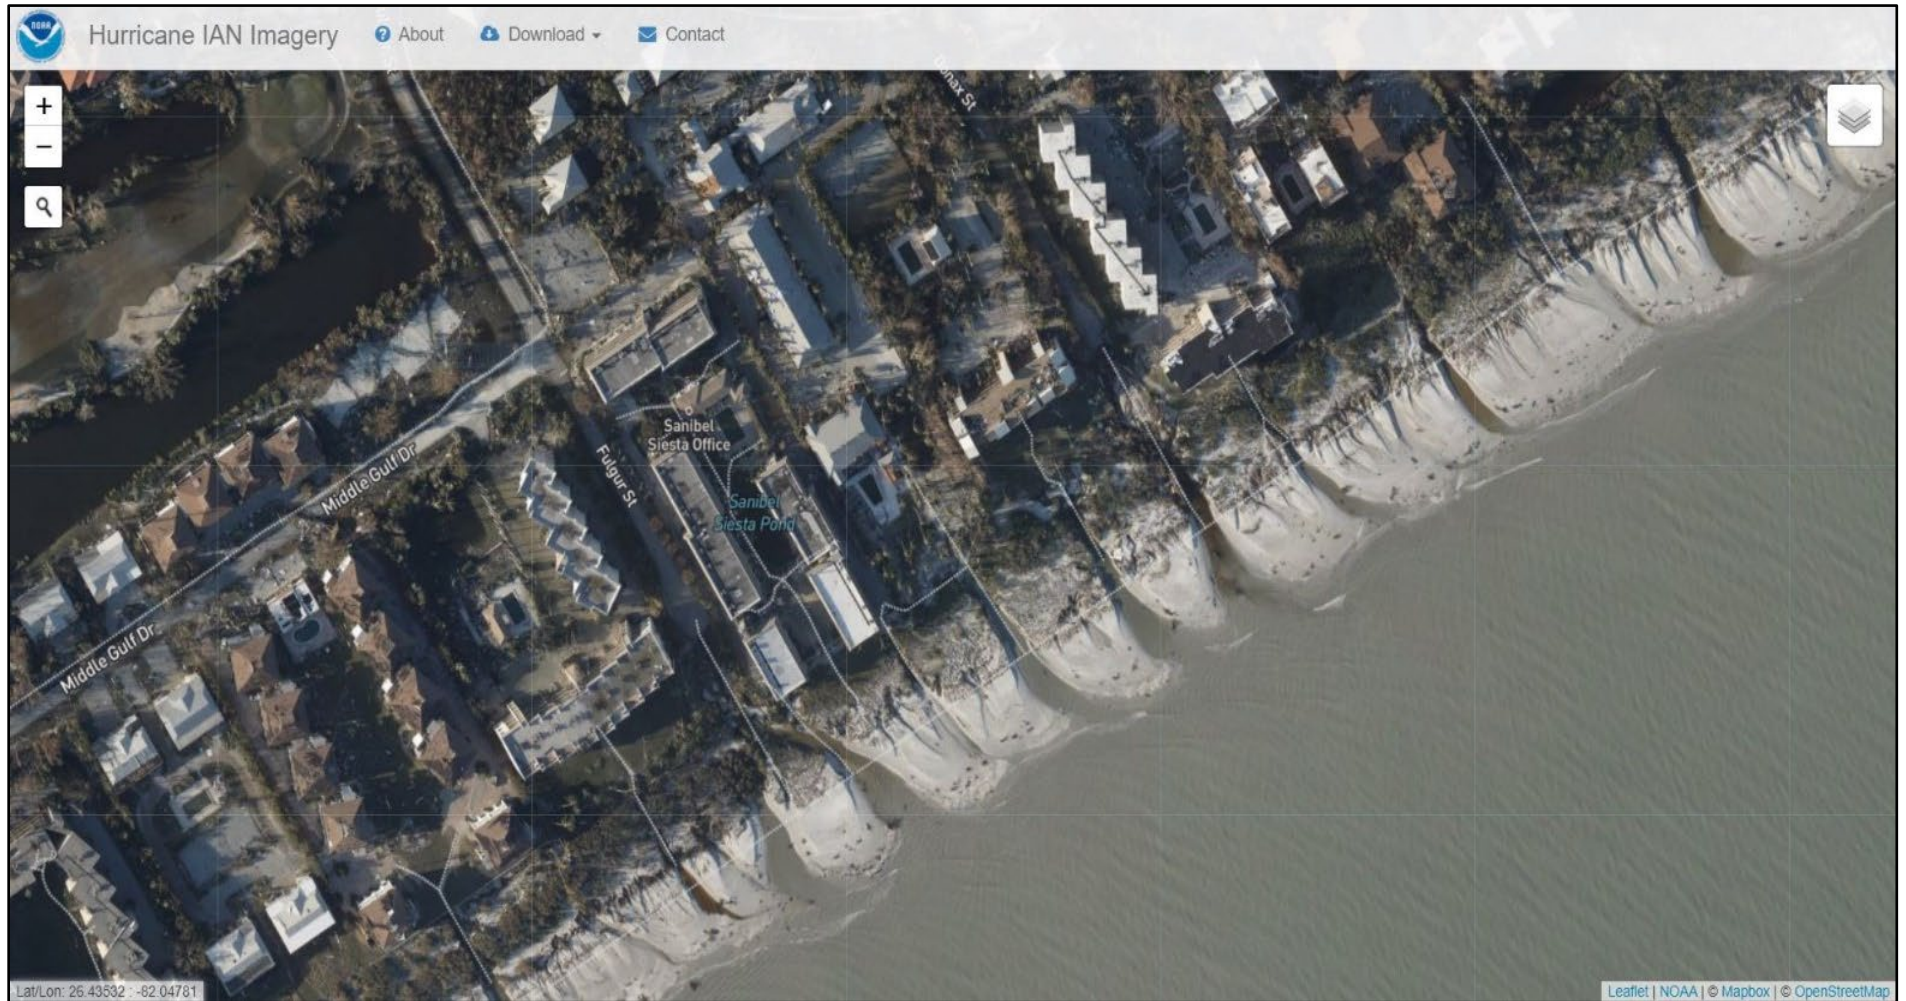
Figure 29. Storm surge discharge gullies on Sanibel Island (NOAA image), near R-162 in Lee County.

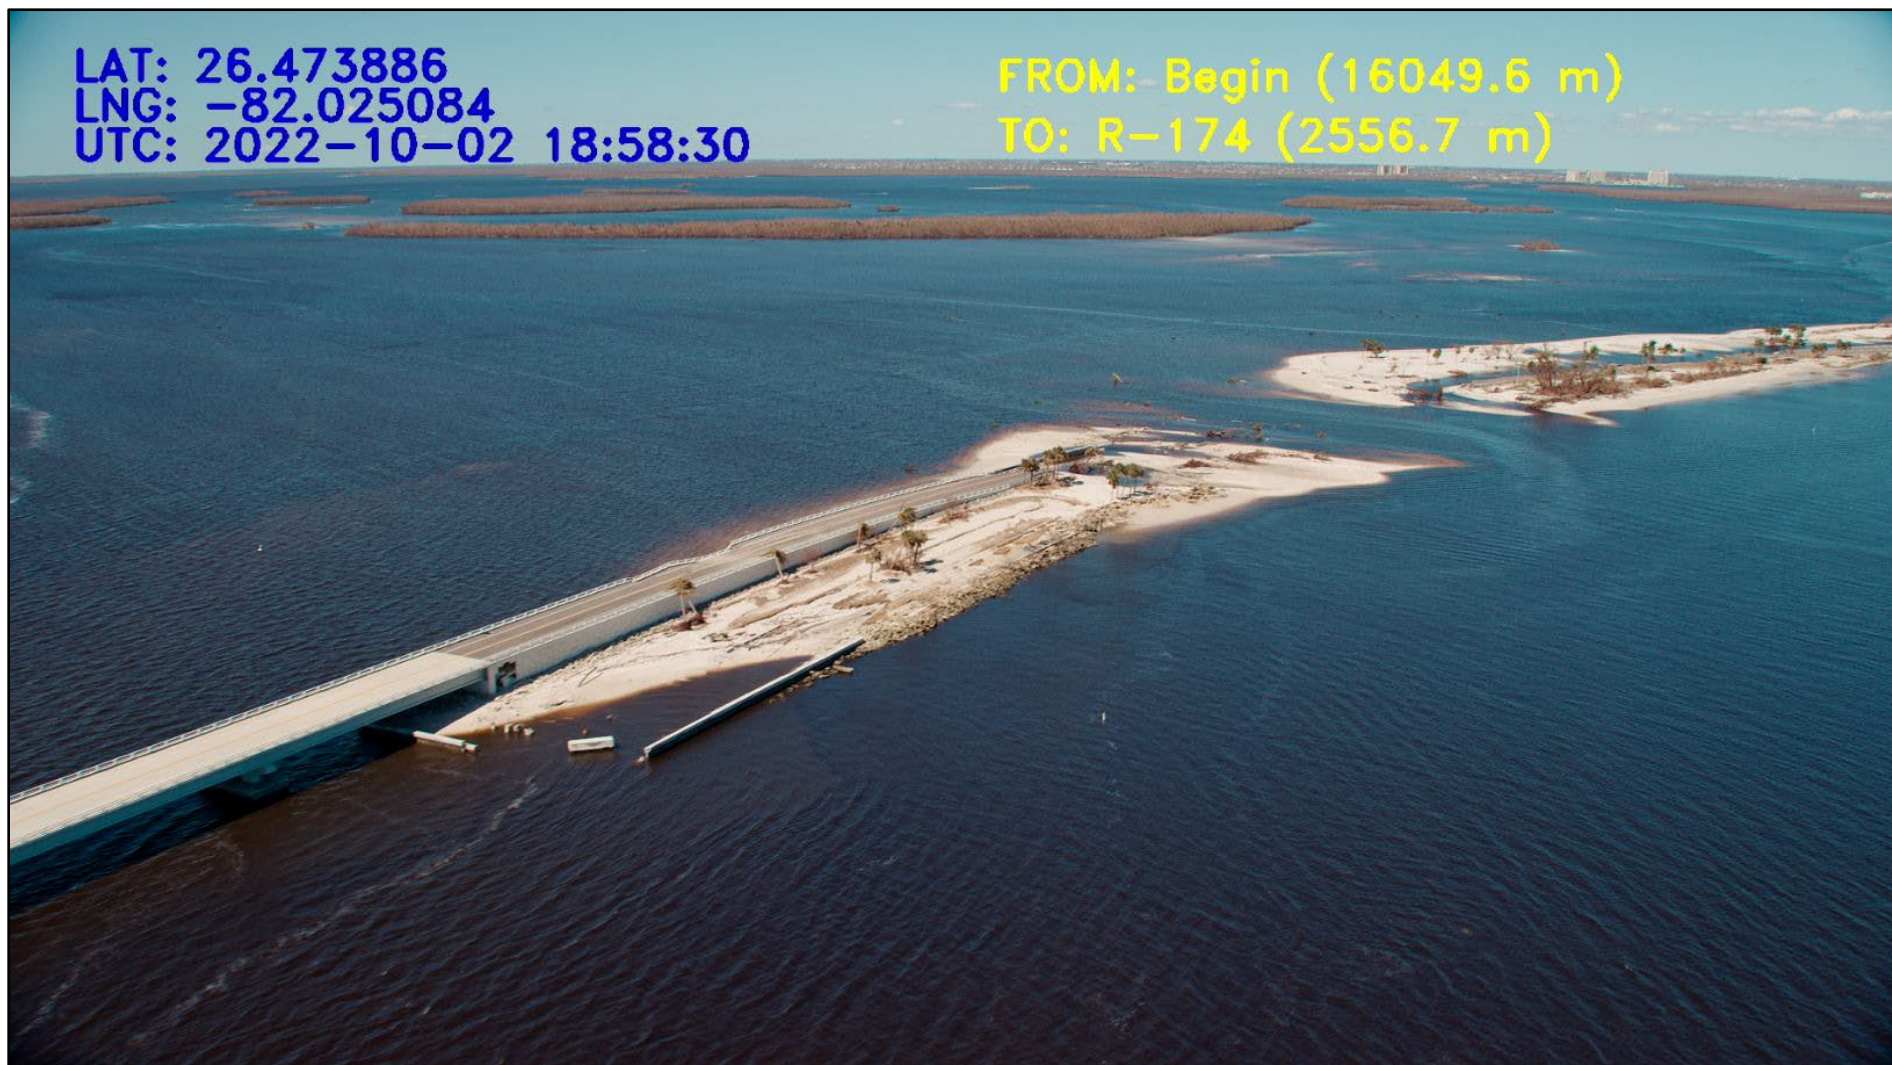
Figure 30. Sanibel Island bridge and causeway destroyed. (Image source: Active Camera Systems and Camera Copters).

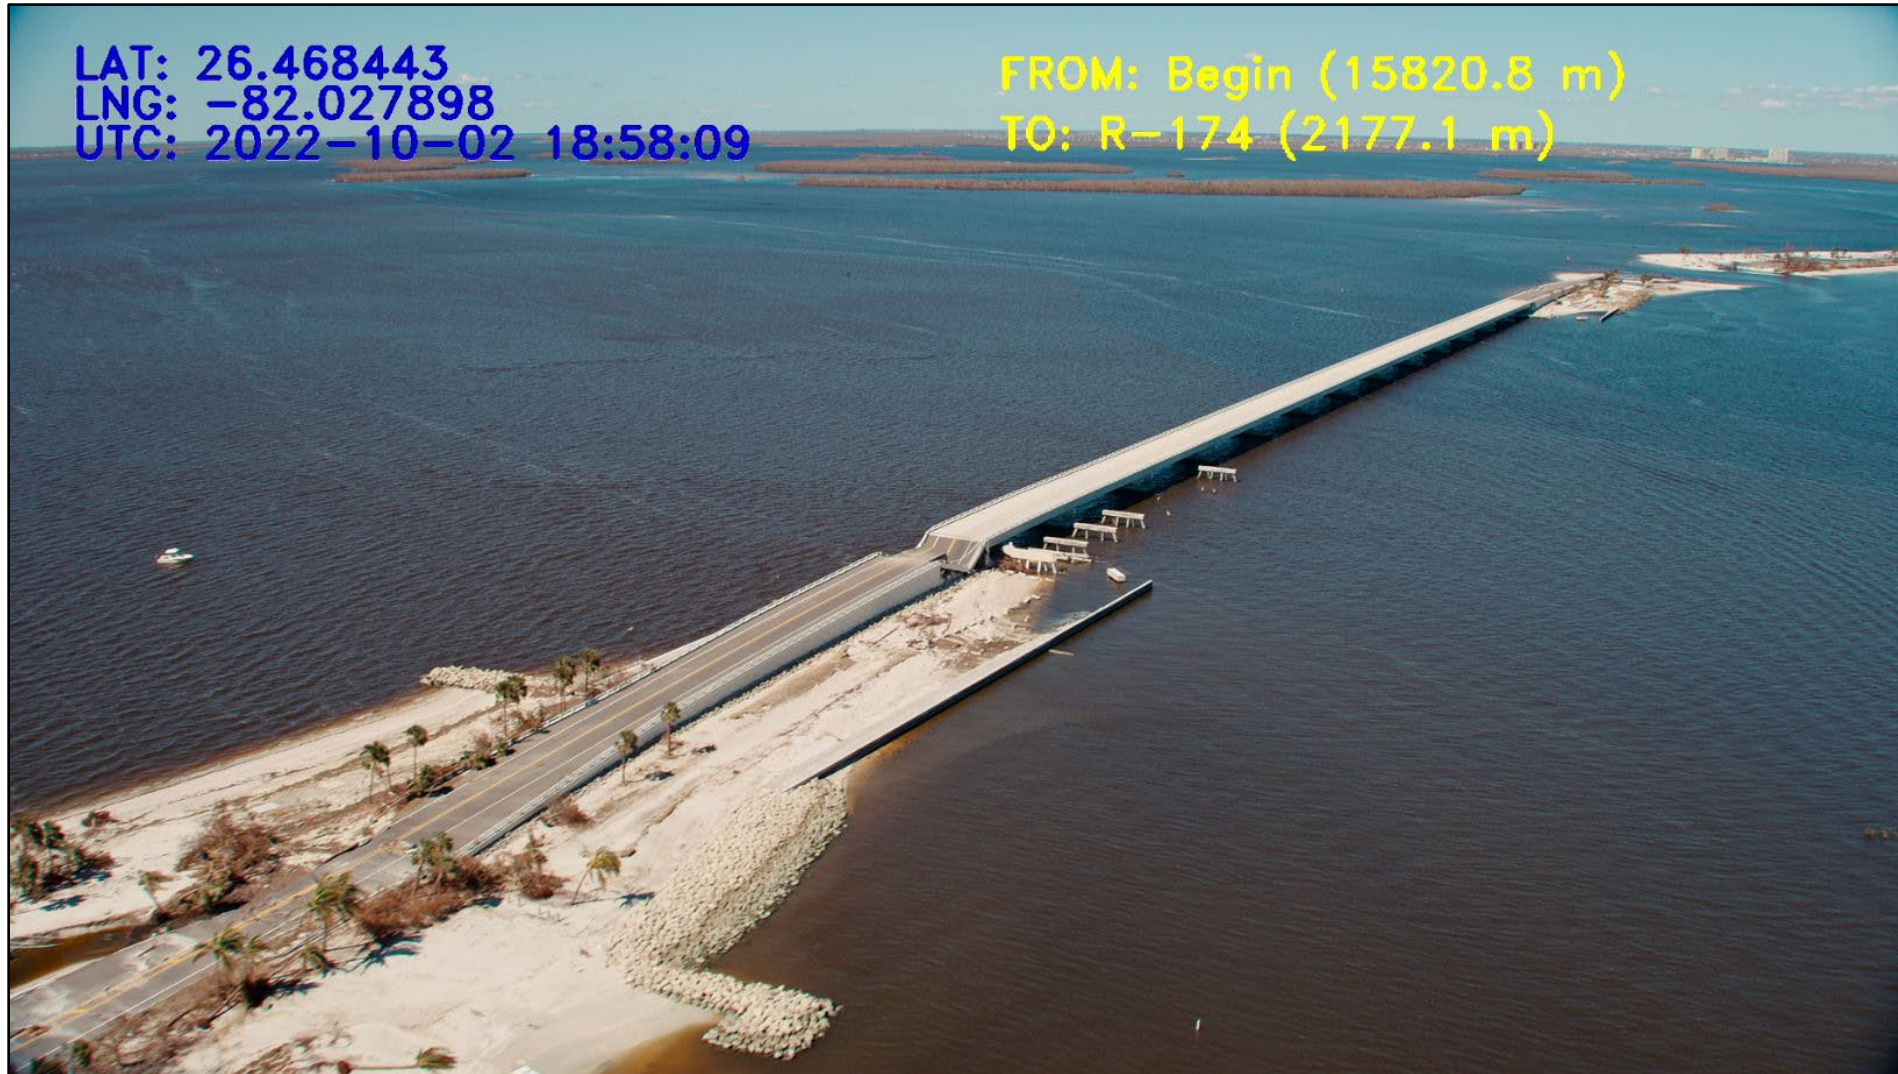
Figure 31. Sanibel Island bridge and causeway destroyed. (Image source: Active Camera Systems and Camera Copters).

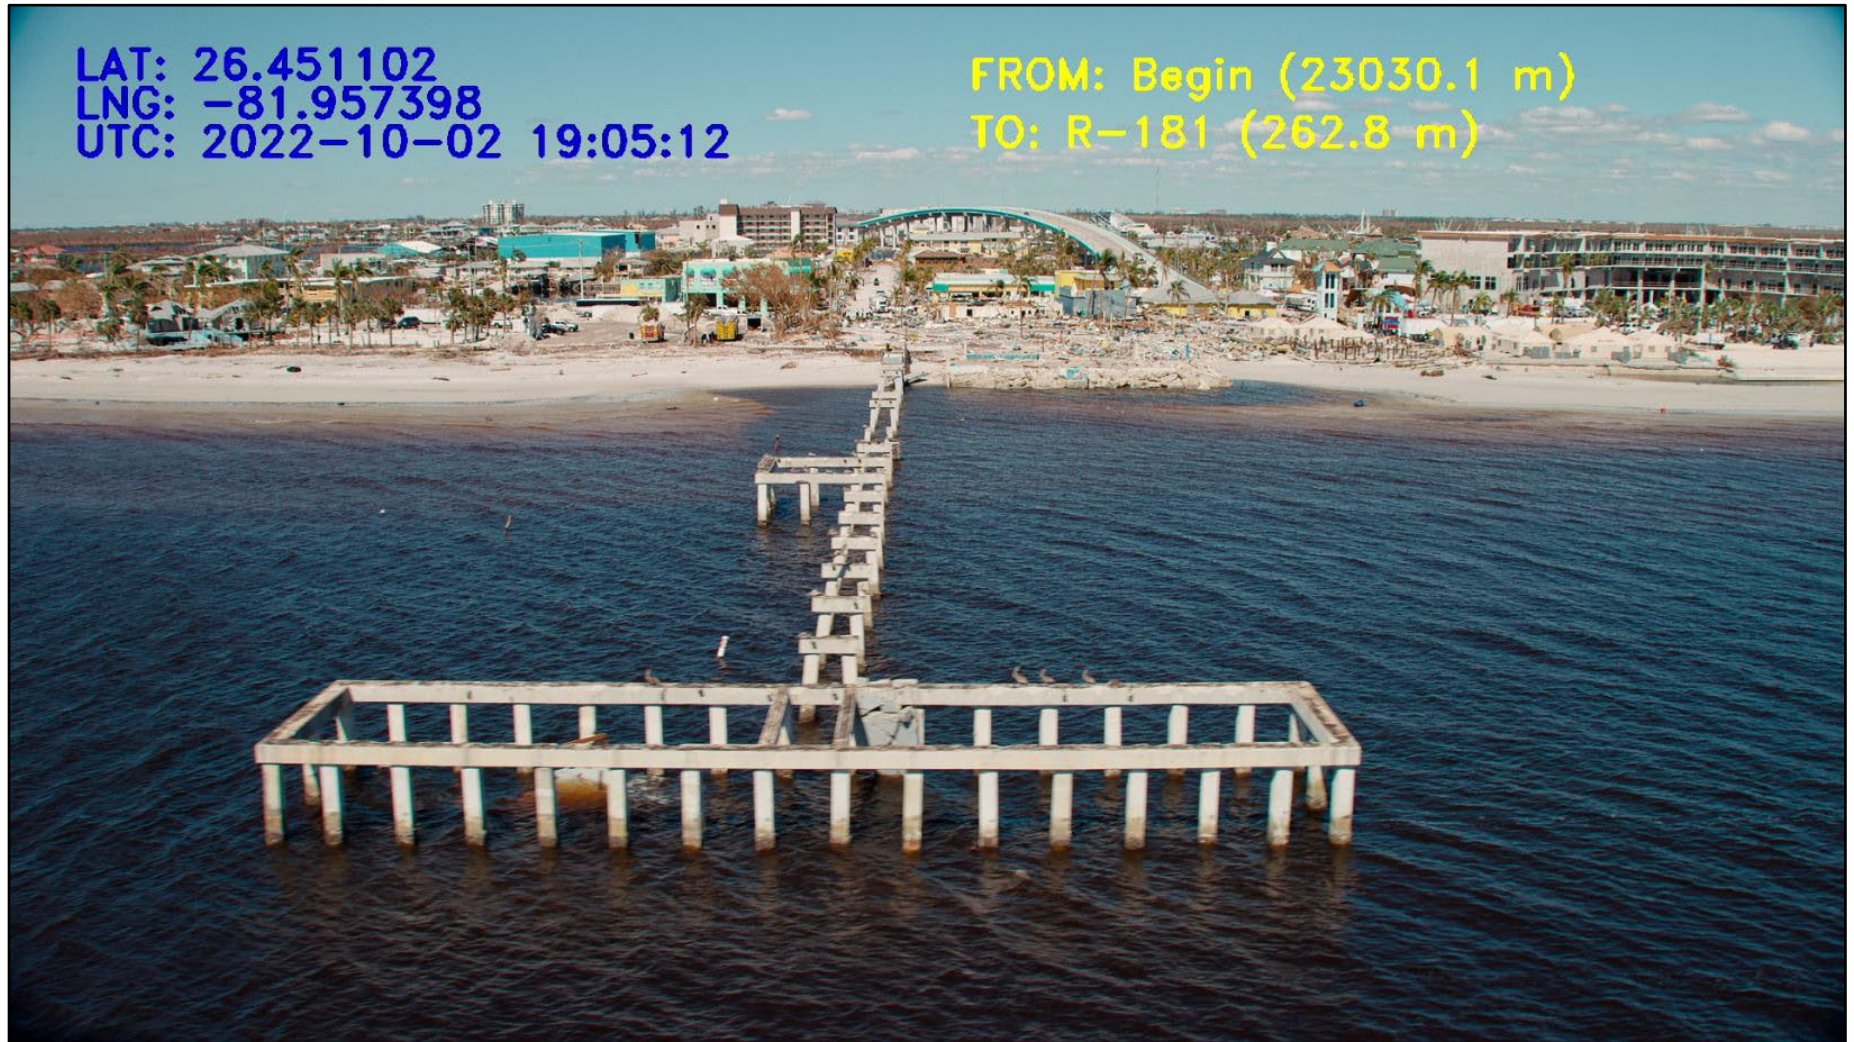
Figure 32. Ft. Myers Beach structures and pier with major damages, R-181 (Image source: Active Camera Systems and Camera Copters).

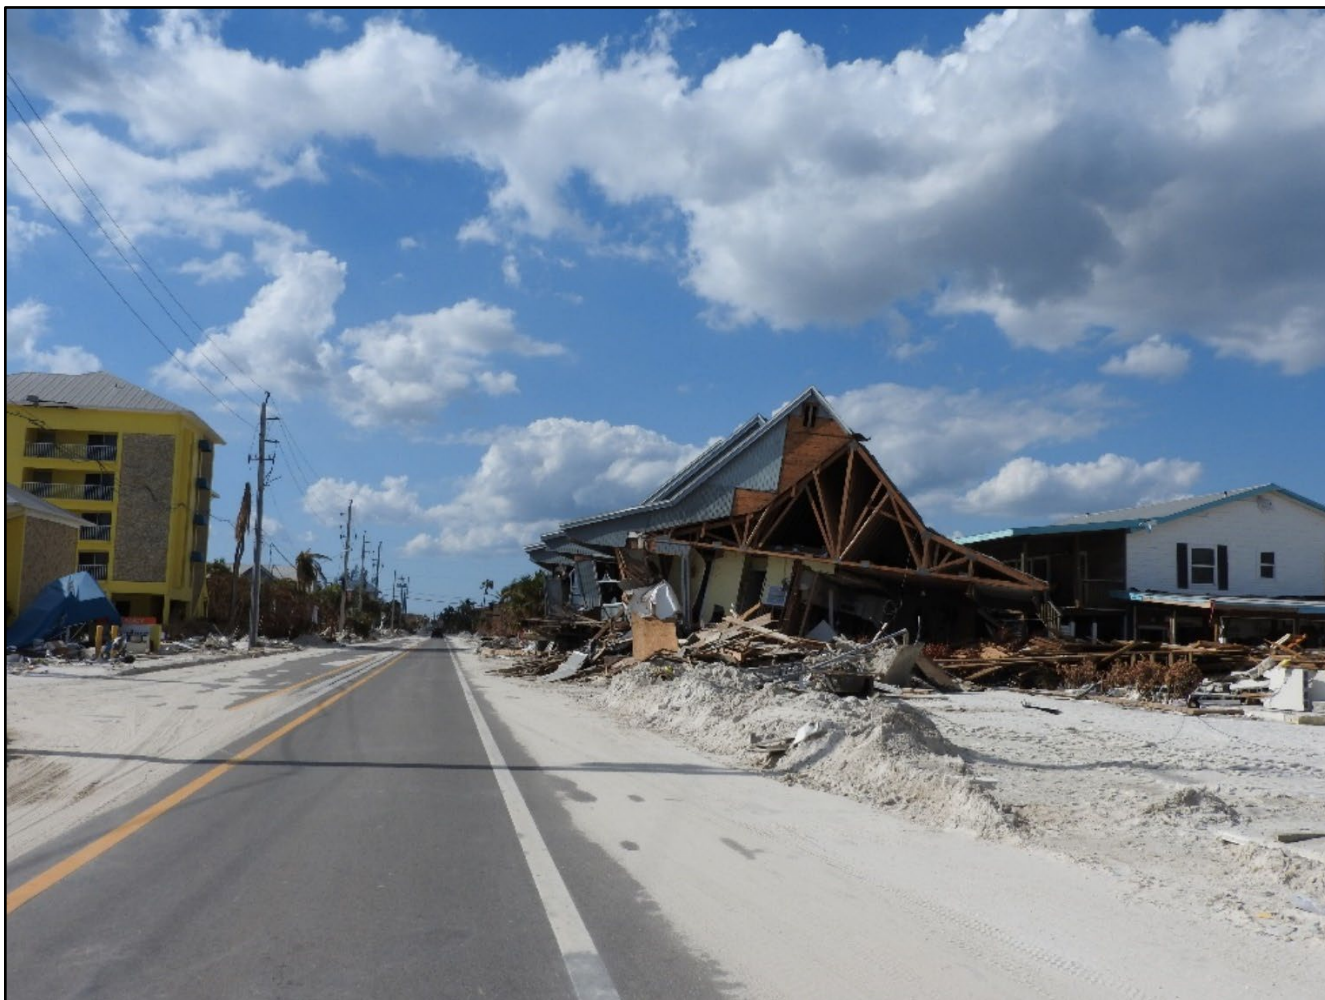
Figure 33. Storm surge transported Lahaina resort structures across Estero Blvd. (R-196).

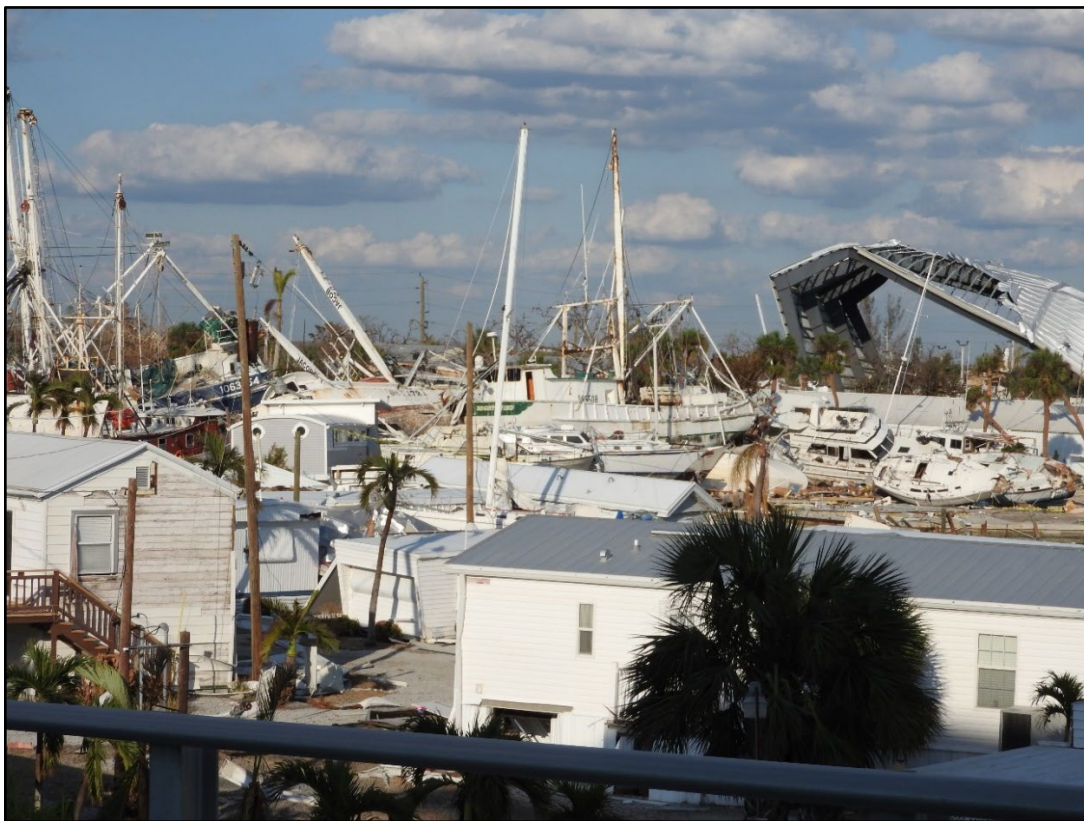
Figure 35. Major damages at the Gulf Marine Yachtworks at bayside of Ft. Myers Beach (R-181).

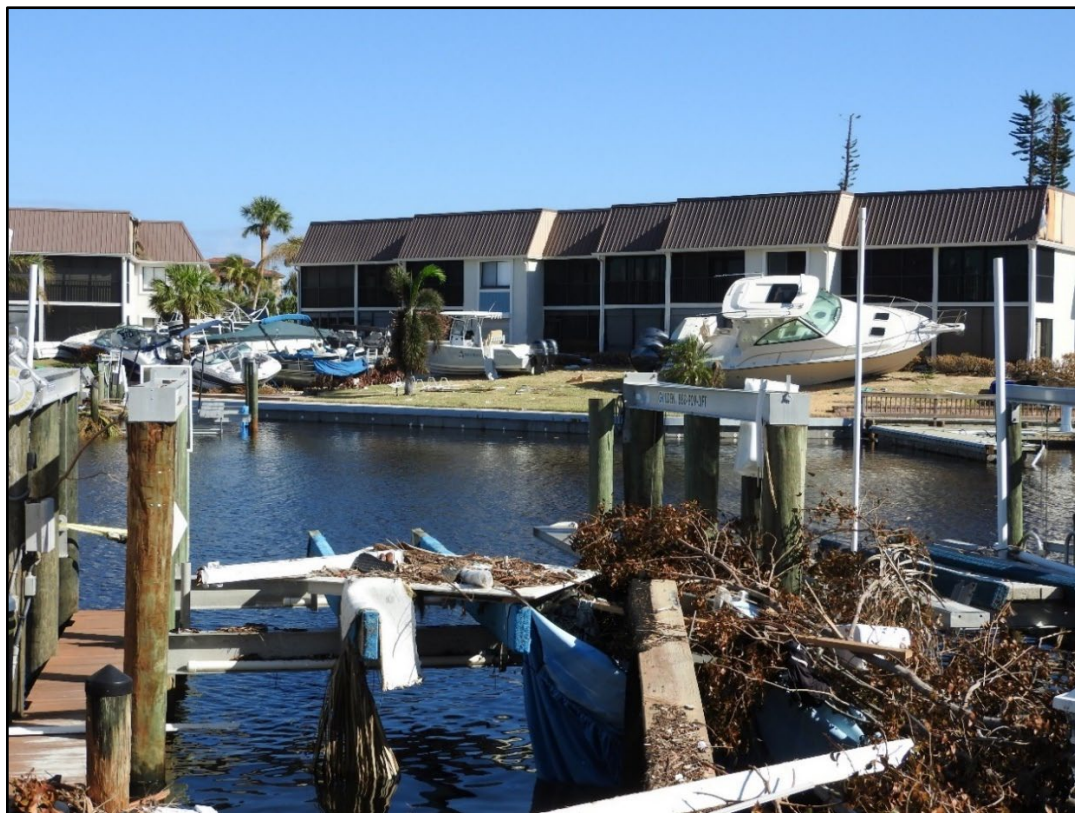
Figure 36. Stranded boats on the yards of multi-family dwellings at Ft. Myers Beach (R-203).

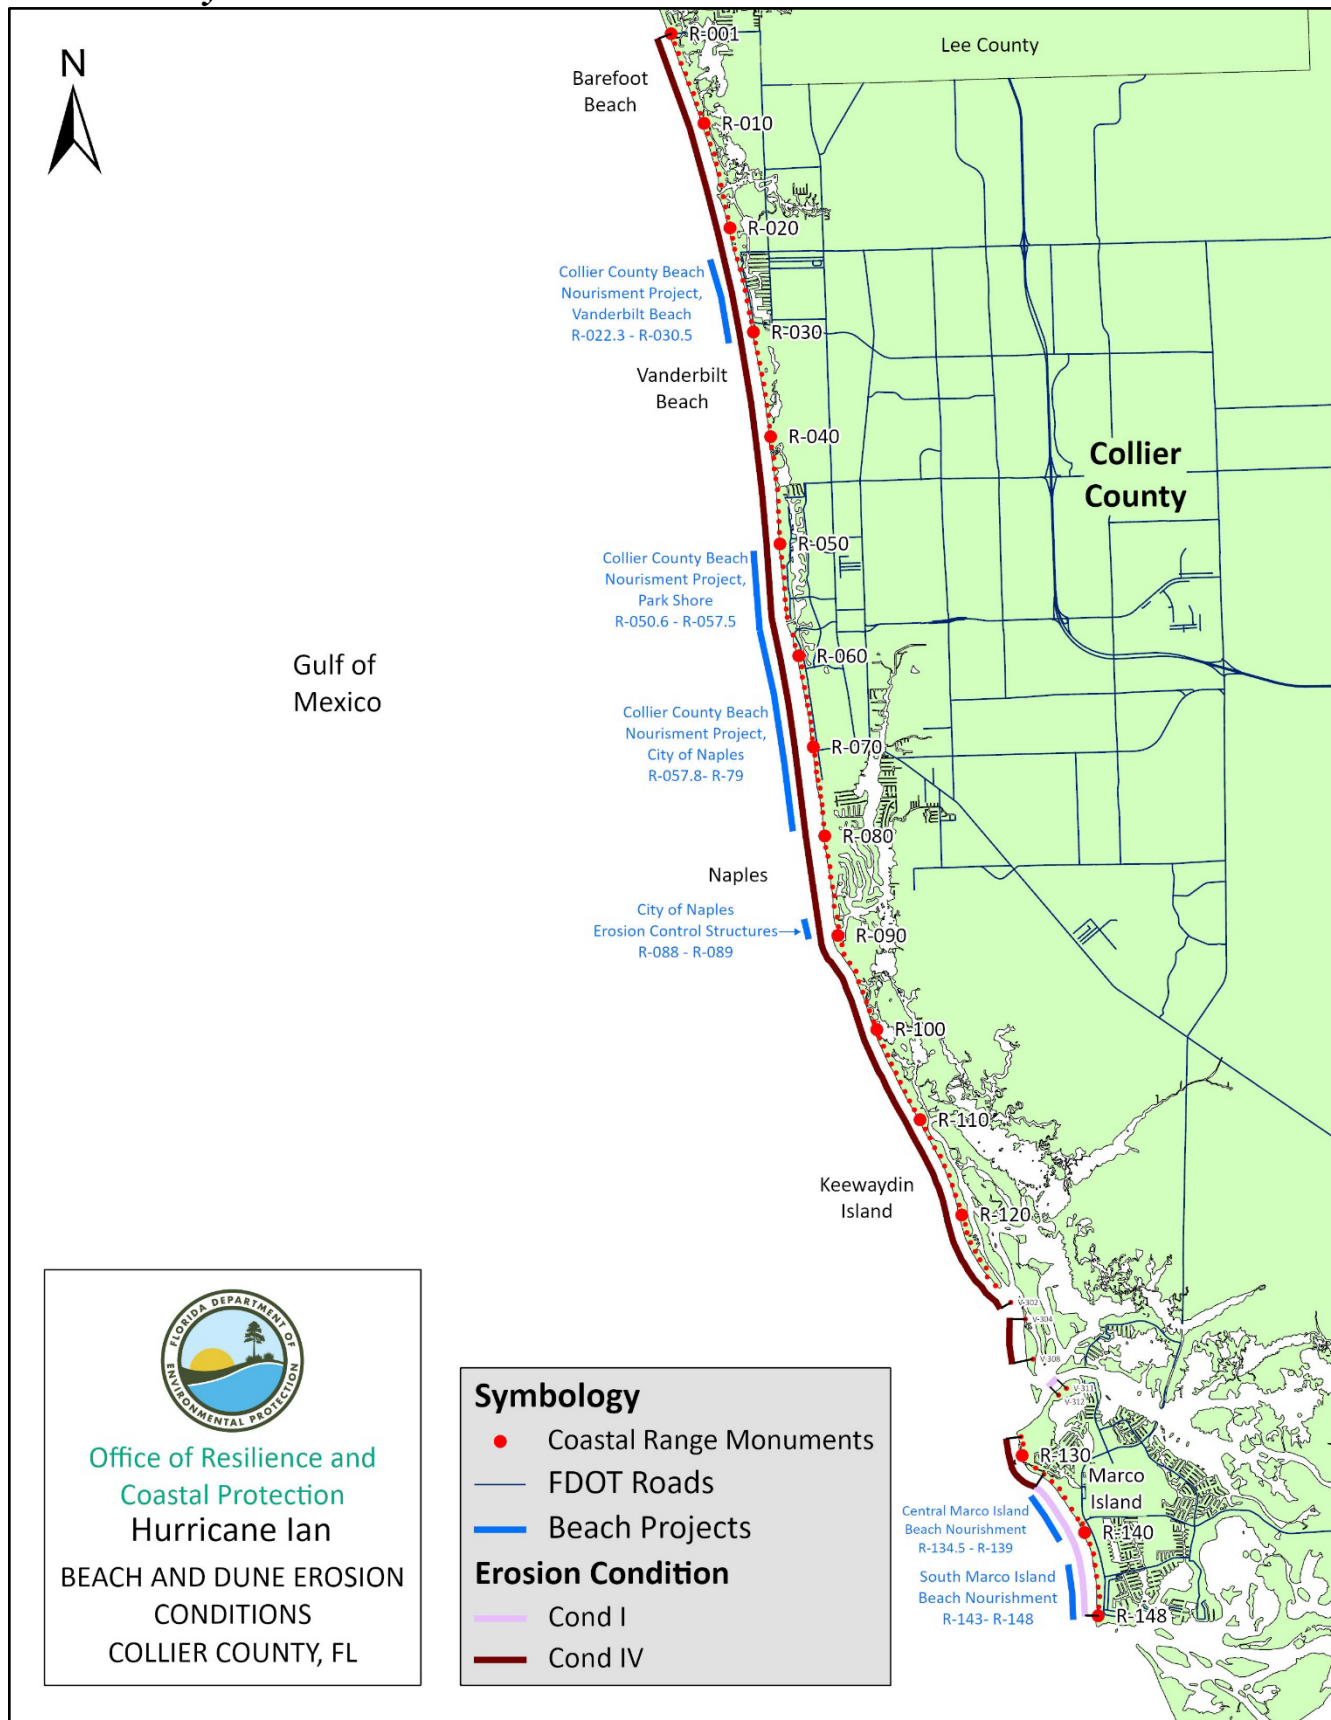
Figure 41. Collier County Beach and Dune Erosion Conditions from Hurricane Ian.

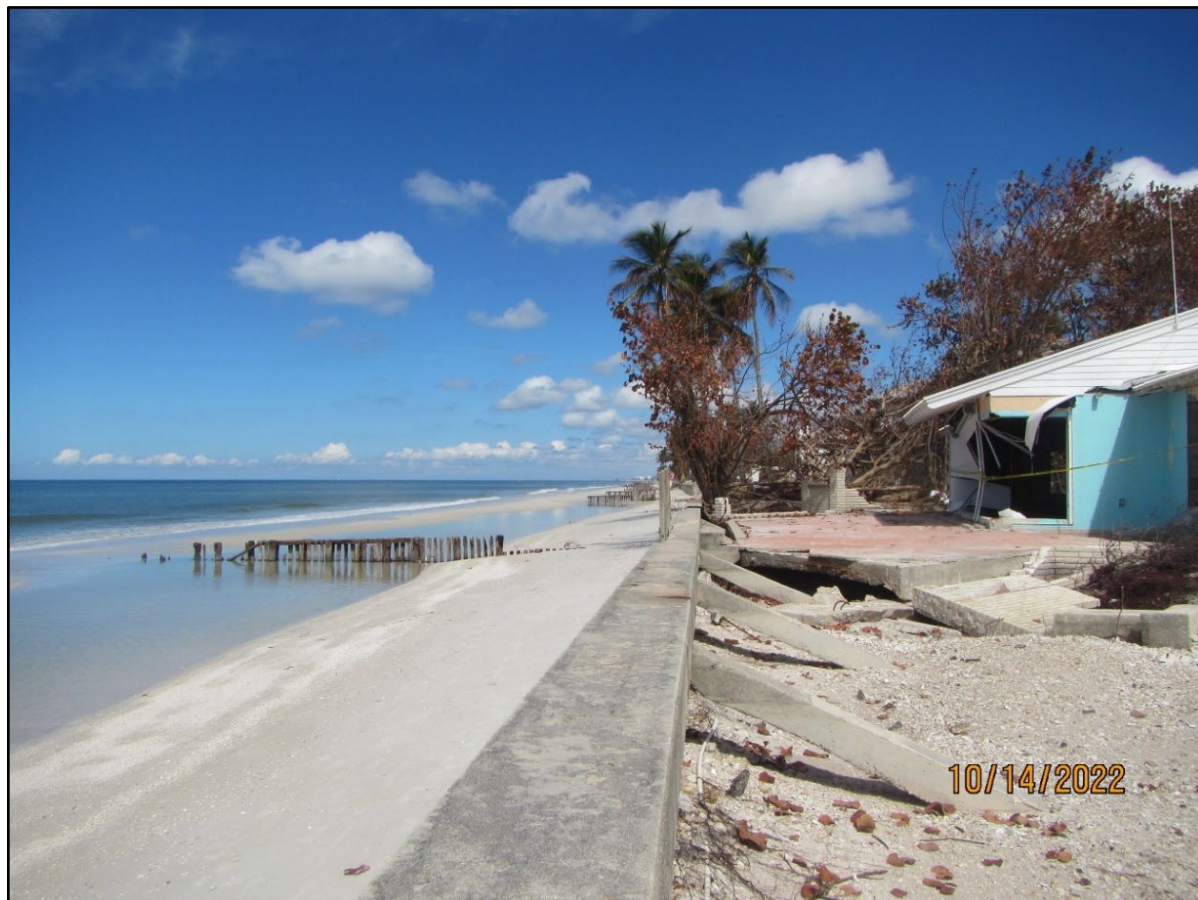
Figure 42. Major beach and dune erosion, Naples (R-85).

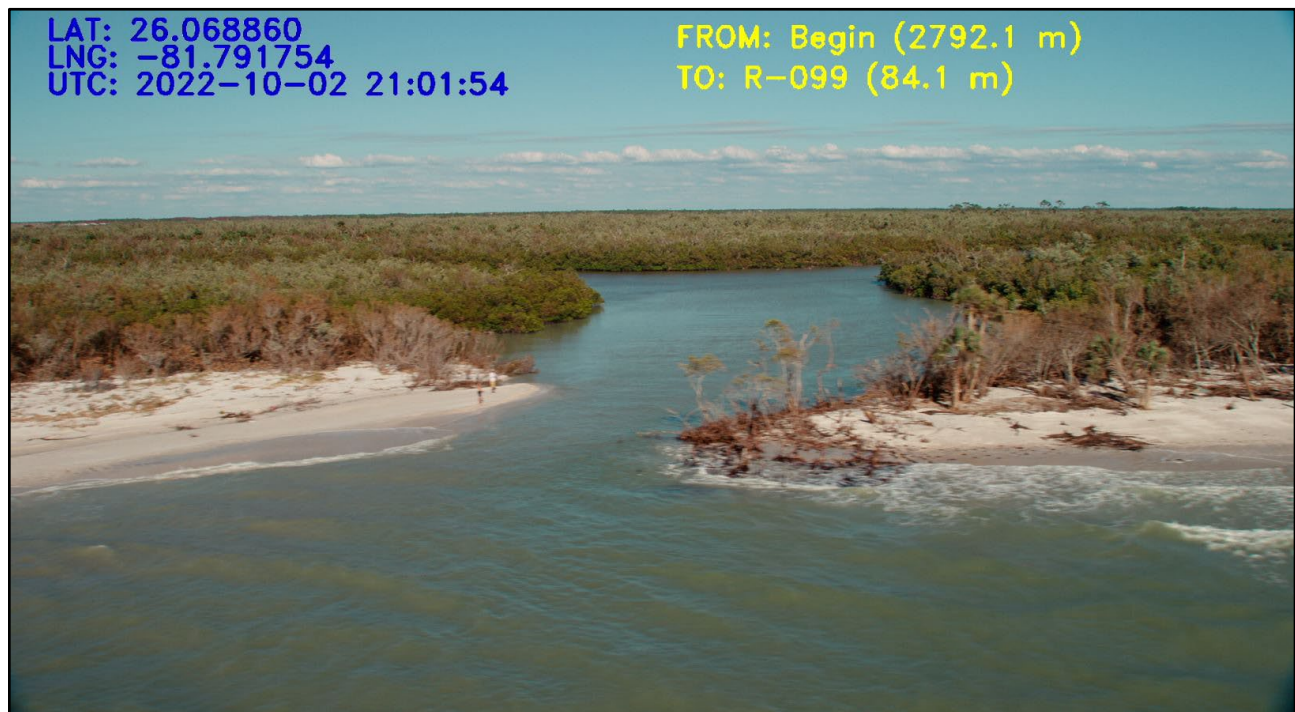
Figure 43. Major breach across Keewaydin Island (R-99).

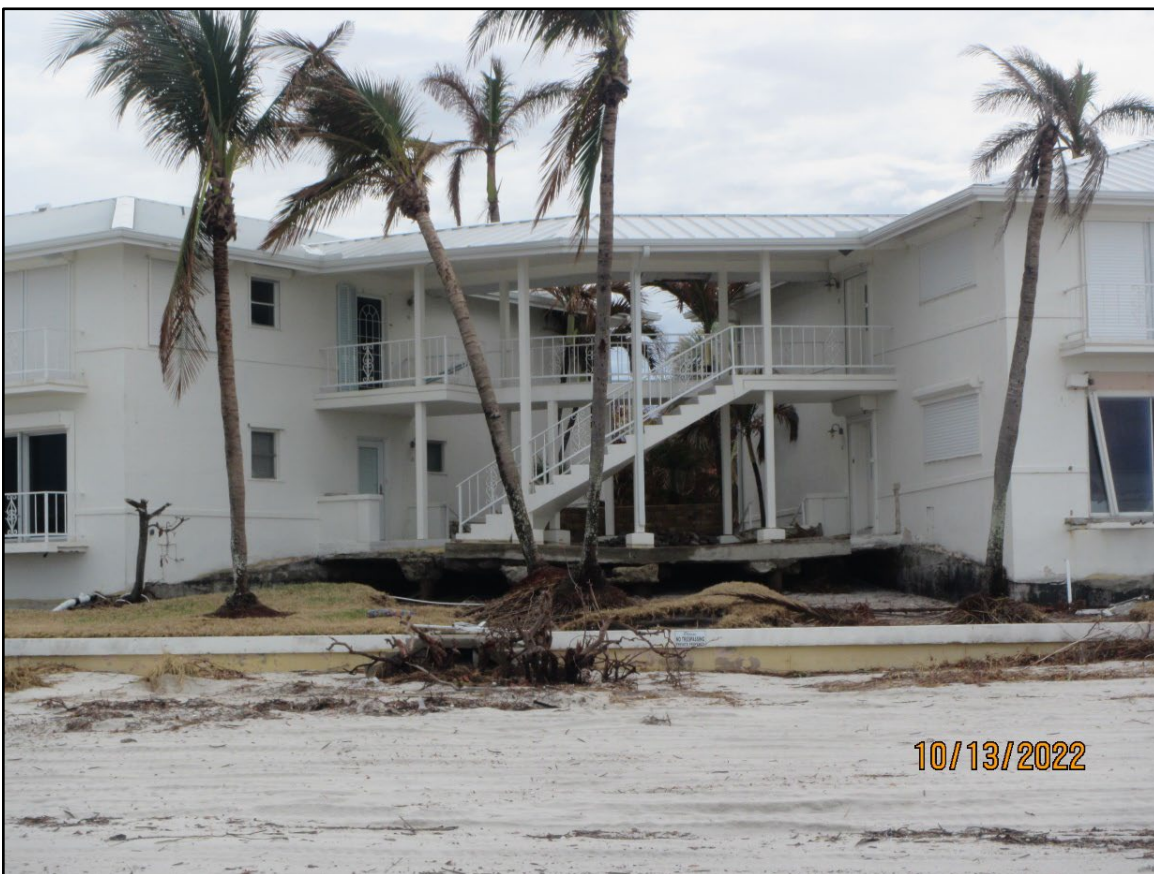
Figure 44. Understructure damage in Naples (R-60).

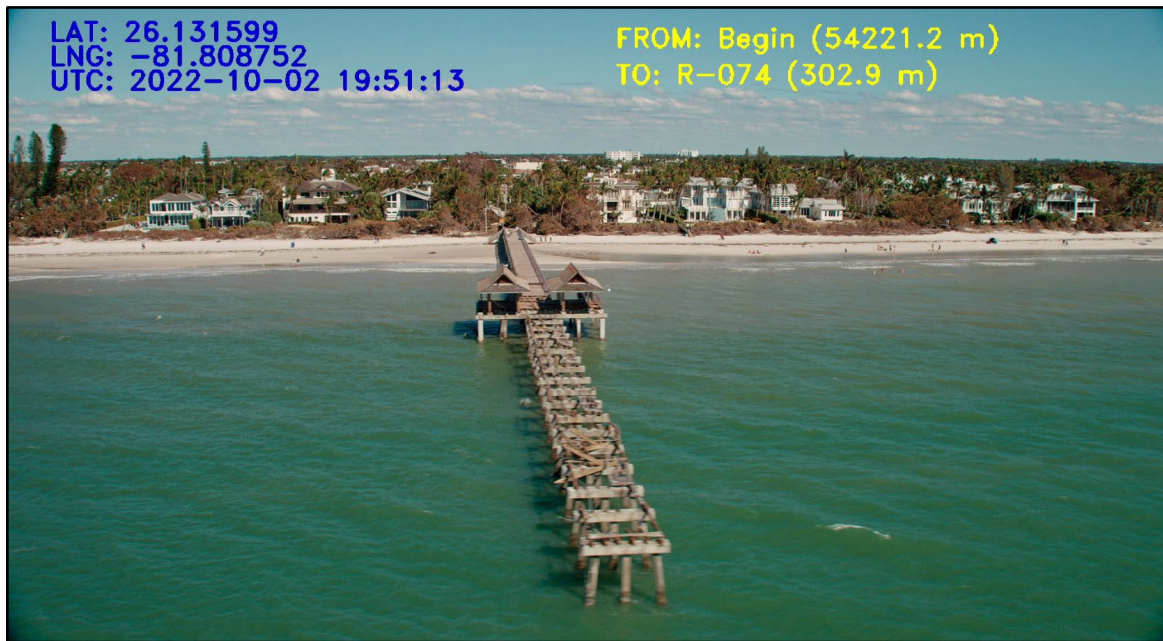
Figure 45. Damage to the Naples Pier (R-74).

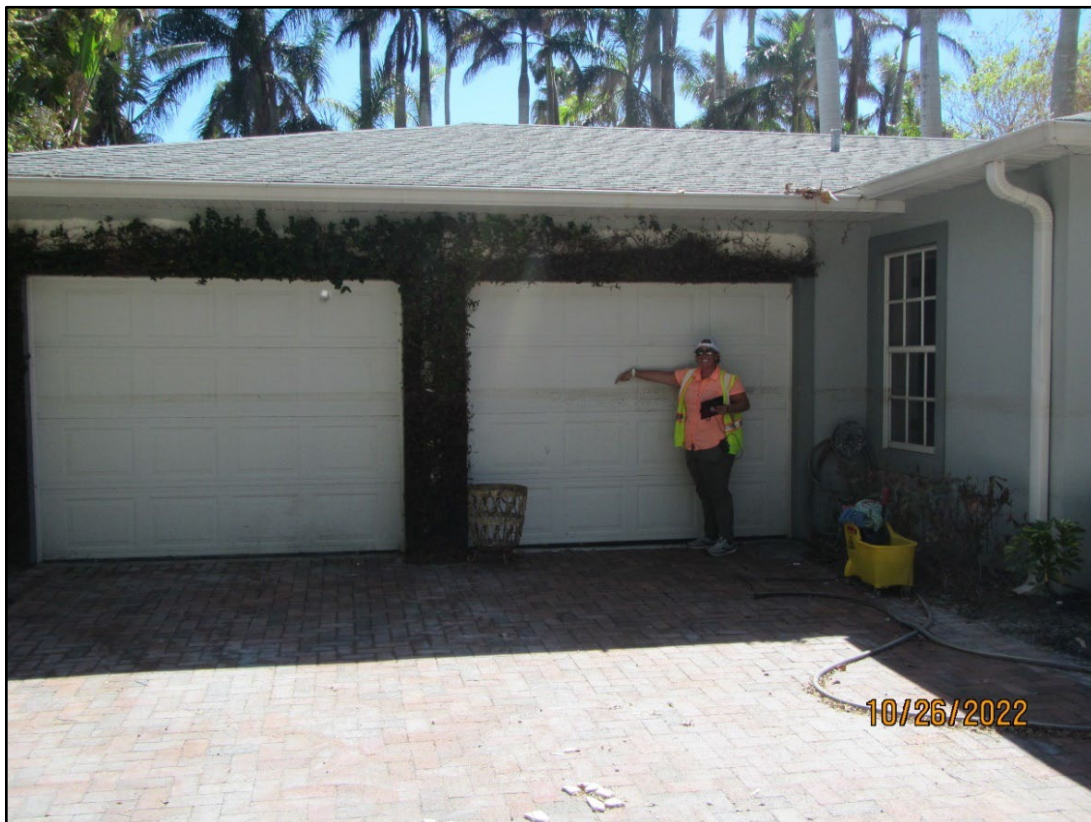
Figure 46. High water mark shown on a single-family dwelling, Naples (R-71).

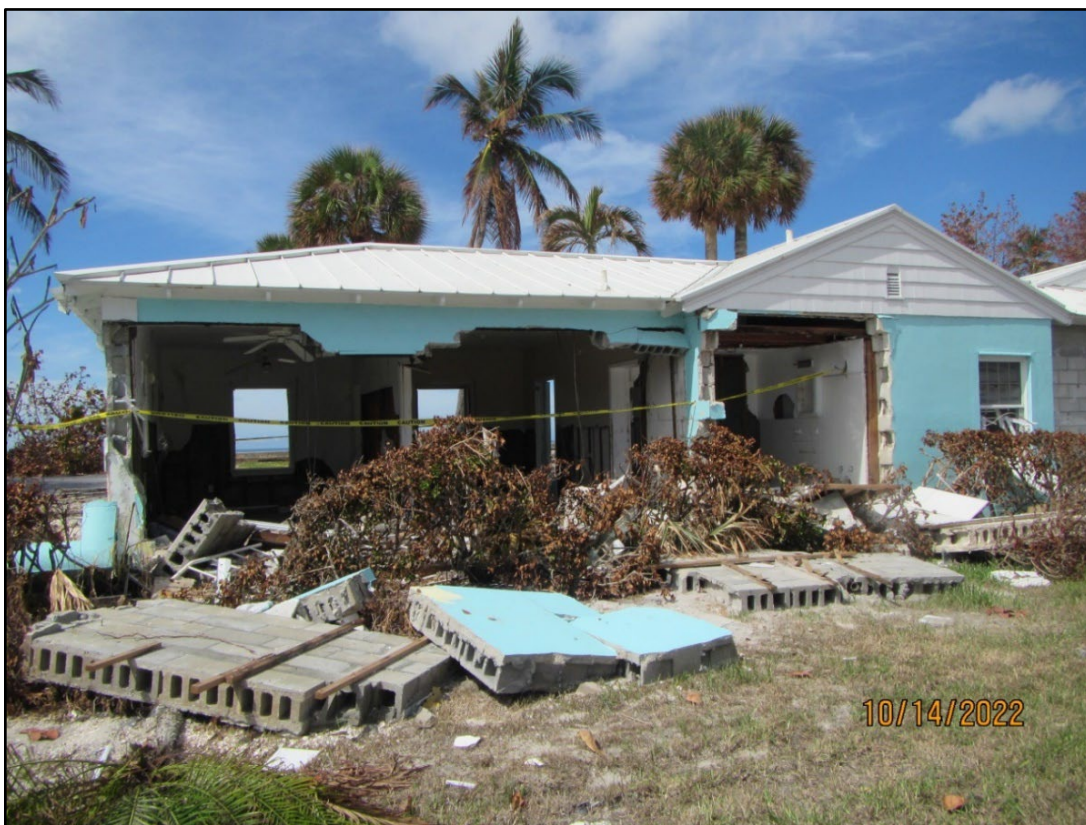
Figure 47. Single-family dwelling with storm surge damage, Naples (R-85).

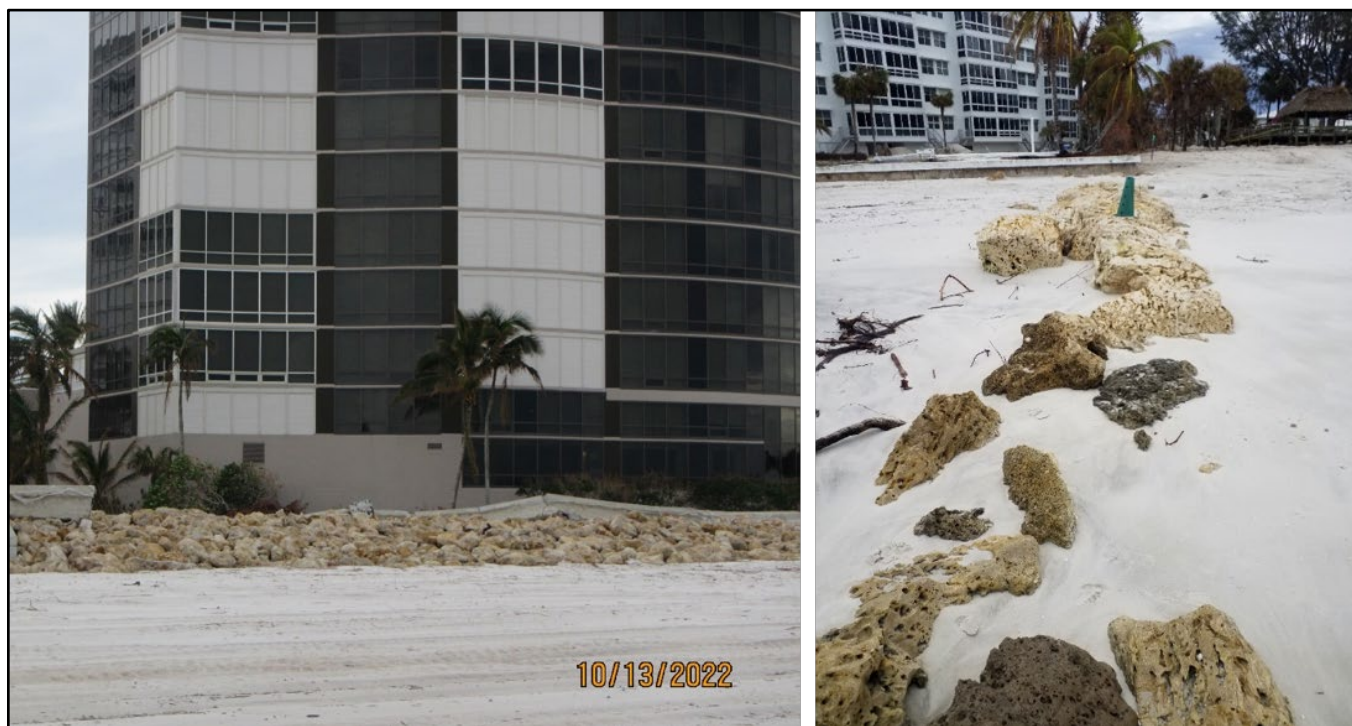
Figure 48. Concrete seawall collapsed in Naples at R-47 (left) and buried groin exposed at R-58 (right).

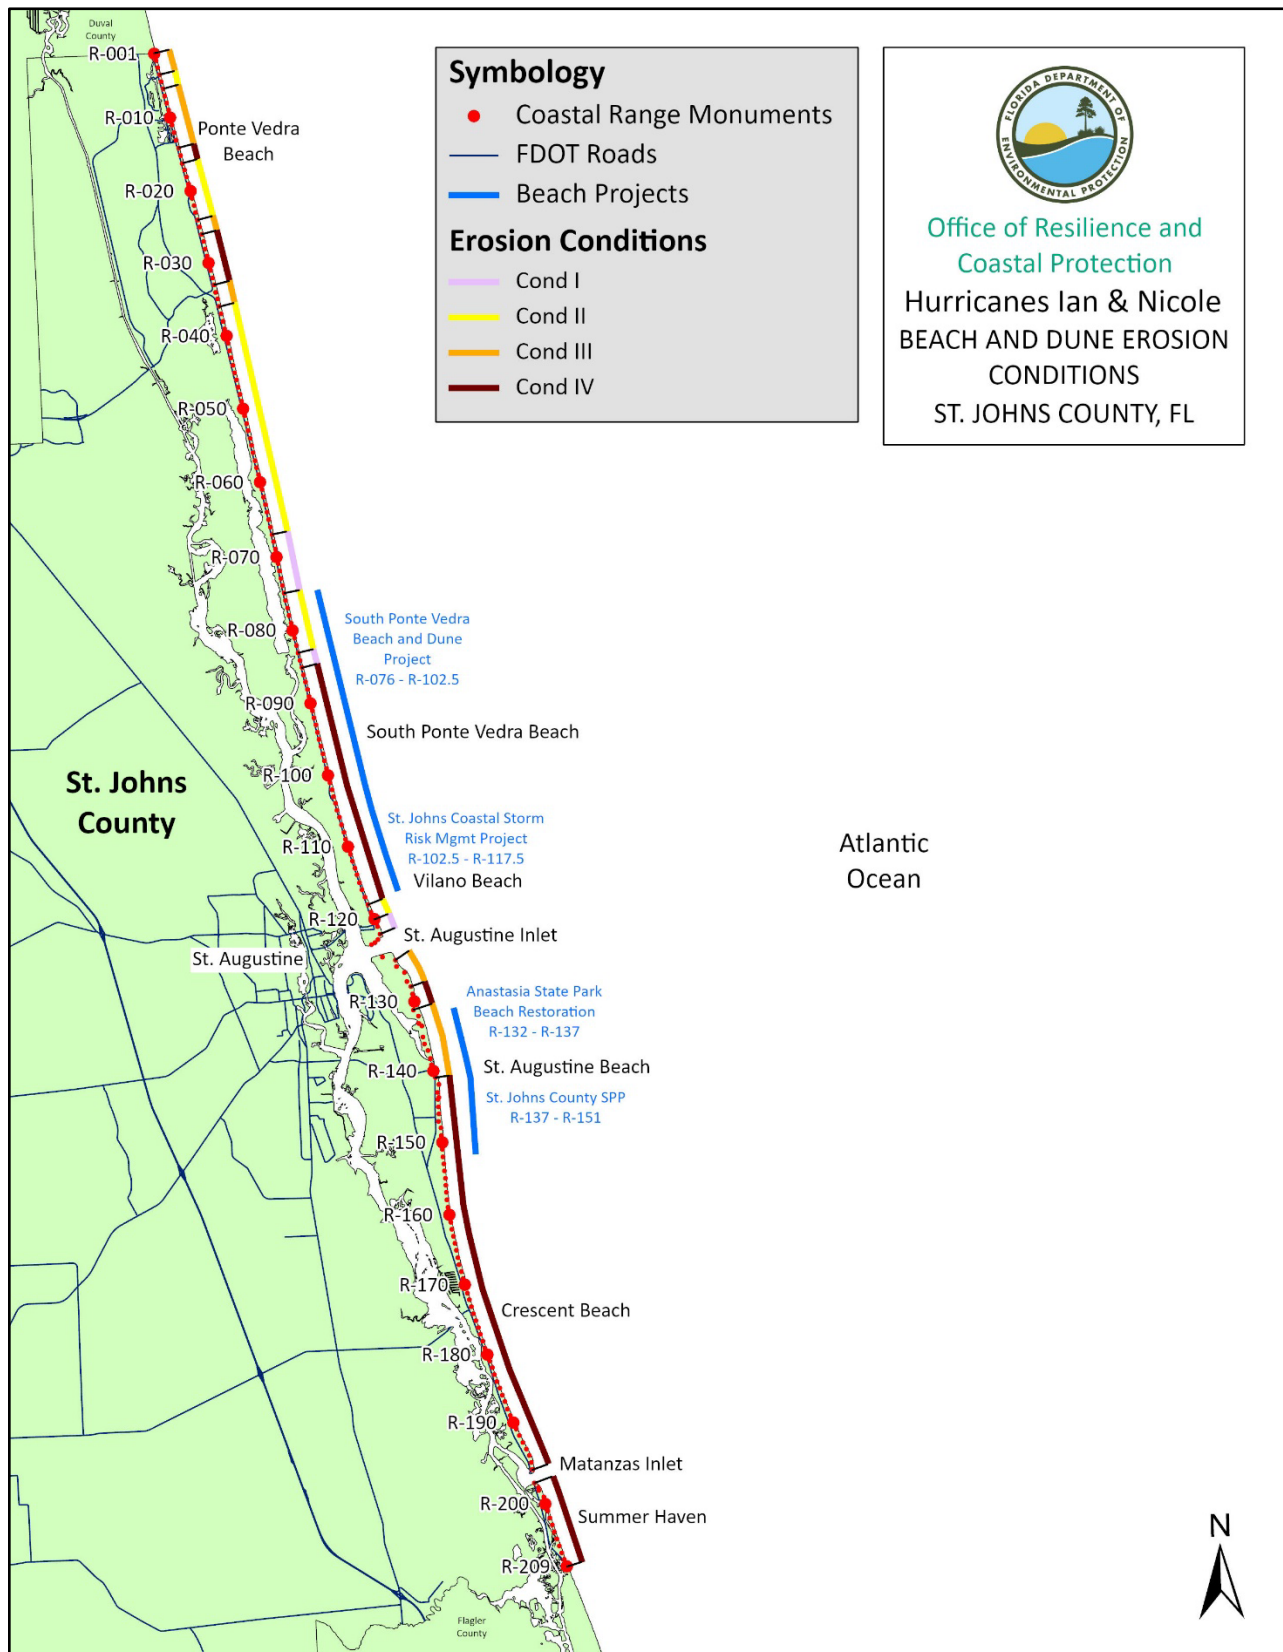
Figure 49. St. Johns County Beach and Dune Erosion Conditions from Hurricanes Ian and Nicole.

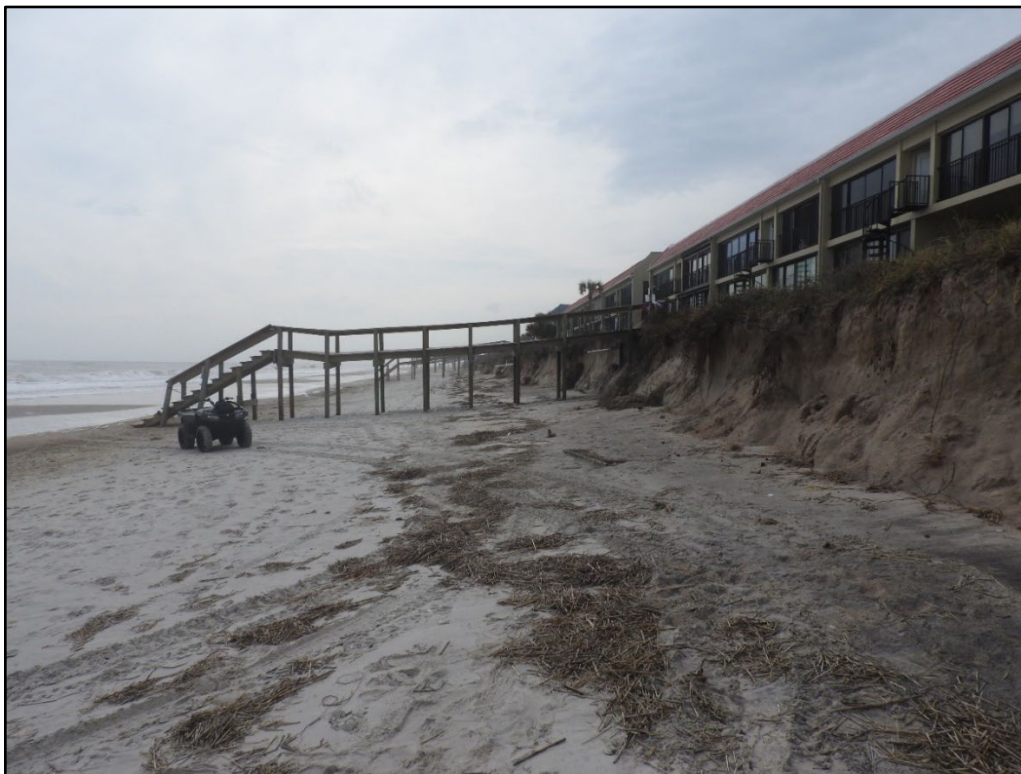
Figure 50. Major beach and dune erosion in Ponte Vedra (R-15).
