Hurricane Ian & Hurricane Nicole
Preliminary Post-Storm Beach Conditions
and Coastal Impact Report

Office of Resilience and Coastal Protection
Florida Department of Environmental Protection
December 2022

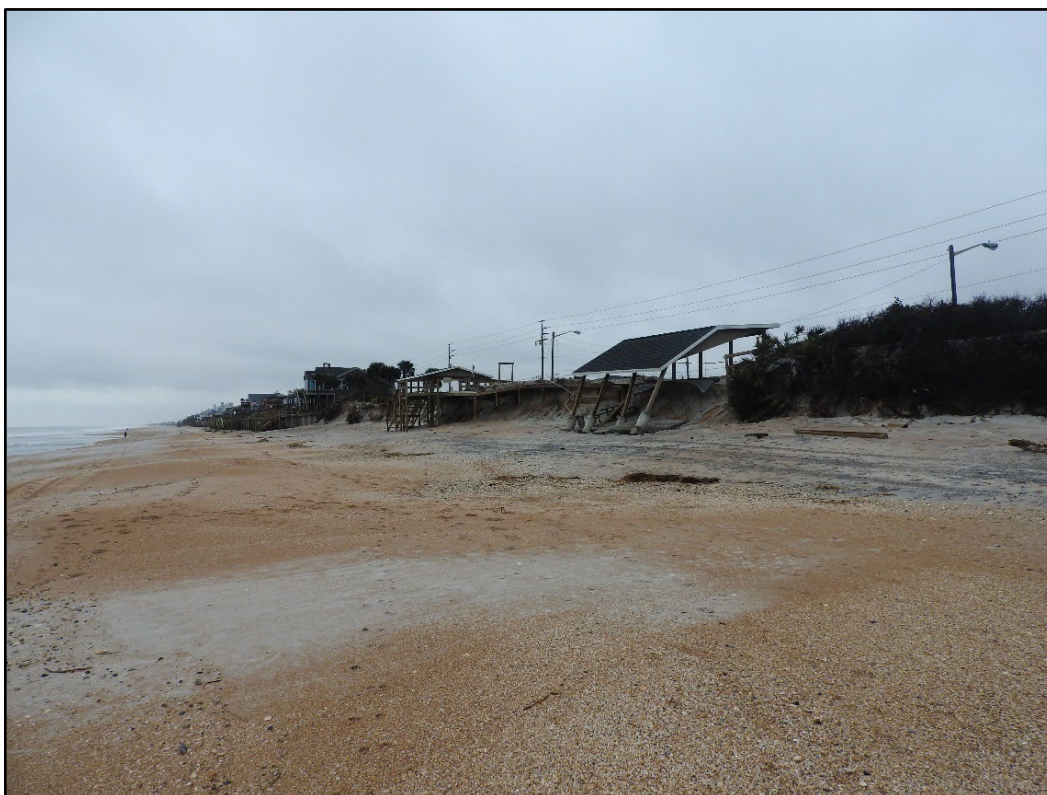
Figure 52. Major damage to a pavilion due to erosion in a county park in South Ponte Vedra (R-95).

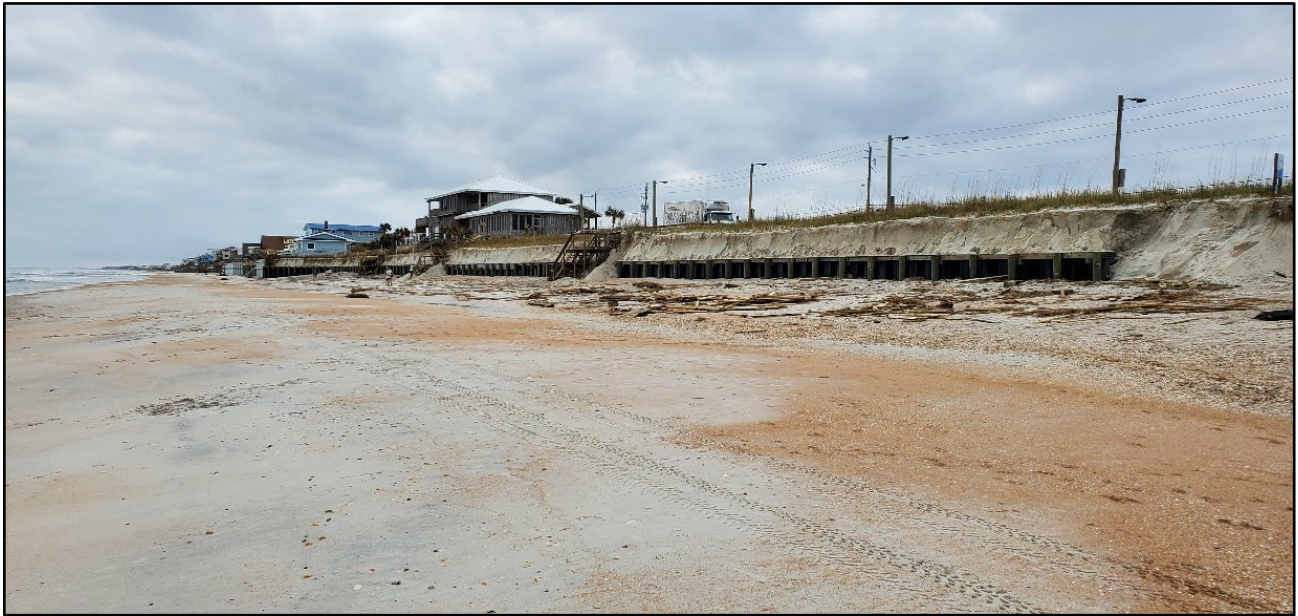
Figure 53. Major beach and dune erosion at the Reef Restaurant, South Ponte Vedra Beach (R-109).

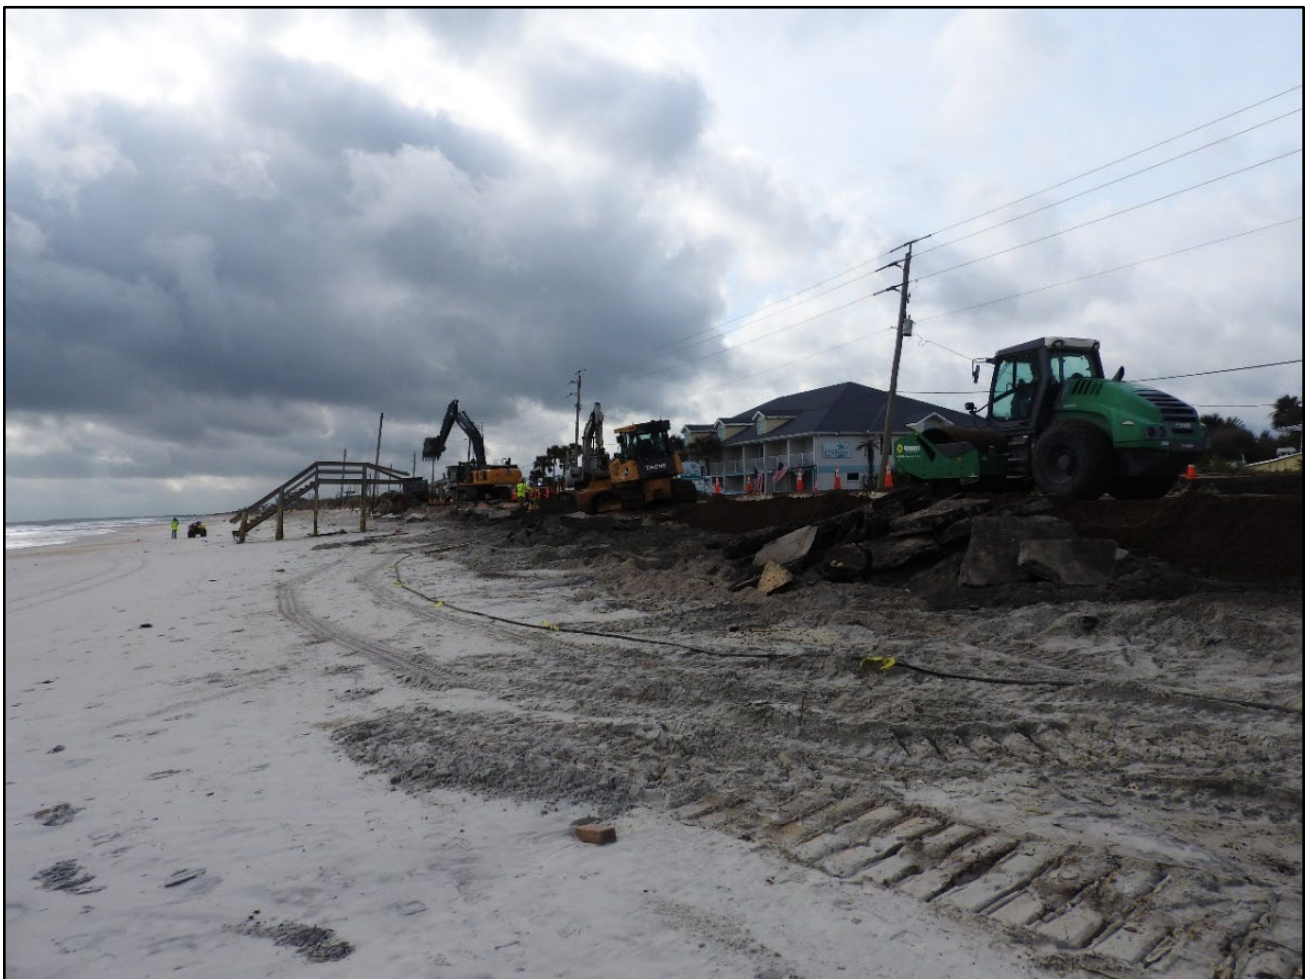
Figure 54. Major beach and dune erosion and road damage at Vilano Beach (R-115).

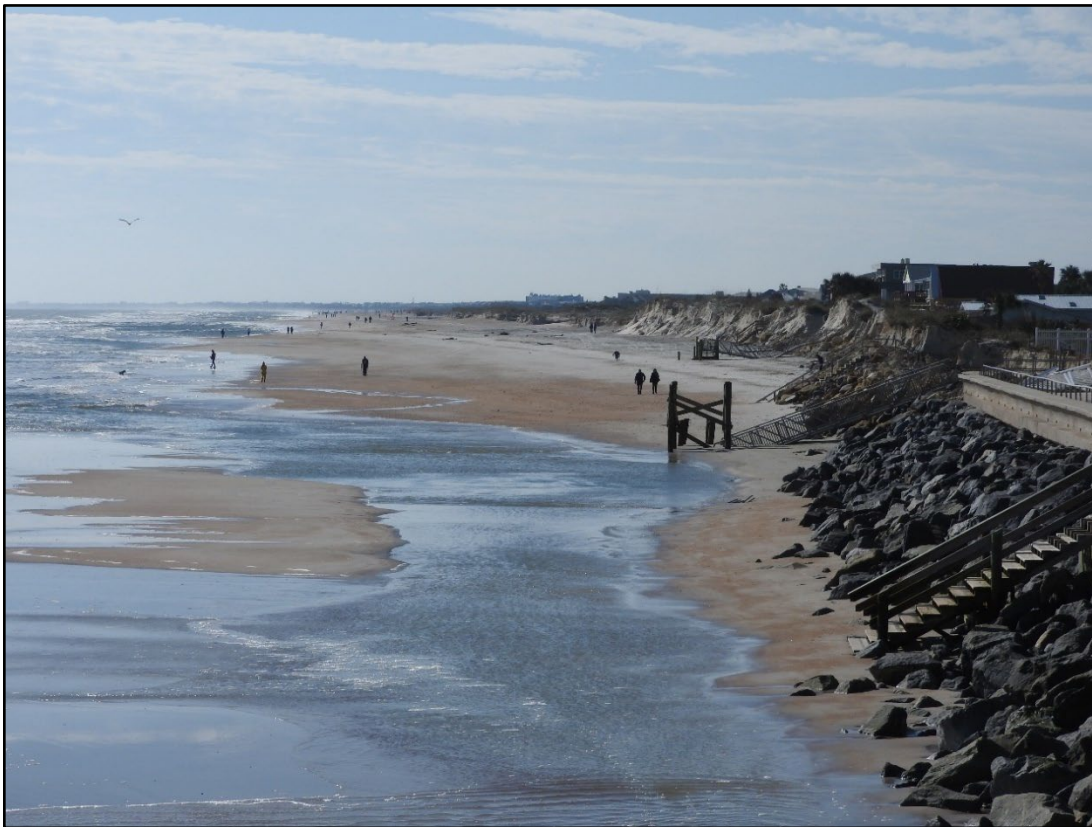
Figure 55. Major beach and upland erosion at St. Augustine Beach, looking south from pier (R-142).

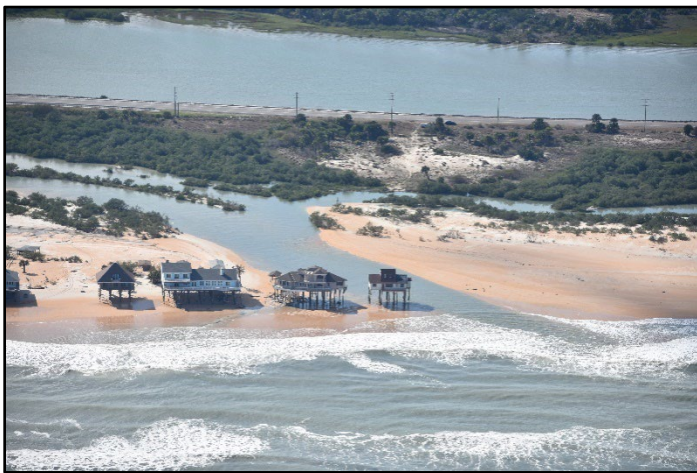
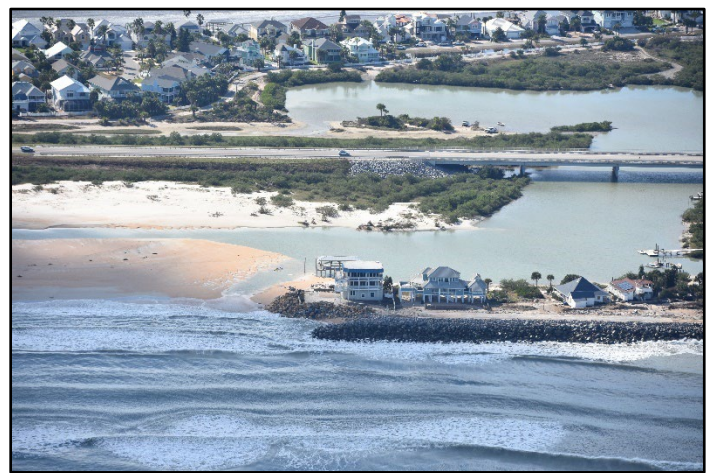
Figure 60. Coastal barrier breaches at Summer Haven at R204.9 (left) and R200 (right). Aerial oblique photos taken by the Civil Air Patrol on November 12, 2022.

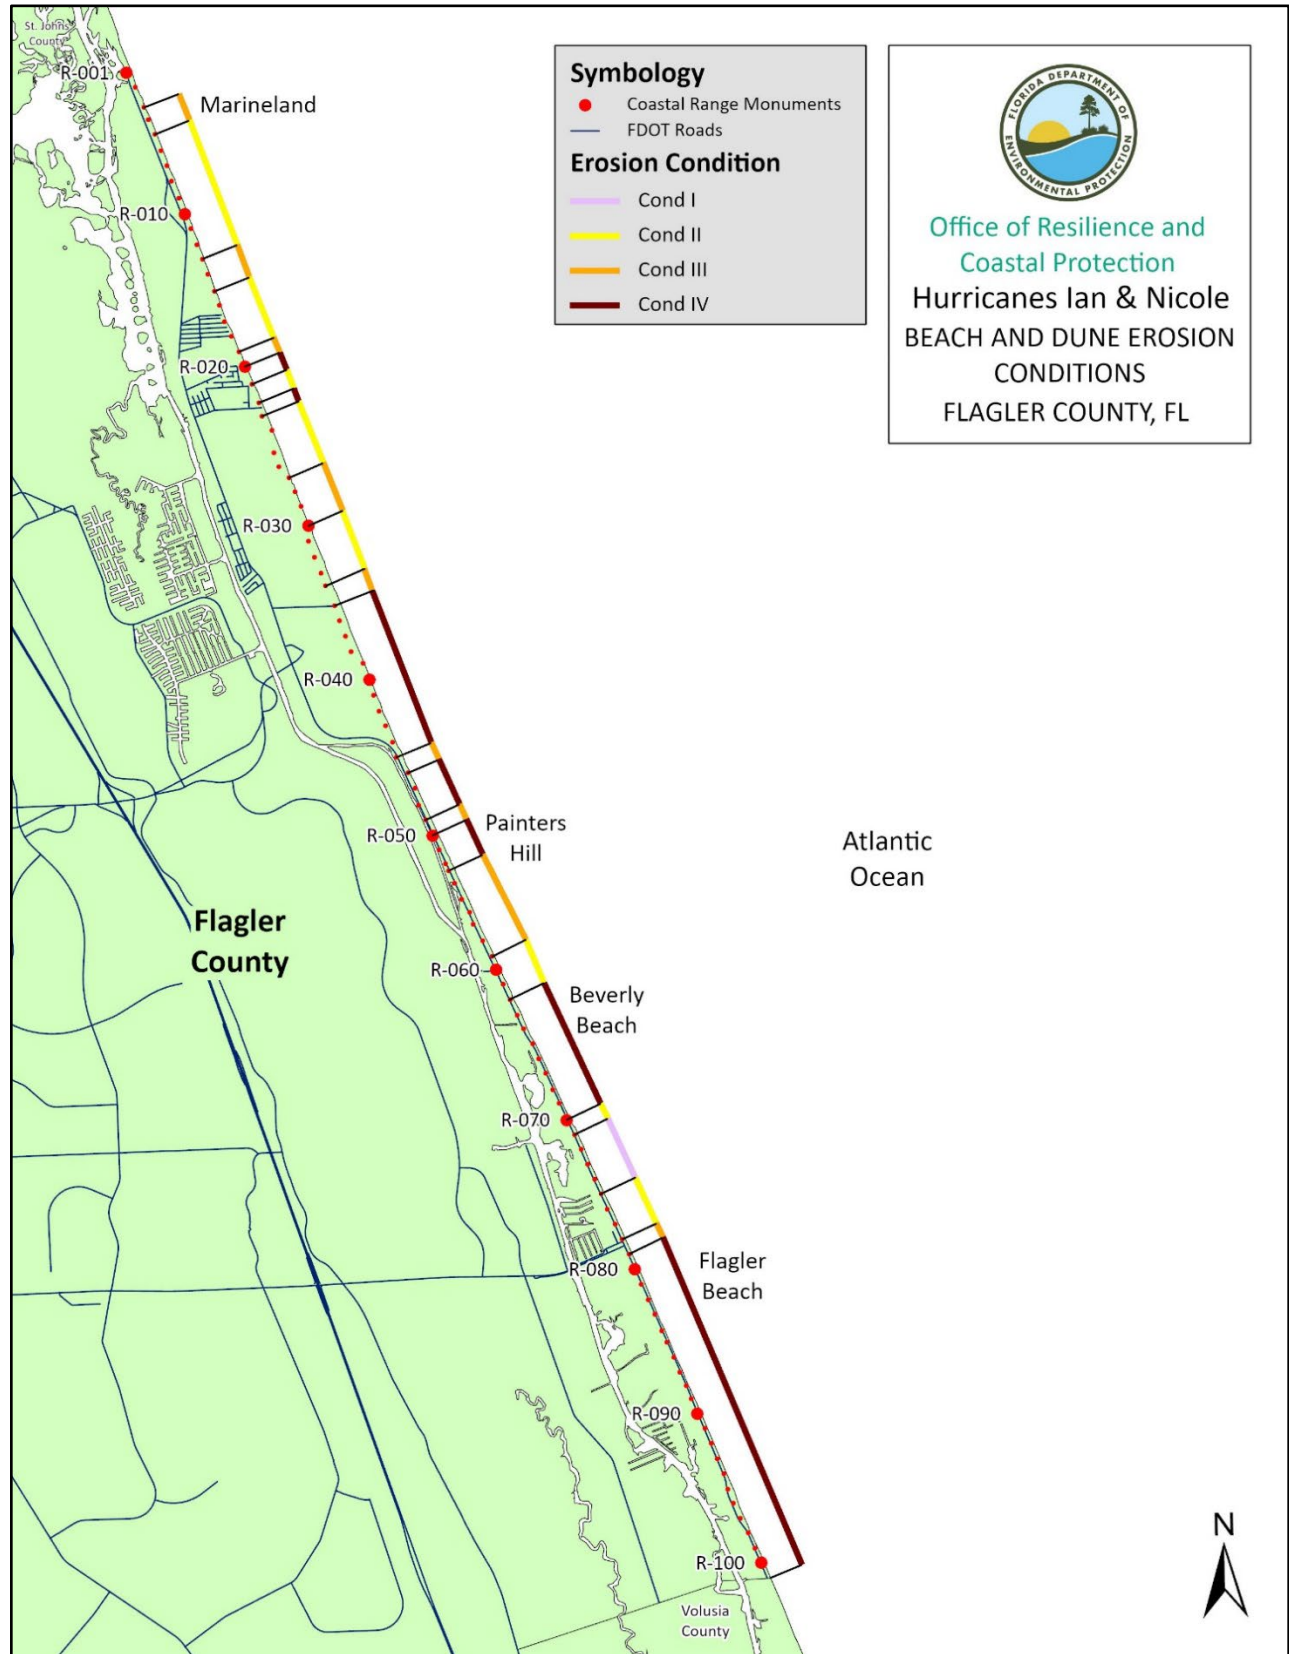
Figure 61. Flagler County Beach and Dune Erosion Conditions from Hurricanes Ian and Nicole.

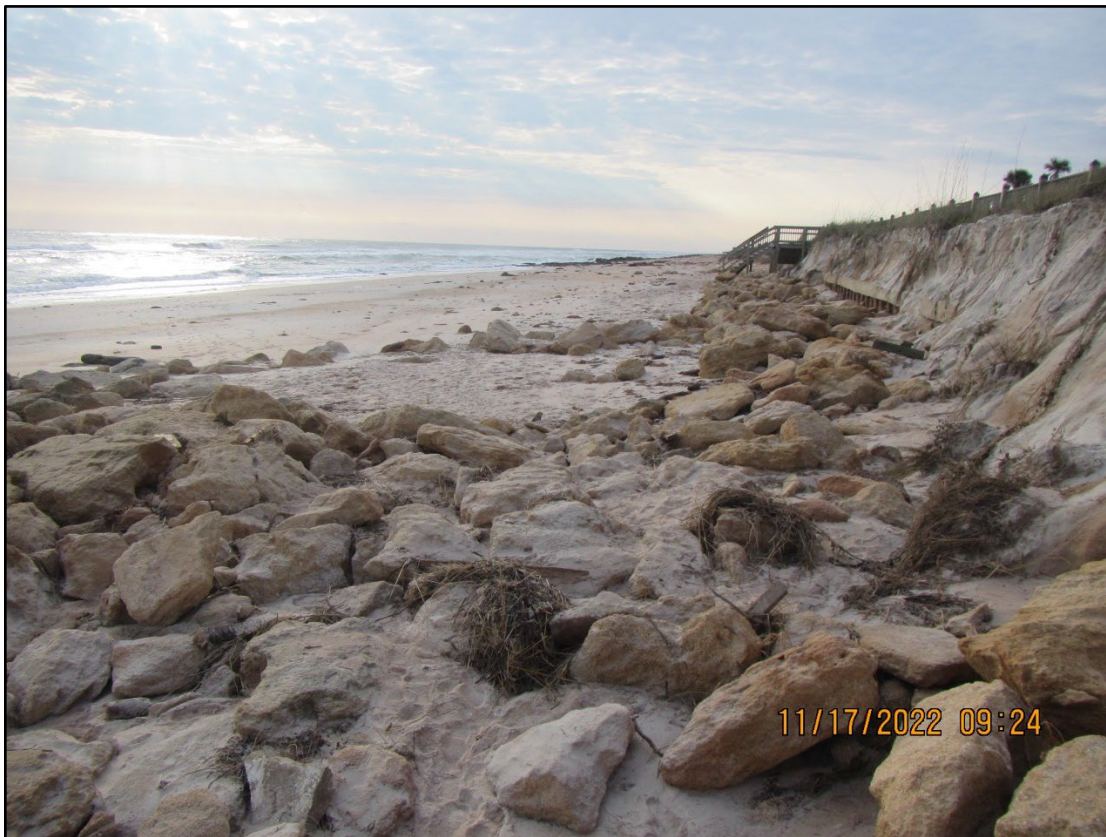
Figure 62. Major beach and dune erosion at Marineland’s River to Sea Preserve (R3).

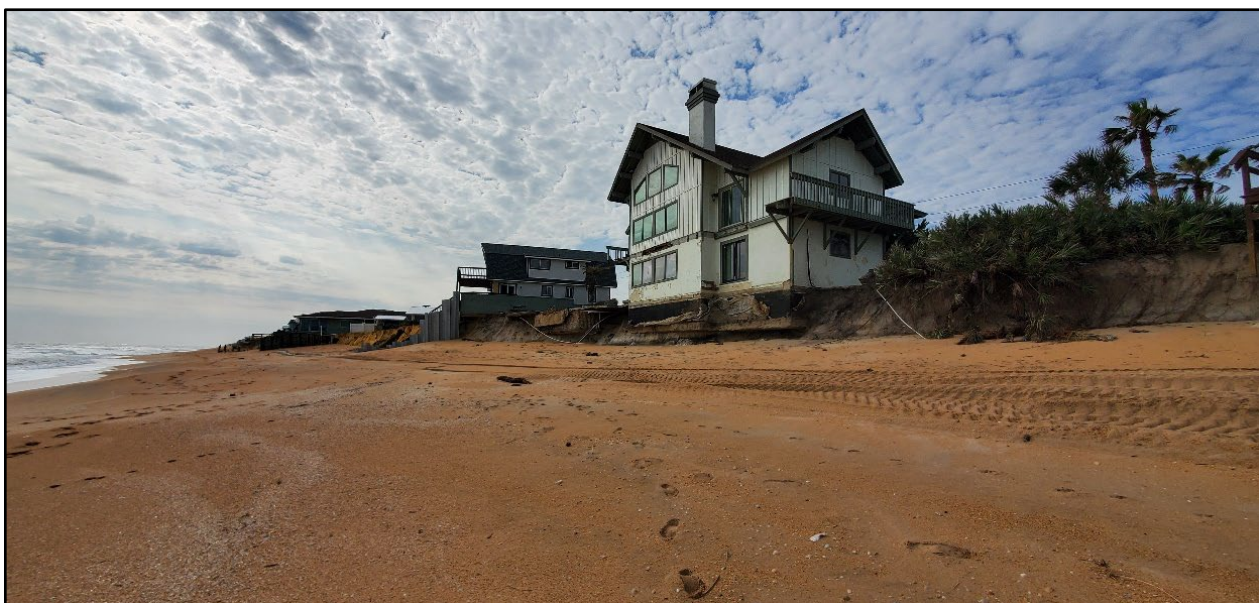
Figure 66. Single-family dwelling with first floor damage and major pool damage in Beverly Beach (R-53).

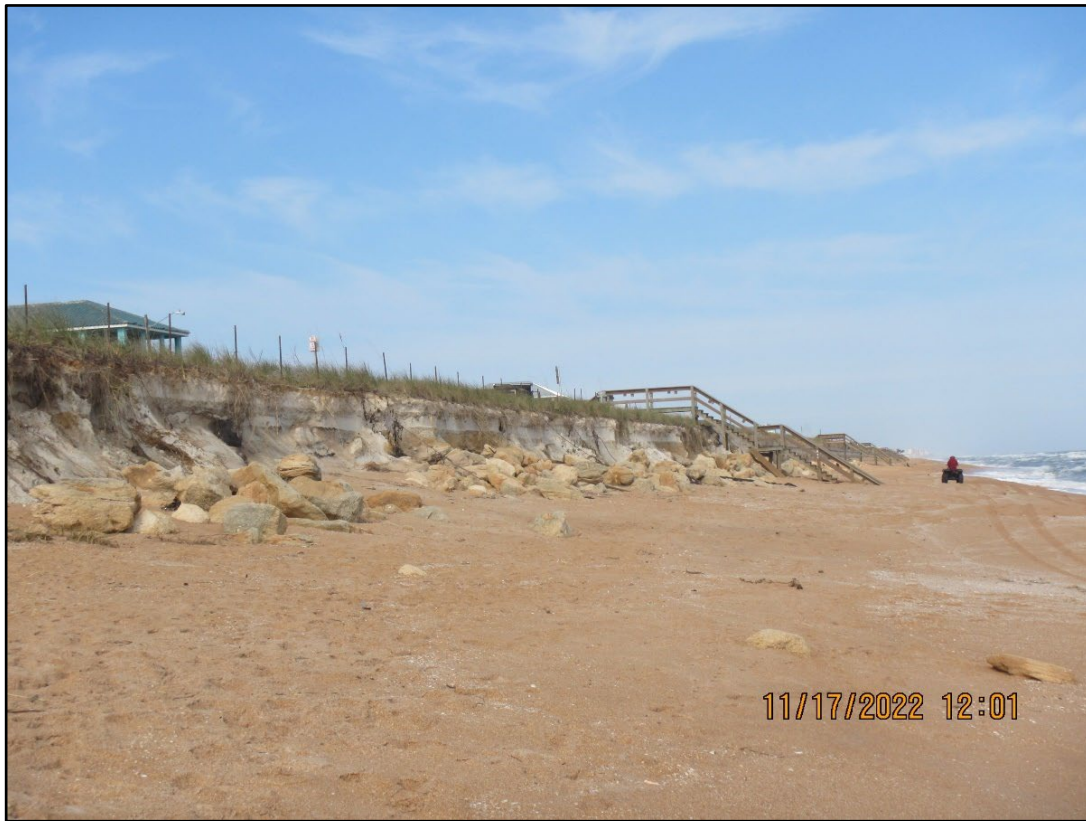
Figure 67. Beverly Beach after Hurricane Nicole (R-69).

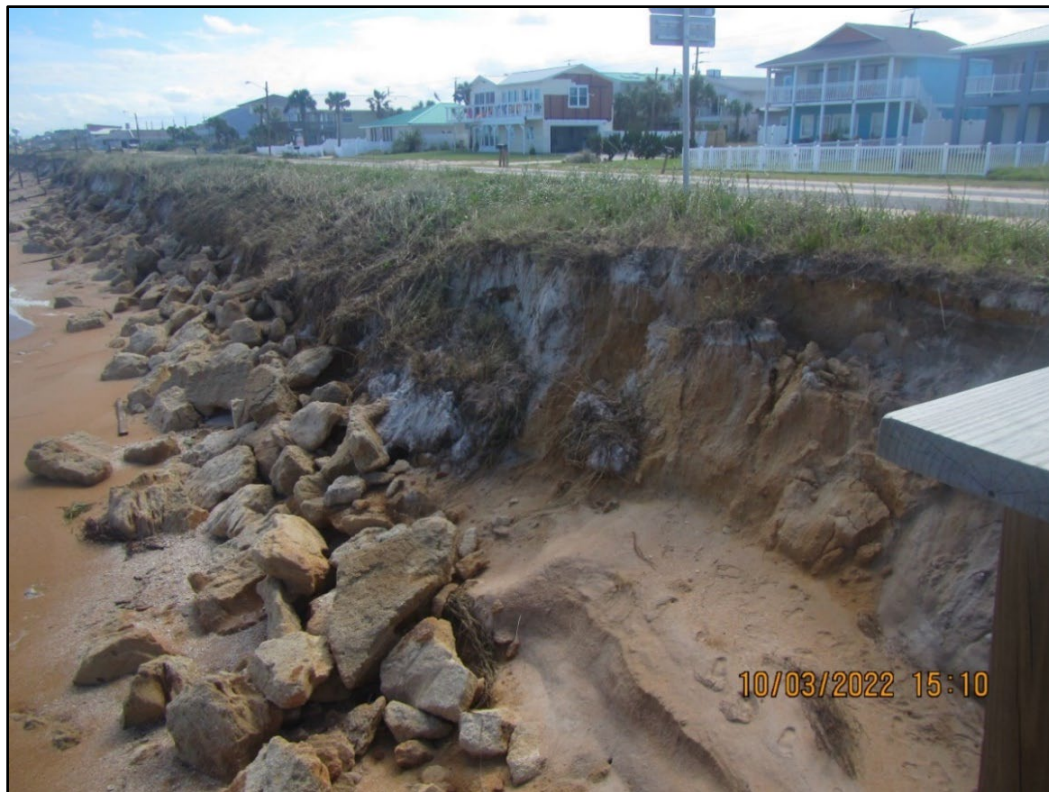
Figure 70. Major revetment damage due to Hurricane Ian south of the pier (R-80).

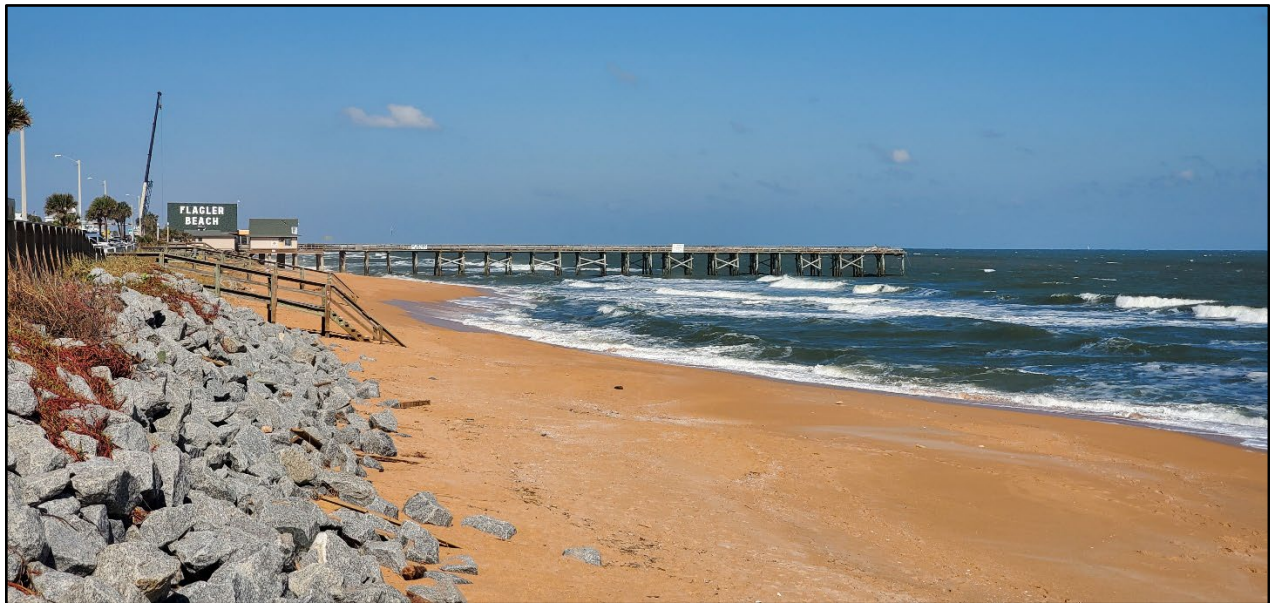
Figure 71. Flagler Beach Fishing Pier with 165 ft. of the seaward end destroyed (R-79).

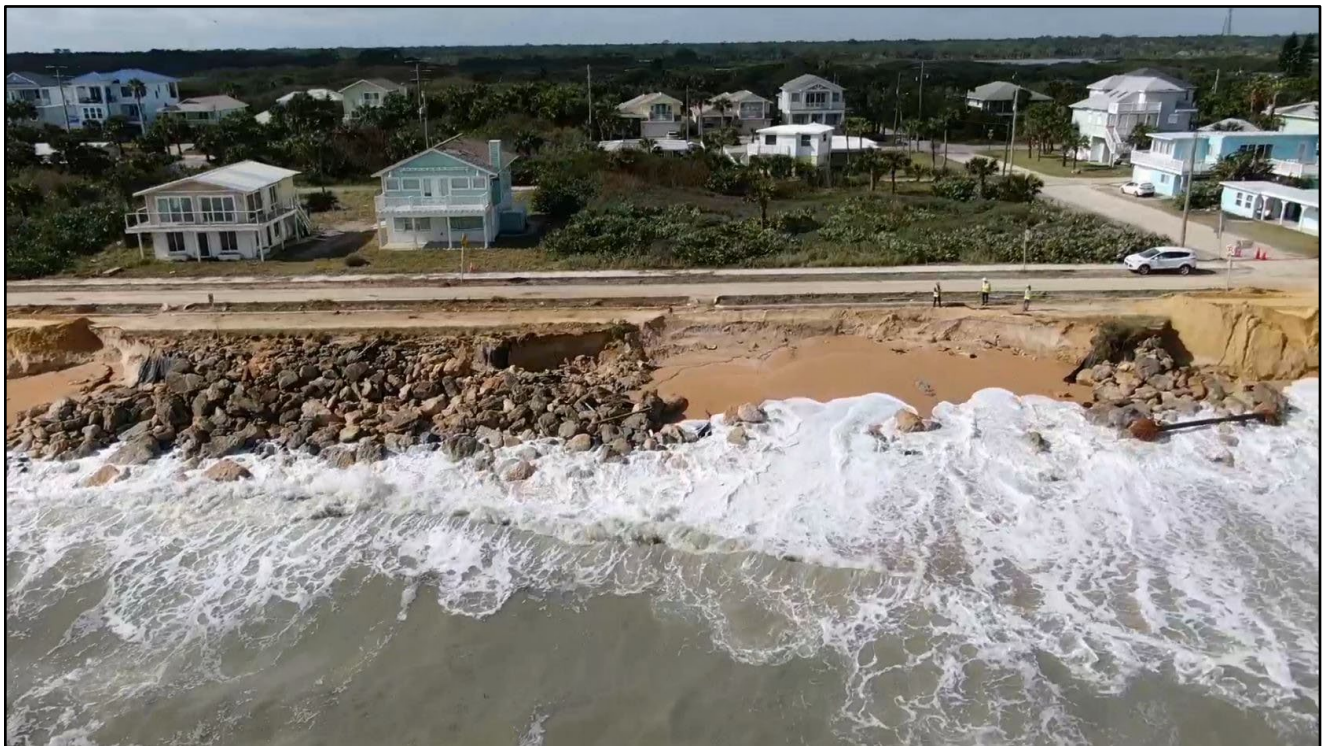
Figure 72. A1A revetment and road damage after Hurricane Nicole in Flagler Beach at 17th Street South (R-88). Drone footage courtesy of Olsen Associates and Flagler County.

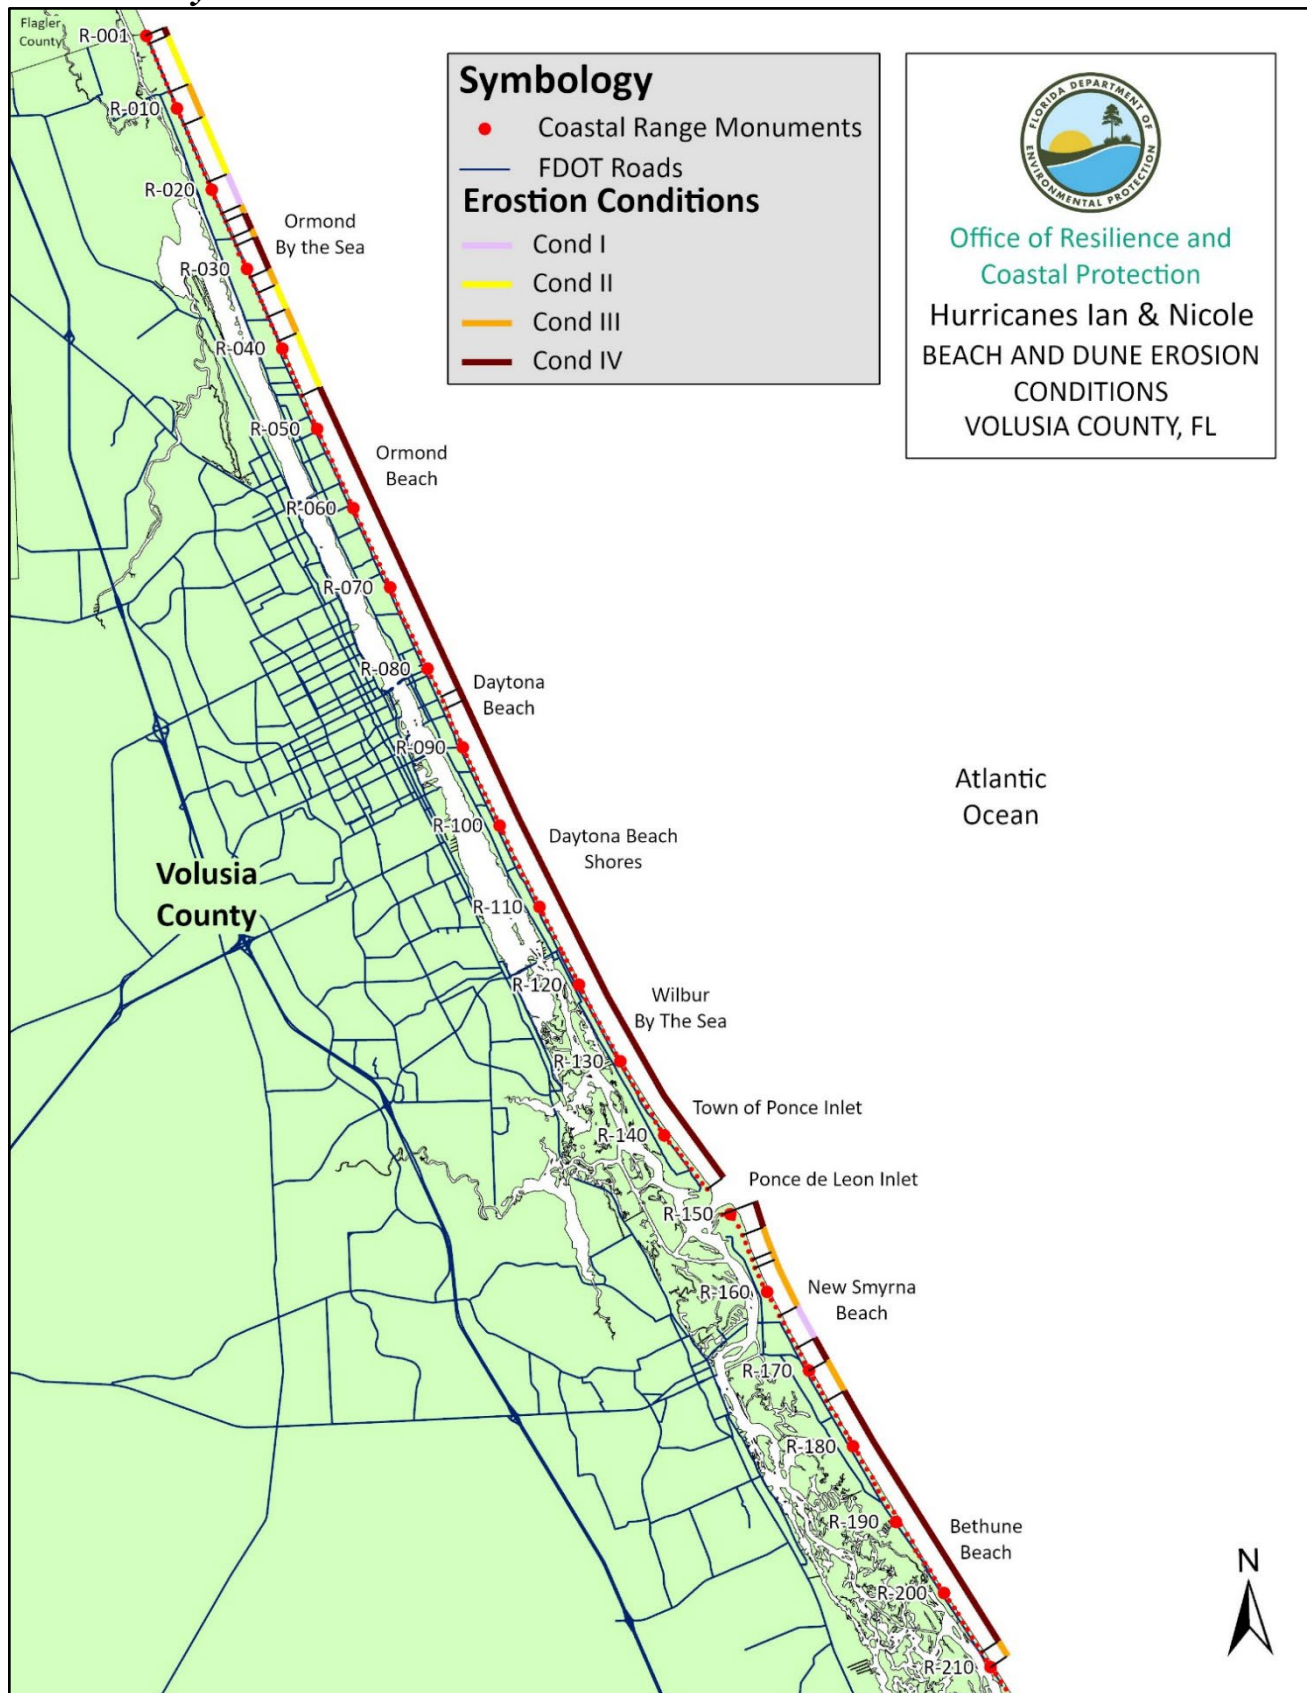
Figure 73. Volusia County Beach and Dune Erosion Conditions from Hurricanes Ian and Nicole.

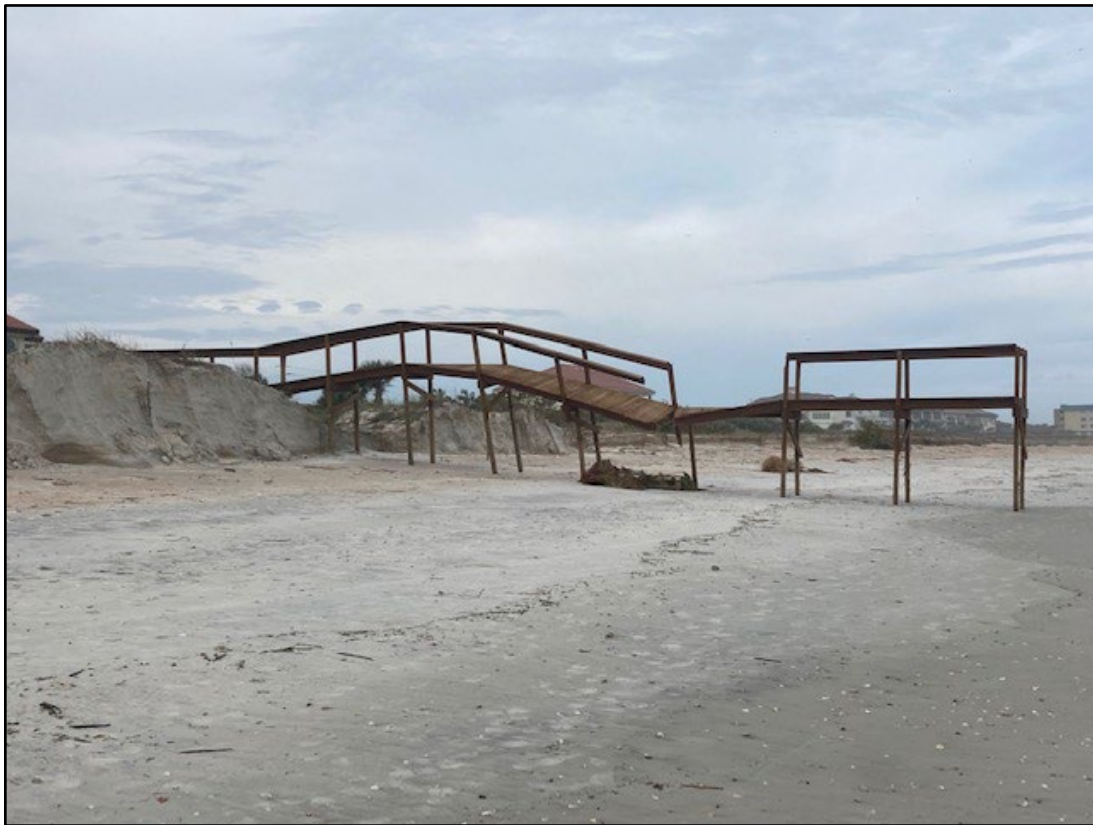
Figure 74. Major beach and dune erosion in the Town of Ponce Inlet (R147).

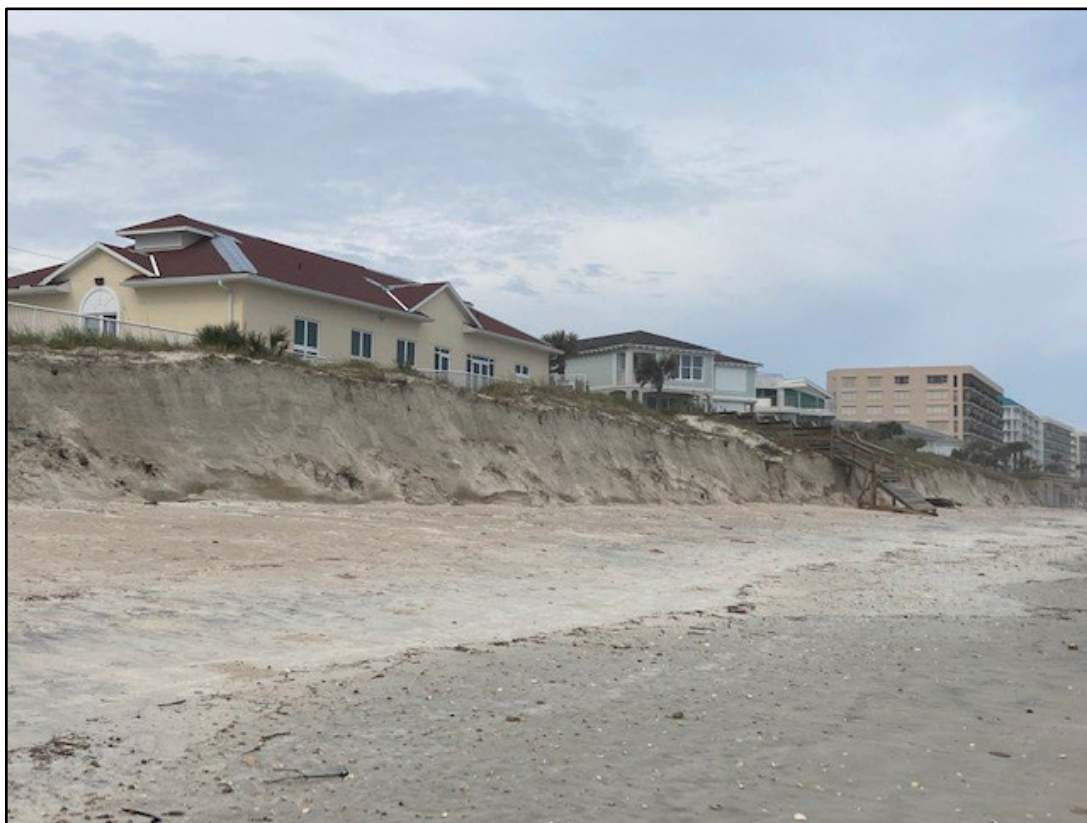
Figure 75. Severe dune erosion threatening upland properties in the Town of Ponce Inlet (R138).

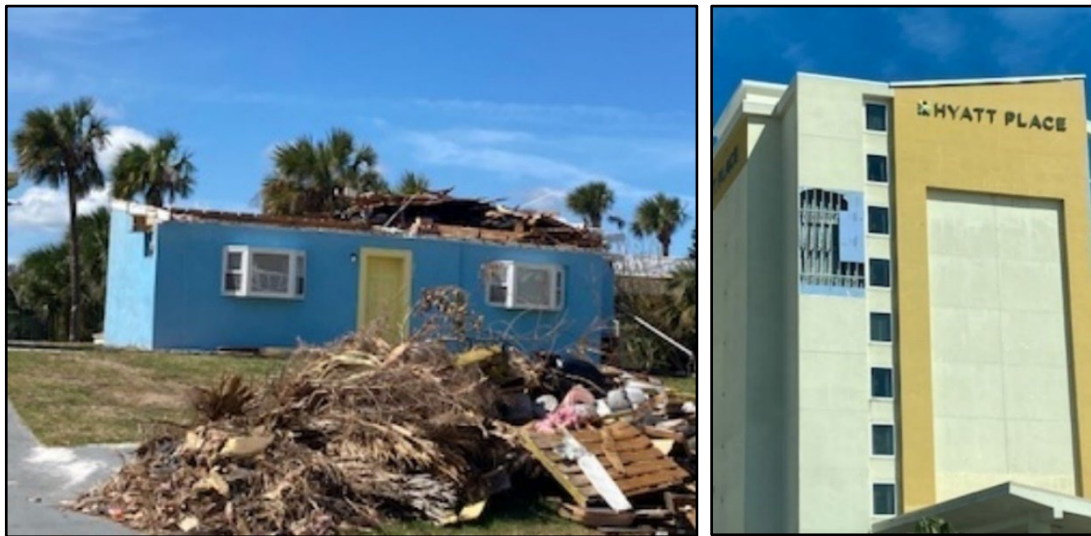
Figure 76. Roof blown off dwelling (left, R94); siding damage on hotel (right, R111).

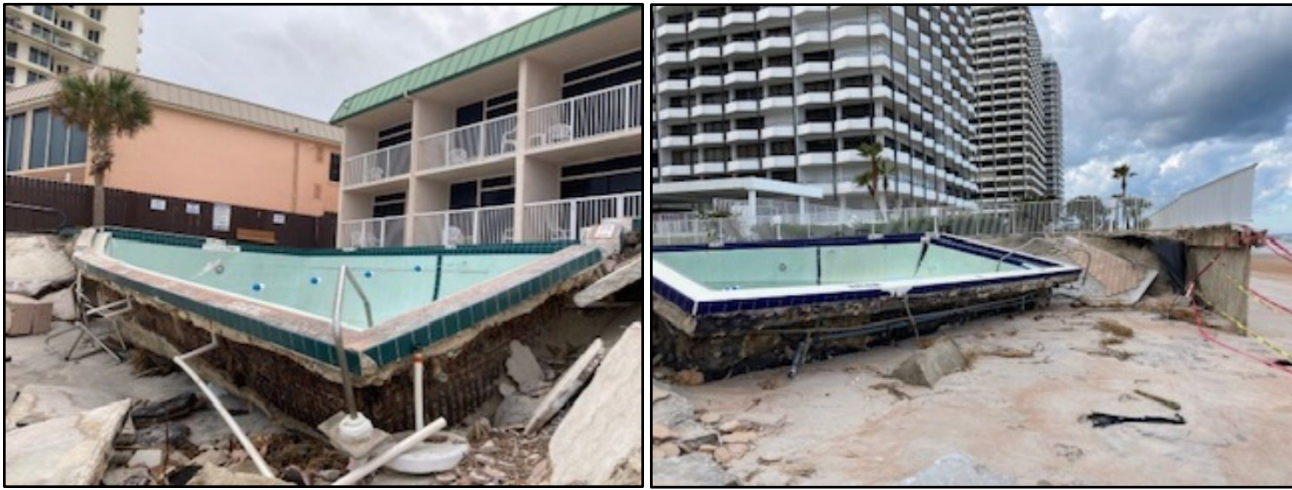
Figure 77. Swimming pools destroyed with seawall failure (R101).

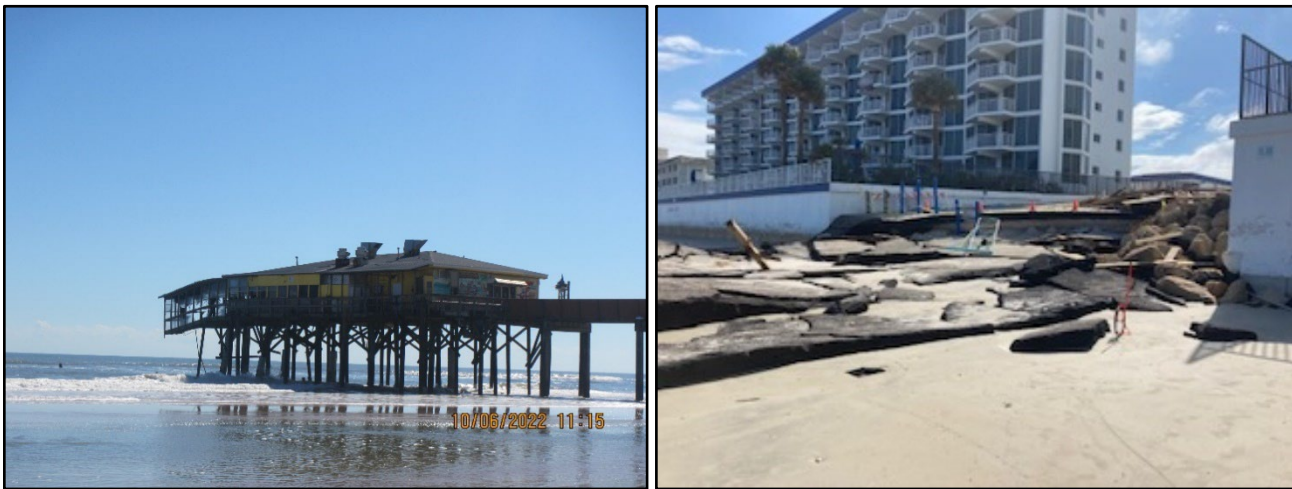
Figure 78. Sun Glow Fishing Pier destroyed (left, R118); Demotte Ave. beach ramp destroyed (right, R116).

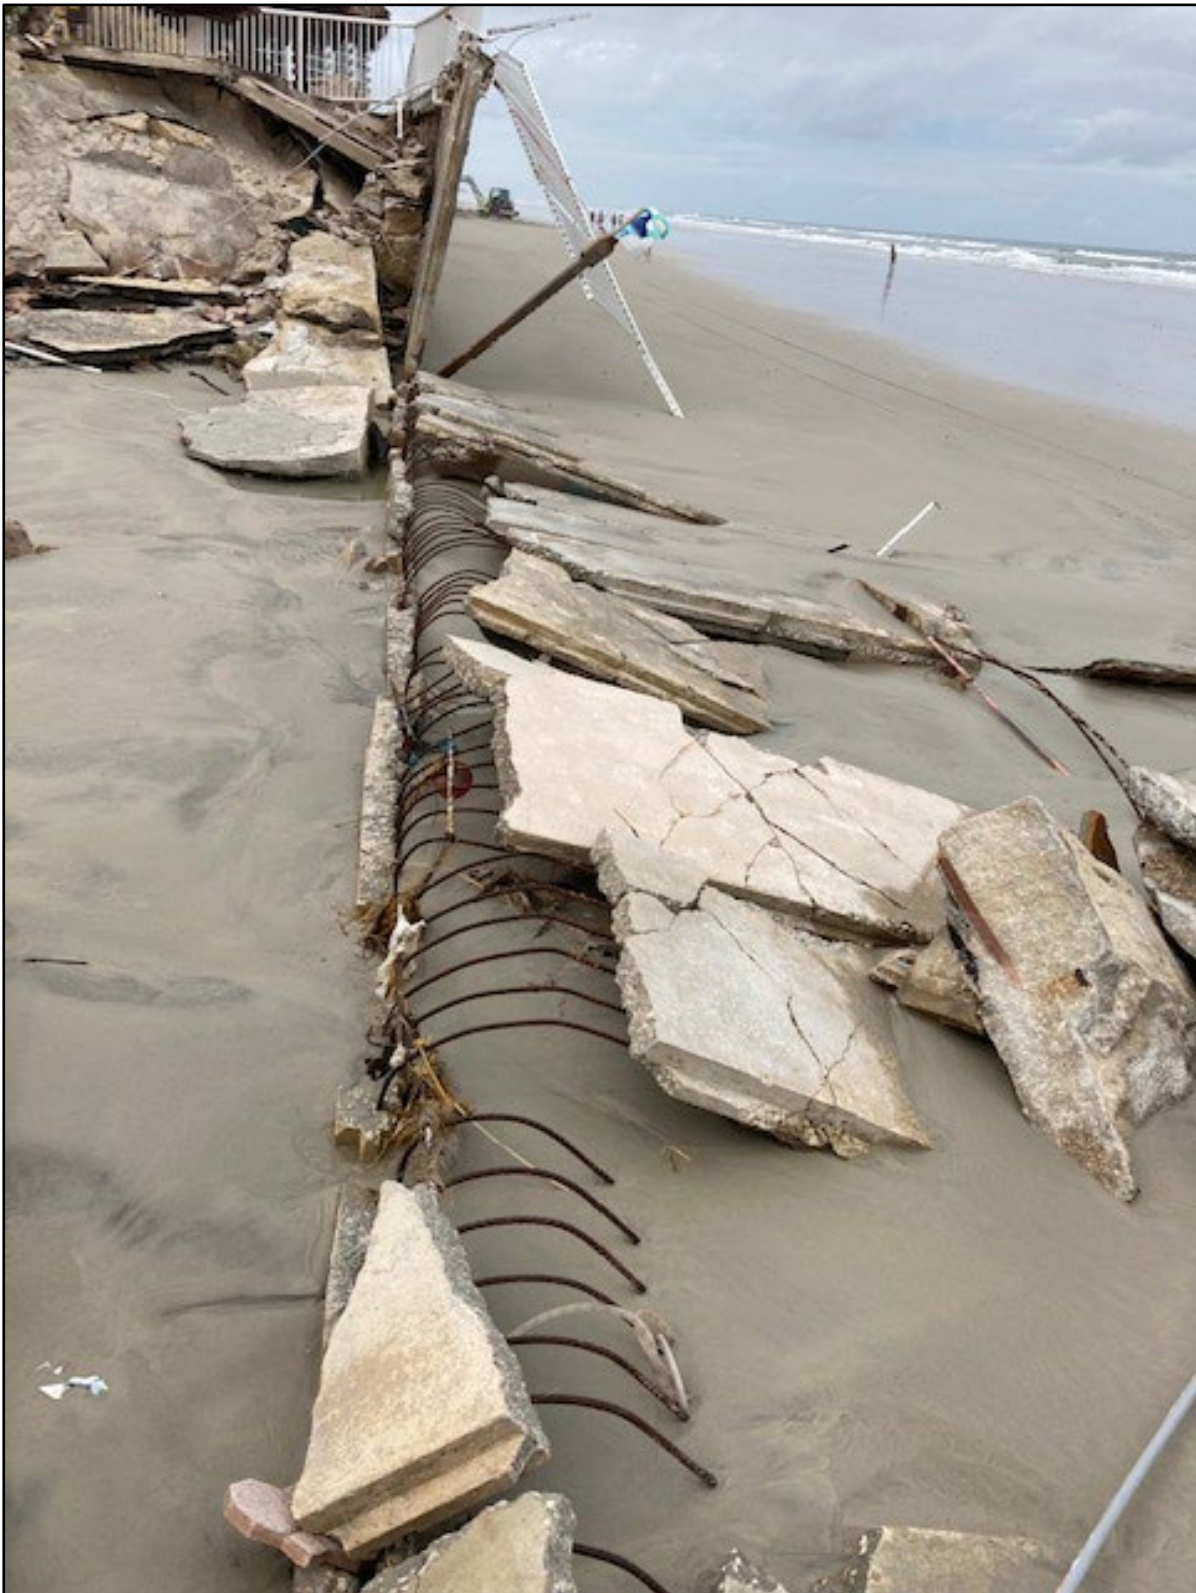
Figure 79. Seawall failure due to inadequate panel thickness of only 4 inches.

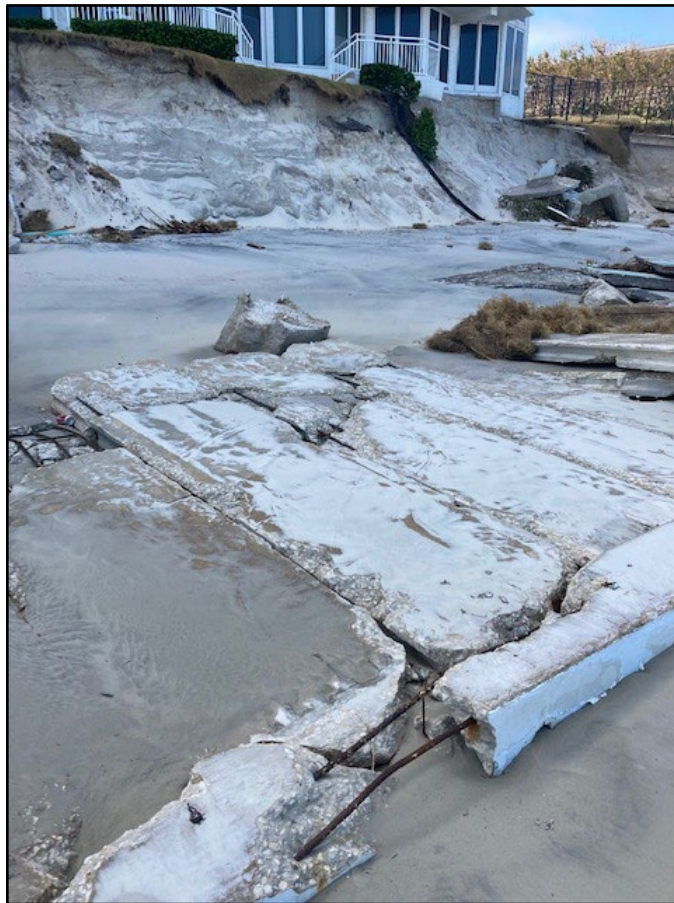
Figure 80. Old seawall with corroded reinforcing steel in Daytona Beach Shores (R116).

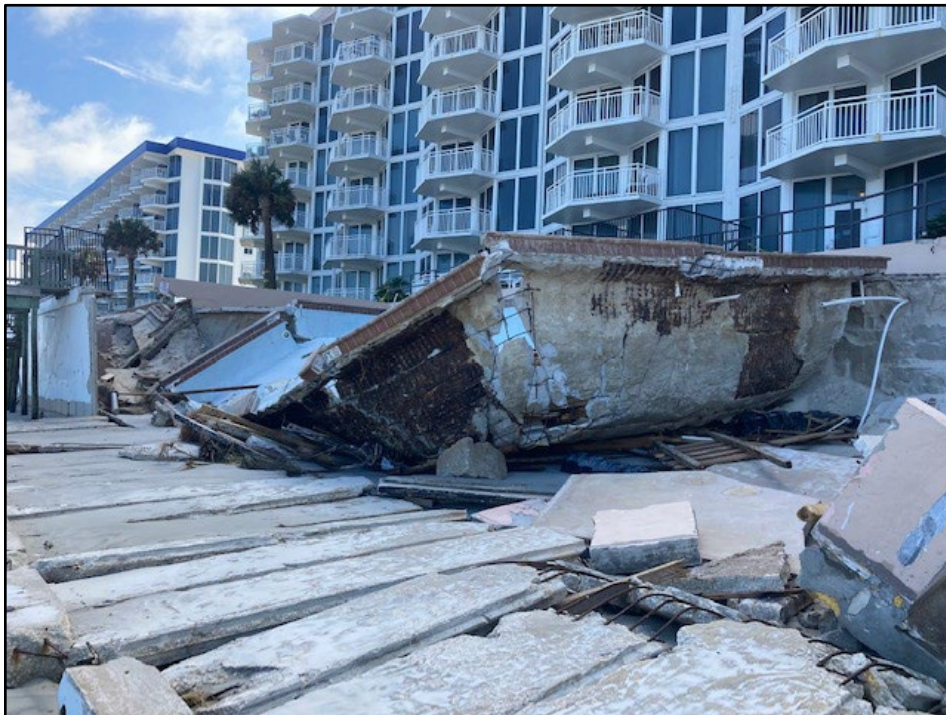
Figure 81. Seawall destroyed with inadequate pile penetration resulting in a destroyed

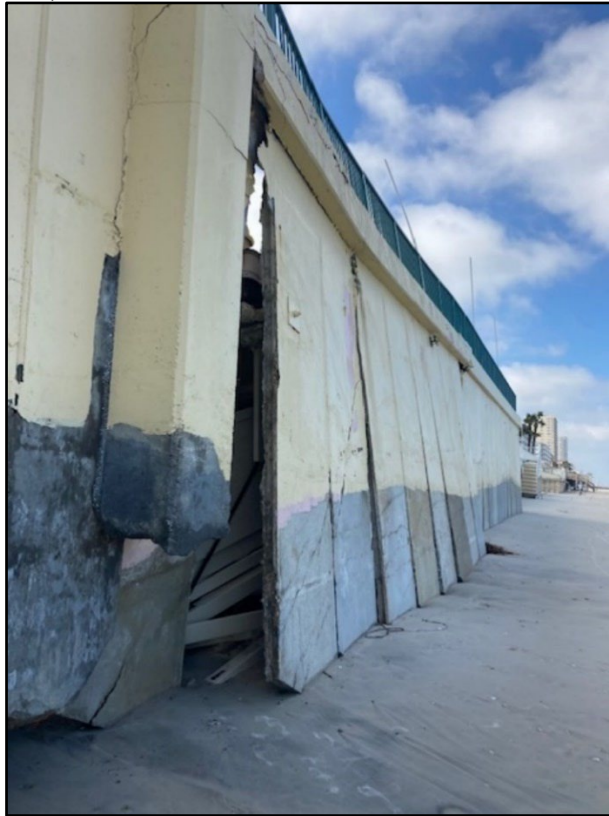
Figure 82. Inadequate sheet pile penetration.

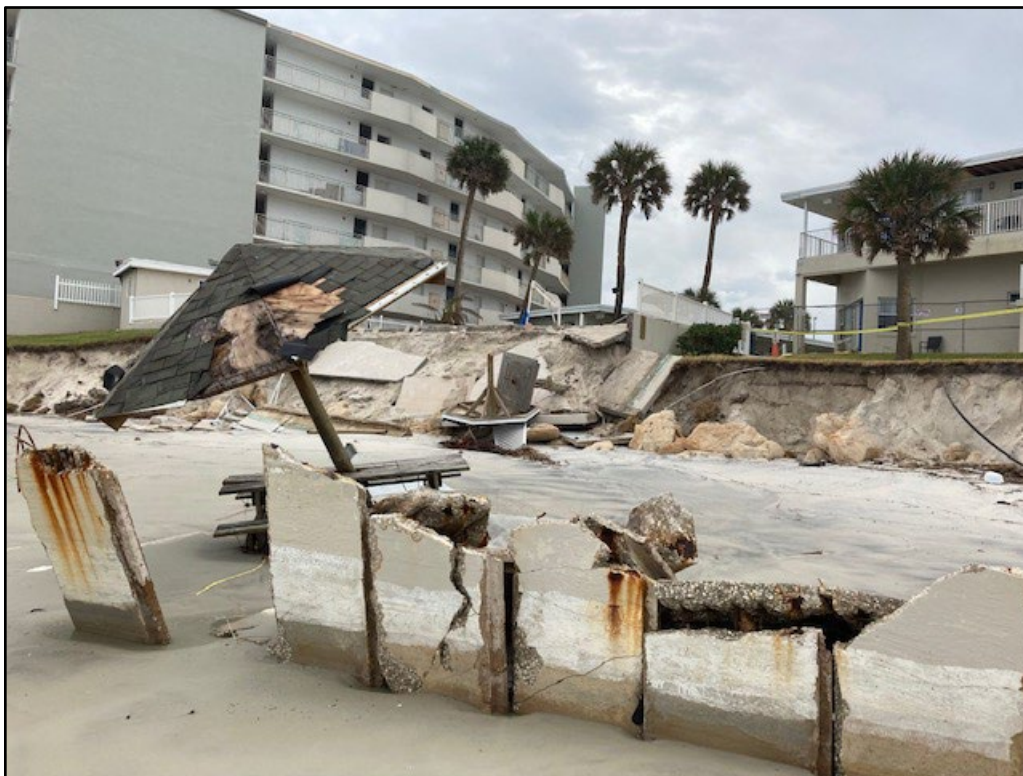
Figure 83. Old seawall destroyed by wave impact loads resulting in substantial
