Hurricane Ian & Hurricane Nicole
Preliminary Post-Storm Beach Conditions
and Coastal Impact Report

Office of Resilience and Coastal Protection
Florida Department of Environmental Protection
December 2022

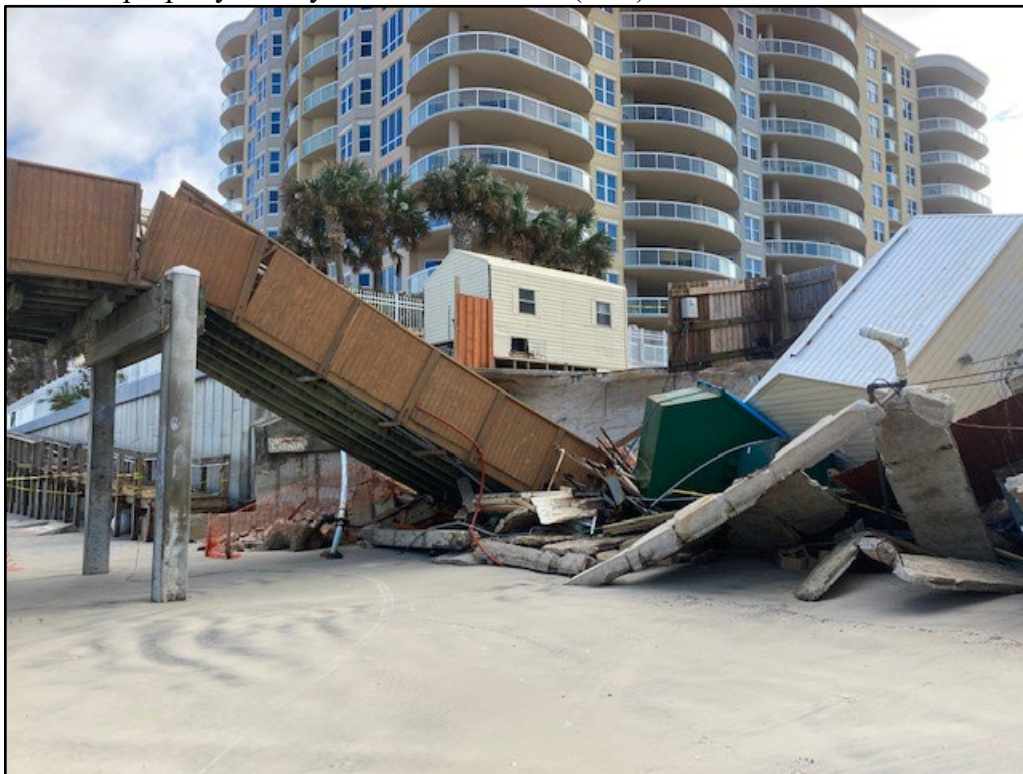
Figure 84. Multiple failures: landward section of Sun Glow Pier, seawall destroyed, building and parking lot destroyed (R118).

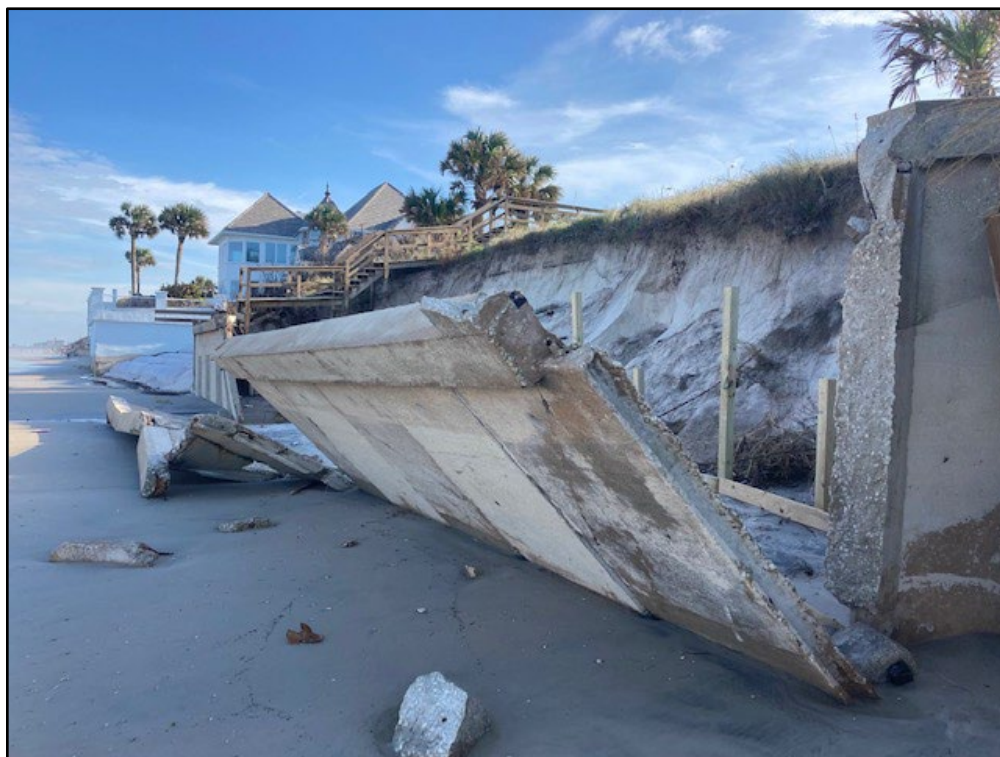
Figure 85. Seawall failure due to beach profile lowering and lack of tie-backs in Wilbur by the Sea (R124).

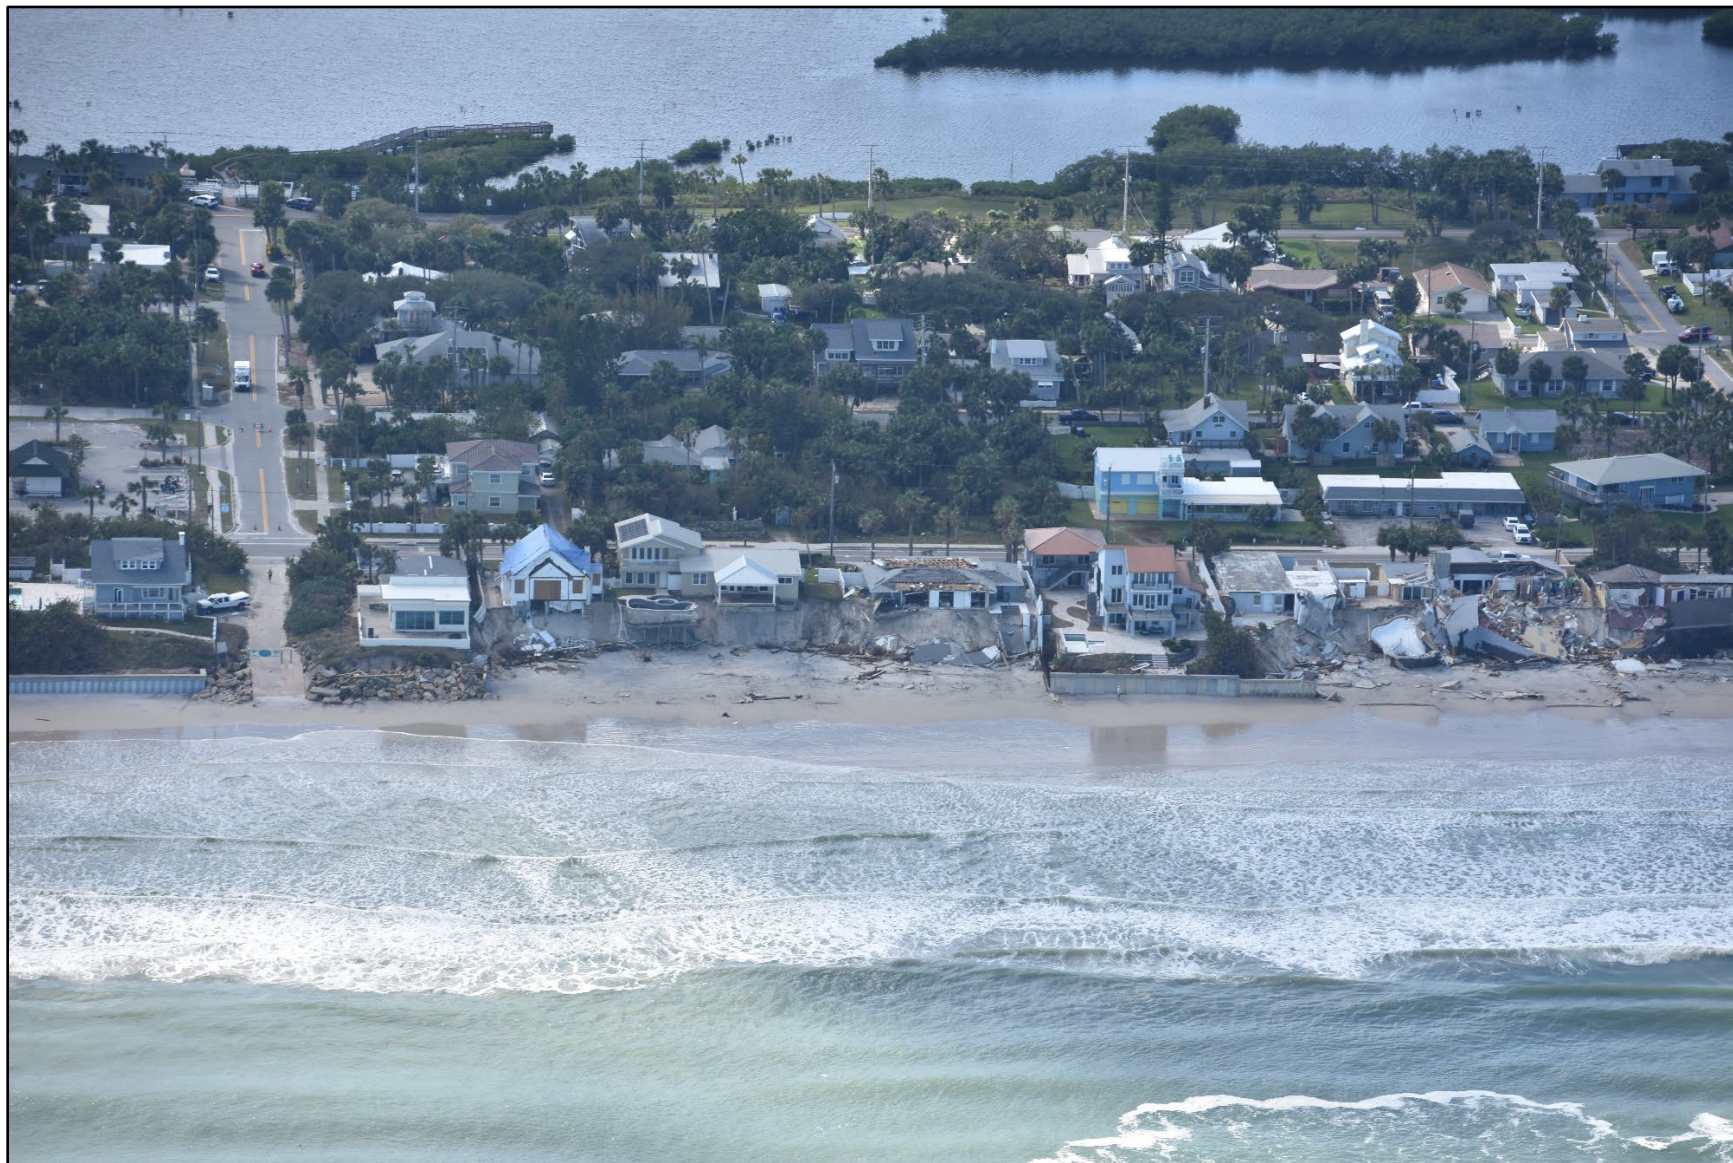
Figure 86. Major erosion damages to seawalls and upland properties at Toronita Avenue in Wilbur by the Sea (R-125).
[Credit: Oblique aerial photo by the Civil Air Patrol, November 12, 2022.]

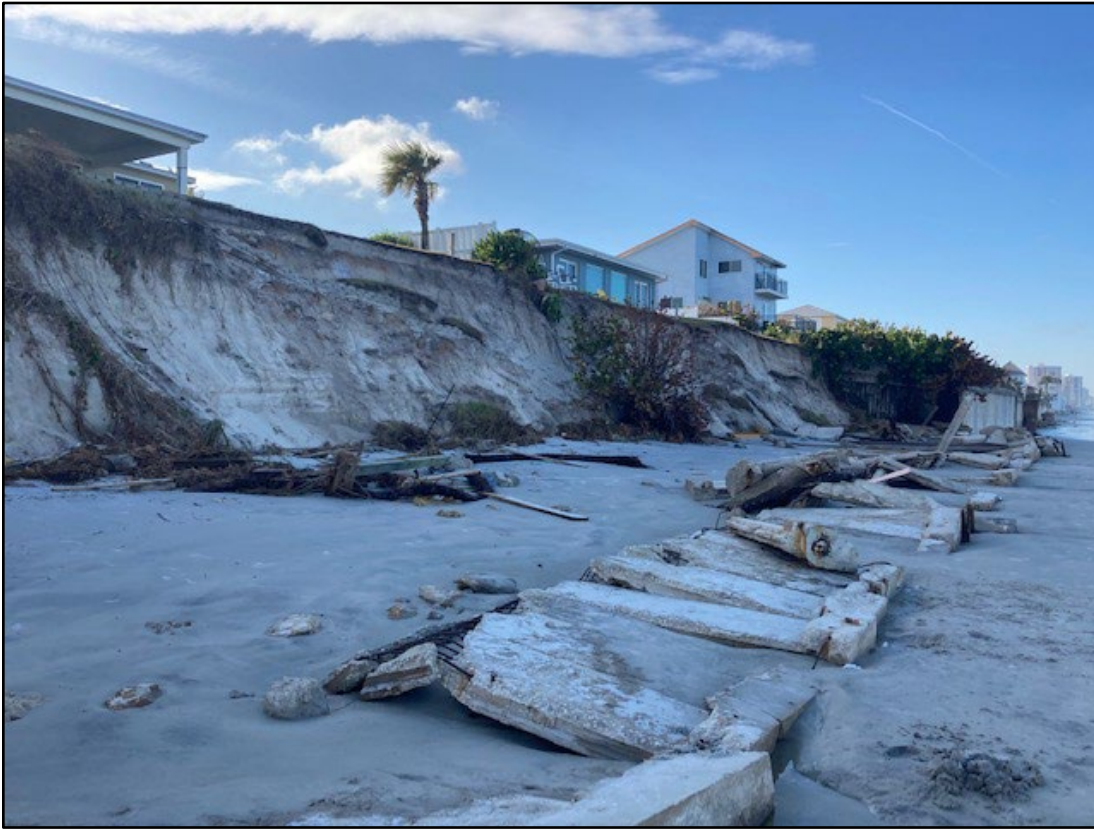
Figure 87. Catastrophic seawall collapse with loss of upland property in Wilbur by the Sea (R125).

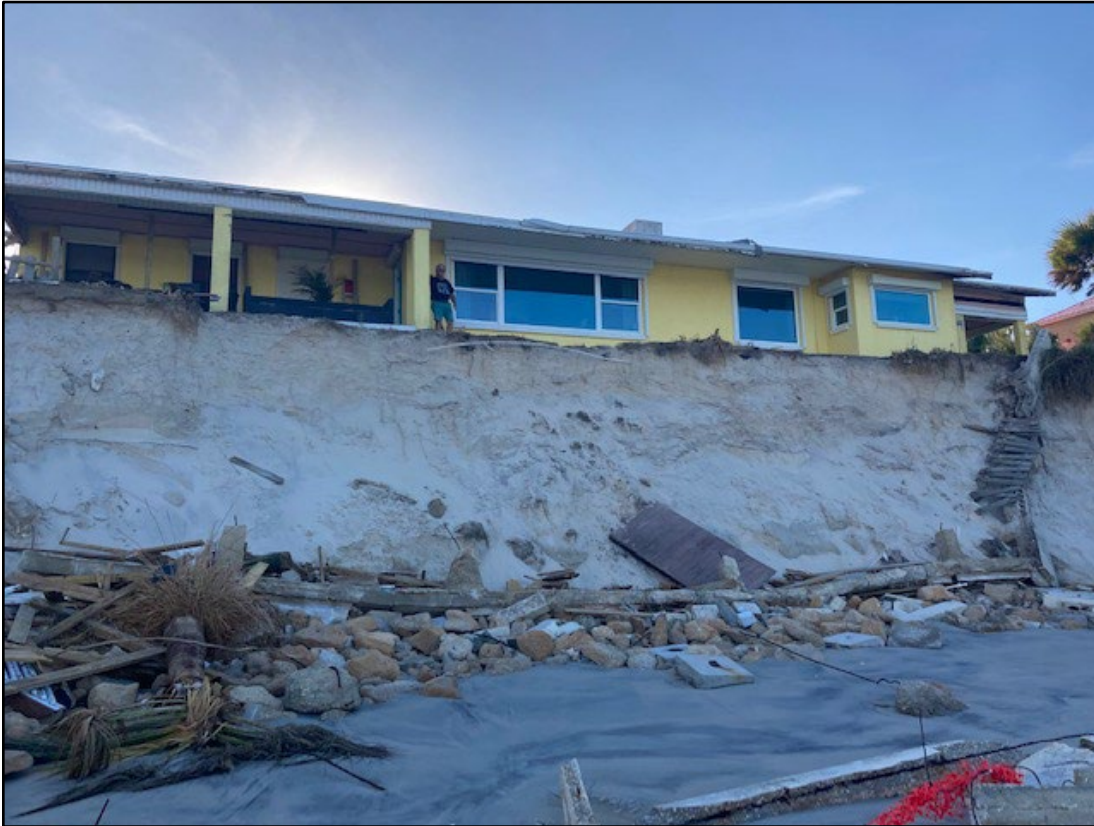
Figure 88. Wilbur-by-the-Sea dwelling threatened following seawall failure (R125).

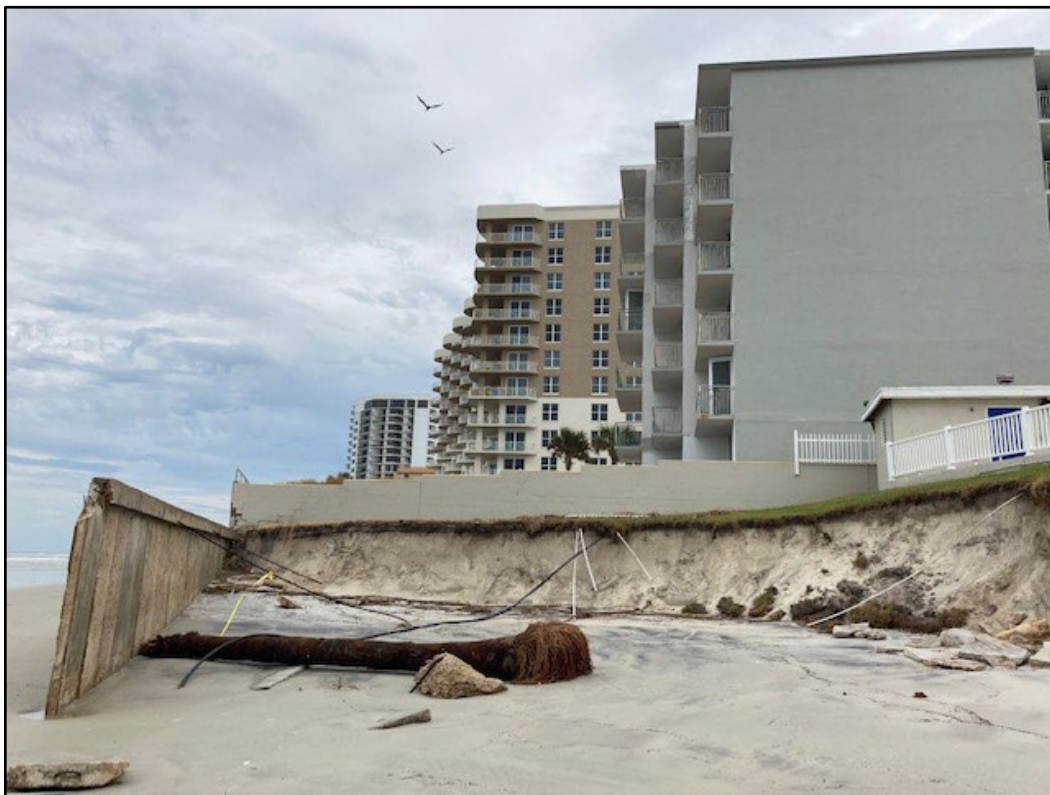
Figure 90. Substantial loss of property with seawall failure.

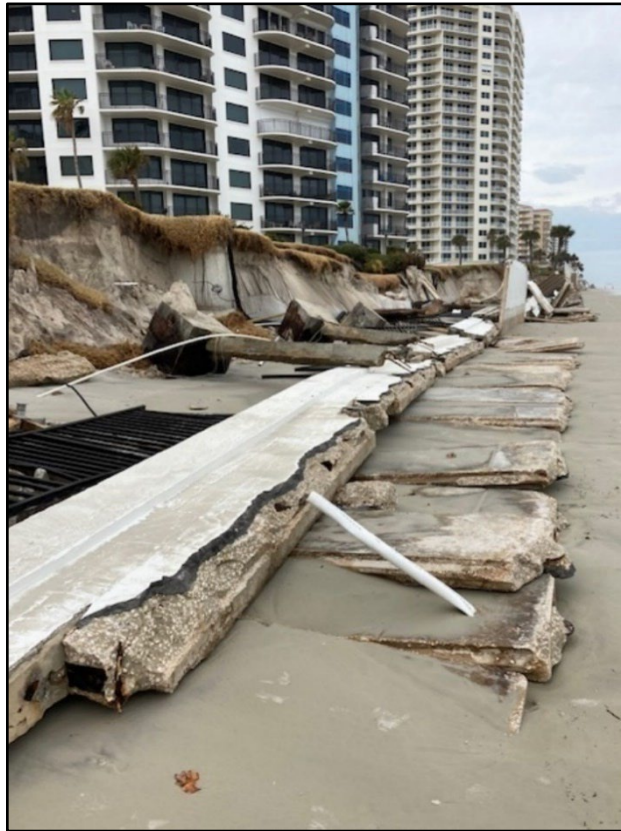
Figure 91. Catastrophic seawall failure threatens buildings in Daytona Beach (R75).

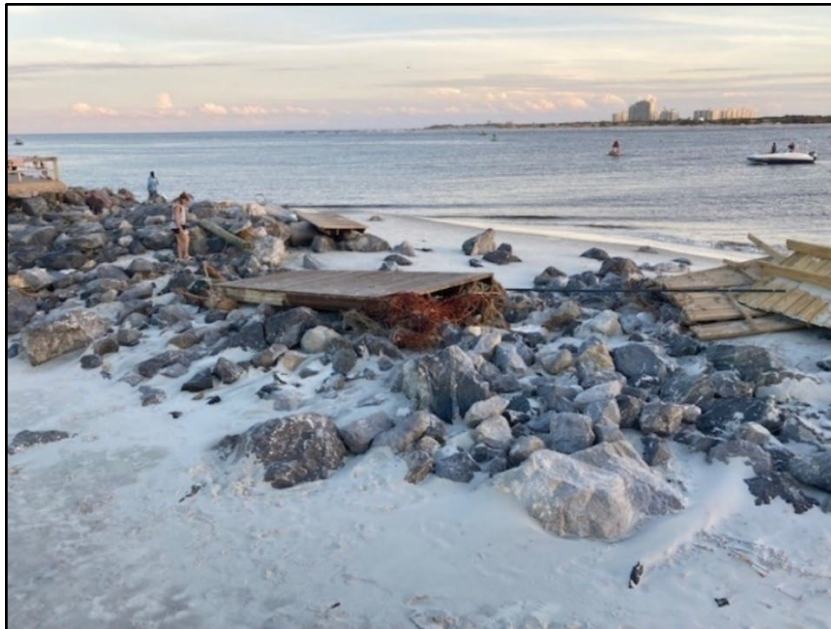
Figure 93. Damaged north jetty to Ponce de Leon Inlet (R-148).

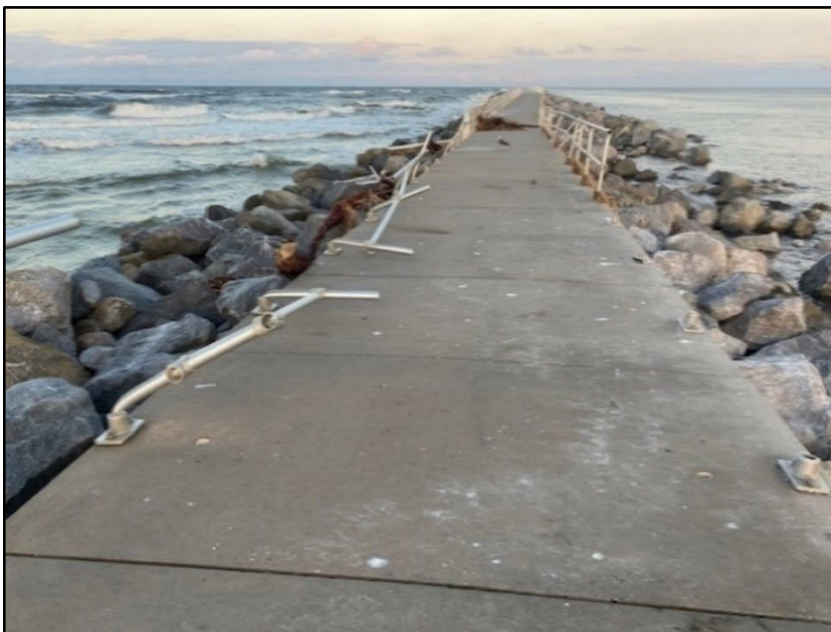
Figure 94. Damaged north jetty fishing pier at Ponce de Leon Inlet (R148).

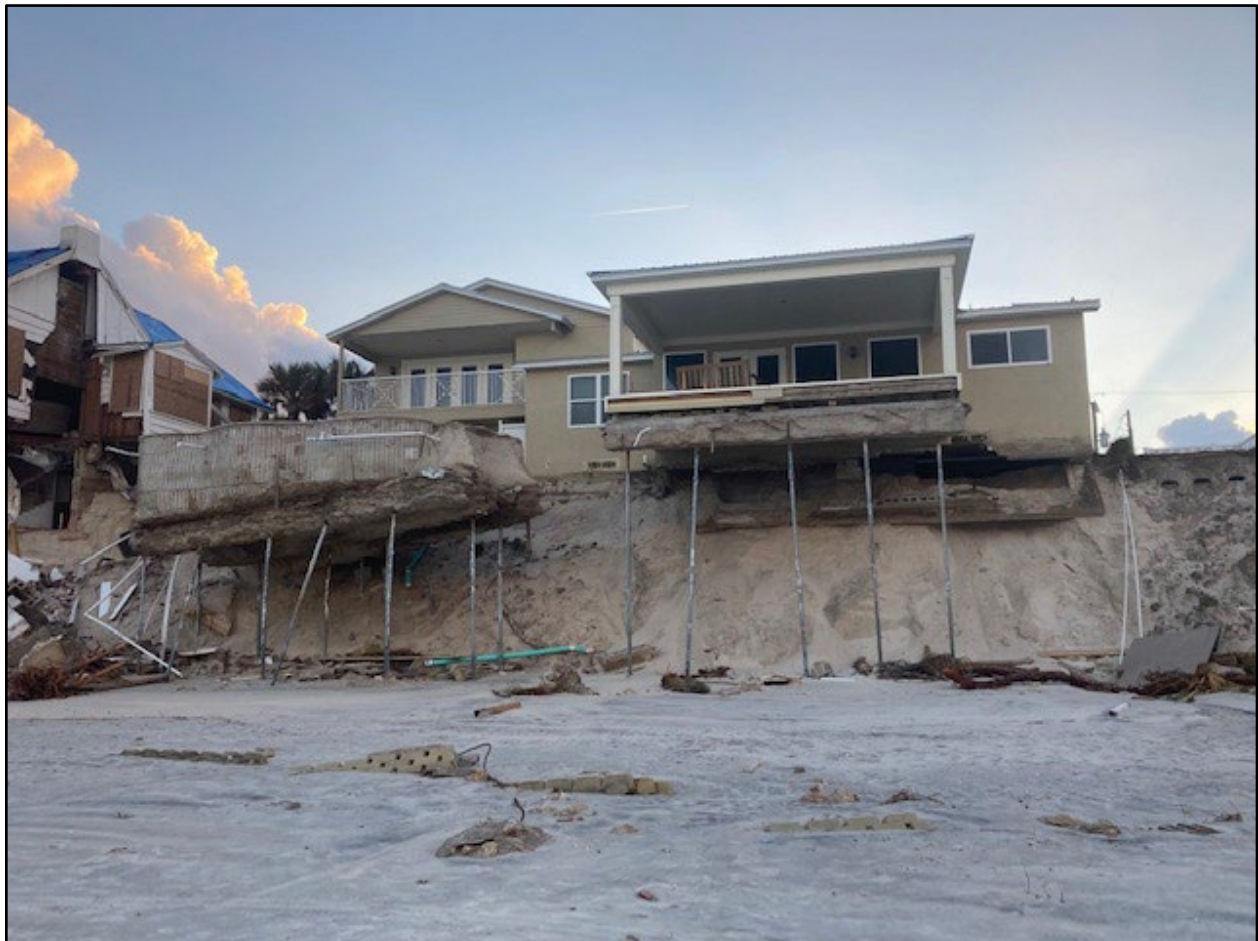
Figure 95. House and pool in imminent danger from major beach and dune erosion .

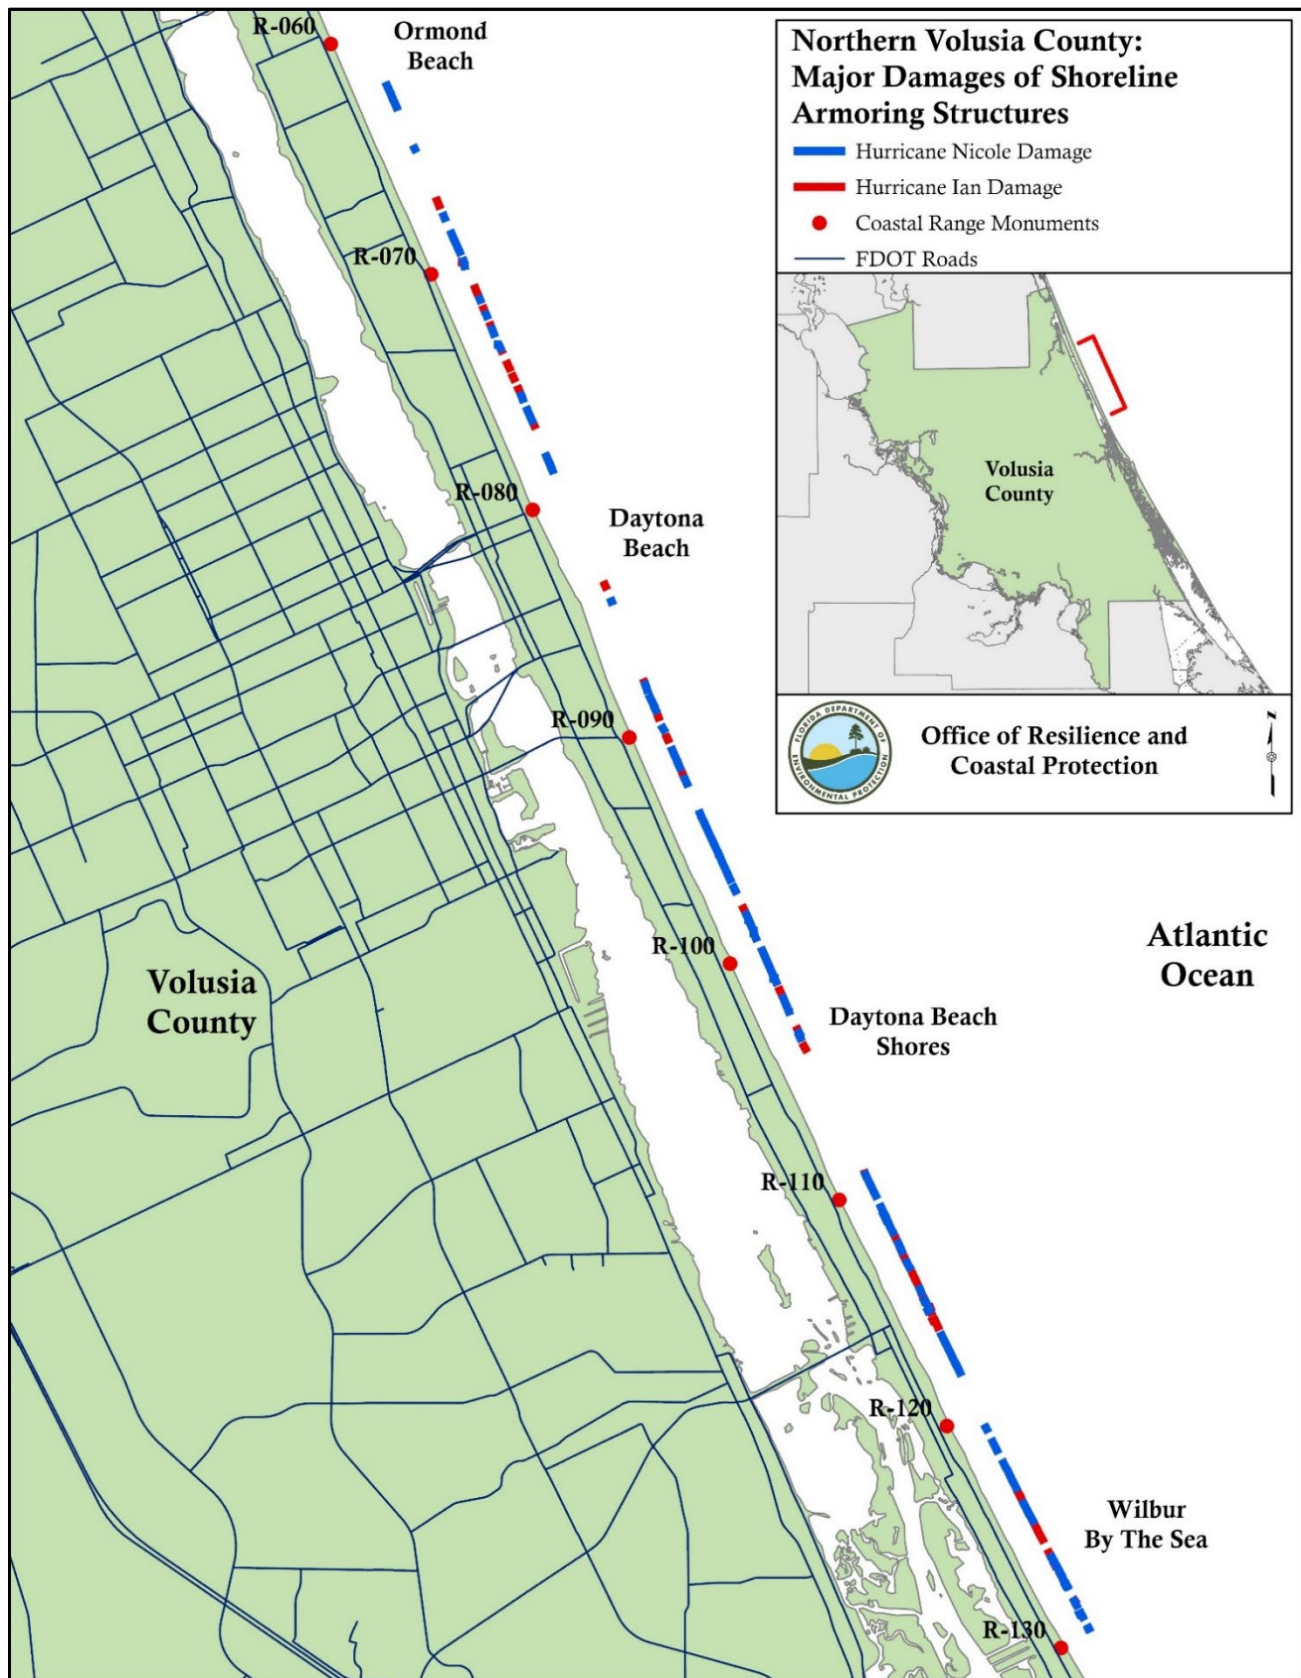
Figure 96. Major damages to armoring after Hurricanes Ian and Nicole in northern Volusia County. **Note:** see Appendix A or Figure 117 that describes the different damage levels to coastal armoring structures.

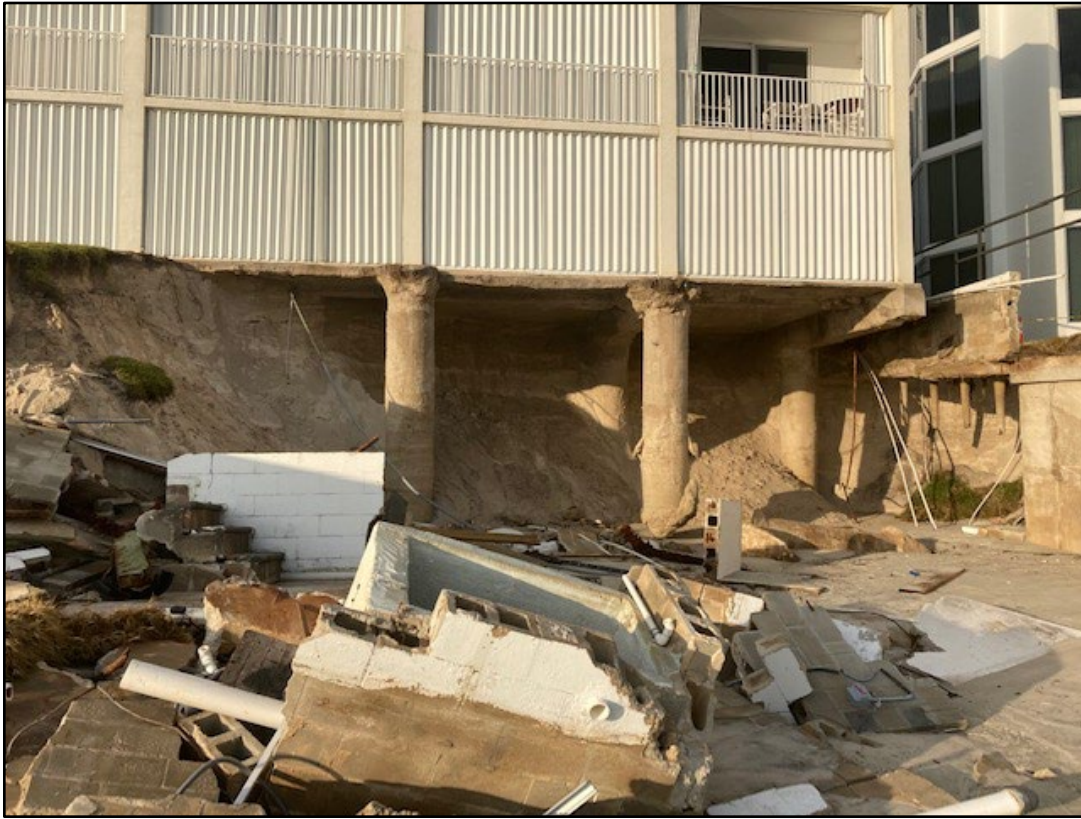
Figure 97. Threatened multifamily dwelling with foundation piles suspended (R117).

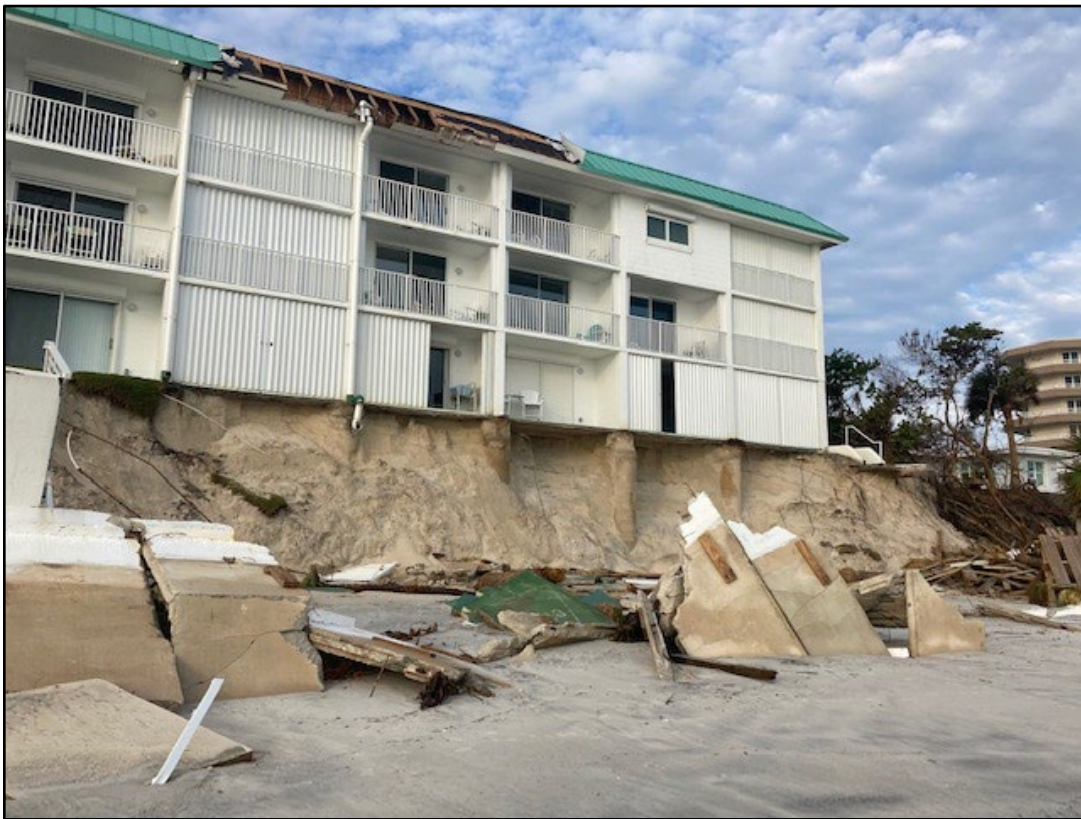
Figure 98. Condominium in imminent danger with roofing and siding damages.

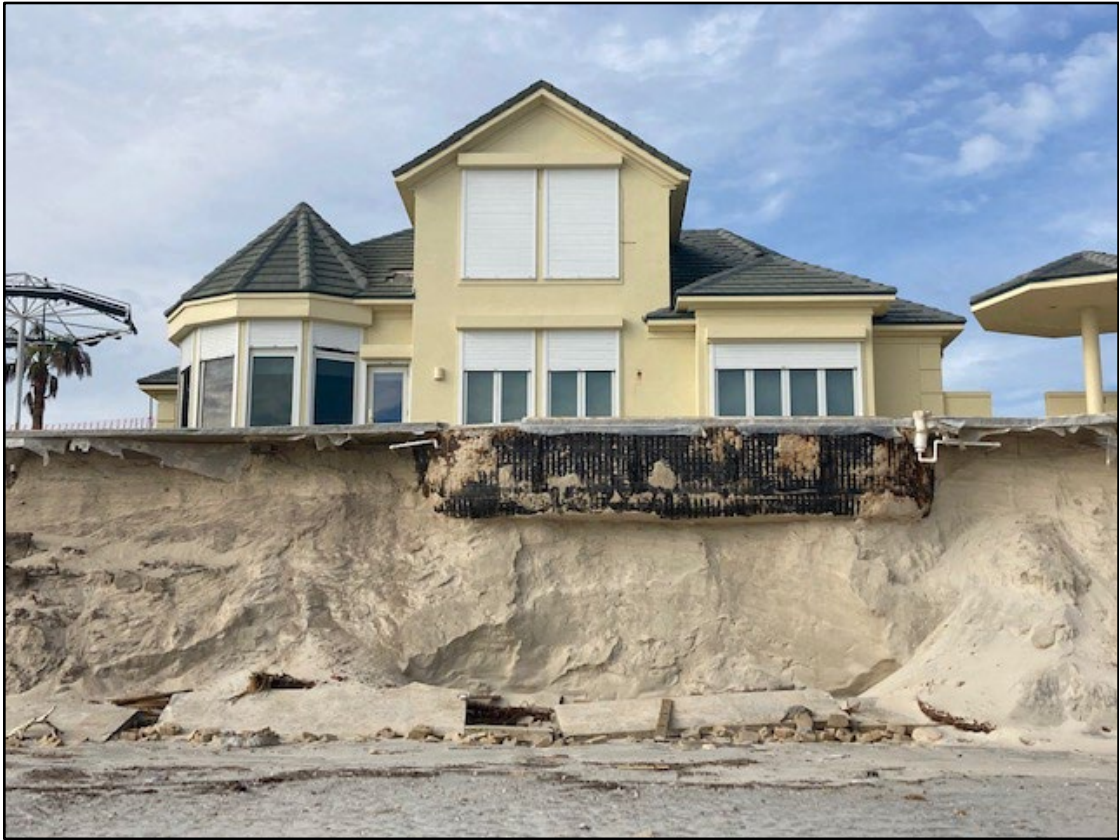
Figure 99. House and pool in imminent danger, Wilbur-by-the-Sea (R122).

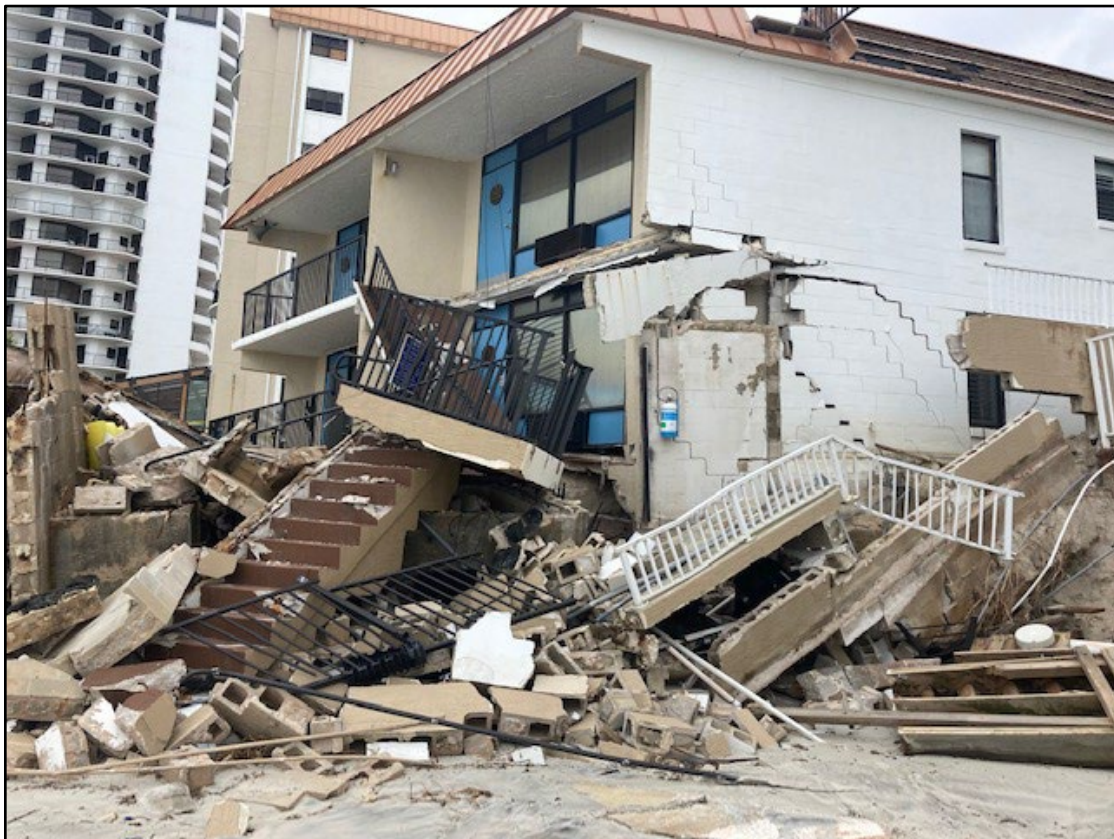
Figure 110. Damaged multifamily dwelling in Volusia County.

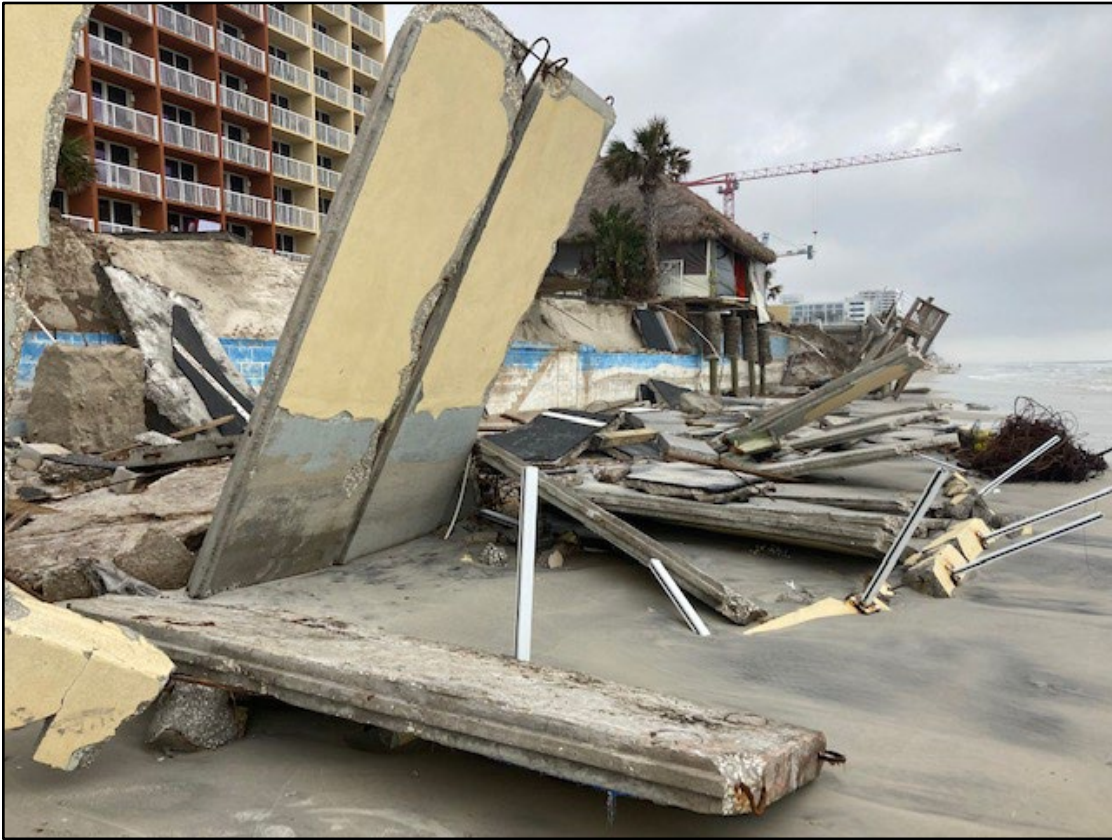
Figure 111. More seawall damage by Hurricane Nicole.

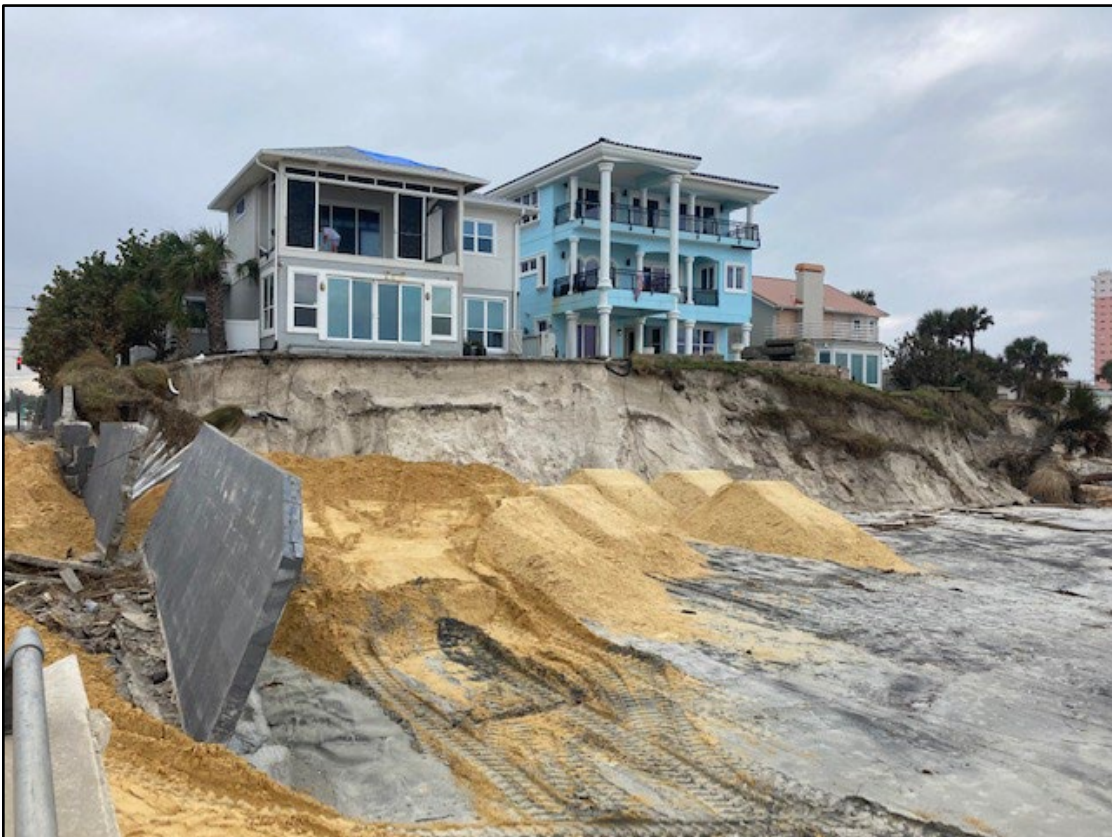
Figure 112. More threatened houses following severe erosion in Daytona Beach Shores (R-103).

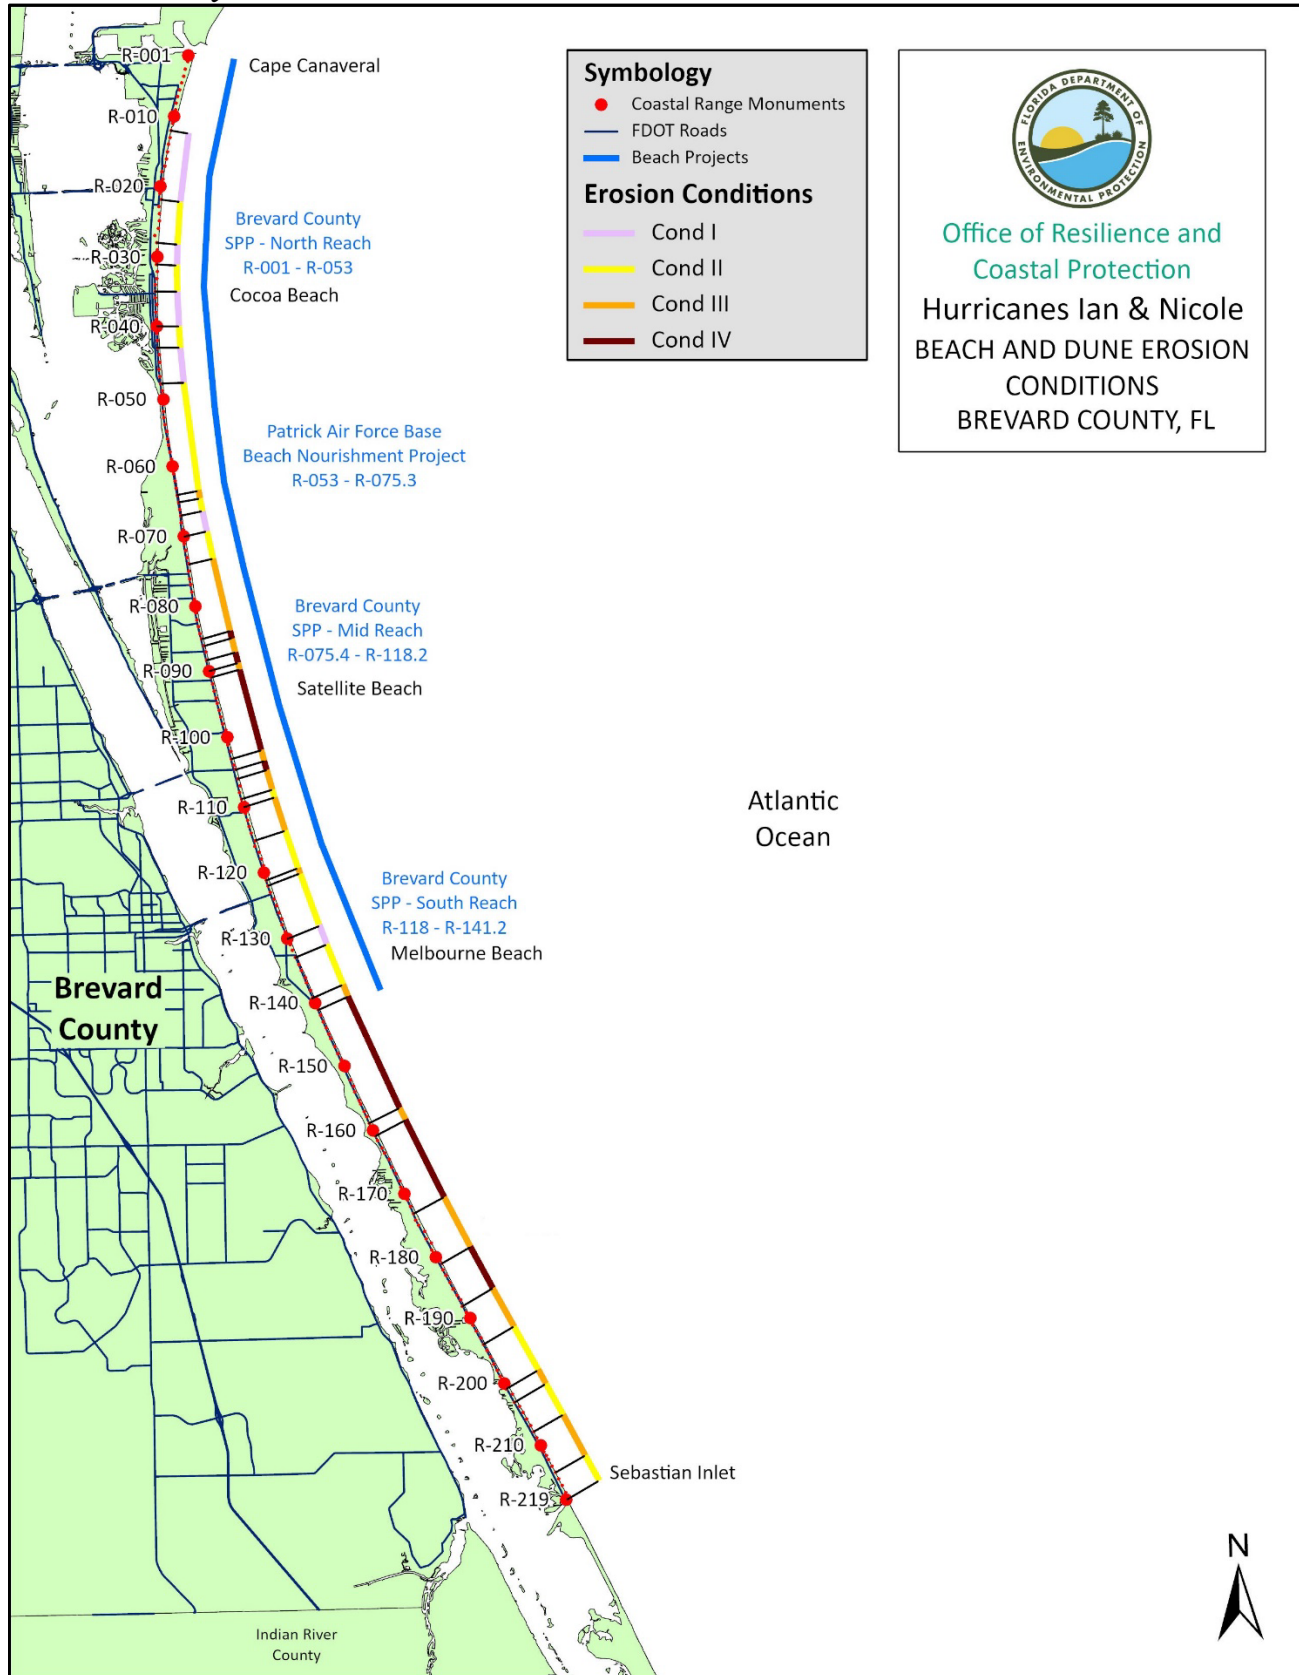
Figure 113. Brevard County Beach and Dune Erosion Conditions from Hurricanes Ian and Nicole.

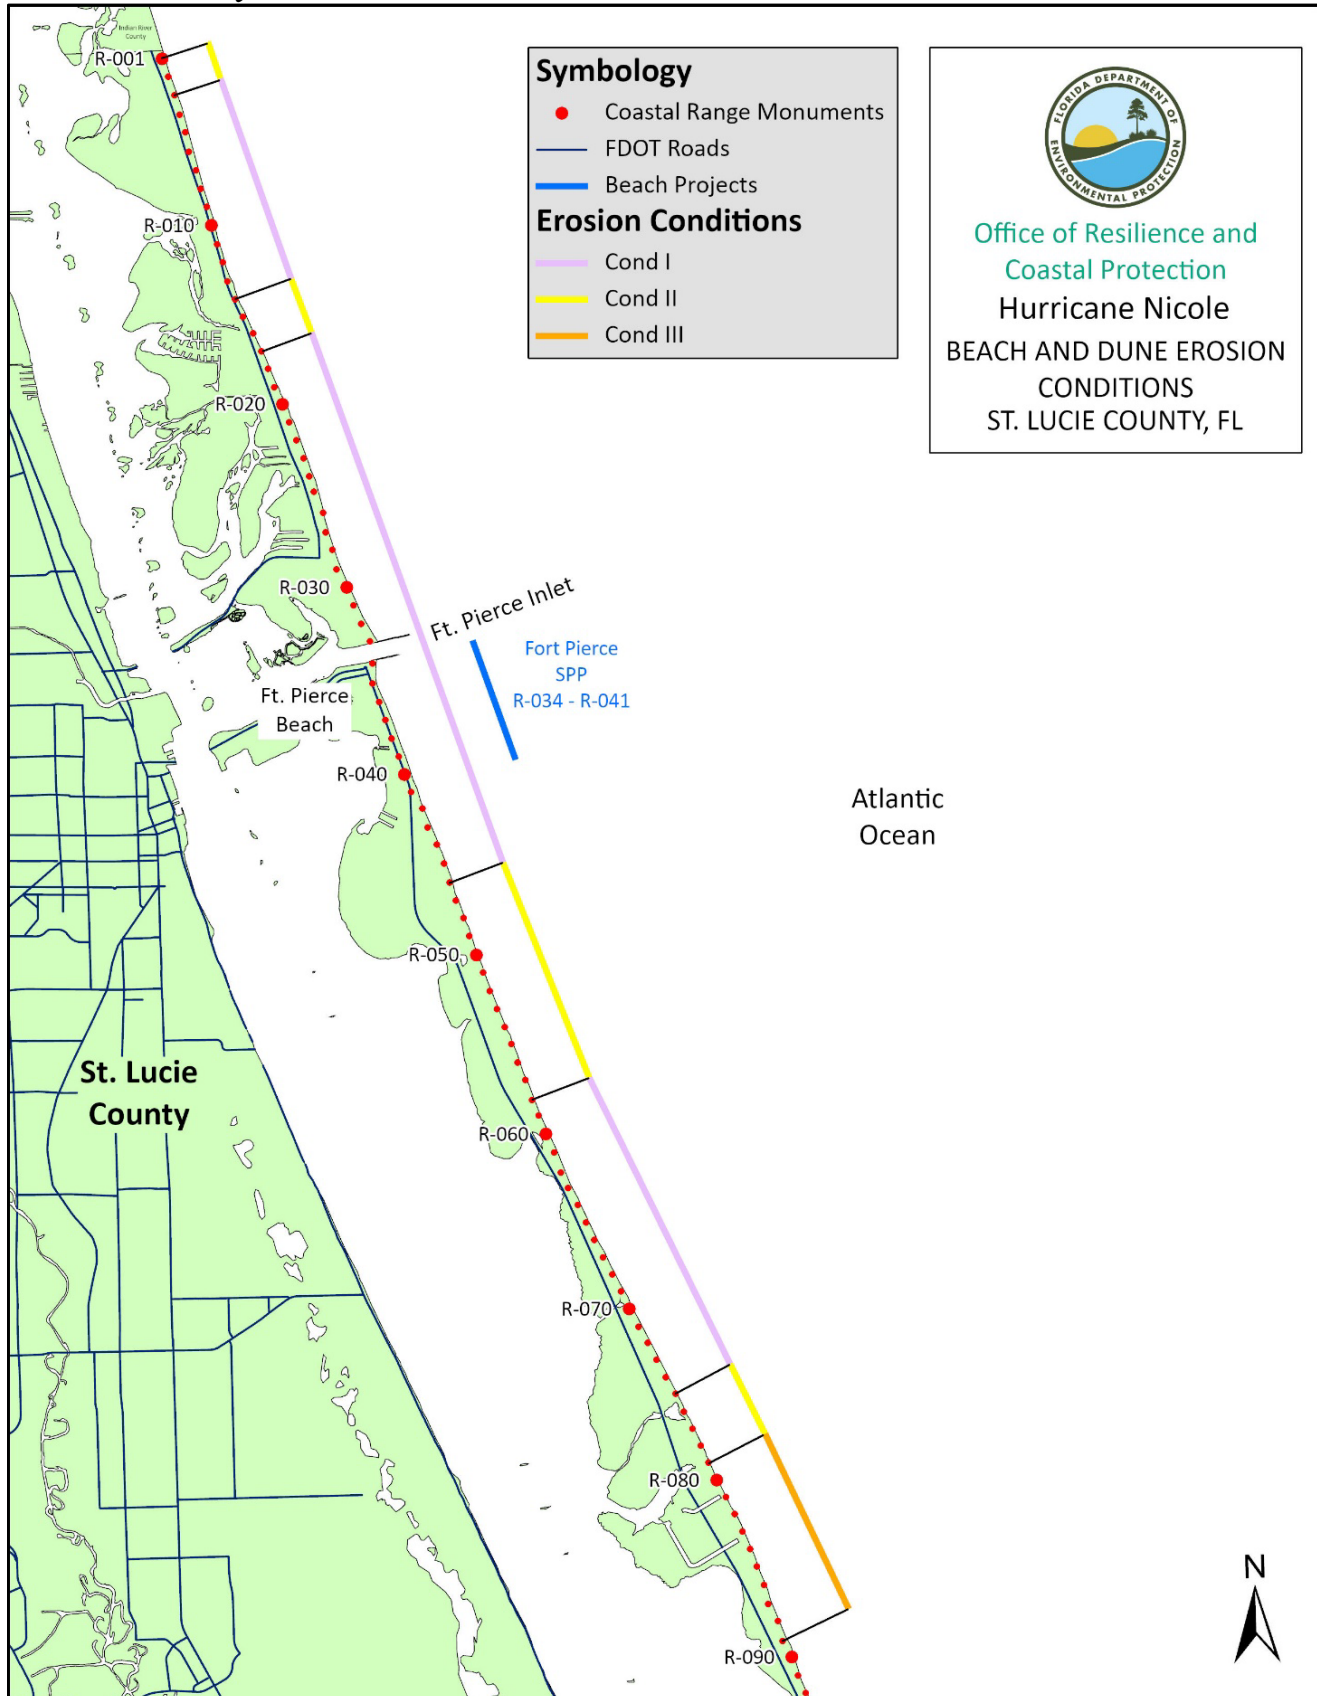
Figure 115. St. Lucie County Beach and Dune Erosion Conditions from Hurricane Nicole.
