Hurricane Ian & Hurricane Nicole
Preliminary Post-Storm Beach Conditions
and Coastal Impact Report

Office of Resilience and Coastal Protection
Florida Department of Environmental Protection
December 2022

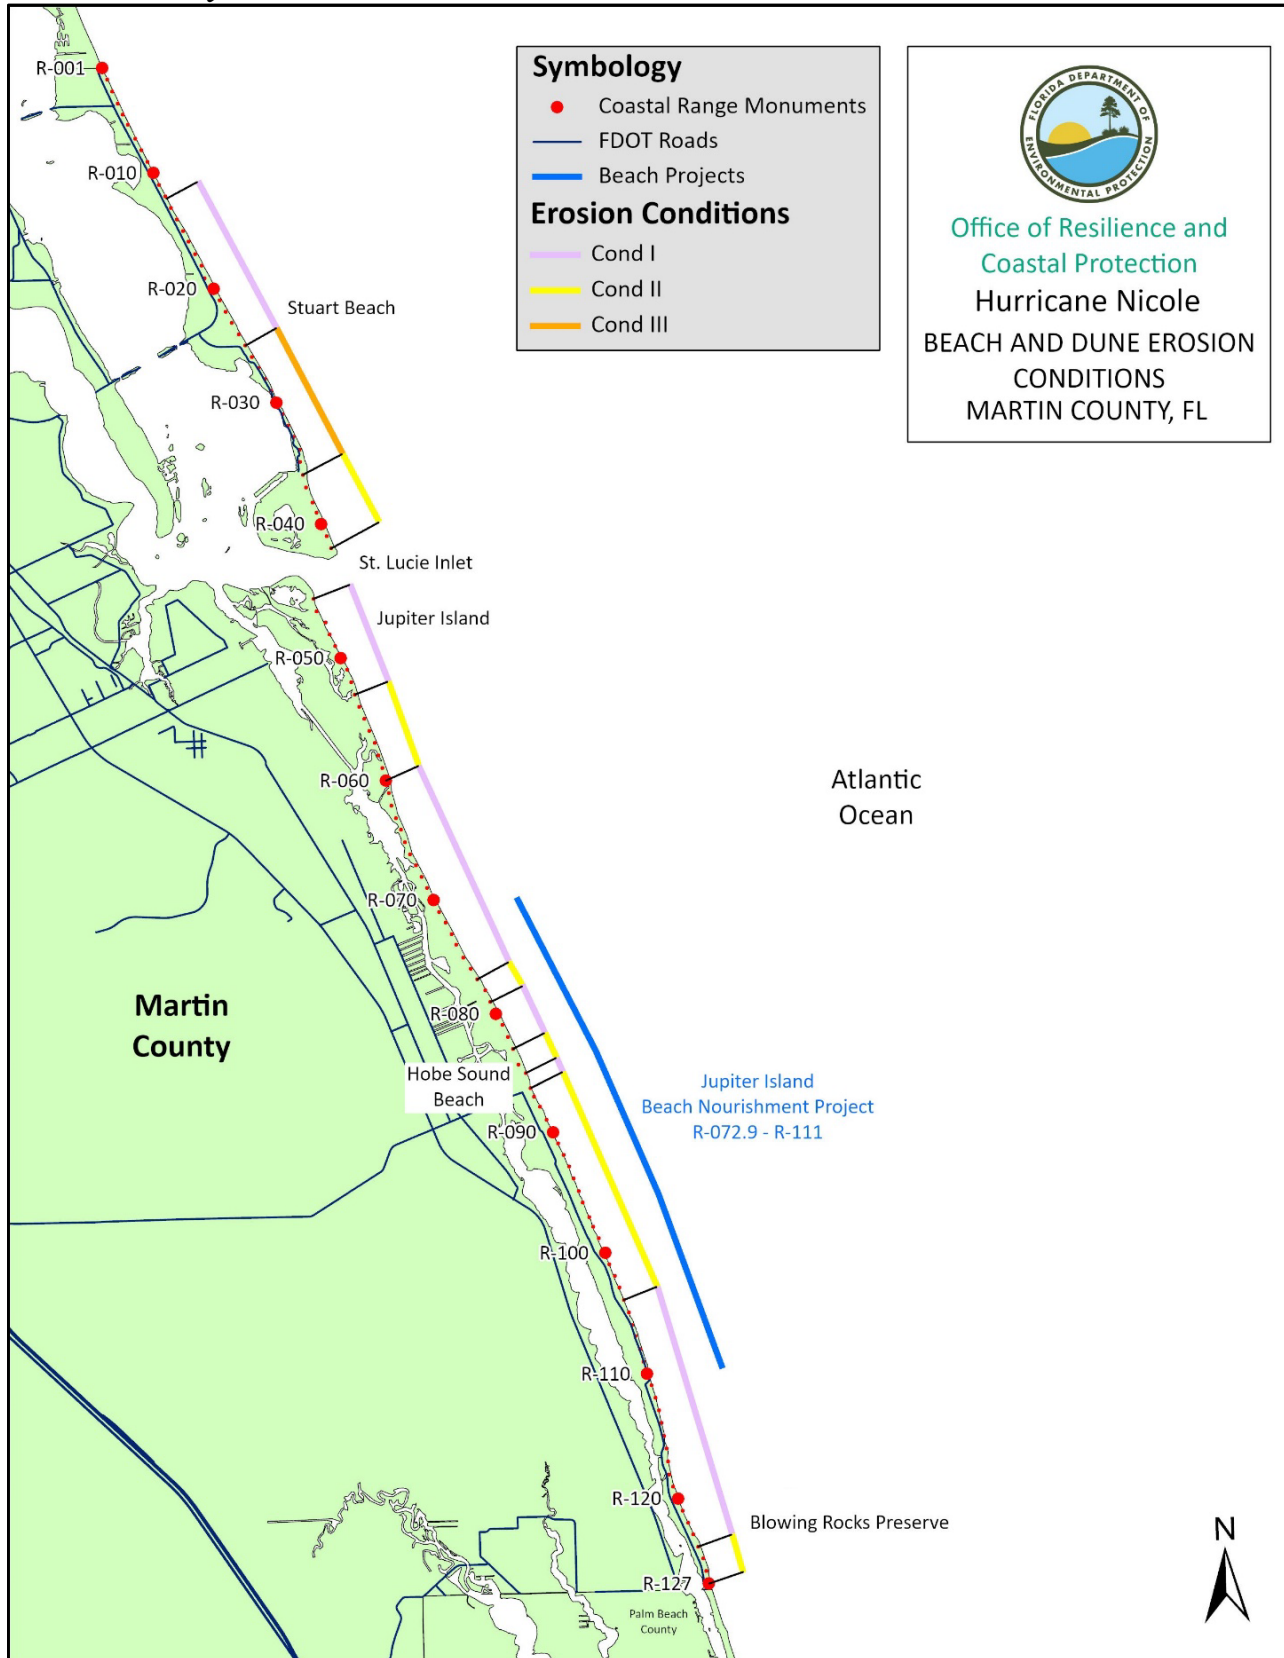
Figure 116. Martin County Beach and Dune Erosion Conditions from Hurricane Nicole.

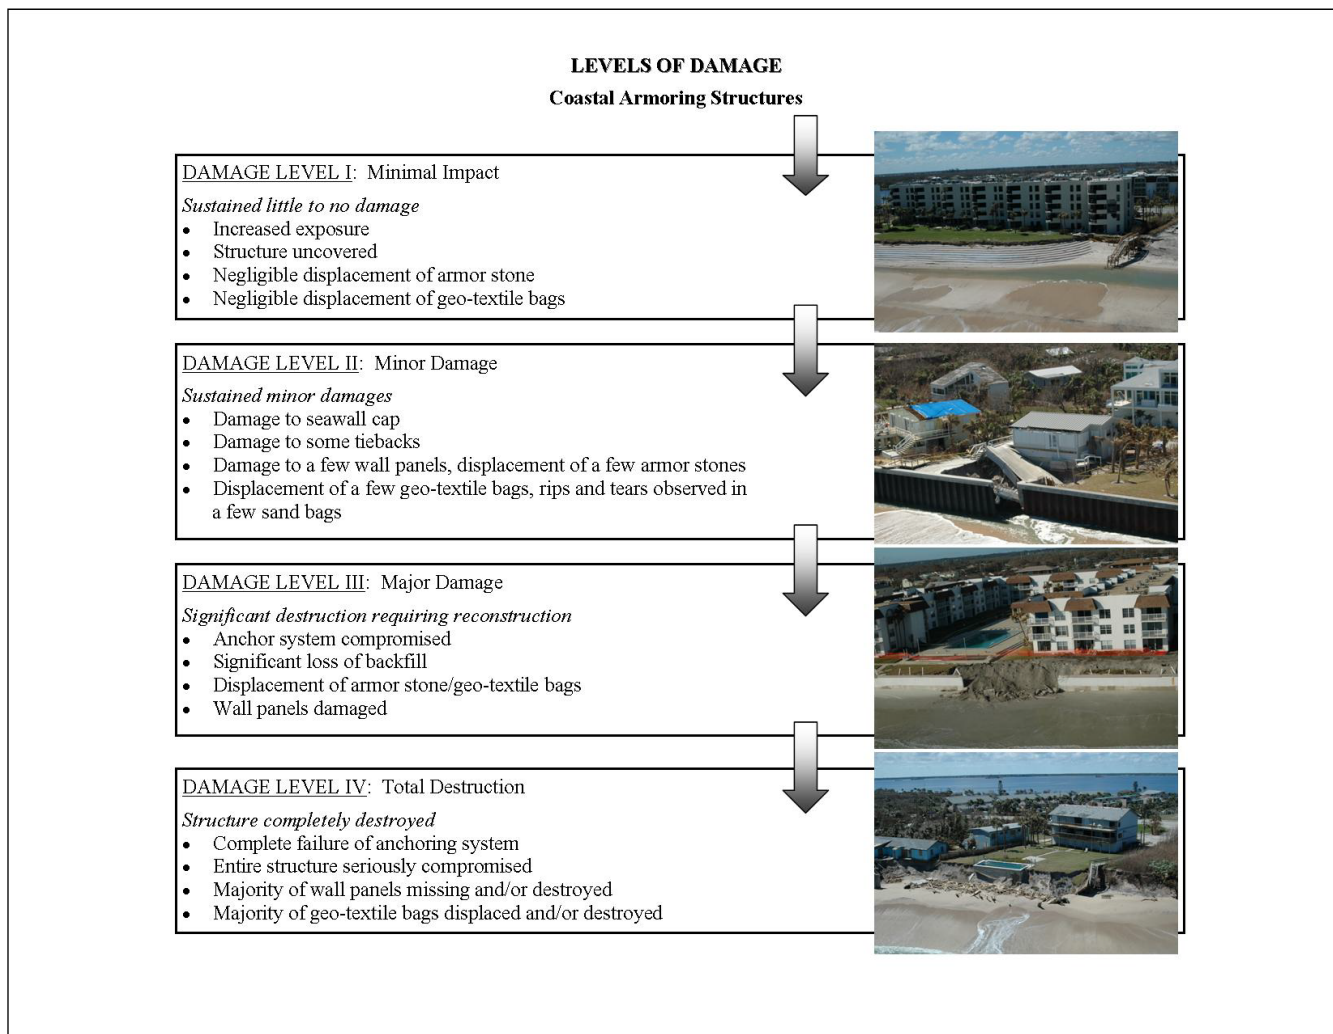
Figure 117. DEP’s Coastal Engineering graphic describing the levels of damage (I – IV) to coastal armoring structures, including seawalls and revetments.
