**Florida Department of Environmental Protection**

# **Update on DEP Septic Tank Research Activities**

**October 20, 2017**

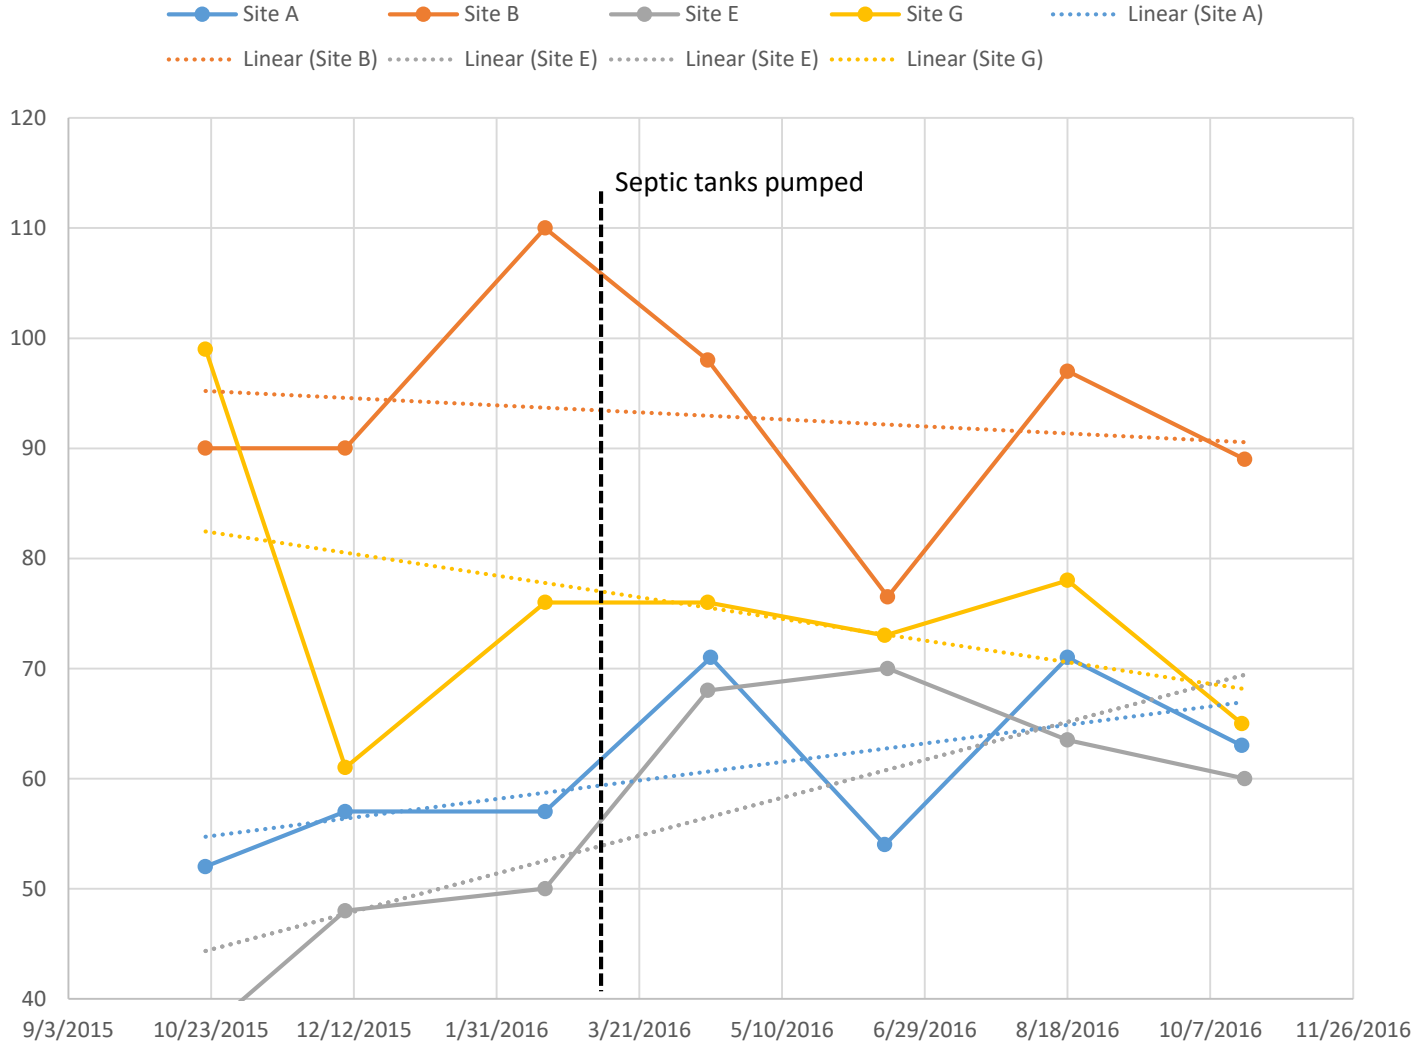
# TN Trends after pumping

- Midway through the study, 4 septic tanks were pumped. Others left as control.
- Septic tanks at sites A, B, E and G were pumped in March 2016, between February and April monitoring events

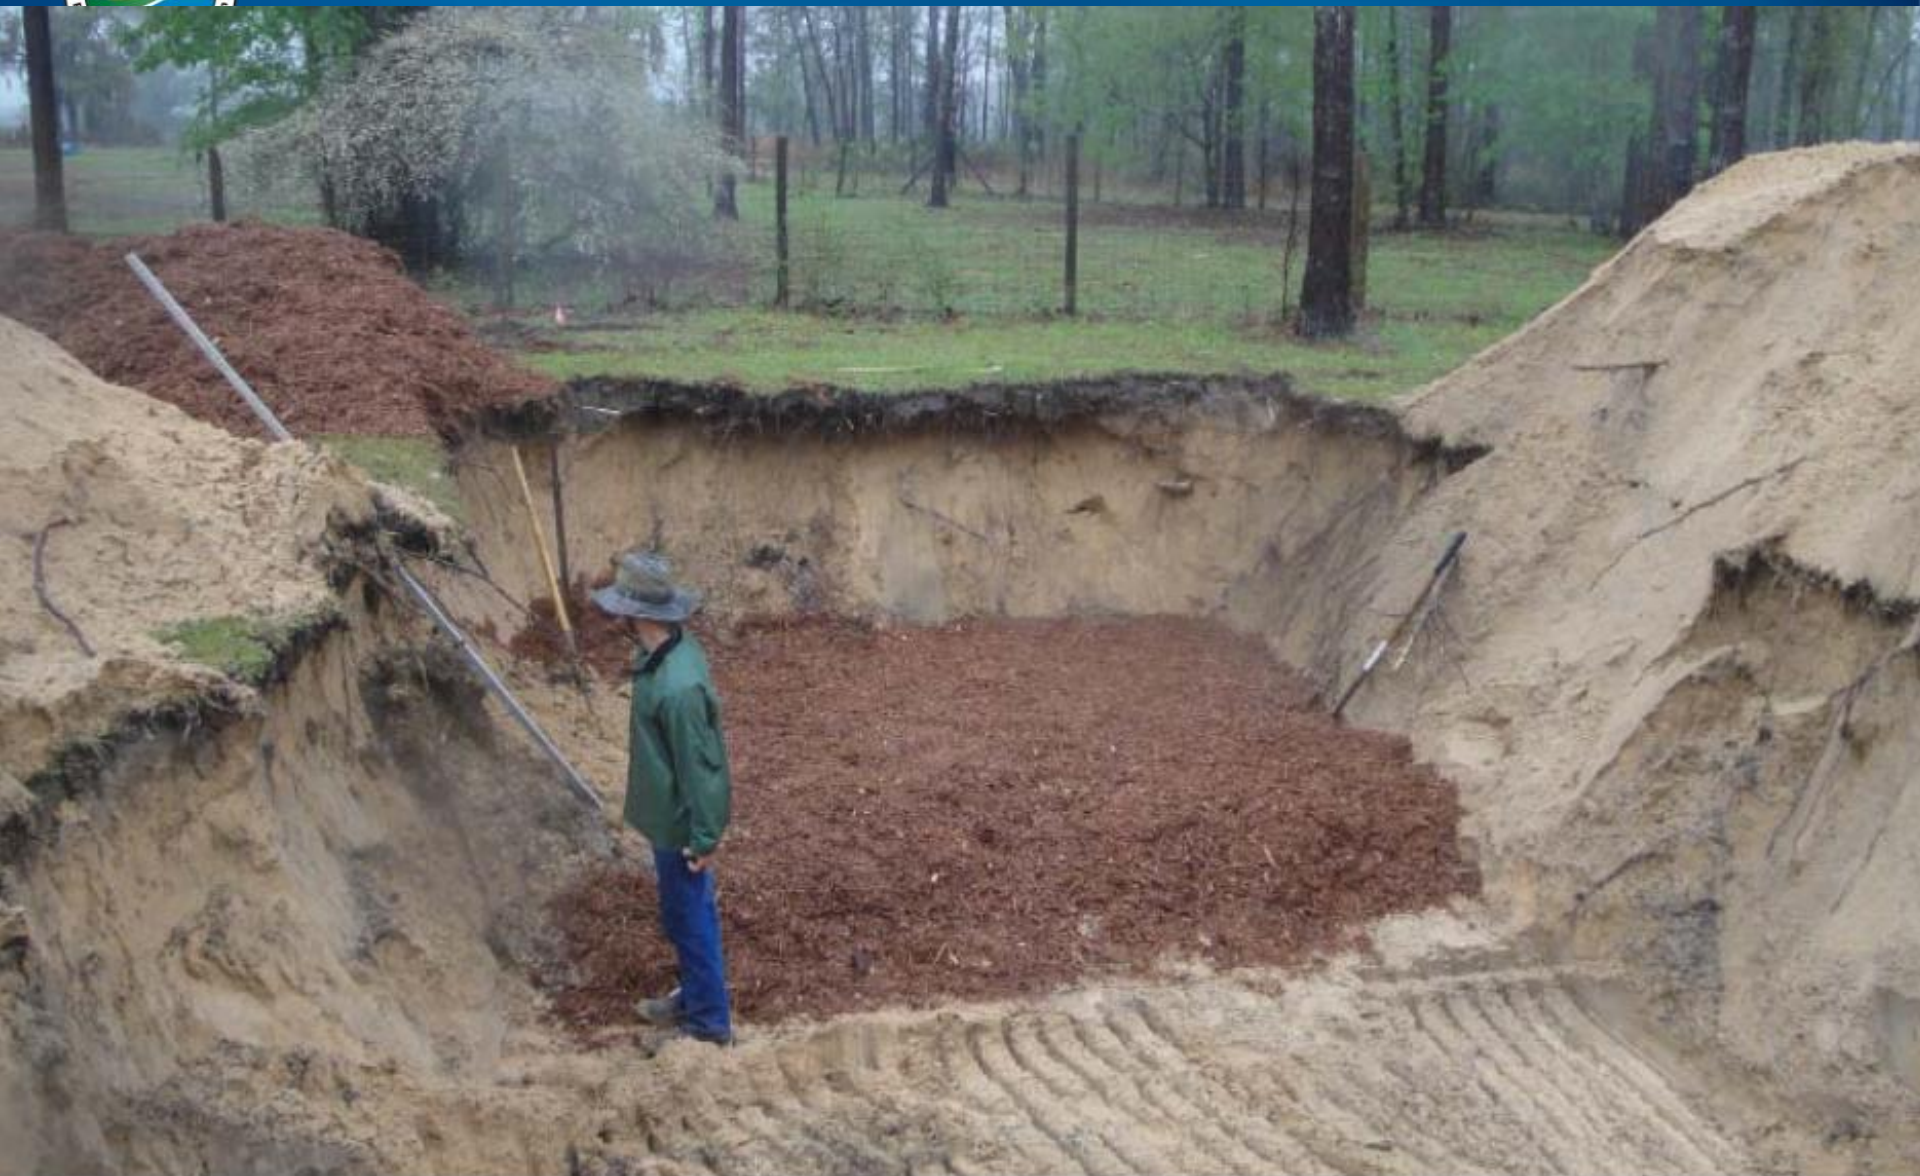
Figure 1. View East: First phase of lignocellulosic layer installation. ~11:20 am

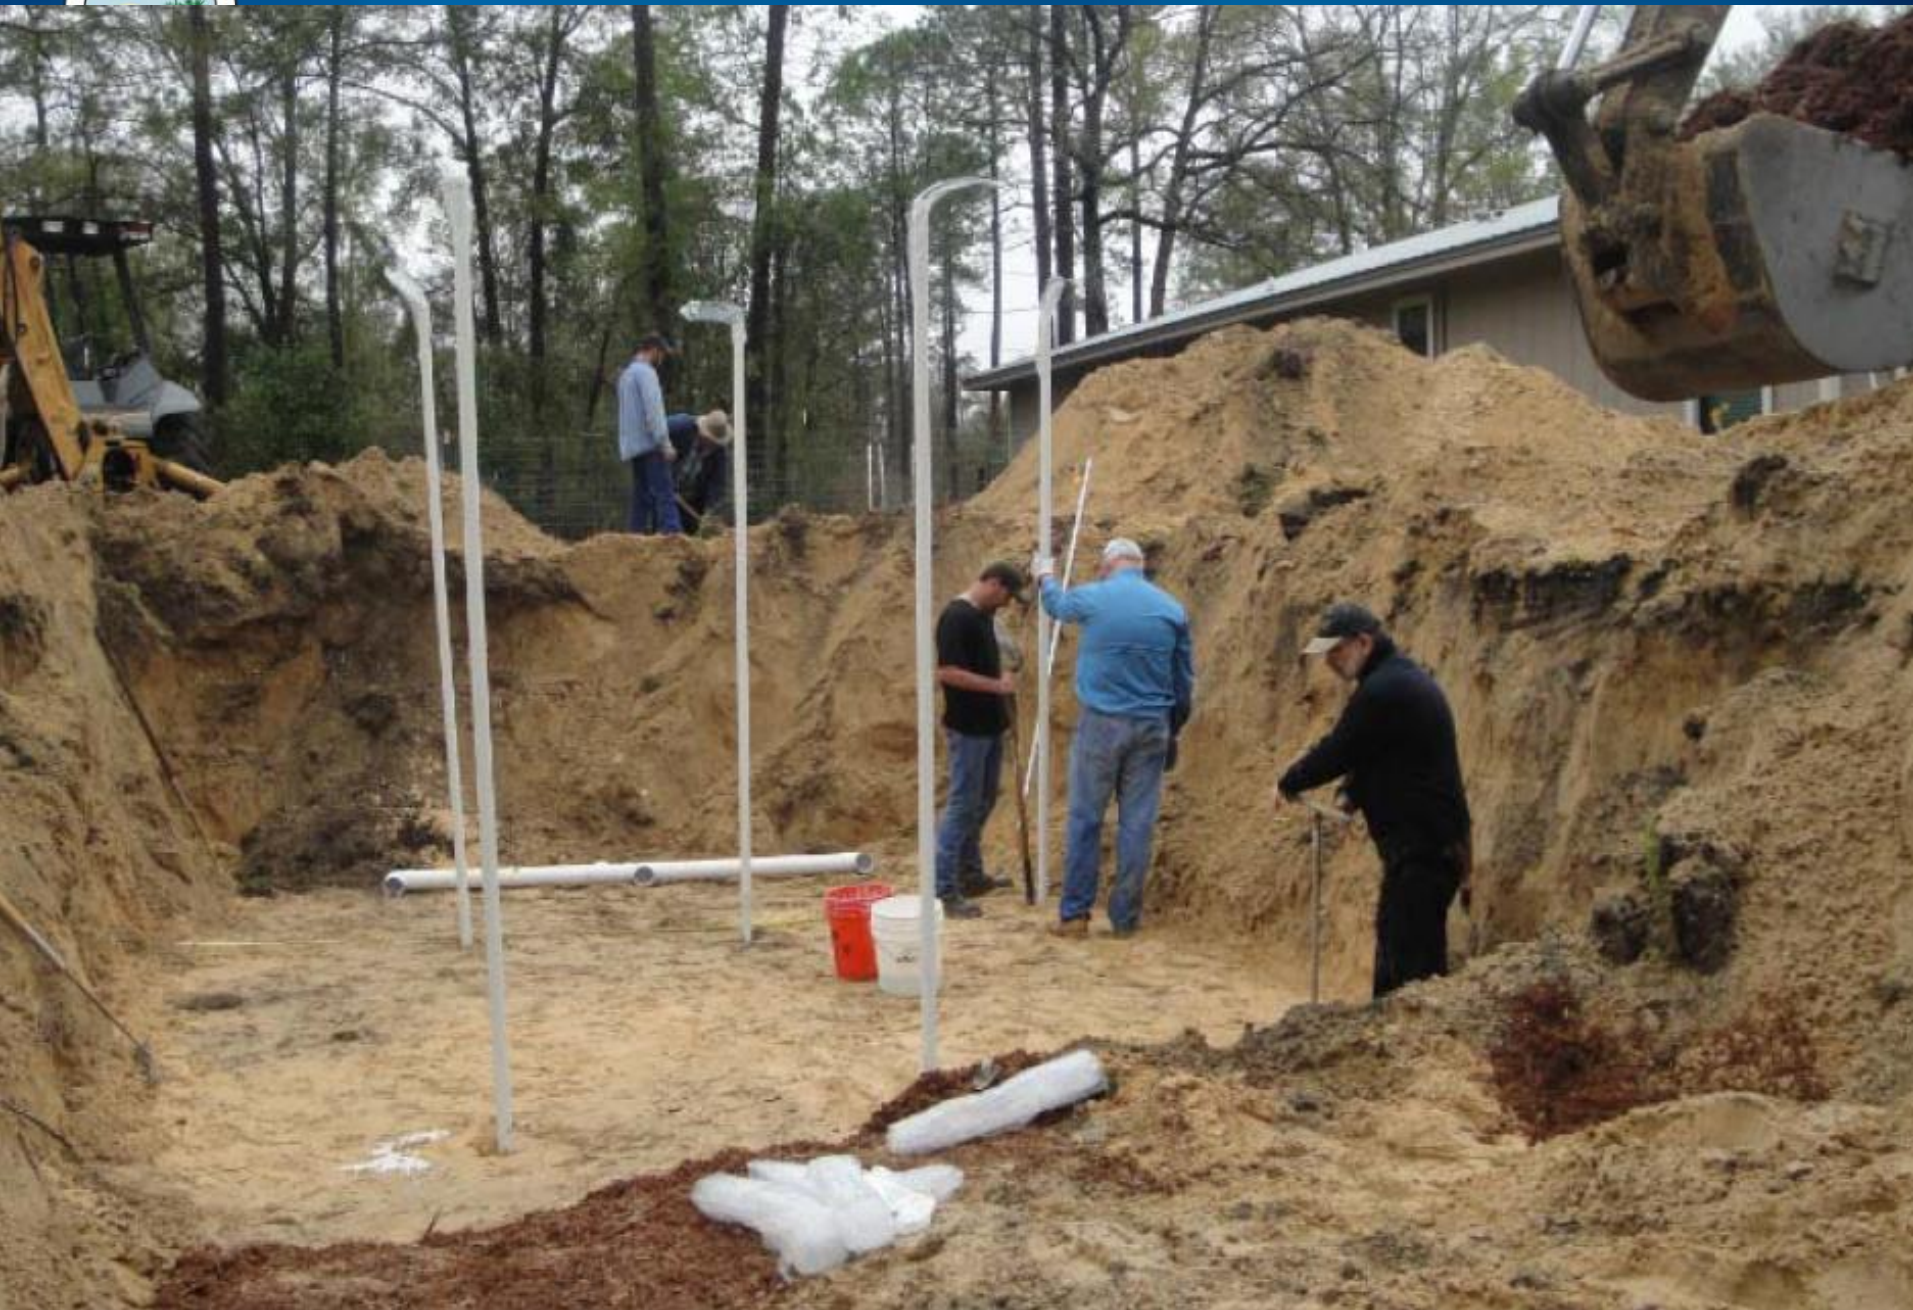
Figure 6. Installation of deep lysimeters (buckets contain silica mix). ~1:55 pm

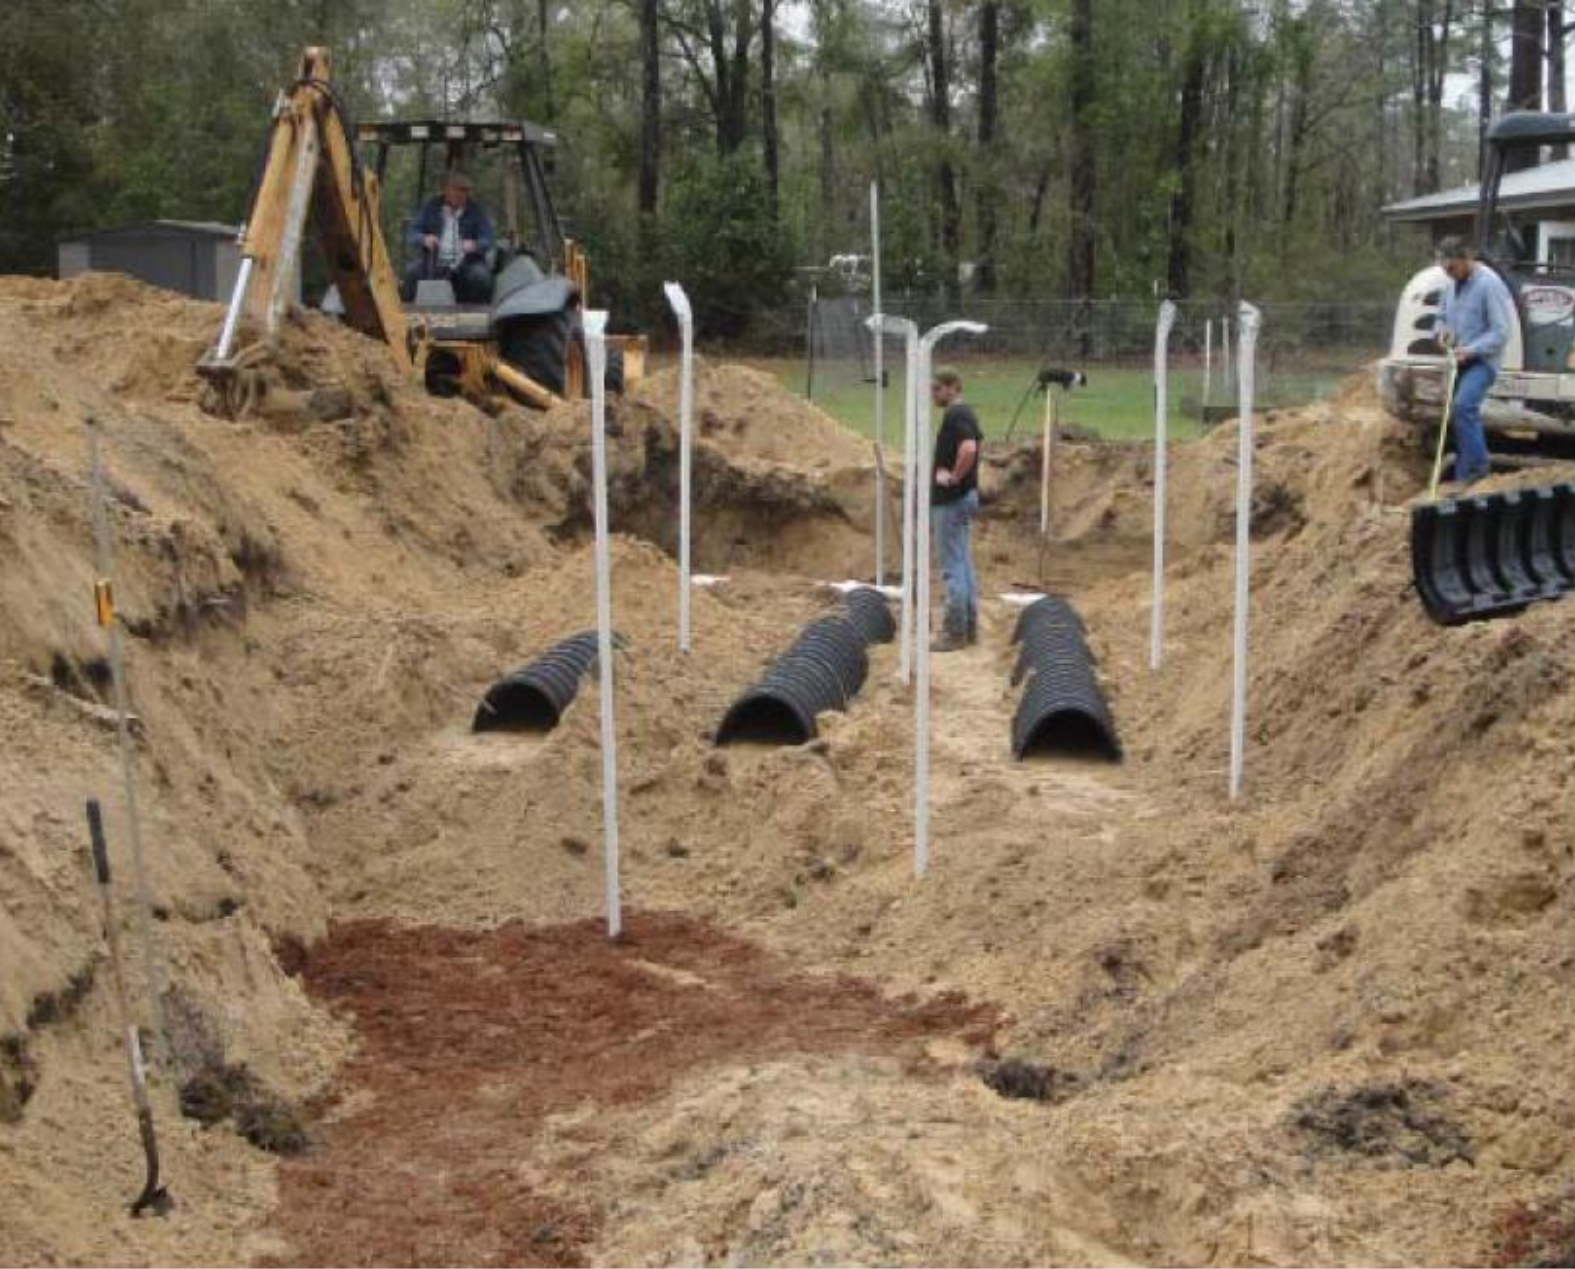
Figure 10. Installation of three rows of chambers at a slight angle to the length axis of the mulch bed. ~4:36 pm

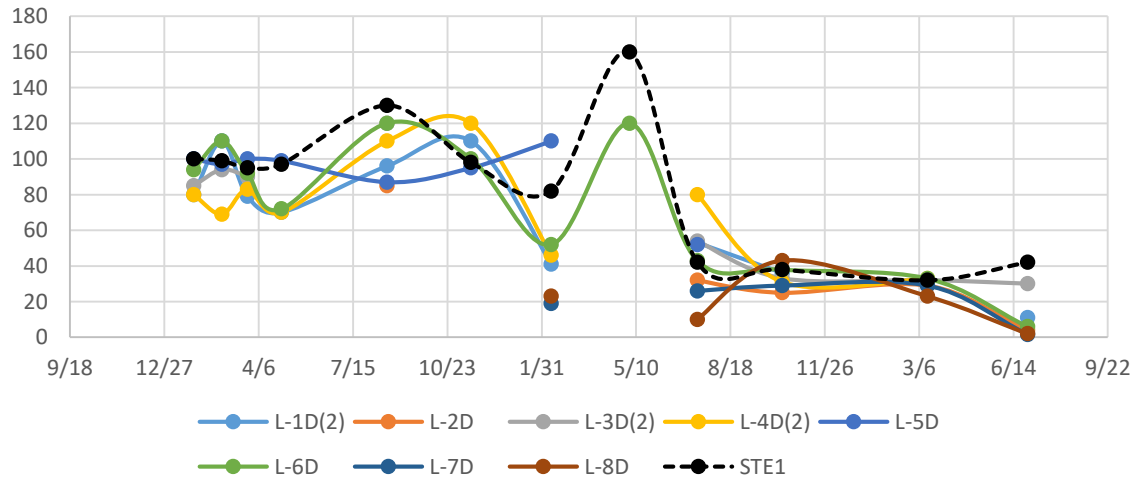
## Deep Lysimeters - Chloride mg/L

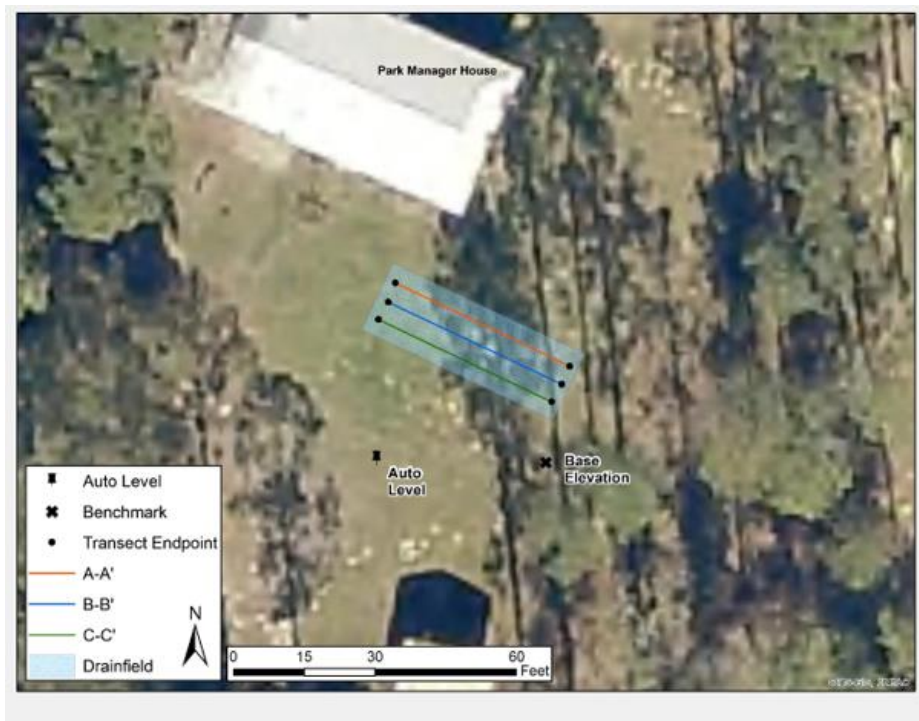
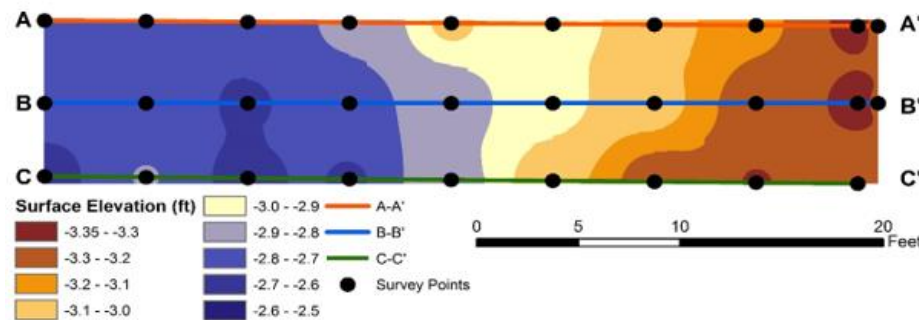
Figure 13. Land Surface Elevation (LSE) Survey of Drainfield July 2017

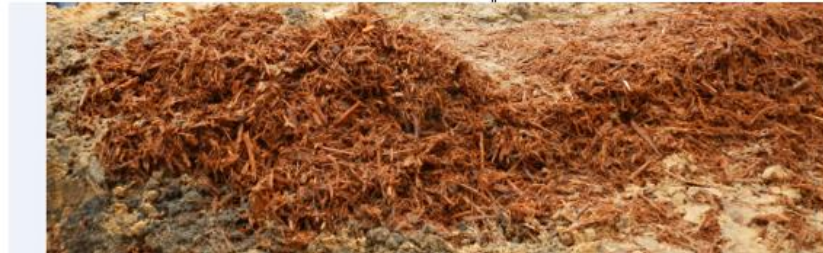
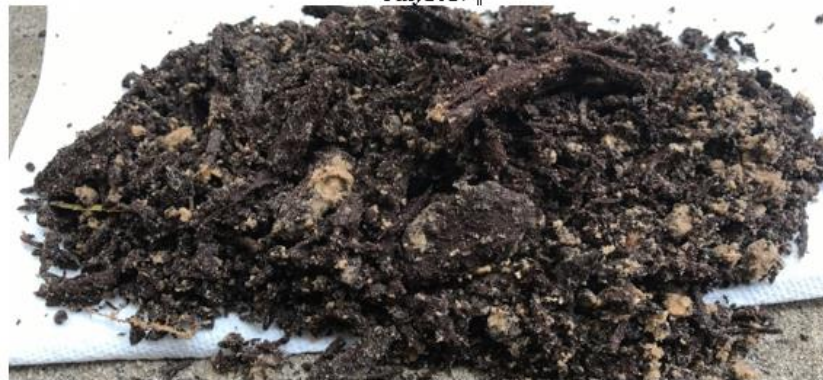
*Figure 15. Photographs of mulch from March-2014 (at installation), January-2015 and July-2017*

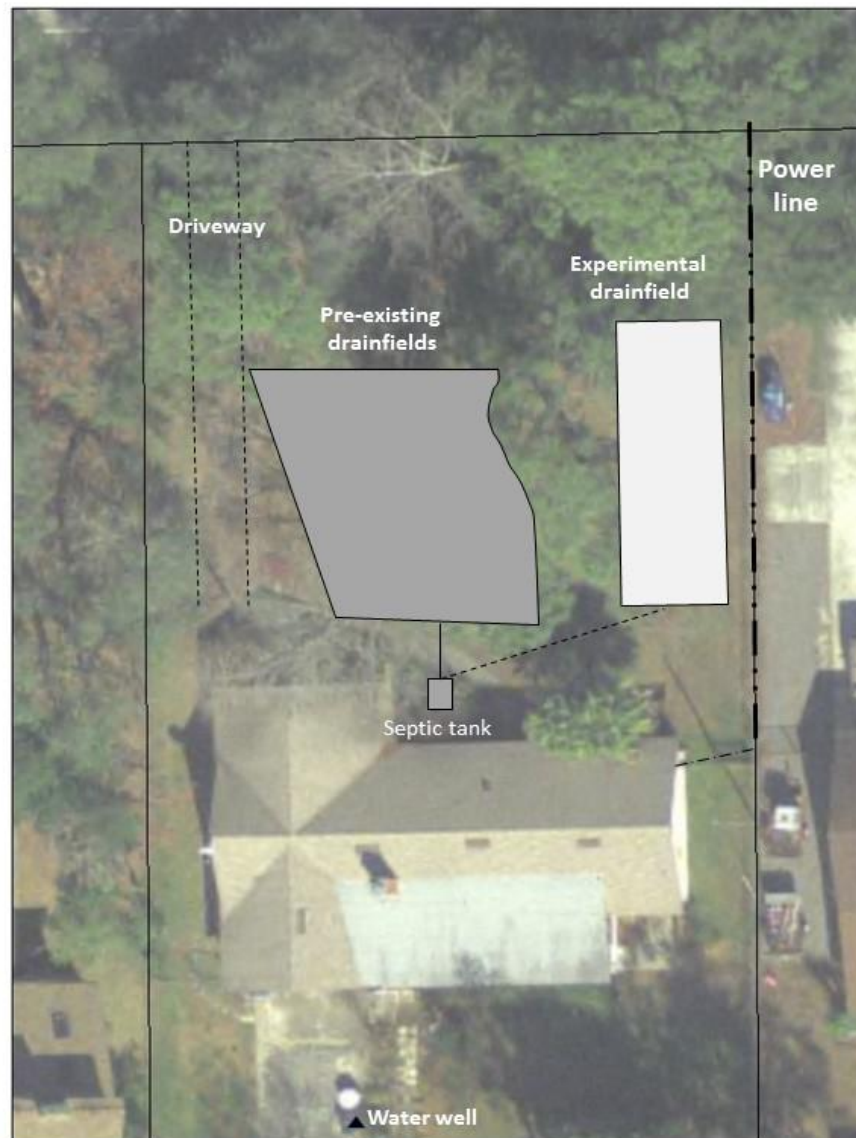
Wood mulch and liner extend  
3-5' beyond edge of drainfield
