## Introduction

## Actions to Stop Pathogens from Entering Our Waterbodies

# Bayou Chico BMAP

# Hillsborough River BMAP

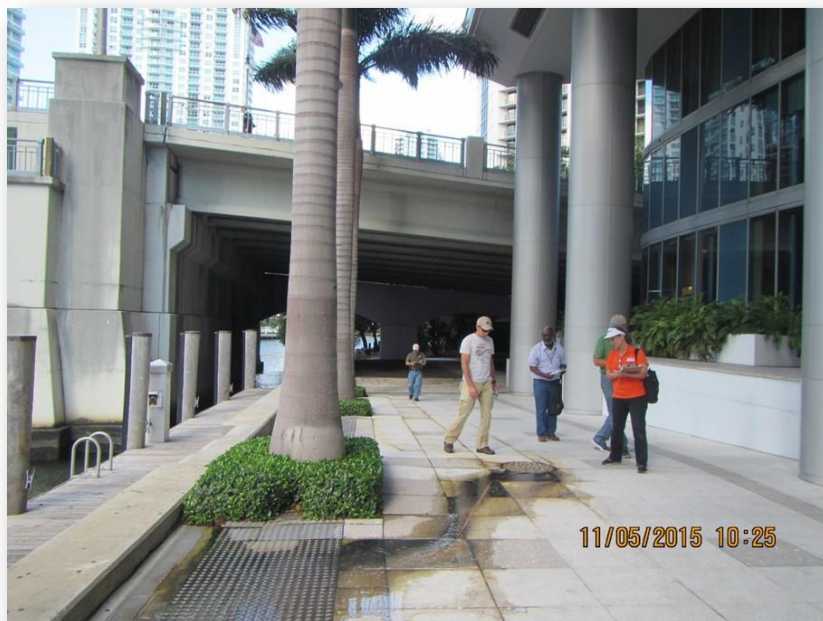
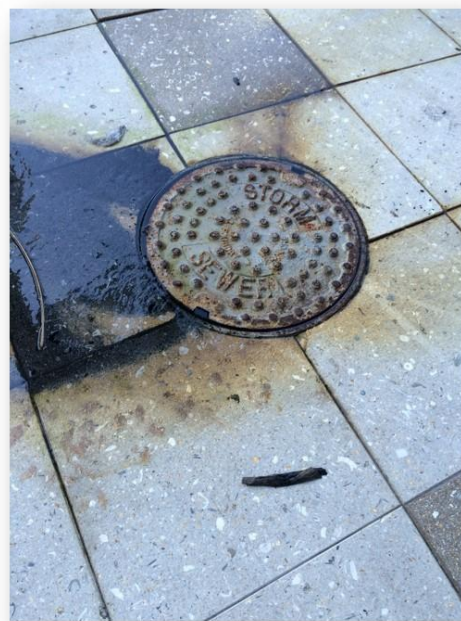
The writing on the manhole cover indicated it contained stormwater but the odor and staining on the sidewalk indicated something much worse. Investigators found two illicit connections from toilets into the stormwater disposal system underground. The toilets were properly connected to sanitary sewer and the stormwater system was vacuumed and sanitized within about a week of the discovery.

Sidewalk stained by sewage discharge from stormwater system

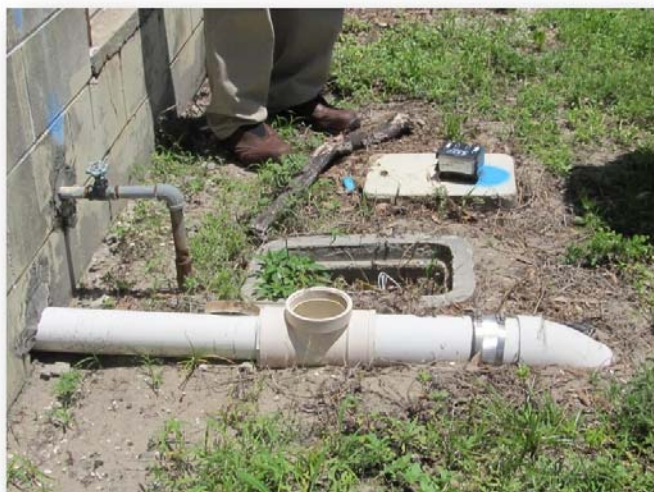
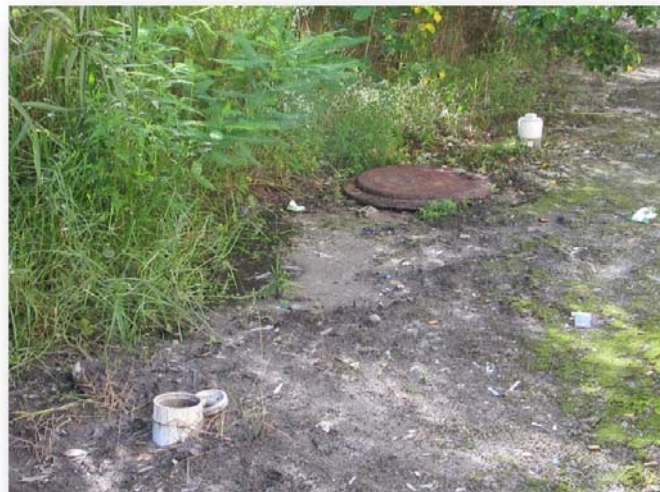
The white PVC pipe below is called a lateral. It conveys sewage from the building to the sanitary sewer conveyances owned by the utility, below ground. The opening on top is an access port to allow plumbers to dislodge blockages. Unfortunately, many property owners remove the clean out cap, as shown above, to drain their yard of flood waters during storms. The problem is that when stormwater enters the sanitary sewer conveyances it causes sewer spills by overloading the sewer system. It also overloads the sanitary sewer utility and reduces their ability to reduce nutrients and in some cases facilities must release improperly treated sewage to the environment. So, please, keep the caps on.

Clean out caps missing from sanitary sewer laterals

In these cases, code enforcement and the utility educated the property owners.

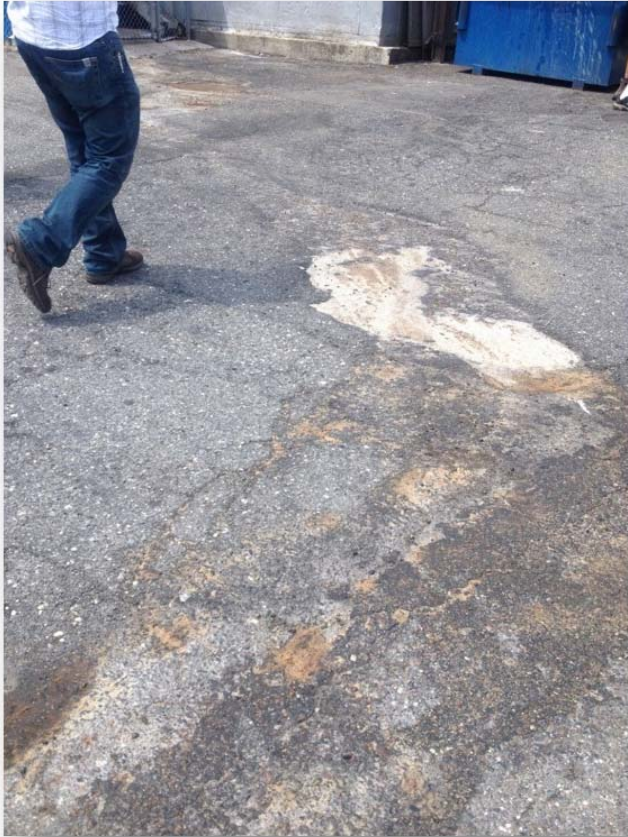
Field staff saw this greasy film on the asphalt and on top of the grease trap cover and suspected it was overflowing. Instead, they determined it had been recently pumped out but a spill occurred after pumping. Restaurants keep the pump out receipts. So, authorities contacted the pump out company to ensure this spill was cleaned up and further spills are prevented.

Greasy sludge on asphalt and grease trap cover

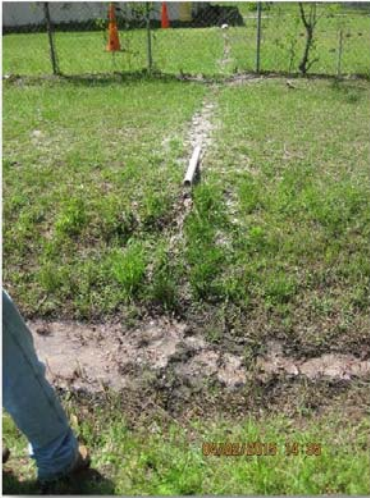
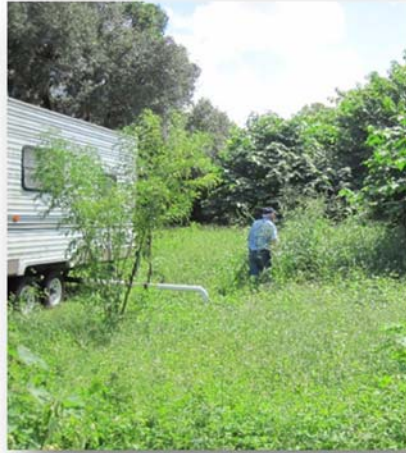
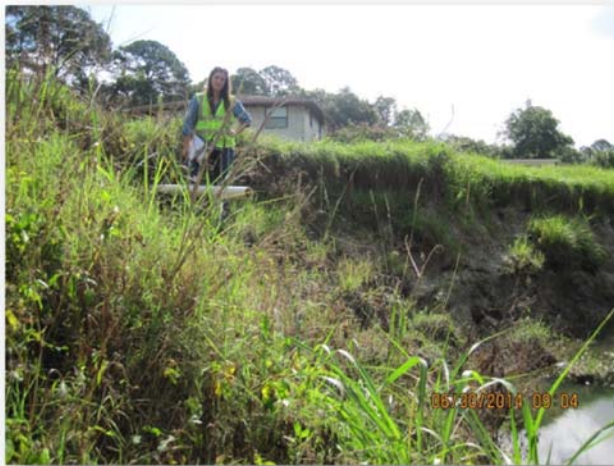
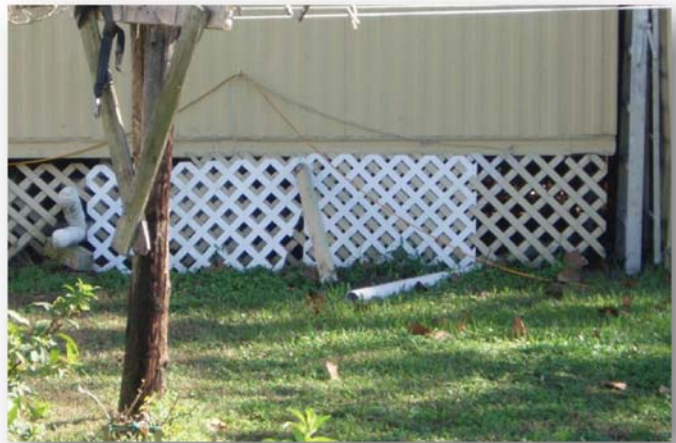
The white PVC pipes in these images are considered illicit discharges because they convey sewage to the environment. In these cases, either the sanitary sewer utility or DOH, worked with code enforcement and required property owners to properly hook into the sanitary sewer conveyances or an onsite septic treatment and disposal system (septic system).

Illicit discharge pipes

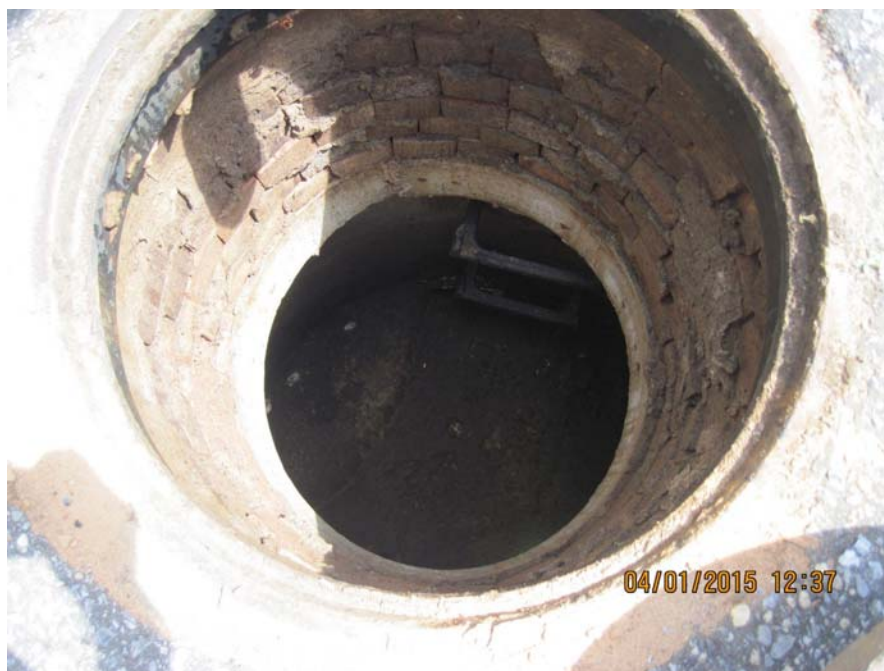
Degrading sanitary sewer manhole

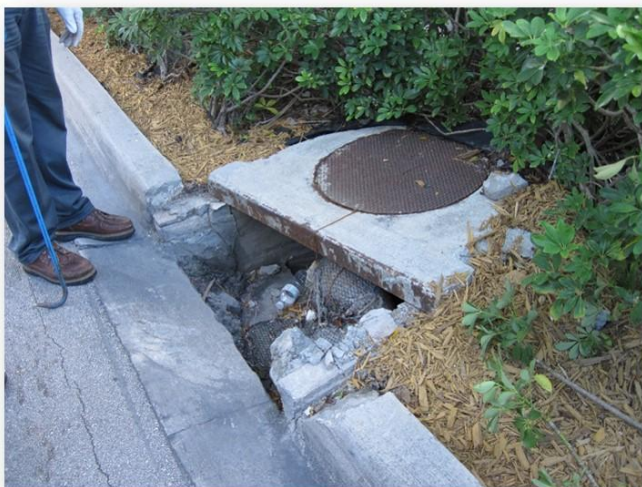
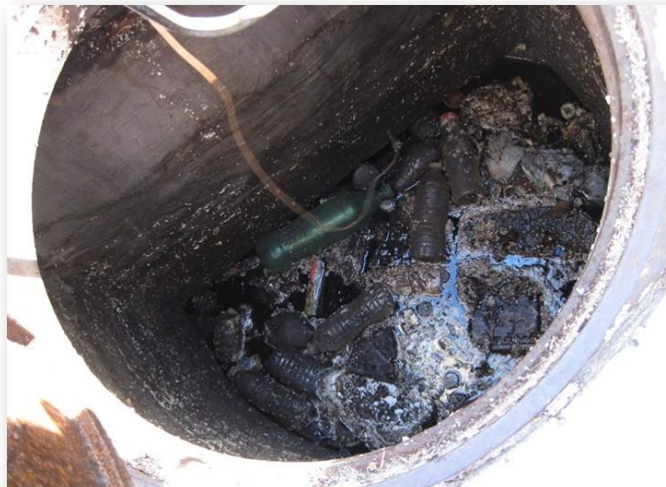
Stormwater system in need of clean out and maintenance

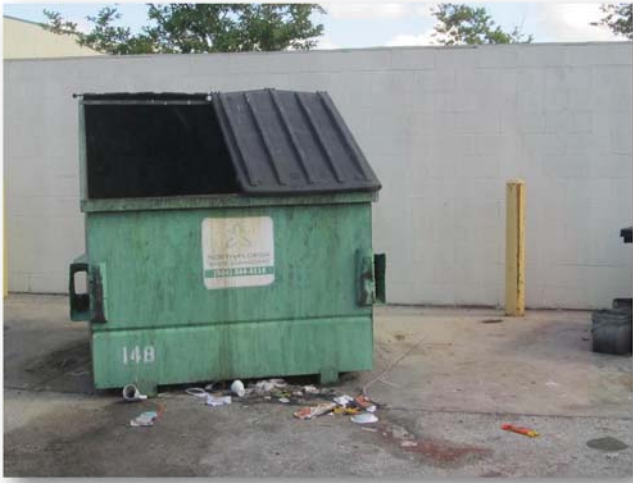
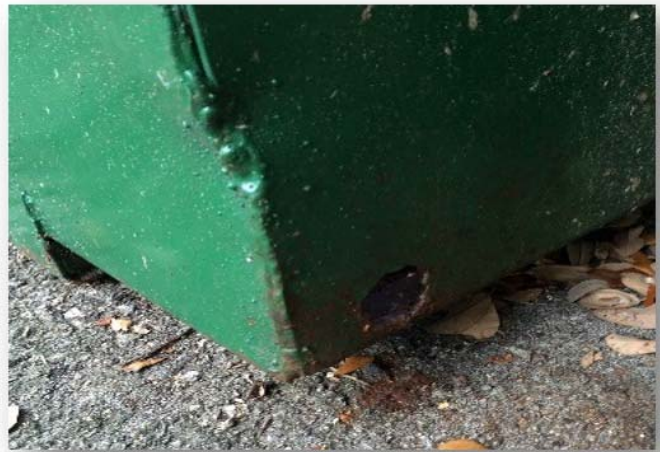
Dumpsters should be in good condition and shouldn't leak. Lids should remain shut to prevent collection of rain water. When dumpsters with rainwater are dumped they often spill, carrying bacteria and trash to storm drains. Lastly, drain ports located at the bottom of a dumpster should be plugged at all times. If there is staining on the ground near a dumpster, better maintenance is probably needed. In these cases, code enforcement spoke with business owners to ensure they understood why its important and how to better maintain their dumpsters.

Left image: Dumpster lid open, trash on ground, staining on asphalt. Right image: Dumpster drain without plug.

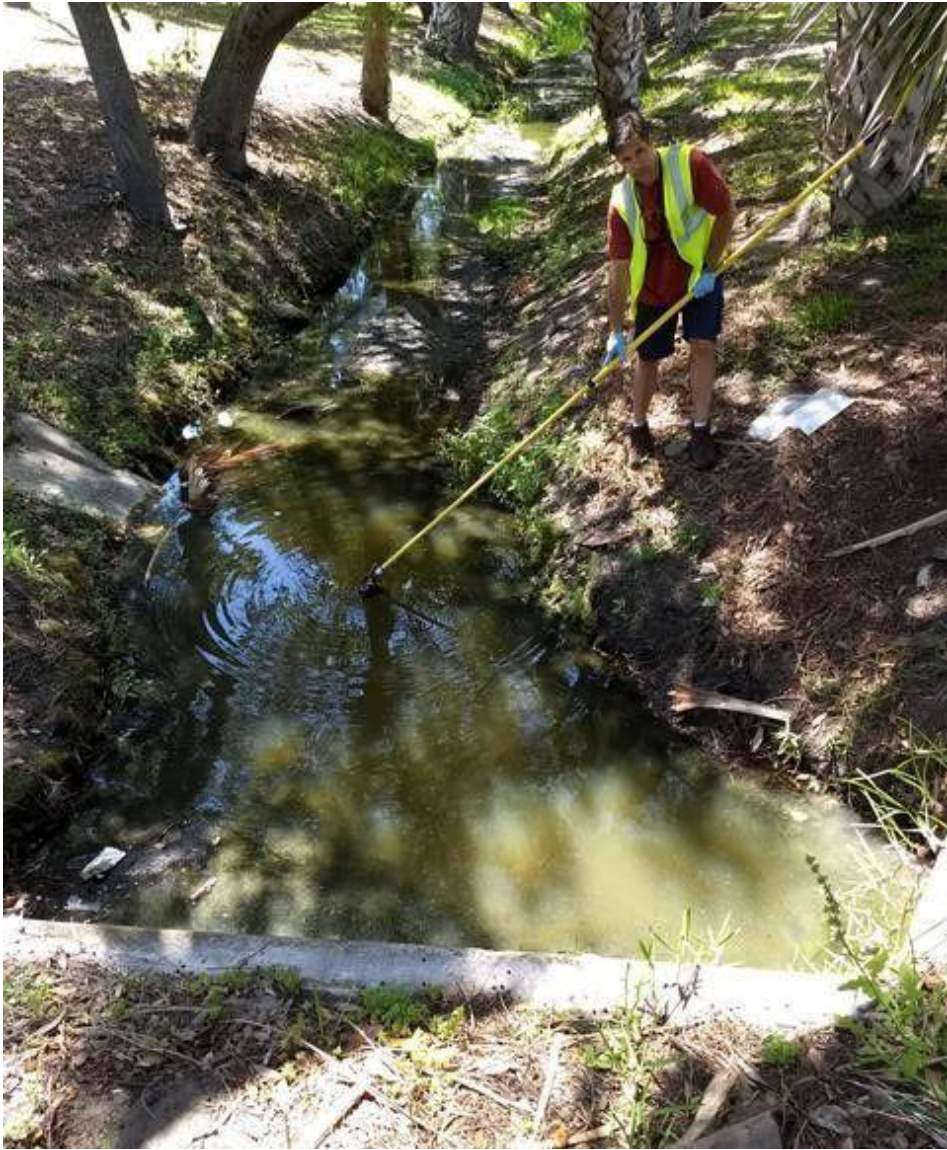
Sampling through a storm grate using a peristaltic pump.

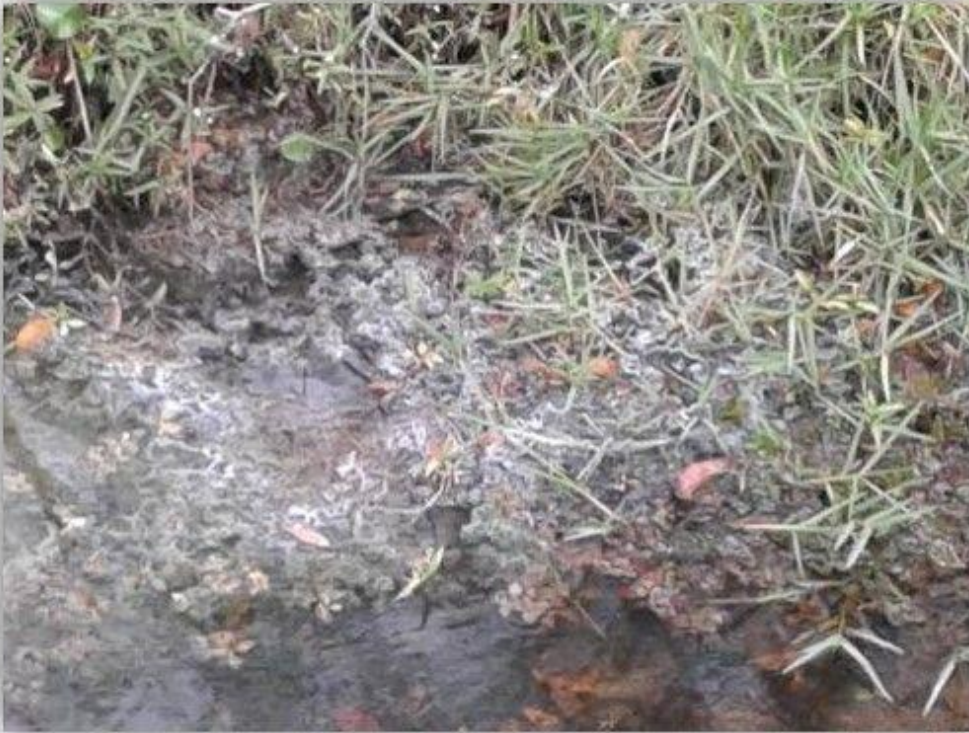
2. They followed mild suds and light bacterial film on submerged vegetation about 700 meters upstream of the original site.

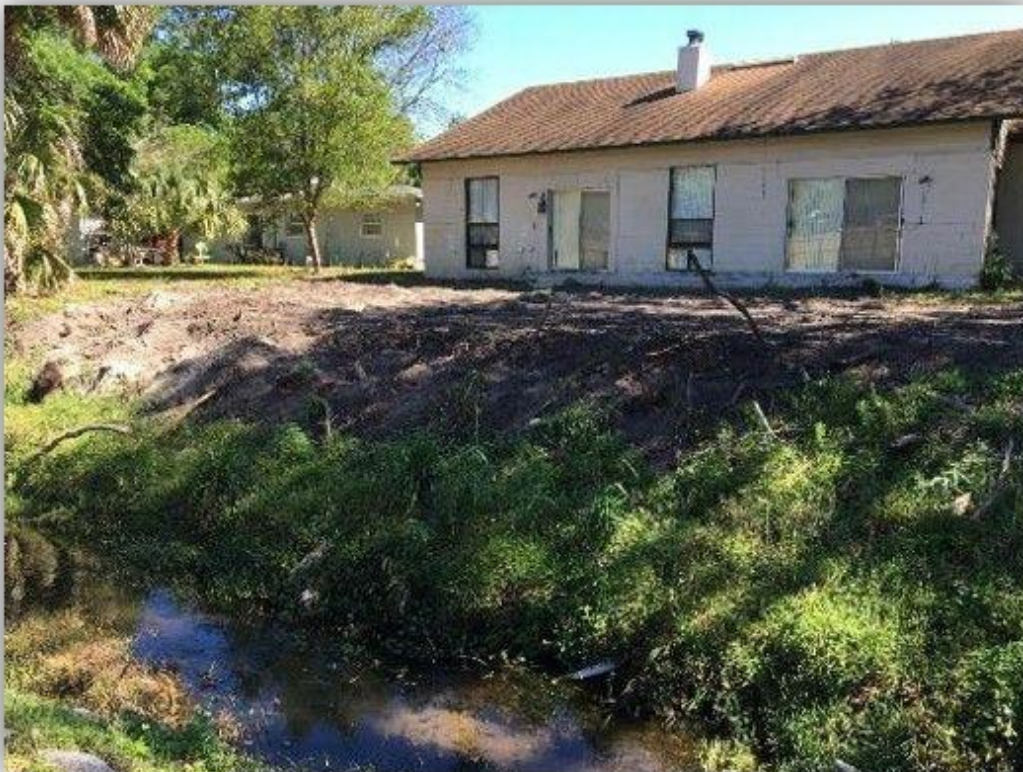
3. They noticed tracks from land moving equipment in the back yard where recent landscaping had been performed.

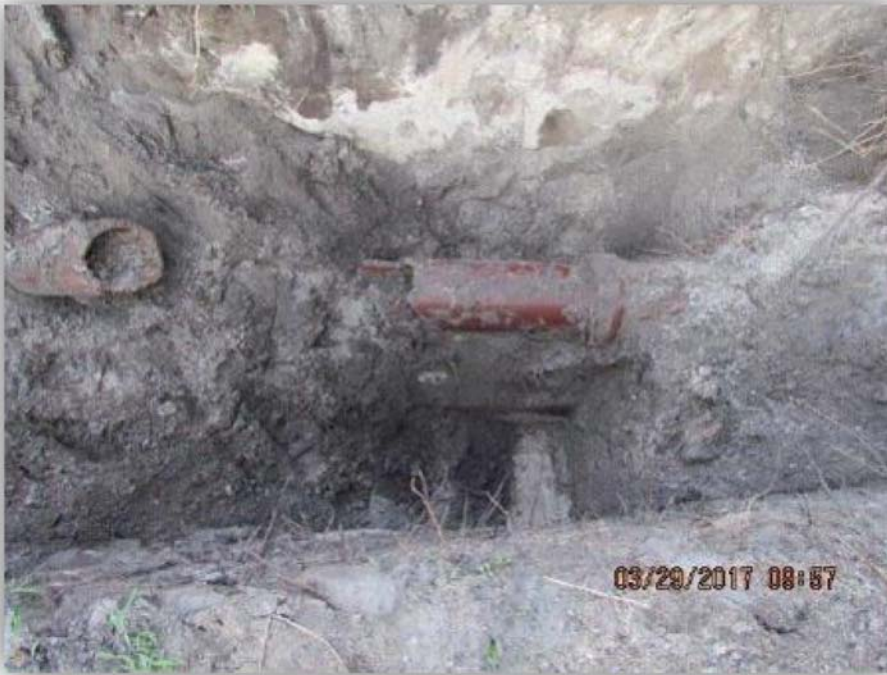
4. The sewer utility further investigated the site and found the clay sewer pipe, which runs underground and adjacent to the creek, had been broken and partially removed.

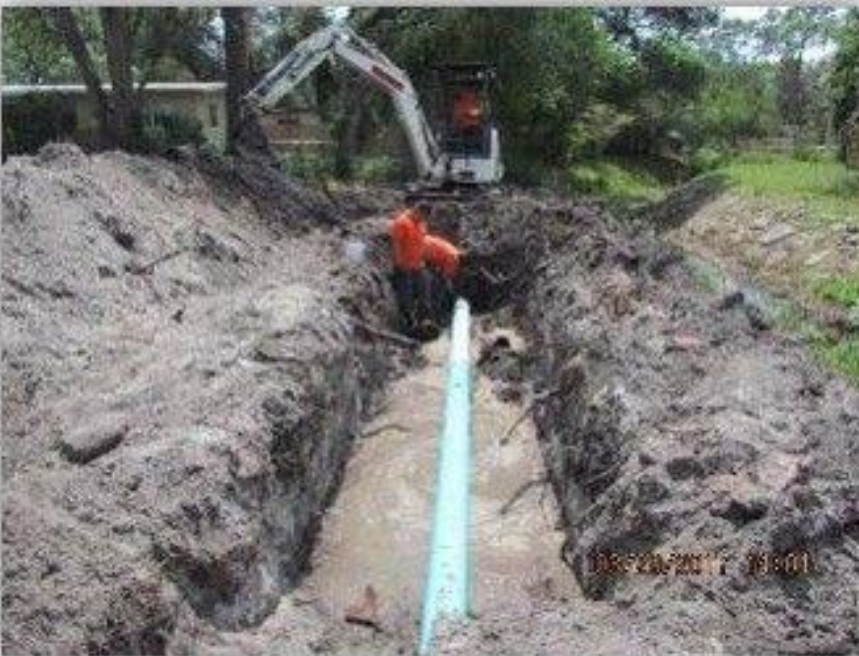
5. So, they replaced a 40' stretch of pipe with PVC pipe and stopped the sewer leak.
