Strategic Beach Management Plan:
Panhandle Gulf Coast Region

Division of Water Resource Management

Florida Department of Environmental Protection

May 2018

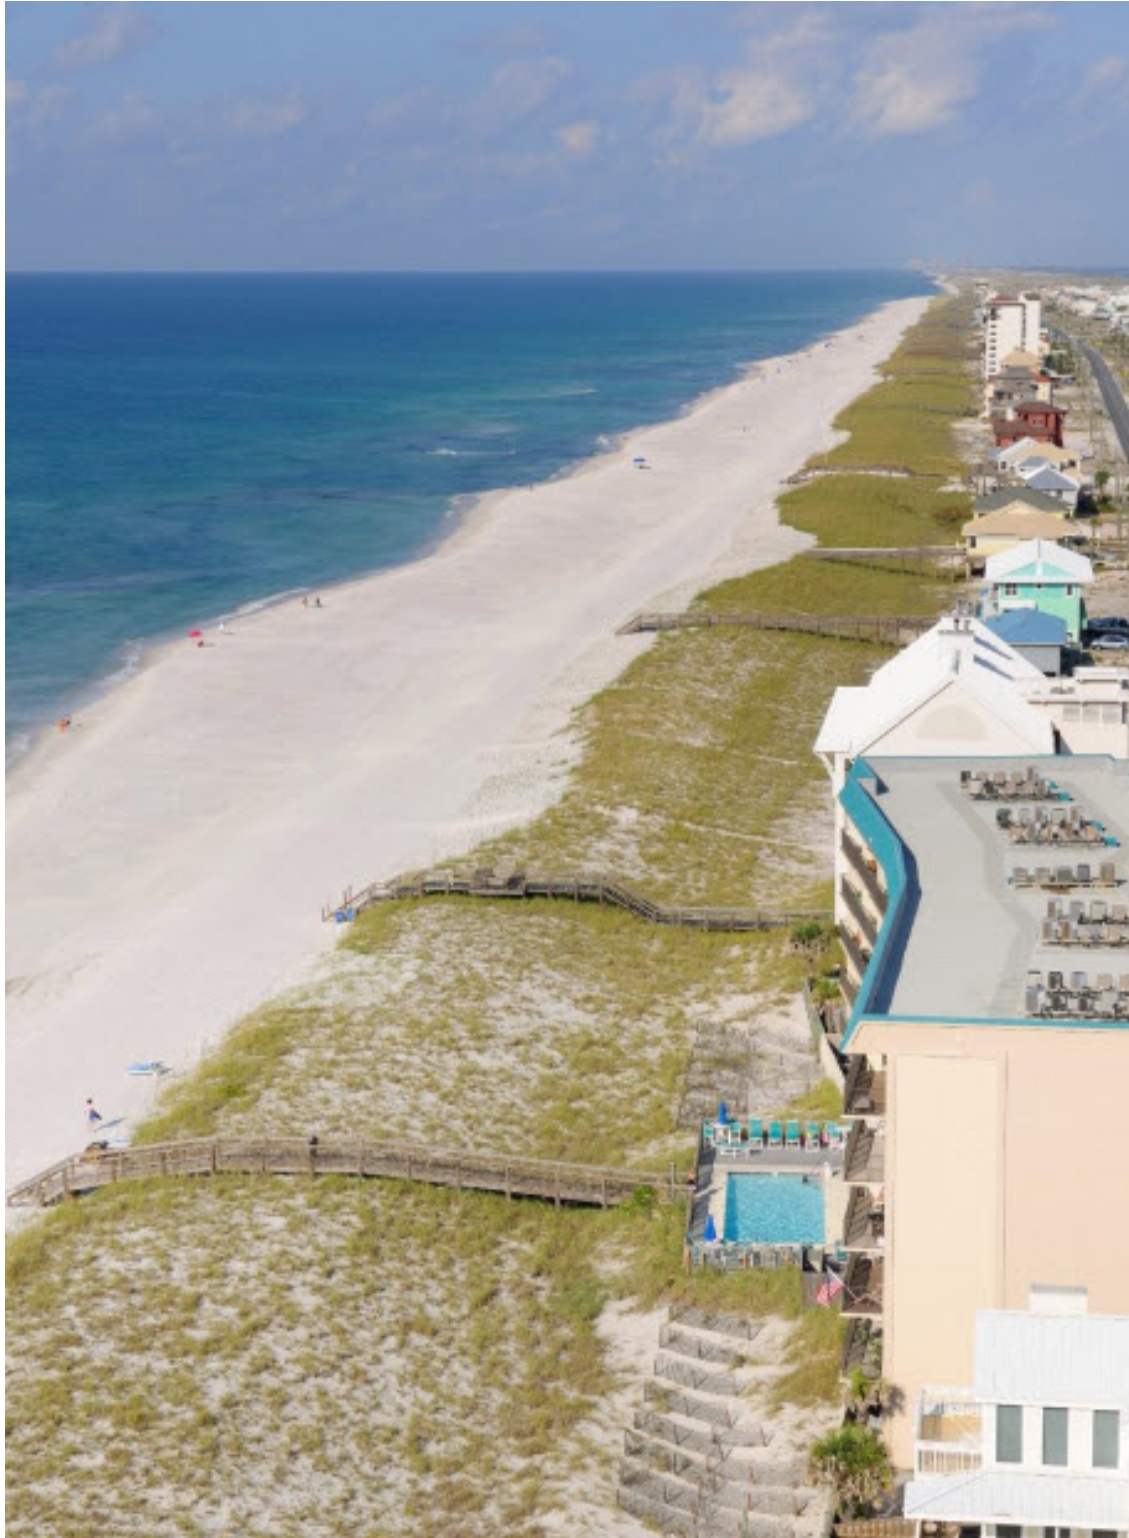
Completed Navarre Beach Nourishment Project in September 2016. Photo courtesy of Michael Walther, P.E.

Beach nourishment was completed in July of 2016, placing approximately 1,311,961 cy of material from an offshore borrow site along 4.1 miles between R-192 and R-213. FEMA will cost share on this beach nourishment project in response to damages sustained during Tropical Storm Debby and Hurricane Isaac.

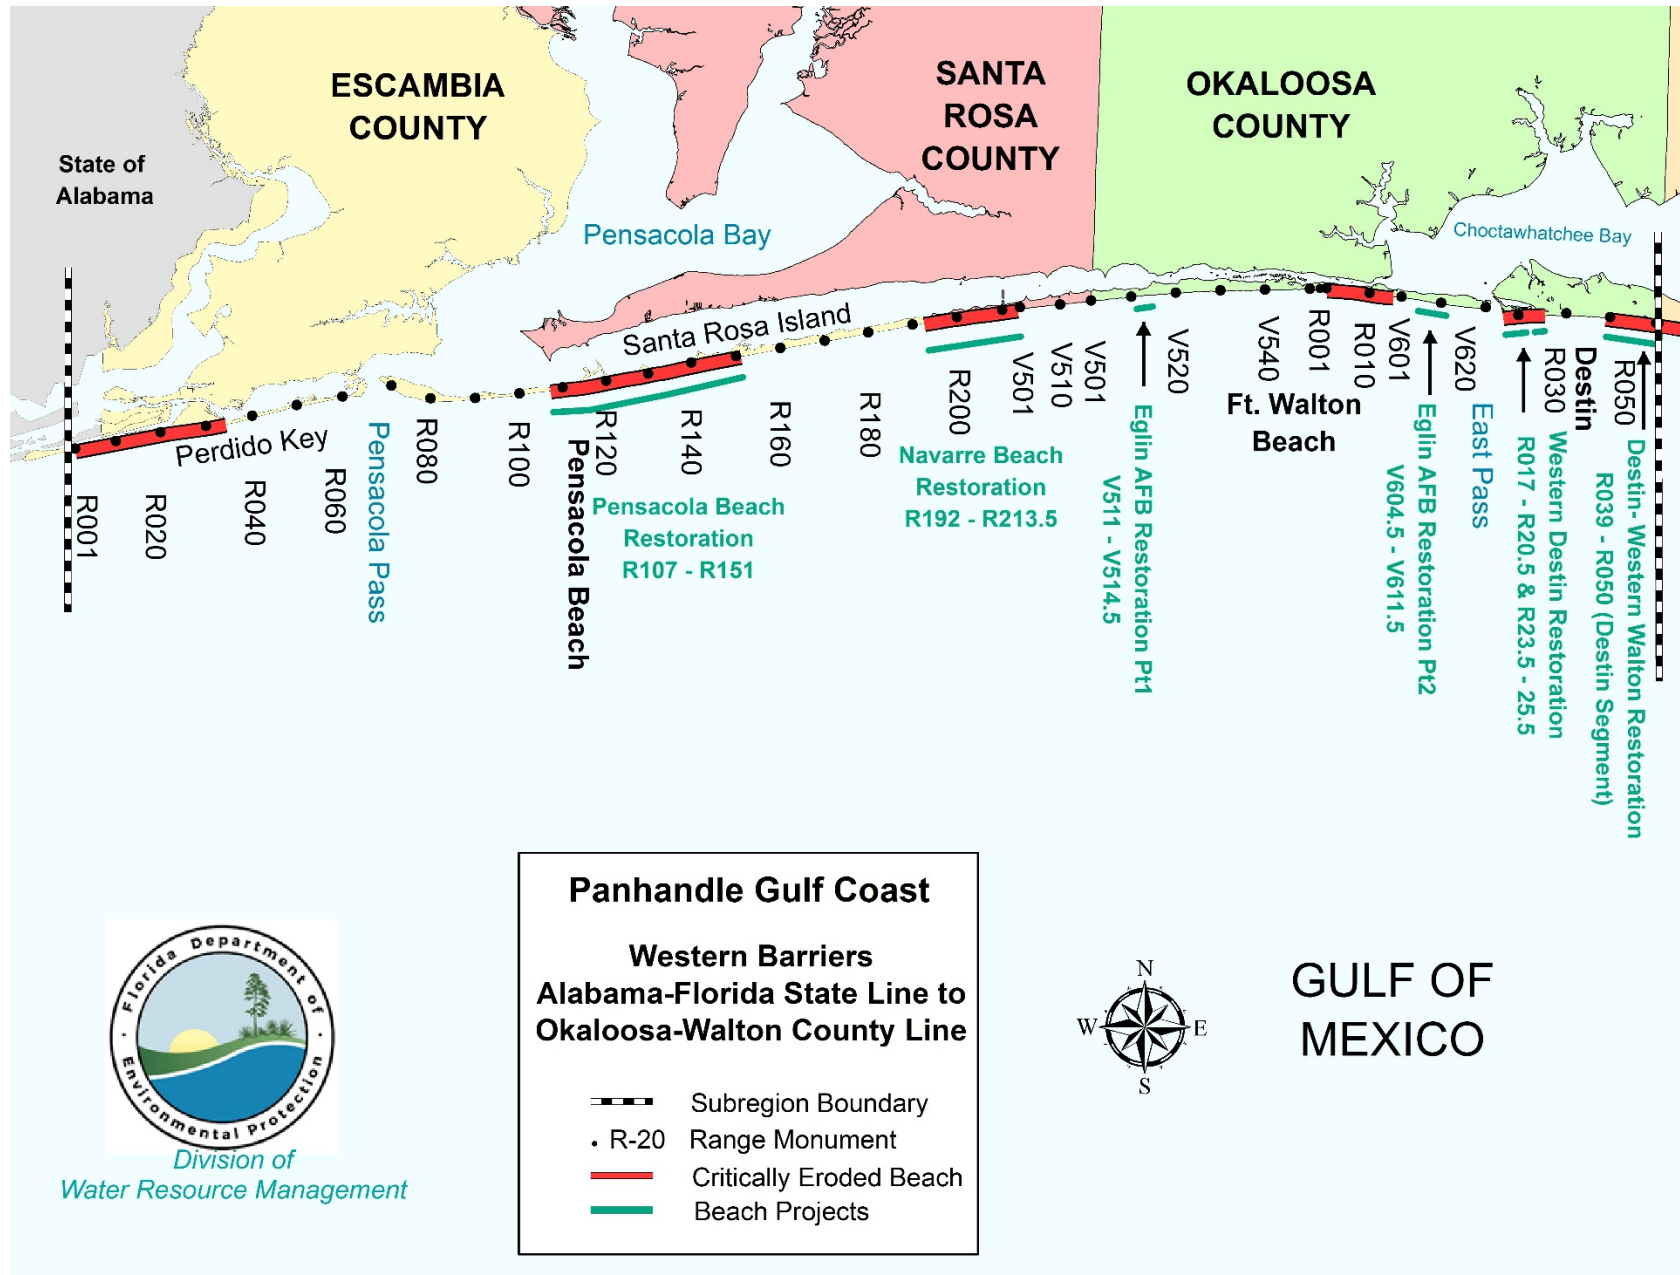
Figure 1. The Western Barriers subregion of the Panhandle region of Florida. View an [interactive map](#) or [COASTS imagery](#).

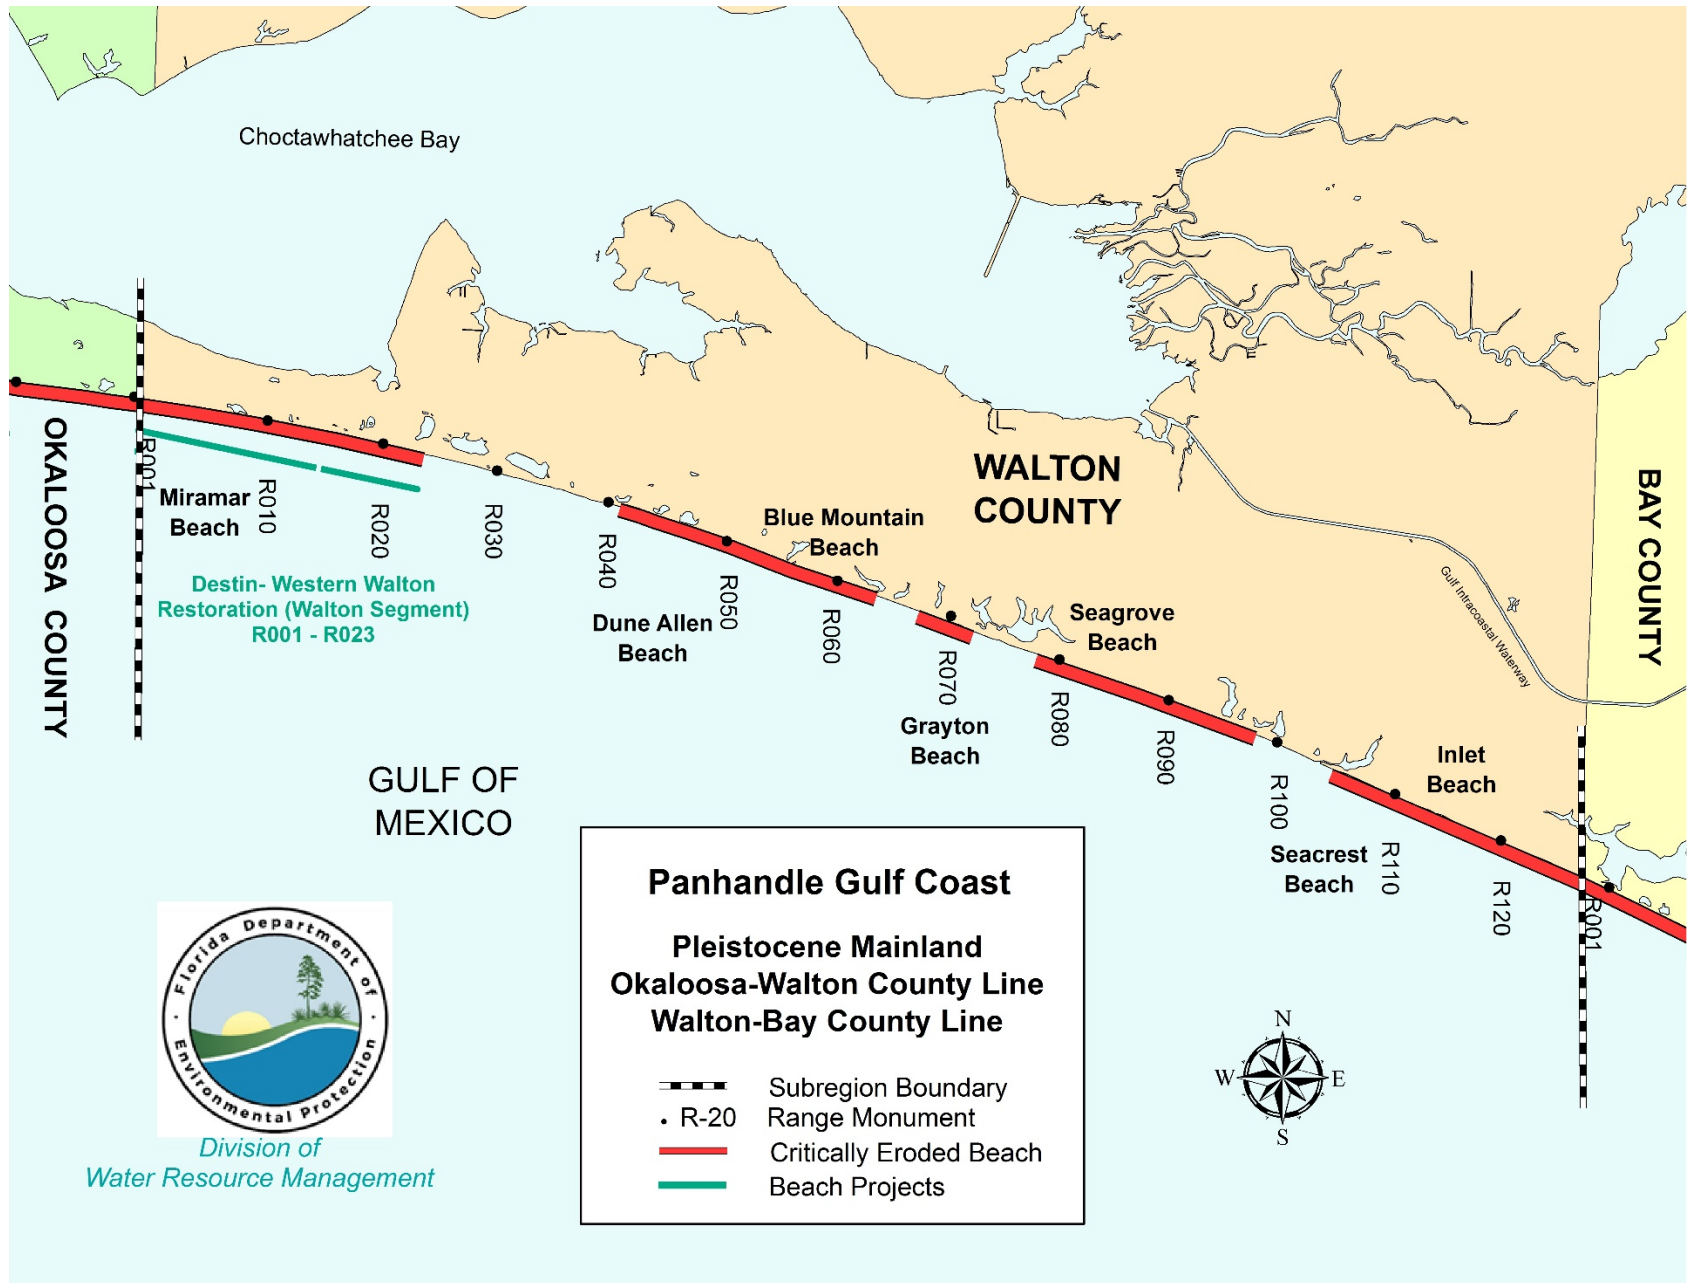
Figure 2. Pleistocene Mainland subregion of the Panhandle region of Florida. View an [interactive map](#) or [COASTS imagery](#).

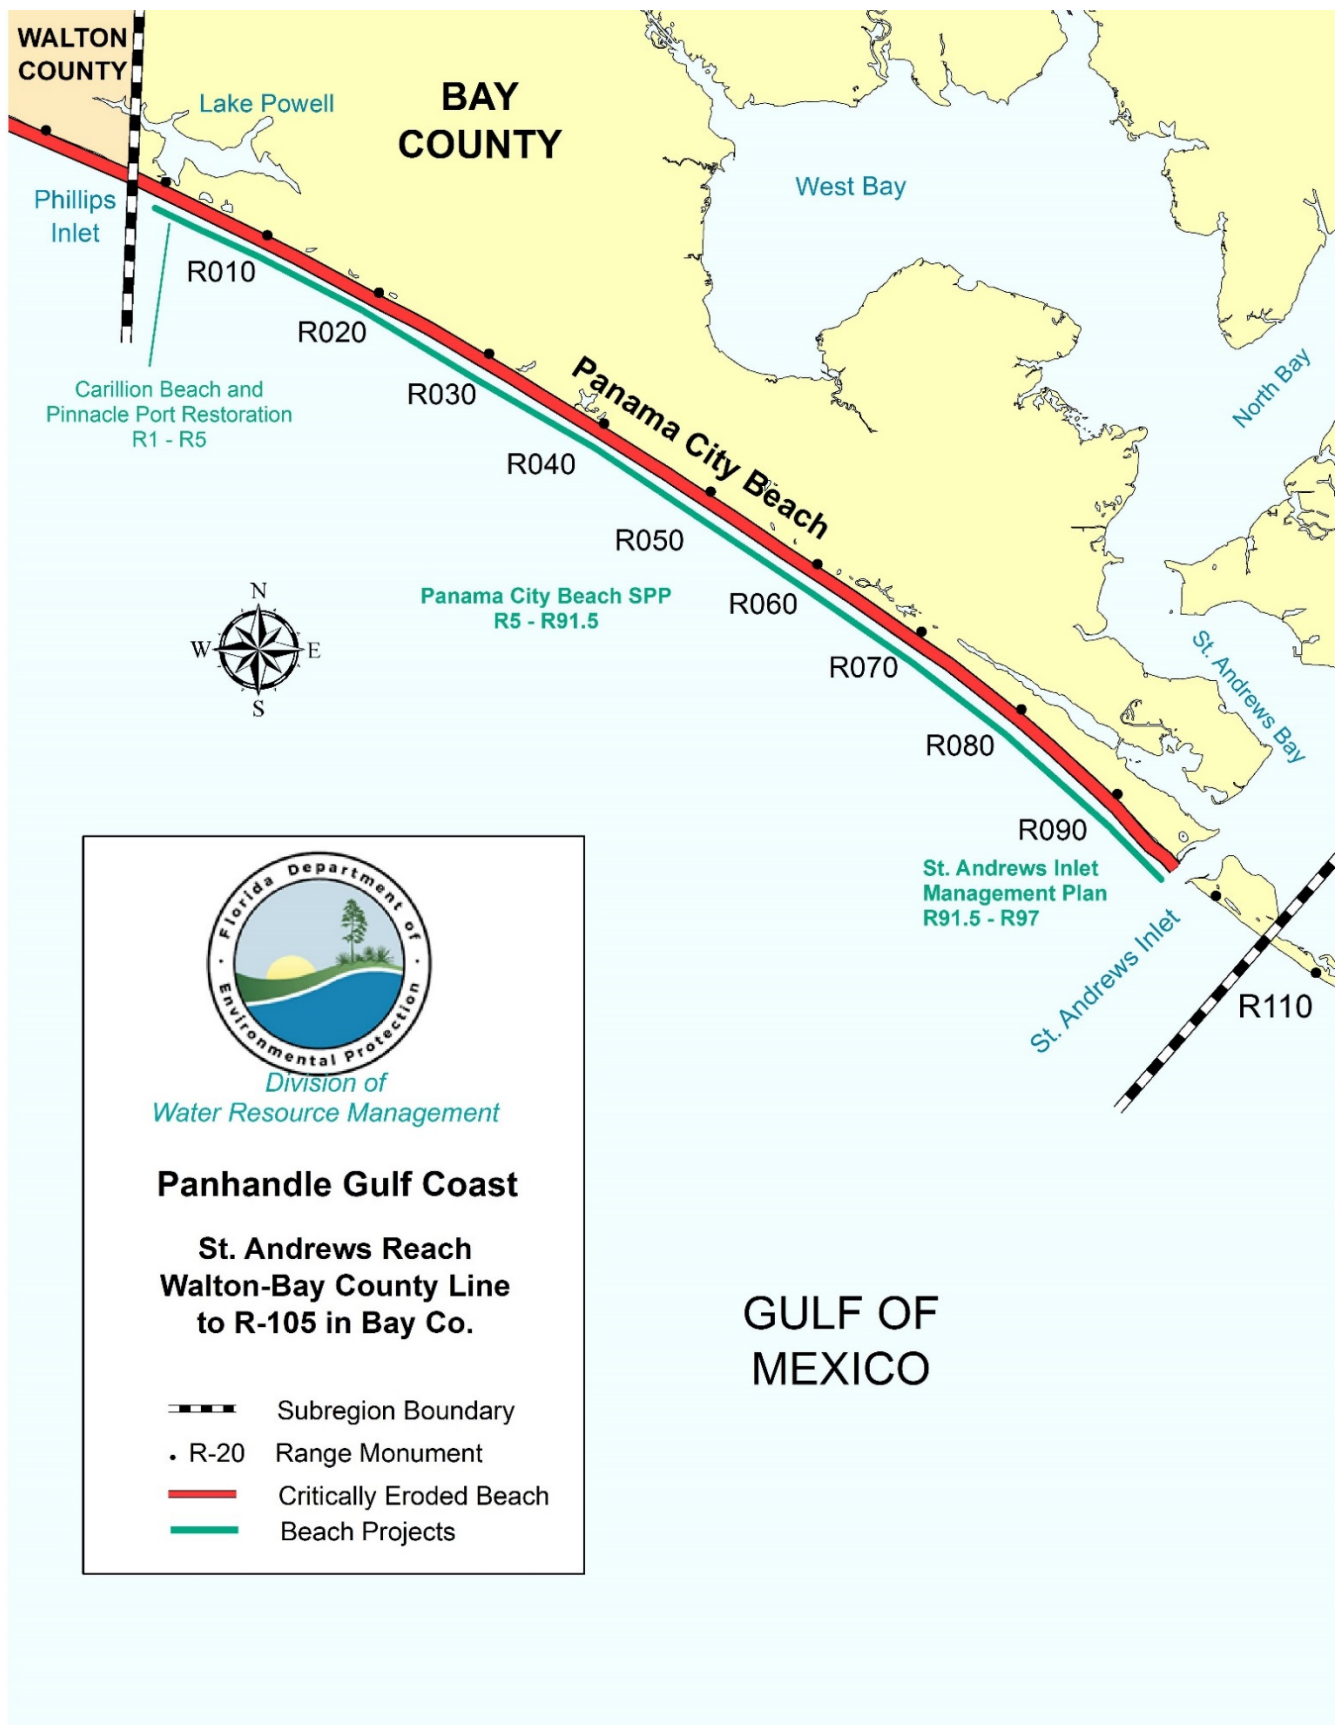
Figure 3. The St. Andrews Reach subregion of the Panhandle region of Florida. View an [interactive map](#) or [COASTS imagery](#).

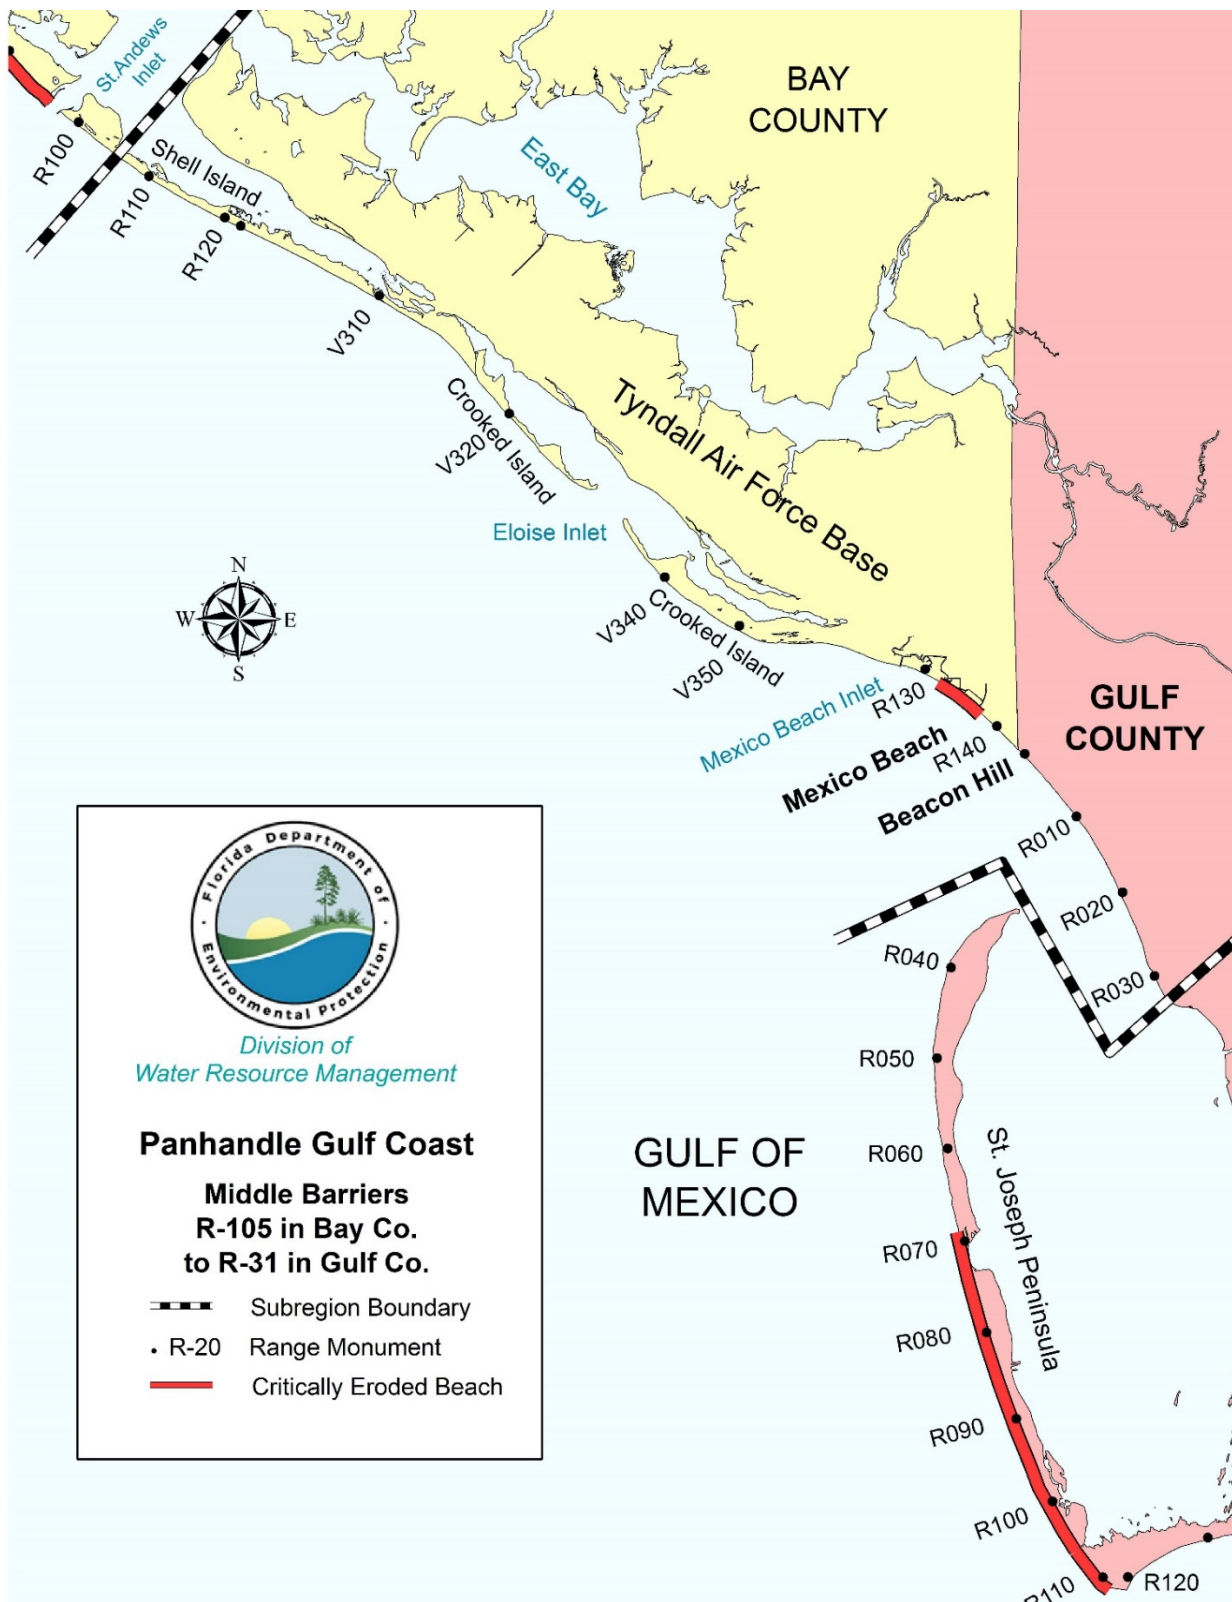
Figure 4. The Middle Barriers subregion of the Panhandle region of Florida. View an [interactive map](#) or [COASTS imagery](#).

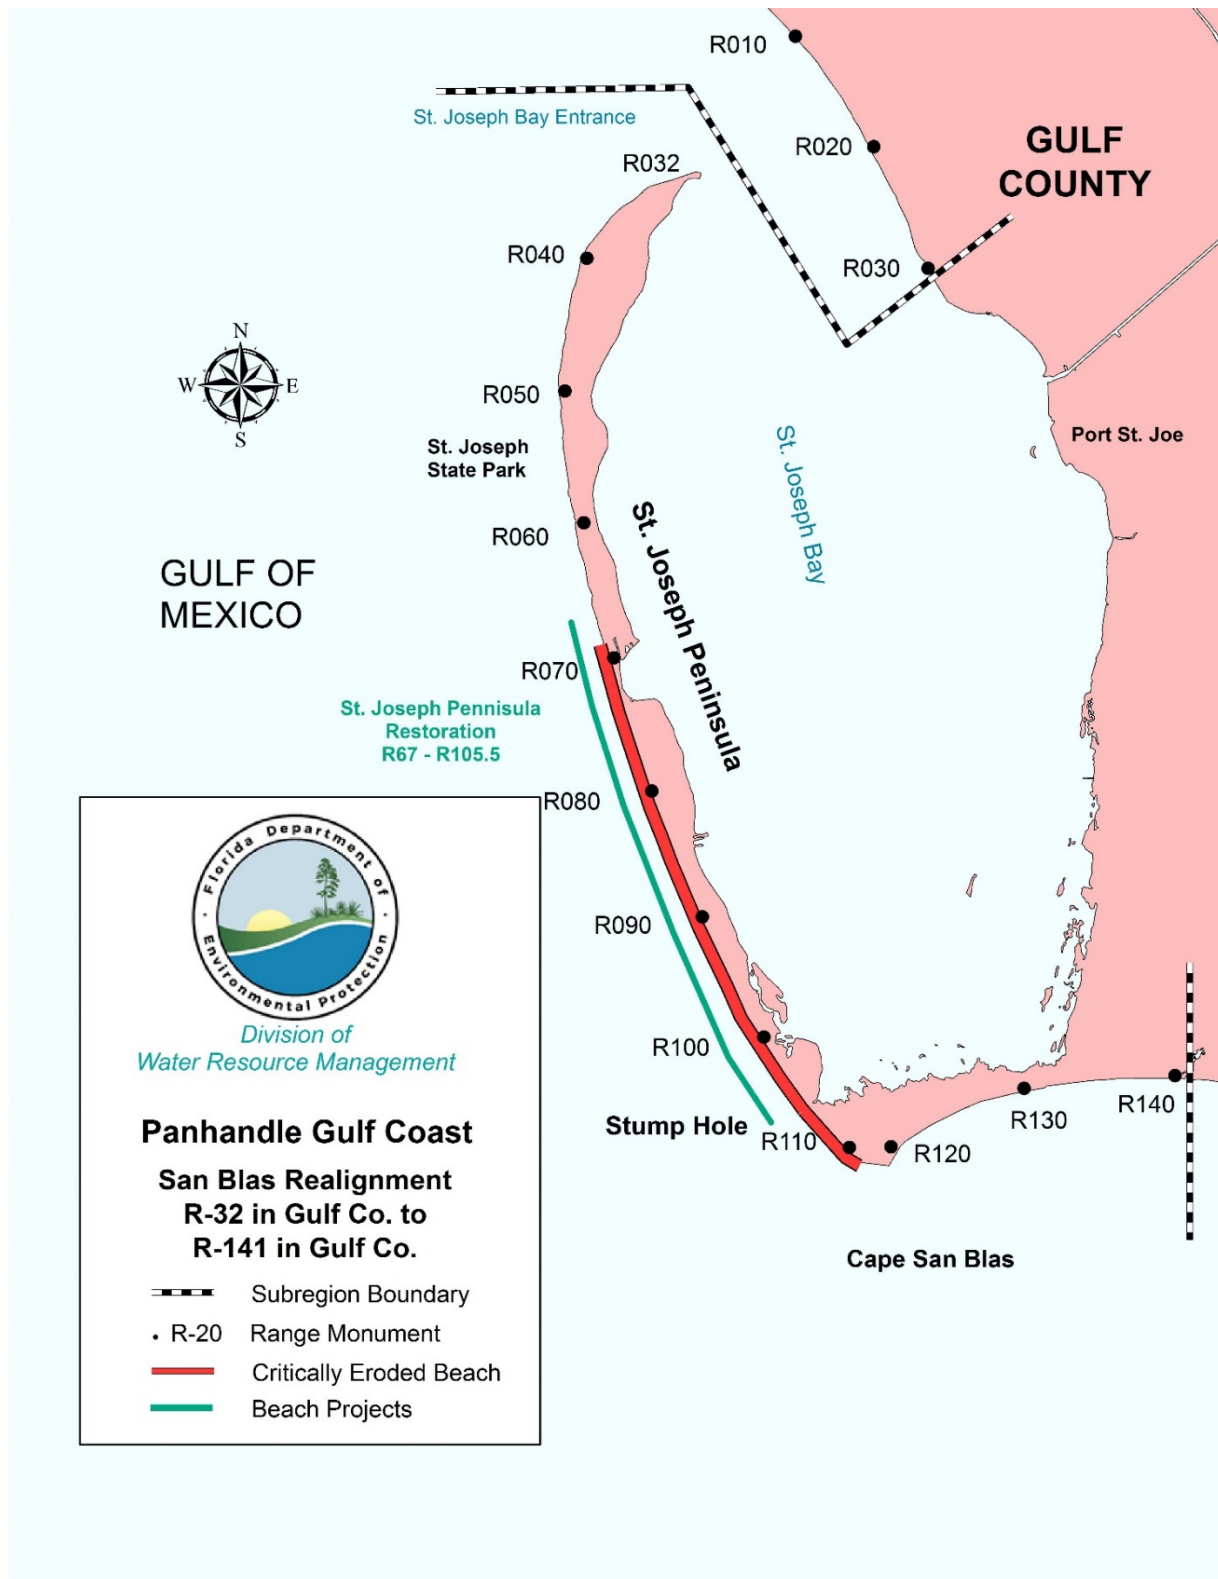
Figure 5. The San Blas Realignment subregion of the Panhandle region of Florida. View an [interactive map](#) or [COASTS imagery](#).

There are 21.2 miles of beaches in the **San Blas Realignment** subregion, which extends from the entrance to St. Joseph Bay and along St. Joseph Peninsula and Cape San Blas to R141 near Money Bayou in Gulf County, as shown on Figure 5. There are 8.3 miles of critically eroded beaches in this subregion, of which 7.3 miles have been restored. Erosion is attributed to tropical storms and hurricanes, and to natural geomorphic changes caused by the pattern of littoral transport of sand in this area.

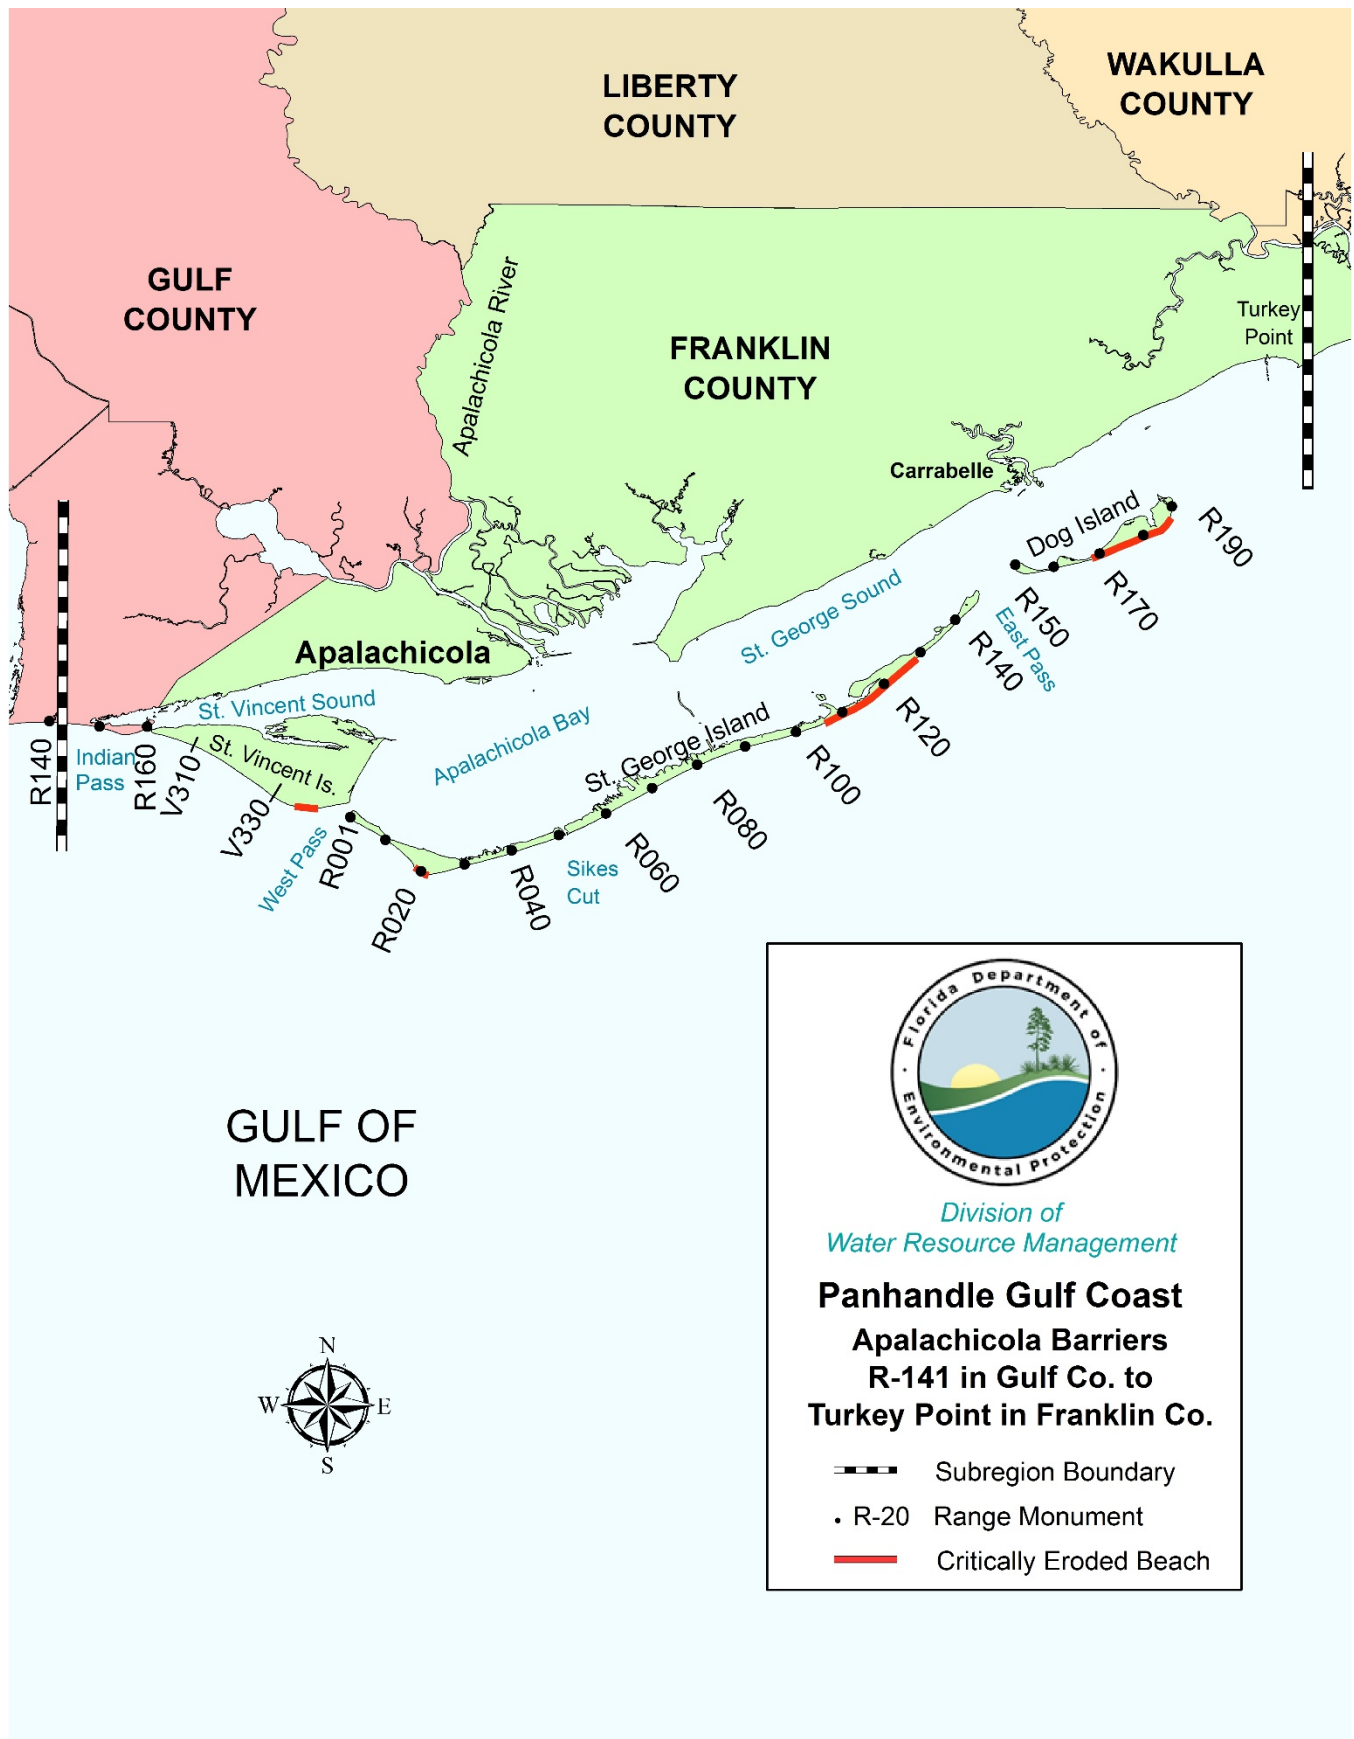
Figure 6. The Apalachicola Barriers subregion of the Panhandle region of Florida. View an [interactive map](#) or [COASTS imagery](#).

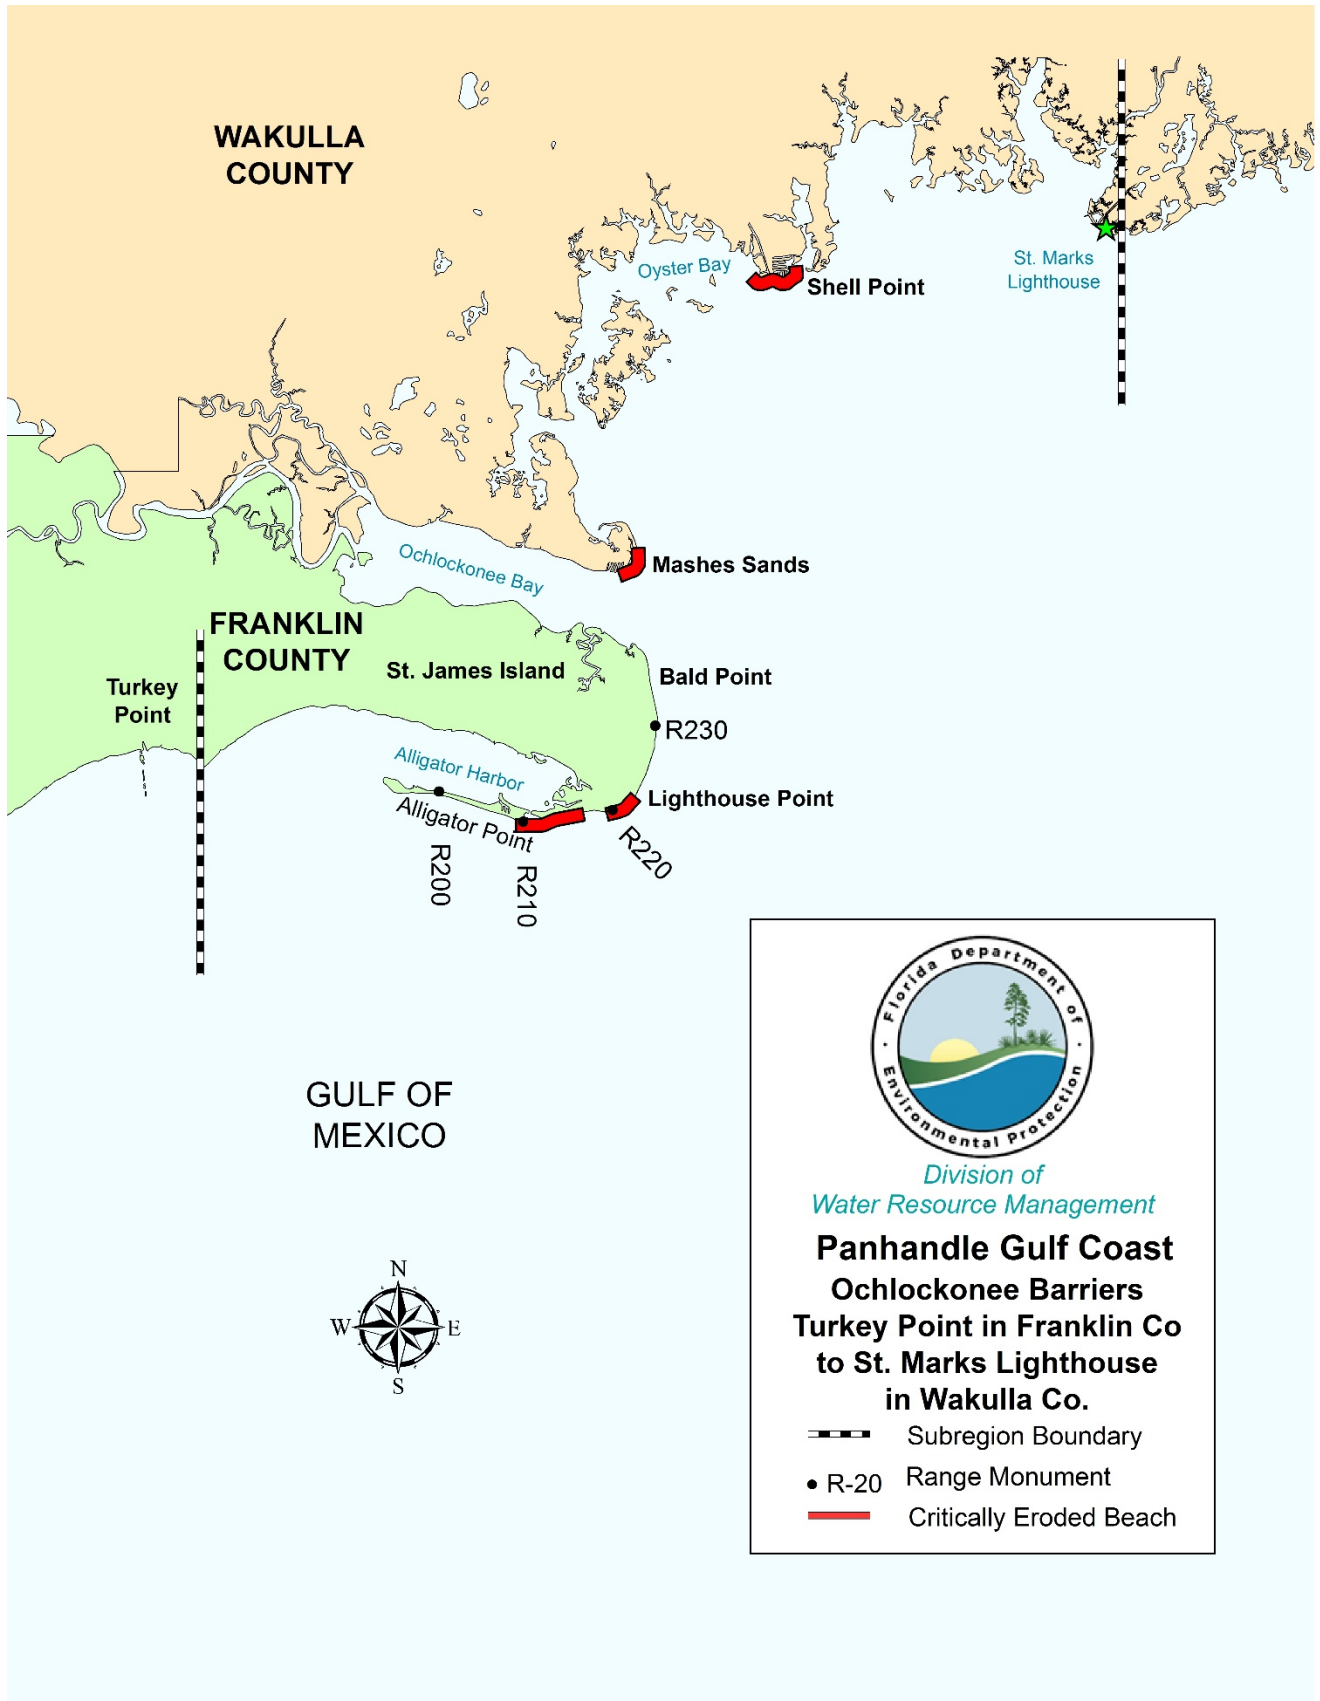
Figure 7. The Ochlockonee Barriers subregion of the Panhandle region of Florida. View an [interactive map](#) or [COASTS imagery](#).
