Strategic Beach Management Plan:
Panhandle Gulf Coast Region

Office of Resilience and Coastal Protection

Florida Department of Environmental Protection

April 2020

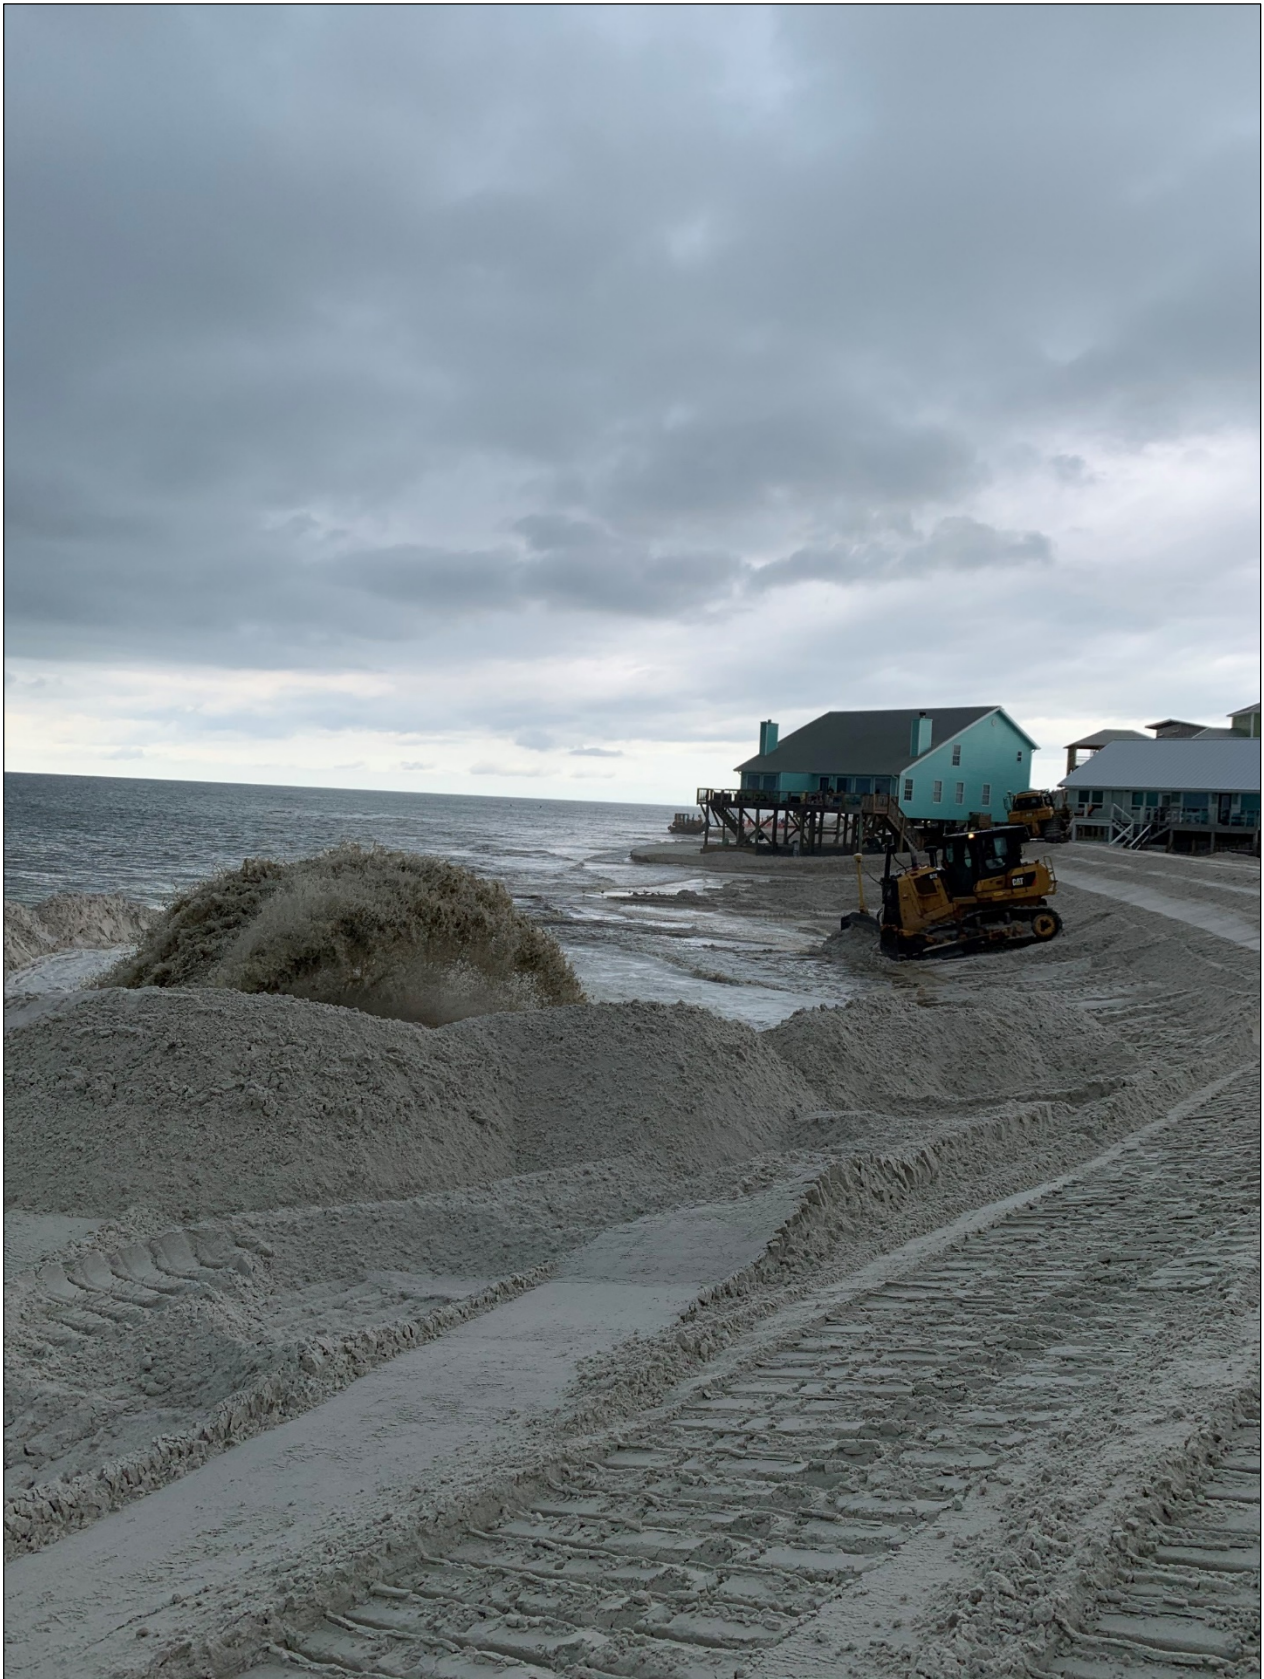
St. Joseph Peninsula Beach Nourishment Project under construction in October 2019. FDEP photo taken by Greg Garis.

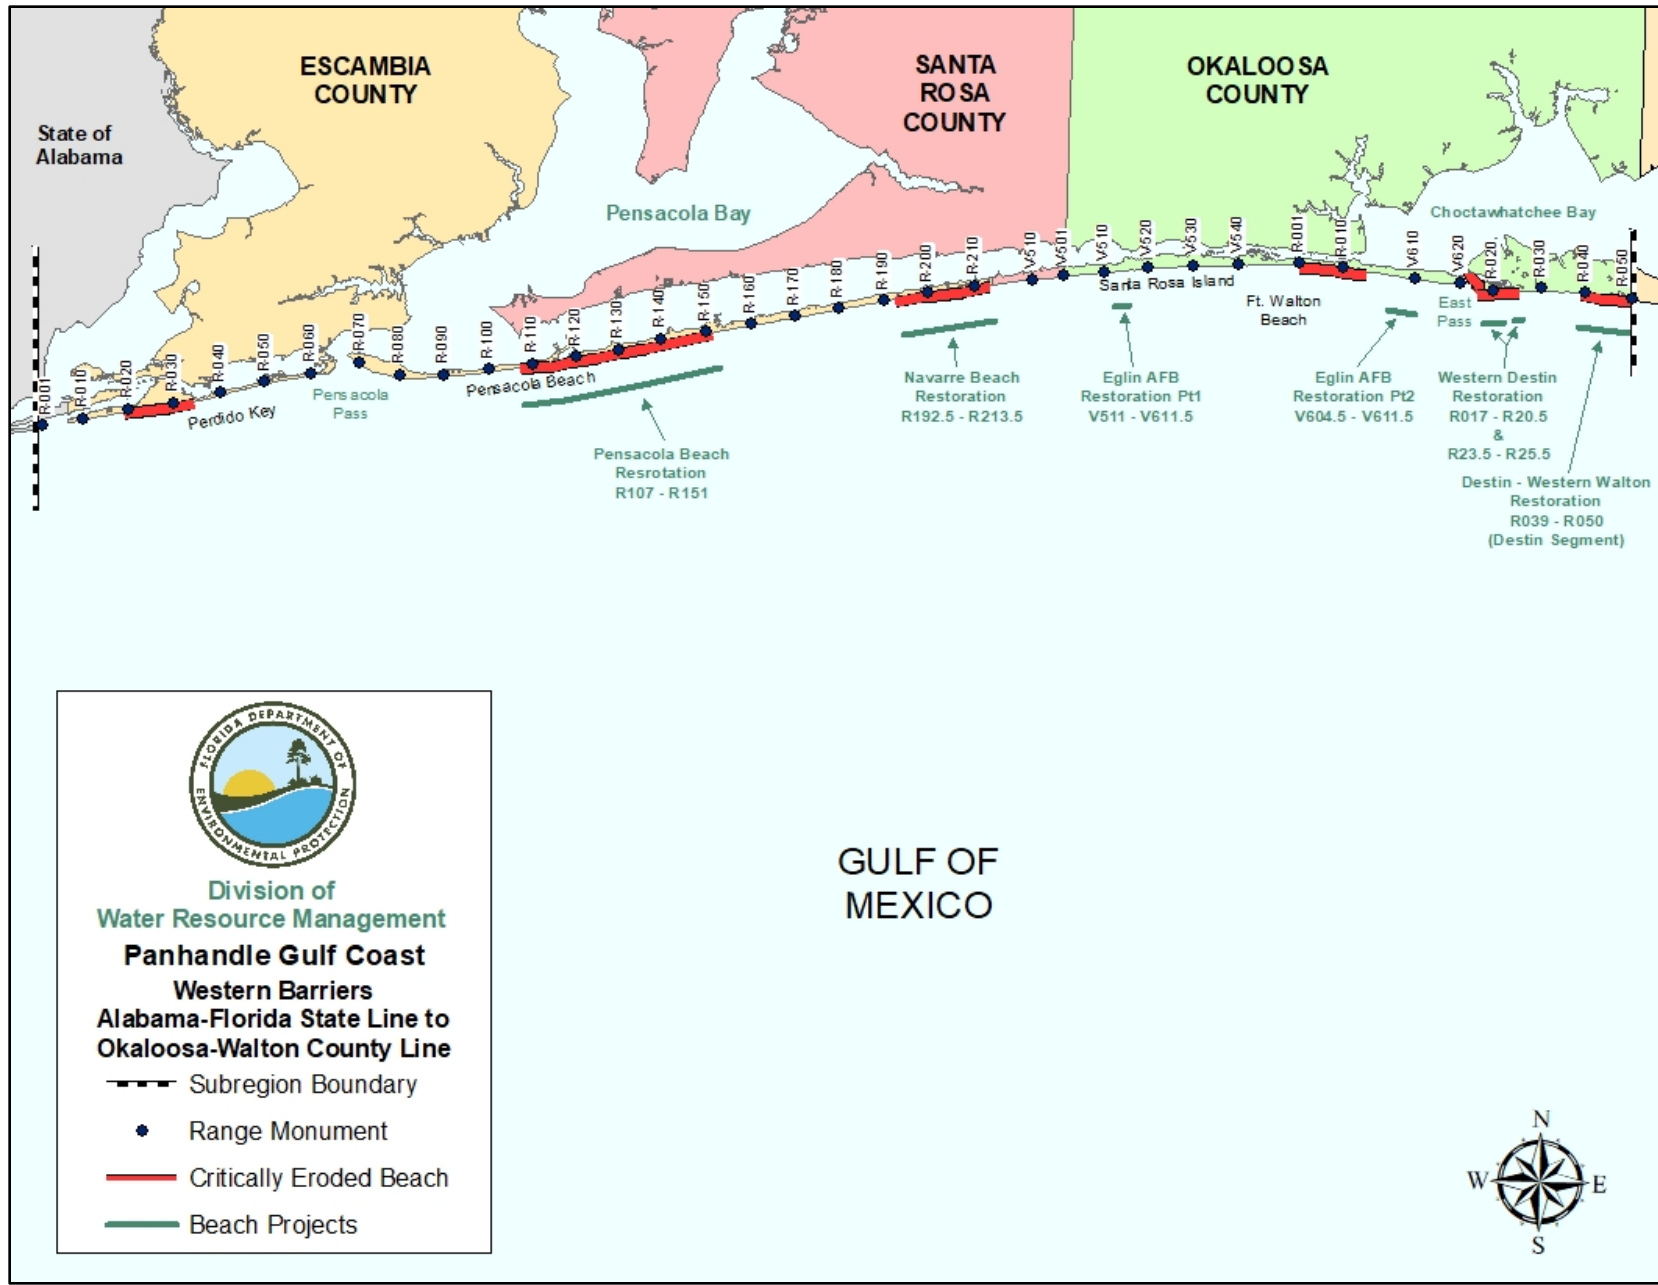
Figure 1. The Western Barriers subregion of the Panhandle region of Florida. View an [interactive map](#) or [COASTS imagery](#).

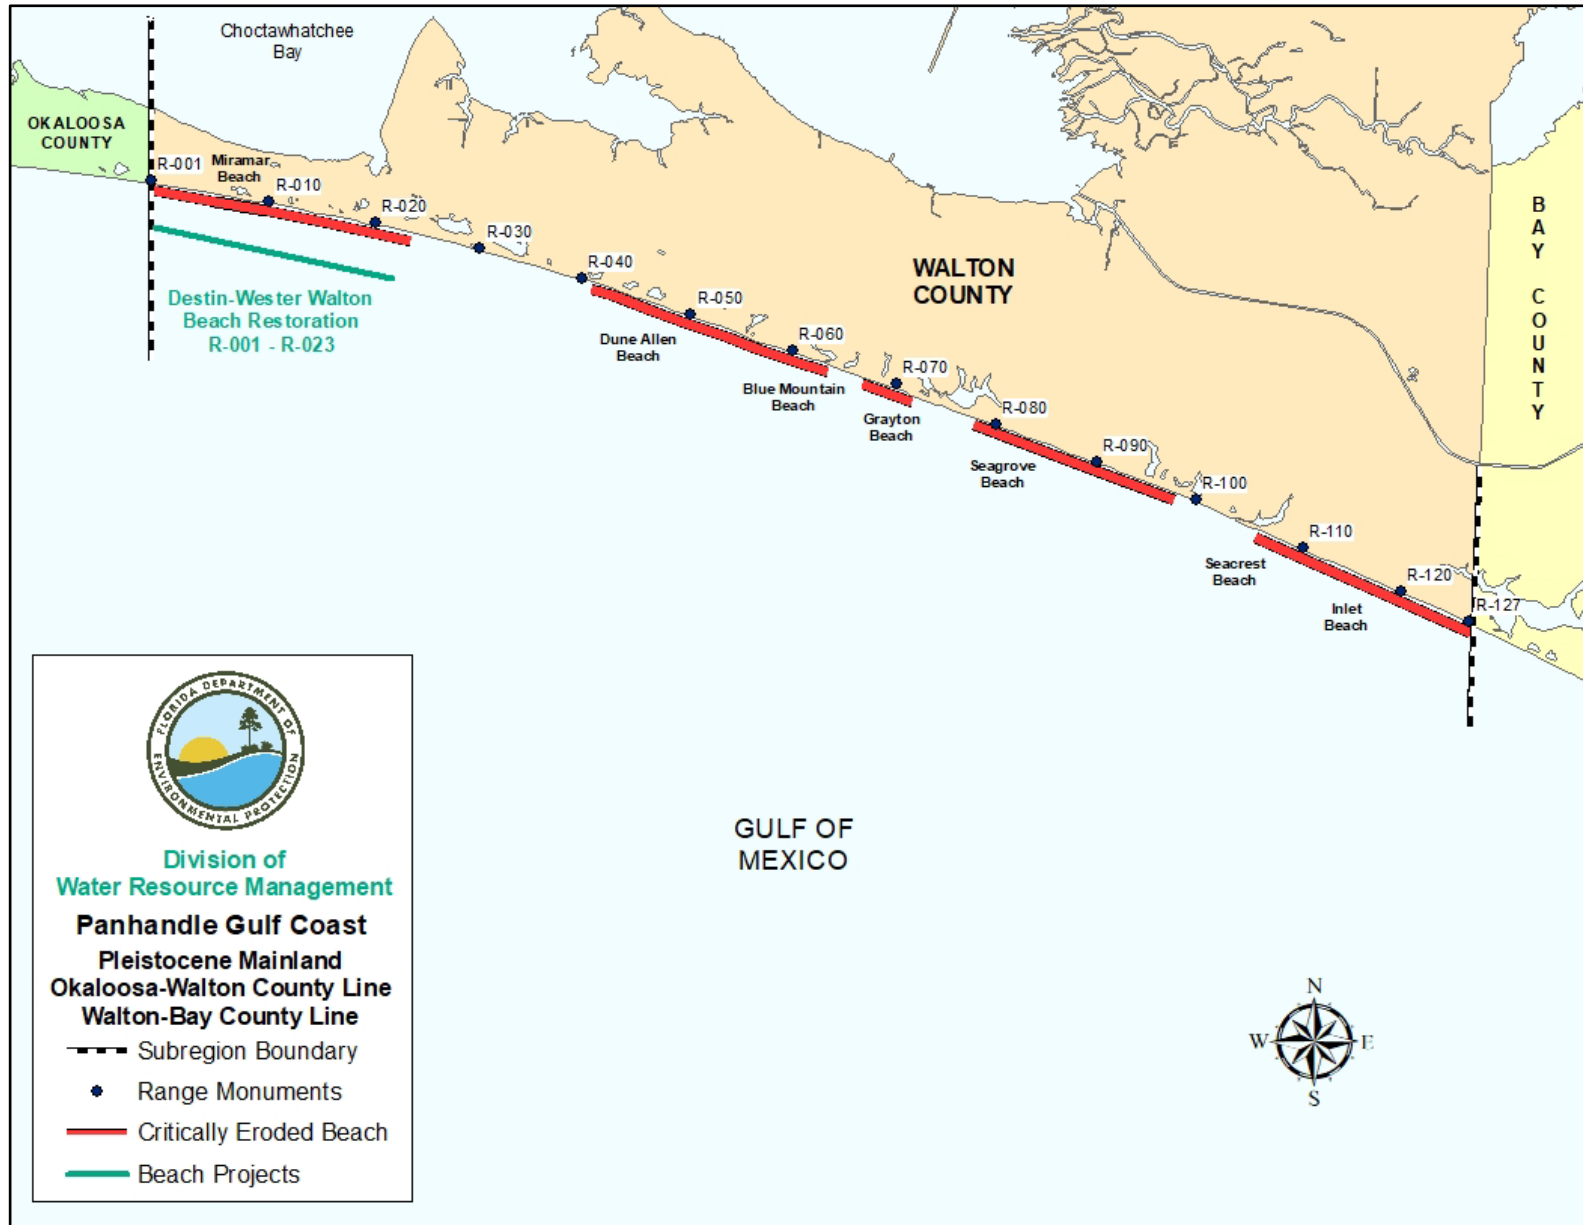
Figure 2. Pleistocene Mainland subregion of the Panhandle region of Florida. View an [interactive map](#) or [COASTS imagery](#).

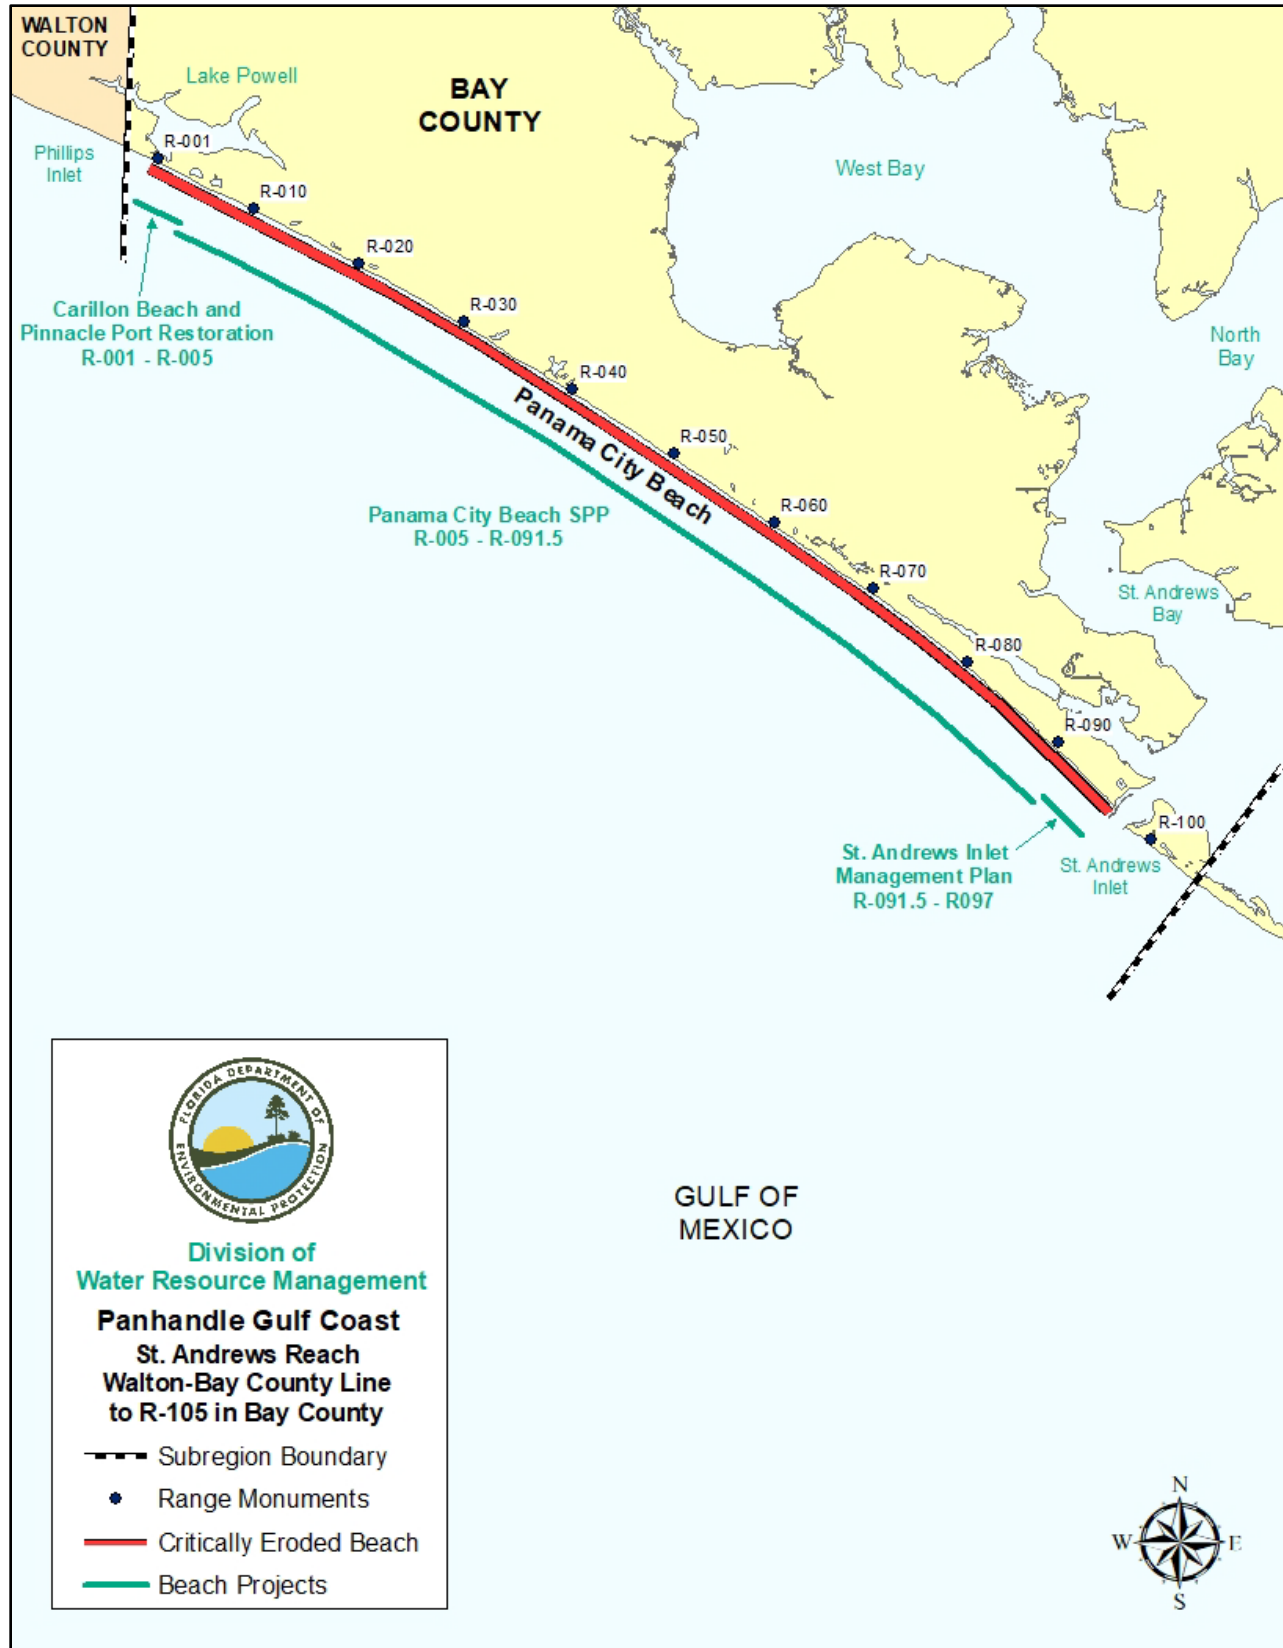
Figure 3. The St. Andrews Reach subregion of the Panhandle region of Florida. View an [interactive map](#) or [COASTS imagery](#).

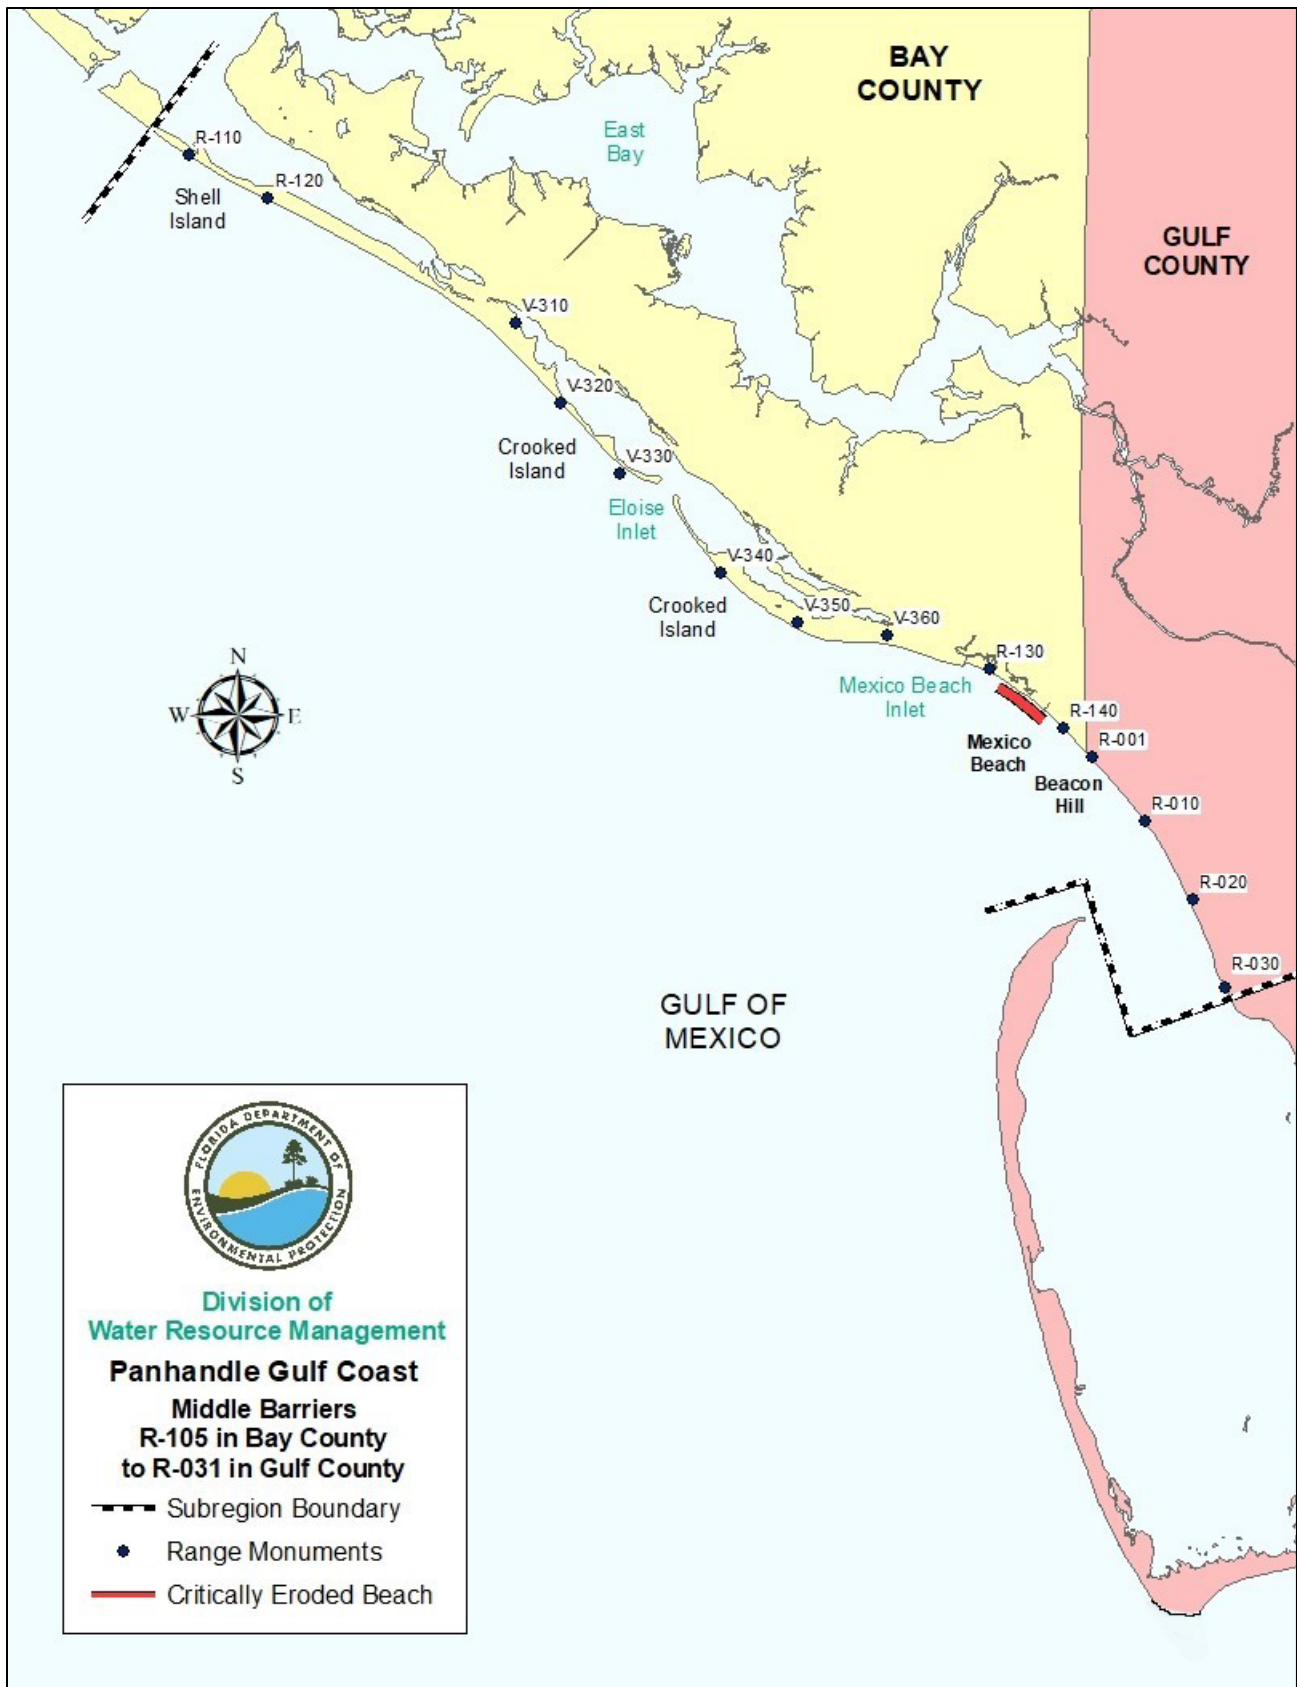
Figure 4. The Middle Barriers subregion of the Panhandle region of Florida. View an [interactive map](#) or [COASTS imagery](#).

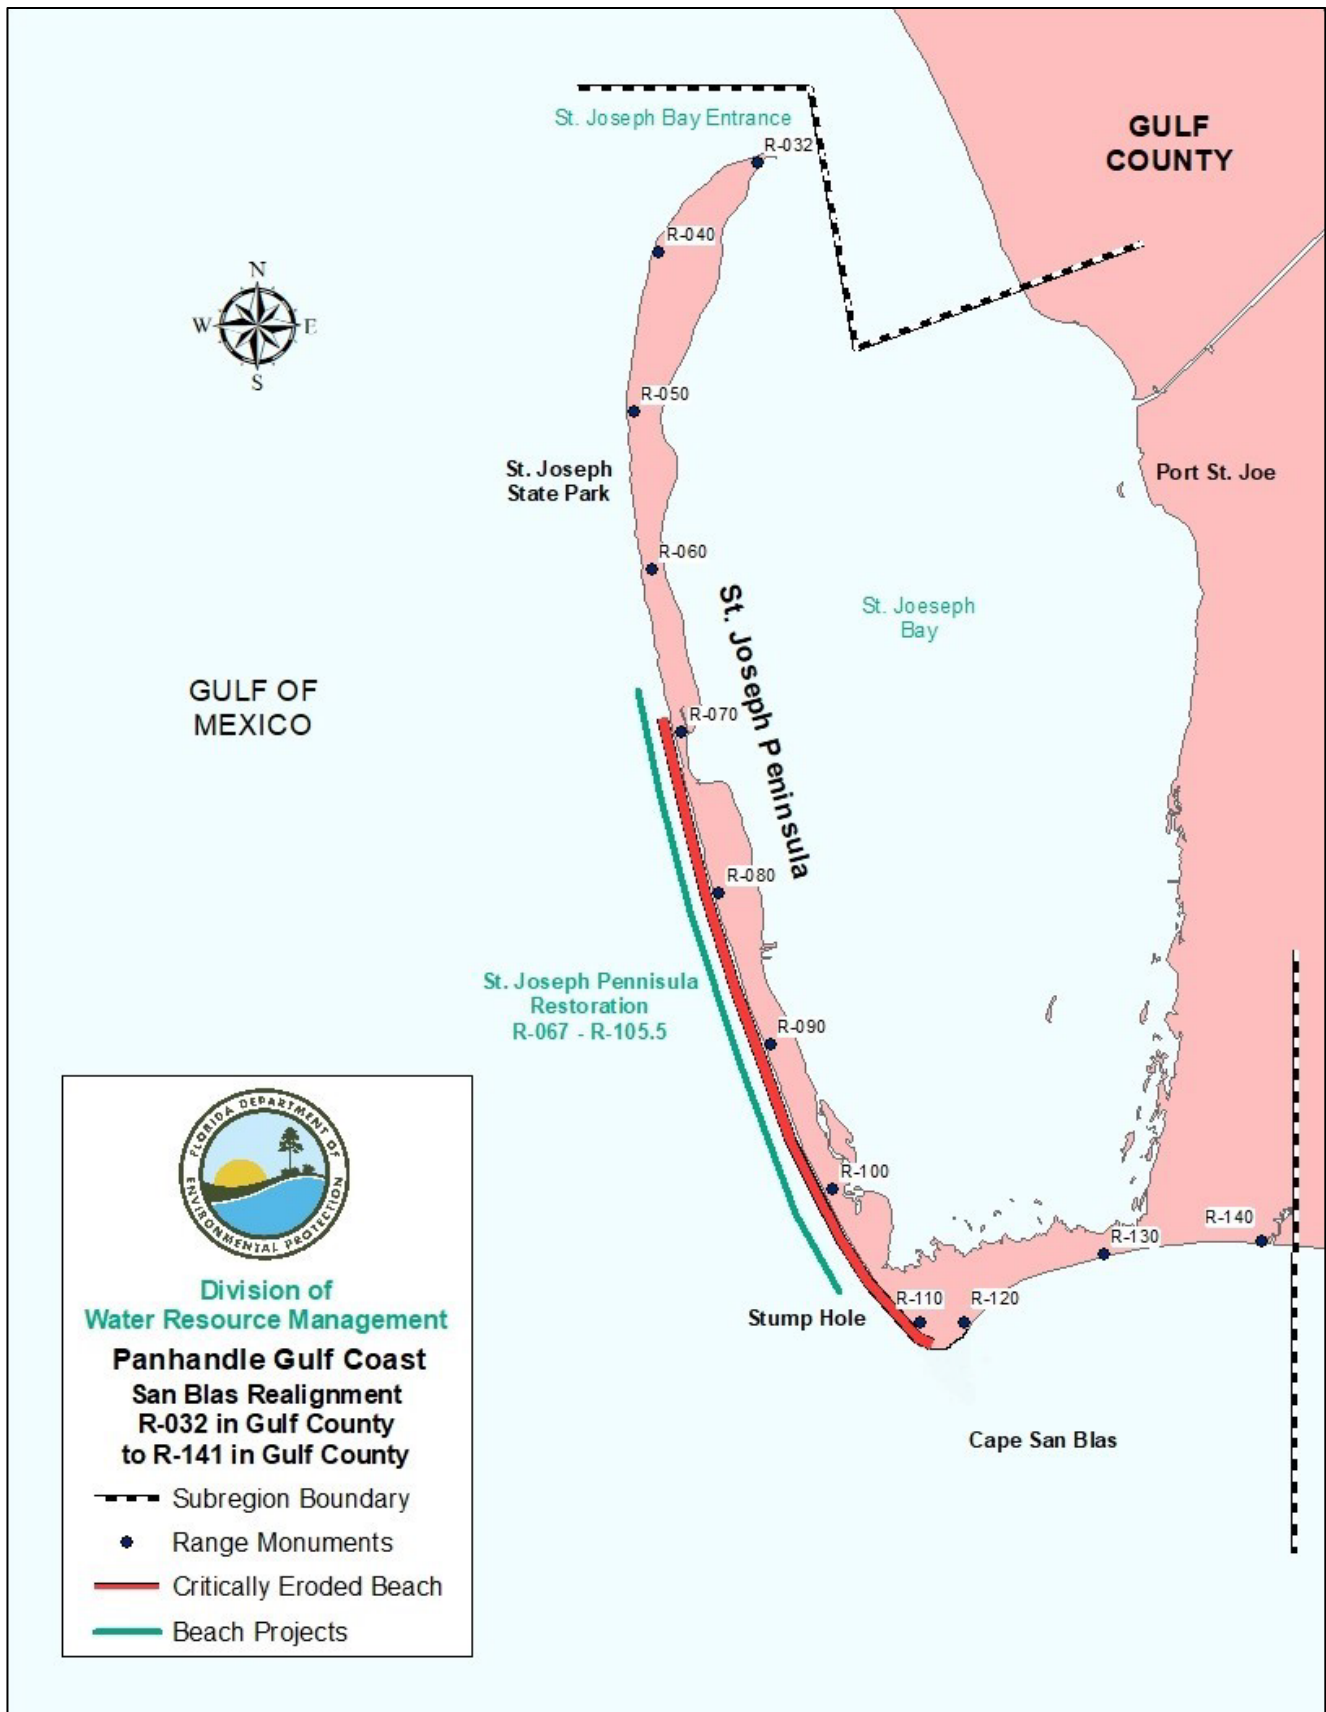
Figure 5. The San Blas Realignment subregion of the Panhandle region of Florida. View an [interactive map](#) or [COASTS imagery](#).

There are 21.2 miles of beaches in the **San Blas Realignment** subregion, which extends from the entrance to St. Joseph Bay and along St. Joseph Peninsula and Cape San Blas to R141 near Money Bayou in Gulf County, as shown on Figure 5. There are 8.3 miles of critically eroded beaches in this subregion, of which 7.5 miles have been restored. Erosion is attributed to tropical storms and hurricanes, and to natural geomorphic changes caused by the pattern of littoral transport of sand in this area.

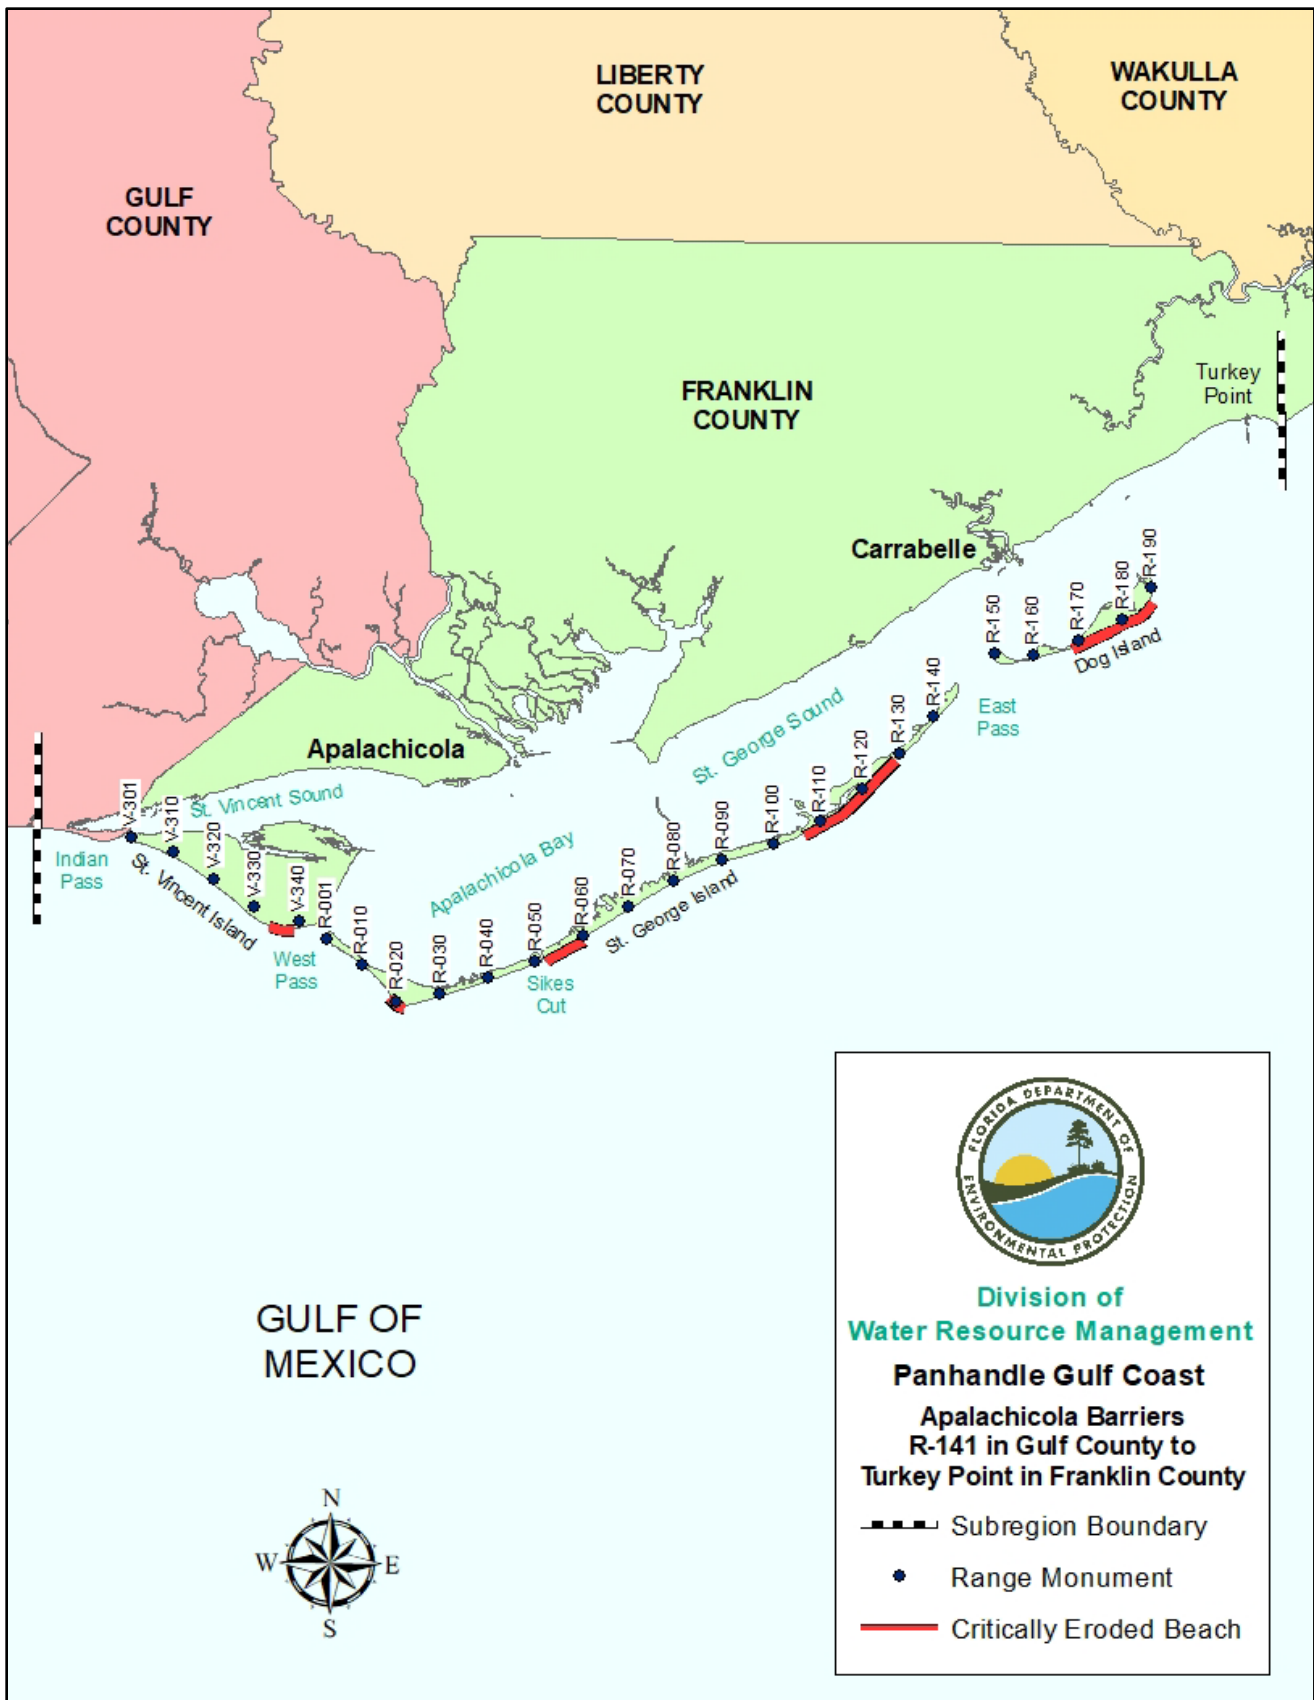
Figure 6. The Apalachicola Barriers subregion of the Panhandle region of Florida. View an [interactive map](#) or [COASTS imagery](#).

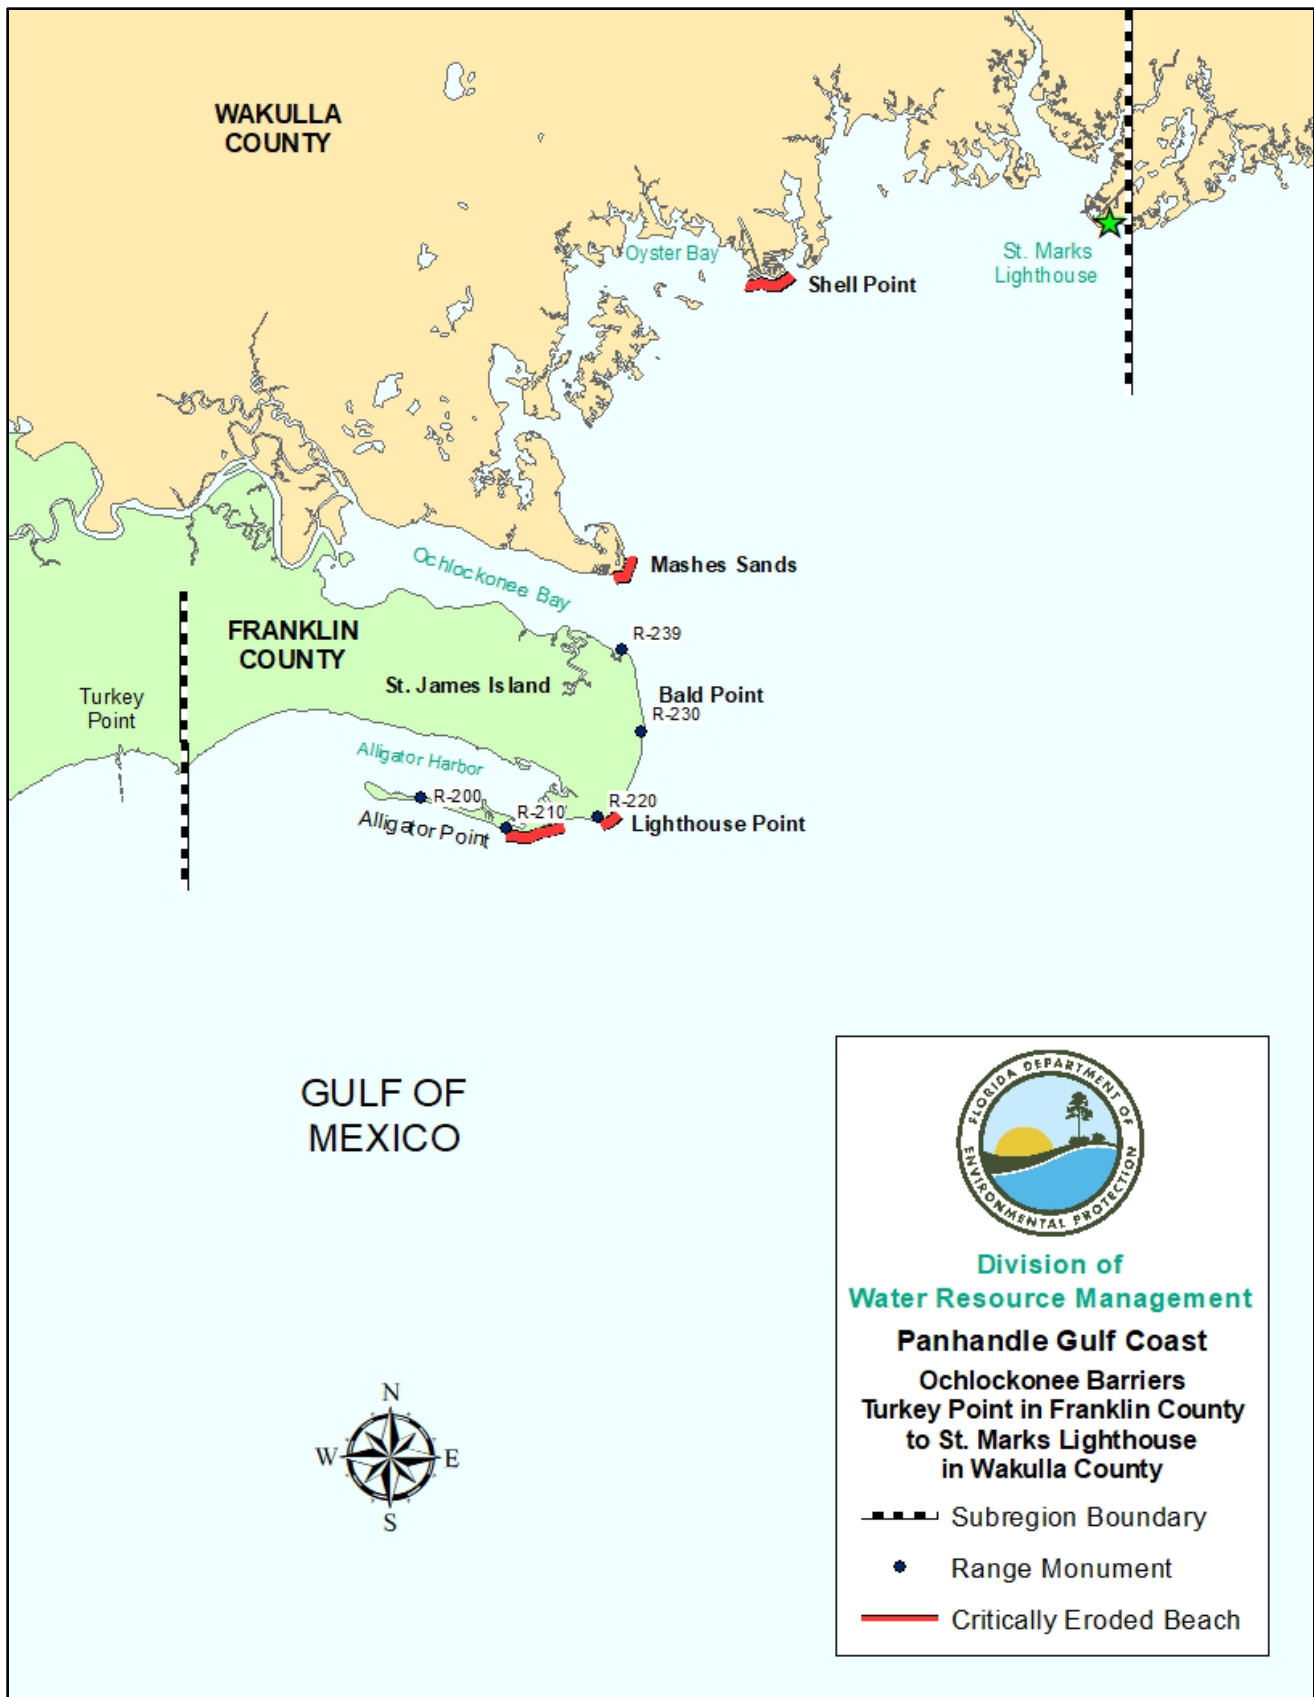
Figure 7. The Ochlockonee Barriers subregion of the Panhandle region of Florida. View an [interactive map](#) or [COASTS imagery](#).
