***Strategic Beach Management Plan:***  
***Panhandle Gulf Coast Region***

**Office of Resilience and Coastal Protection**  
**Florida Department of Environmental Protection**

**August 2026**

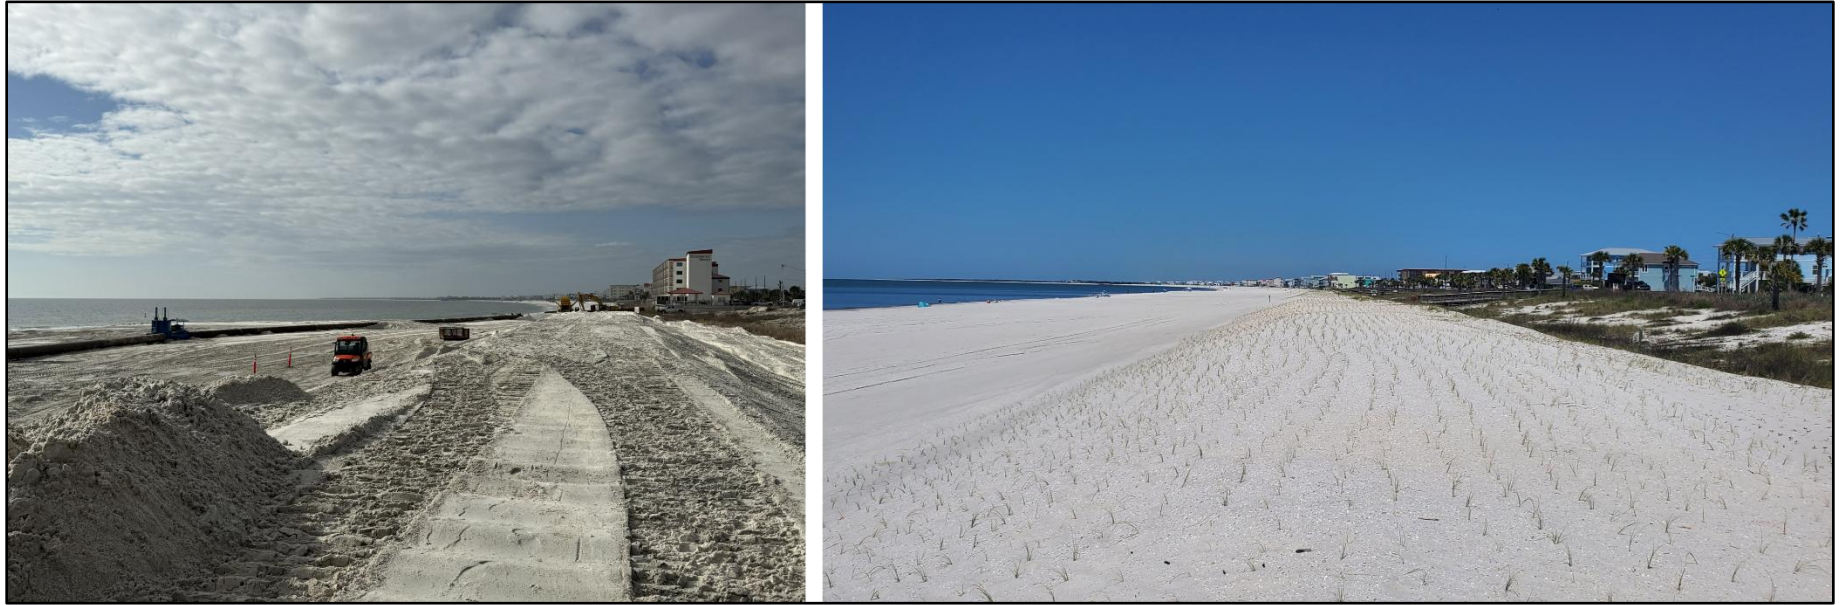
Project Photo 8. Before and after photos of the Mexico Beach – Beach and Dune Restoration Project that was constructed between January 2025 and April 2025. Photo on the left was taken by Lisa Armbruster just east of the El Governor Resort and photo on the right was taken by Guy Weeks (DEP staff), near R139 and 5<sup>th</sup> Street. See additional [construction photos](#) of beach nourishment projects.

This is a 0.9-mile segment of critically eroded beach within the City of Mexico Beach located nearly a mile east of Mexico Beach Inlet. Assisted recovery of the beach and dune system within the most eroded developed areas was conducted following Hurricanes Opal, Earl, Ivan, Dennis and Michael. Following the impact of Ivan, emergency protective berms were constructed using funds from FEMA. A feasibility study sponsored by the Department and the City of Mexico Beach was conducted in 2008. This study recommended increasing the sand bypassing at the inlet, constructing a beach restoration project in the critical erosion area and modifying the bypassing protocol following an additional feasibility investigation. Additional nourishment and protective measures were needed, including the construction of a beach berm, sand fence, vegetative plantings and a bypass system that would utilize some of the sand bypass material excavated from west of the inlet on Crooked Island and hauled by truck to the critically eroded area. The city submitted an application to the Department in March 2010 to conduct a truck haul project. However, the city did not have the funding to complete the permitting requirements, and the permit application was withdrawn in May 2012. Mexico Beach's beach and dunes system and 99% of the coastal development seaward of US 98 had major damages due to Hurricane Michael in 2018. The Department issued a permit modification (JCP#0290631-006-JN) in August 2019 to rebuild 3.1 miles of beach and dune between R127.7 to R144 that were impacted by Hurricane Michael. The city initiated an emergency dune (FEMA Berm) project that was constructed in summer 2019 along Mexico Beach between R127.7 to R144 (3.1 miles) with the placement of 95,000 cy of sand, 282,400 coastal dune plants and 15,600 linear feet of sand fencing. The beach restoration project placed 1,102,100 cy of offshore material between R127.7 and R144 (Bay/Gulf County line) with the construction being completed in April 2025 along 3.1 miles of shoreline.

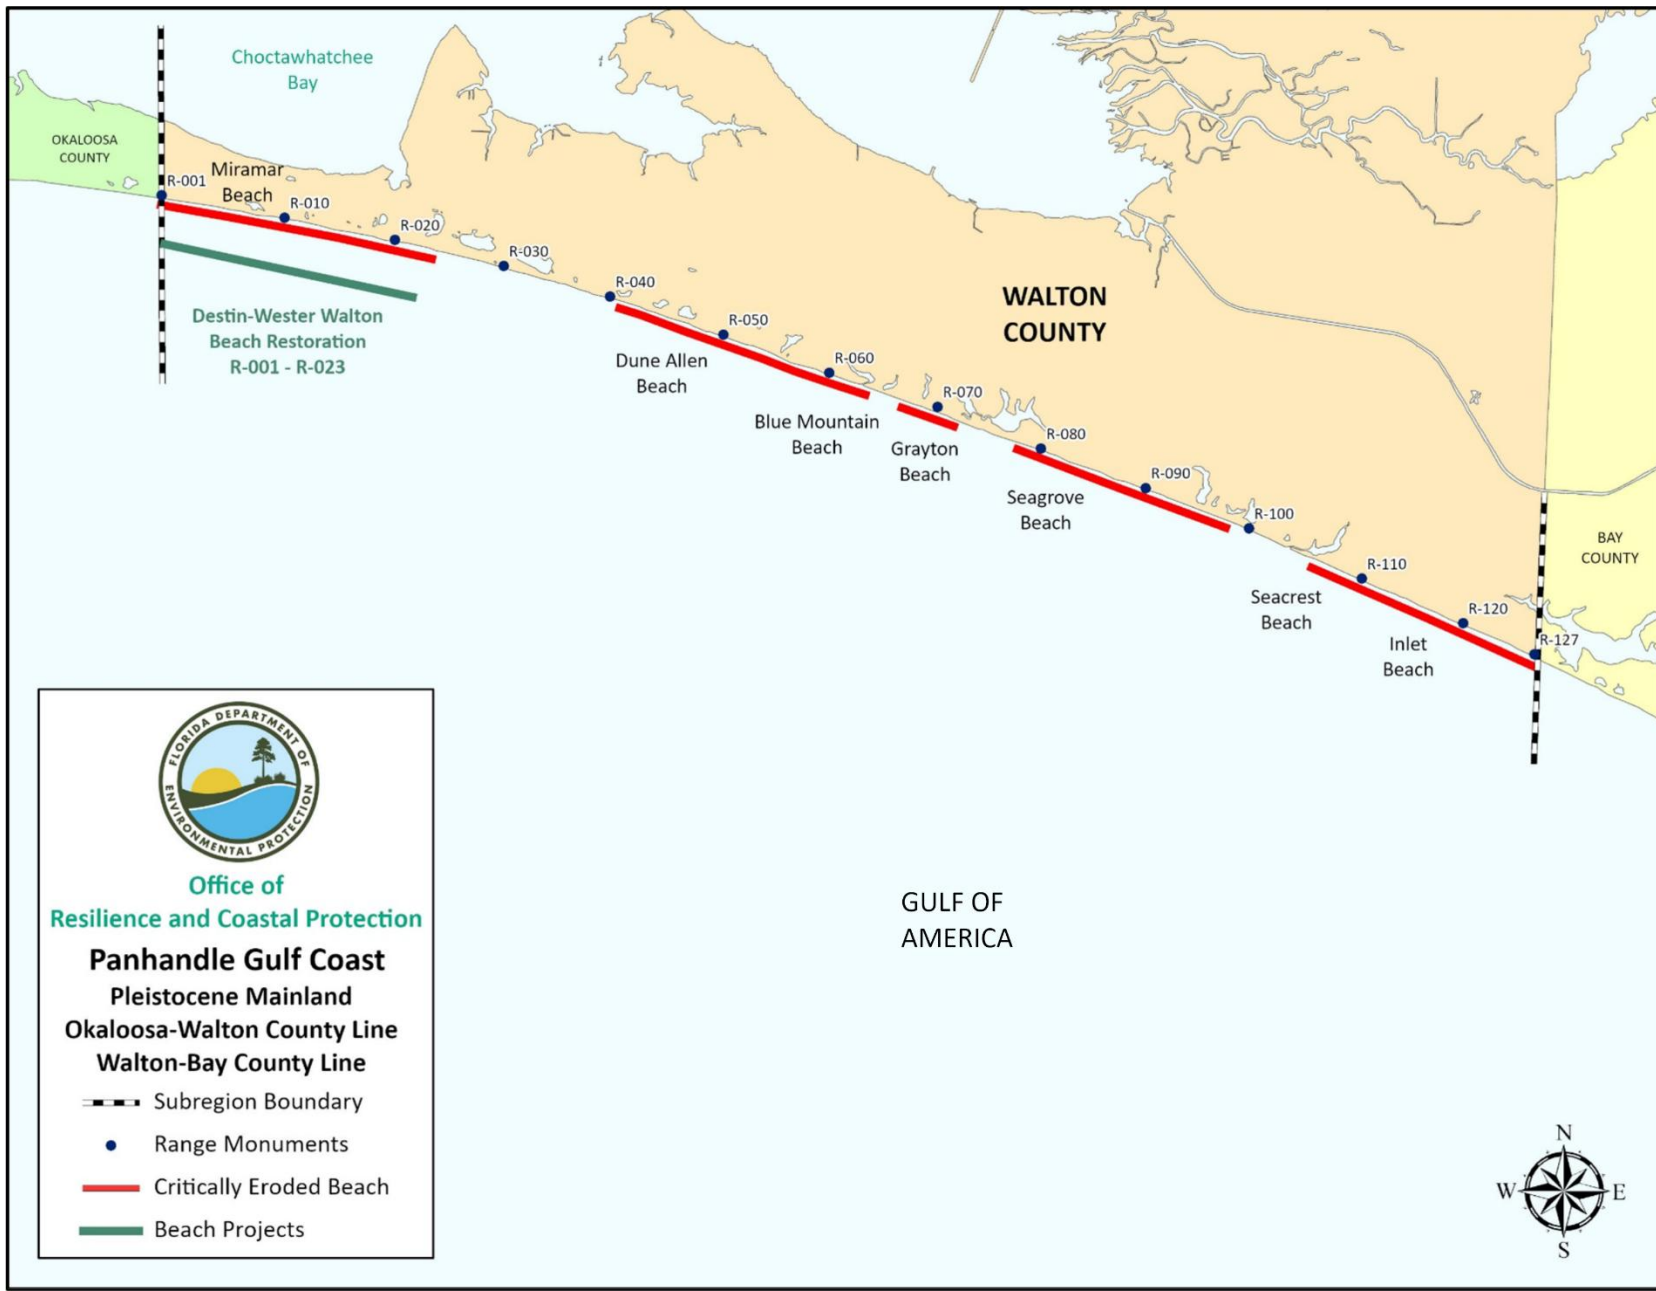
**Figure 2.** Pleistocene Mainland subregion of the Panhandle region of Florida. View the Department's [interactive map](#).

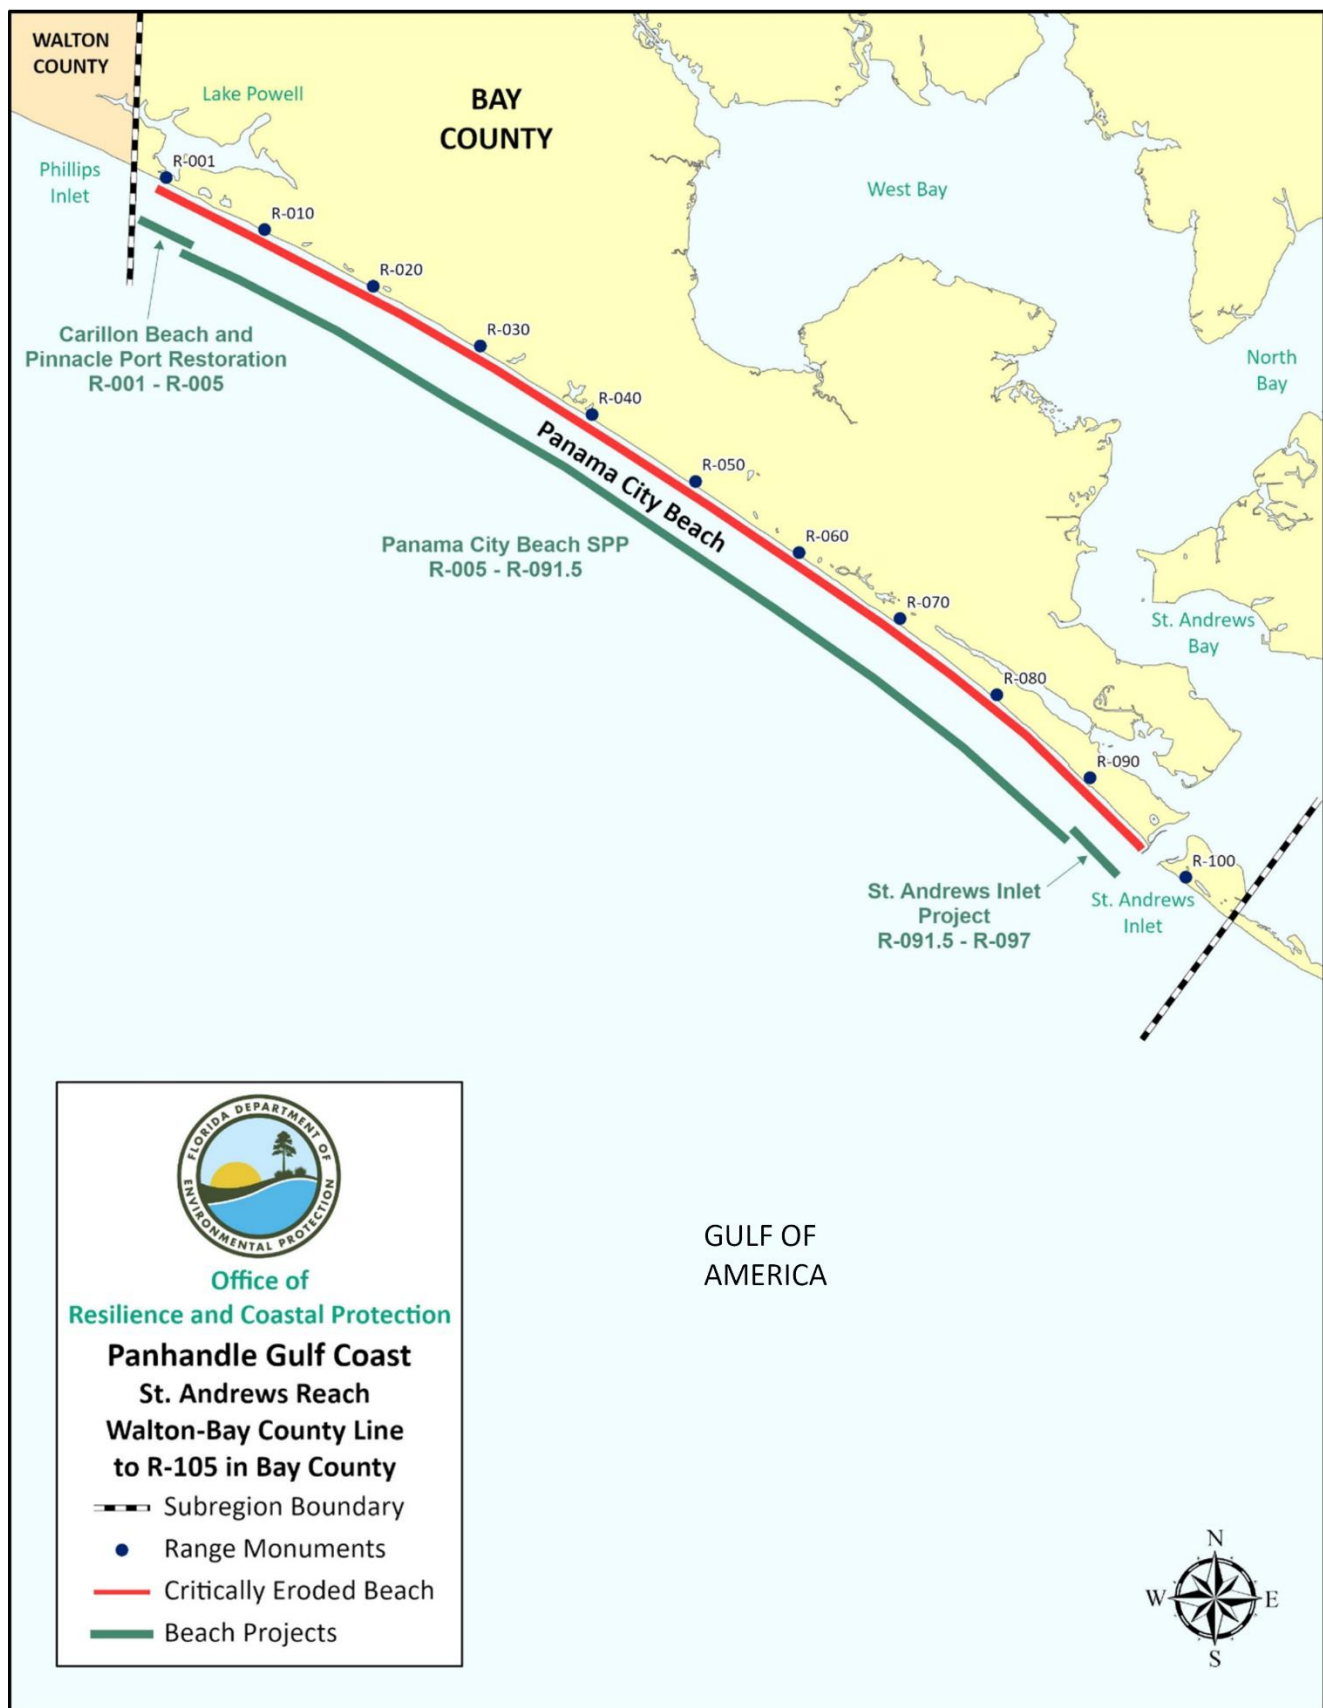
**Figure 3.** The St. Andrews Reach subregion of the Panhandle region of Florida. View the Department's [interactive map](#).

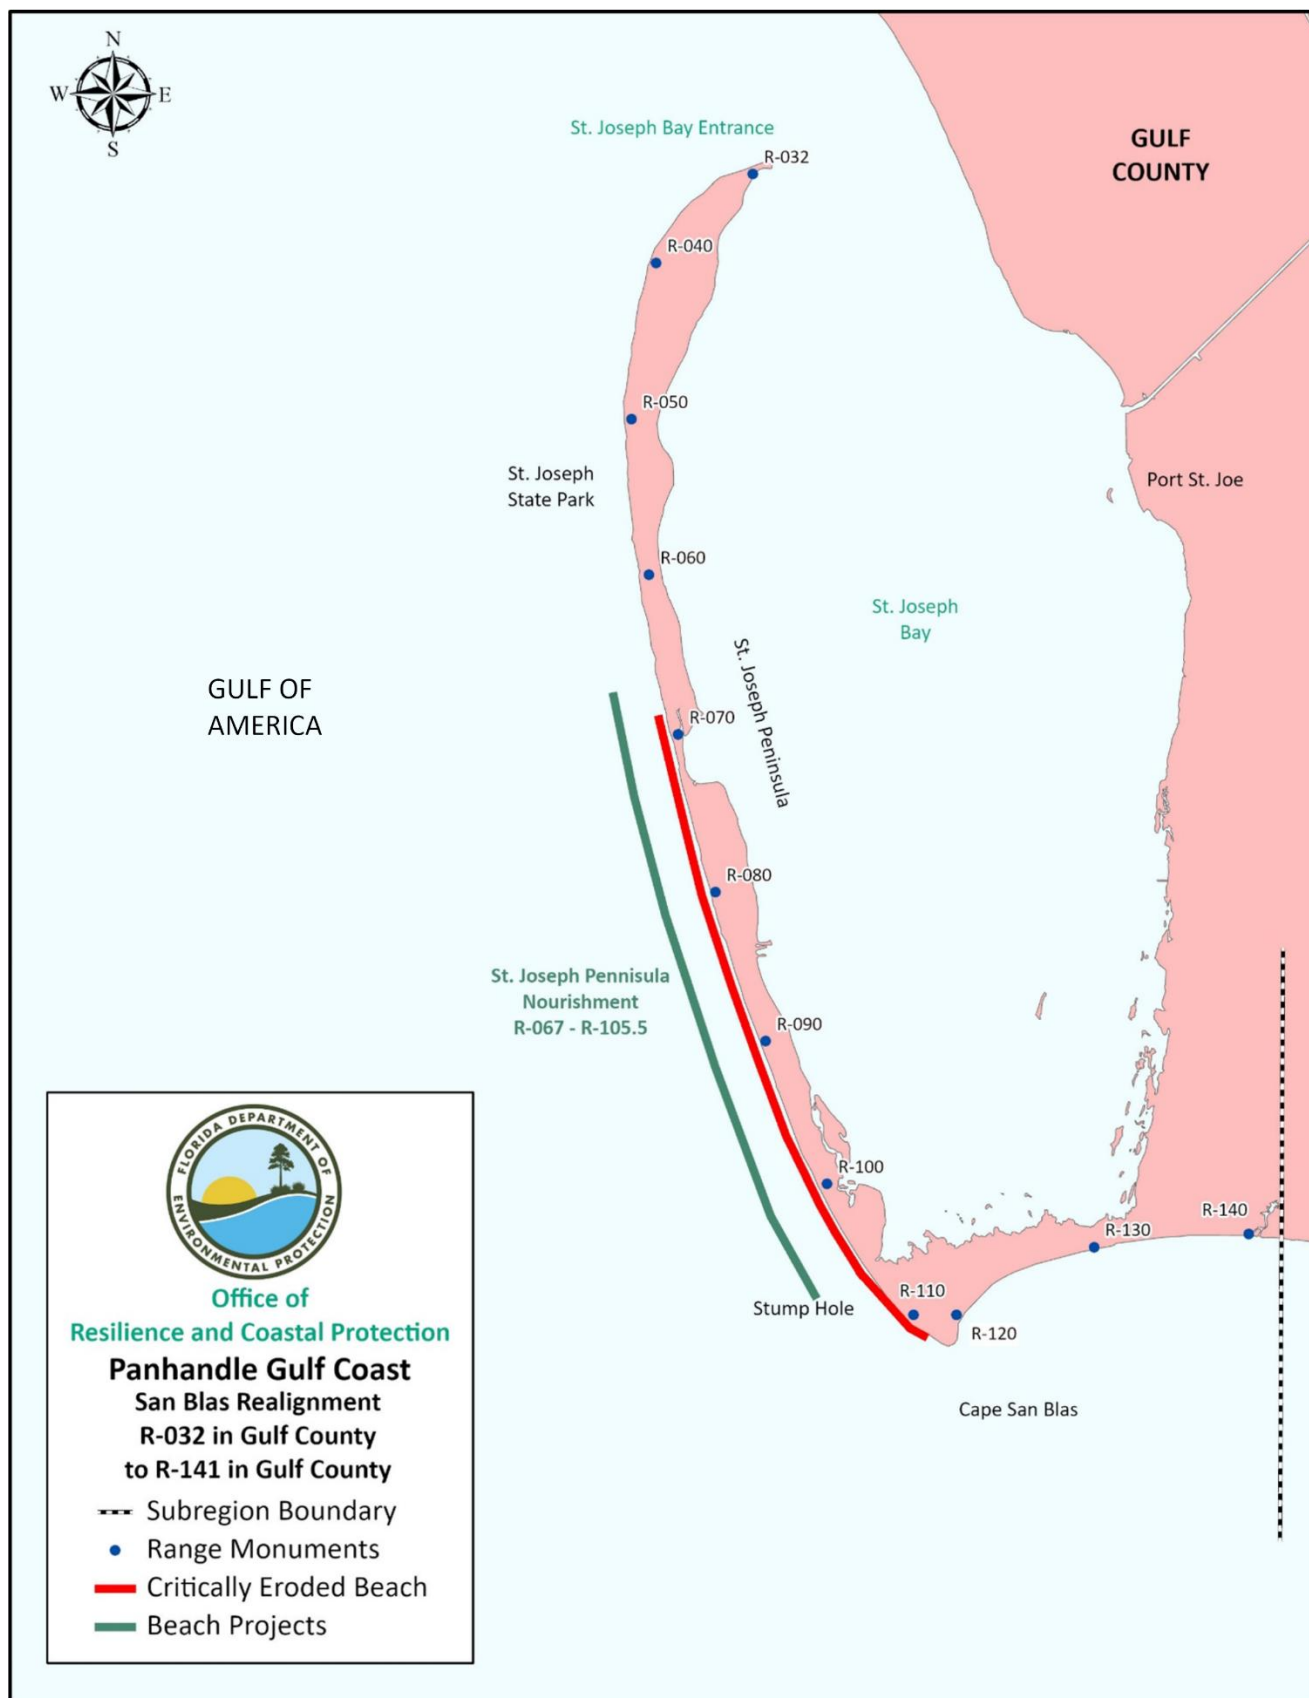
**Figure 5.** The San Blas Realignment subregion of the Panhandle region of Florida. View the Department’s [interactive map](#).
