***Strategic Beach Management Plan:***  
***Southwest Gulf Coast Region***  
**Office of Resilience and Coastal Protection**  
**Florida Department of Environmental Protection**  
**August 2026**

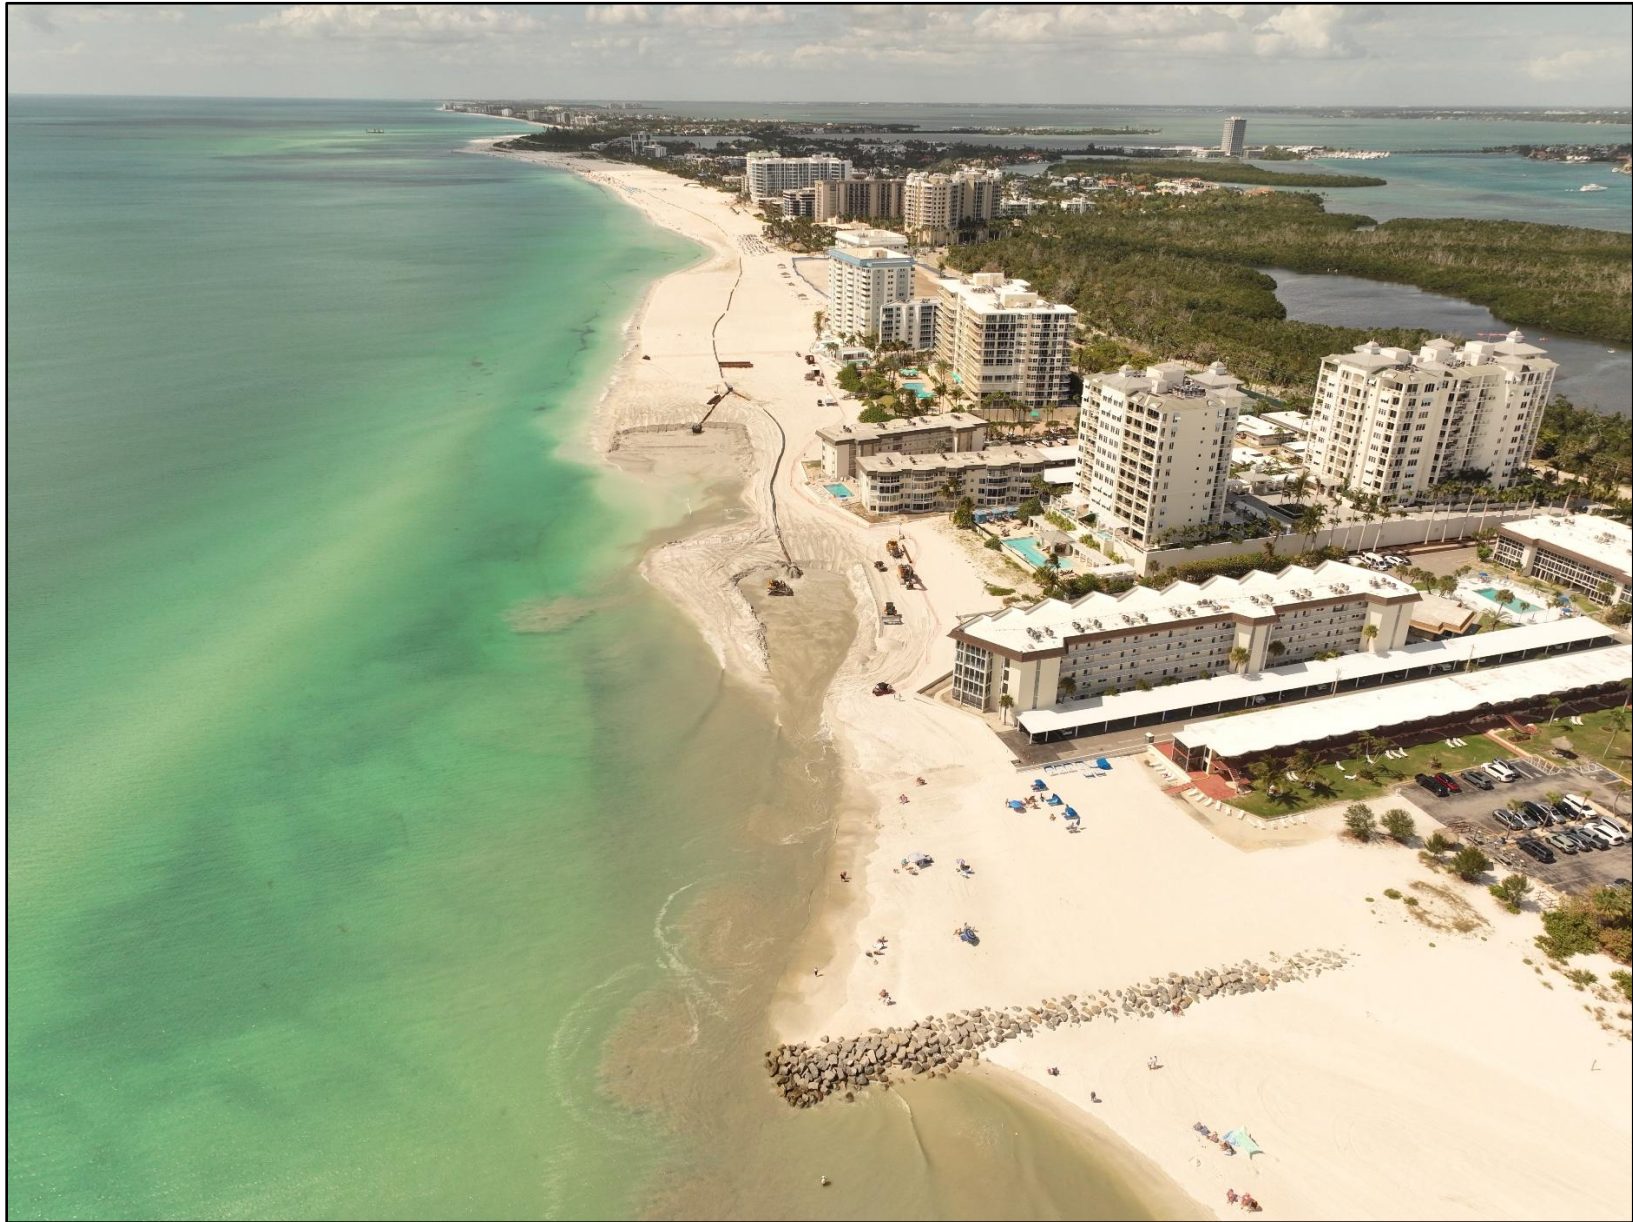
Project Photo 6. Lido Key Shore Protection Project being constructed in April 2026, near R42 and R43. Photo courtesy of Morjana Signorin, P.M., with Coastal Protection Engineering (CPE). See additional [construction photos](#) of beach nourishment projects.

The USACE constructed the initial federal **Lido Key Hurricane and Storm Damage Reduction Project** between July 2020 and April 2021, with placement of approximately 683,084 cy of sand between R-36.5 and R-44 dredged from Big Sarasota Pass along with the construction of two rock groins at the southern end of Lido Key at approximately R-42.5 and R-43.1. The beach nourishment portion of the project was completed in December 2020, and the groins were constructed between January 2021 and April 2021. Following the erosion from Hurricanes Helene and Milton (2024) and shoaling in the inlet, the Lido Key Hurricane and Storm Damage Reduction Project received beneficial use of approximately 300,000 cy of sand dredged from New Pass by the USACE in early 2026, placed between R37 and R43.5. The tentative next full beach nourishment for Lido Key is expected in 2030.

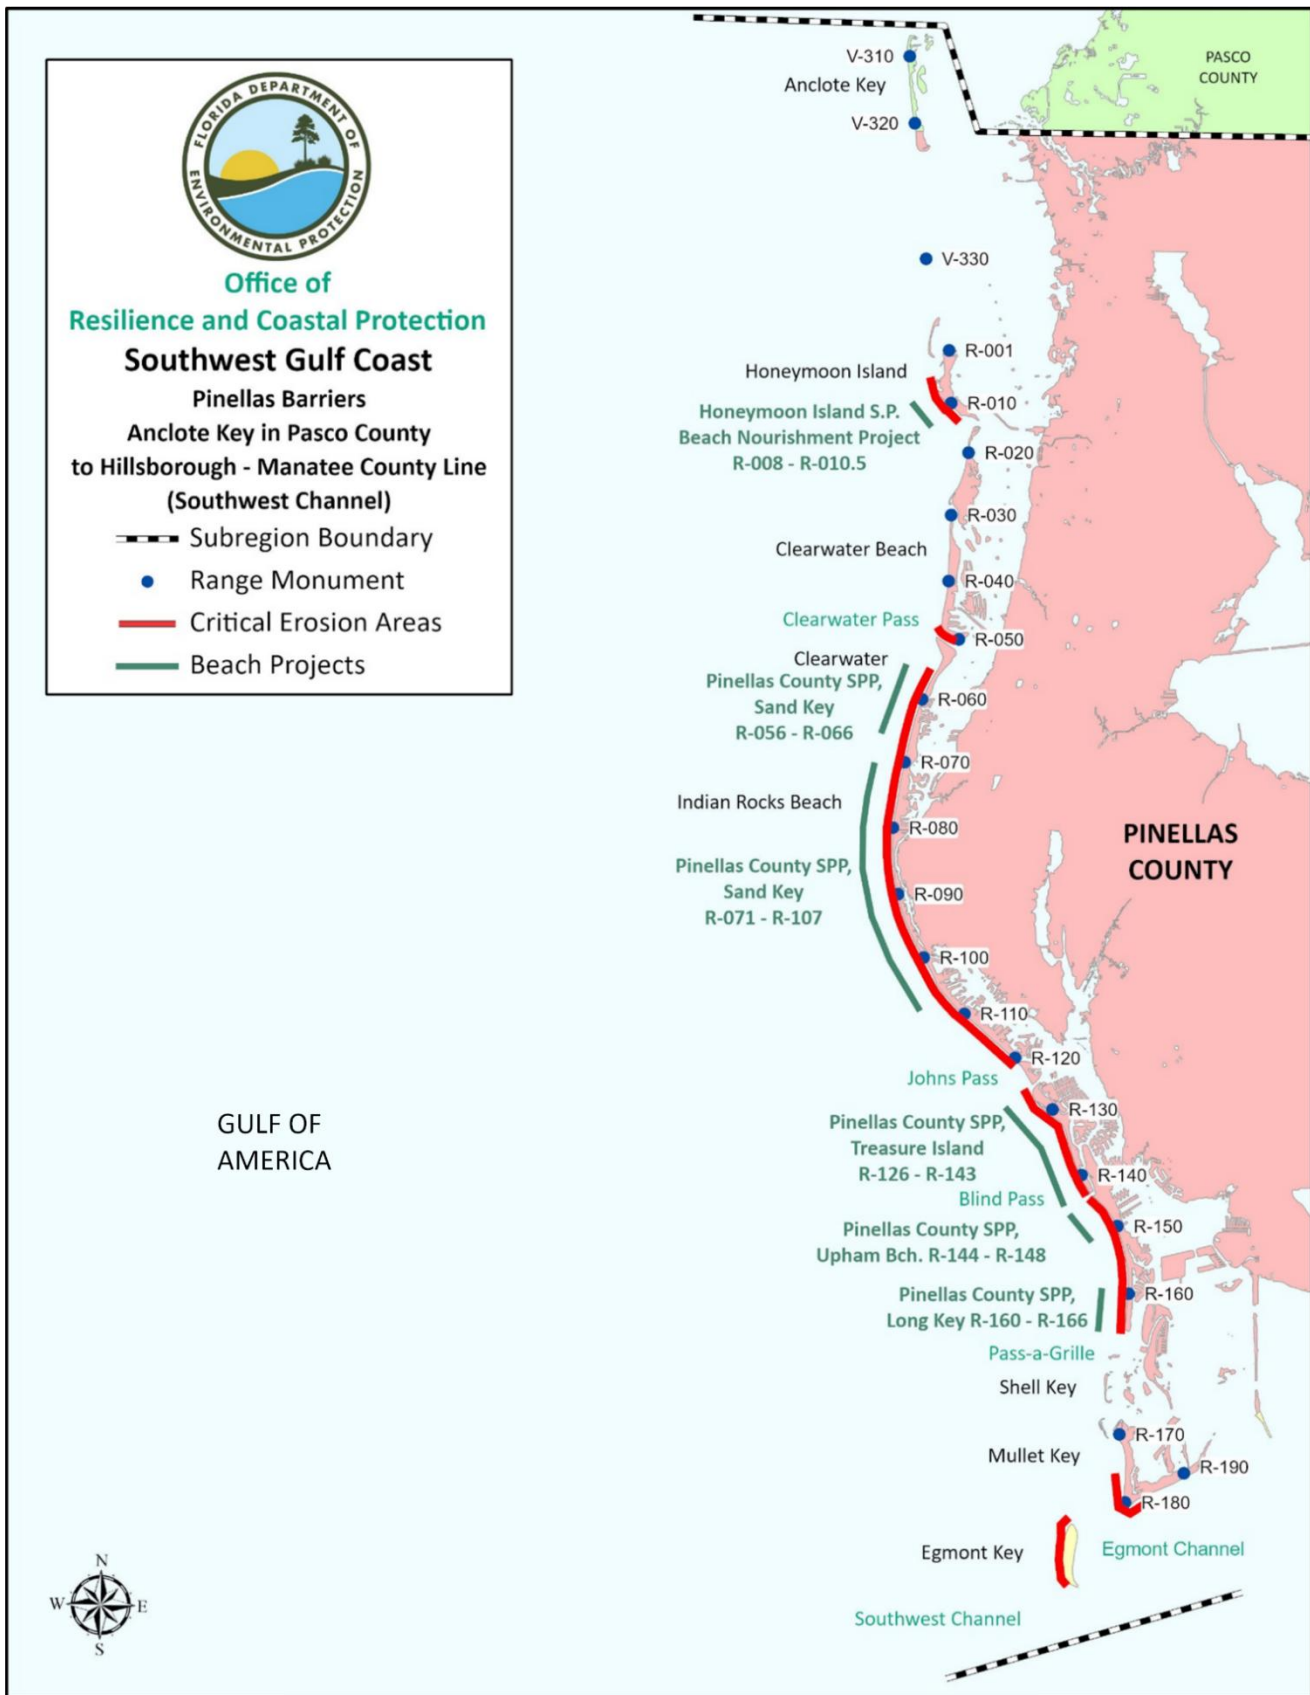
**Figure 1.** Map of Pinellas Barriers subregion of the Southwest region of Florida. View an [interactive map](#).

There are 39.3 miles of beaches in the **Pinellas Barriers** subregion, which extends from Anclote Key in Pasco County to the Southwest Channel entrance to Tampa Bay in Hillsborough County, as shown on Figure 1. There are 21.4 miles of critically eroded beaches in this subregion, of which 14.8 miles have been restored.

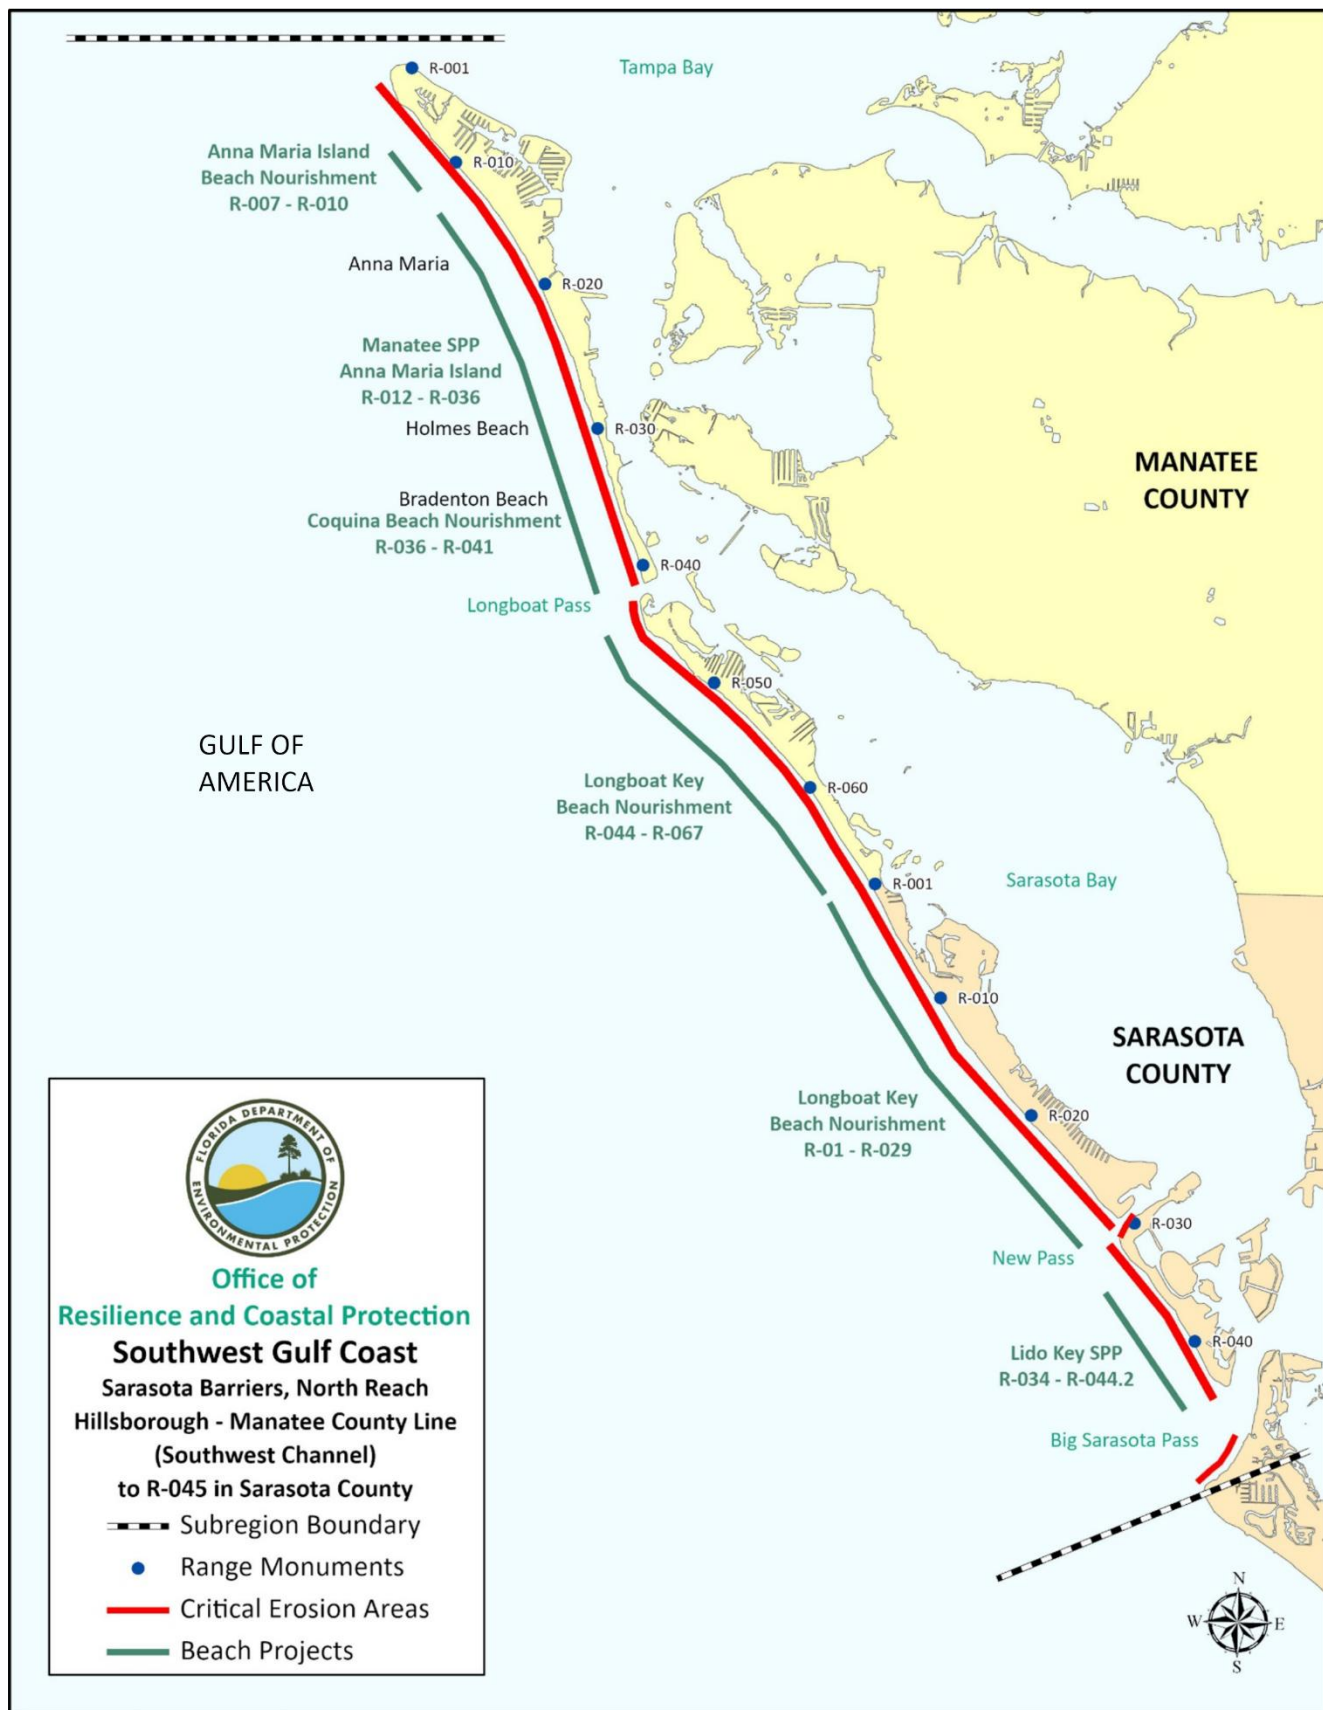
**Figure 2.** Map of Sarasota Barriers North Reach subregion of the Southwest region of Florida. View an [interactive map](#).

There are 21.4 miles of beaches in the **Sarasota Barriers North Reach** subregion, which extends from the Southwest Channel entrance of Tampa Bay in Manatee County to Sarasota Point (R45) on the northwest end of Siesta Key in Sarasota County, as shown on Figure 2. There is a total of 20.8 miles of critically eroded beaches in this subregion (13.0 miles in Manatee County and 7.8 miles in Sarasota County), of which 17.7 miles have been restored and maintained.
