***Strategic Beach Management Plan:***  
***Florida Keys Region***

**Office of Resilience and Coastal Protection**  
**Florida Department of Environmental Protection**

**August 2026**

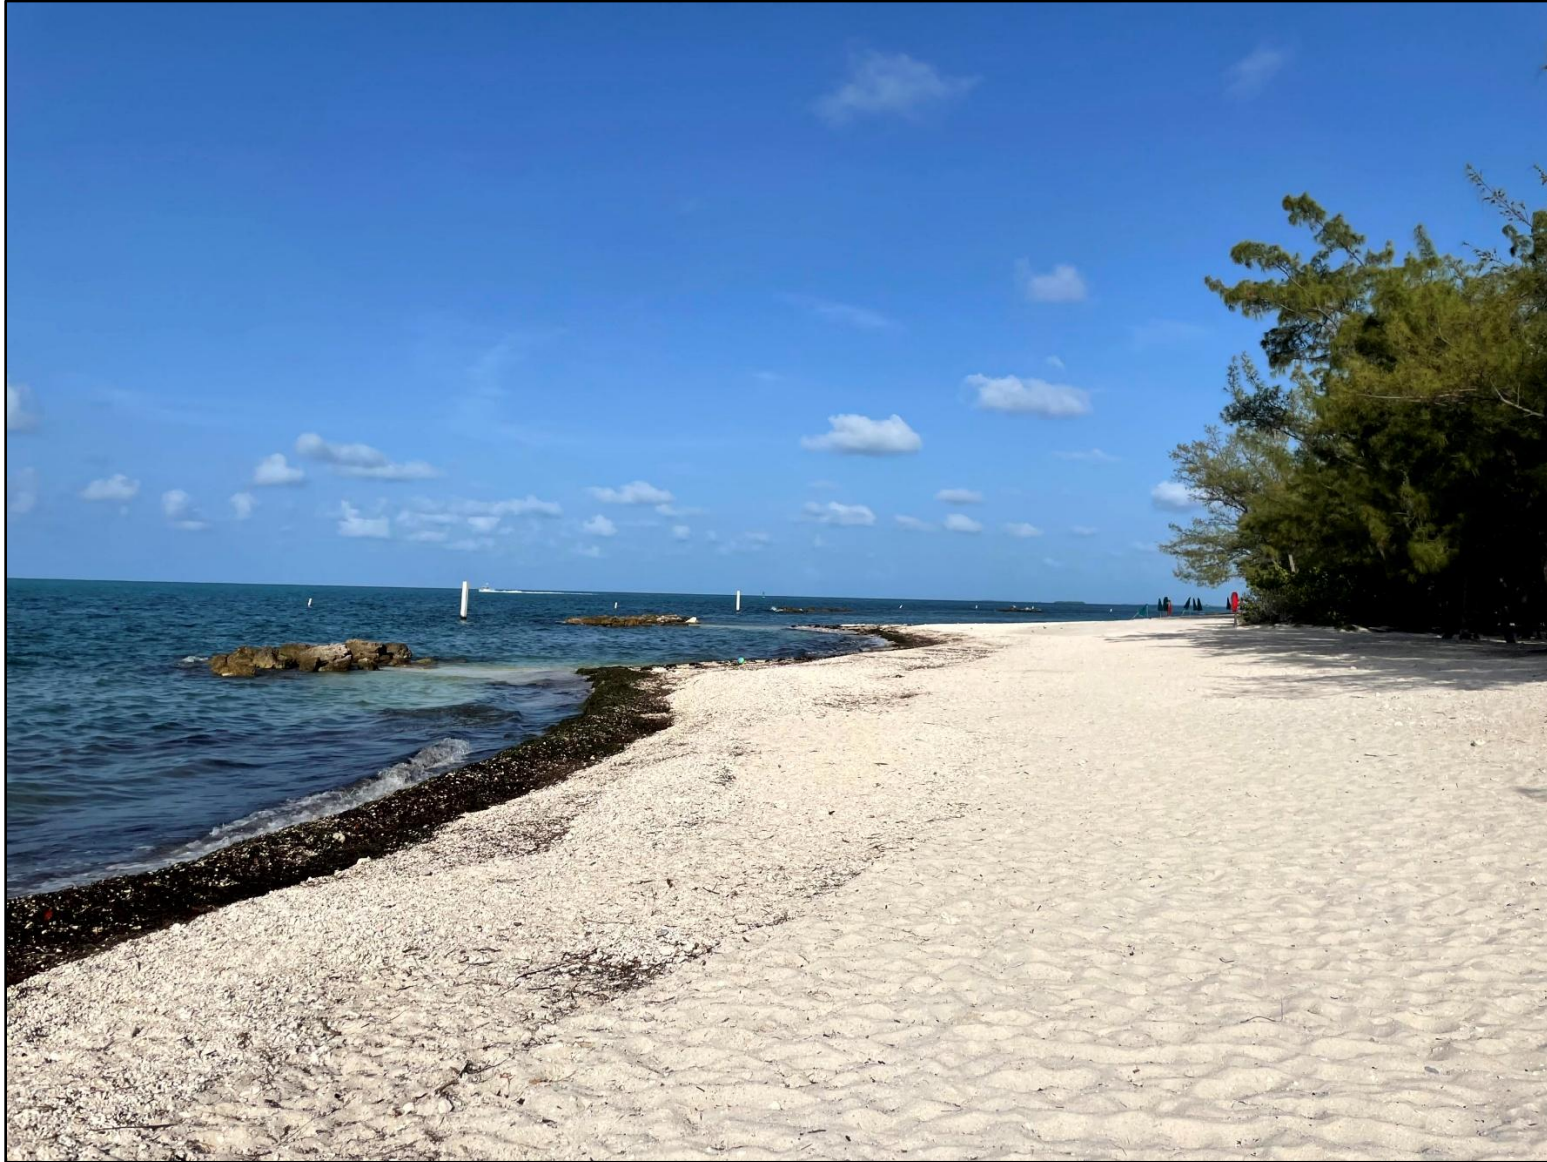
Project Photo 5. Fort Zachary Taylor State Park beach post-construction in Key West. Photo taken by DEP staff member John Irving in July 2023. Additional [construction photos](#) of beach nourishment projects.

A sand source investigation was concluded in October 2005, recommending the use of silicate sands from an upland sand source rather than the carbonate sands originally proposed. The restoration, by truck haul, was completed in December 2008, using 3,600 cubic yards of sand from an upland mine. Rehabilitation of the offshore breakwaters and terminal groin were permitted in 2011. Rehabilitation is planned to be coupled with a moderate truck haul to restore the beach to the 2008 design template. The truck haul placed approximately 200 cubic yards at the Fort Zachary Taylor Historic State Park beach in early 2016. Dune stabilization and dune plantings (101 plants) have occurred within the state park since Hurricane Irma (2017). Due to erosion from Hurricane Ian (2022), beach nourishment took place again at the park in the winter of 2022/2023 with placement of approximately 2000 cubic yards of upland sand at the park's beach.

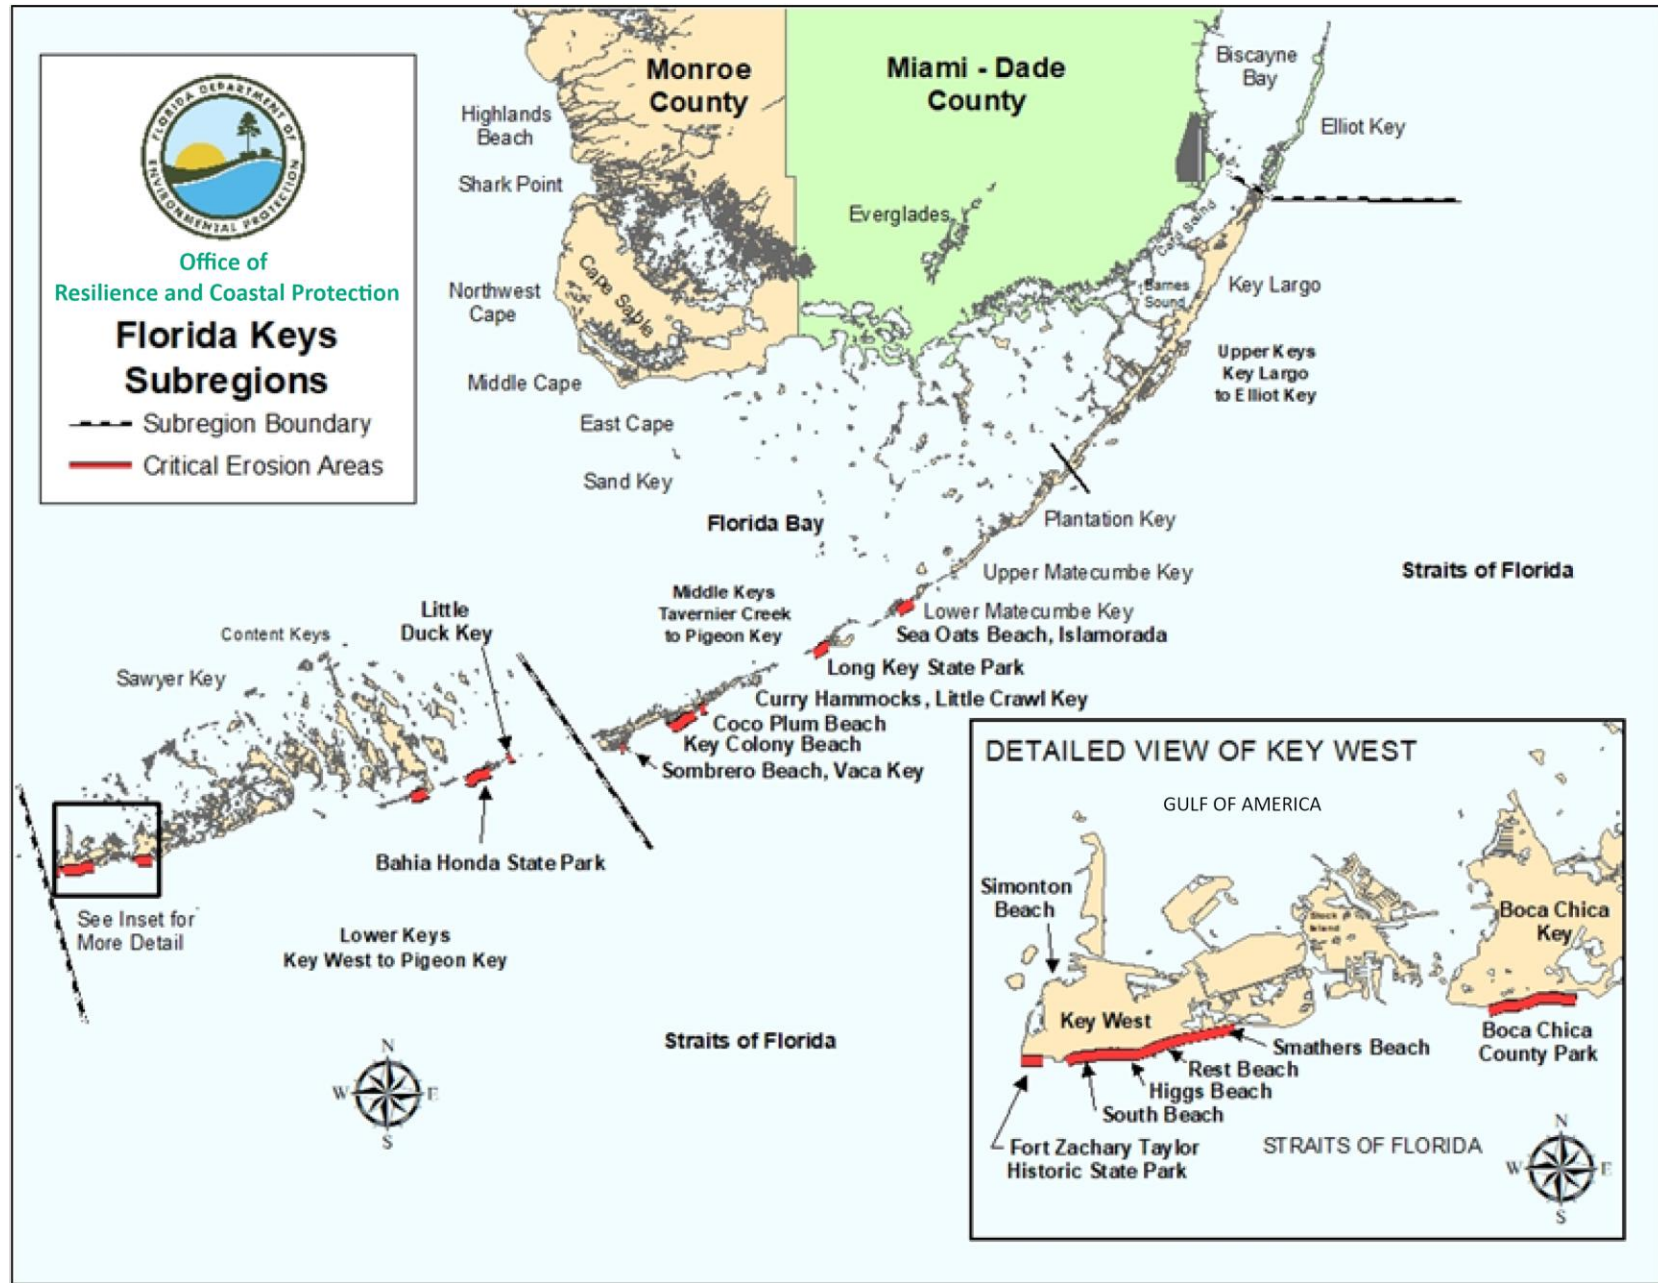
**Figure 1.** Map of the Florida Keys subregions. View the Department’s [interactive map](#).

The **Upper Keys** subregion extends from Soldier Key to Tavernier Creek. No natural beaches exist in the Upper Keys subregion.

The **Middle Keys** subregion extends from Tavernier Creek to Pigeon Key. There are 6.0 miles of critically eroded beaches in this subregion.

The **Lower Keys** subregion extends from Pigeon Key to Key West. There are 7.8 miles of critically eroded beaches in this subregion.

The **Distal Sand Keys** subregion extends west of Key West and includes Woman Key, Boca Grande Key, the Marquesas Keys, and the Tortuga Keys. This subregion has beach erosion conditions that have not been adequately studied for inclusion in this plan.
