Weeki Wachee Springs State Park

Approved Management Plan - 2022

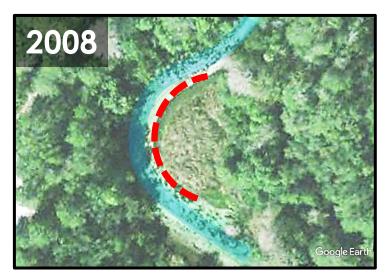
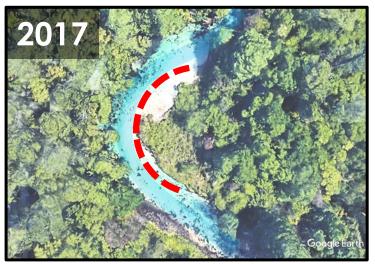
Point Bar Monitoring

The Carrying Capacity Study (Wood 2020) identified a total of 34 impacted point bars along the river within the study area. Thirty of the 34 points bars are within or adjacent to the park boundary, which is an important distinction that has management jurisdiction implications. The Carrying Capacity Study also conducted a point bar aerial assessment that involved interpreting historical aerial imagery from 2008 to 2017 and calculating an estimated loss of vegetation over the past decade. The calculations are shown in the table below. Six point bars with the clearest aerial imagery were selected, one of which is now the site associated with the new kayak takeout point. Point Bar 1 is shown in the images to the right, and Point Bar 24 is on the opposite side of the river from the new kayak takeout point. Establishing an increased staff and management presence at the new kayak takeout point should work to discourage docking and in-water activities at this point bar. For the purposes of visitor use management, the data shown below represents the baseline conditions of the point bars. All of these point bars will be monitored over the course of this planning period to help managers determine the effectiveness of management actions.

The six point bars that will be selected for long-term monitoring are intended to be representative samples that demonstrate the effectiveness of management actions on the river as a whole. Improving conditions at these six point bars will not only represent overall resource improvement on the river, but it will also suggest that user behavior has improved and indicate that docking and in-water activities have been reduced, if not eliminated altogether. Declining conditions would represent further resource degradation and signal to managers that user behavior has not been adequately addressed.

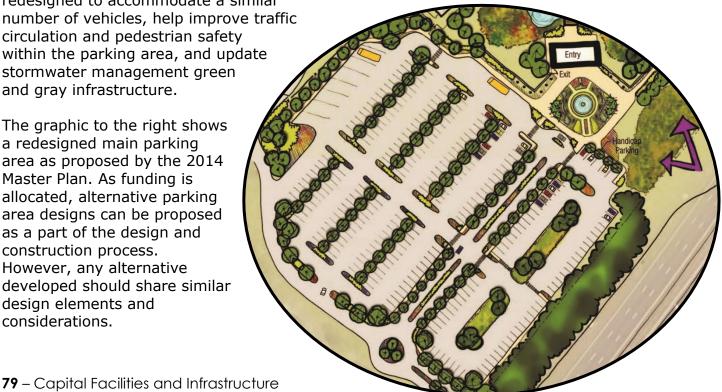
The graphic to the right shows a redesigned main parking area as proposed by the 2014 Master Plan. As funding is allocated, alternative parking area designs can be proposed as a part of the design and construction process. However, any alternative developed should share similar design elements and considerations.

Design elements to be considered should include a similar vehicle capacity relative to the existing parking area. The redesigned parking area should also have dedicated large bus and RV parking spaces. To improve traffic circulation, the visitor drop-off area should be separated from parking spaces and include a dedicated drop-off lane in order to minimize conflict between the visitors already parked unloading their vehicles and the visitors trying to drop off. Native vegetation and bioswales should be incorporated throughout the redesigned parking area to improve stormwater management capabilities and to create natural buffers that could potentially provide shading and reduce the heat island effect, creating a more pleasant visitor experience on hot summer days. Lastly, connectivity within the redesigned parking area and with the kayak parking area should be improved. Sightlines between the two parking areas are obstructed and need to be addressed to improve vehicle and pedestrian safety. Sidewalks and other pedestrian infrastructure should also be explored. All redesign concepts should consider how the redesigned parking area will be incorporated into the new entrance road concept, which will be discussed in further detail below.

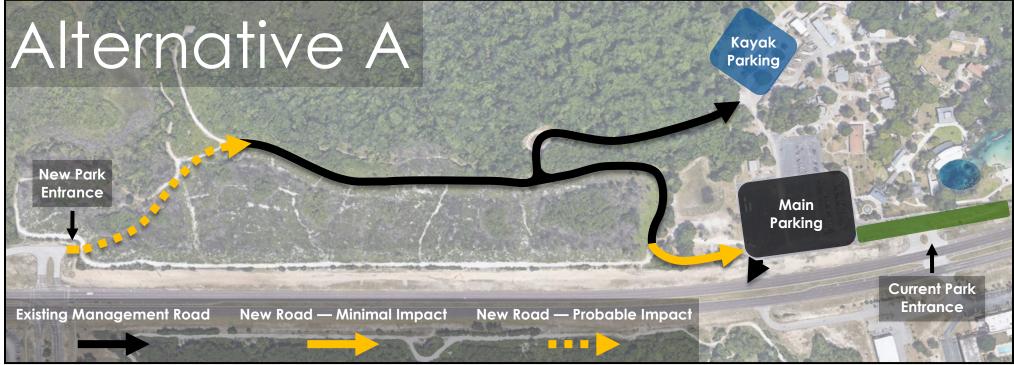
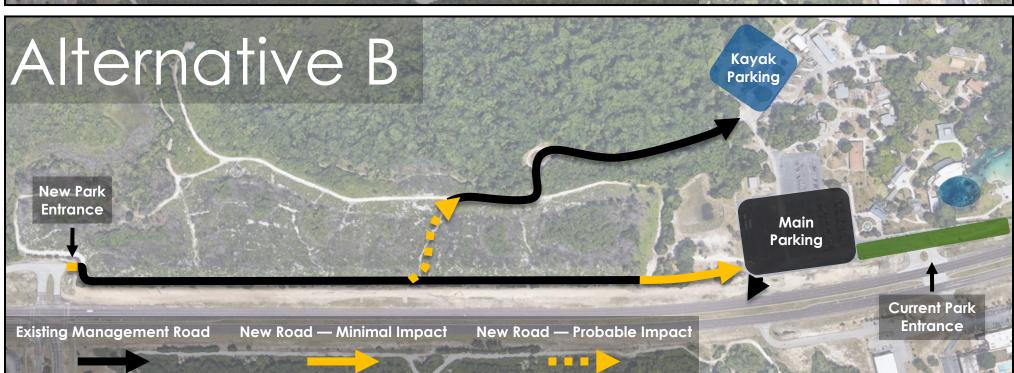
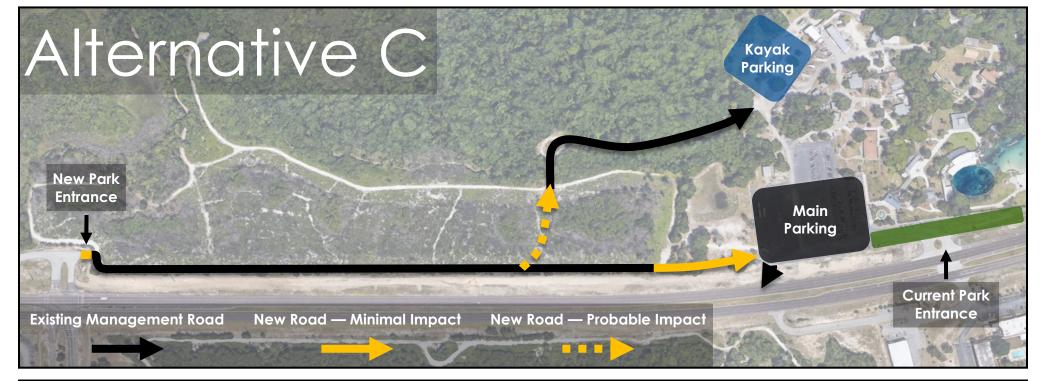
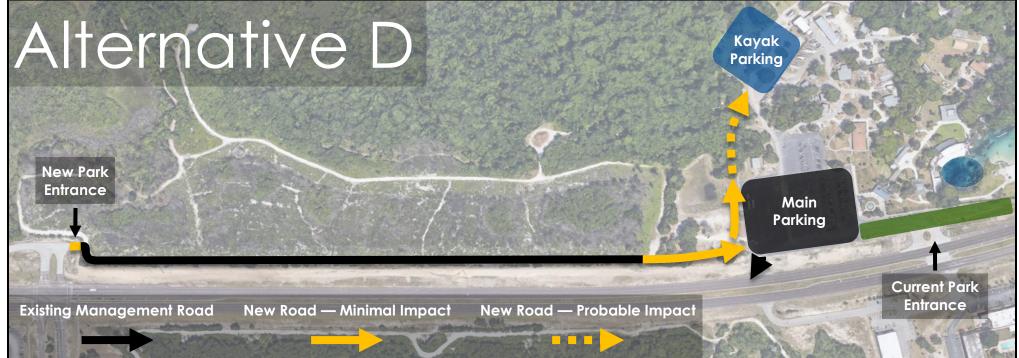
Weeki Wachee Springs State Park **Entrance Alignment Potential Alternatives**

Similar to the main paved parking area redesign concept, additional alternatives can be considered as a part of the design and construction phase once funding has been allocated for the project. The entrance alternatives map is intended to showcase a range of possible options and is not necessarily intended to determine a preferred alternative. Resource impacts will need to be further analyzed and studied in-depth prior to making a final decision. However, certain goals of a new entrance road and ranger station should be considered during the design phase. The main goals of a new park entrance road are to create a traditional state park visitor experience and to develop independent entrance roads to the main paved parking area and the kayak parking area. The current entrance to the park is used by all visitors, which can cause conflicts between vehicles travelling to and from the kayak parking area and visitors in the main parking area. In addition, the current park entrance is also used as an exit and visitors travelling north on US 19 have to cross up to six lanes of traffic when exiting the park. The new entrance should improve visitor safety within in the park, as well as for vehicles leaving the park.

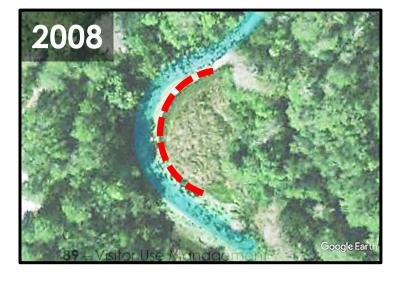
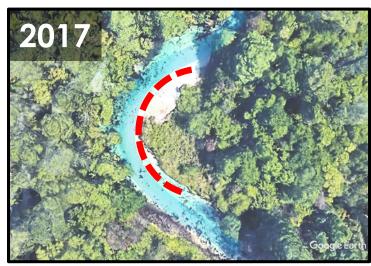
to the resource damage shown in the two images below. The images show the same point bar in the river in 2008 and 2017. The image from 2008 represents a relatively healthy, ecologically intact point bar. Over years of use, the cumulative effect of users docking their vessels and trampling the vegetation has significantly impacted the point bars, as shown in the 2017 image. A key takeaway by the DRP is that while a restriction on the number of users allowed to access the river could certainly help reduce the probability of resource impacts, a capacity limit alone cannot address resource impacts if docking and in-water activities are not sufficiently addressed.

Point Bar	PB 1	PB 6	PB 21	PB 22	PB 24	PB 28
2008 Aerial	7,031 ft²	11,661 ft²	7,493 ft²	8,508 ft ²	7,012 ft²	3,213 ft ²
2017 Aerial	5,337 ft²	10,603 ft²	6,063 ft ²	7,008 ft²	6,201 ft ²	2,237 ft²
Net Loss	1,694 ft²	1,058 ft²	1,430 ft²	1,500 ft²	811 ft²	976 ft²
Percent Loss	-24%	-9%	-19%	-18%	-11%	-30%

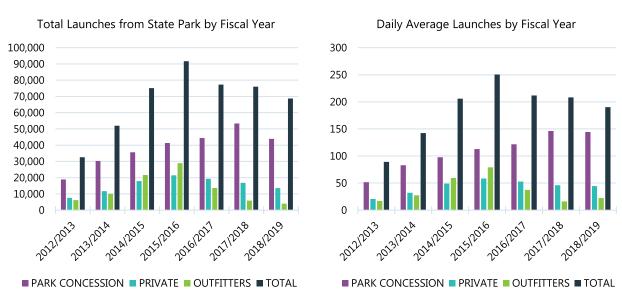
Figure 3.1 – Long-Term State Park Vessel Launch Data (by Fiscal Year)

The State Park provided daily total counts of vessels launched from their facilities from 7/1/2012 to 6/1/2019 (State Park fiscal year, FY, starts July 1st and ends June 30th). **Figure 3.1** shows the total vessel launches (left panel) and the daily average launches (right panel) for each FY by type (park concession, private, outfitter, and total). The total and daily average launches from the State Park increased each FY by approximately 20,000 vessel launches per year and 50 vessel launches per day between FY 2012/2013 and FY 2015/2016, when vessel launches peaked at approximately 90,000 per year and an average of 250 per day. While no data for launches from the State Park area were available prior to 2012, staff have stated that the vendor owned 60 kayaks in years prior.

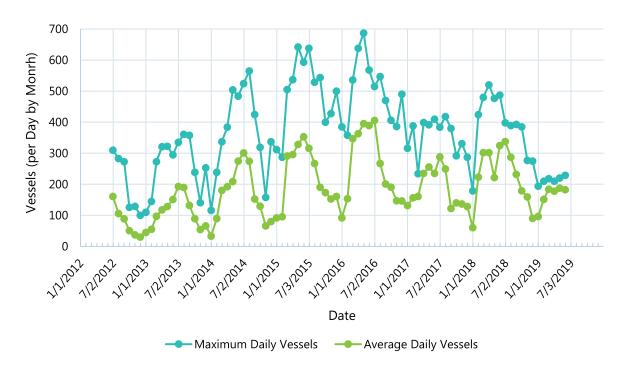
Figure 3.2 – State Park Daily Total Vessels (Max and Average Monthly Values)

day⁶, which is approximately equivalent to 192 vessels per day (calculated from a regression equation using Wood study data of kayaks and canoes vs. users: Users = 1.46*Vessels). A change to the way the UMP was being enforced occurred in October 2018. Additionally, the disposables ban went into effect in January 2019. The new enforcements occurred later during the study and may have reduced the number of vessels that launched from the State Park. But it is unknown what other factors may have also led to the reduction from previous years.

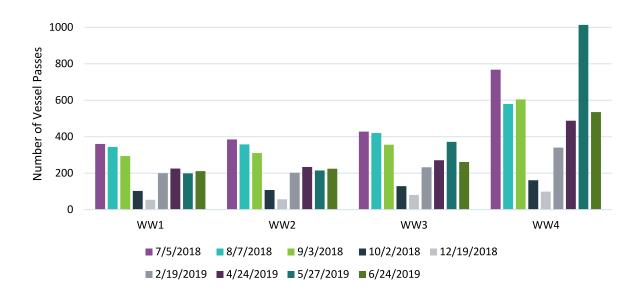
Figure 3.3 – Daily Total Number of Vessel Passes by Sample Site

with the daily total number of users (Users = 1.46*Vessels, R^2 =0.99) and therefore follows a similar distribution. **Appendix B** shows the total daily users observed on each sampling day.

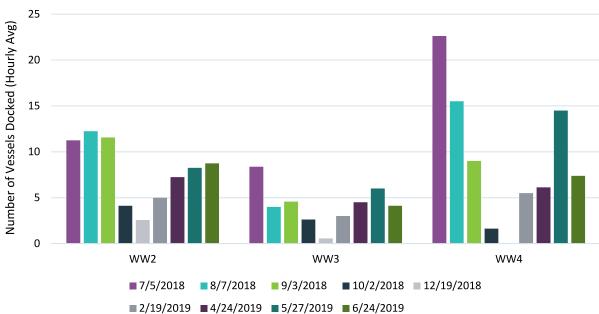
Figure 3.7 – Average Number of Vessels Docked Per Hour by Site

The number of vessels docking and the number of people exiting vessels to recreate (i.e. wading/swimming) on the point bars were also recorded during sampling events (field and camera observations). Field observations showed that docking of vessels flattened and/or damaged vegetation on the bars, exposing roots and the underlying soil matrix, which was subsequently washed away 1) during rain events, 2) when water levels increased, or 3) from boat wake. The average number of vessels docking on point bars per hour was calculated and is shown in Figure 3.7. Station WW1 is within the original State Park boundary, where visitors are not allowed to dock or leave their vessels, so it is not included in the plots (all values were zero). The 4th of July holiday saw the highest average number of vessels docked per hour, with an average of 22 docked per hour at WW4, which was when the rope swing was still active. All three sites follow a similar pattern with higher numbers per hour docking during the high recreation months (May-September) and fewer numbers per hour docking in the low recreation months (October-April). It should be noted that the average number of vessels per hour decreased over the course of the study at both WW2 and WW4. The decrease at WW2 may be due to fewer vessels launching from the State Park during the higher recreation months, which may be related to the enforcement of user versus vessel limits and also perhaps due to the disposables ban (less partying was observed occurring at this bar post ban). Figure 3.8 shows a photo of users docked and recreating at the point bar at station WW5, including people wading, swimming and using the rope swing. The decrease in number of people docked at WW4 may have been due to the rope swing tree falling down. The average number of people on the point bar wading and swimming per hour was also calculated and is shown in **Appendix B**; it follows a similar distribution as the vessels but with higher numbers per hour since there are typically 1.46 users per vessel.

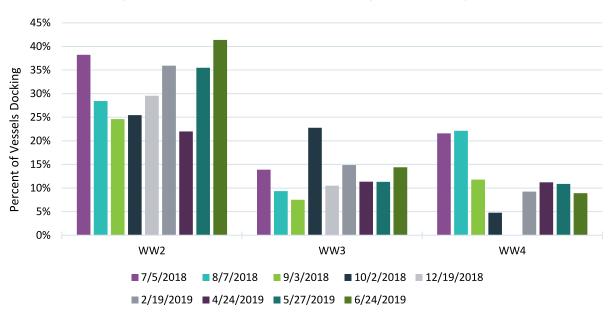
Figure 3.9 - Percent of Vessels Docking (per hour) by Site

Figure 3.9 shows the percentage of passing vessels that docked at each point bar. The number of vessels docked per people wading and swimming are notably higher during the higher recreation season, but the percentage of vessels docking remains relatively stable throughout the year at WW2 and WW3. Station WW2 had the highest percentage of passing vessels that docked on the point bar (between 20% and 40%), likely because it was directly downstream of the original

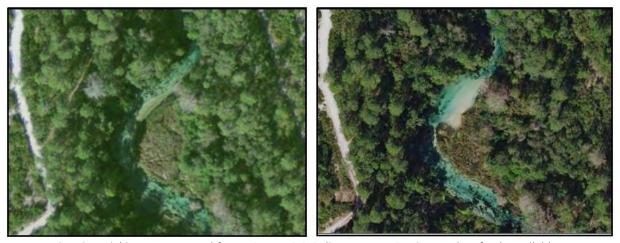
Figure 4.1 – Reduction in Vegetation from 2008 to 2017 at Weeki Wachee Point Bar 1

Figure 4.1 shows the point bar at Wood Station WW2 (the historic exit of the State Park) in 2008 compared to 2017, and the vegetation loss of approximately 1600 ft². This side by side comparison clearly shows the magnitude of vegetation and subsequent organic soil loss at this point bar, and kayaks can even be seen docked in the 2017 image on the right. **Figure 4.2** shows the cumulative percent reduction in vegetation among all 6 point bars assessed compared to the average daily vessels launched from the State Park in each fiscal year (FY 2012/2013 plotted as 2013, etc.). State

Note: Historic aerial imagery sourced from ESRI ArcGIS Online Imagery Services and/or freely available downloadable imagery from SWFWMD and FDOT. Left Image: Aerial 10/2008; Bar vegetated area = 7,031 sq. ft. Right Image: Aerial 6/2017; Bar vegetated area = 5,337 sq. ft.

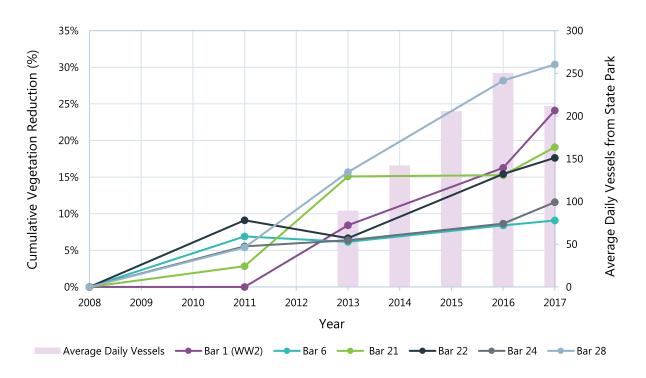
Figure 4.2 – Cumulative Percent Reduction of Vegetation on Point Bars Compared to Average Daily State Park Vessel Launches

Note: Cumulative vegetation reduction is calculated as (vegetated area in year X – vegetated area in 2008)/vegetated area in 2008. The earliest State Park vessel launch data begins in June 2012. Point bar locations shown in **Map 4.**

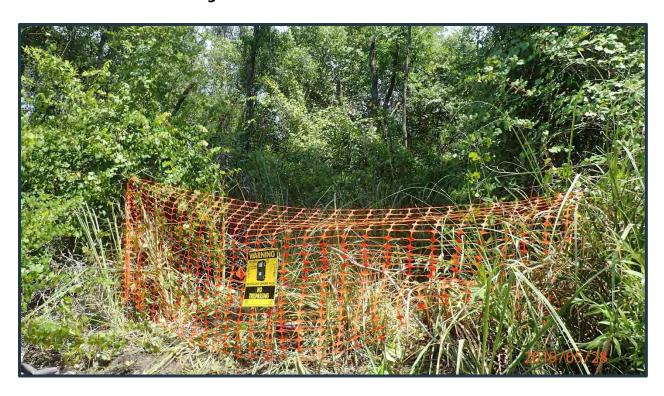
Figure 4.4 – Construction Fence Barrier

Each of the 5 lanes was randomly assigned a trampling intensity (0, 25, 50, 100, or 200 passes), with one pass defined as walking at a natural gait in one direction. Trampling was performed by the same individual to provide consistency across sites. After receiving the designated intensity of trampling, the immediate effects to soil and vegetation were recorded and photographed. Signage informing that the site was restricted was placed onto construction fencing that was held up by steel rebar was installed as a barrier at each trampling site to restrict site access to the research plots (**Figure 4.4**).

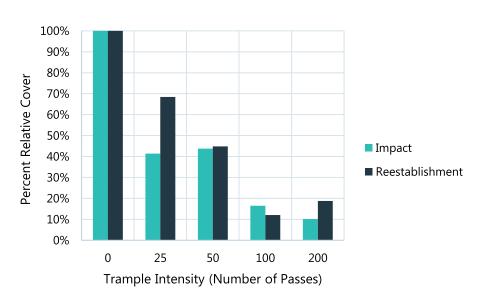
Figure 4.7 – Relative Cover After Impact and Reestablishment at Trample Bar 1

Figures 4.7 - 4.9 show the relationship between relative cover and the intensity of trampling received to the study site after the initial 2-week period (impact) and 6-month period (interim reestablishment). Impact is defined as 2 weeks after trampling because it leaves sufficient time to observe plant deaths due to trampling (as opposed to immediately after trampling when vegetation still appear alive but flattened). After the 2-week impact period, the recovery period begins with some reestablishment of mostly opportunistic invasive vegetation, and the first interim recovery observations were taken at 6 months. It should be noted that recovery may take much longer than 6 months (depending on environmental and seasonal factors), and that 12-month recovery data will be collected, although it will occur outside of the carrying capacity study contract period. Overall, after the initial 2-week trampling event, percent relative cover decreased in response to the increasing trampling intensity across all 3 bars.

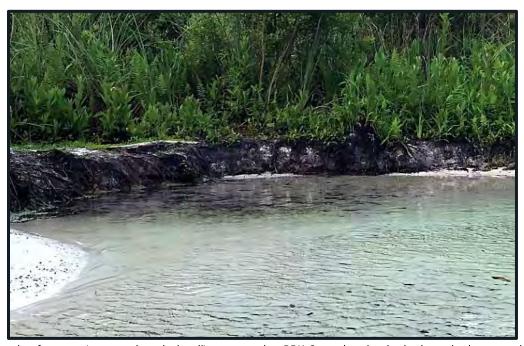
Figure 4.13 – Weeki Wachee Scarp Example (Point Bar 1)

Note: Example of a scarp (unnatural vertical wall), representing BRK-2 as a breakpoint in the point bar mapping exercise.

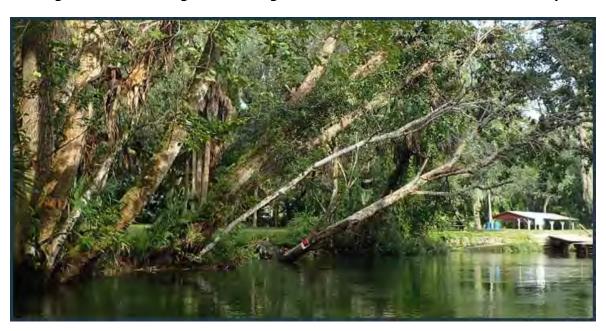
Figure 4.15 – Leaning Trees on Right Bank at Weeki Wachee Christian Camp

bend, at the Weeki Wachee Christian Camp, 1 large bay tree had fallen during the end of the study, exposing the root system and disturbing the soils of the bank. Along the same outer bend at the Christian Camp, several more leaning trees were noted along with approximately 6 feet of bank undercutting (**Figure 4.15**). Bank undercutting increases potential for tree fall when trees are rooted into the undercut bank, which can create a hazard and obstruction for navigation when the tree falls into the river. Outer bends with severe undercutting can also be associated with point bar enlargement, which appears to be occurring on several bars.

While conducting cumulative assessments on Weeki Wachee River, it was noted that many trees were leaning over or into the water at an angle that would make the trees susceptible to an impending tree fall, particularly within FPZ-3. Many of the leaning trees had roots that appear to have been exposed from soil washout/erosion and moderate to severe bank undercutting. Along the spring run from the State Park to Rogers Park, 76 leaning trees were observed (56 in FPZ-3, 26 in FPZ-2). Overall, the leaning trees appeared to be on outer bends of the river. At one outer
