HURRICANE ANDREW STORM SUMMARY AND IMPACTS ON THE BEACHES OF FLORIDA SPECIAL REPORT

**US Army Corps
of Engineers**
Jacksonville District

**Florida Department of
Natural Resources**
Division of Beaches and Shores

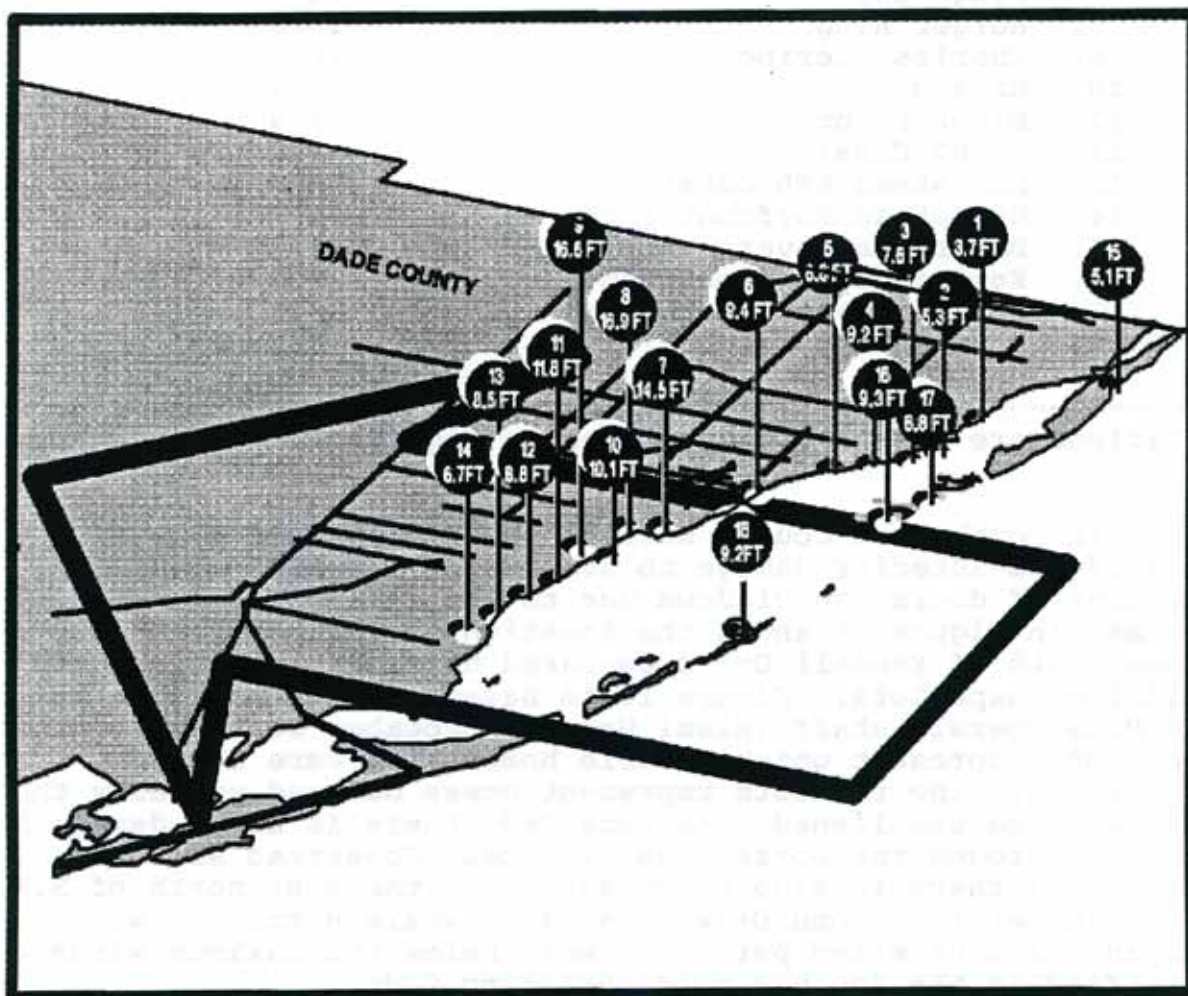
FIGURE 9

5. The surge levels reported for the hurricane are shown in Table 3. The locations for the surge elevations are displayed in Figure 9. These surges compare fairly well with the predicted surges for a category 4 storm from the Flood Insurance Study for Dade County (FEMA, 1987) shown in Figure 10. The Bakers Haulover Inlet tide gage record is shown in Figure 11. Historically, drownings due to surge and flooding account for 90 percent of hurricane deaths. For Hurricane Andrew, these deaths only account for 13 percent of the total. This is due in part to the location of landfall, the coastline of which was in a lightly developed area. The landfall area from S.W. 184th Street (Eureka Drive) to Turkey Point has 90 percent of the fringing mangroves left in Dade County. The area's natural resources are depicted in Figure 12. A cross-section of the surge profile along the shoreline on Key Biscayne at the time of storm landfall is shown in Figure 13.

STORM SURGE DEPTHS

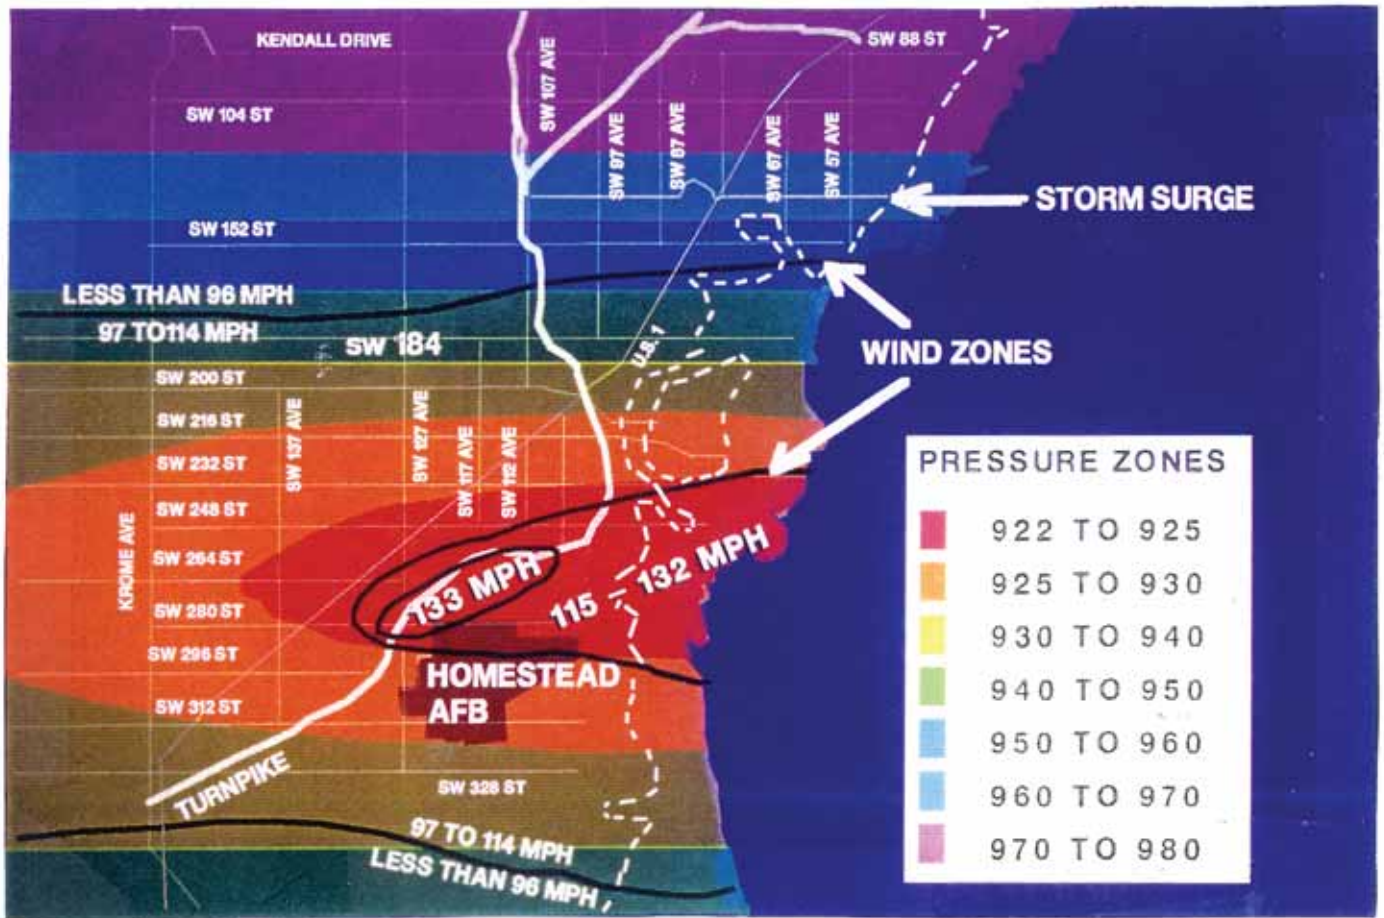
FIGURE 14
 PRESSURE ZONES, WIND ZONES AND STORM SURGE CONTOUR

6. A summary map developed by the Miami Herald (December 20, 1992) showing the pressure zones, wind contours, and inland limit of surge impact is shown in Figure 14. The barometric pressure gradients in Figure 14 are based on data analyzed by Mr. Ed Rappoport of the National Hurricane Center in Miami. The wind zones in Figure 14 are based on preliminary estimates of sustained wind strength by NOAA scientist Mr. Peter Black.

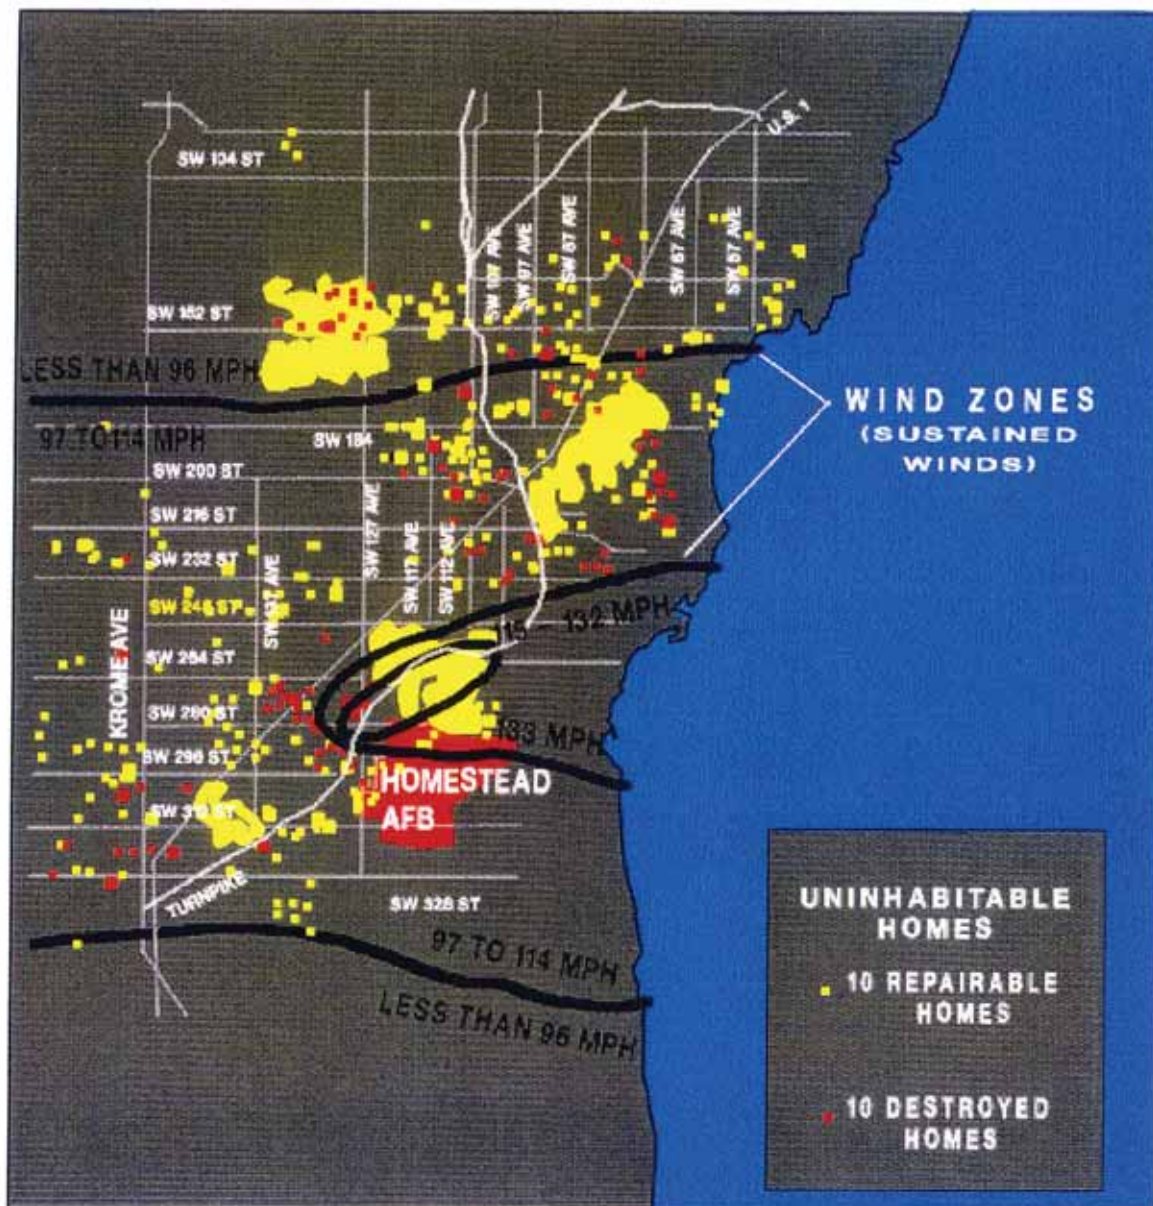
FIGURE 15

homes in South Dade County suffered hurricane roof damage. Much of the interior damage to structures was also caused by the loss of doors and windows due to the intense wind pressure. The map in Figure 15 shows the location of the nearly 15,000 homes south of Kendall Drive declared uninhabitable by county building inspectors. Figure 15 is based on data analyzed by the Miami Herald staff (Miami Herald, December 20, 1992). The blue dots represent uninhabitable homes that were deemed repairable. The red dots represent homes damaged so badly that they will be demolished. As expected, there is heavy damage in the area around the worst wind zone near Homestead Airforce Base. But there is also heavy damage in the zone north of S.W. 168th Street (Richmond Drive), an area where hurricane winds stayed below 96 miles per hour, well below the maximum winds specified in the South Florida Building Code.

LOCATION OF UNINHABITABLE HOMES

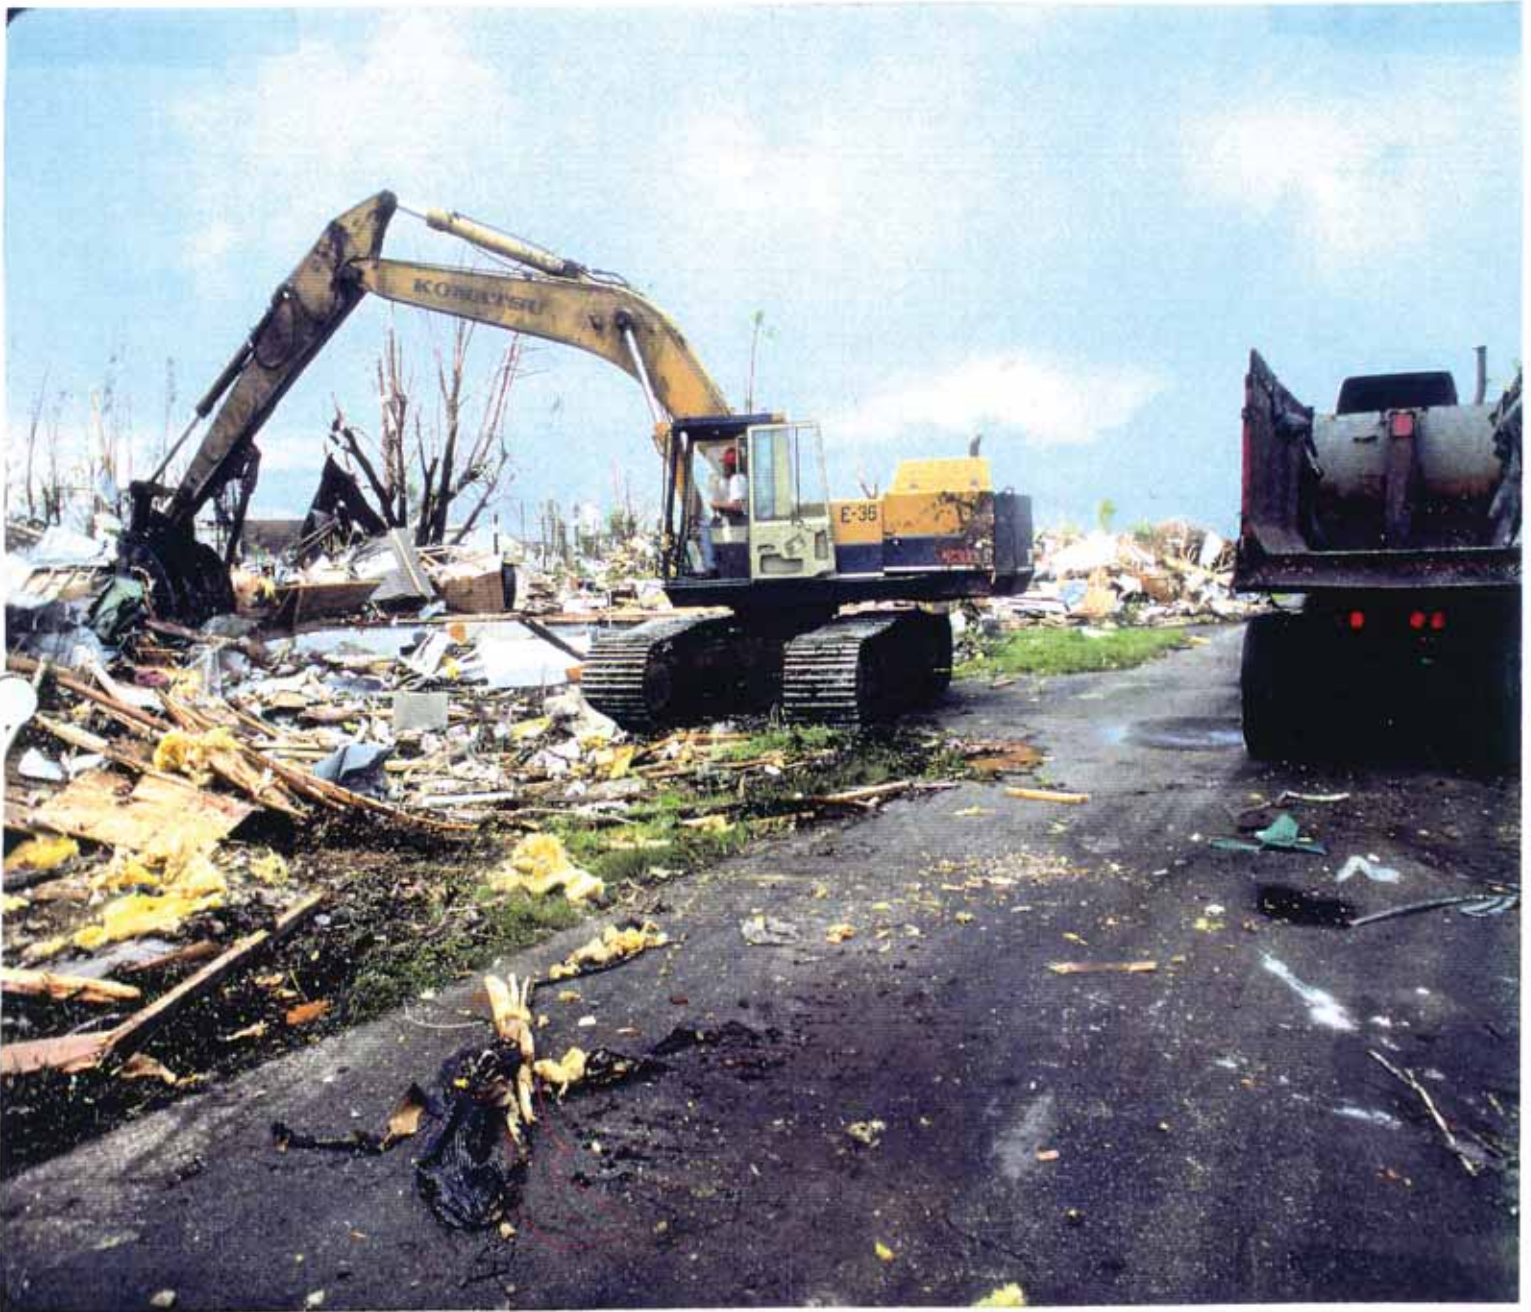
FIGURE 24
DEBRIS REMOVAL

19. Construction and demolition material is estimated at 1.3 million cubic yards of debris, equivalent to 13 Nimitz class aircraft carriers. A total of 39 burn sites have been approved by Dade County. Figure 25 shows a typical burn site. HARO had responsibility for removal of sunken vessels in and around four marinas. The debris removal work is continuing, with an estimated completion date of November 1993.

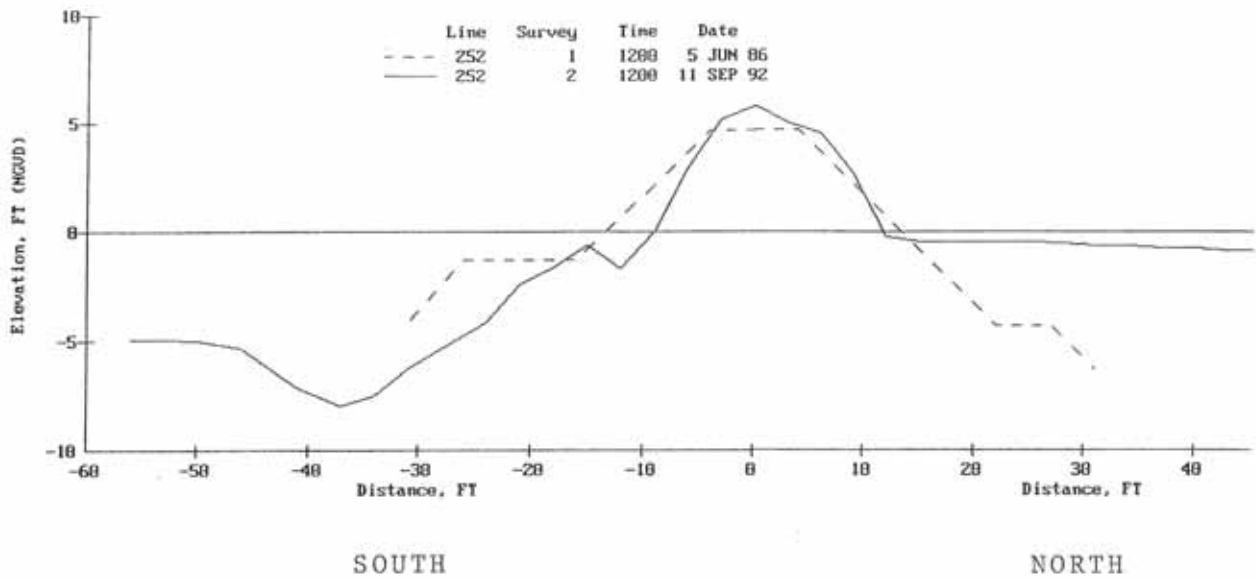
KEY BISCAVNE TERMINAL GROIN, DADE COUNTY, FLORIDA
 DESIGN TEMPLATE & POST HURRICANE ANDREW SURVEY

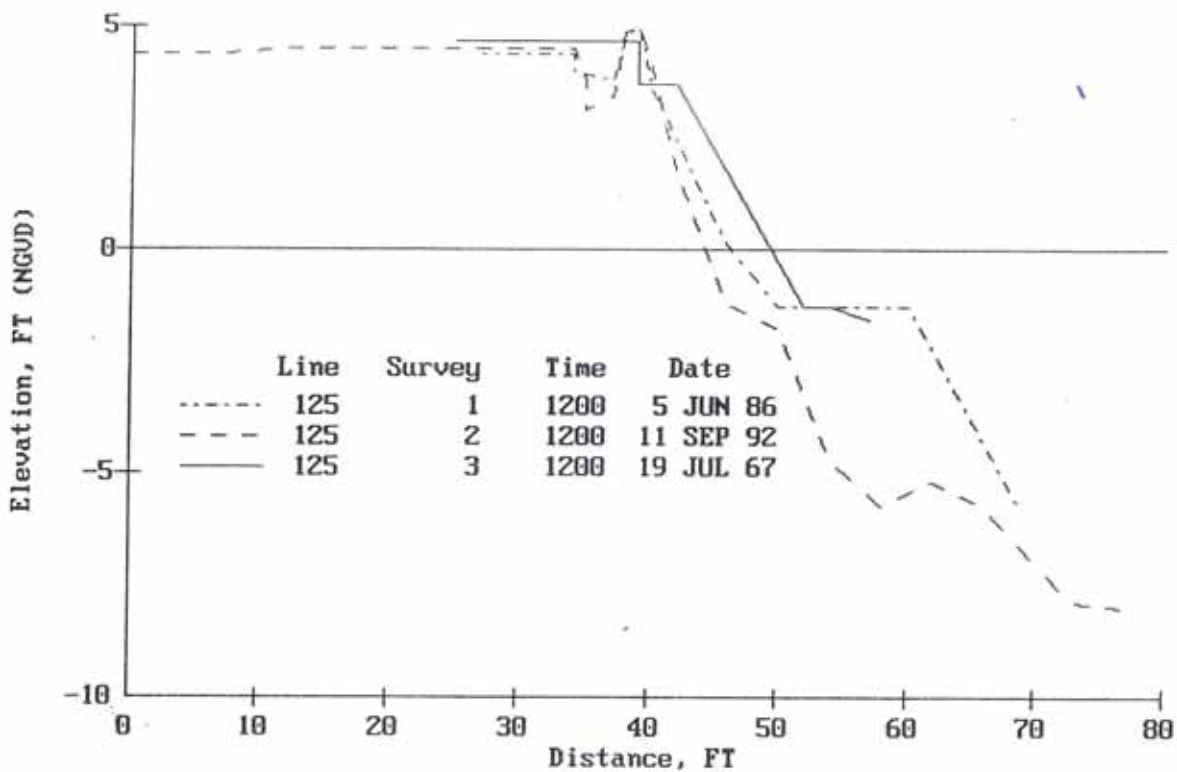
CAPE FLORIDA LIGHTHOUSE REVETMENT, DADE COUNTY, FL
 DESIGN TEMPLATE & PRE AND POST HURRICANE ANDREW SU

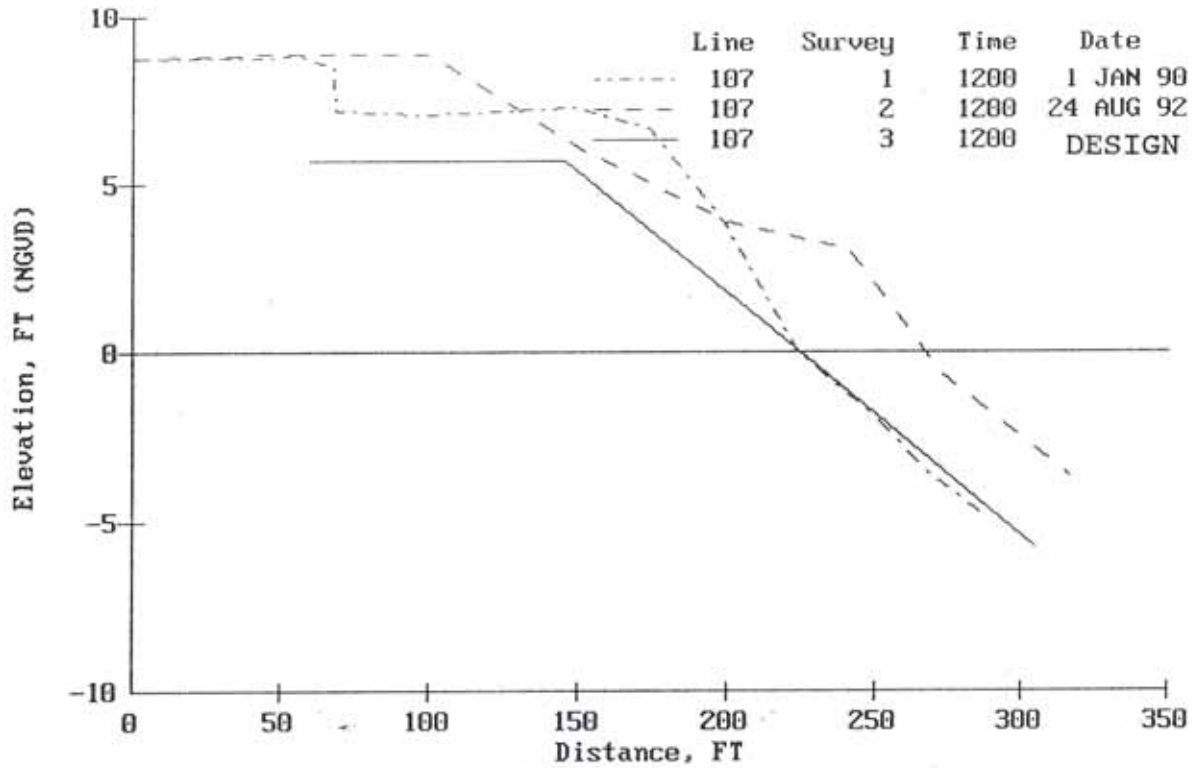
KEY BISCAYNE, DADE COUNTY, FLORIDA
 PRE & POST HURRICANE ANDREW & DESIGN TEMPLATE
