MEMORANDUM

SUBJECT: April 2019 Supplemental Site Assessment Results and Recommendations
Rolling Hills Construction and Demolition (C&D) Debris Disposal Facility
6990 Rolling Hills Road
Pensacola, Escambia County, Florida

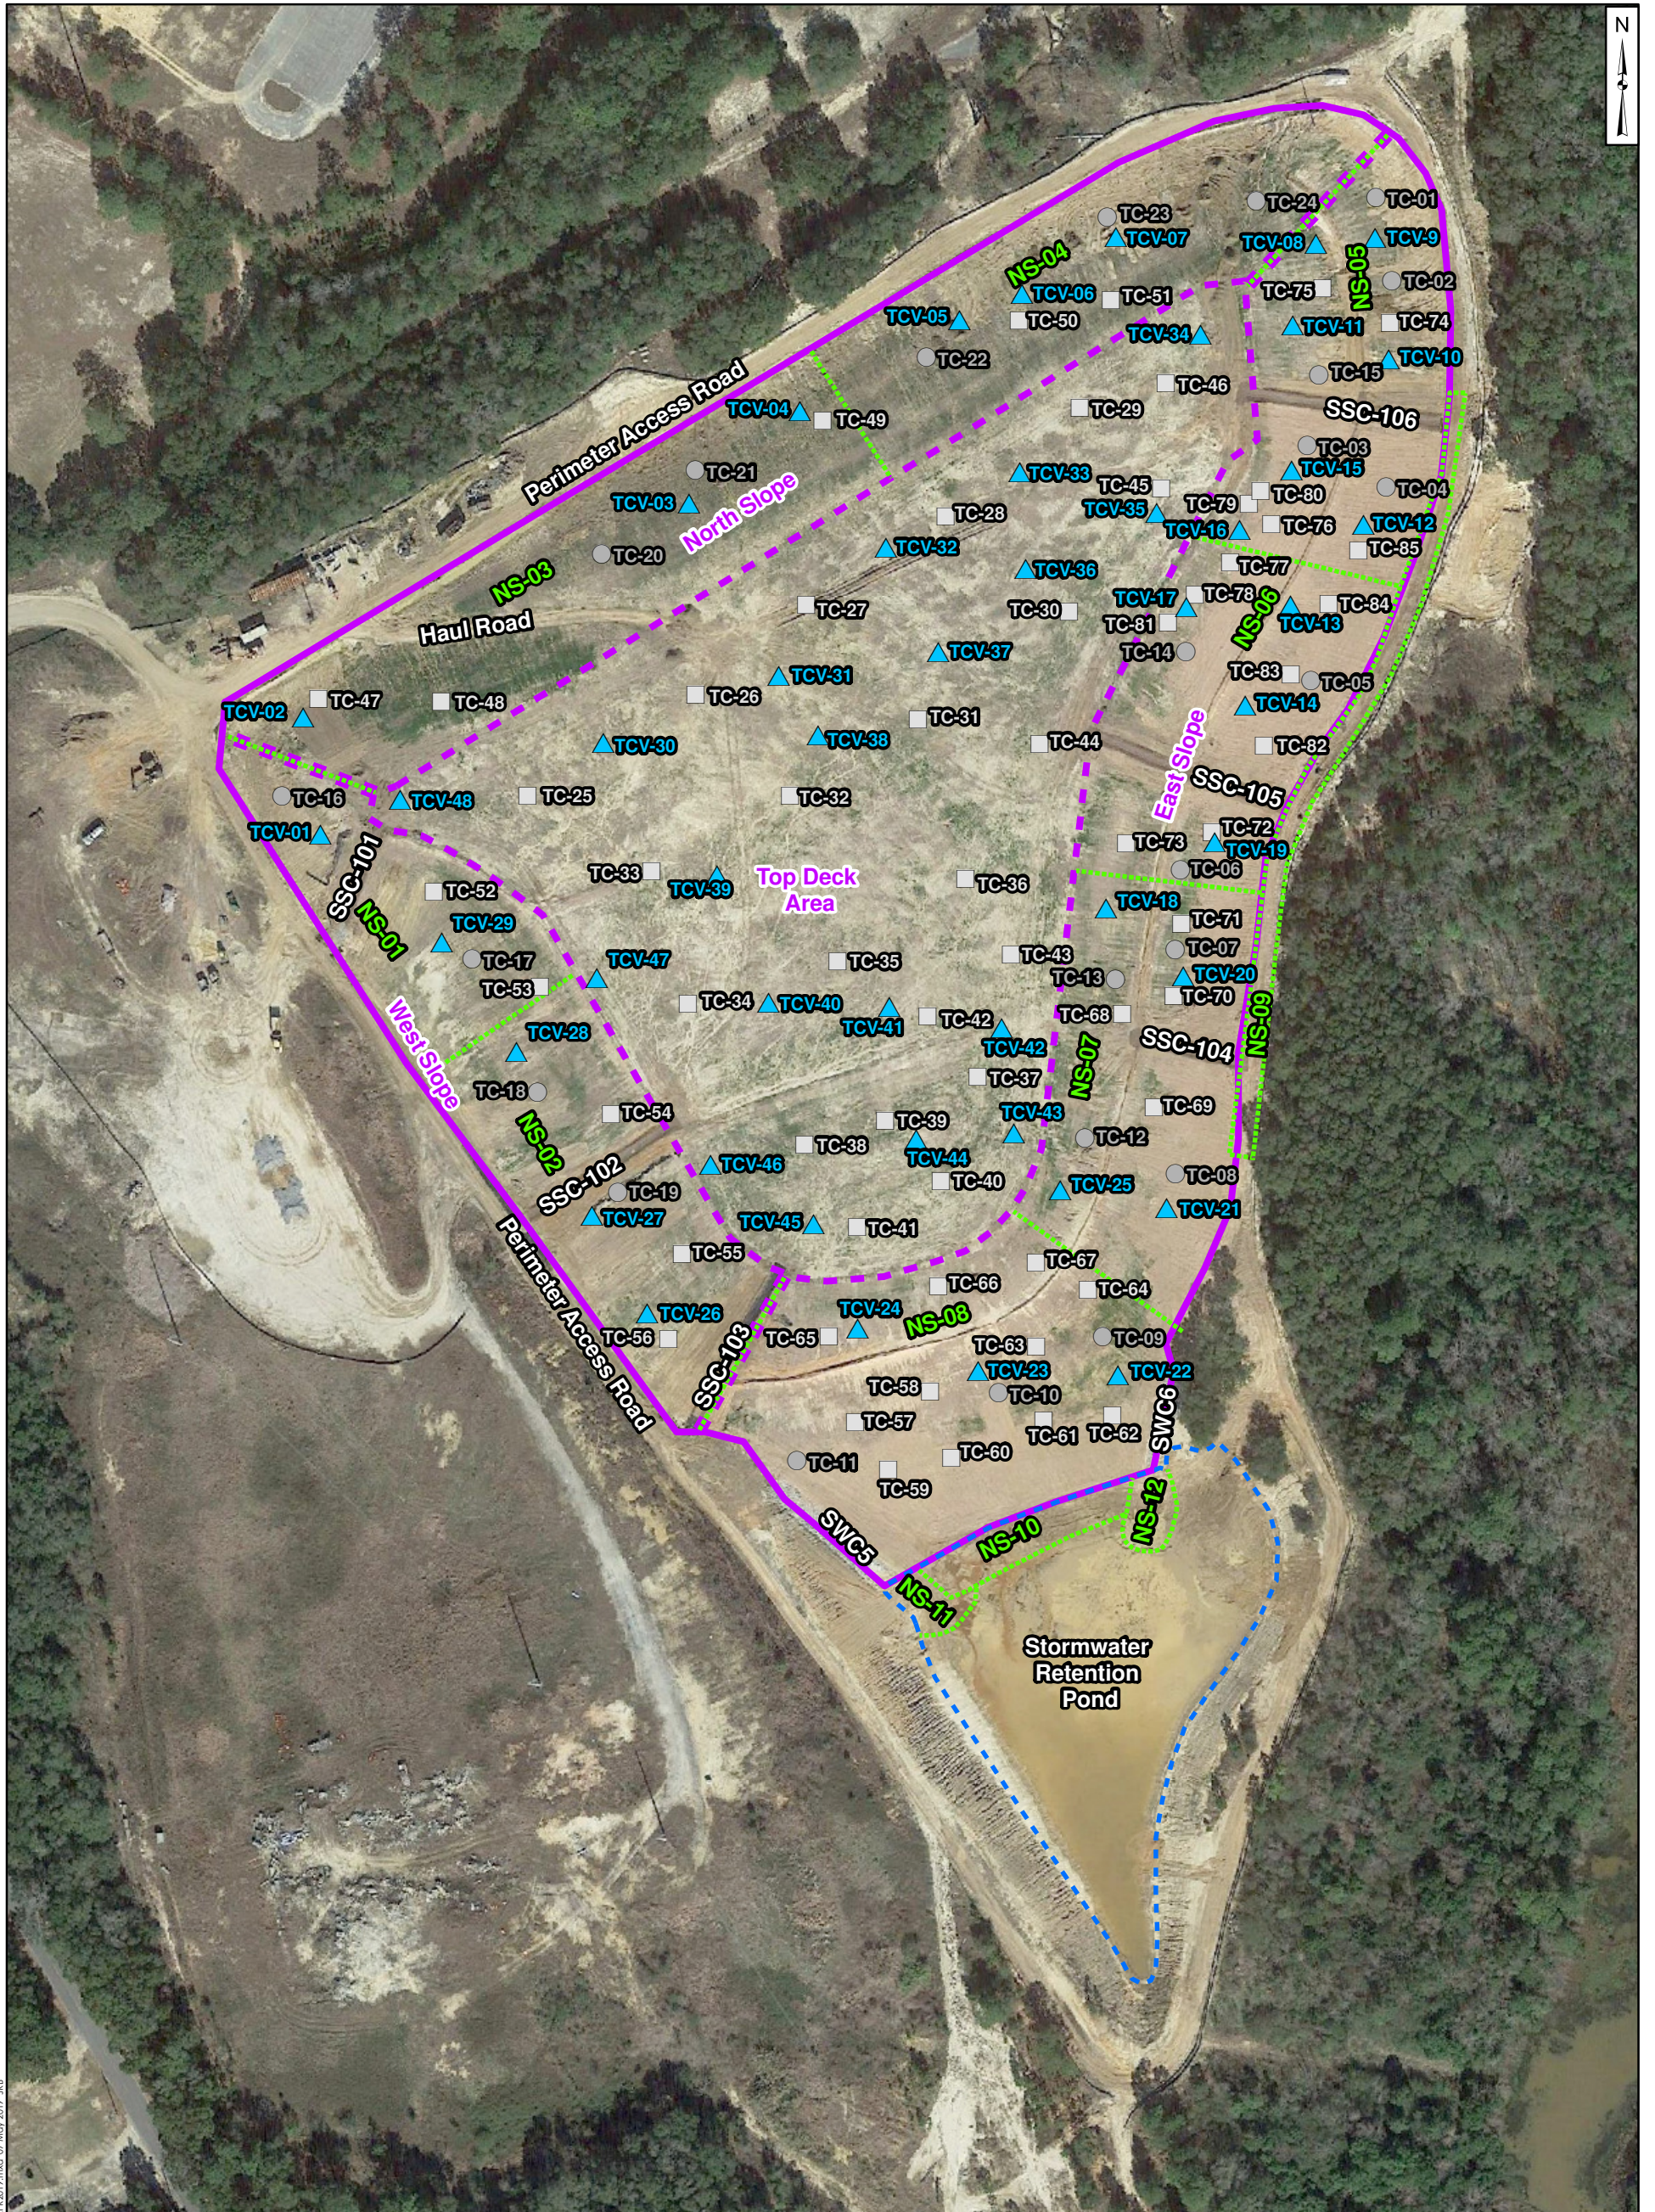
Figure
1

To facilitate description of Site conditions in this memorandum, the approximately 20-acre disposal area has been divided into four areas as depicted in **Figure 1**. The areas are identified as the North Slope (extends approximately 1,100 feet (ft) from the northwest corner to the northeast corner of the Site), East Slope (extends approximately 1,400 ft from the northeast

corner to the southwest corner of the Site), West Slope (extends approximately 700 ft from the northwest corner to the southwest corner of the Site), and Top Deck Area (top area of the Site, generally graded at a 2 percent slope). The stormwater retention pond, also shown on **Figure 1**, is an ancillary feature at the Site.

To evaluate the thickness of the cover system soils, Geosyntec advanced 48 hand-augured boreholes (TCV-01 to TCV-48) as illustrated in **Figure 1**. Borehole locations were selected in close proximity to previous borehole locations (i.e., to confirm previous measurements) and between previous borehole locations (i.e., to further refine estimated construction quantities).
