*Preliminary Hurricane Michael Post-Storm
Beach Conditions and Coastal Impact Report*

**Division of Water Resource Management
Florida Department of Environmental Protection
November 2018**

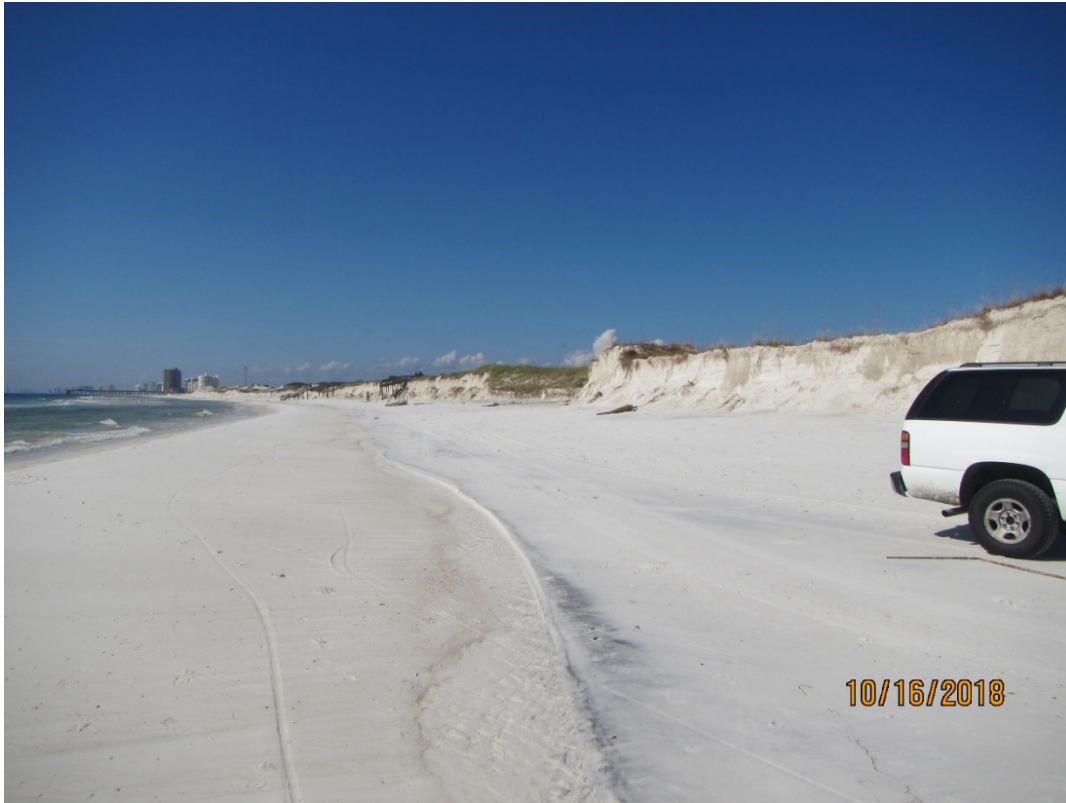
Figure 18. Beach and dune erosion near R97, St. Andrews State Park.

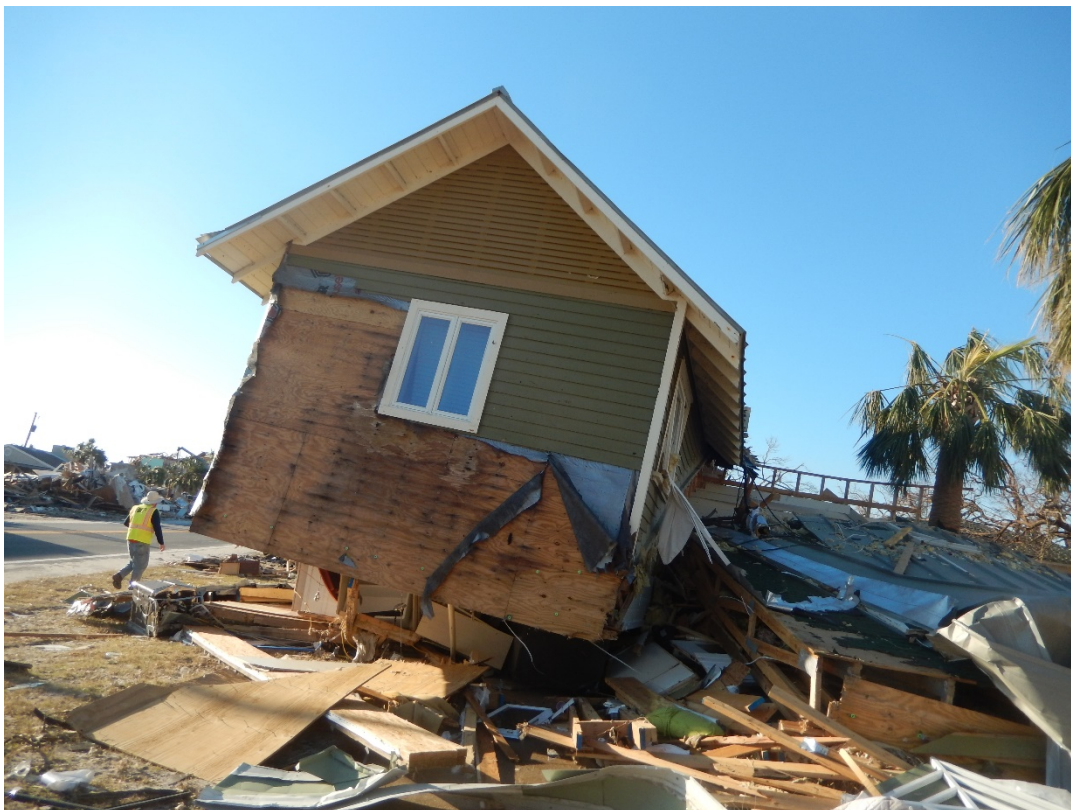
Figure 30. Beach dwelling transported across U.S. 98 by the storm surge.

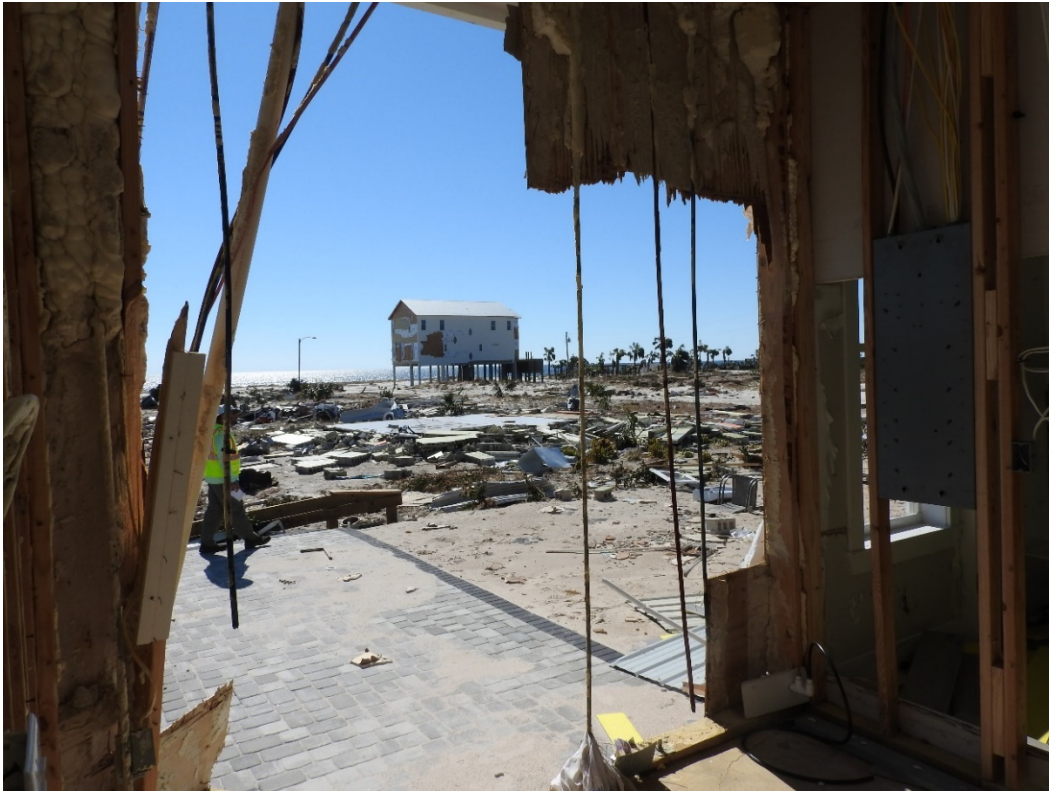
Figure 31. Dwellings destroyed by storm surge near R132, Mexico Beach.

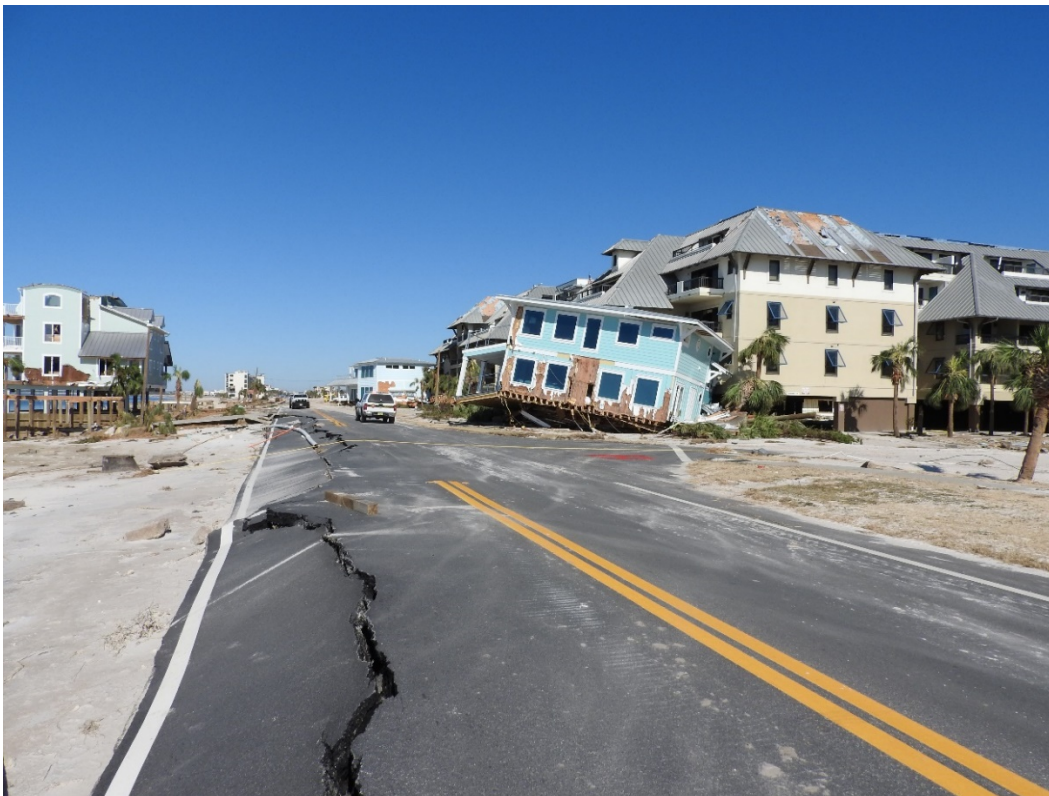
Figure 32. Dwelling transported across U.S. 98 by the storm surge near R136.

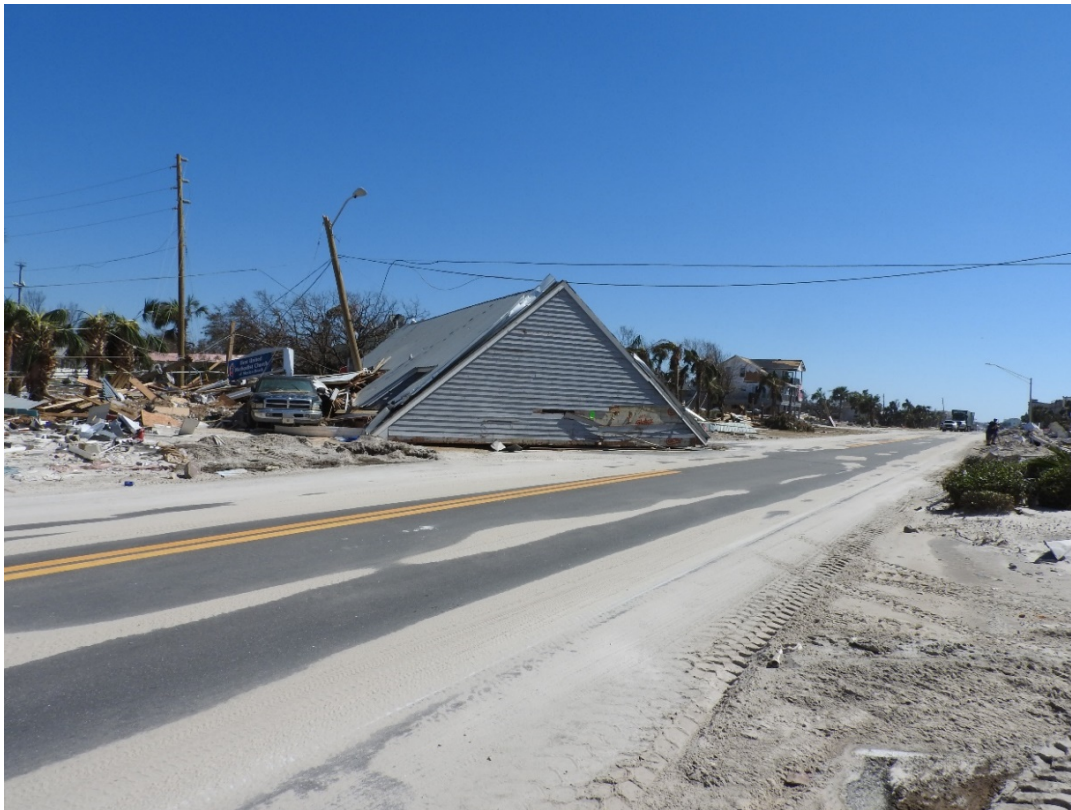
Figure 33. Roof of dwelling transported across U.S. 98 by the storm surge near R138.

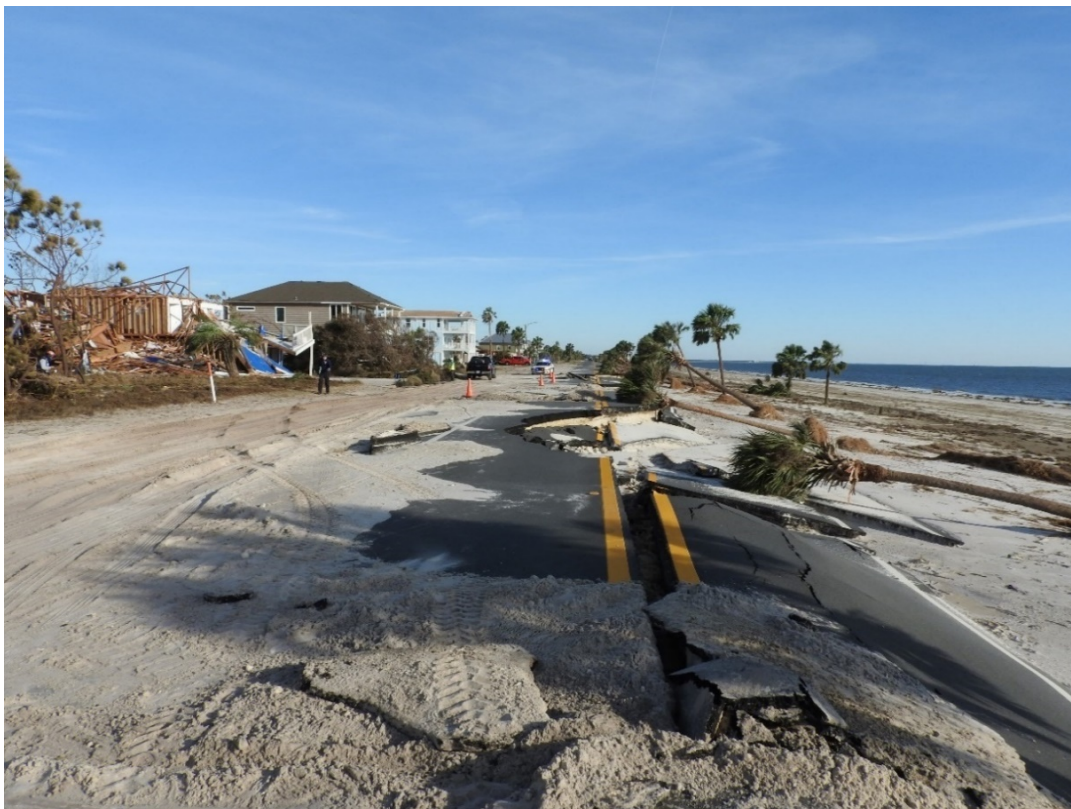
Figure 34. Segment of U.S. 98 destroyed near R139, Mexico Beach.

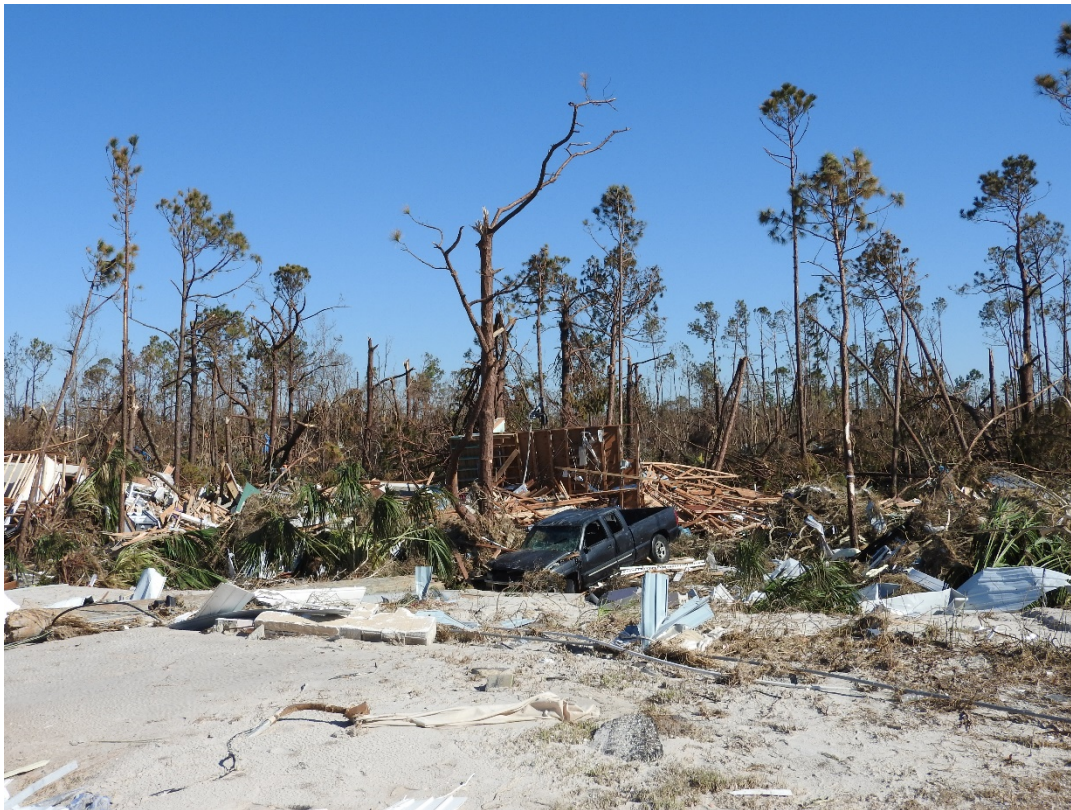
Figure 35. Debris transported by the storm surge inland, Mexico Beach.

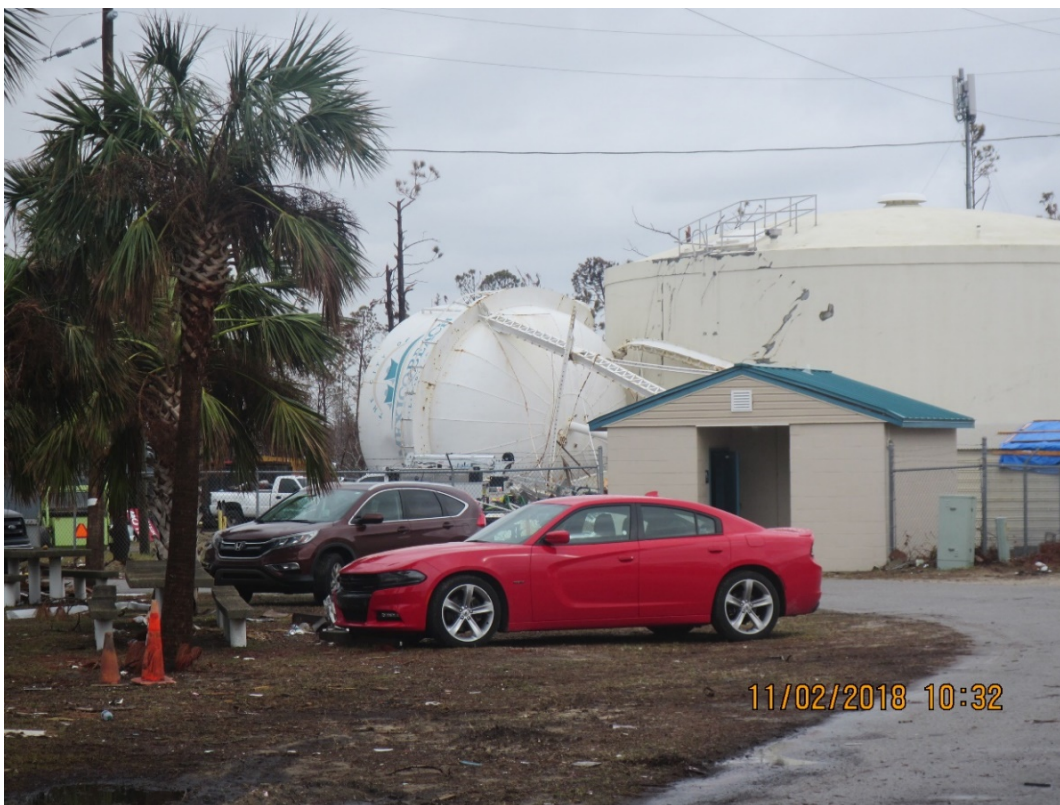
Figure 36. City water tower collapsed under high winds near R134, Mexico Beach.

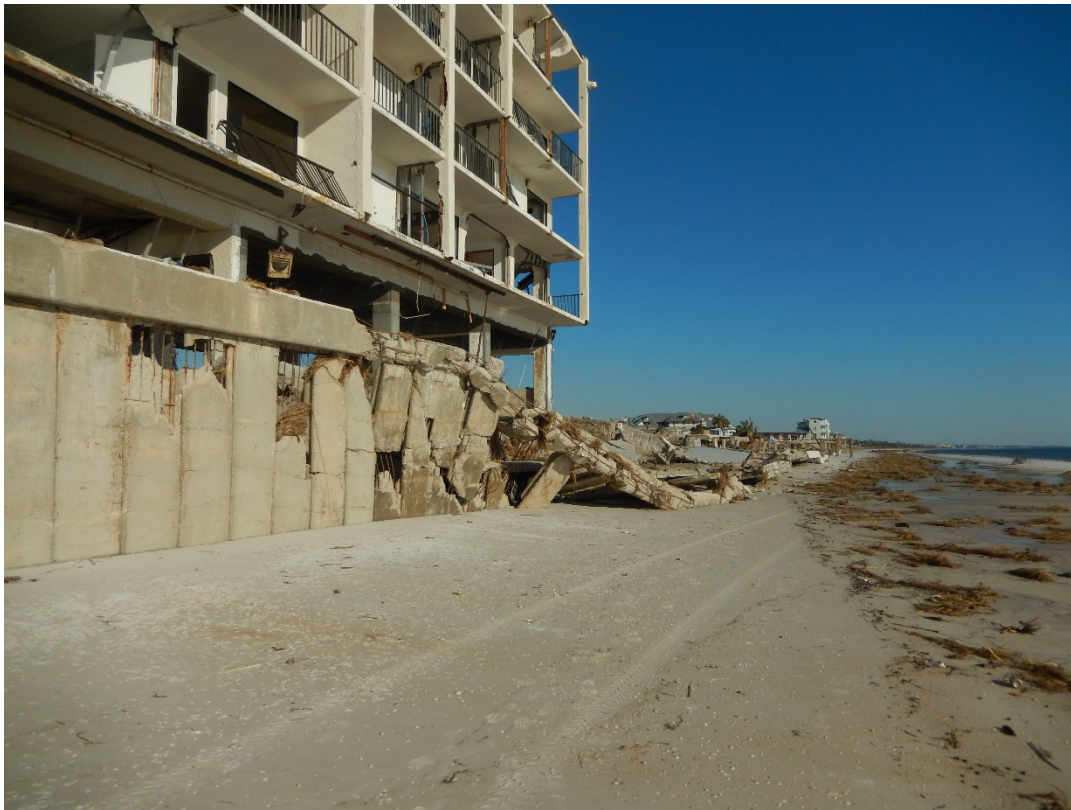
Figure 37. Over 700 feet of reinforced concrete seawall destroyed at R135.

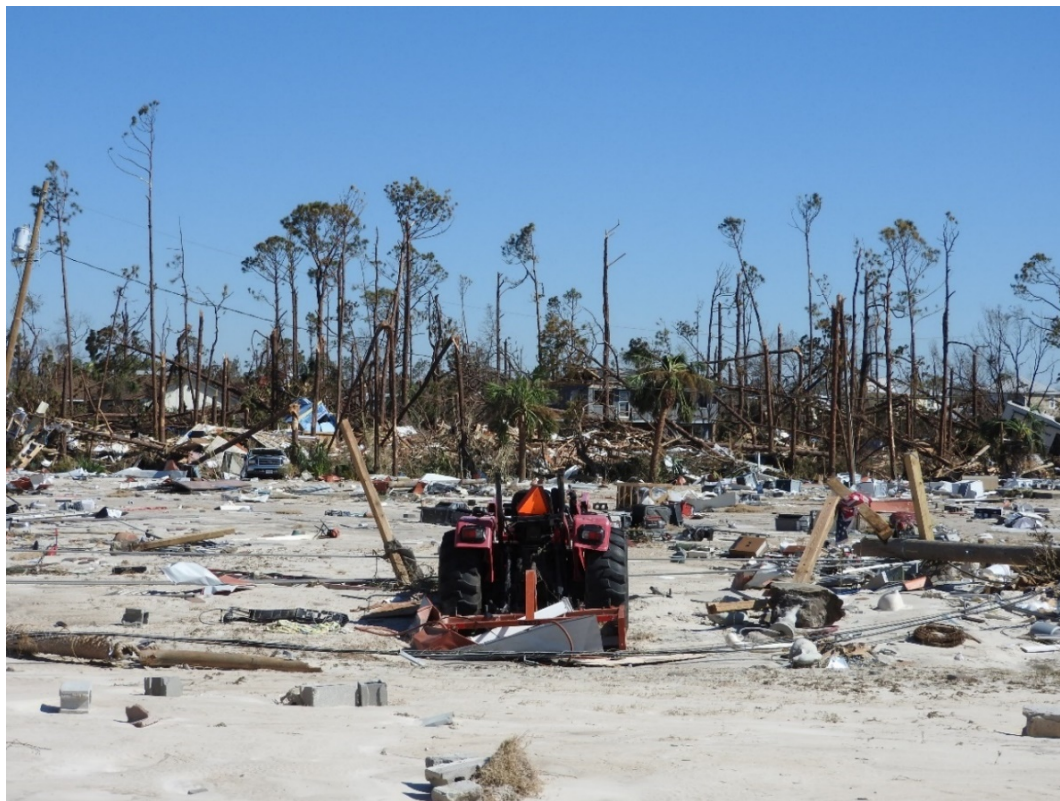
Figure 38. Storm surge transported debris and sand overwash across U.S. 98 near R135, Mexico Beach.

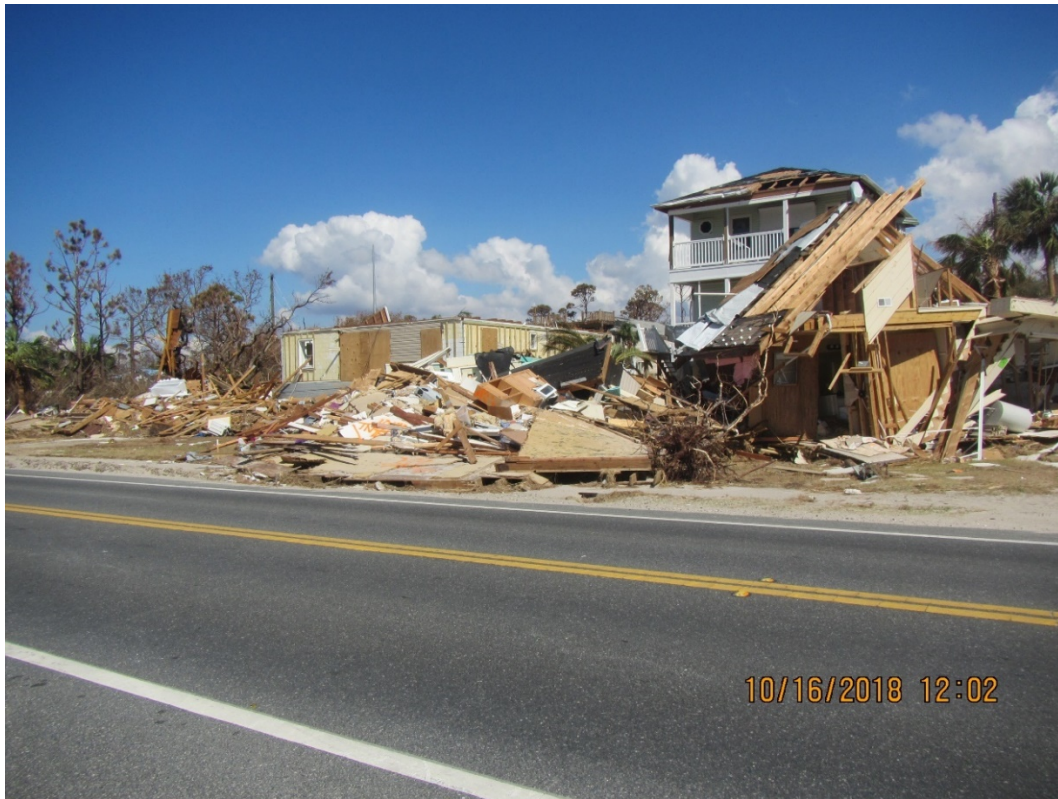
Figure 42. Dwellings along U.S. 98 destroyed near R3, Beacon Hill.

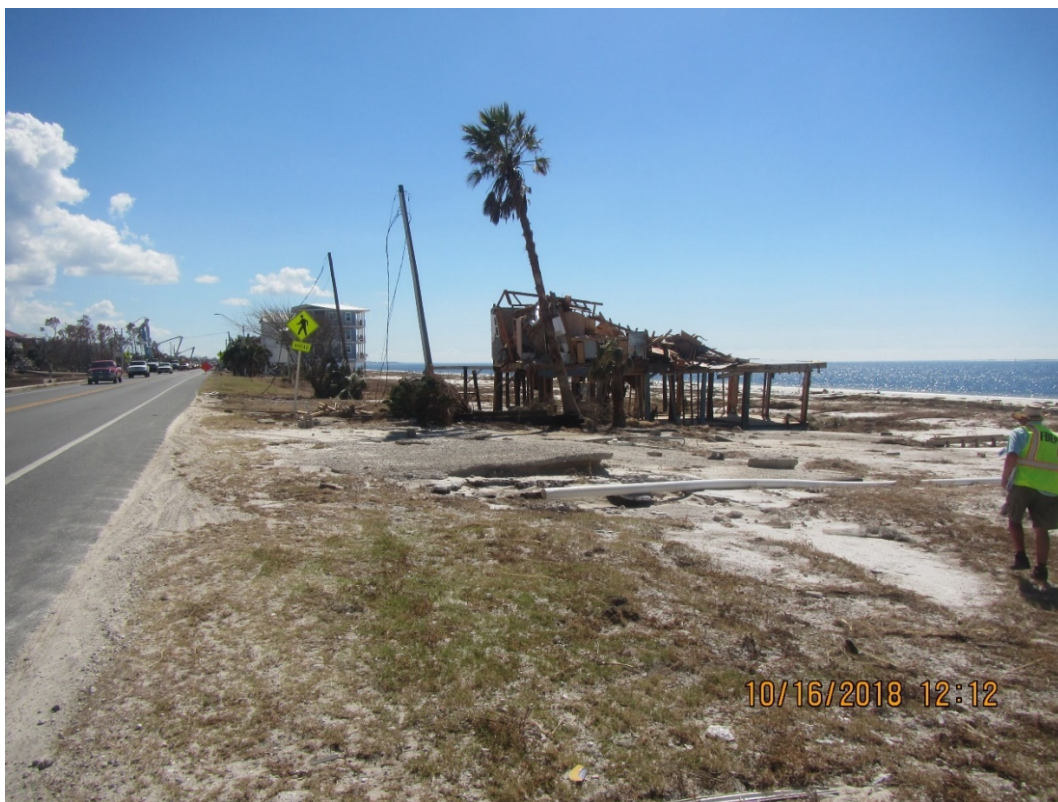
Figure 43. Dwellings destroyed along U.S. 98 near R3.5, Beacon Hill.

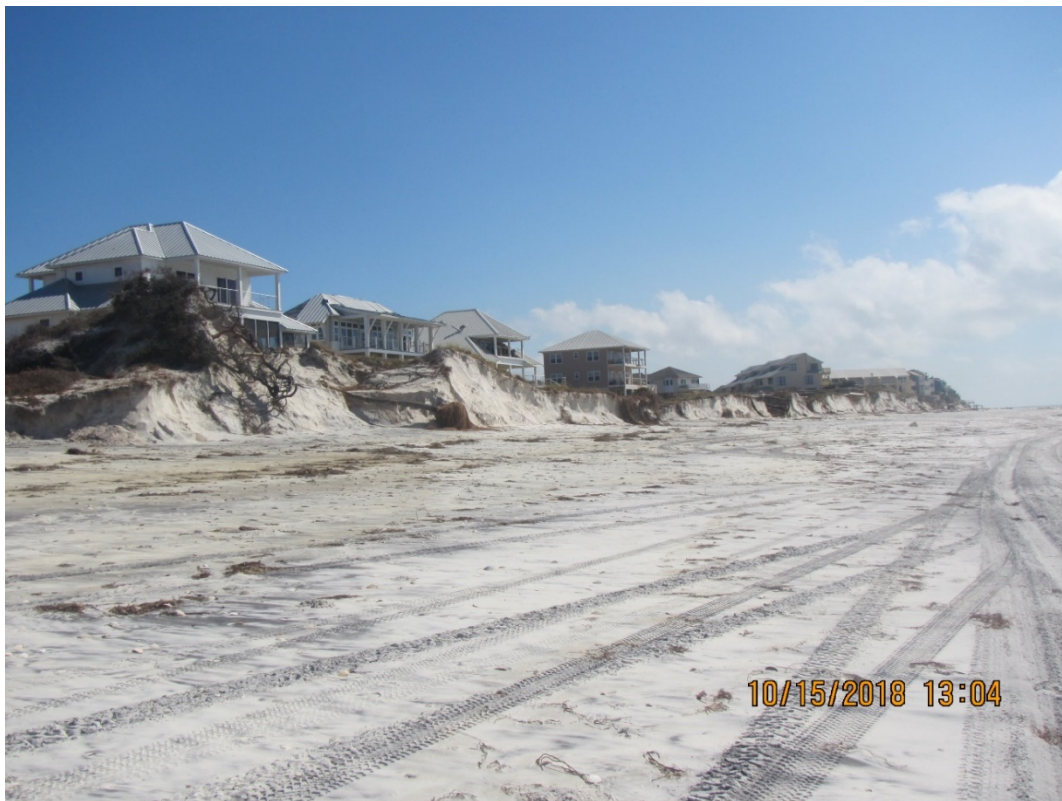
Figure 56. Major dune erosion, R77, St. Joseph Peninsula.

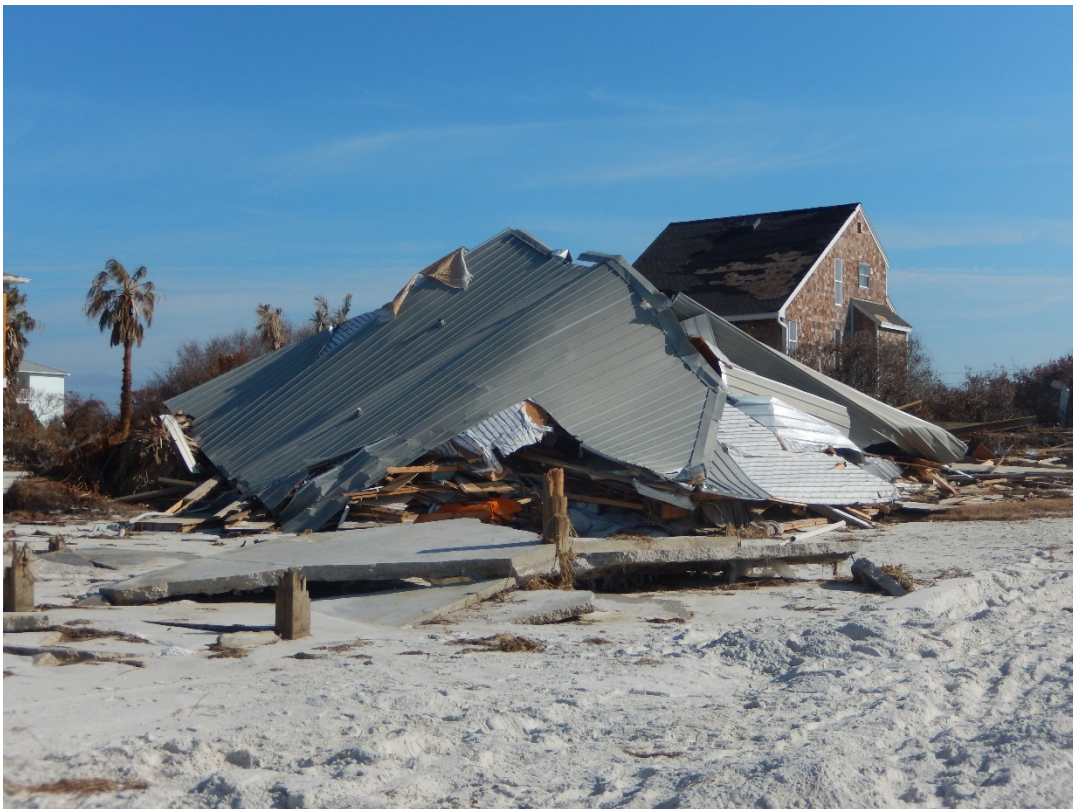
Figure 60. *Dwelling destroyed near R99.5, St. Joseph Peninsula.*

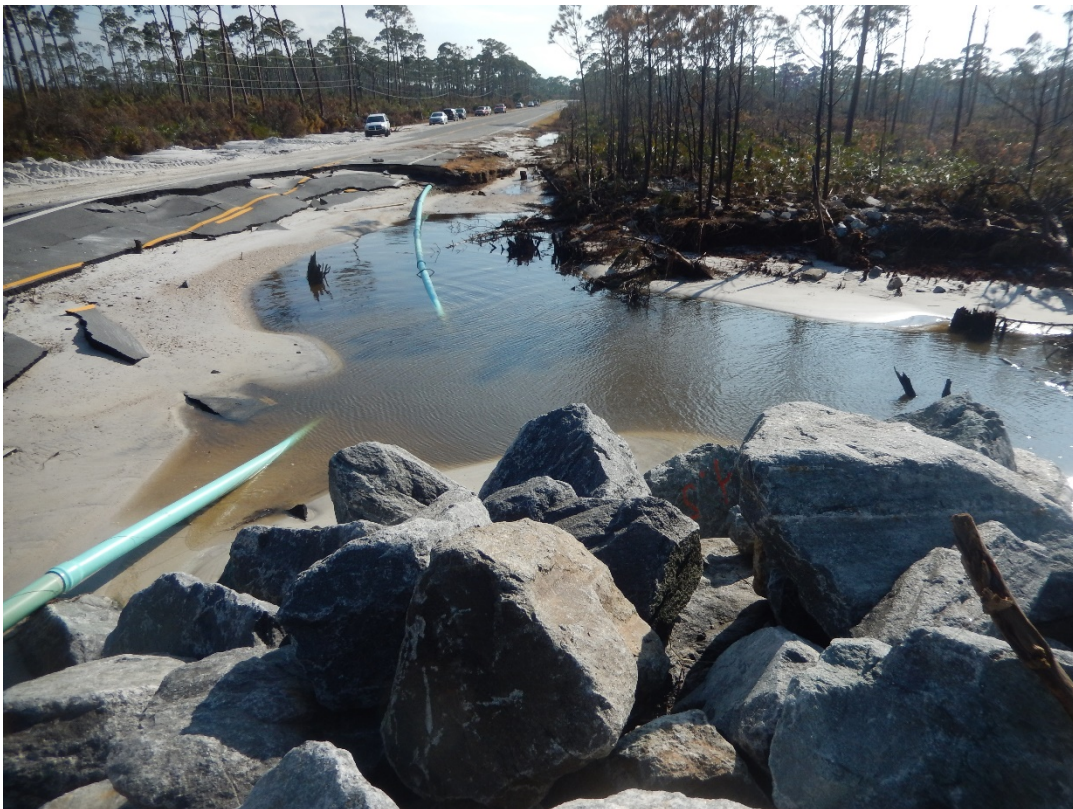
Figure 64. County Road 30E destroyed south of the Stump Hole revetment, R107.

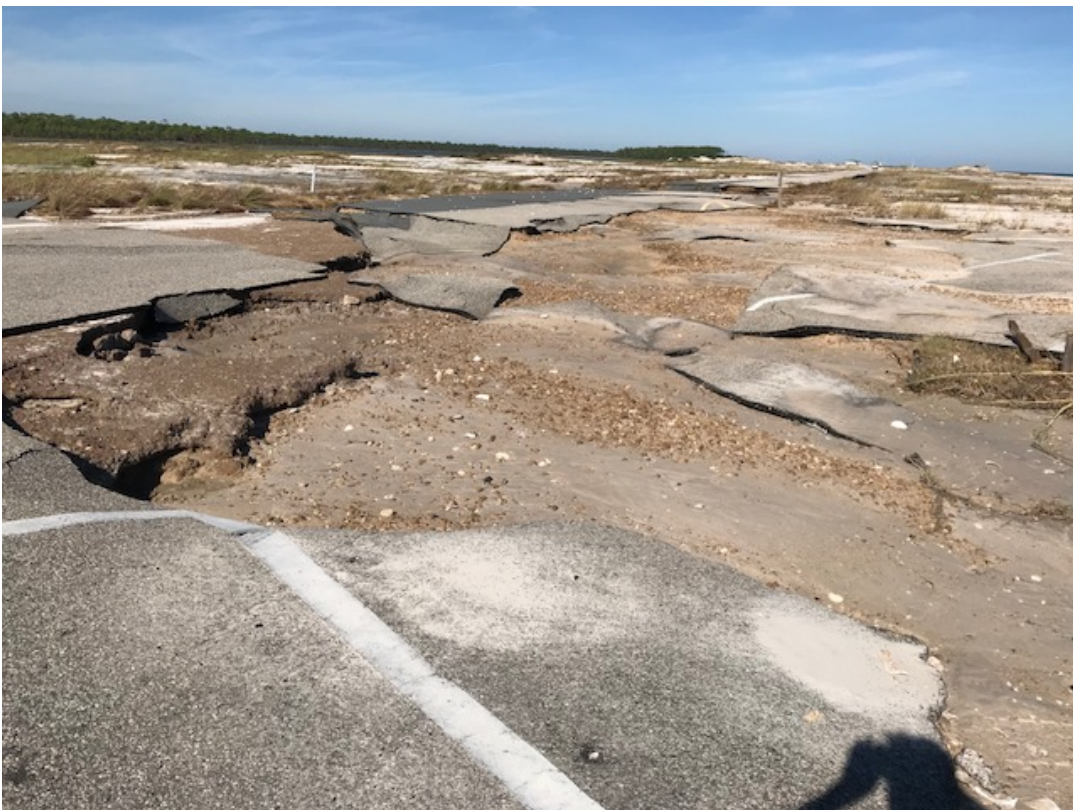
Figure 77. *State park road destroyed near R108, St. George Island.*

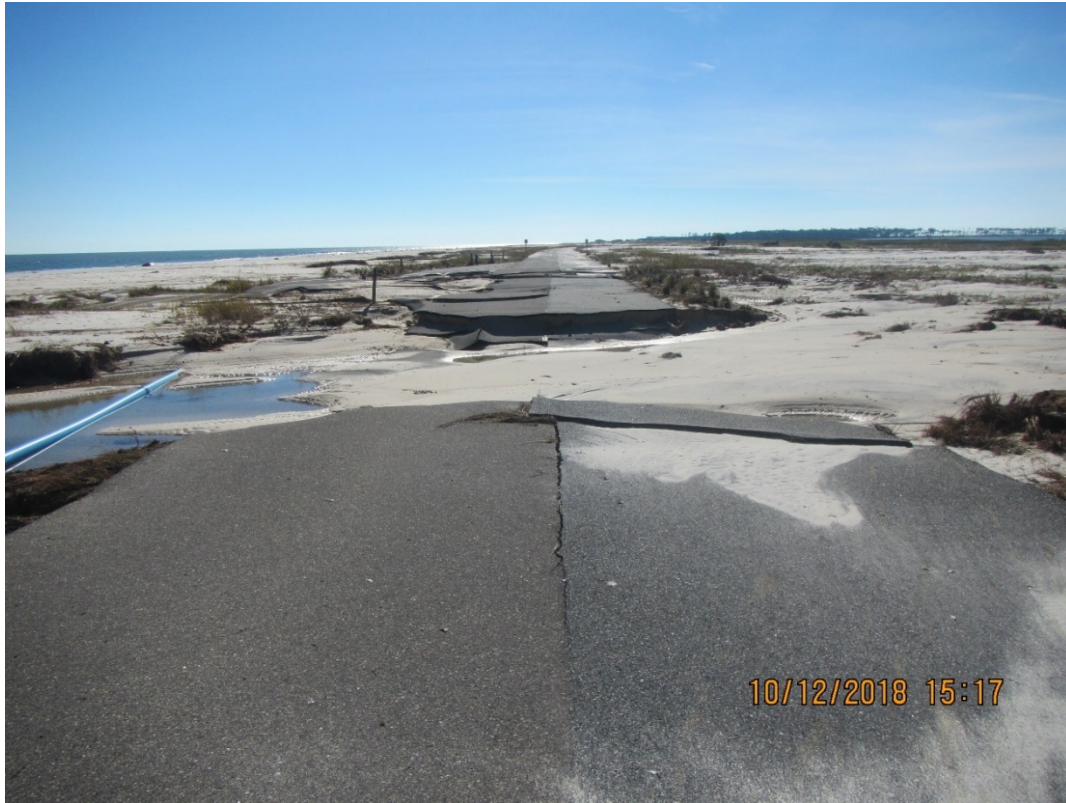
Figure 78. Dunes leveled and park road destroyed at R114, St. George Island.

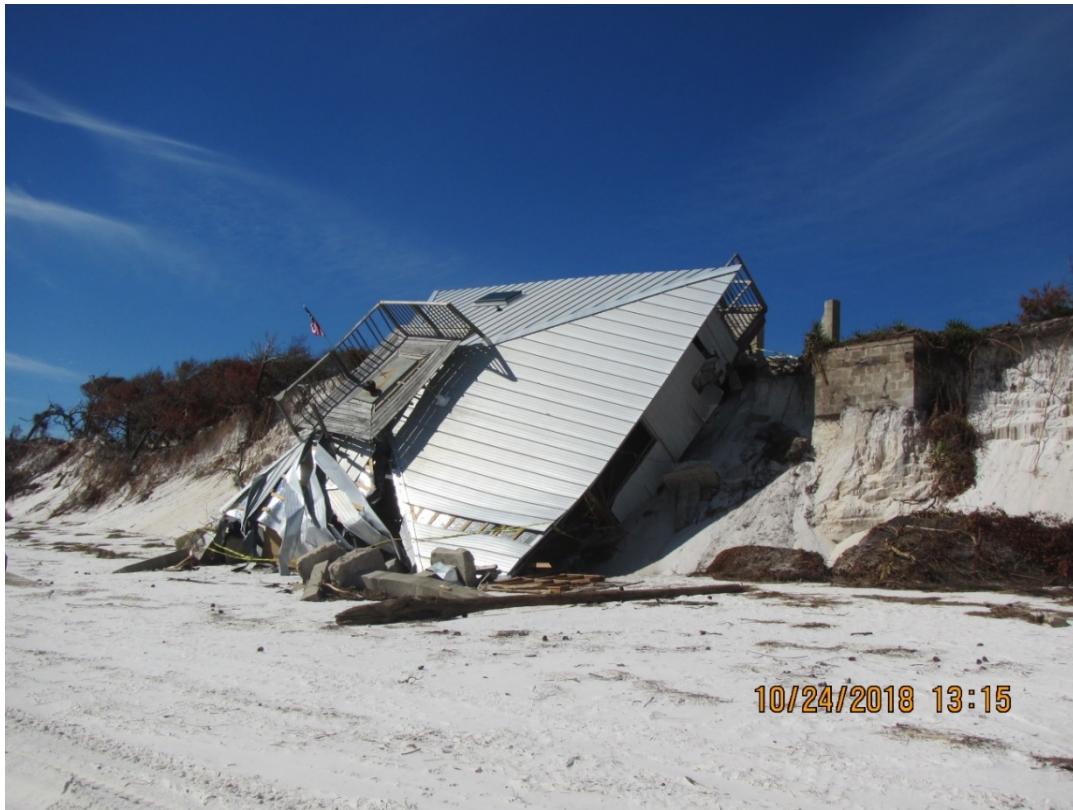
Figure 82. Dwelling destroyed near R173, Dog Island.

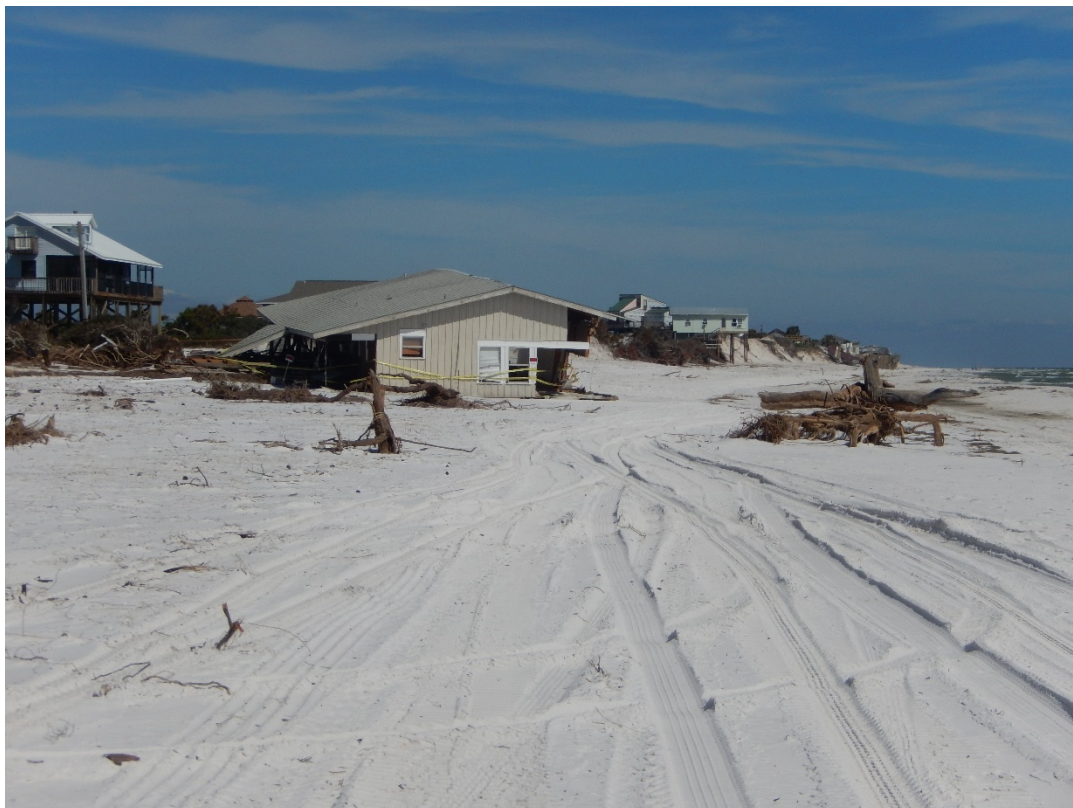
Figure 83. Dwelling destroyed near R174, Dog Island.

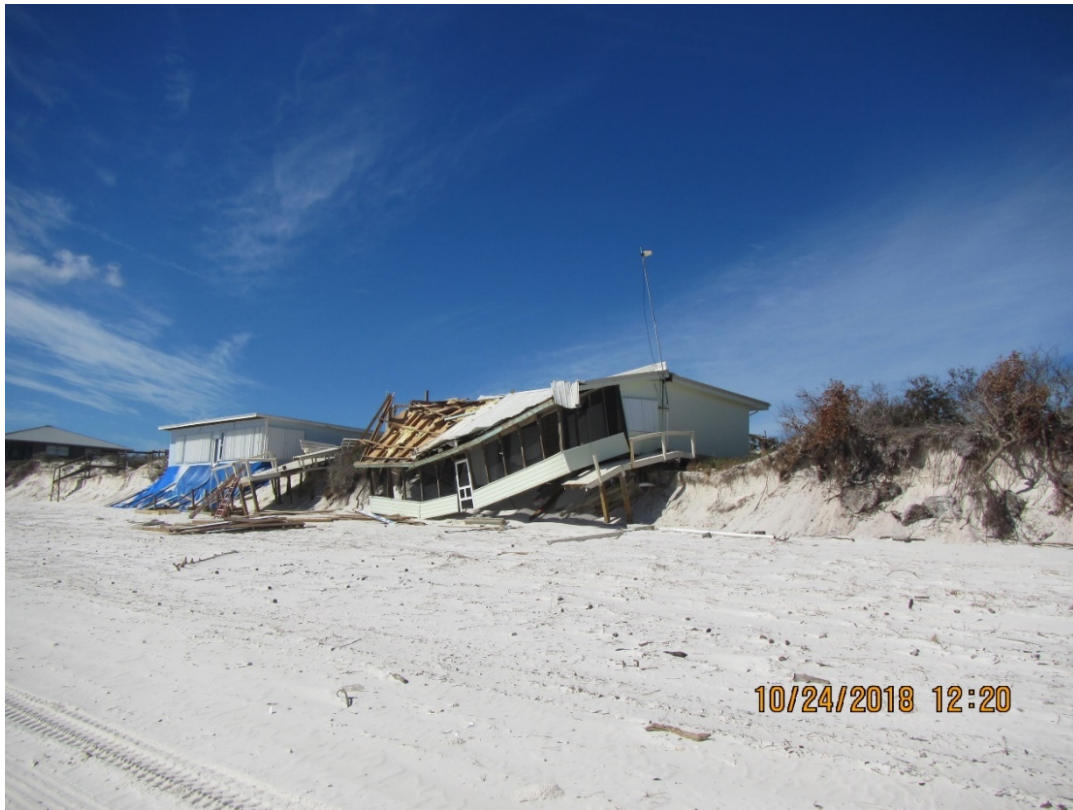
Figure 86. Dwelling destroyed near R179, Dog Island.

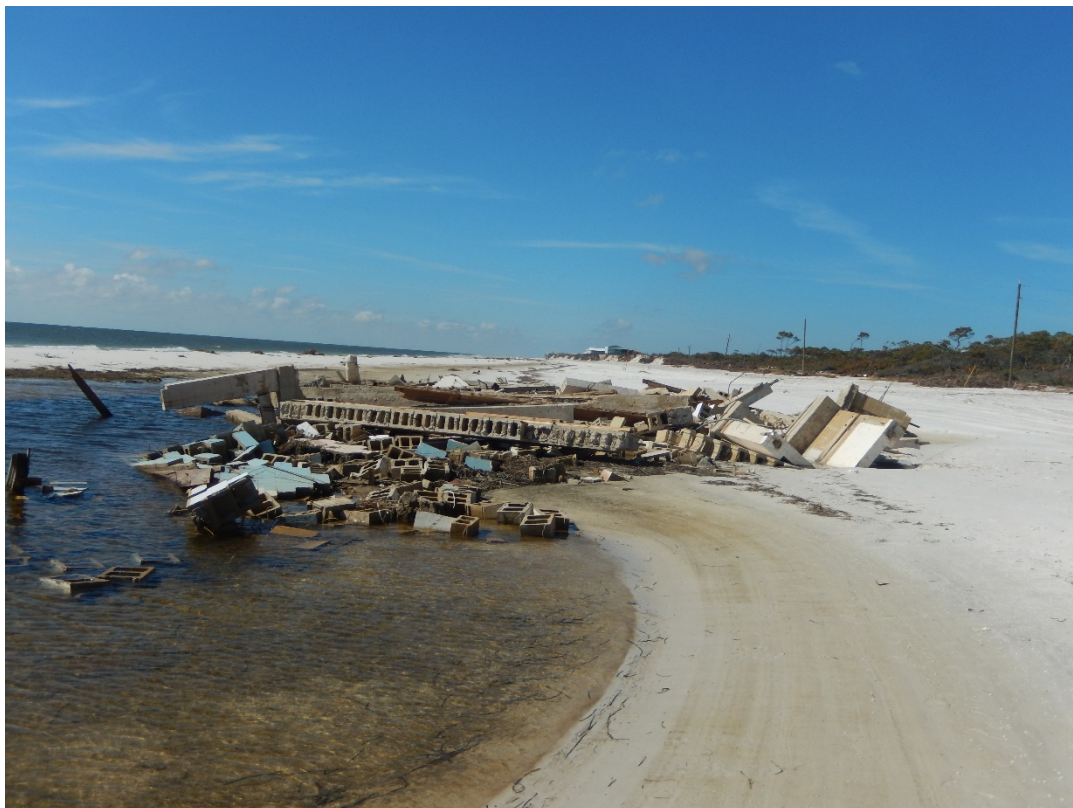
Figure 87. Pelican Inn destroyed near R183, Dog Island.

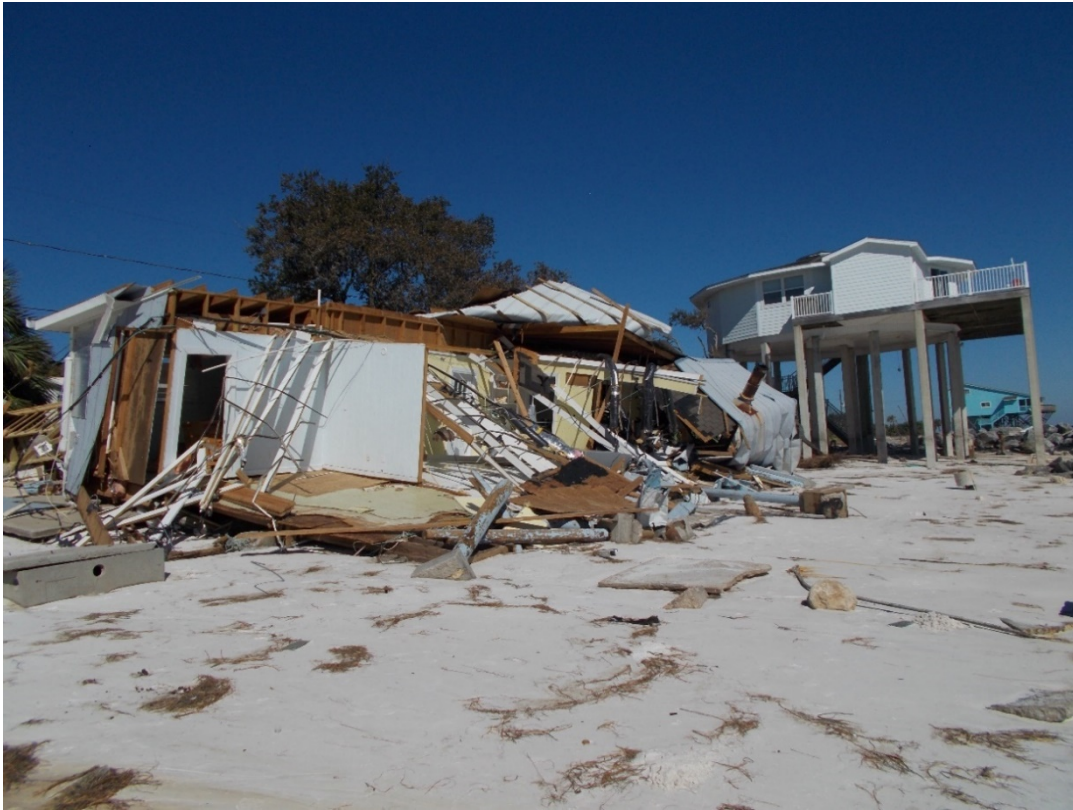
Figure 90. Dwelling destroyed near R211, Southwest Cape.
