*Hurricane Michael Post-Storm
Beach Conditions and Coastal Impact Report*

**Division of Water Resource Management
Florida Department of Environmental Protection**

January 2019

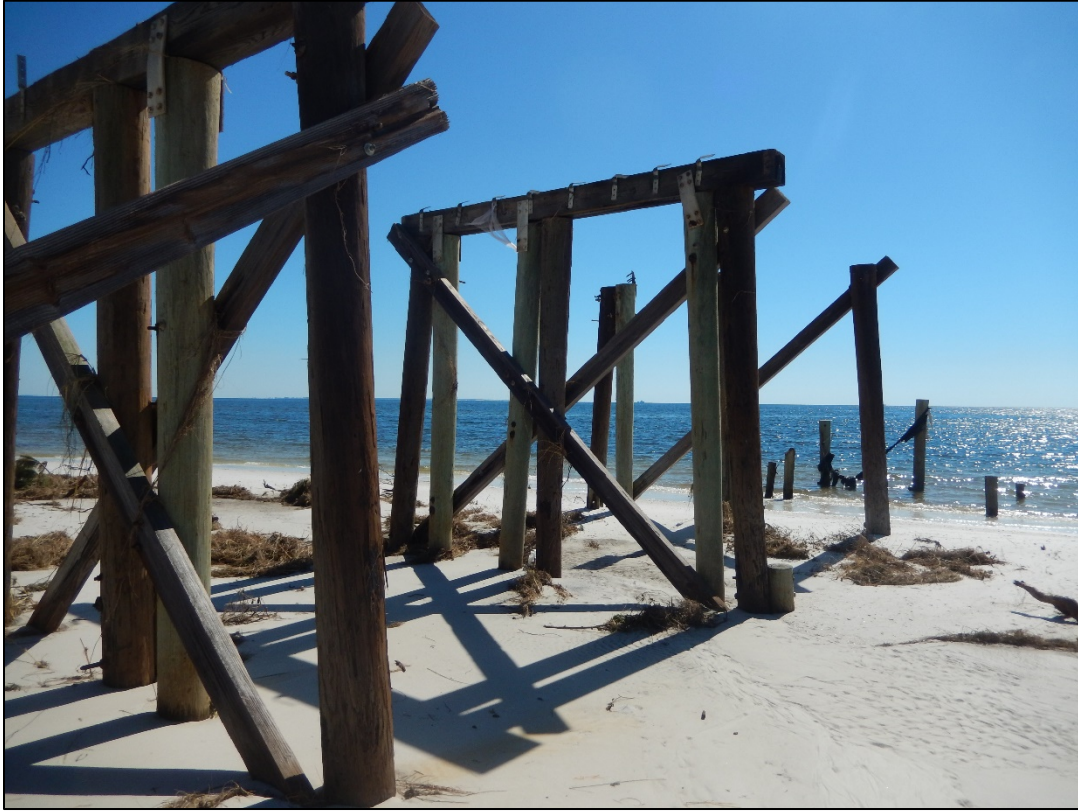
Figure 30. Mexico Beach pier destroyed near R129.

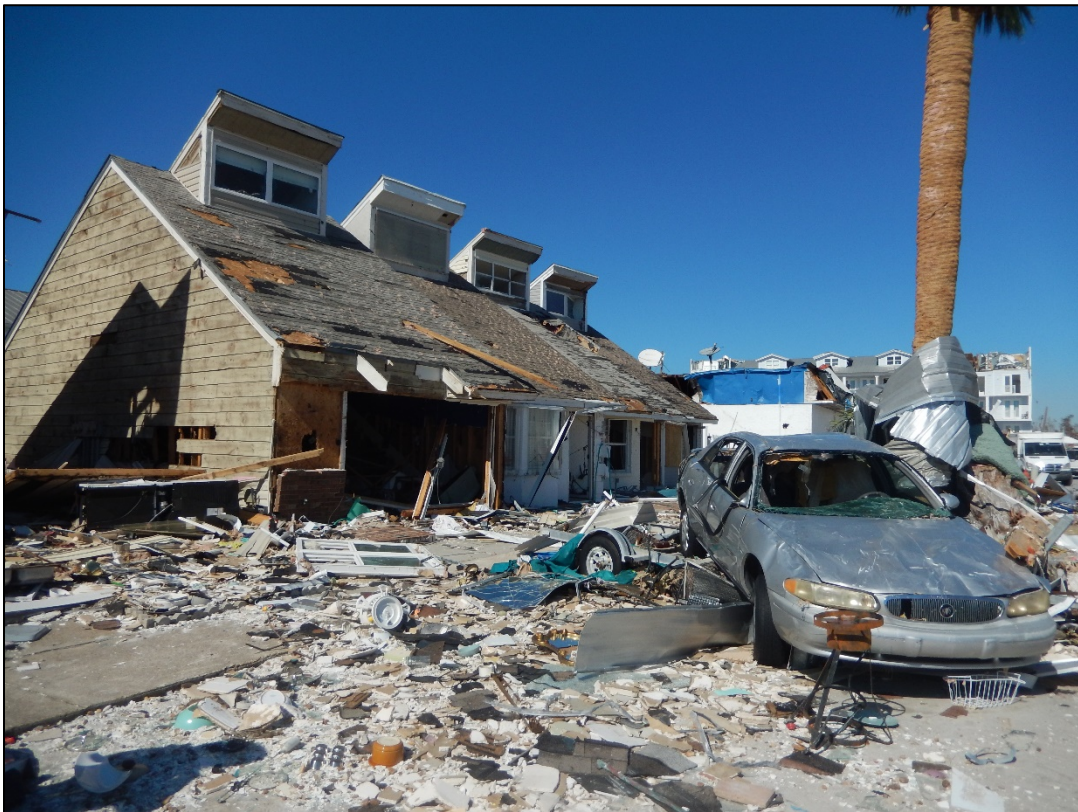
Figure 31. Multifamily dwelling destroyed near R129, Mexico Beach.

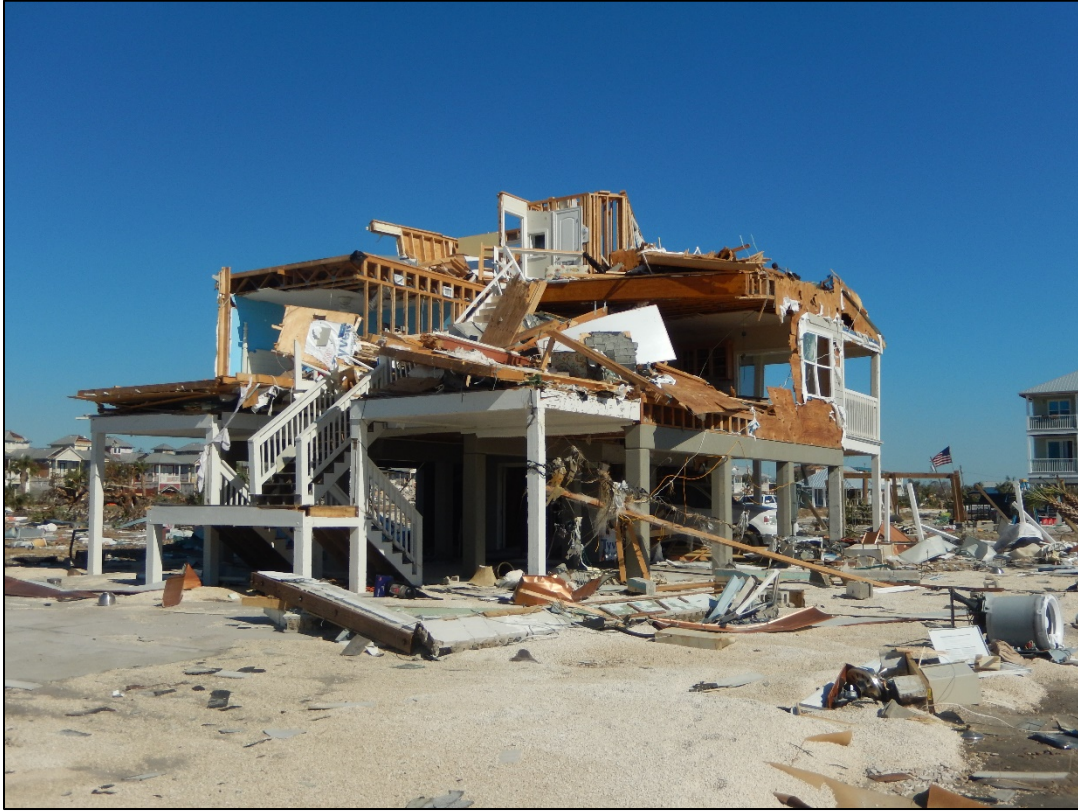
Figure 32. Pile-supported dwelling destroyed near R129, Mexico Beach.

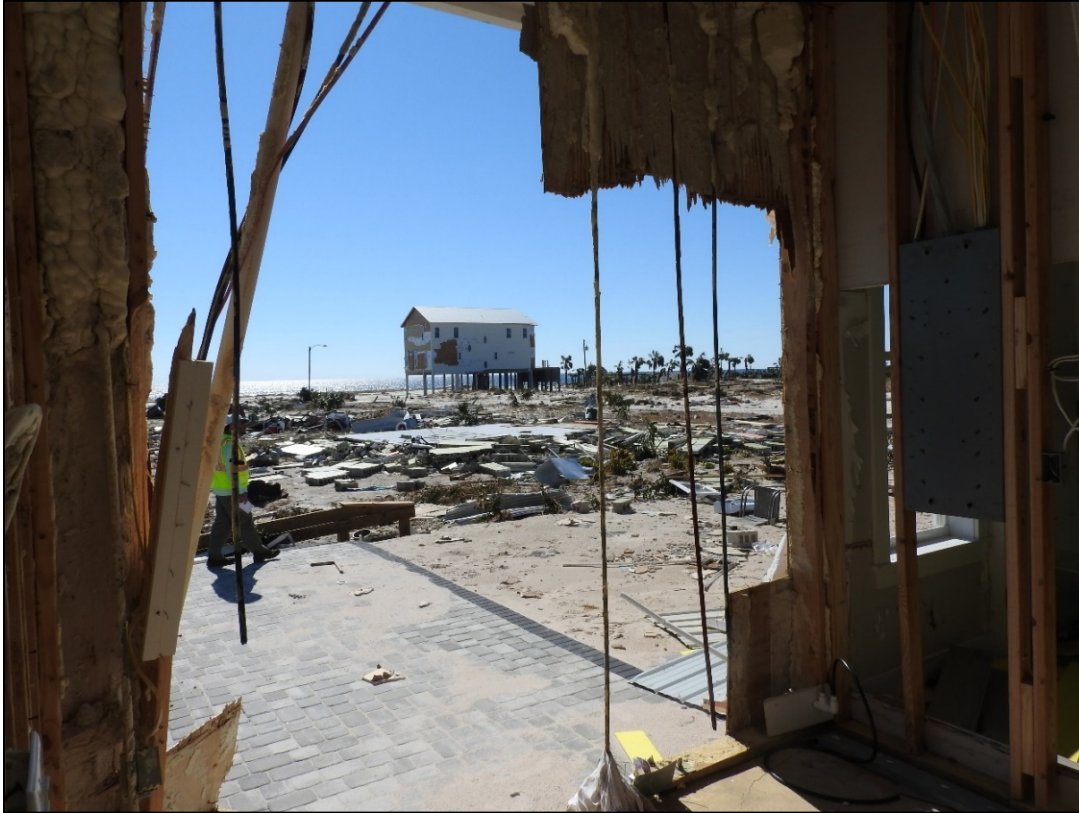
Figure 36. Dwellings destroyed by storm surge near R132, Mexico Beach.

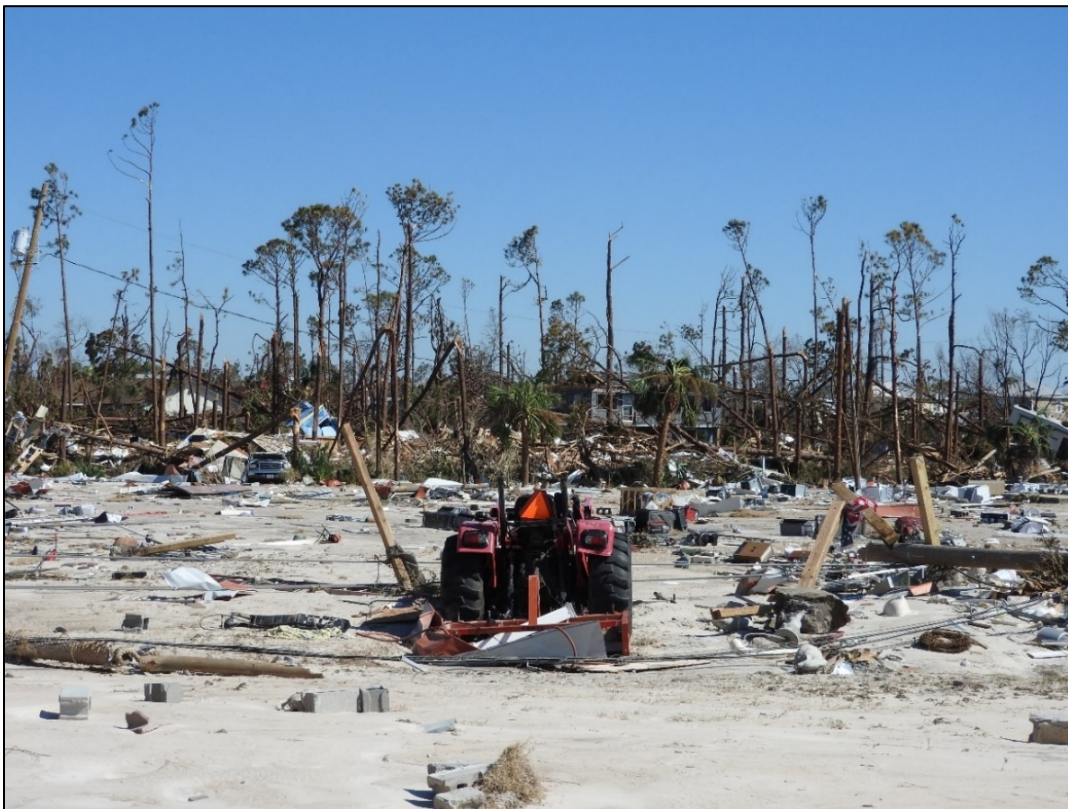
Figure 39. Storm surge transported debris and sand overwash across U.S. 98 near R135, Mexico Beach.

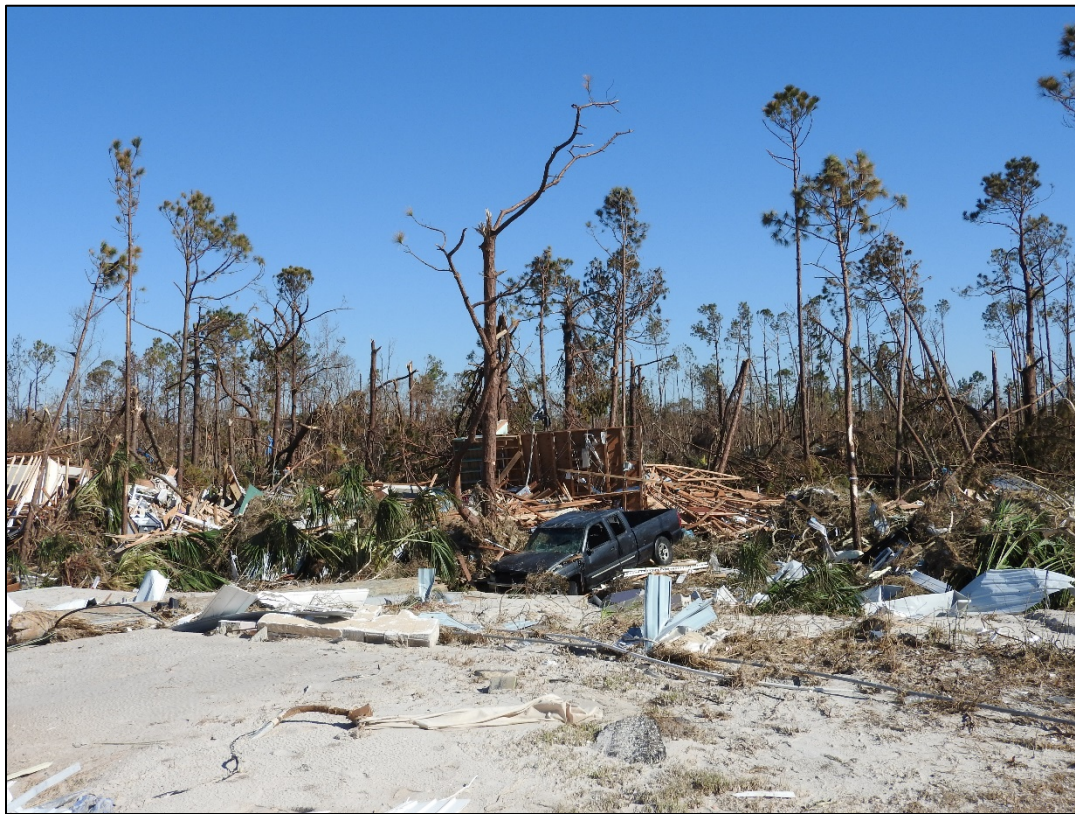
Figure 40. Debris transported by the storm surge inland near R136, Mexico Beach.

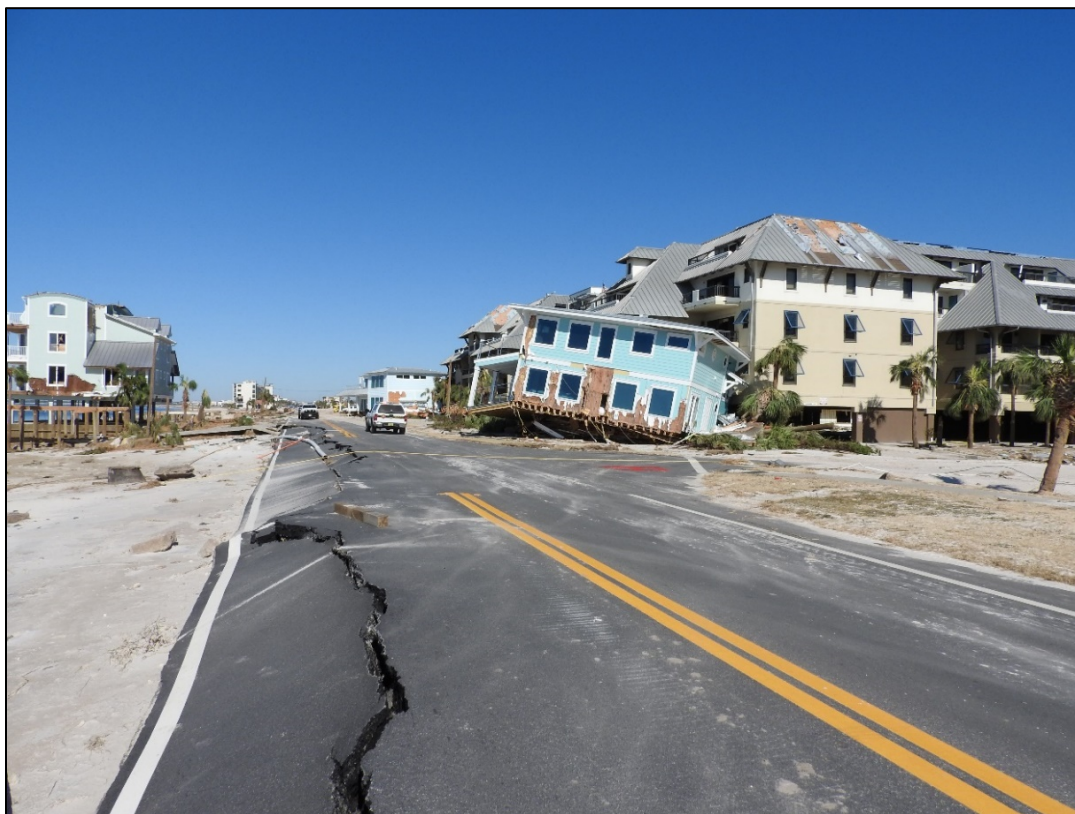
Figure 41. Dwelling transported across U.S. 98 by the storm surge near R136, Mexico Beach.

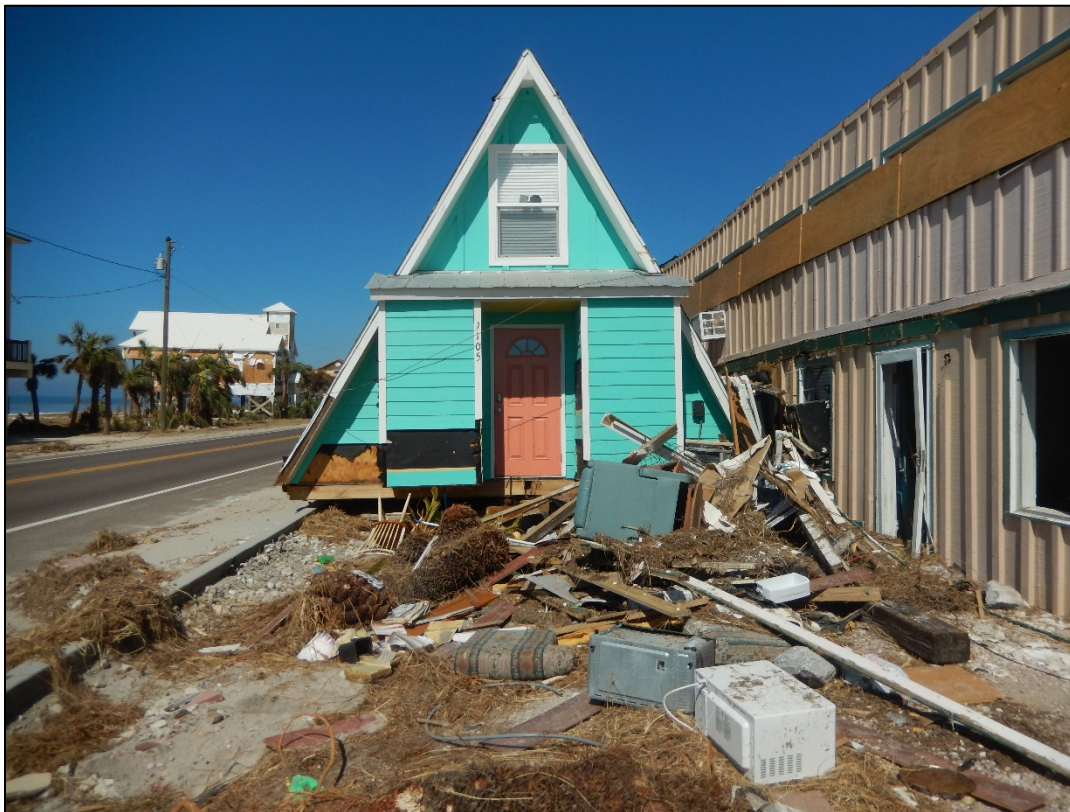
Figure 56. Dwelling transported across U.S. 98 by the storm surge near R2, Beacon Hill.

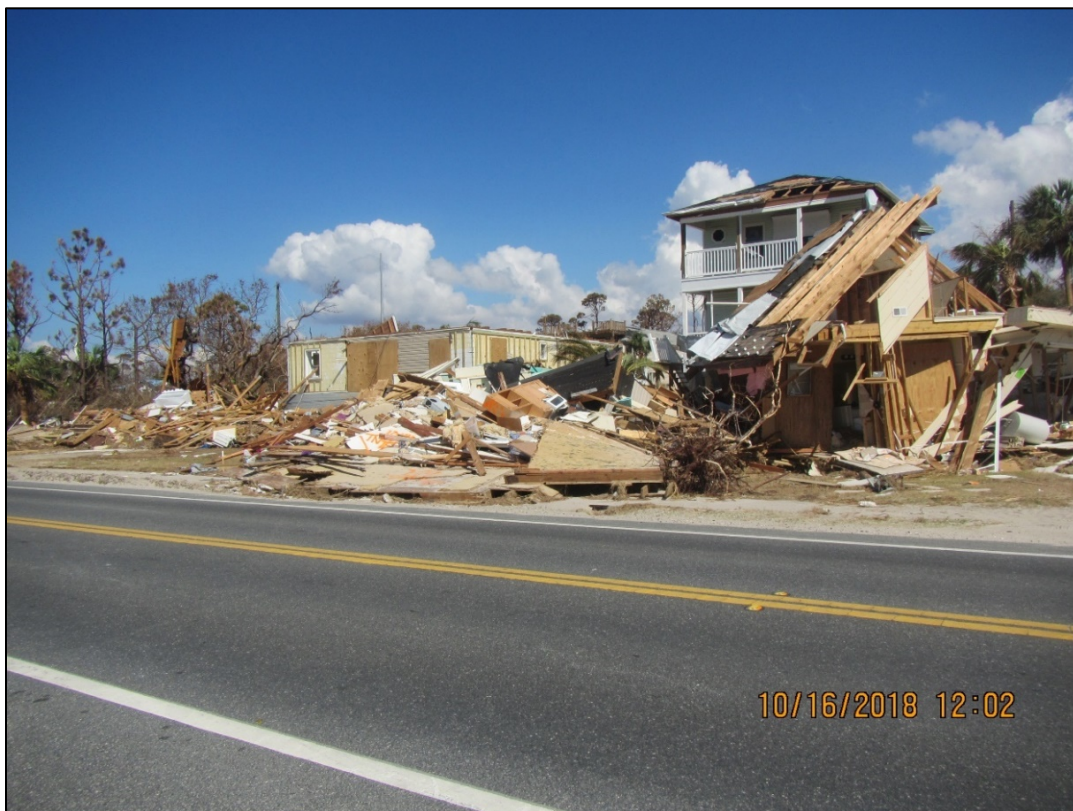
Figure 57. Dwellings along U.S. 98 destroyed near R3, Beacon Hill.

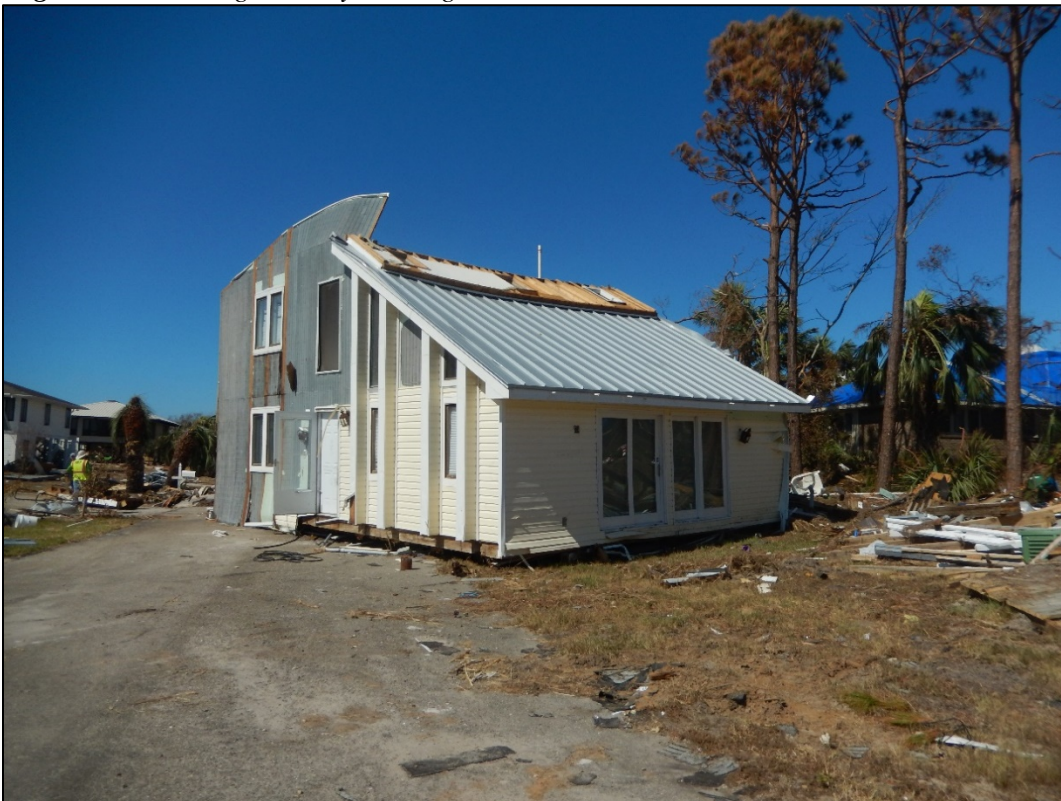
Figure 59. Dwelling transported by storm surge onto Trade Winds Dr. near R6, Beacon Hill.

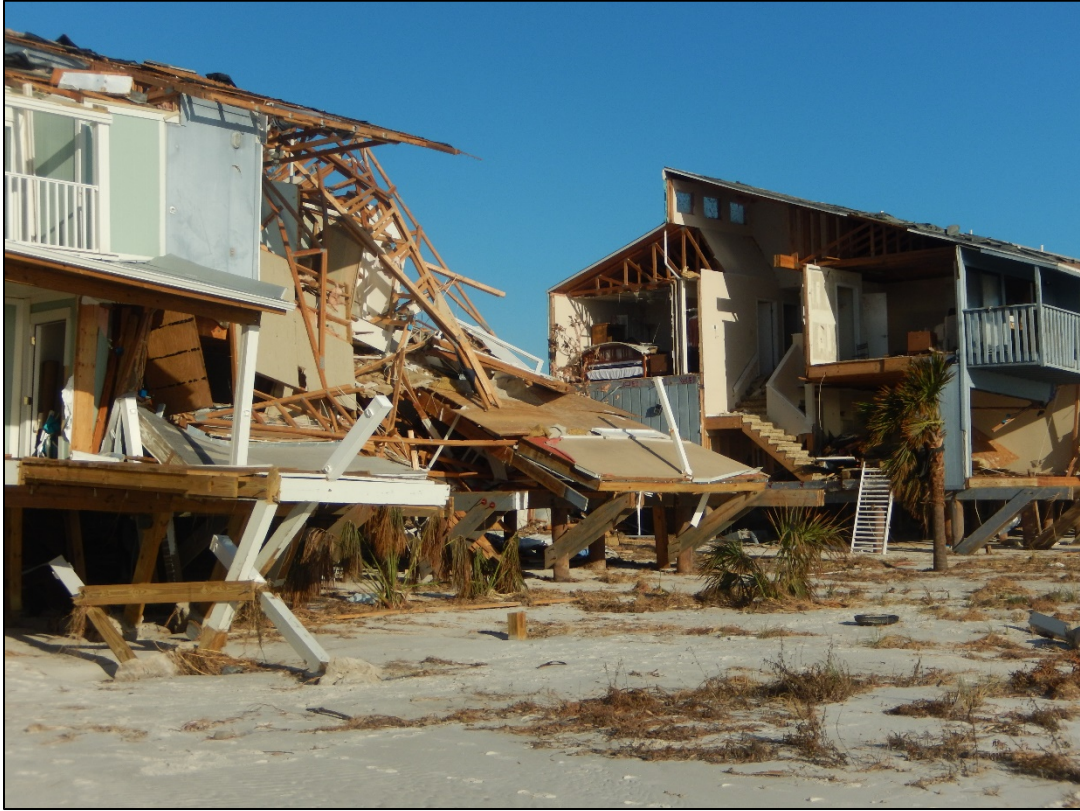
Figure 61. Townhouses destroyed near R7, Beacon Hill.

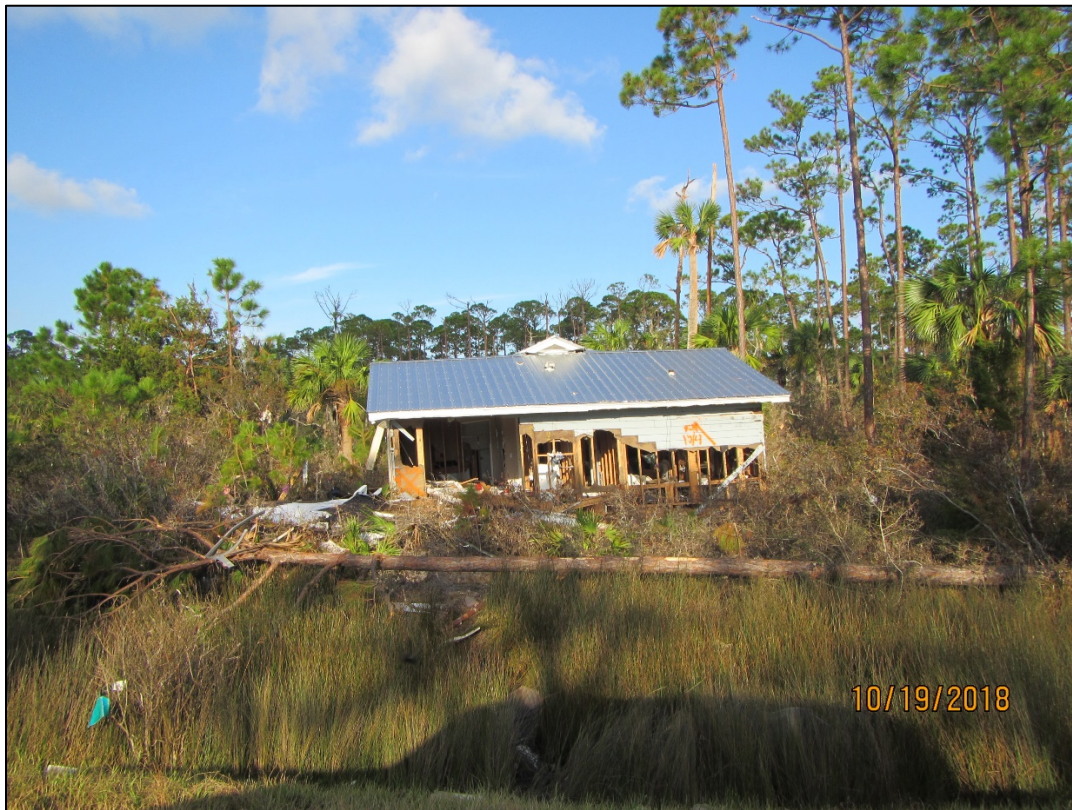
Figure 67. Destroyed dwelling transported across S.R.30A by the storm surge, St. Joseph Bay.

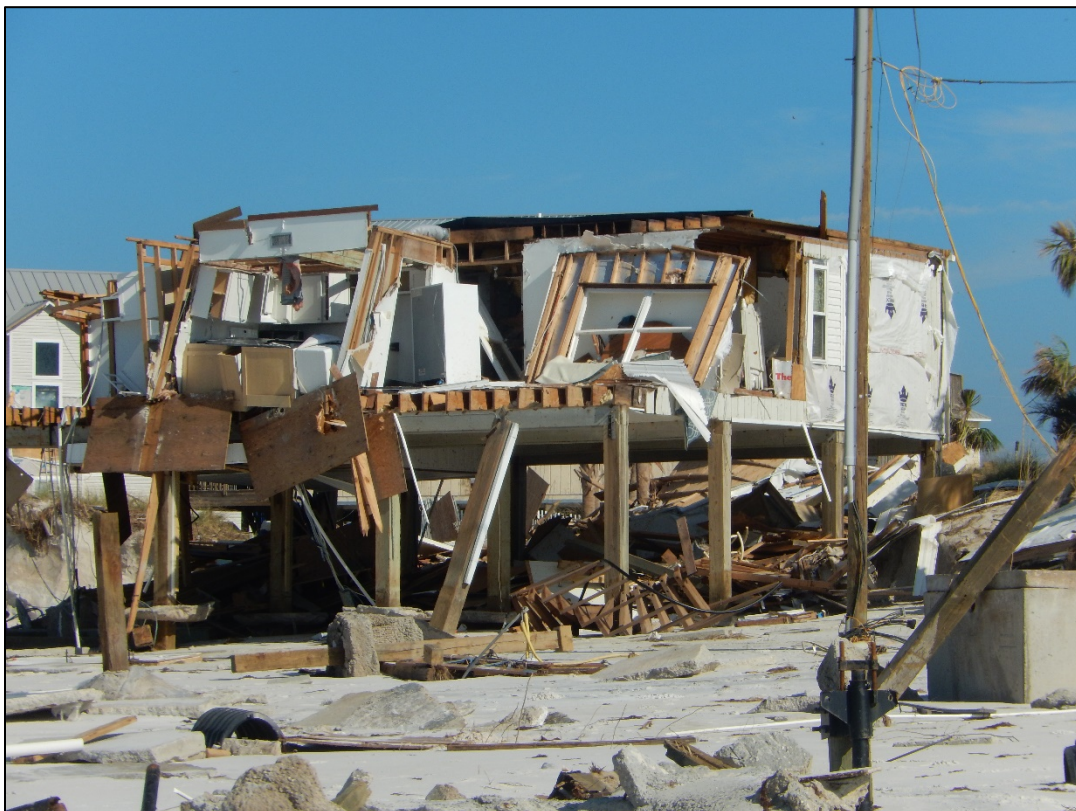
Figure 70. Pile-supported dwelling destroyed near R97.5, St. Joseph Peninsula.

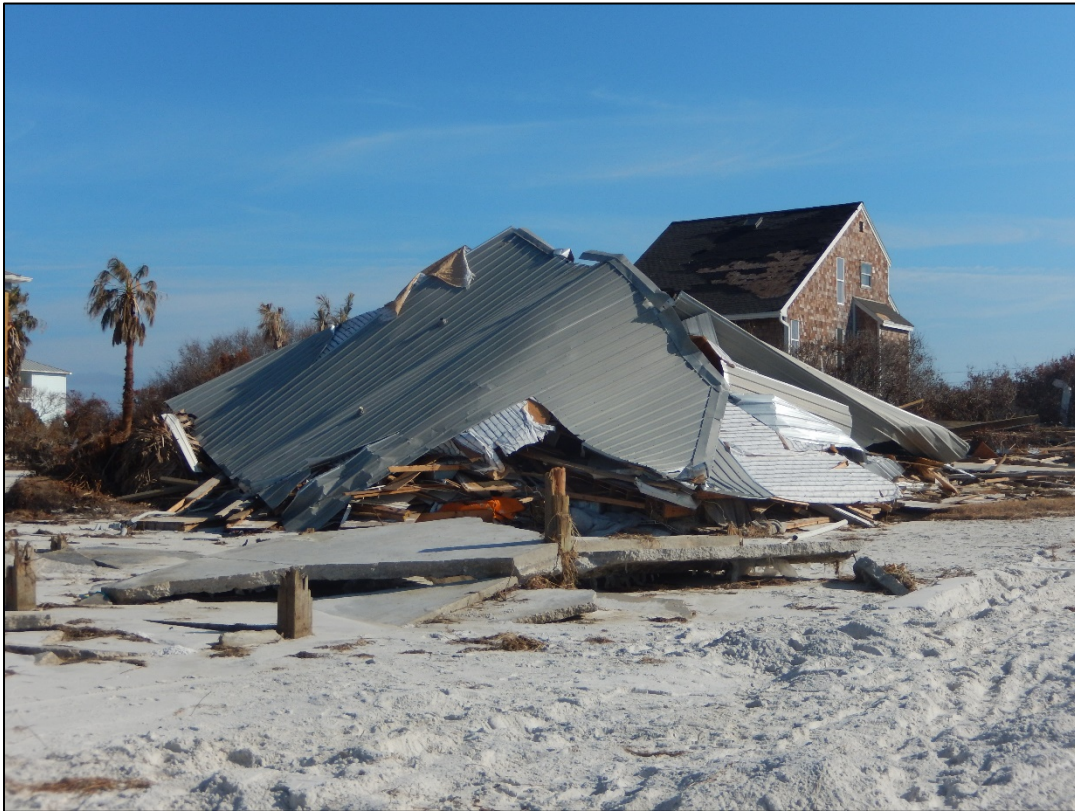
Figure 71. Dwelling destroyed near R99.5, St. Joseph Peninsula.

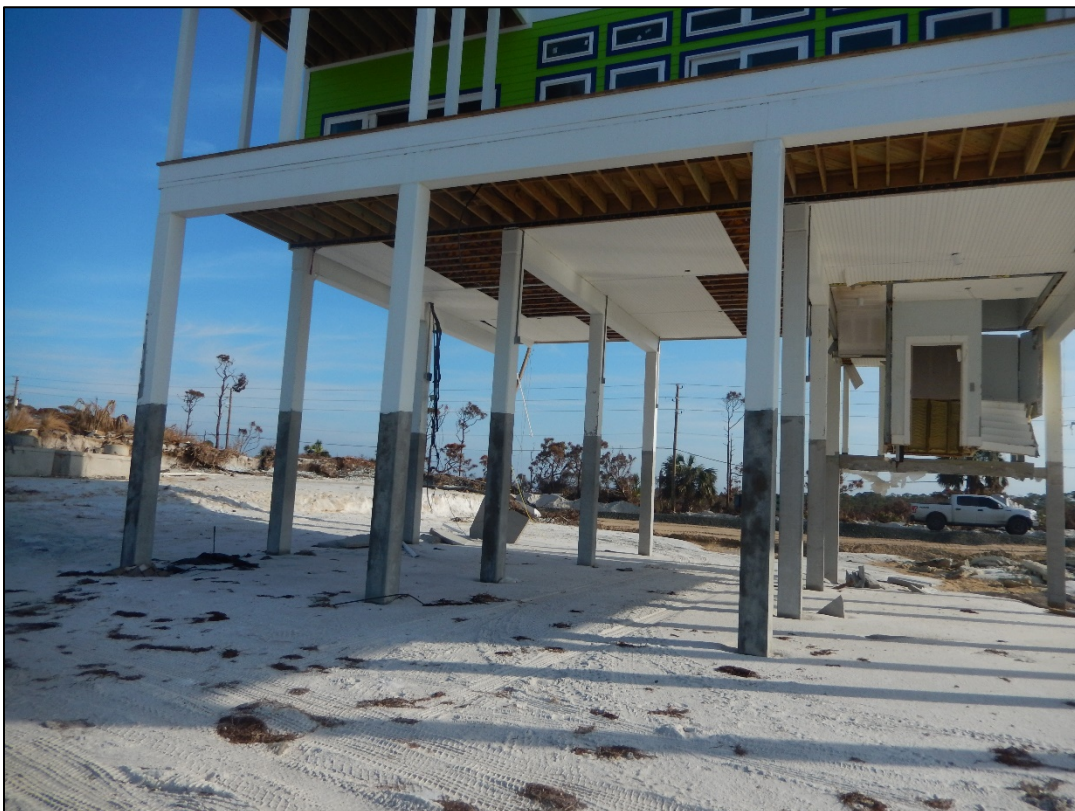
Figure 72. Over six feet of vertical loss of grade beneath structure near R104.

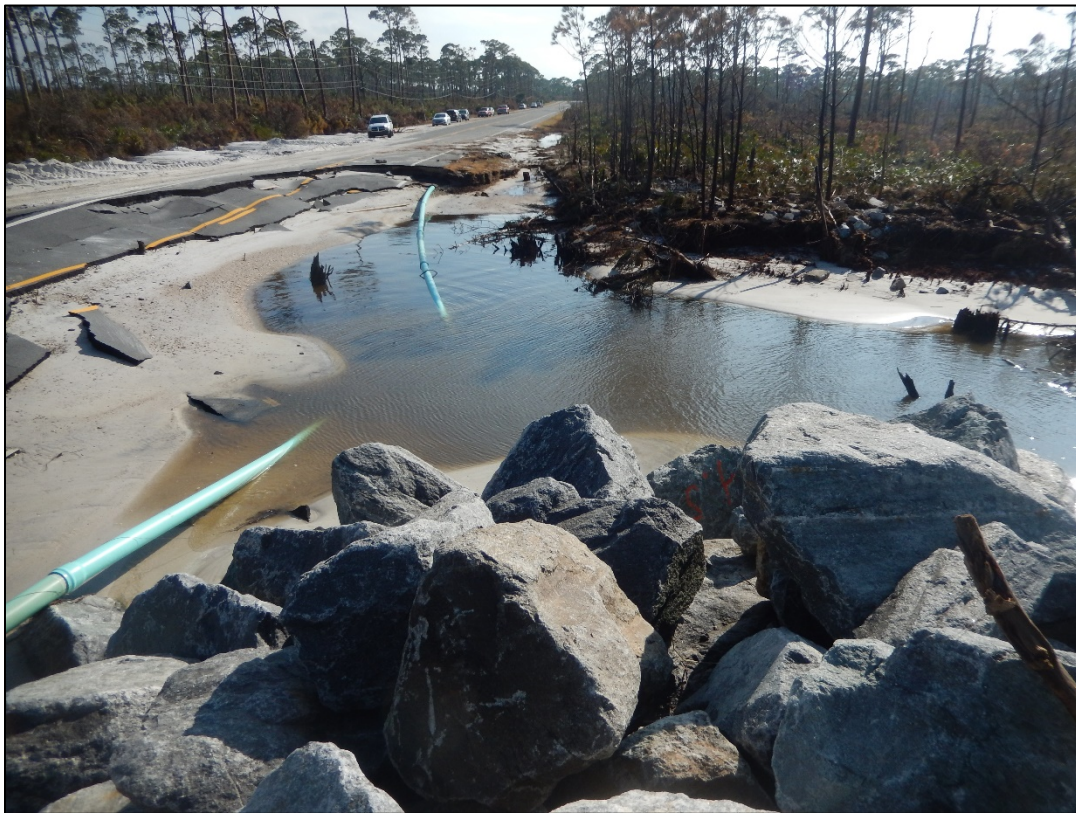
Figure 75. County Road 30E destroyed south of the Stump Hole boulder mound, R107.

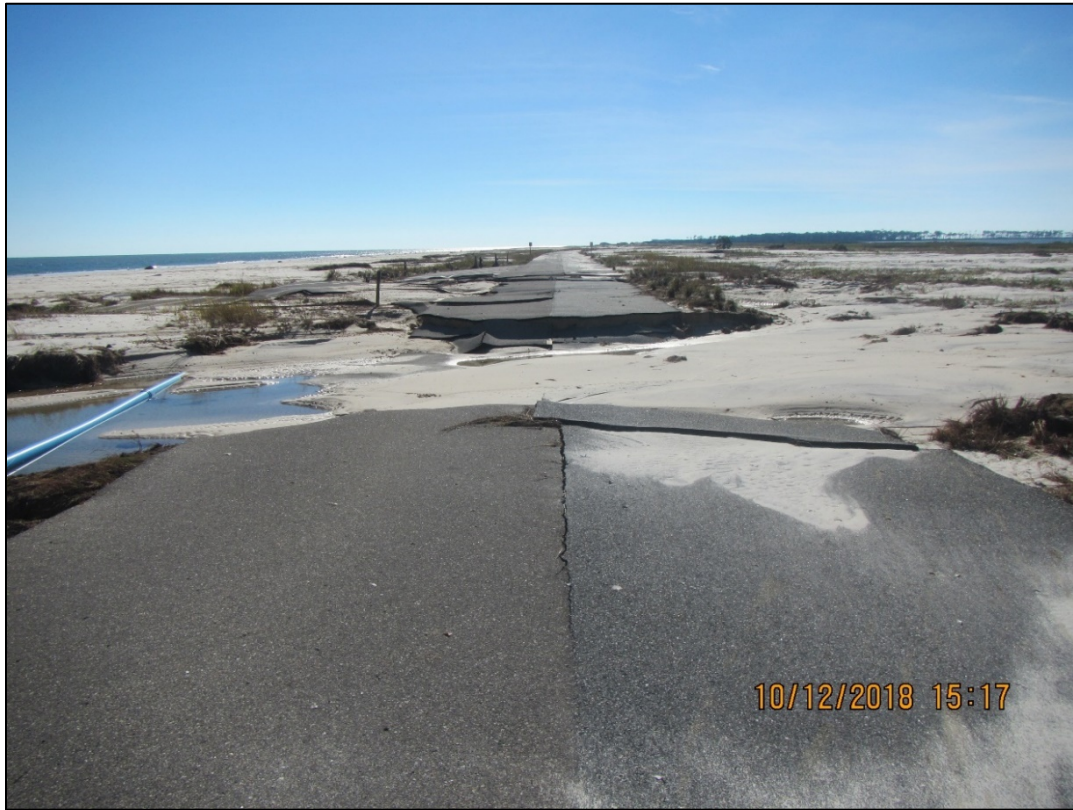
Figure 91. Dunes leveled and park road destroyed at R114, St. George Island.

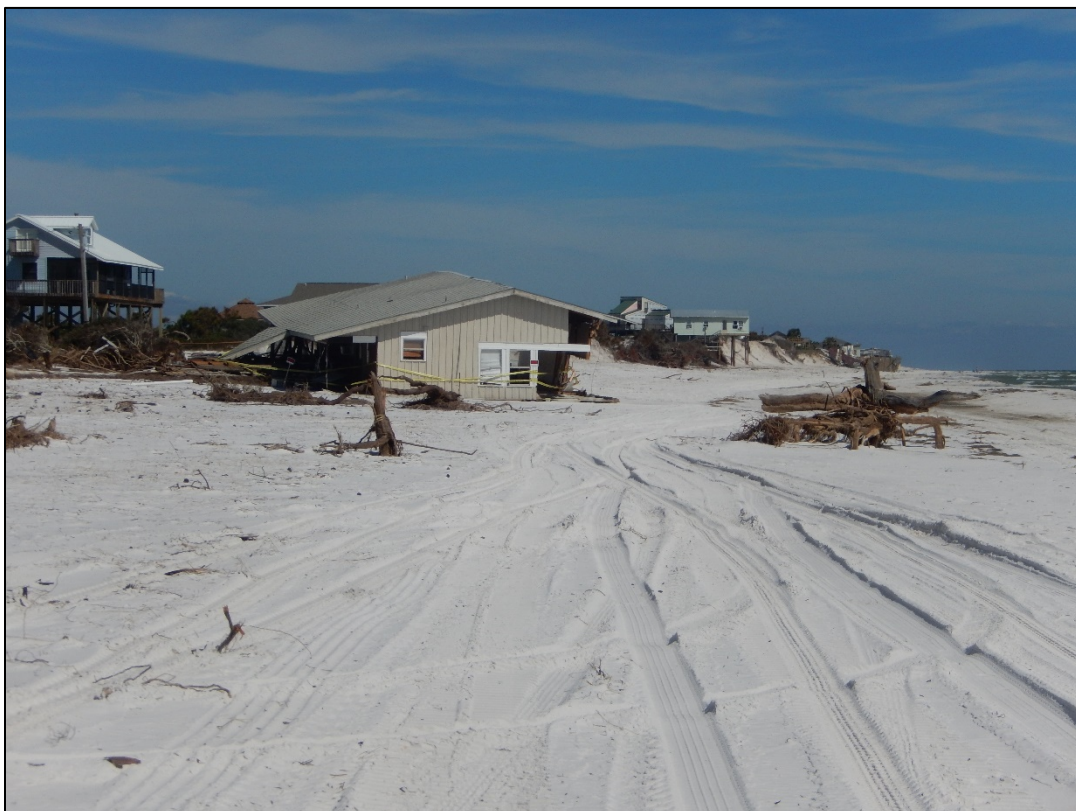
Figure 94. Dwelling destroyed near R174, Dog Island.

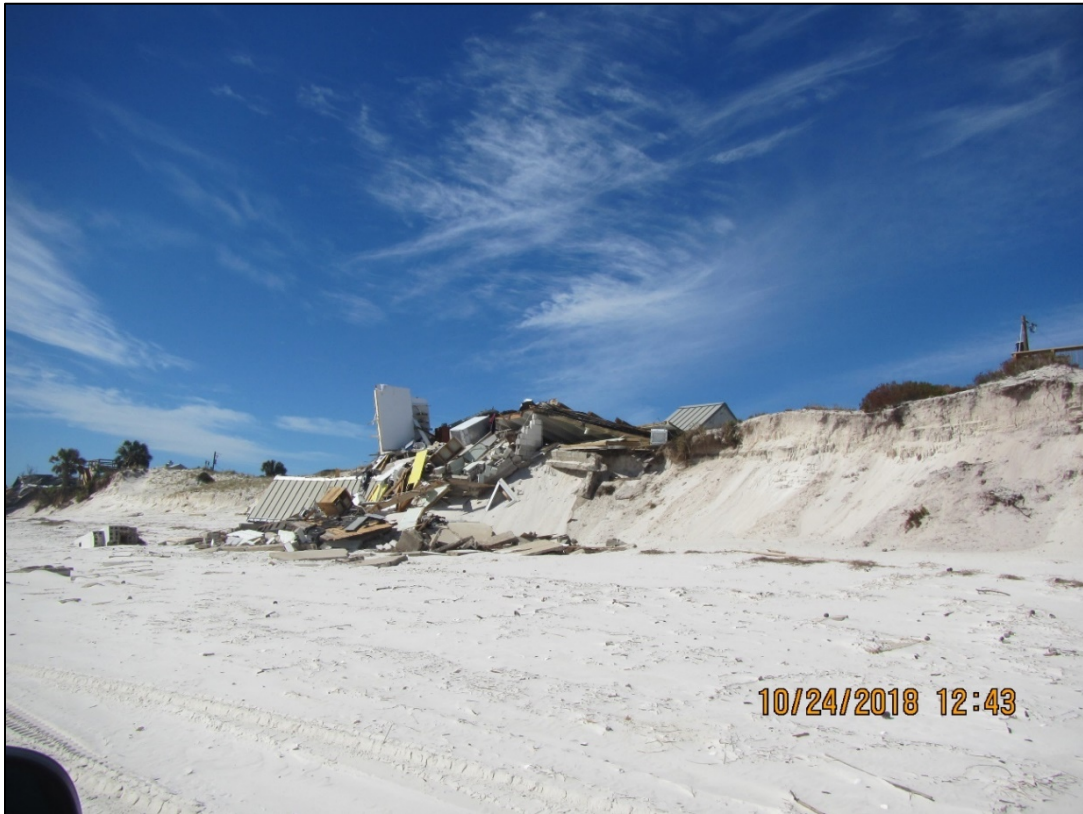
Figure 95. Dwelling destroyed near R176, Dog Island.

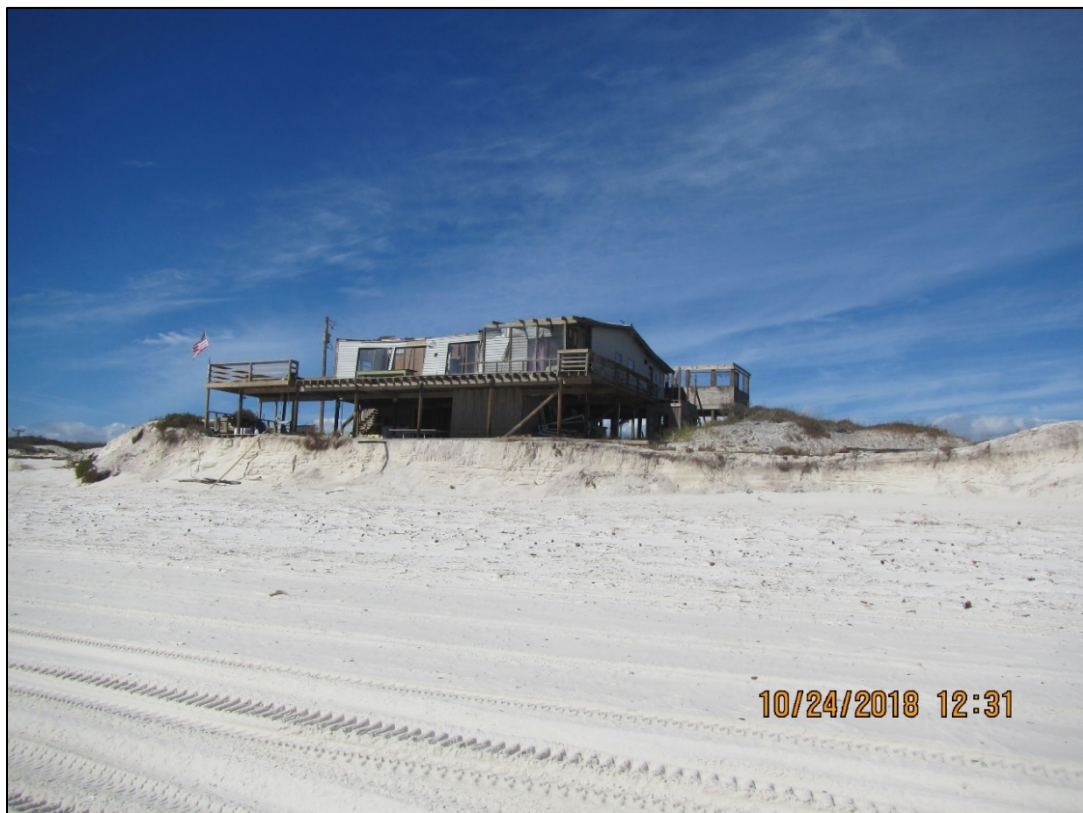
Figure 96. Dwelling destroyed near R178, Dog Island.

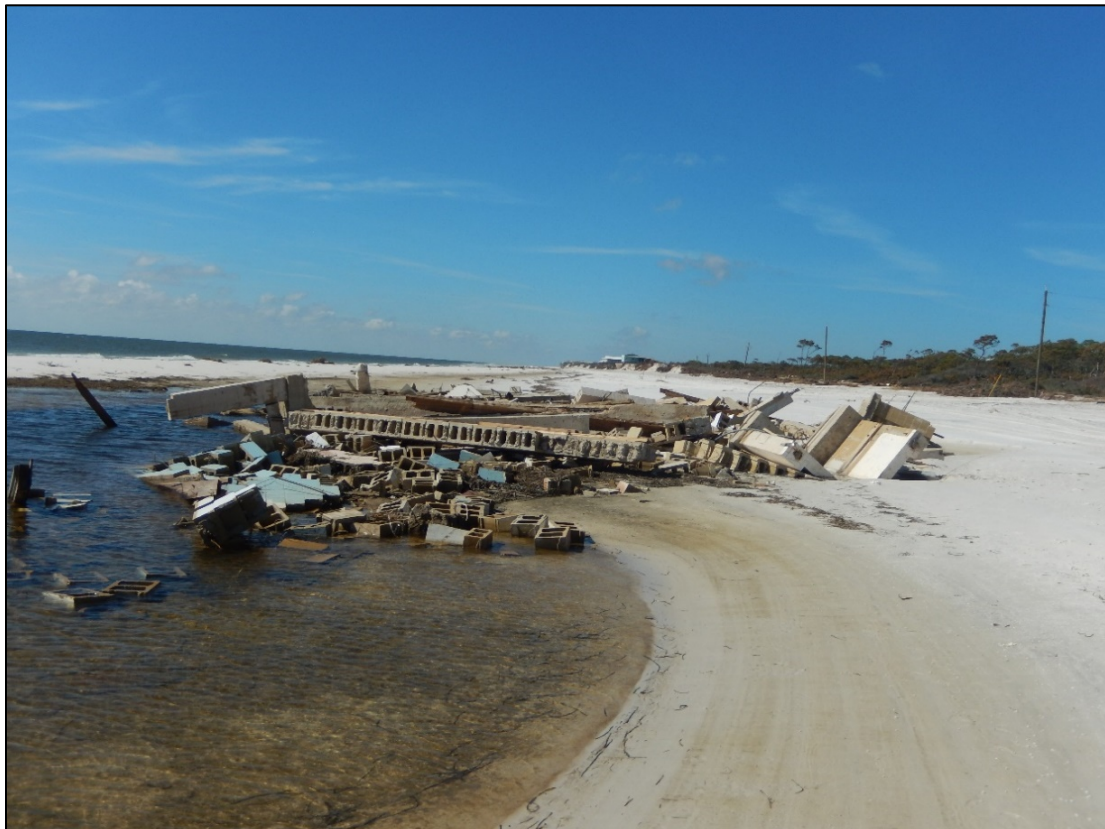
Figure 98. Pelican Inn destroyed near R183, Dog Island.

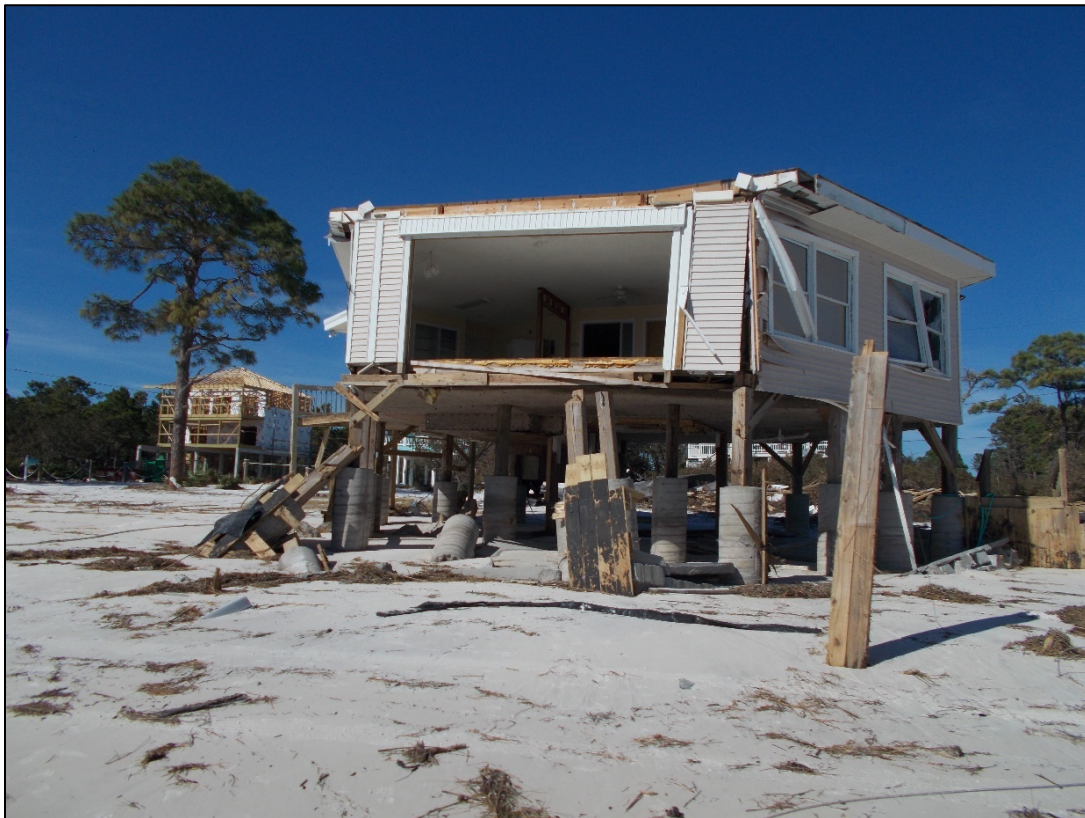
Figure 100. Dwelling destroyed near R210, Southwest Cape.

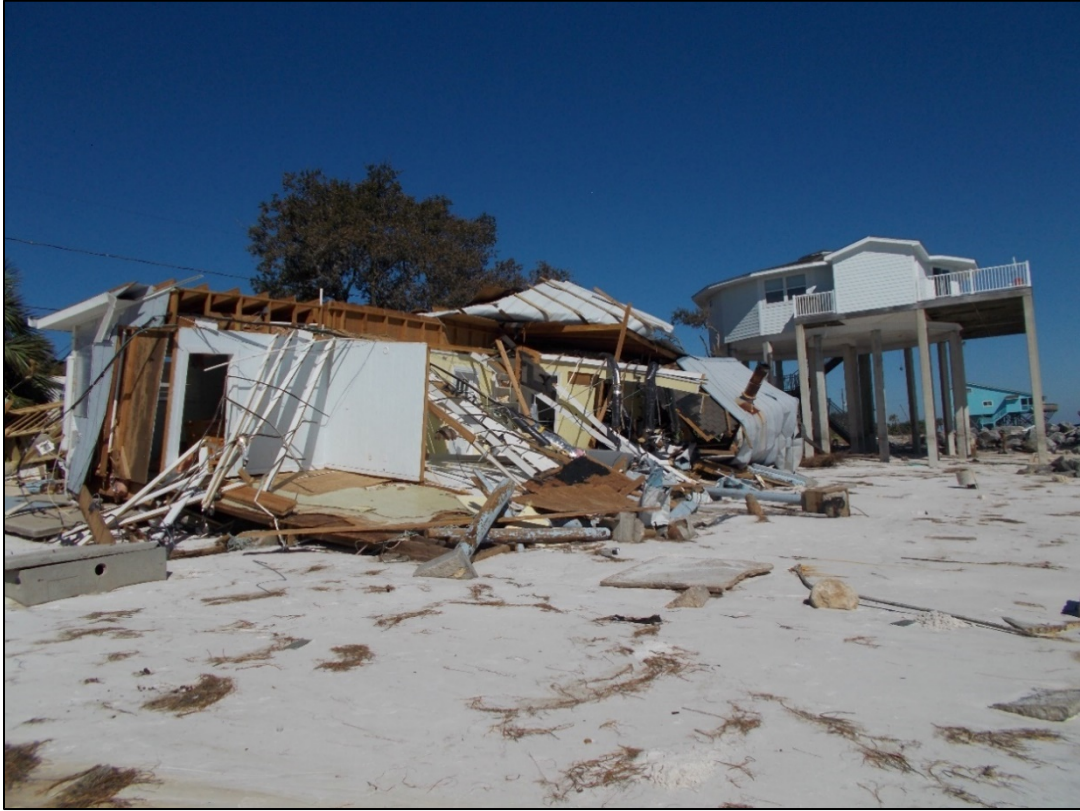
Figure 101. Dwelling destroyed near R211, Southwest Cape.
