# Anatomy of a Petroleum Storage Tank System As It Relates to Cleanup

**Presenter: Chip Green, PE, Palm Beach County  
Department of Environmental Resources Management  
(DERM)**

Tallahassee, FL | April 28-30, 2026

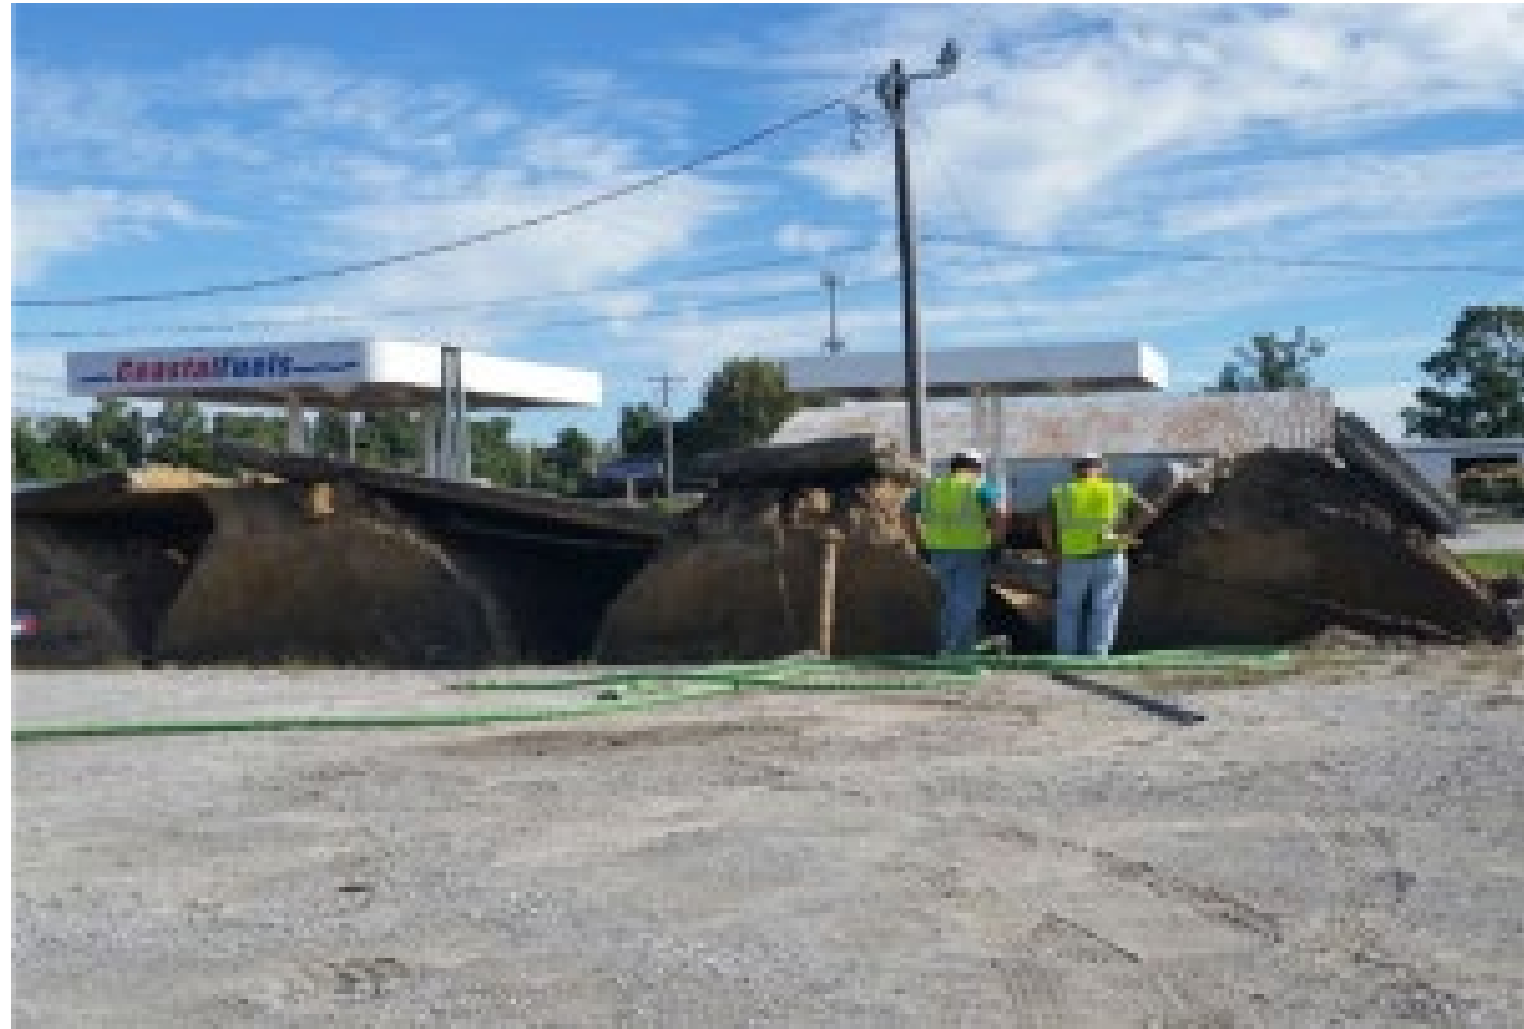
# UST BALLASTING – WHY DO IT?

Hurricane  
Matthew 2016

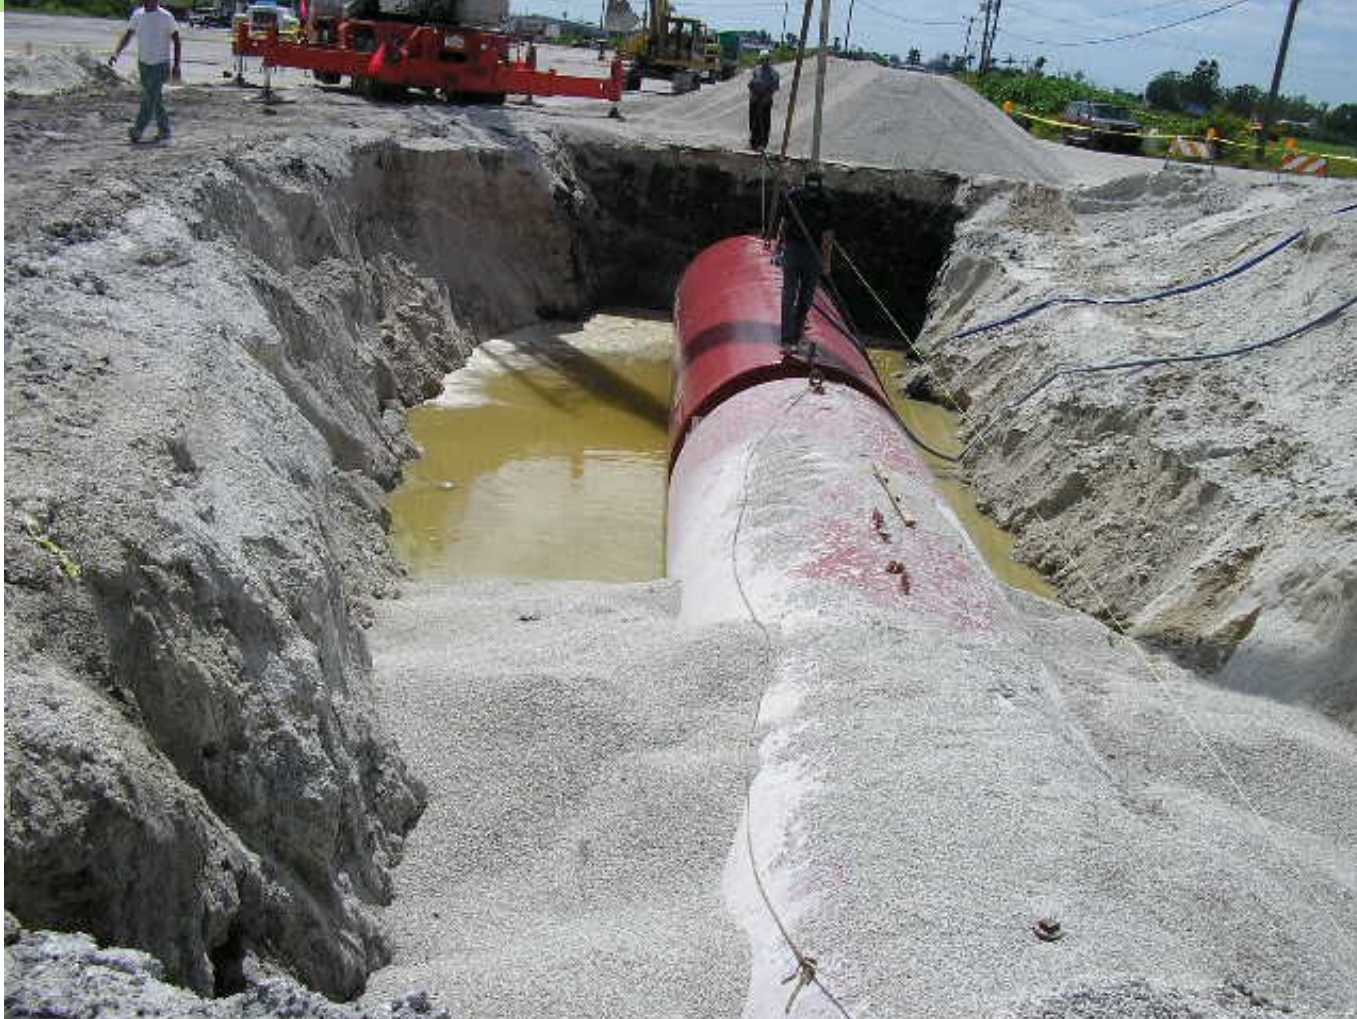
# PEA ROCK CONSIDERATIONS

- The majority of tanks are backfilled with pea rock, a.k.a., pea gravel.
- It compacts well and flows into voids such as the tank shadow better than sand.

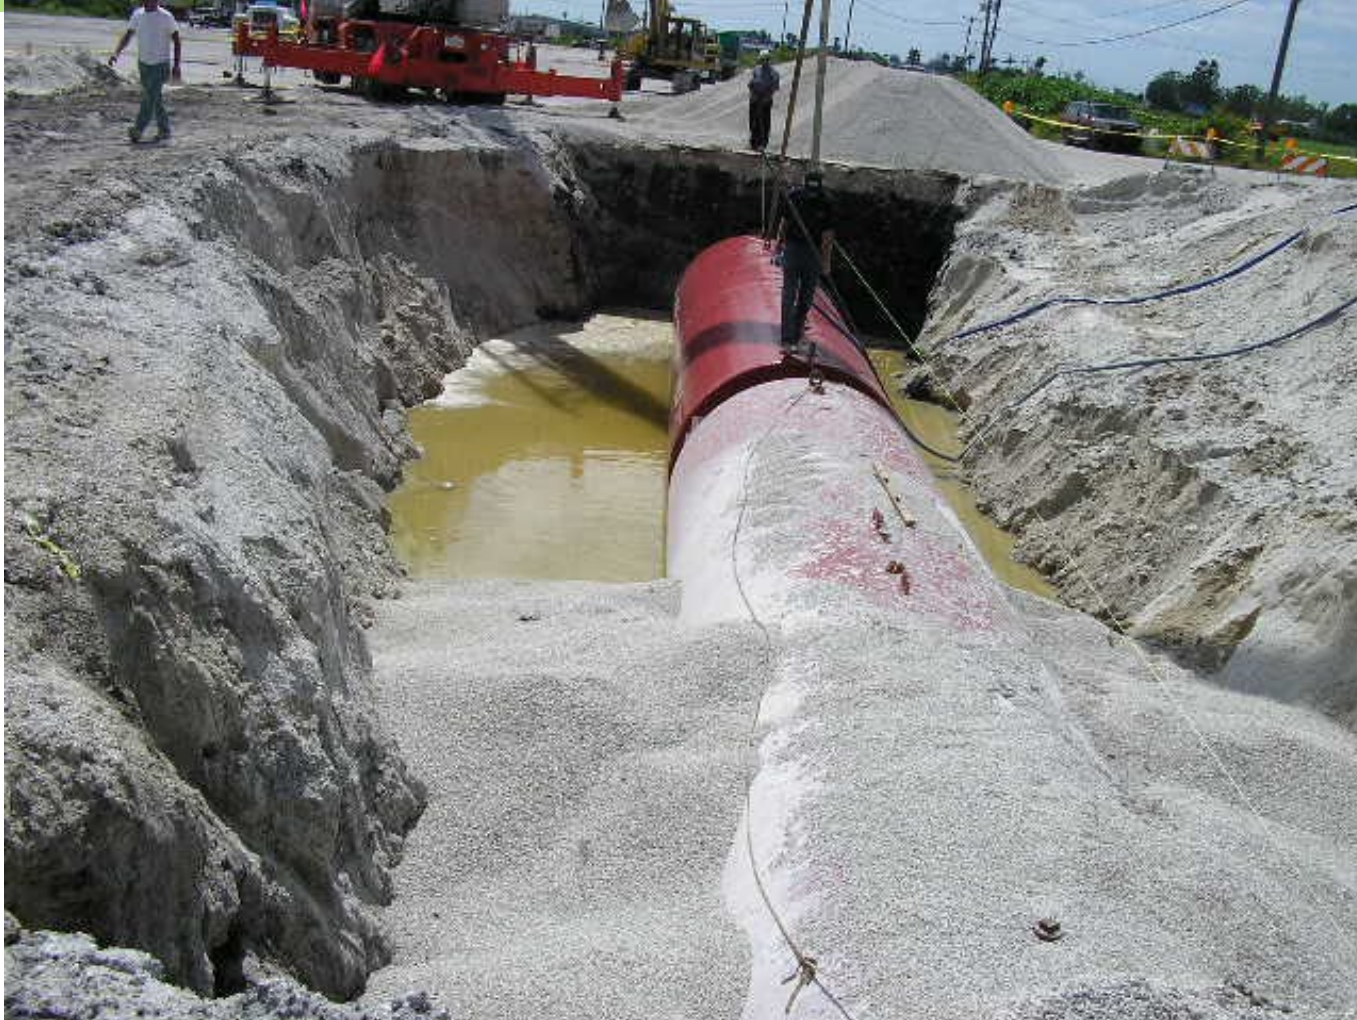
# PEA ROCK CONSIDERATIONS

- Grain/particle size is small enough, so the tank surface is not damaged.
- Protects the tank from damage by rocks and debris in native soil.

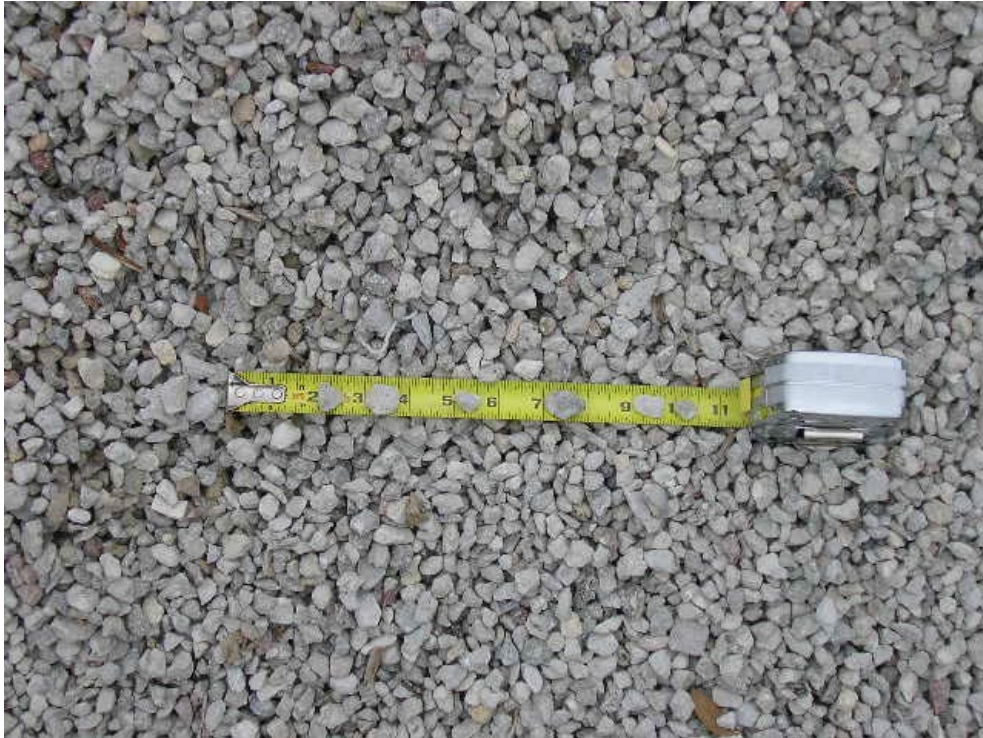
# PEA ROCK CONSIDERATIONS

- Is technically #78 stone (3/8"-1/4").
- #67 crushed stone is often sold as “pea rock”. Particle size is ~3/4”.
- The hydraulic conductivity (k) of pea rock is 1,000-30,000 ft/day (depending on compaction).

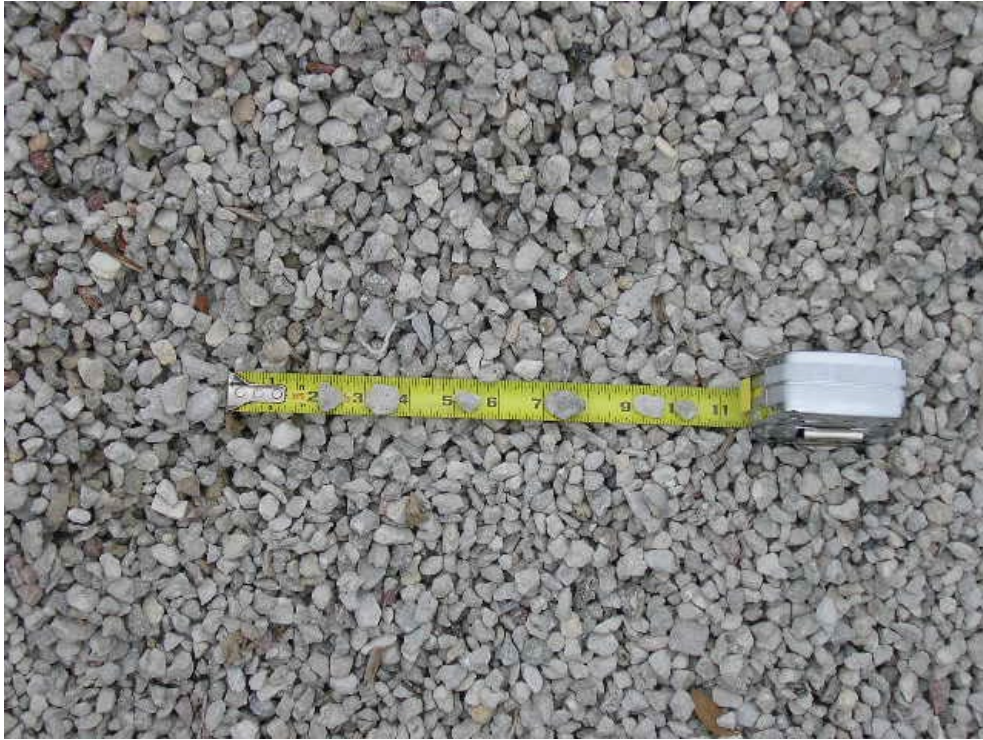
# PEA ROCK CONSIDERATIONS

- The hydraulic conductivity ( $k$ ) of consolidated sand is 10-1,000 ft/day.
- Silty and clayey soils have even less conductivity/permittivity.

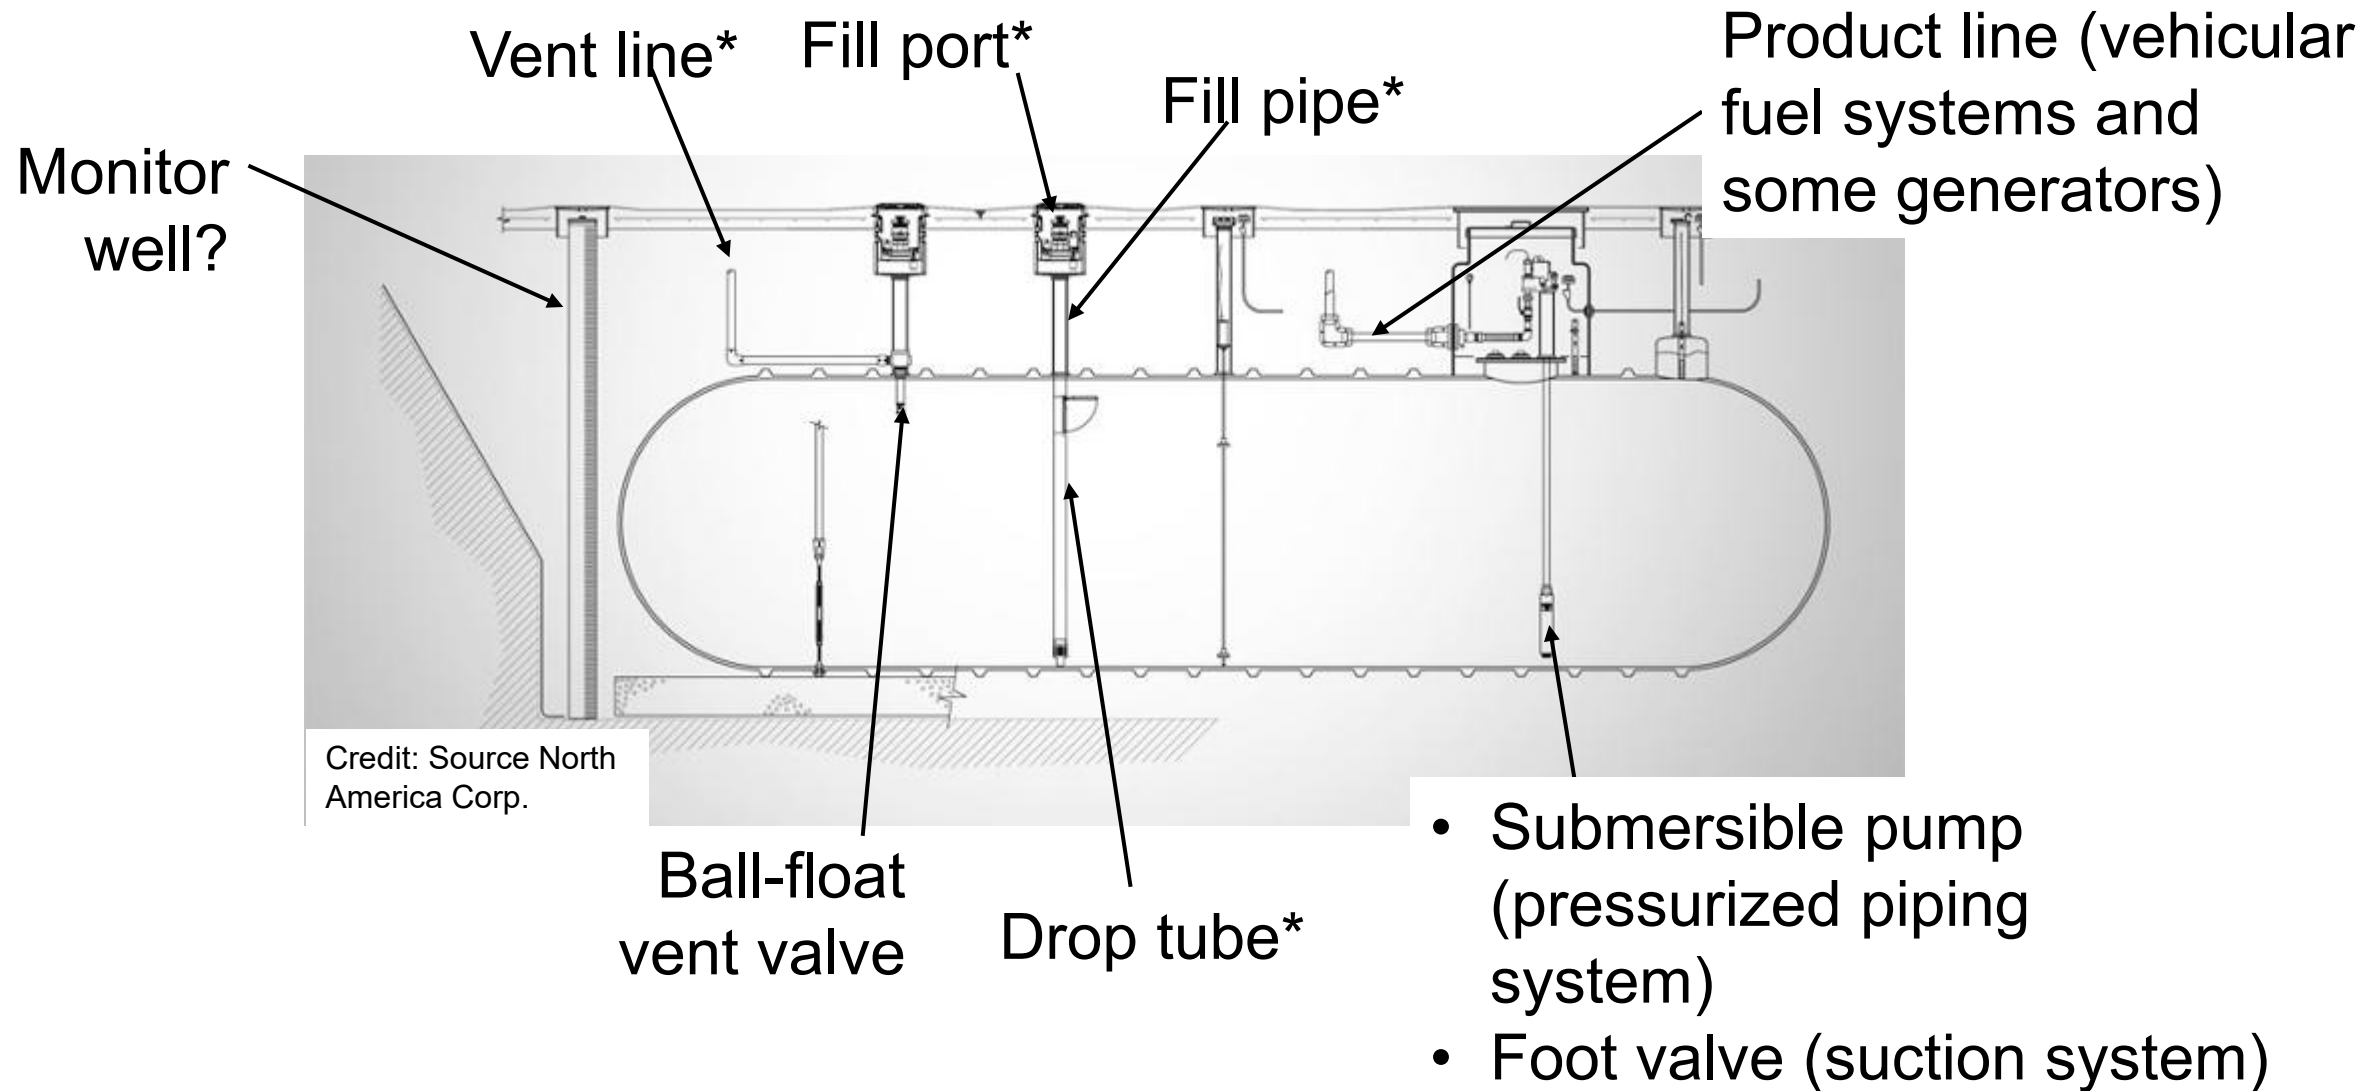
# SINGLE-WALL UST COMPONENTS

## SIDE VIEW

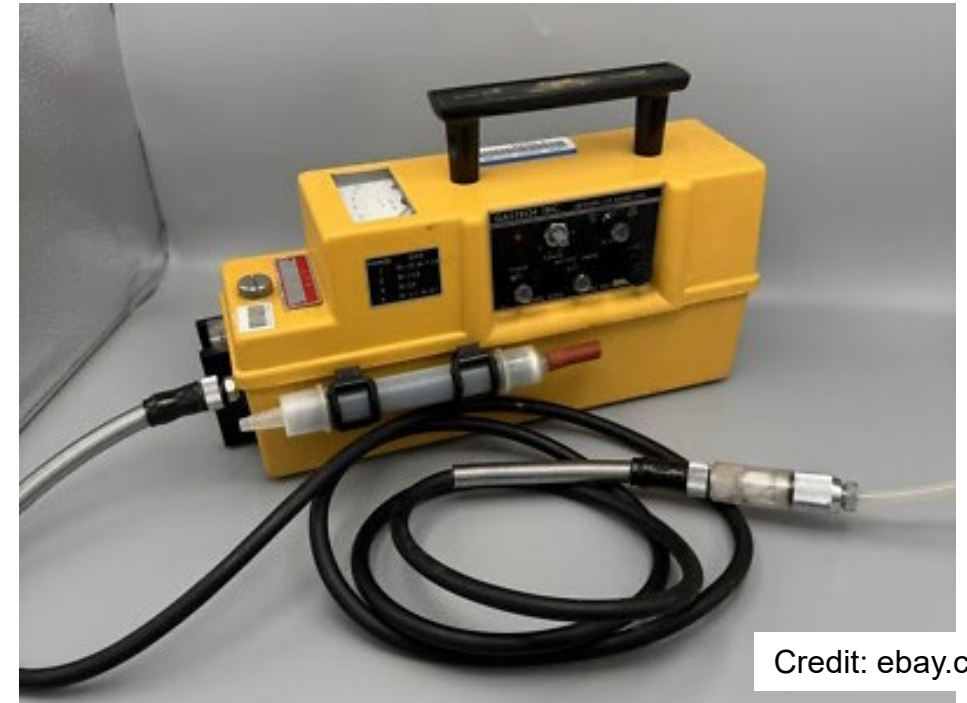
Gastech Vapor Analyzer

- Review monthly monitor well logs kept by the facility.
- Review weekly inventory reconciliation done by the facility.
- Use a vapor analyzer in the monitor wellheads.
- Bail the wells.

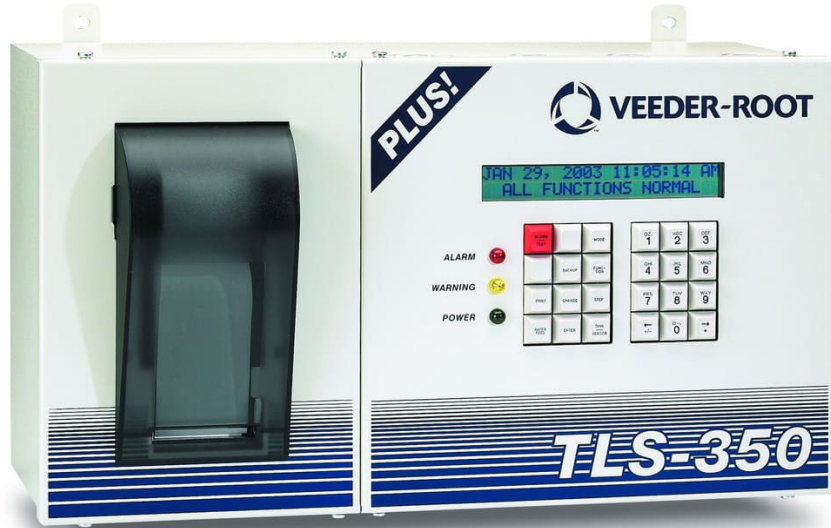
# AUTOMATIC TANK GAUGING (ATG) AND ELECTRONIC MONITORING

- First saw limited use in the 1980's, primarily with single-wall systems as a form of electronic inventory control capable of detecting a leak of 0.2 gallons per hour (gph).
- They proved to be reliable and gained popularity due to their facilitation of fuel inventory. Tank owners no longer had to stick their tanks; they could have a very accurate measurement instantly.

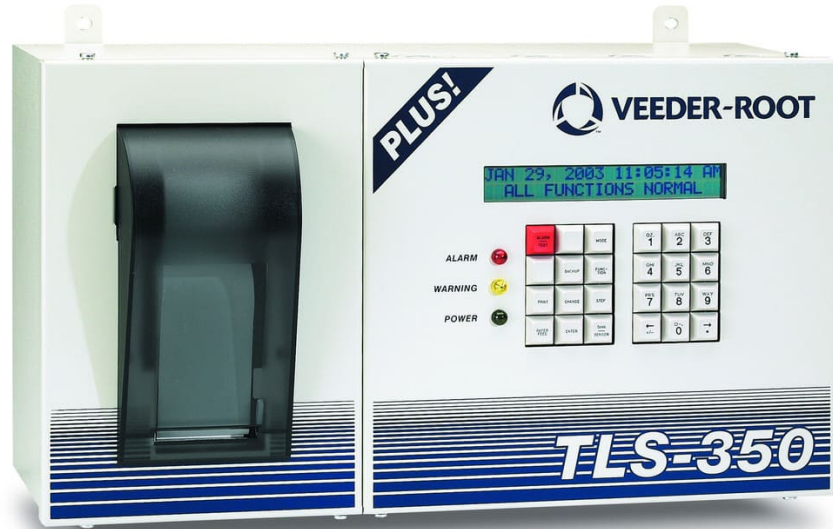
# AUTOMATIC TANK GAUGING (ATG) AND ELECTRONIC MONITORING

- With the advent of secondary containment components in the 1990's, liquid sensors became commonplace accessories.

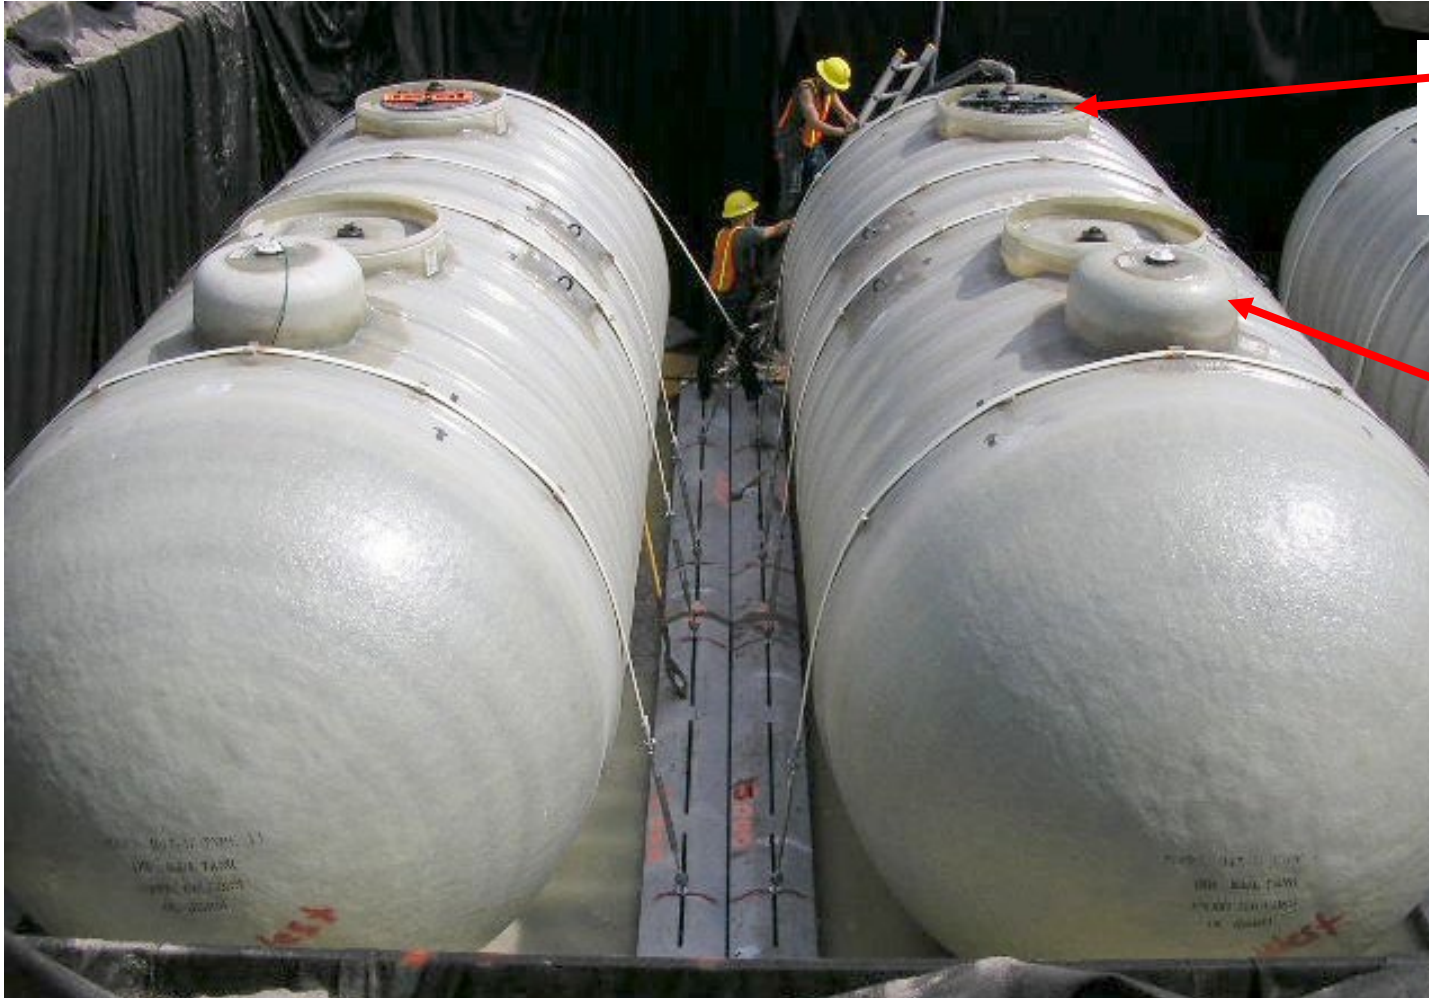
# D.W. FIBERGLASS UST

Collar for attaching a sump with epoxy.

Tank annulus (i.E., Interstice) is brine-filled. For operational monitoring, a liquid level sensor is installed here.

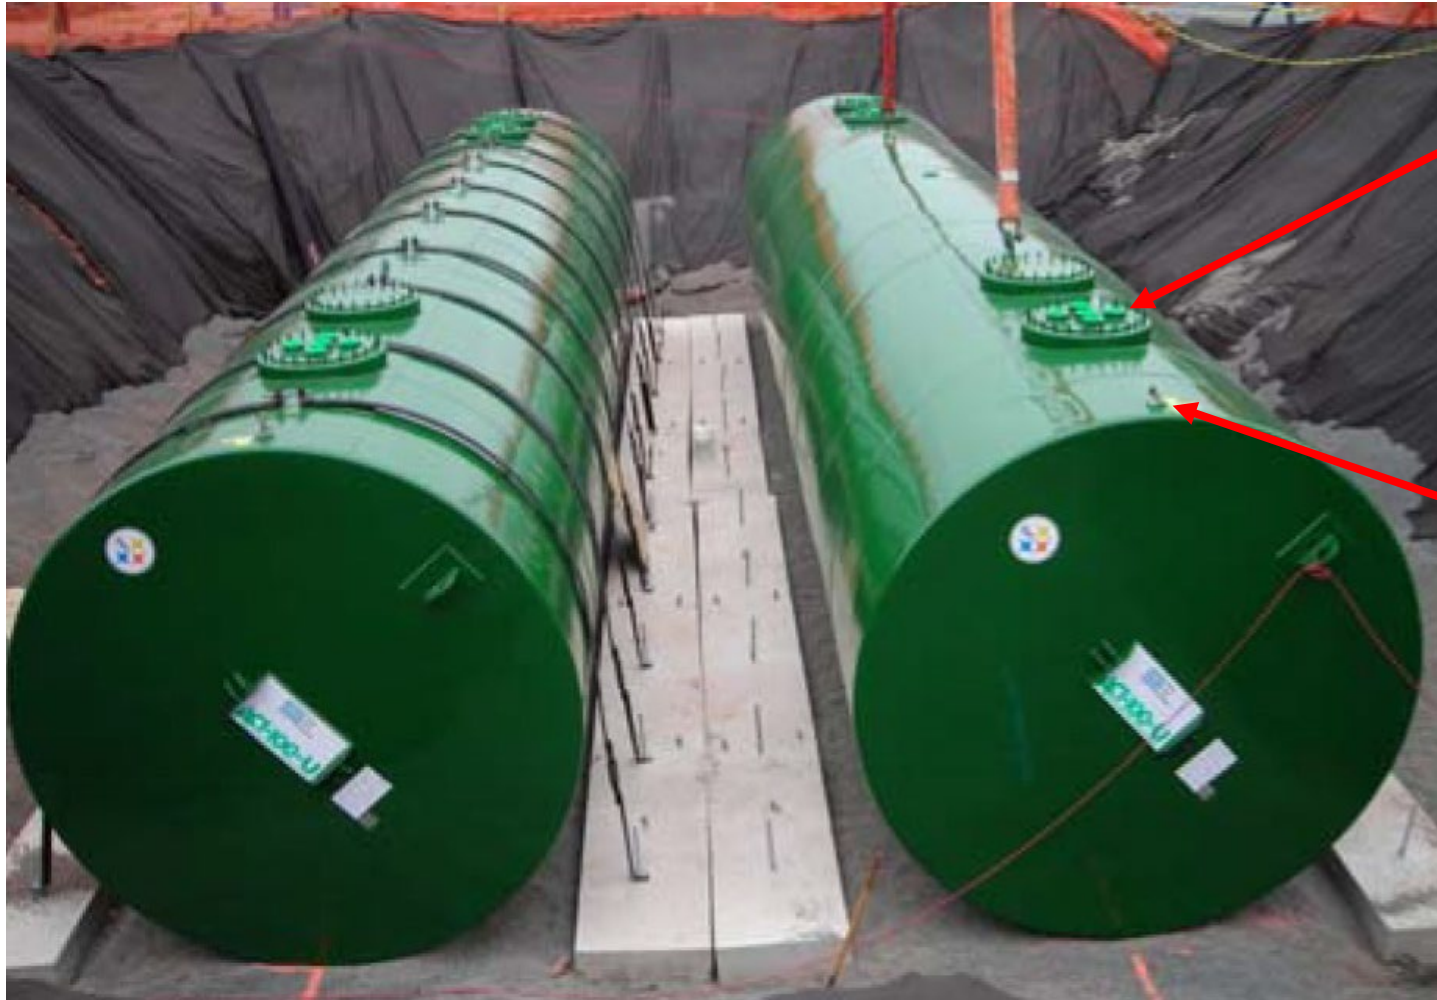
# D.W. FIBER-GLASS-CLAD STEEL UST

Sump is bolted to tank top and sealed with an o-ring on this model.

Tank is shipped with the annulus under vacuum. Operational monitoring is normally by vacuum gauge/sensor or liquid detecting sensor, though a tank stick could be used.

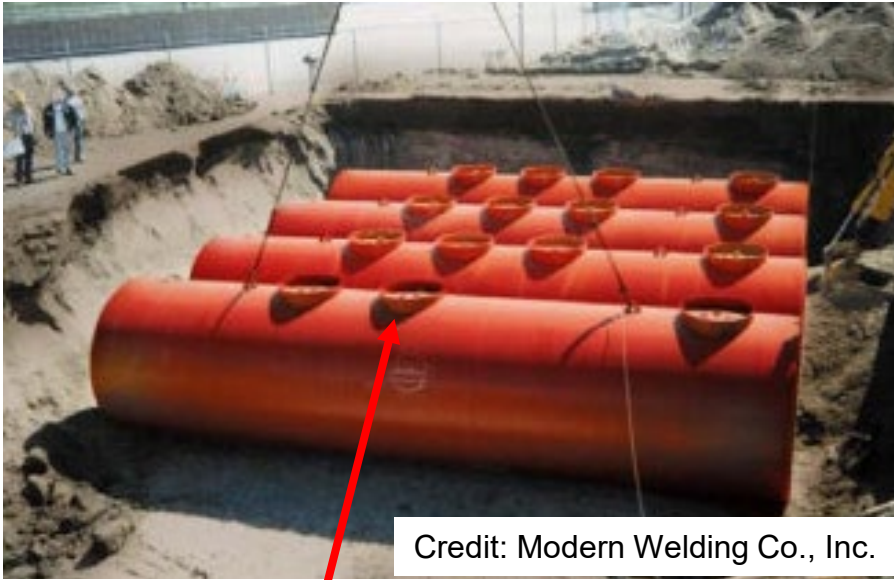
These tanks have optional sump collars.

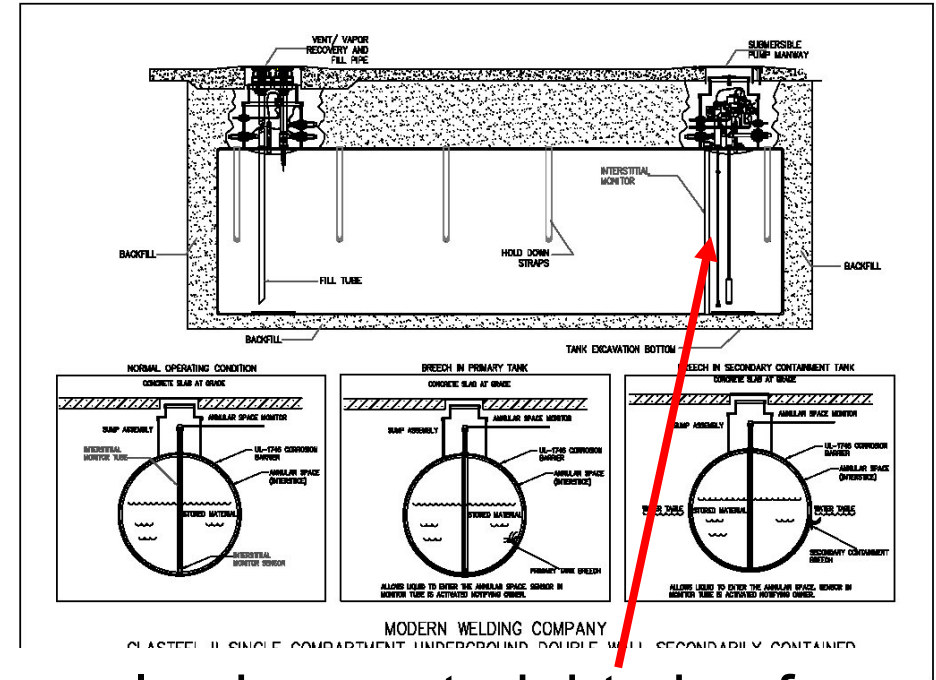
The annulus has a straight pipe for monitoring. Annulus is intended to remain dry. Operational monitoring is normally by vacuum or liquid sensor, though a tank stick could be used.

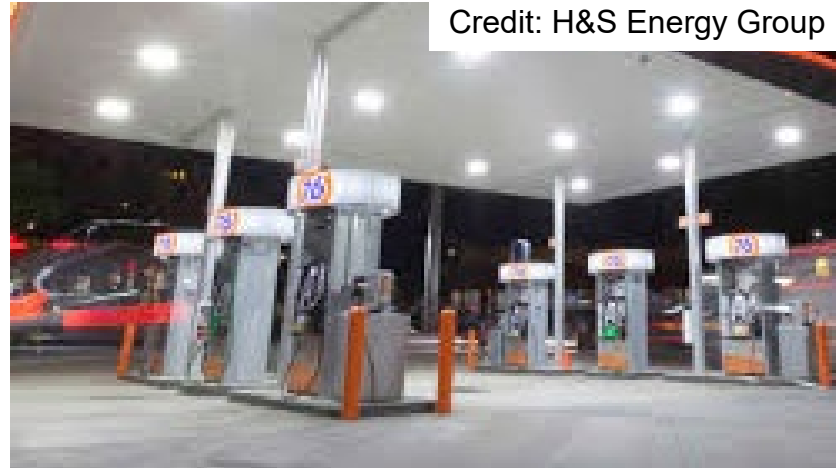
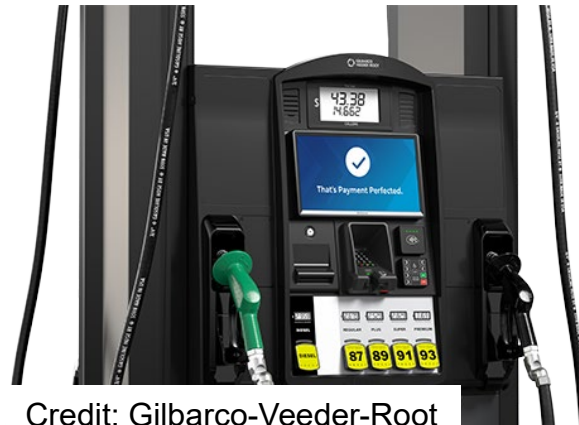
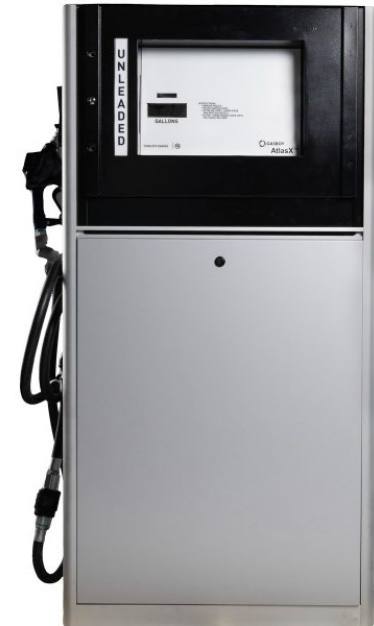
Pressurized Piping: Multi-product dispenser (MPD)

I. Pressurized System  
– almost all retail stations, and the majority of other **vehicular** fueling facilities. A Submersible Turbine Pump (STP) pushes the fuel from the bottom of the tank to a dispenser. The line stays pressurized, even when the pump is off.

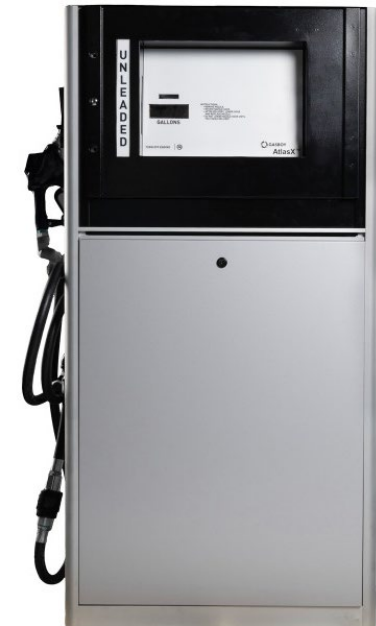
Typical suction pump and dispenser

II. Suction System – small private vehicular fueling systems, and most emergency generator tanks. The pump is in the dispenser, and pulls the fuel from the tank.

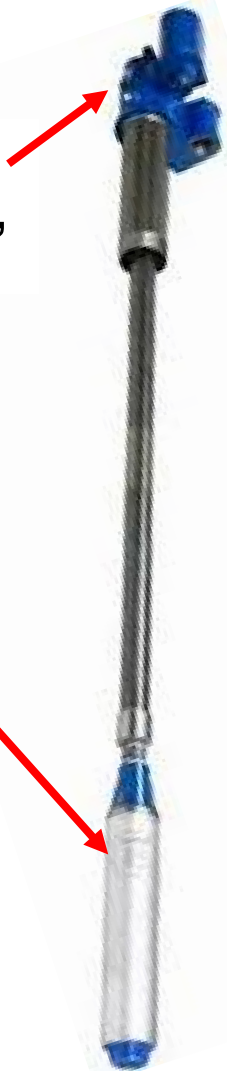
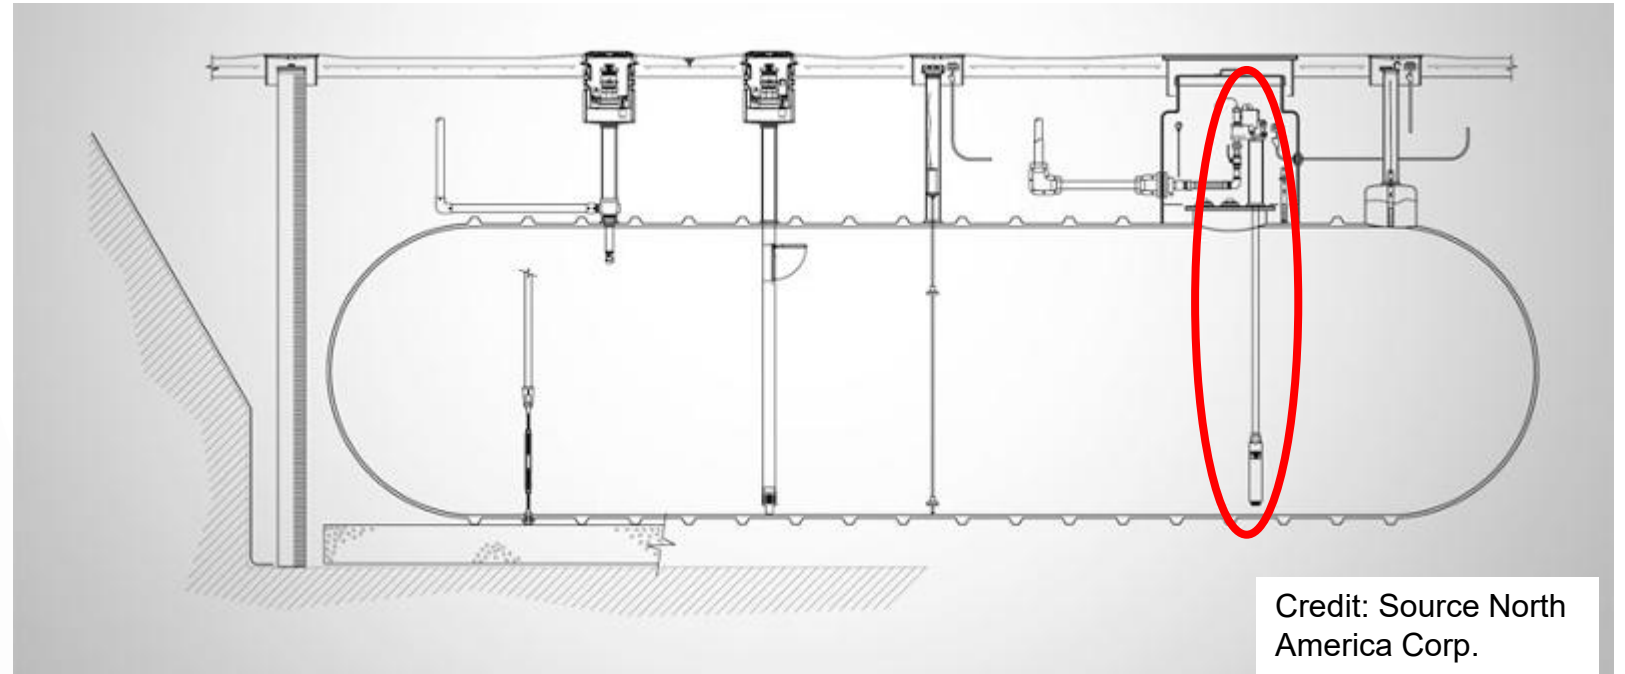
# SUBMERSIBLE TURBINE PUMPS (STP's)

“Manifold”,  
or “Packing”

Turbine  
Pump

- Pressurized systems. Fuel is pushed by a submersible pump located at the bottom of the tank.
- Could be fiberglass or plastic (a.k.a. “flex” pipe).
- Primary pipe almost always 2” diameter, typically delivering 8-12 gallons per minute (gpm) @ 30 pounds per square inch (psi).
- Secondary (outer containment pipe) is either coaxial with the primary or 1” larger in diameter than the primary line.
- Many truck stops have “high-flow” STP’s, or two standard STP’s per line, and 3” diameter primary pipe. These systems deliver 30+ gpm @ 40-80 psi.

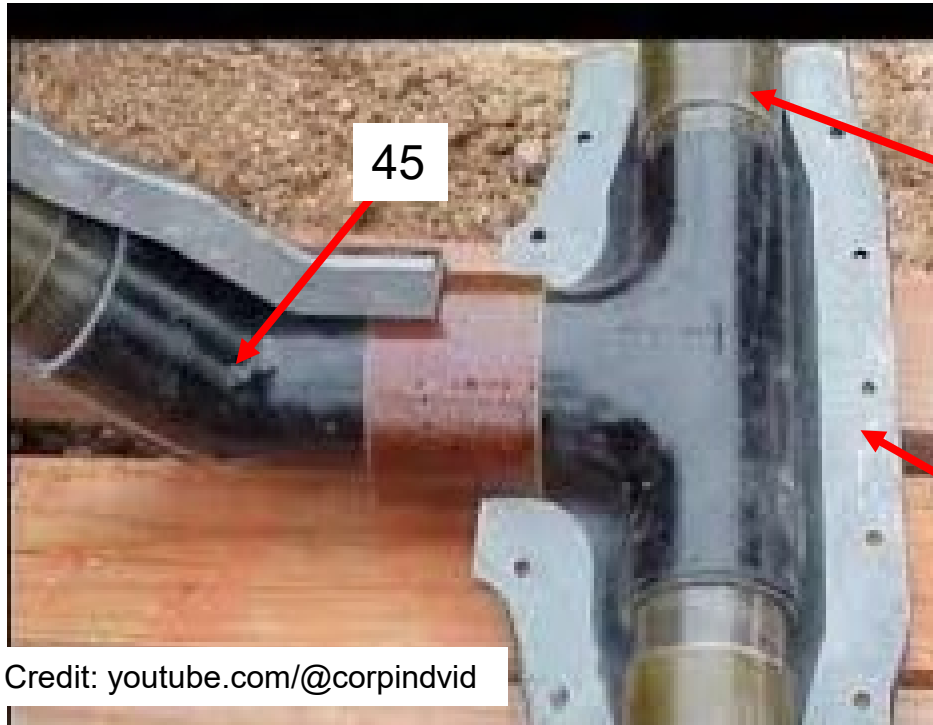
- Primary fittings are slip fittings, sealed with epoxy glue.
- Secondary fittings are “clamshell fittings”, with the two halves bolted together and sealed with an epoxy/fiber mix.

2"  
COAXIAL  
PIPE

2 2/3"  
PIPE

Clamshell  
secondary fitting

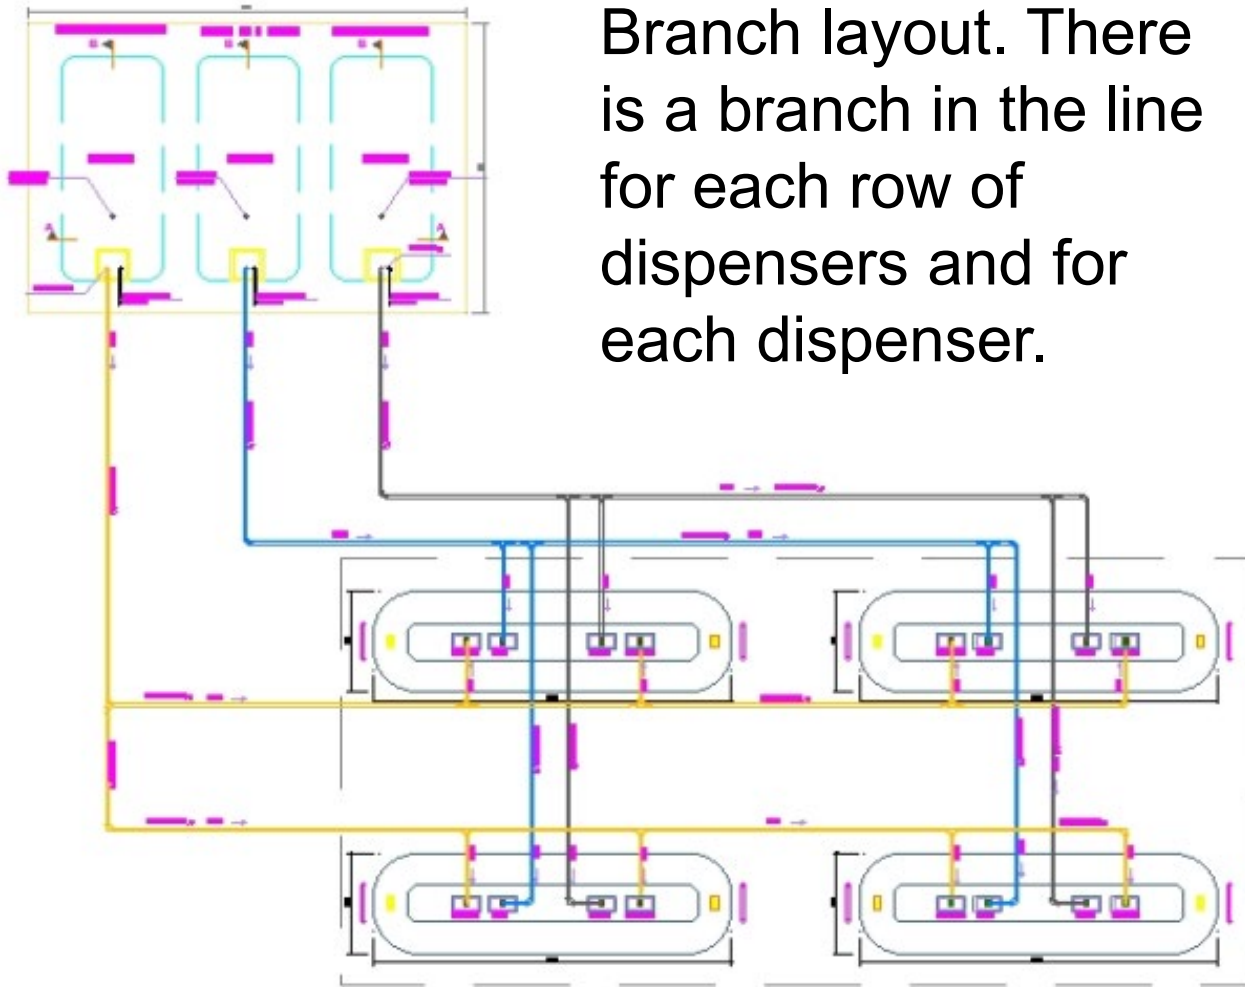
# FIBERGLASS PIPE LAYOUT

Branch layout. There is a branch in the line for each row of dispensers and for each dispenser.

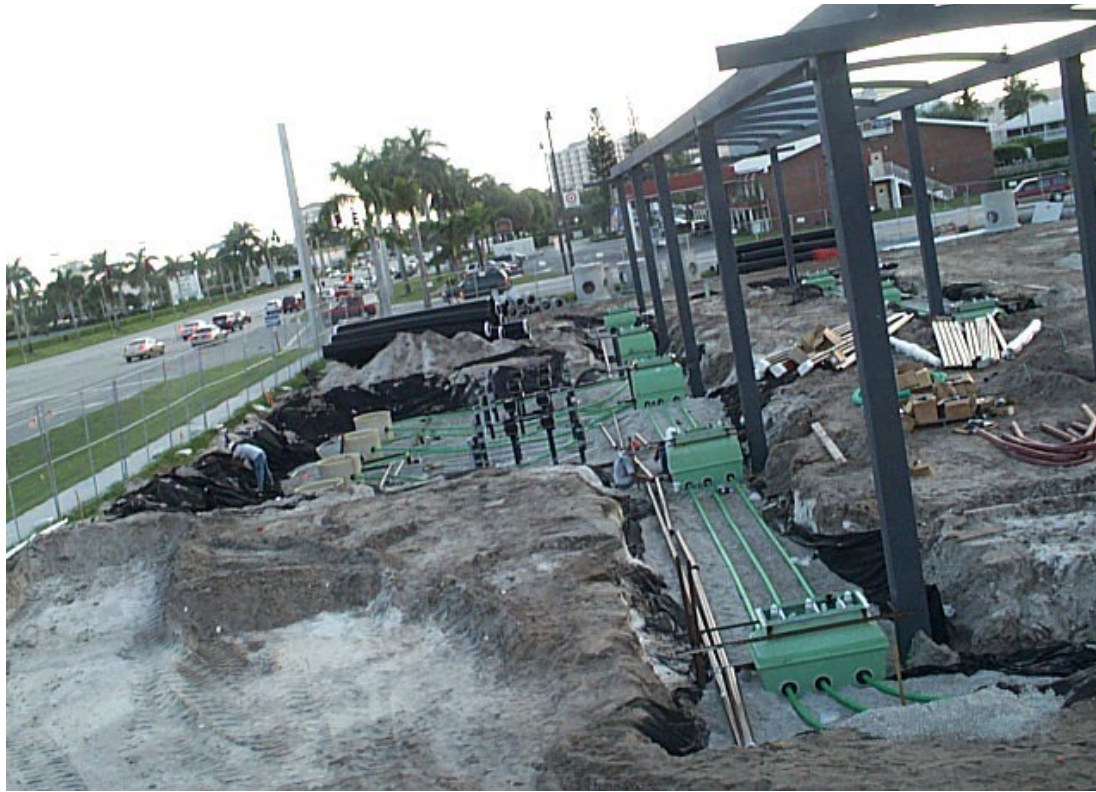
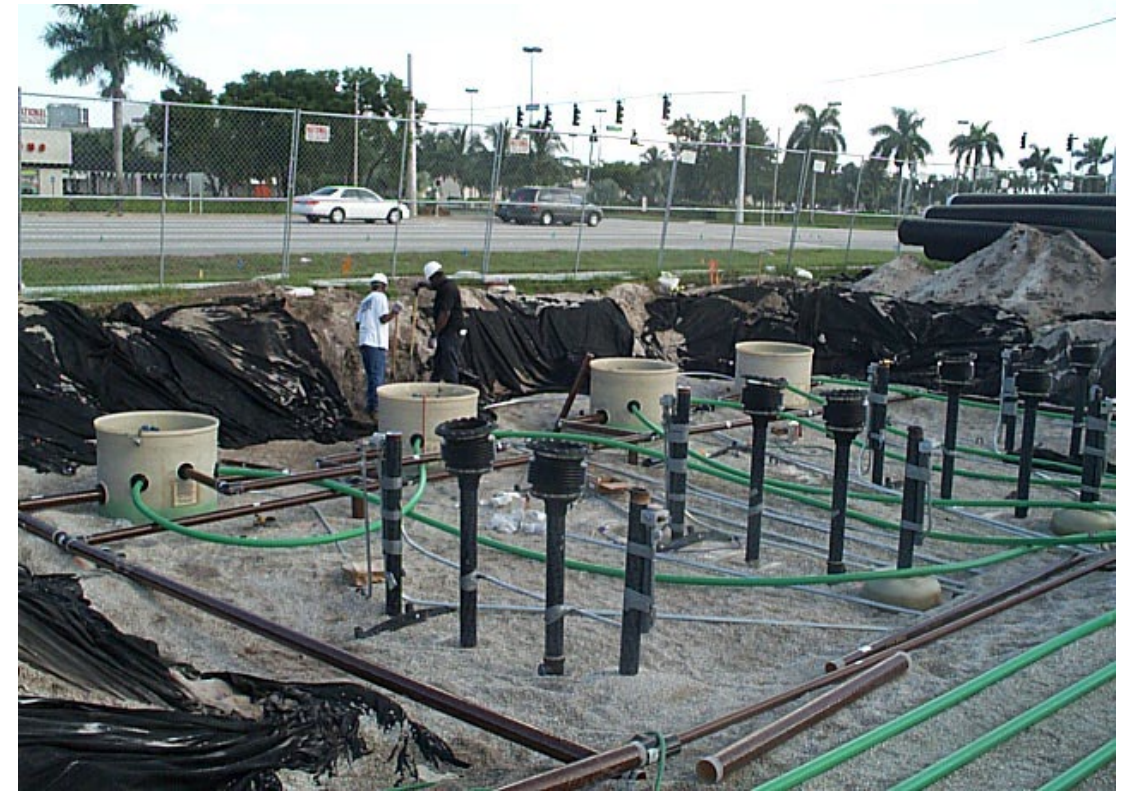
# PLASTIC FLEX PIPING

Only the product lines are plastic. Vent and vapor recovery piping is almost always fiberglass, since it does not have to be double-wall.

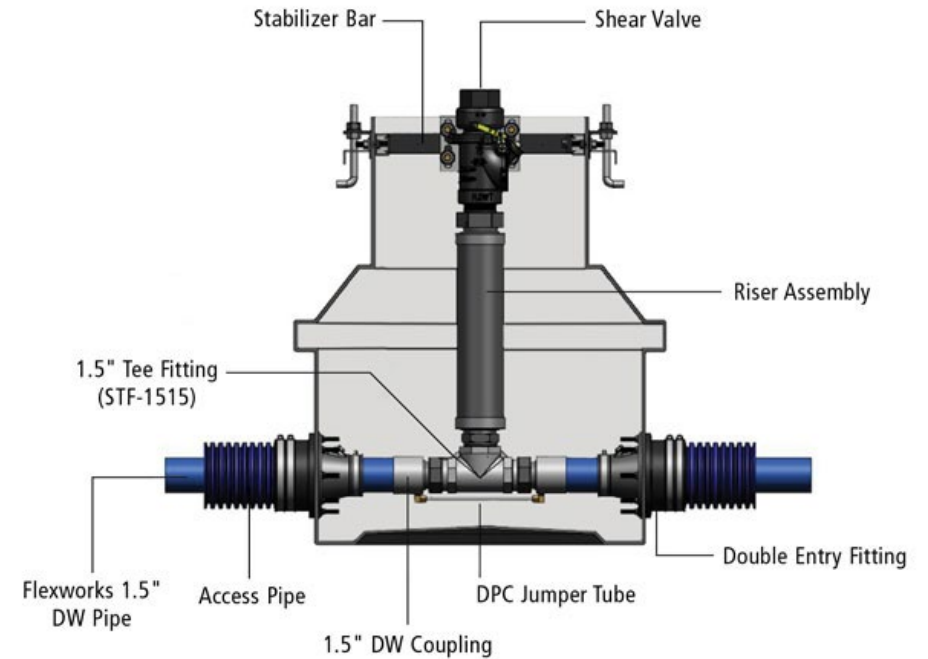
### Access pipe

- Provides ducting for periodic replacement of the coaxial product line

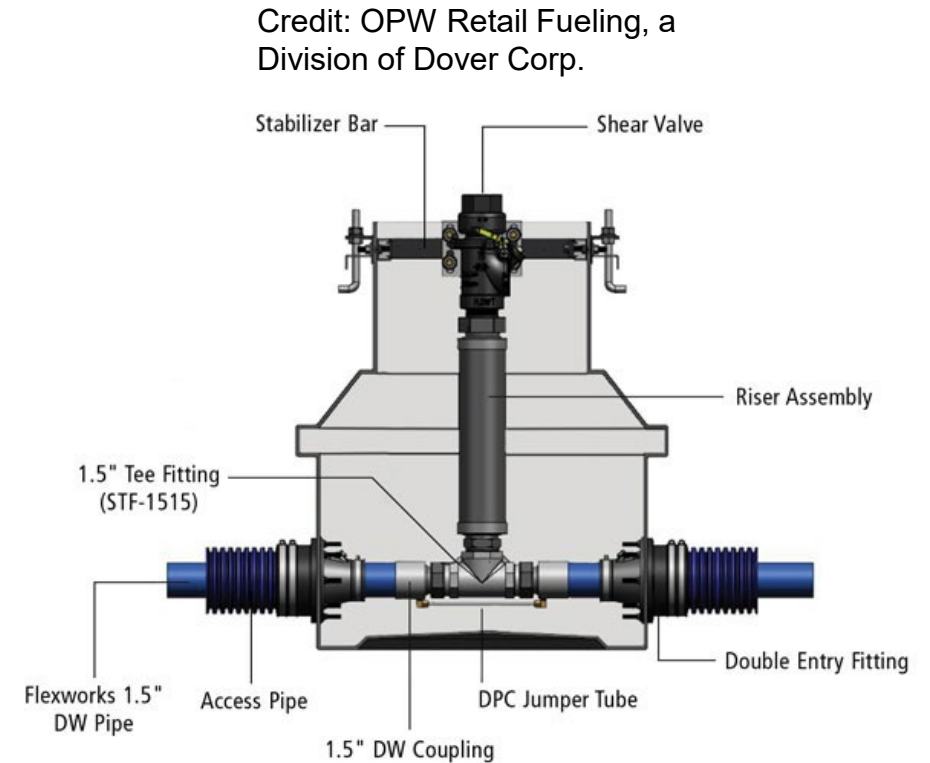
## Access pipe

- Optional.
- May provide some tertiary containment but is not designed for that or rated as such.

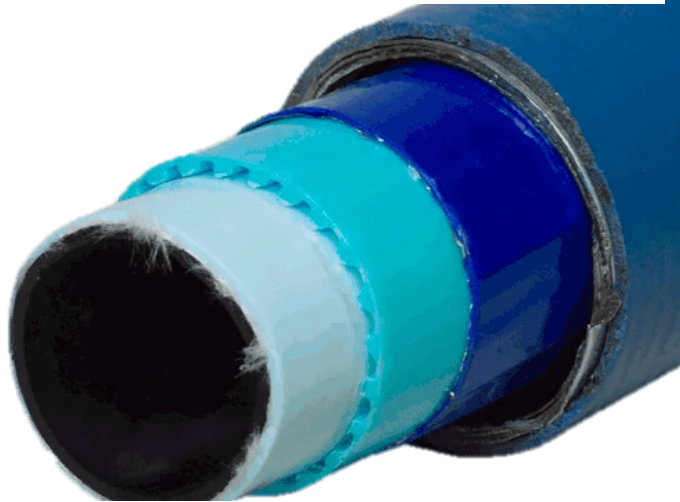
Coaxial flex-pipe with duct

- Metallic ducting.
- The duct protects the flex-pipe from UV exposure.
- Rated for use aboveground and over water.
