# Anatomy of a Petroleum Storage Tank System As It Relates to Cleanup

**Presenter: Chip Green, PE, Palm Beach County  
Department of Environmental Resources Management  
(DERM)**

Tallahassee, FL | April 28-30, 2026

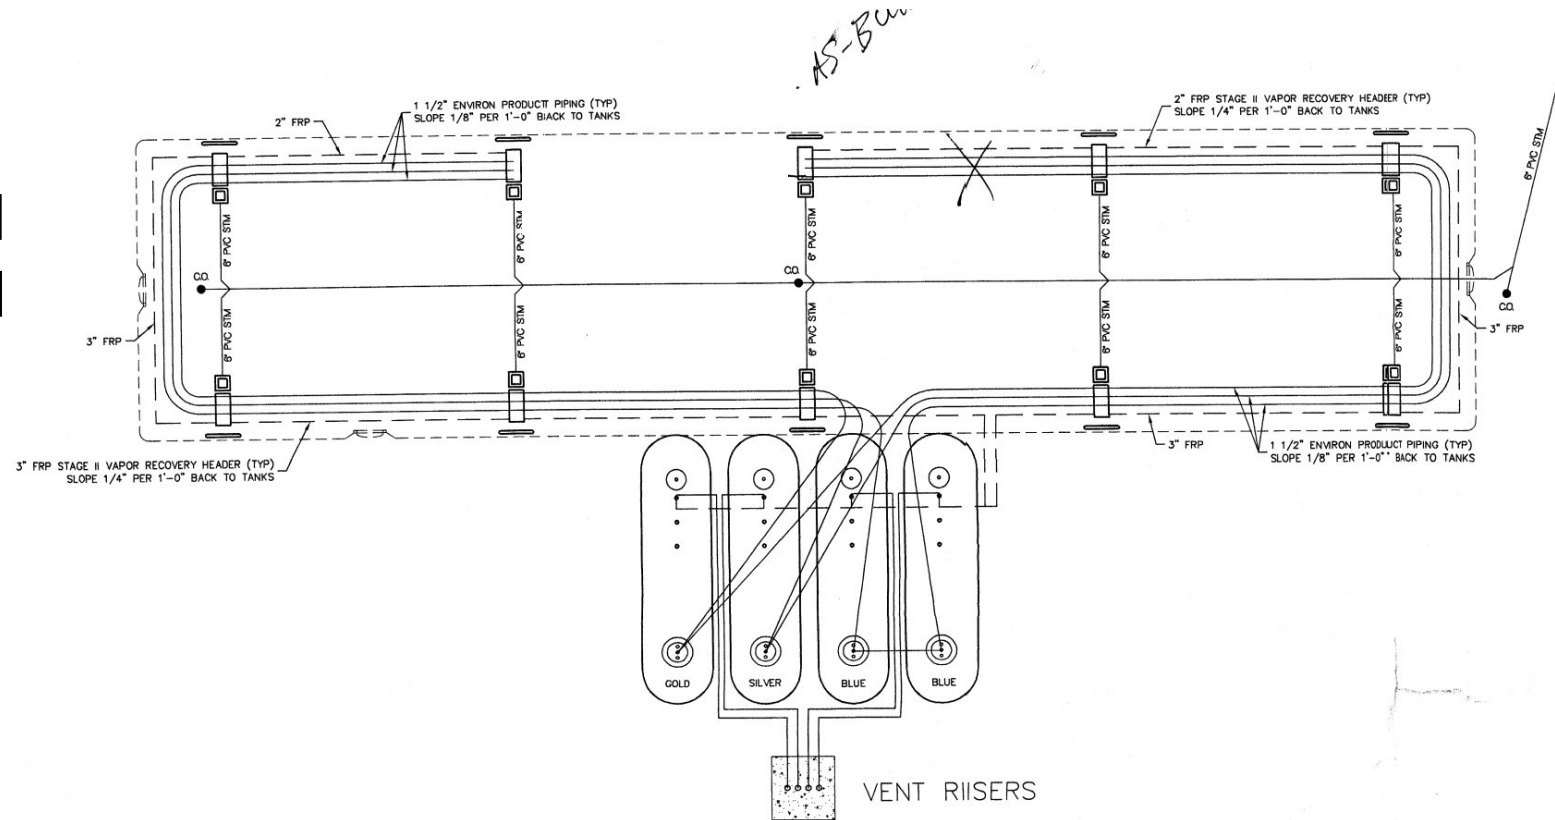
# PLASTIC FLEX PIPING LAYOUT

Loop layout. All fittings are contained in a sump. No buried fittings.

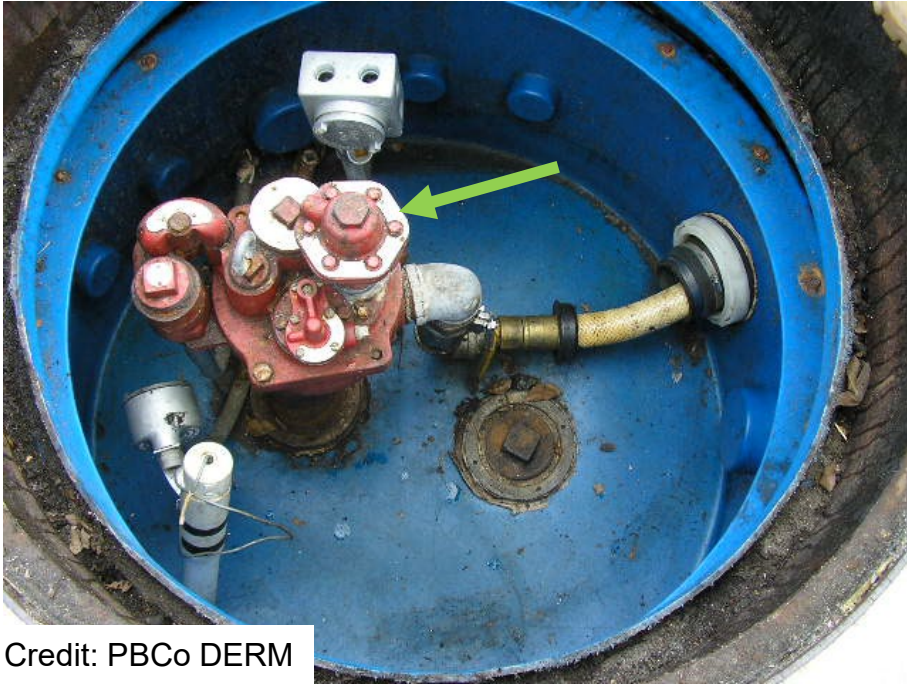
“Old School”: Mechanical Line Leak Detector (MLLD). Shuts off the product line @ 3 gph, then slowly re-sets.

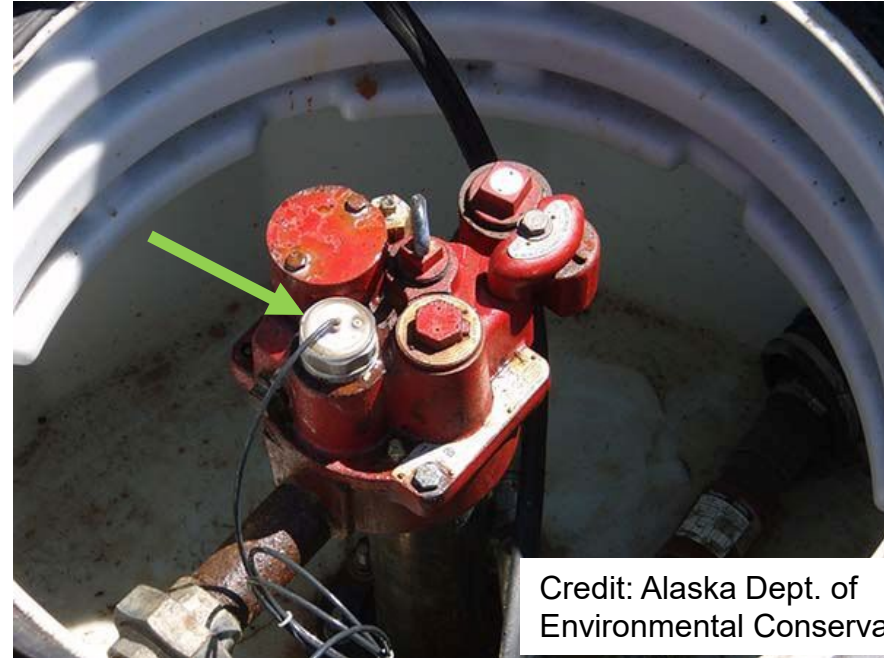
Preferred technology: Electronic Line Leak Detector (ELLD or “PLLD”). Shuts off the product line @ 0.1 gph with audible alarm and automatic shut-down.

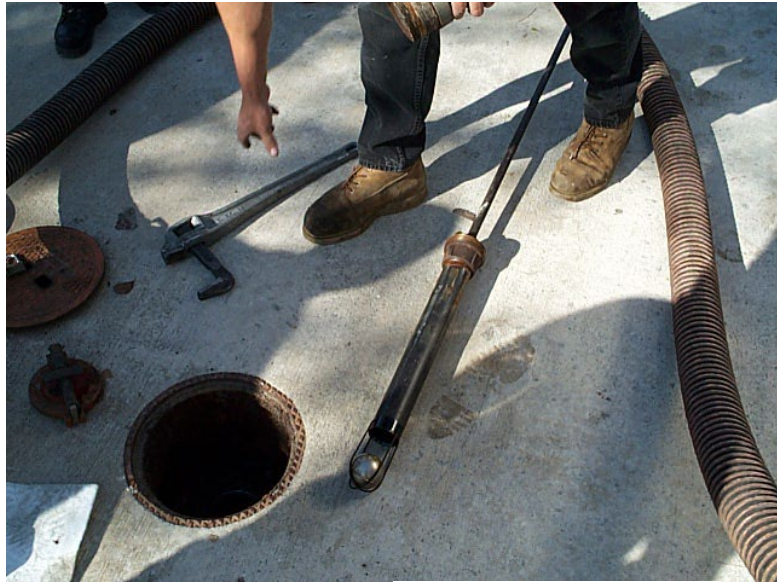
# OVERFILL PROTECTION: BALL-FLOAT, THE "OLD SCHOOL" METHOD.

- Spill containment, i.e., spill buckets, were not required until 1991. Fuel delivery hoses hold about 18 gals and were often emptied into the ground around the fill port before the advent of spill buckets.
- A 2004 Leak Autopsy Study by DEP revealed that the most common cause of discharges was leaky spill buckets.
- Spill buckets are problematic to this day.
- Overfill protection measures are often **circumvented** by delivery personnel.
  - Ball-float vent valves.
  - Flapper drop tubes.

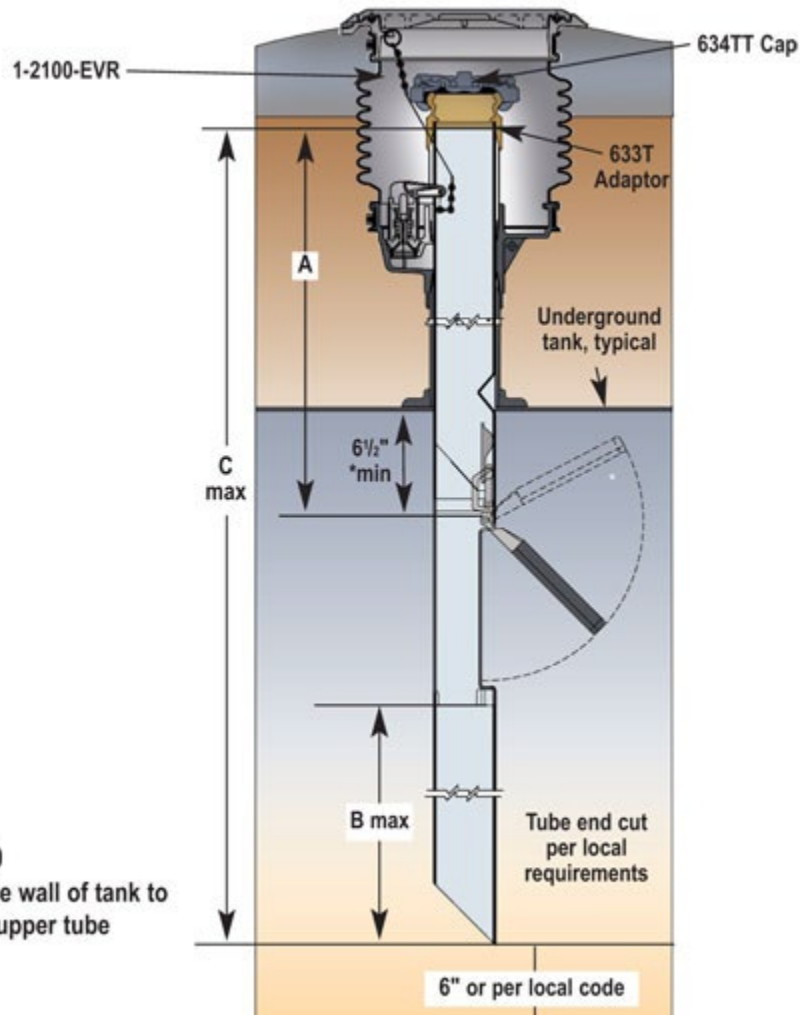
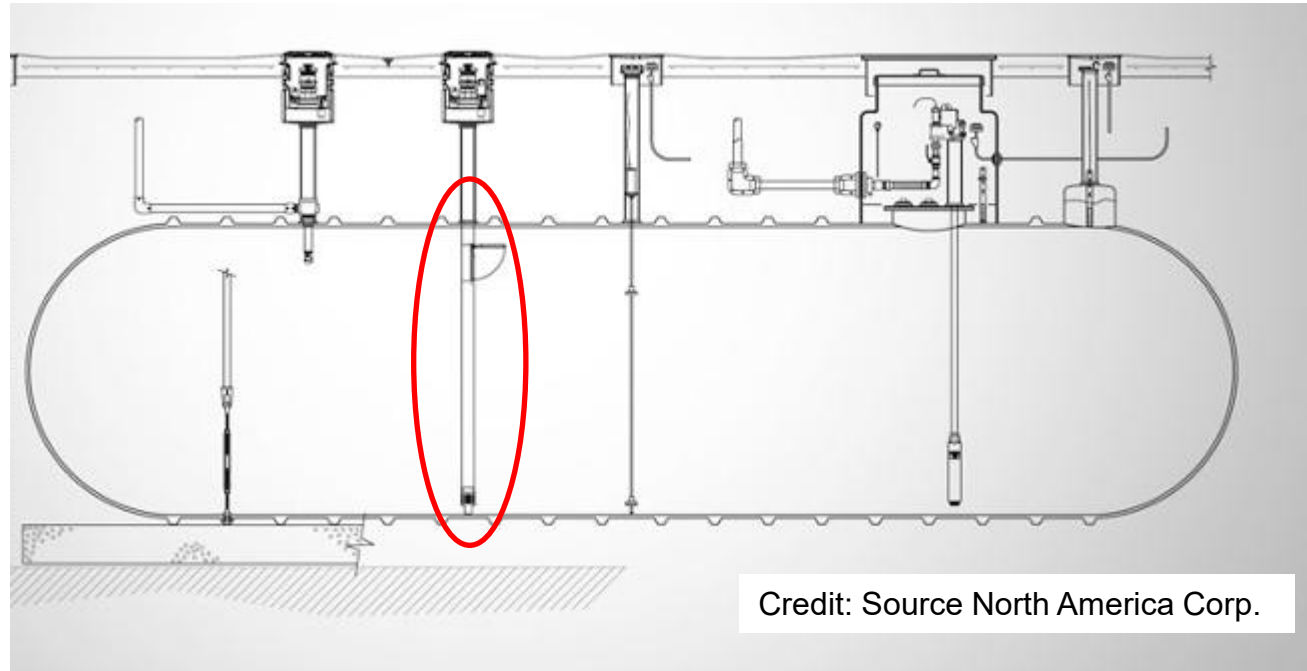
# OVERFILL PROTECTION (PREFERRED METHOD): OVERFILL PREVENTION DROP TUBE (“FLAPPER”)

Called “flow shut-off” in the tank registration codes that appear in the first cover page report for each facility.

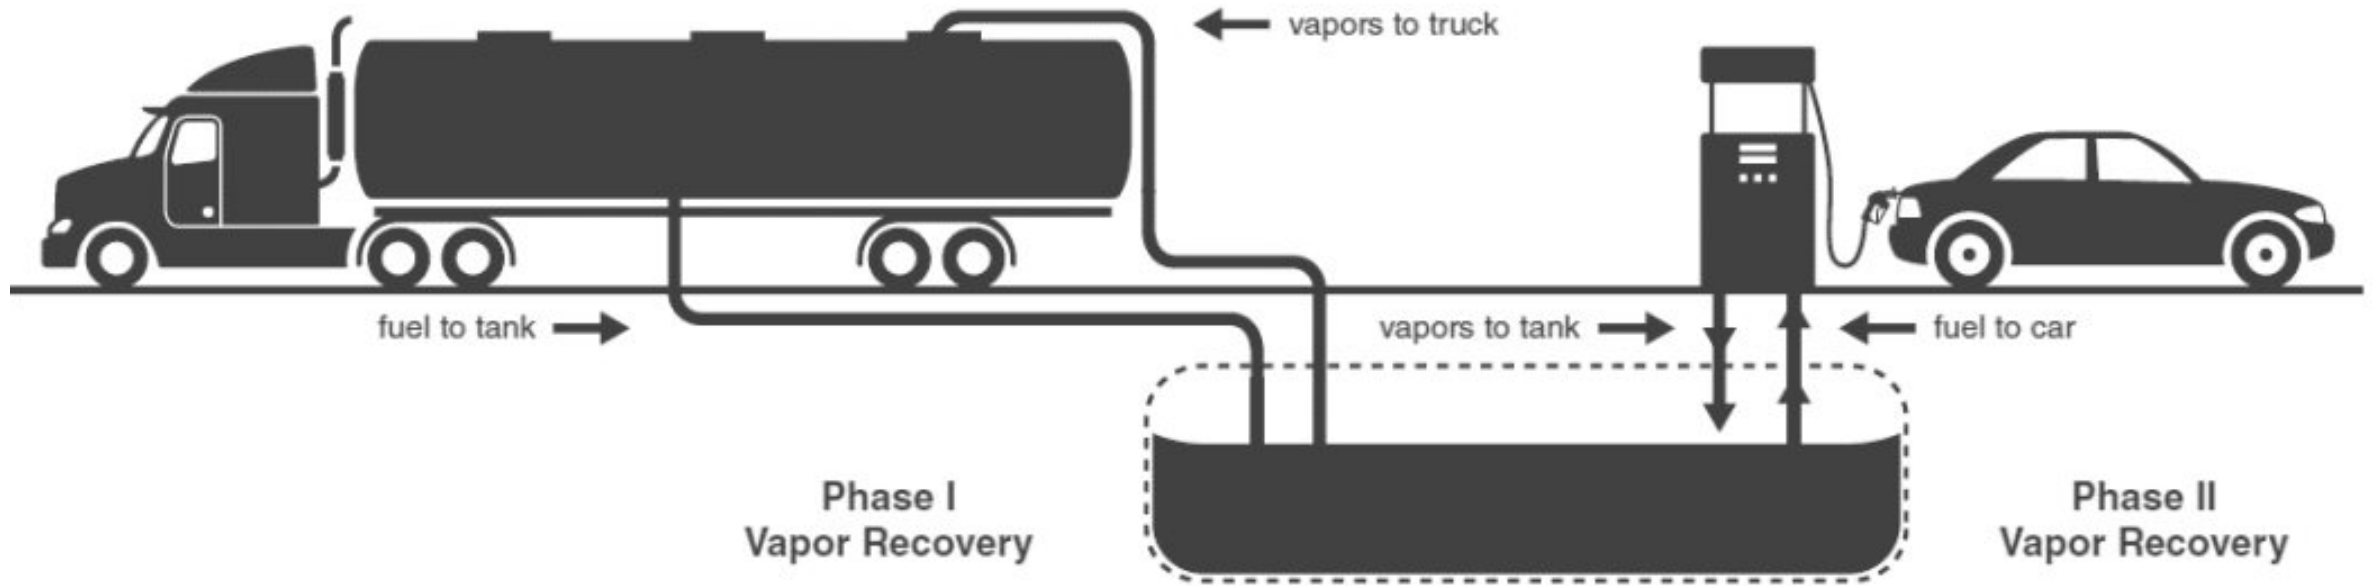
# VAPOR RECOVERY

- Federally mandated.
- Purpose is to reduce vapor emissions, save fuel.
- Stage 1 (Phase 1):
  - UST-to-delivery tanker .
  - Vapors are routed back into in the delivery tanker, where they condense under pressure (3 psi max).
  - Can be a 2-point or coaxial connection.
  - First required in Florida in 1993 and is still required.
  - Approx. 2300 tons annually are recovered nationwide.

- Stage 2 (Phase 2):
  - Vehicle-to-UST.
  - Required from 1993-2007 in Florida.
  - Captures vapors from the dispenser nozzle and routes them back into the UST by way of coaxial dispenser hoses and underground piping (normally single-wall fiberglass).
  - Most stations de-commissioned their Stage 2 components. Underground piping was often abandoned in place.

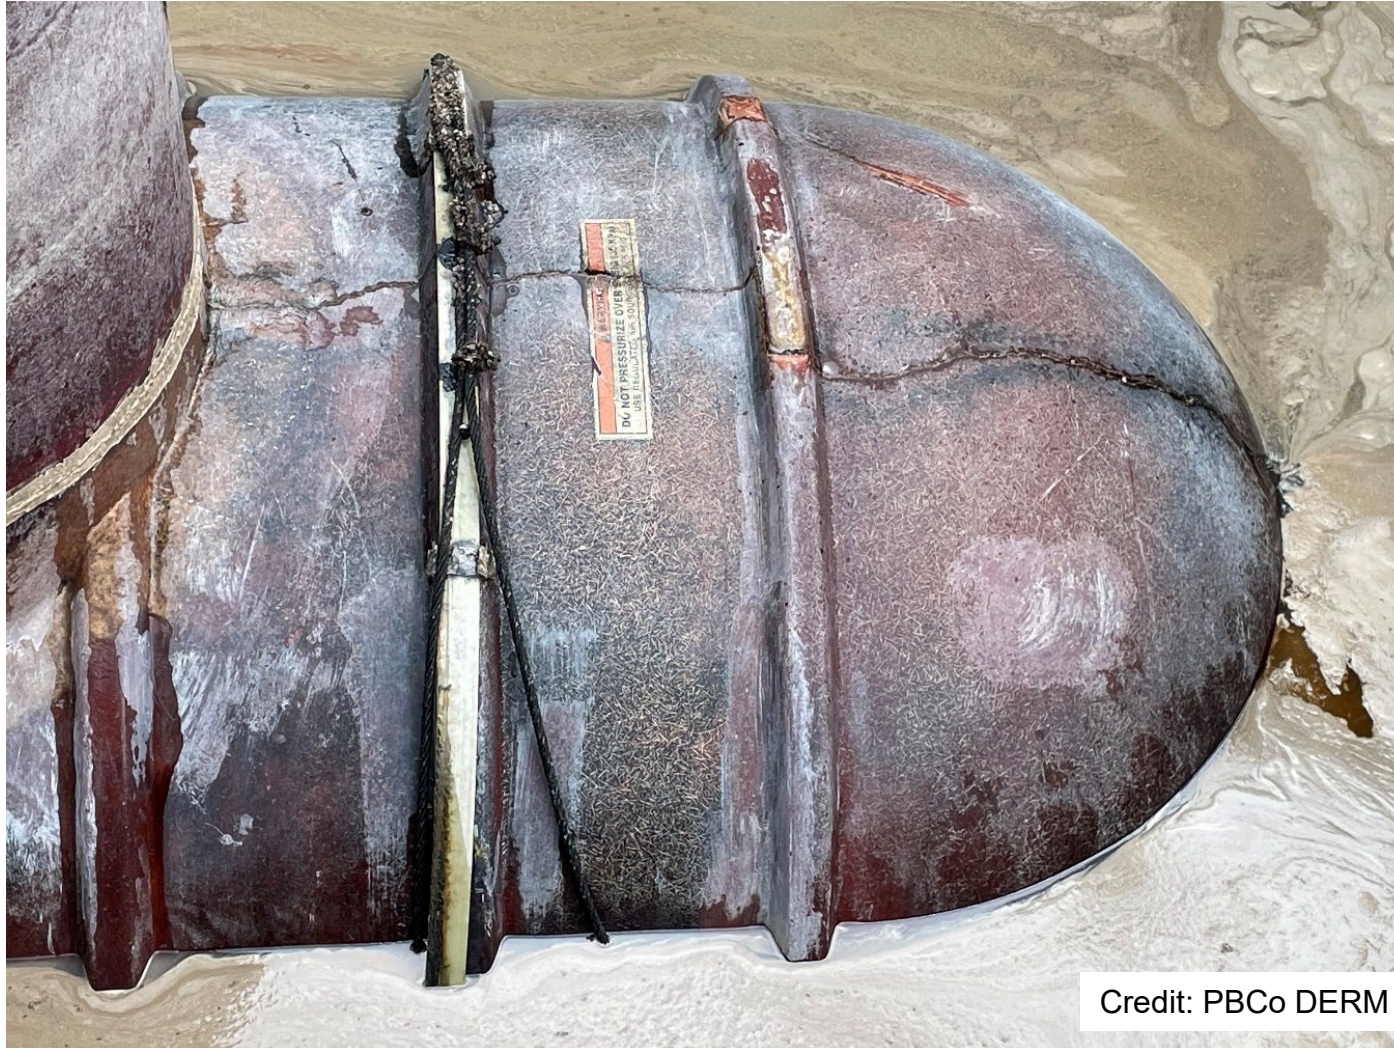
6000 Gallon  
Double-wall  
Emergency  
Generator Tank

After an overfilling of the UST, the Veeder-Root alarmed and water and fuel started showing up in the piping sump and tank interstitial. Next morning UST was put out of service and emptied. Days/weeks following, fuel and water was repeatedly pumped from the piping sump and tank primary. Eventually recovery and monitoring wells were installed.”

- The tank suffered from fatigue failure. Each time the tank was filled, it was pressurized beyond its design capacity.
- This was an emergency generator tank, so even though the tank was installed in 2004, it wasn't filled very often.

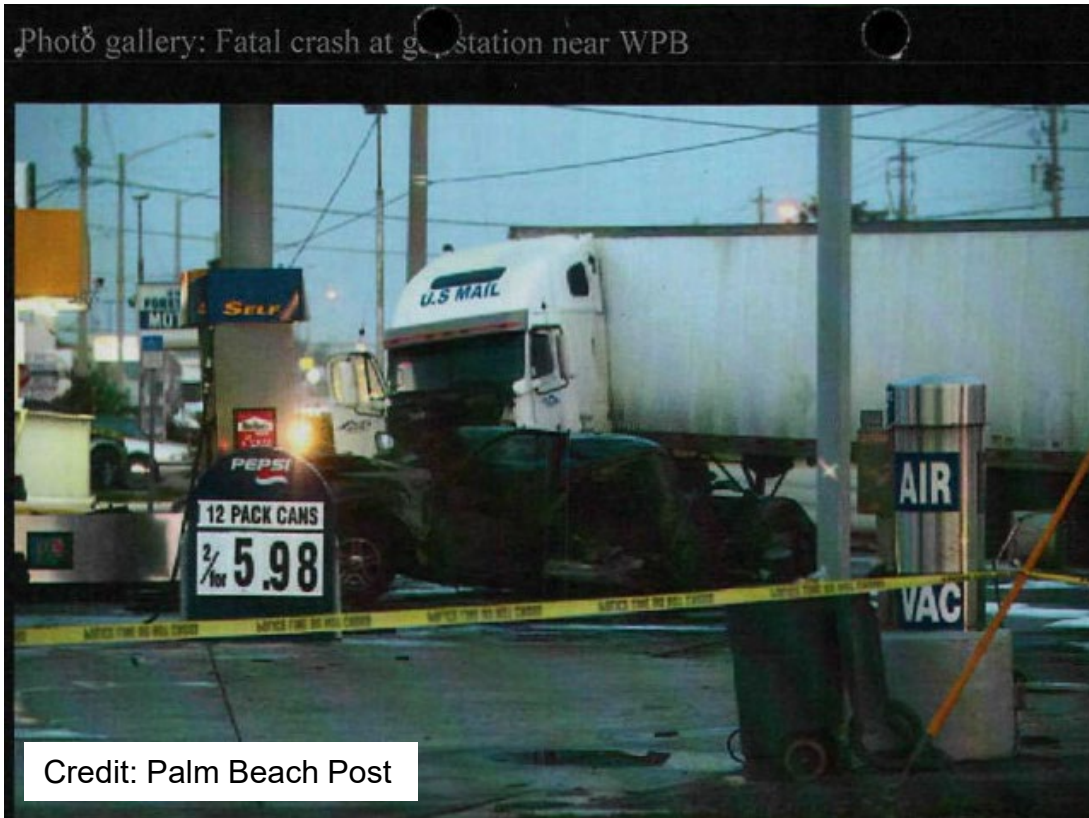
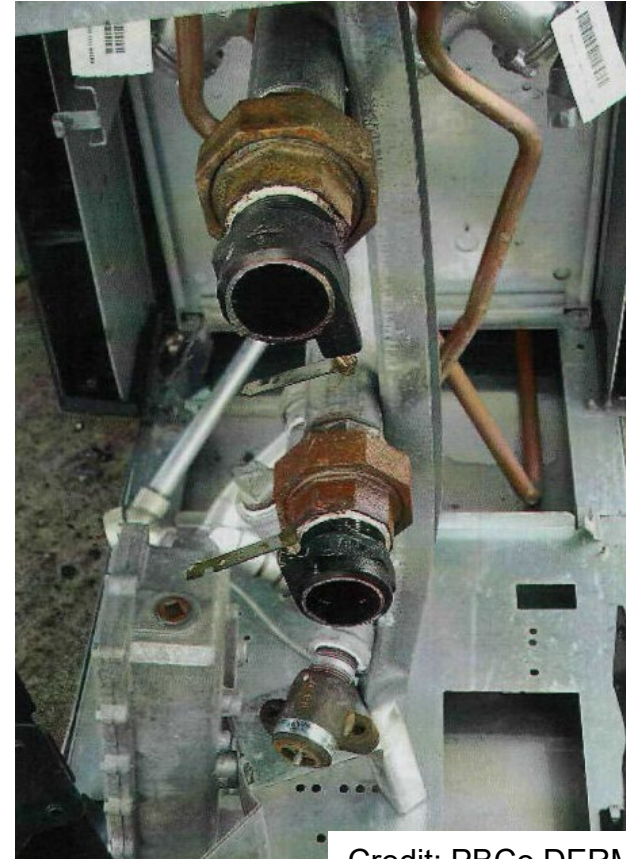
# INCIDENTS @ MPD's VEHICLE CRASH

**Shear  
Valves  
Work!**

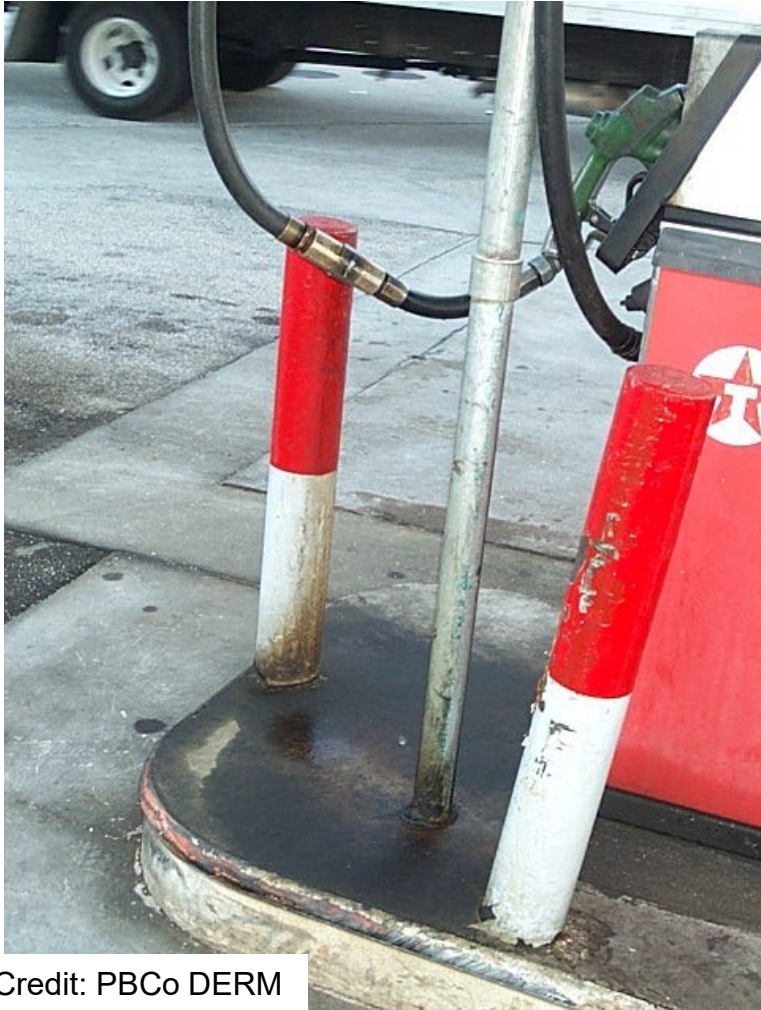
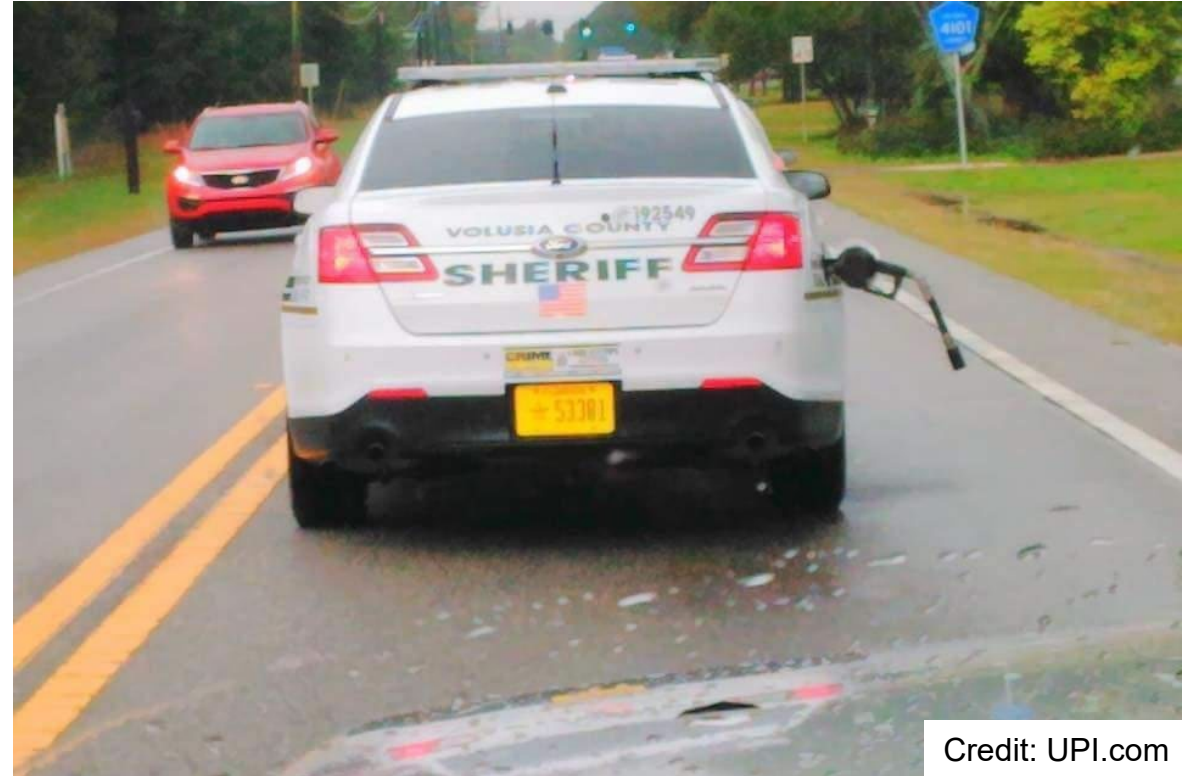
# INCIDENTS @ MPD's LEAKY HOSE FITTINGS

**Breakaways Work!**
