Assessment and Remediation of Petroleum-Impacted sites within Karst Environments – Addressing Potential Complications With Positive Solutions

Presented by Polk and Escambia County Local Programs

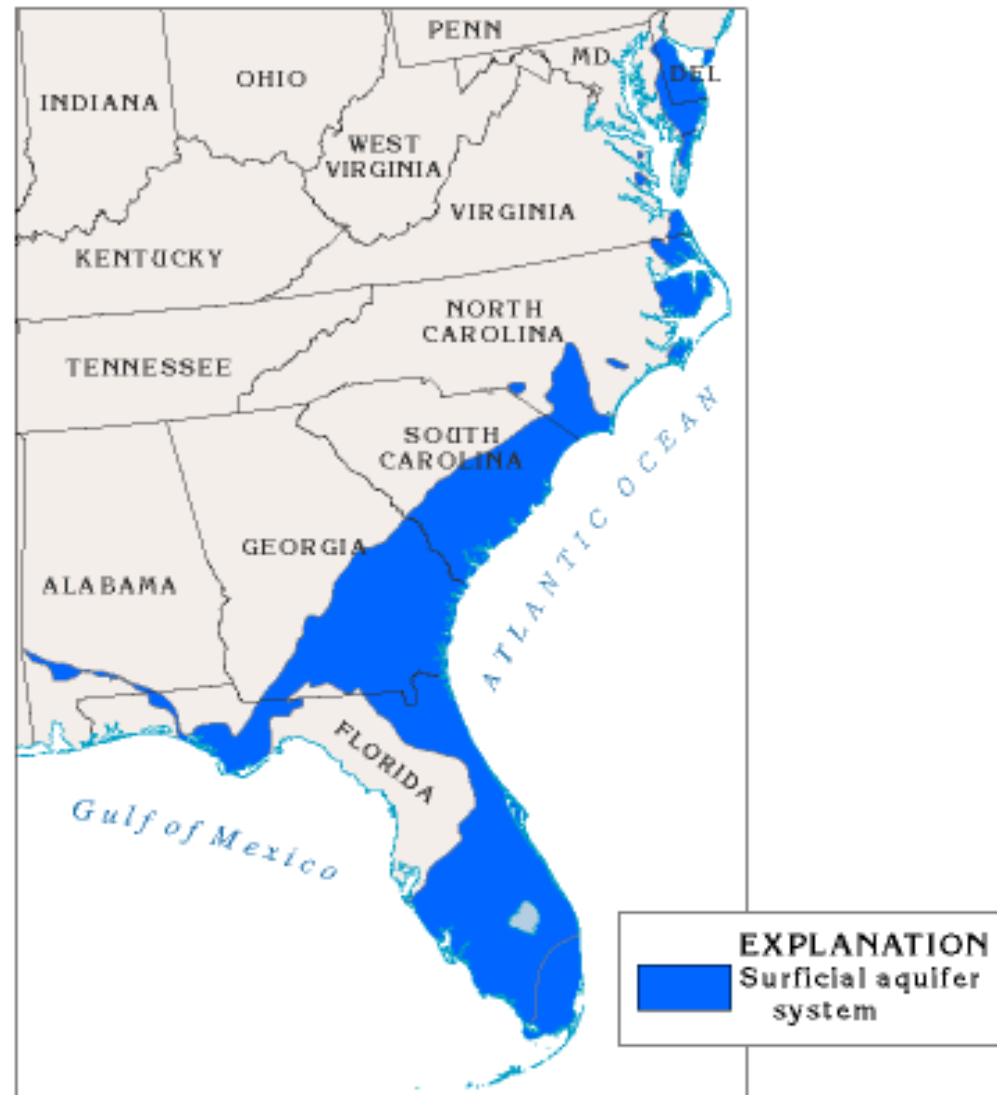
The Surficial aquifer system extends throughout large areas in the Coastal Plain of Florida, Georgia and South Carolina. The Surficial aquifer is the uppermost aquifer in the Northern Atlantic Coastal Plains aquifer system. The surficial aquifer extends over large parts of the Delmarva Peninsula and the eastern coastal plain of North Carolina.

- The **Surficial Aquifer System** is the major source of drinking water in St. Johns, Flagler and Indian River counties, as well as Titusville and Palm Bay. It is typically shallow (less than 50 ft. thick) and is often referred to as a 'water table' aquifer, but in Indian River and St. Lucie Counties, it can be up to 400 ft. thick.

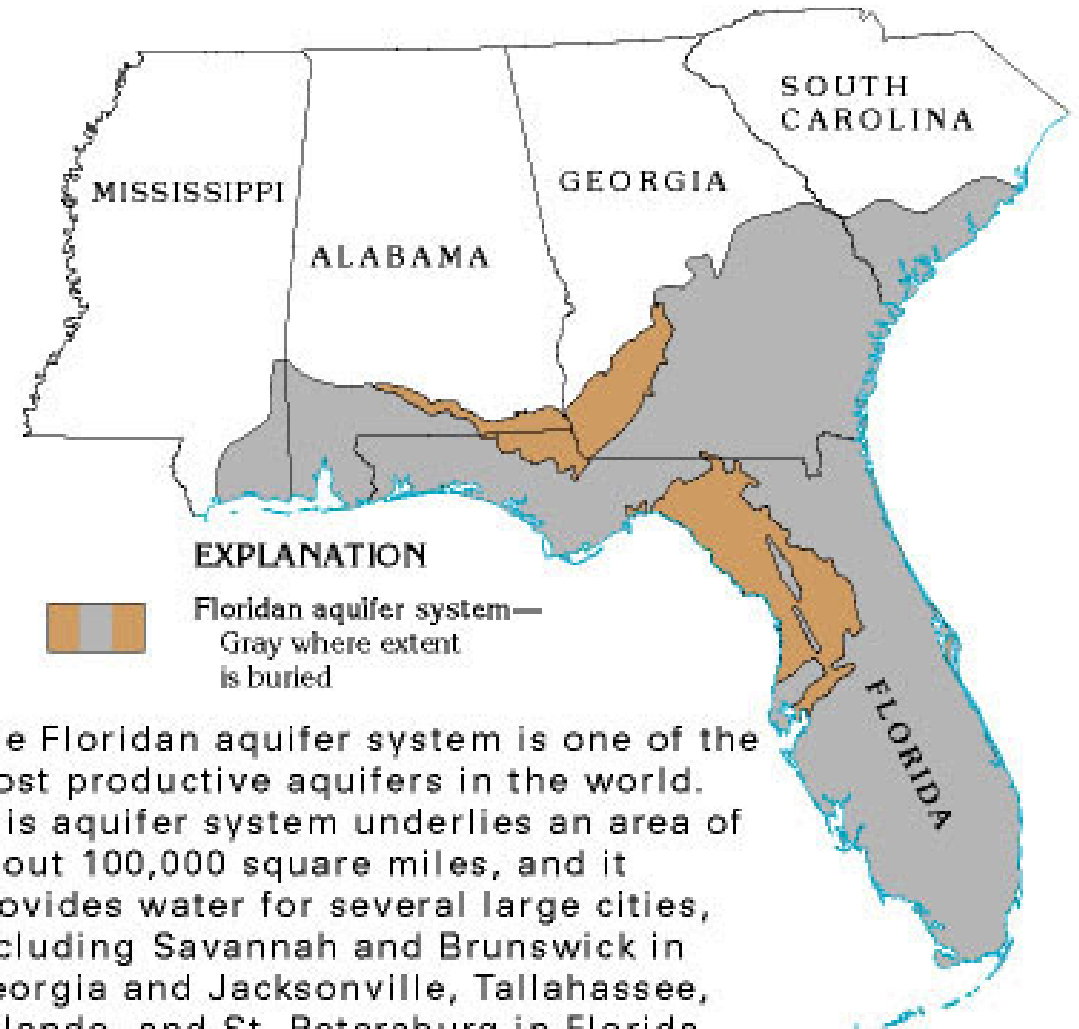
The Floridan aquifer system is one of the most productive aquifers in the world. This aquifer system underlies an area of about 100,000 square miles, and it provides water for several large cities, including Savannah and Brunswick in Georgia and Jacksonville, Tallahassee, Orlando, and St. Petersburg in Florida.

- The **Floridan Aquifer System** is a principal productive artesian aquifer covering almost 100,000 sq. miles including all of Florida and parts of Georgia, Alabama, Mississippi (not used due to high salinity and depth), and South Carolina. It behaves as one aquifer over much of its extent, although rocks of lower permeability create hydrologic separation between the UFA and LFA sub-regionally. The majority of freshwater is contained in the UFA and is used for water supply and is the main source of groundwater in the Kissimmee Basin. In south Florida, the UFA is brackish and used as reverse osmosis water, blending with shallower fresh Biscayne groundwater, and aquifer storage/recovery. The LFA has fresh to brackish water in northeastern Florida and Georgia, while in south Florida it is saline and used to dispose of effluent from wastewater treatment processes.

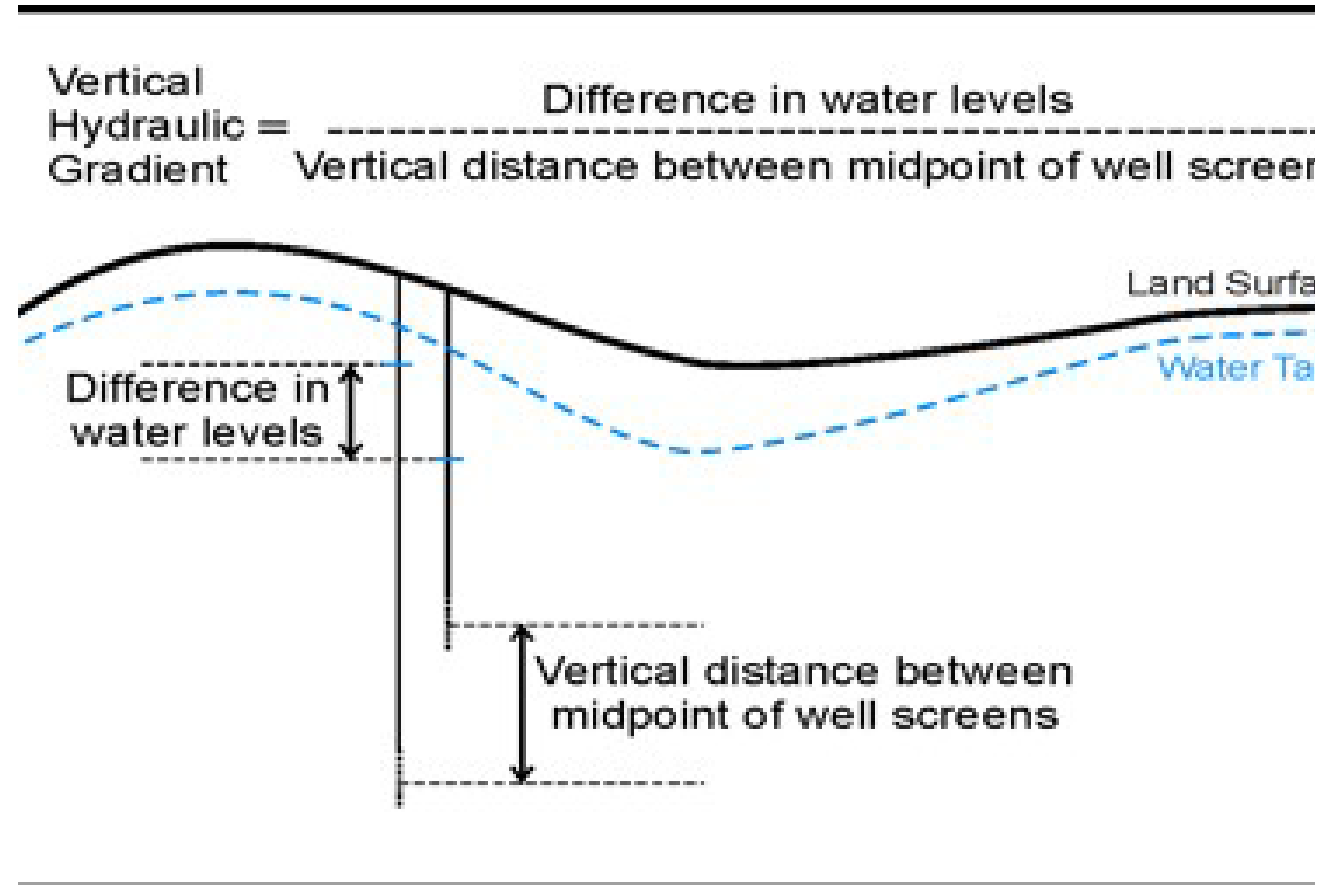
Vertical Hydraulic Gradient

- At many sites, the vertical hydraulic gradient is small in comparison to the horizontal hydraulic gradient. At karst sites with shallow Limestone, vertical hydraulic gradients may be very significant, leading to downward migration of contaminant plumes. Subtract the hydraulic head value of the deeper well from the shallower well value and divide by the vertical distance between the midpoints of the well screens.
- A quick look at the groundwater (gw) elevations of nearby-clustered wells (shallow, intermediate, deep, etc.), should provide evidence if a vertical hydraulic gradient is present with gw elevations dropping in feet as the wells get deeper. This assumes no confining layers are present.

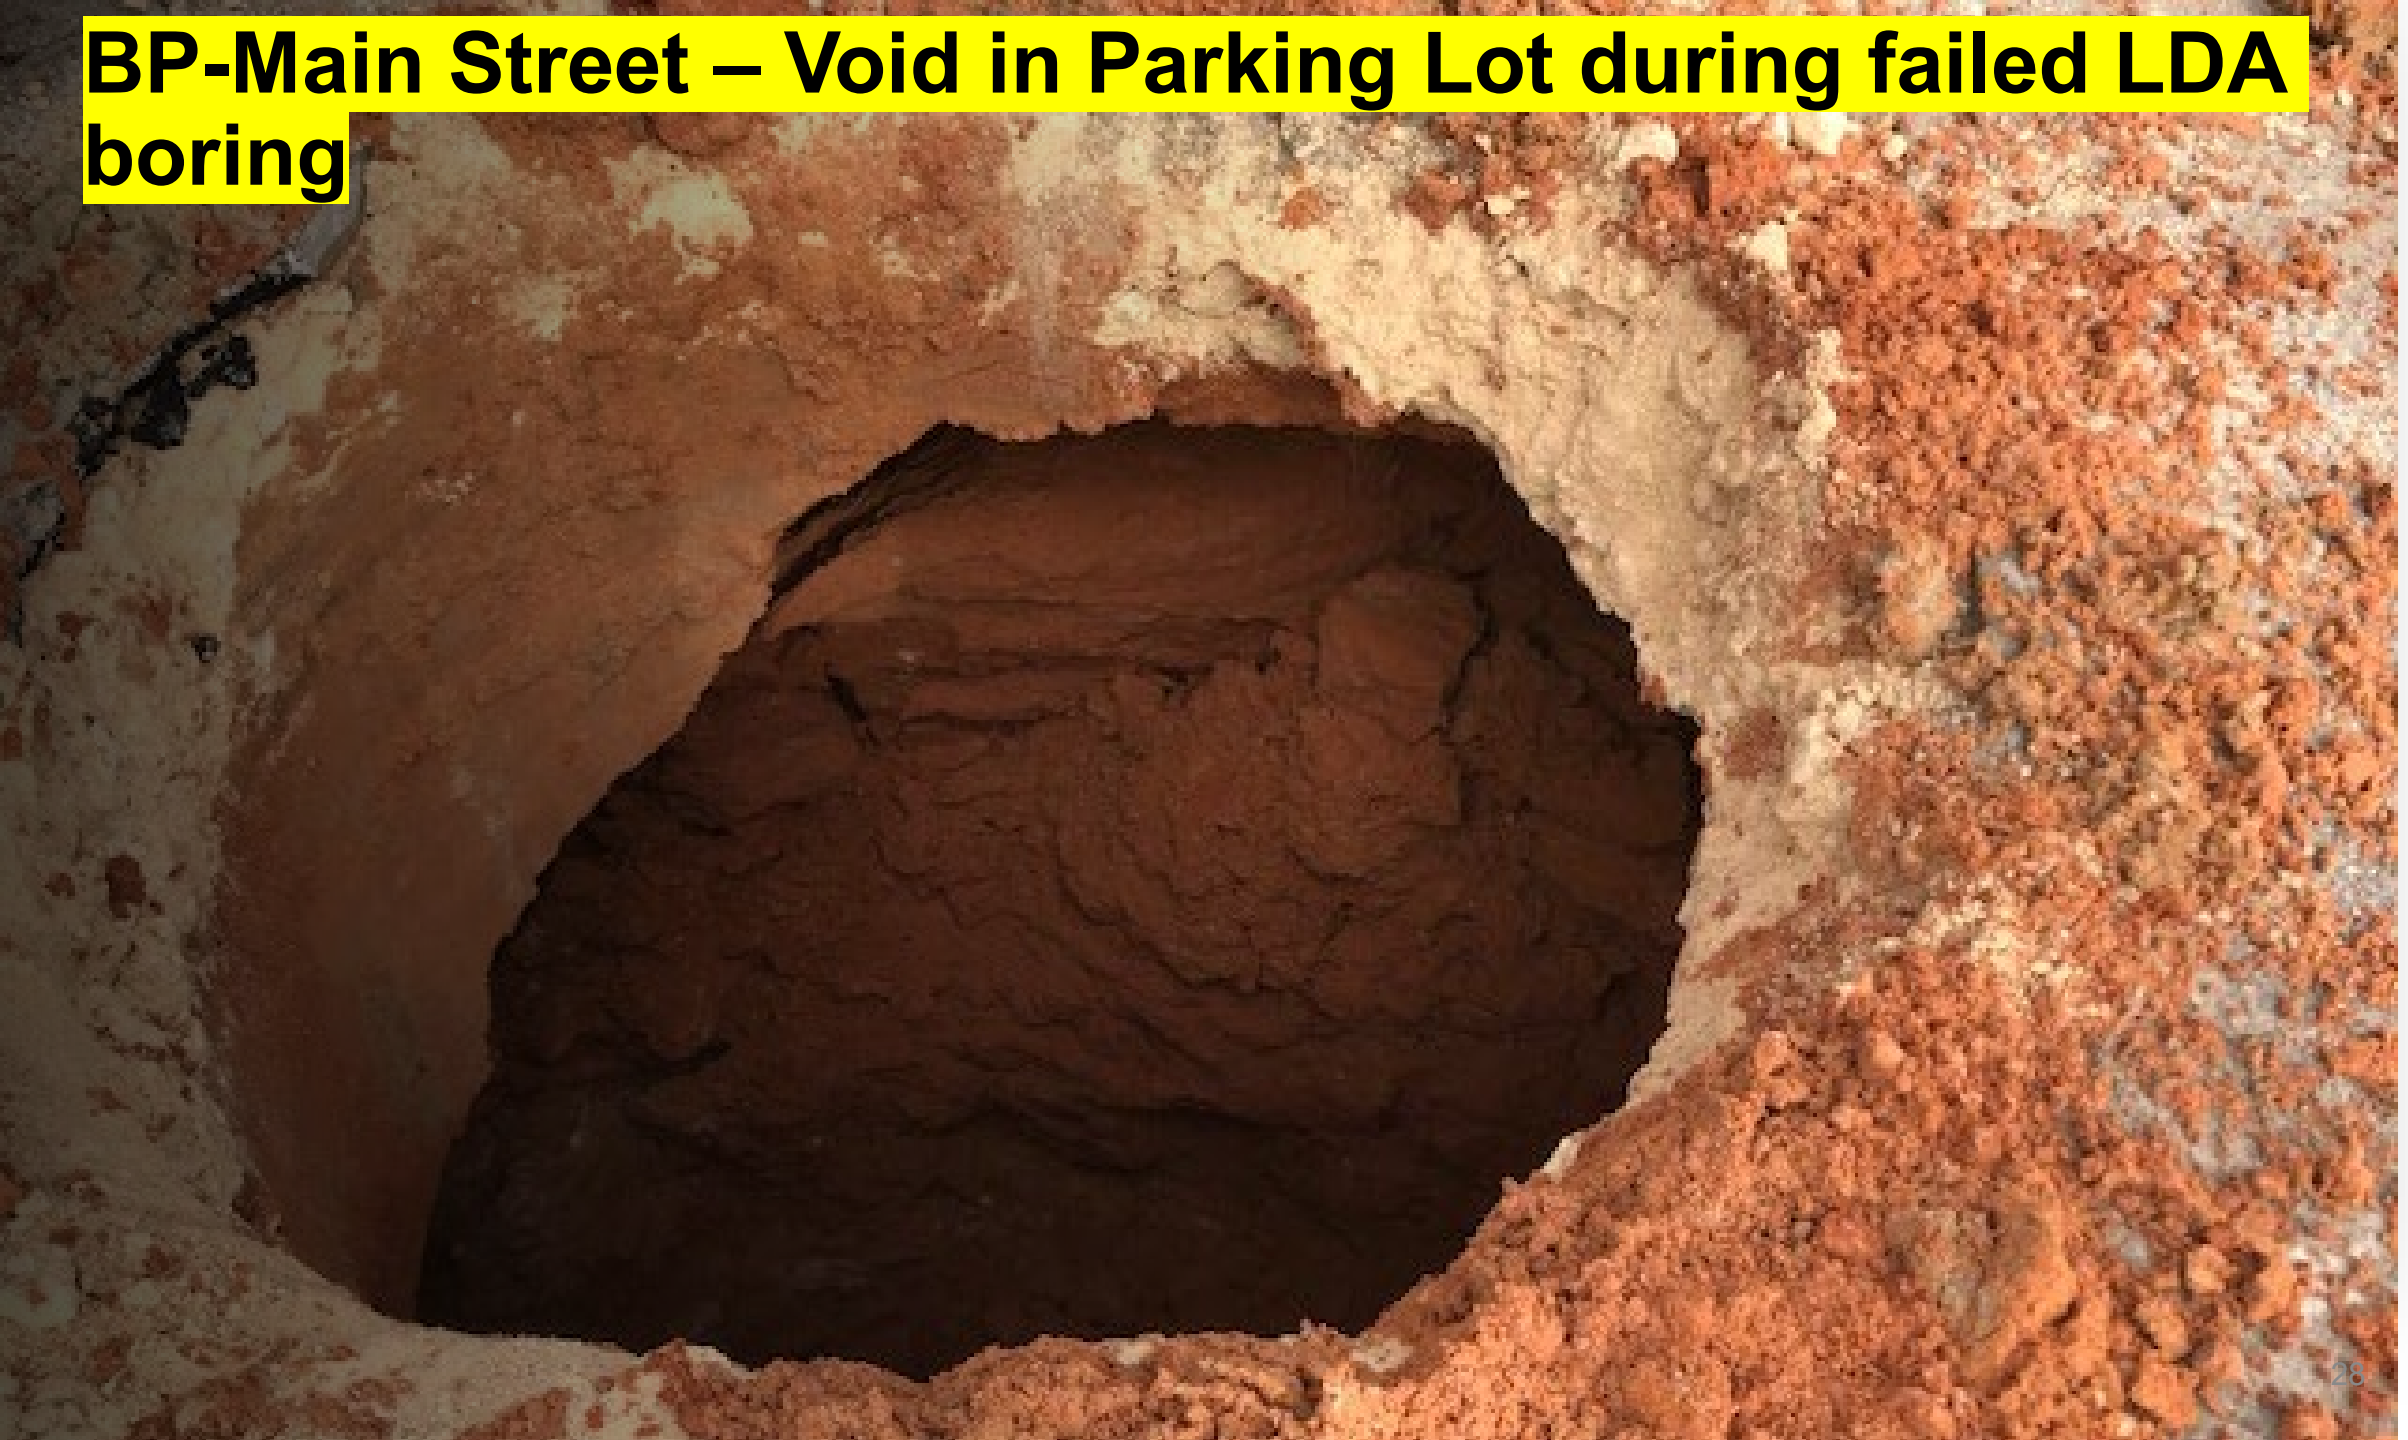
BP-Main Street – Void in Parking Lot during failed LDA boring

A Pilot Test Plan was approved in 2018 to evaluate the effectiveness of dual phase extraction from discrete depth intervals at the BP-Main Street site. Three depth intervals were to be investigated following the installation of three nested wells inside a three-foot diameter borehole advanced to the top of the Limestone via LDA. During LDA borehole advancement, a large void was observed after having advanced the LDA borehole less than 12-feet bls. Flowable fill was used to fill the void. No determination was made regarding the origin of the void.

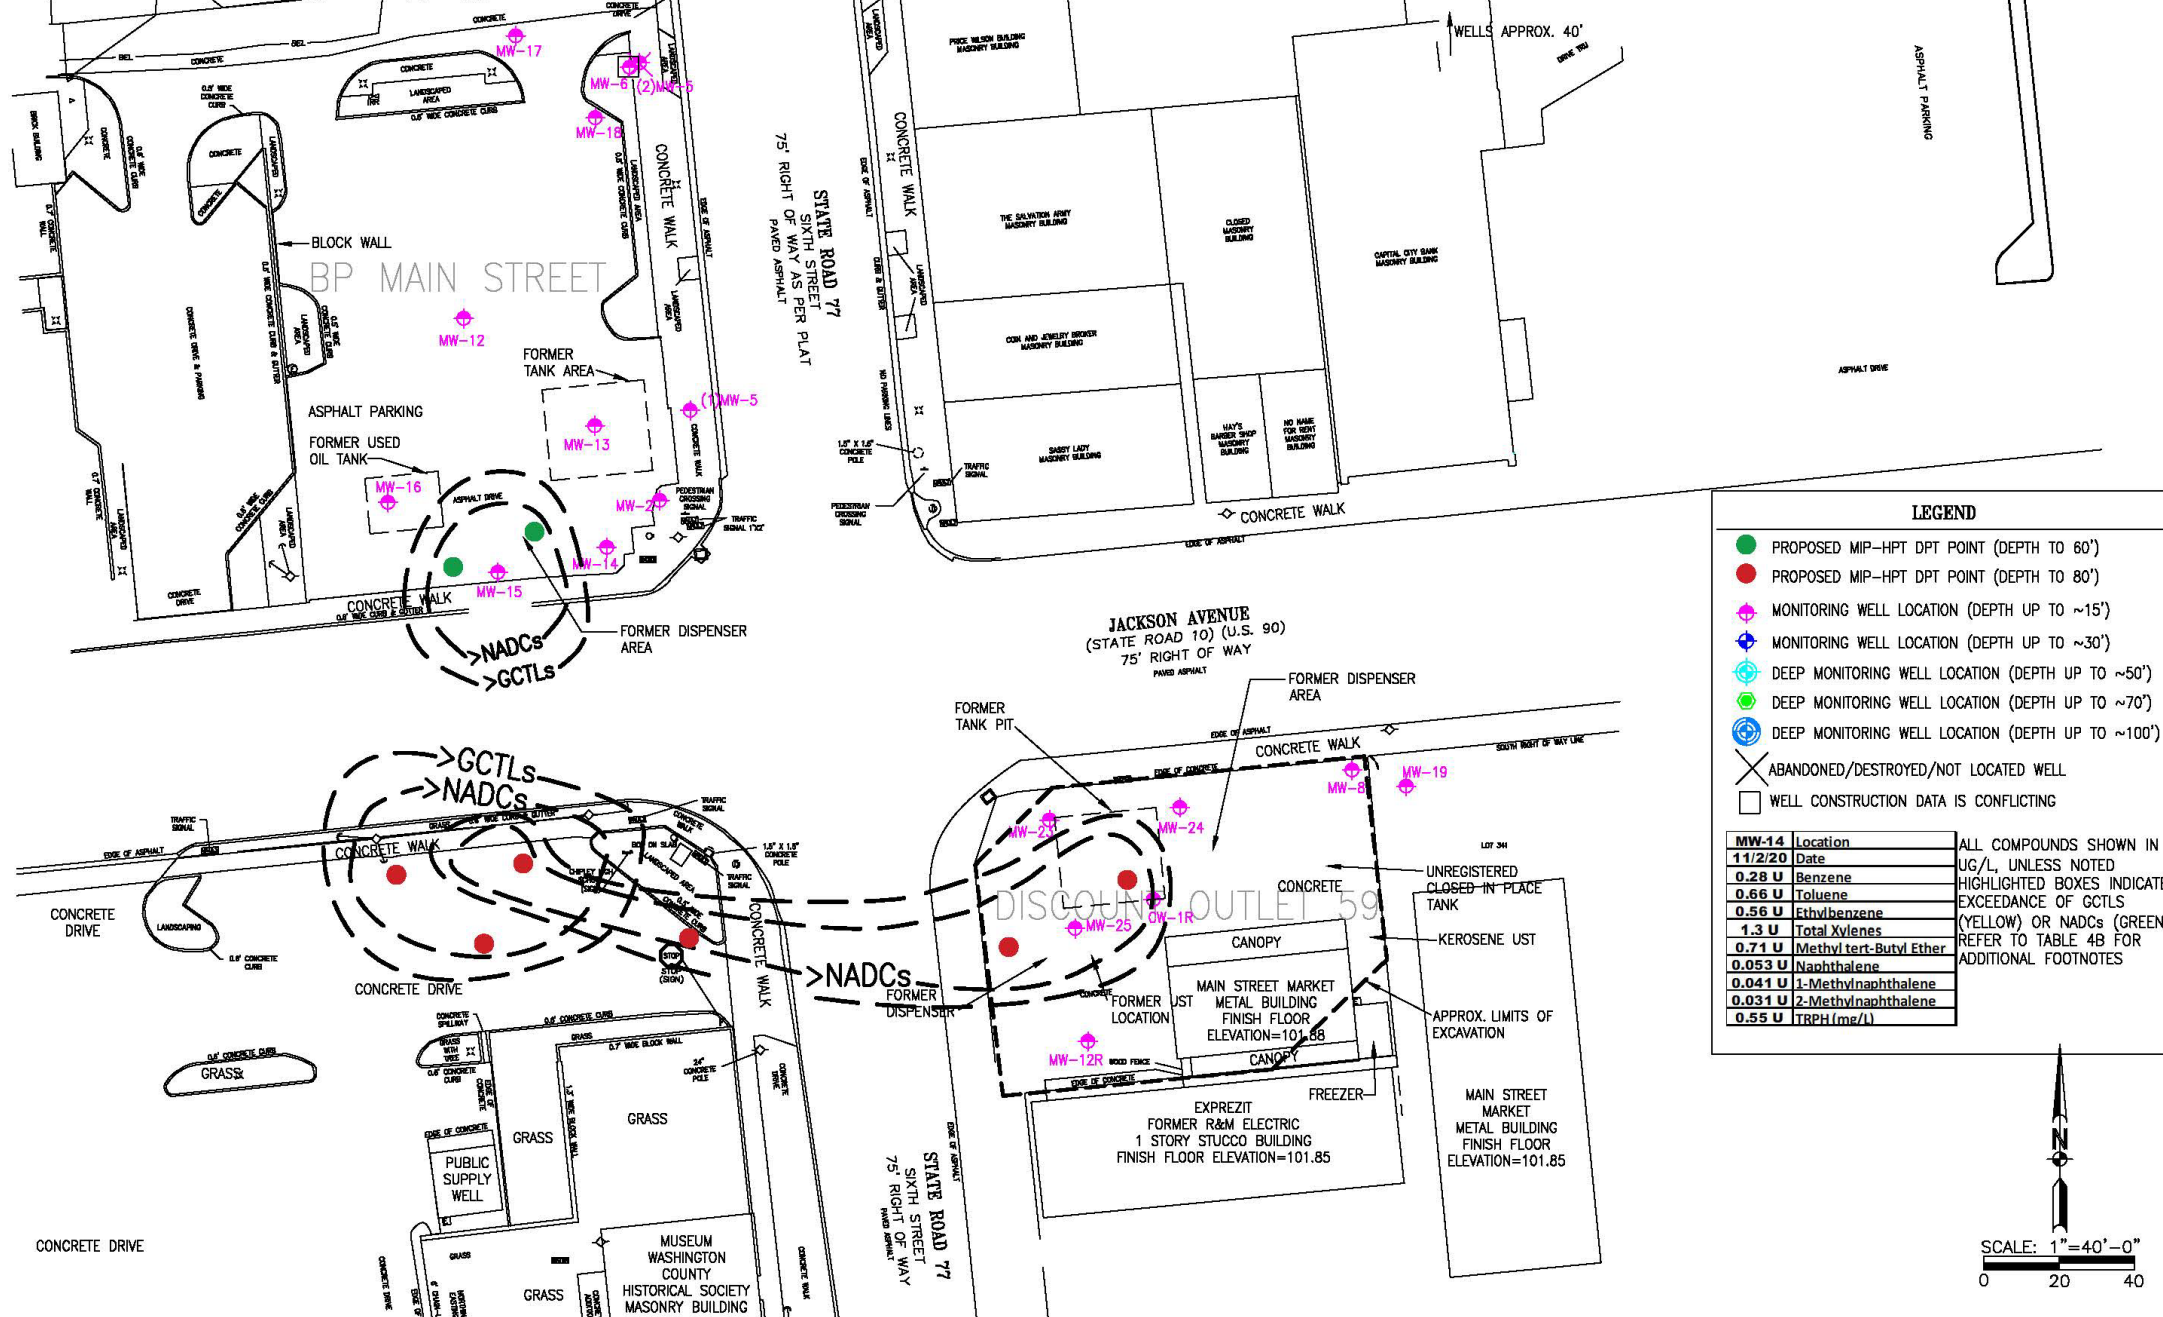
FIGURE 5 - PROPOSED DPT POINTS USING MIP-HPT

A DPT Membrane Interface Probe (MIP)/Hydraulic Profiling Tool (HPT) equipped with Photo Ionization Detector (PID) and Electrical Conductivity Dipole (ECD) were advanced to the Limestone at several locations on the BP-Main Street site, the adjacent offsite property to the south (the former location of the Public Supply Well) and at the Discount Outlet 59 from Exprezit #759 site.

- Two borings to 60-feet bls at BP-Main Street site. (MIP-1, MIP-2)
- Four borings to 80-feet bls at the City of Chipley property to the south of BP-Main Street. (MIP-3, MIP-4, MIP-5, MIP-6)
- Two borings to 80-feet bls at Discount Outlet 59 from Exprezit #759. (MIP-7, MIP-8)

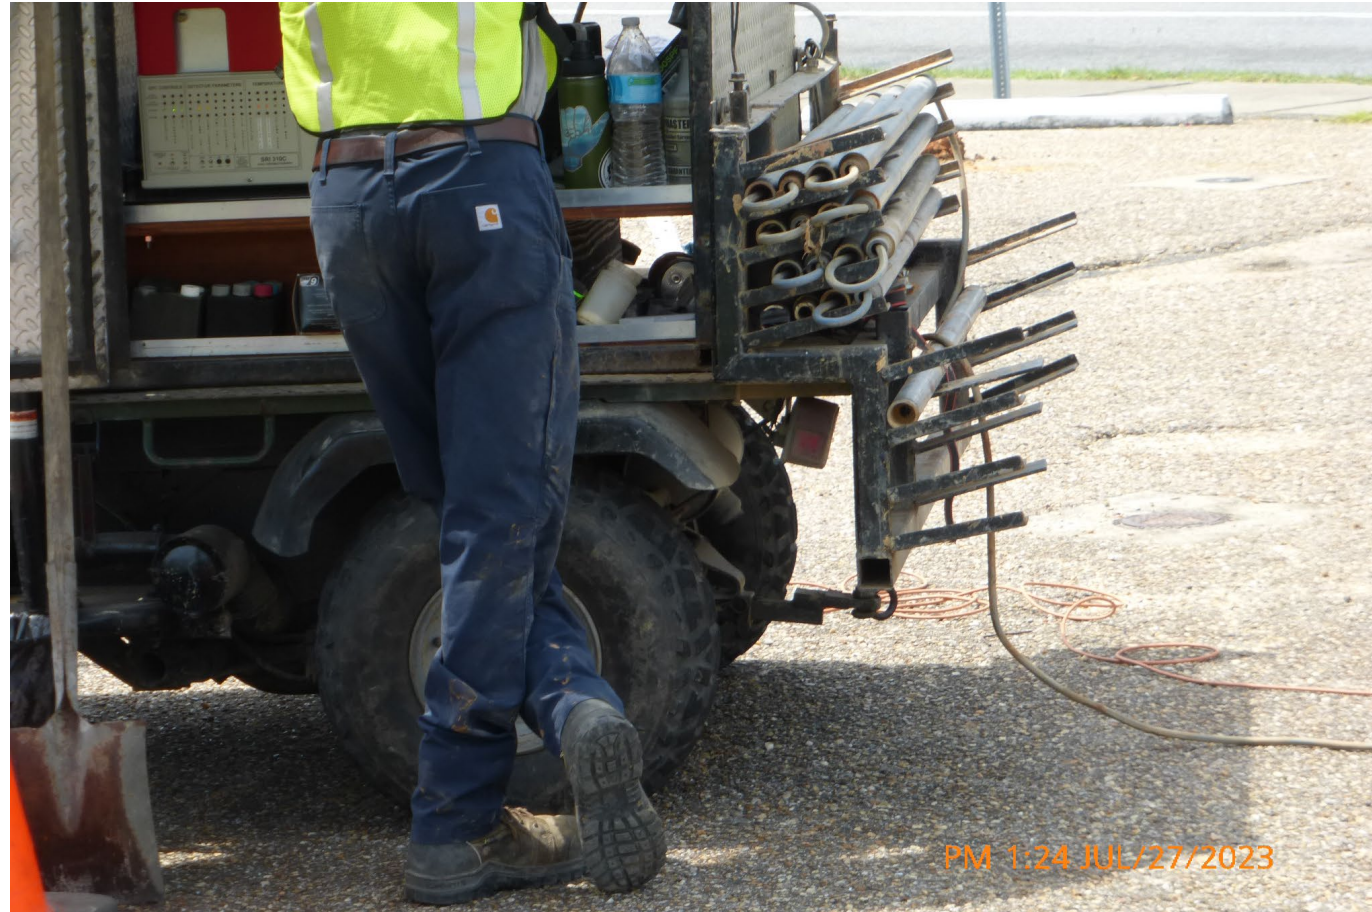
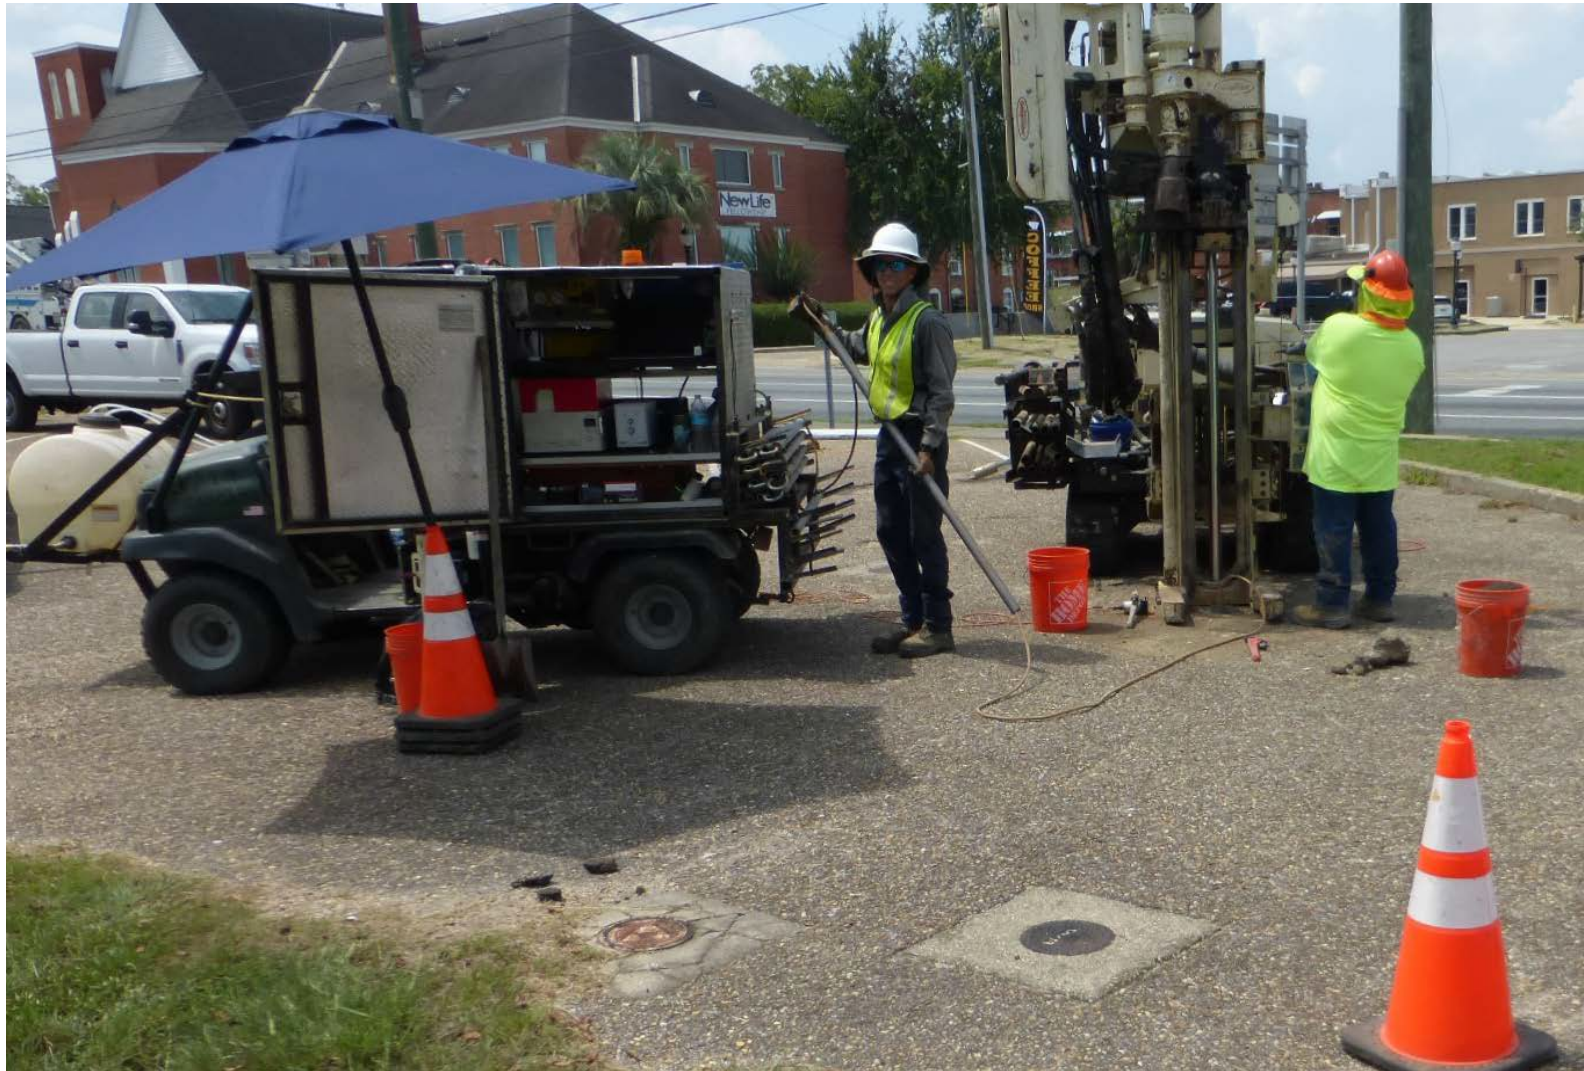
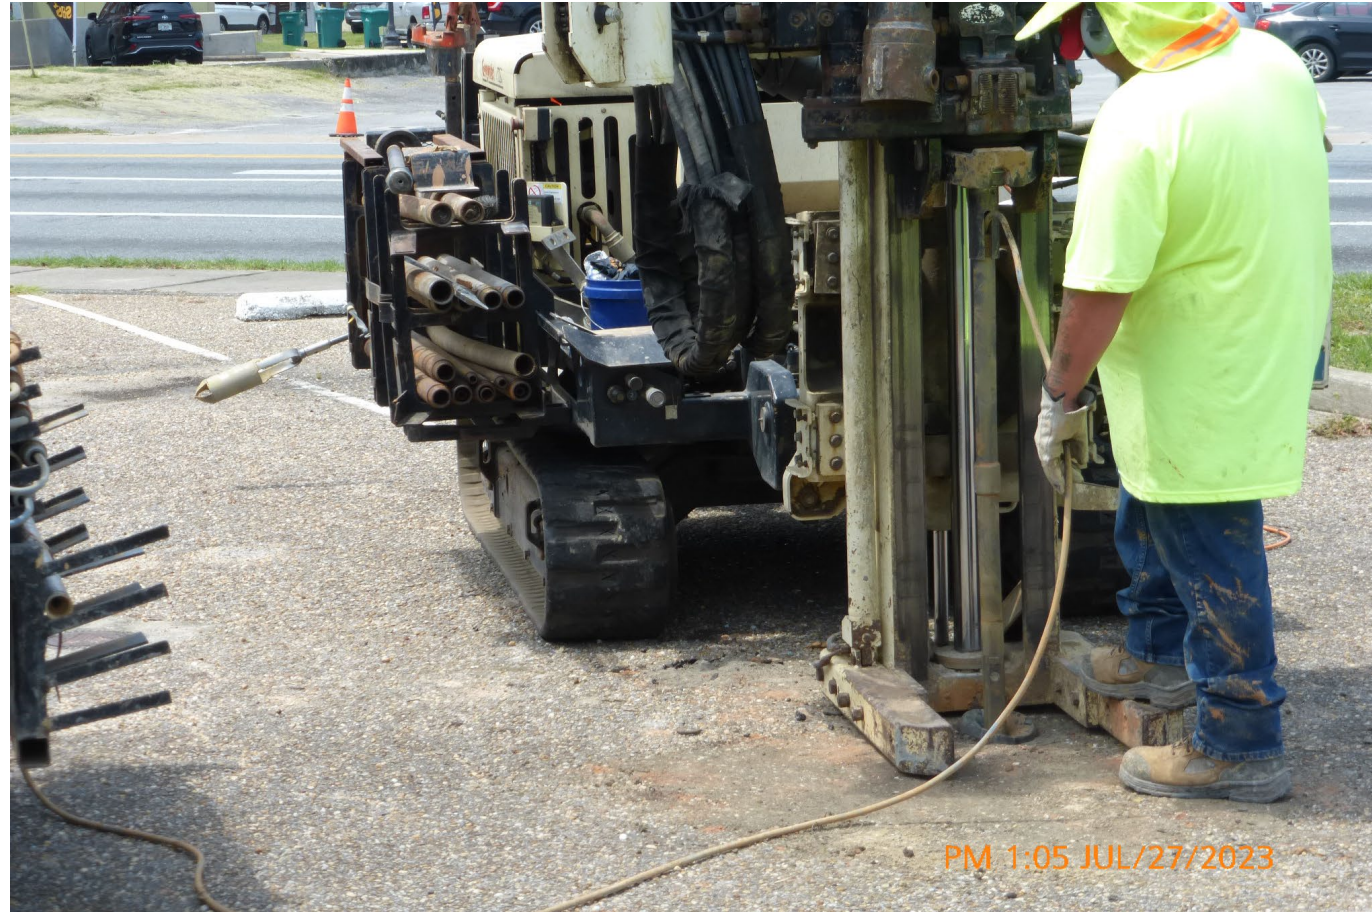
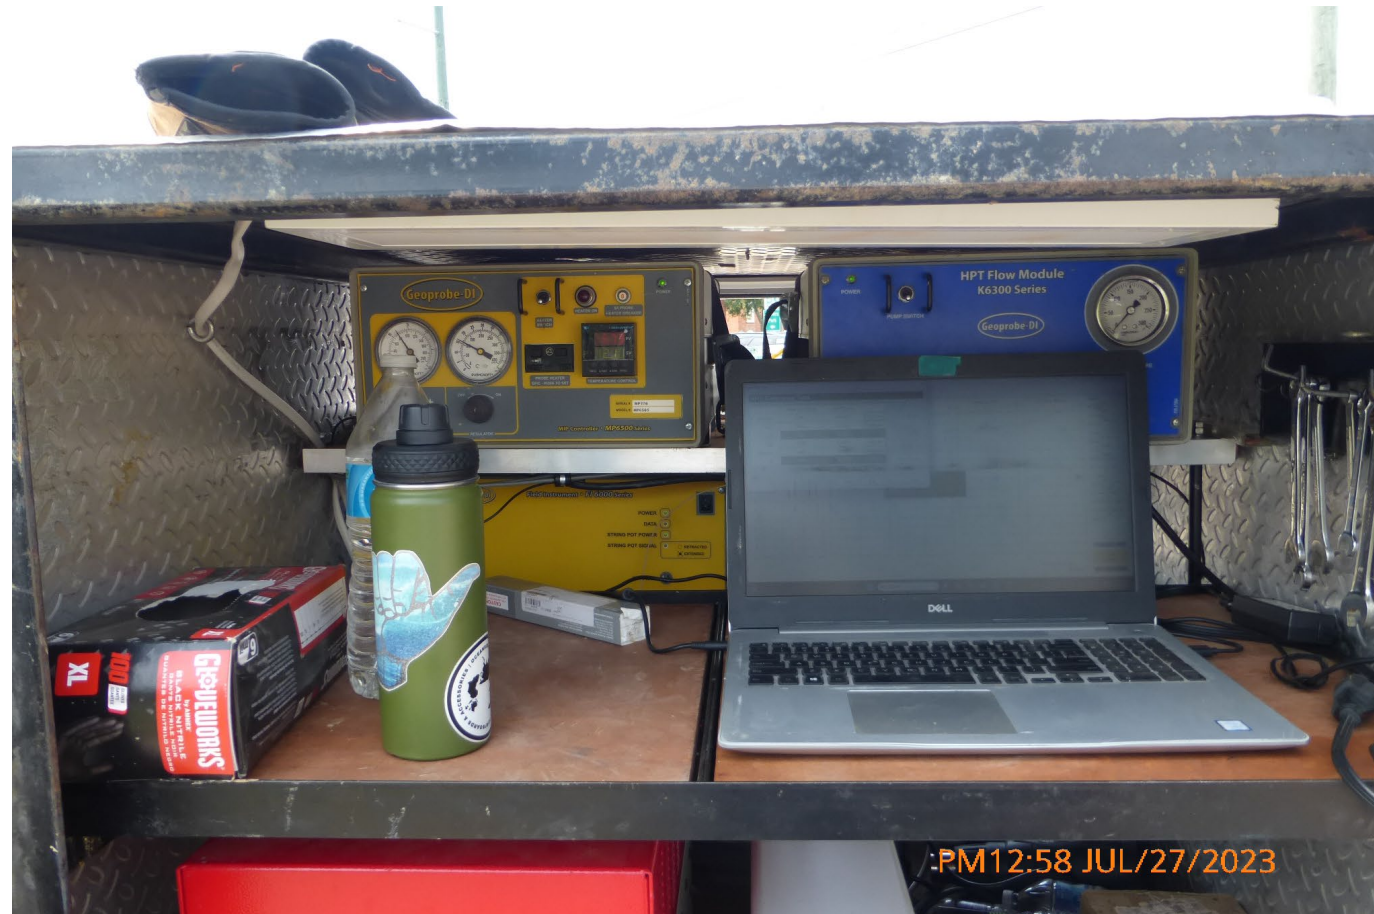
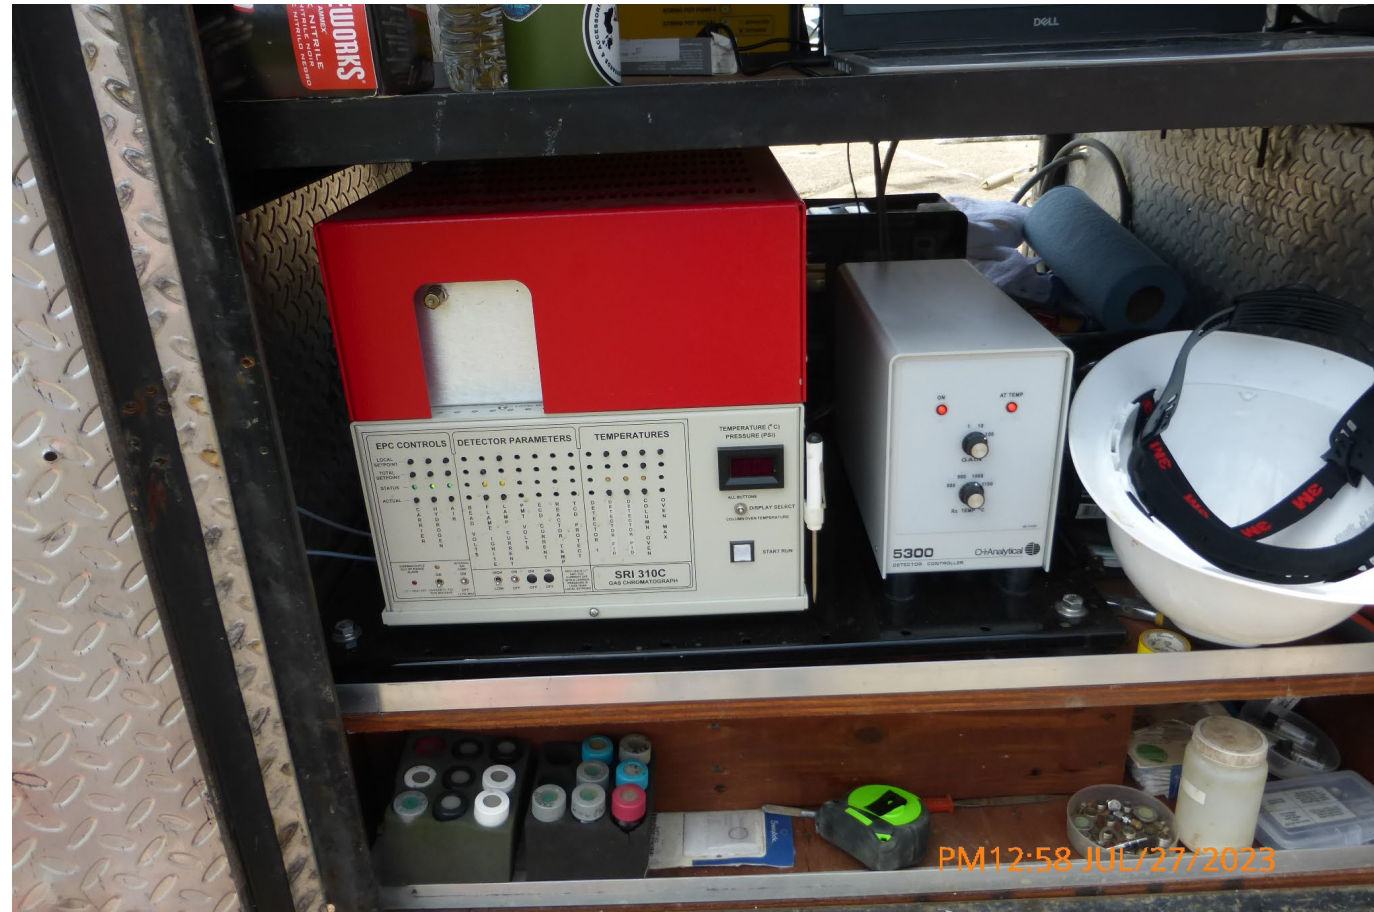
BP-Main Street : MIP/HPT Tooling & Instrumentation
