RE: Topsail Hill Preserve State Park – Lease No. 3967

Topsail Hill Preserve State Park

Location: Walton County

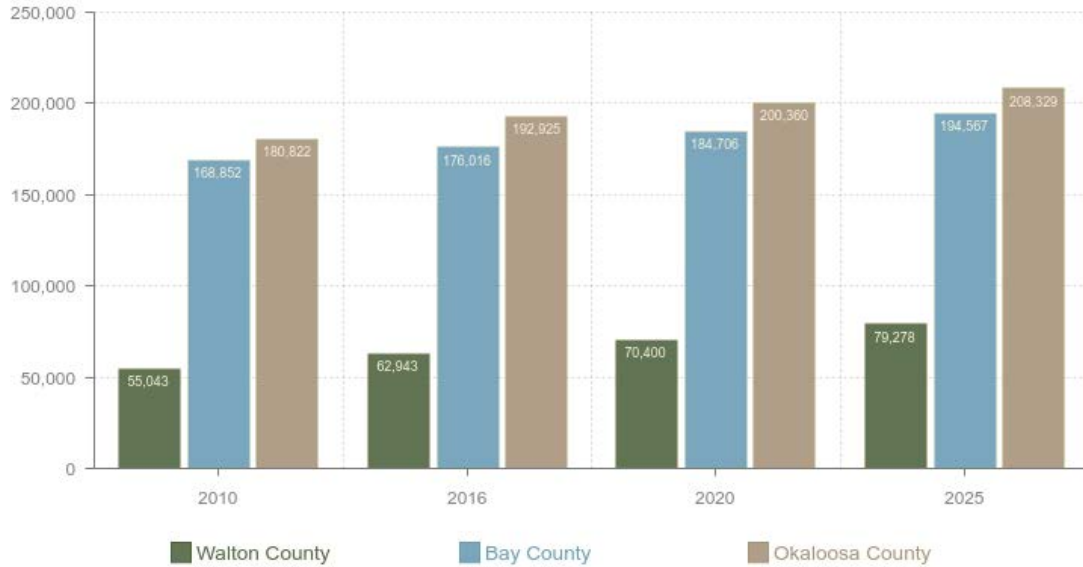
Above: Figure 1. Walton, Bay, and Okaloosa County Population Projections. *census.gov*.

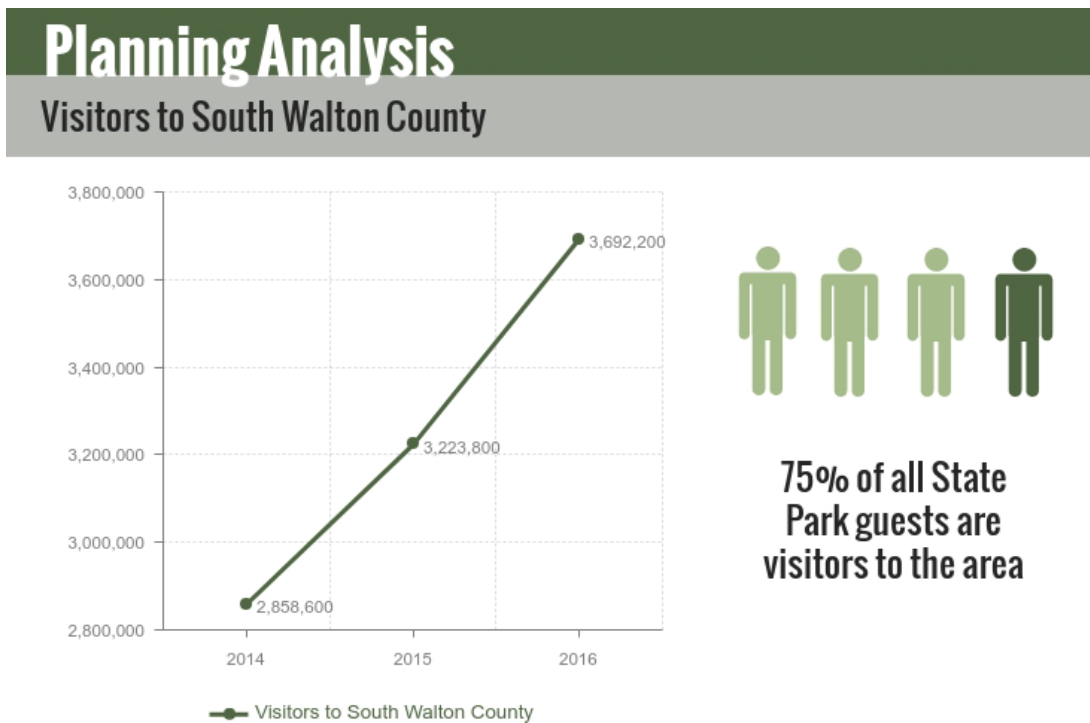
Above: Figure 2. Visitors to South Walton County. Walton County Tourist Development Council.

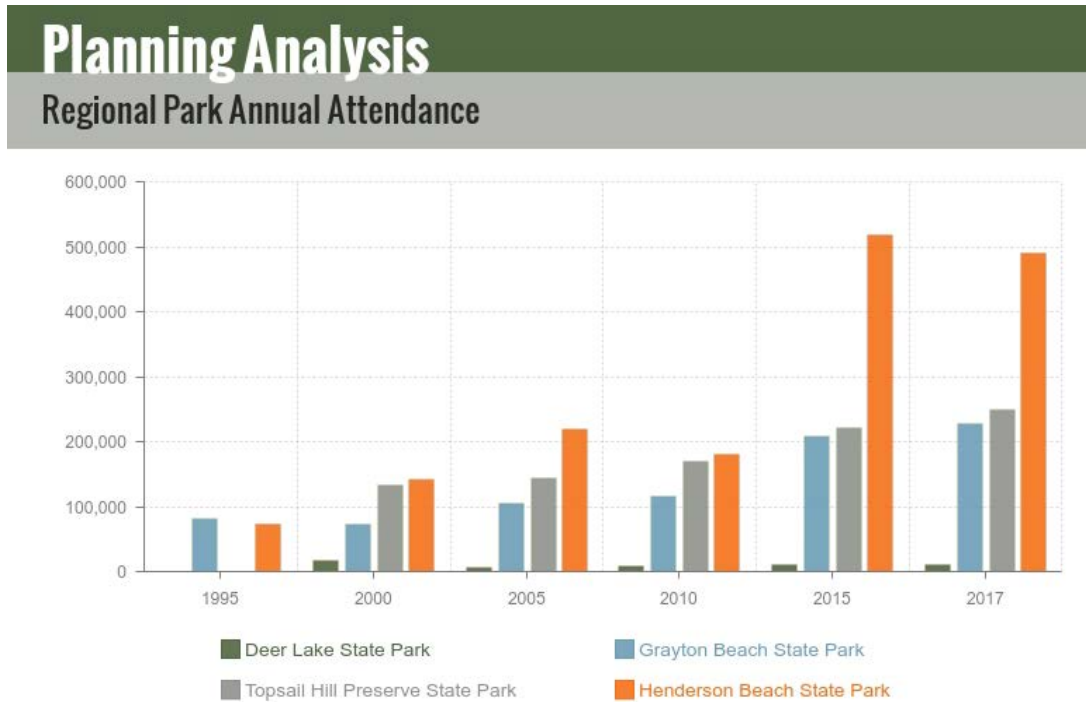
Above: Figure 3. Regional Park Annual Attendance. 2017 DRP.
