Big Carlos Pass Inlet Management Plan

Office of Resilience and Coastal Protection

Florida Department of Environmental Protection

October 2024

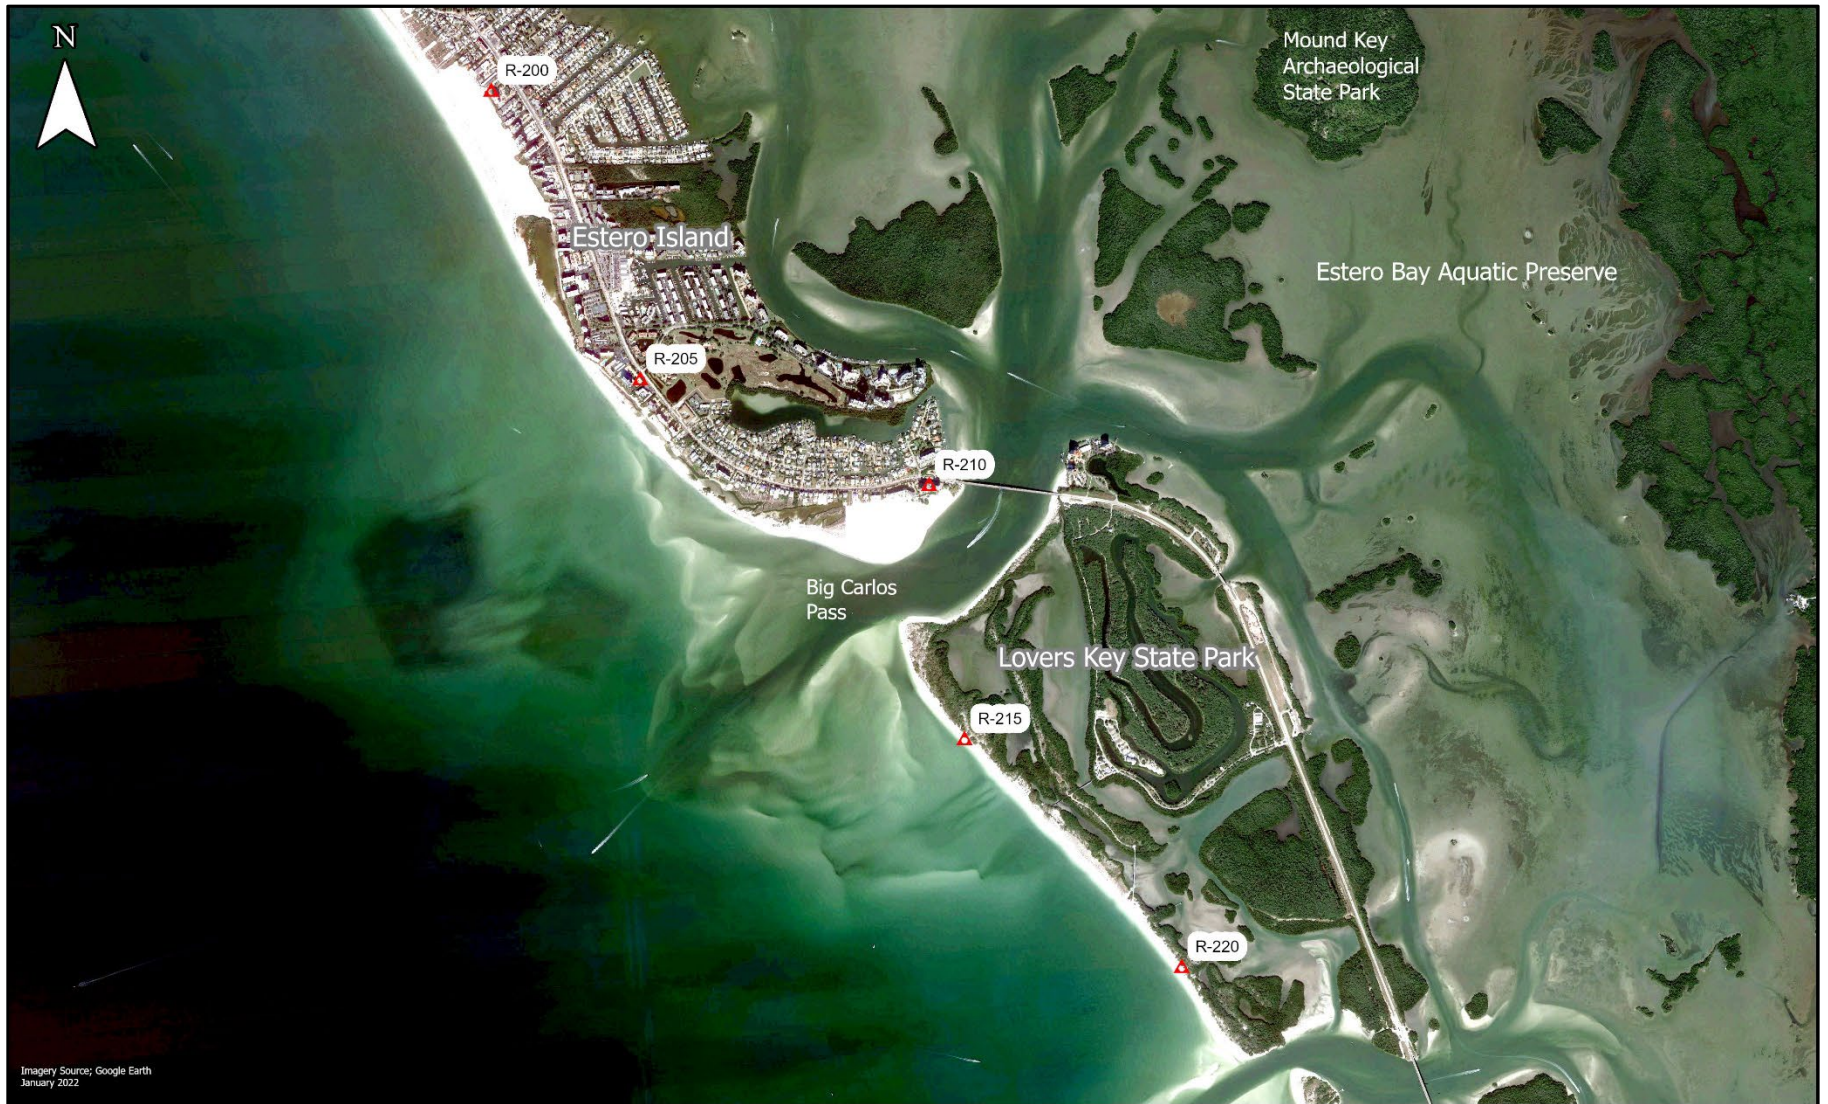
Figure 2. Google Earth aerial image of Big Carlos Pass from January 2022, before Hurricane Ian made landfall.

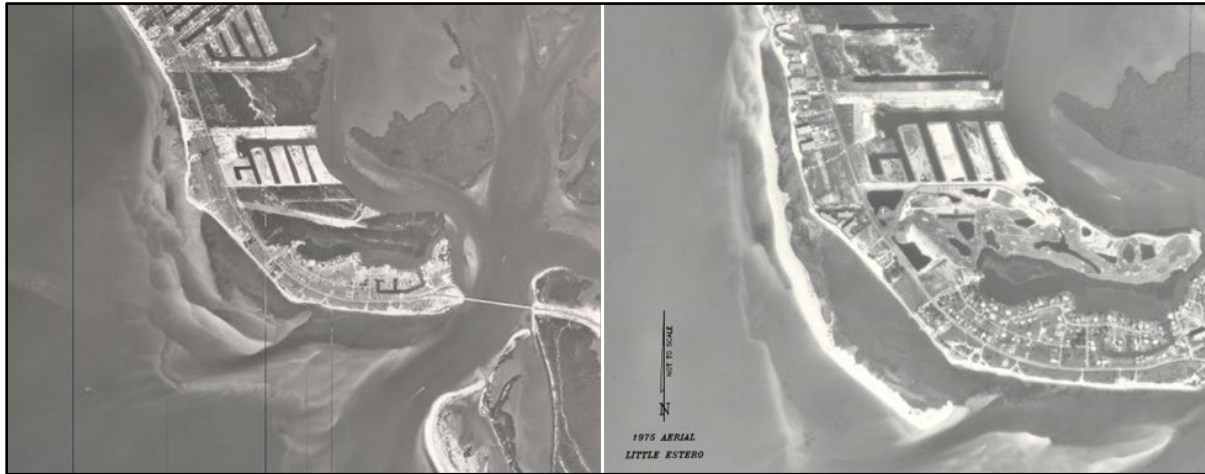
Figure 3. Estero Island and Big Carlos Pass in 1968 (left photo) and Little Estero Island completely emerged in 1975 (right photo).

the Big Carlos Pass ebb shoal and its migration and attachments to the southern two miles of Estero Island. The 1968 aerial shows numerous submerged shoals exist as part of the ebb tidal delta of Big Carlos Pass in the Gulf of Mexico. By 1975, Little Estero Island had completely emerged as an island off southern Estero Island (**Figure 3**).

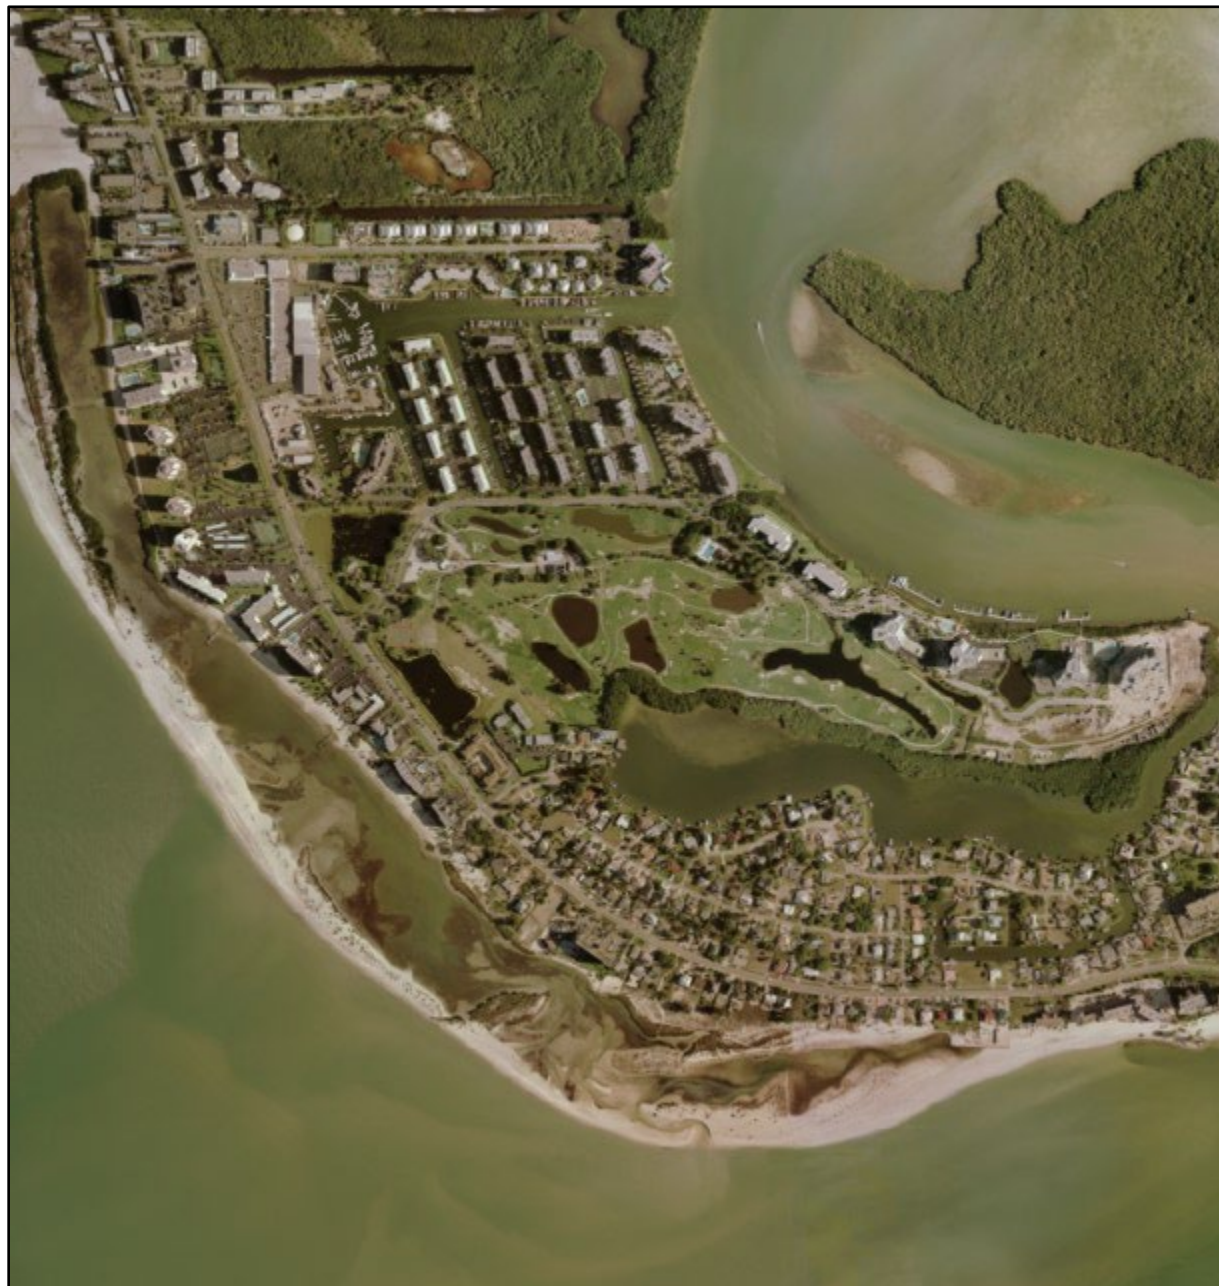
Figure 4. Aerial photo (2002) showing the southeastern attachment of Little Estero Island to Estero Island at Big Carlos Pass (from Clark, 2022).

A subtropical storm in June 1982, called the No Name Storm, caused substantial erosion to the beaches adjacent to Big Carlos Pass. The southern half of Little Estero Island disintegrated above the tide levels by erosion and remained existant as a swash bar only exposed at low tide. Emergence of a nearshore sand bar and southward longshore transport resulted in the natural restoration of Little Estero Island and spit growth continued southward resulting in multiple attachments with Estero Island. Aerial photography in 2002 shows Little Estero Island's final attachment on the Big Carlos Pass shoreline near or to the east of R209 (**Figure 4**).

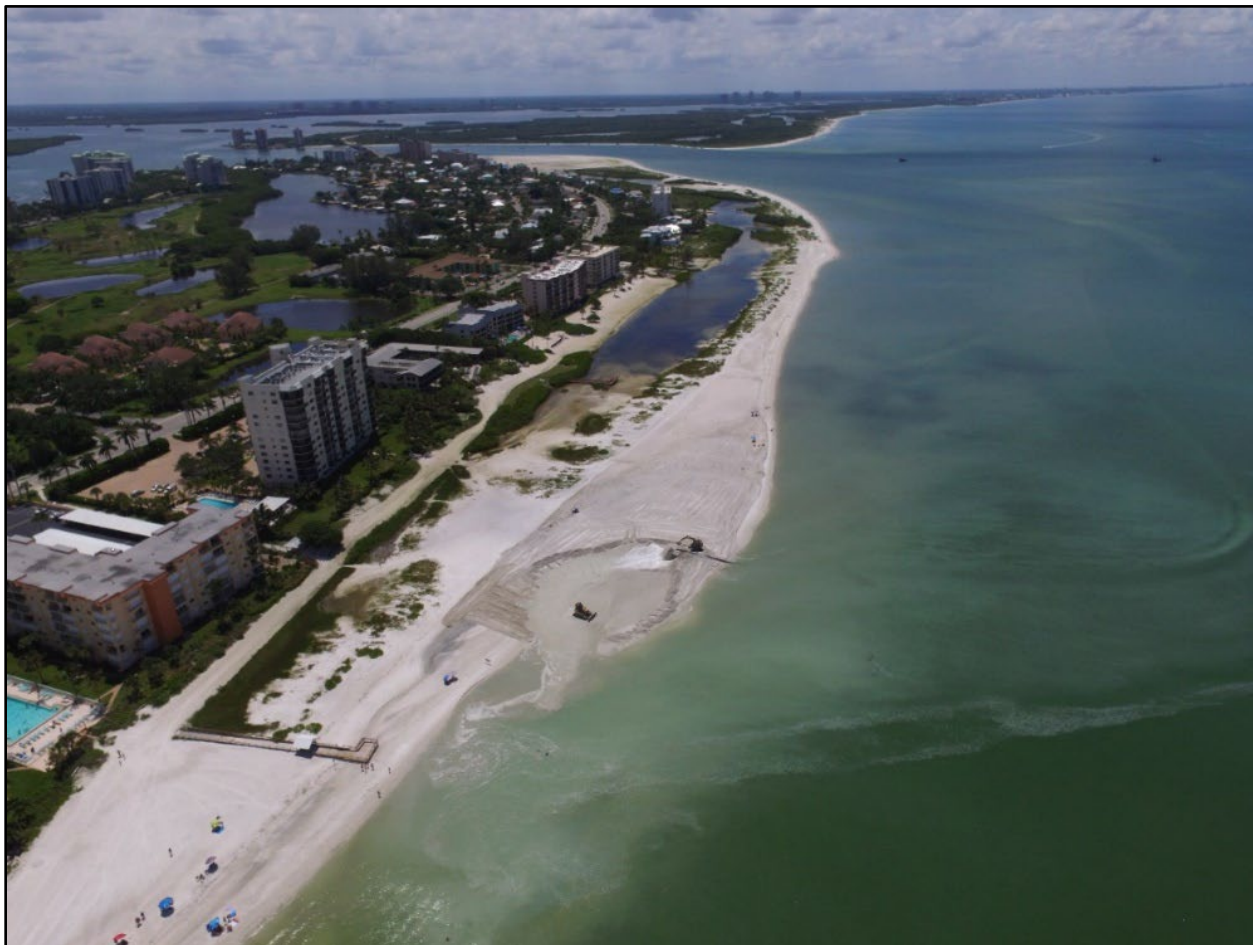
Figure 5. The 2017 fill placement at R-204 during Big Carlos Pass channel maintenance project (photo provided by Humiston & Moore, Inc.).

shoal borrow areas and south Estero Island was nourished in 2017 from the inlet channel maintenance project that placed 55,465 cubic yards of material between R203.5 and R205.2 (**Figure 5**).

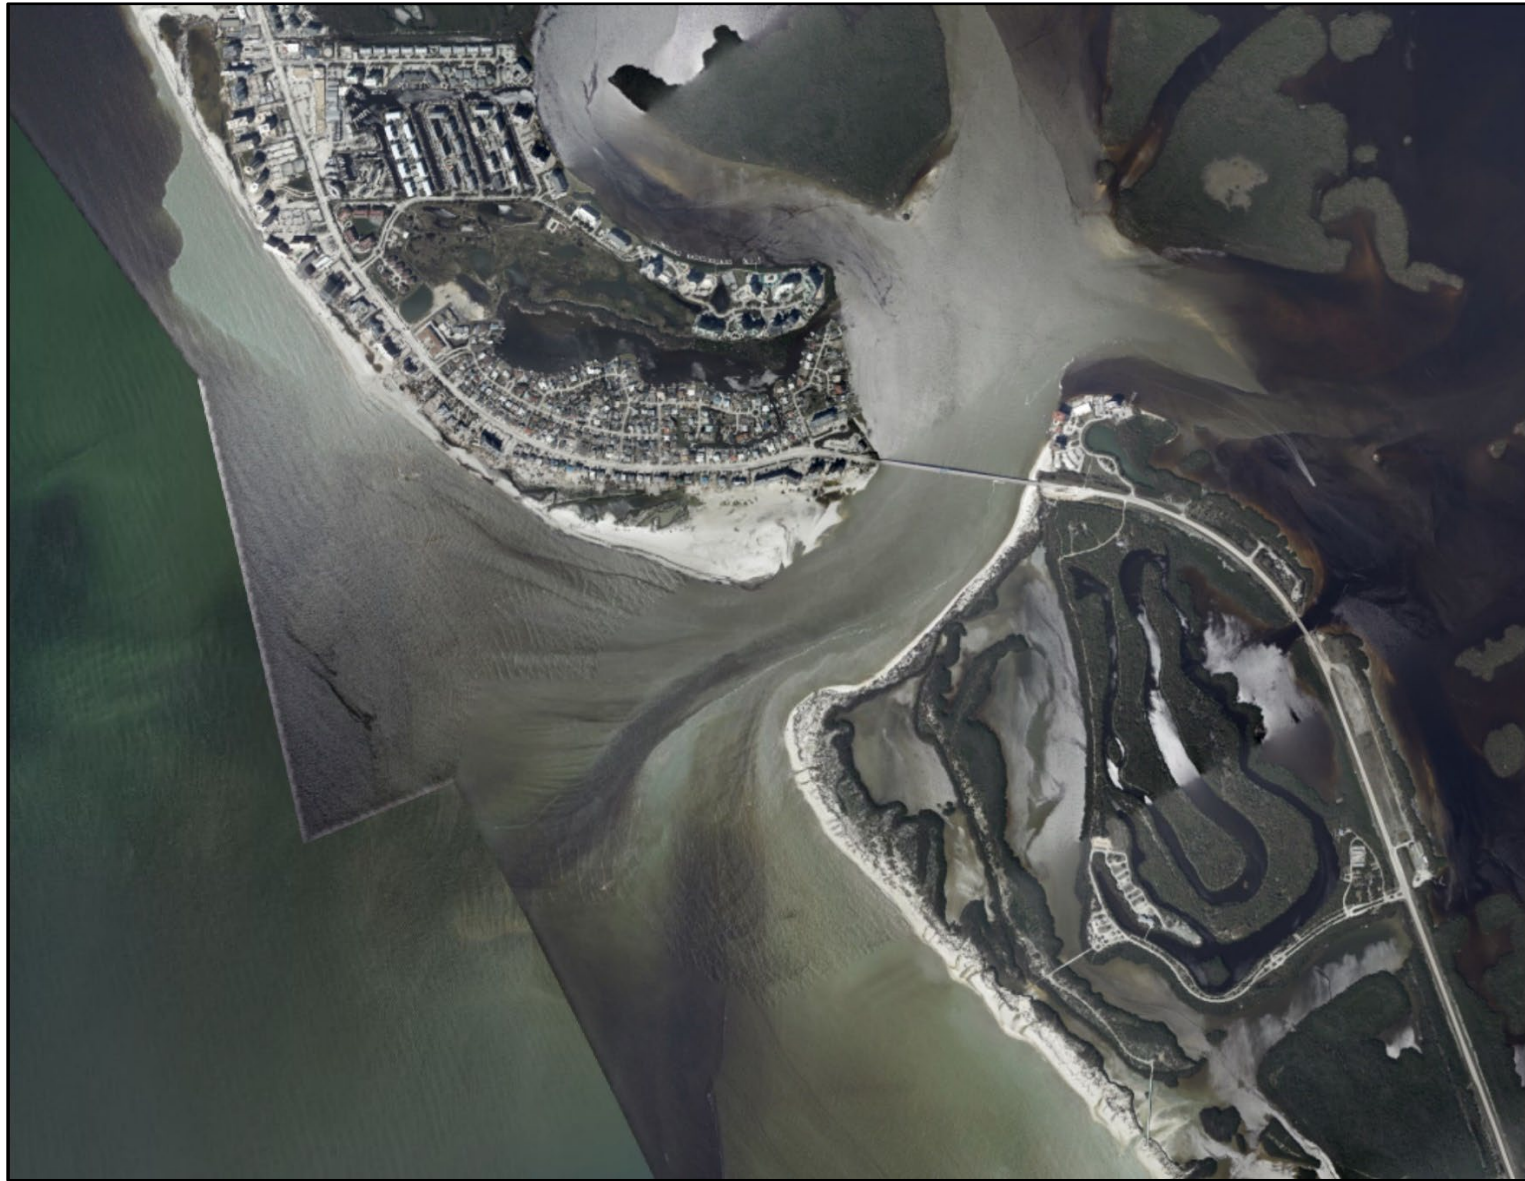
Figure 6. Big Carlos Pass and adjacent beaches on Sept. 30, 2022. Image is post Hurricane Ian's landfall.

In September 2022, category 4 [Hurricane Ian](#) inflicted catastrophic damage and erosion to Lee County. Major morphological changes were incurred along the beaches adjacent to Big Carlos Pass (**Figure 6**).
